**CONSERVATION AND SEISMIC STRENGTHENING OF
ARCHITECTURAL HERITAGE**
BYZANTINE CHURCHES
OF THE NINTH TILL THE FOURTEENTH CENTURIES IN MACEDONIA

Dissertation submitted for DPhil Degree

Lazar Sumanov

York 1999

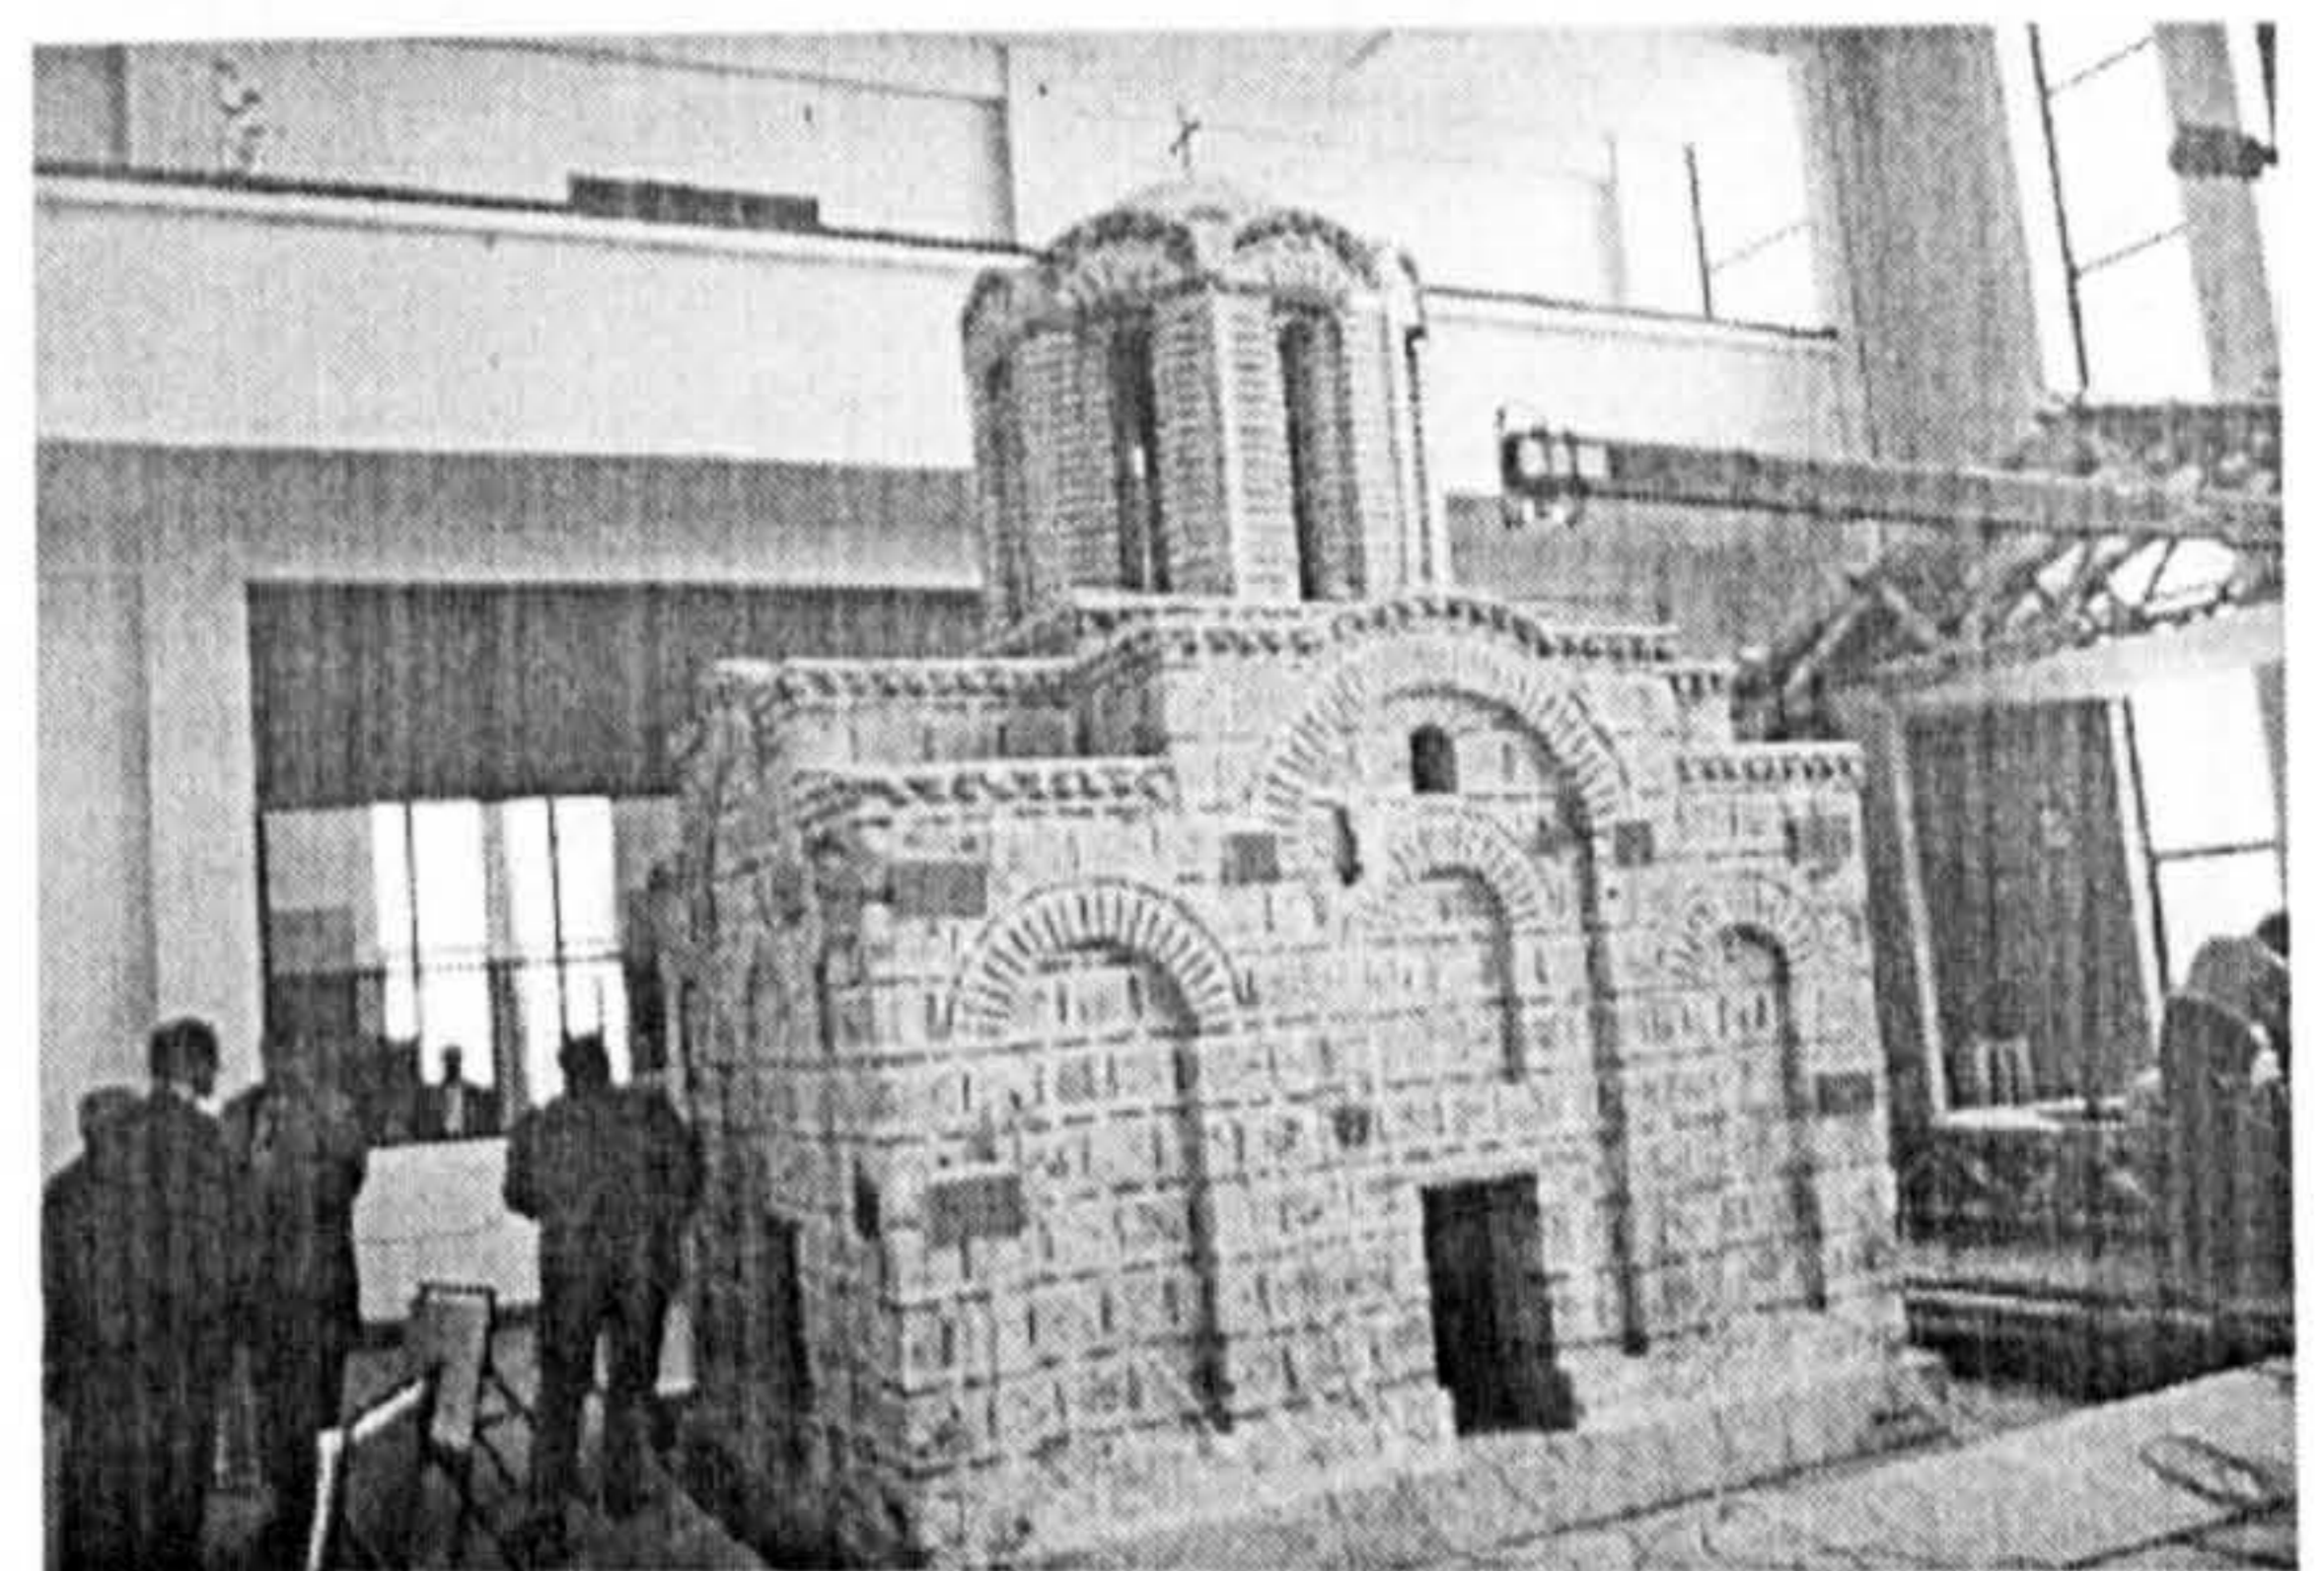
Figure 5.44 Completed repair and strengthening of damaged model.
 a) - East facade; b) - South and East facade; c) - North and West facade;
 d) - South and West facade.

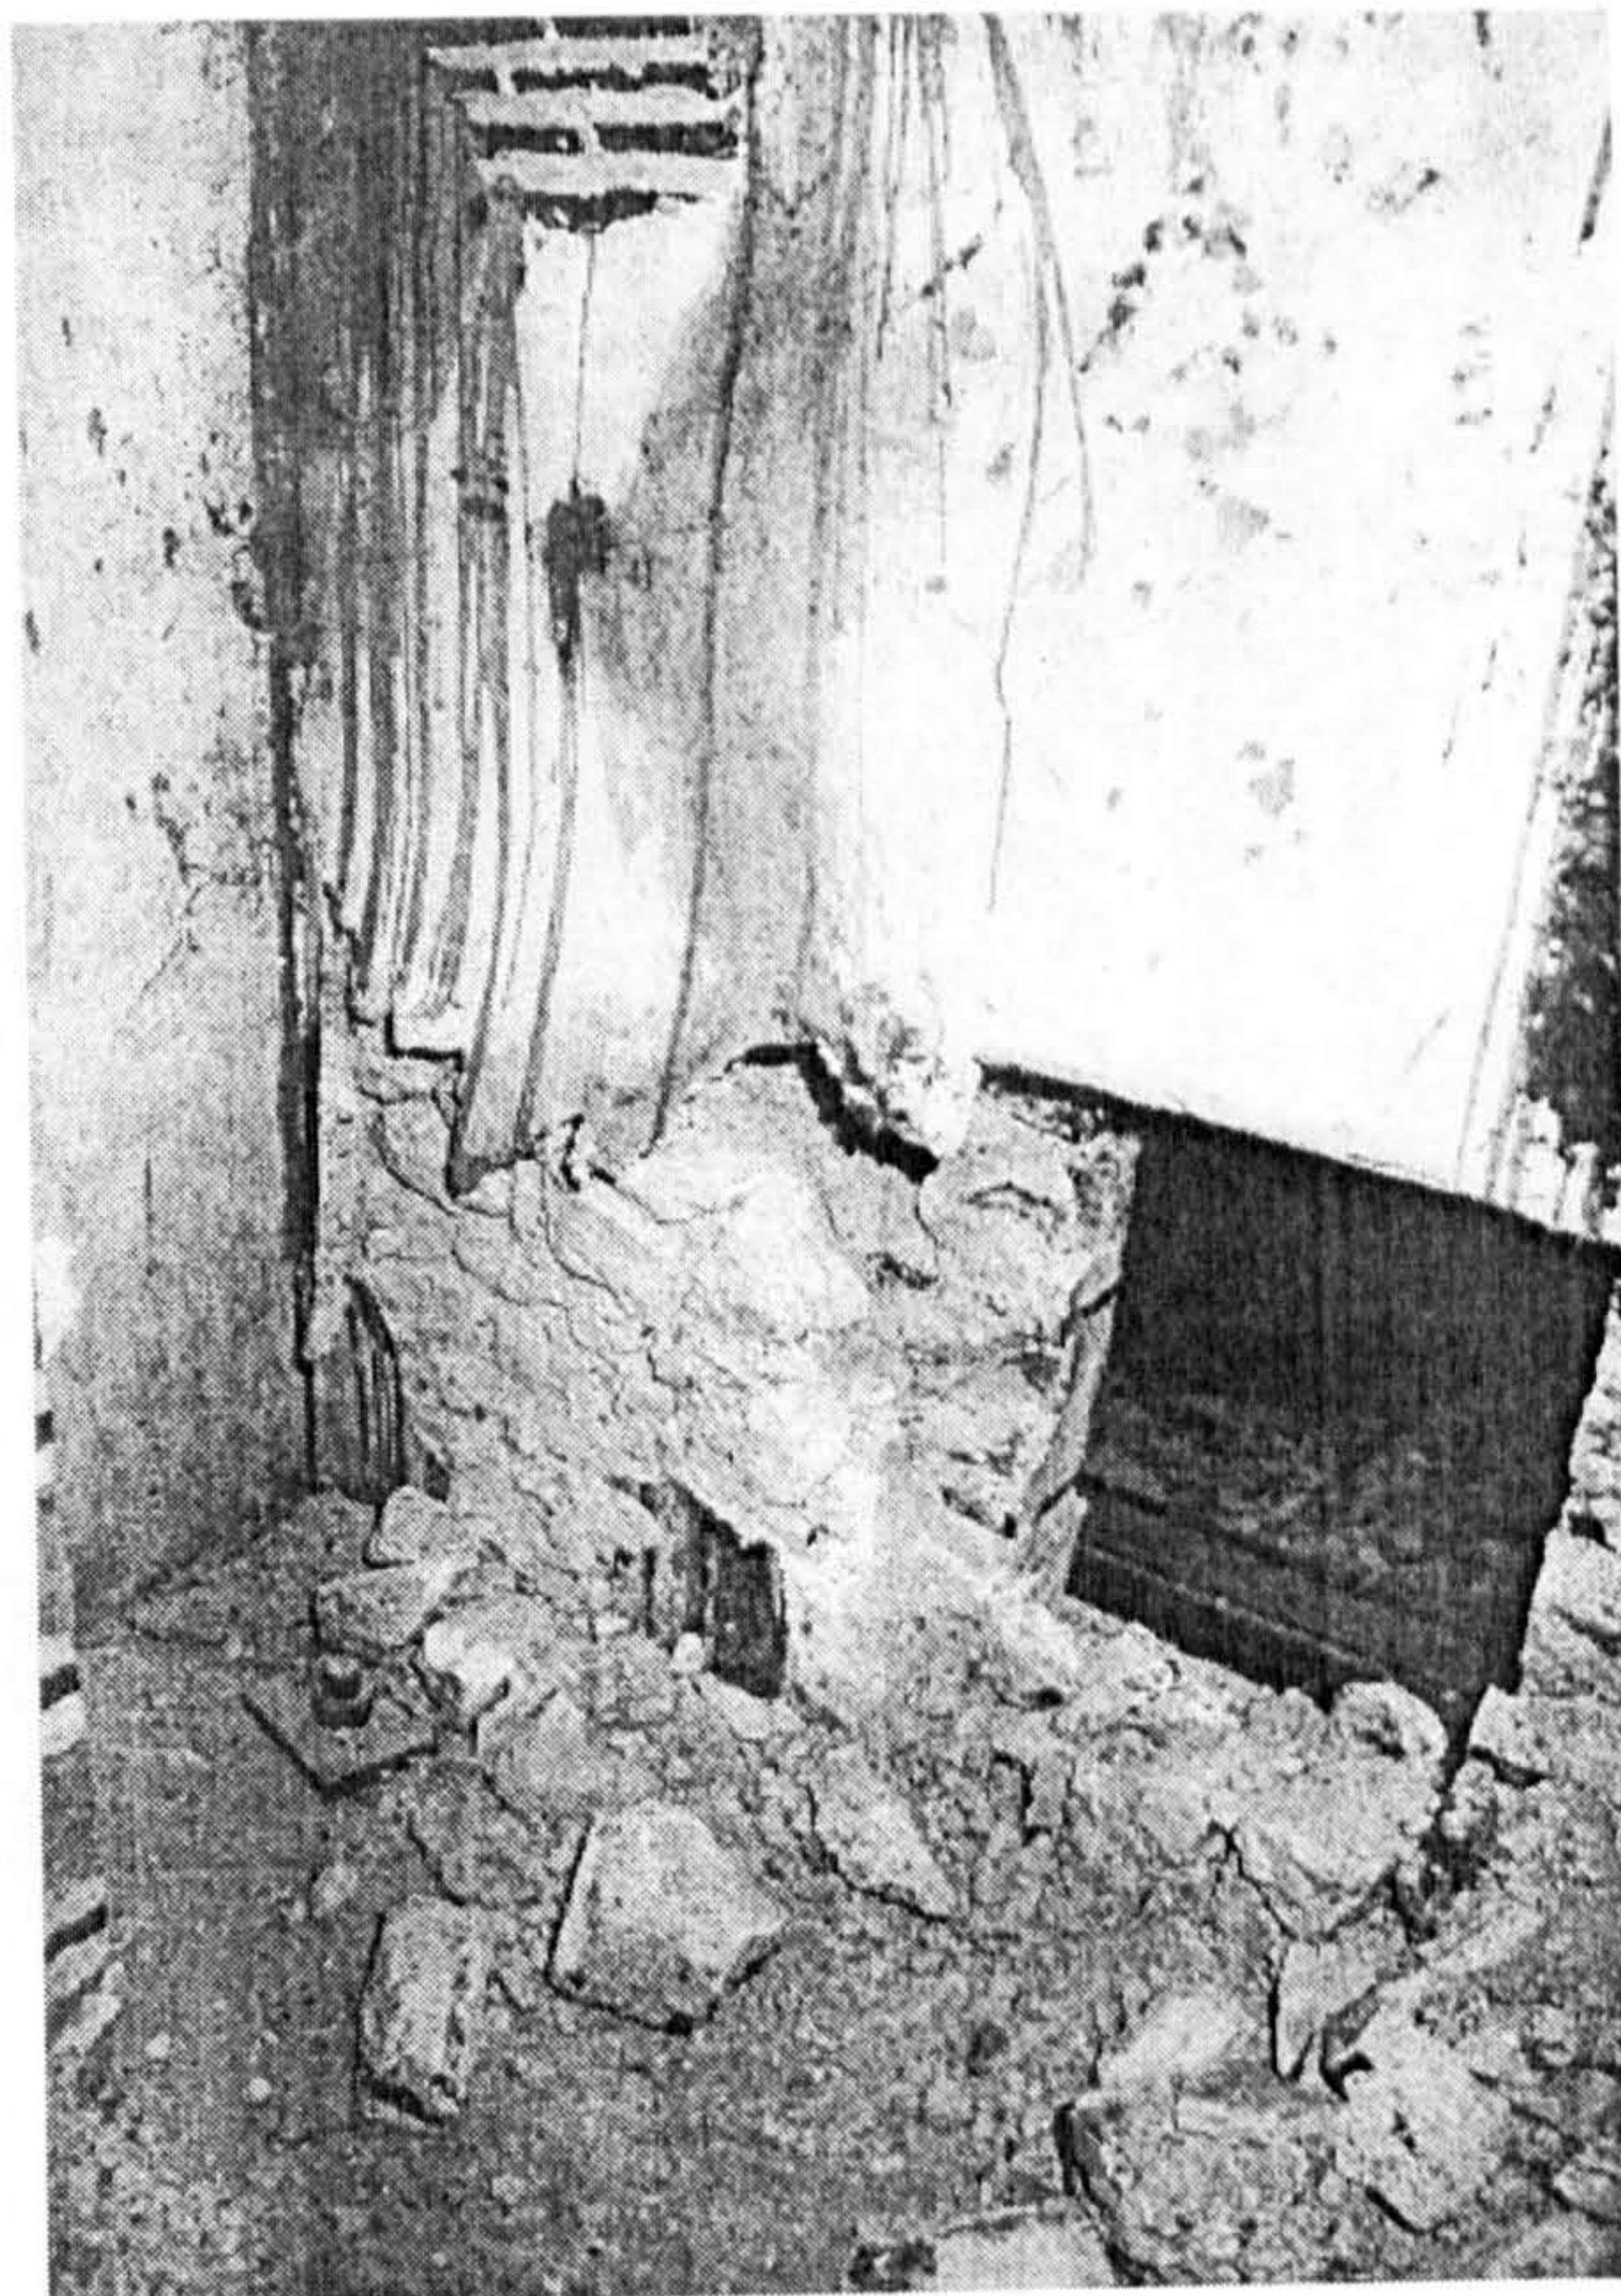
Figure 5.46 *Damage pattern of strengthened model after the final shaking table test.*
a) - Interior. Western wall; b) - Dome and vaults.
