ARCHAEOLOGY OF DESTRUCTION

A REINTERPRETATION OF CASTLE SLIGHTINGS IN THE ENGLISH CIVIL WAR

Thesis submitted for the degree of
Doctor of Philosophy
University of York
Department of Archaeology

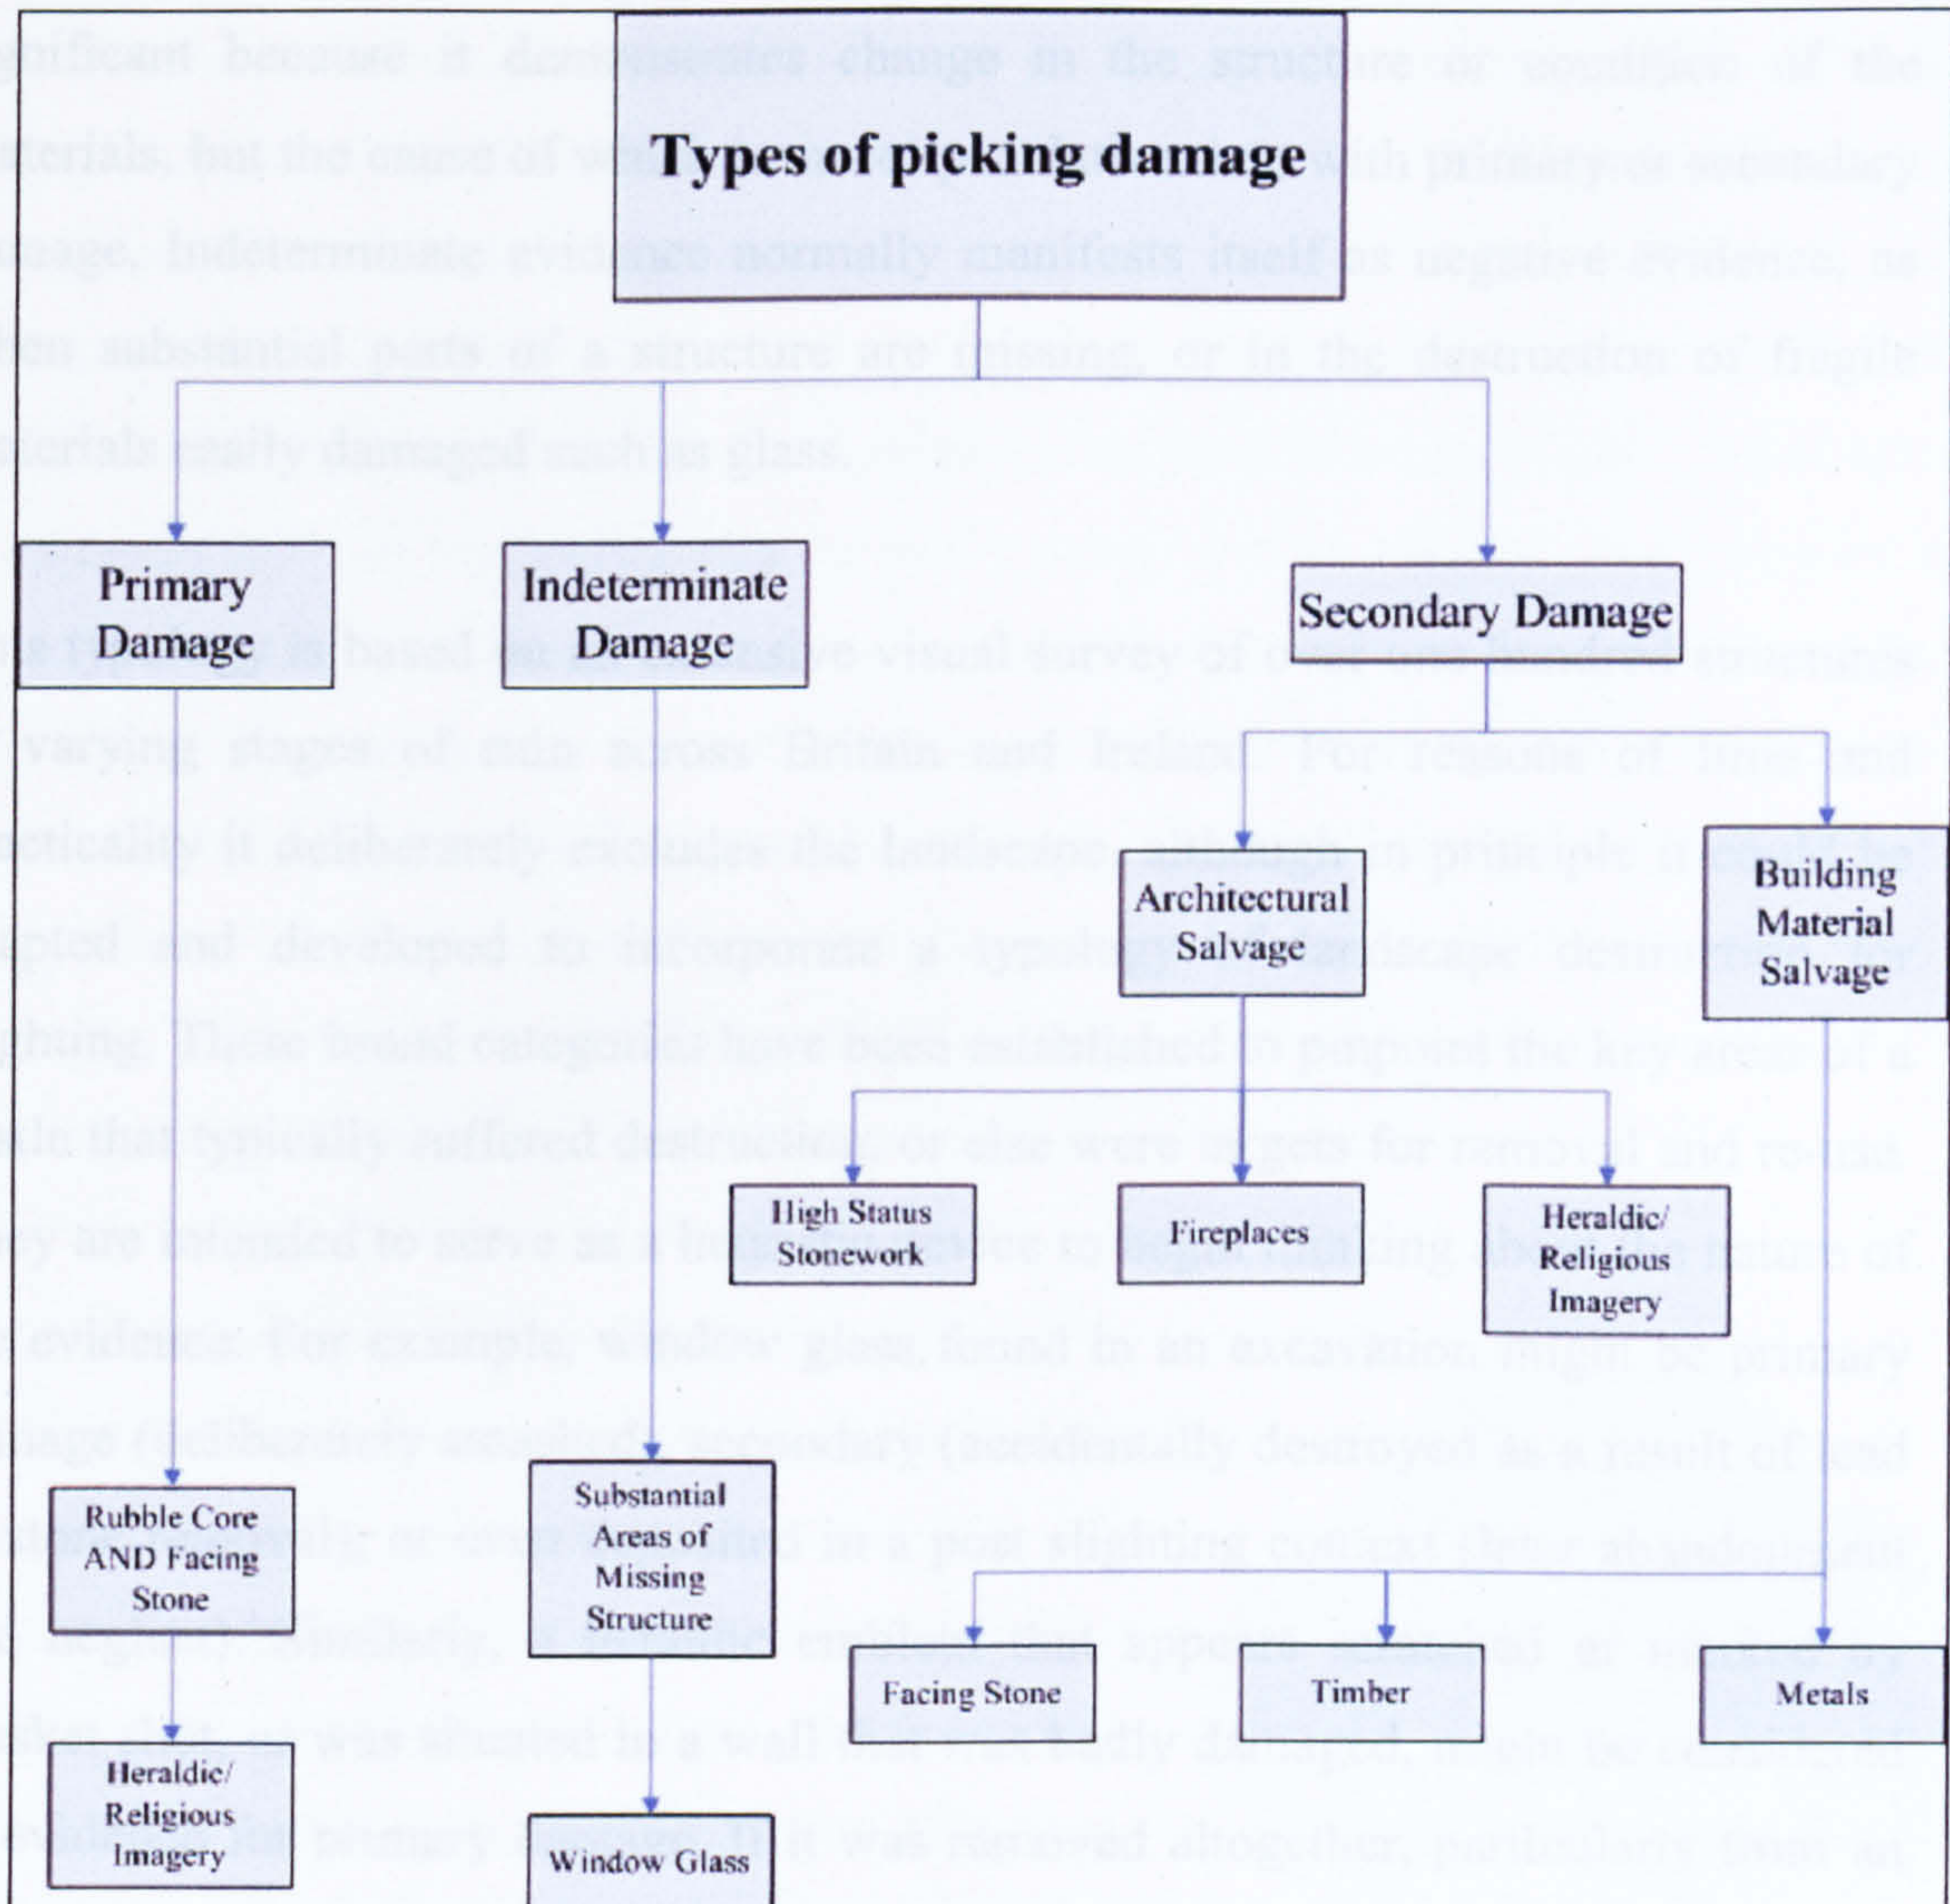
Diagram 4.1 Classification chart showing primary, indeterminate, and secondary damage types and how they are manifested.

Diagram 4.1 Classification chart showing primary, secondary, and indeterminate damage types and how they are manifested.

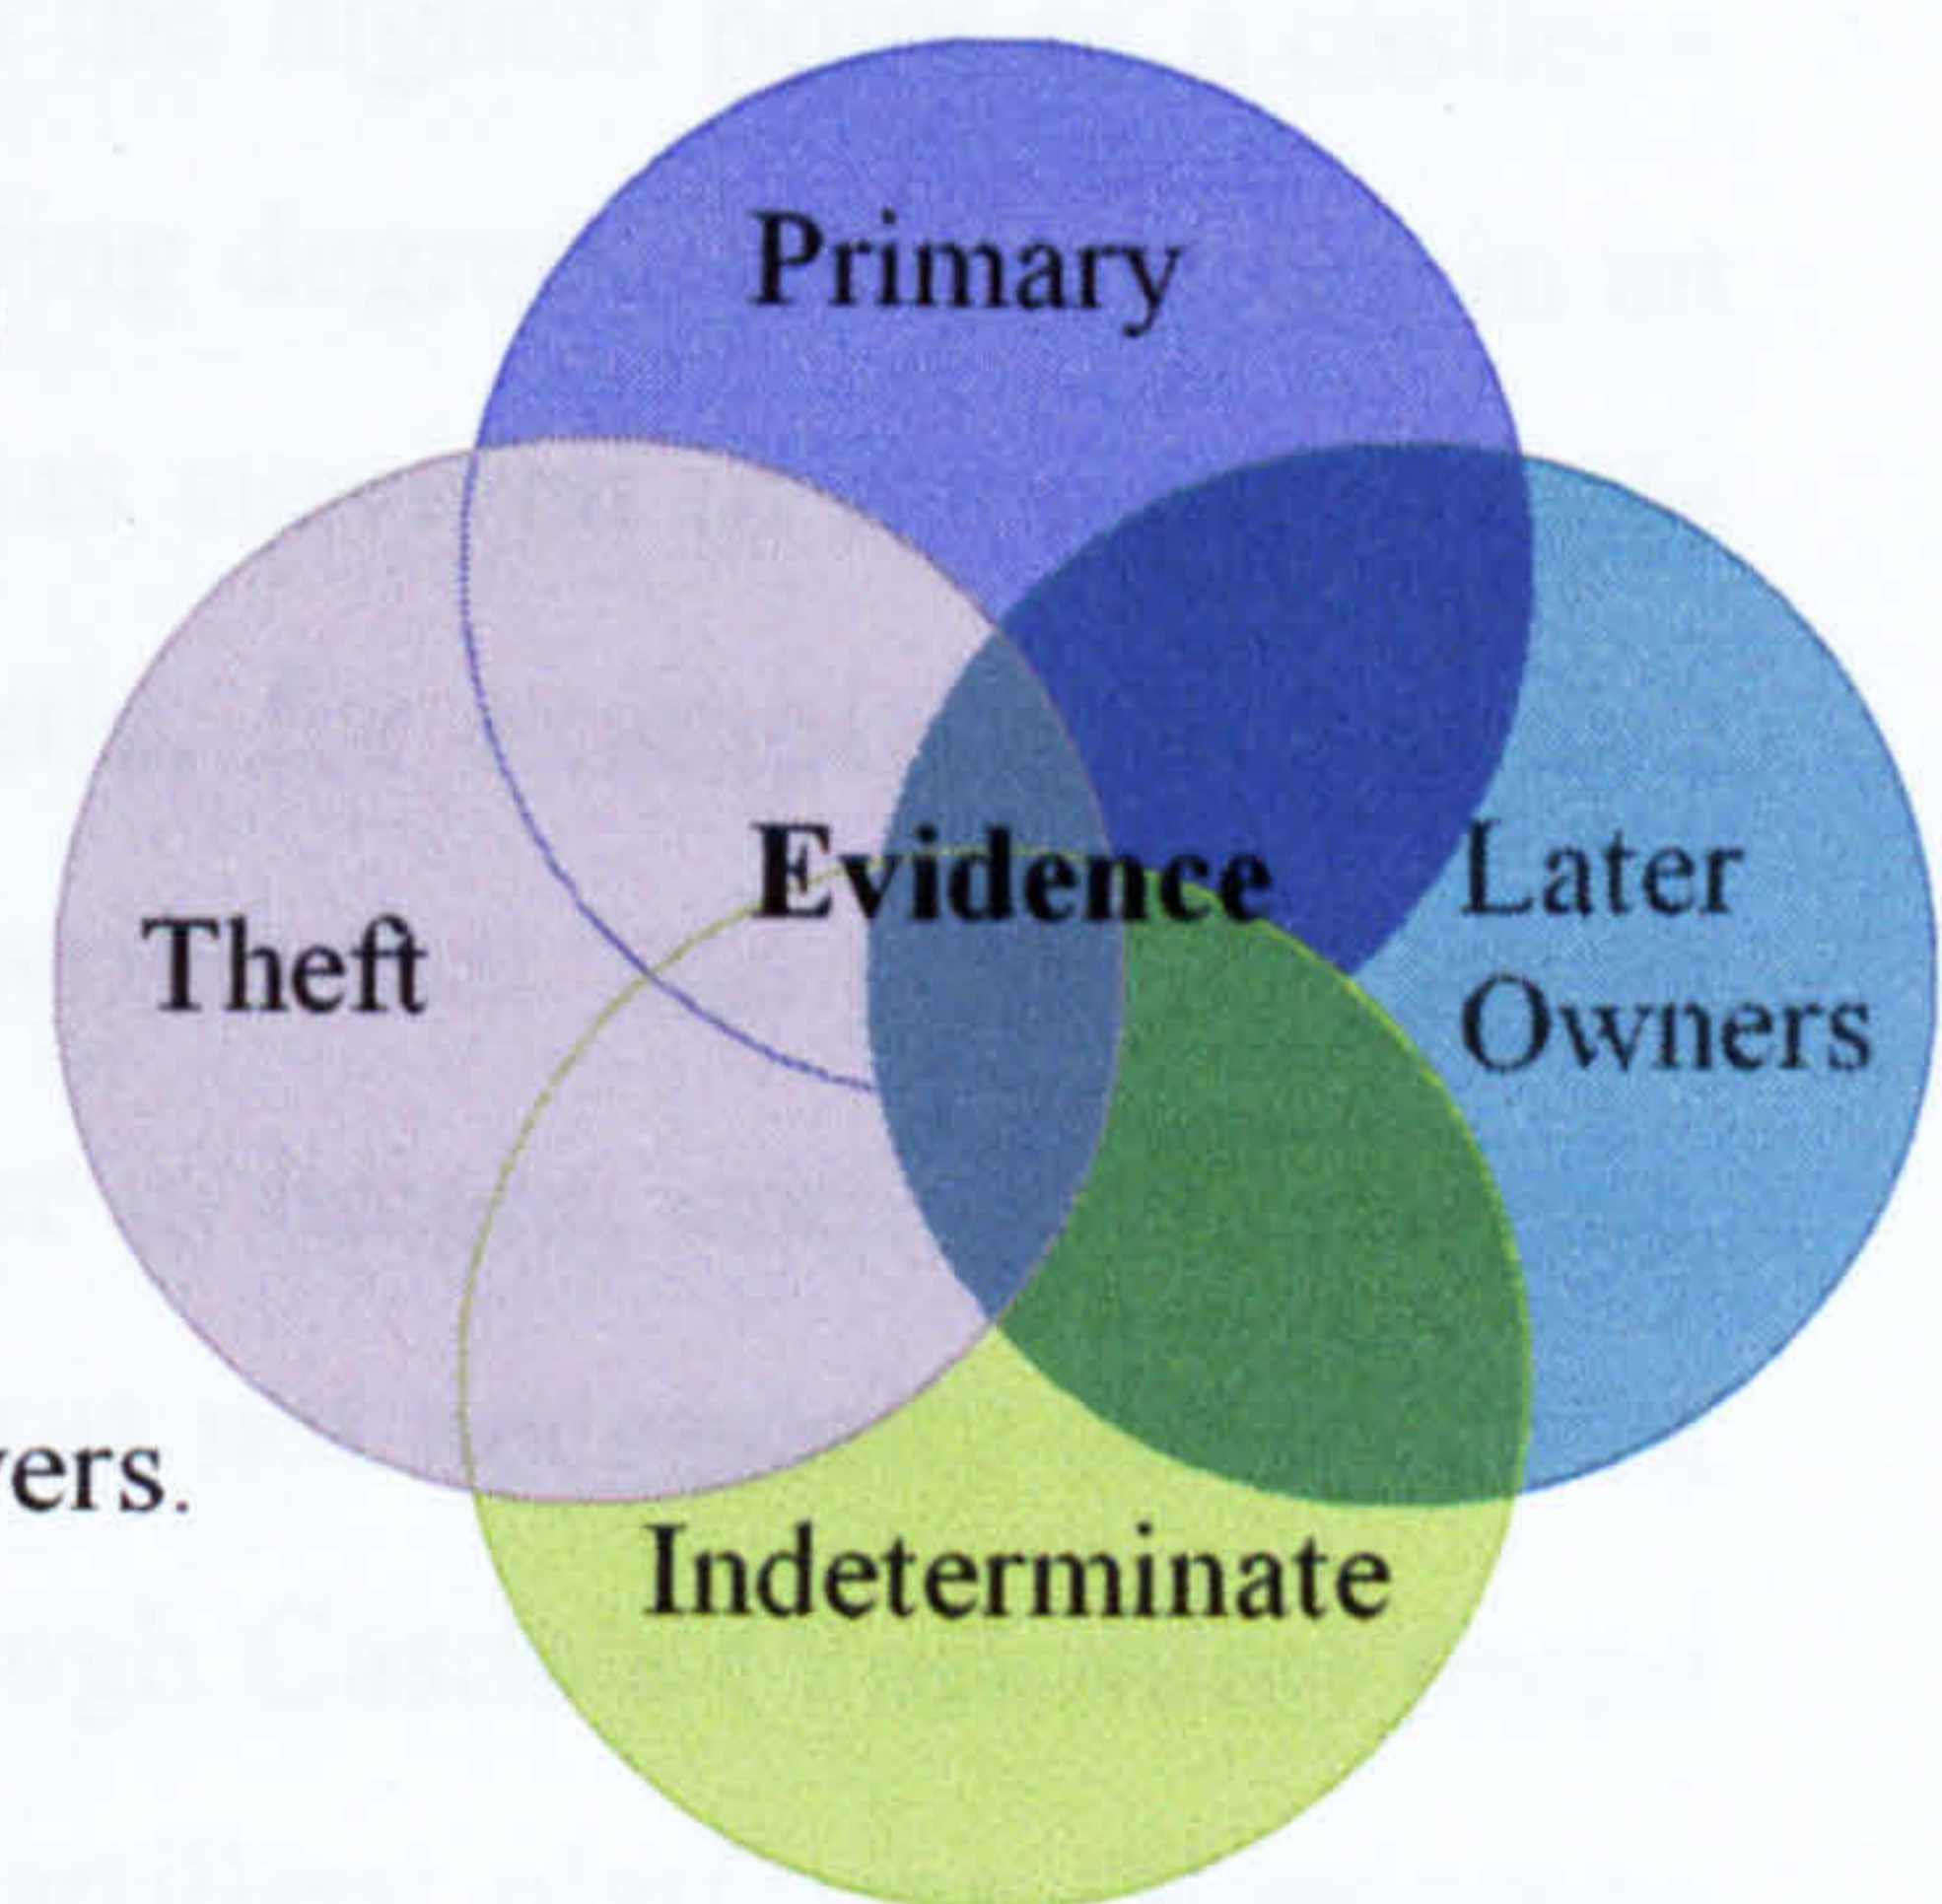
Diagram 4.2 Primary damage and the interrelationships affecting interpretation of evidence

Diagram 4.2 Primary damage and the interrelationships affecting interpretation of evidence.

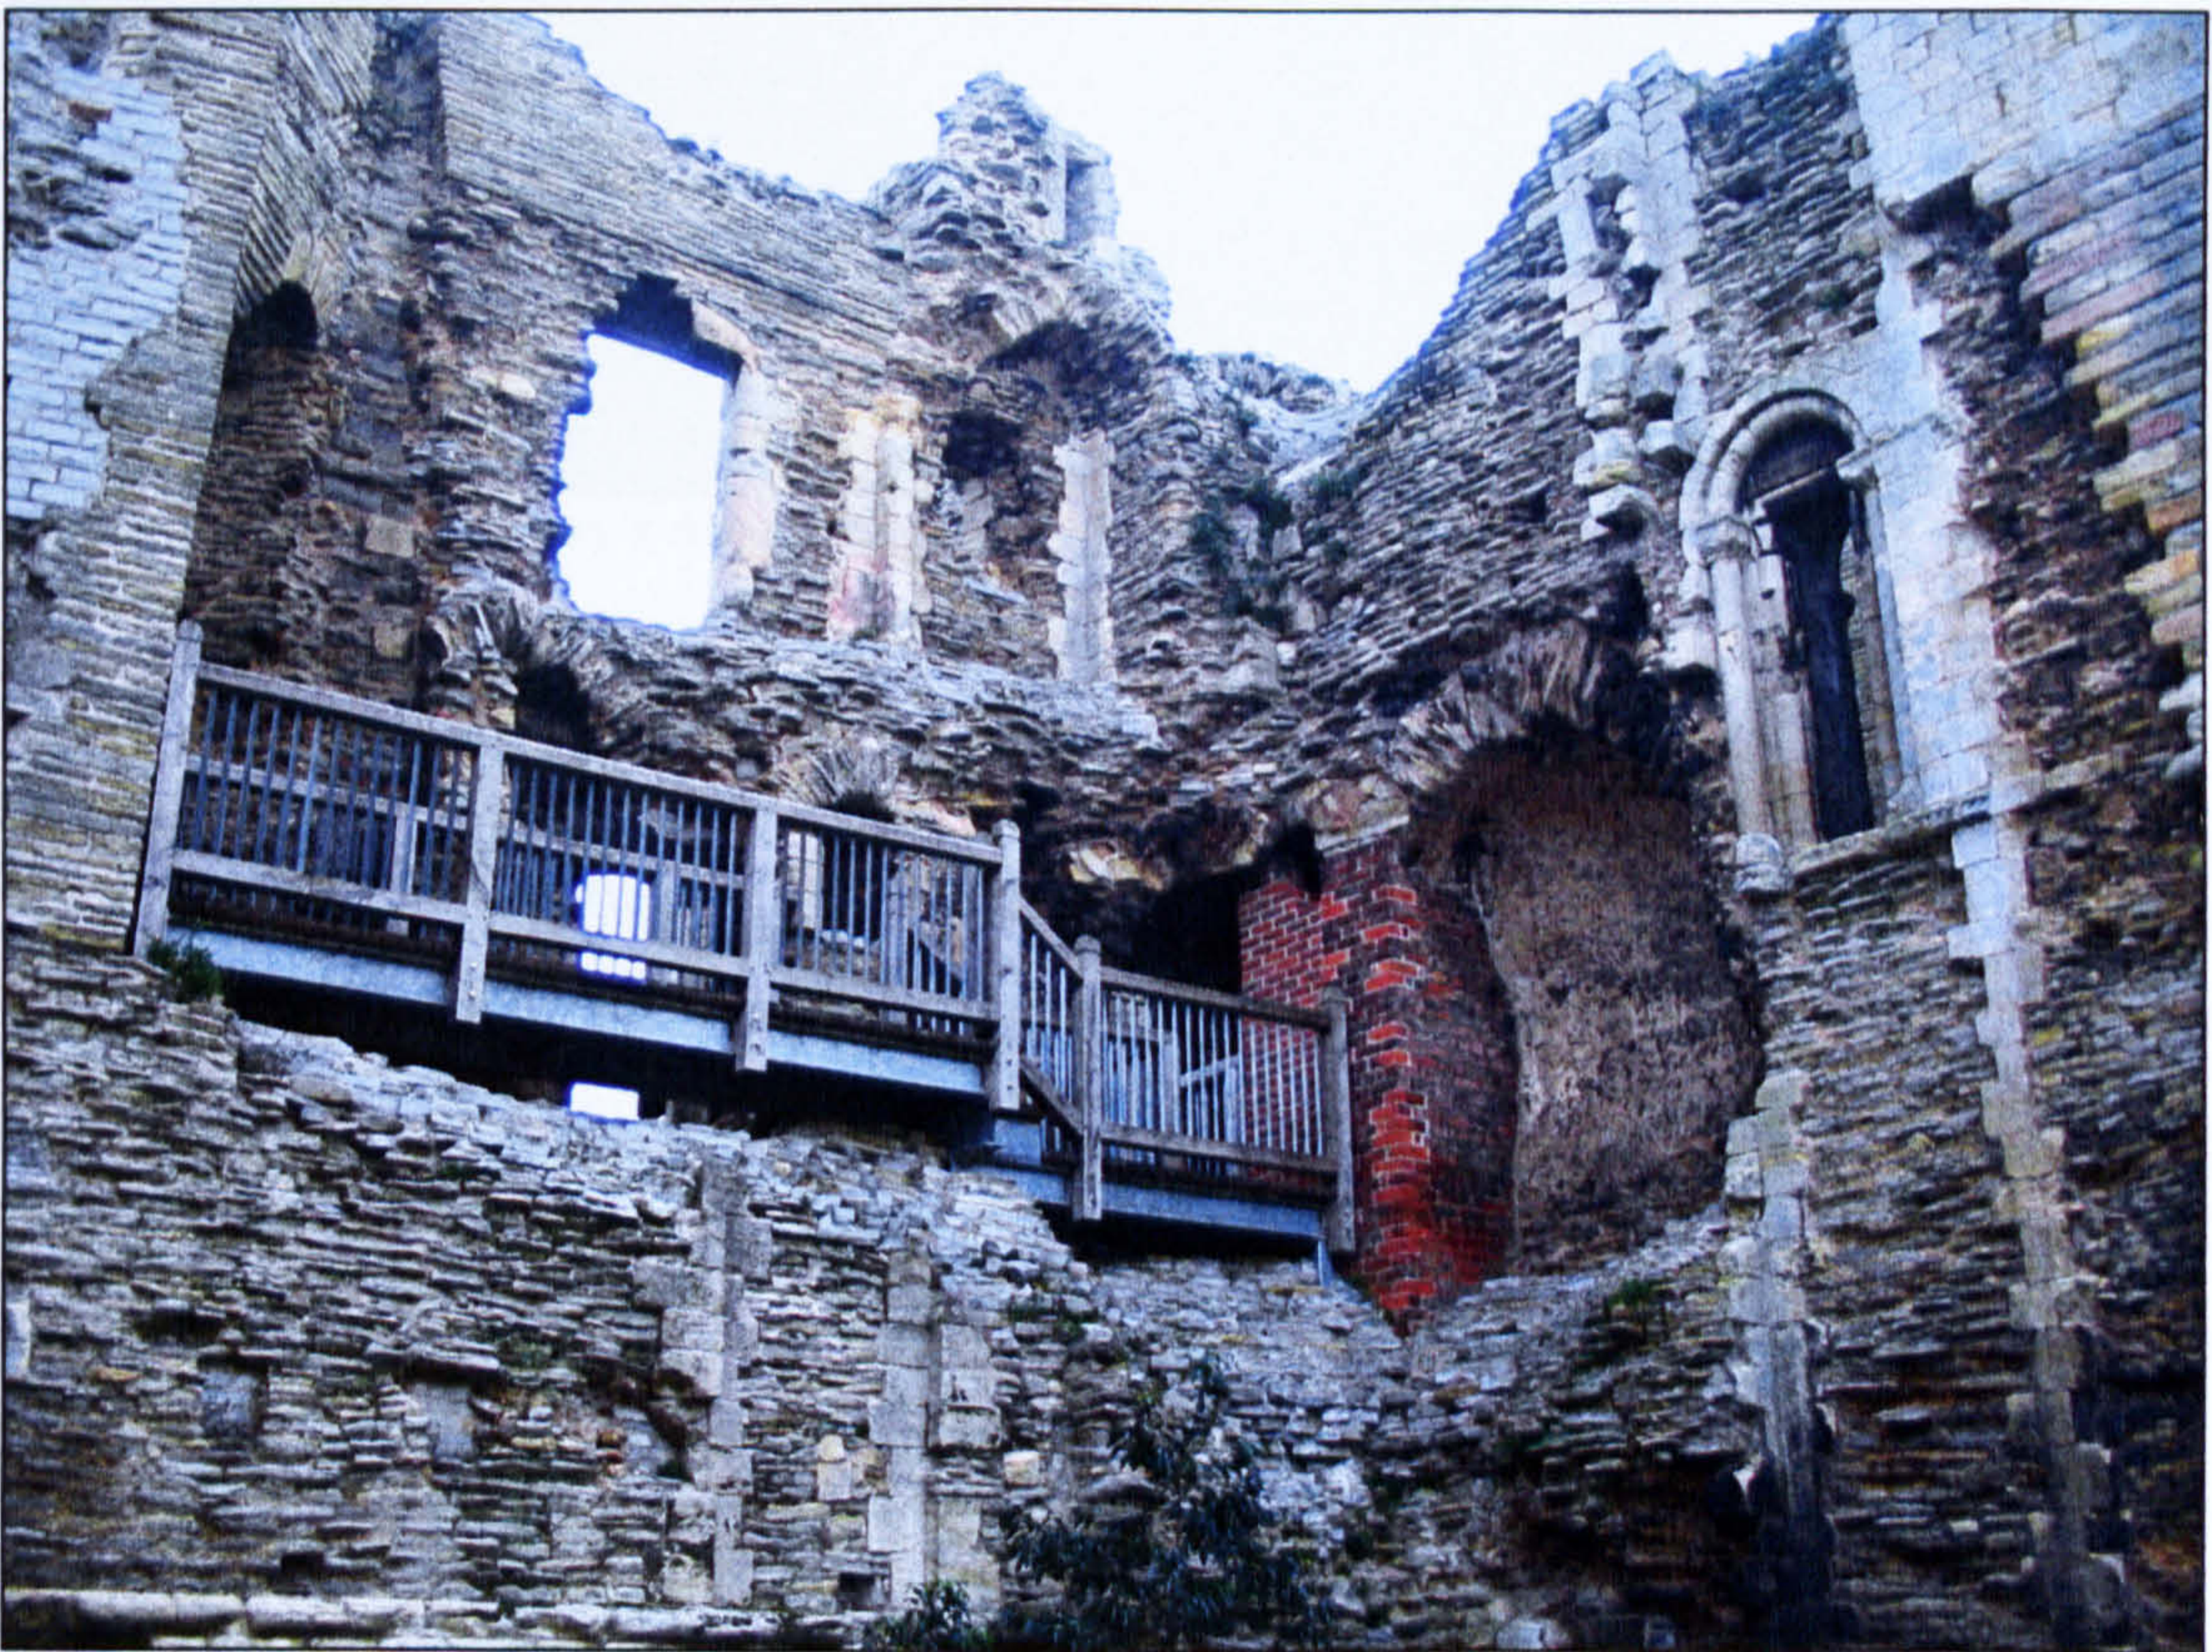
Figure 3.1 Explosion damage pattern in Gatehouse at Newark Castle (Nottinghamshire) as defined by its cratered out shape and highlighted by extensive Victorian restoration.

Figure 3.1 Explosion damage pattern in Gatehouse at Newark Castle (Nottinghamshire) as defined by its cratered out shape and highlighted by extensive Victorian restoration.

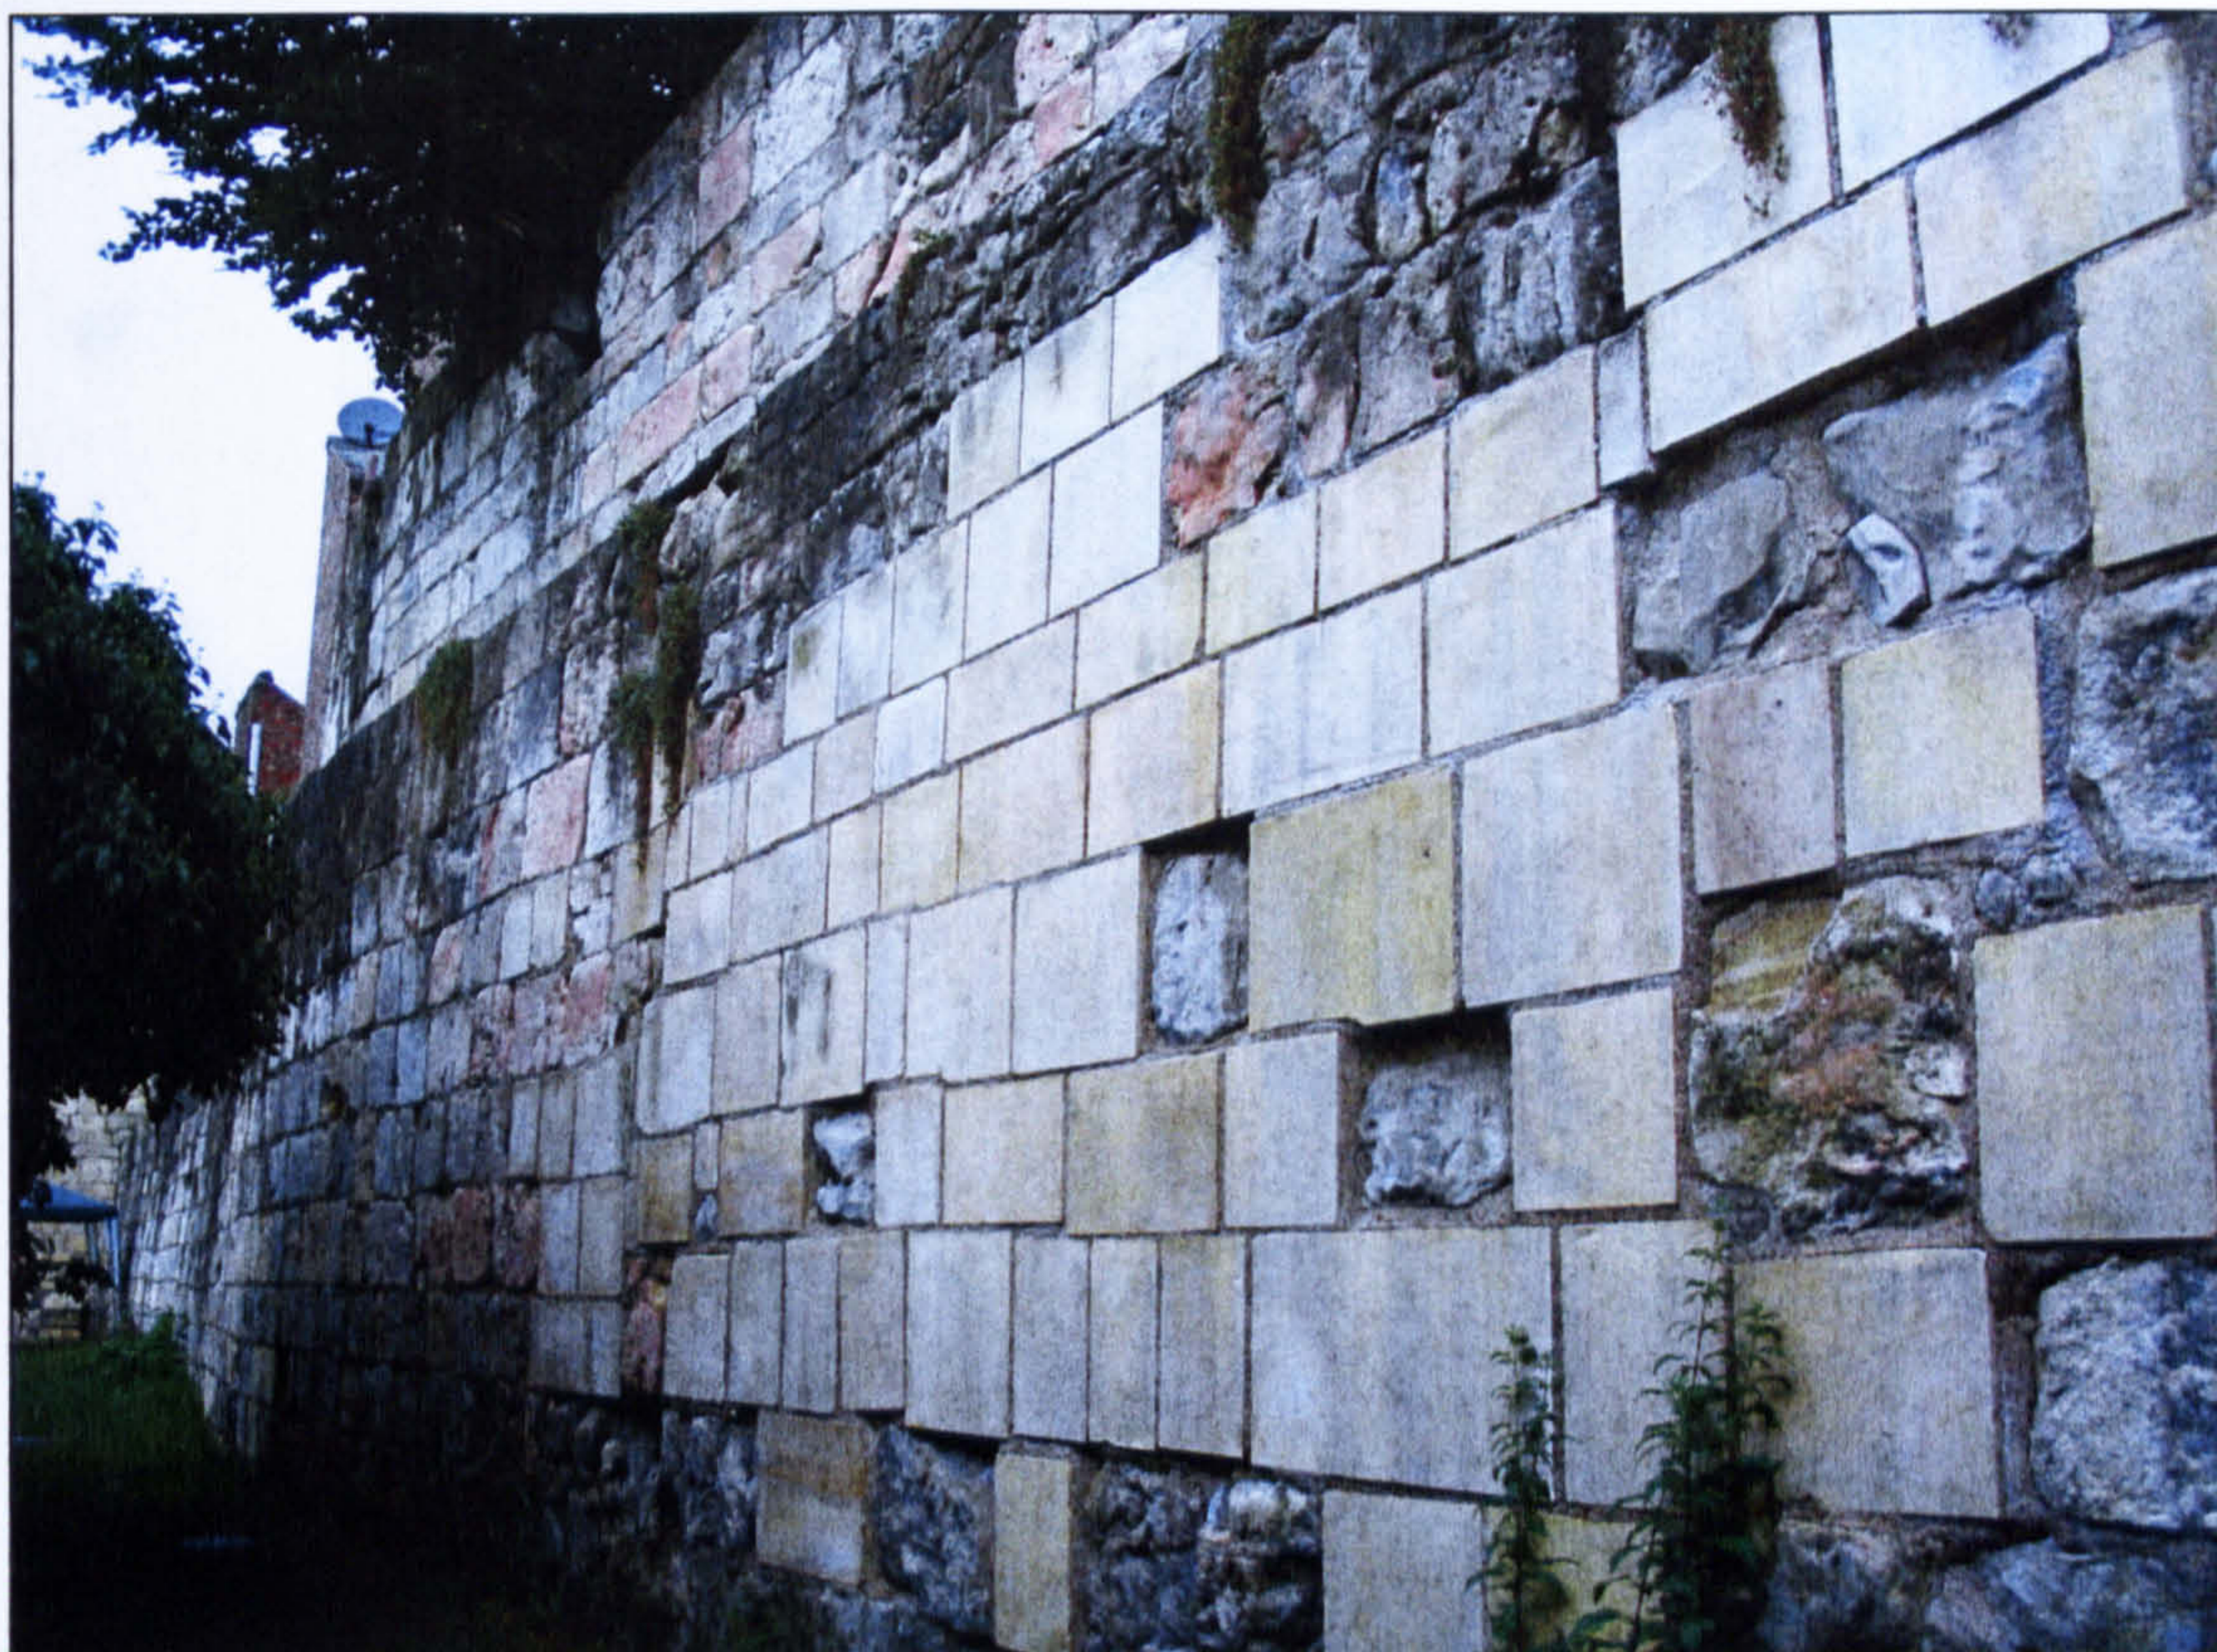
Figure 3.2 Wall at St. Mary's Abbey (York) showing fire damage *in situ*, as well as new ashlar blocks.

Figure 3.2 Wall at St. Mary's Abbey (York) showing fire damage *in situ*, as well as new ashlar blocks.

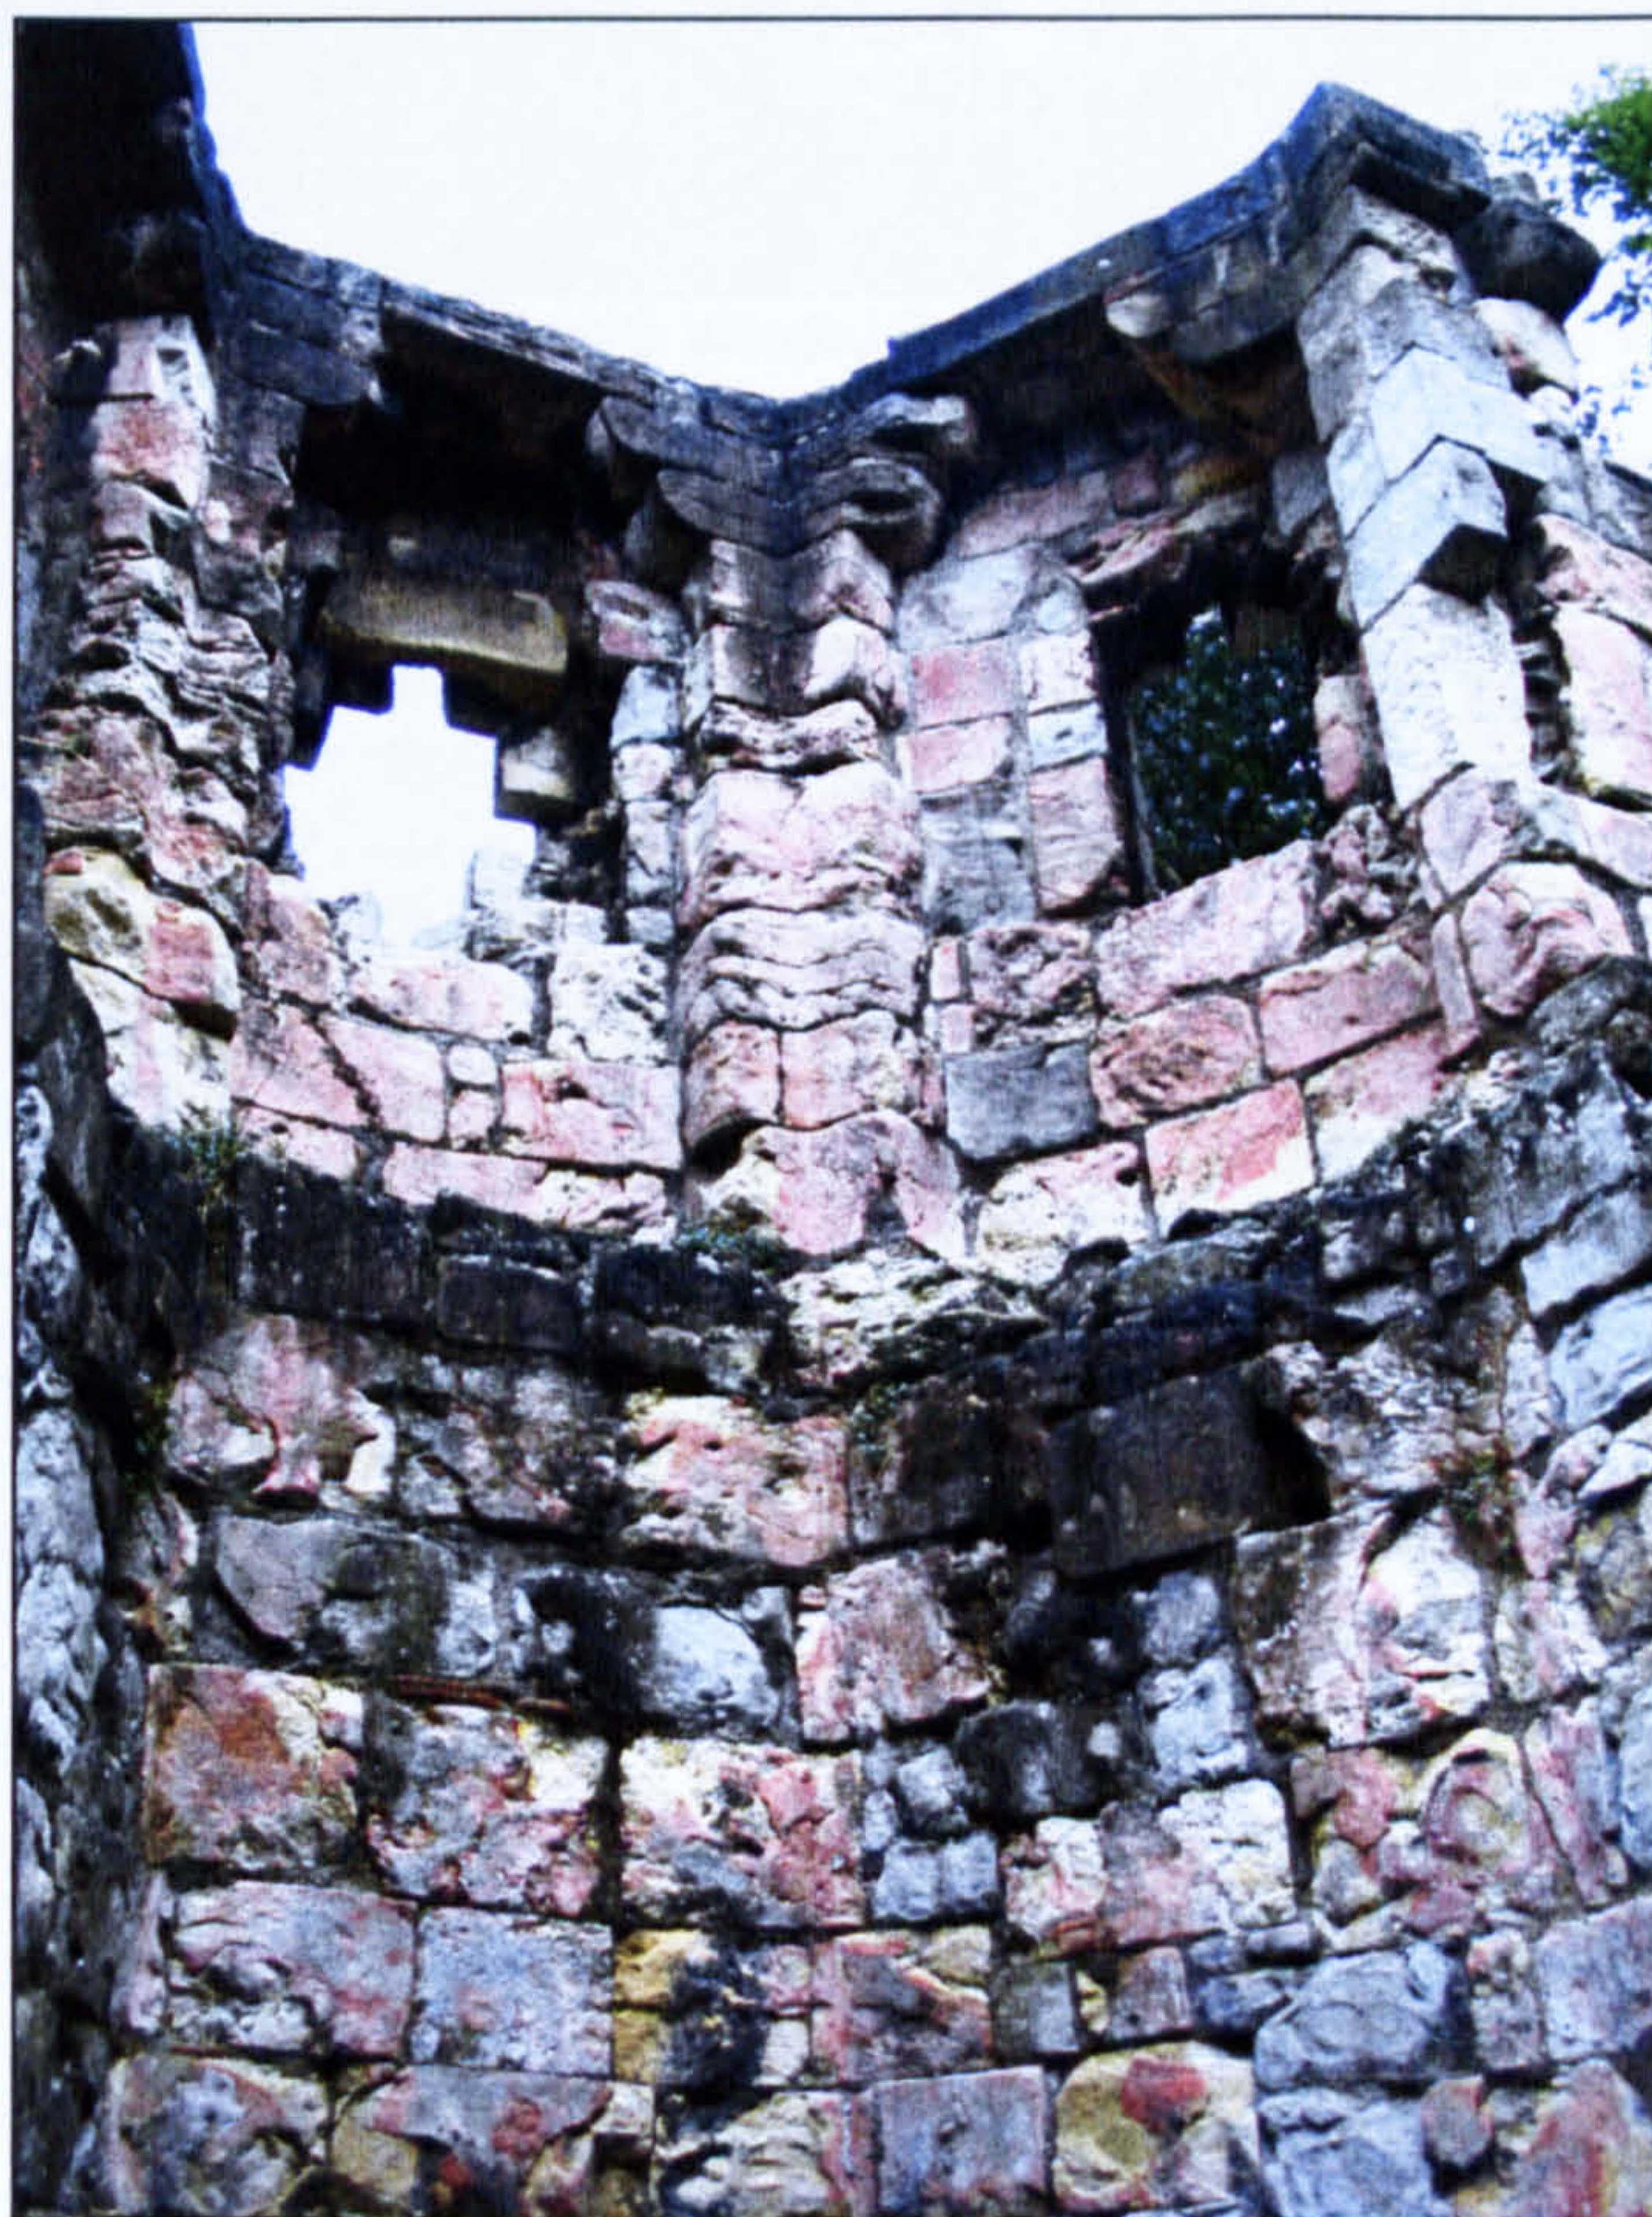
Figure 3.3 Extensive reddening and surface degradation of fire damaged wall, St. Mary's Abbey.

Figure 3.3 Extensive reddening and surface degradation of fire damaged wall, St. Mary's Abbey.

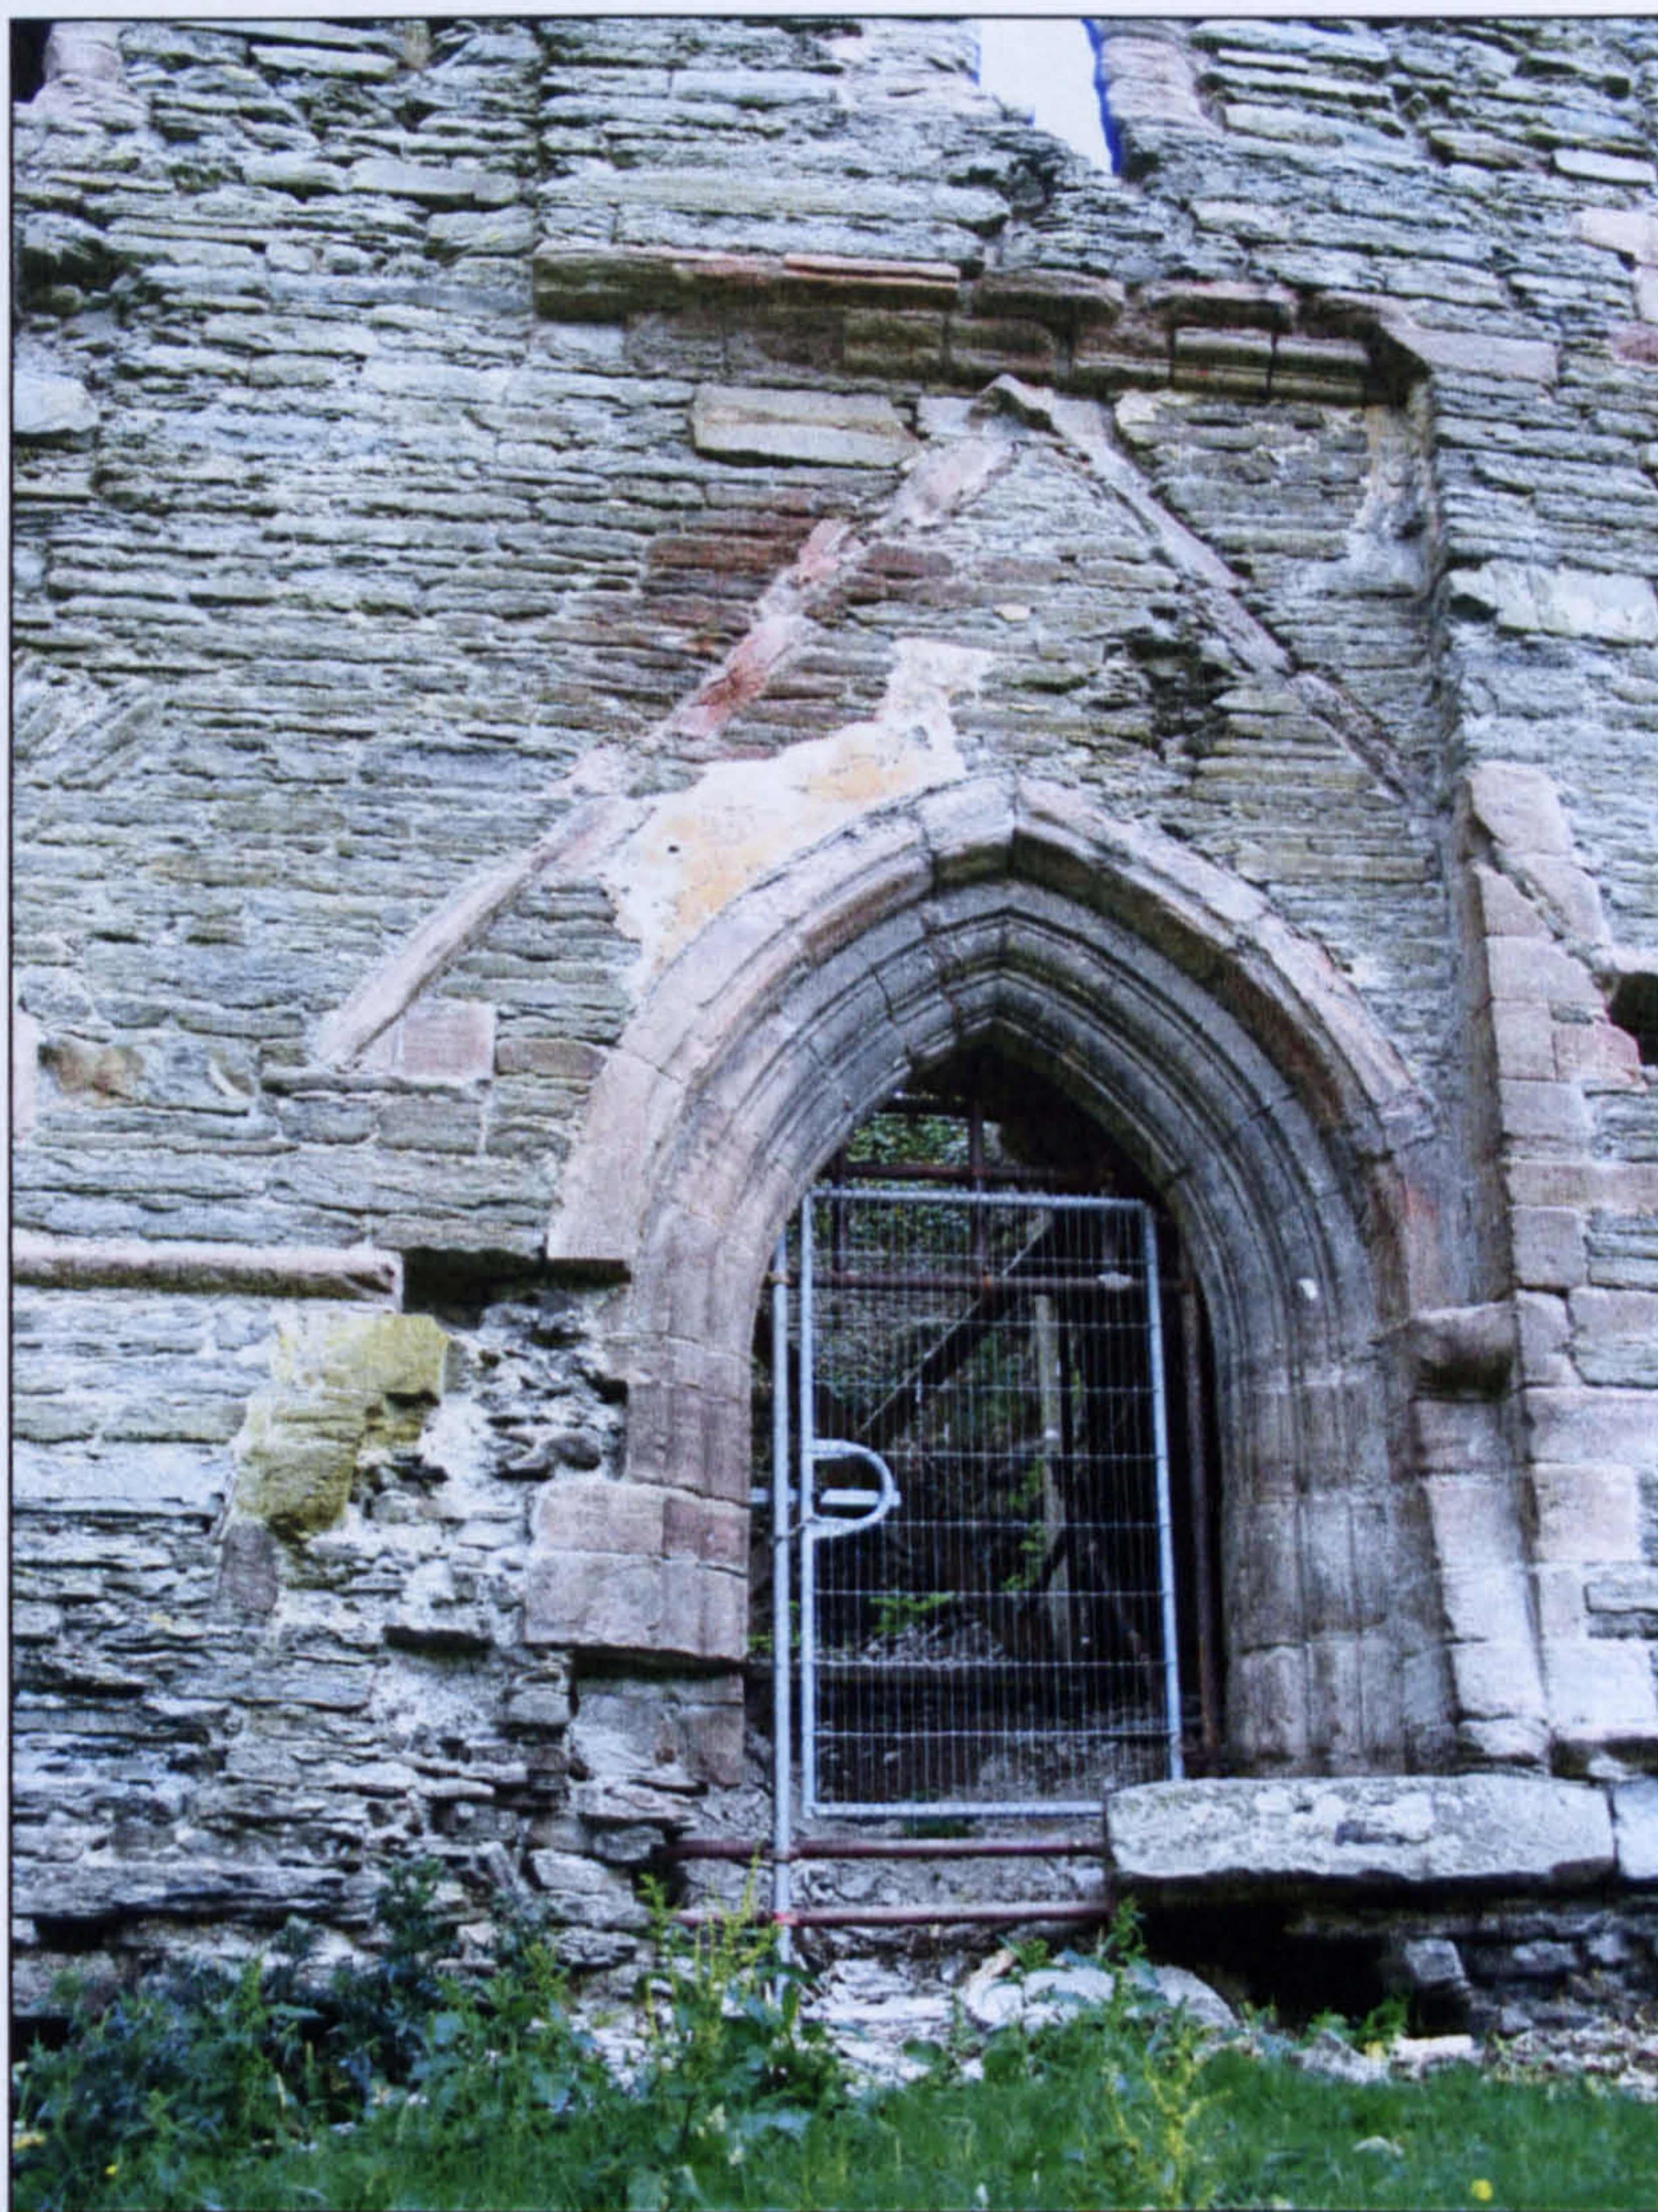
Figure 3.4 Porch area of Hopton Castle with alleged fire damage in upper left area of entranceway.

Figure 3.4 Porch area of Hopton Castle (Shropshire) with alleged fire damage in upper left area of entranceway.
