ARCHAEOLOGY OF DESTRUCTION

A REINTERPRETATION OF CASTLE SLIGHTINGS IN THE ENGLISH CIVIL WAR

Thesis submitted for the degree of
Doctor of Philosophy
University of York
Department of Archaeology

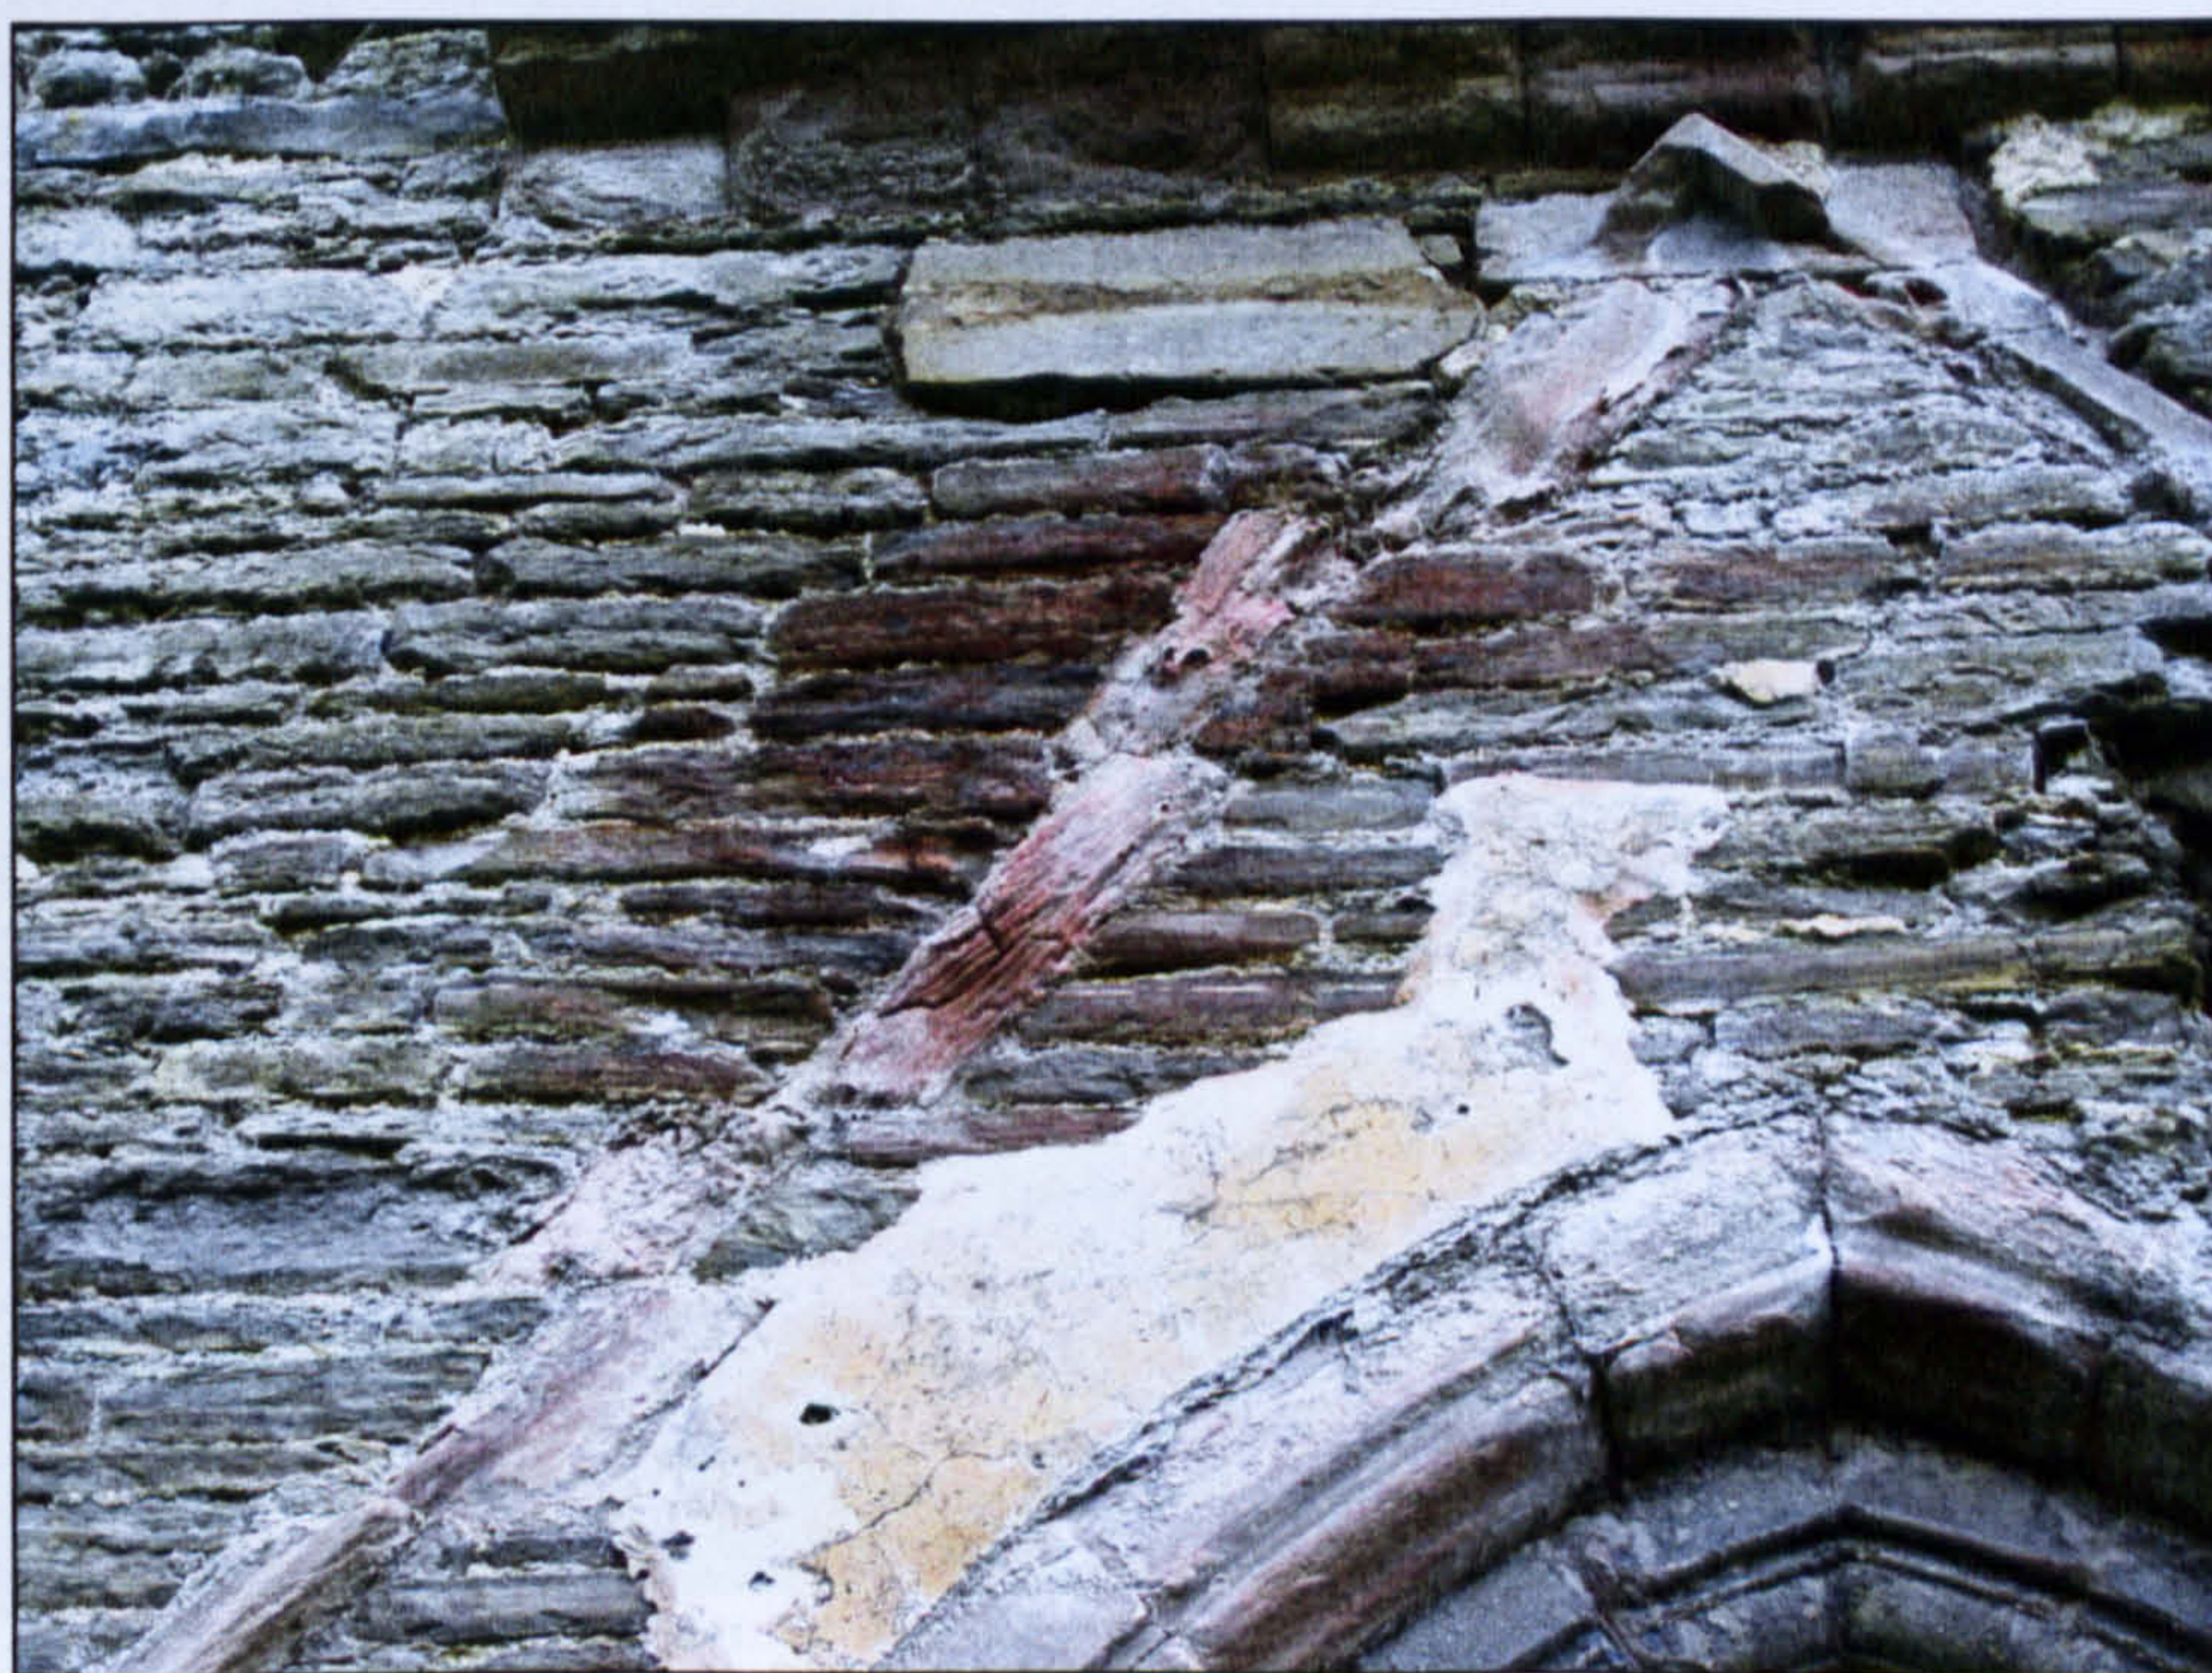
Figure 3.5 Close-up of fire damage area, Hopton Castle.

Figure 3.5 Close-up of fire damage area, Hopton Castle (Shropshire).

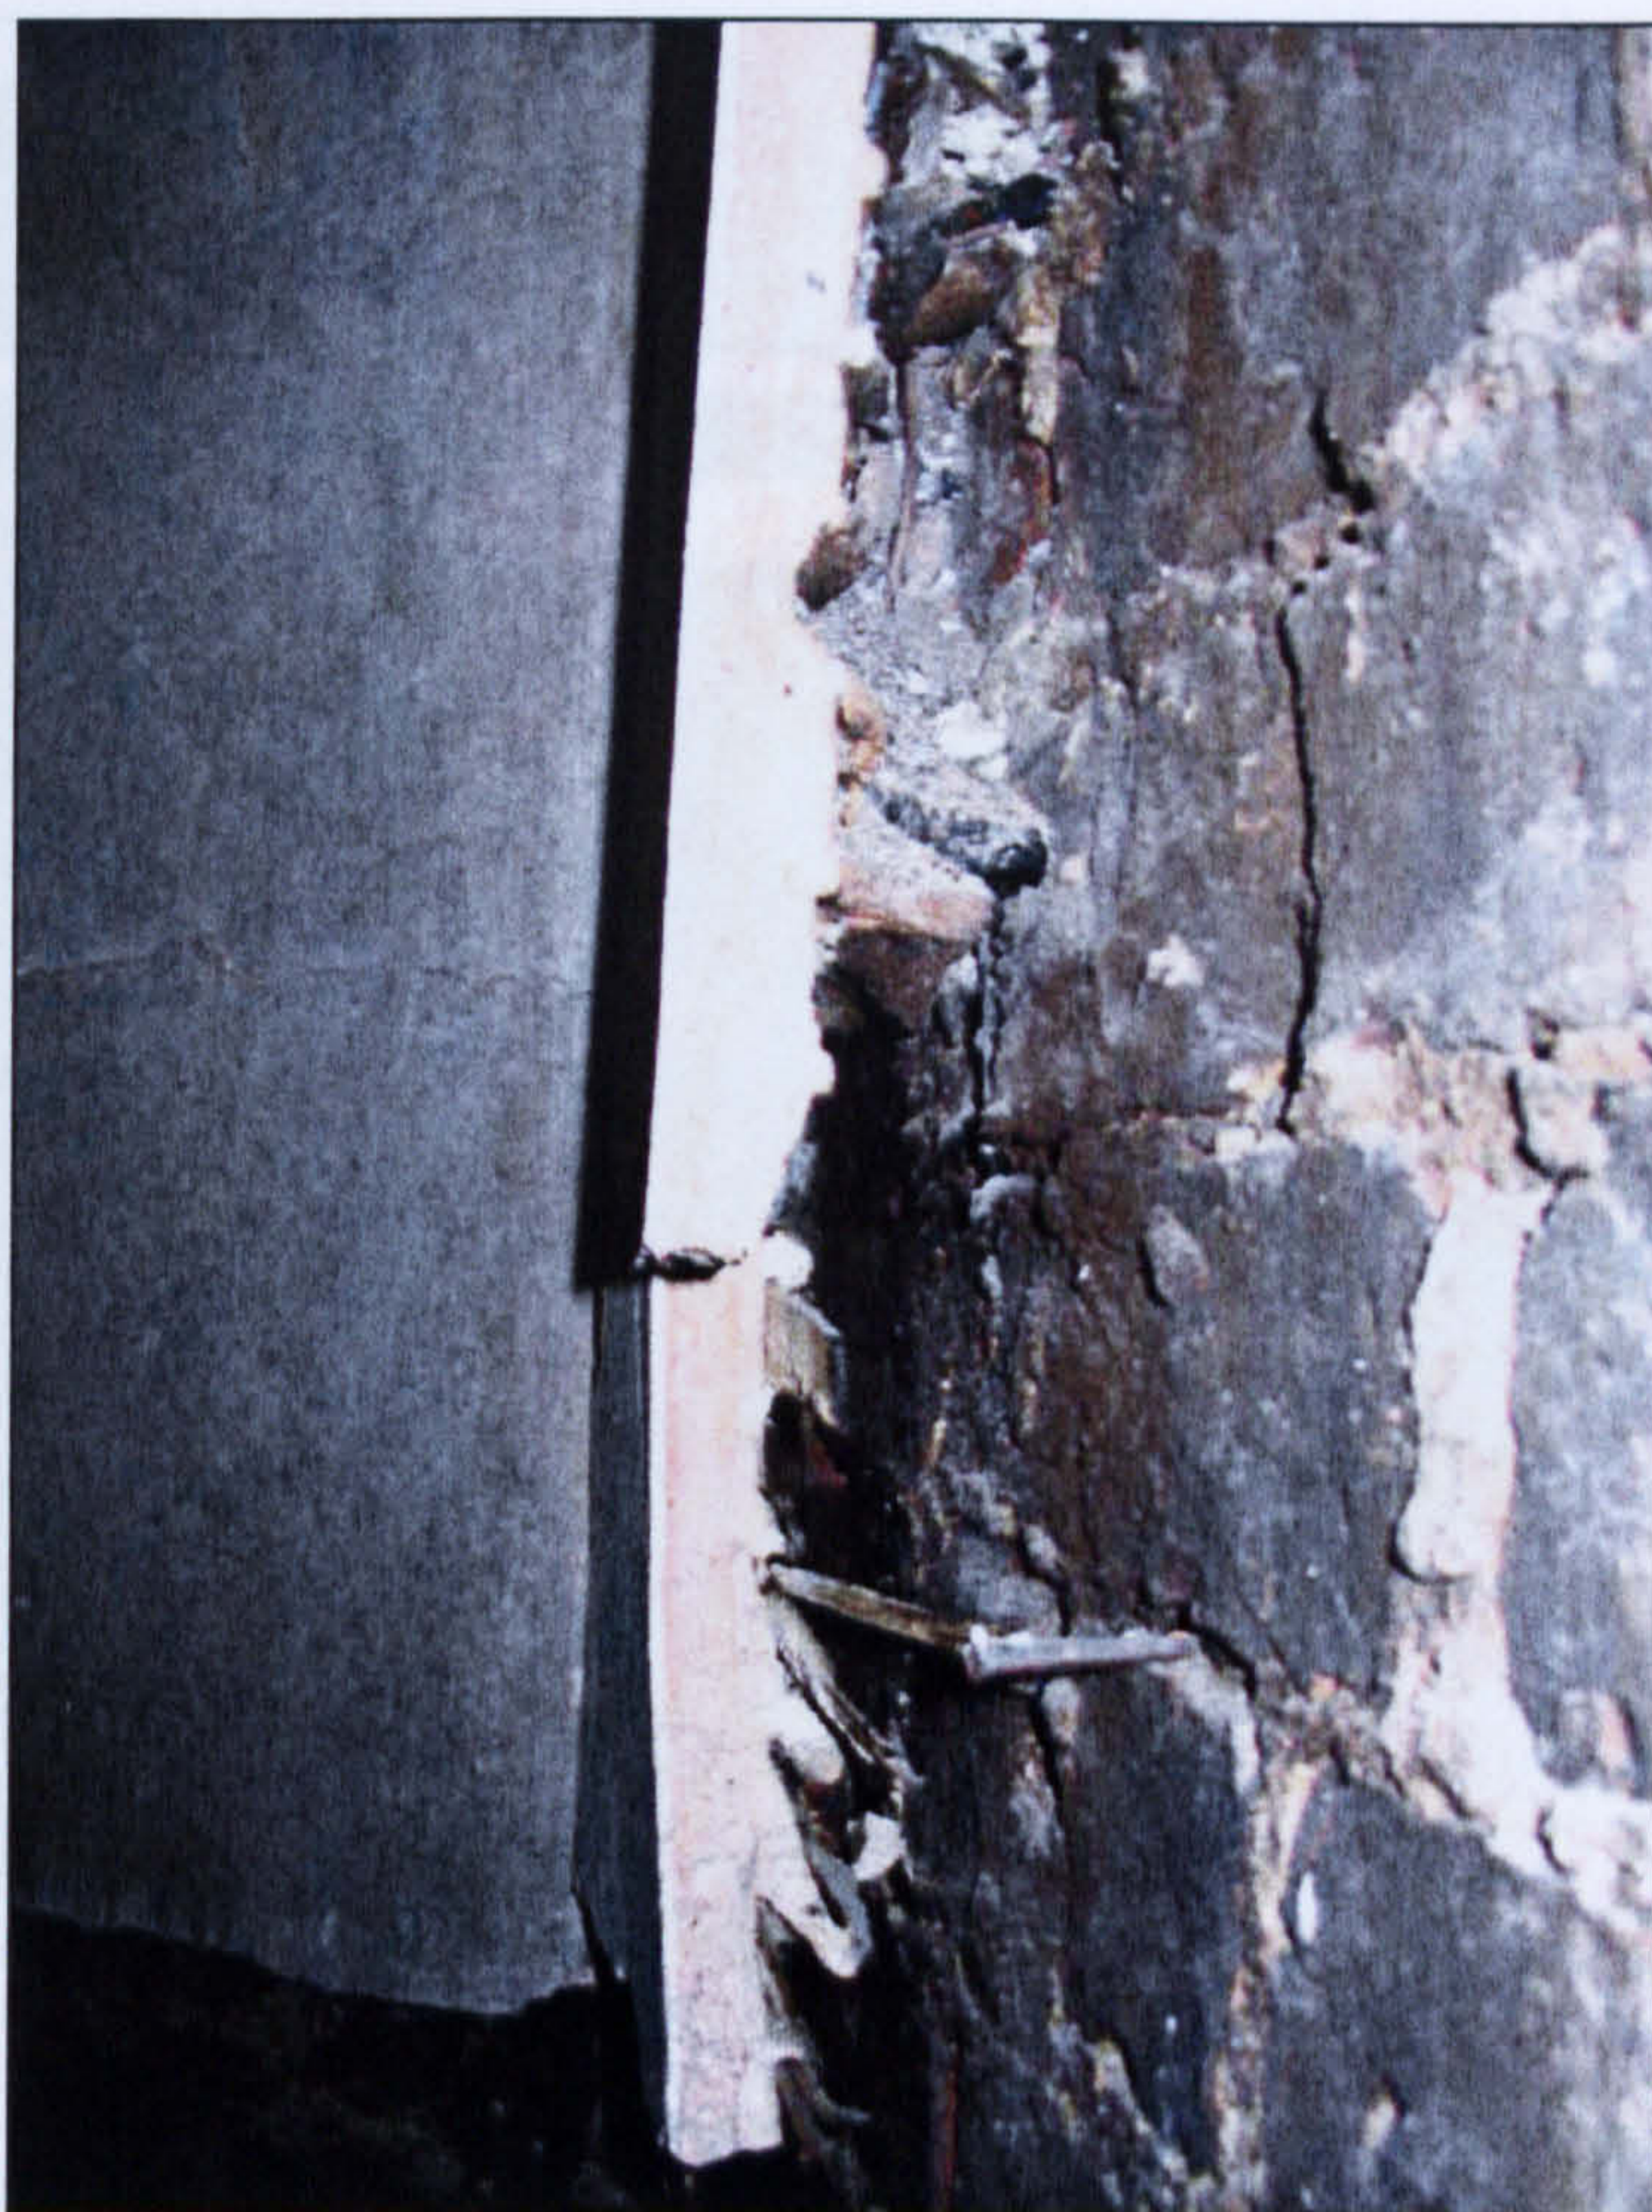
Figure 3.6 Panelling nailed into the wall at Allerton Castle, showing the air space that fed the fire.

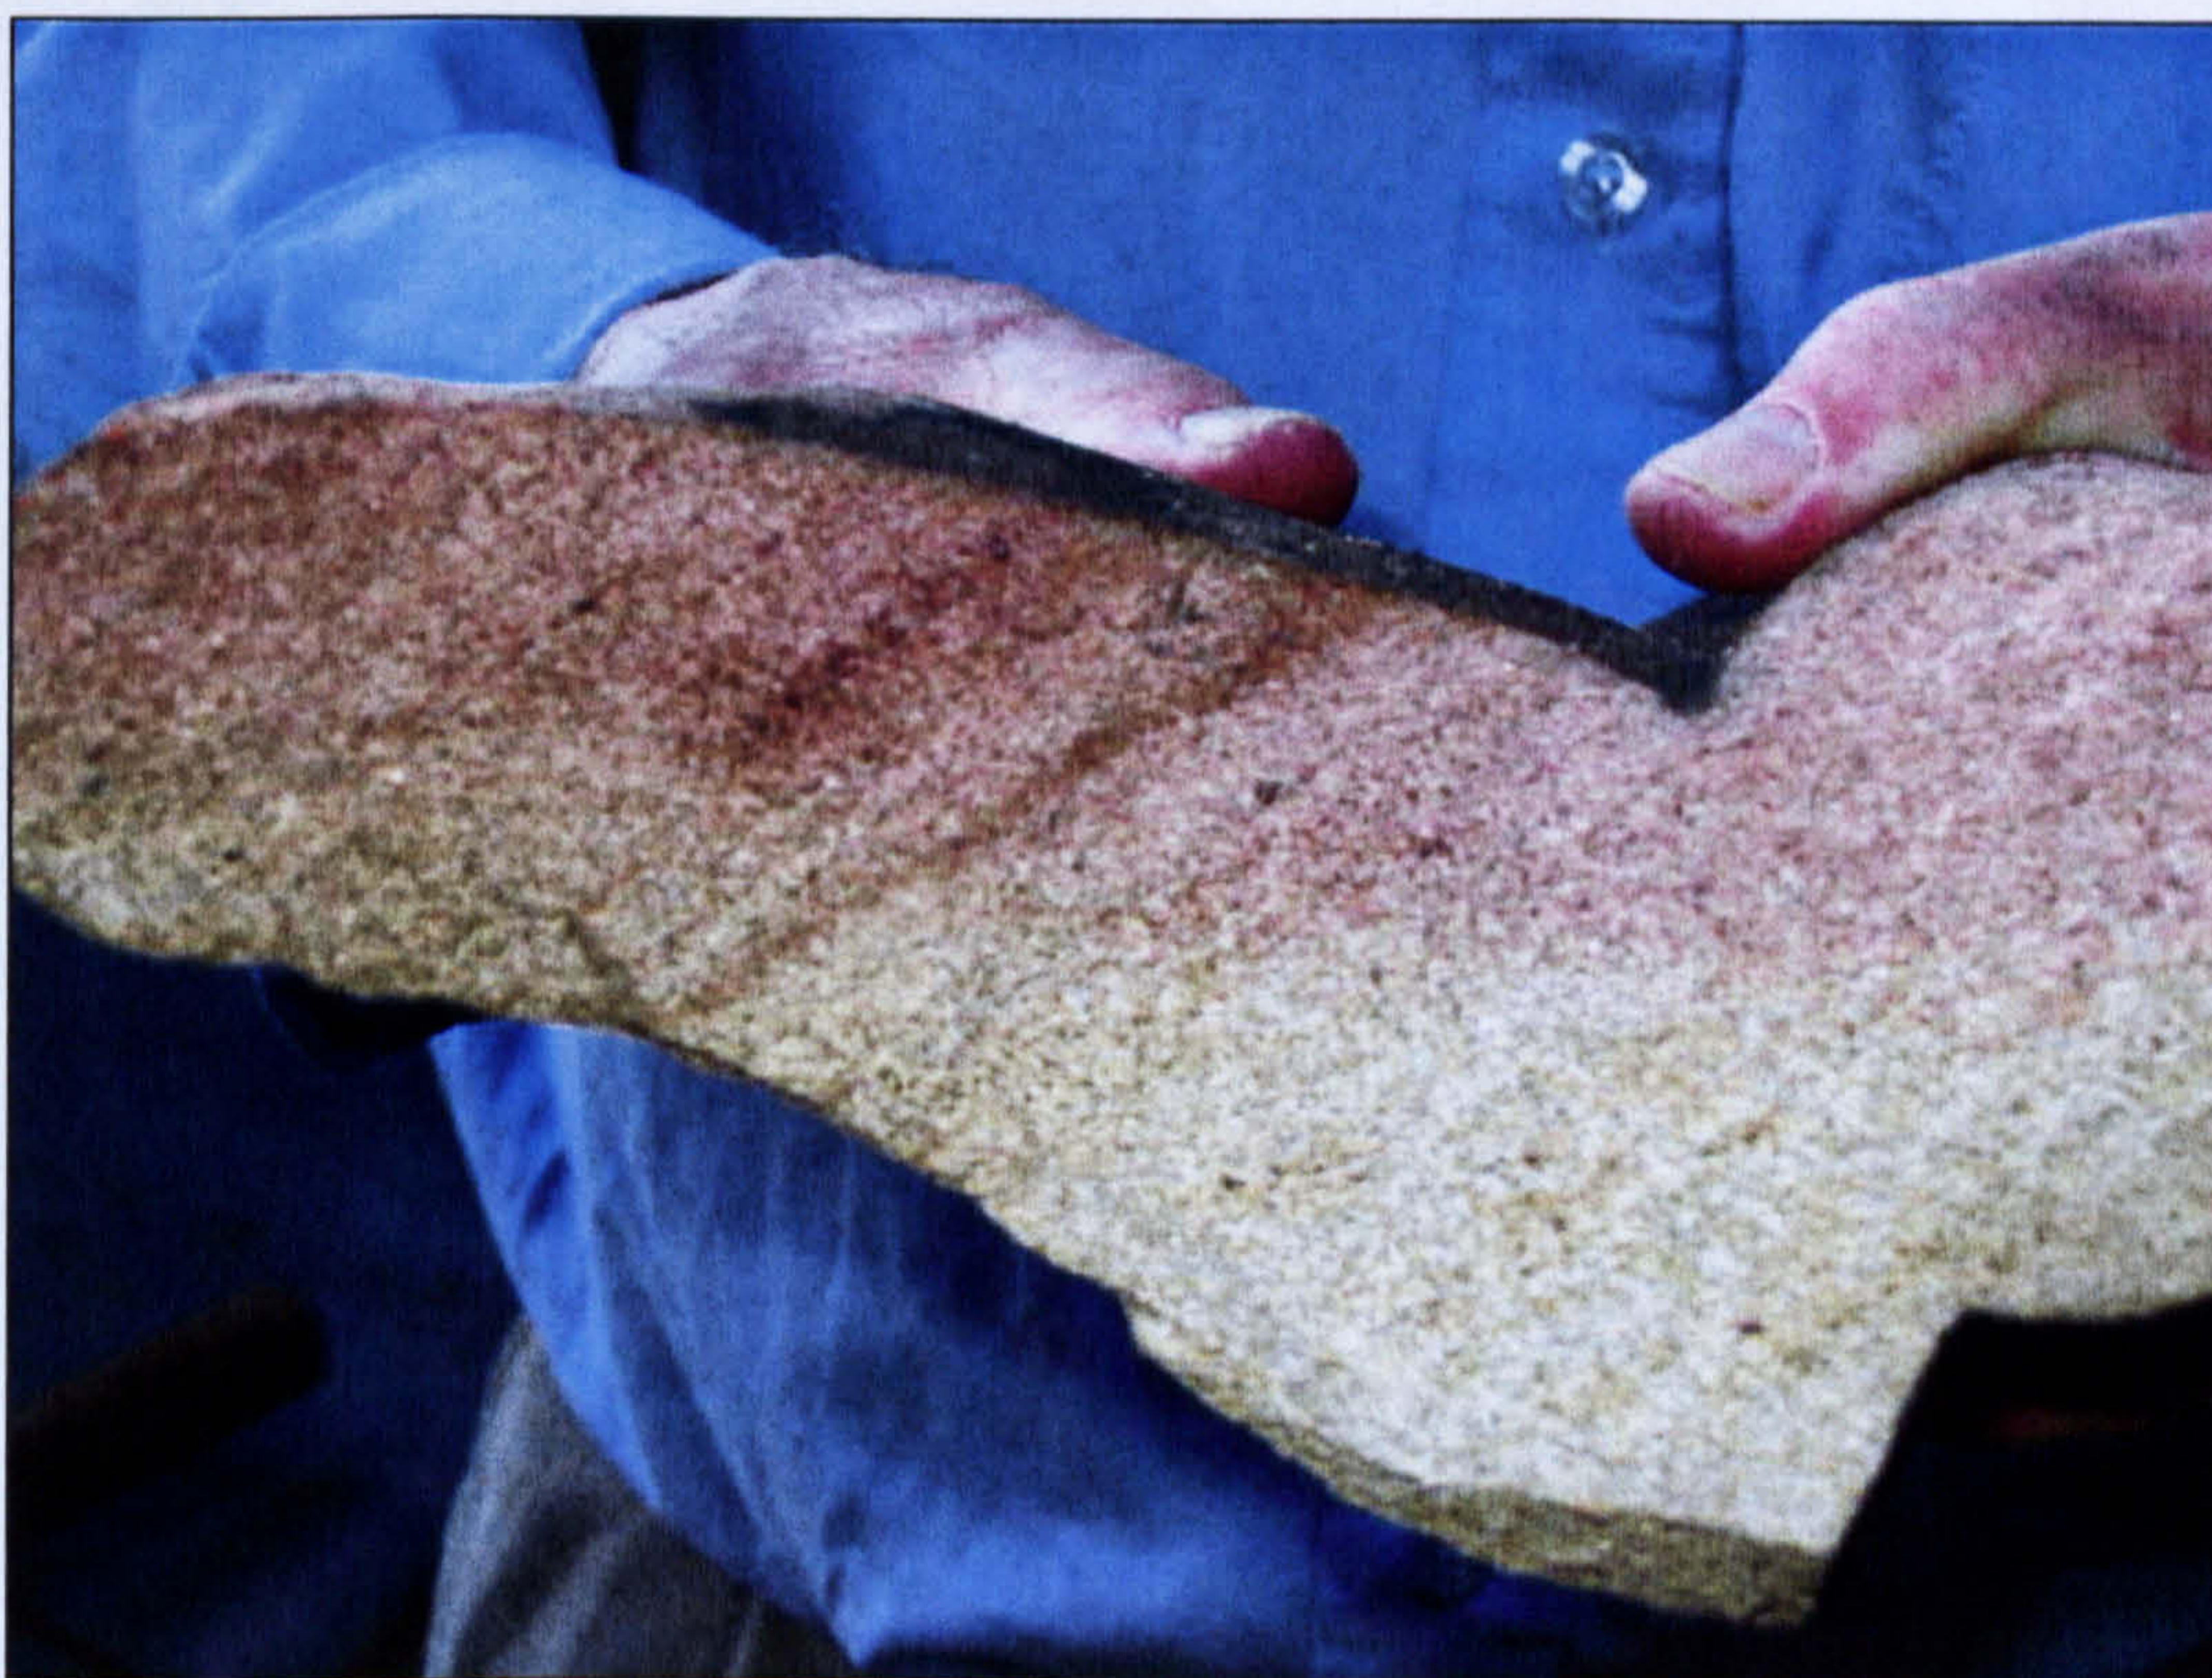
Figure 3.7 Fire damaged stone from Allerton Castle, showing signs of surface reddening.

Figure 3.7 Fire damaged stone from Allerton Castle (Yorkshire), showing signs of surface reddening.

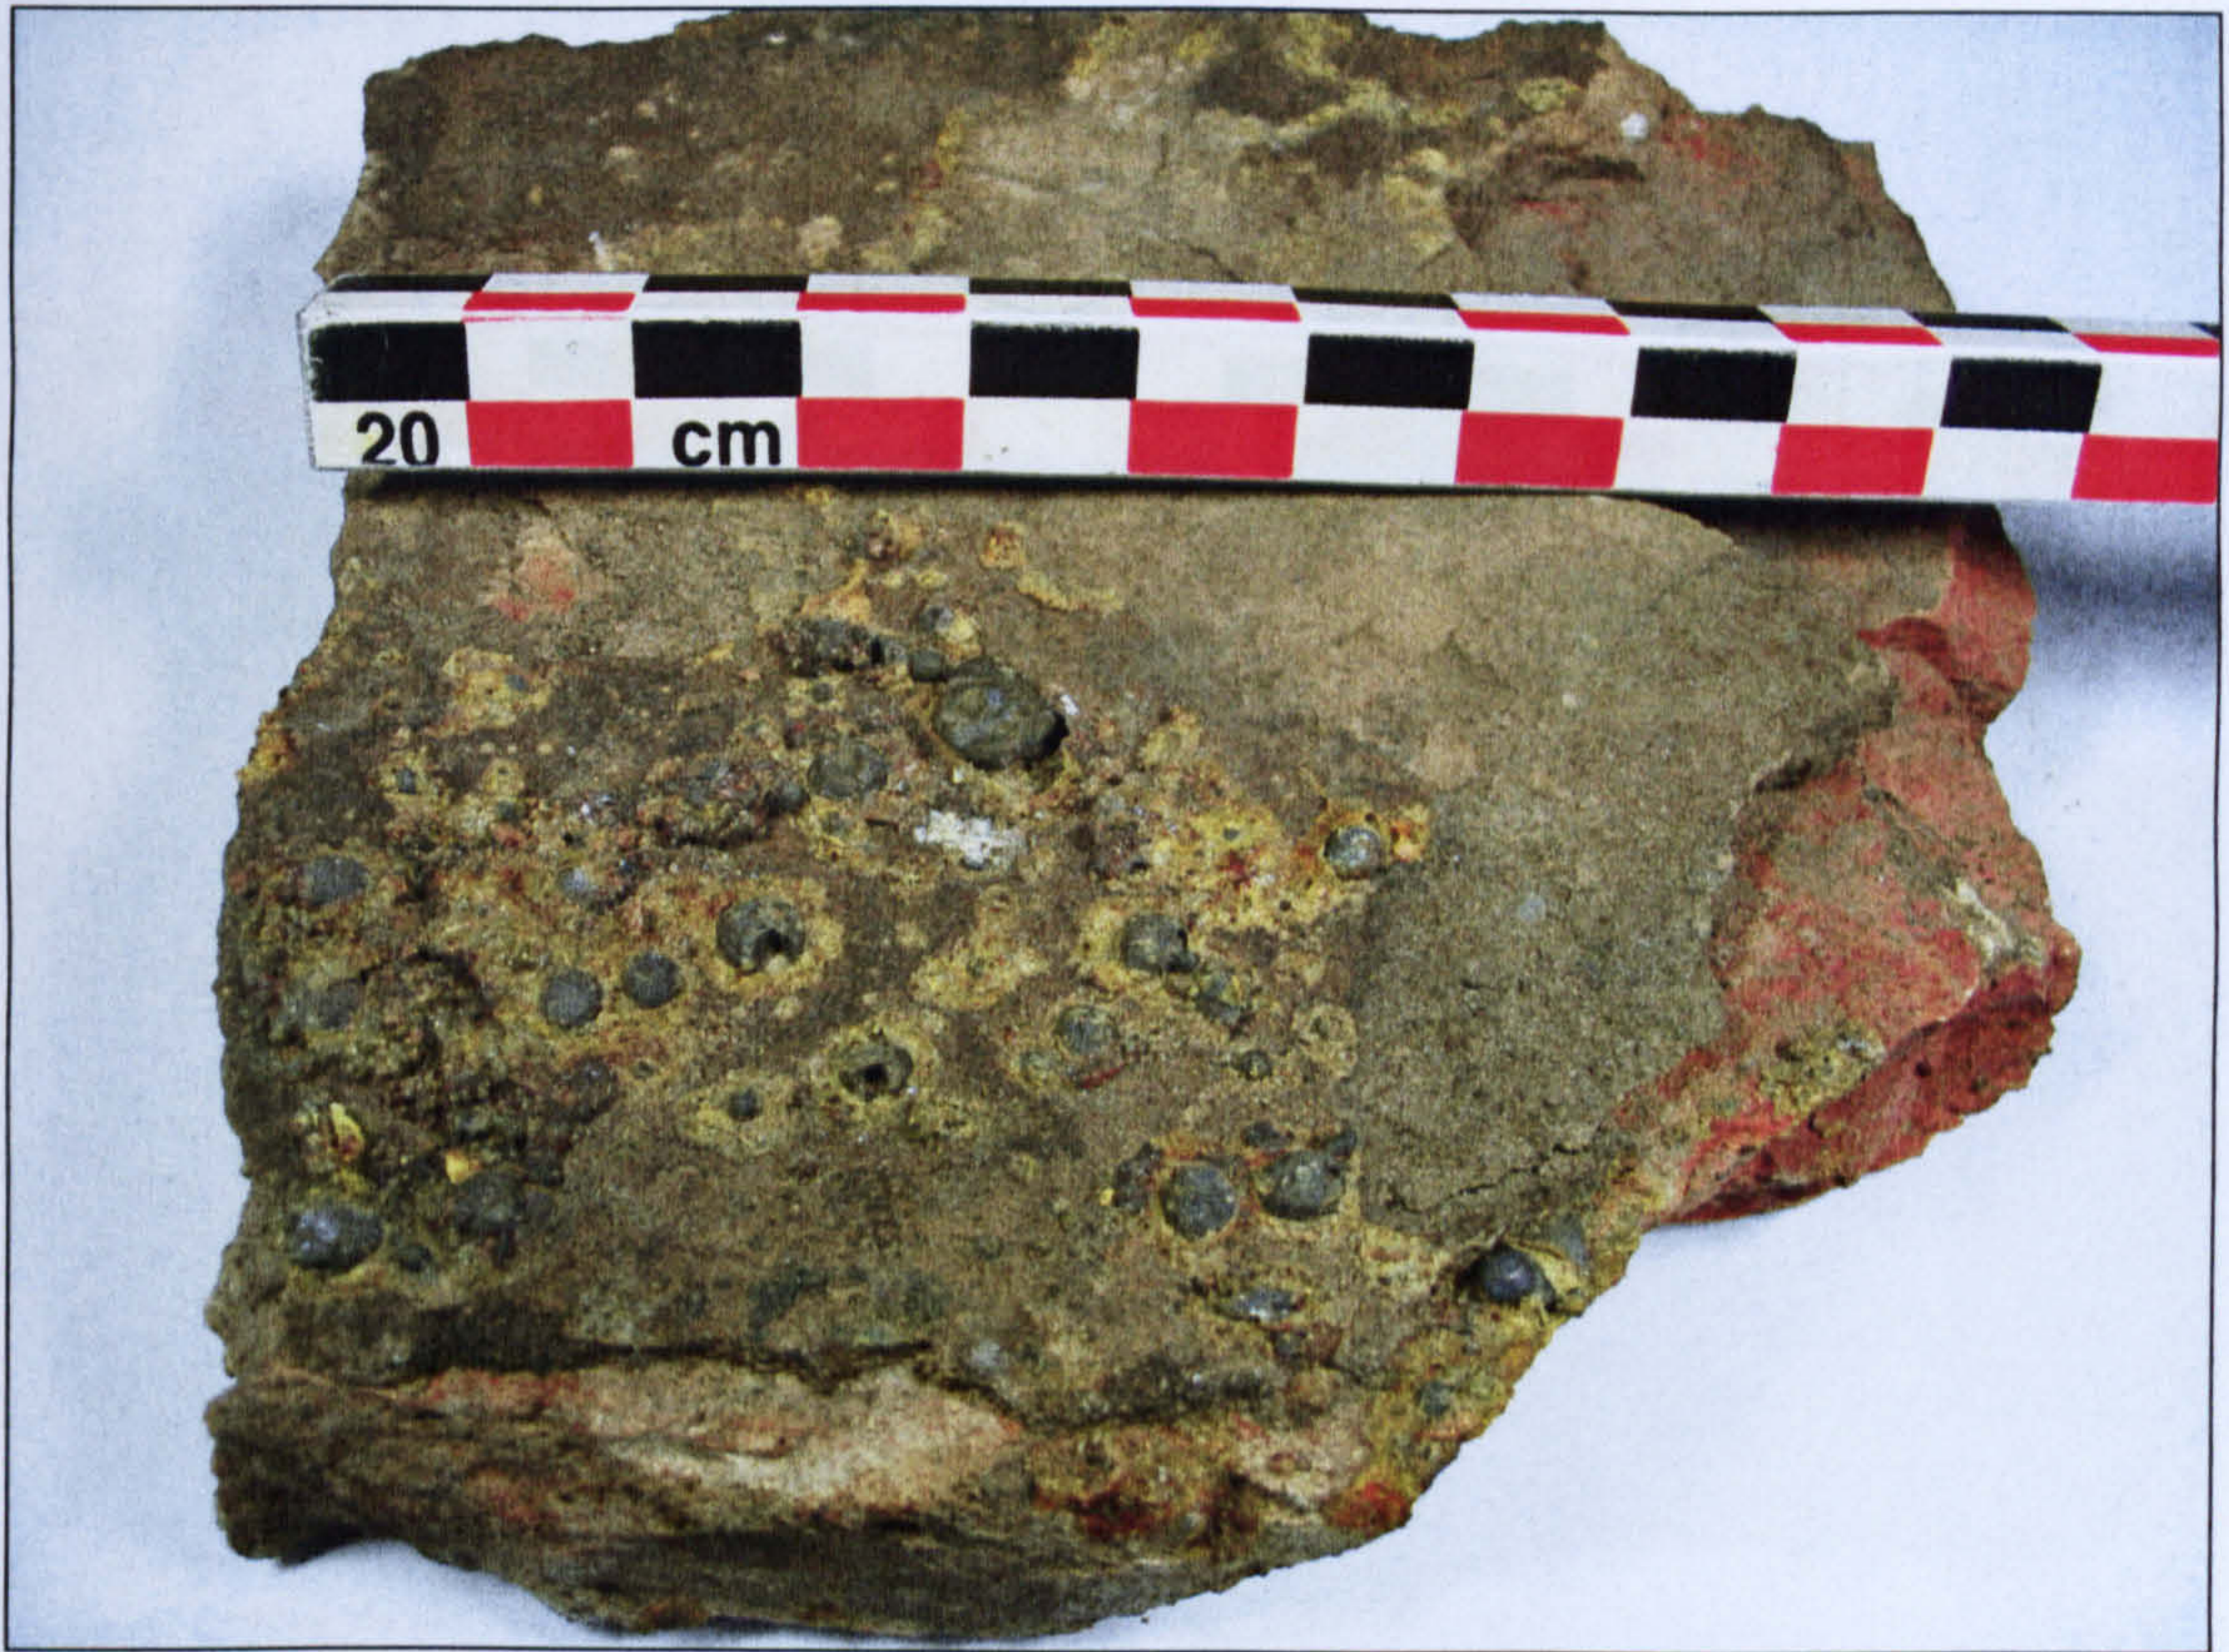
Figure 3.8 Fire damaged tile with melted drops of lead attached (Allerton Castle).

Figure 3.8 Fire damaged tile with melted drops of lead attached (Allerton Castle).

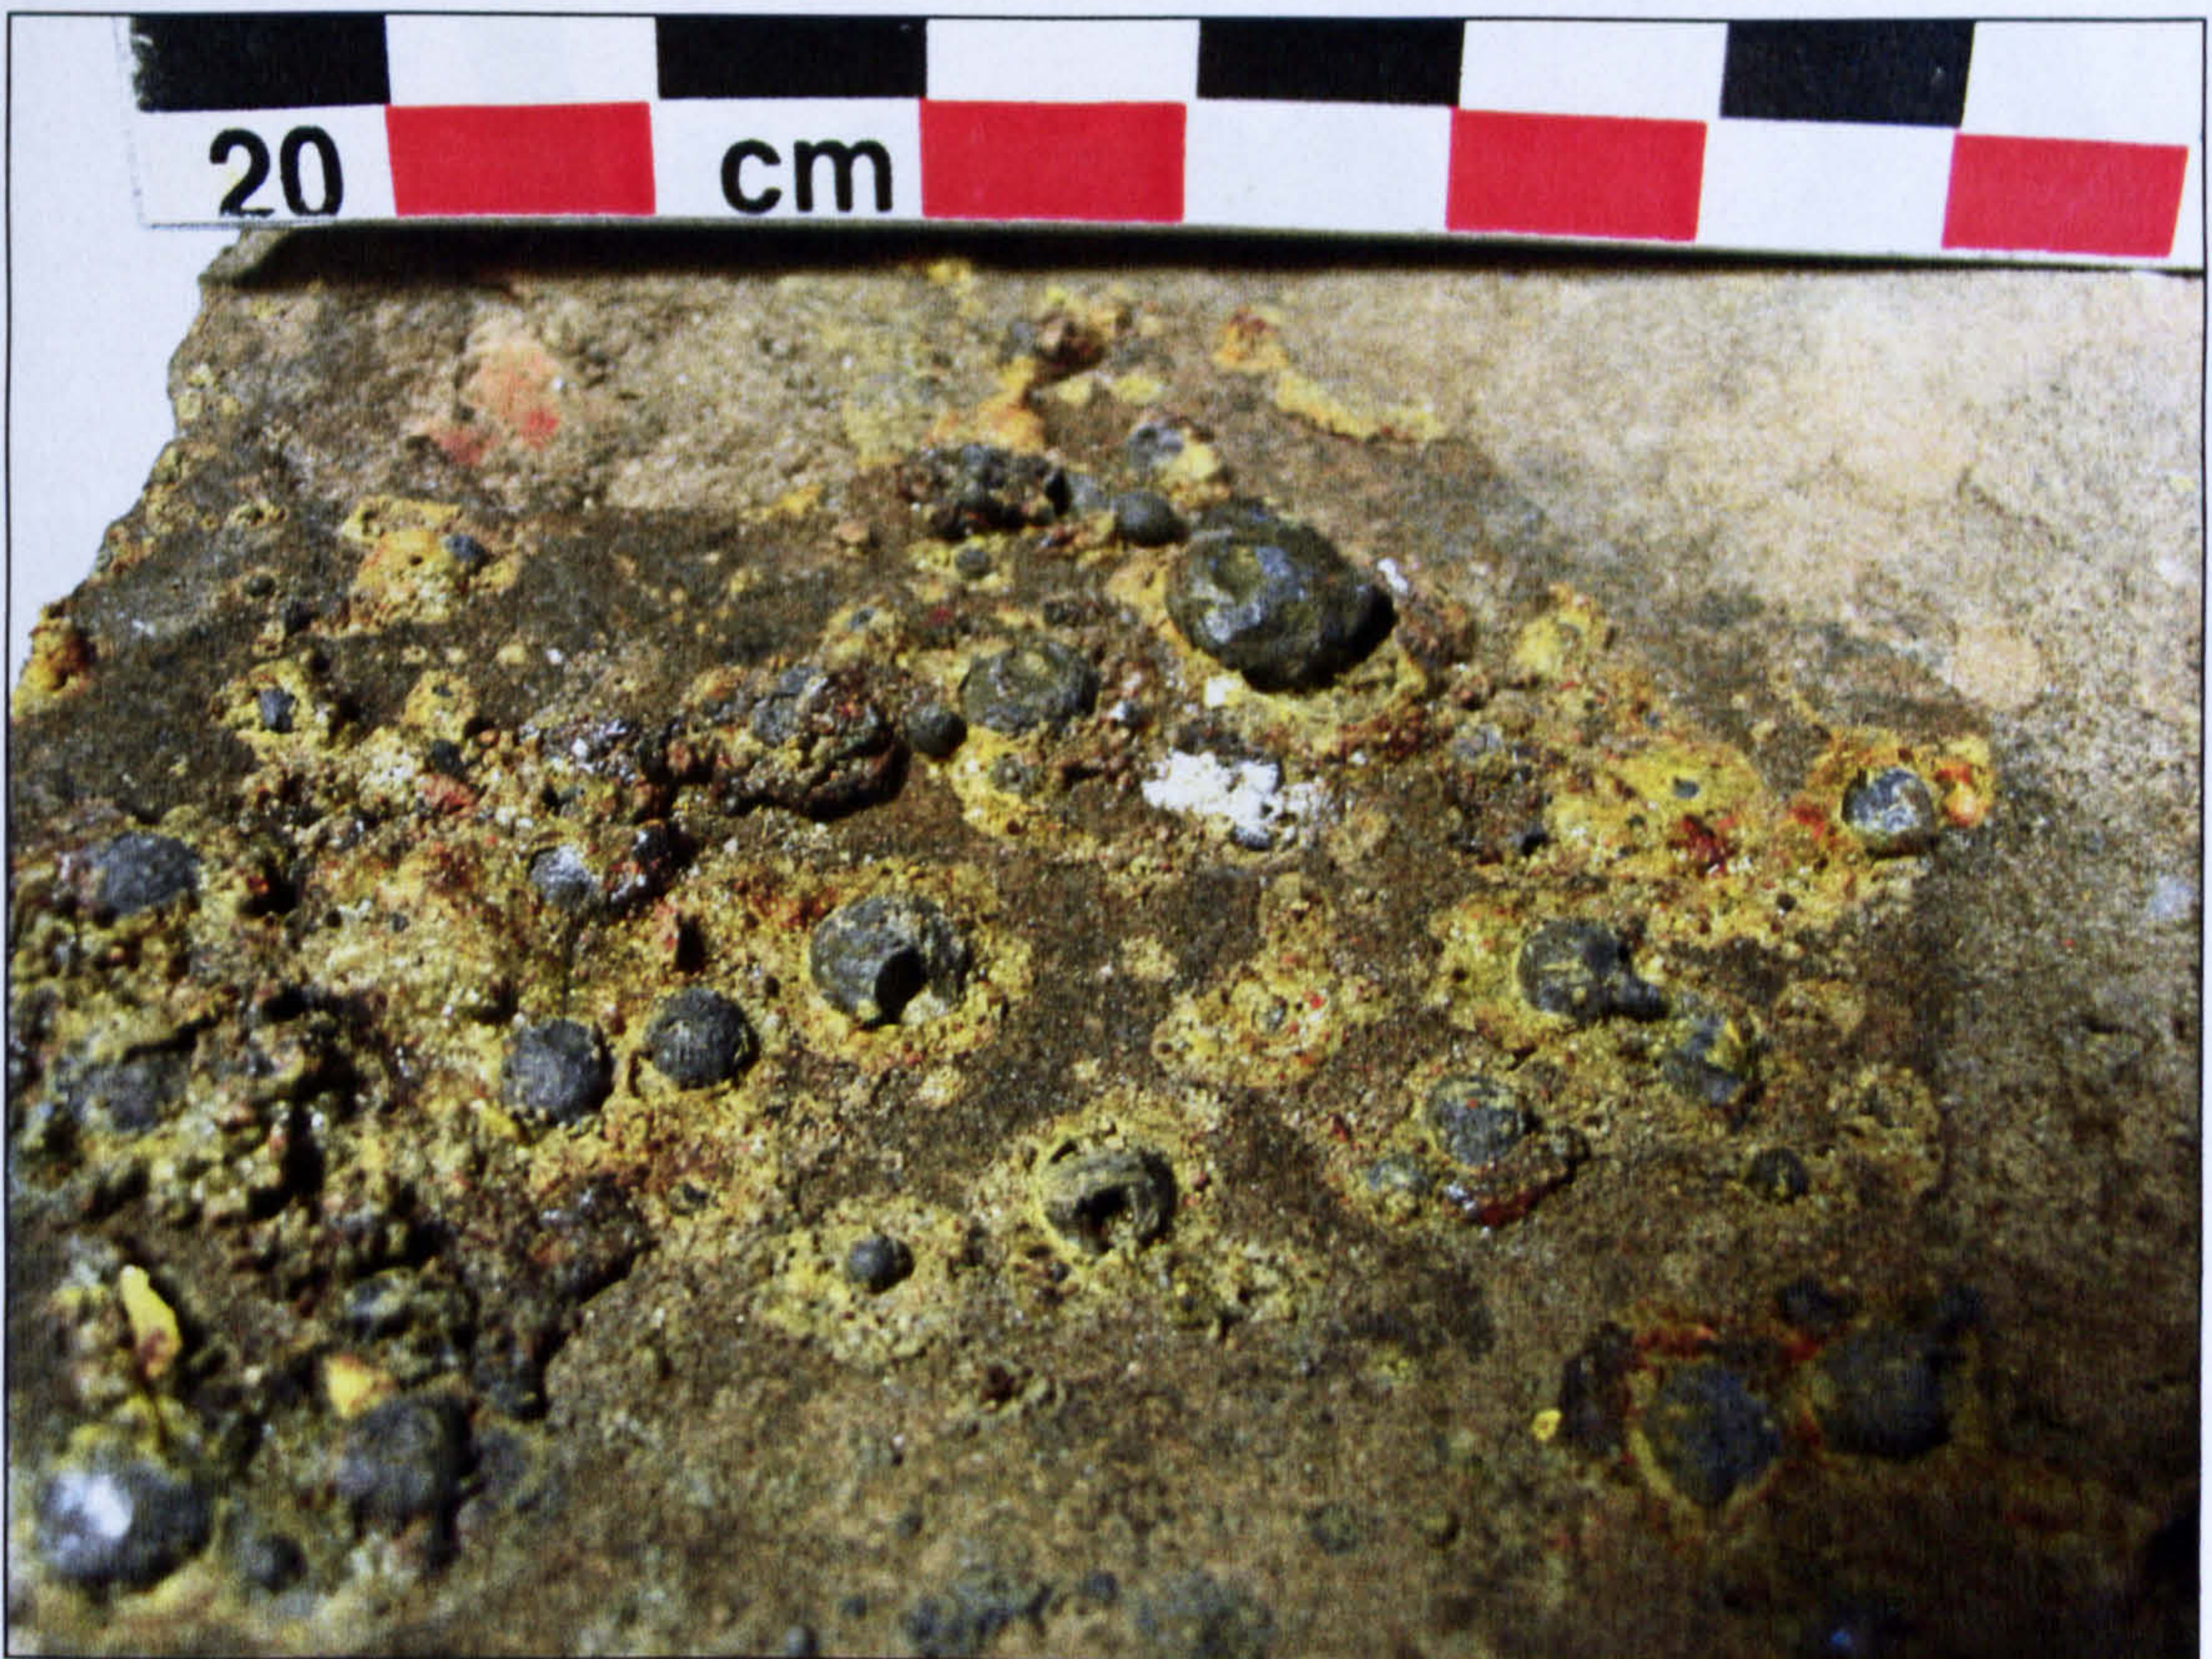
Figure 3.9 Close-up of fire damaged tile with melted drops of lead attached (Allerton Castle).

Figure 3.9 Close-up of fire damaged tile with melted drops of lead attached (Allerton Castle).

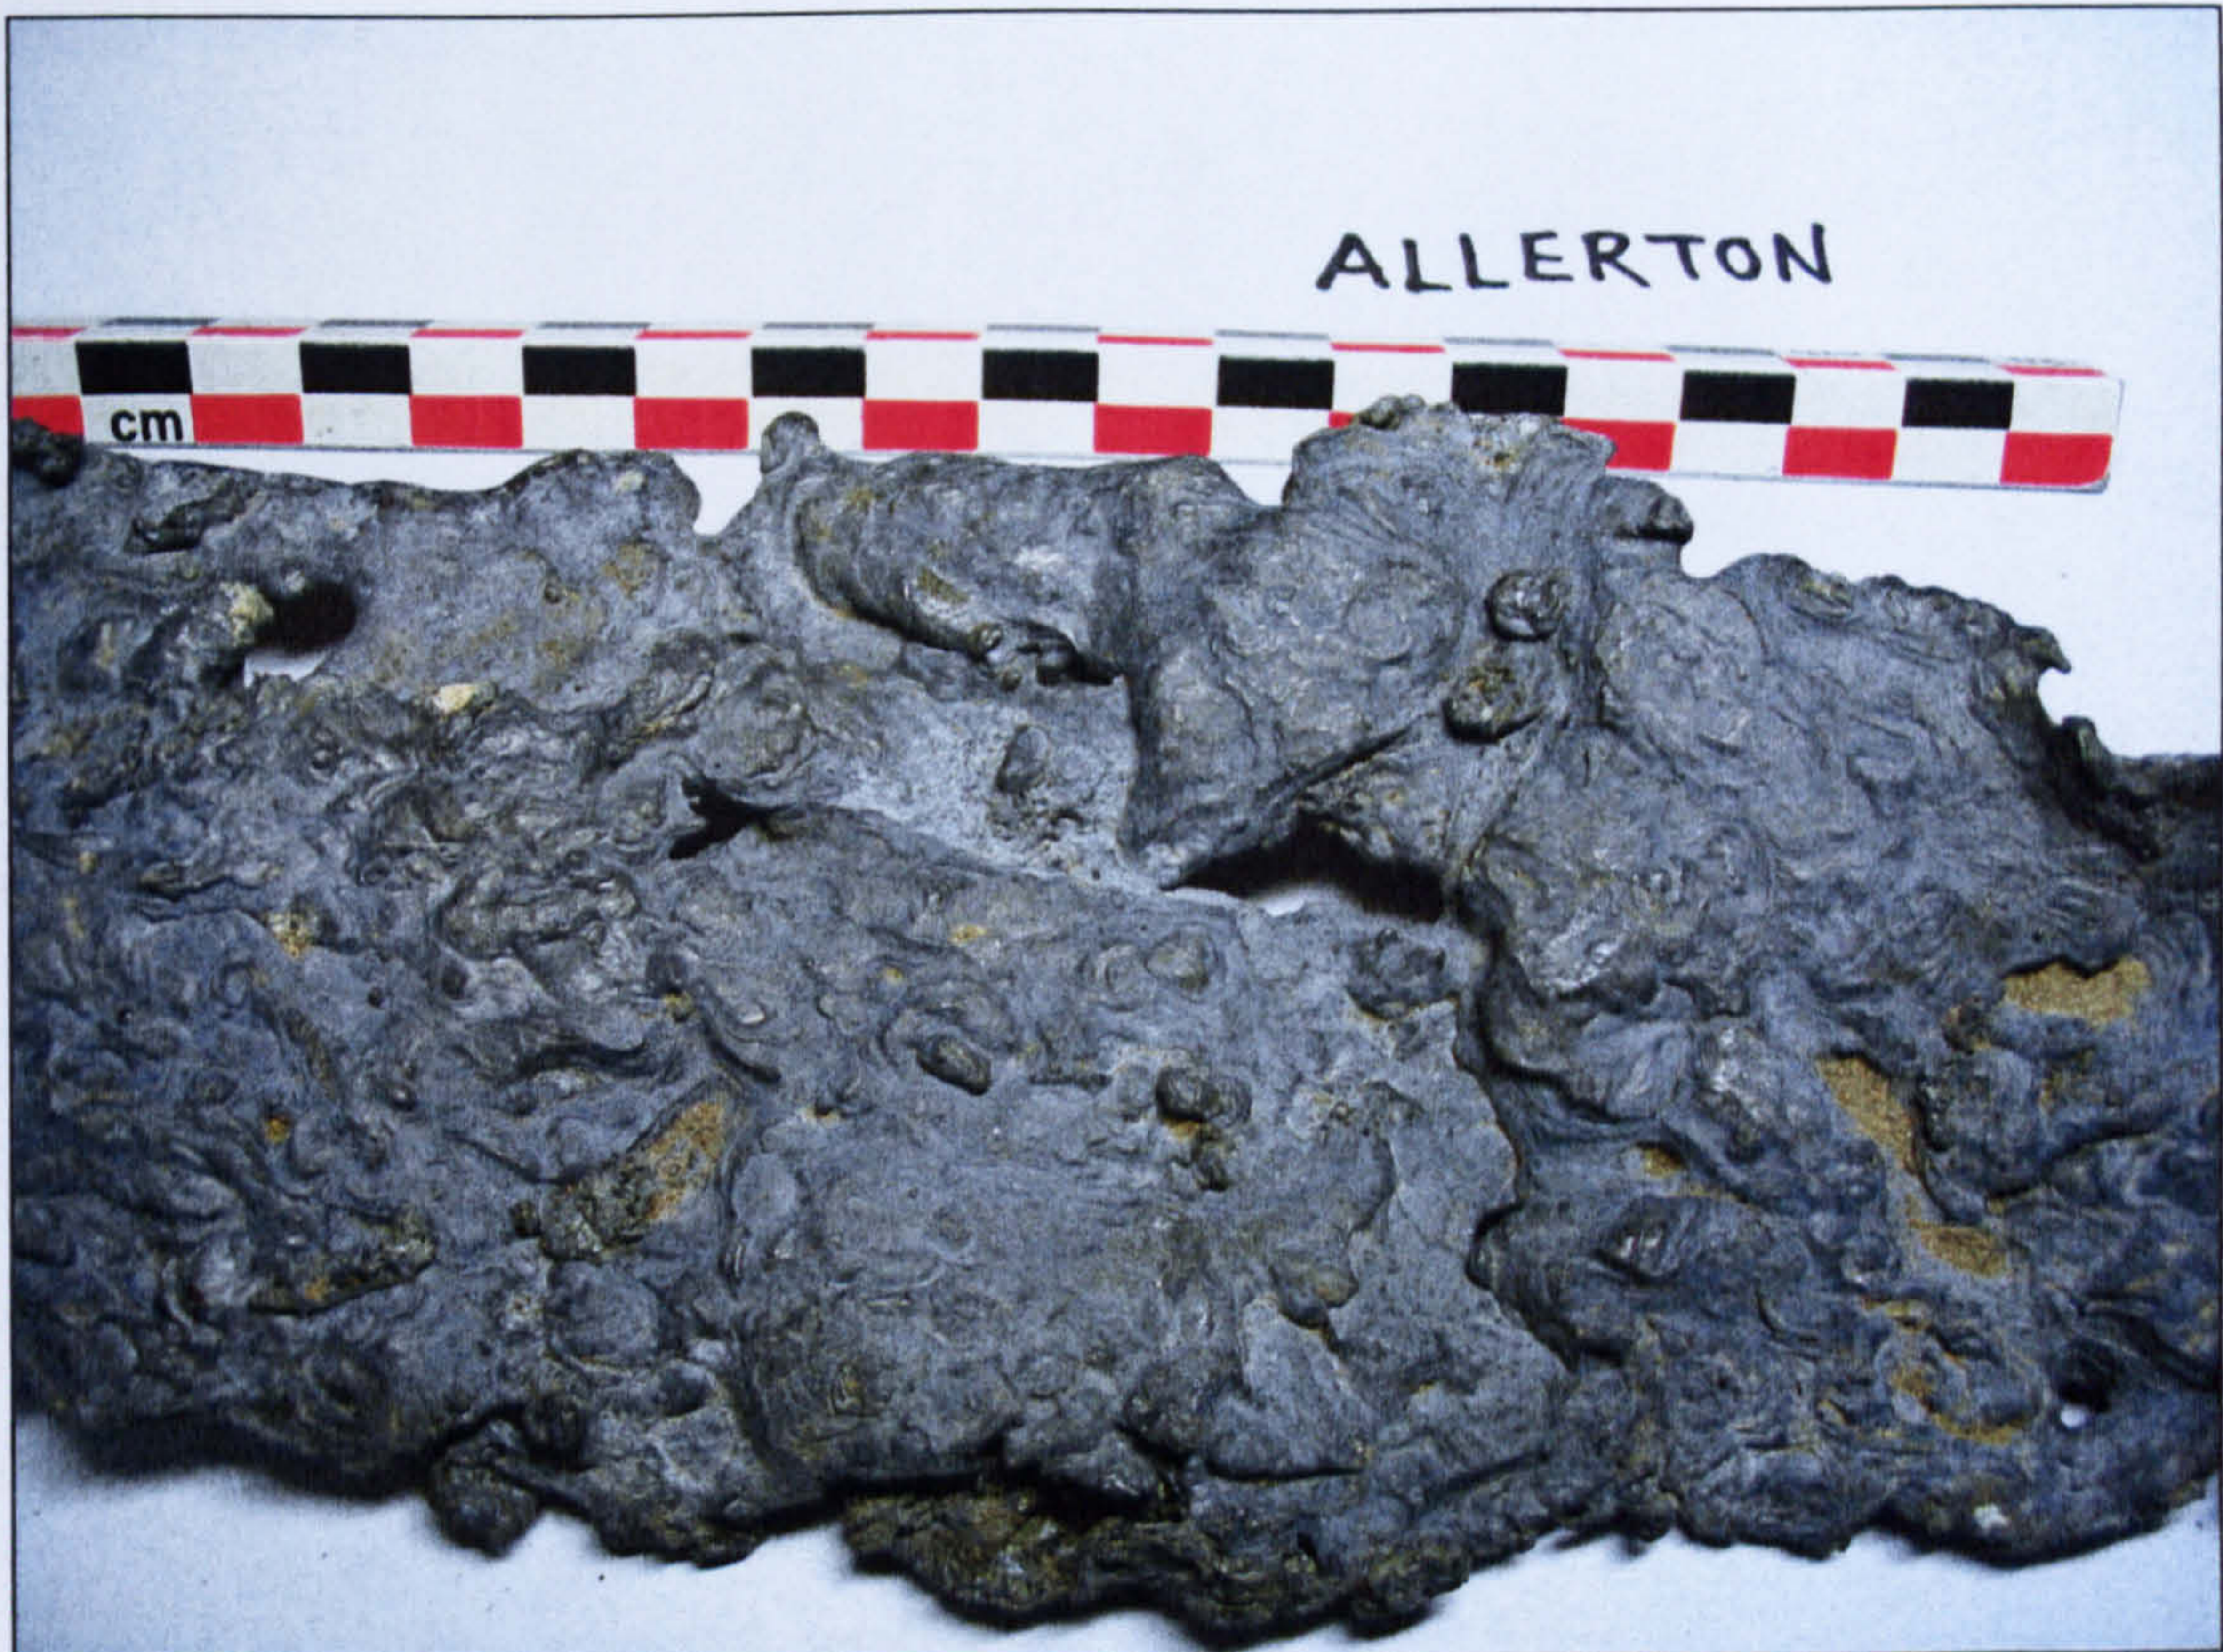
Figure 3.10 Melted lump of lead found onsite after the fire (Allerton Castle).

Figure 3.10 Melted lump of lead found onsite after the fire (Allerton Castle).
