ARCHAEOLOGY OF DESTRUCTION

A REINTERPRETATION OF CASTLE SLIGHTINGS IN THE ENGLISH CIVIL WAR

Thesis submitted for the degree of
Doctor of Philosophy
University of York
Department of Archaeology

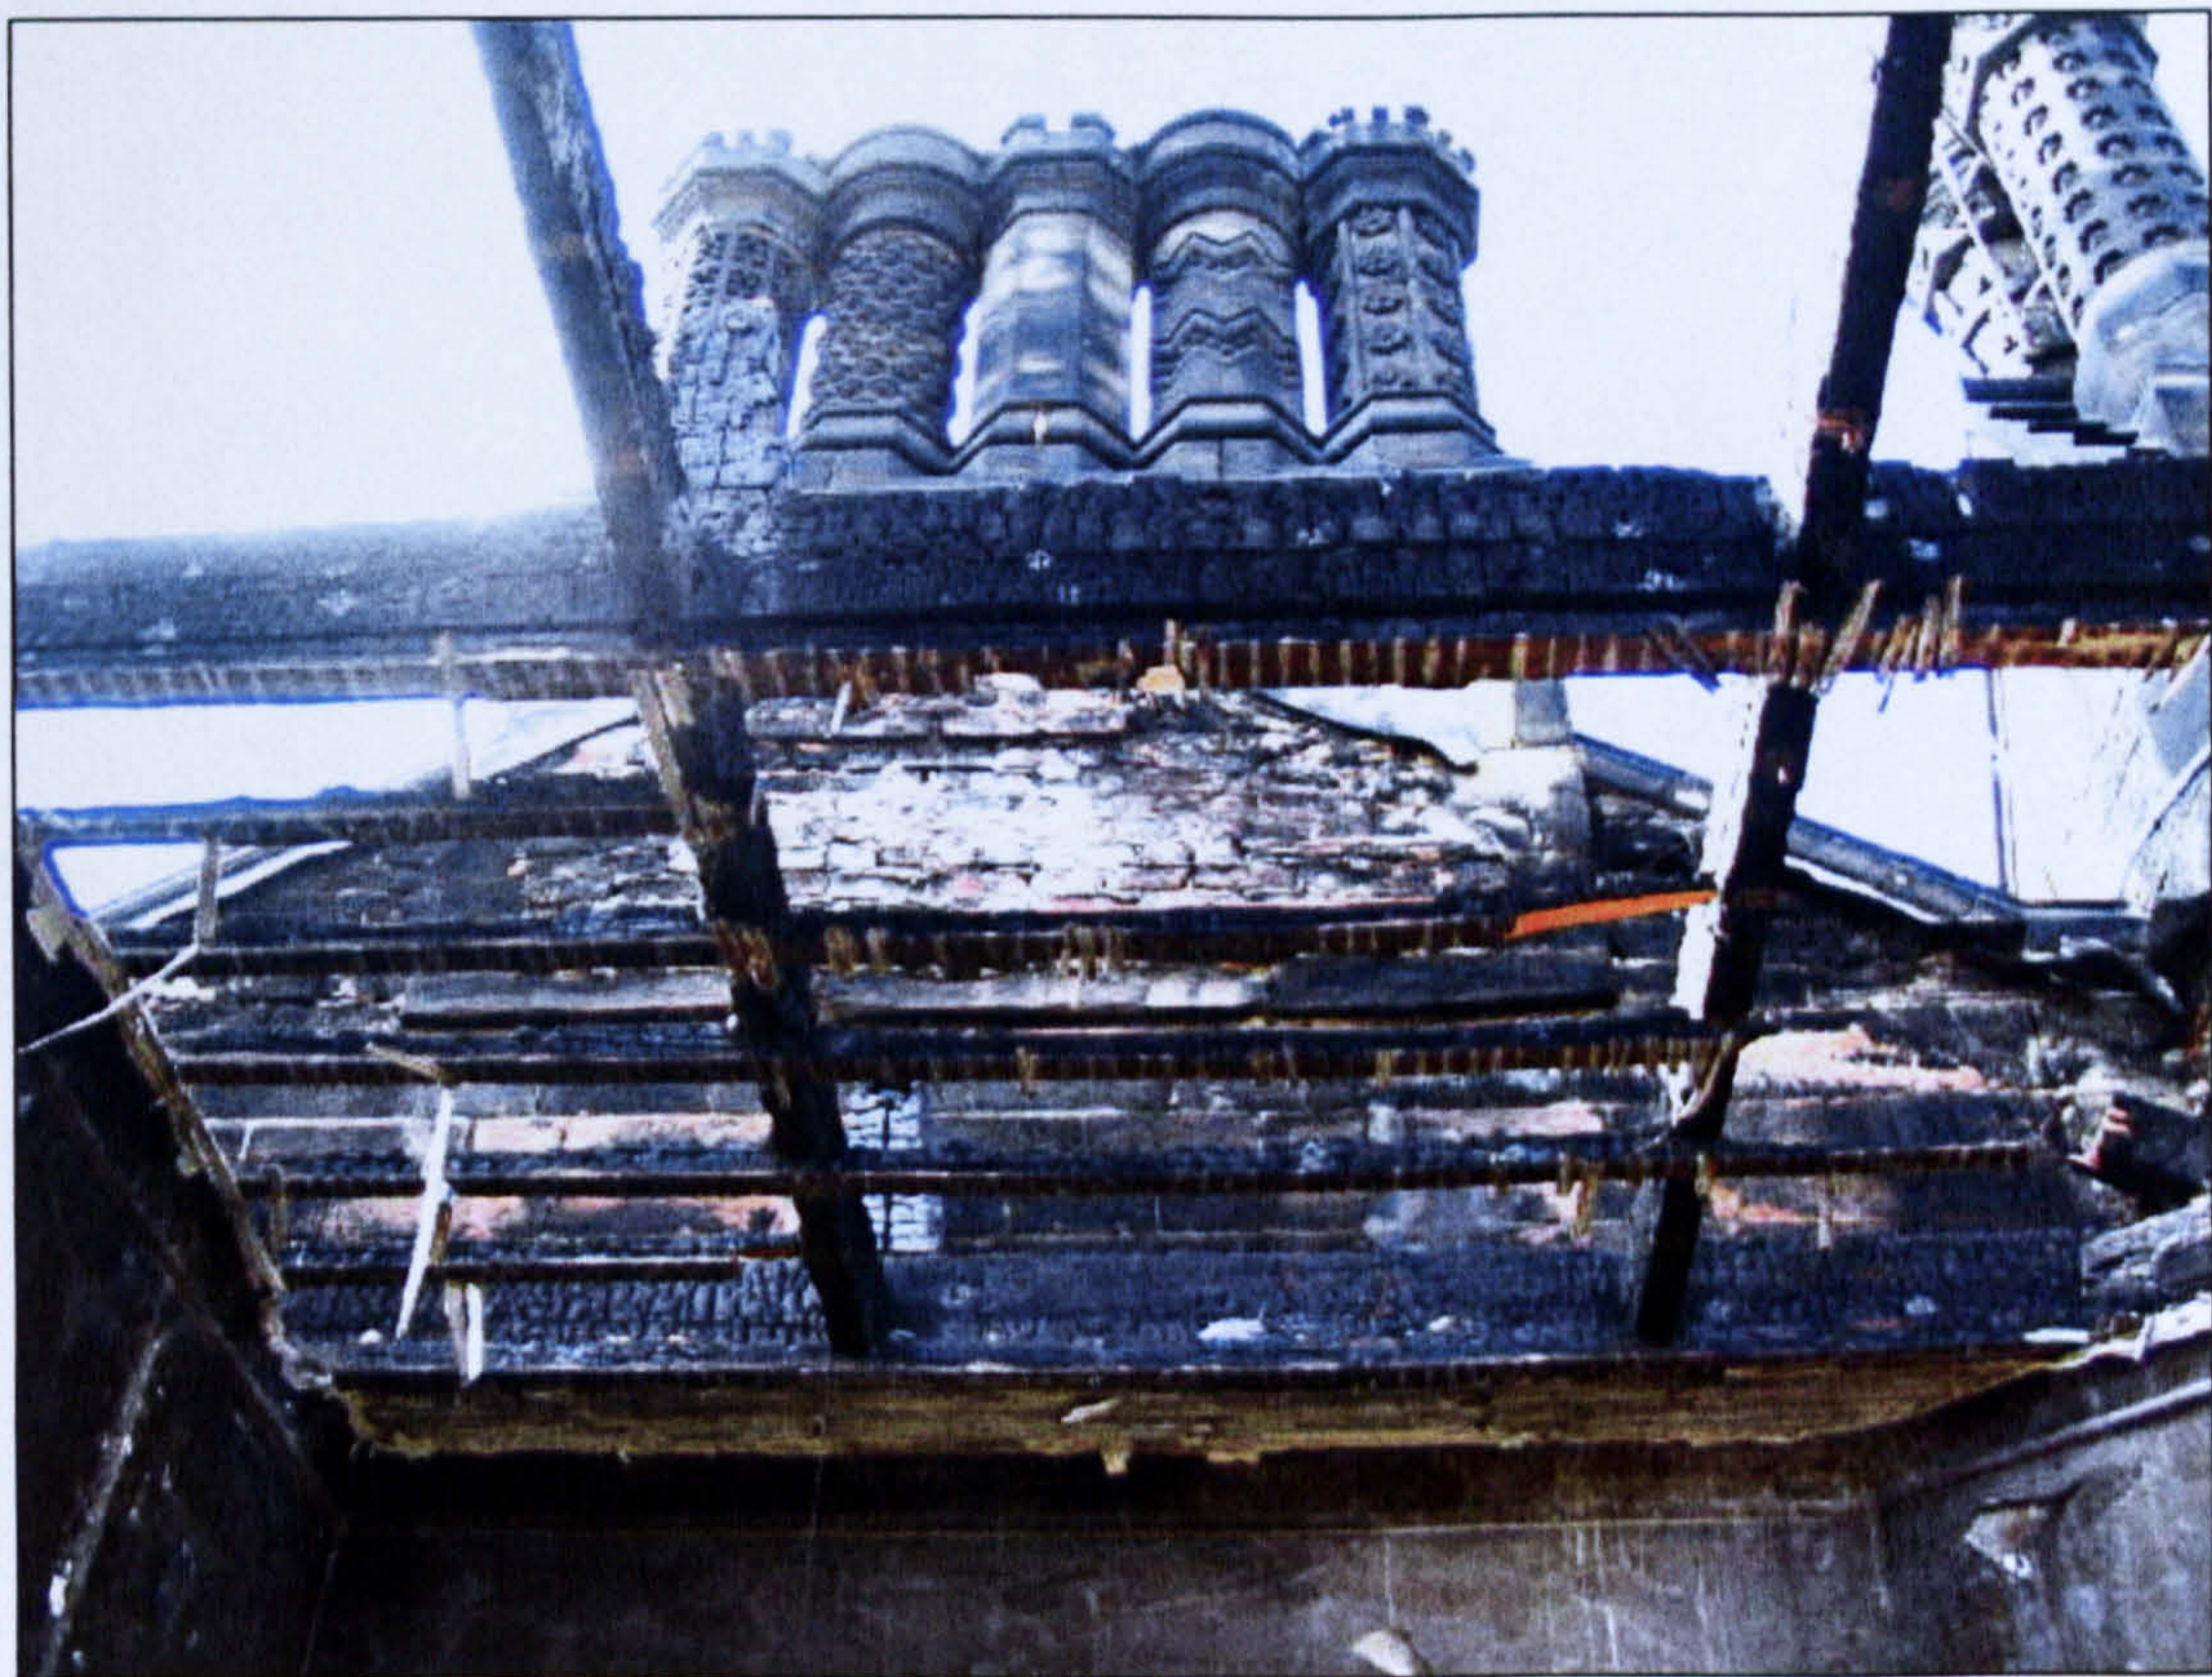
Figure 3.11 Roofing timber beams still *in situ*, showing signs of surface charring (Allerton Castle).

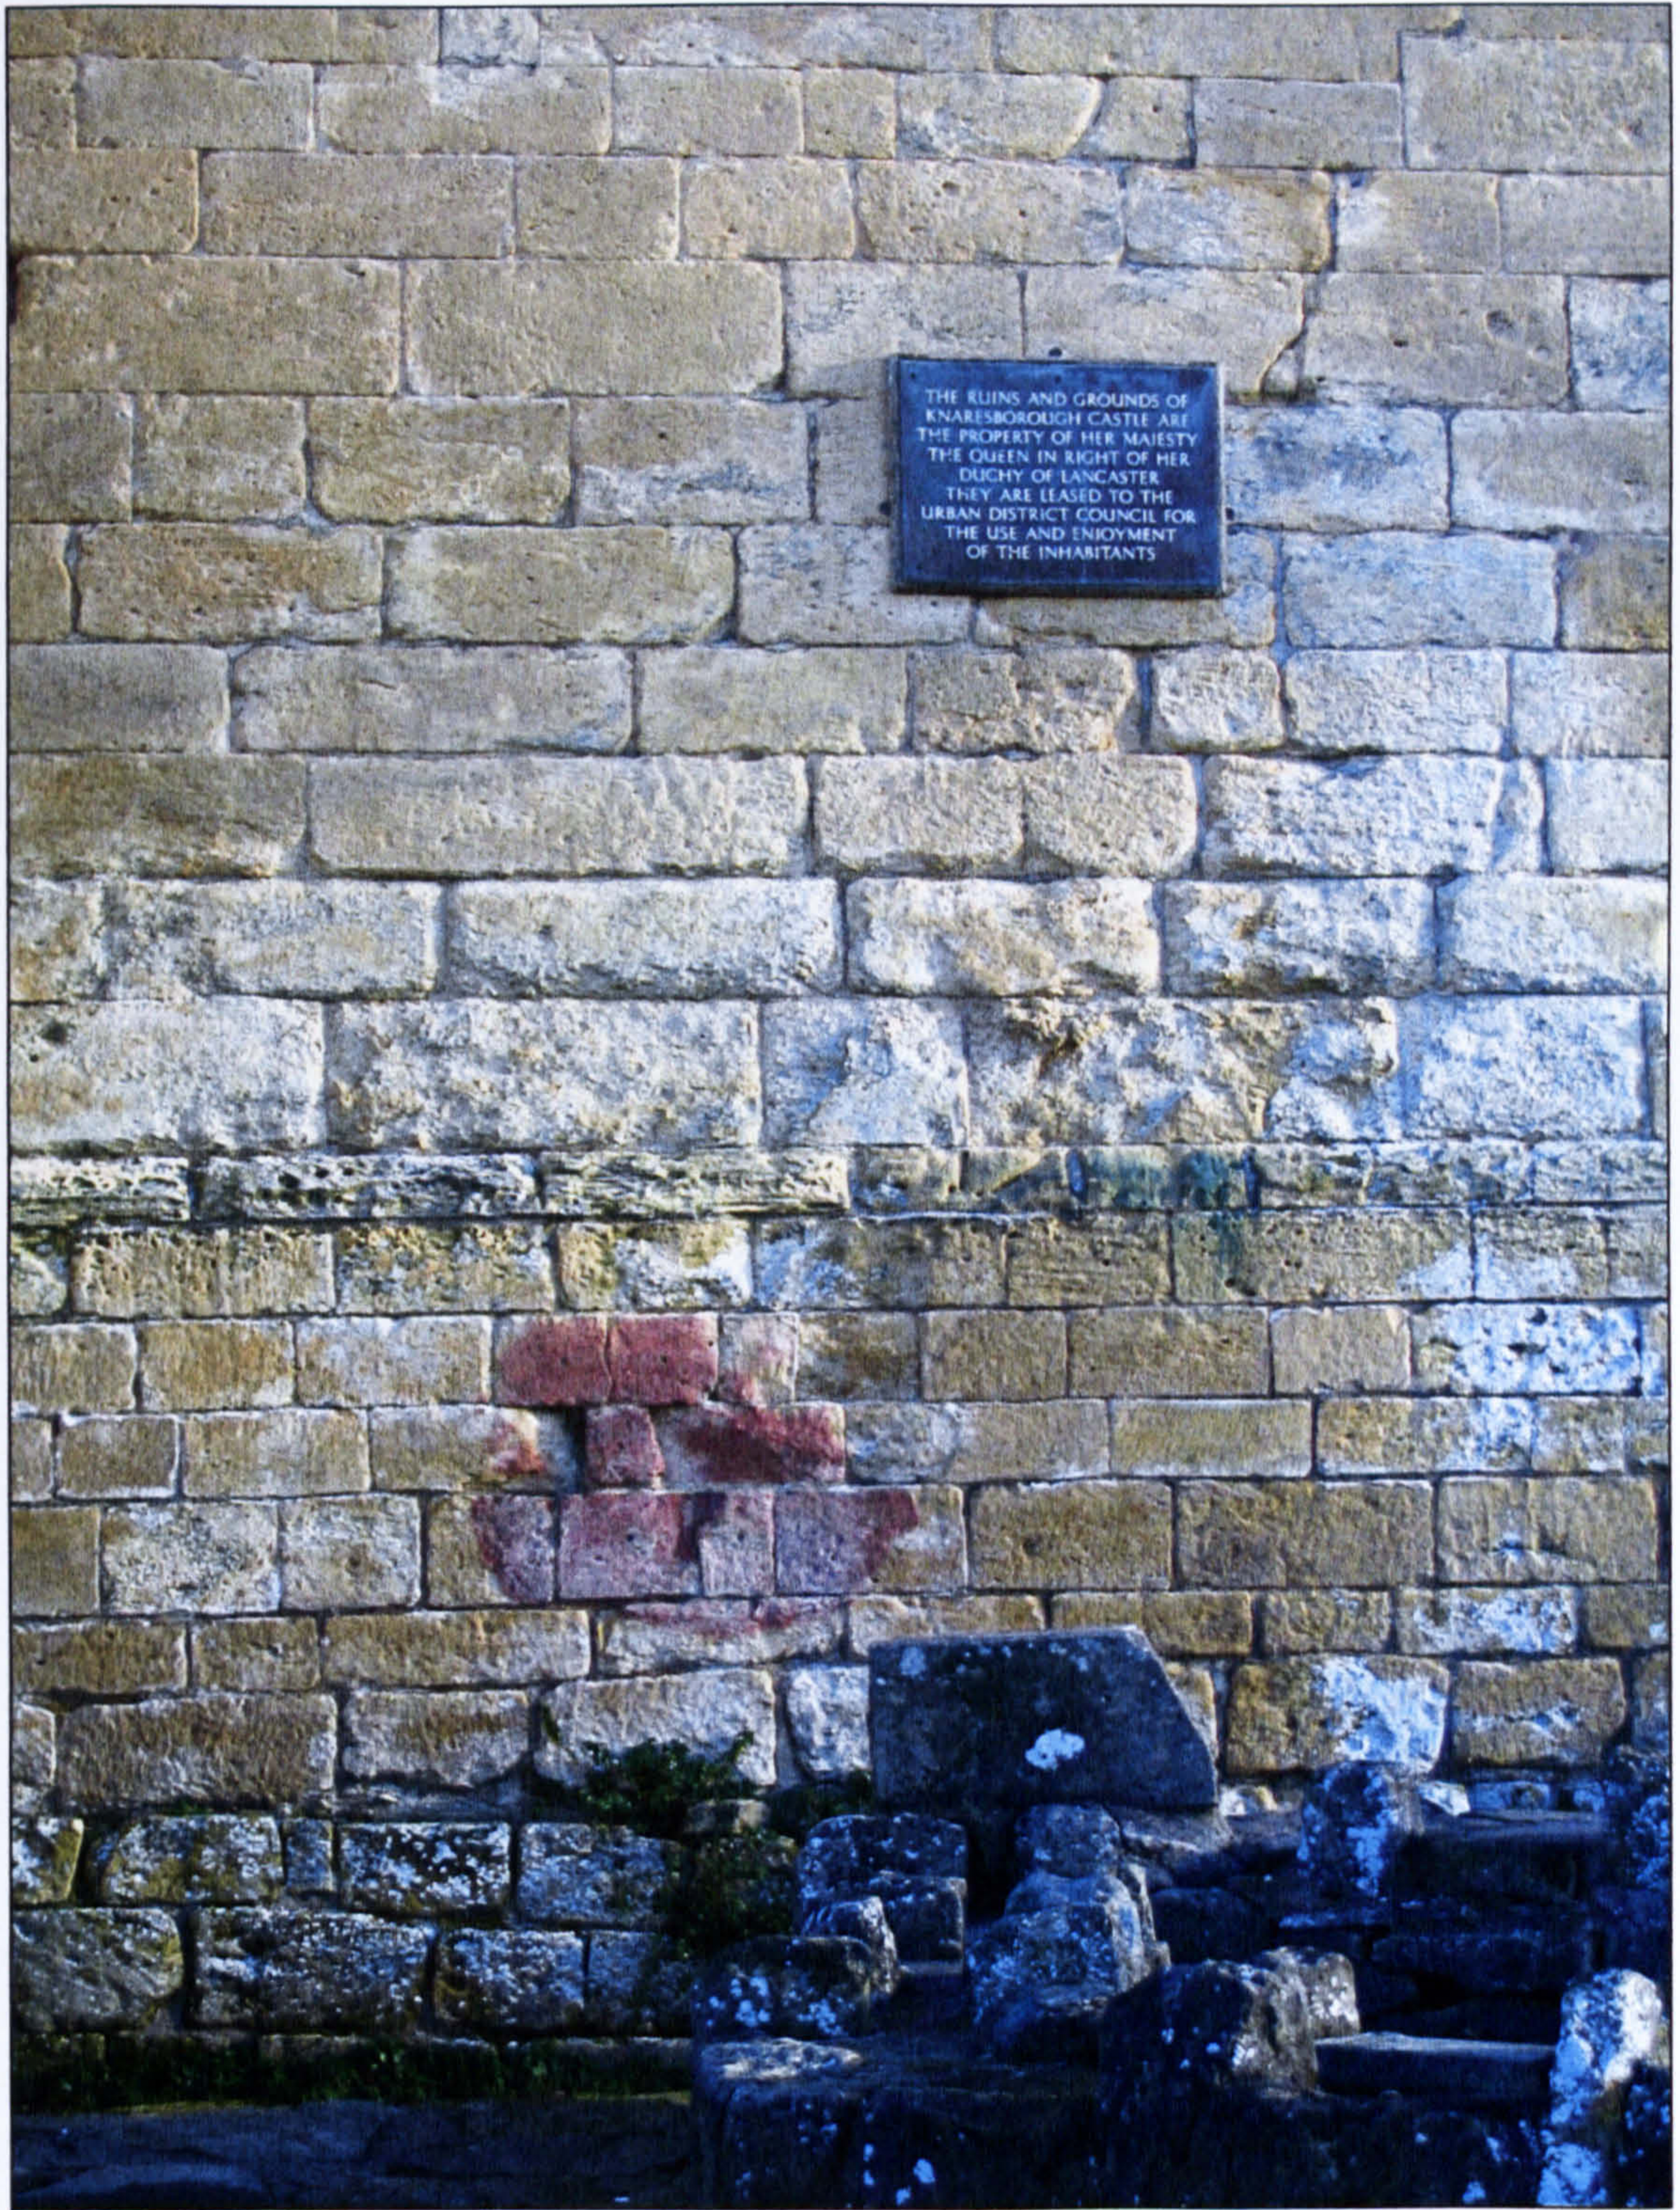
Figure 3.12 West side of keep, showing a small fire damage pattern low to the ground (Knaresborough Castle).

Figure 3.12 West side of keep, showing a small fire damage pattern low to the ground (Knaresborough Castle).

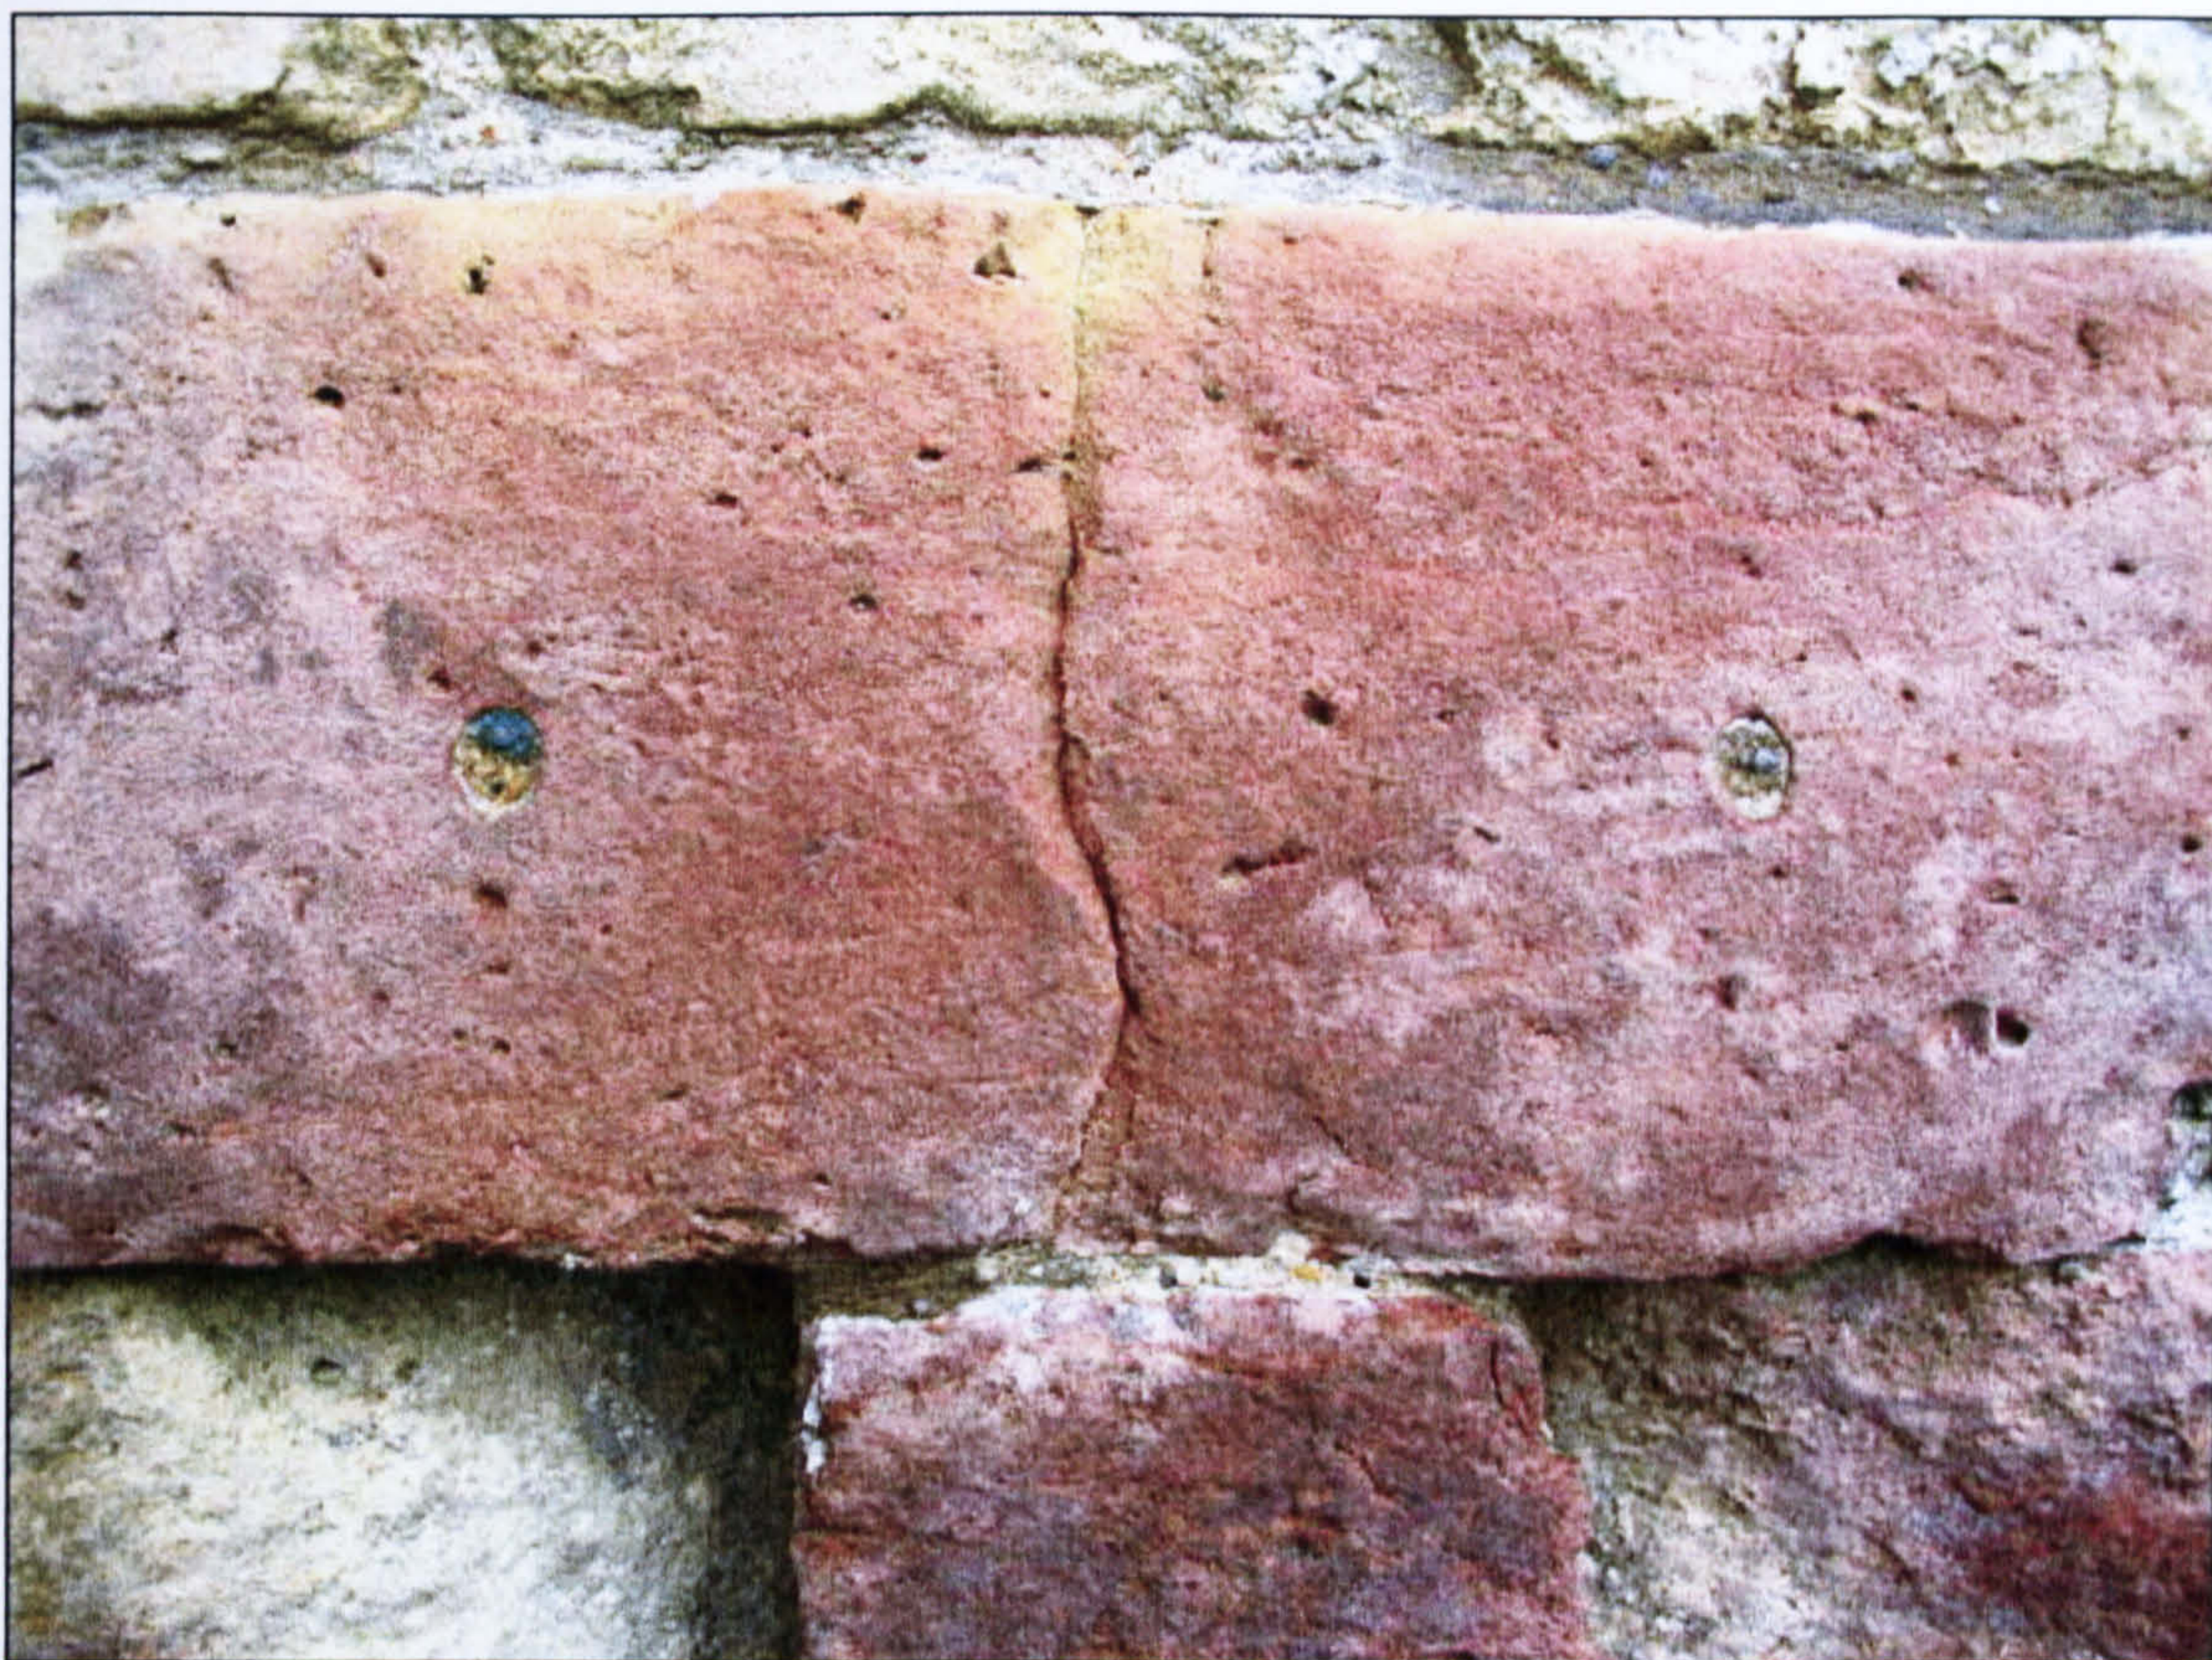
Figure 3.13 Close-up of the Knaresborough keep damage pattern, showing the twin bore holes on either side of the centre crack.

Figure 3.13 Close-up of the Knaresborough keep damage pattern, showing the twin bore holes on either side of the centre crack.

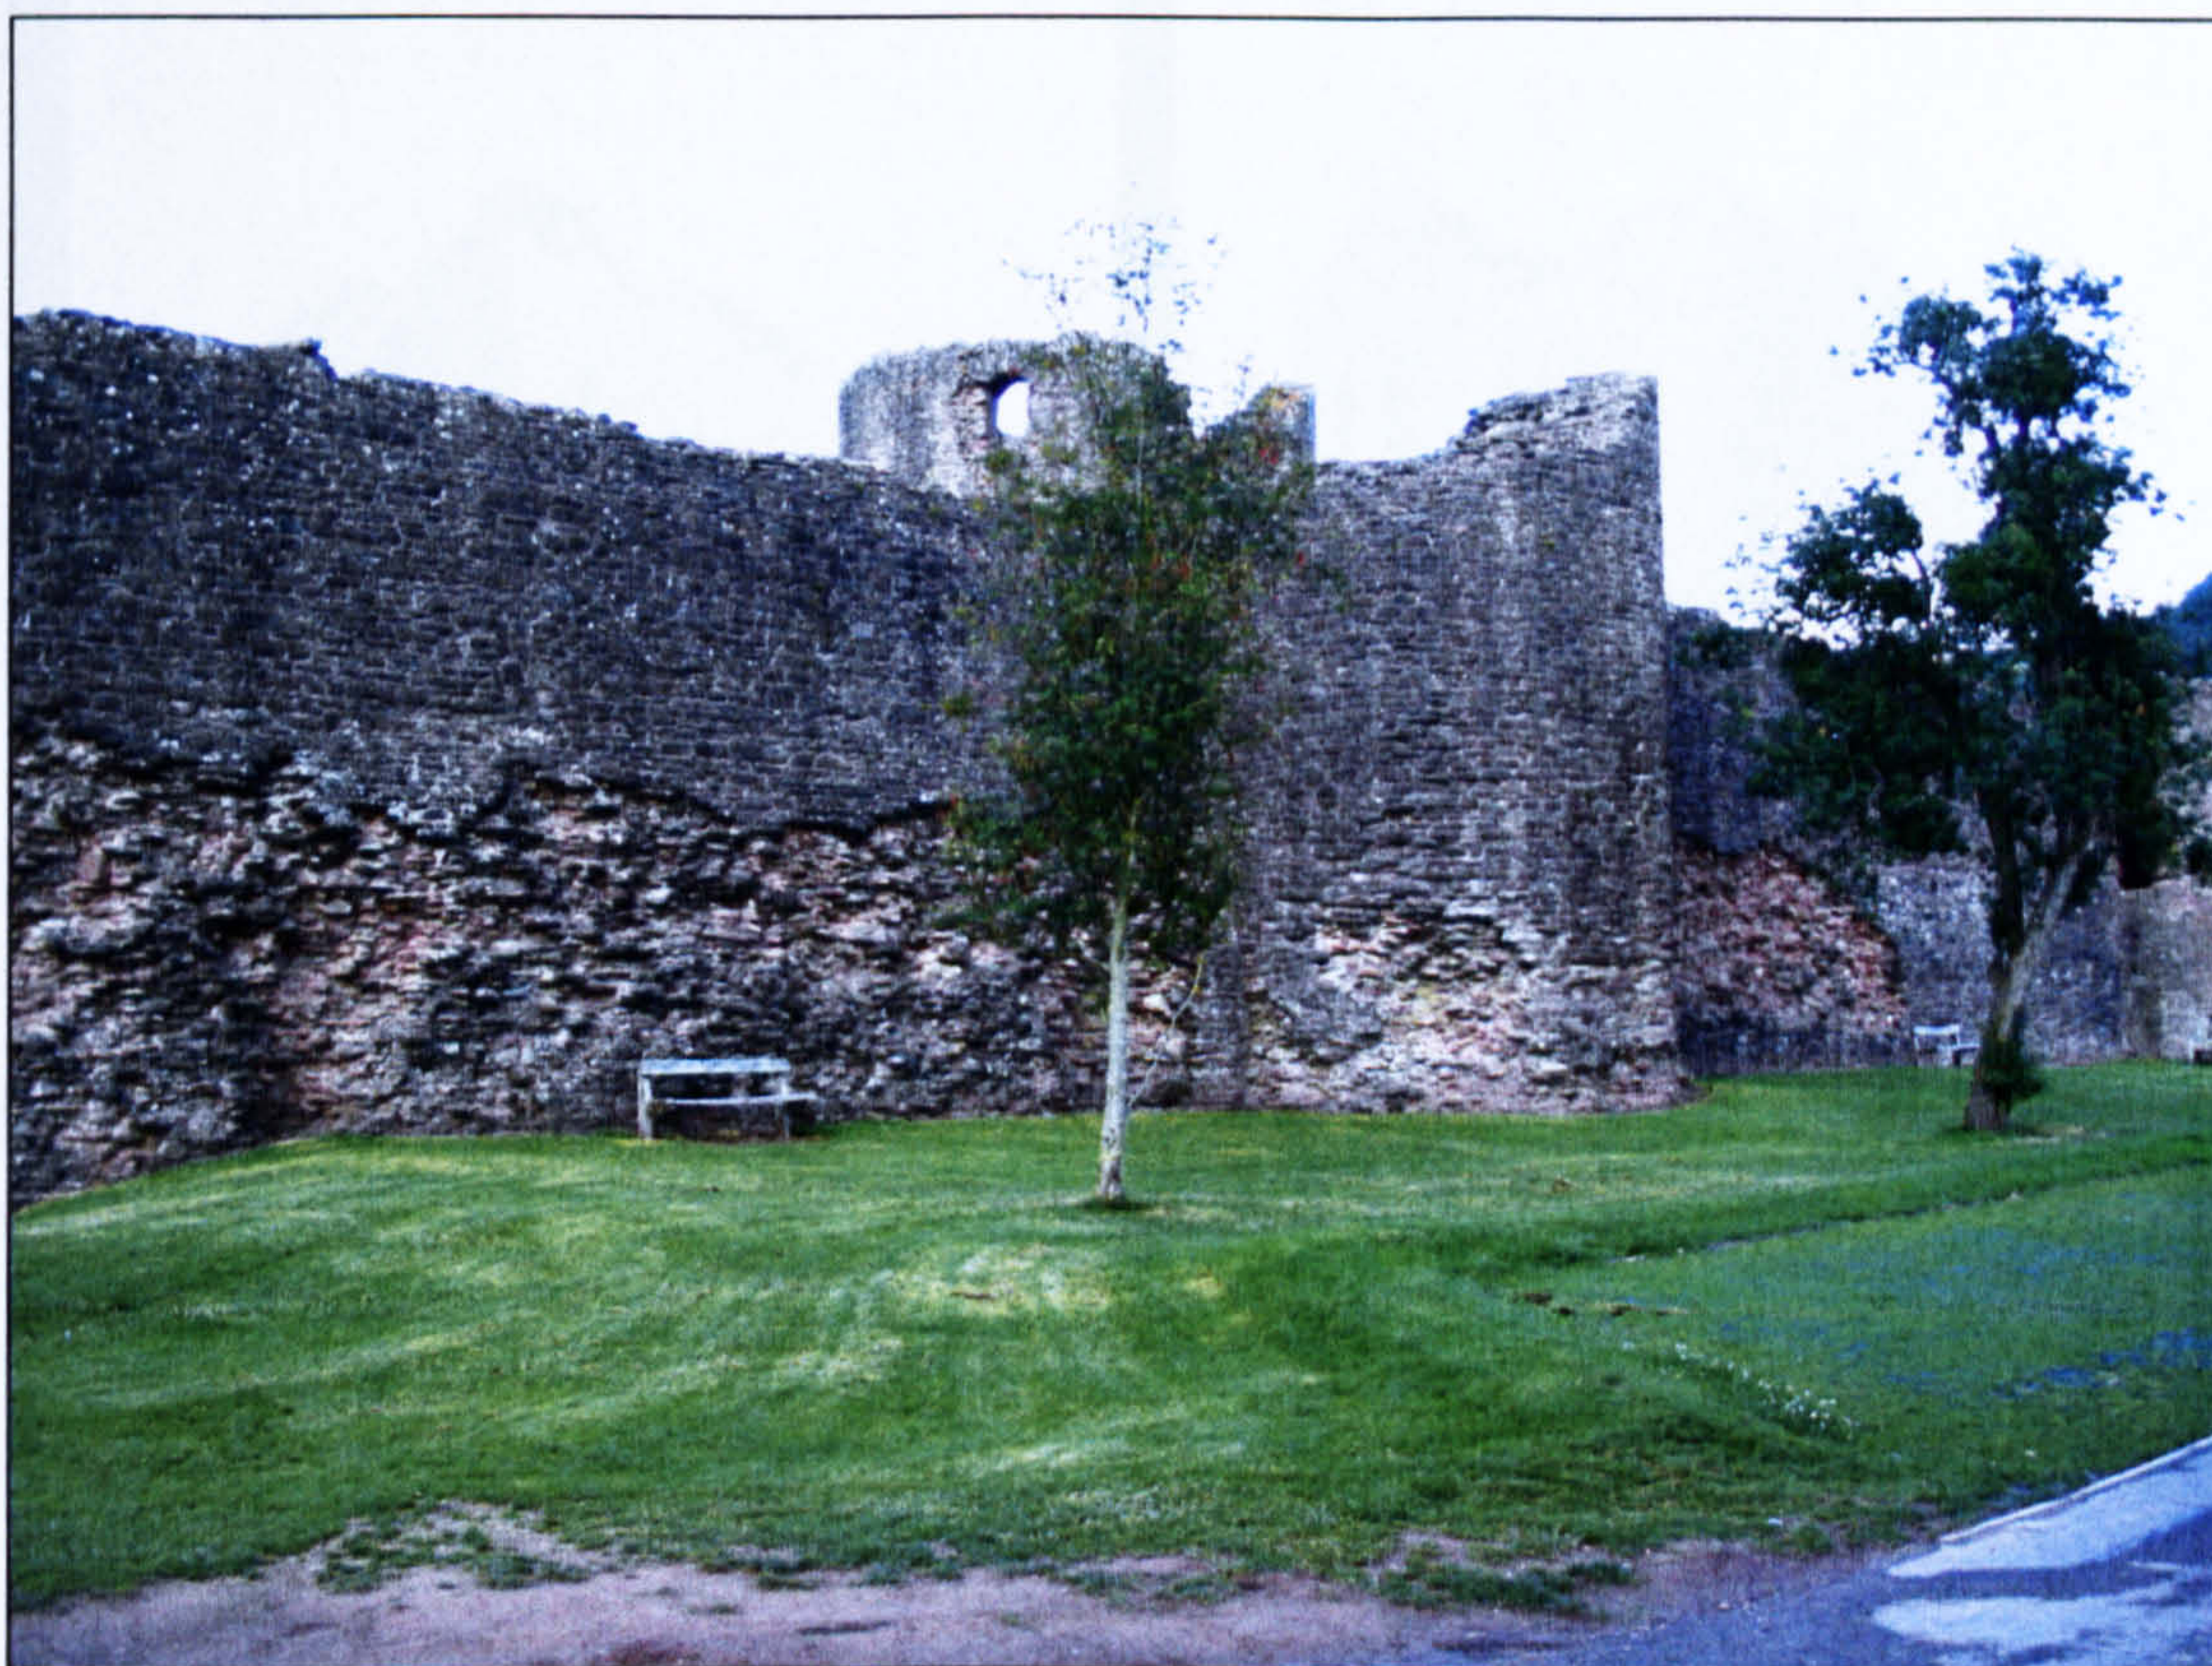
Figure 3.14 External wall of Skenrith Castle (Wales) showing robbed out lower half.

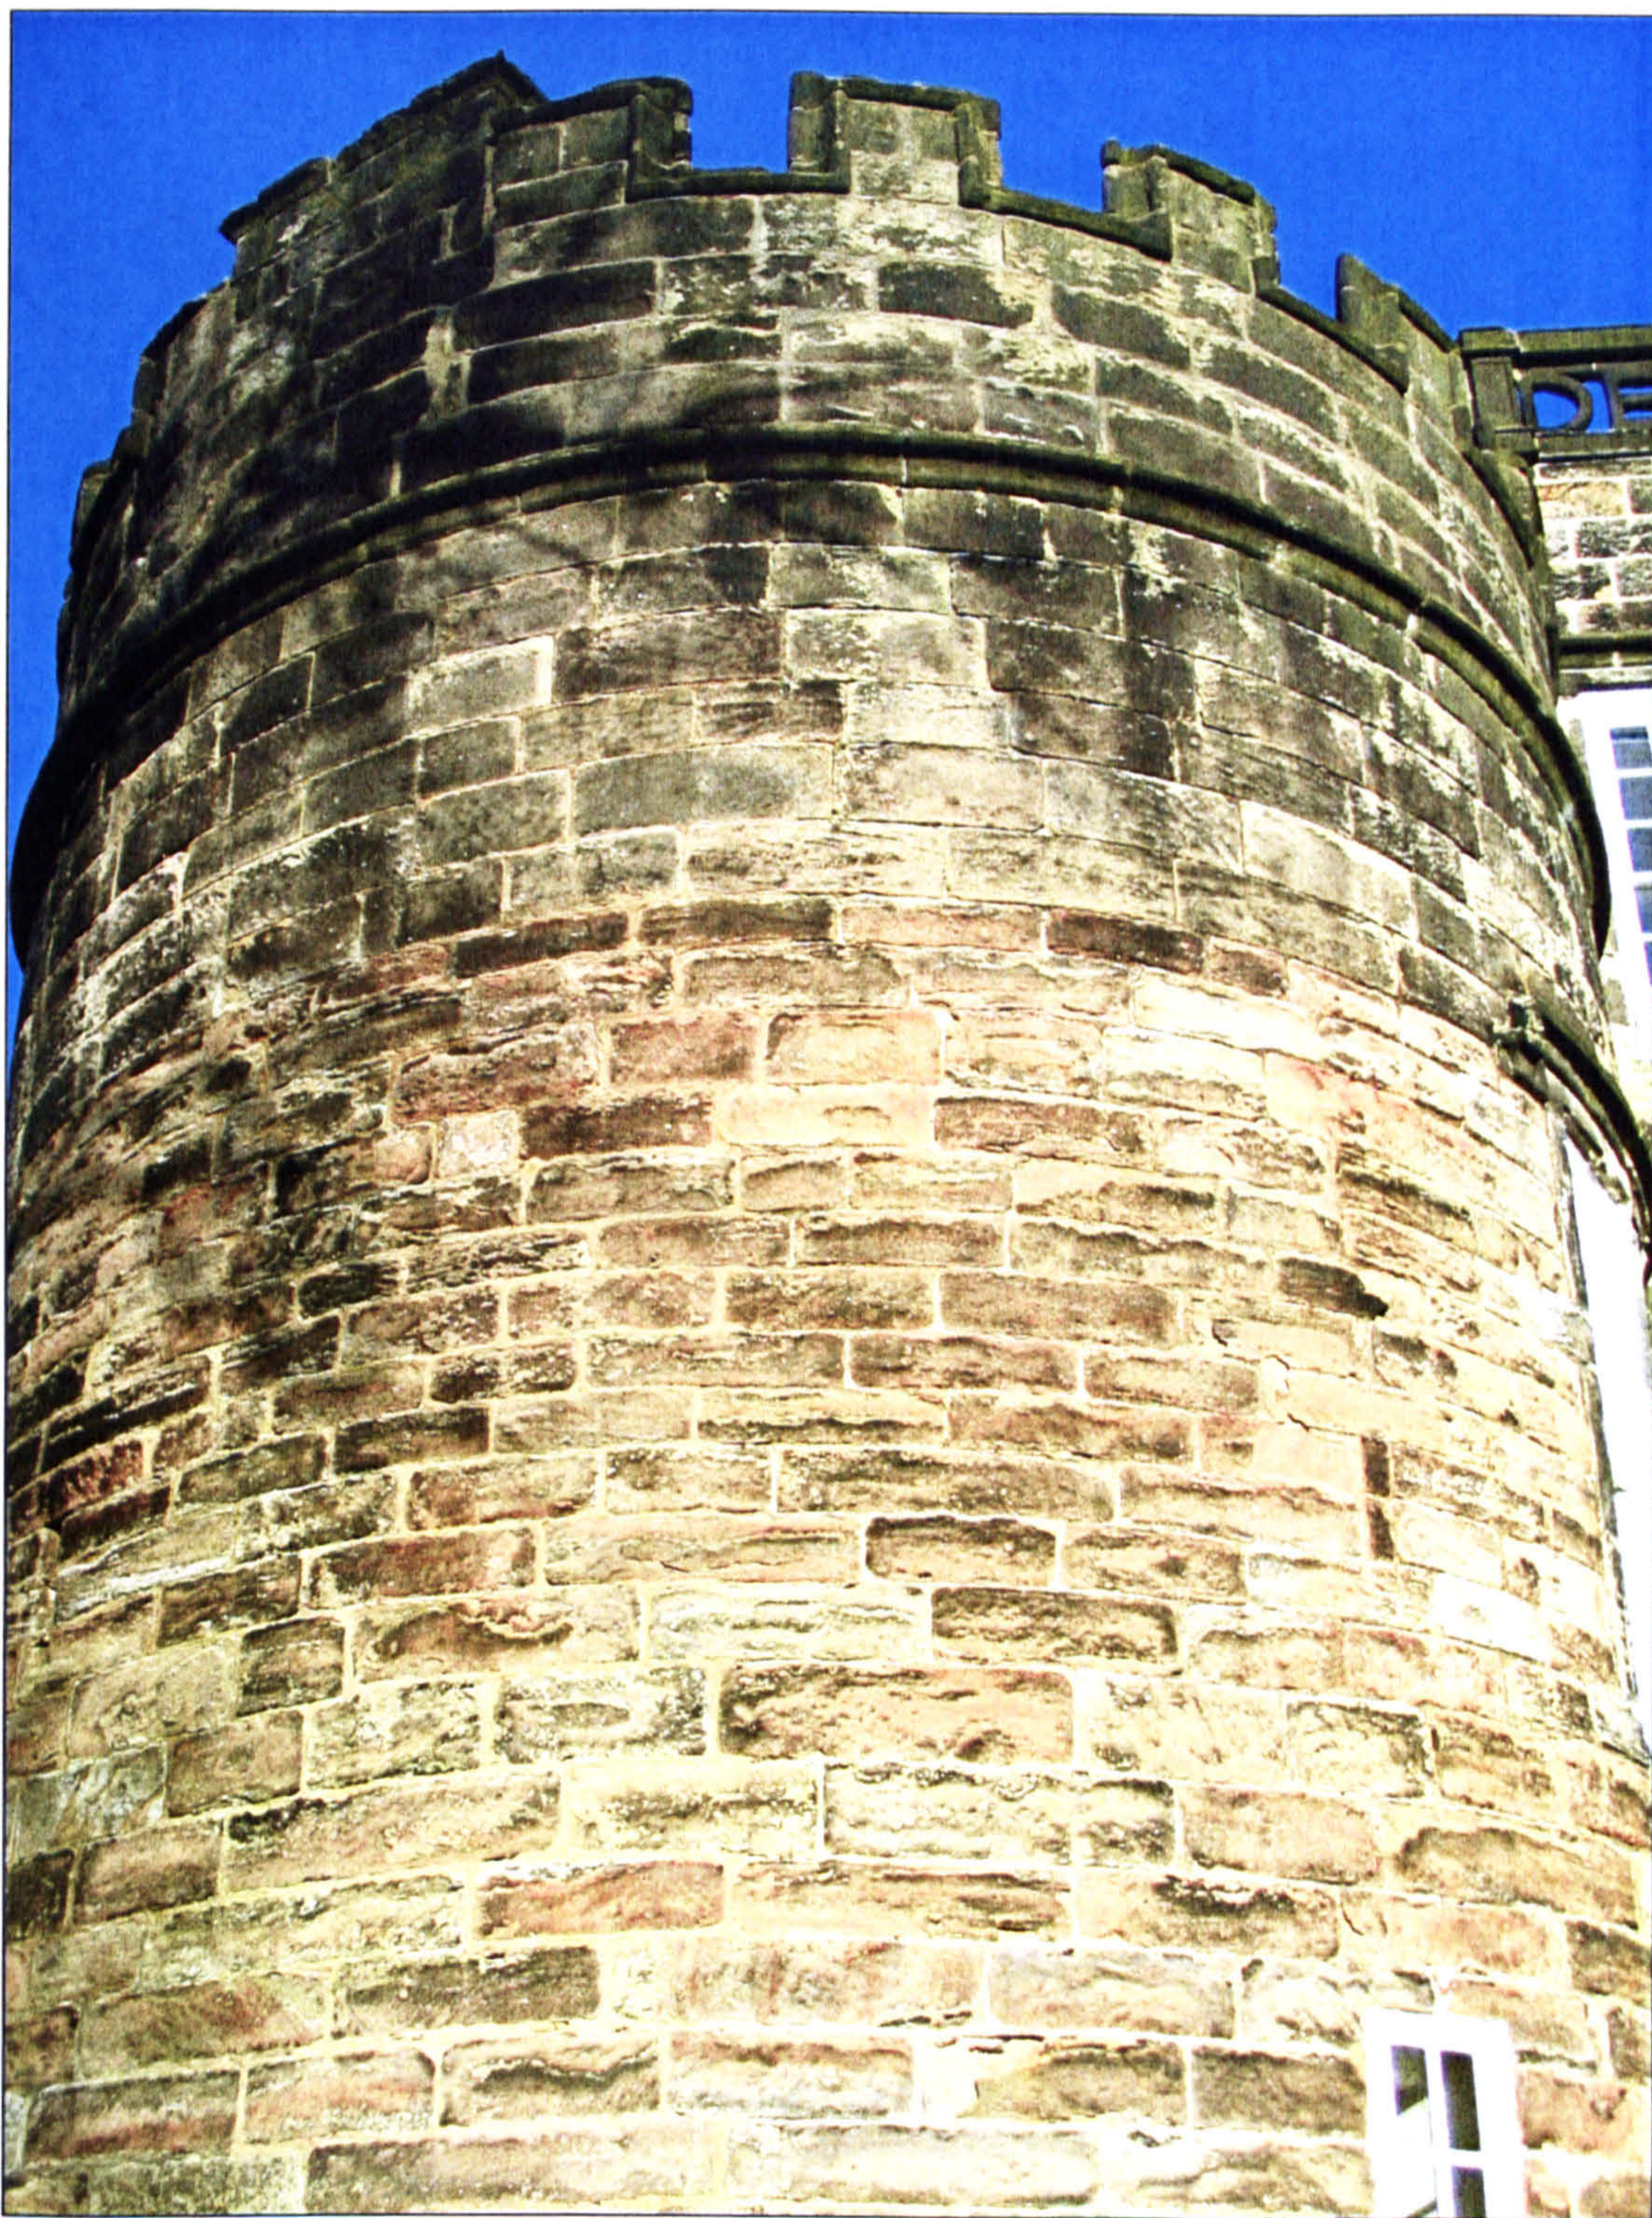
Figure 4.2 Close-up of the left turret of the Outer Gate, Skipton Castle, detailing pre- and post-slighting construction.

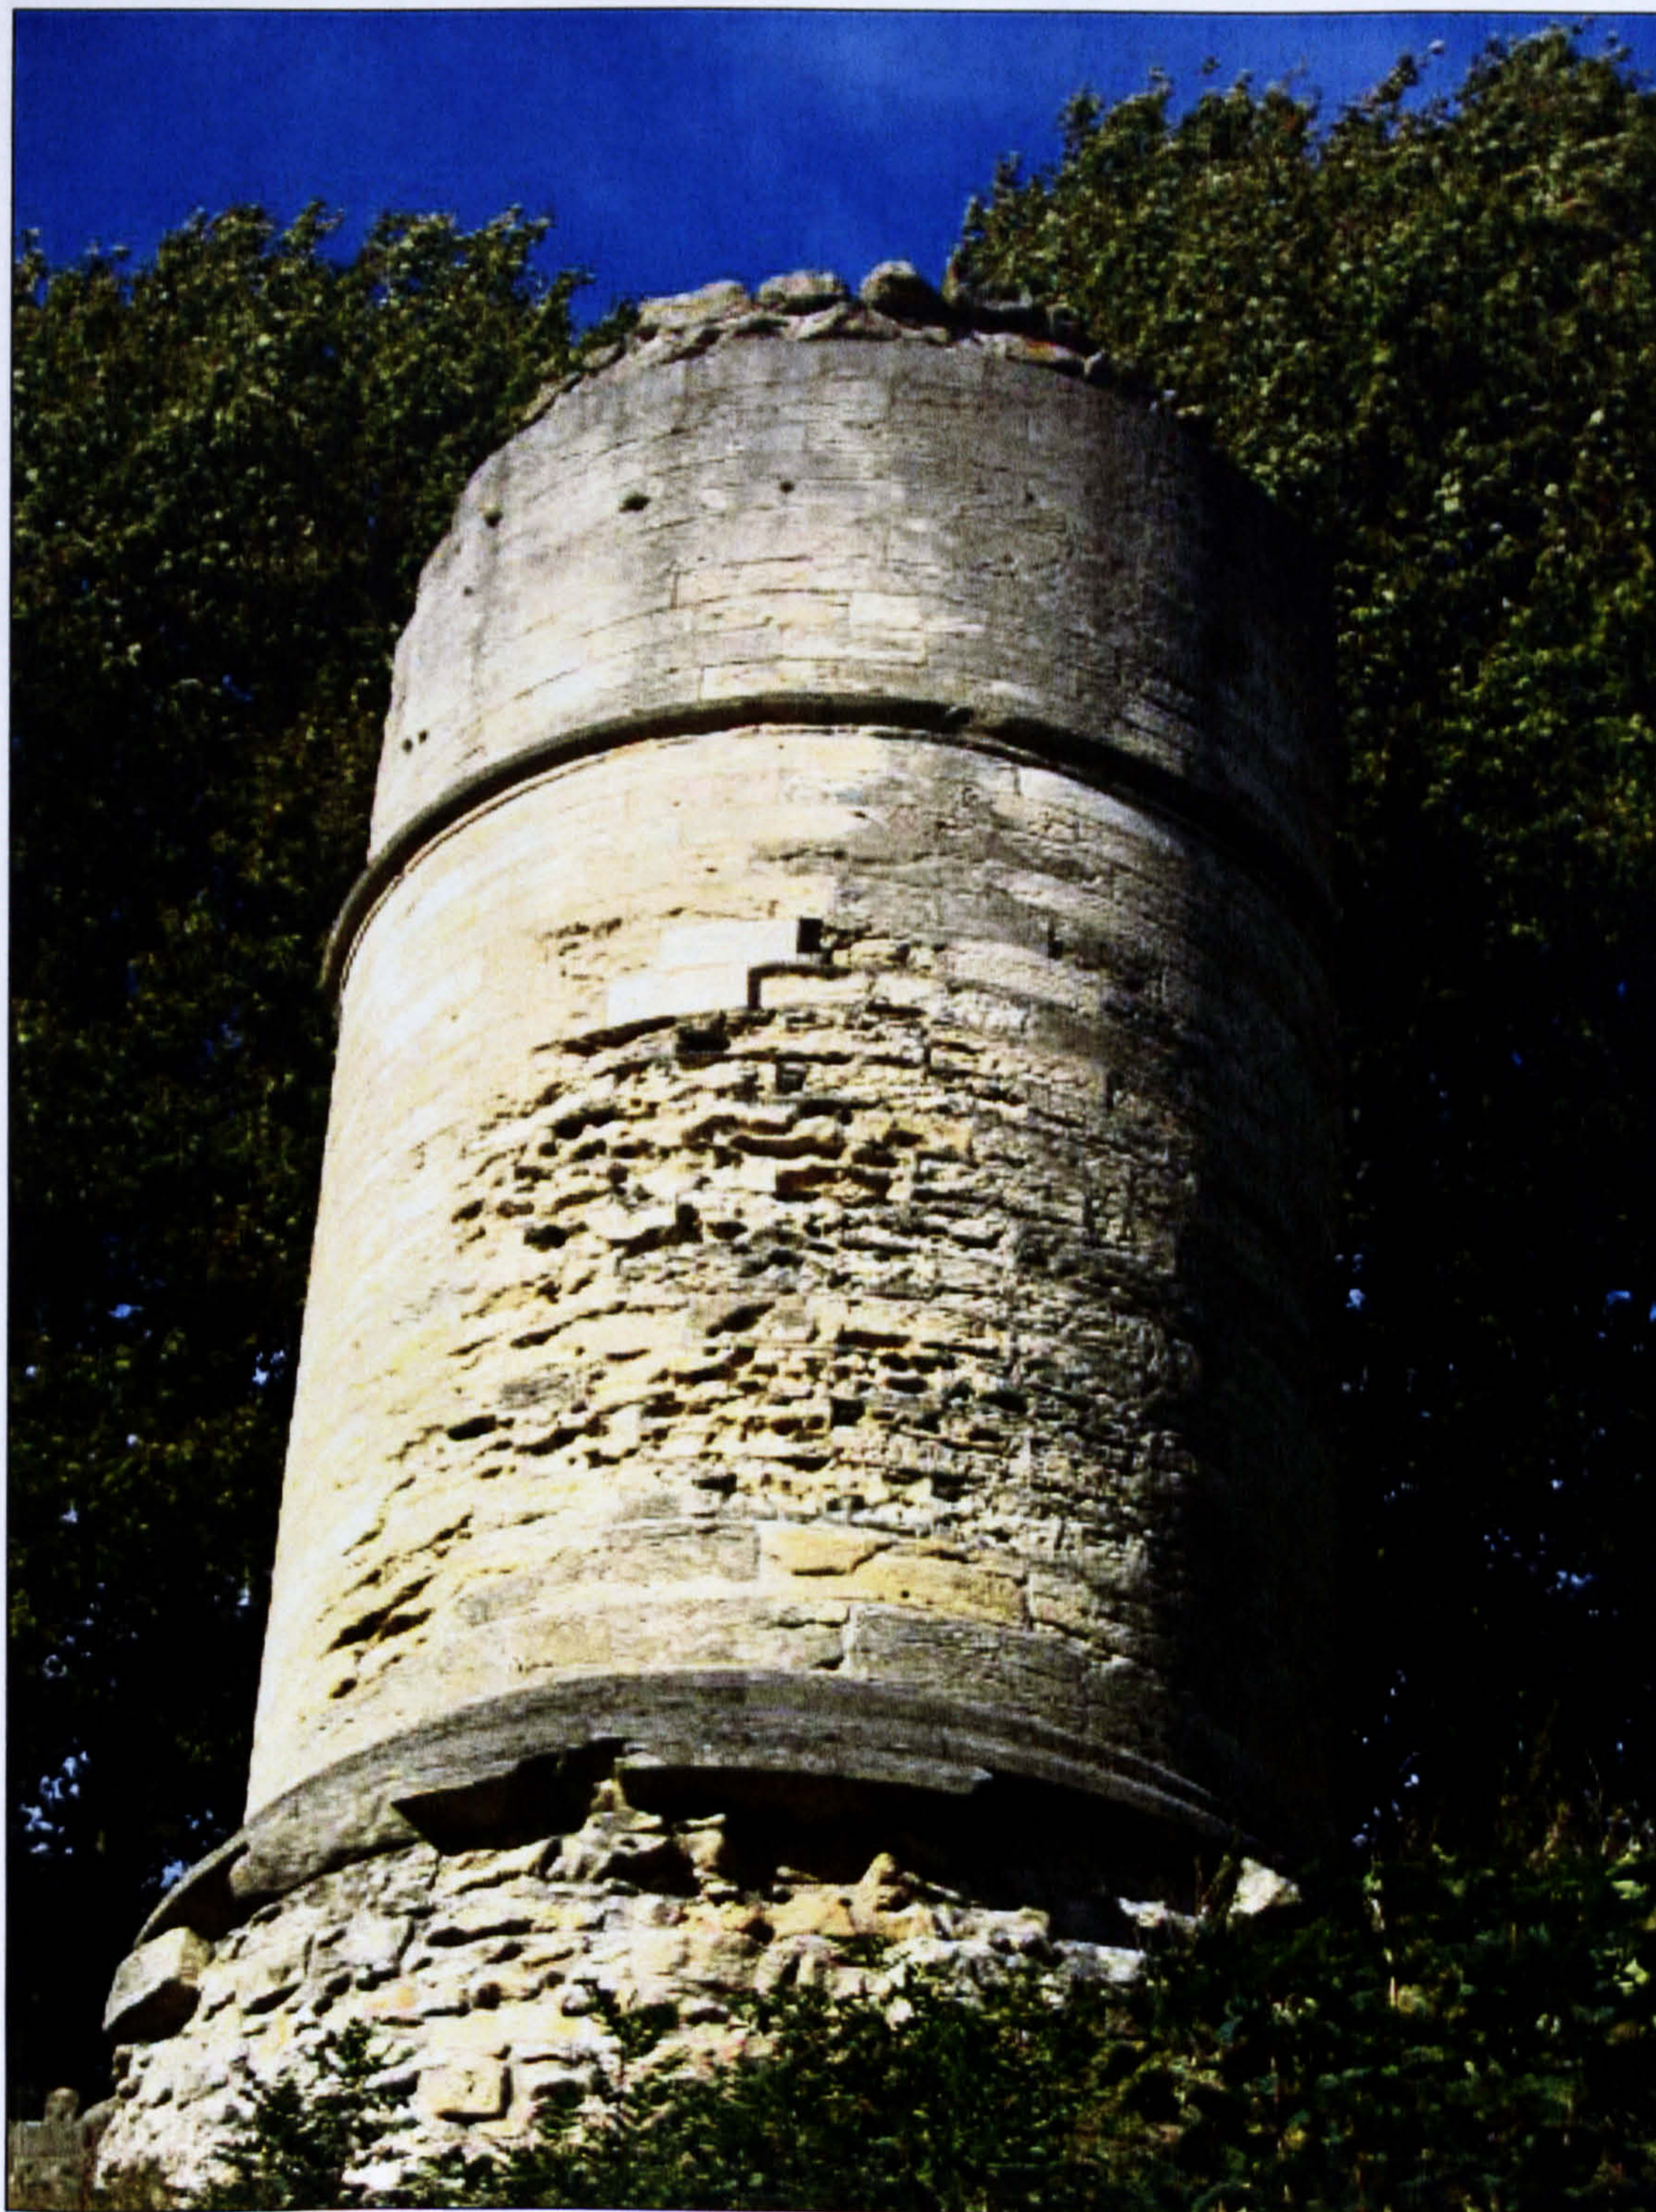
Figure 4.15 T1 showing weathering damage and replaced ashlar.

Figure 4.15 T1 showing weathering damage and replaced ashlar.
