ARCHAEOLOGY OF DESTRUCTION

A REINTERPRETATION OF CASTLE SLIGHTINGS IN THE ENGLISH CIVIL WAR

Thesis submitted for the degree of
Doctor of Philosophy
University of York
Department of Archaeology

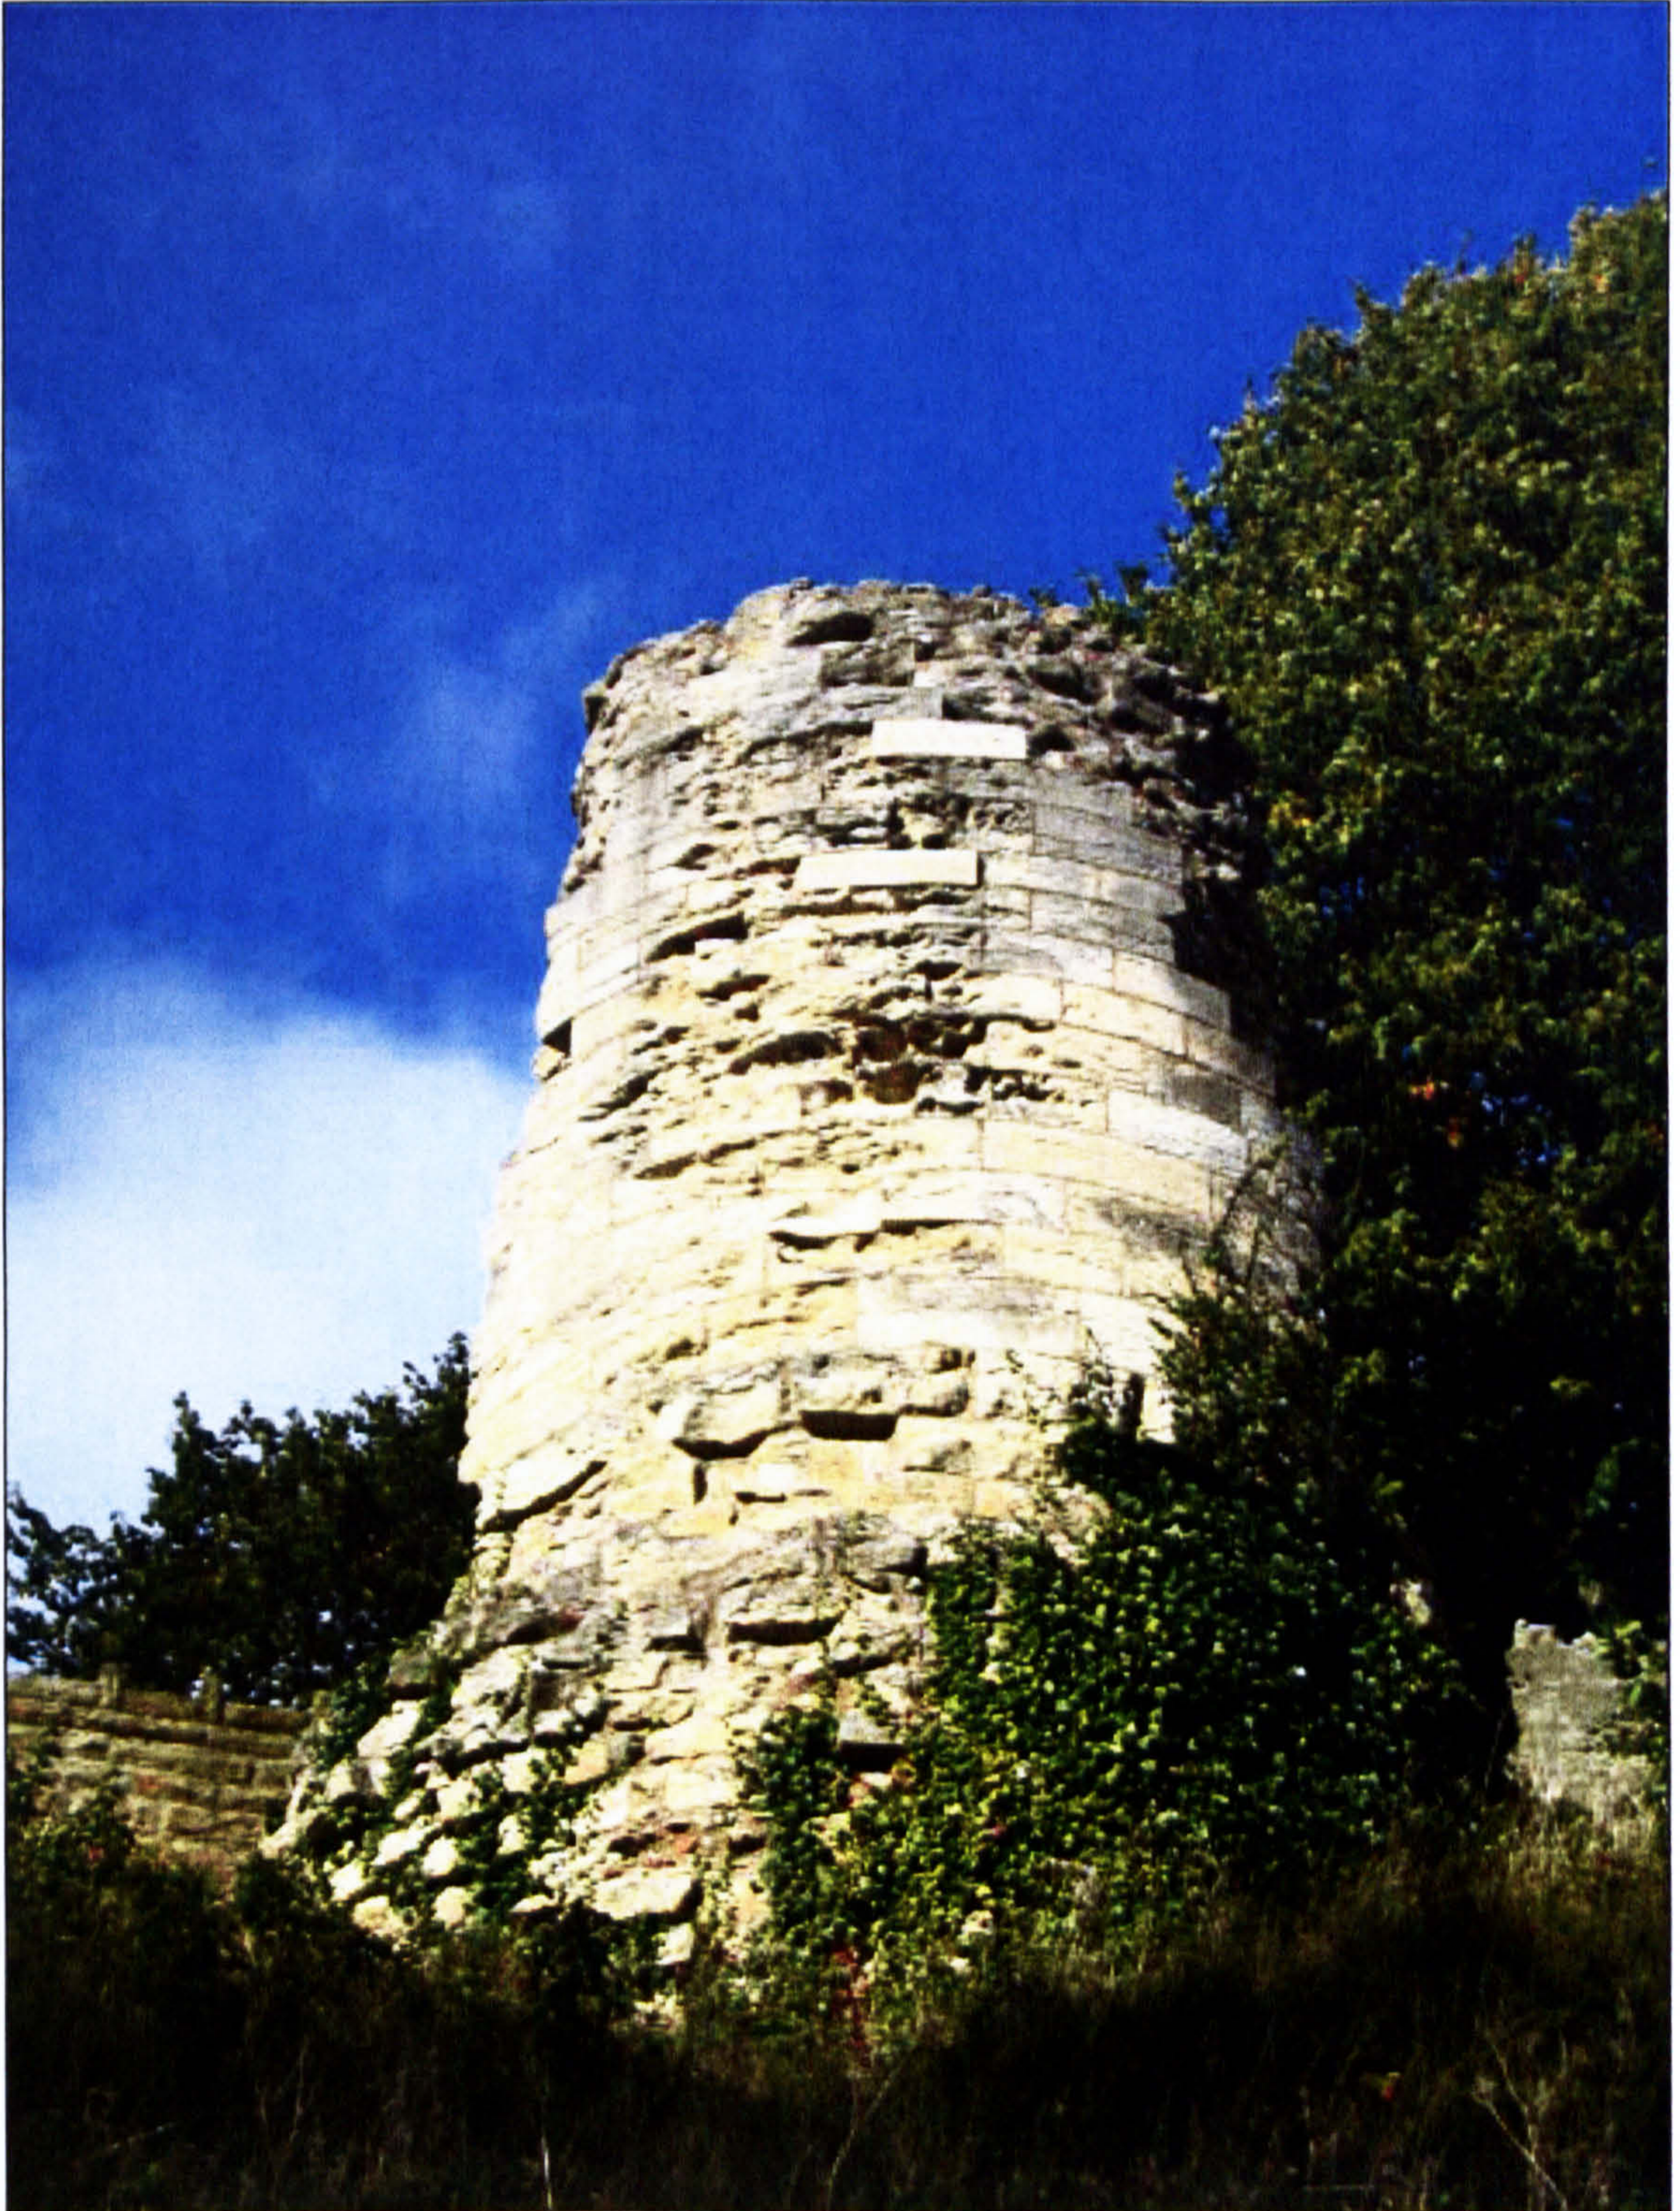
Figure 4.16 T2 showing weathering damage and replaced ashlar.

Figure 4.16 T2 showing weathering damage and replaced ashlar.

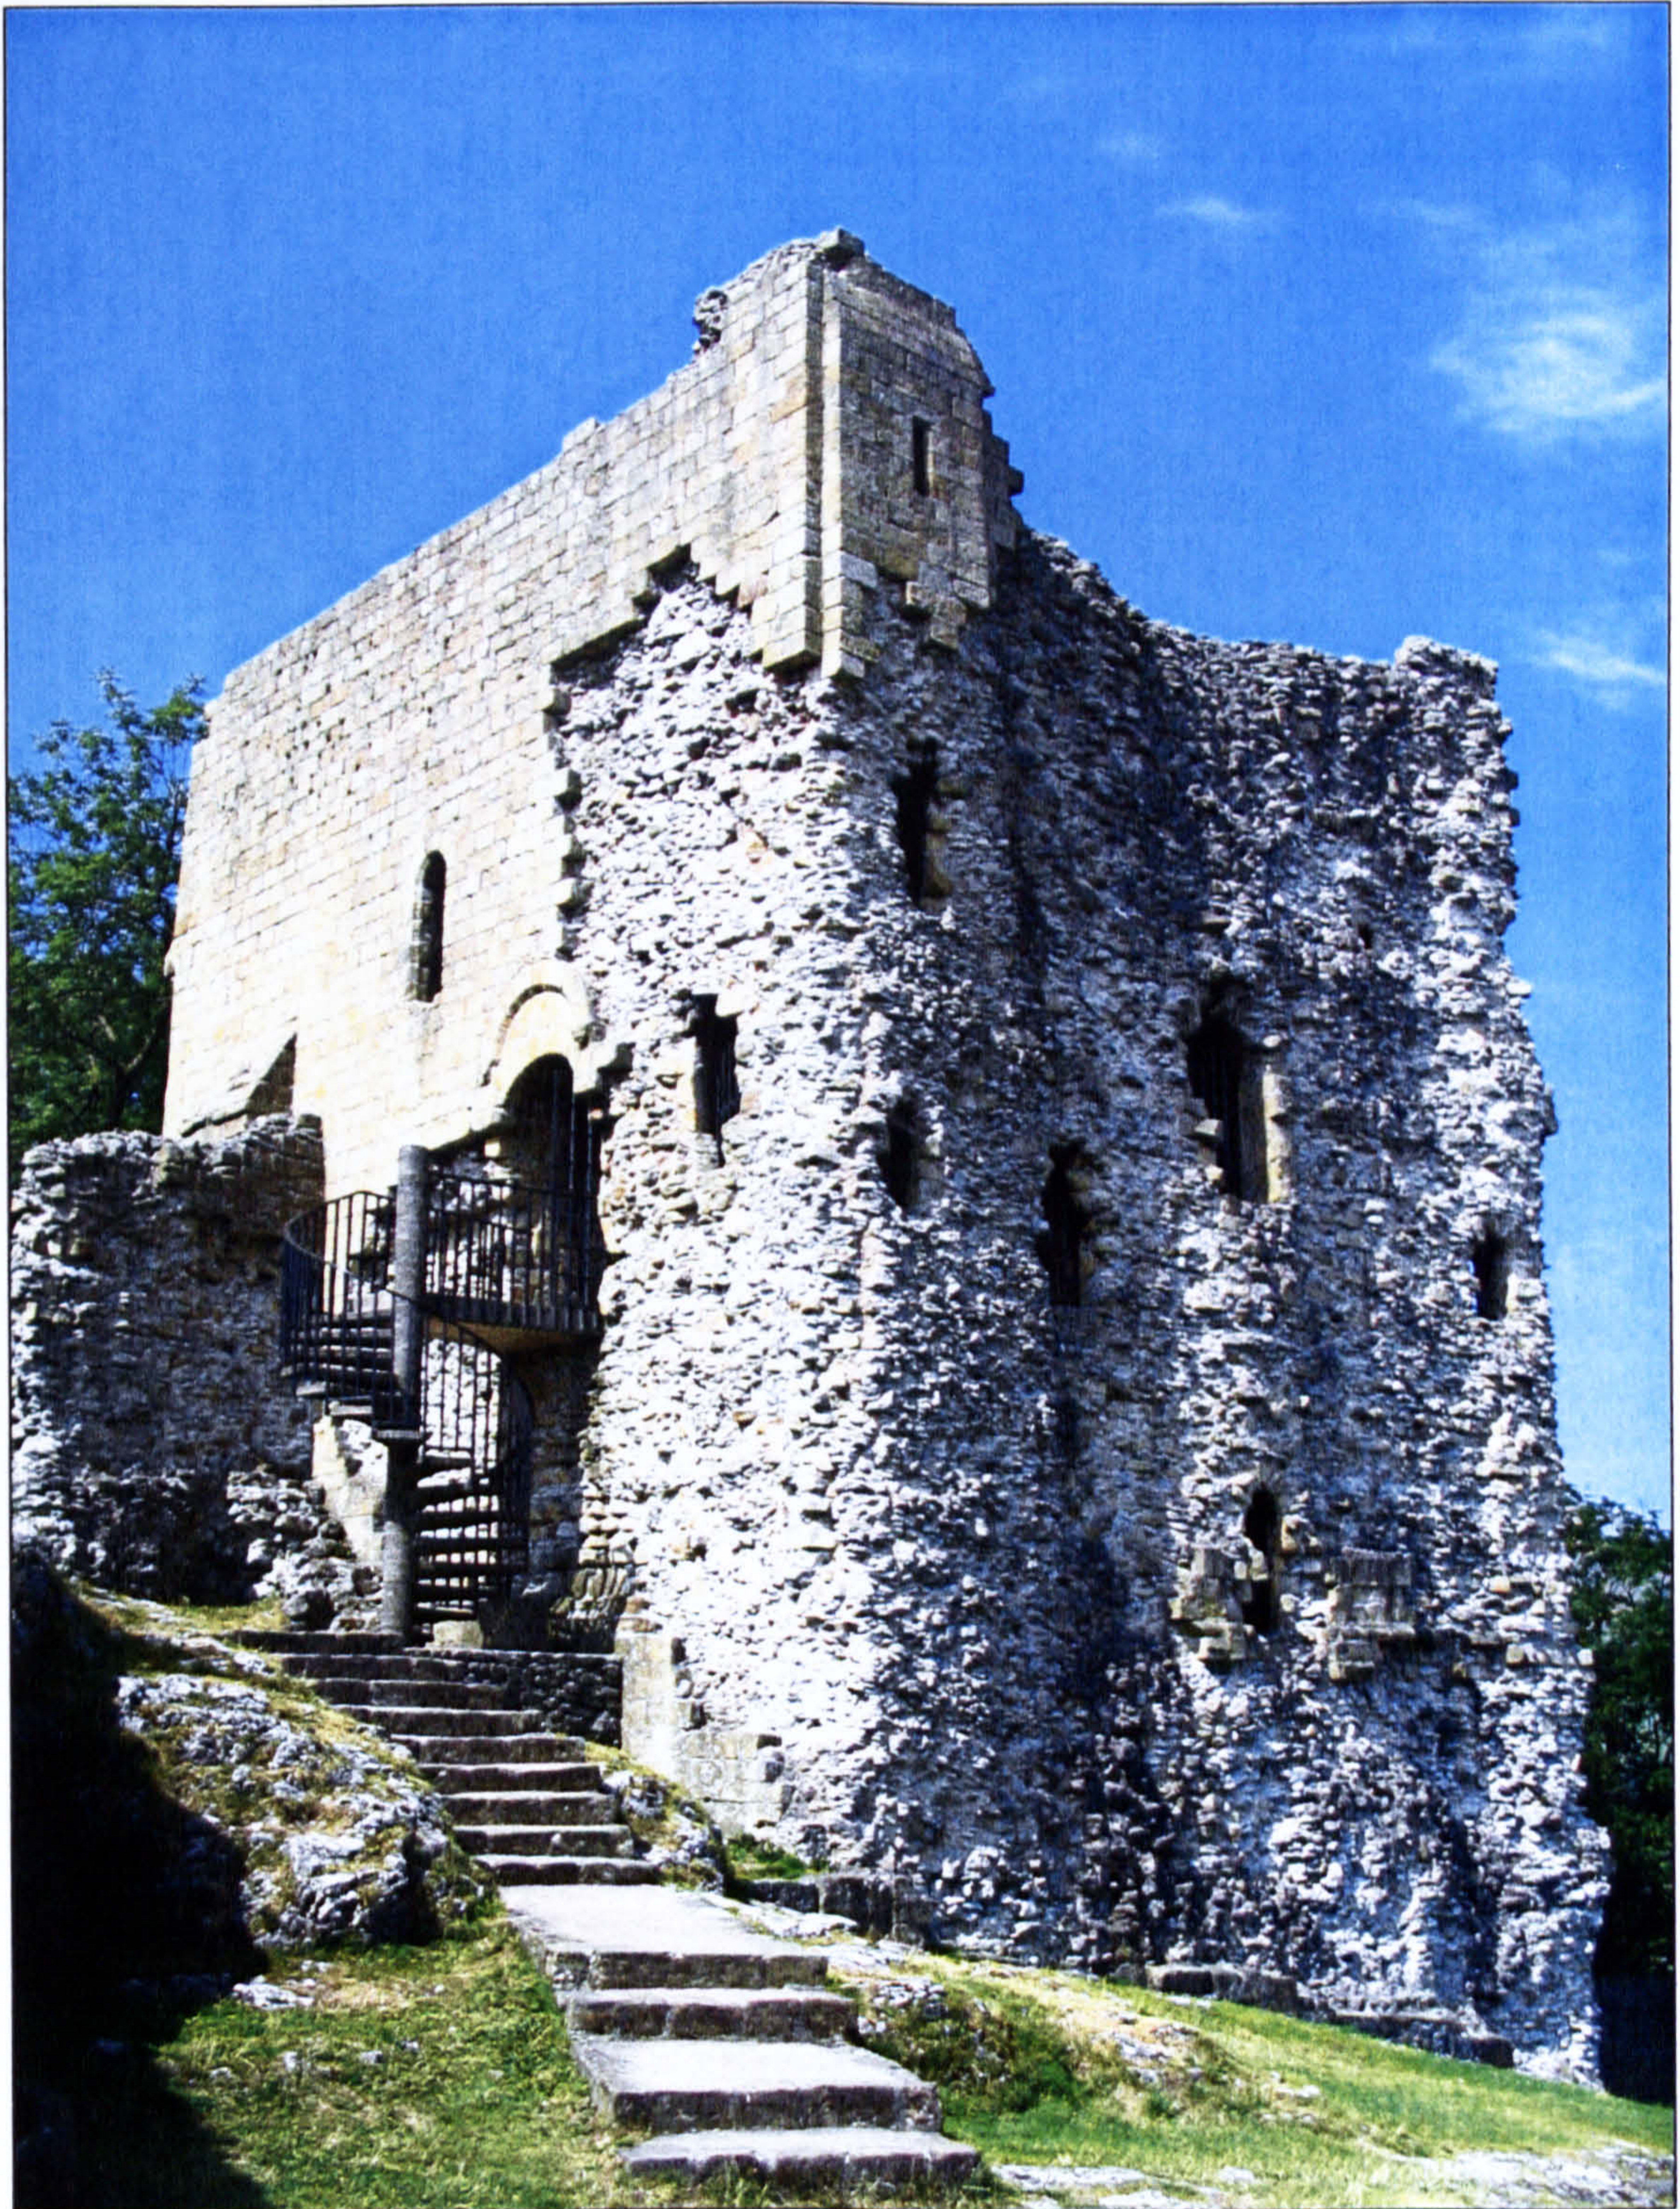
Figure 4.34 Peveril Castle Keep, looking south, showing the scale of secondary damage.

Figure 4.34 Peveril Castle Keep, looking south, showing the scale of secondary damage.

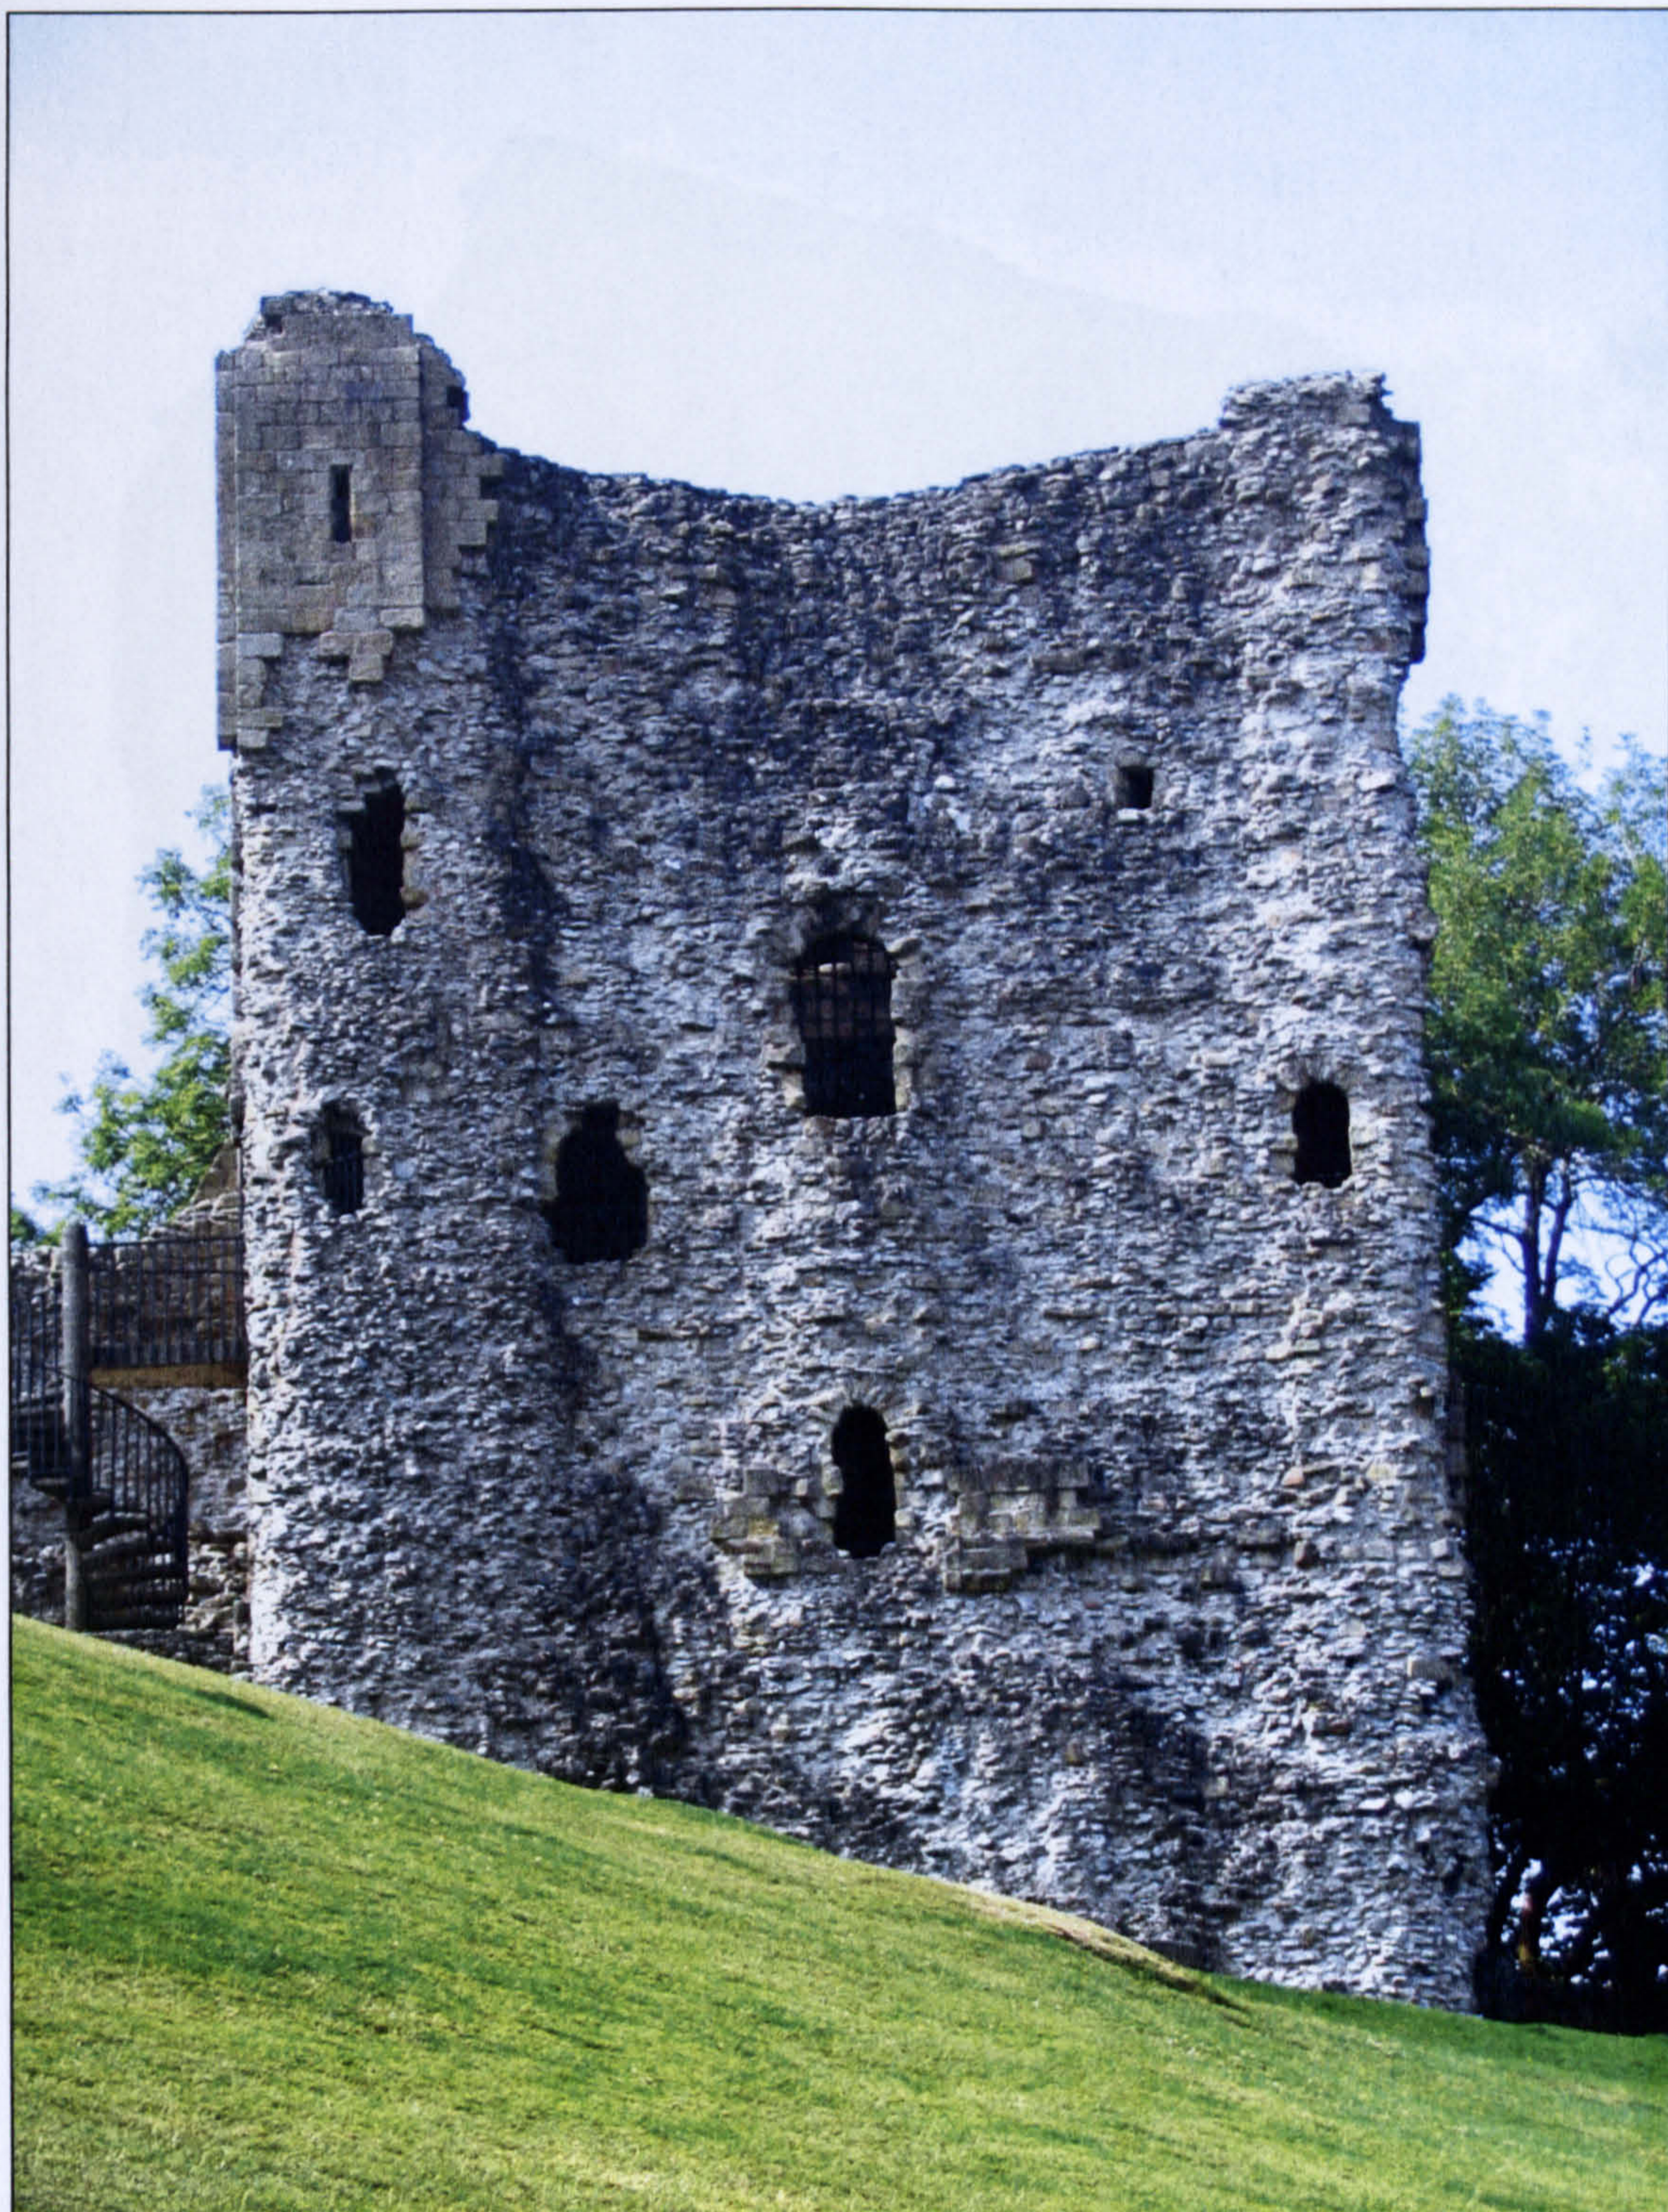
Figure 4.35 Peveril Castle Keep, looking southeast, showing the scale of secondary damage.

Figure 4.35 Peveril Castle Keep, looking southeast, showing the scale of secondary damage.

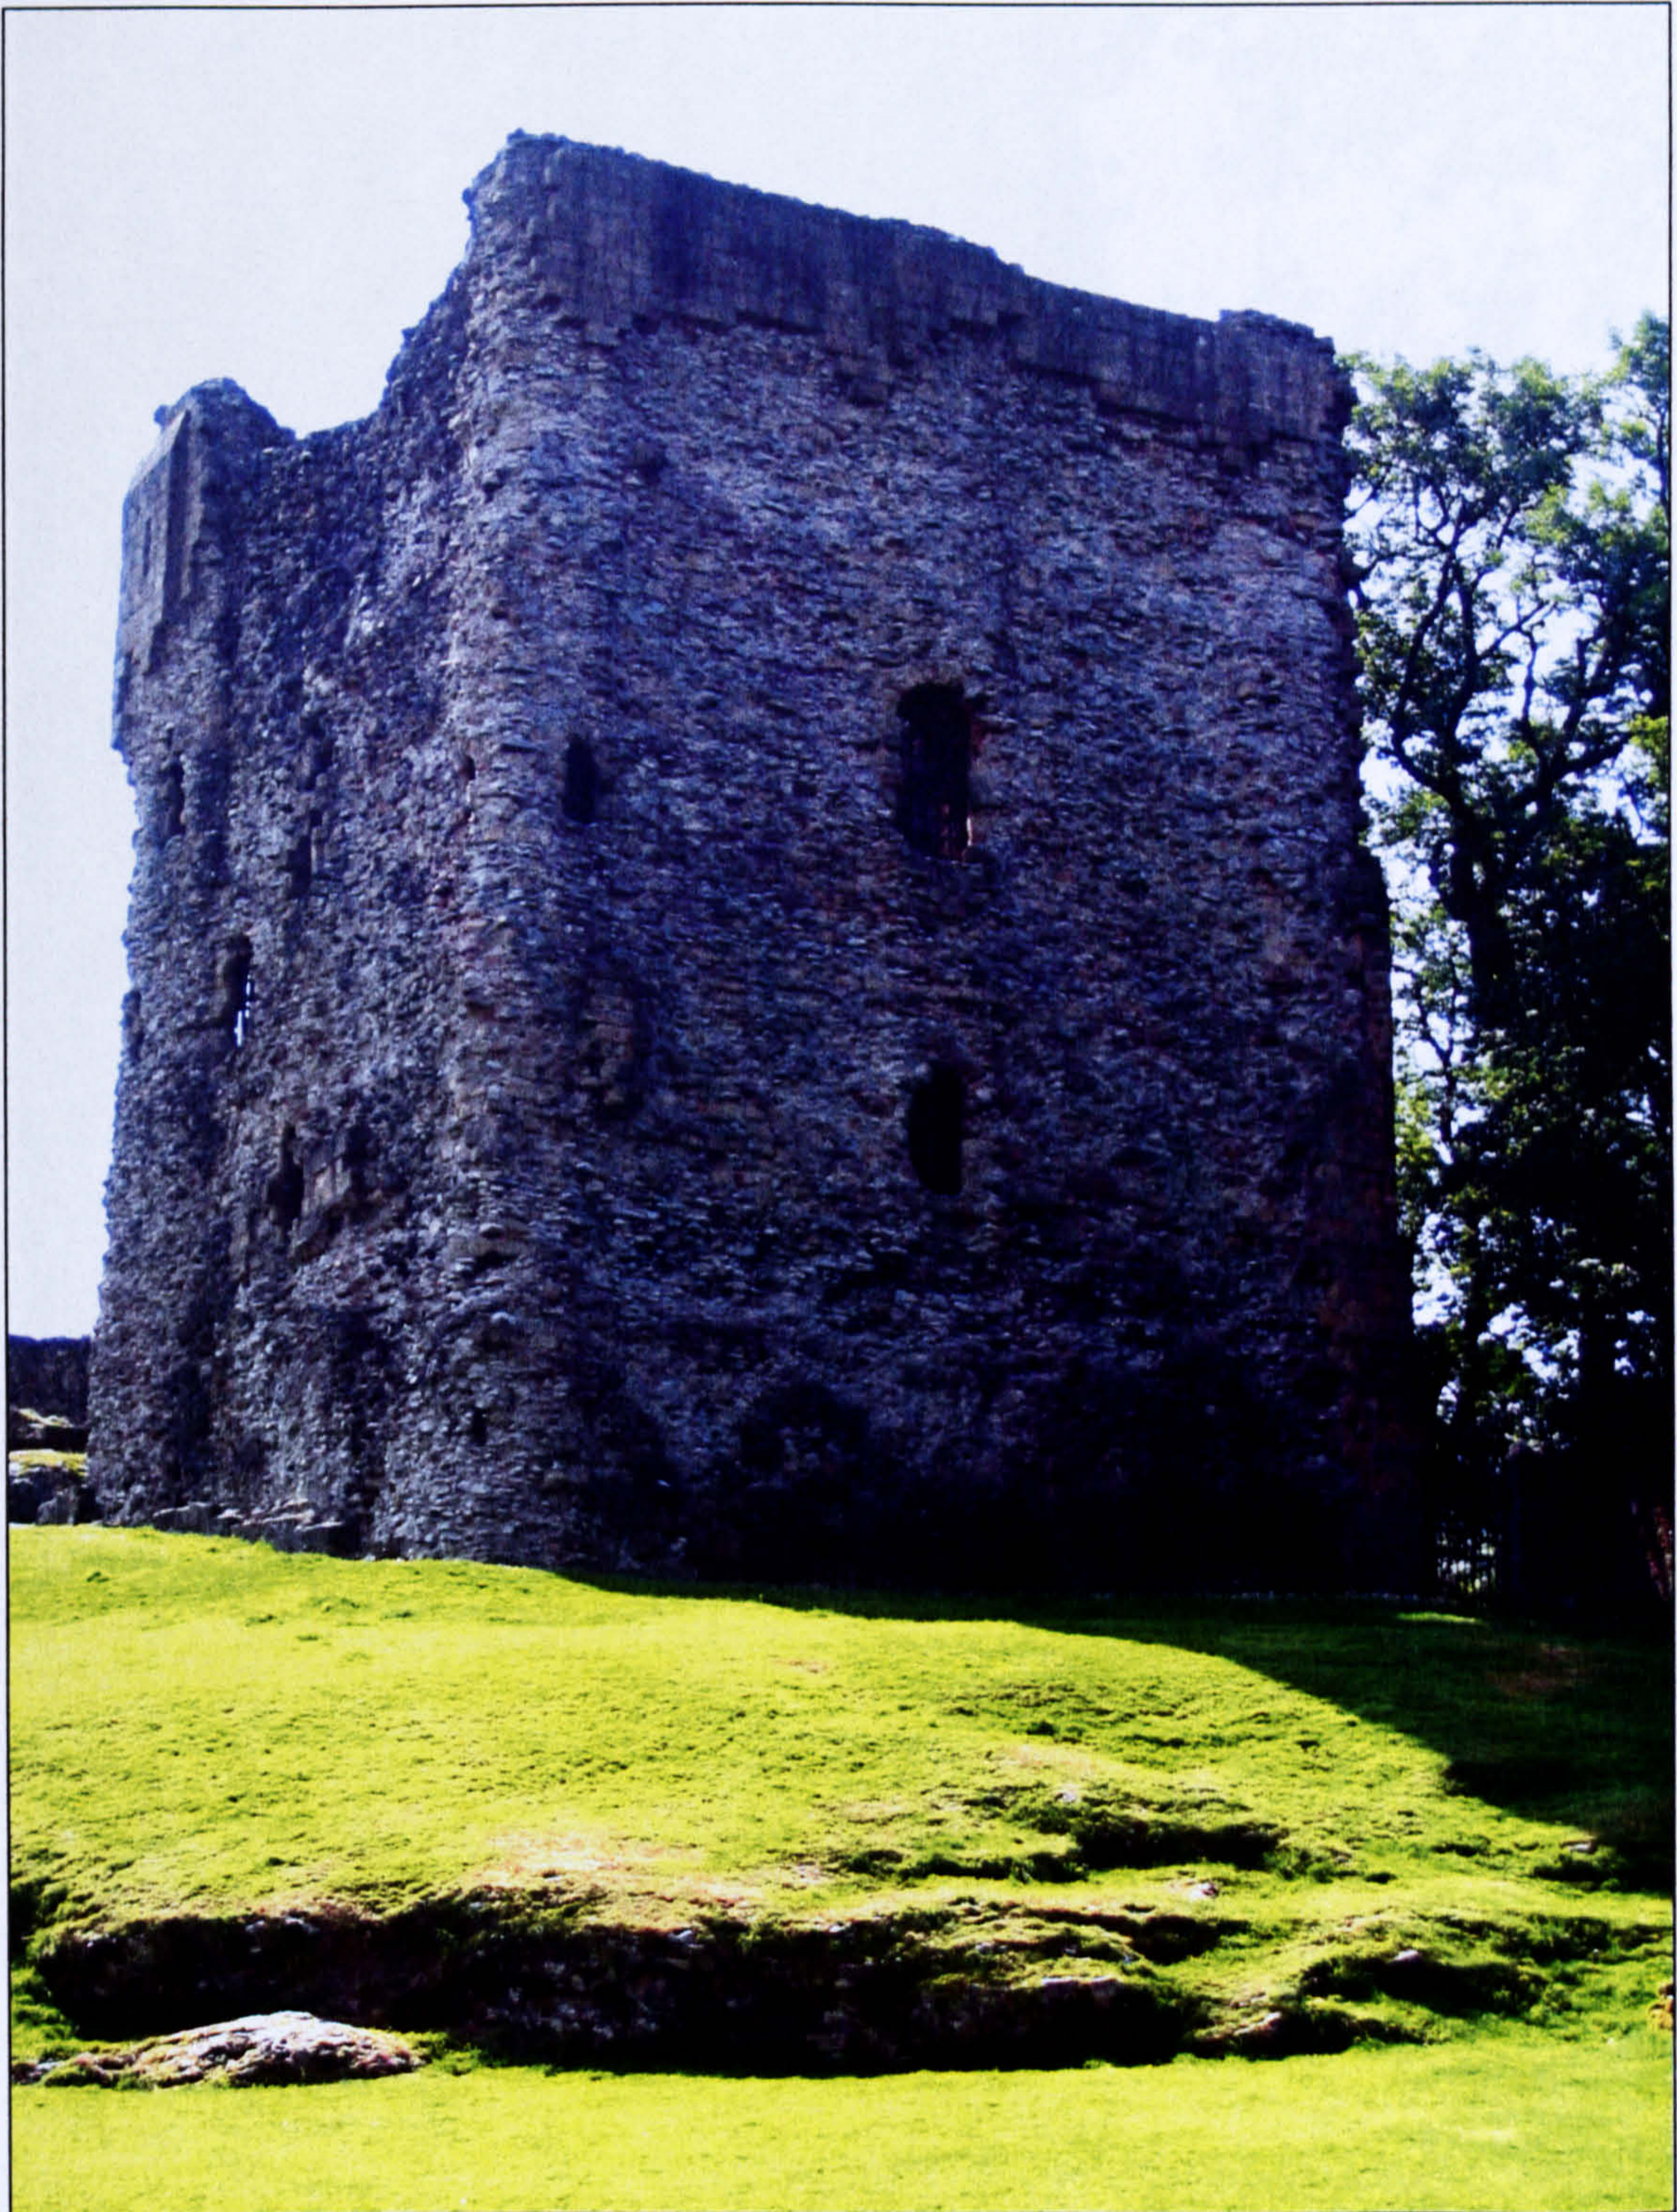
Figure 4.36 Peveril Castle Keep, looking east, showing the scale of secondary damage.

Figure 4.36 Peveril Castle Keep, looking east, showing the scale of secondary damage.

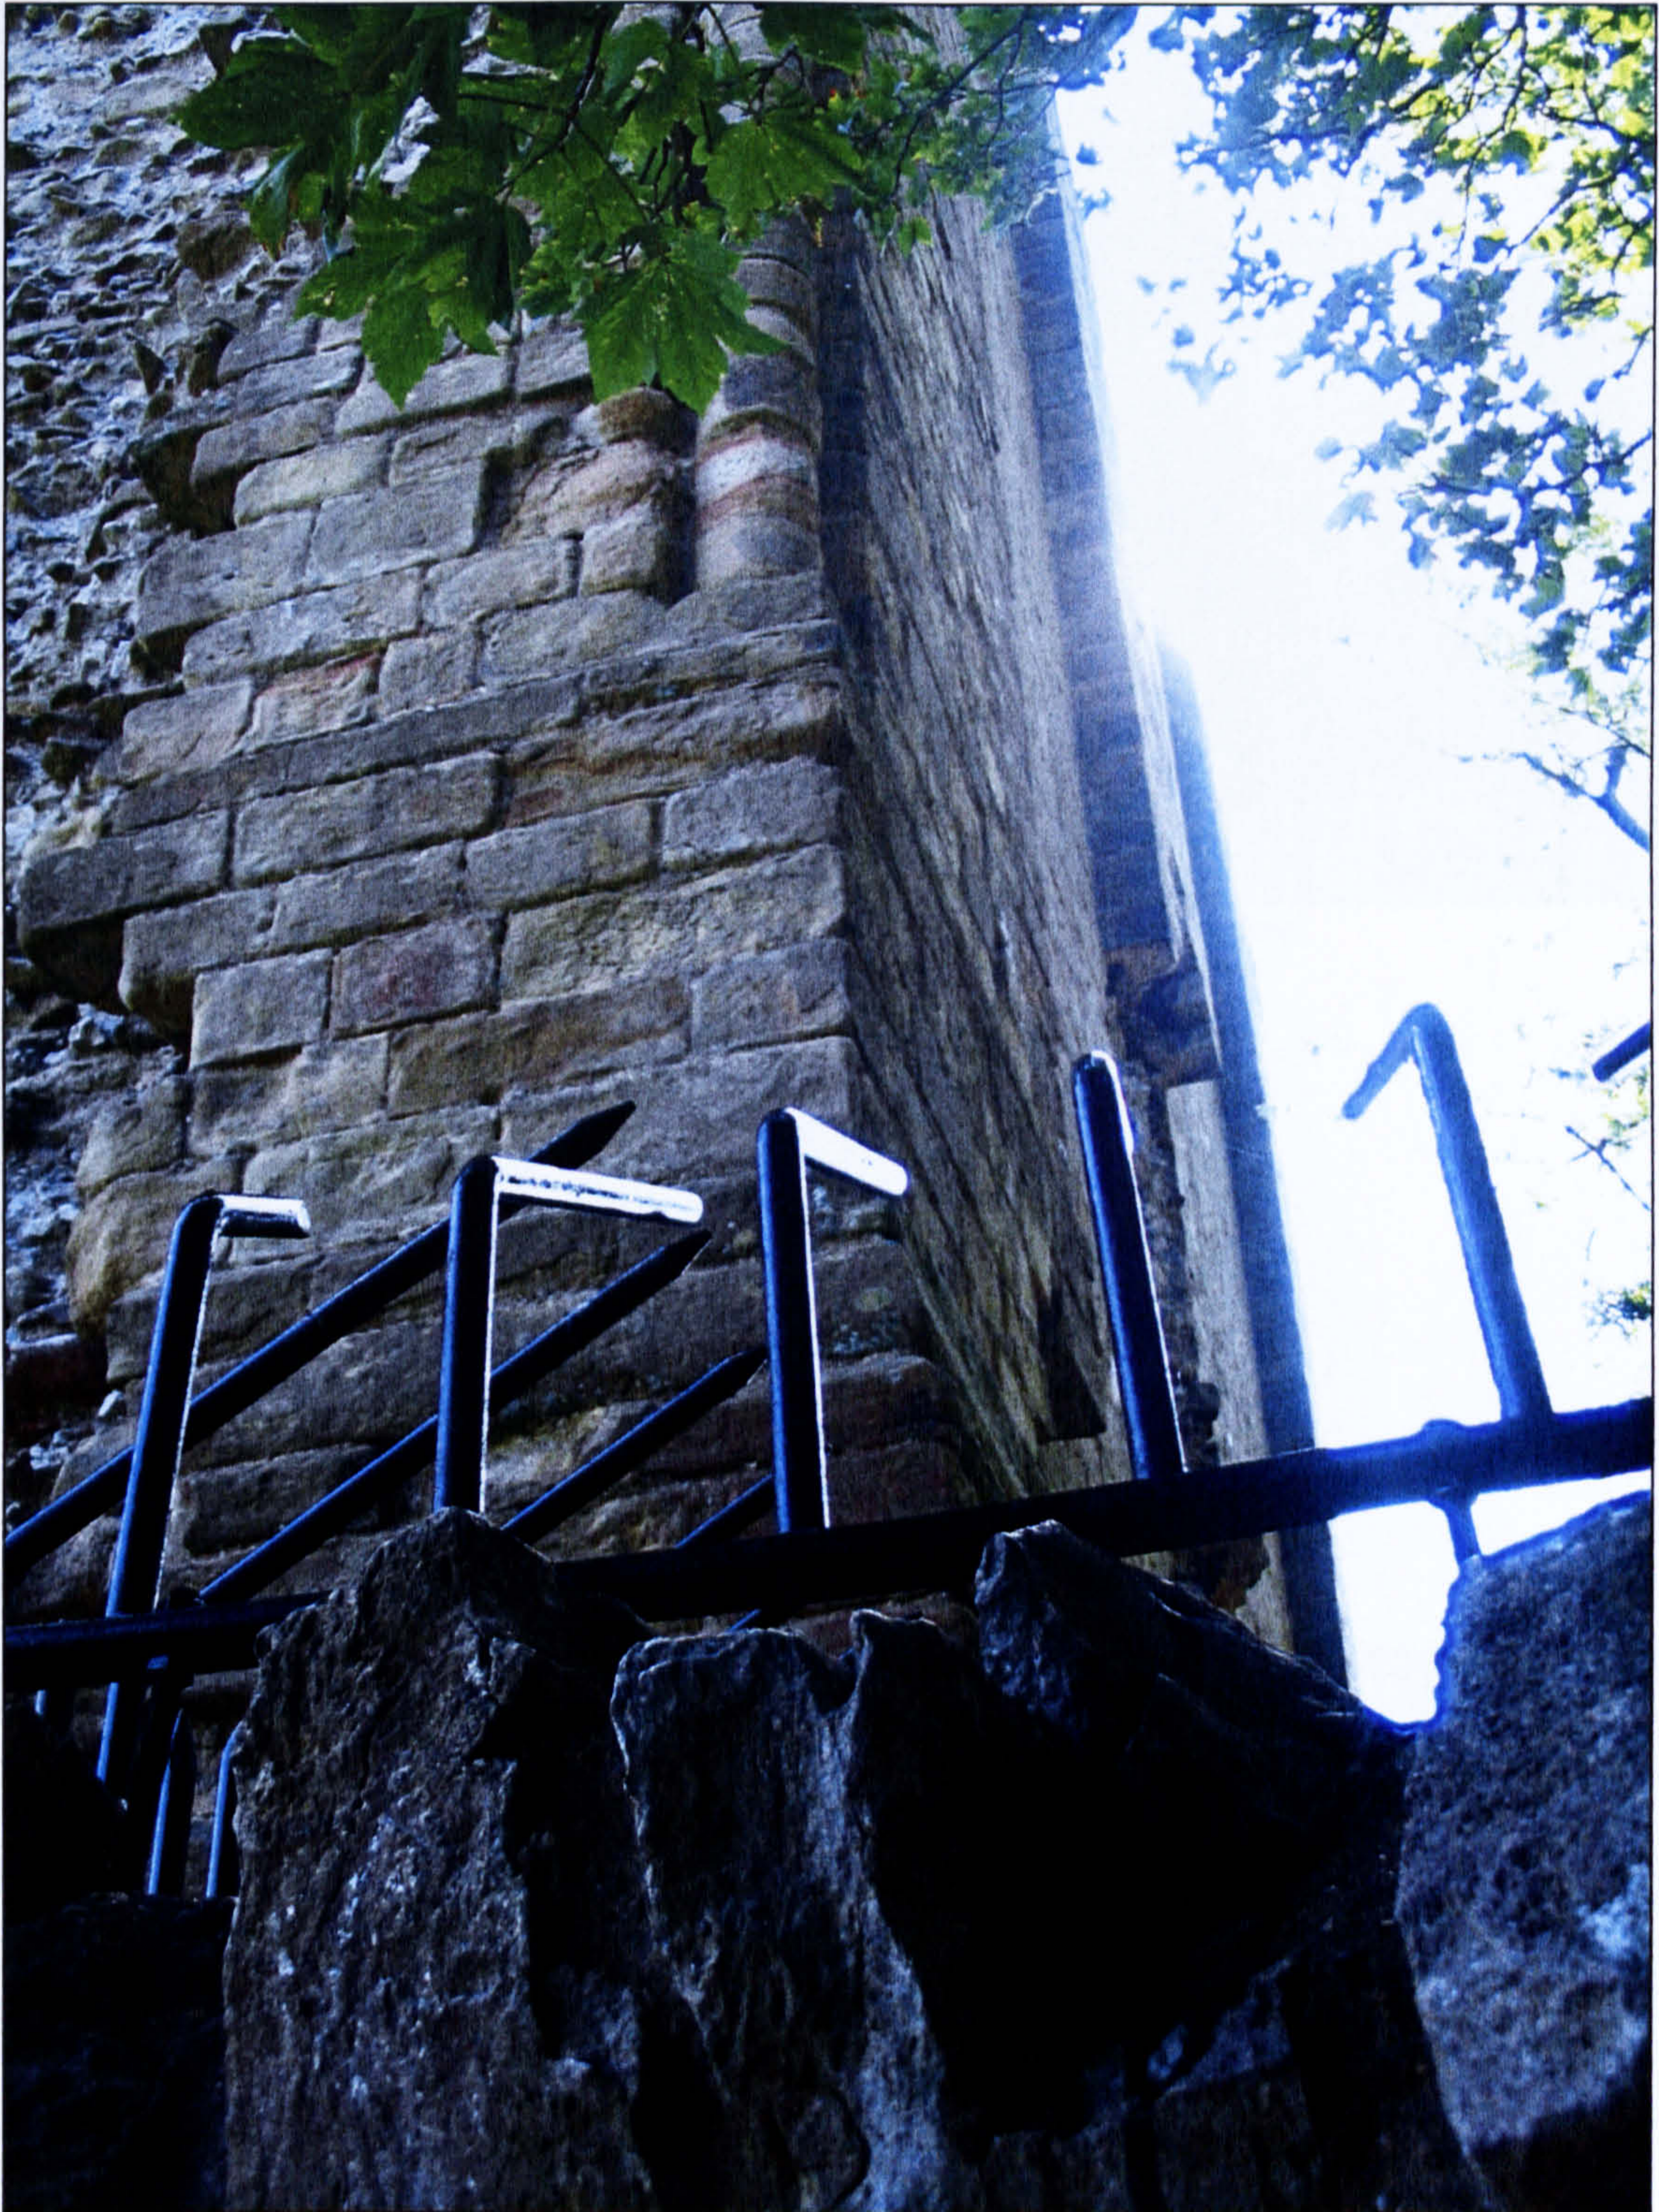
Figure 4.37 The southern corner of Peveril Castle Keep, showing how the inaccessible side of the castle has retained its facing stone.

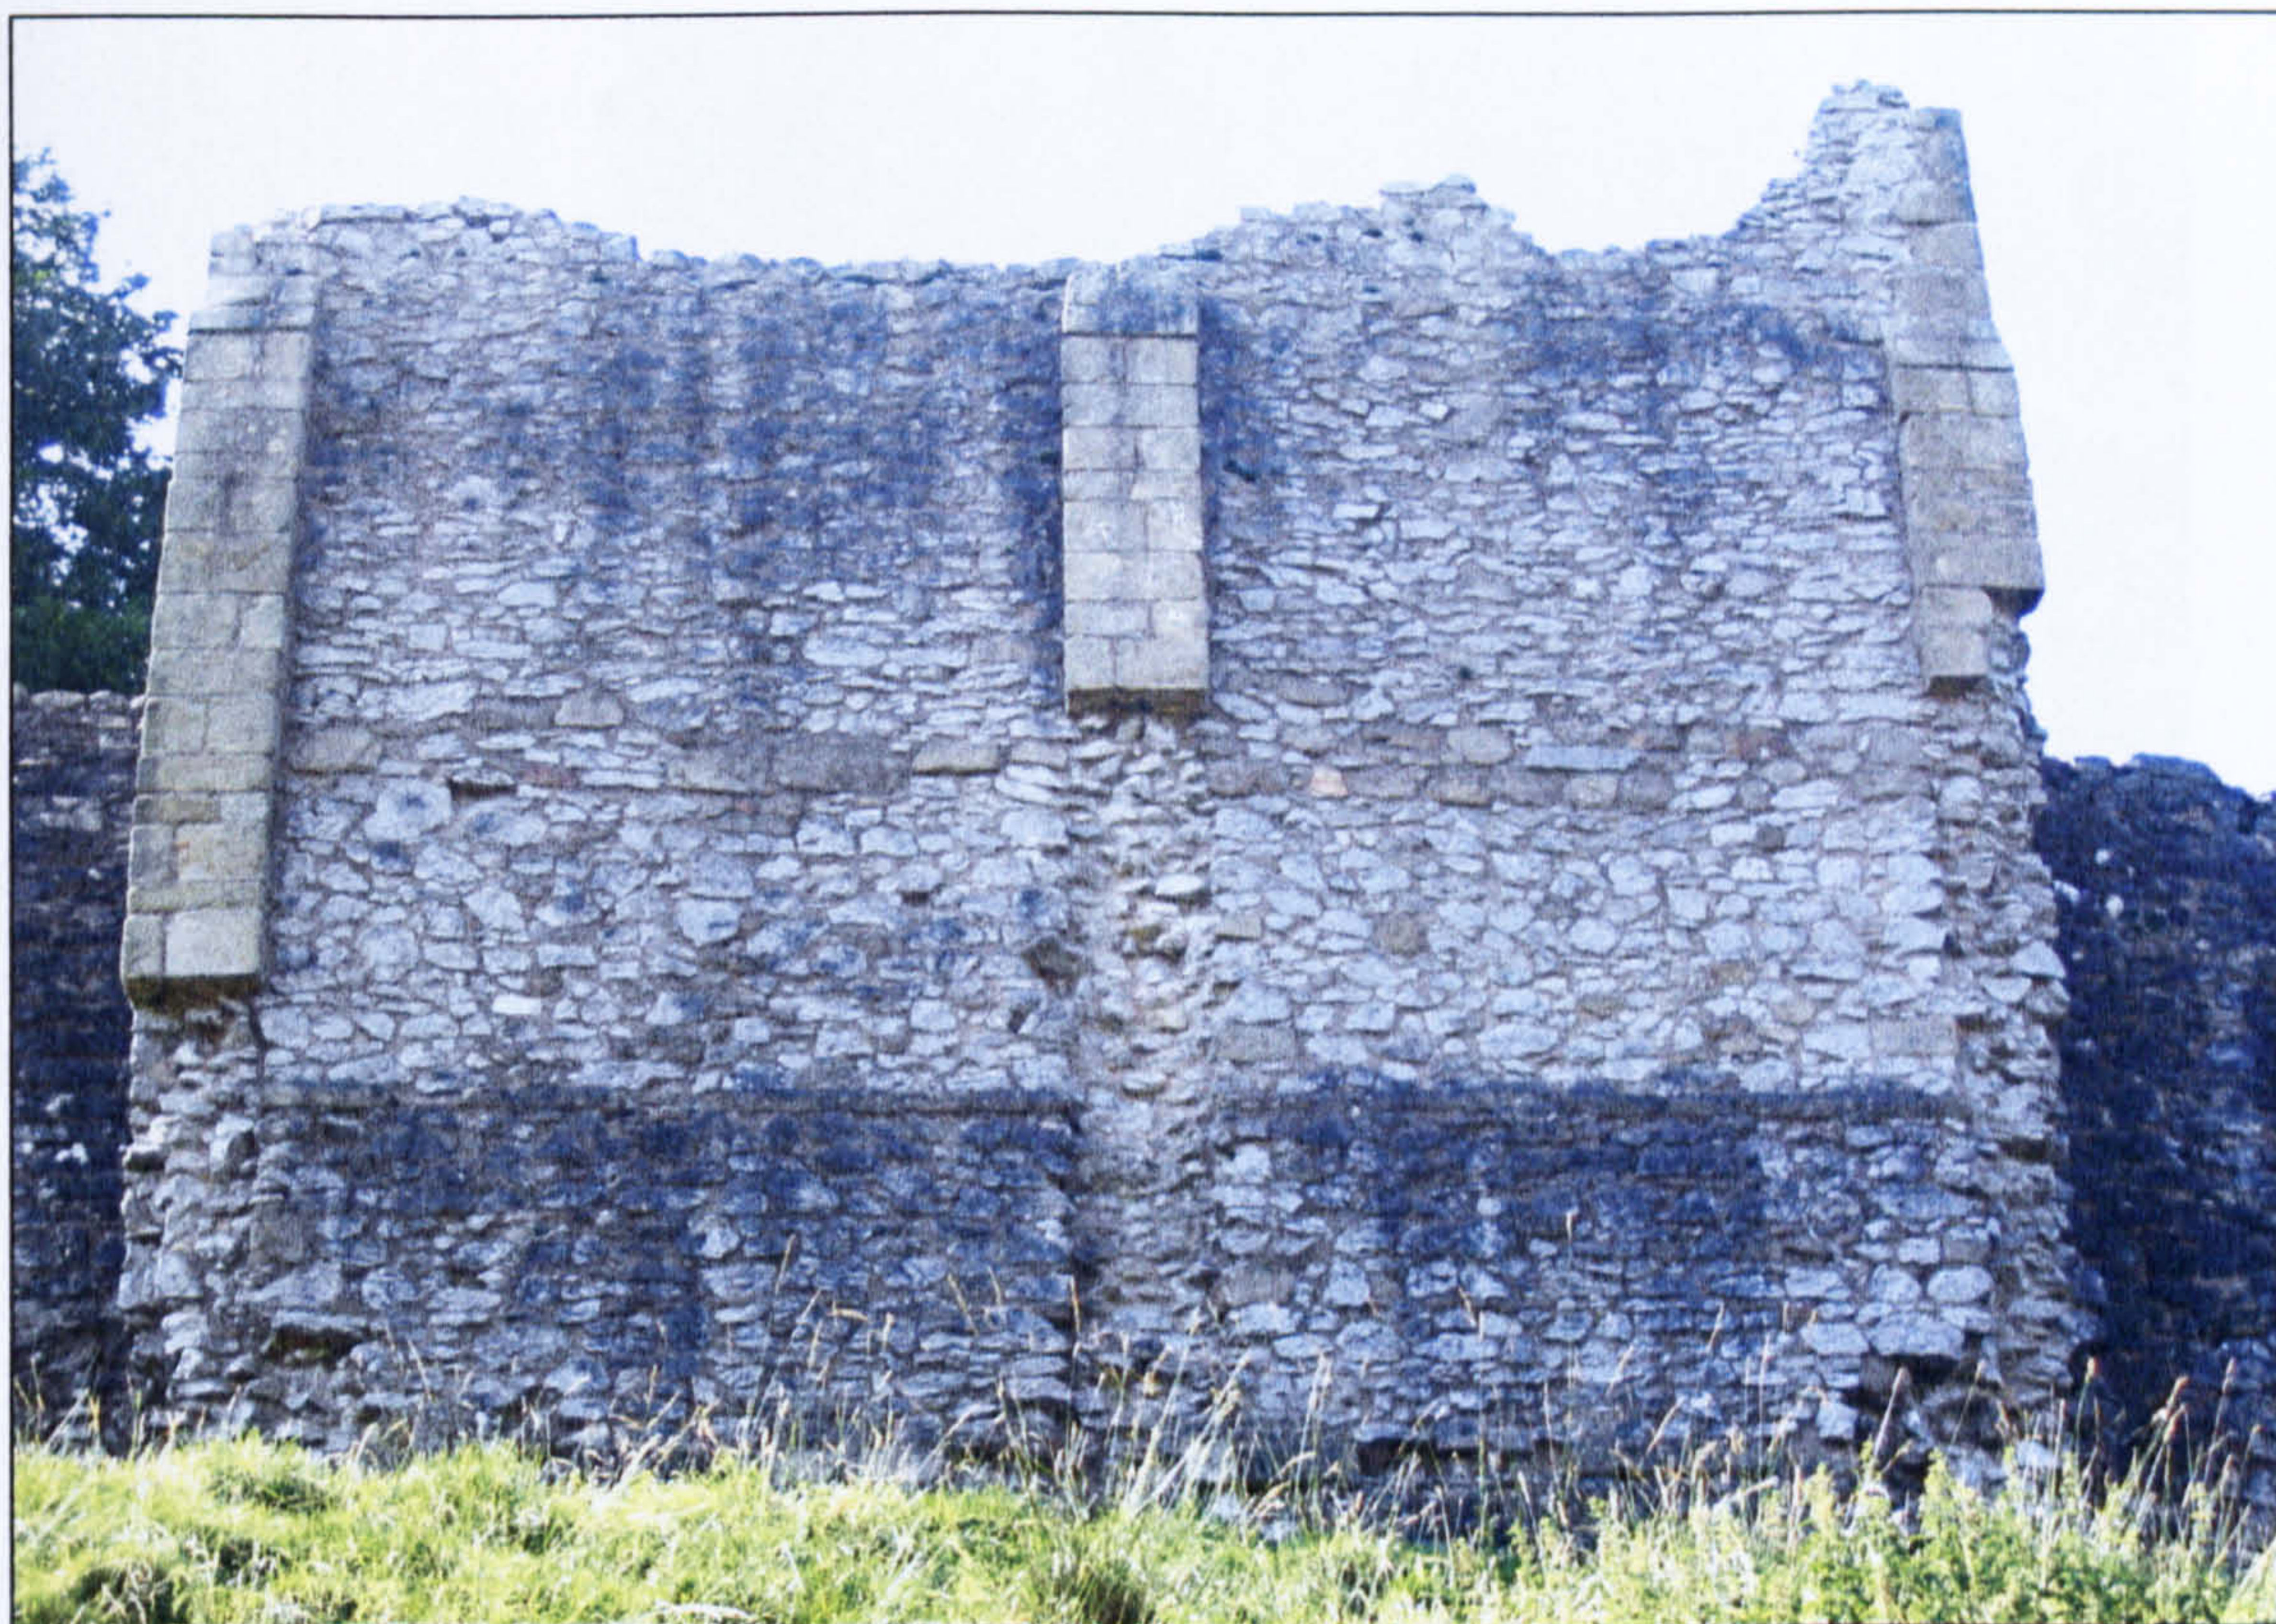
Figure 4.38 Secondary damage at Peveril Castle in the form of removed Quoins.

Figure 4.38 Secondary damage at Peveril Castle in the form of removed Quoins.
