ARCHAEOLOGY OF DESTRUCTION

A REINTERPRETATION OF CASTLE SLIGHTINGS IN THE ENGLISH CIVIL WAR

Thesis submitted for the degree of
Doctor of Philosophy
University of York
Department of Archaeology

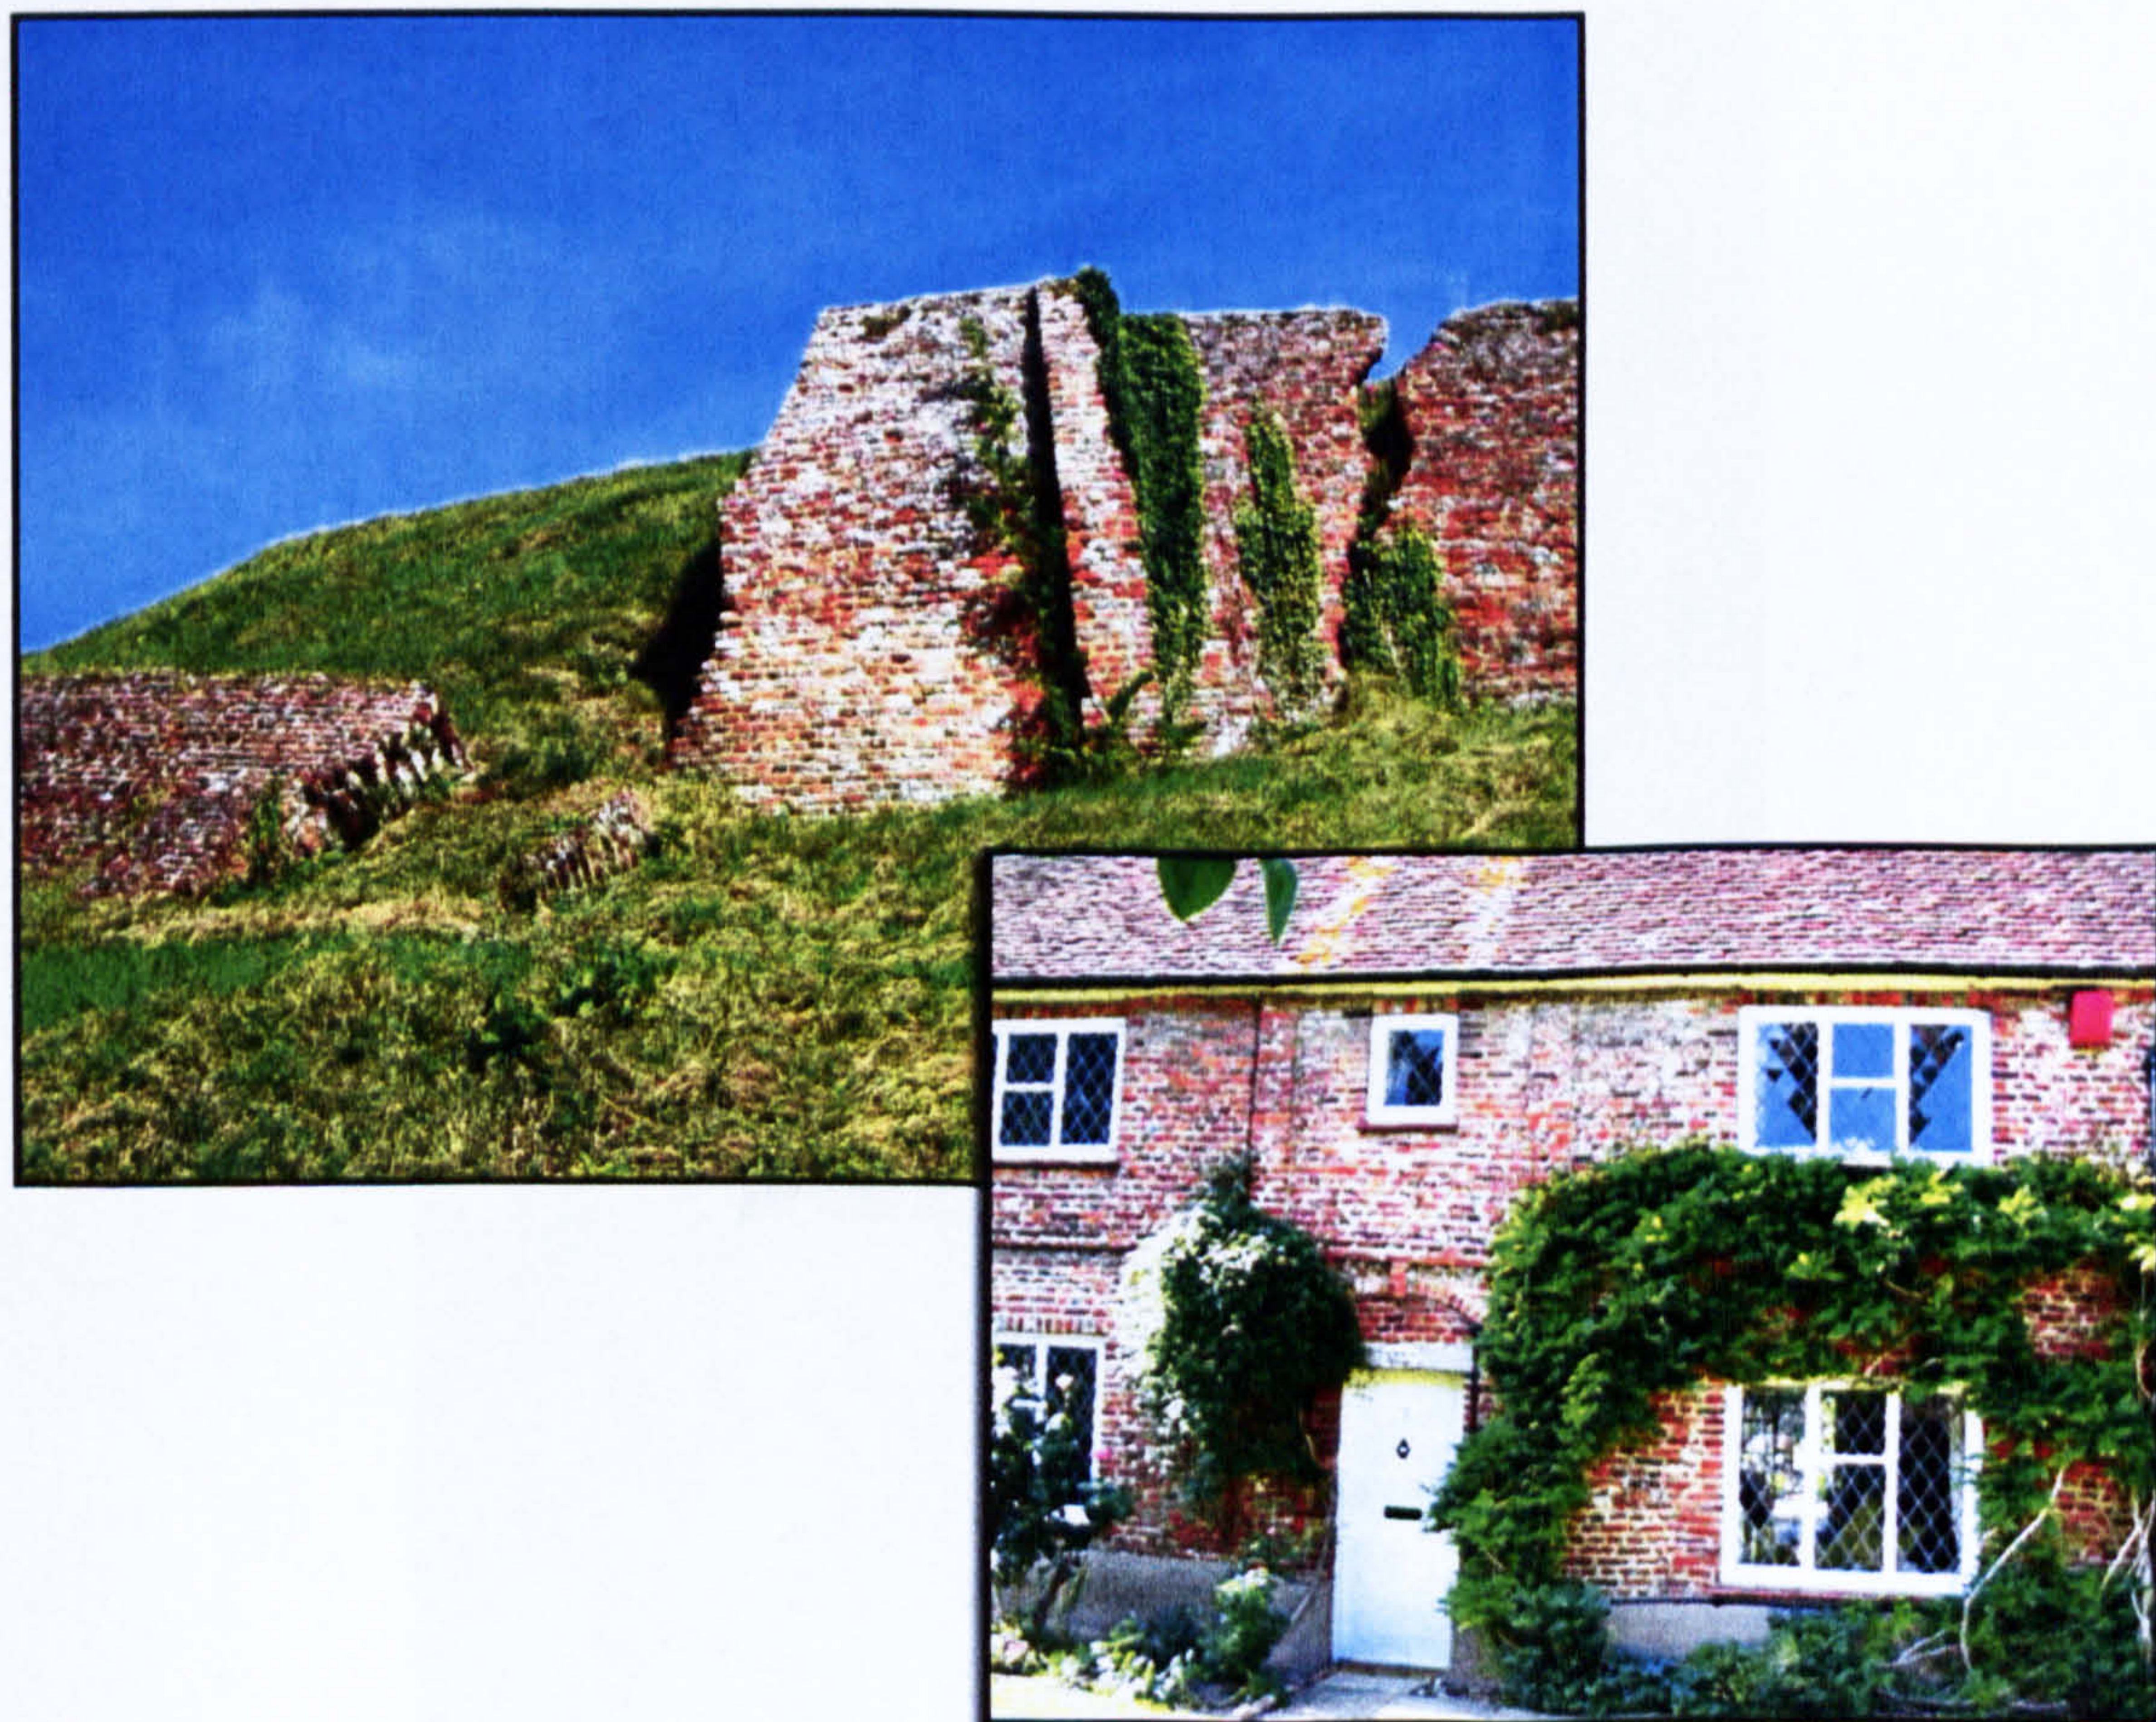
Figure 4.39 *Left*: Damaged curtain wall at Basing House. *Right*: House built from castle brick in Old Basing.

Figure 4.39 *Left:* Damaged curtain wall at Basing House. *Right:* House built from castle brick in Old Basing.

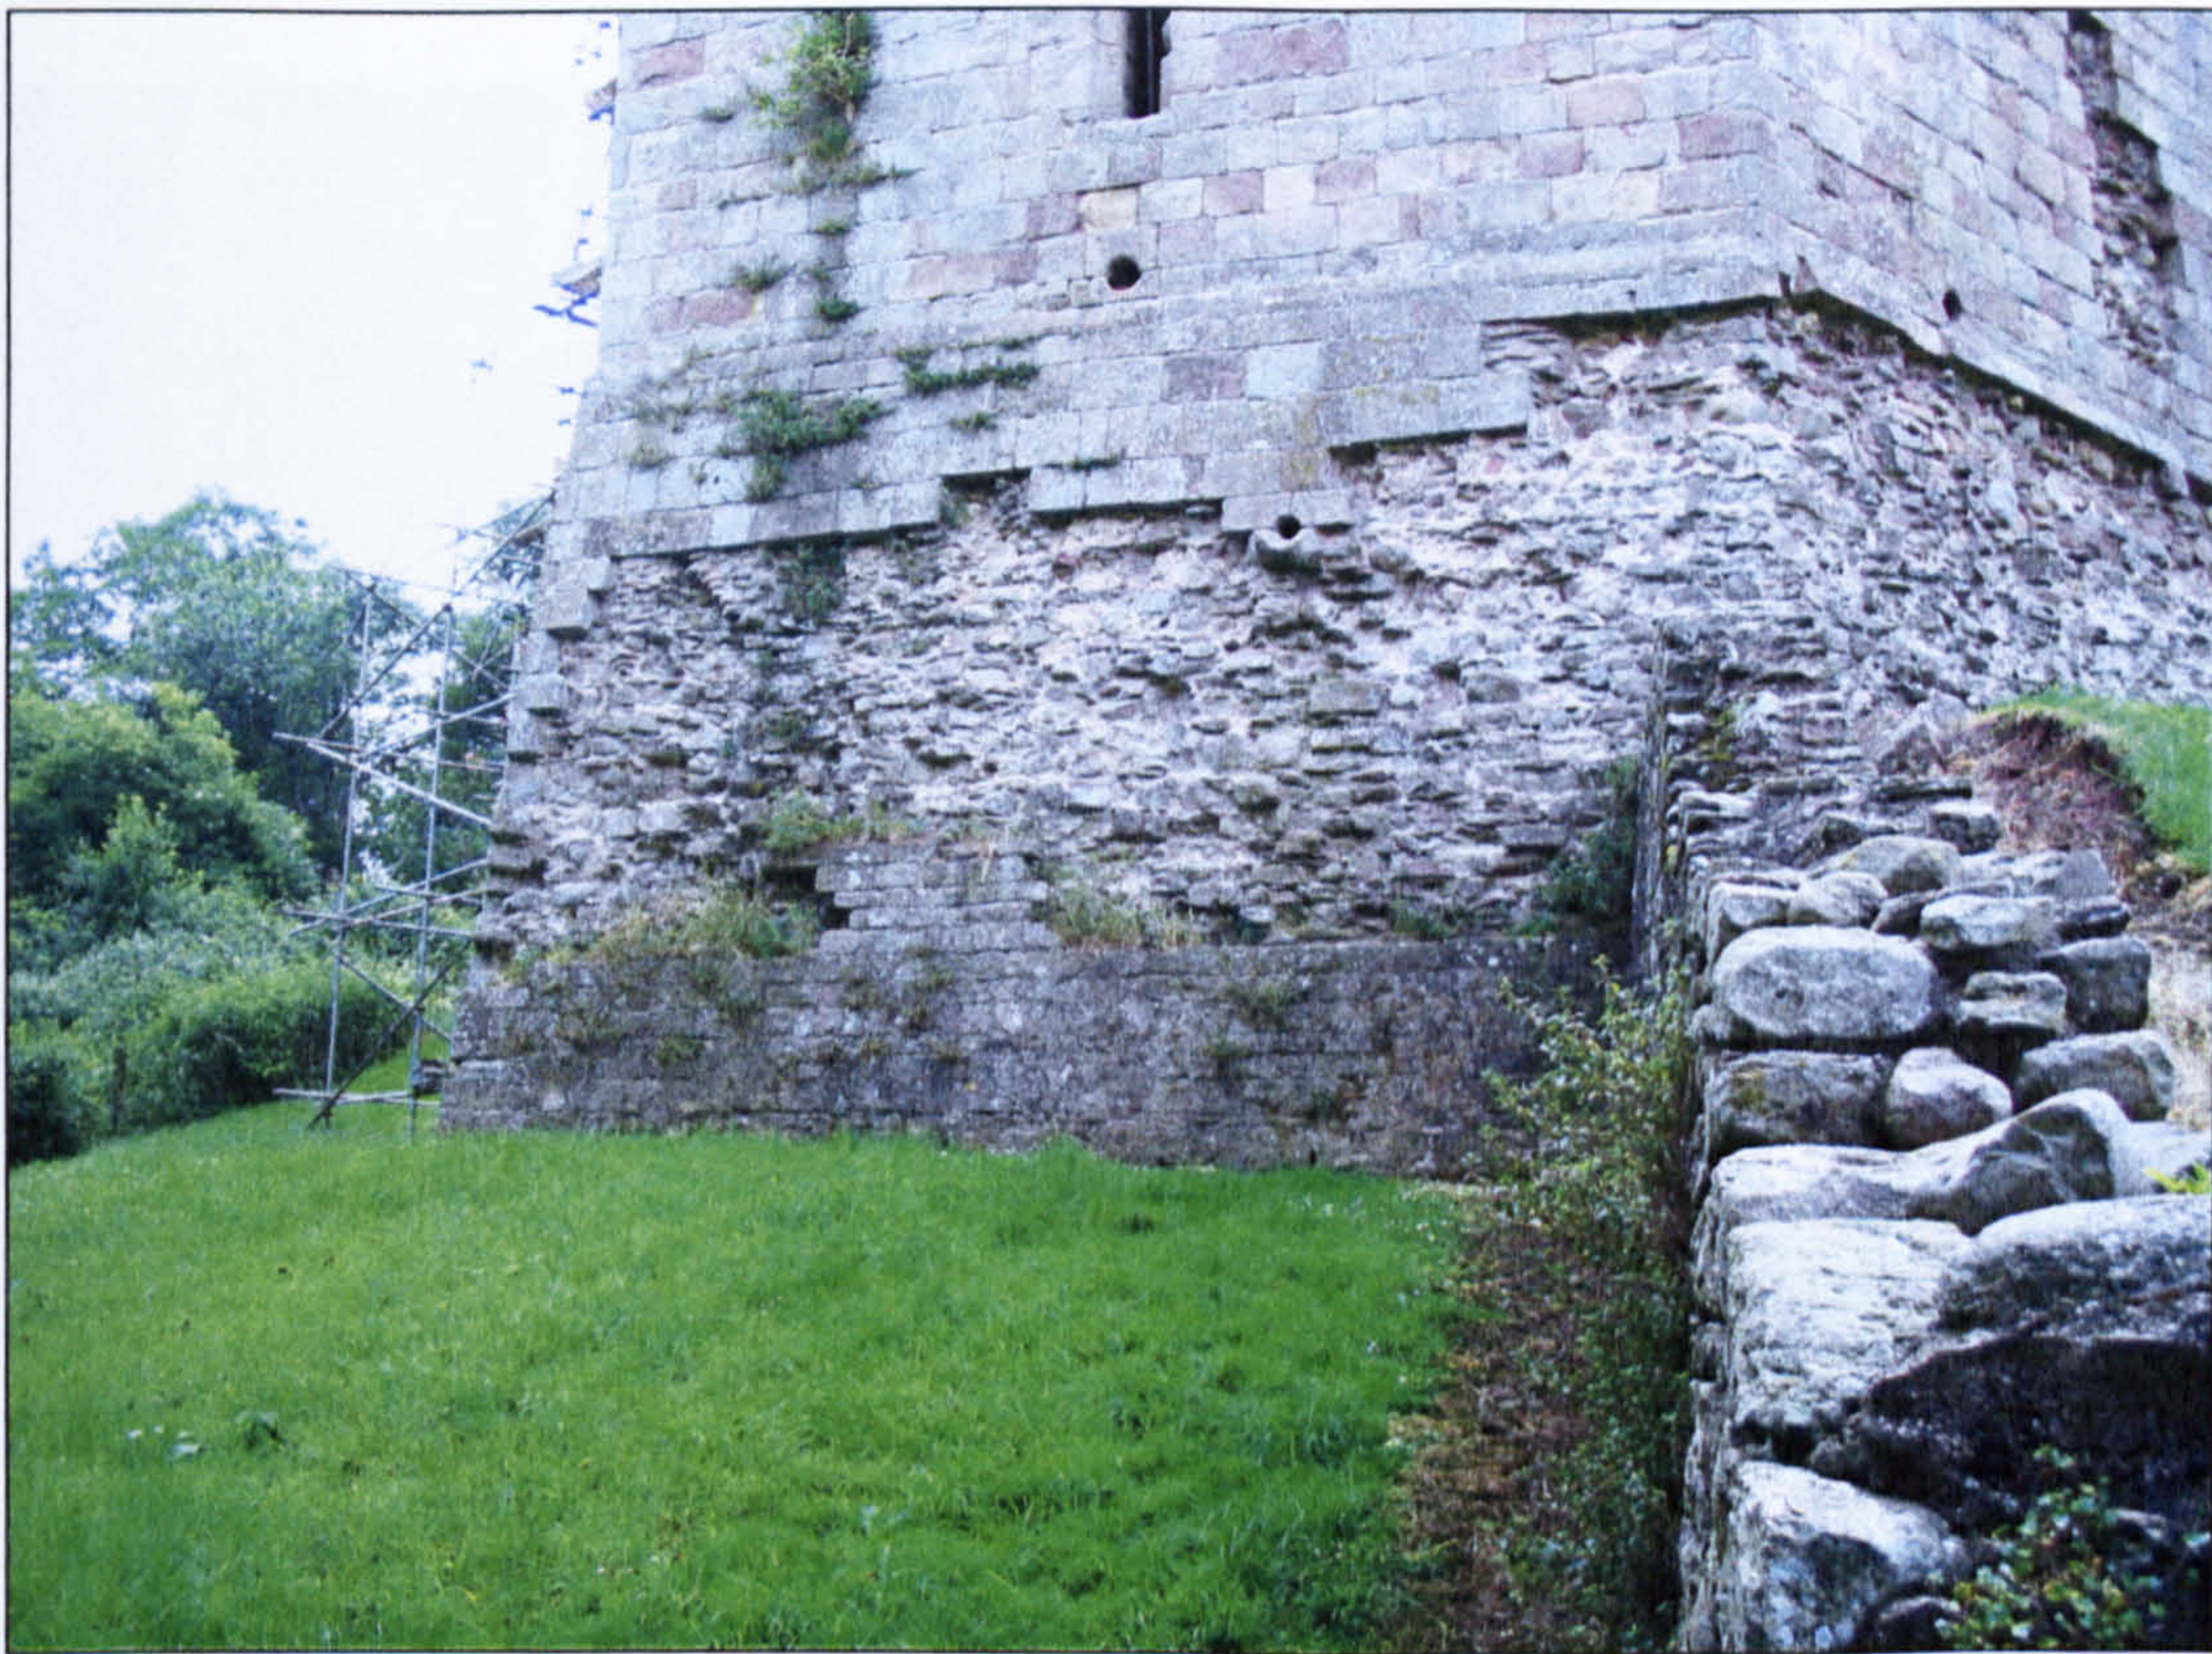
Figure 4.40 Possible robbing pattern at Raglan Castle (Wales).

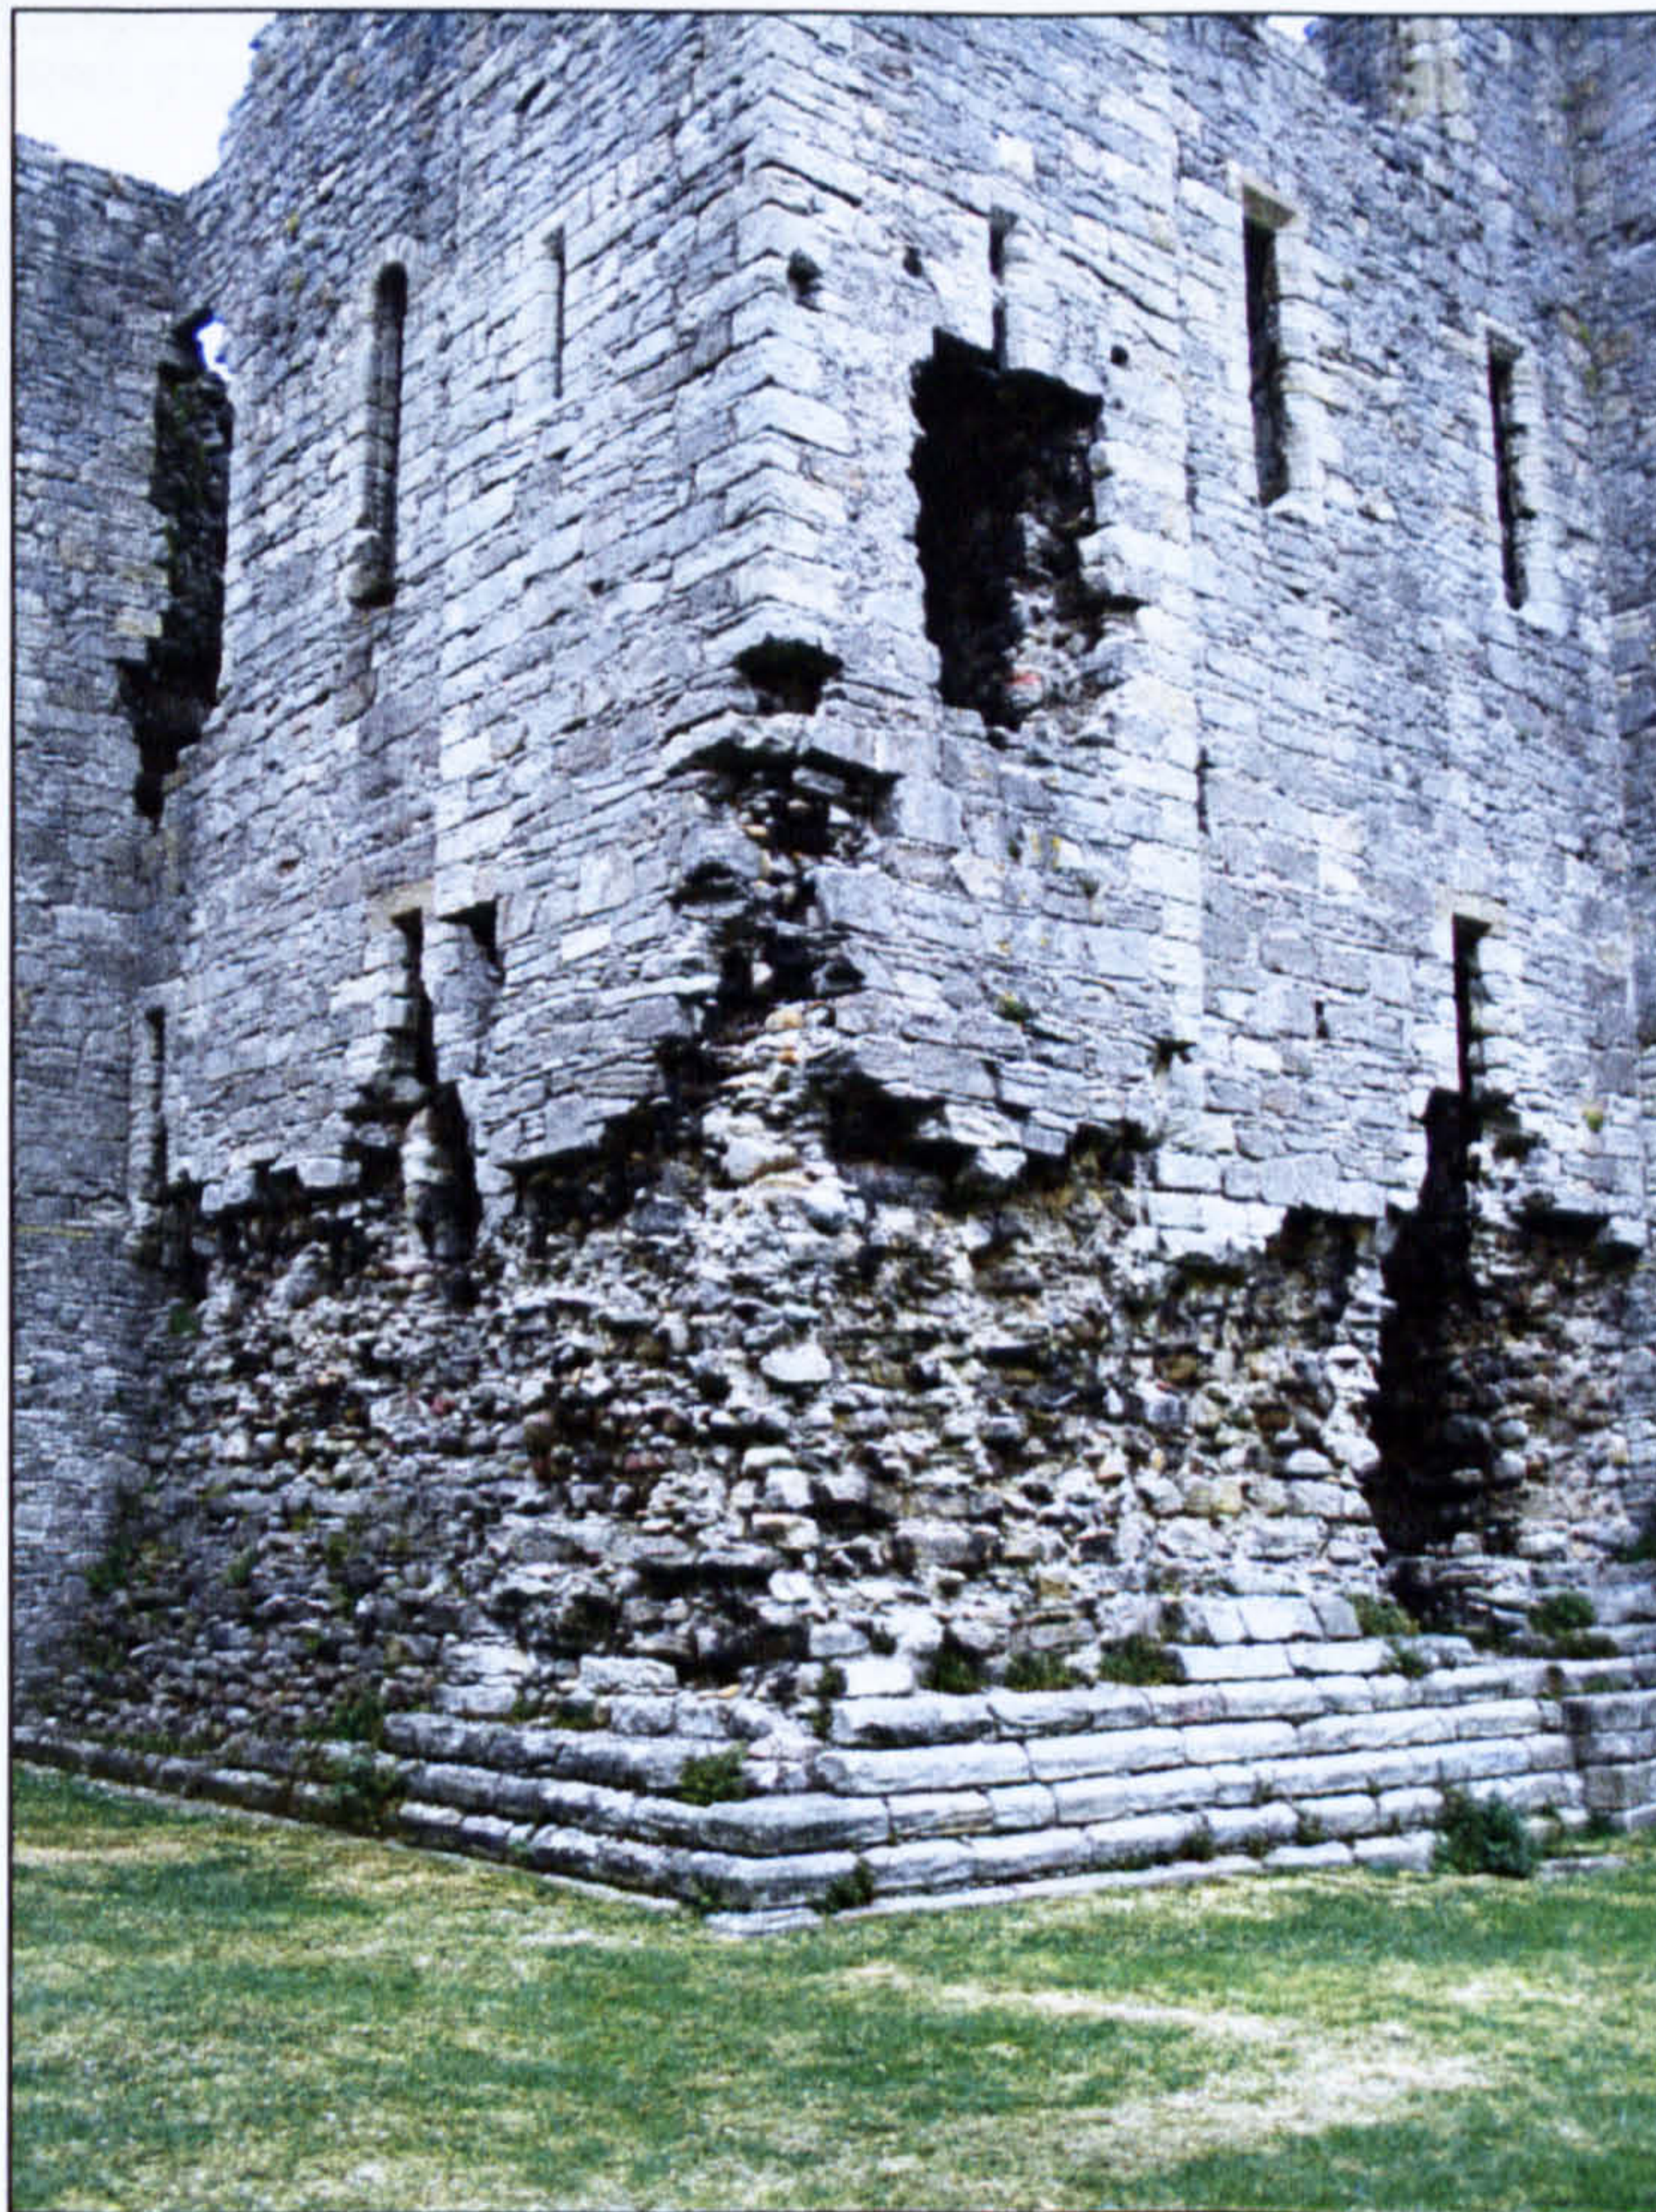
Figure 4.41 Secondary damage pattern in the form of removed facing stone at Middleham Castle (Yorkshire).

Figure 4.41 Secondary damage pattern in the form of removed facing stone at Middleham Castle (Yorkshire).

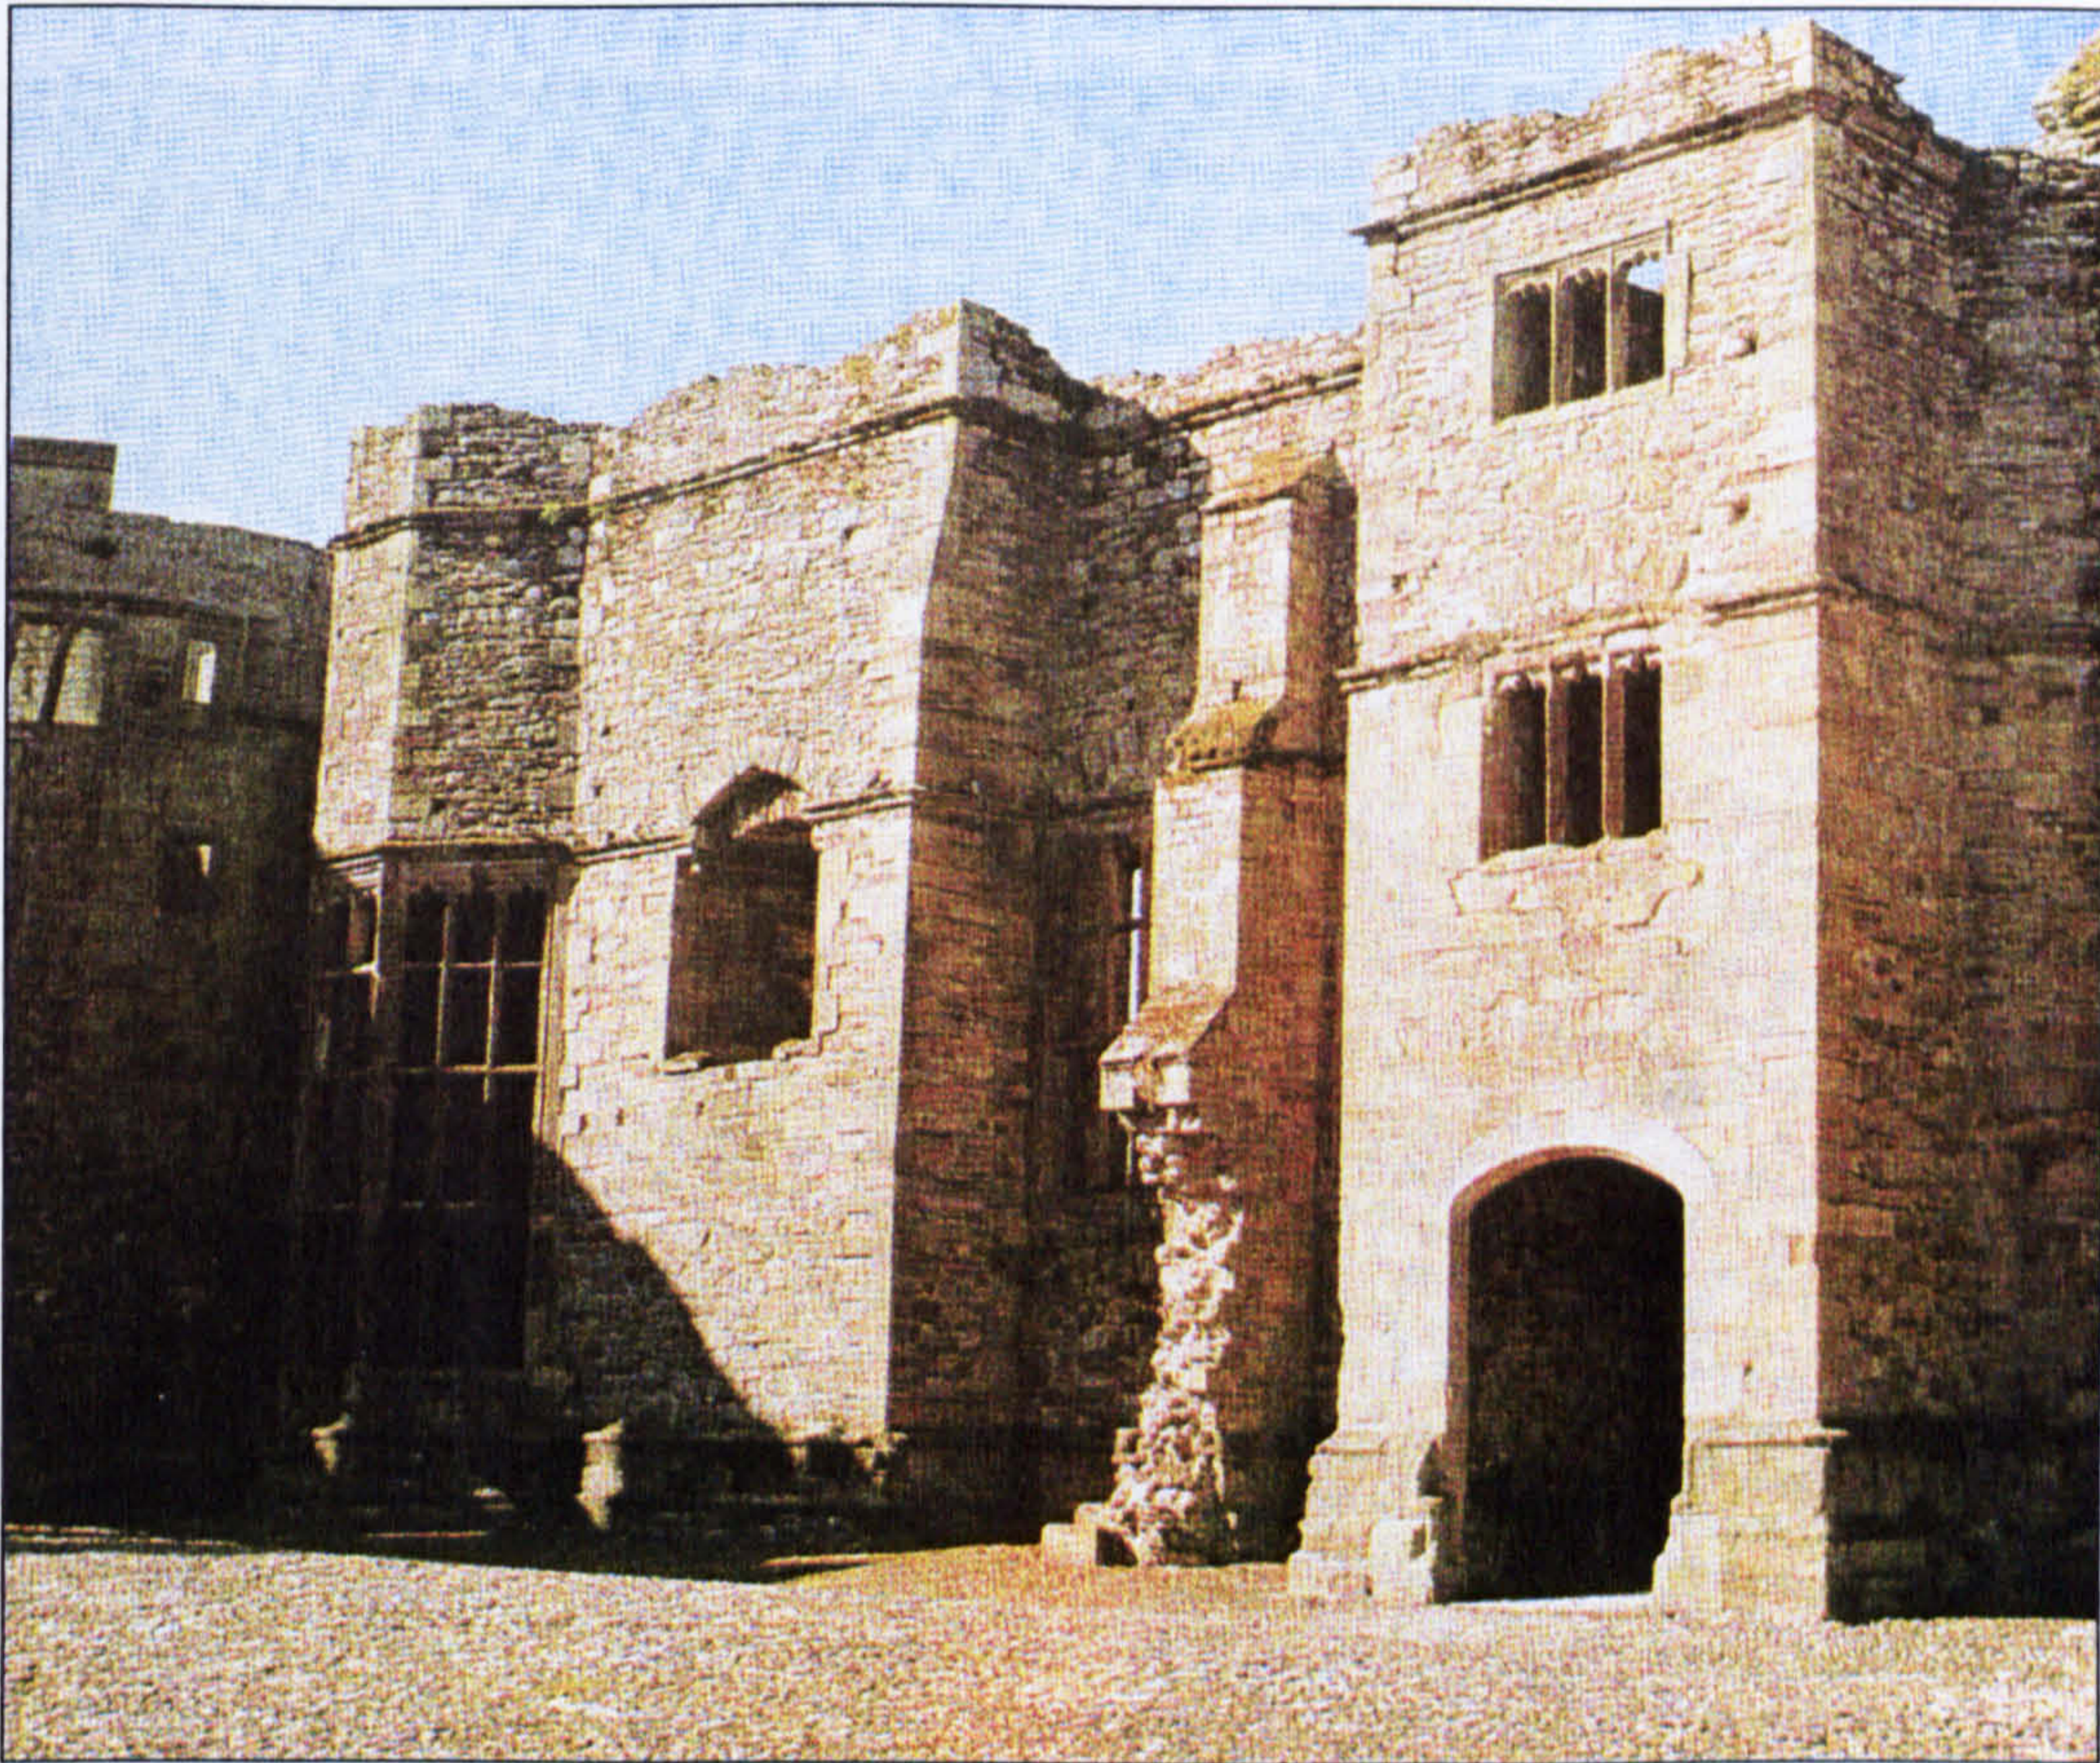
Figure 4.55 The Pitched Stone Court at Raglan Castle (Wales), showing secondary damage of a possible removed high status object (Kenyon 1988).

Figure 4.55 The Pitched Stone Court at Raglan Castle (Wales), showing secondary damage of a possible removed high status object (Kenyon 1988).

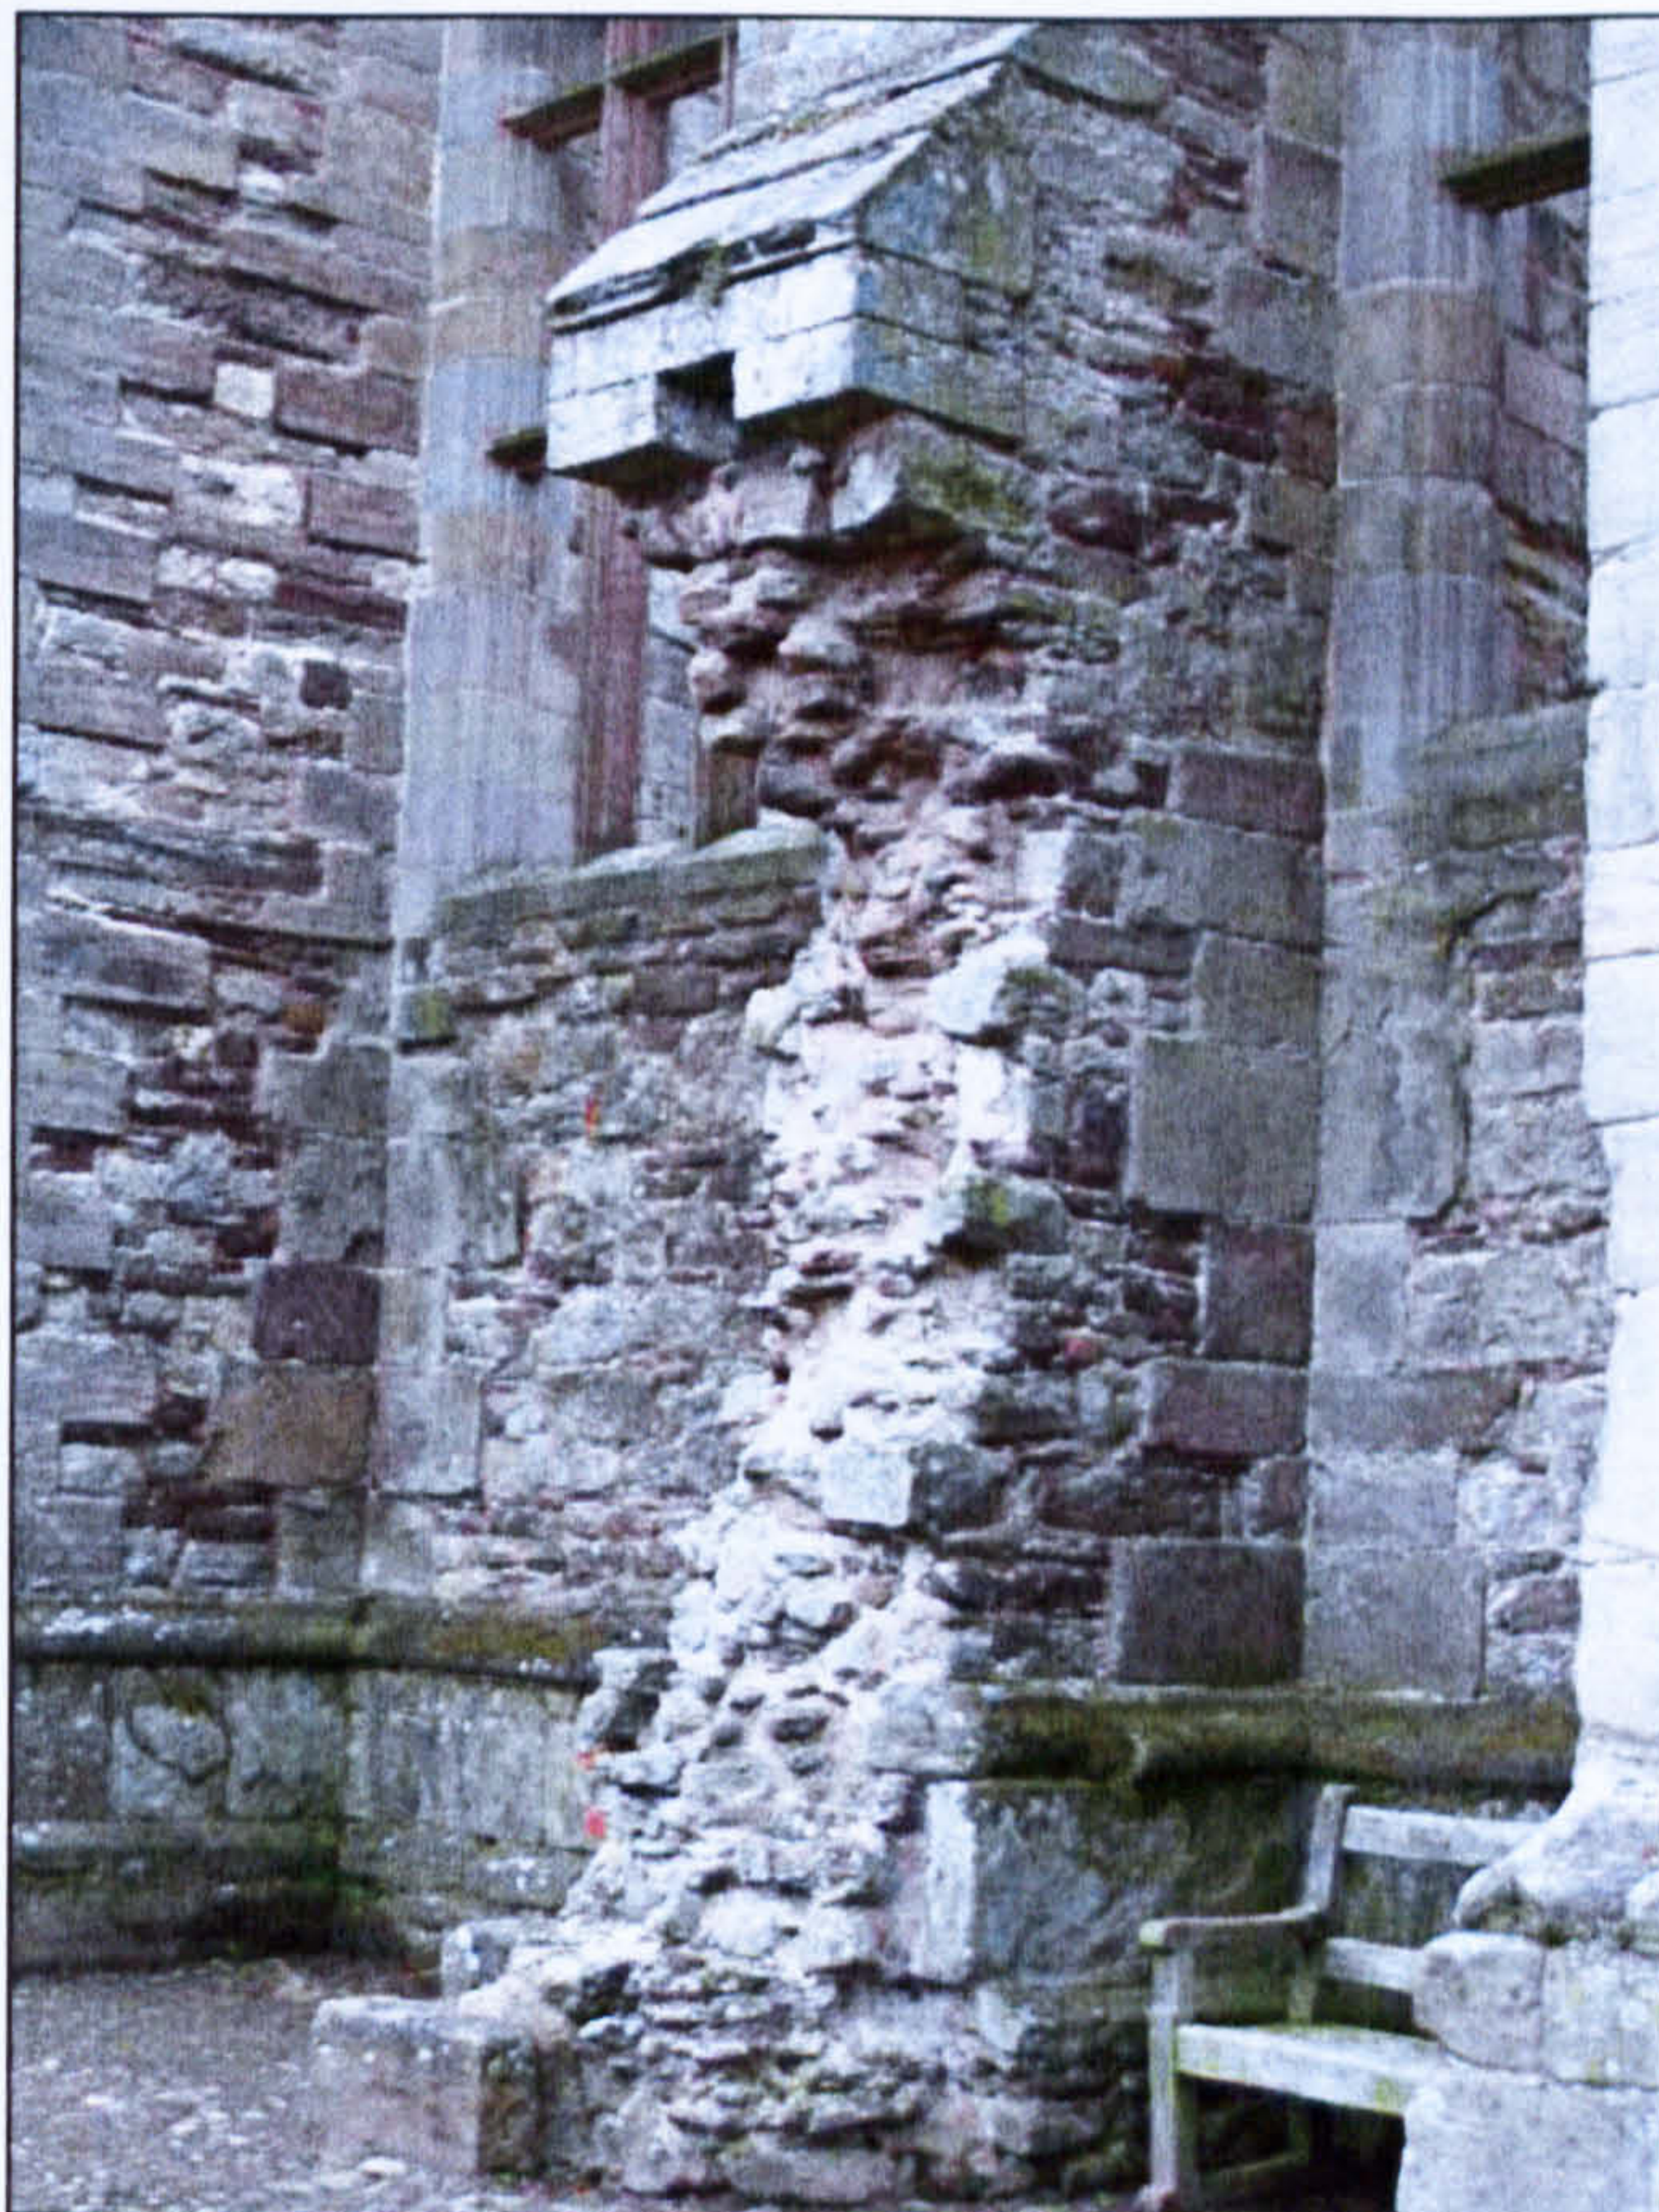
Figure 4.56 Close-up of secondary damage in Pitched Stone Court at Raglan Castle (Wales).

Figure 4.56 Close-up of secondary damage in Pitched Stone Court at Raglan Castle (Wales).

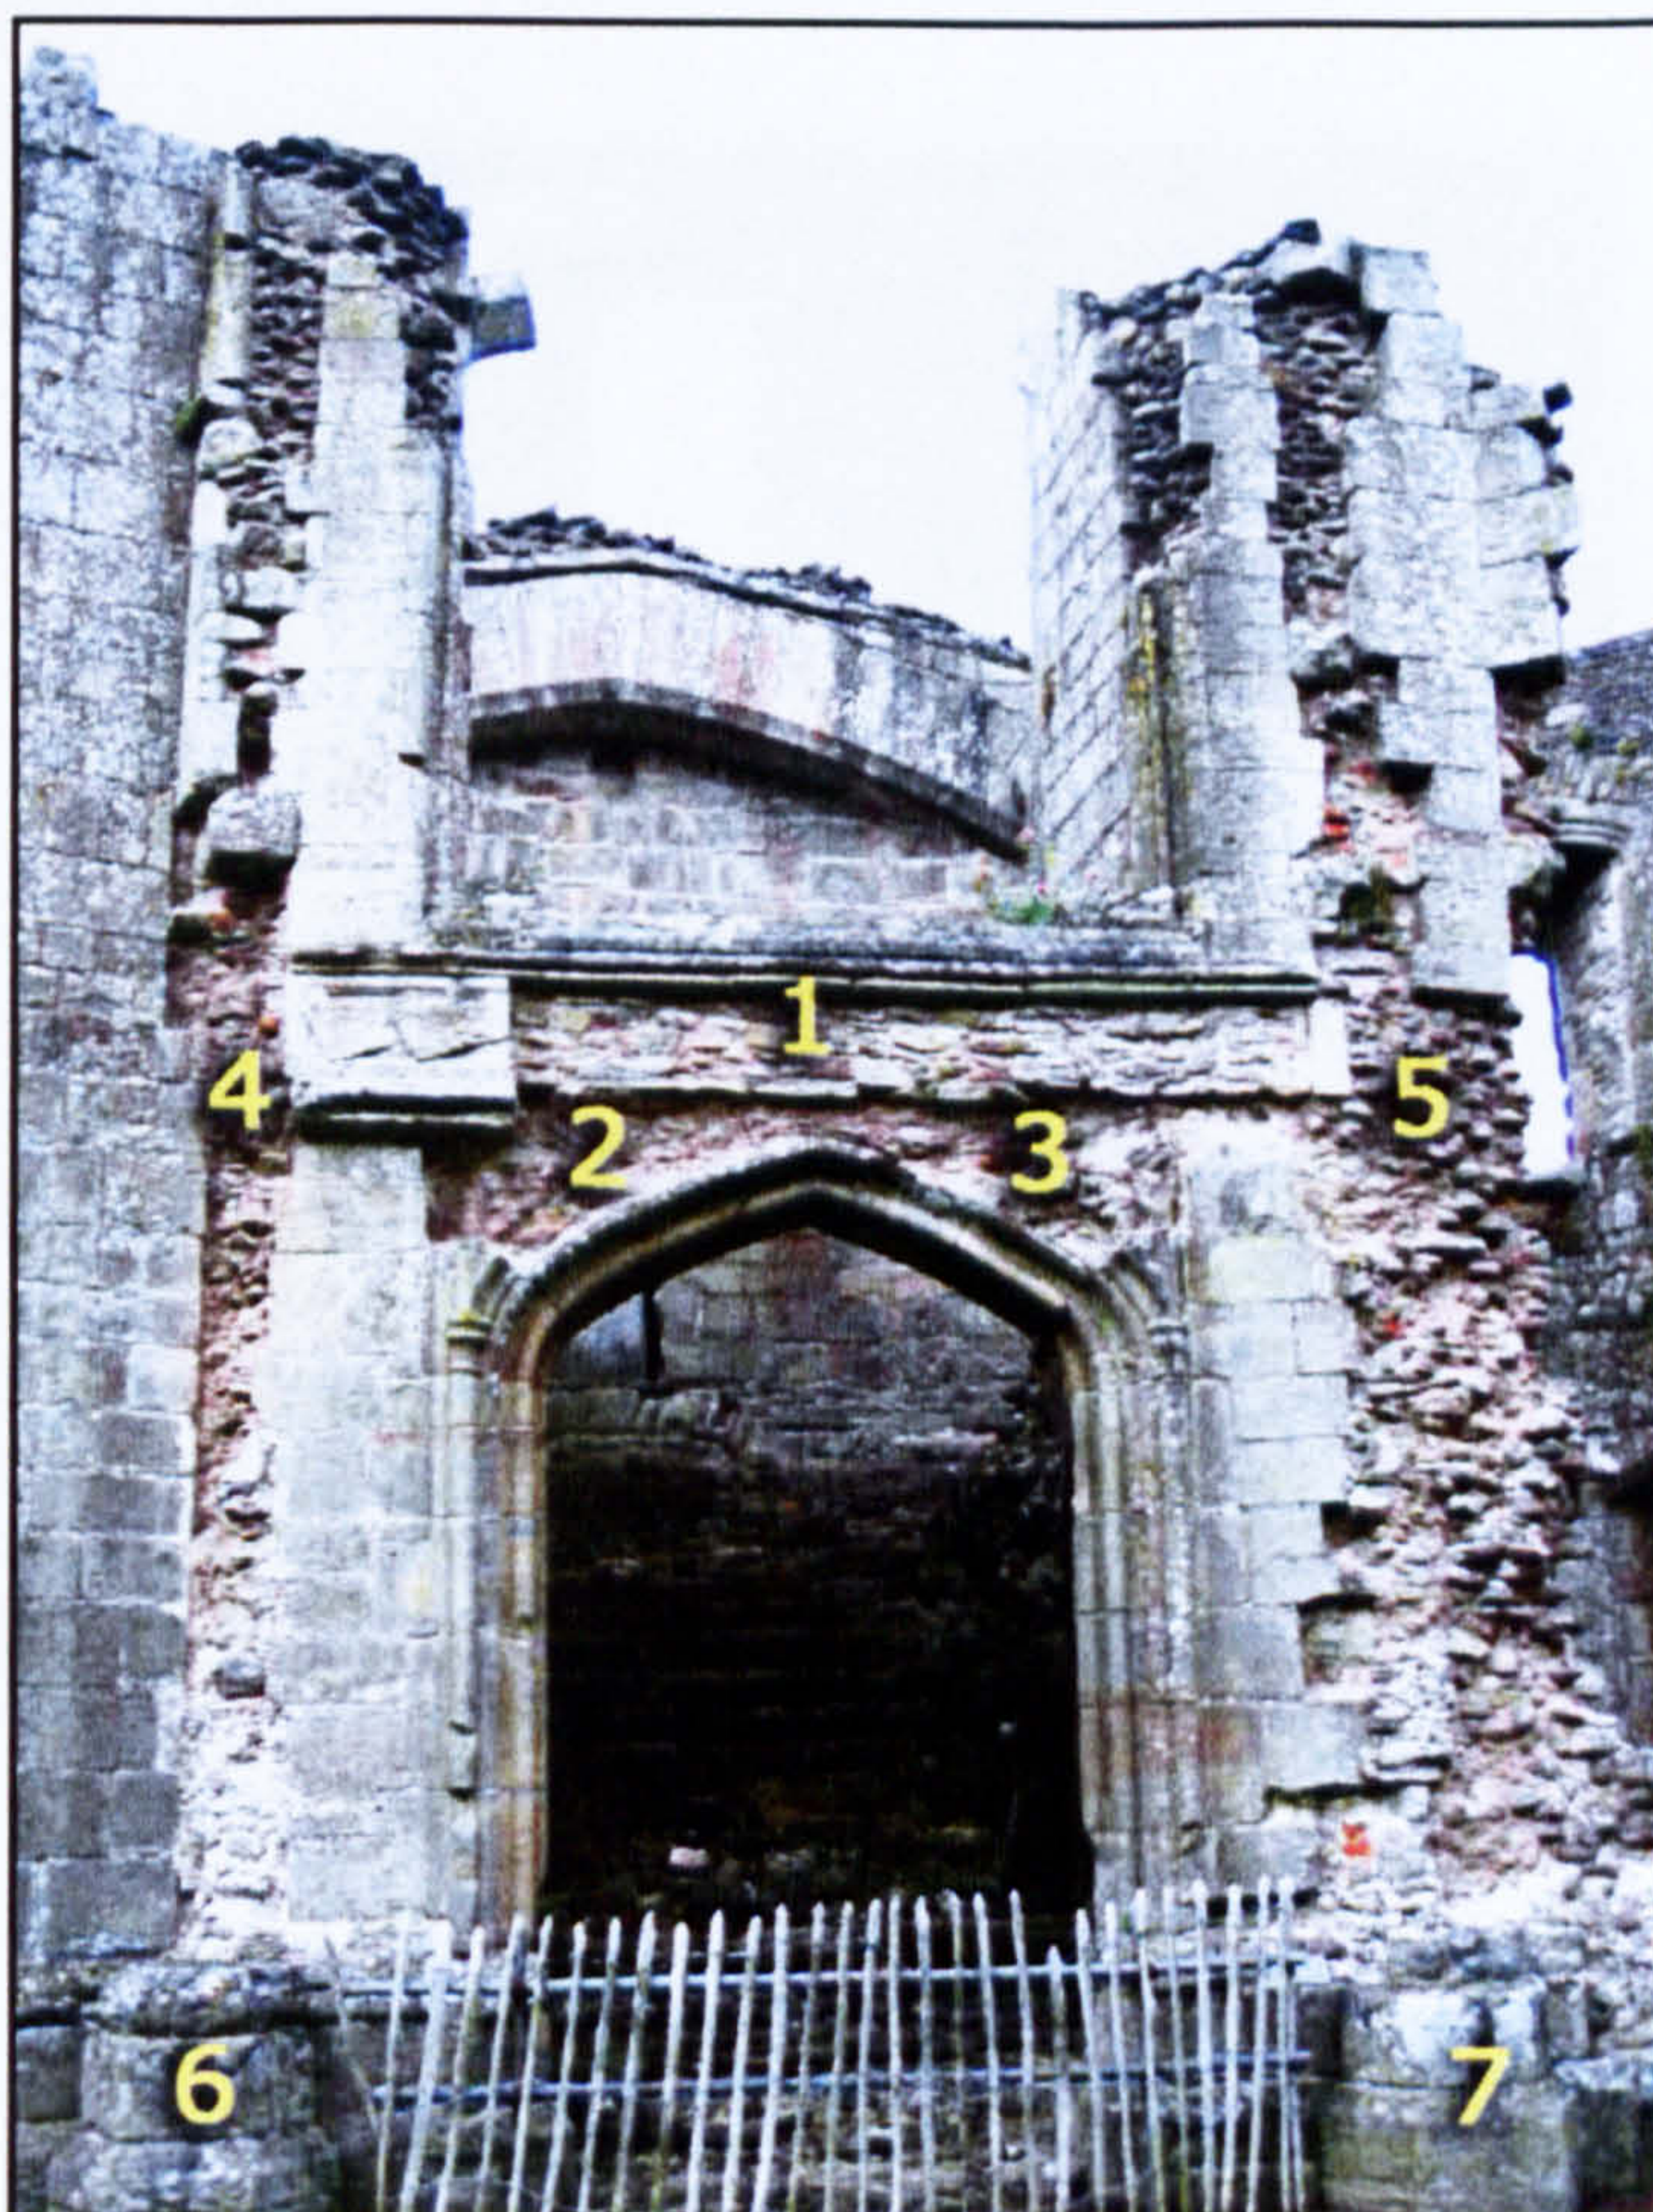
Figure 4.58 The Grand Stair leading to the apartments in the Fountain Court, with areas of secondary damage and various features numbered.

Figure 4.58 The Grand Stair leading to the apartments in the Fountain Court, with areas of secondary damage and various features numbered.
