ARCHAEOLOGY OF DESTRUCTION

A REINTERPRETATION OF CASTLE SLIGHTINGS IN THE ENGLISH CIVIL WAR

Thesis submitted for the degree of
Doctor of Philosophy
University of York
Department of Archaeology

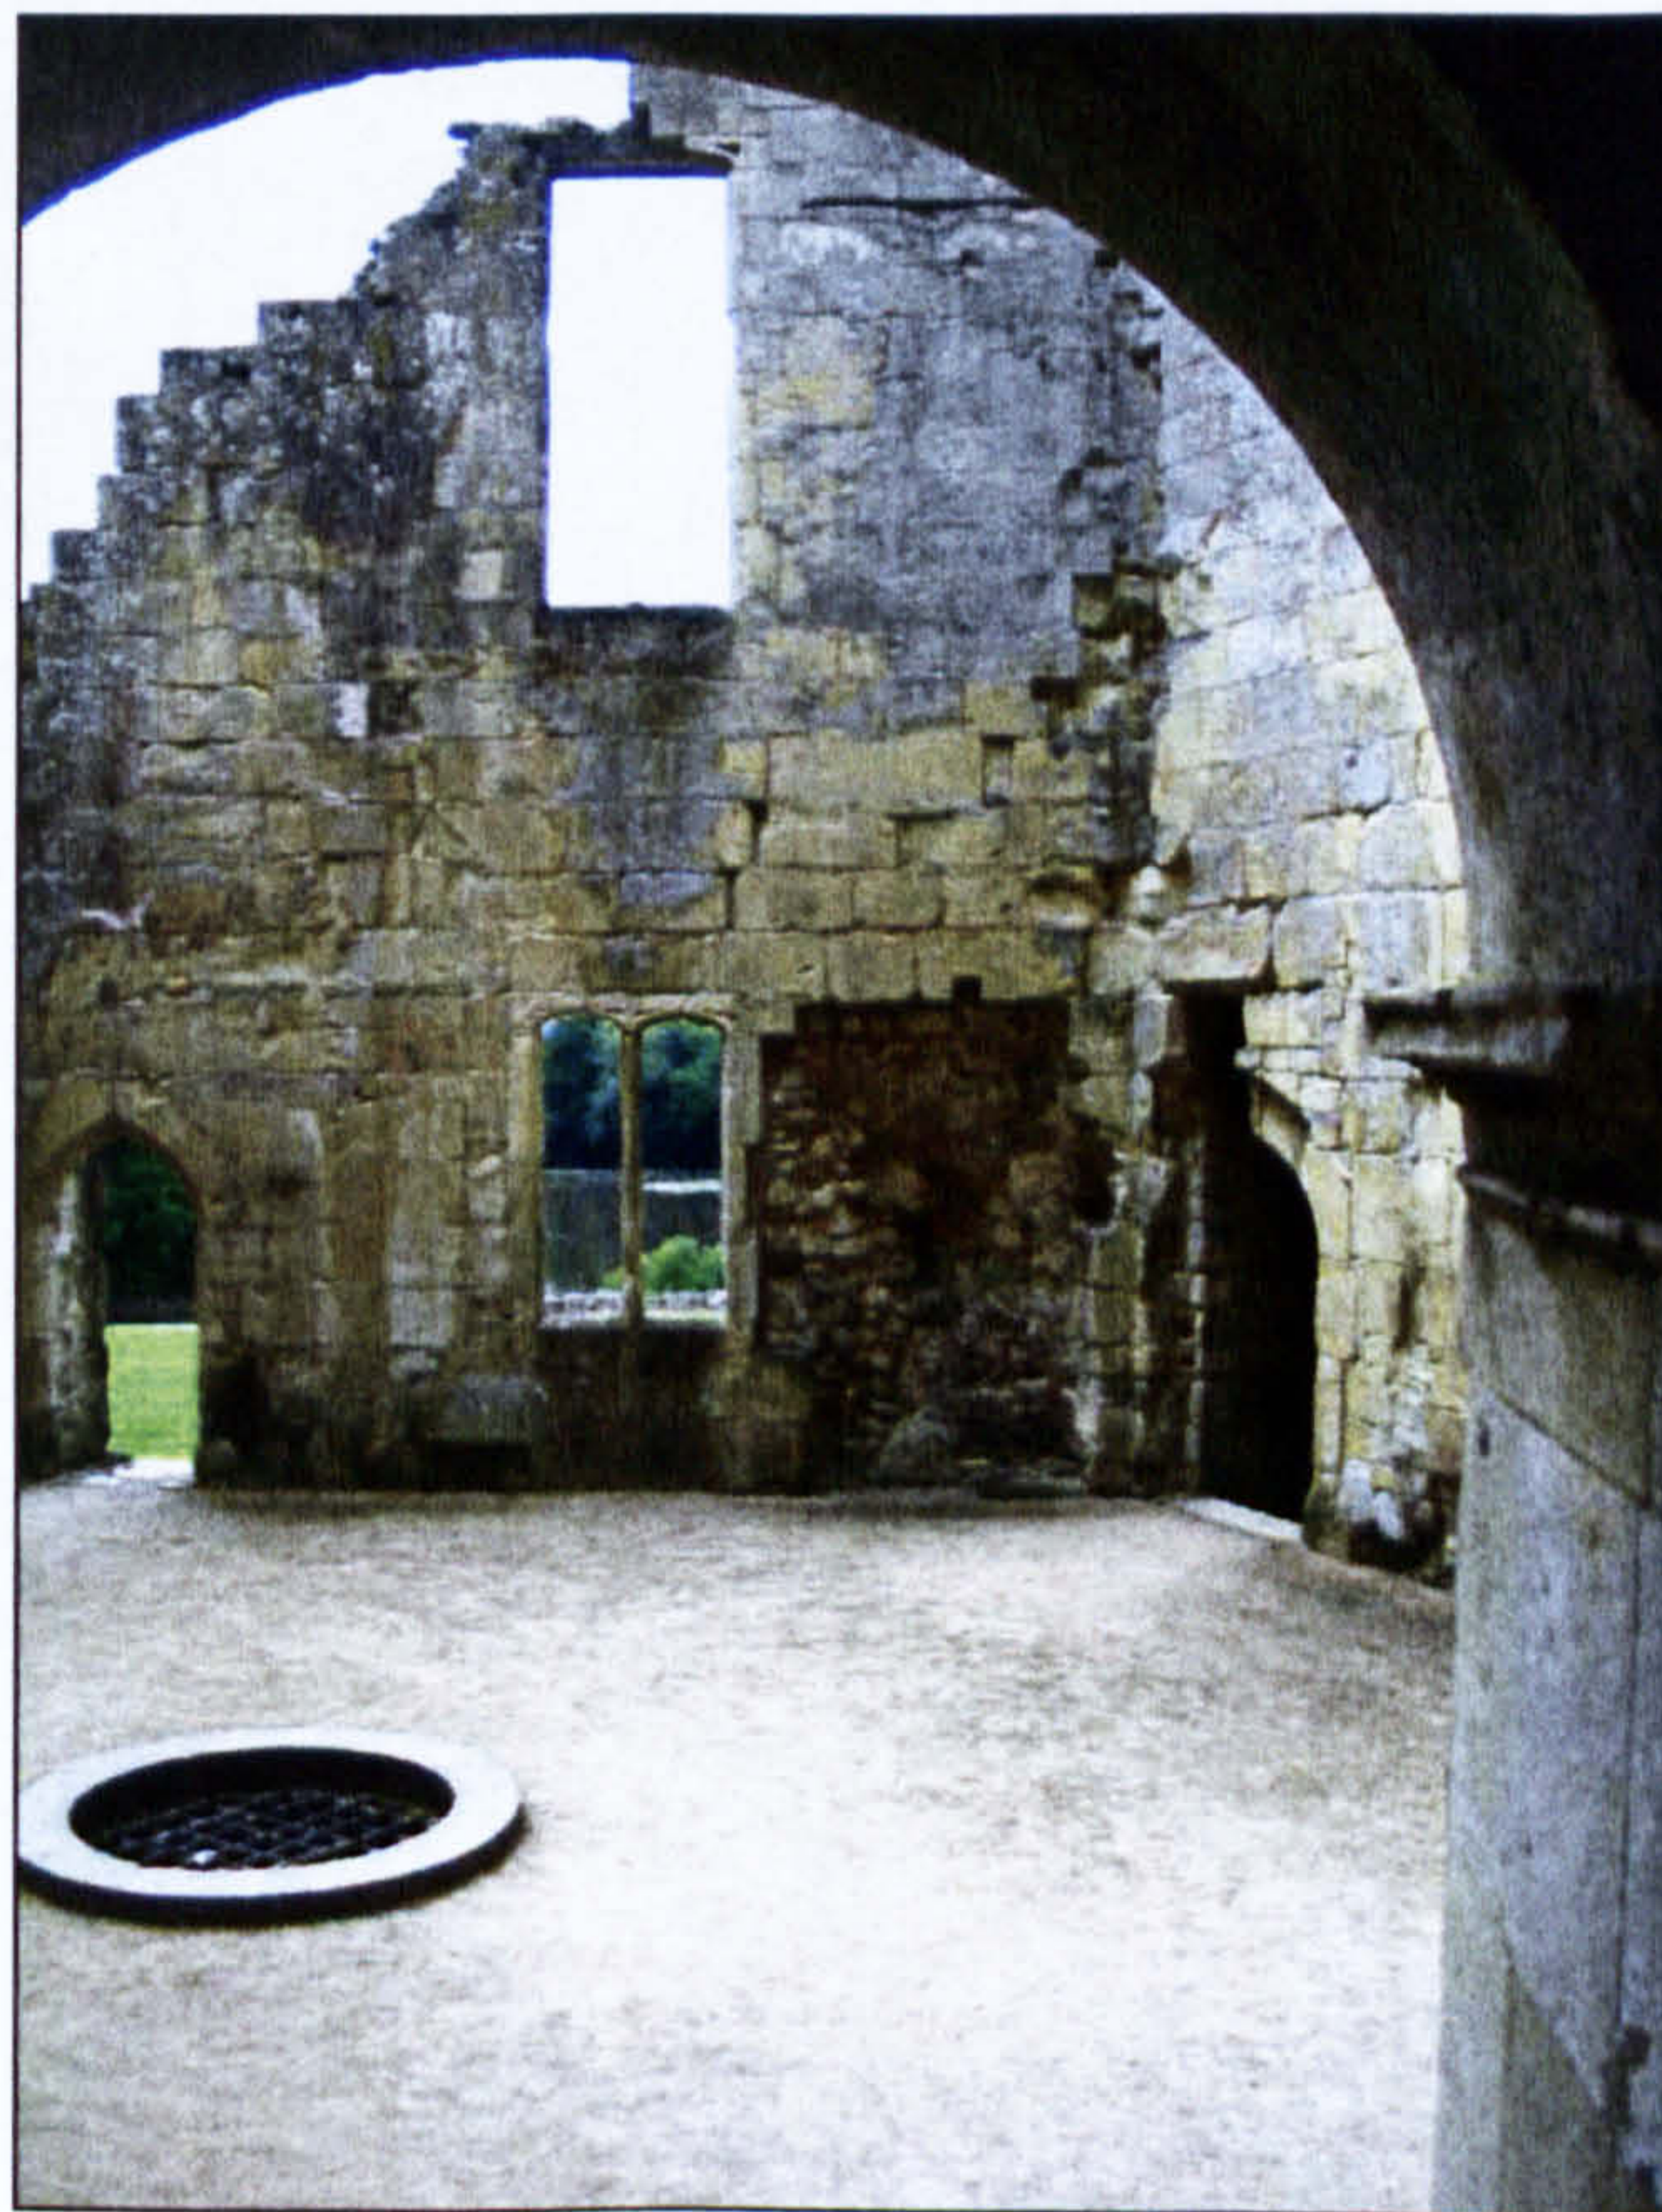
Figure 4.60 View from the Great Hall staircase of secondary damage pattern at Old Wardour Castle (Wiltshire).

Figure 4.60 View from the Great Hall staircase of secondary damage pattern at Old Wardour Castle (Wiltshire).

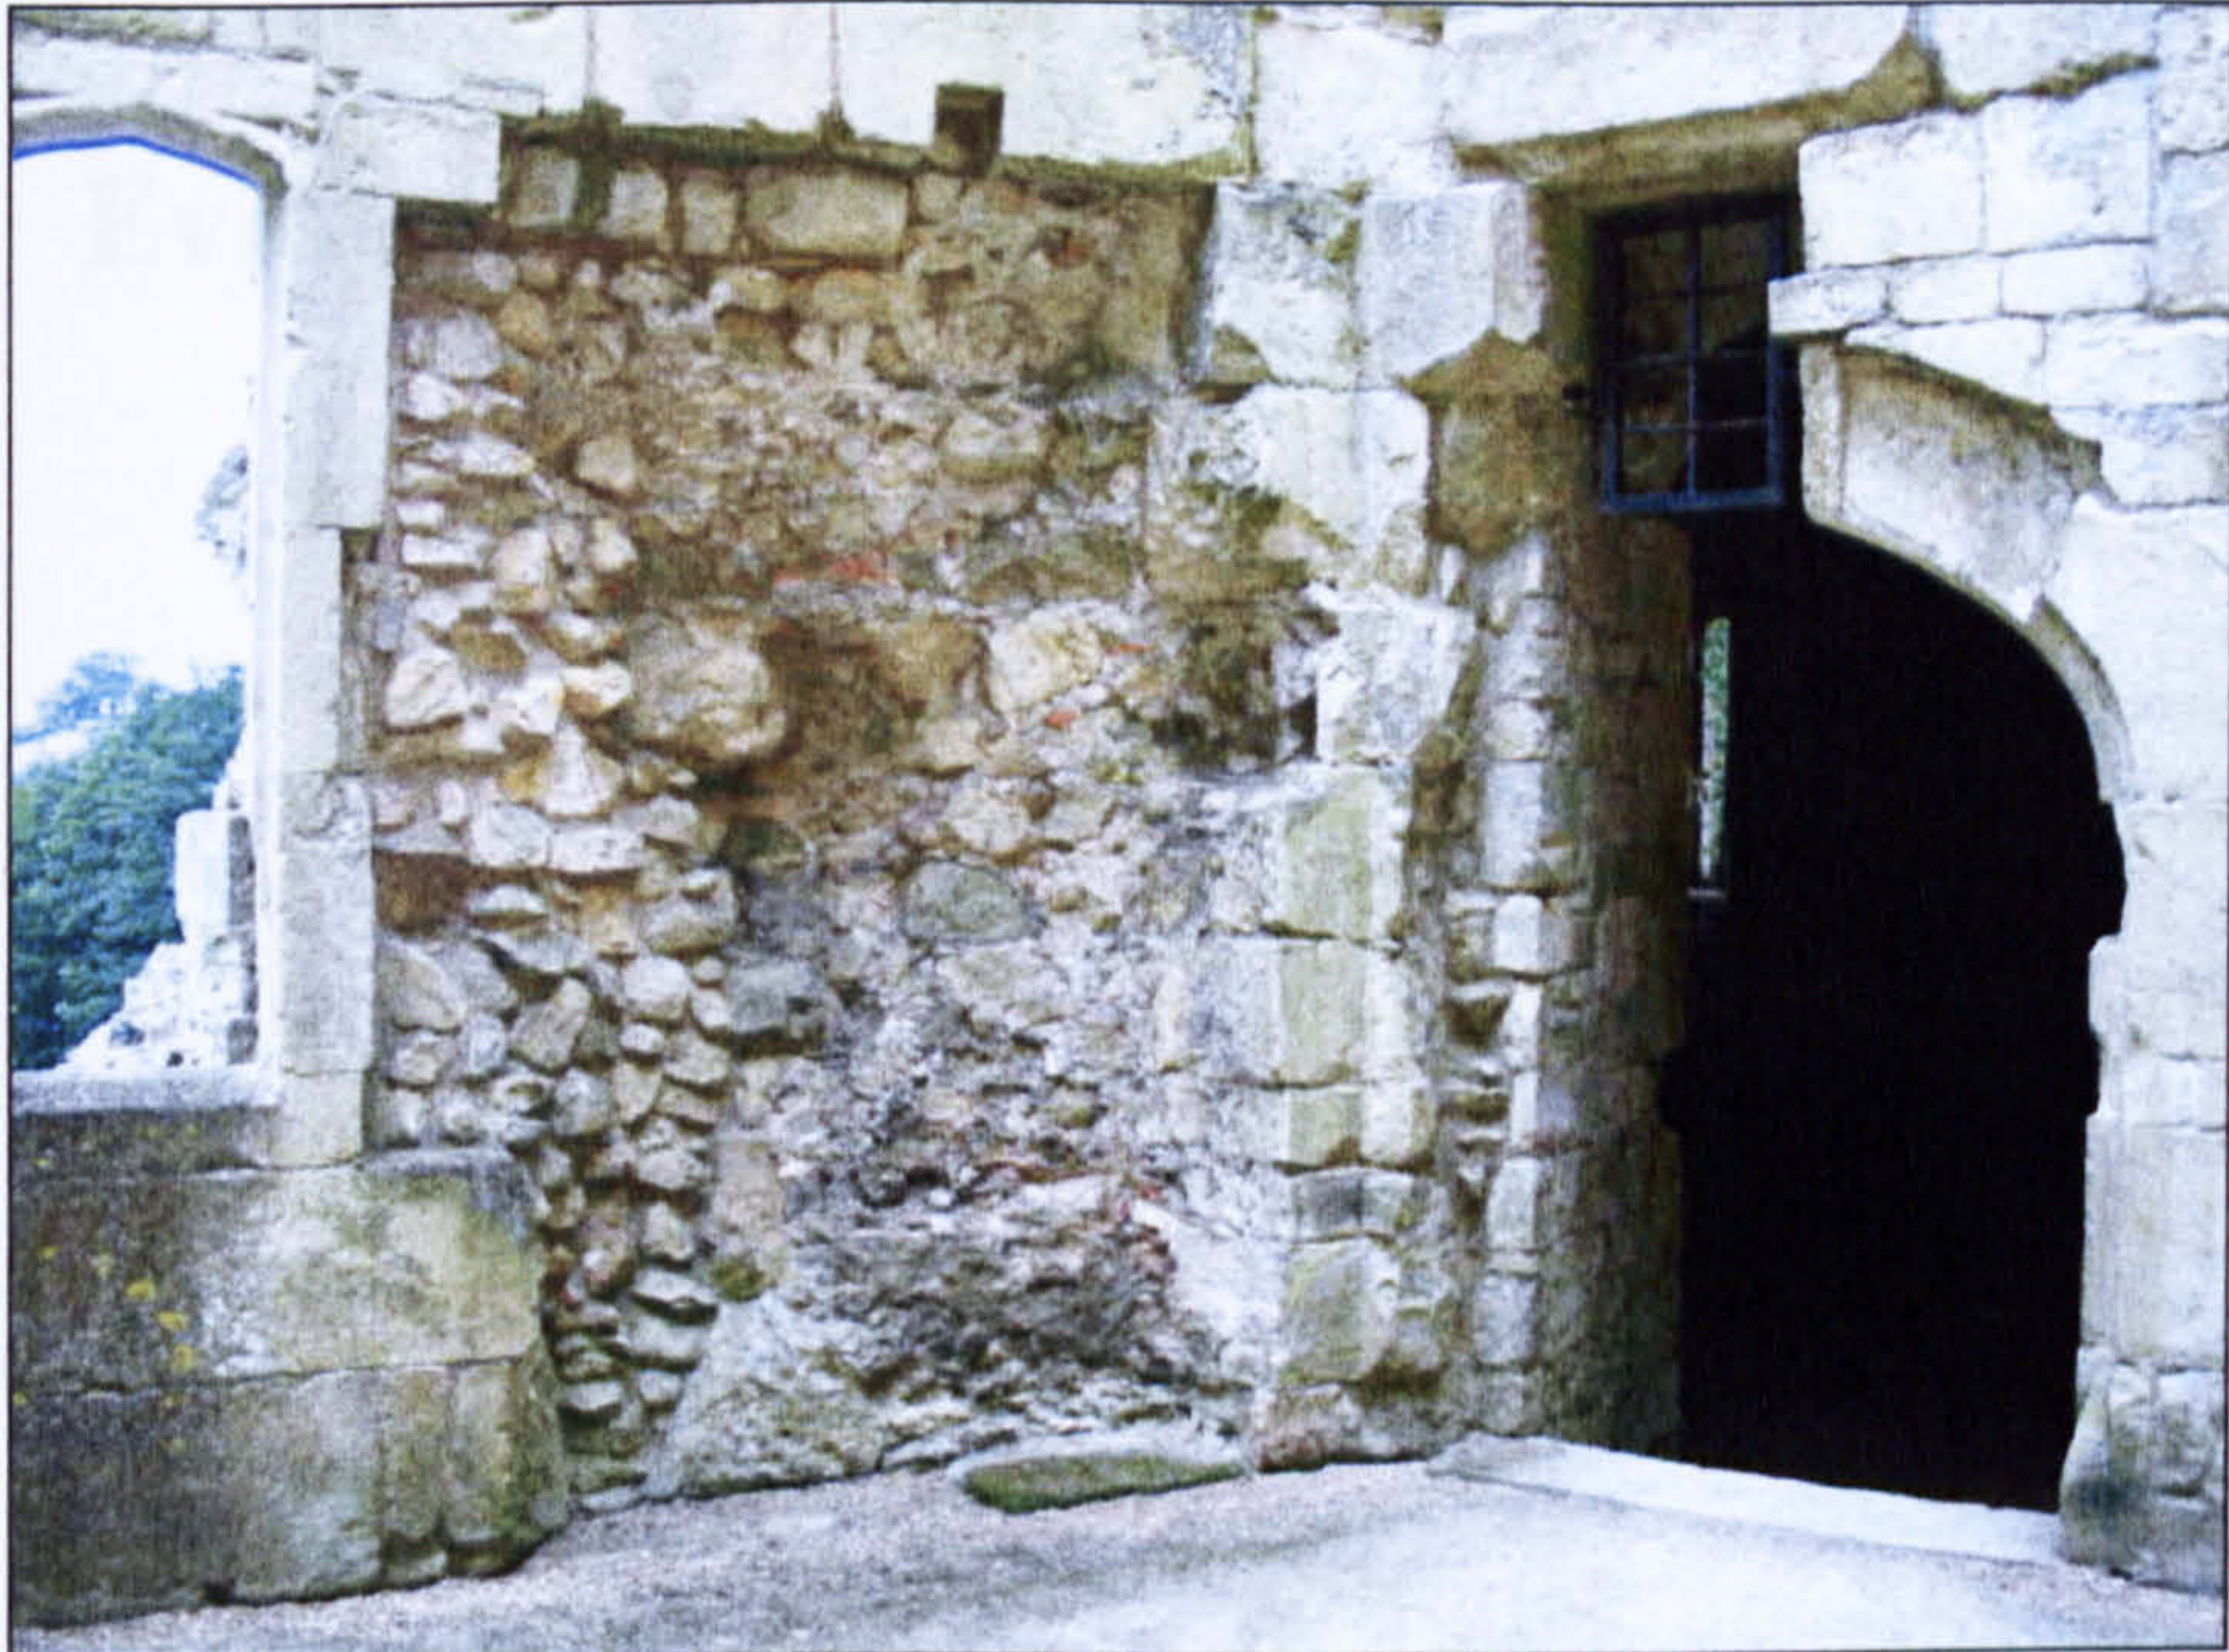
Figure 4.61 Close-up of secondary damage pattern across from the Great Hall staircase at Old Wardour (Wiltshire).

Figure 4.61 Close-up of secondary damage pattern across from the Great Hall staircase at Old Wardour (Wiltshire).

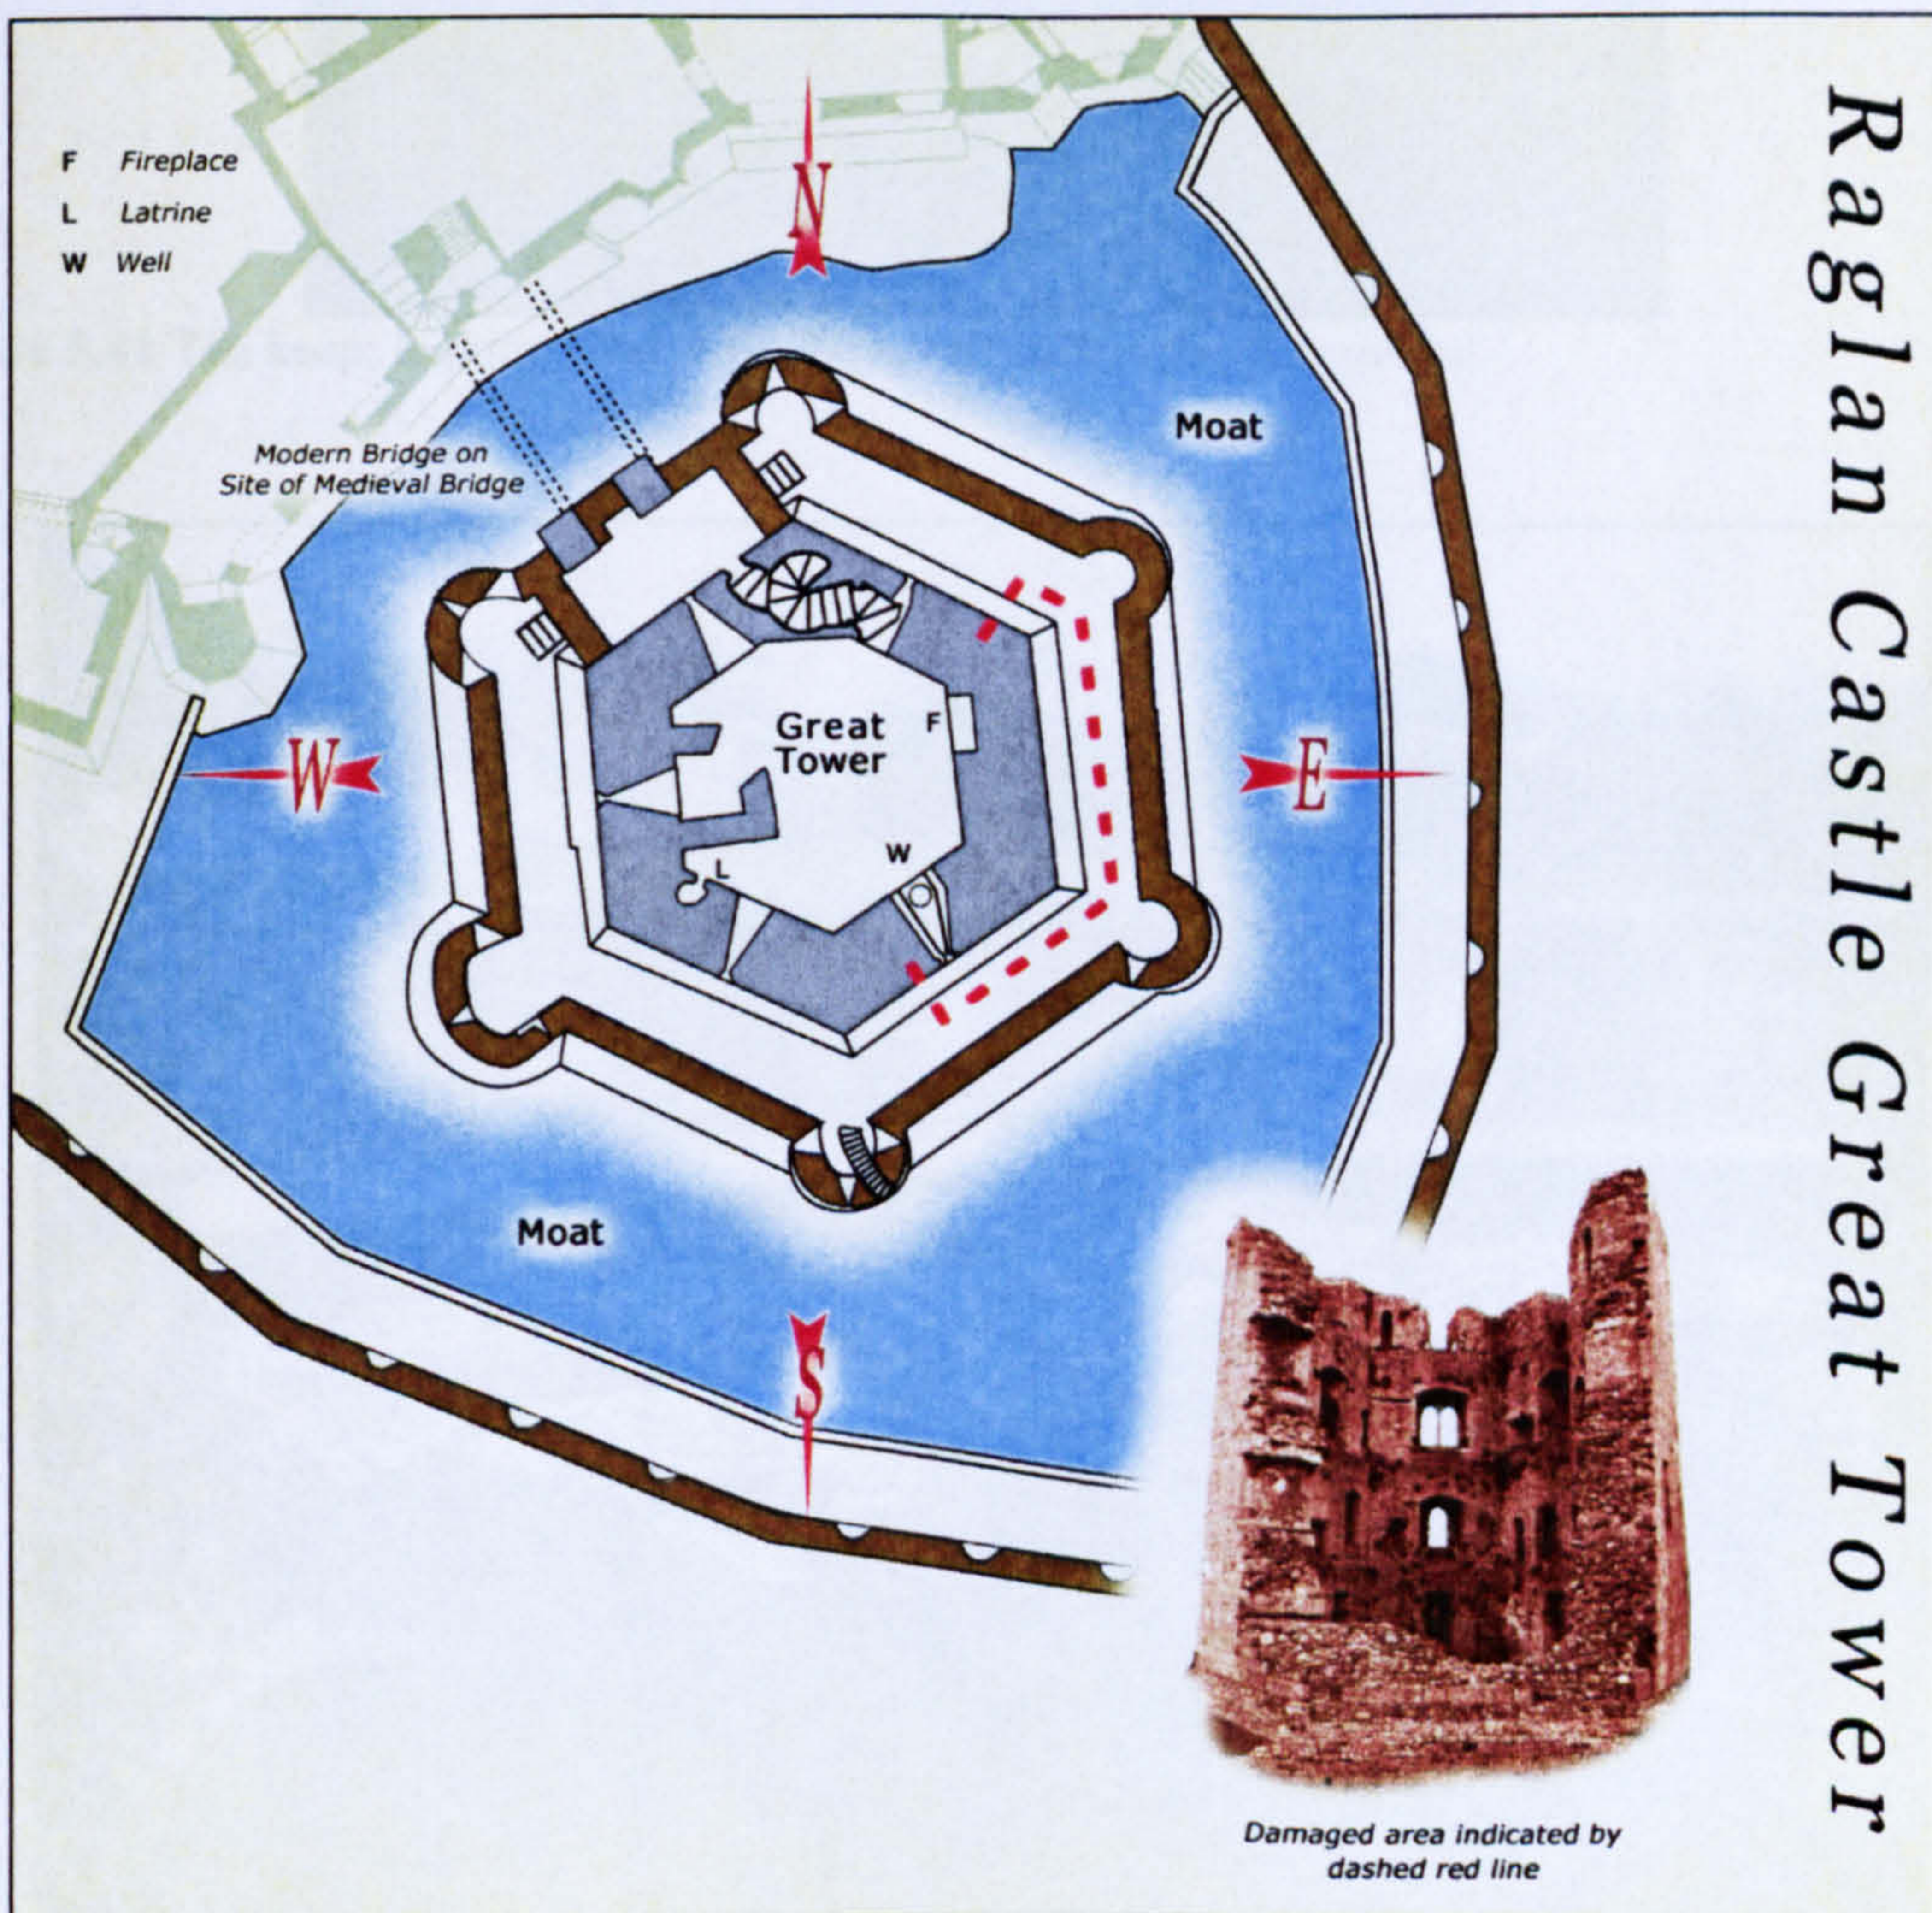
Figure 5.40 Ground plan of keep, showing approximate area of missing masonry (San Jack Media after Kenyon 2003).

Figure 5.40 Ground plan of keep, showing approximate area of missing masonry (San Jack Media after Kenyon 2003).

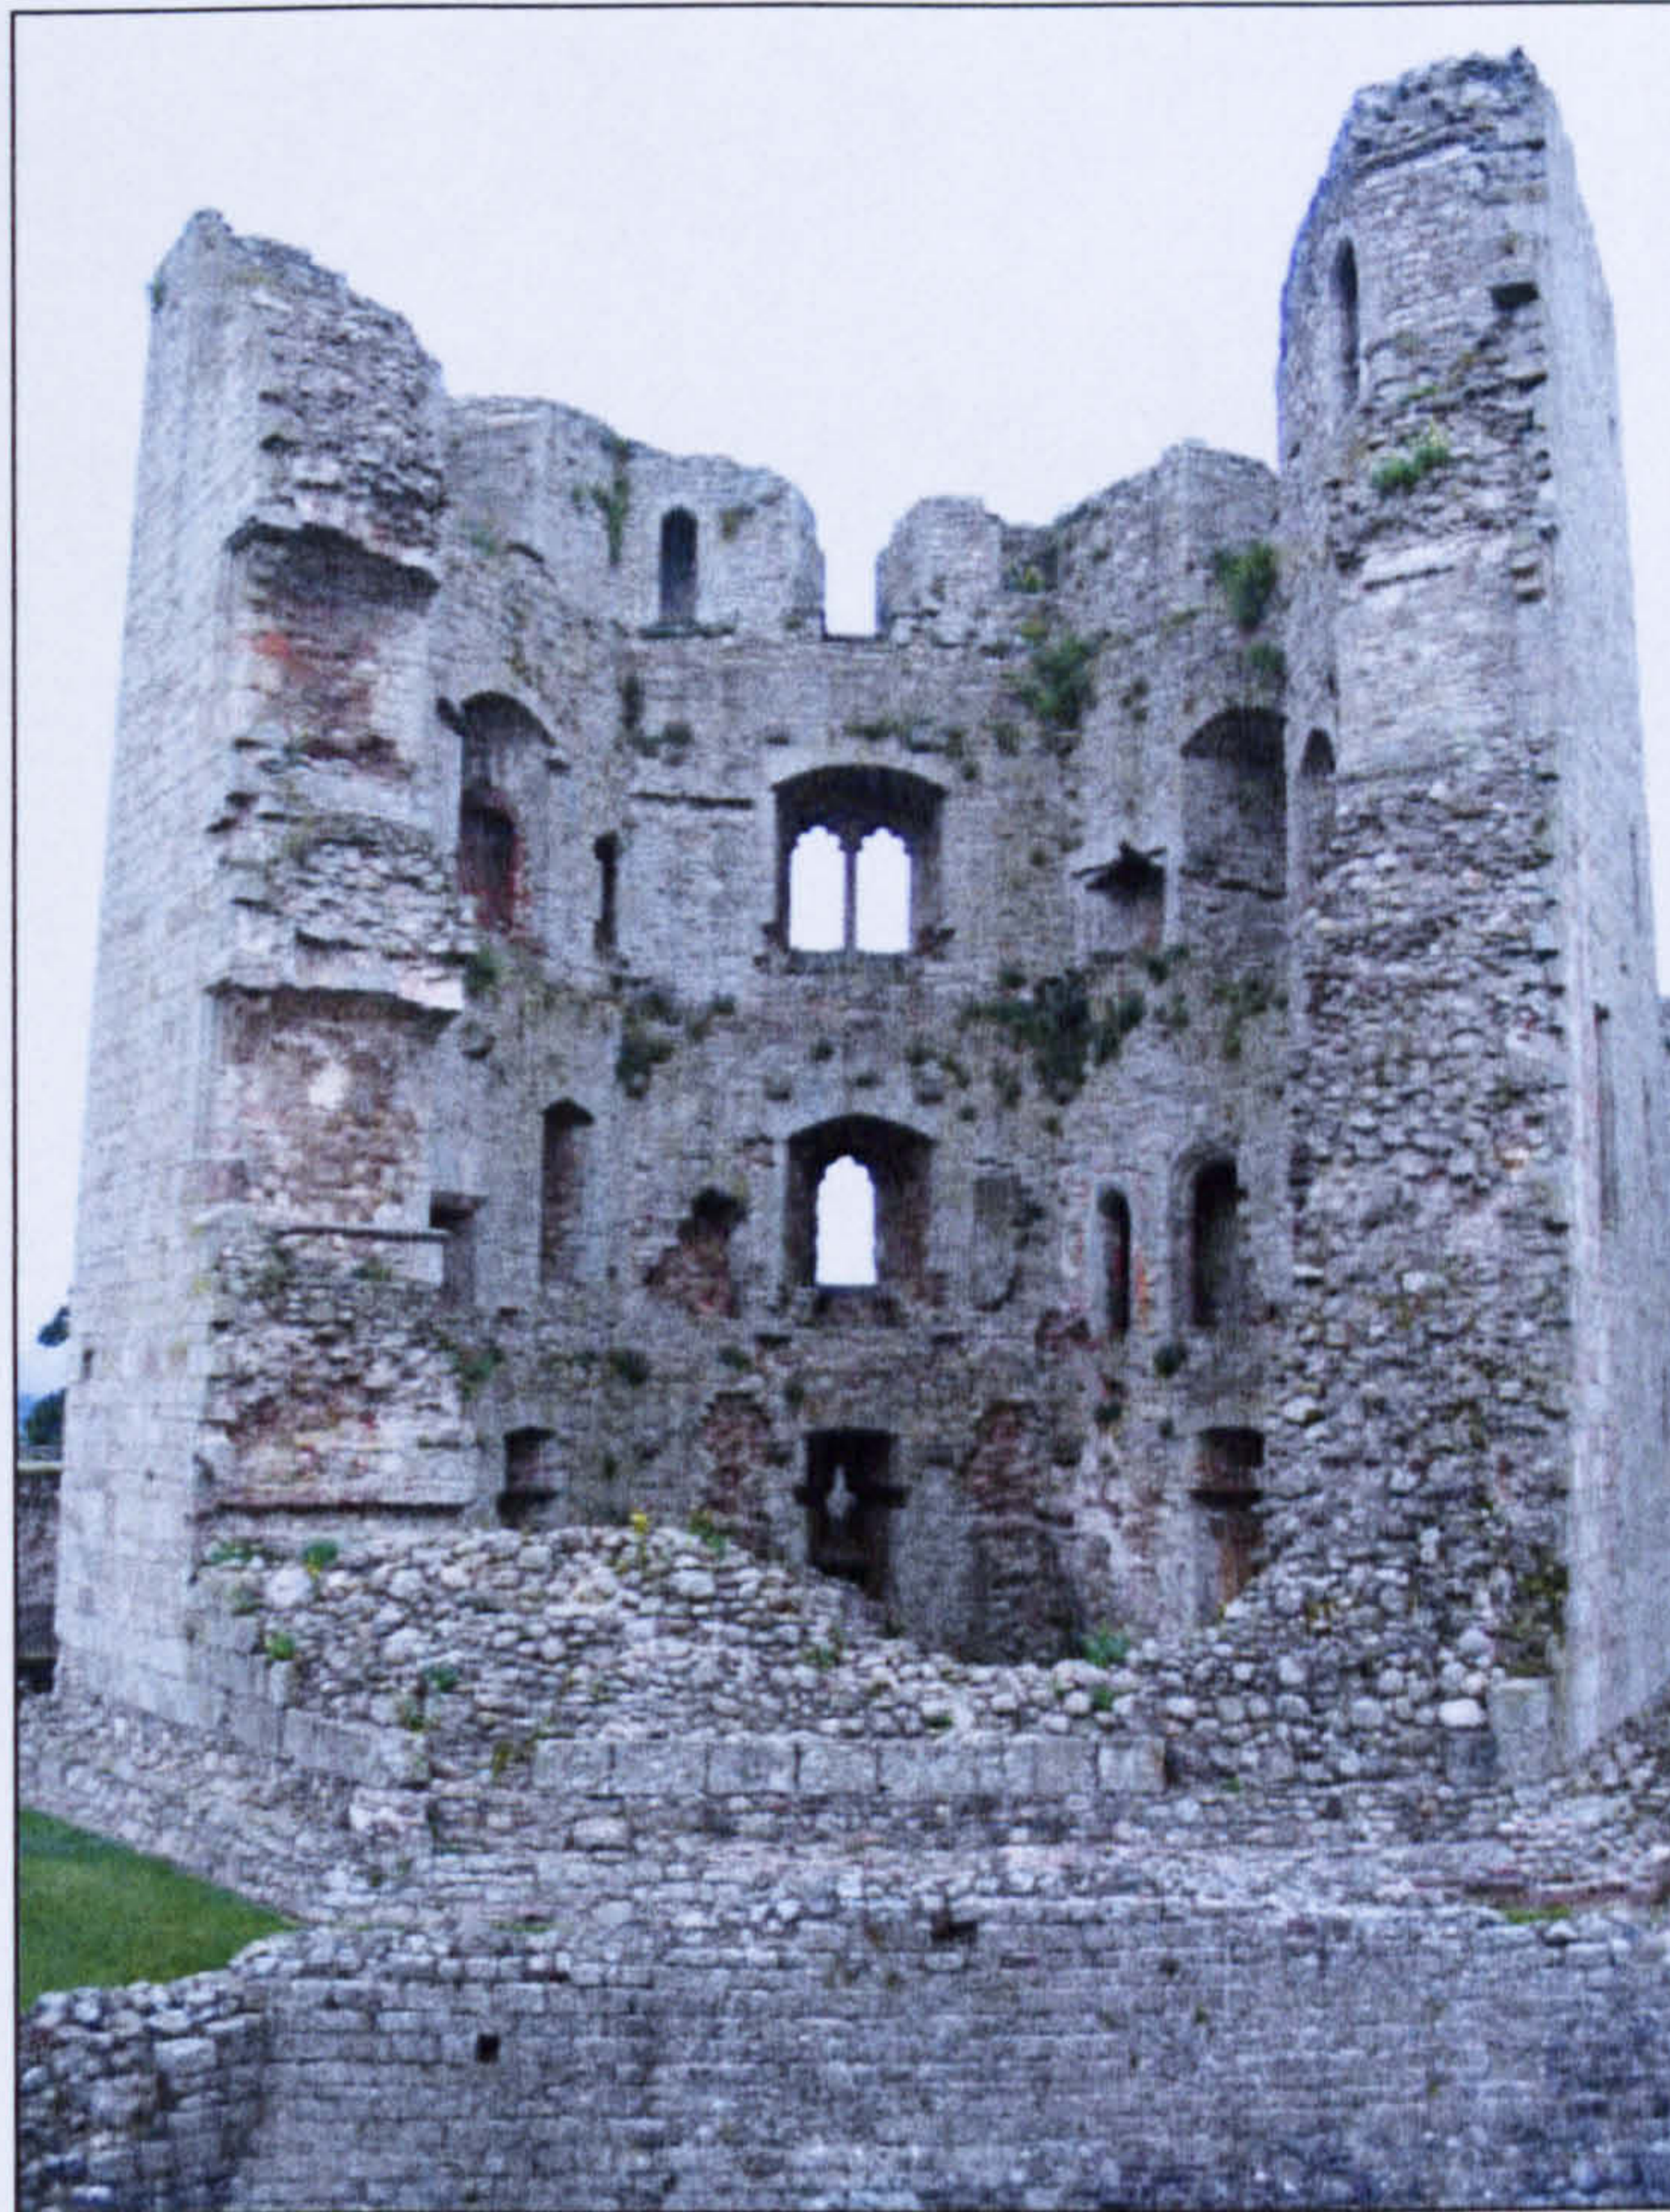
Figure 5.41 The keep, looking west, with the apron wall in the foreground.

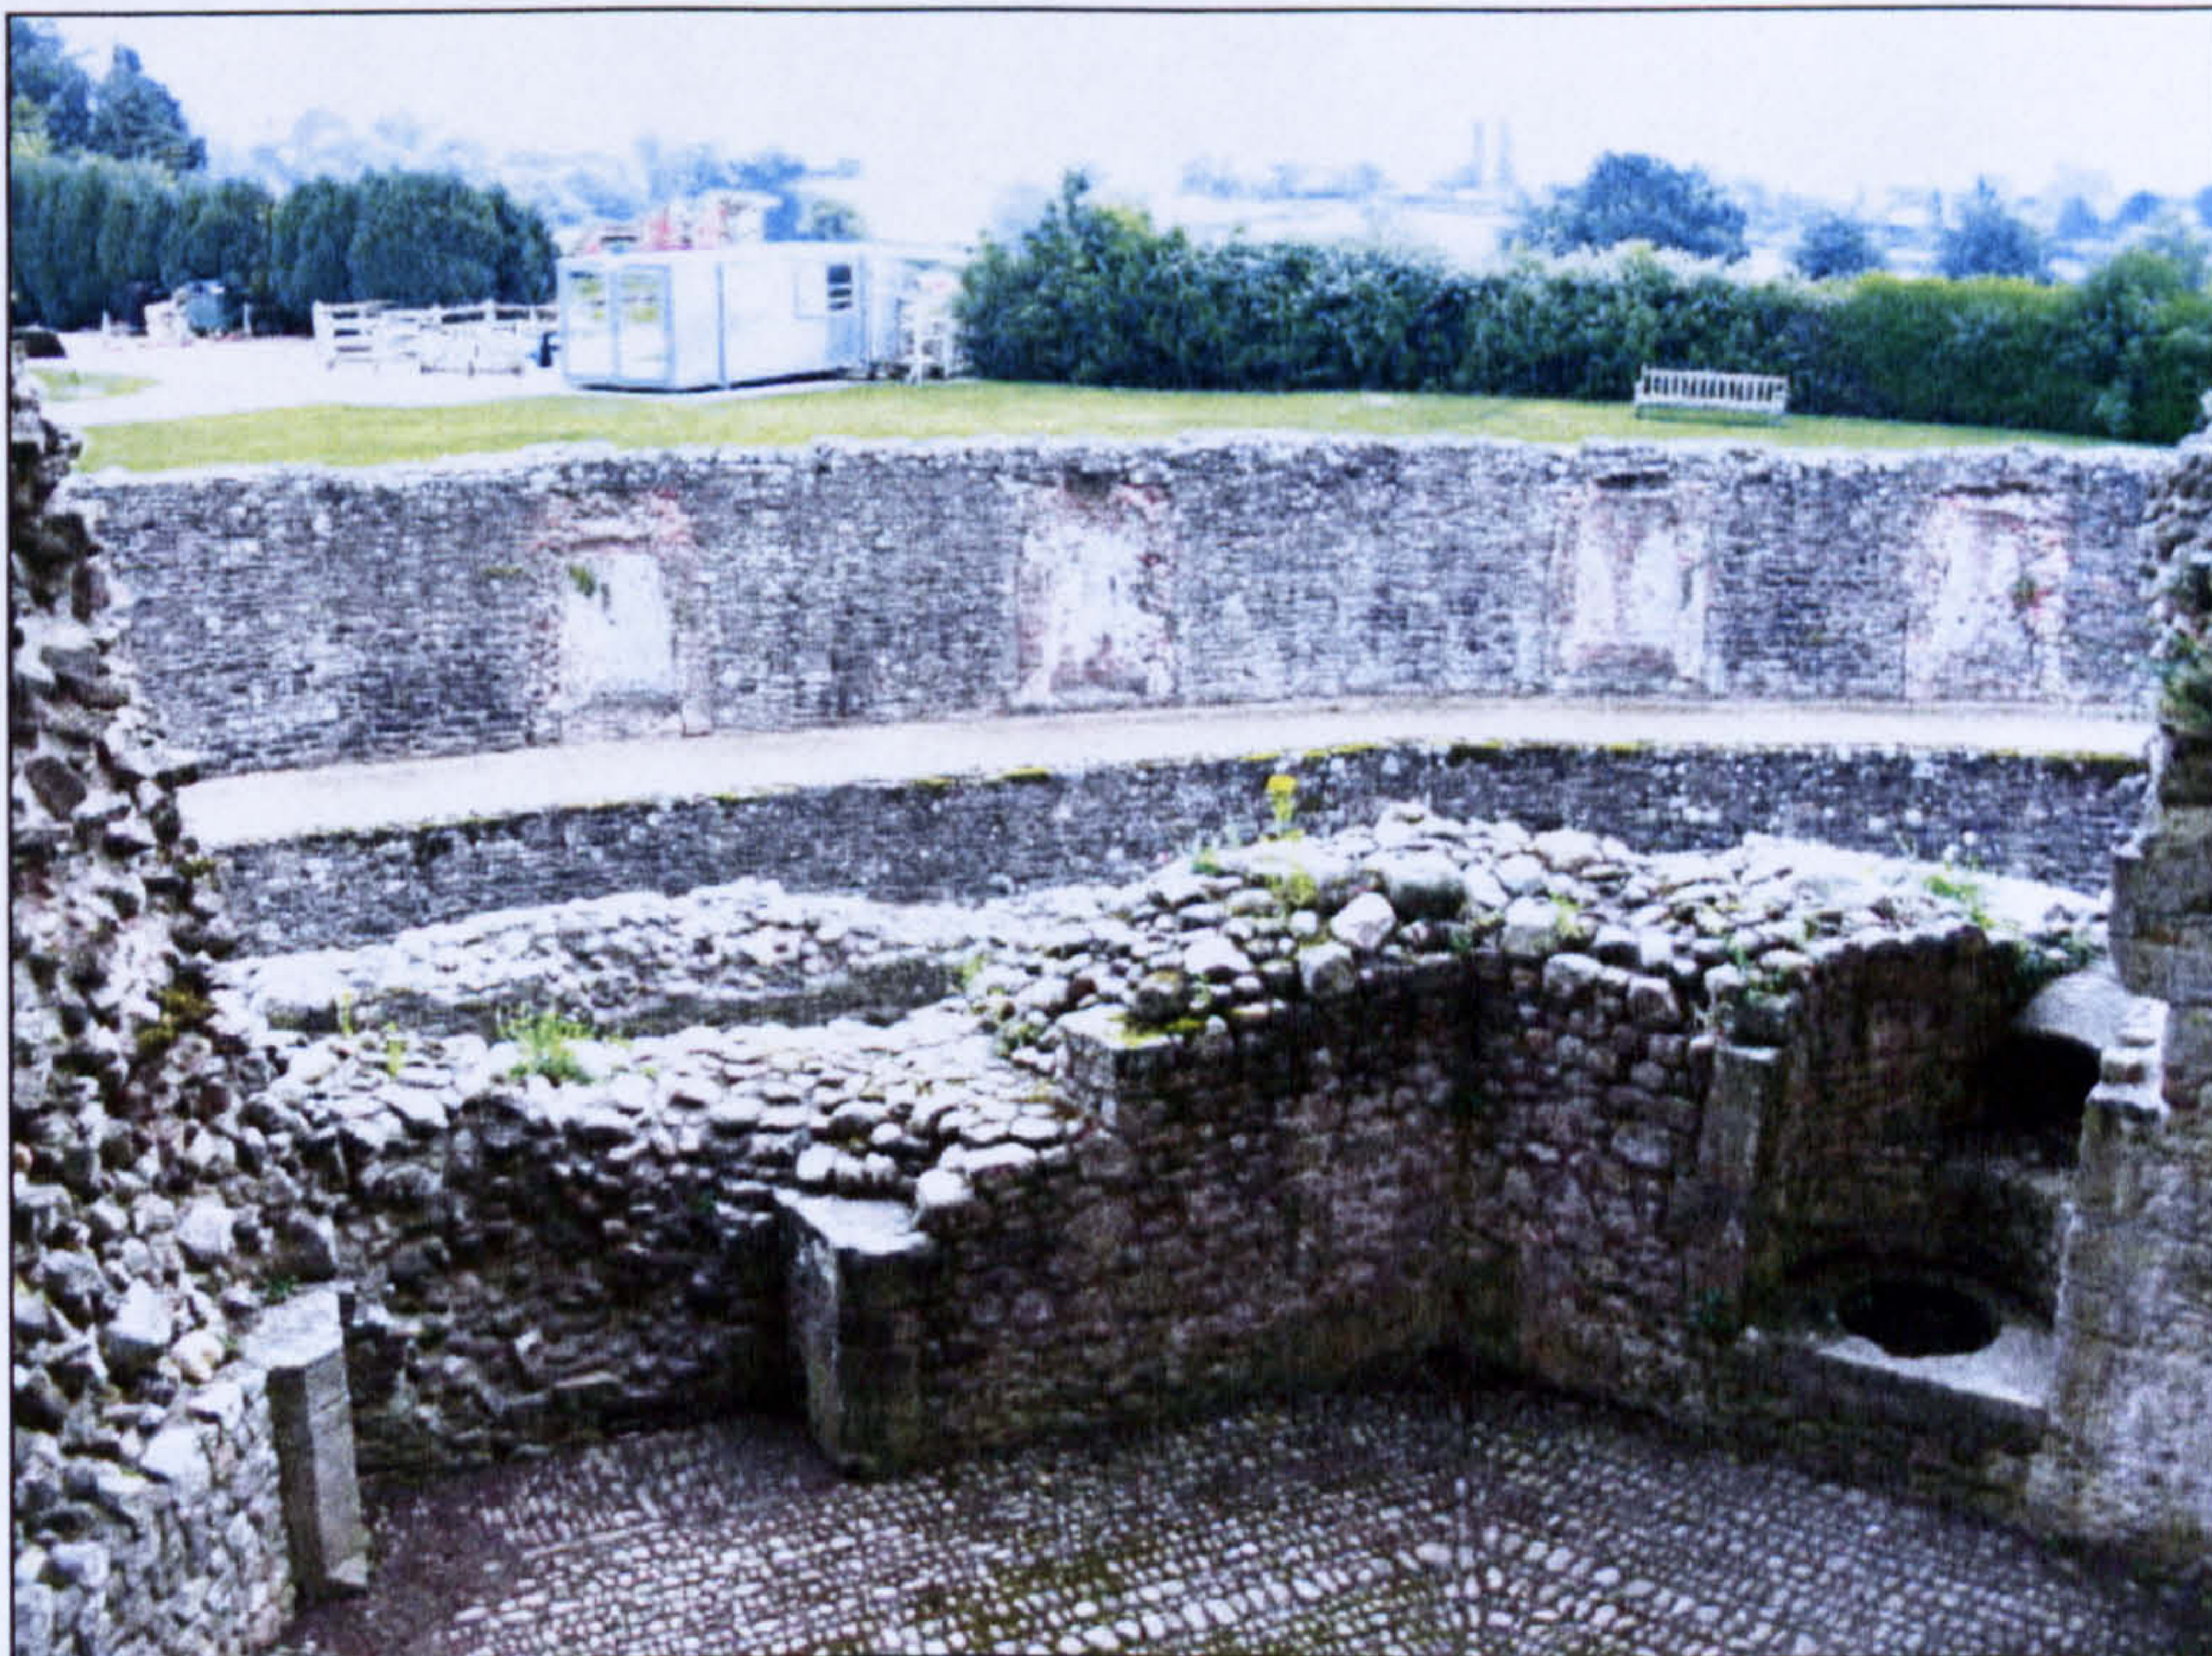
Figure 5.42 The remains of the damaged wall, showing two structural voids in the form of a fireplace (left) and well (right).

Figure 5.42 The remains of the damaged wall, showing two structural voids in the form of a fireplace (left) and well (right).

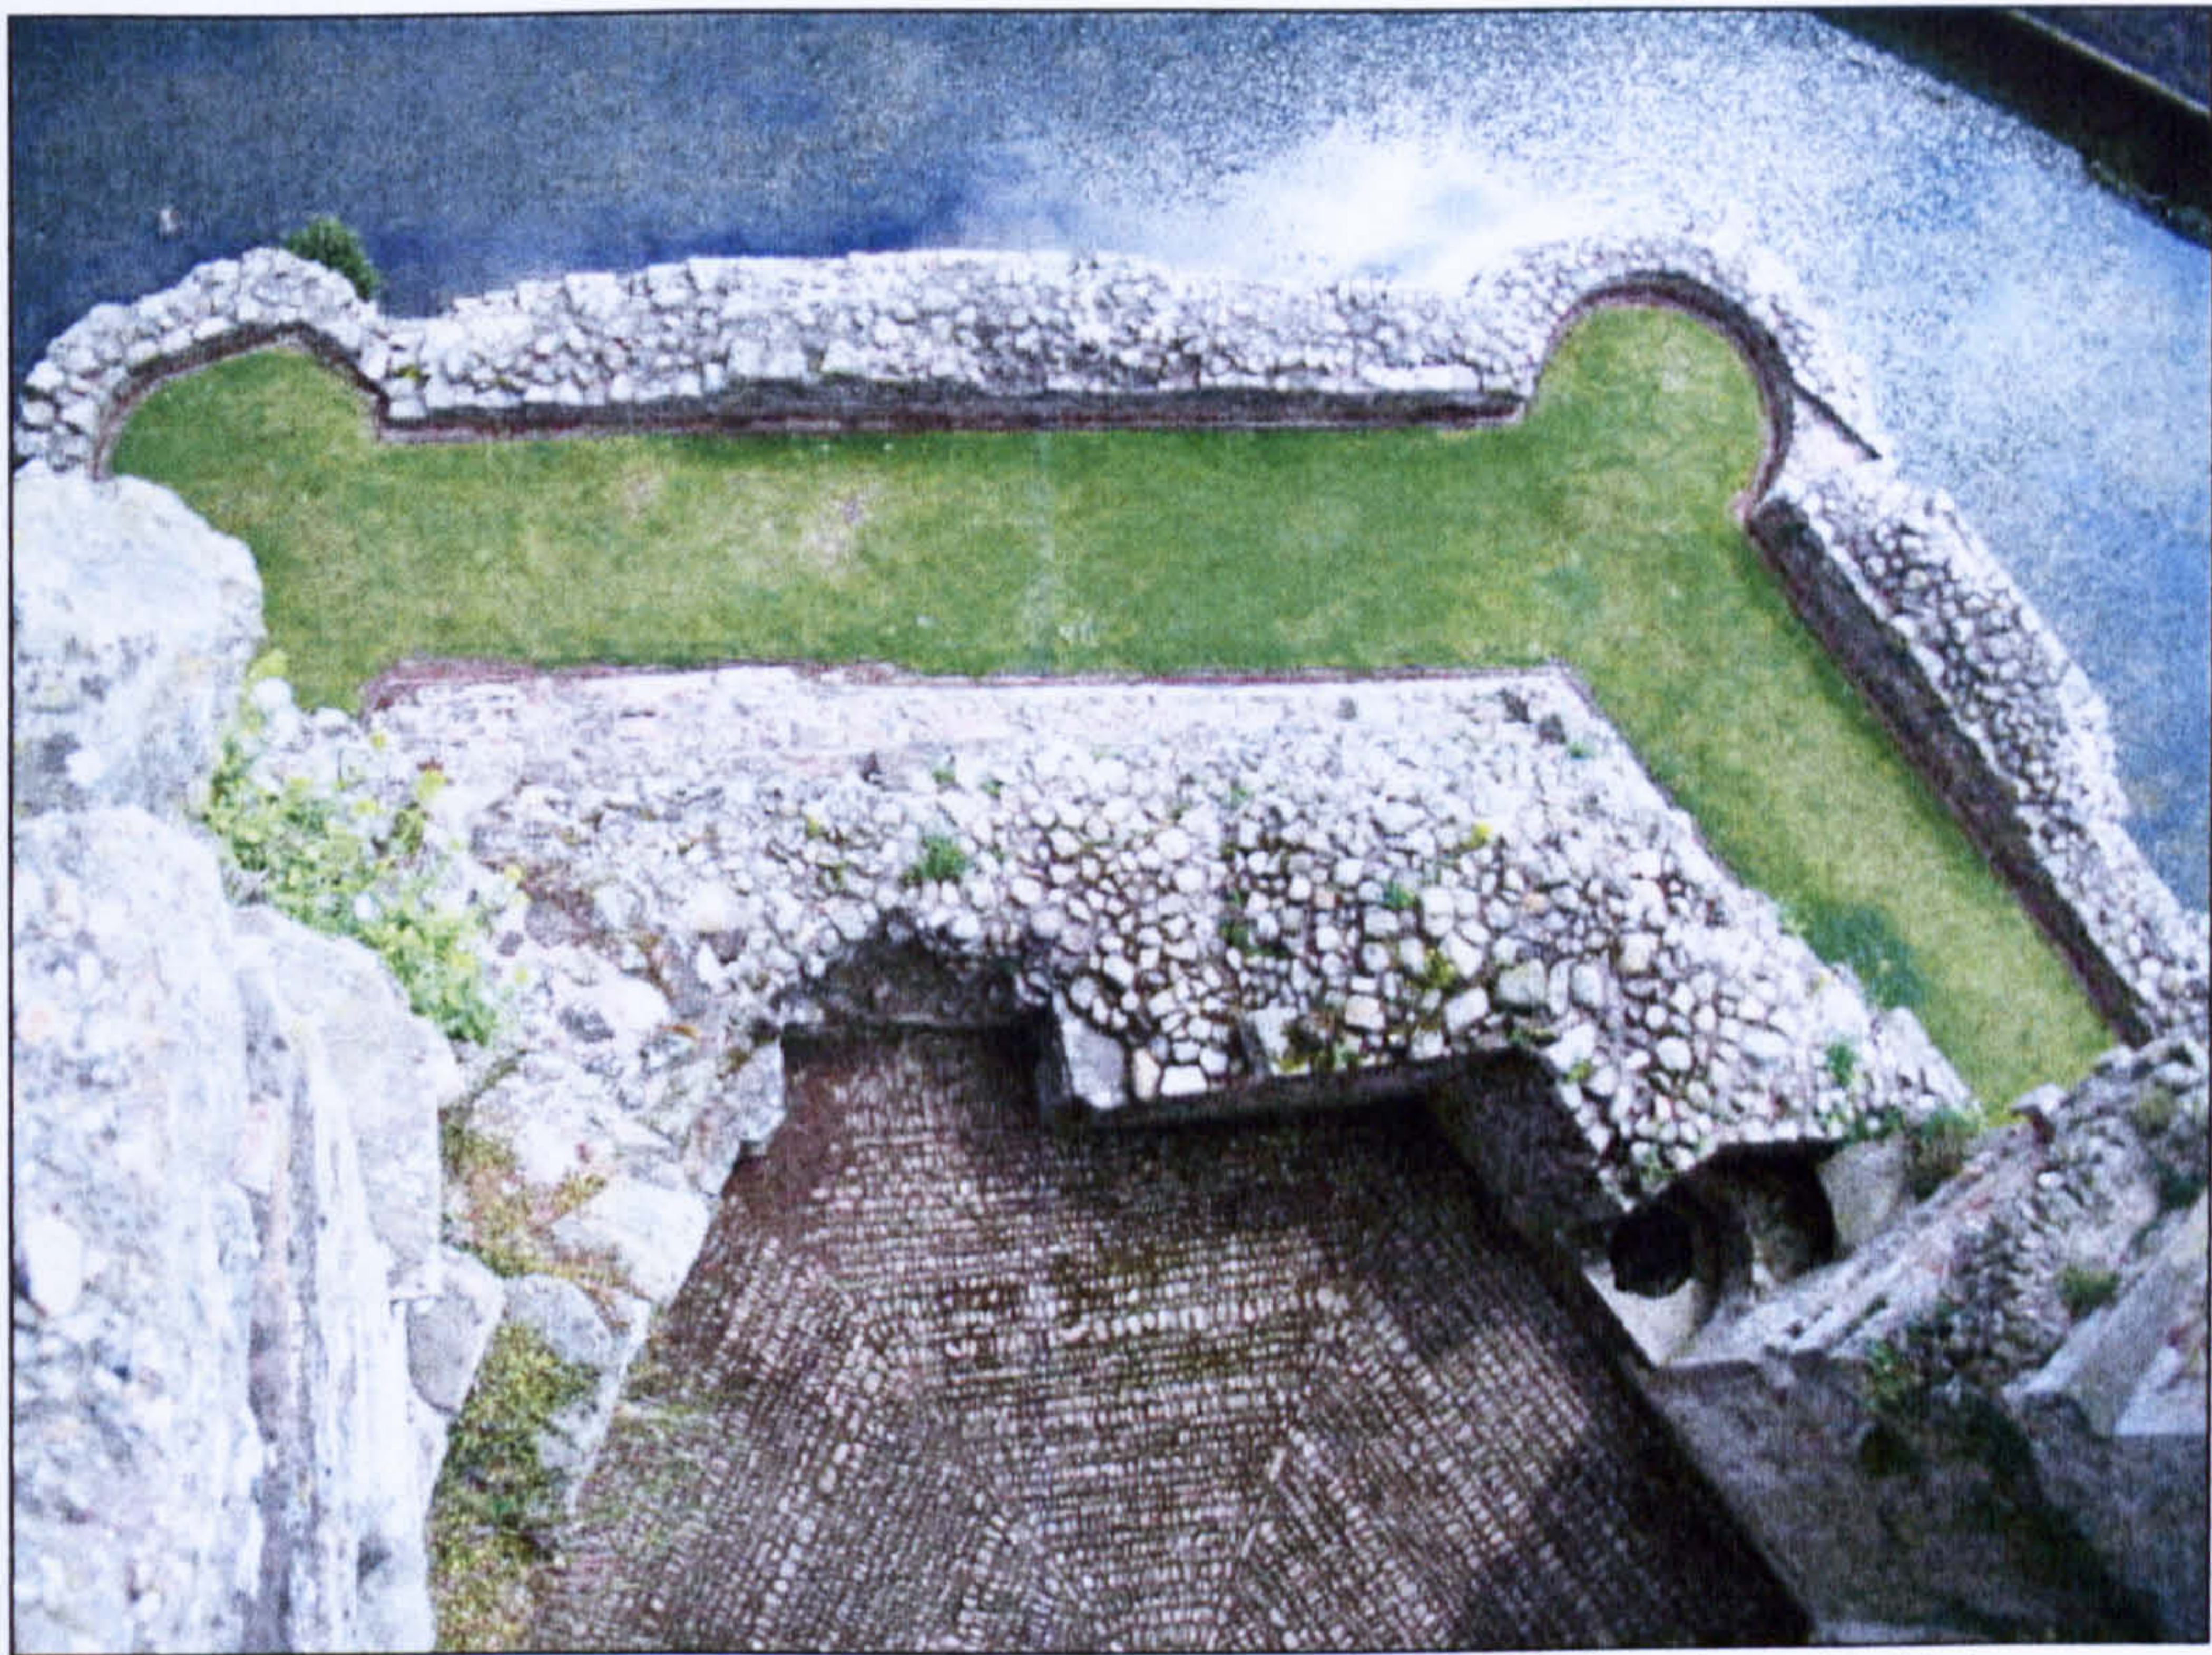
Figure 5.43 The damaged wall viewed from above, showing the variations in wall thickness.

Figure 5.43 The damaged wall viewed from above, showing the variations in wall thickness.
