ARCHAEOLOGY OF DESTRUCTION

A REINTERPRETATION OF CASTLE SLIGHTINGS IN THE ENGLISH CIVIL WAR

Thesis submitted for the degree of
Doctor of Philosophy
University of York
Department of Archaeology

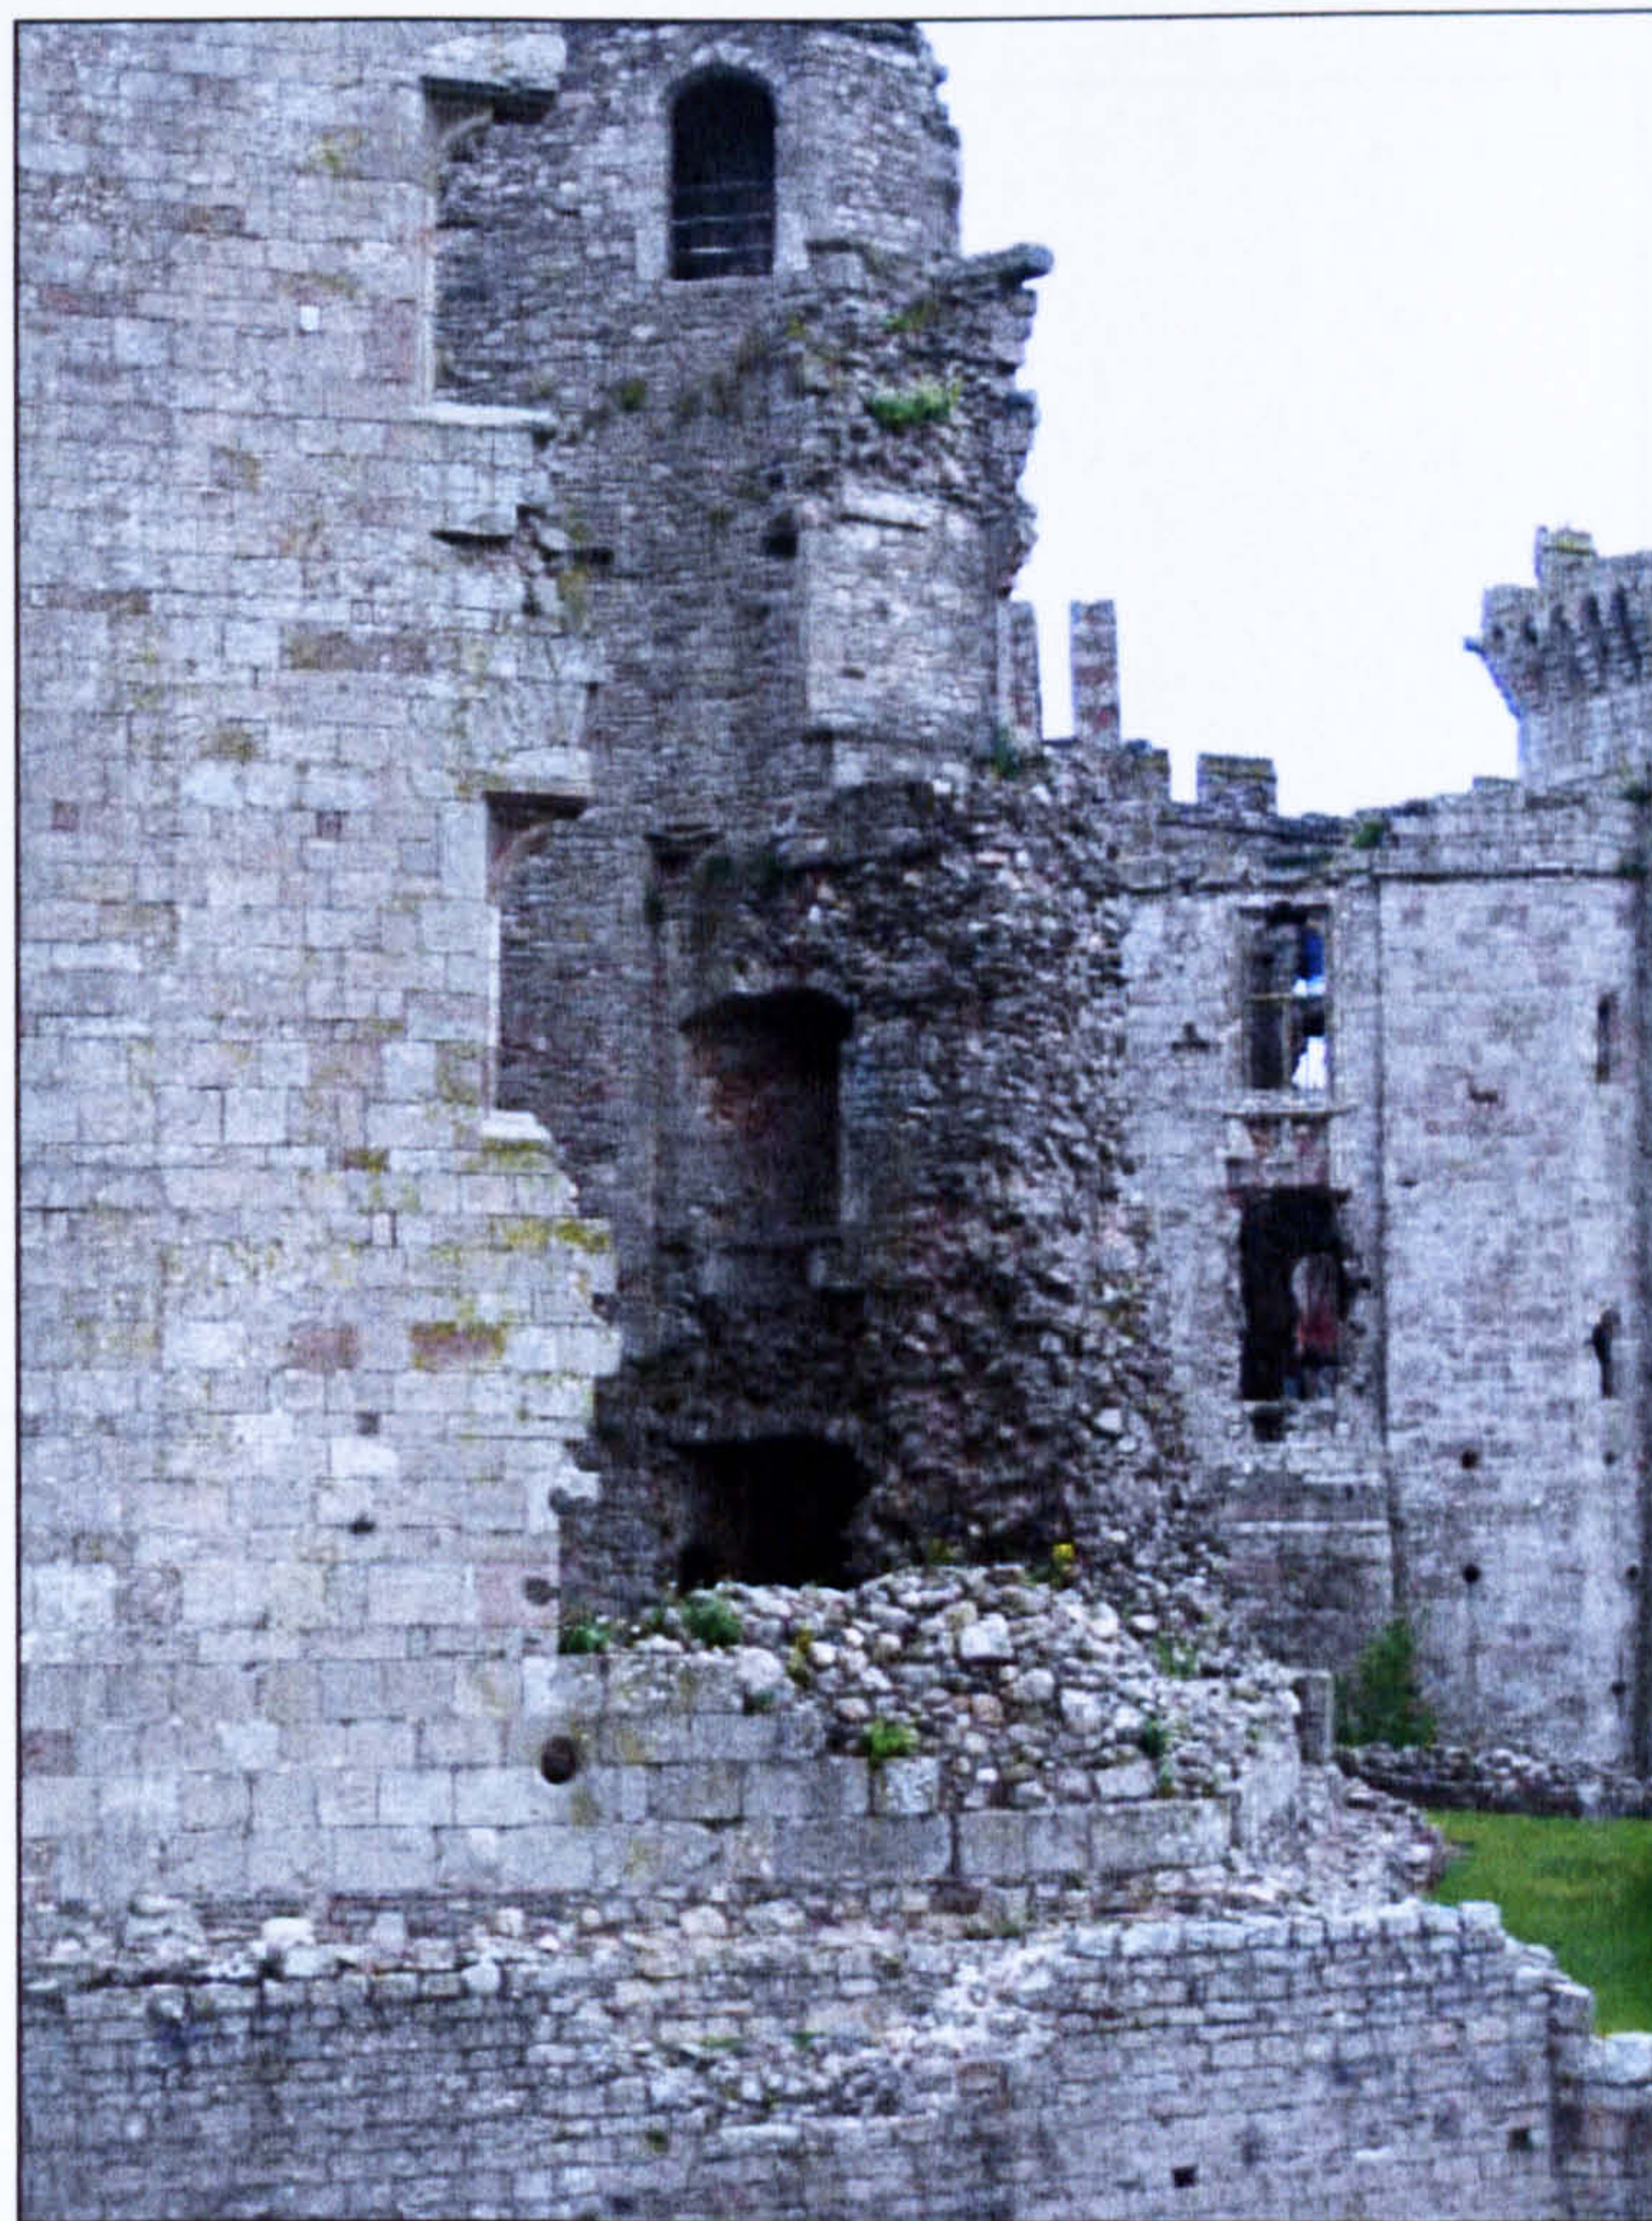
Figure 5.44 The remains of the southeast wall, showing the series of windows situated above the well.

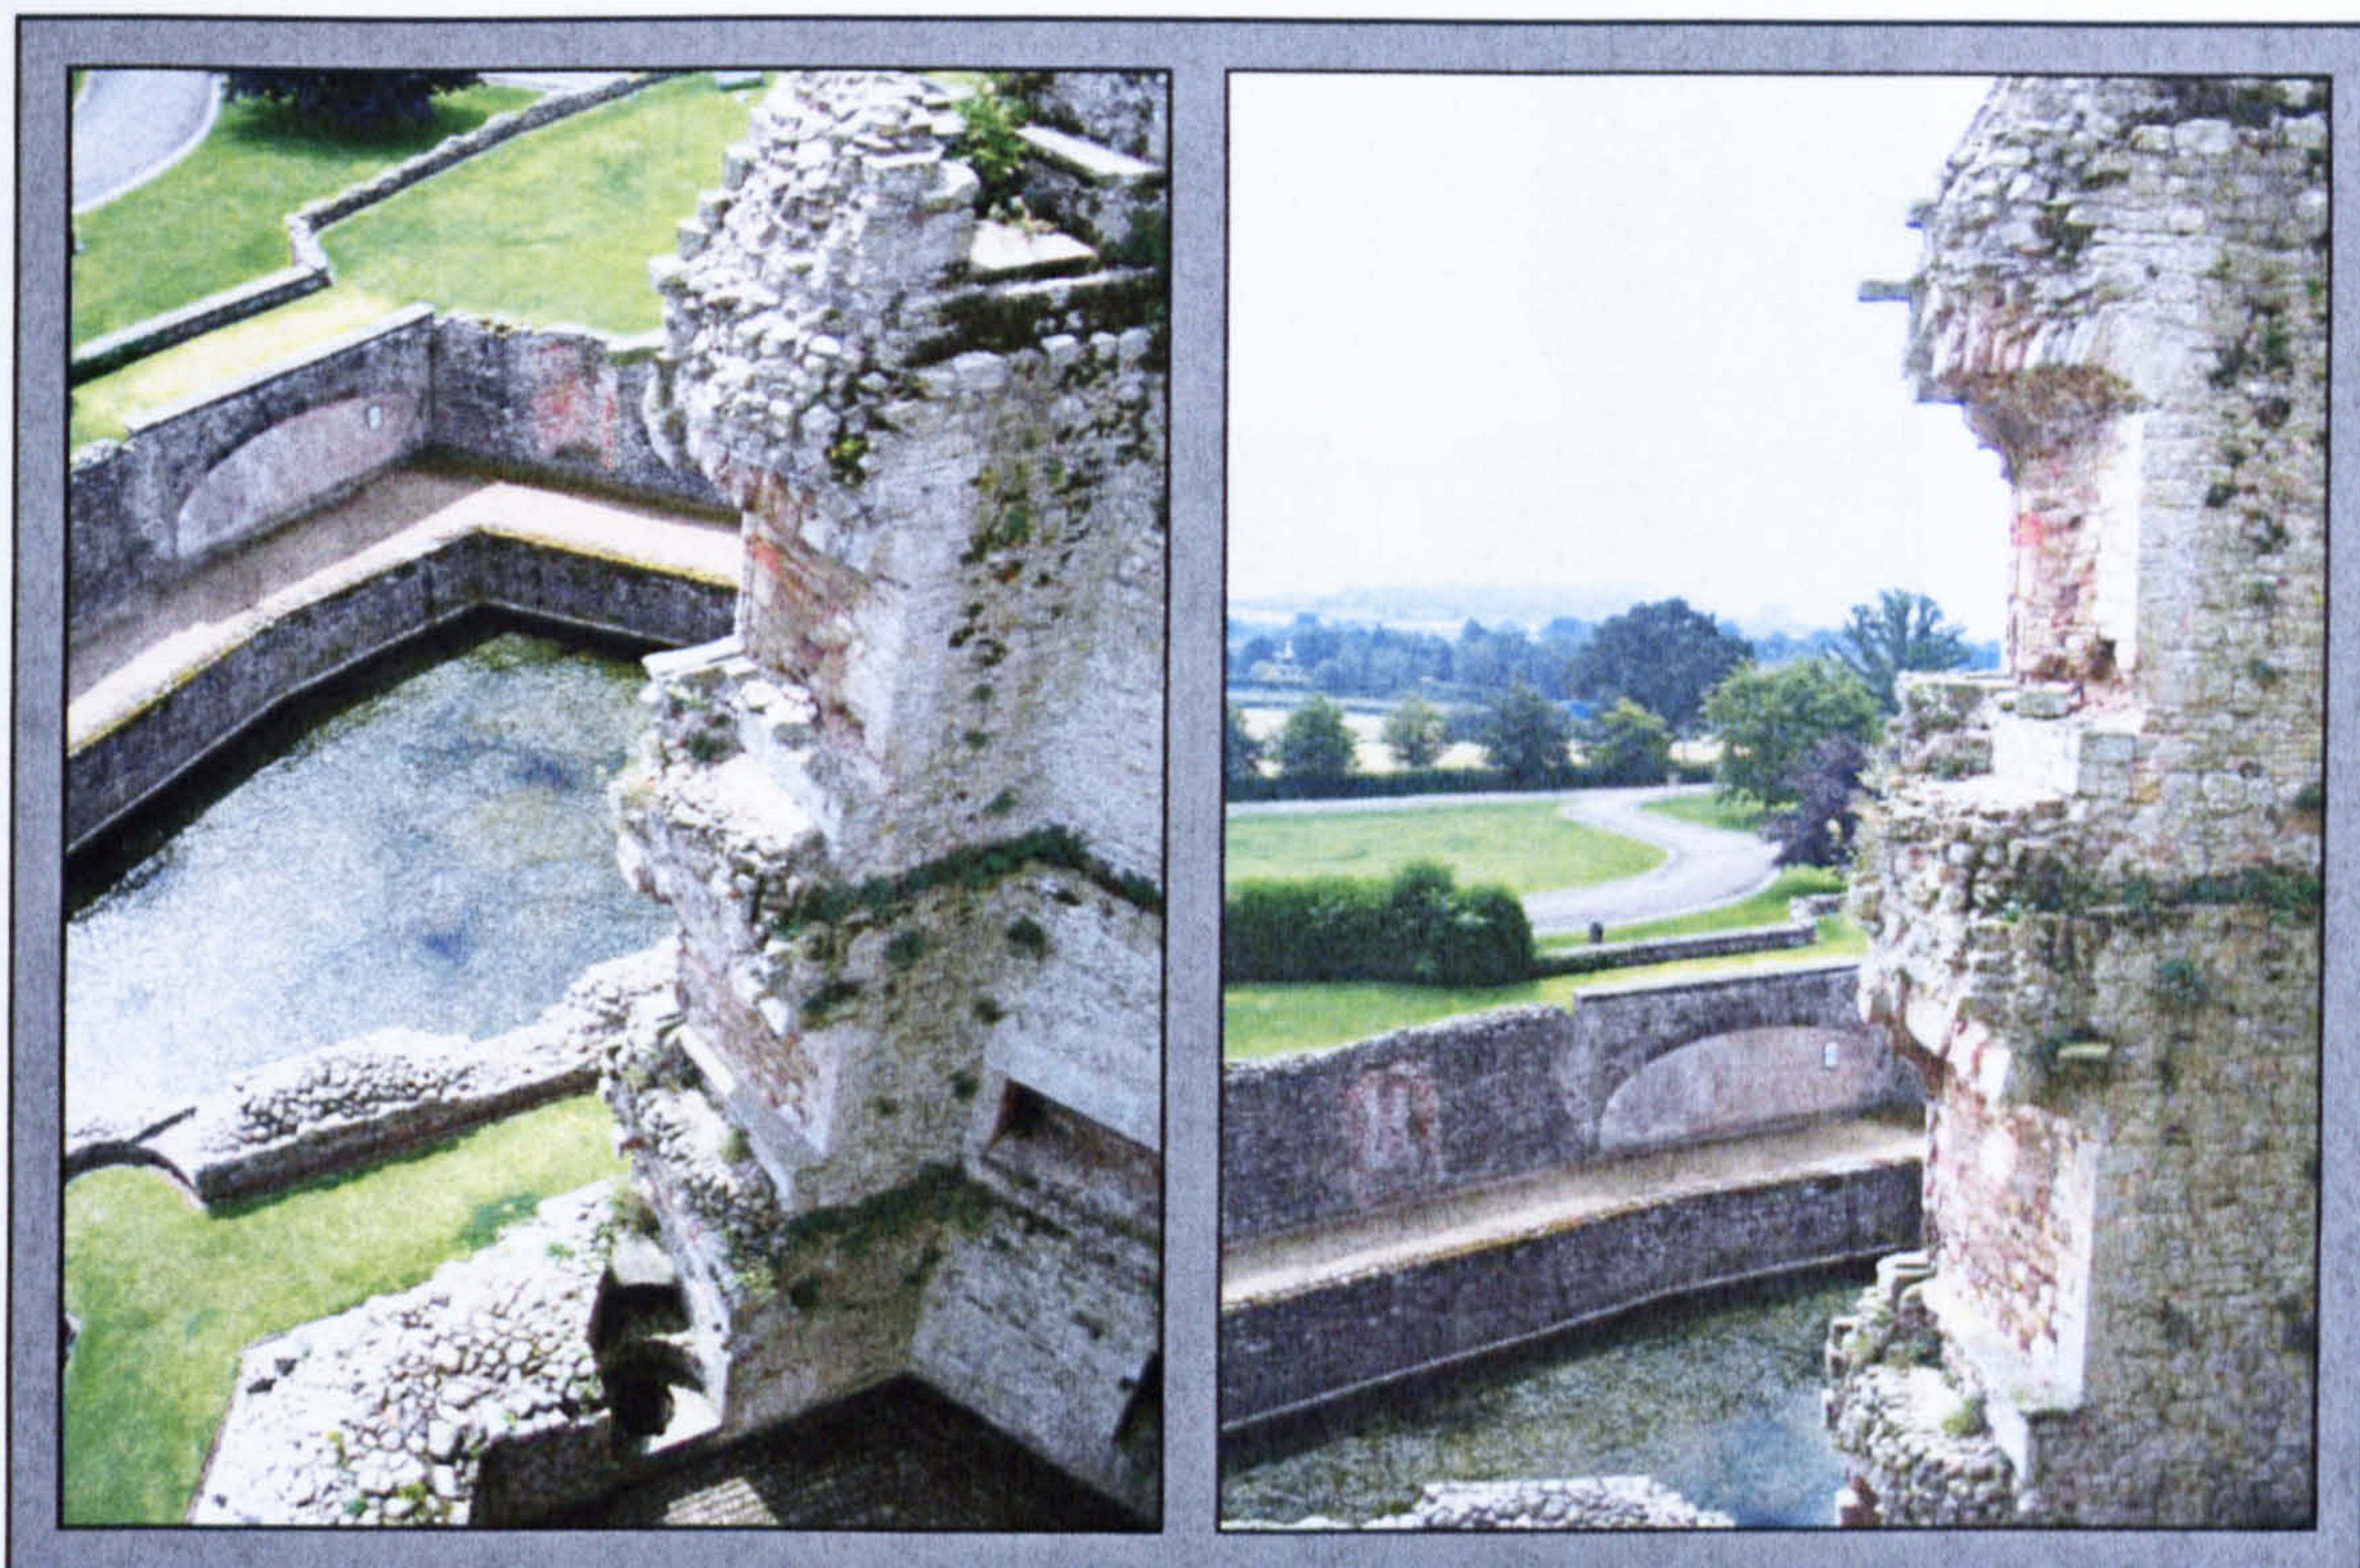
Figure 5.45 *Left:* The vertical destruction pattern in the southeast wall. *Right:* A close-up of two of the bisected windows in the wall.

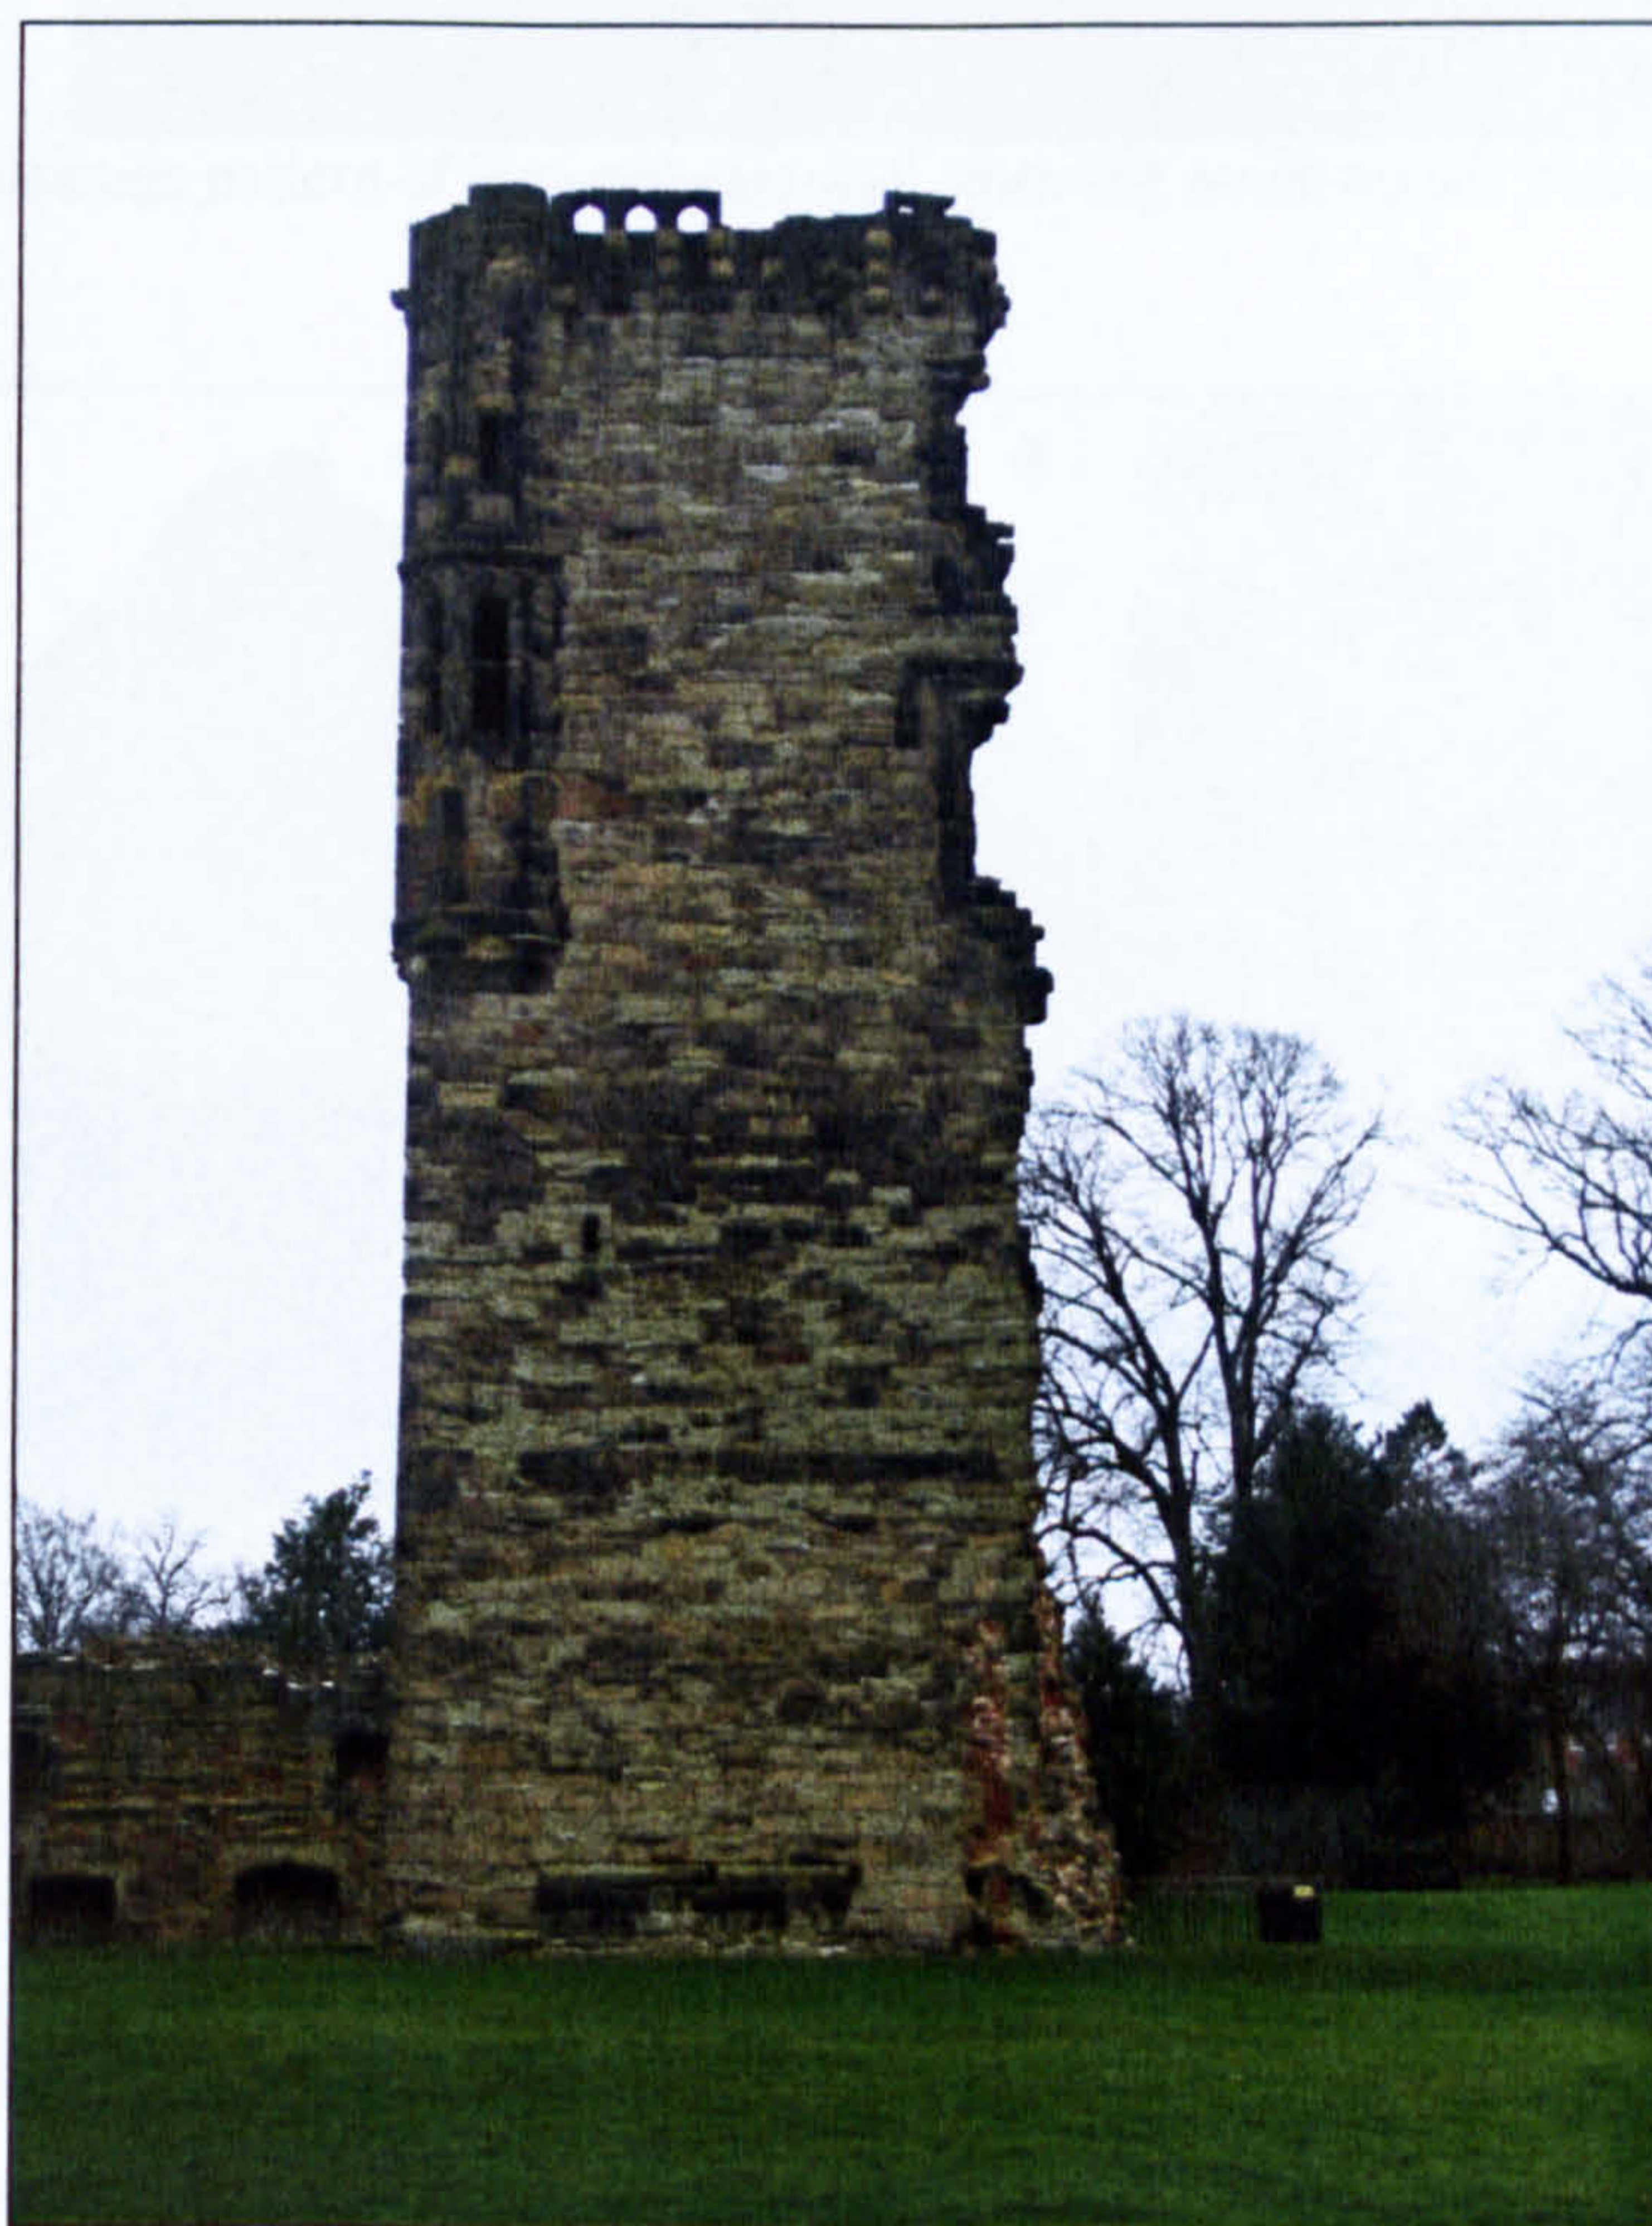
Figure 5.46 A profile view of Hastings Tower at Ashby de la Zouch (Leicestershire), showing a vertical damage pattern and the bisection of two upper windows.

Figure 5.46 A profile view of Hastings Tower at Ashby de la Zouch (Leicestershire), showing a vertical damage pattern and the bisection of two upper windows.

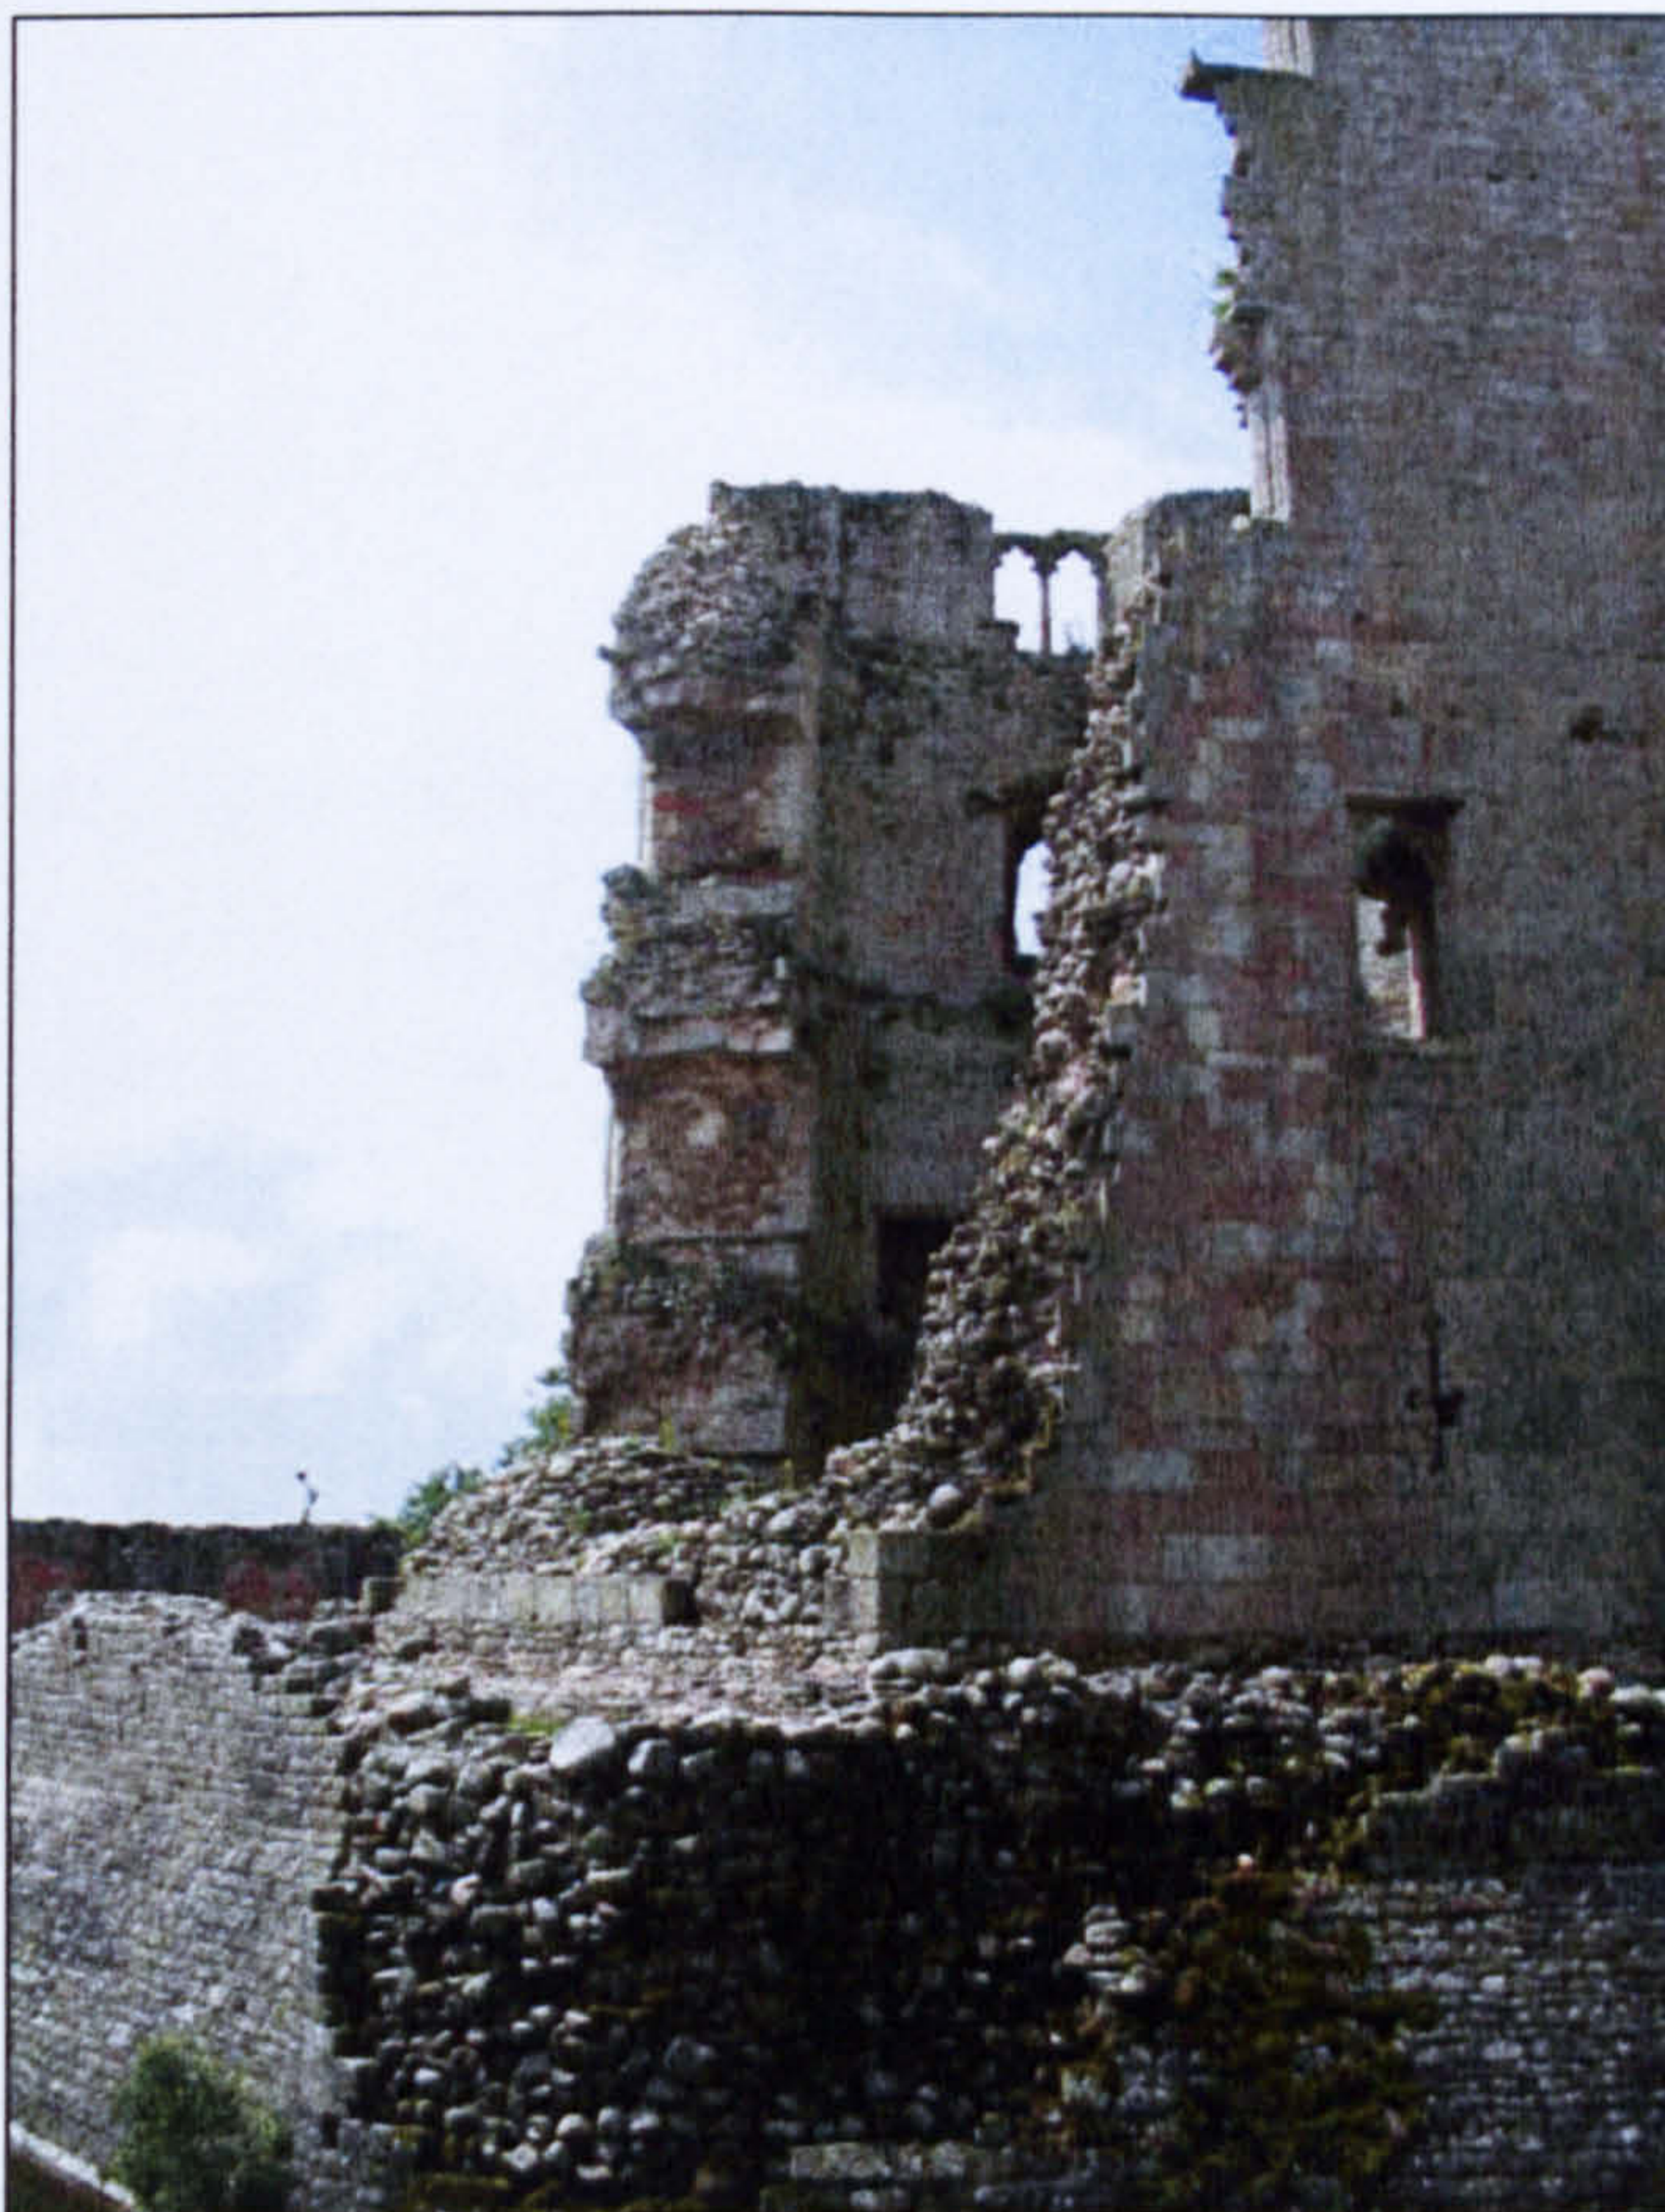
Figure 5.47 The damage pattern of the northeast wall, showing much higher placed windows.

Figure 5.47 The damage pattern of the northeastern wall, showing much higher placed windows.

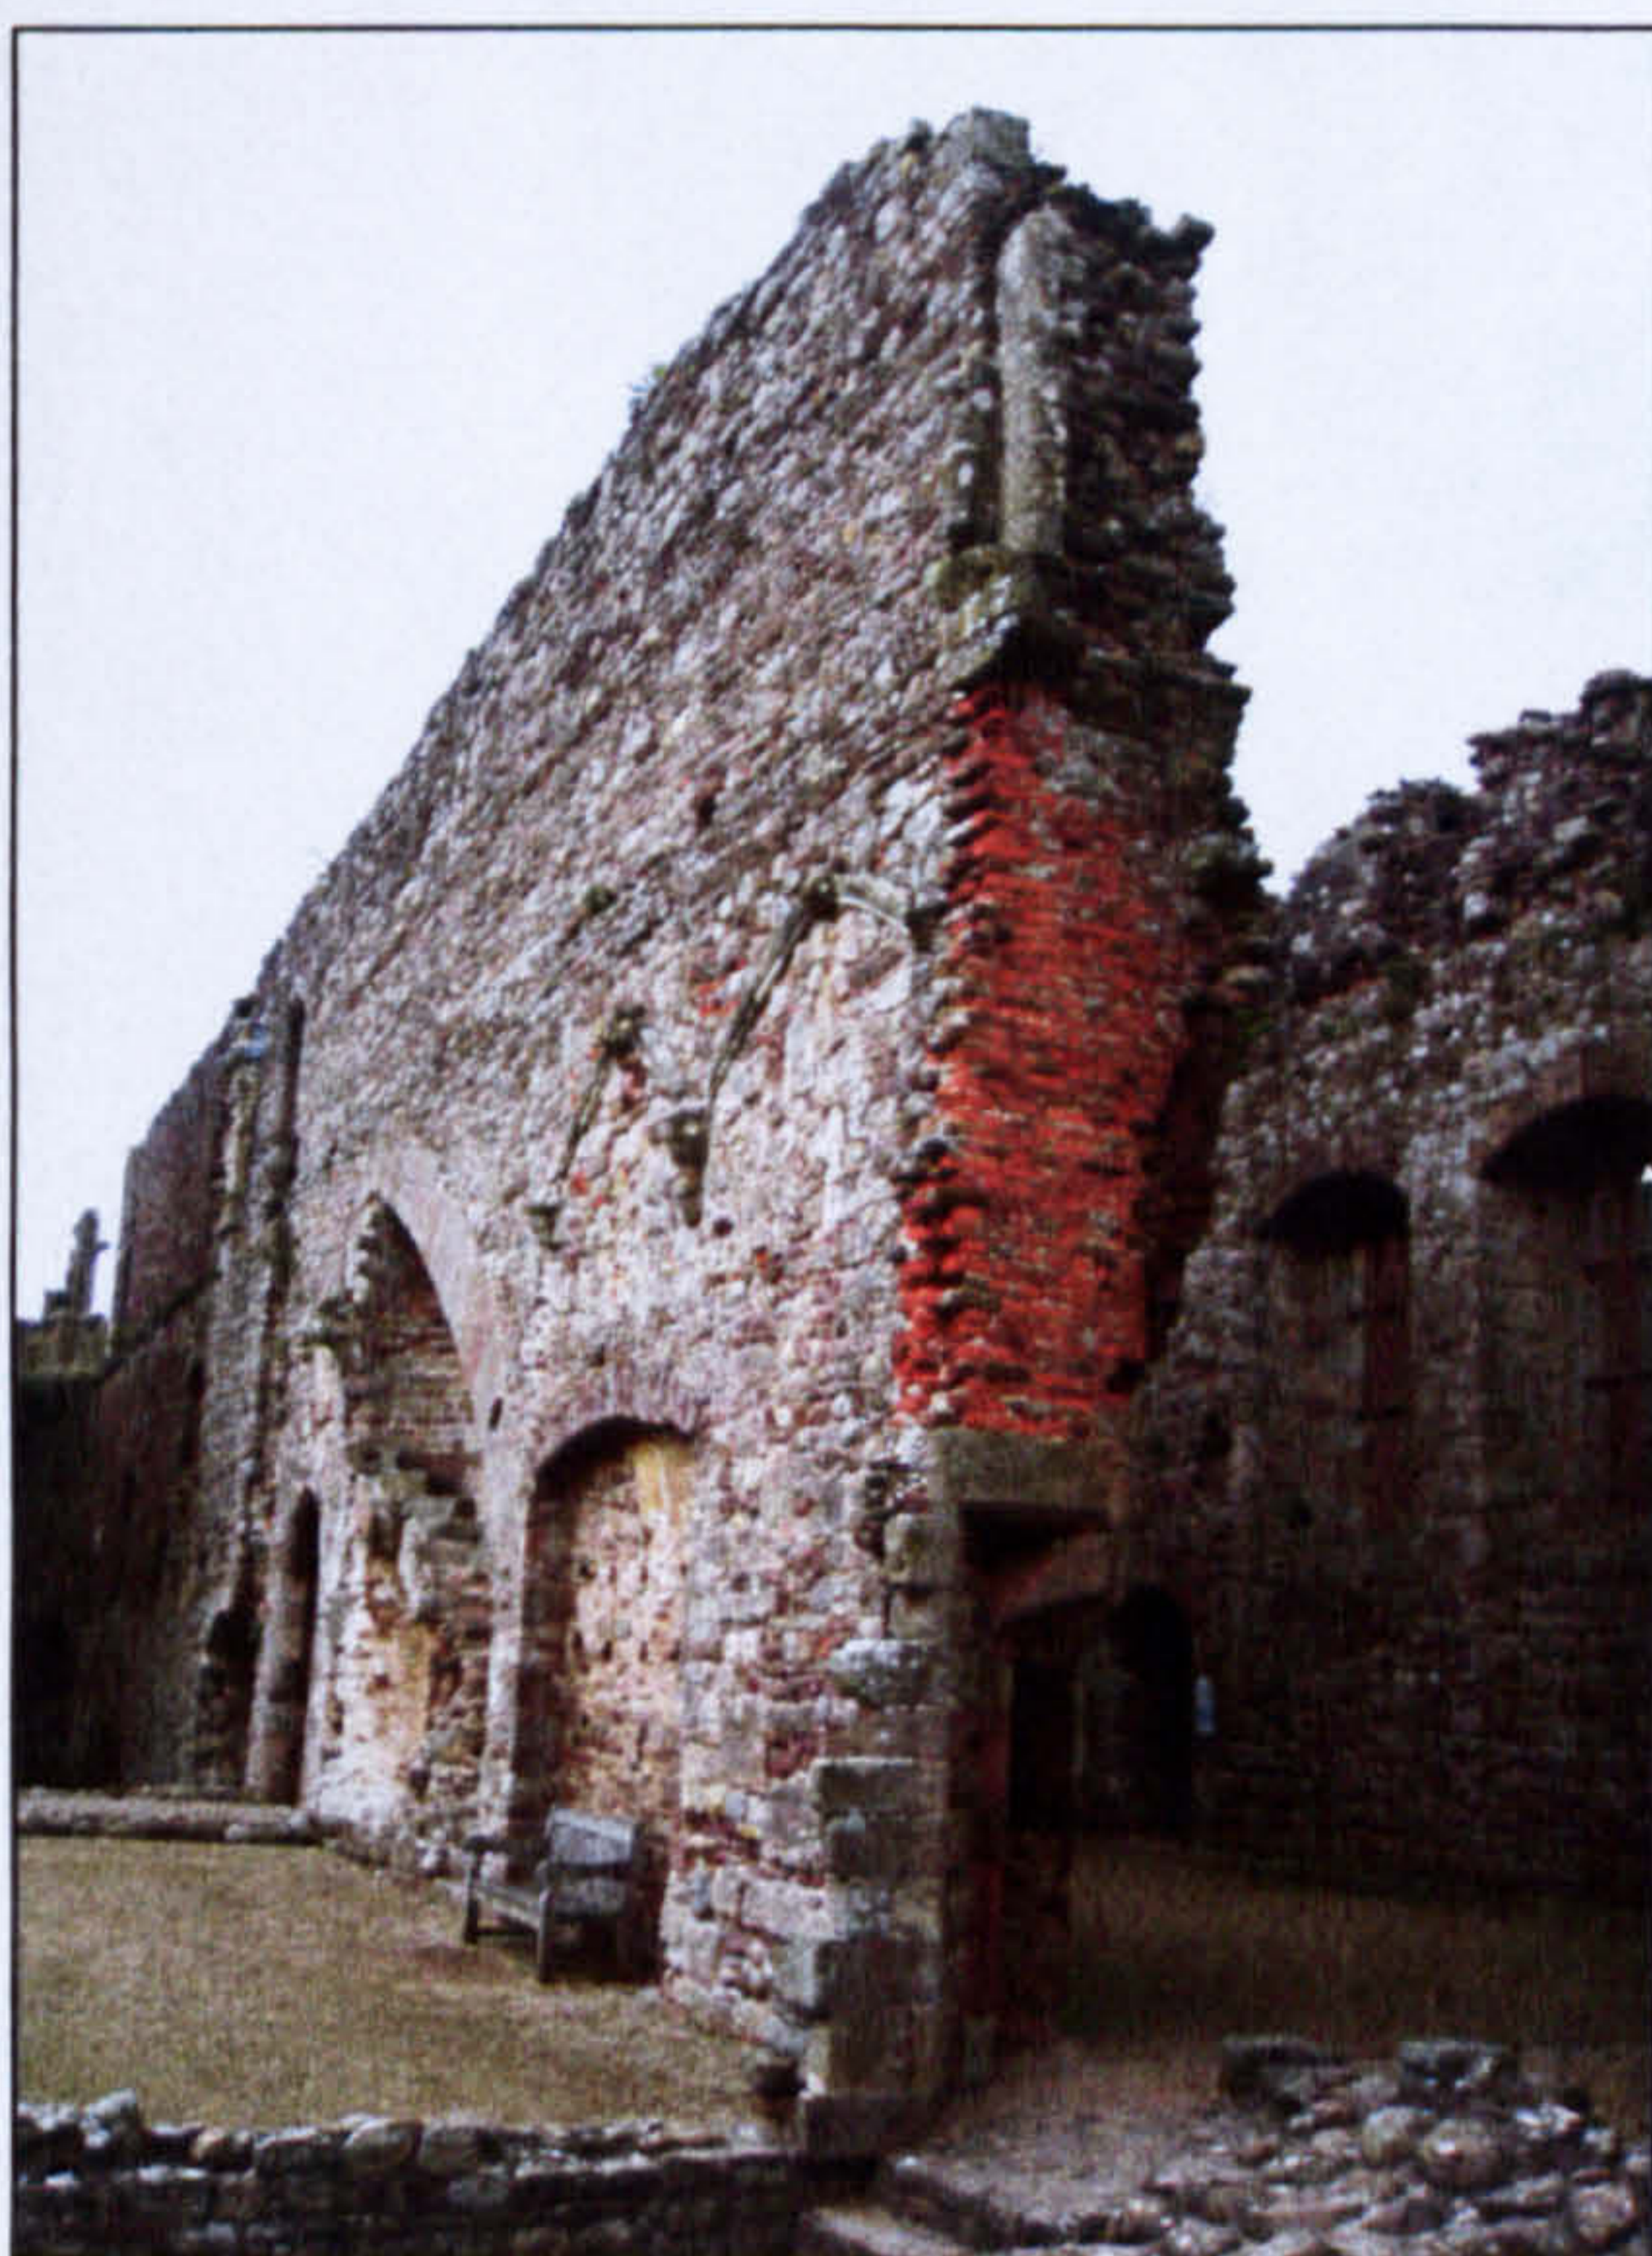
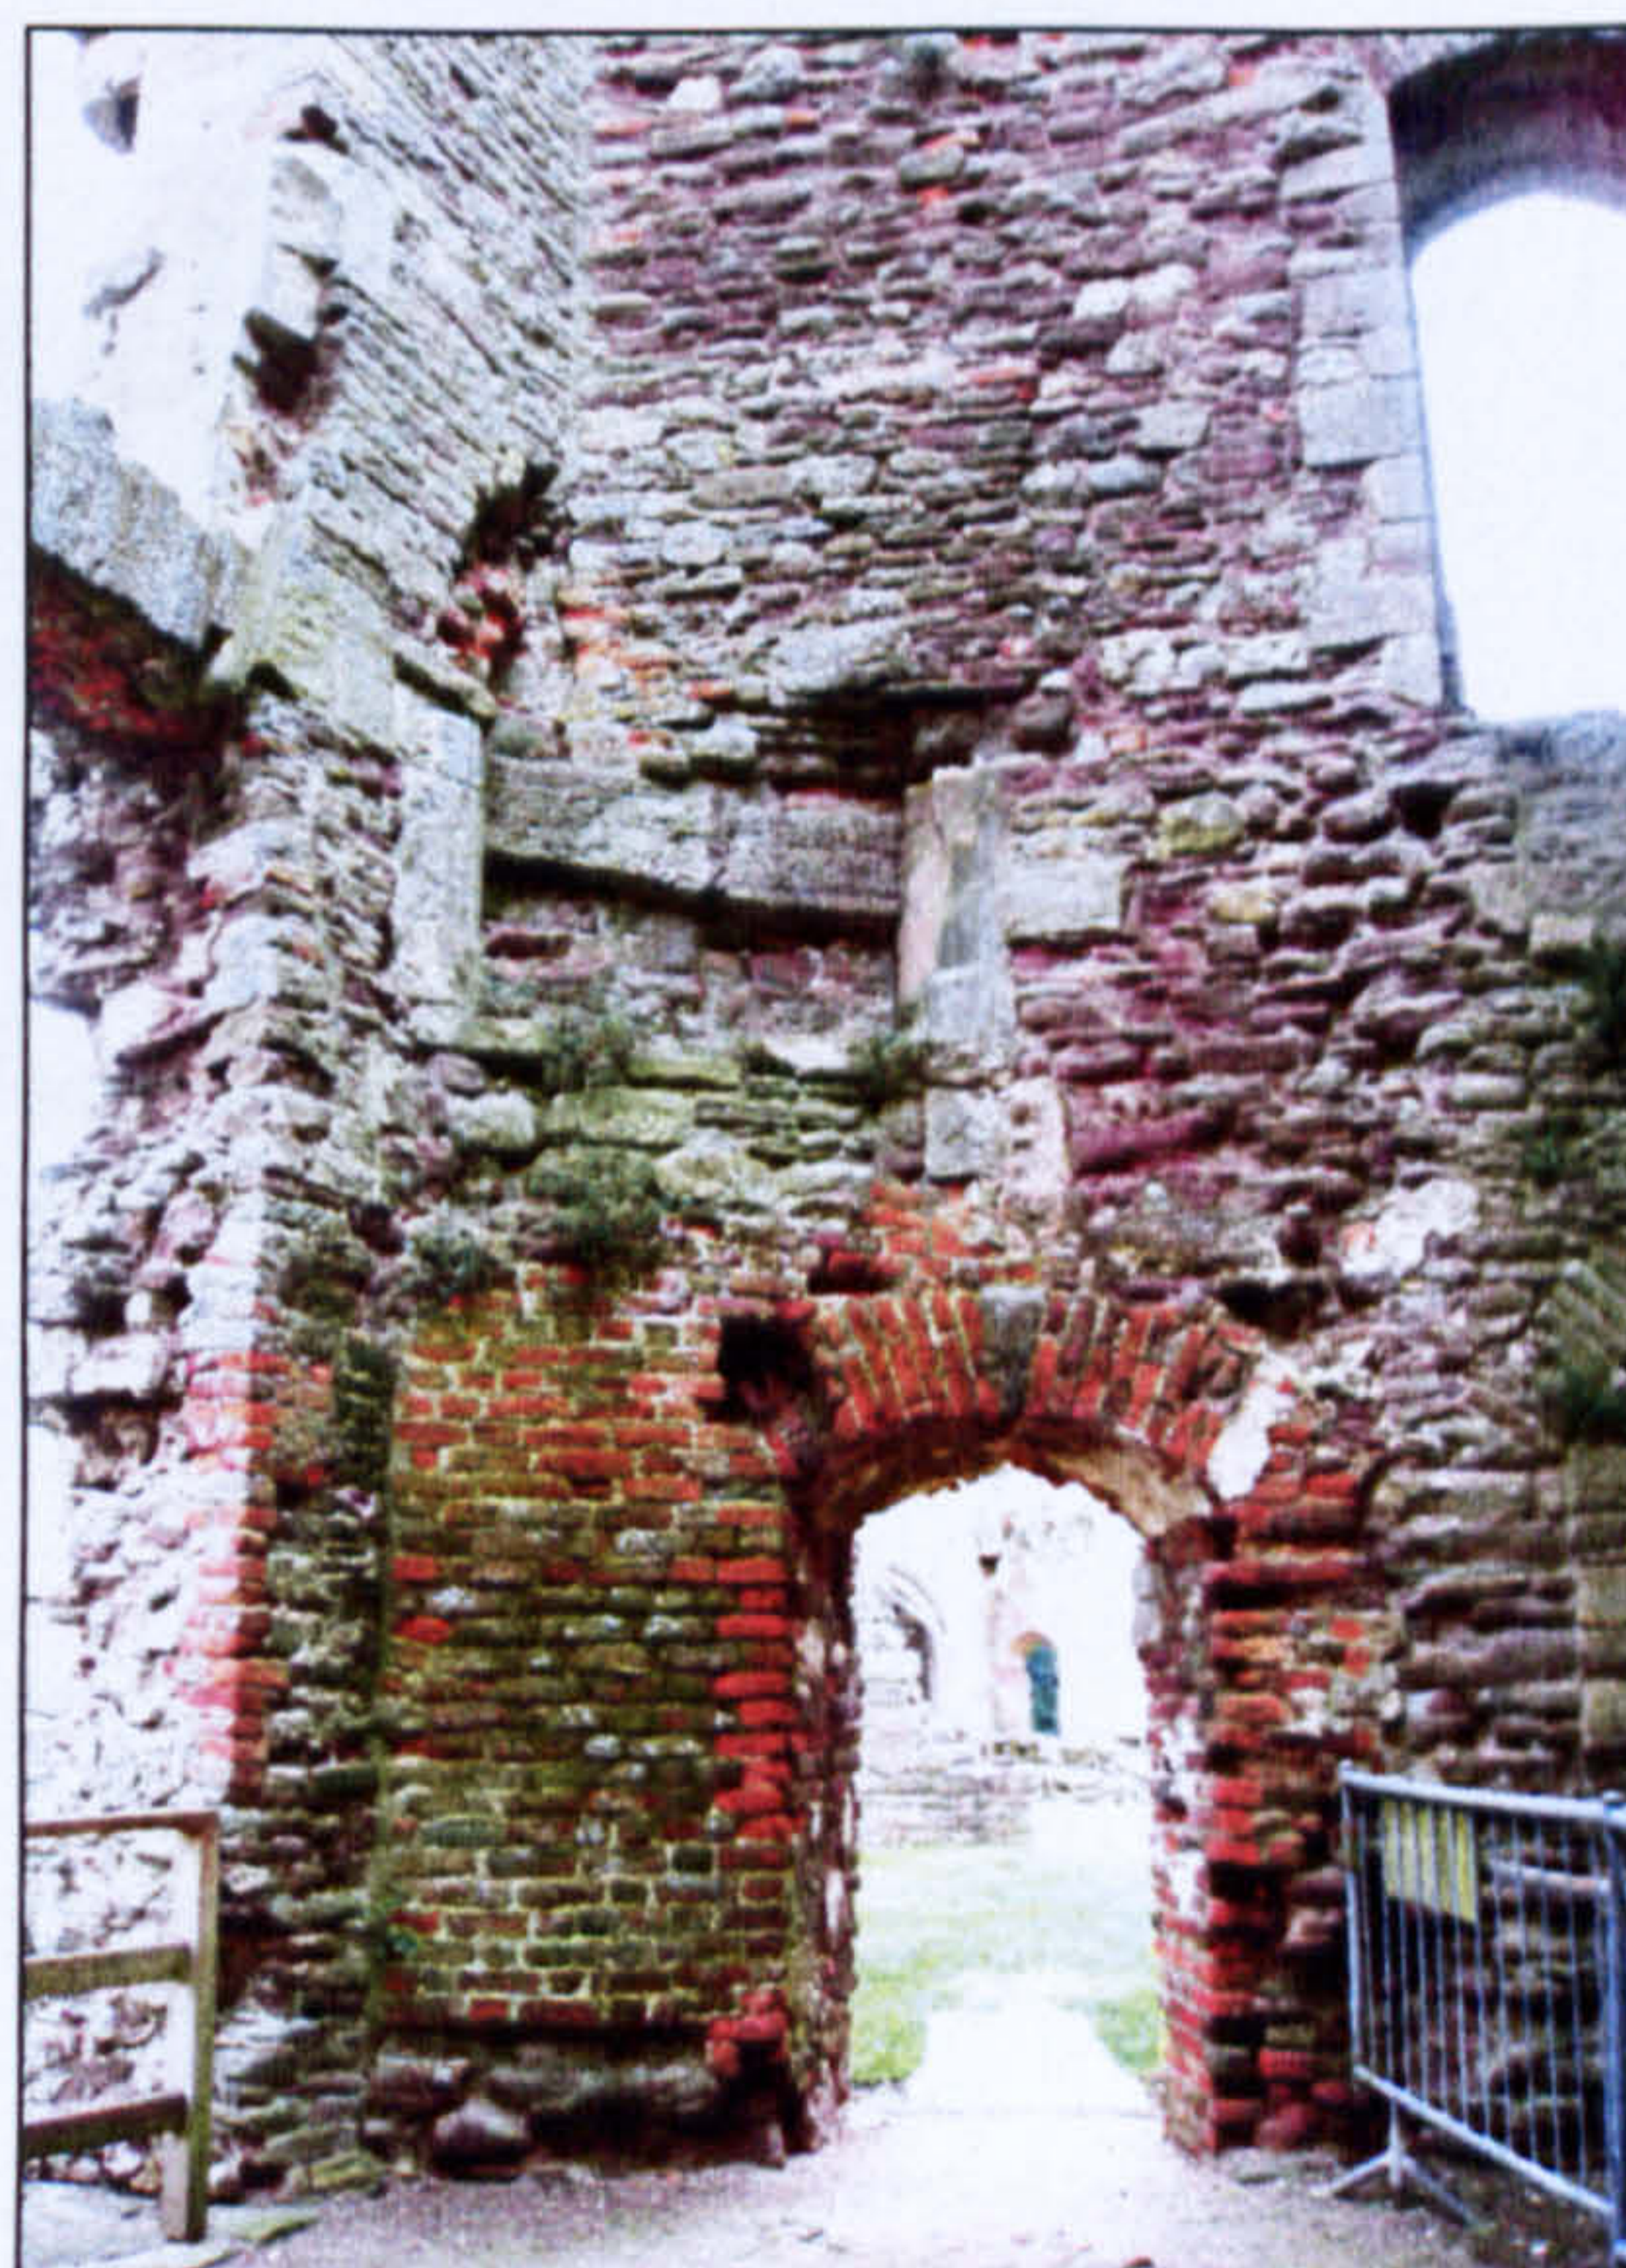
Figure 5.48 Evidence for repair work in the structural remains of Raglan Castle.

Figure 5.48 Evidence for repair work in the structural remains of Raglan Castle.
