ARCHAEOLOGY OF DESTRUCTION

A REINTERPRETATION OF CASTLE SLIGHTINGS IN THE ENGLISH CIVIL WAR

Thesis submitted for the degree of
Doctor of Philosophy
University of York
Department of Archaeology

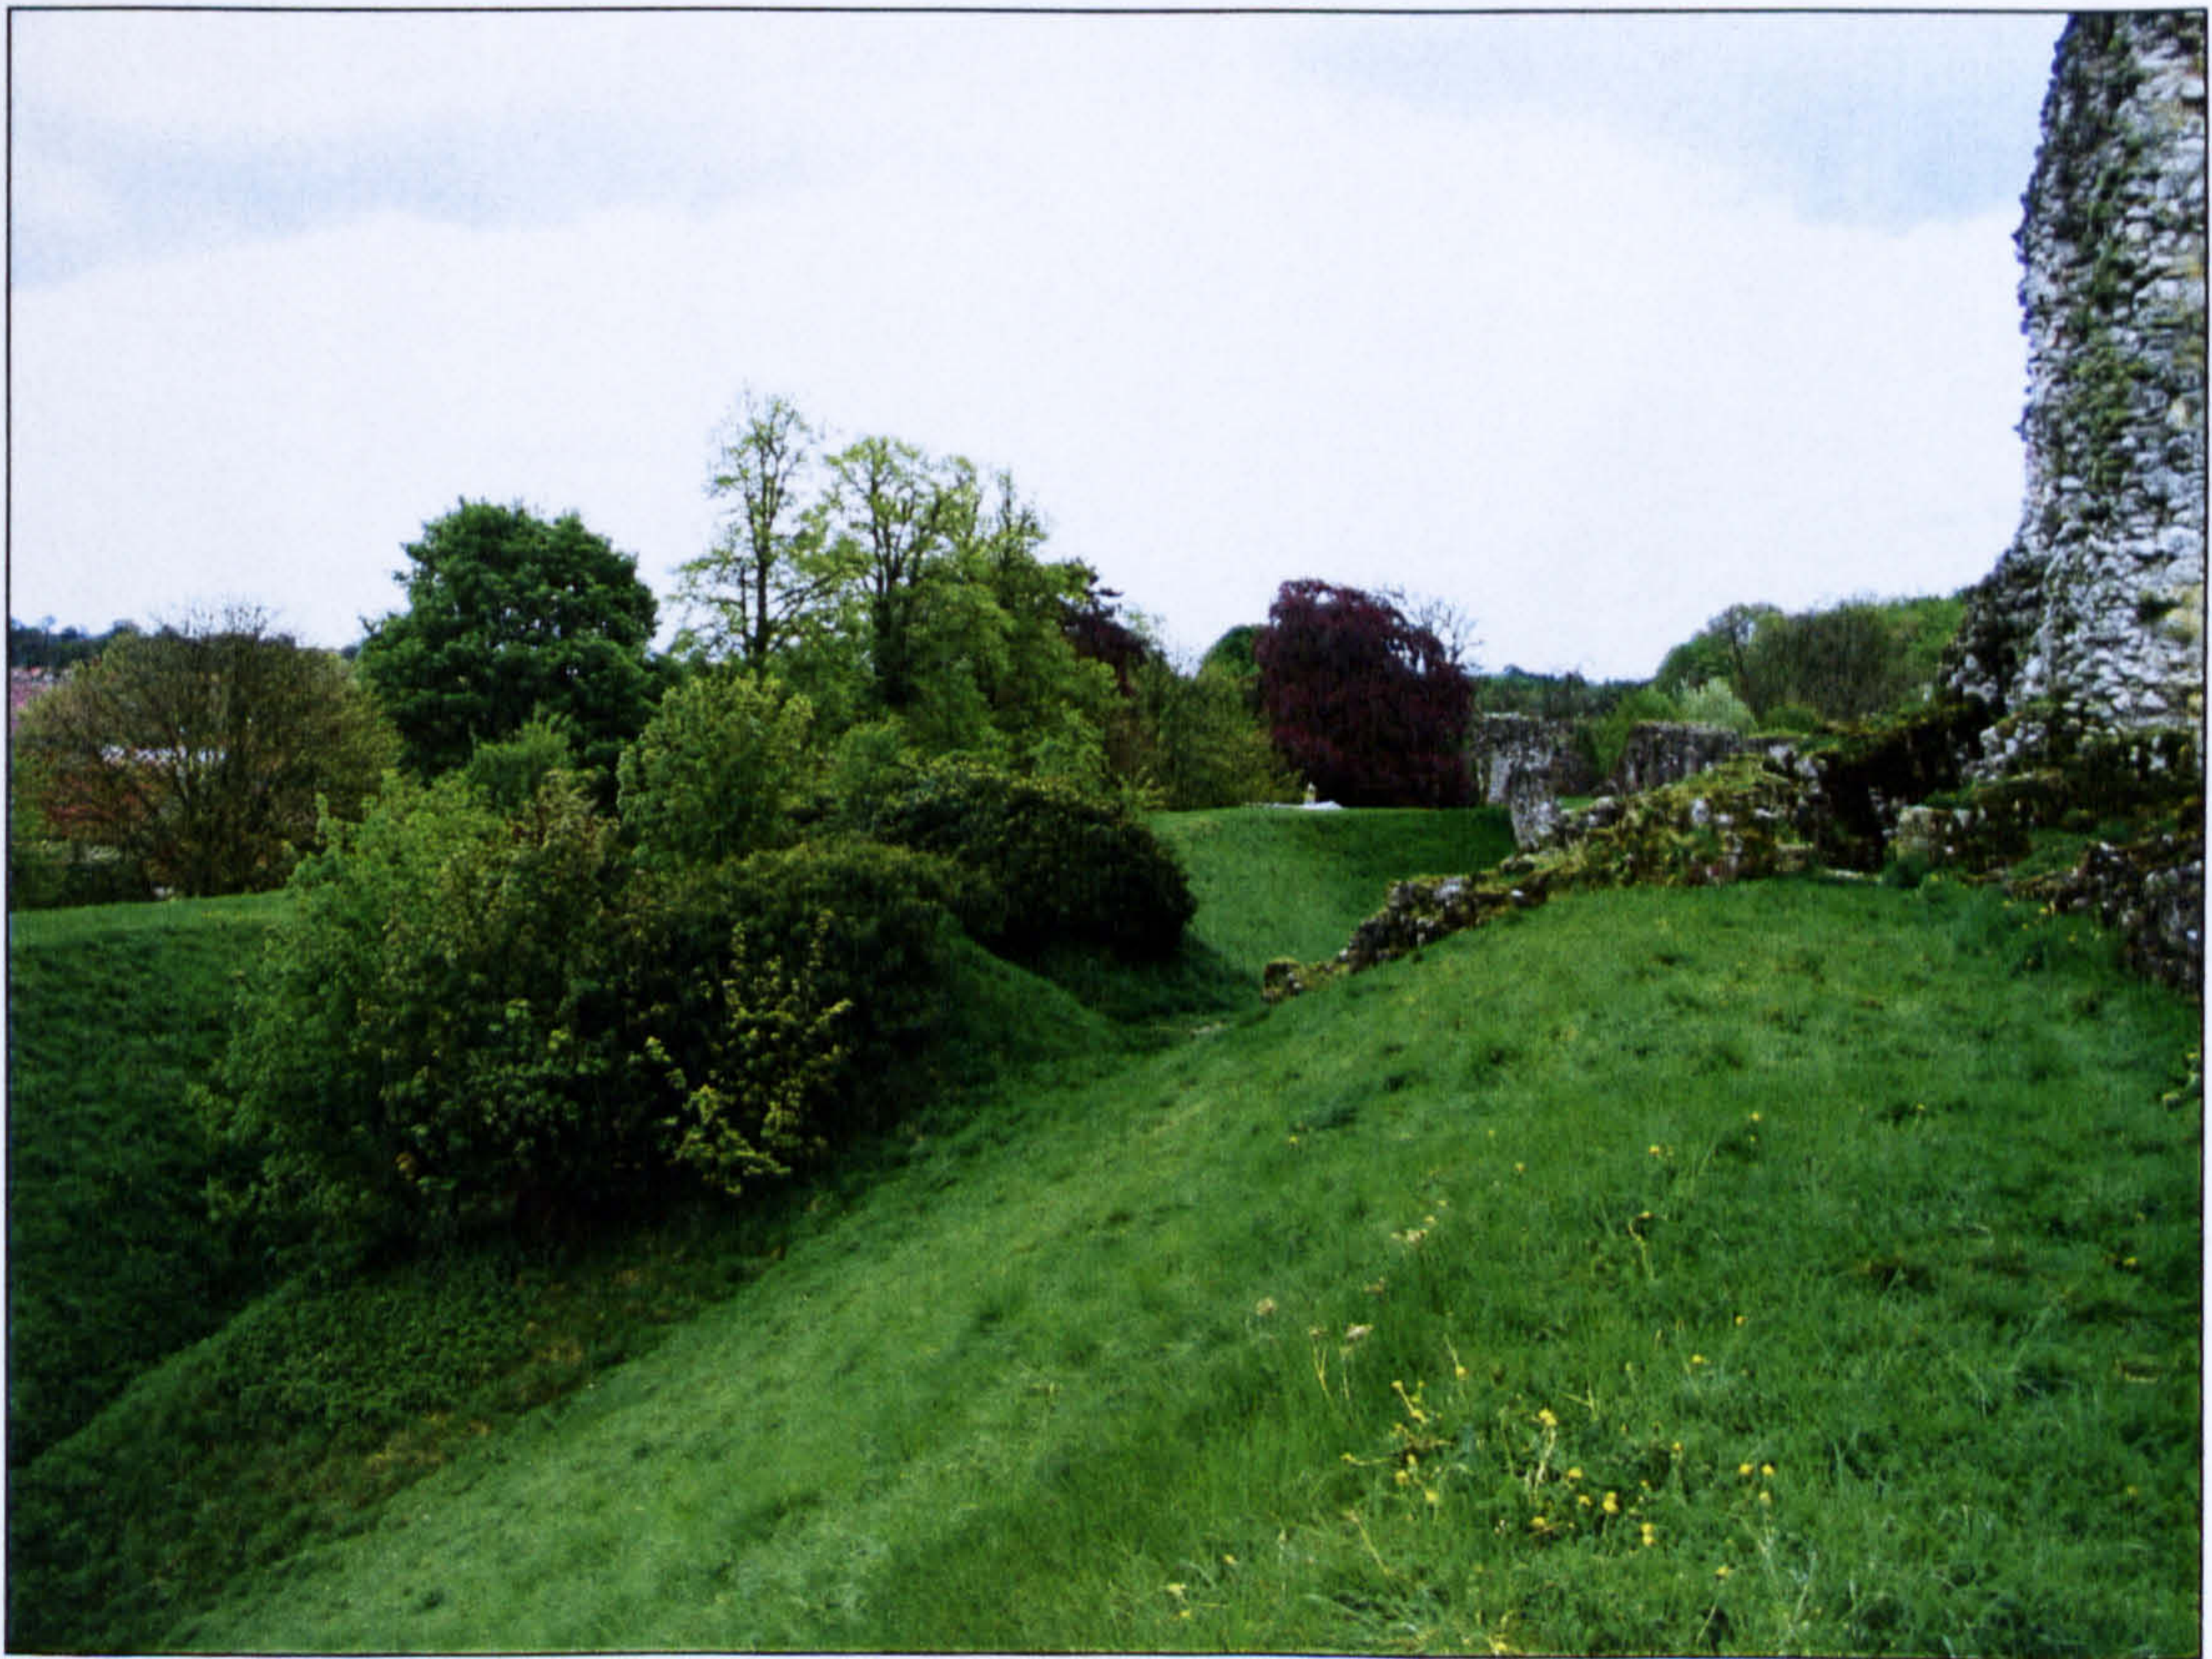
Figure 5.51 Vegetation covered debris at the foot of the East Tower.

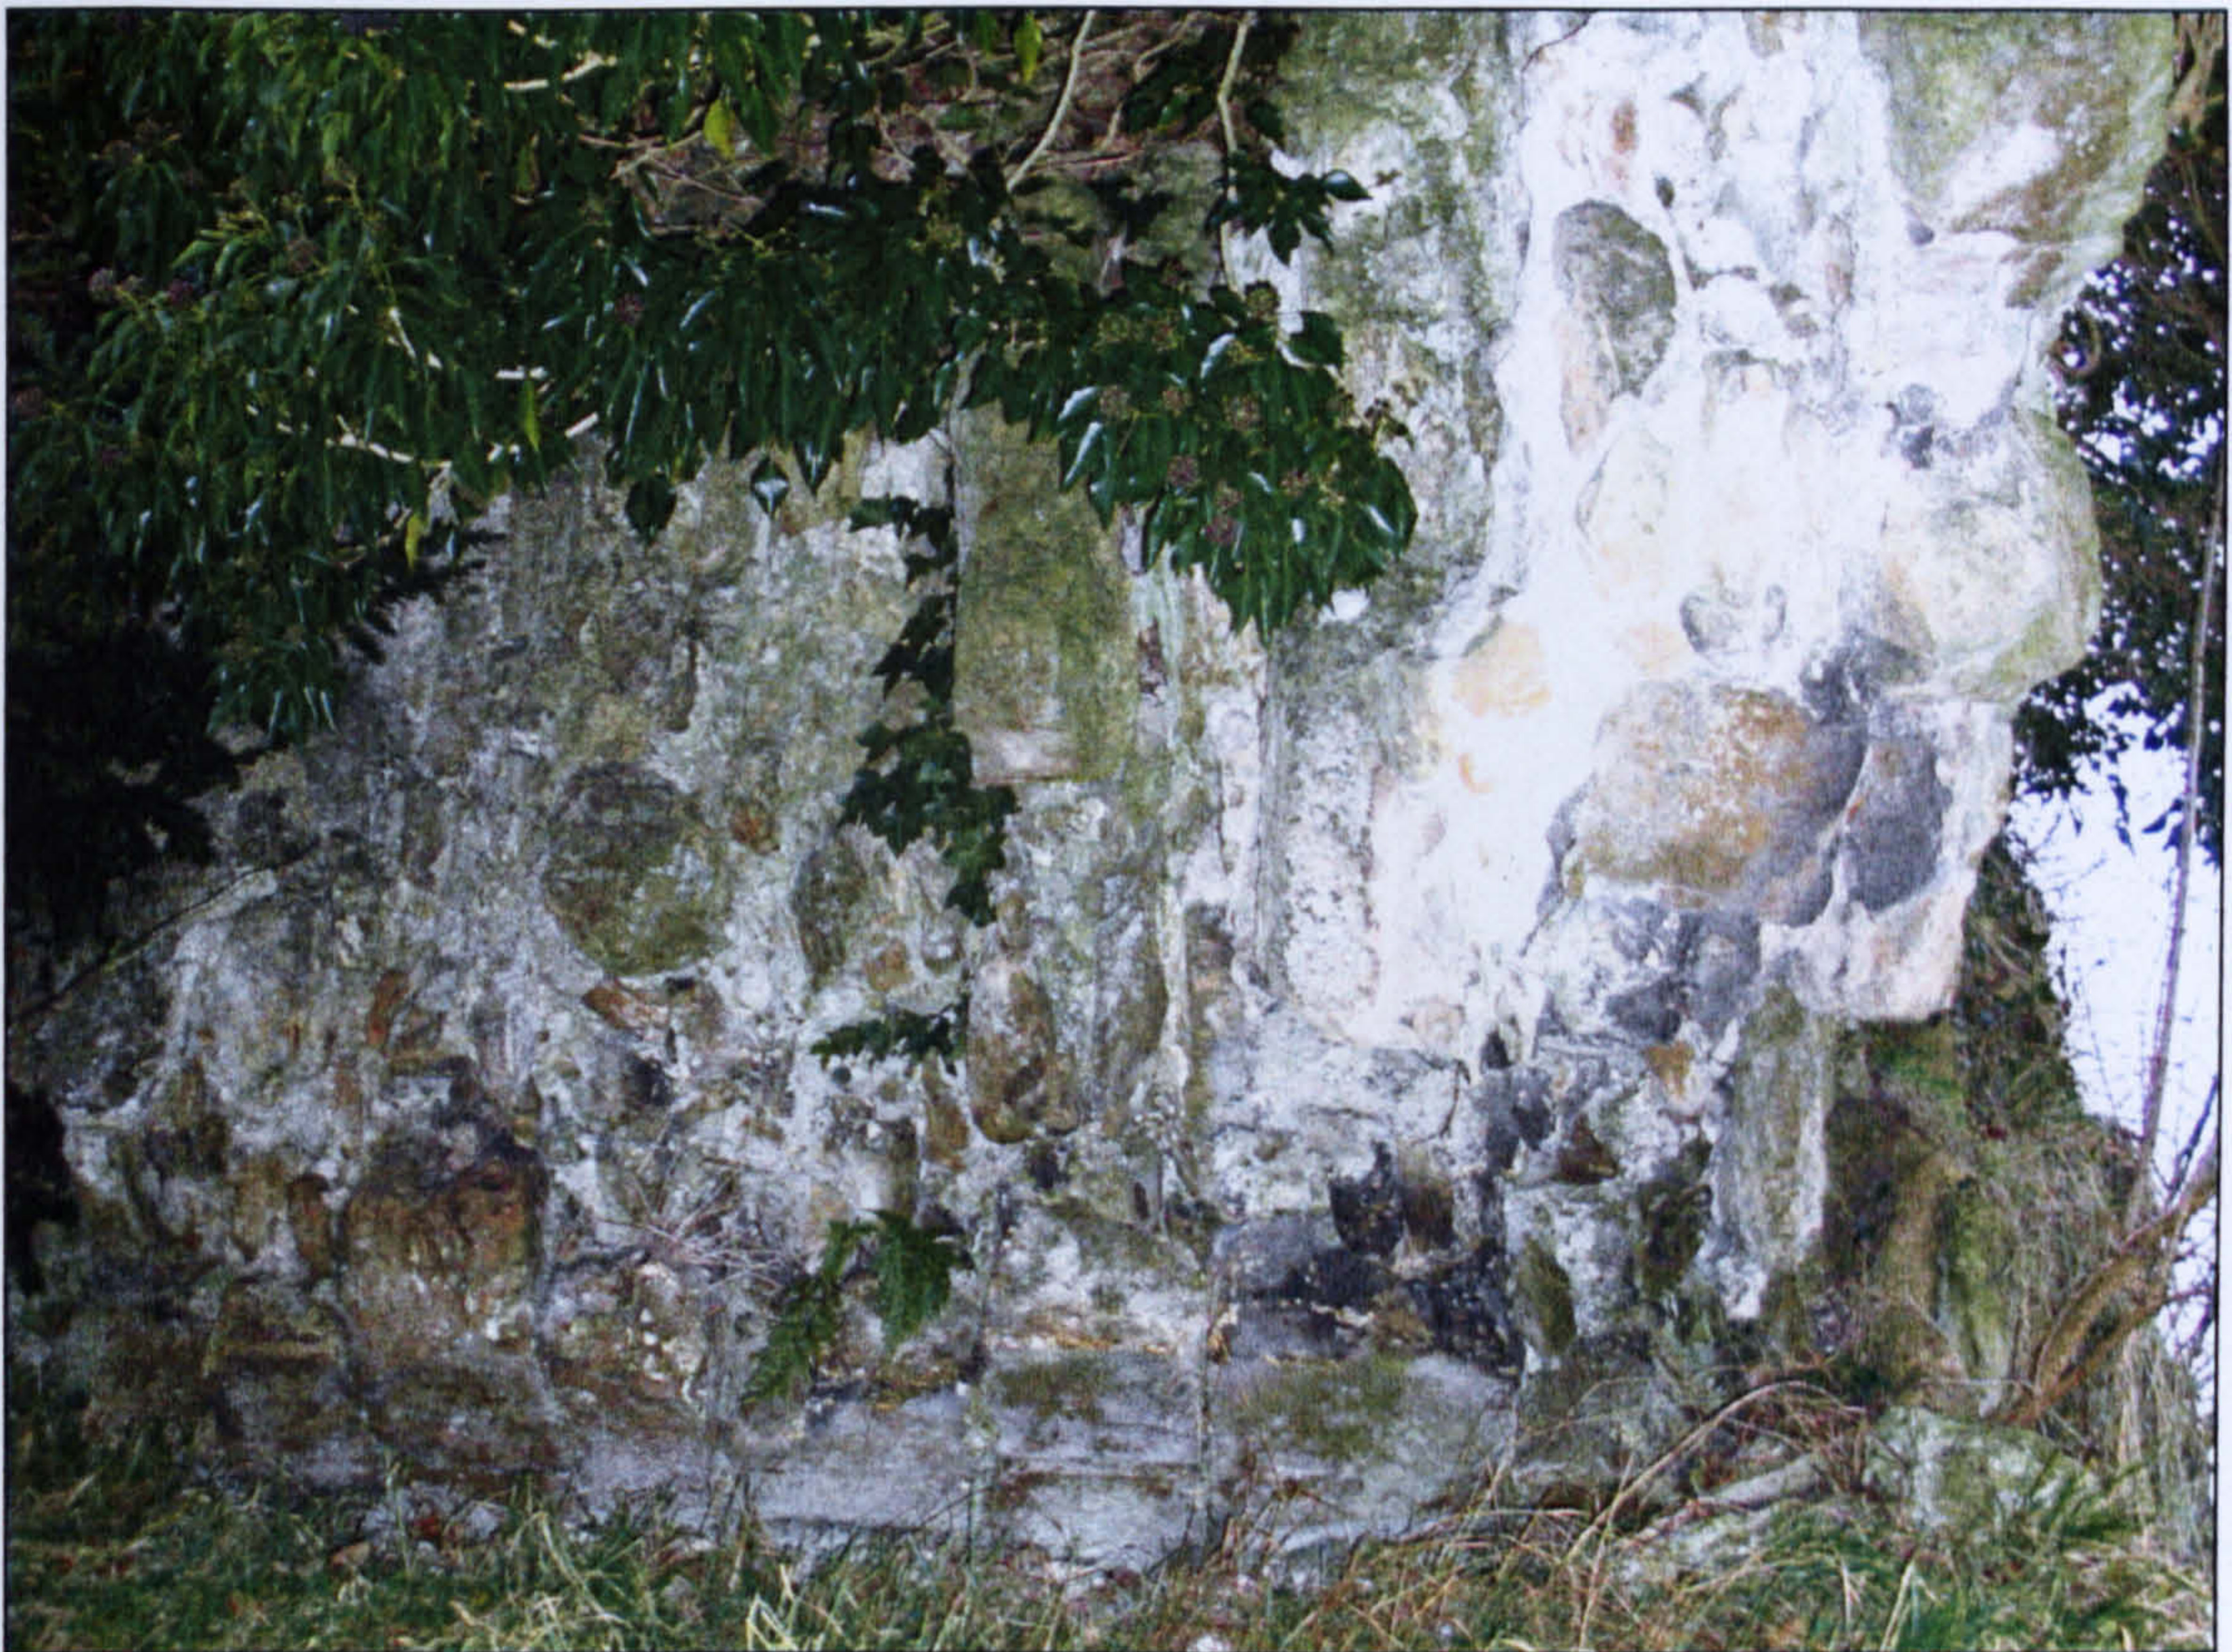
Figure 5.52 Close-up of rubble debris from the keep, currently located in the castle ditch.

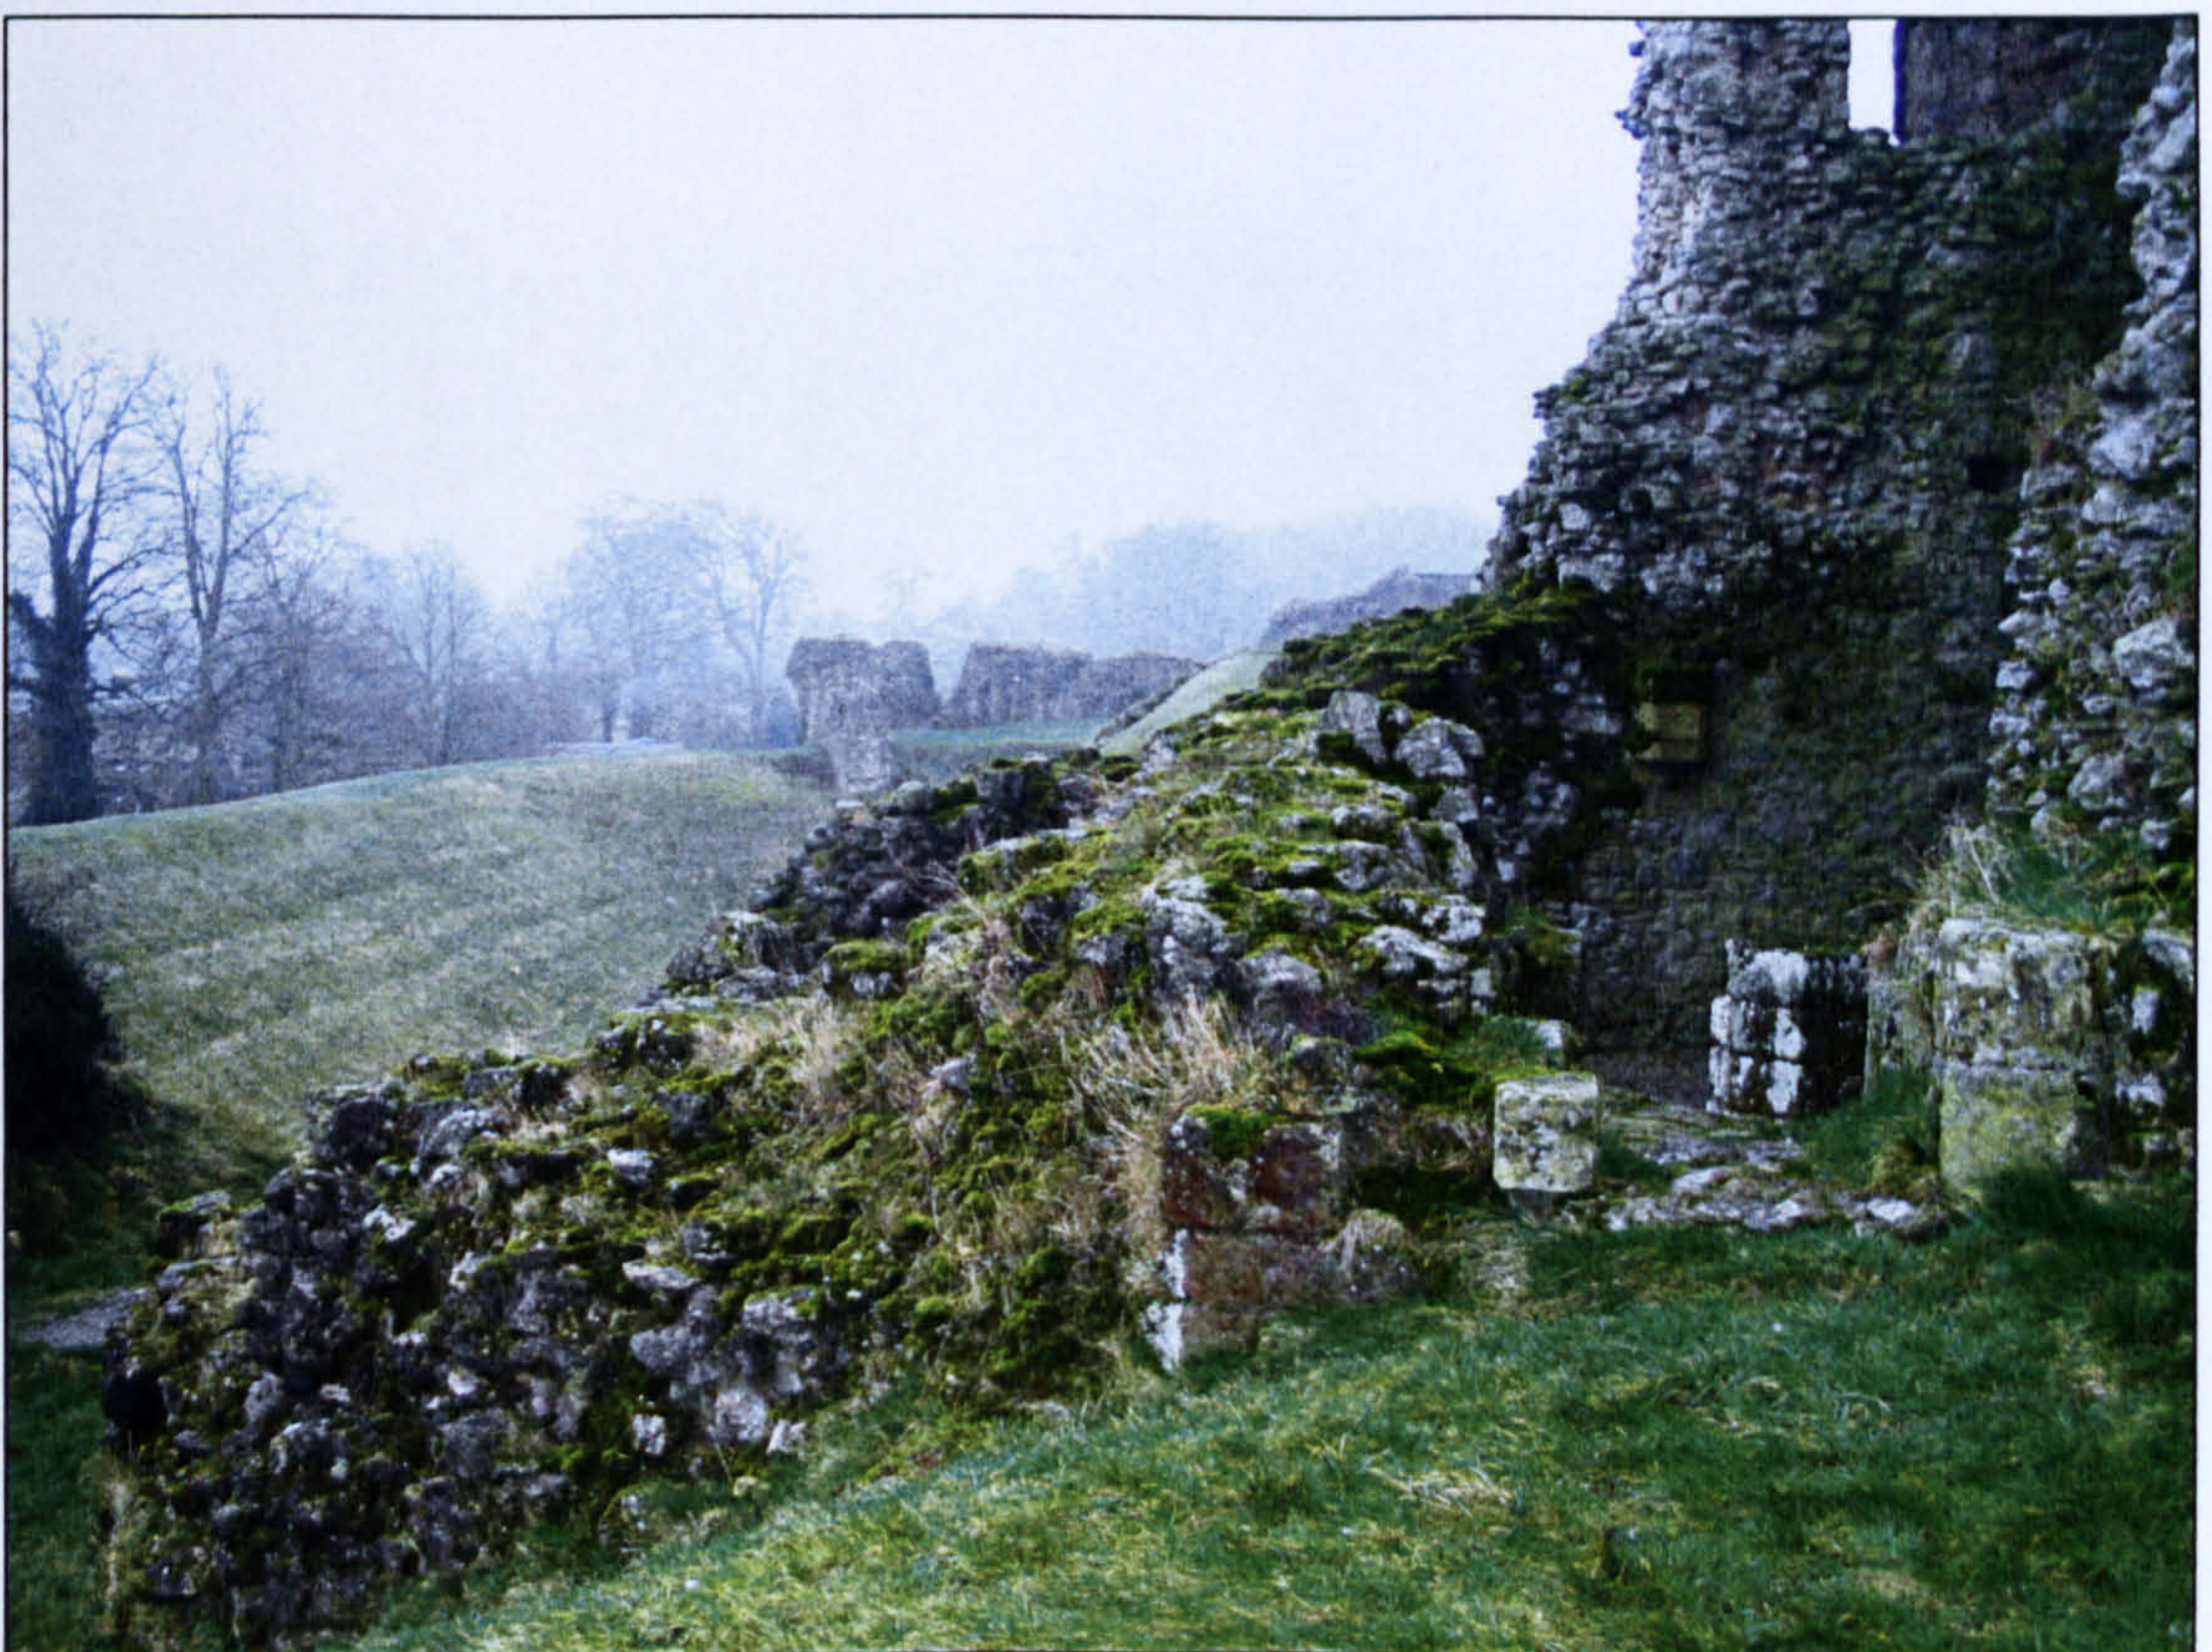
Figure 5.53 External side of the keep with the postern gate on the right, looking southeast.

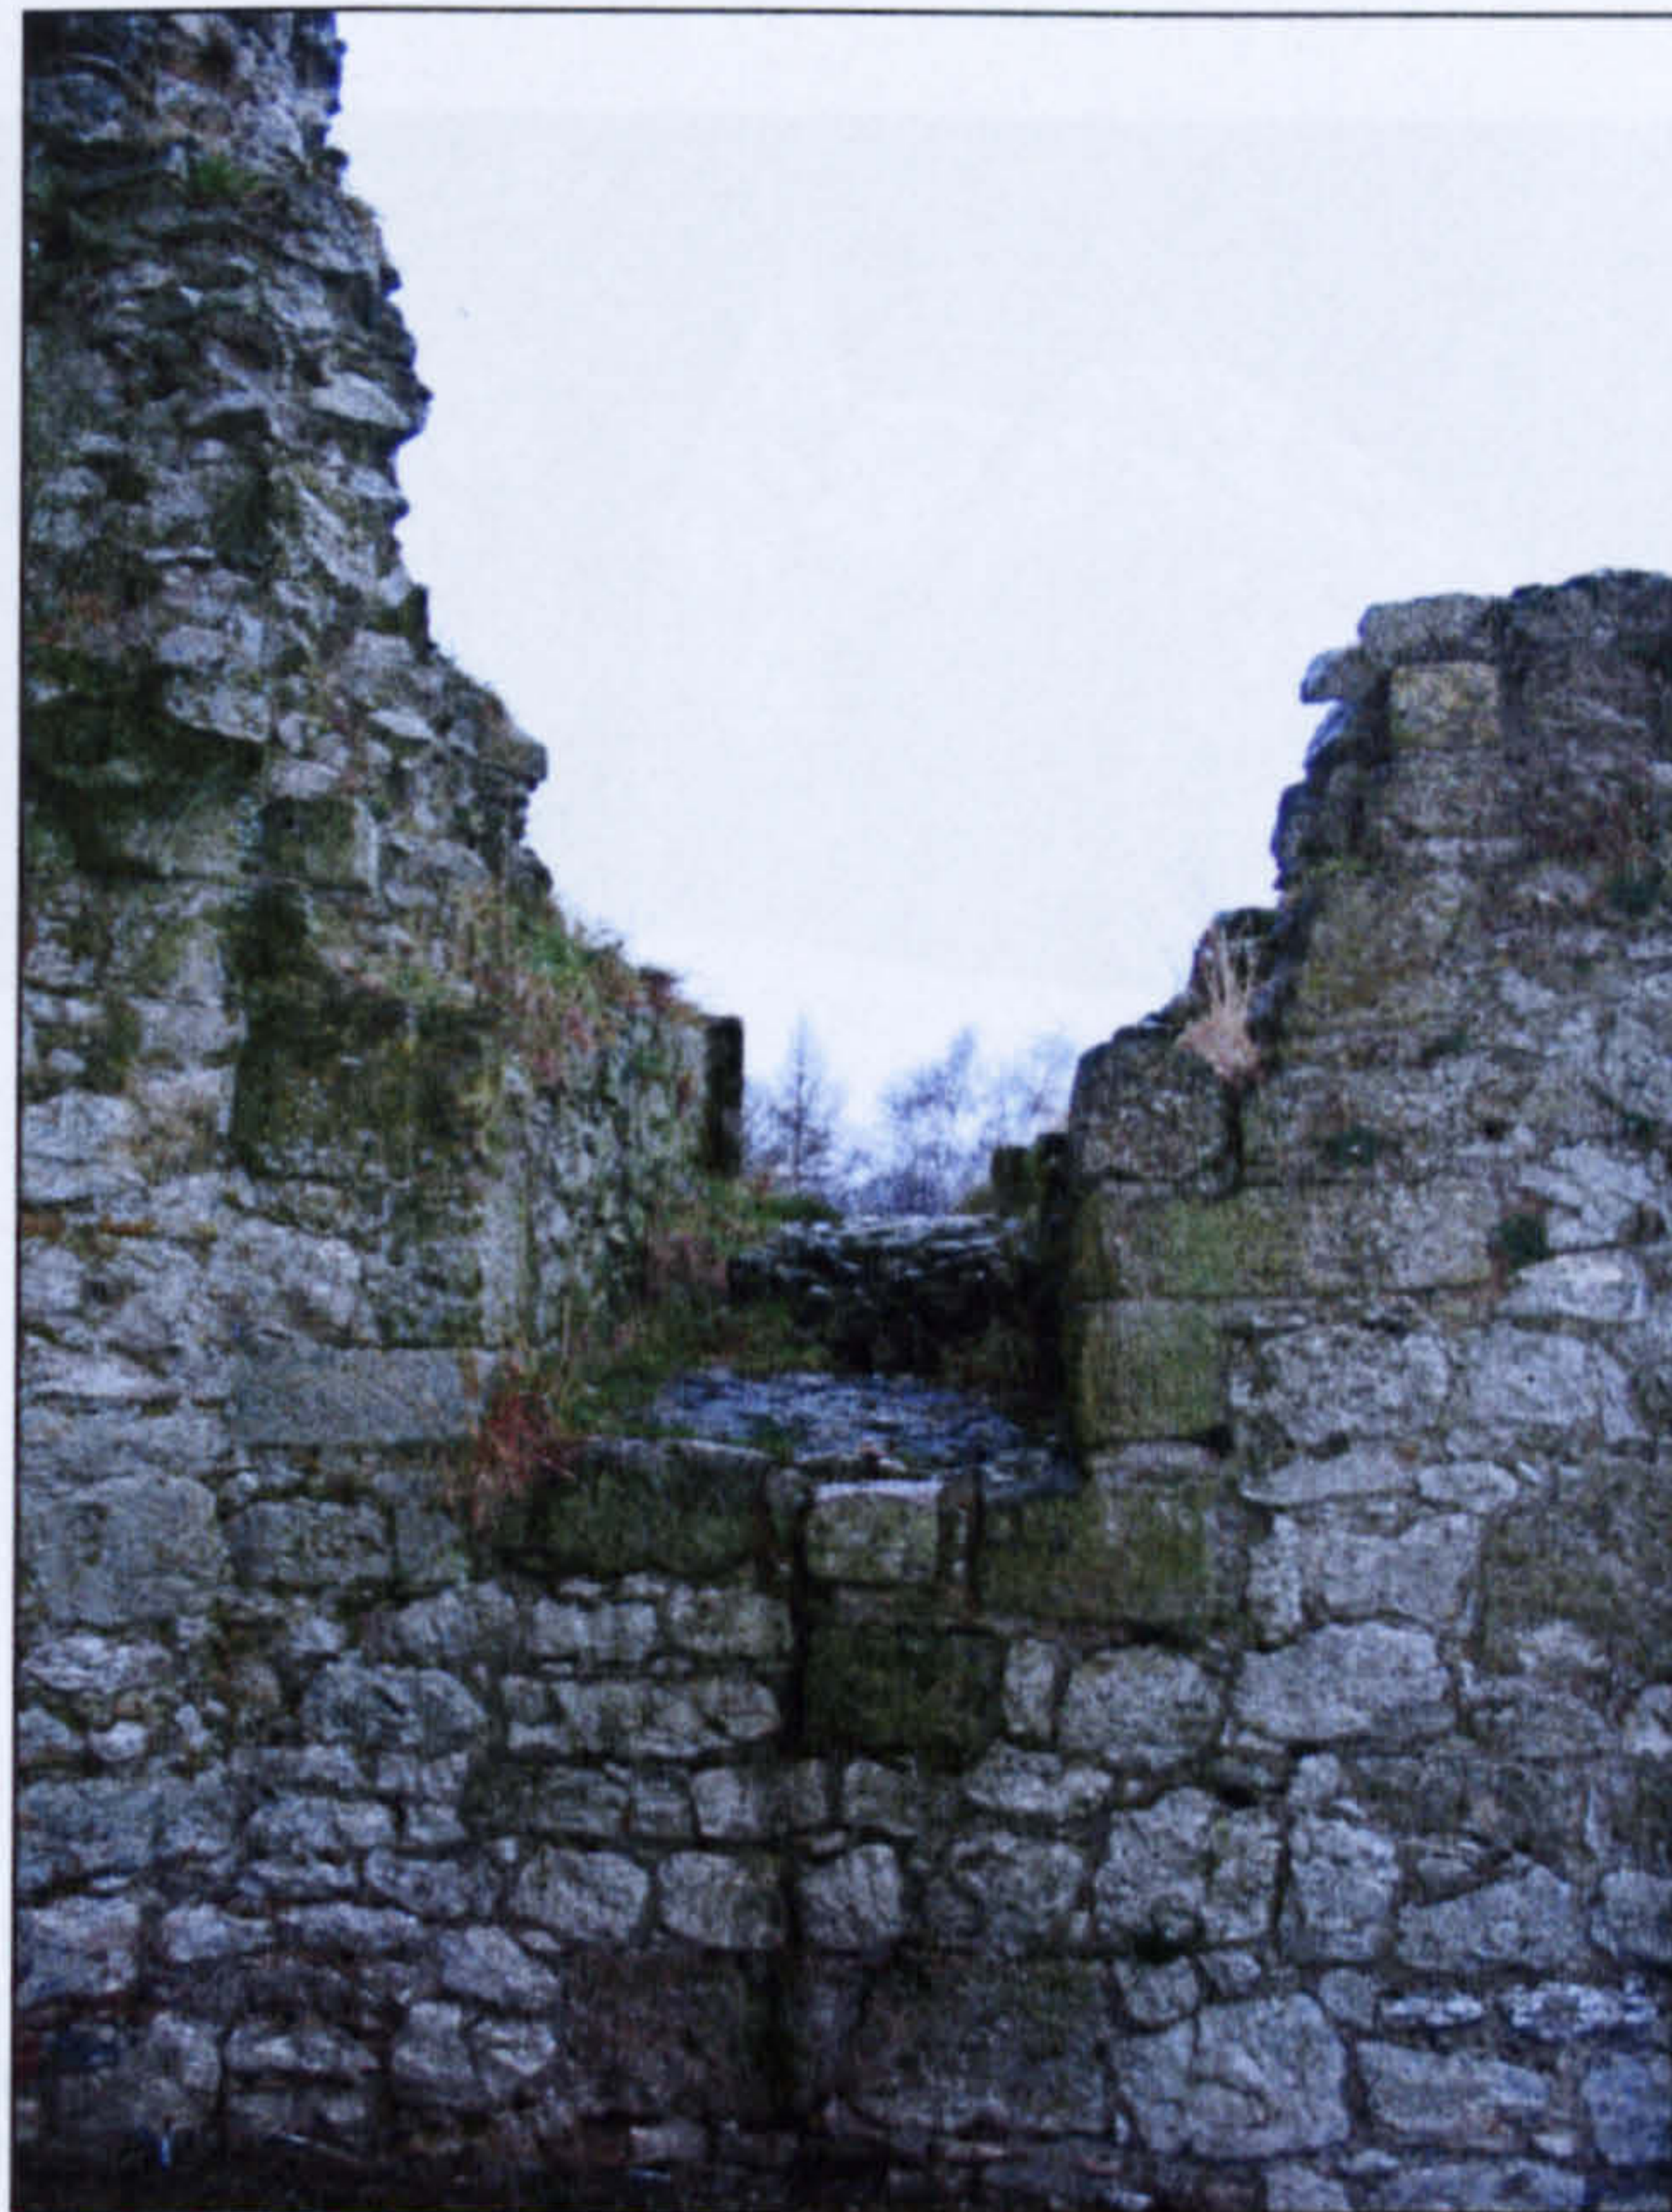
Figure 5.54 Close-up of the internal side of the postern gate.

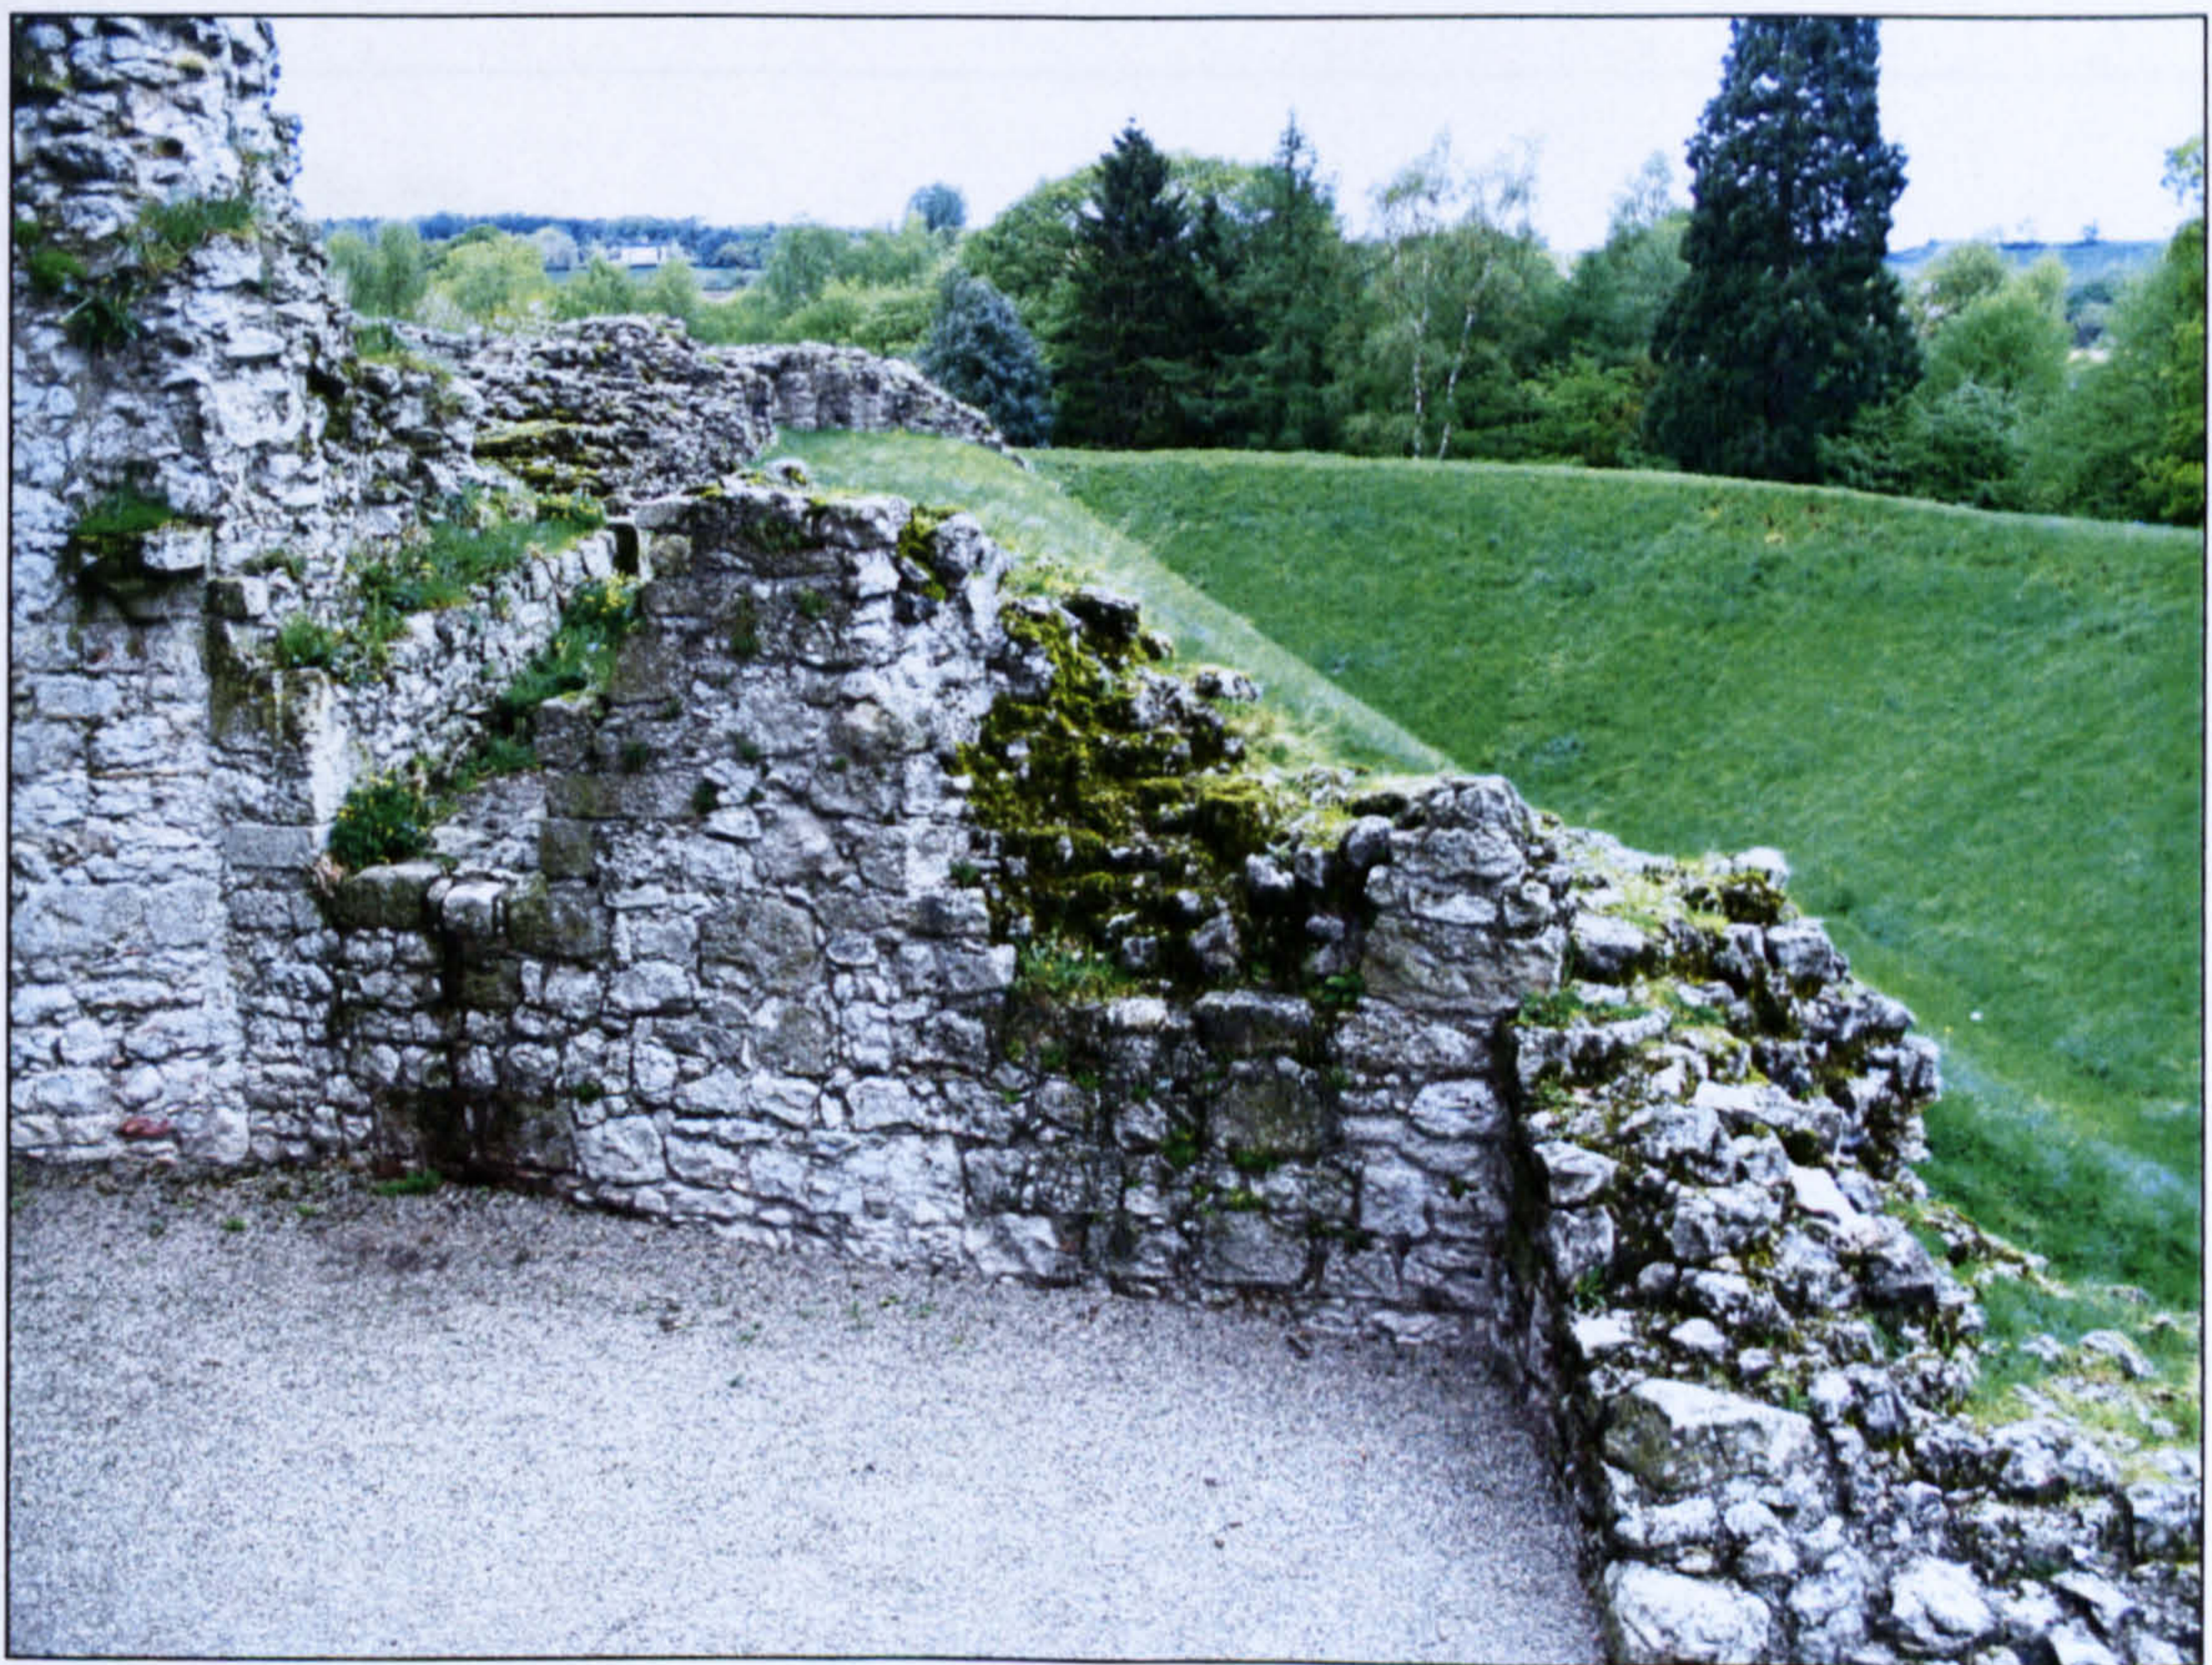
Figure 5.55 The internal north wall of the keep, showing the gradations of wall height, the postern gate (left), and corner recess (right).

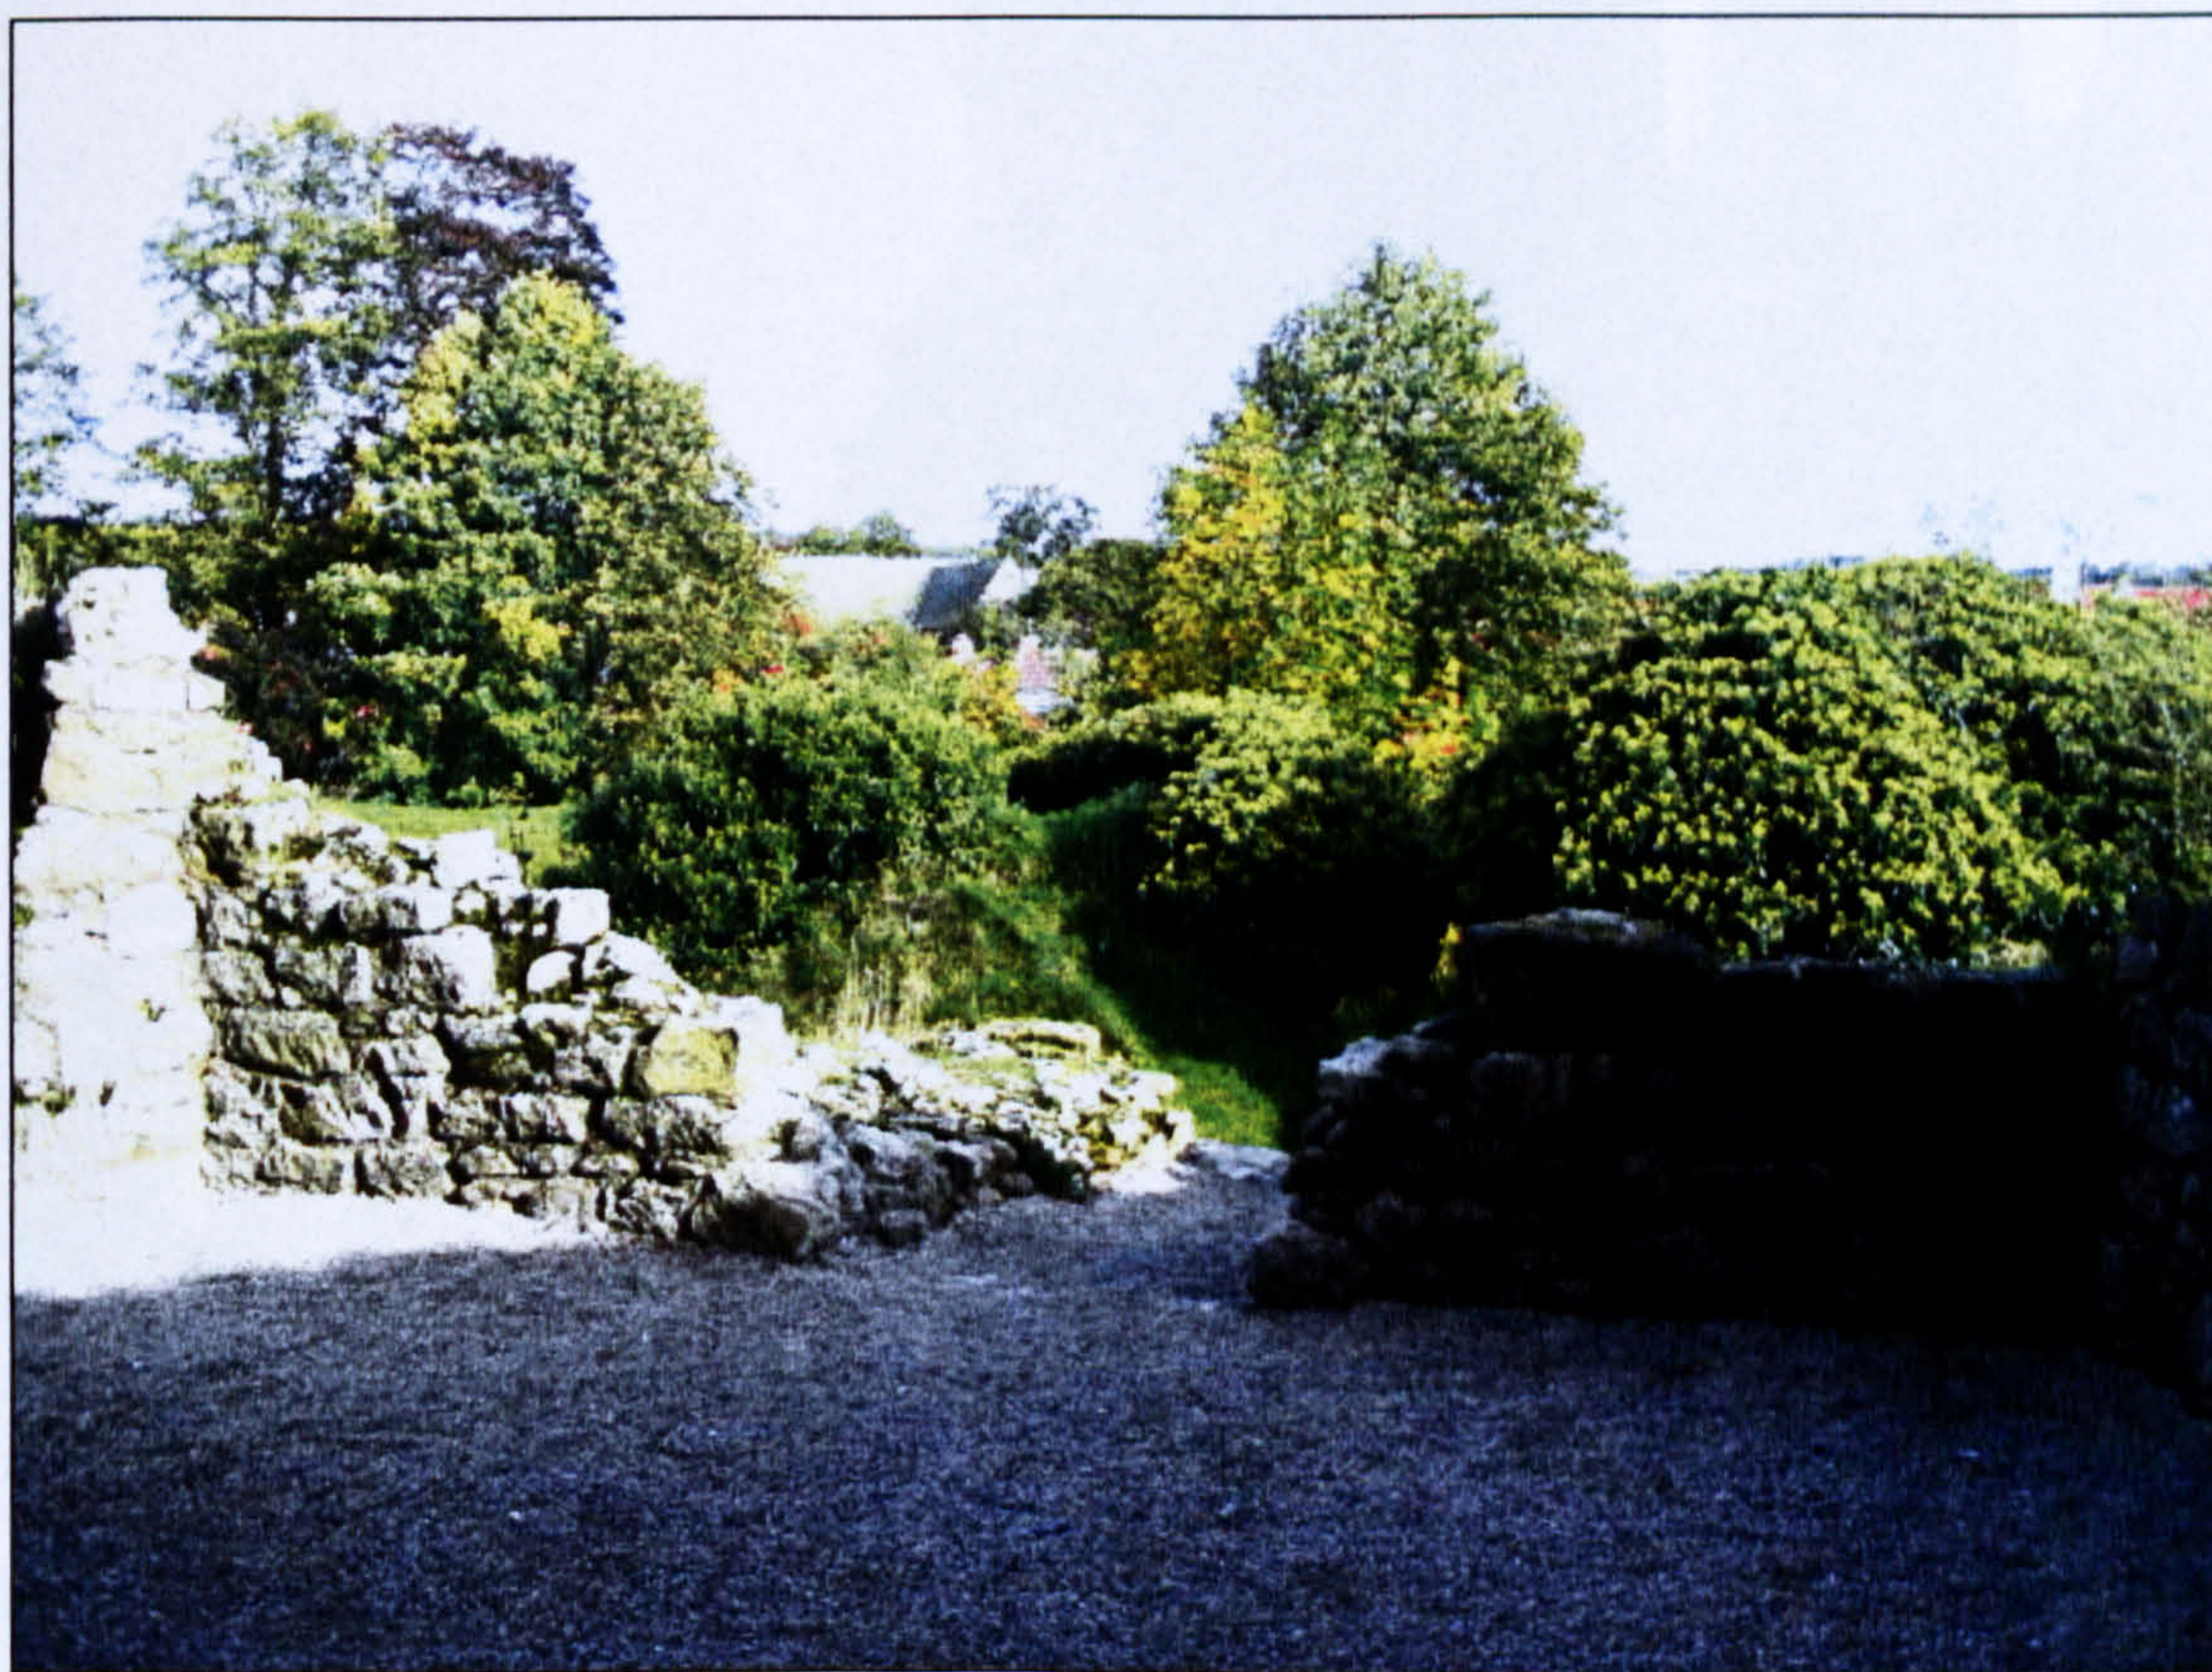
Figure 5.57 The northeast internal wall of the keep, viewed from the keep interior.
