ARCHAEOLOGY OF DESTRUCTION

A REINTERPRETATION OF CASTLE SLIGHTINGS IN THE ENGLISH CIVIL WAR

Thesis submitted for the degree of
Doctor of Philosophy
University of York
Department of Archaeology

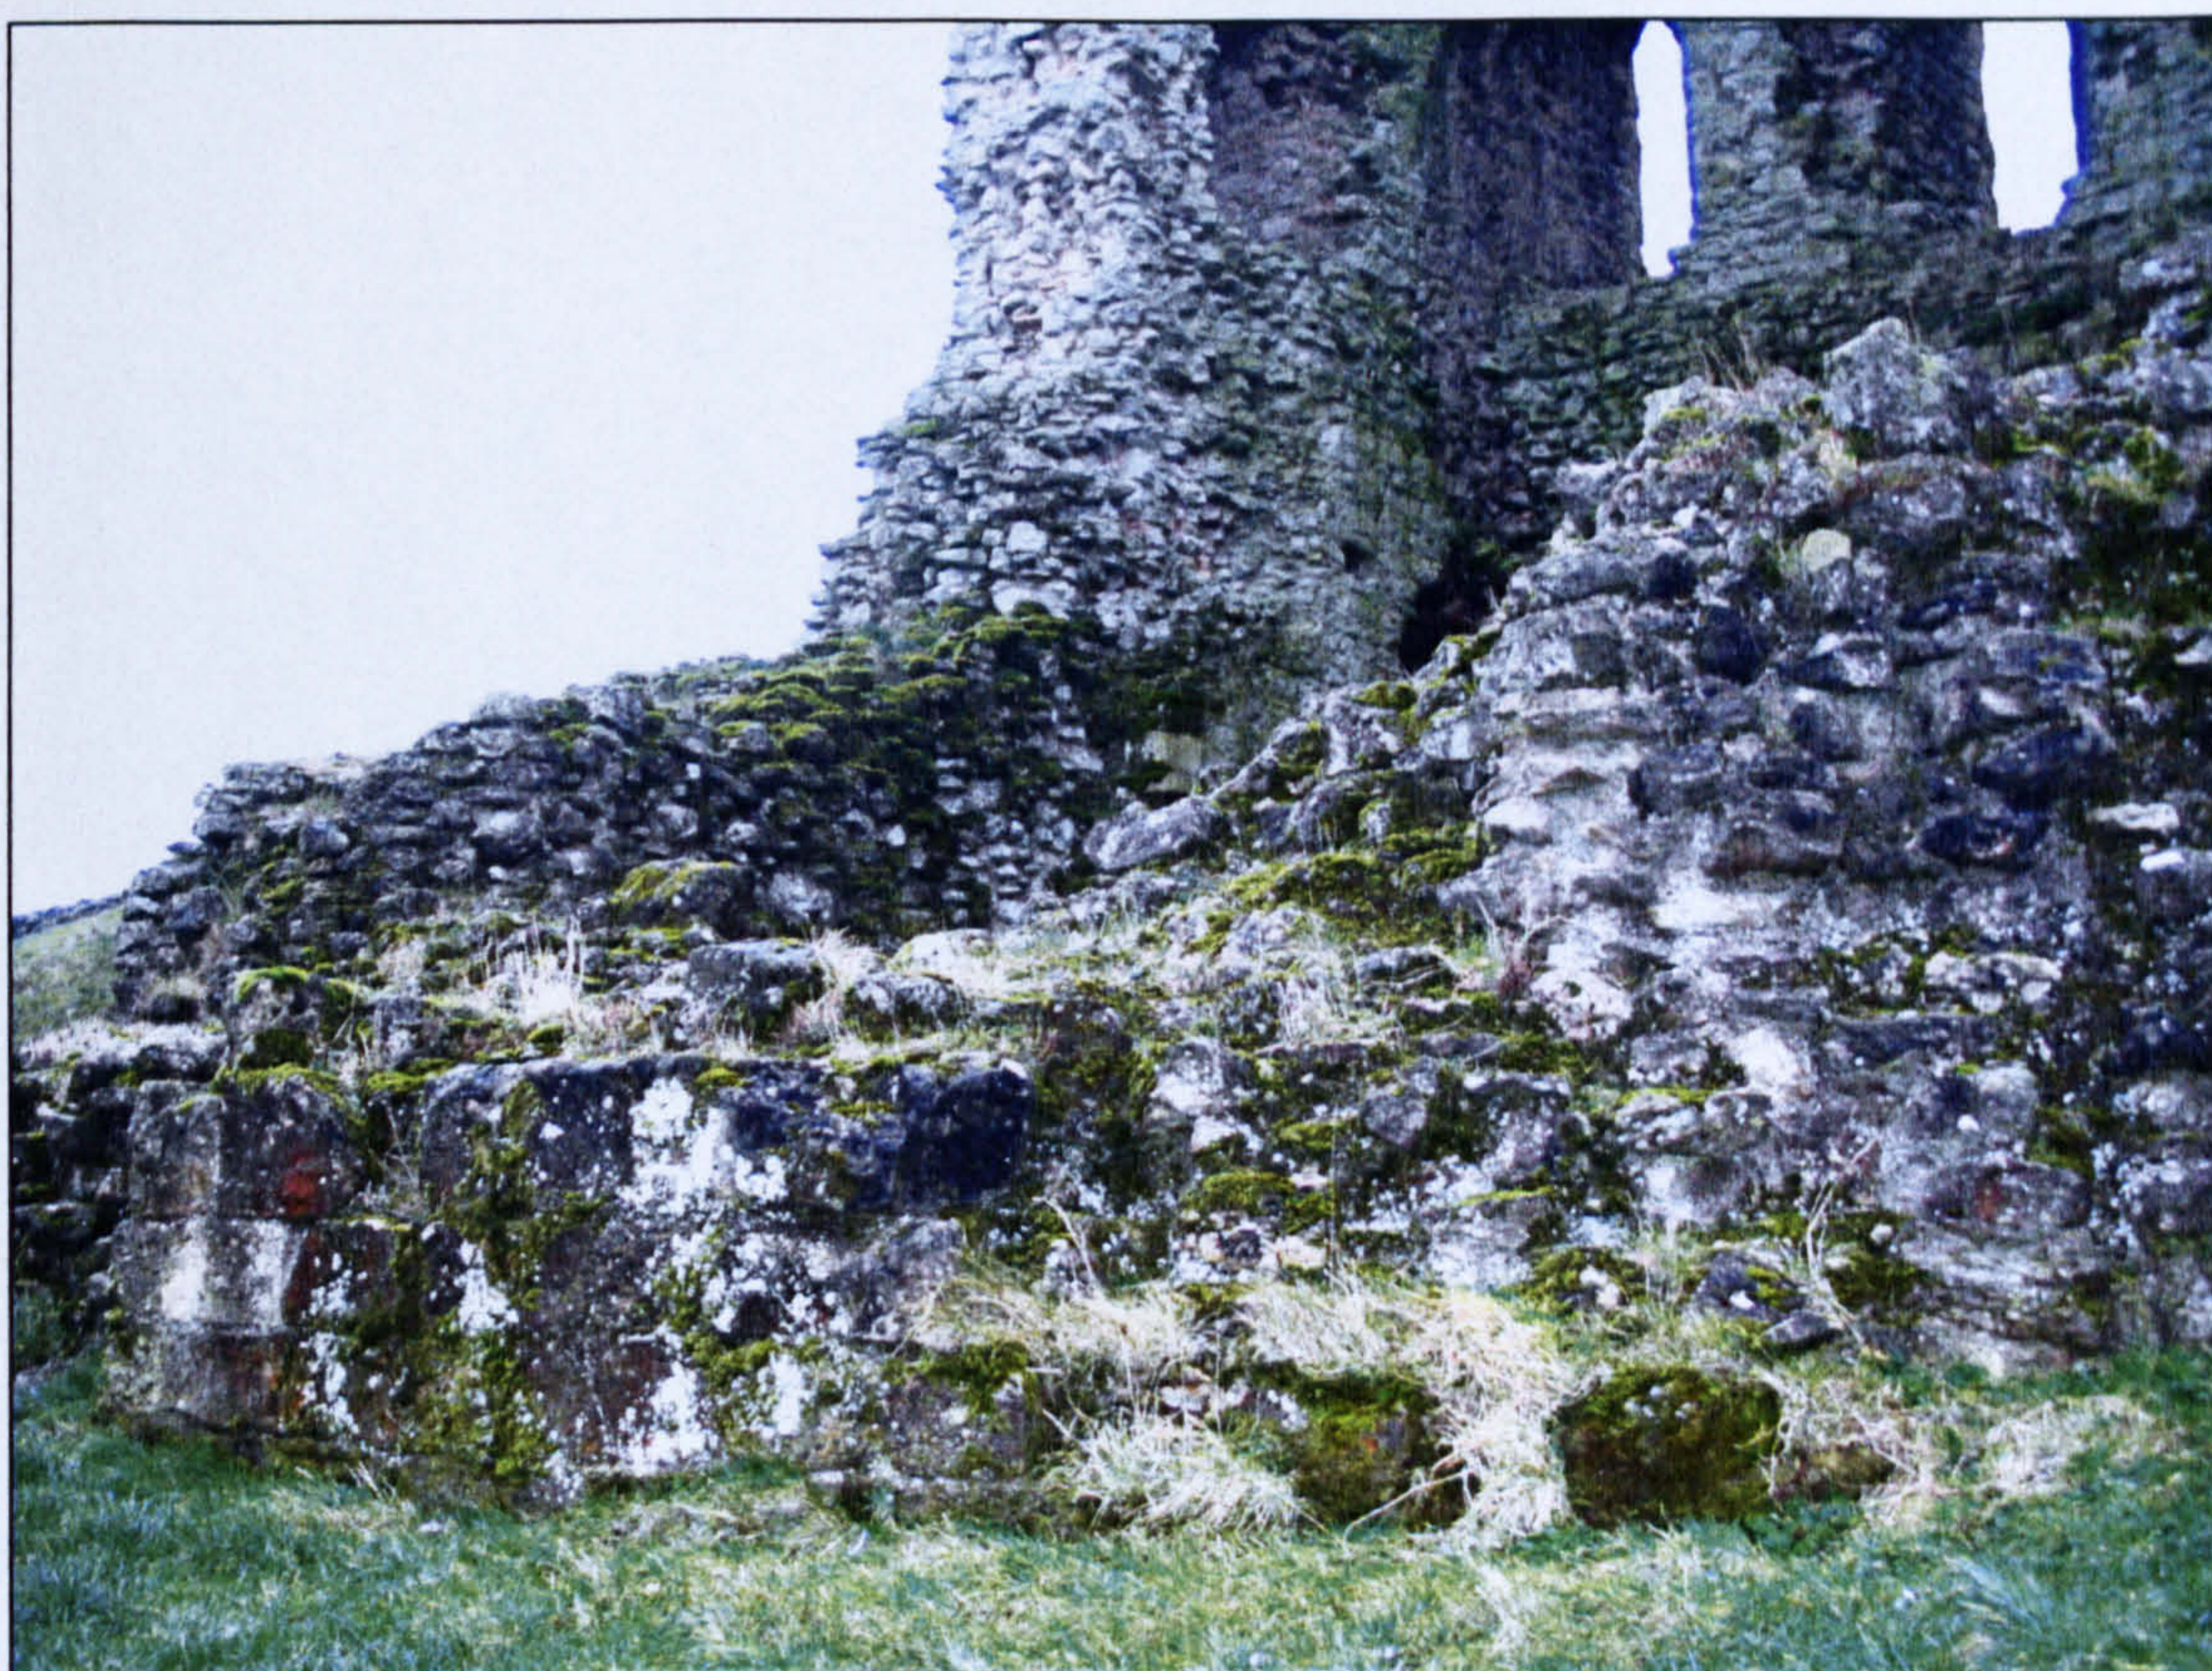
Figure 5.59 The external side of the northeast wall showing the gradations of height.

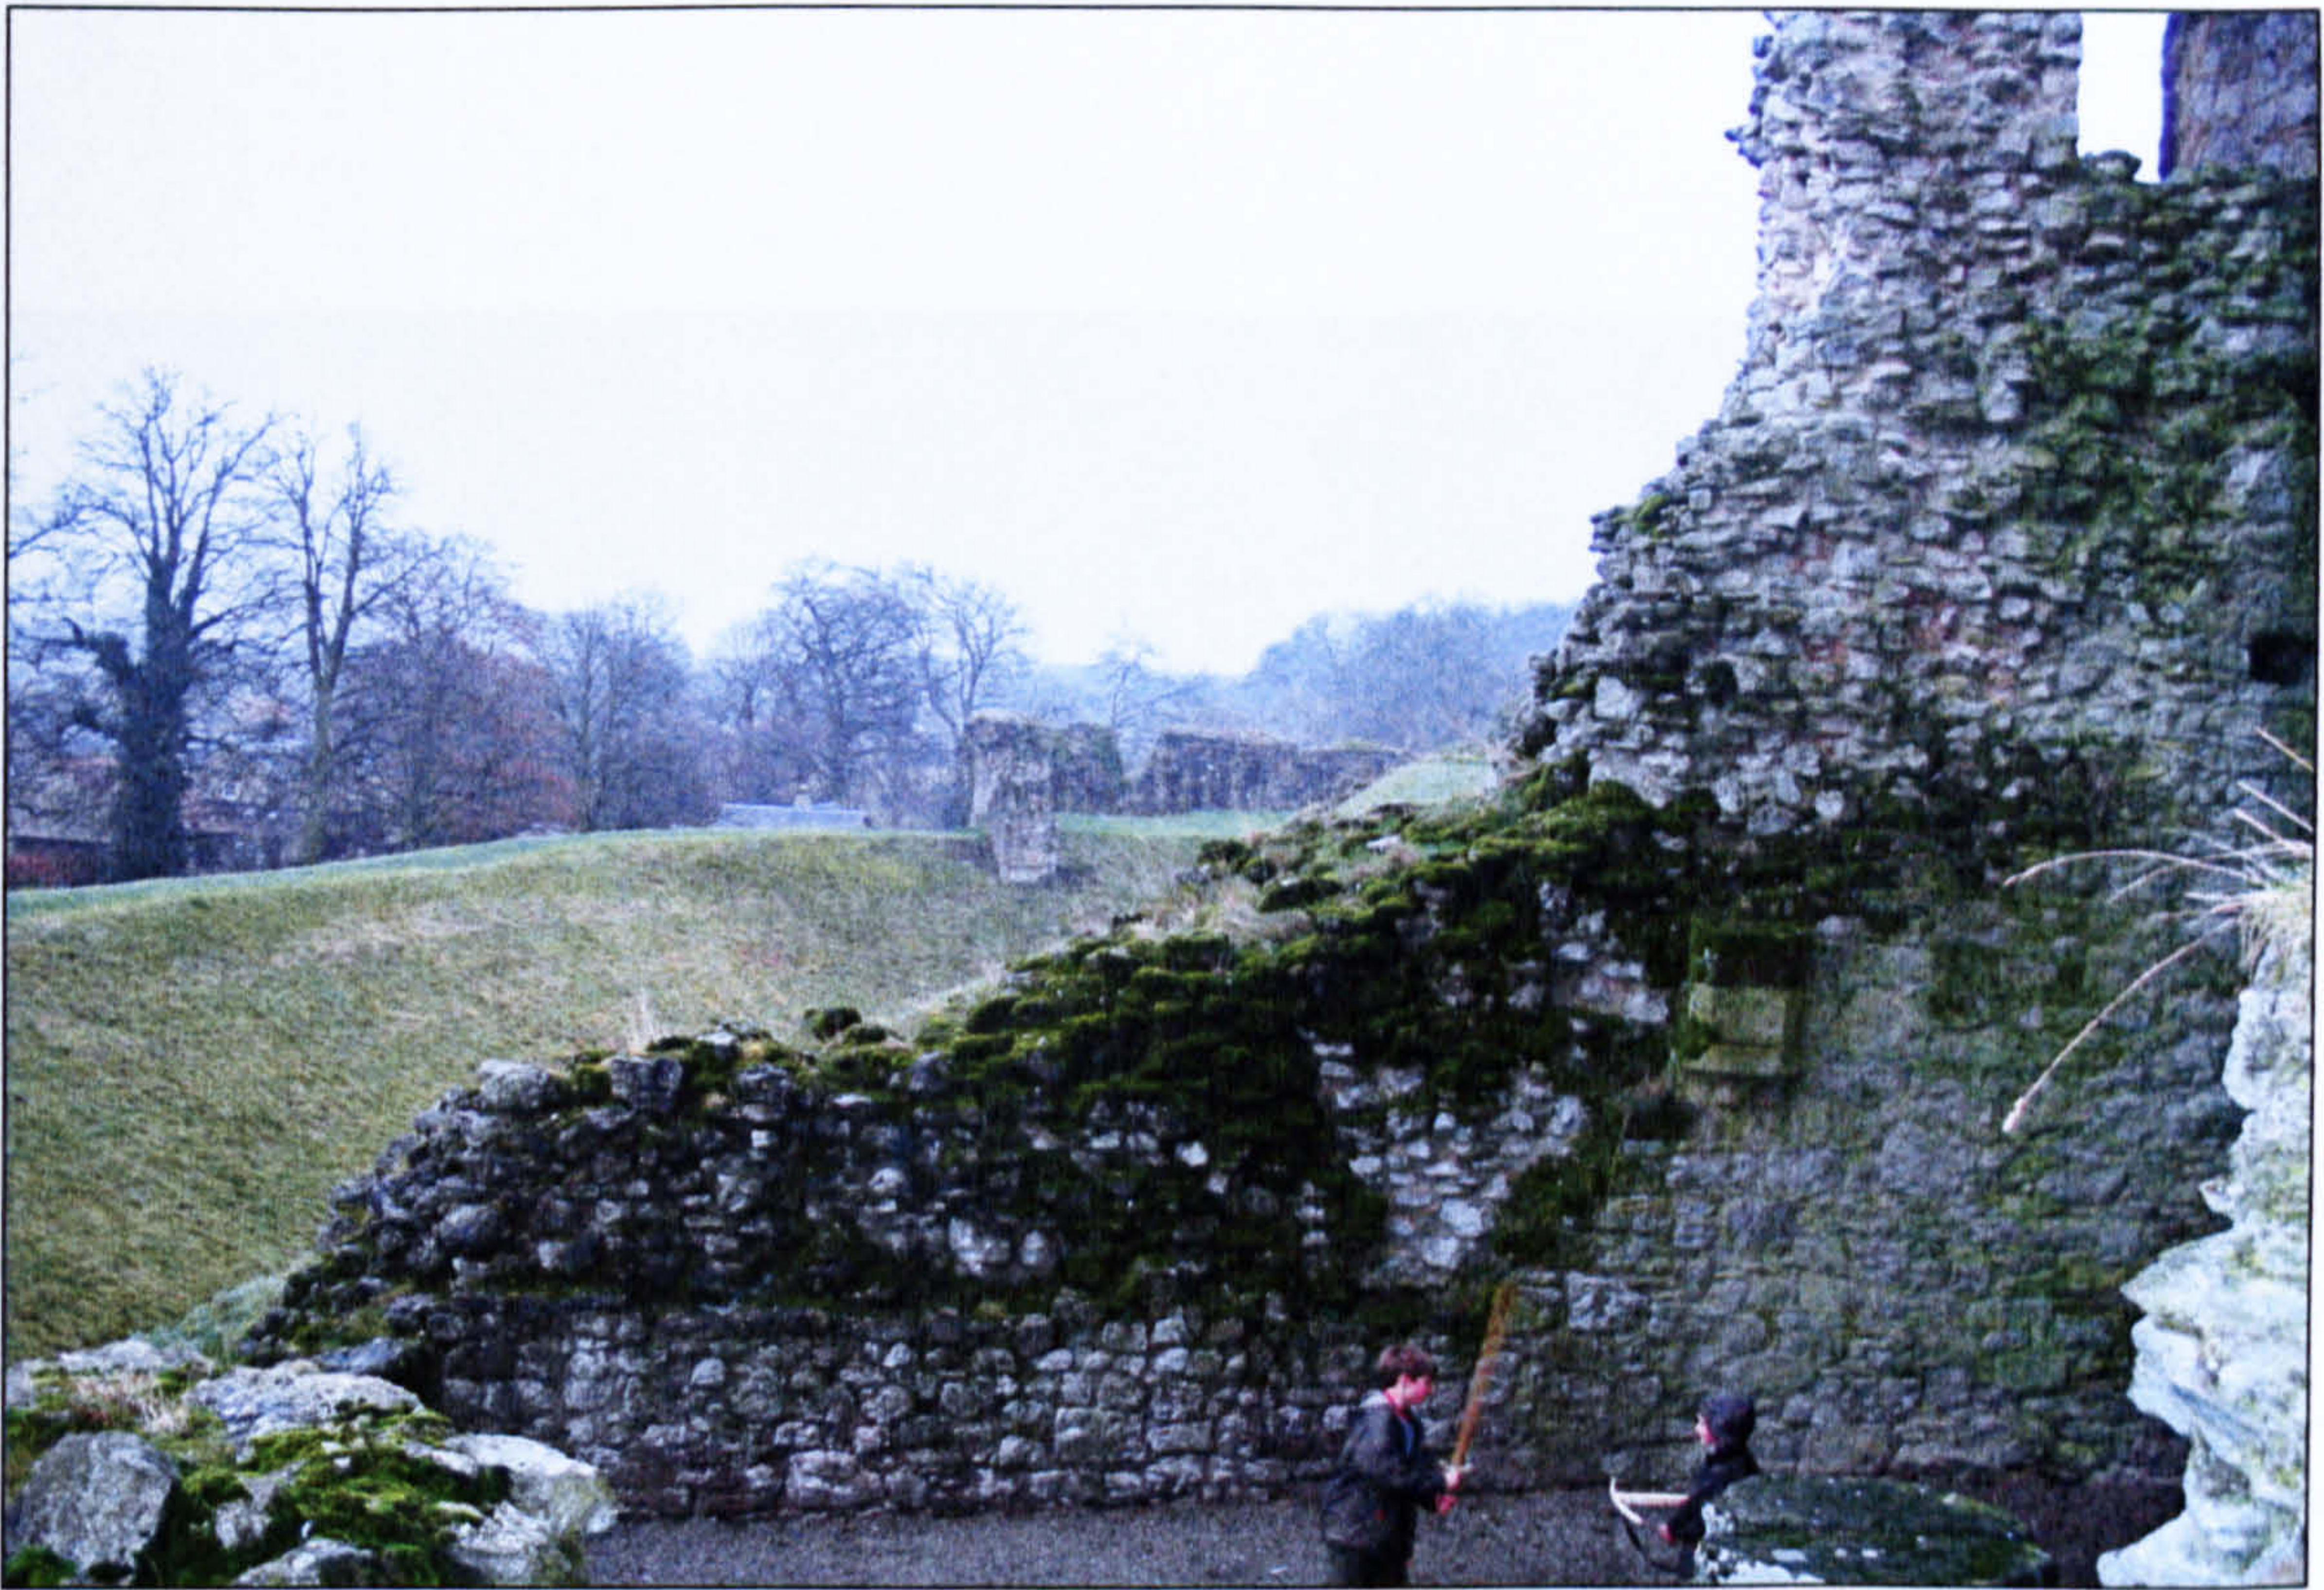
Figure 5.63 The remains of the east wall, internal elevation.

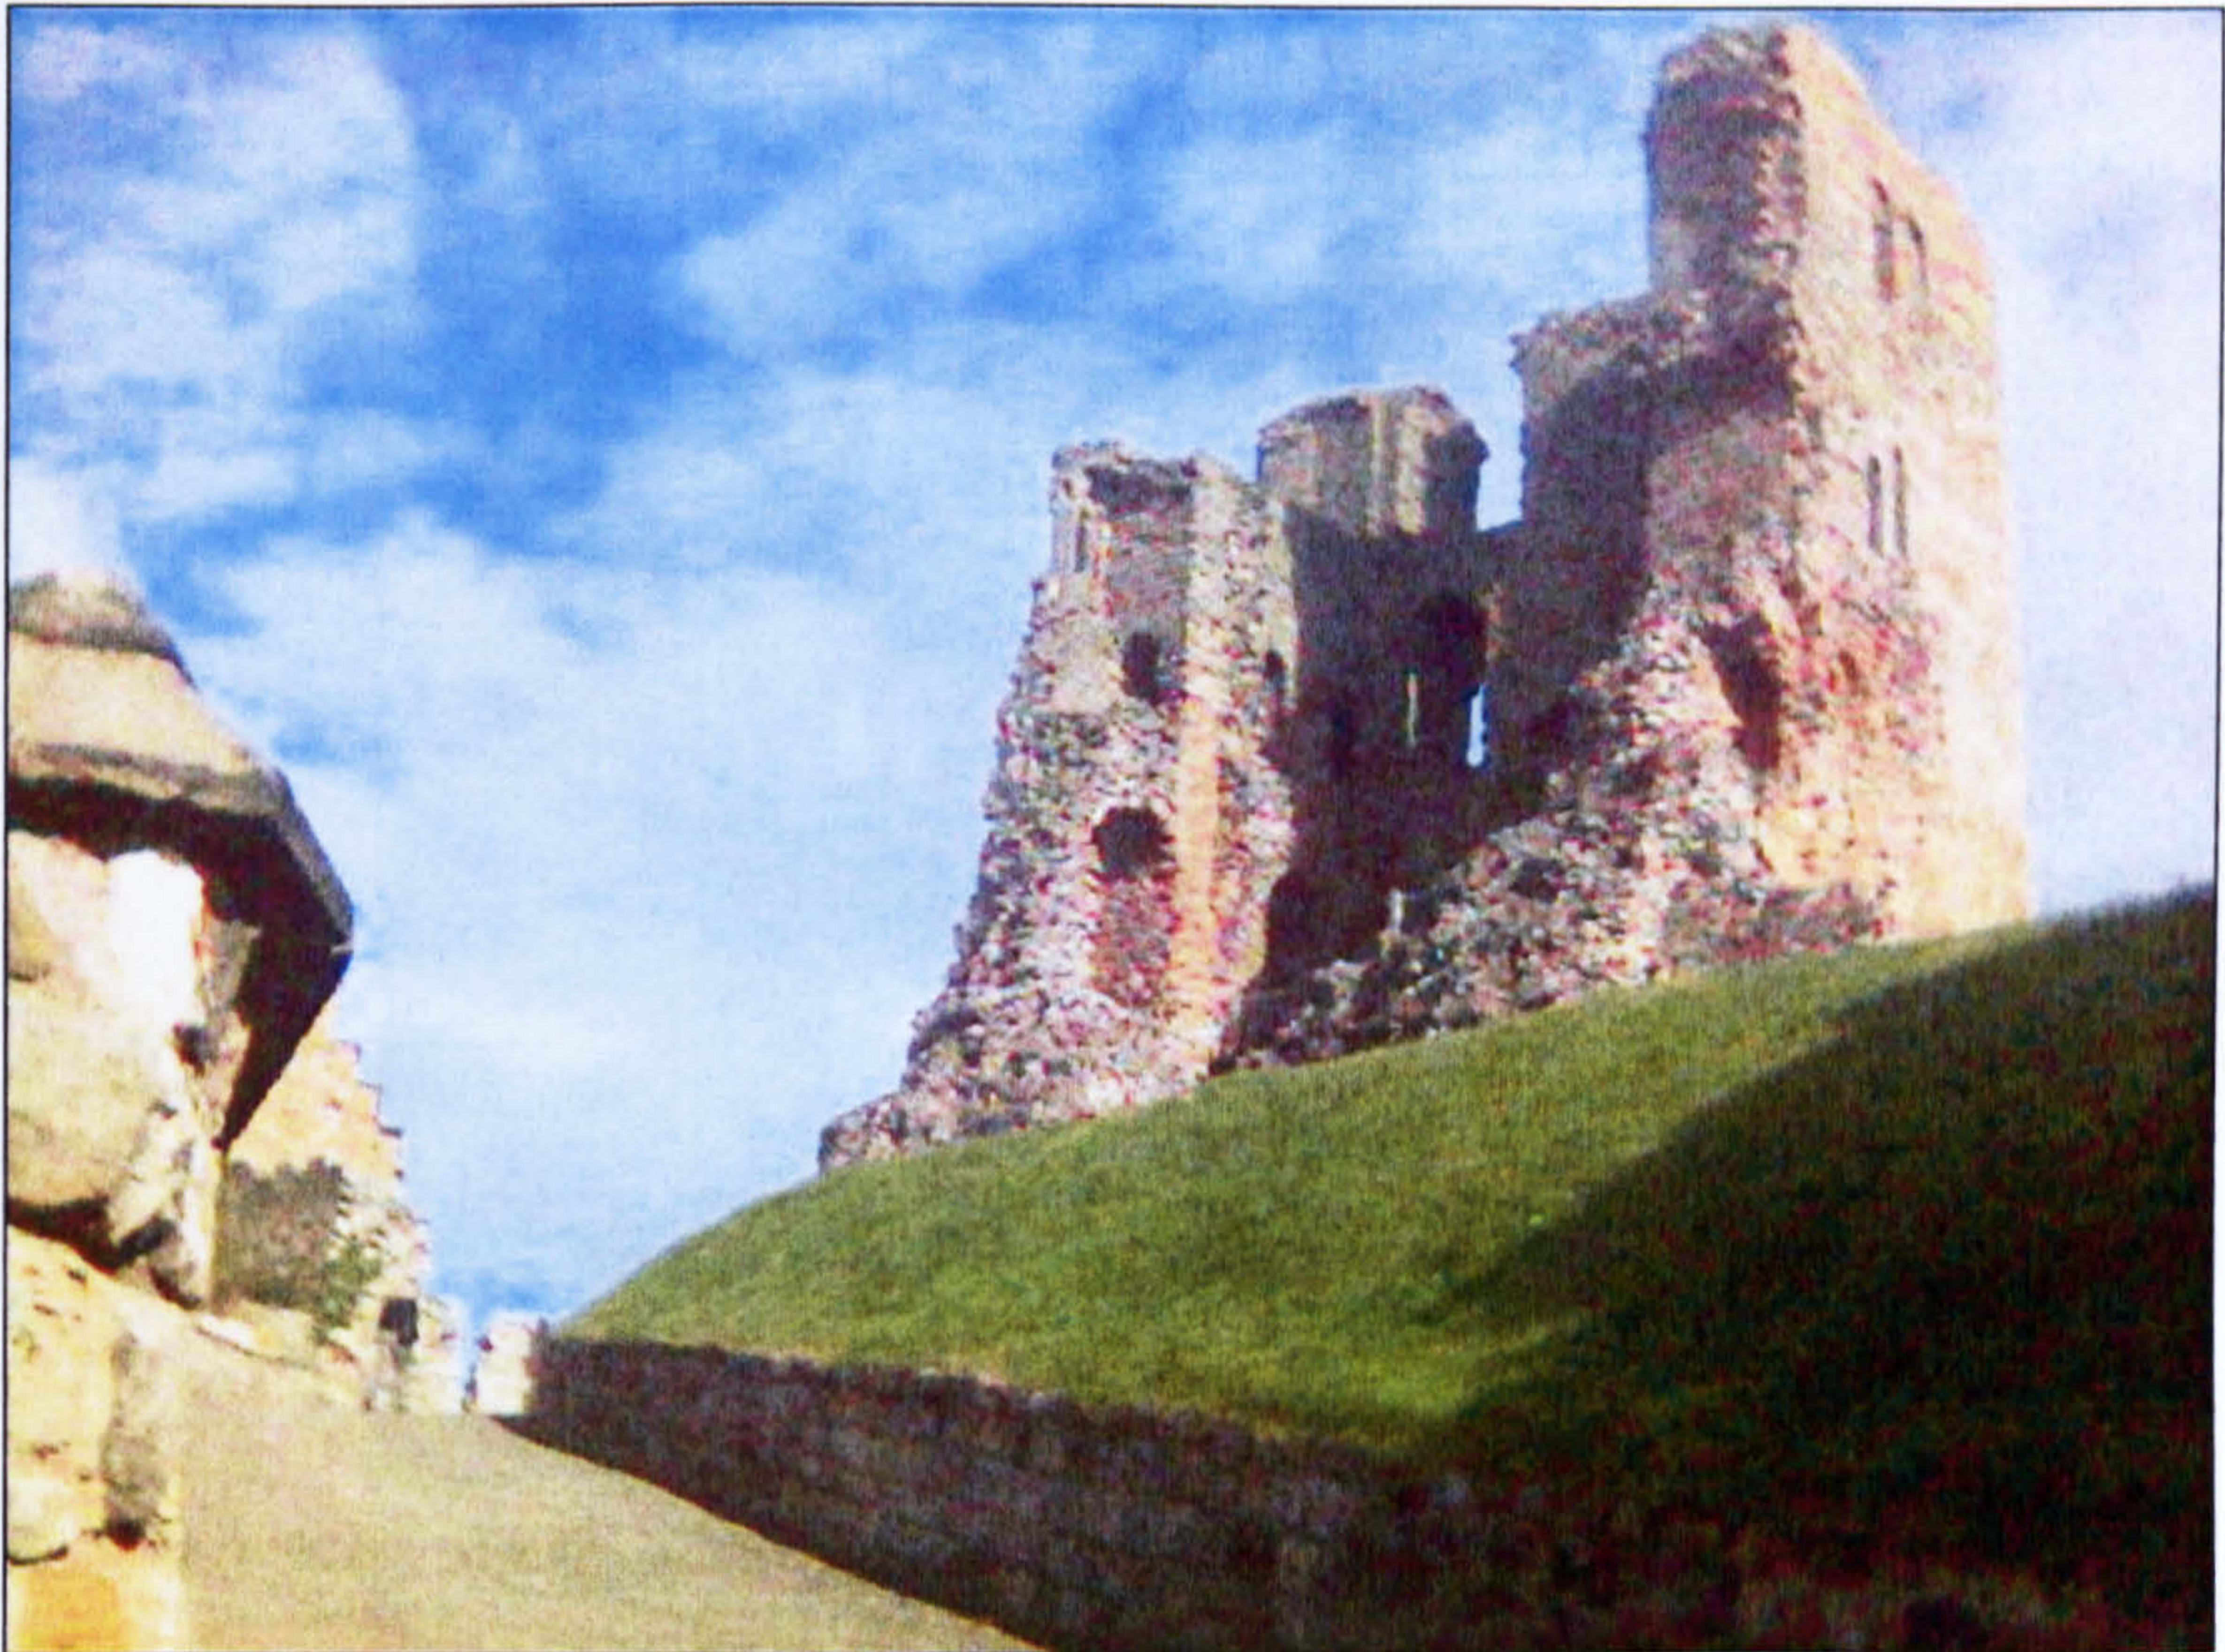
Figure 5.65 The collapsed west wall of Scarborough Castle Keep (Yorkshire), looking northeast.

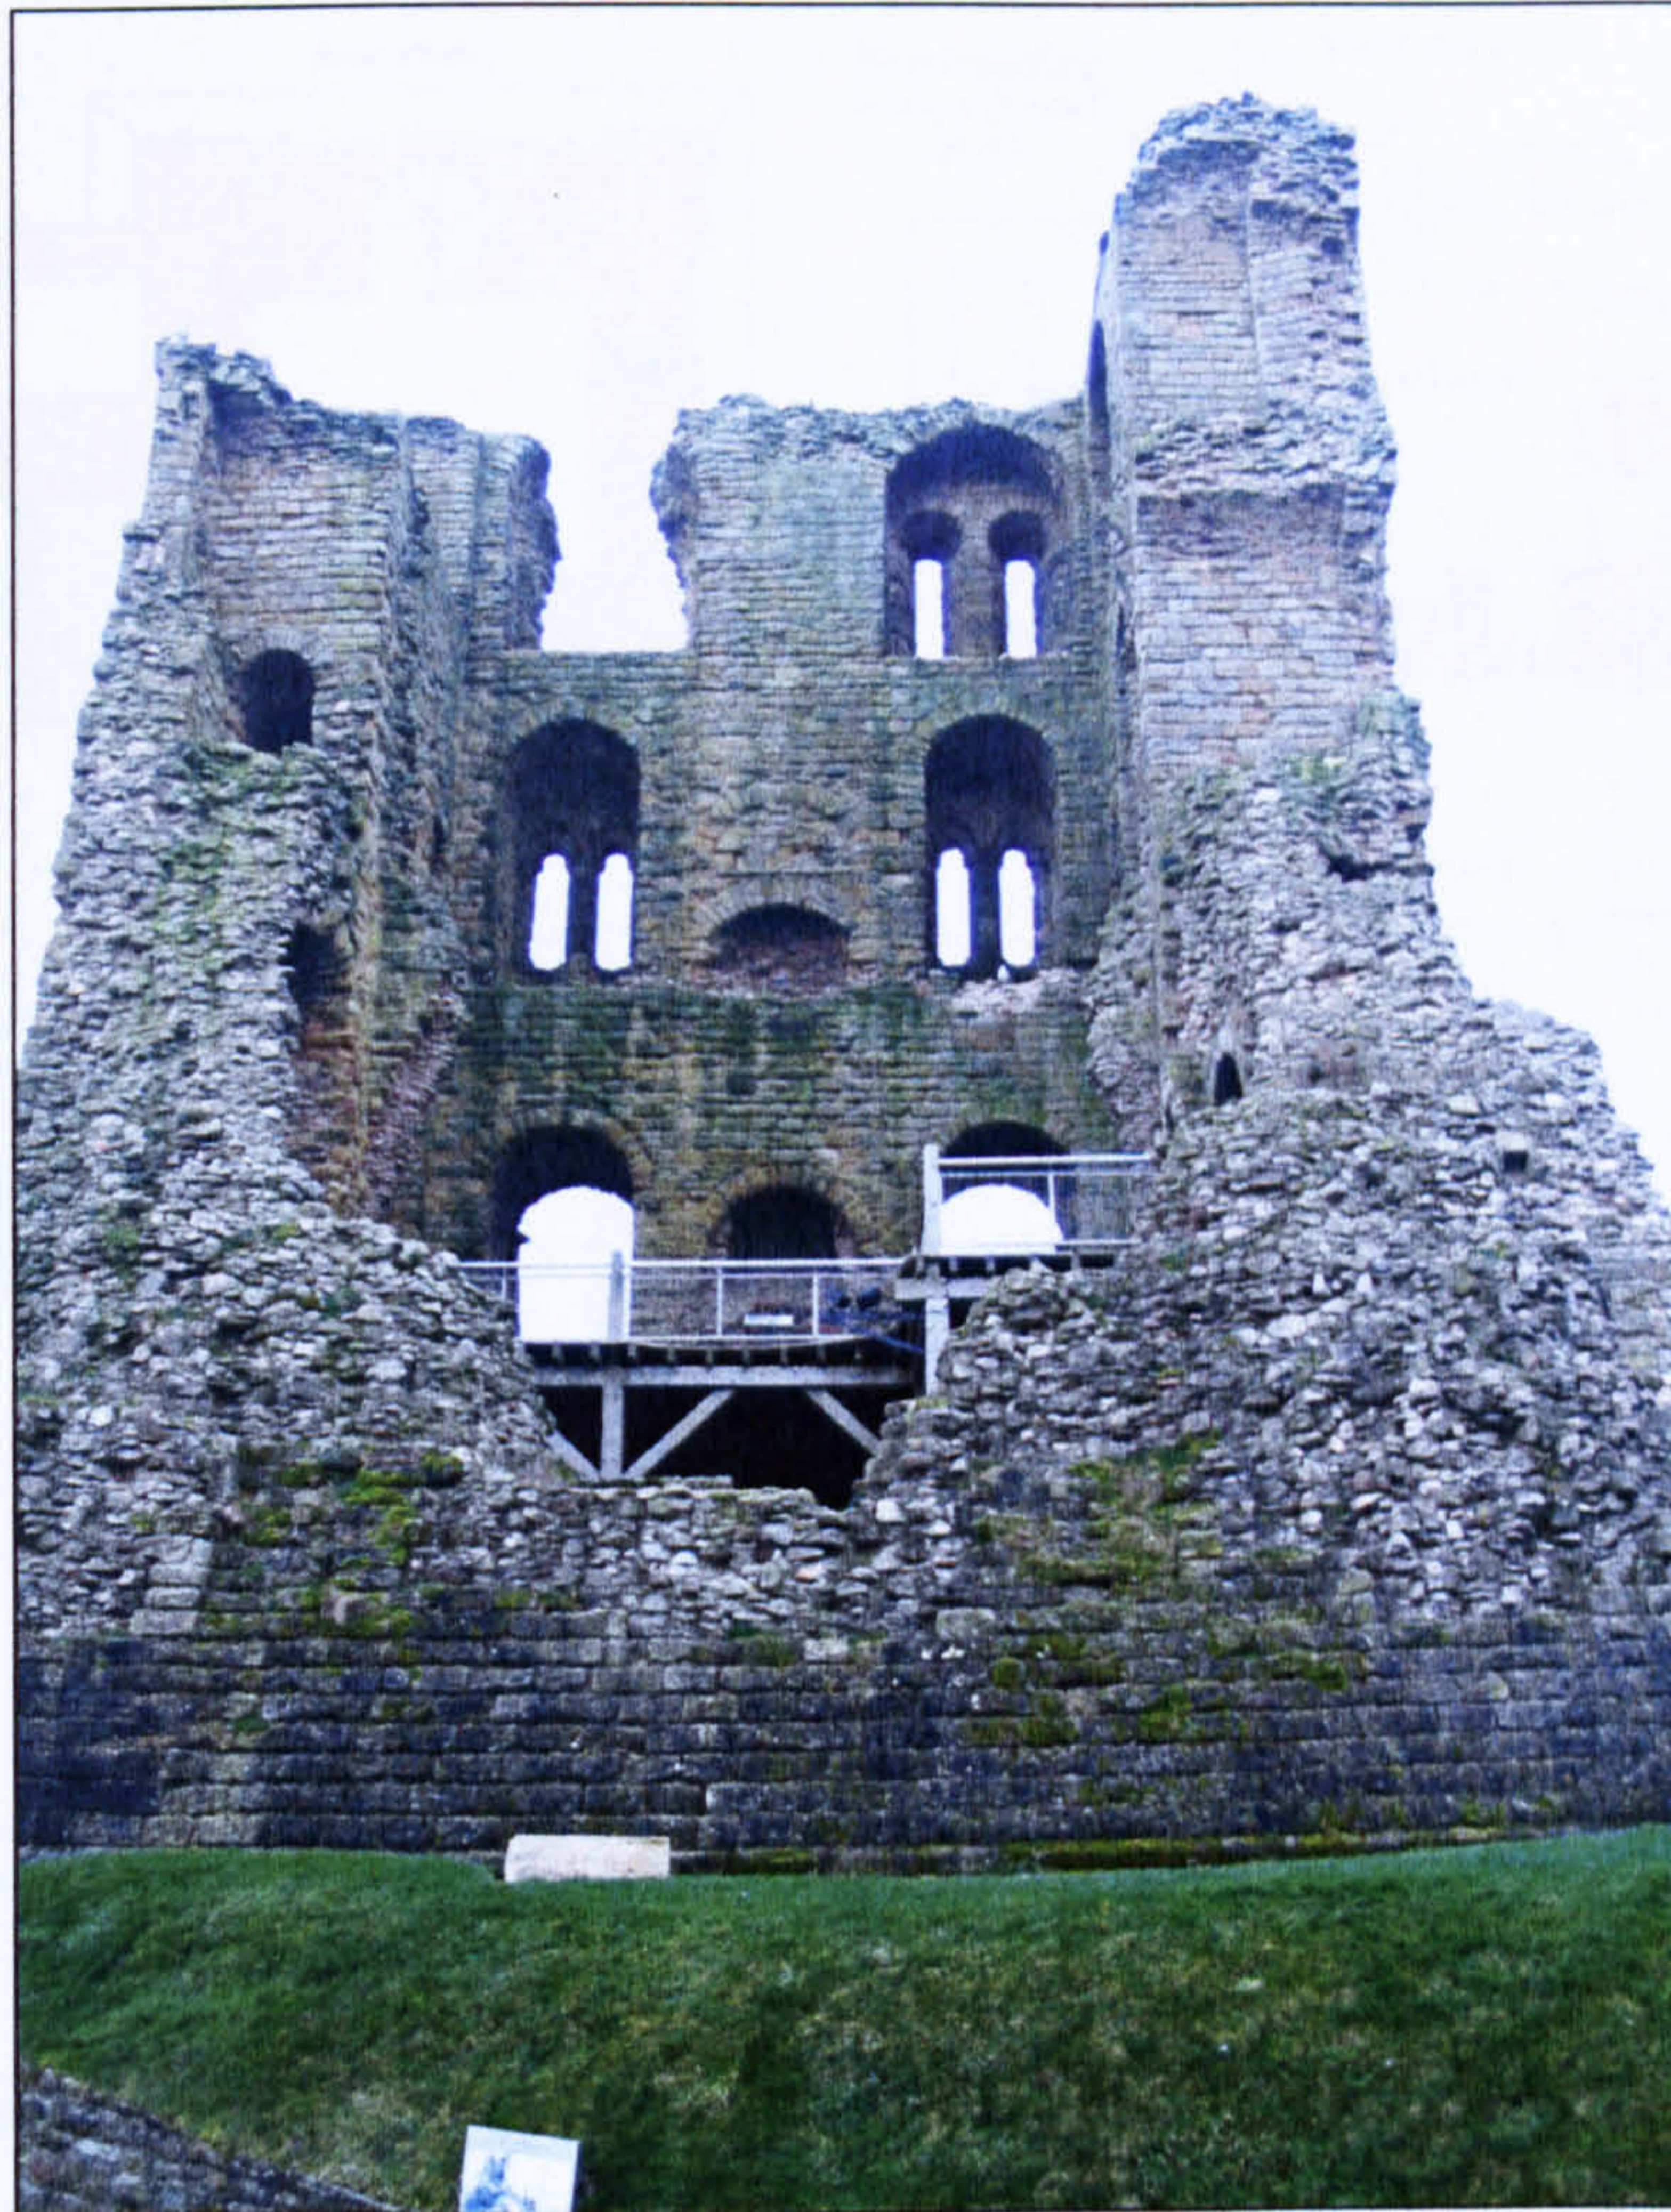
Figure 5.67 The damaged west wall of Scarborough Castle Keep, looking east.

Figure 5.67 The damaged west wall of Scarborough Castle Keep (Yorkshire), looking east.

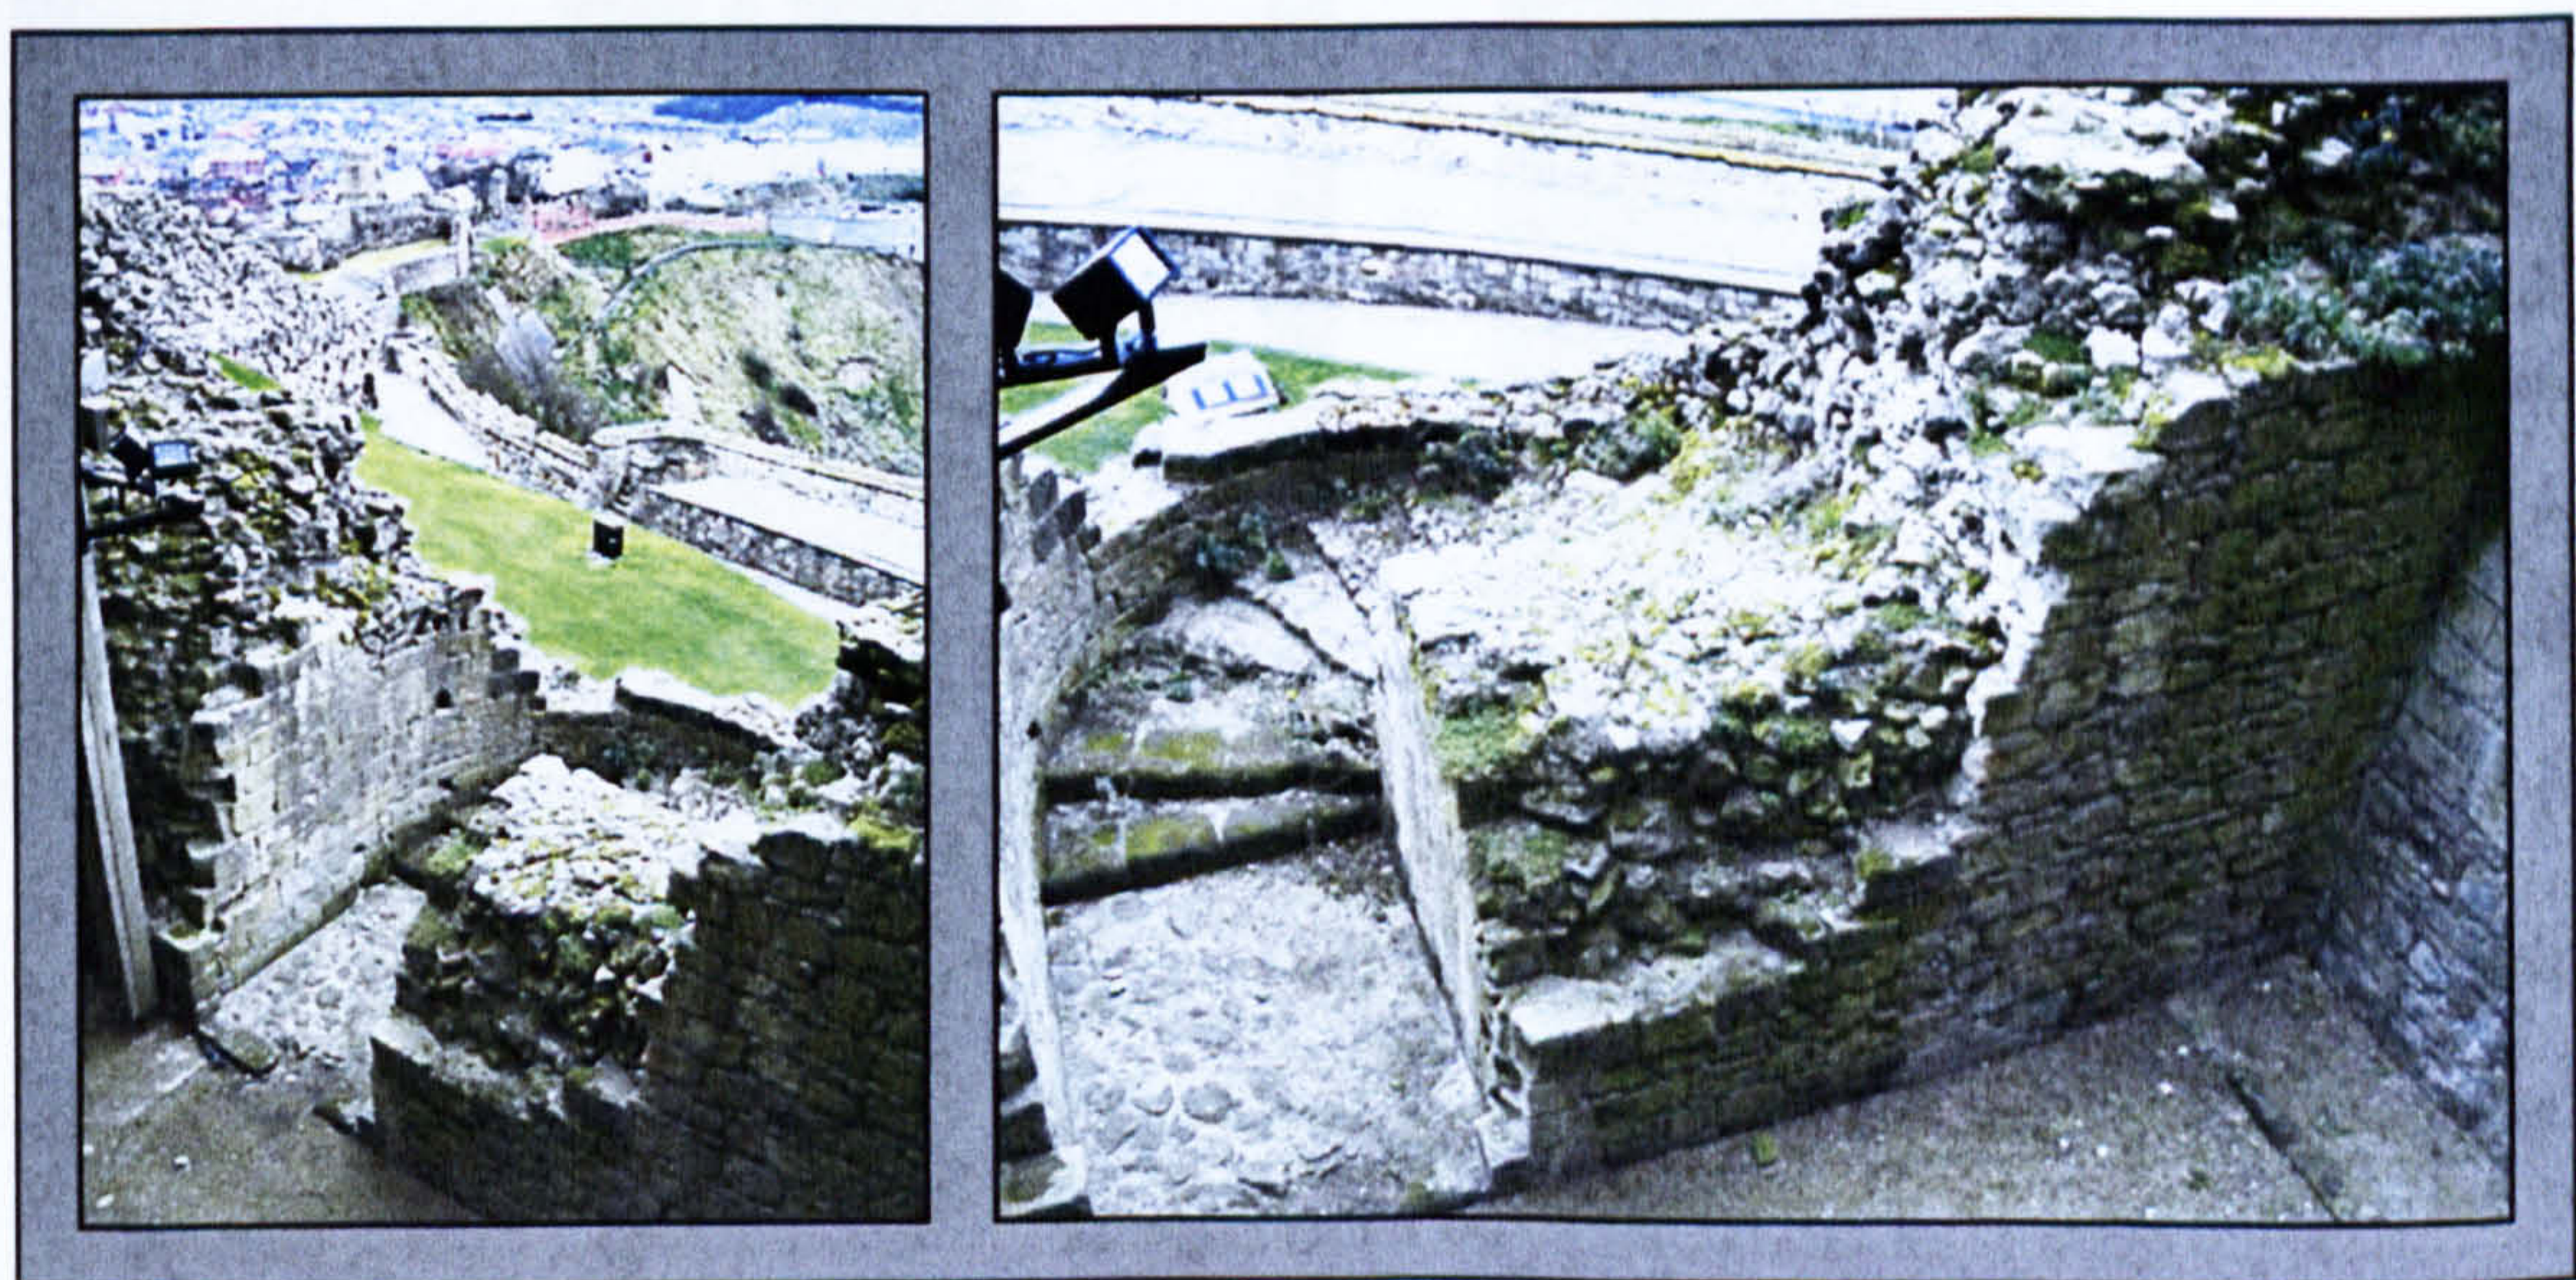
Figure 5.68 *Left*: Stairwell at Scarborough Castle Keep, looking southwest. *Right*: Scarborough Castle Keep looking northwest.

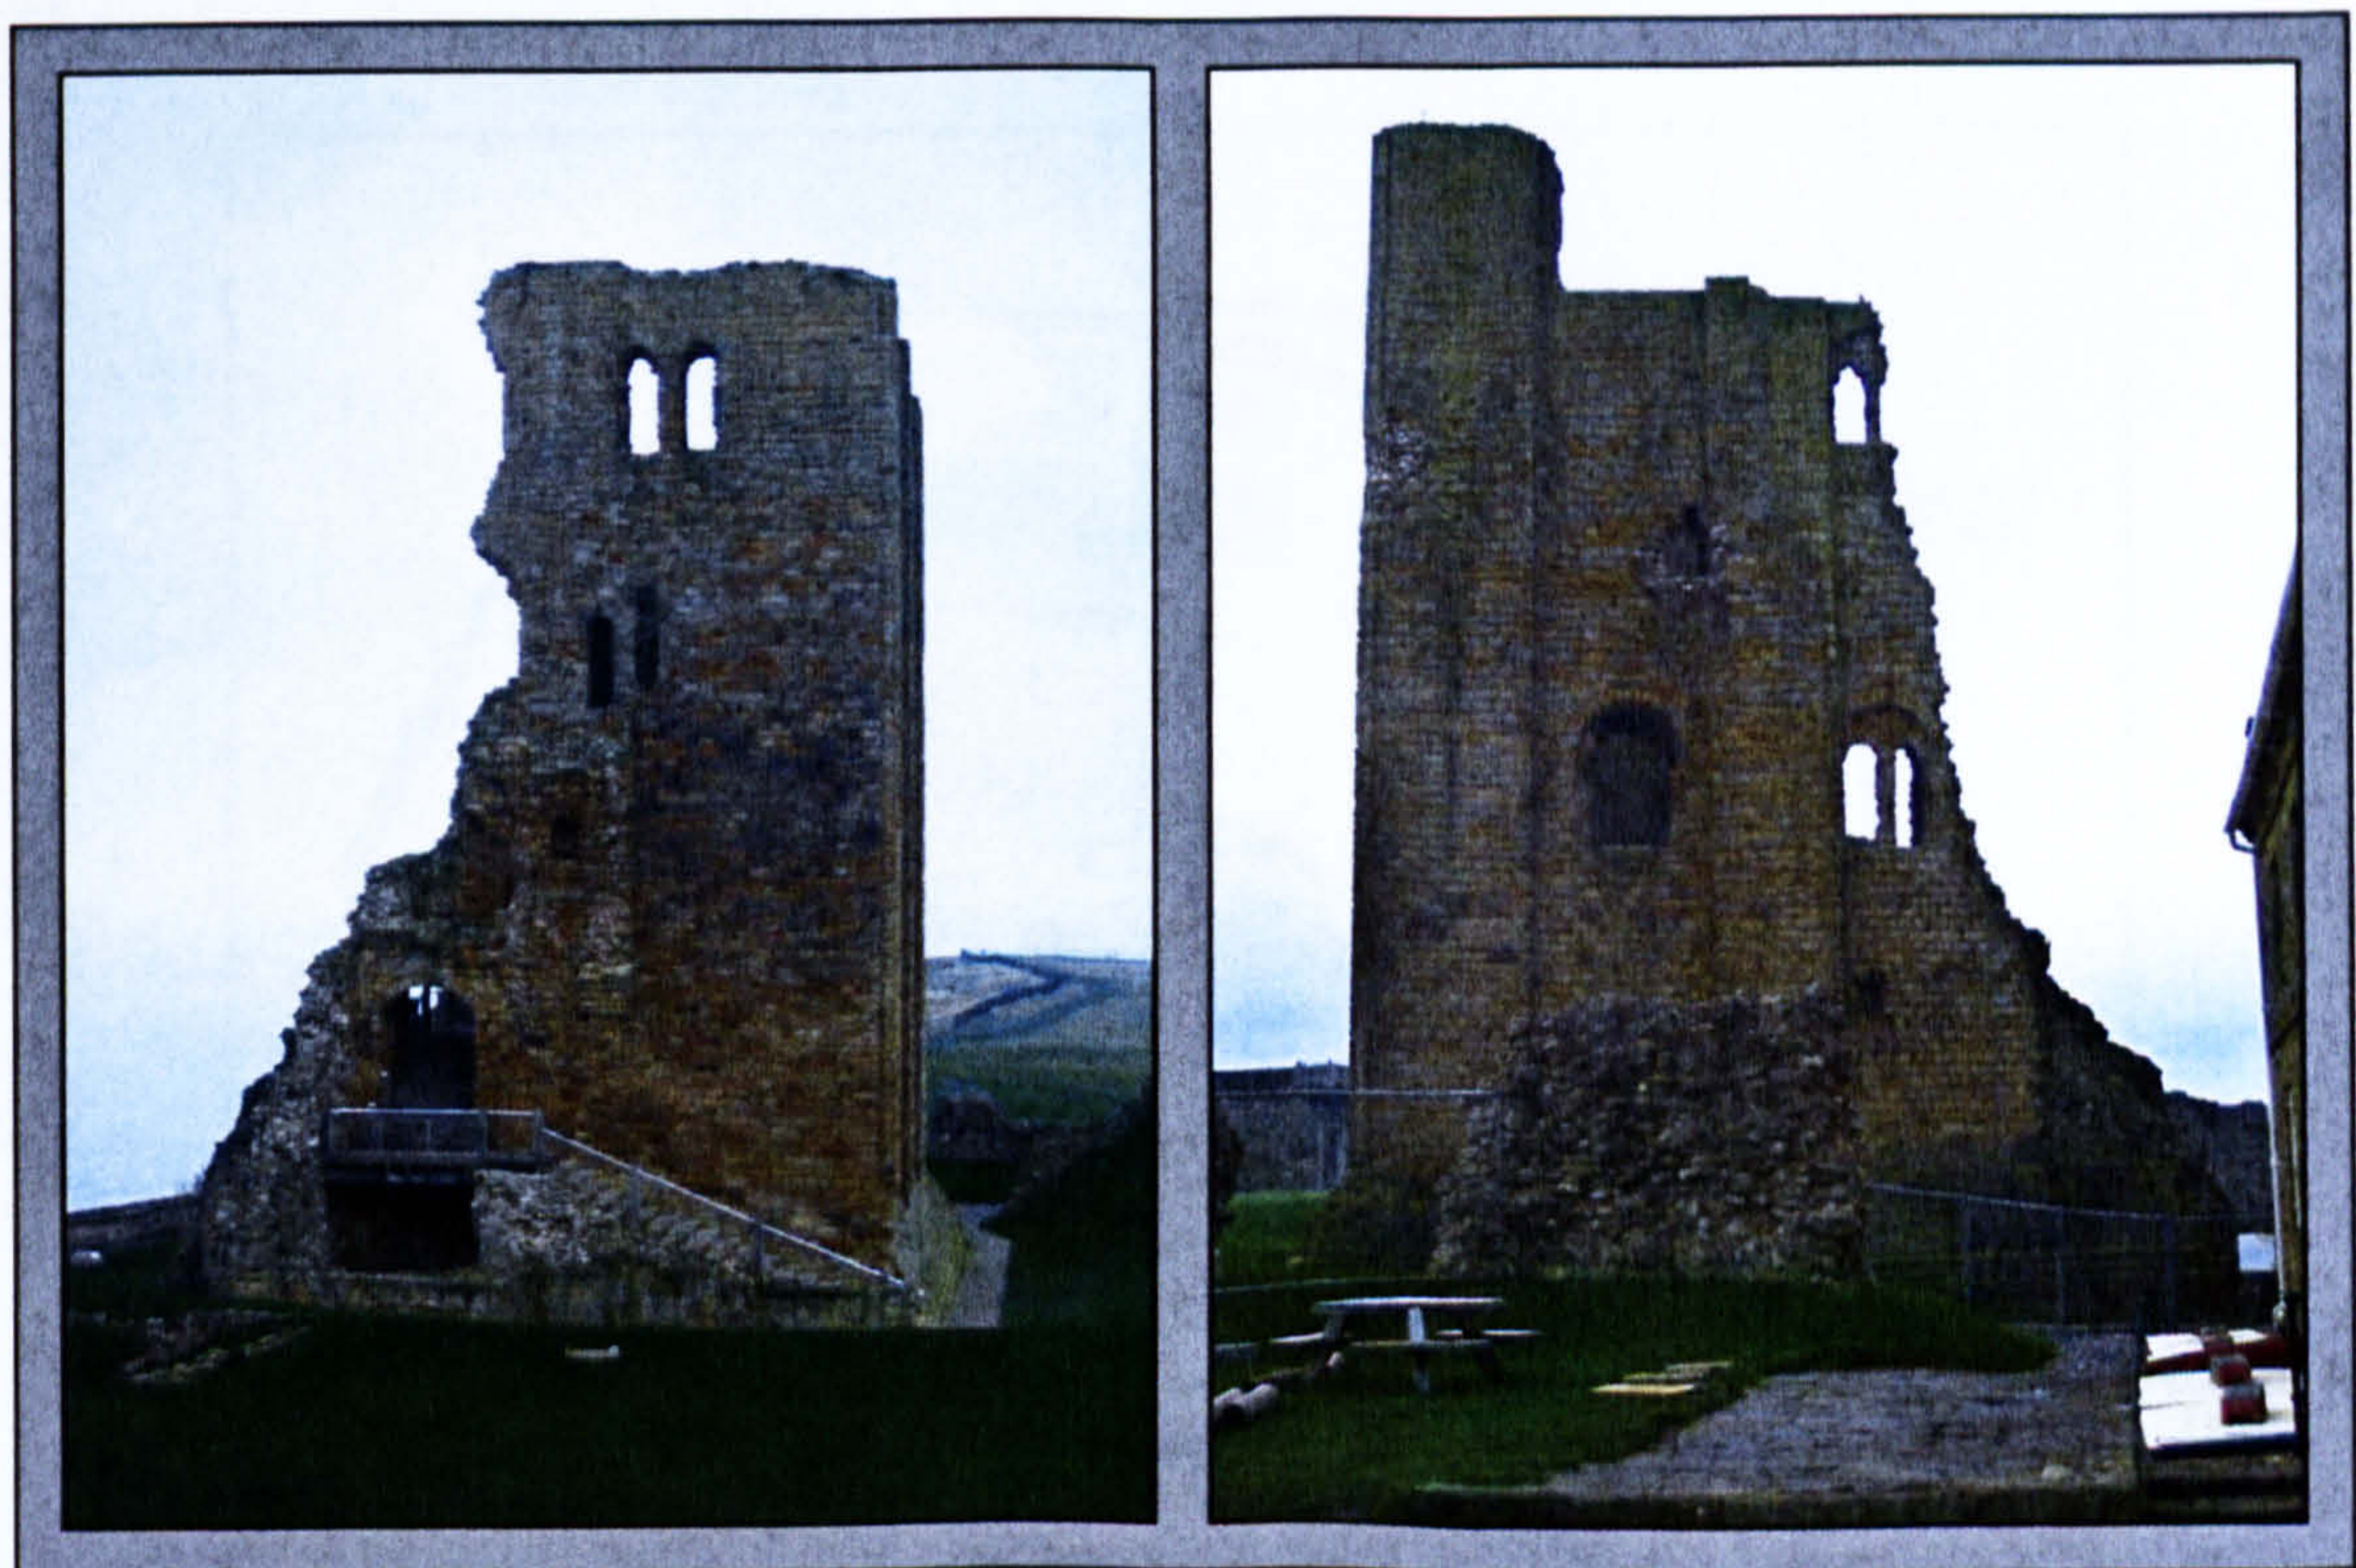
Figure 5.70 Profile views of Scarborough Castle Keep showing the destruction pattern of the remaining fabric. *Left*: Looking north. *Right*: Looking south.
