ARCHAEOLOGY OF DESTRUCTION

A REINTERPRETATION OF CASTLE SLIGHTINGS IN THE ENGLISH CIVIL WAR

Thesis submitted for the degree of
Doctor of Philosophy
University of York
Department of Archaeology

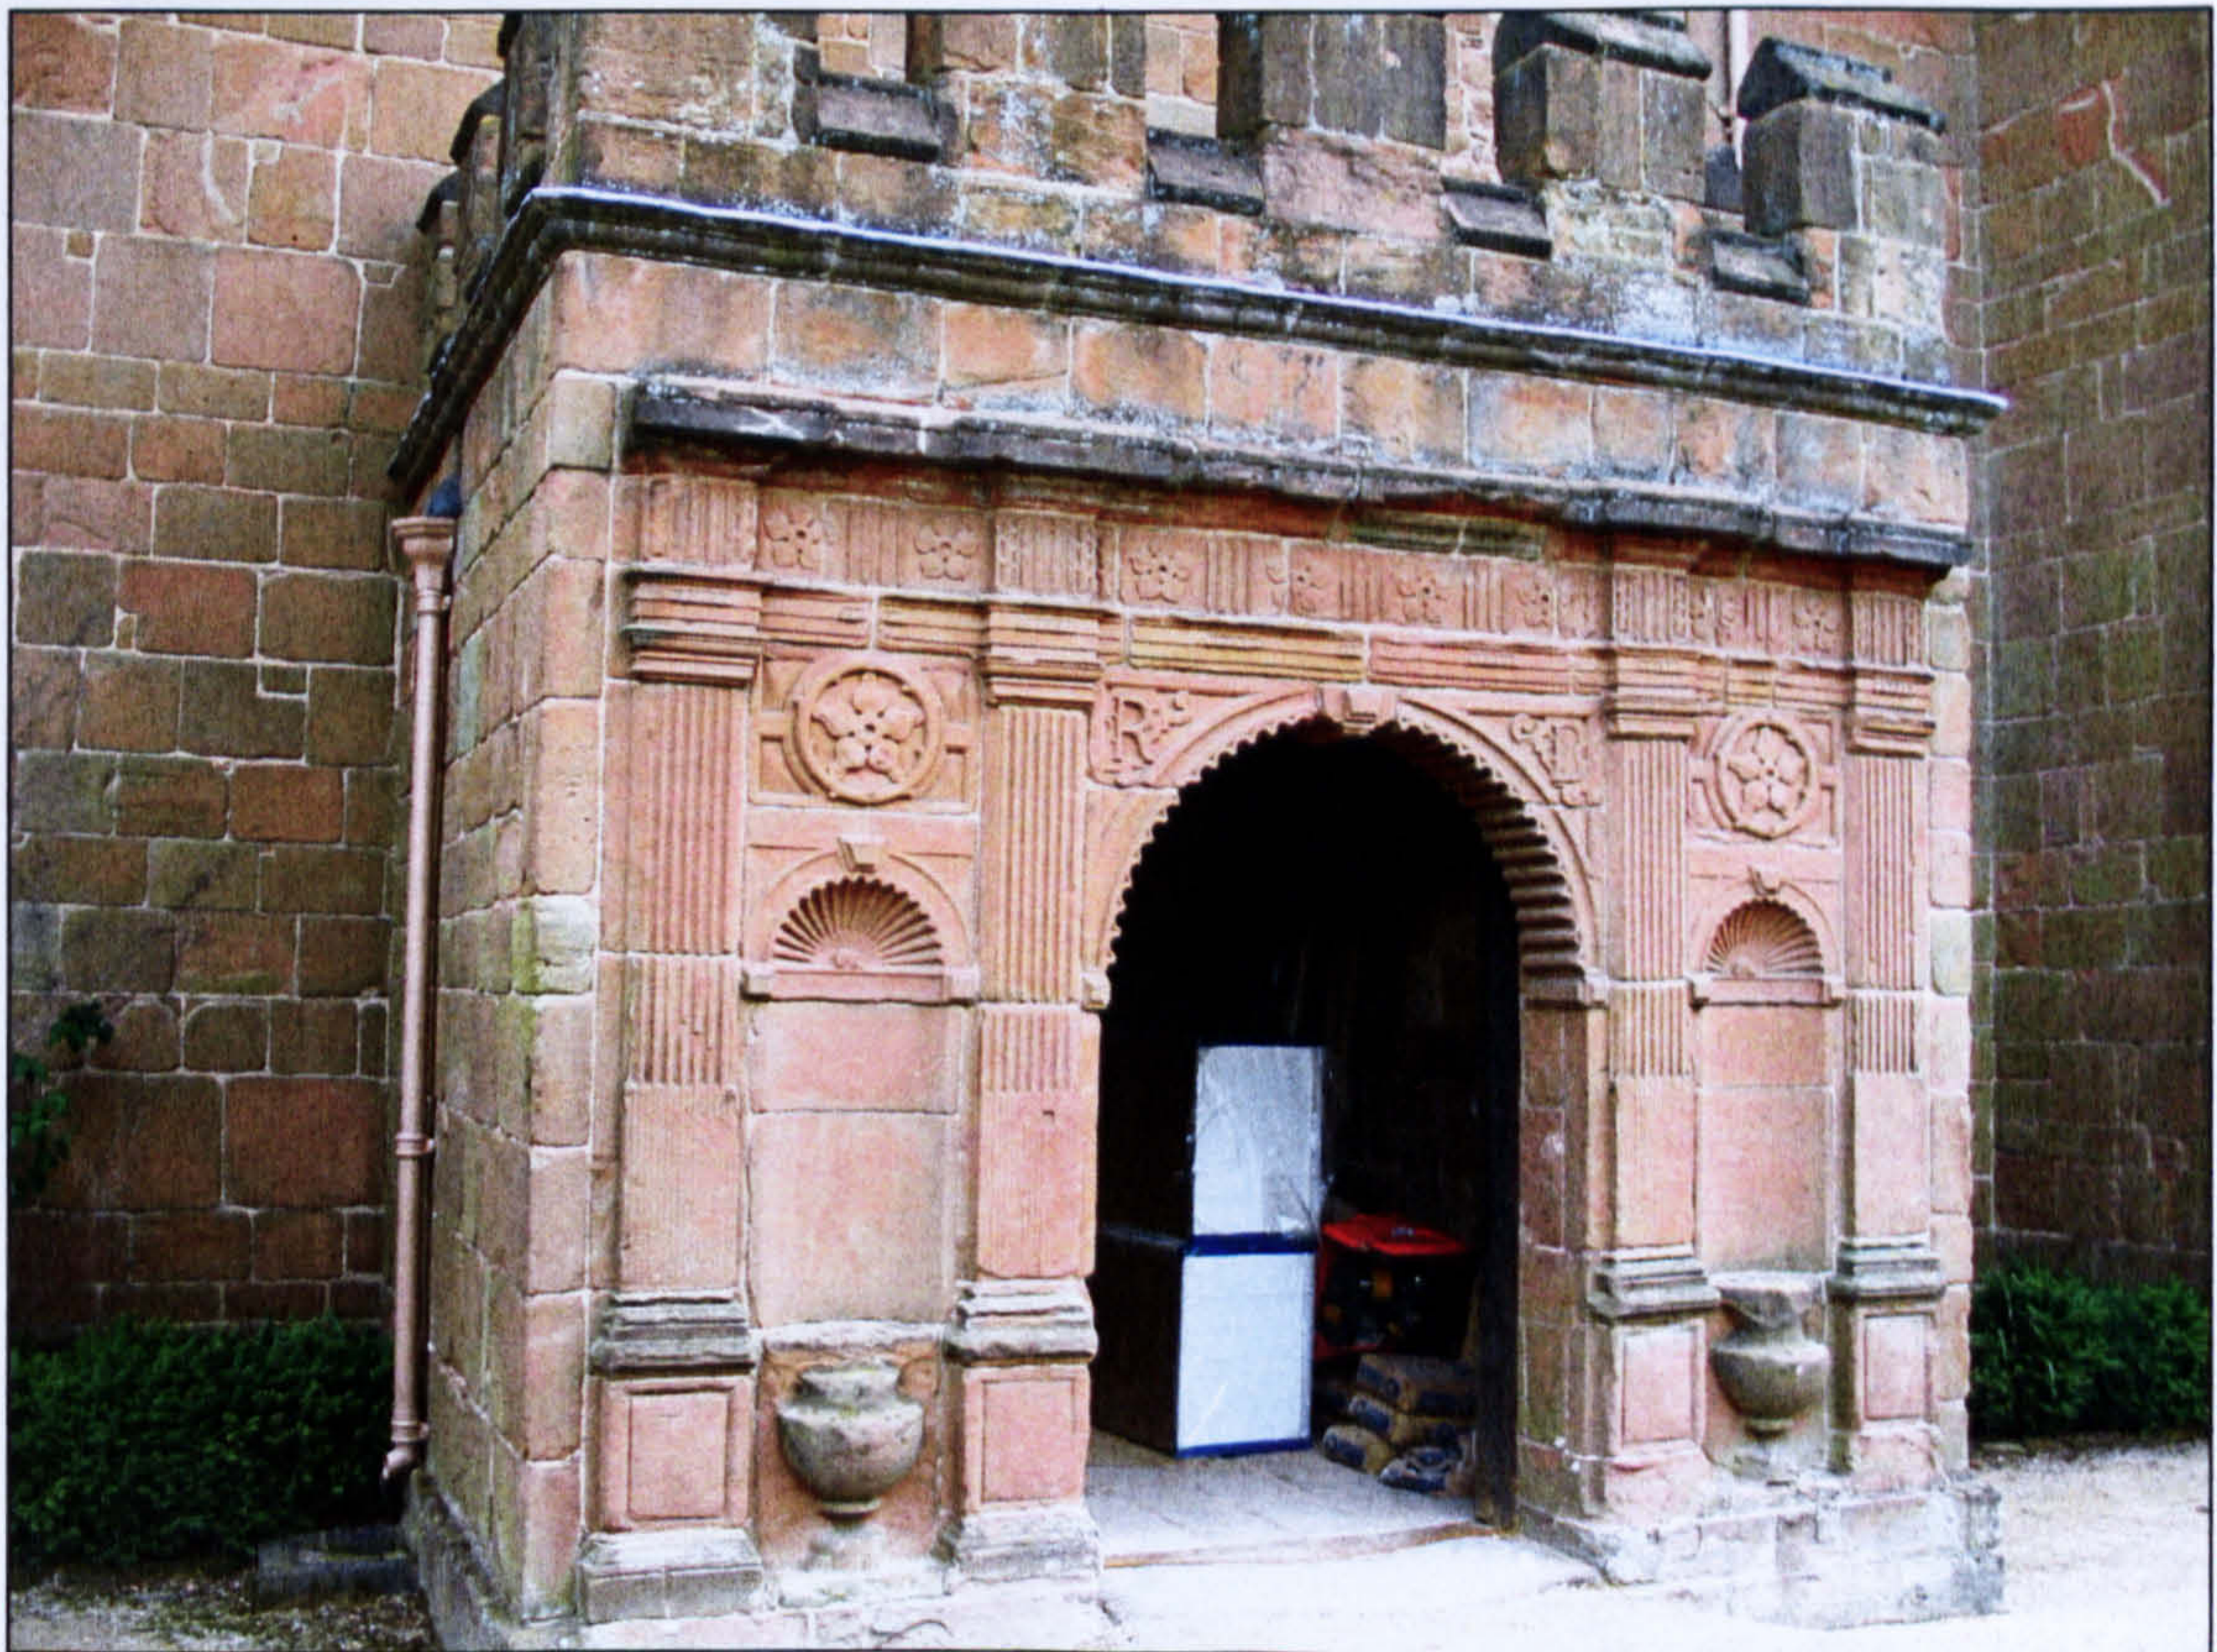
Figure 6.12 Close-up of the classical frontispiece of Leicester's porch. Carved into the stone are Leicester's initials and variations of his family badges.

Hawkesworth's subtle architectural messages changed, however, the closer the visitor got to the entrance of the porch. This was achieved through the removal of a classical frontispiece from John of Gaunt's Hall (Renn 1991, 12) and the repositioning of it within the west porch (Figure 6.12). This frontispiece had been constructed in the sixteenth century by the Earl of Leicester, and bore his initials and several Tudor Rose roundels. Leicester was particularly fond of promoting his lineage and family name through possessions and architecture (Morris 2006, 46-7), and *his* placement of the frontispiece in the medieval Great Hall could arguably be interpreted as an attempt to establish a link with Kenilworth's medieval and Royal past. Hawkesworth's subsequent repositioning of it as the main showpiece of the entrance to his home is equally illustrative of his aspirations. In particular, it established *his* link to the man whose 'castle' he now lived in by appropriating a lineage and past that was not his own.

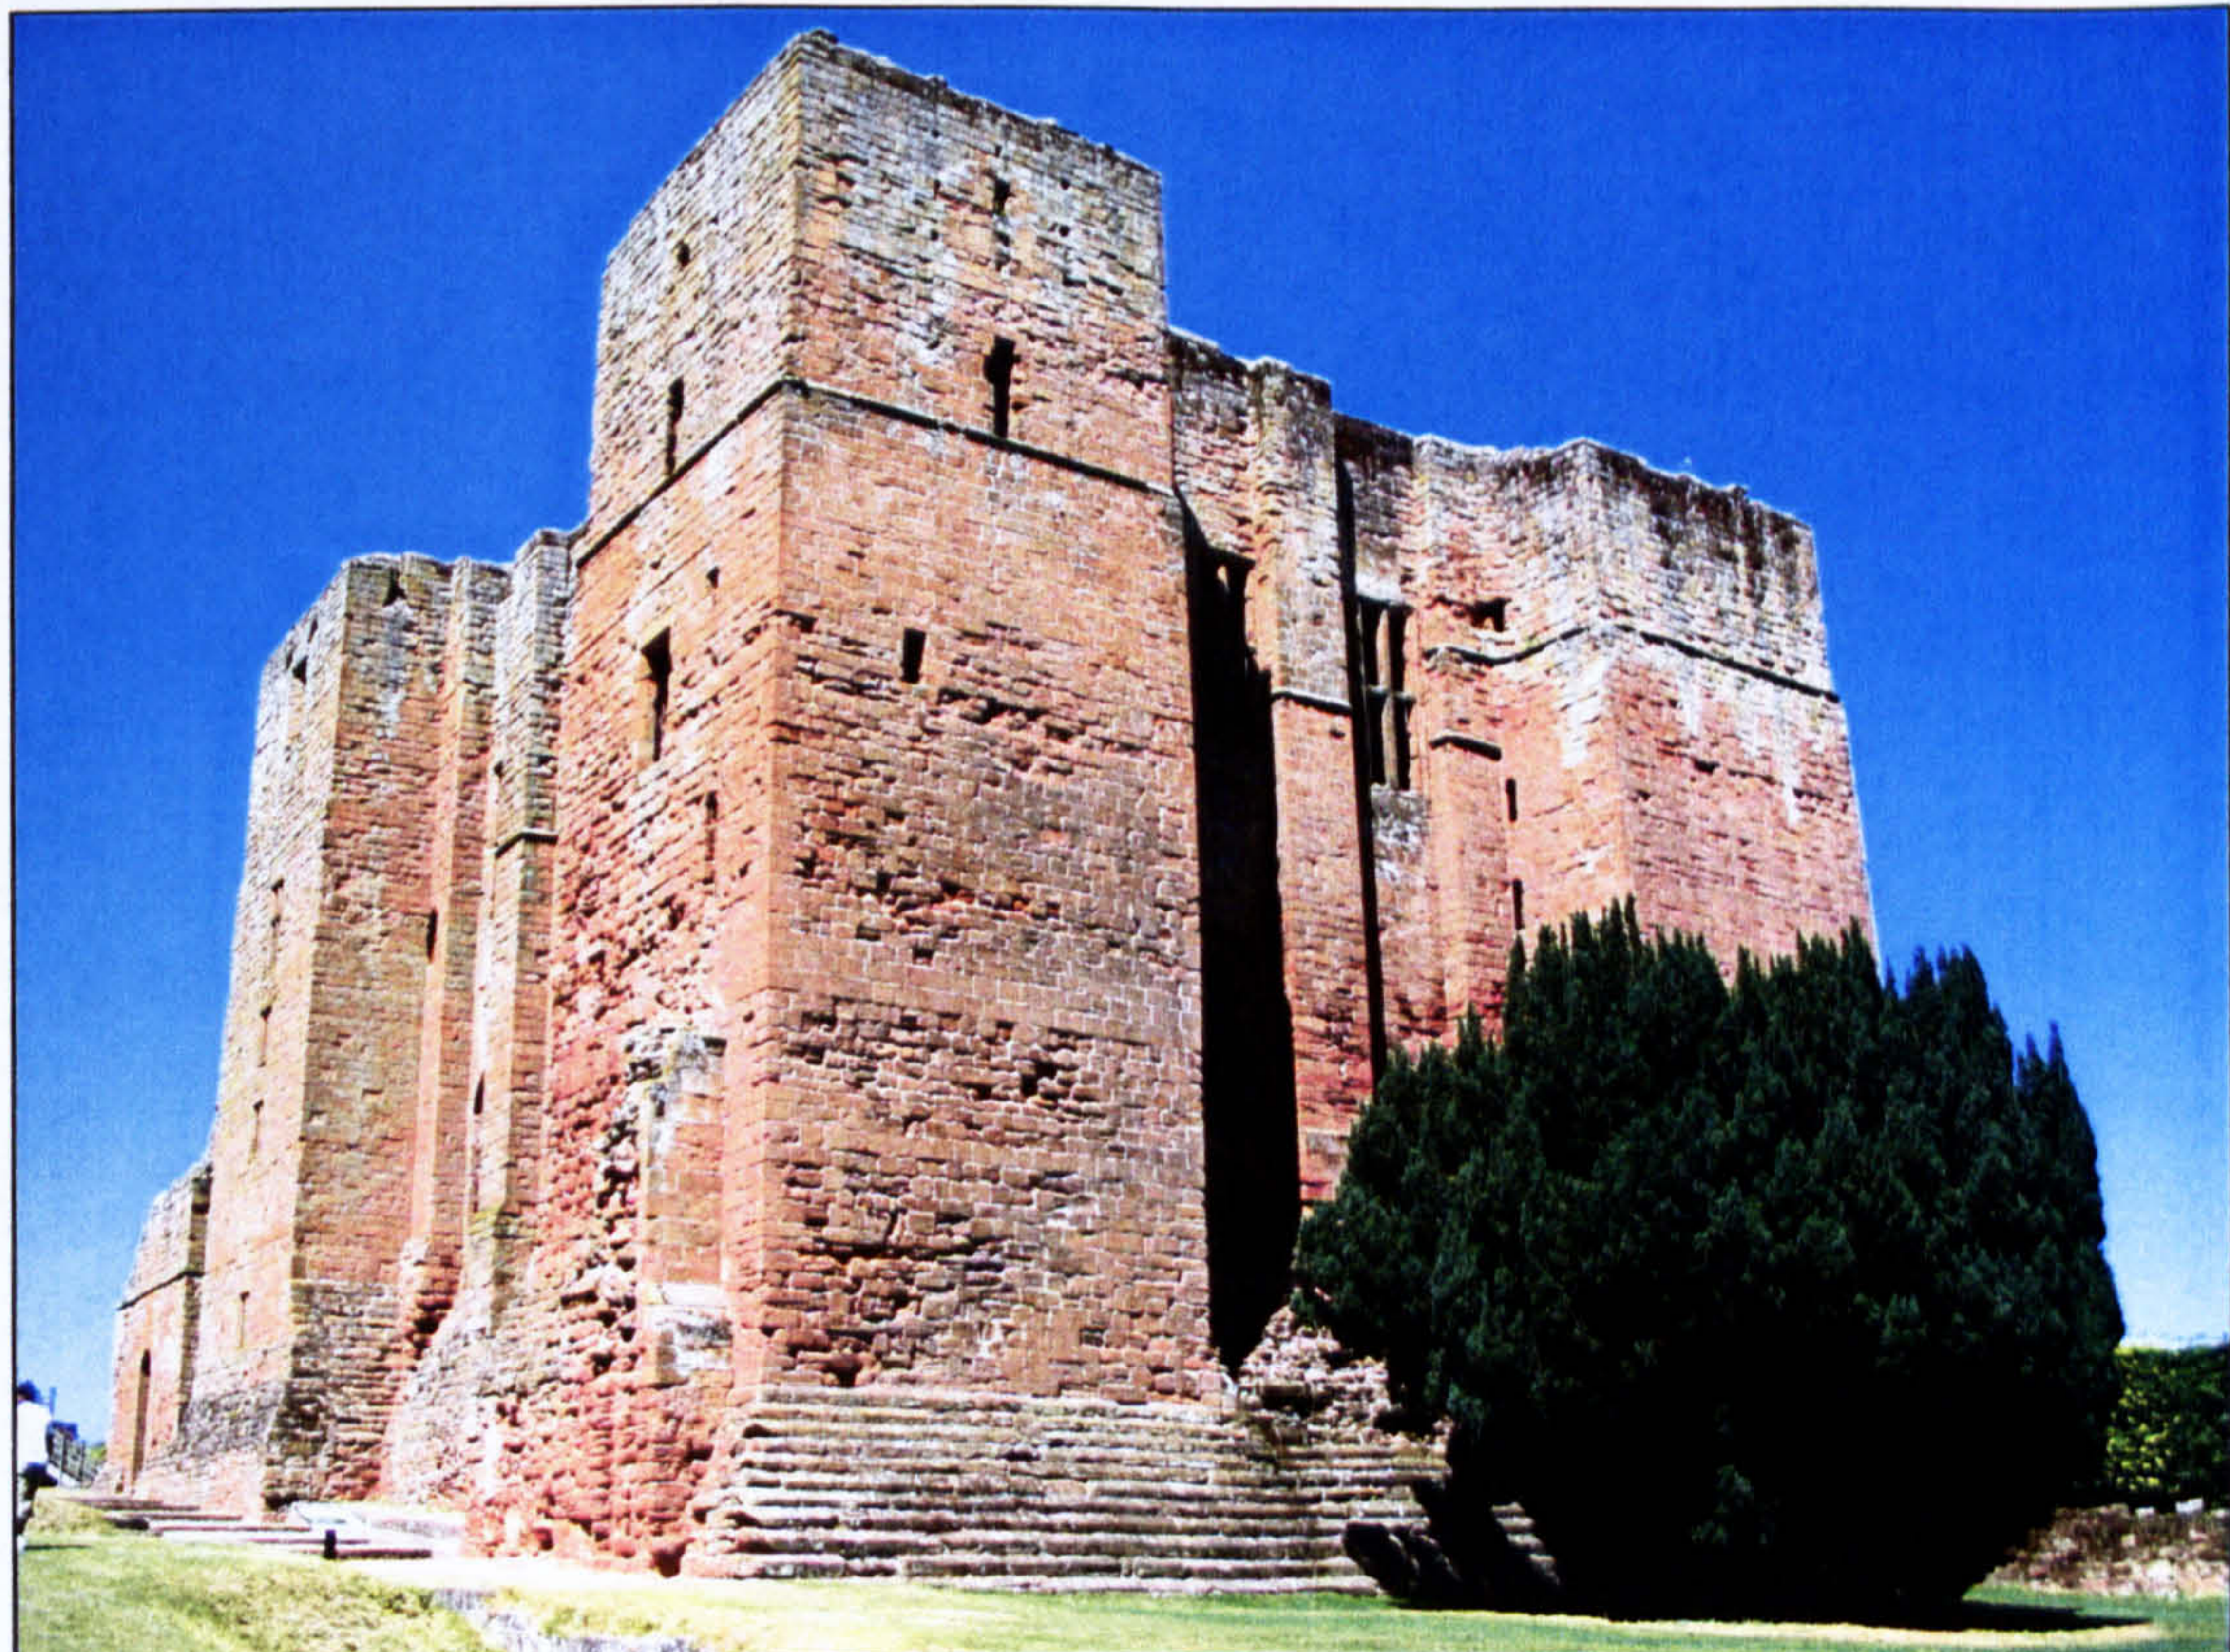
Figure 6.19 The keep from the southeast, showing its solid Norman construction and corner turrets.

The Norman keep of Kenilworth is a rectangular structure measuring 58ft x 87 ft and standing approximately 80ft high (Thompson 1912, 132), with higher corner turrets (Figure 6.19). The walls of the keep are more than 13ft thick in some places. The entrance to the keep is through a forebuilding on the western side next to the NW corner tower (Figure 6.20). Internally, it consisted of a basement chamber measuring

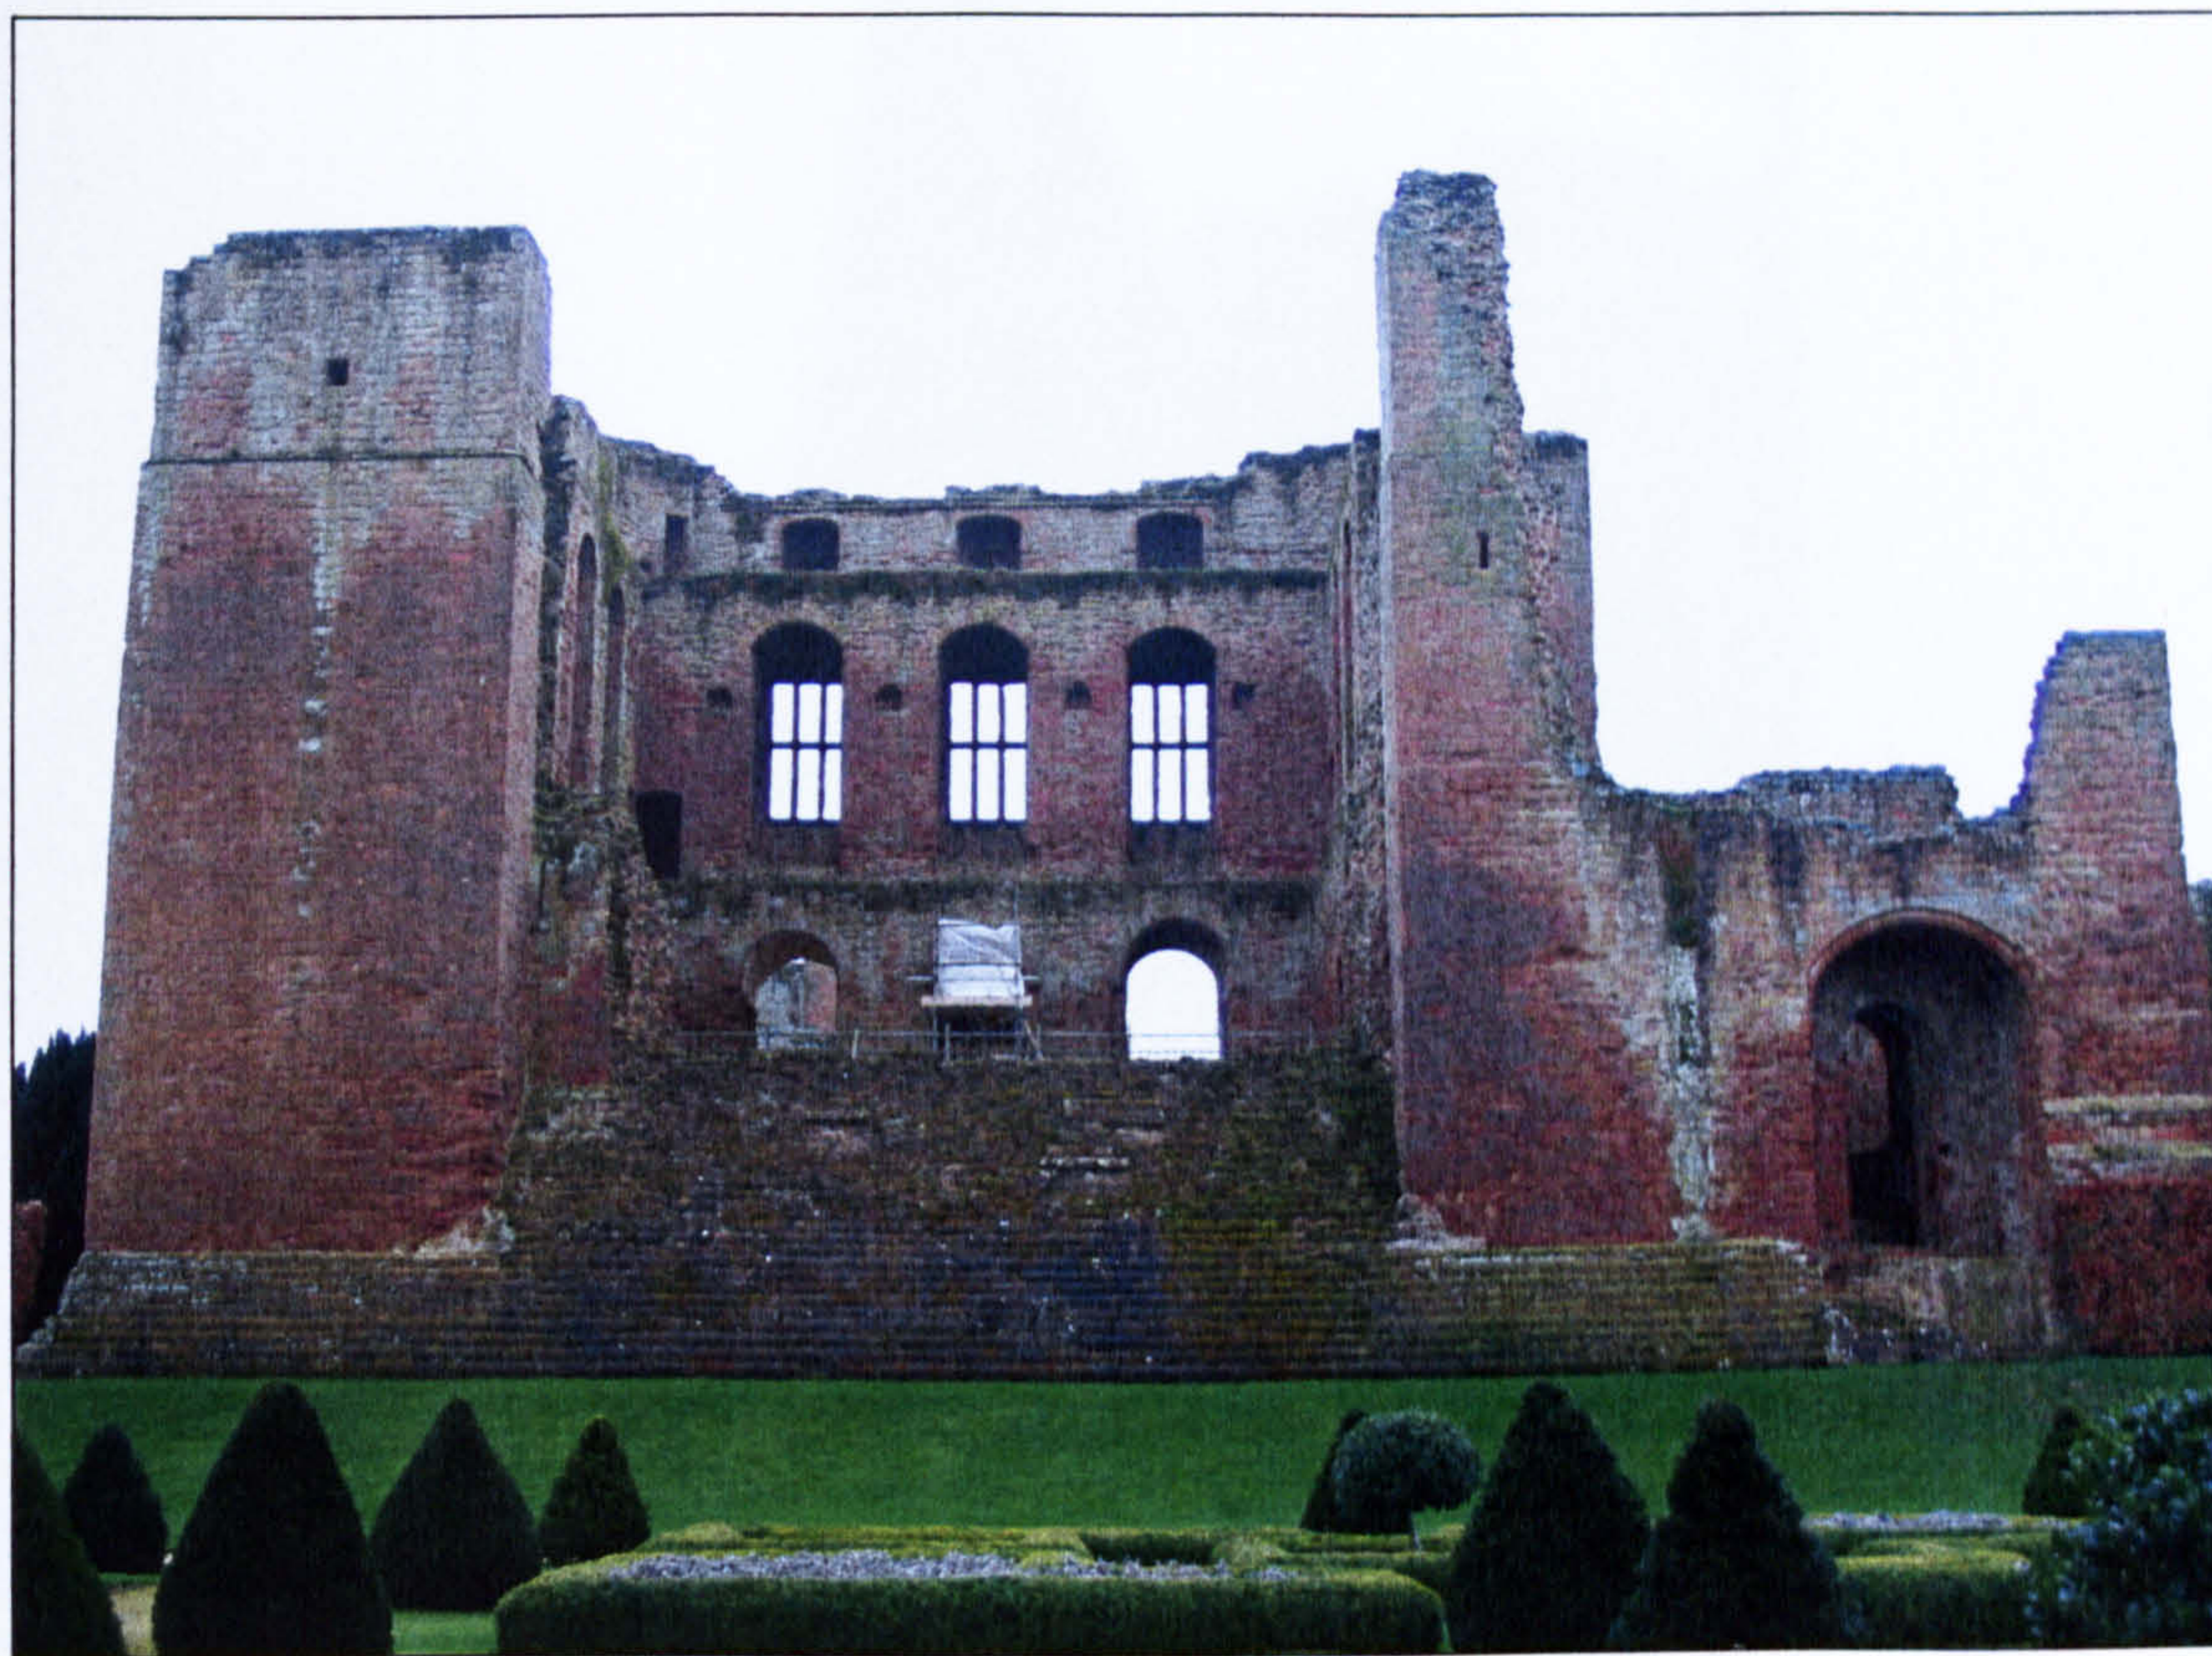
Figure 6.20 The north side of the keep, showing the forebuilding to the right.

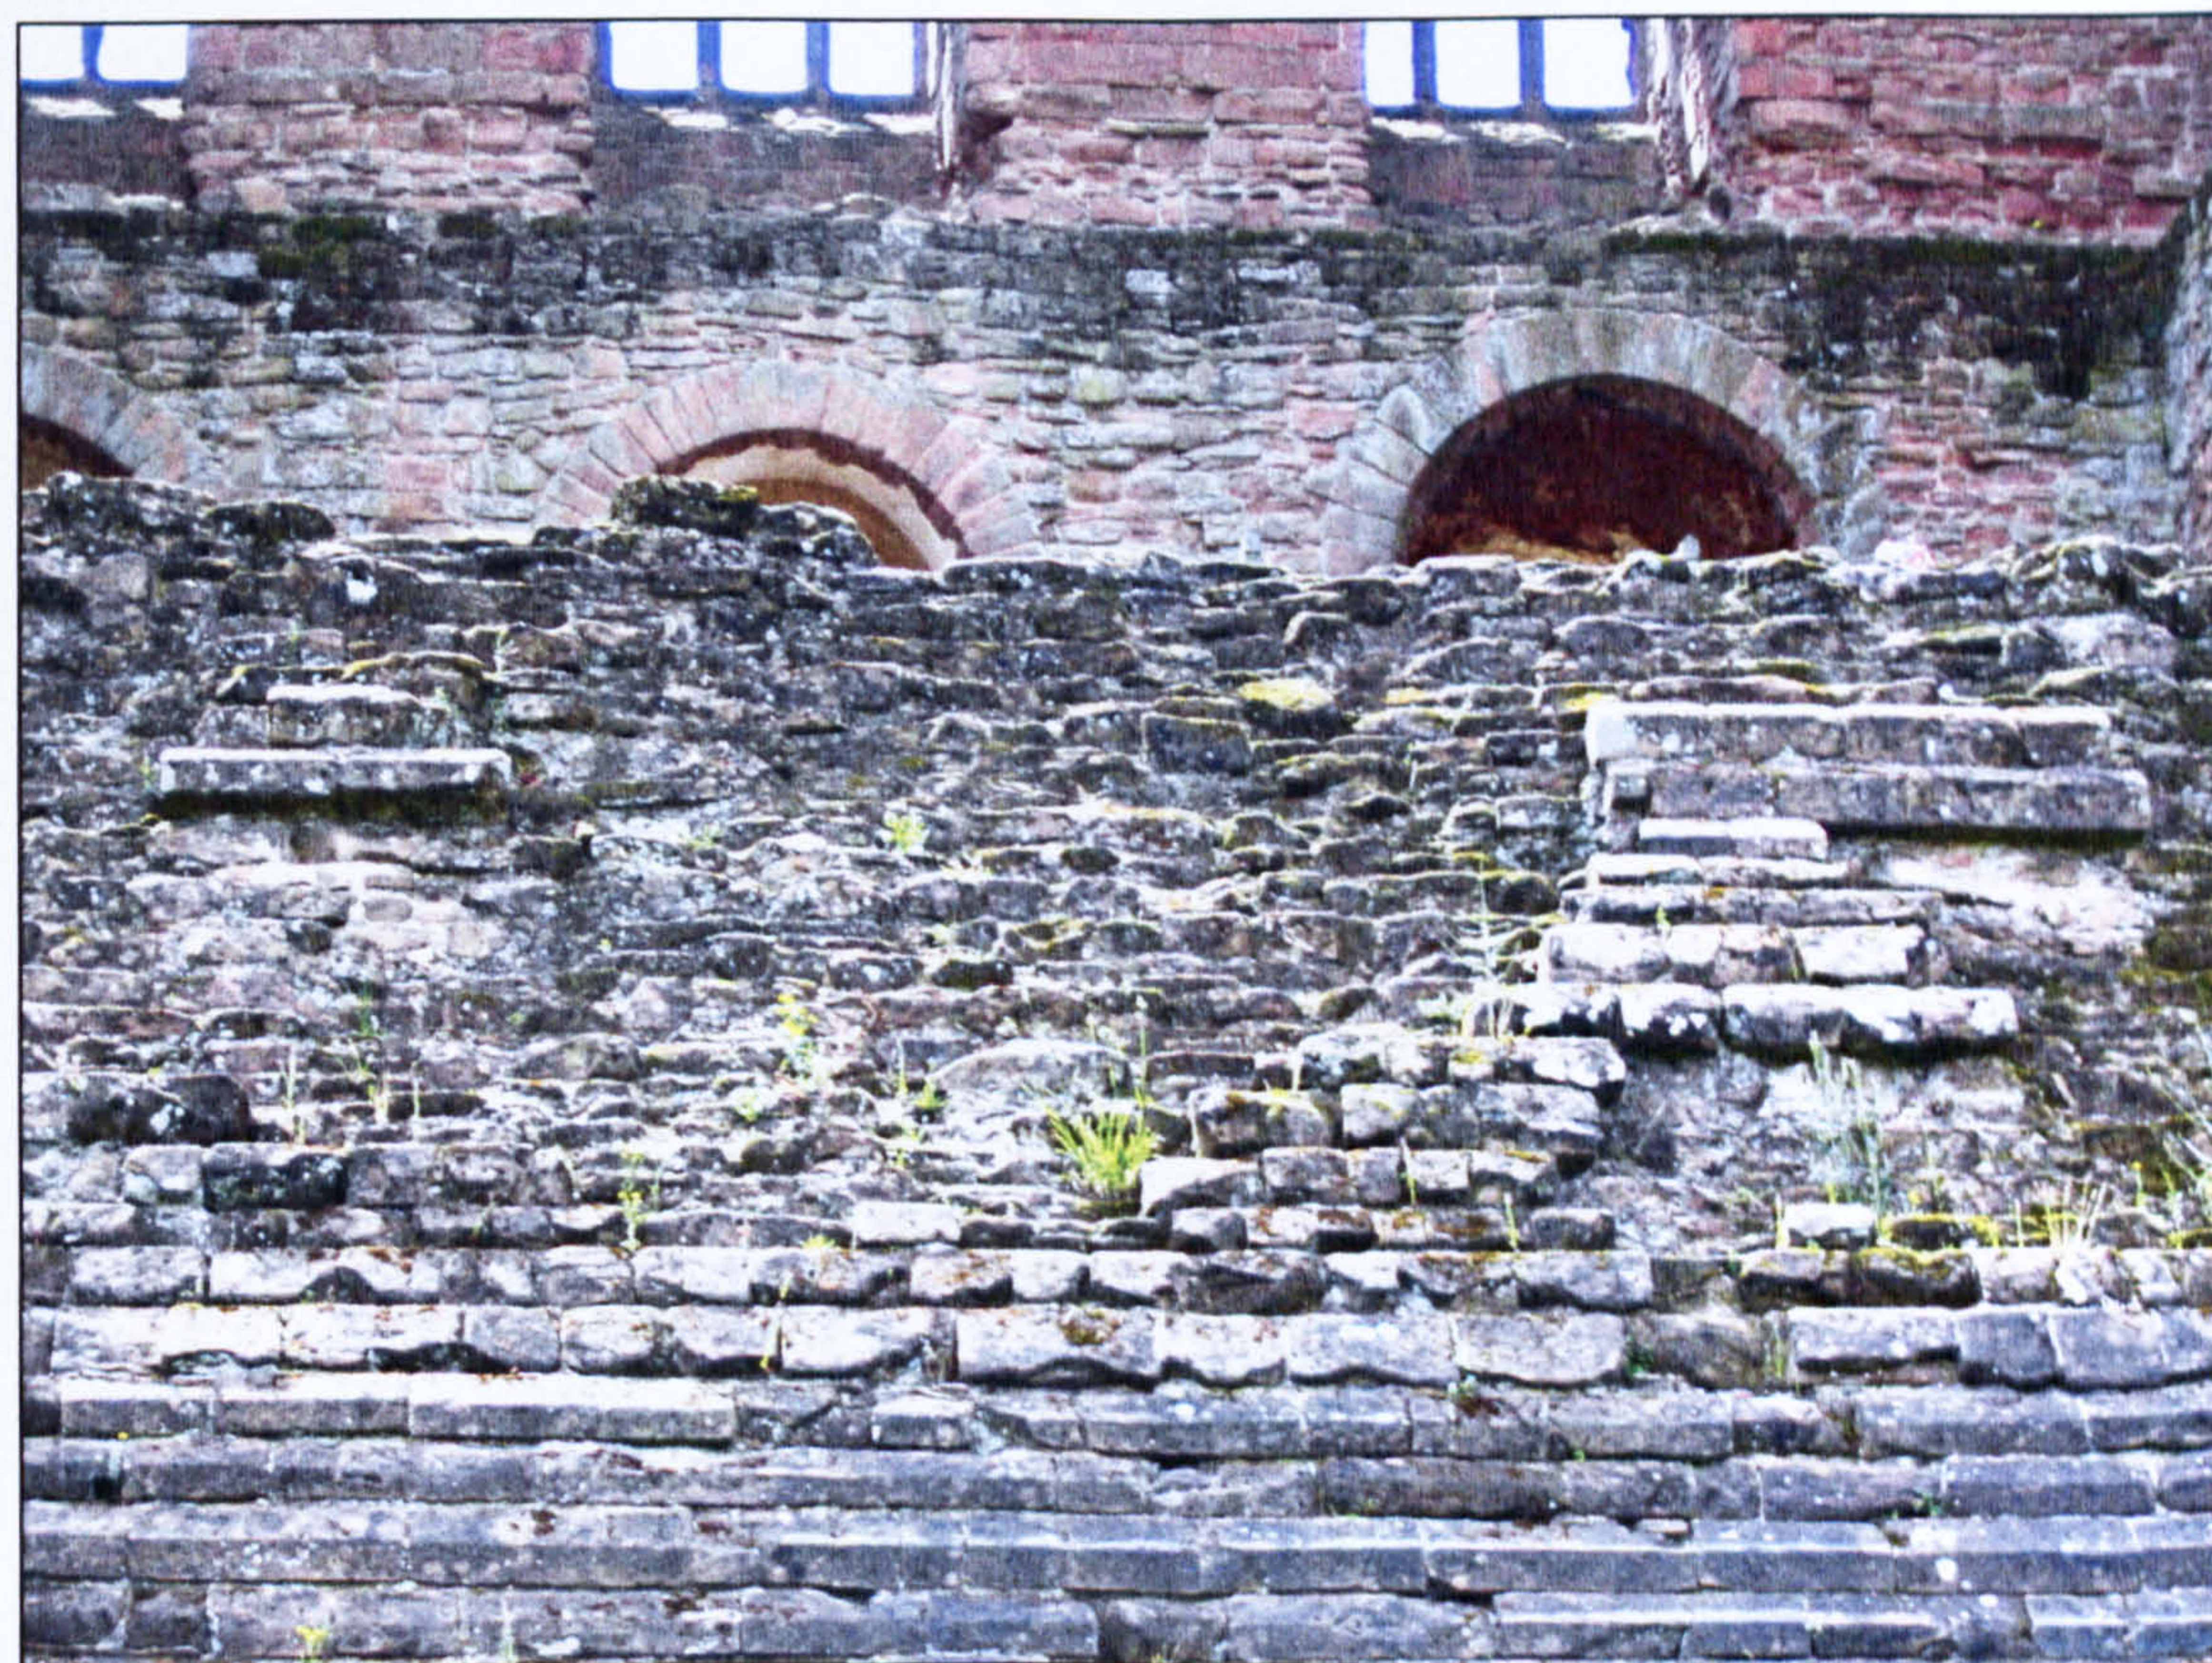
Figure 6.21 Close-up of the damaged stonework of the upper plinth of the north side of the keep.

Figure 6.21 Close-up of the damaged stonework of the upper plinth of the north side of the keep.

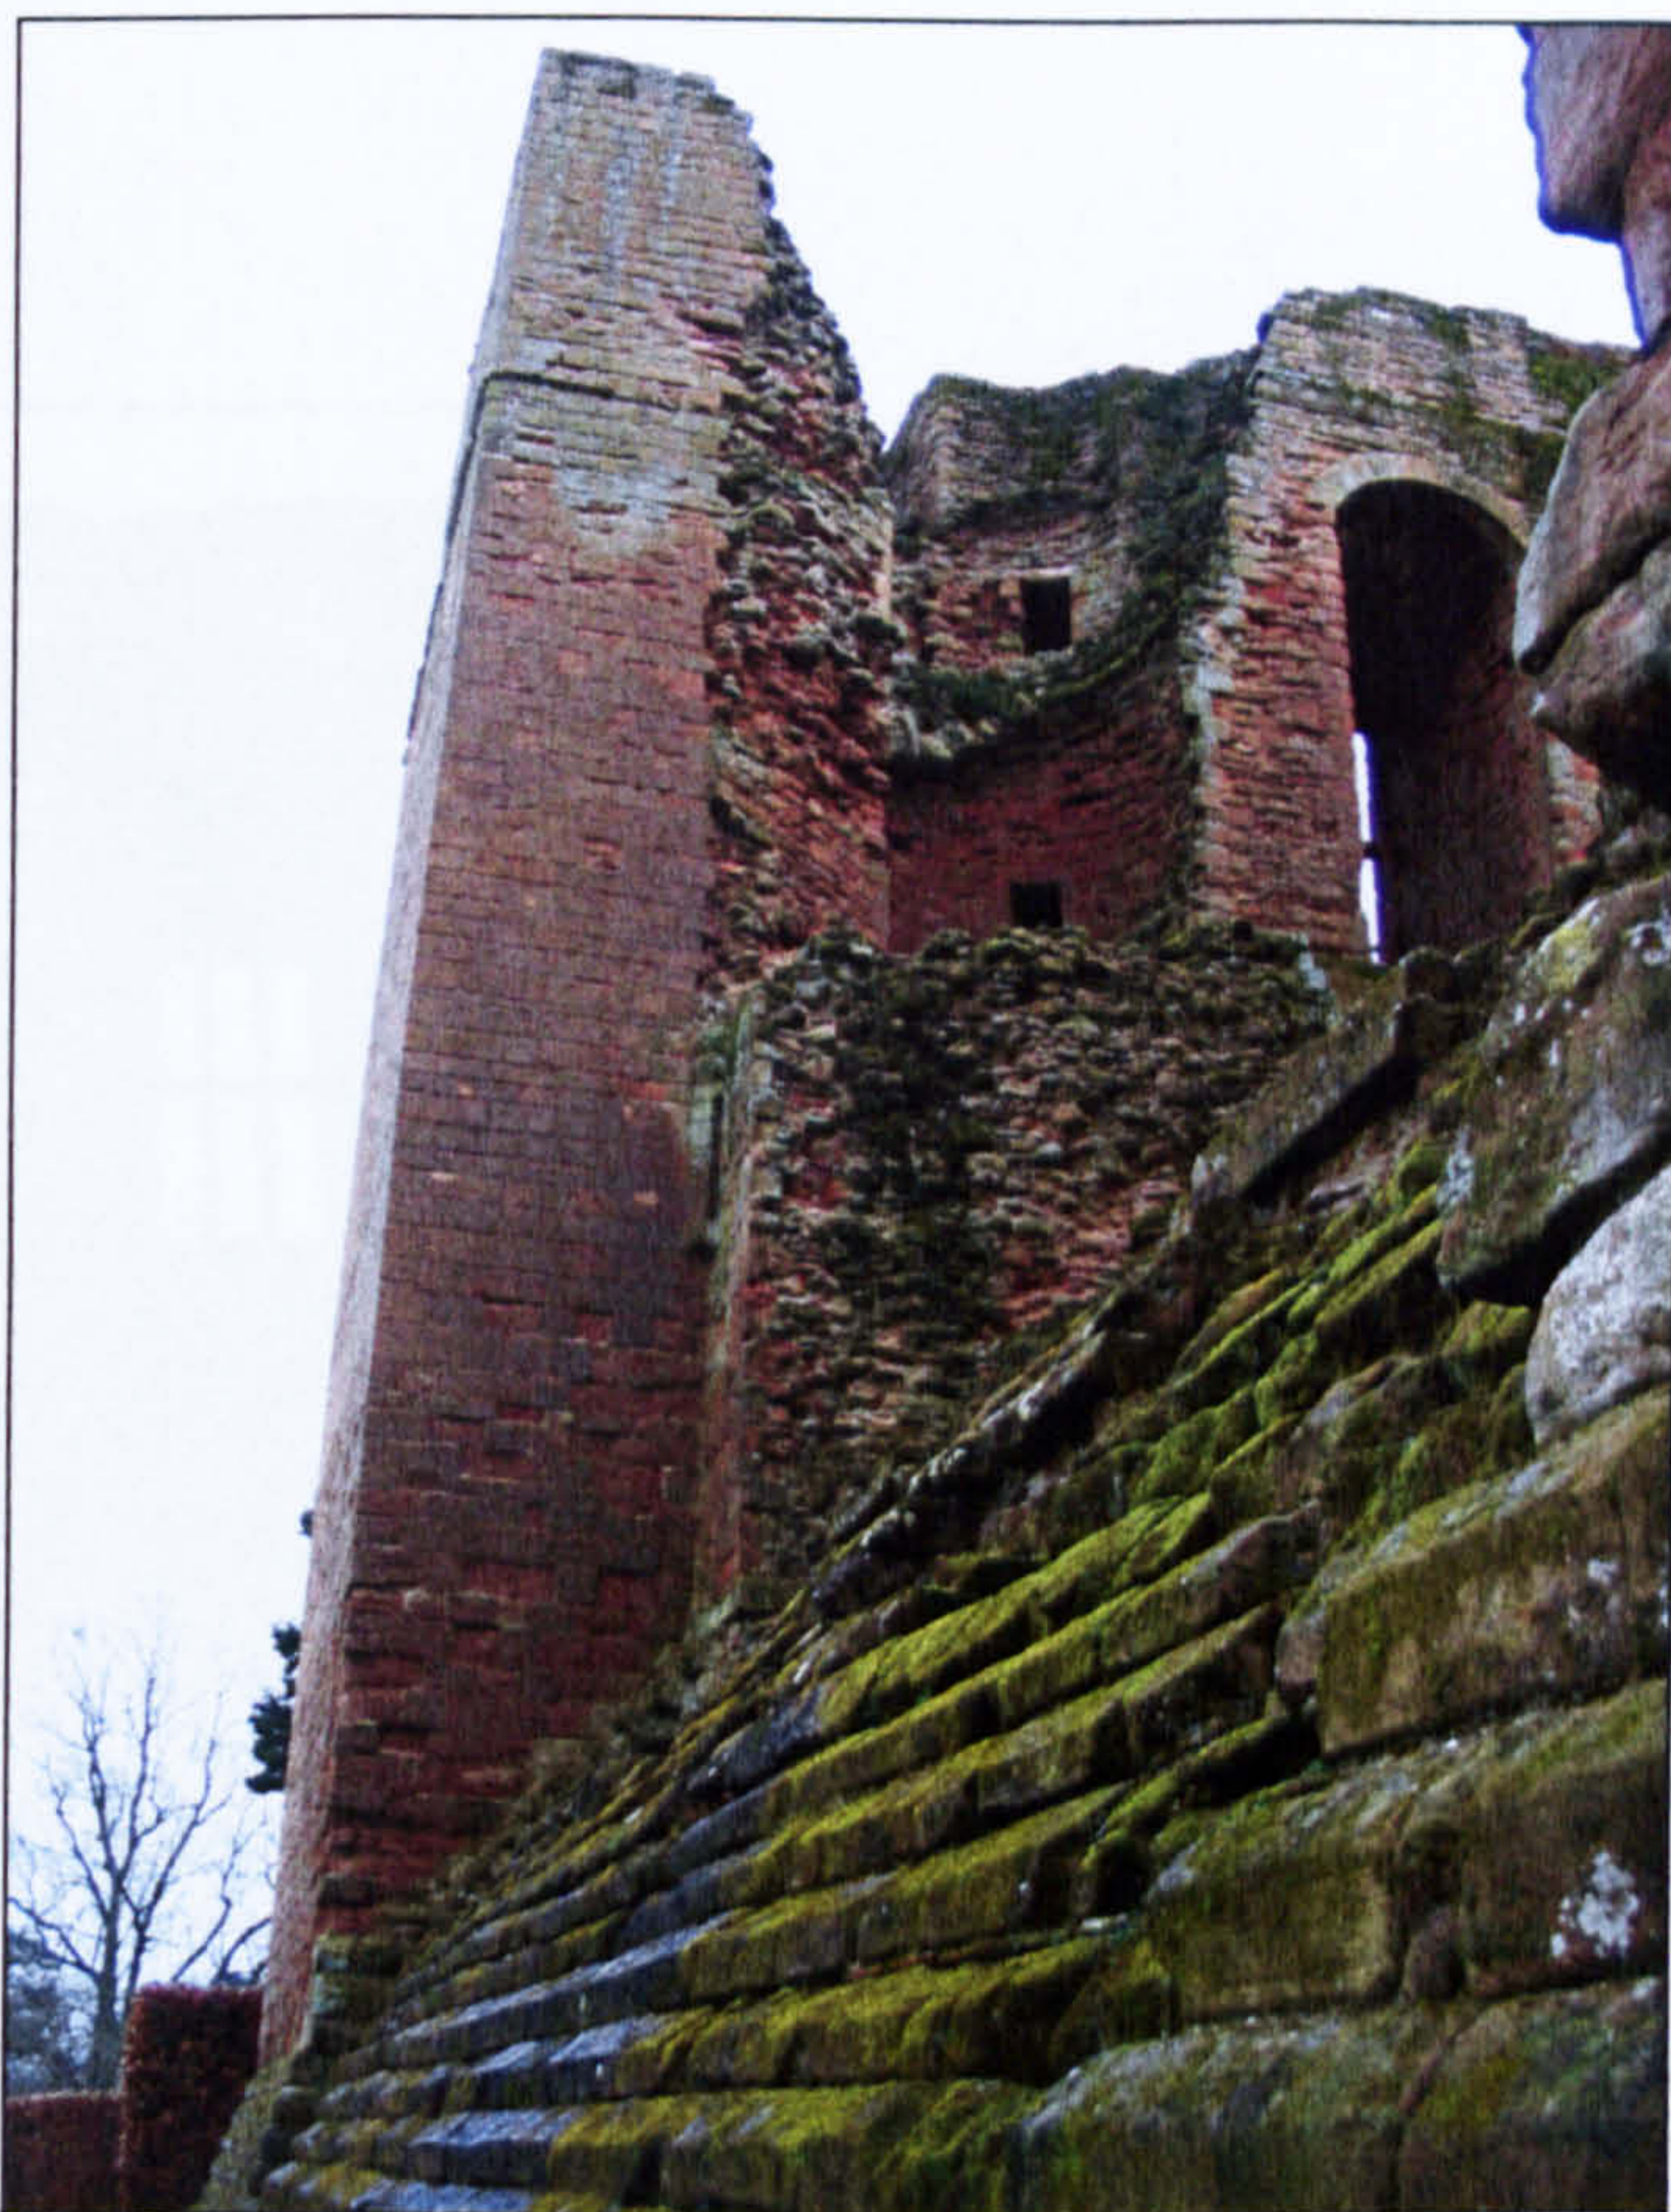
Figure 6.22 The northeast corner, showing the former point of connection with the north wall.

60 ft by 30 ft and 20 feet high, and an upper chamber that stood about 40 feet high (Clark 1884, 132). The northern, eastern, and southern elevations are surrounded by a splayed plinth that, on the northern face, projects outward for several feet. Three of the four elevations all are completely intact, but the northern wall is missing down to plinth level, the upper courses of which show considerable damage (Figure 6.21). This loss of the north wall has exposed the rubble core of the NE and NW corners where the former points of contact with the north wall can be clearly seen (Figures 6.22 and 6.23).

The main evidence behind the picking narrative is the neat, linear destruction pattern found in the northeast and northwest corners of the keep (Figure 6.28). The exposed rubble core where the missing north wall was bonded to the east and west walls is patterned in more or less straight lines all the way down, with undamaged ashlar on either side. In the northeast corner, this is partially explained by the presence of an upper story stairwell (Figure 6.29). The base of the stairwell is comprised of large stones thickly bonded and is partly a Victorian reconstruction (Clark 1884, 133; compare with antiquarian views in Figure 6.18). As the keep is known to have been ‘made safe’ in 1878 (Ballard 2006, 168), it is possible that this partially reconstructed ‘buttress’ was intended to give an additional element of support to the northeast turret.
