ARCHAEOLOGY OF DESTRUCTION

A REINTERPRETATION OF CASTLE SLIGHTINGS IN THE ENGLISH CIVIL WAR

Thesis submitted for the degree of
Doctor of Philosophy
University of York
Department of Archaeology

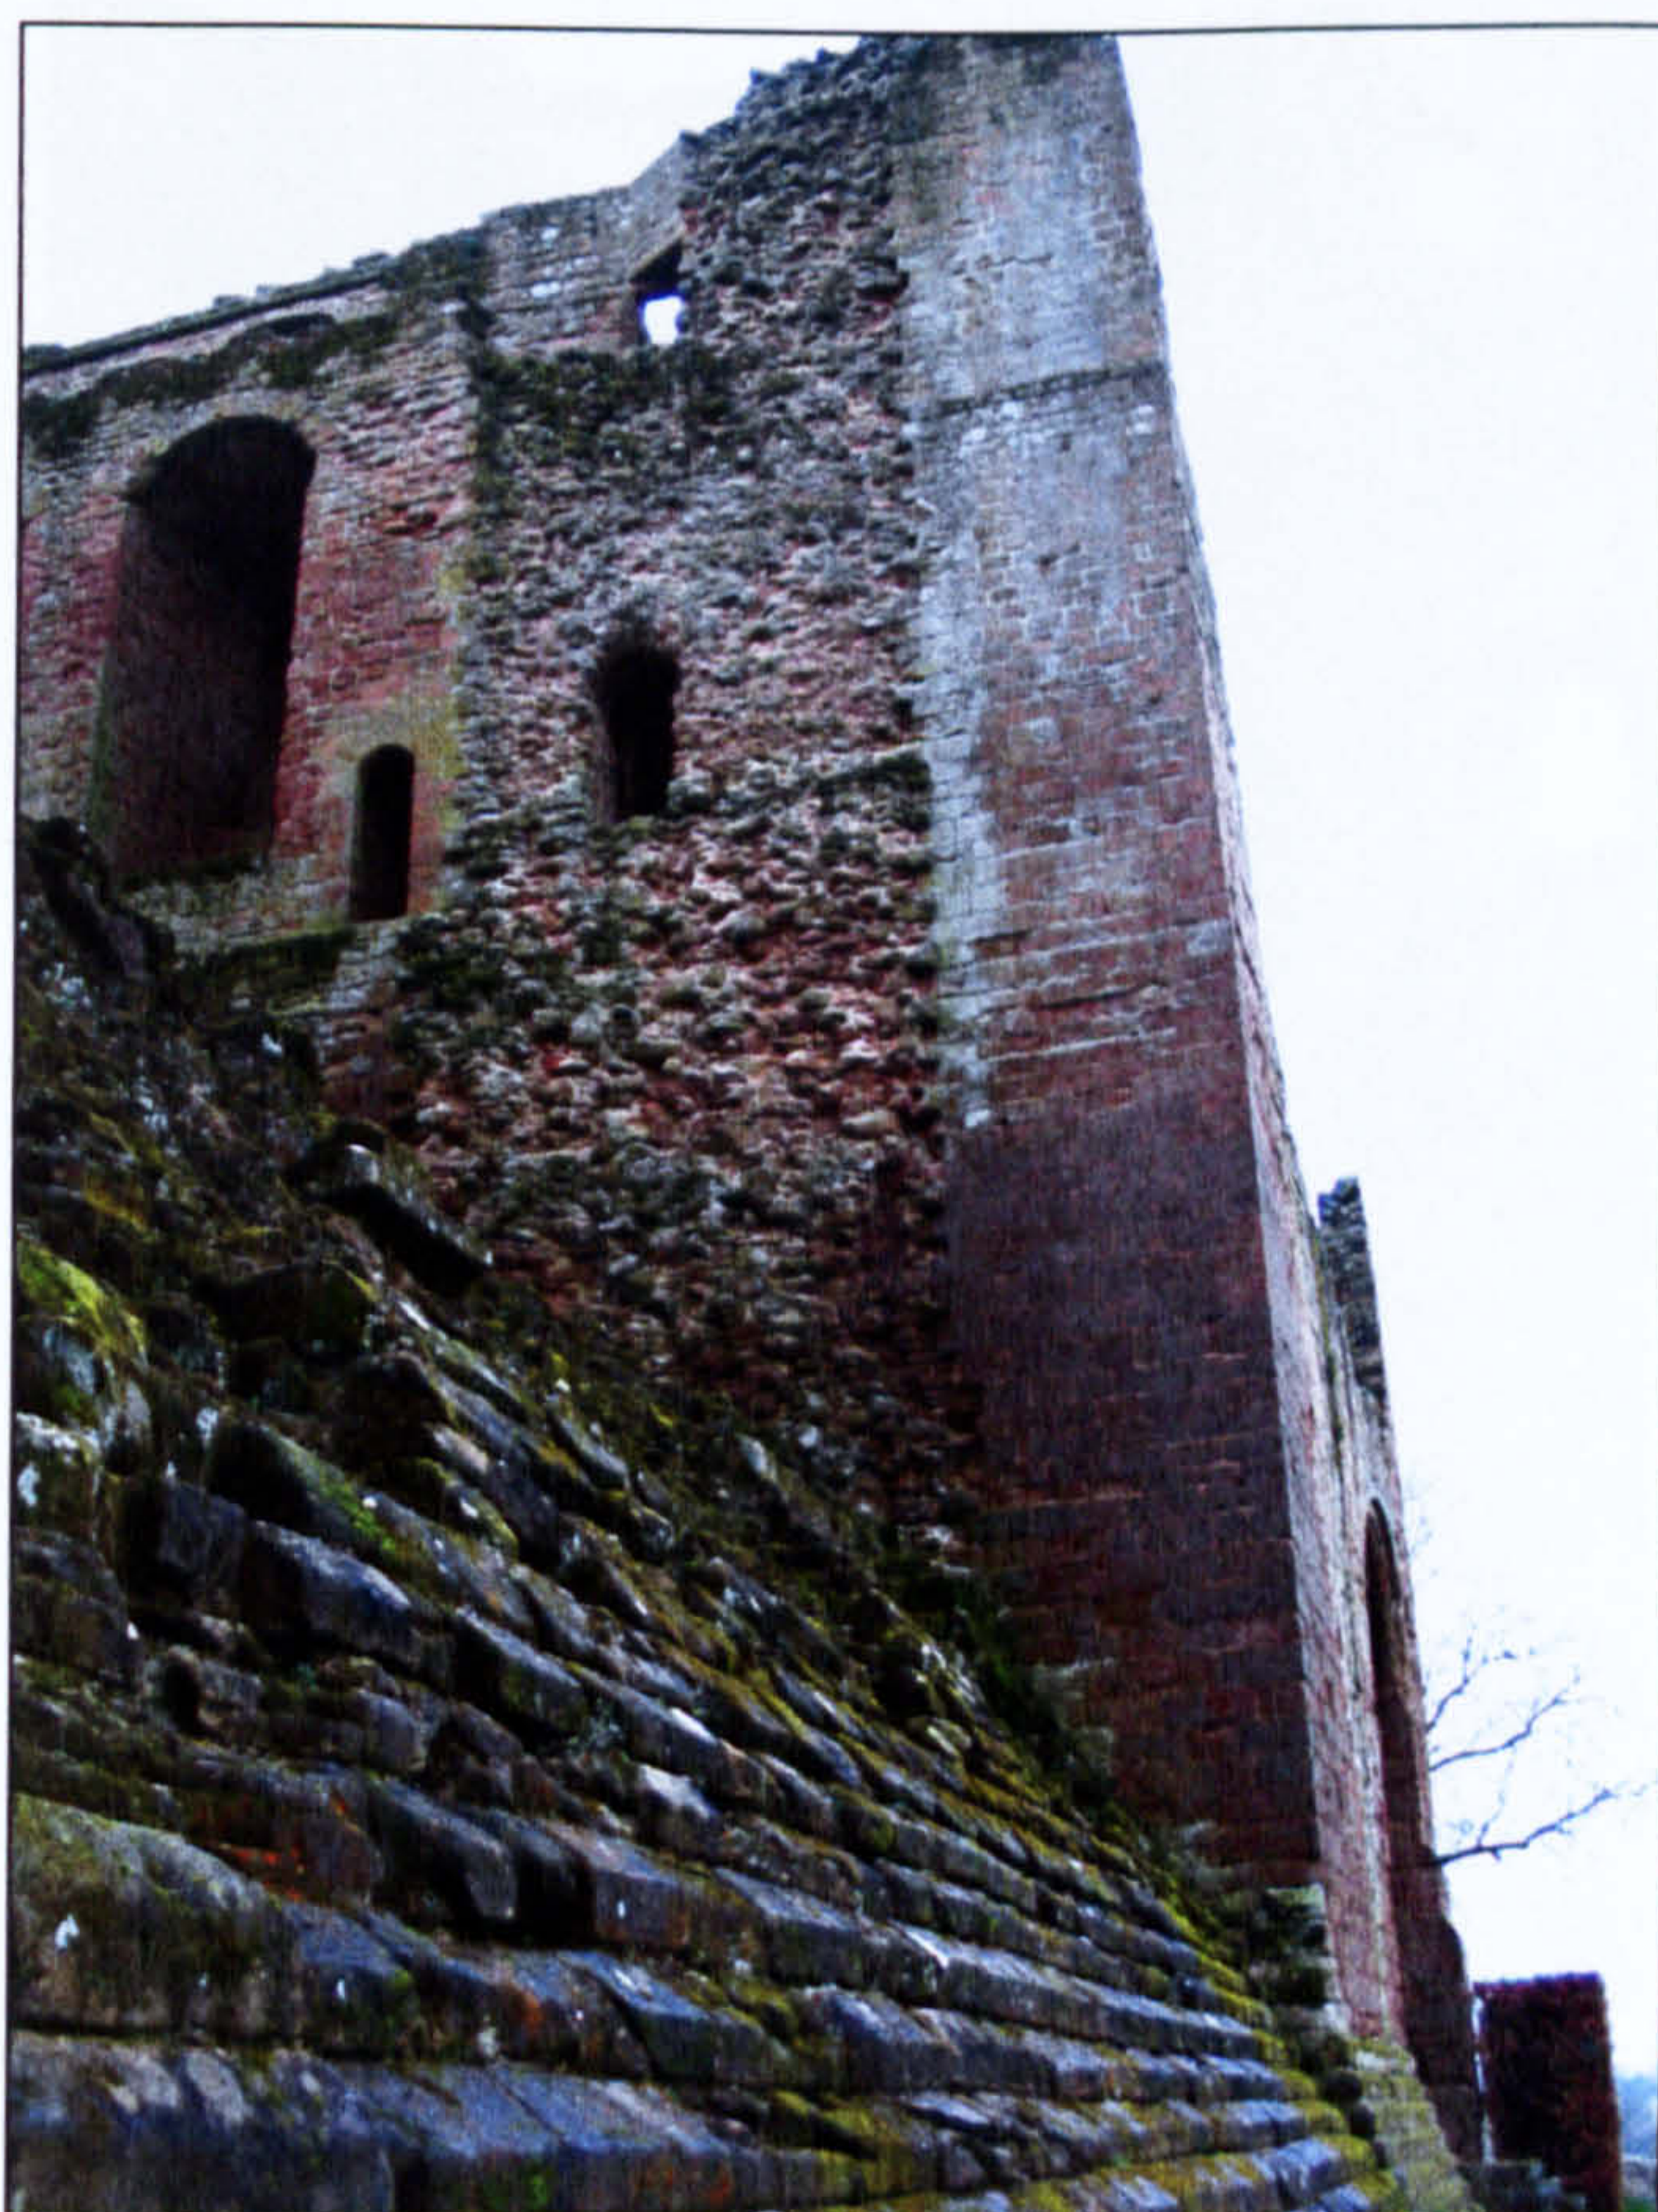
Figure 6.23 The northwest corner, showing the former point of connection with the north wall.

60 ft by 30 ft and 20 feet high, and an upper chamber that stood about 40 feet high (Clark 1884, 132). The northern, eastern, and southern elevations are surrounded by a splayed plinth that, on the northern face, projects outward for several feet. Three of the four elevations all are completely intact, but the northern wall is missing down to plinth level, the upper courses of which show considerable damage (Figure 6.21). This loss of the north wall has exposed the rubble core of the NE and NW corners where the former points of contact with the north wall can be clearly seen (Figures 6.22 and 6.23).

The main evidence behind the picking narrative is the neat, linear destruction pattern found in the northeast and northwest corners of the keep (Figure 6.28). The exposed rubble core where the missing north wall was bonded to the east and west walls is patterned in more or less straight lines all the way down, with undamaged ashlar on either side. In the northeast corner, this is partially explained by the presence of an upper story stairwell (Figure 6.29). The base of the stairwell is comprised of large stones thickly bonded and is partly a Victorian reconstruction (Clark 1884, 133; compare with antiquarian views in Figure 6.18). As the keep is known to have been ‘made safe’ in 1878 (Ballard 2006, 168), it is possible that this partially reconstructed ‘buttress’ was intended to give an additional element of support to the northeast turret.

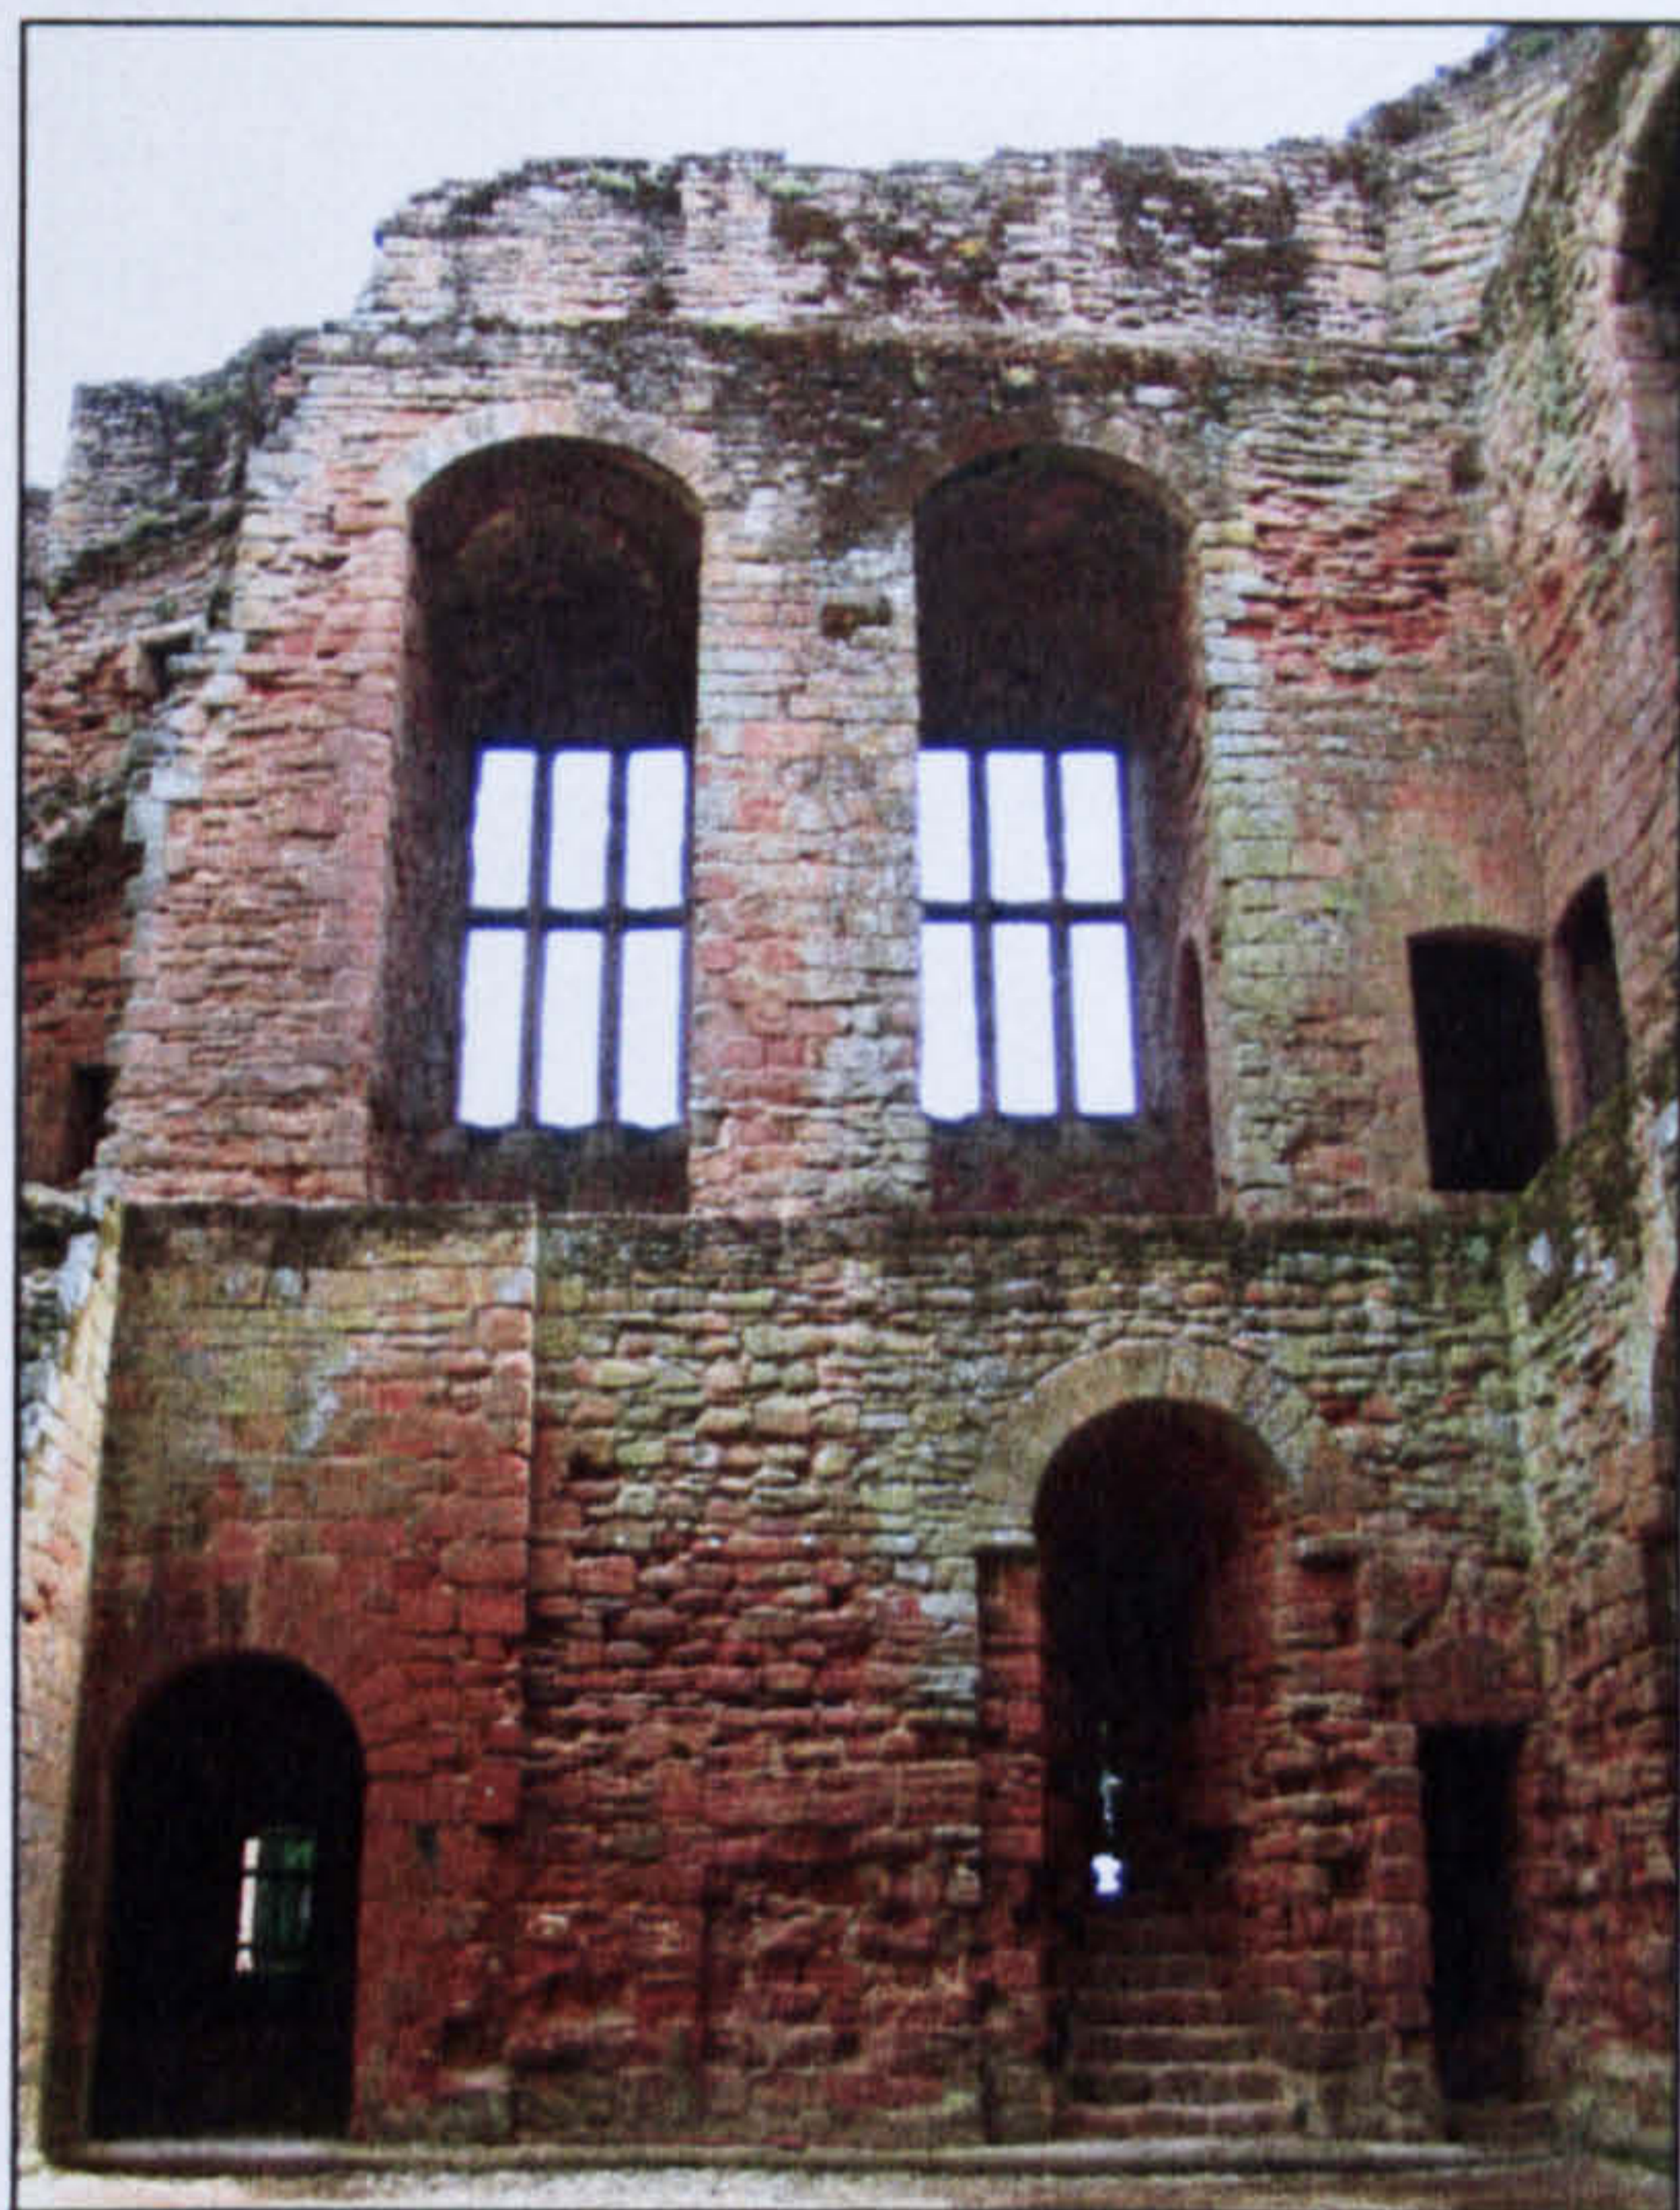
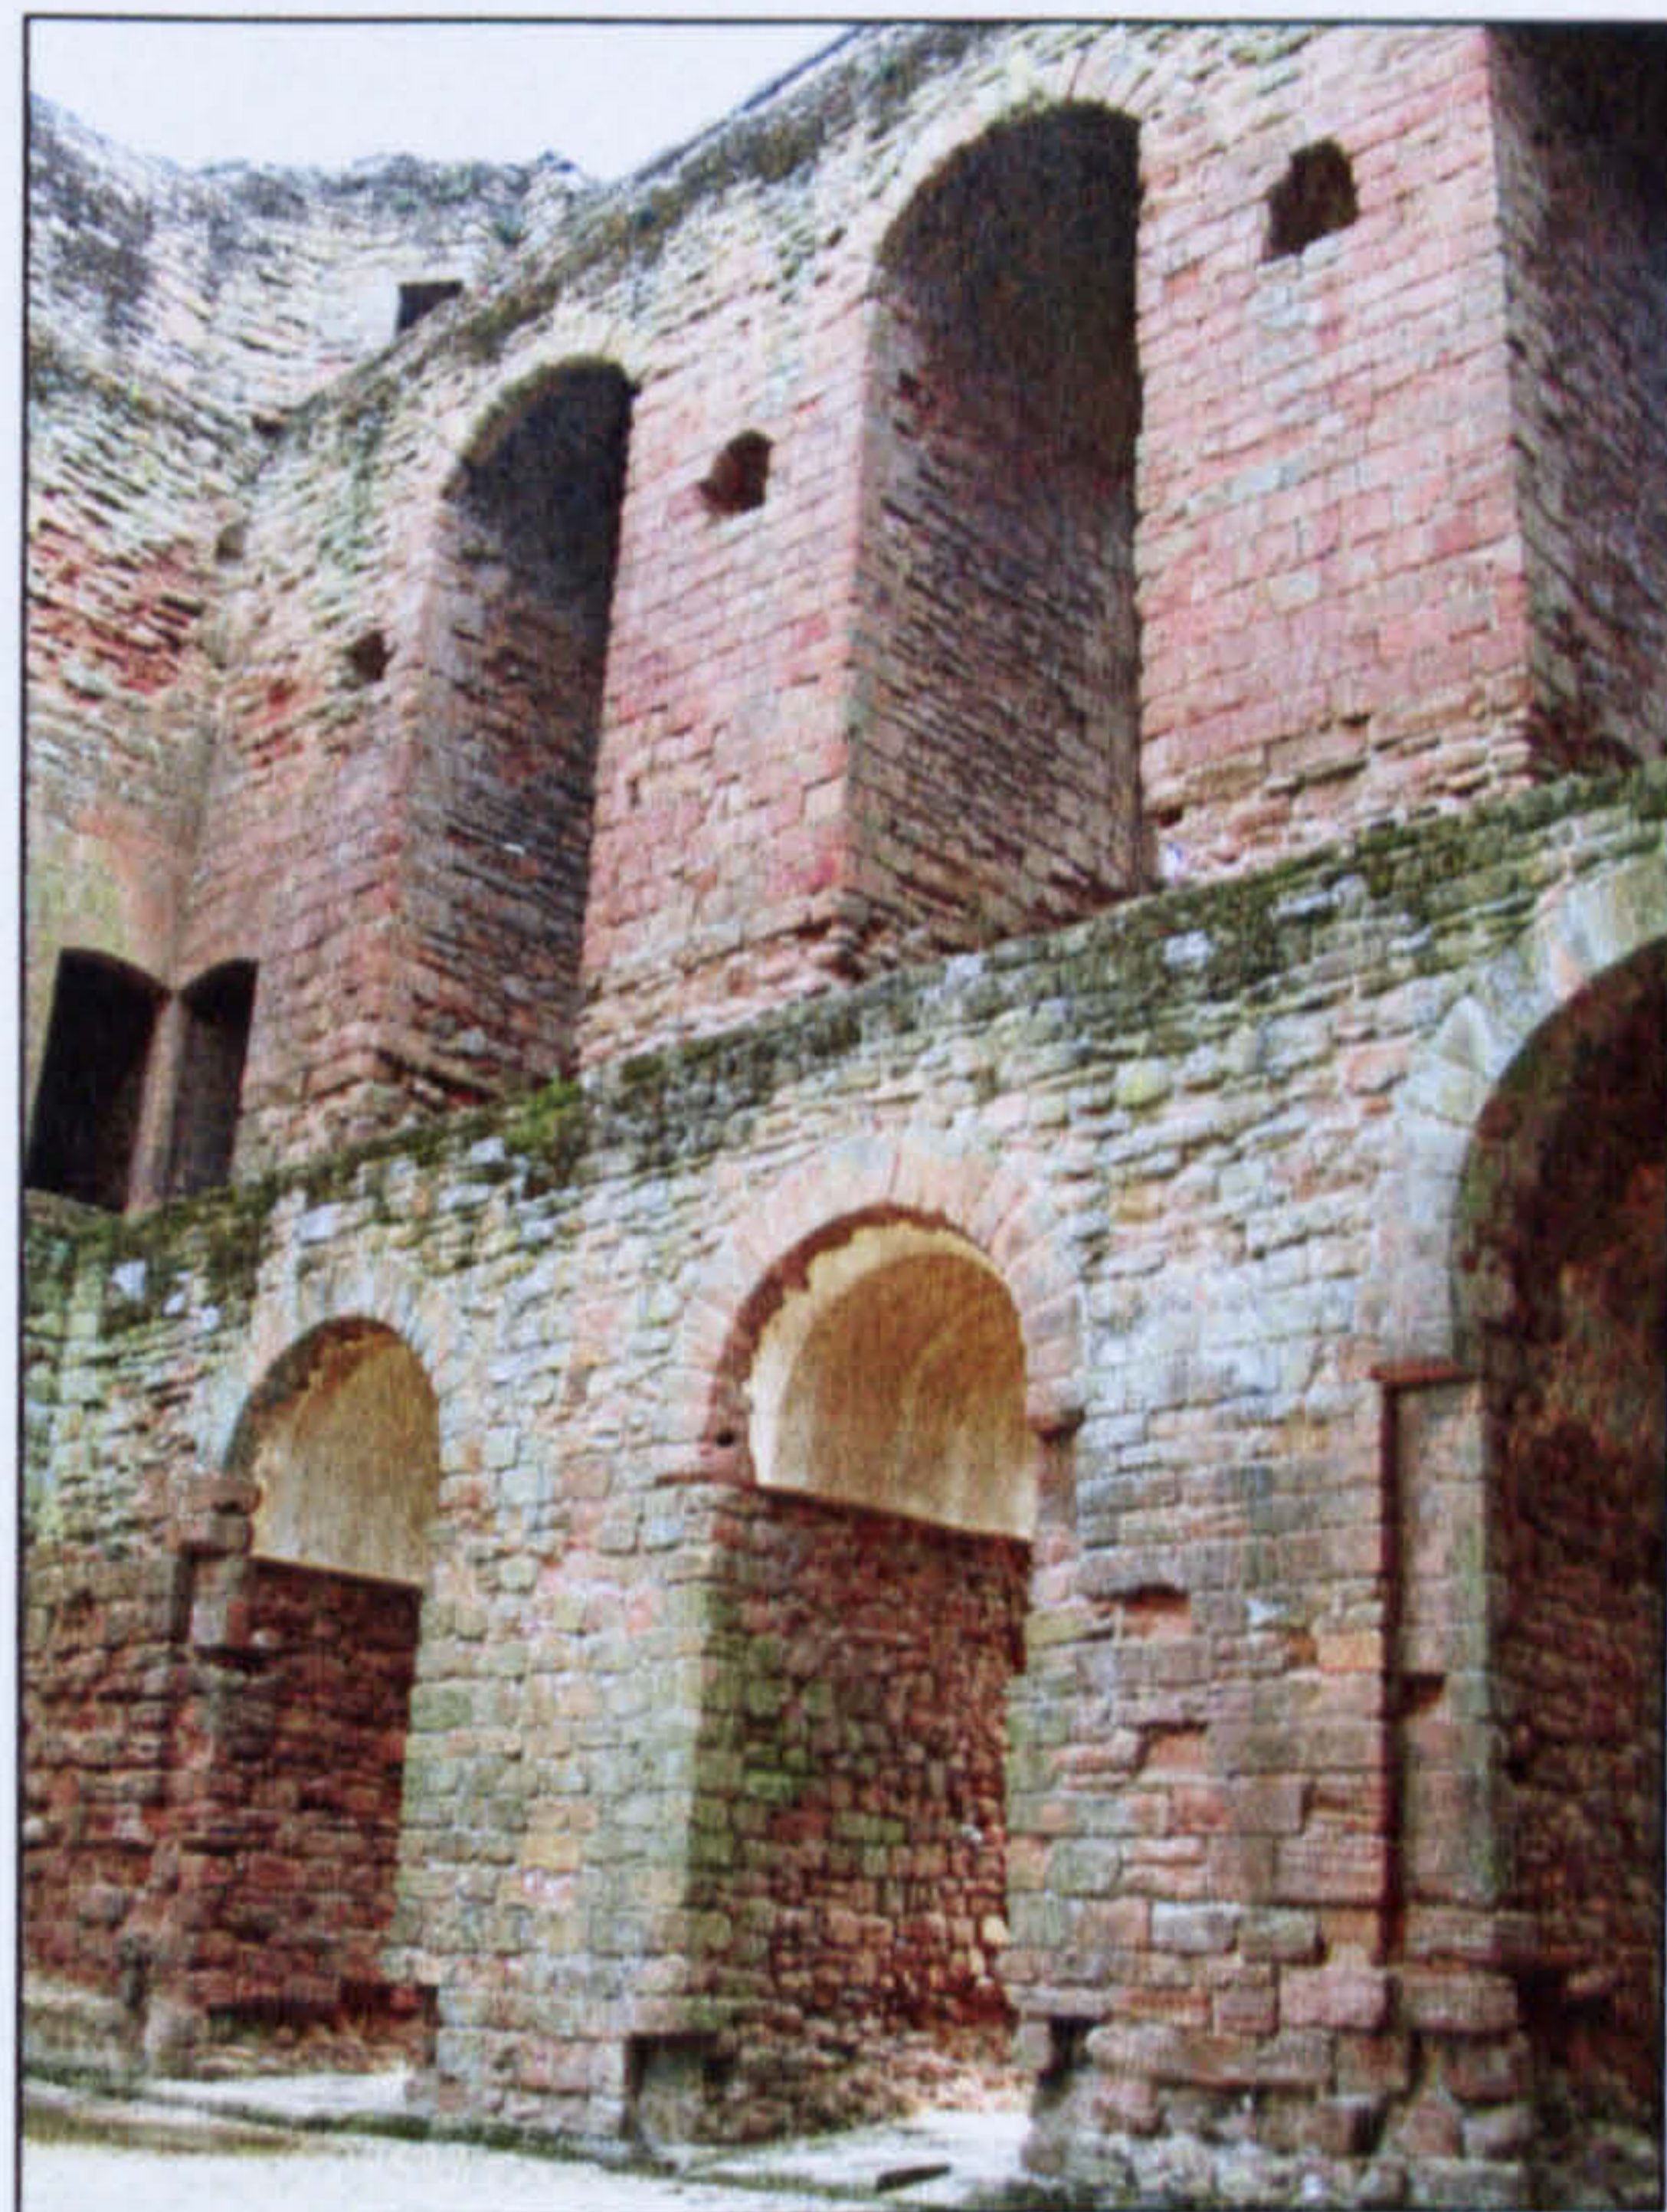
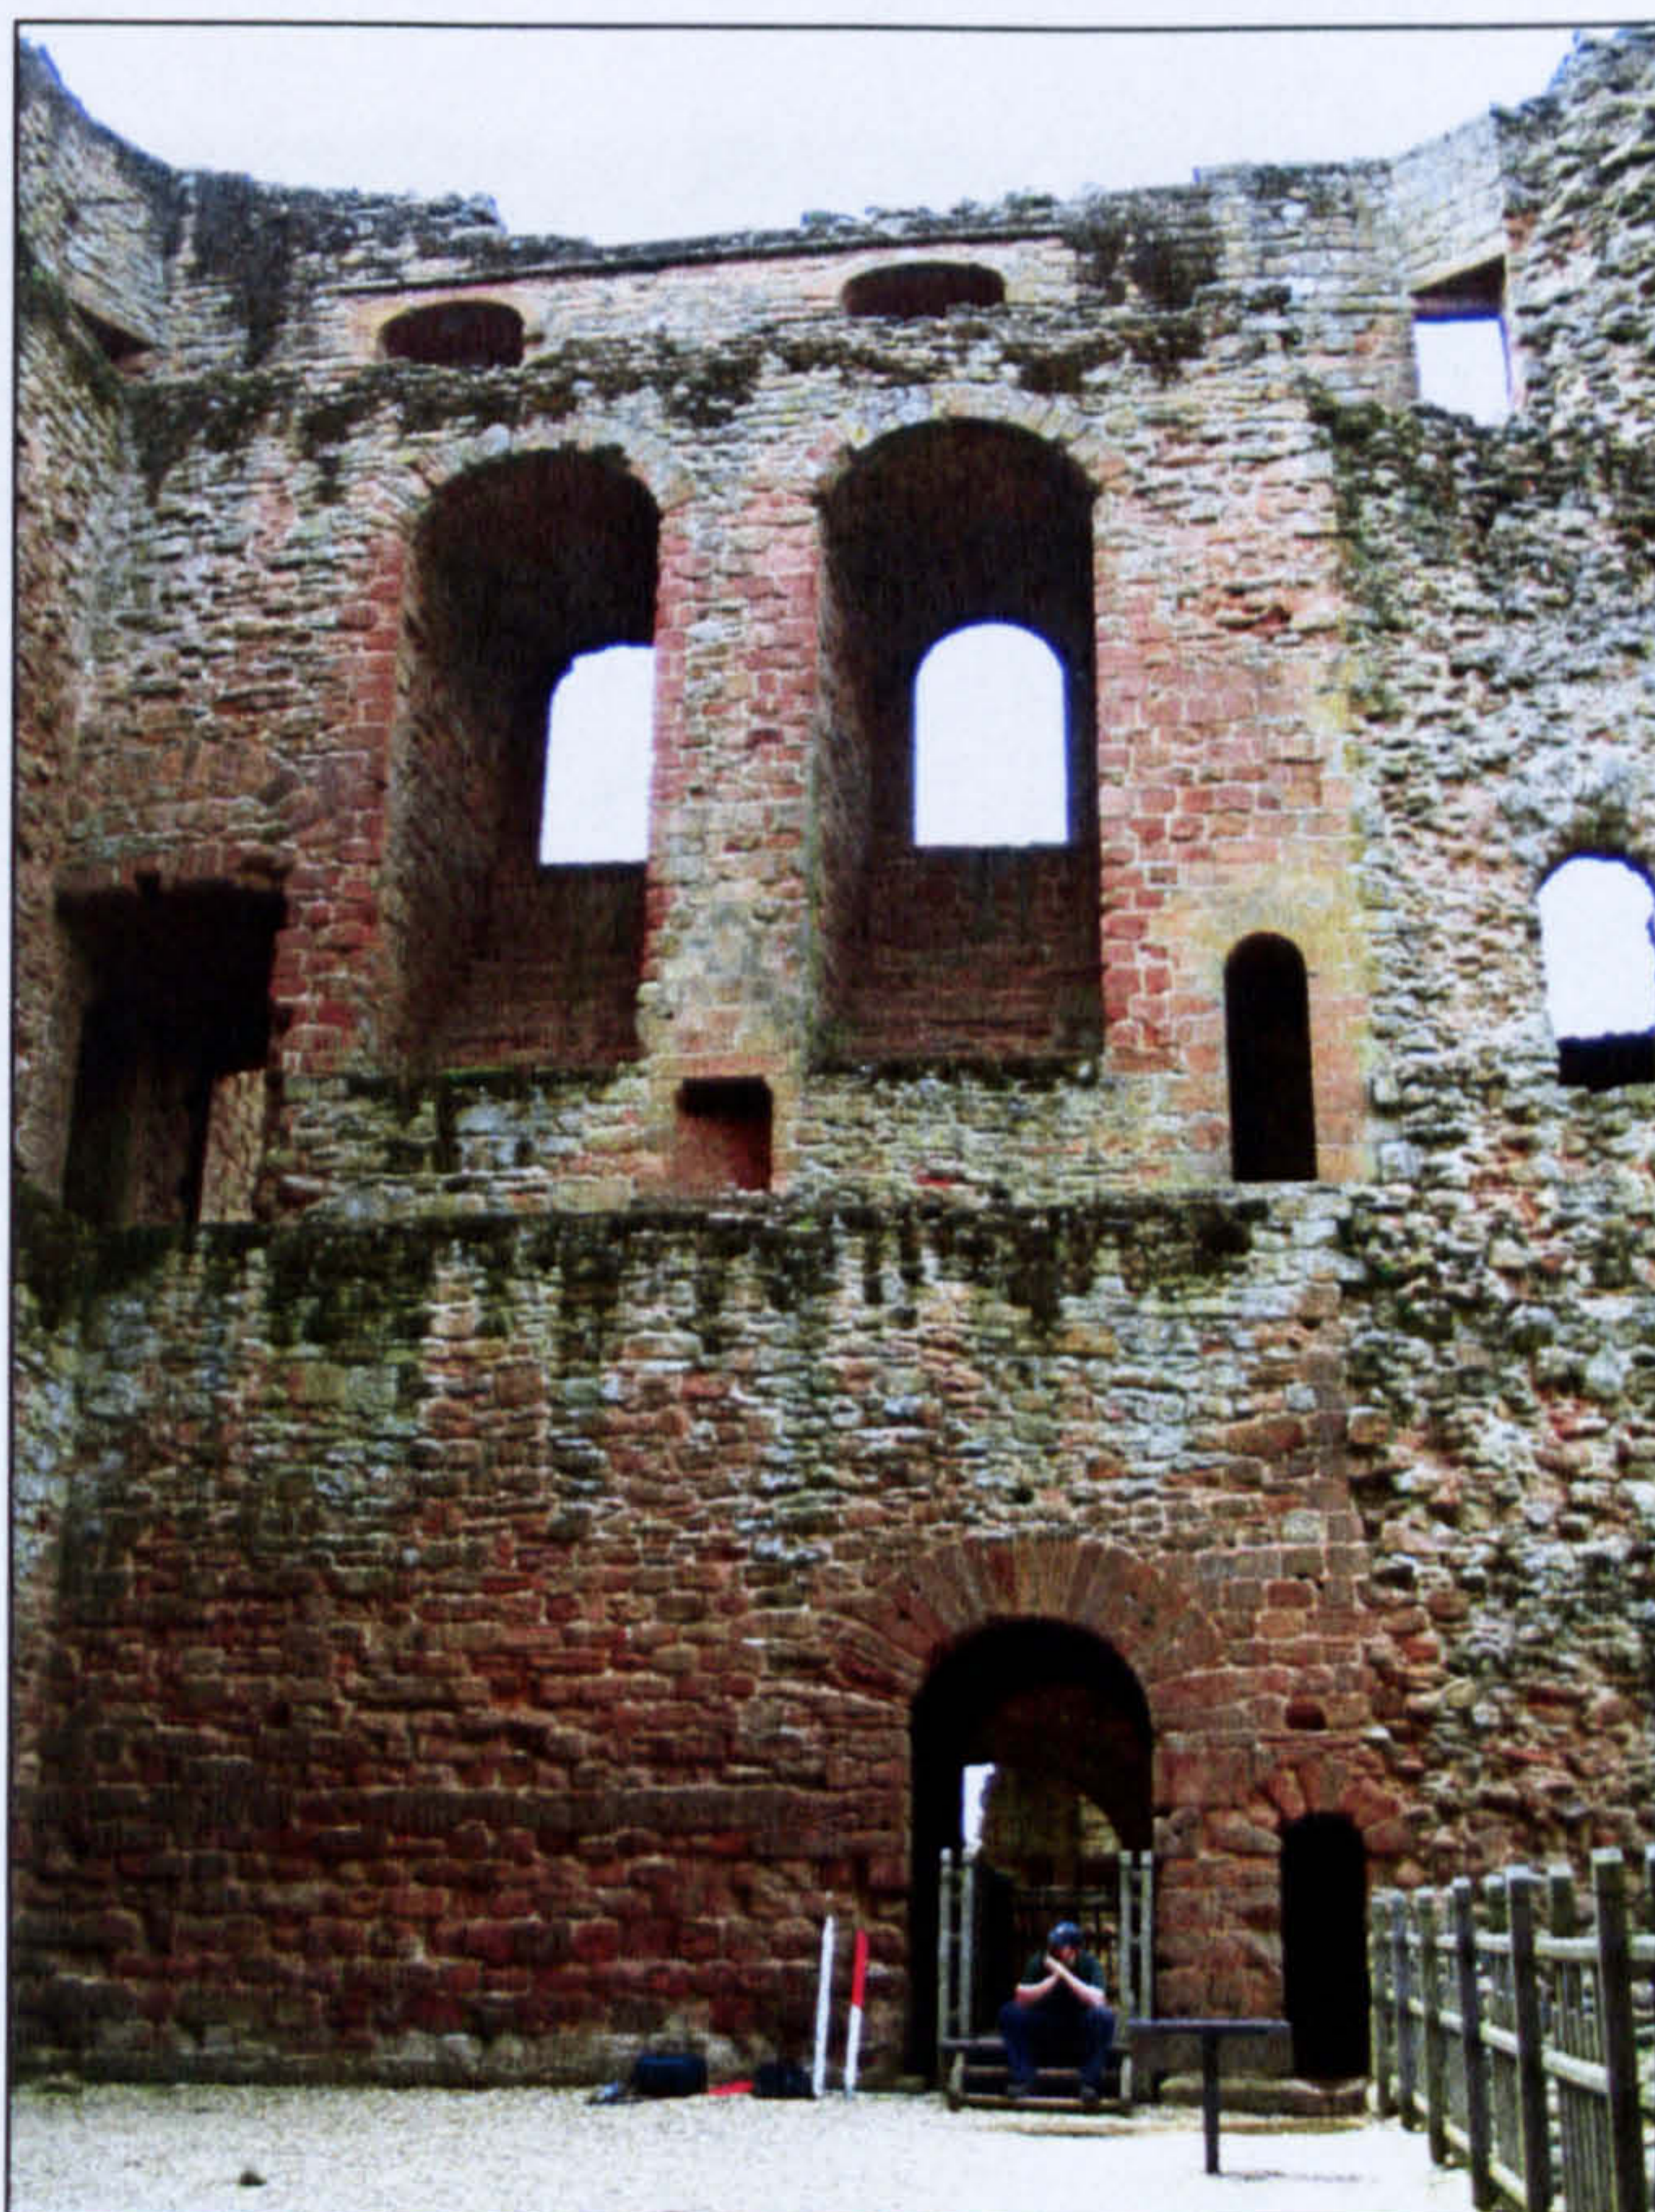
Figure 6.24 *Clockwise from top left:* The internal elevations of the east, south, and west walls, all showing a substantial amount of original, undamaged stonework.

The first step is to assess the condition of the three surviving internal walls, all of which show remarkably few signs of damage (Figure 6.24). The lack of secondary damage inside the keep indicates that the removal of facing stone was not a priority for the slighers, although this becomes more speculative regarding the missing north wall. There is also no evidence that timber removal was a priority, as all of the joists in the south wall remain undamaged *in situ* (Figure 6.25). This suggests that timber was either removed at the north wall end, or else was ignored and the picking of the north wall was strictly executed to cause primary damage. However, some timber removal would still have been necessary as the north wall could not have been demolished without first dismantling the roof and supporting timber infrastructure above. Clark (1884, 135) mentions that some of the roofing features were obscured by ‘recent repairs’, but none of these ‘repairs’ can be detected in the stonework of the three internal elevations. The absence of trauma and obvious signs of conservation work therefore suggests that if the north wall *was* picked, the execution of it did not damage the other three internal walls of the keep.

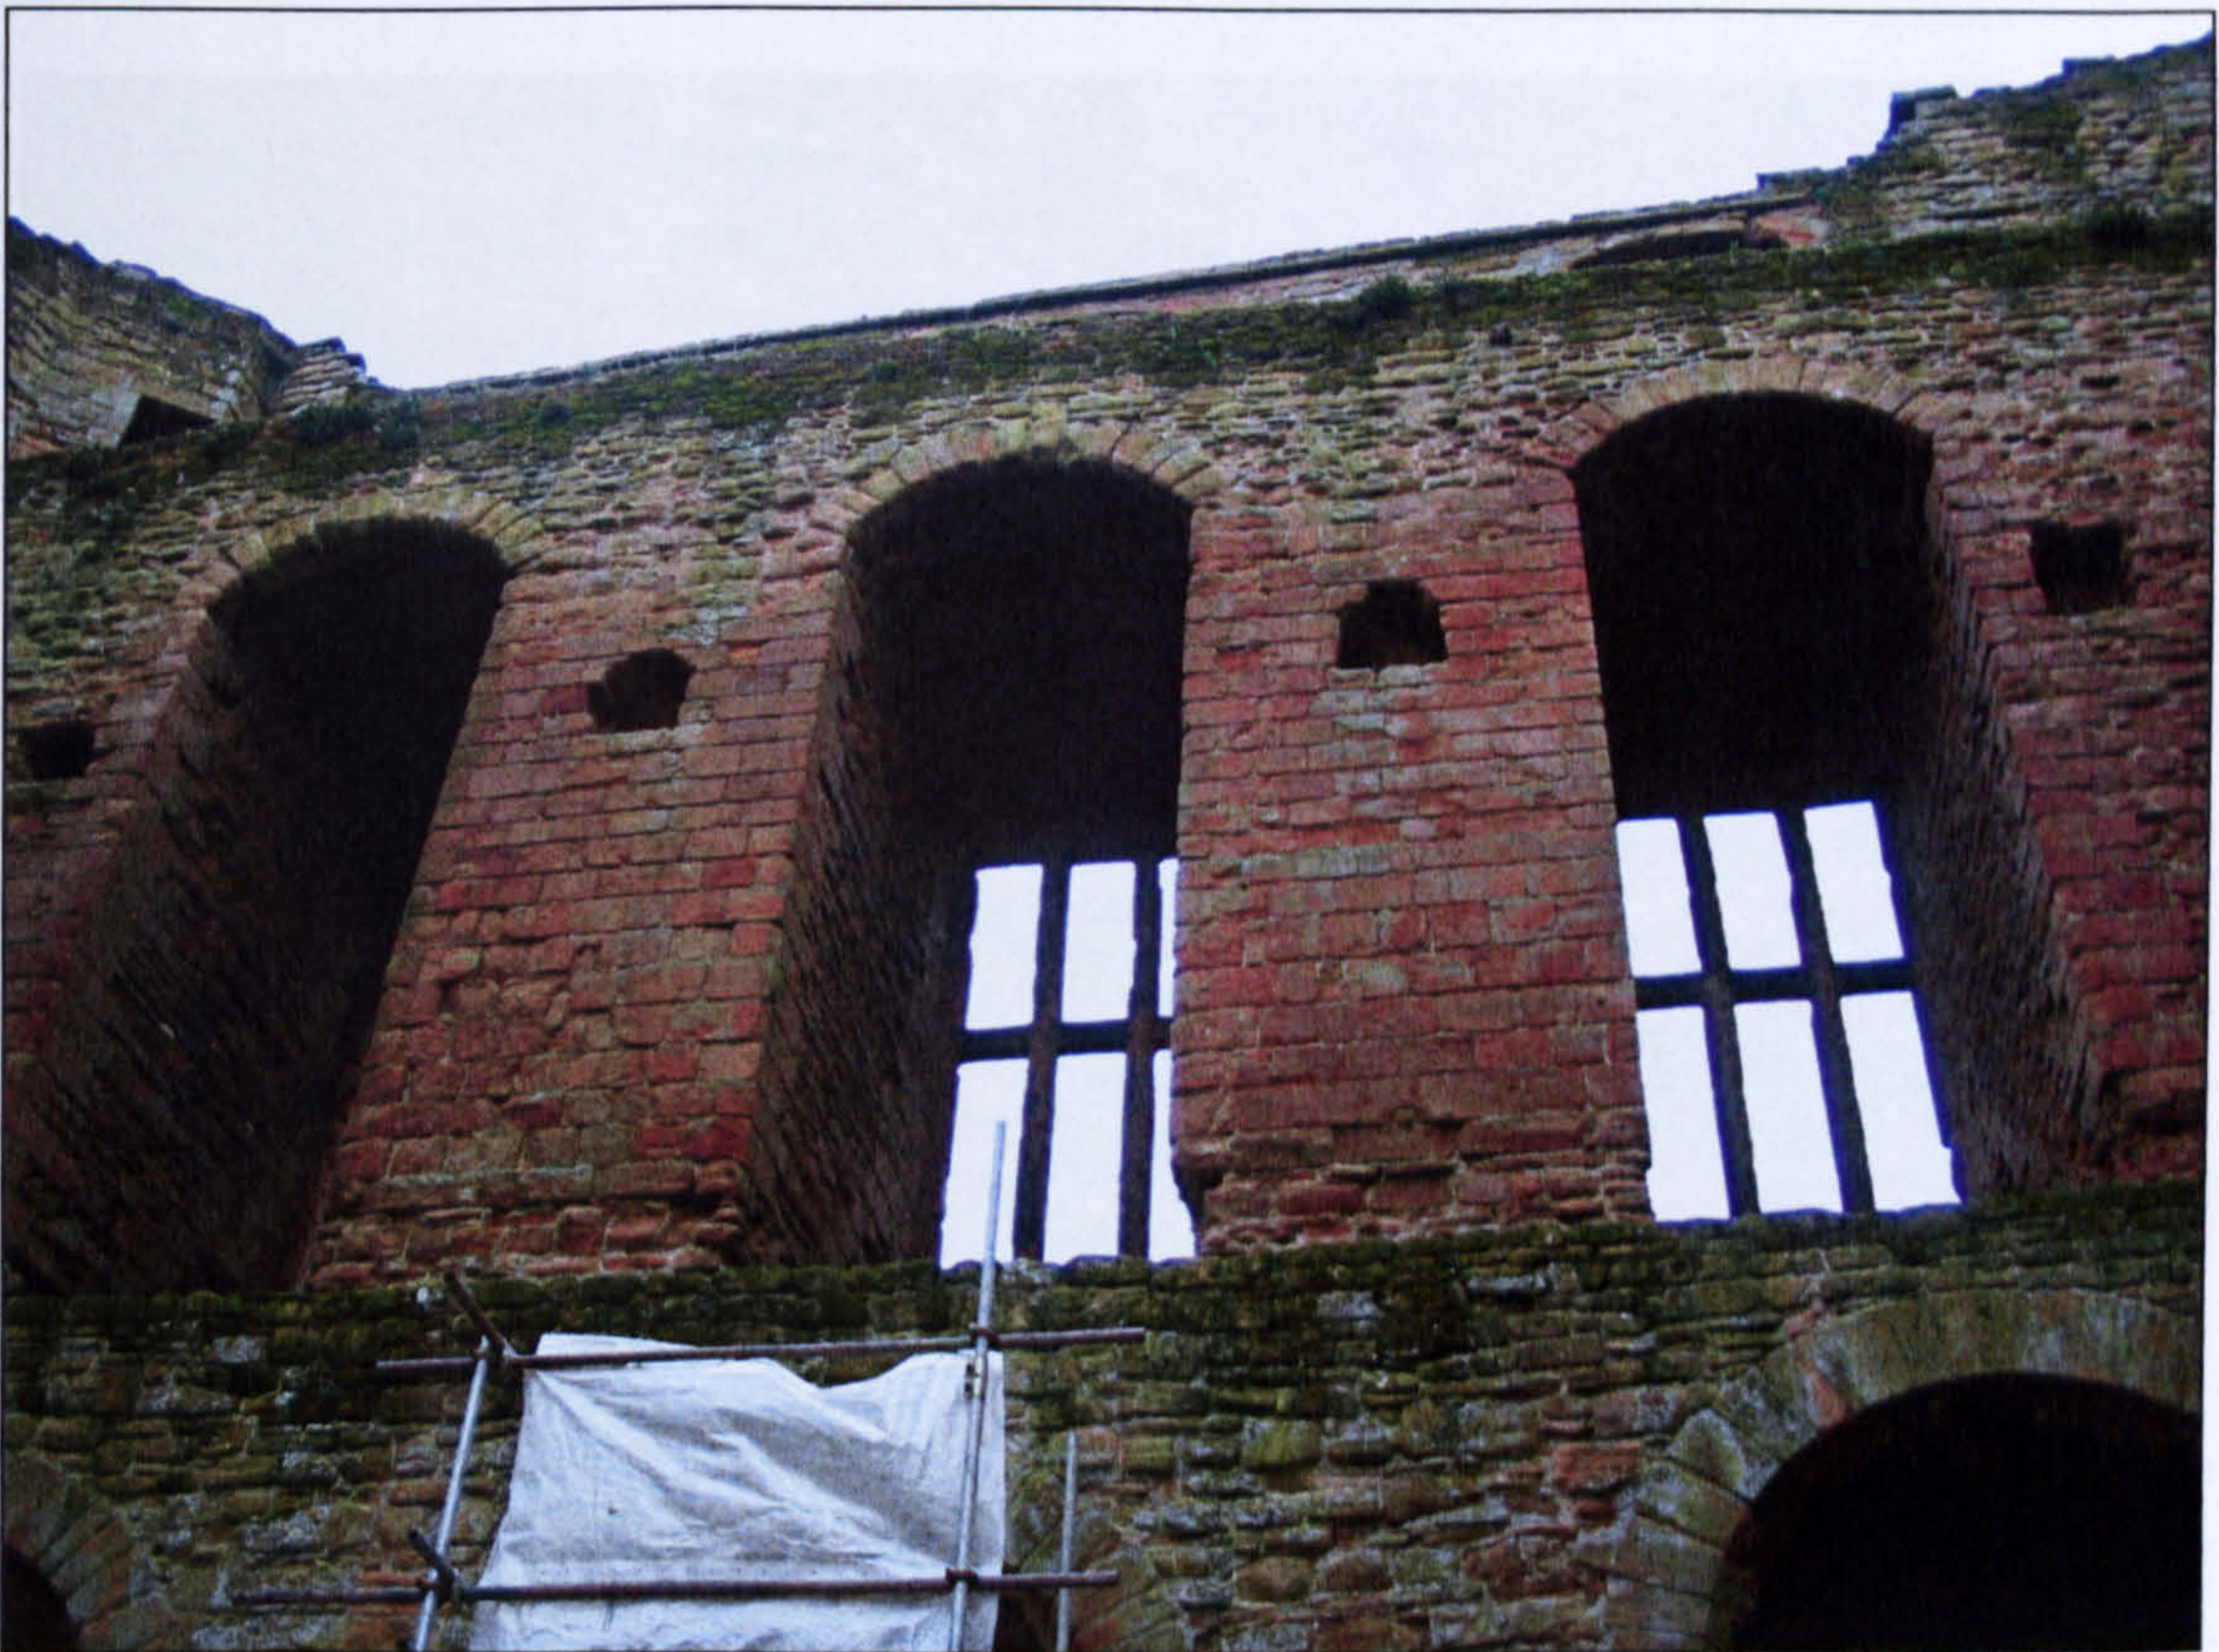
Figure 6.25 The upper half of the internal, south wall of the keep, showing intact and undamaged joist holes.
