ARCHAEOLOGY OF DESTRUCTION

A REINTERPRETATION OF CASTLE SLIGHTINGS IN THE ENGLISH CIVIL WAR

Thesis submitted for the degree of
Doctor of Philosophy
University of York
Department of Archaeology

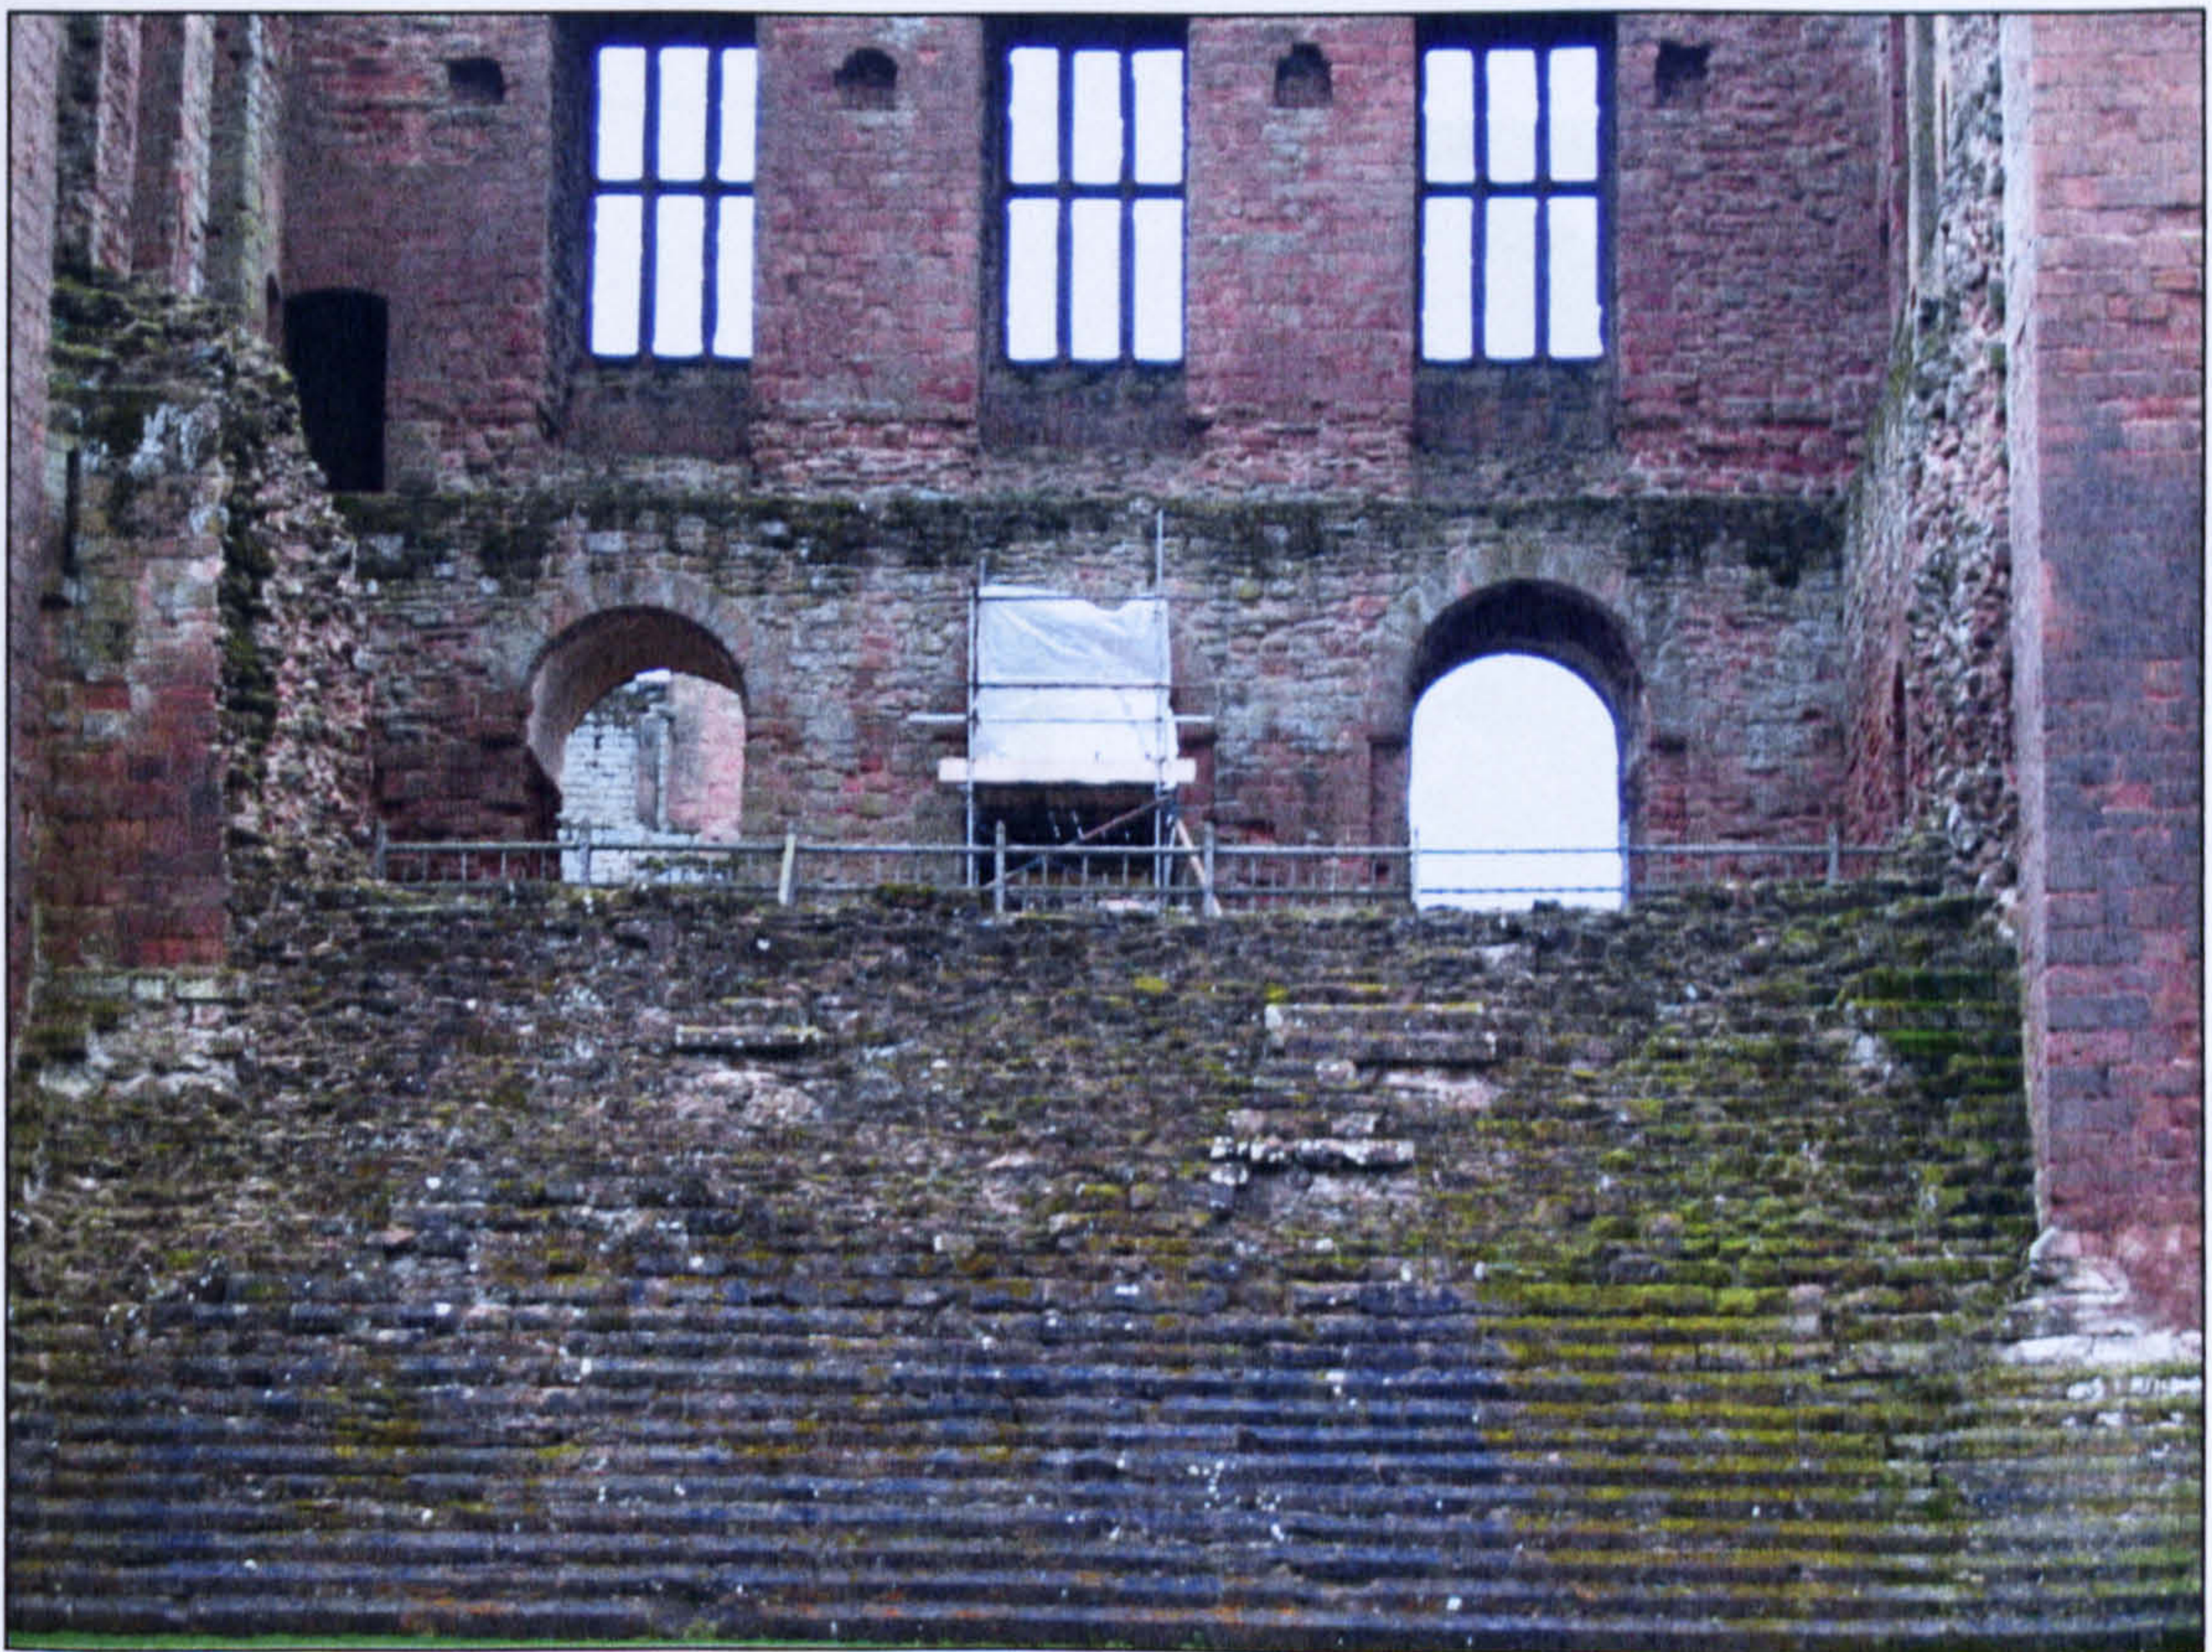
Figure 6.26 The north plinth, showing the damaged upper courses.

Figure 6.26 The north plinth, showing the damaged upper courses.

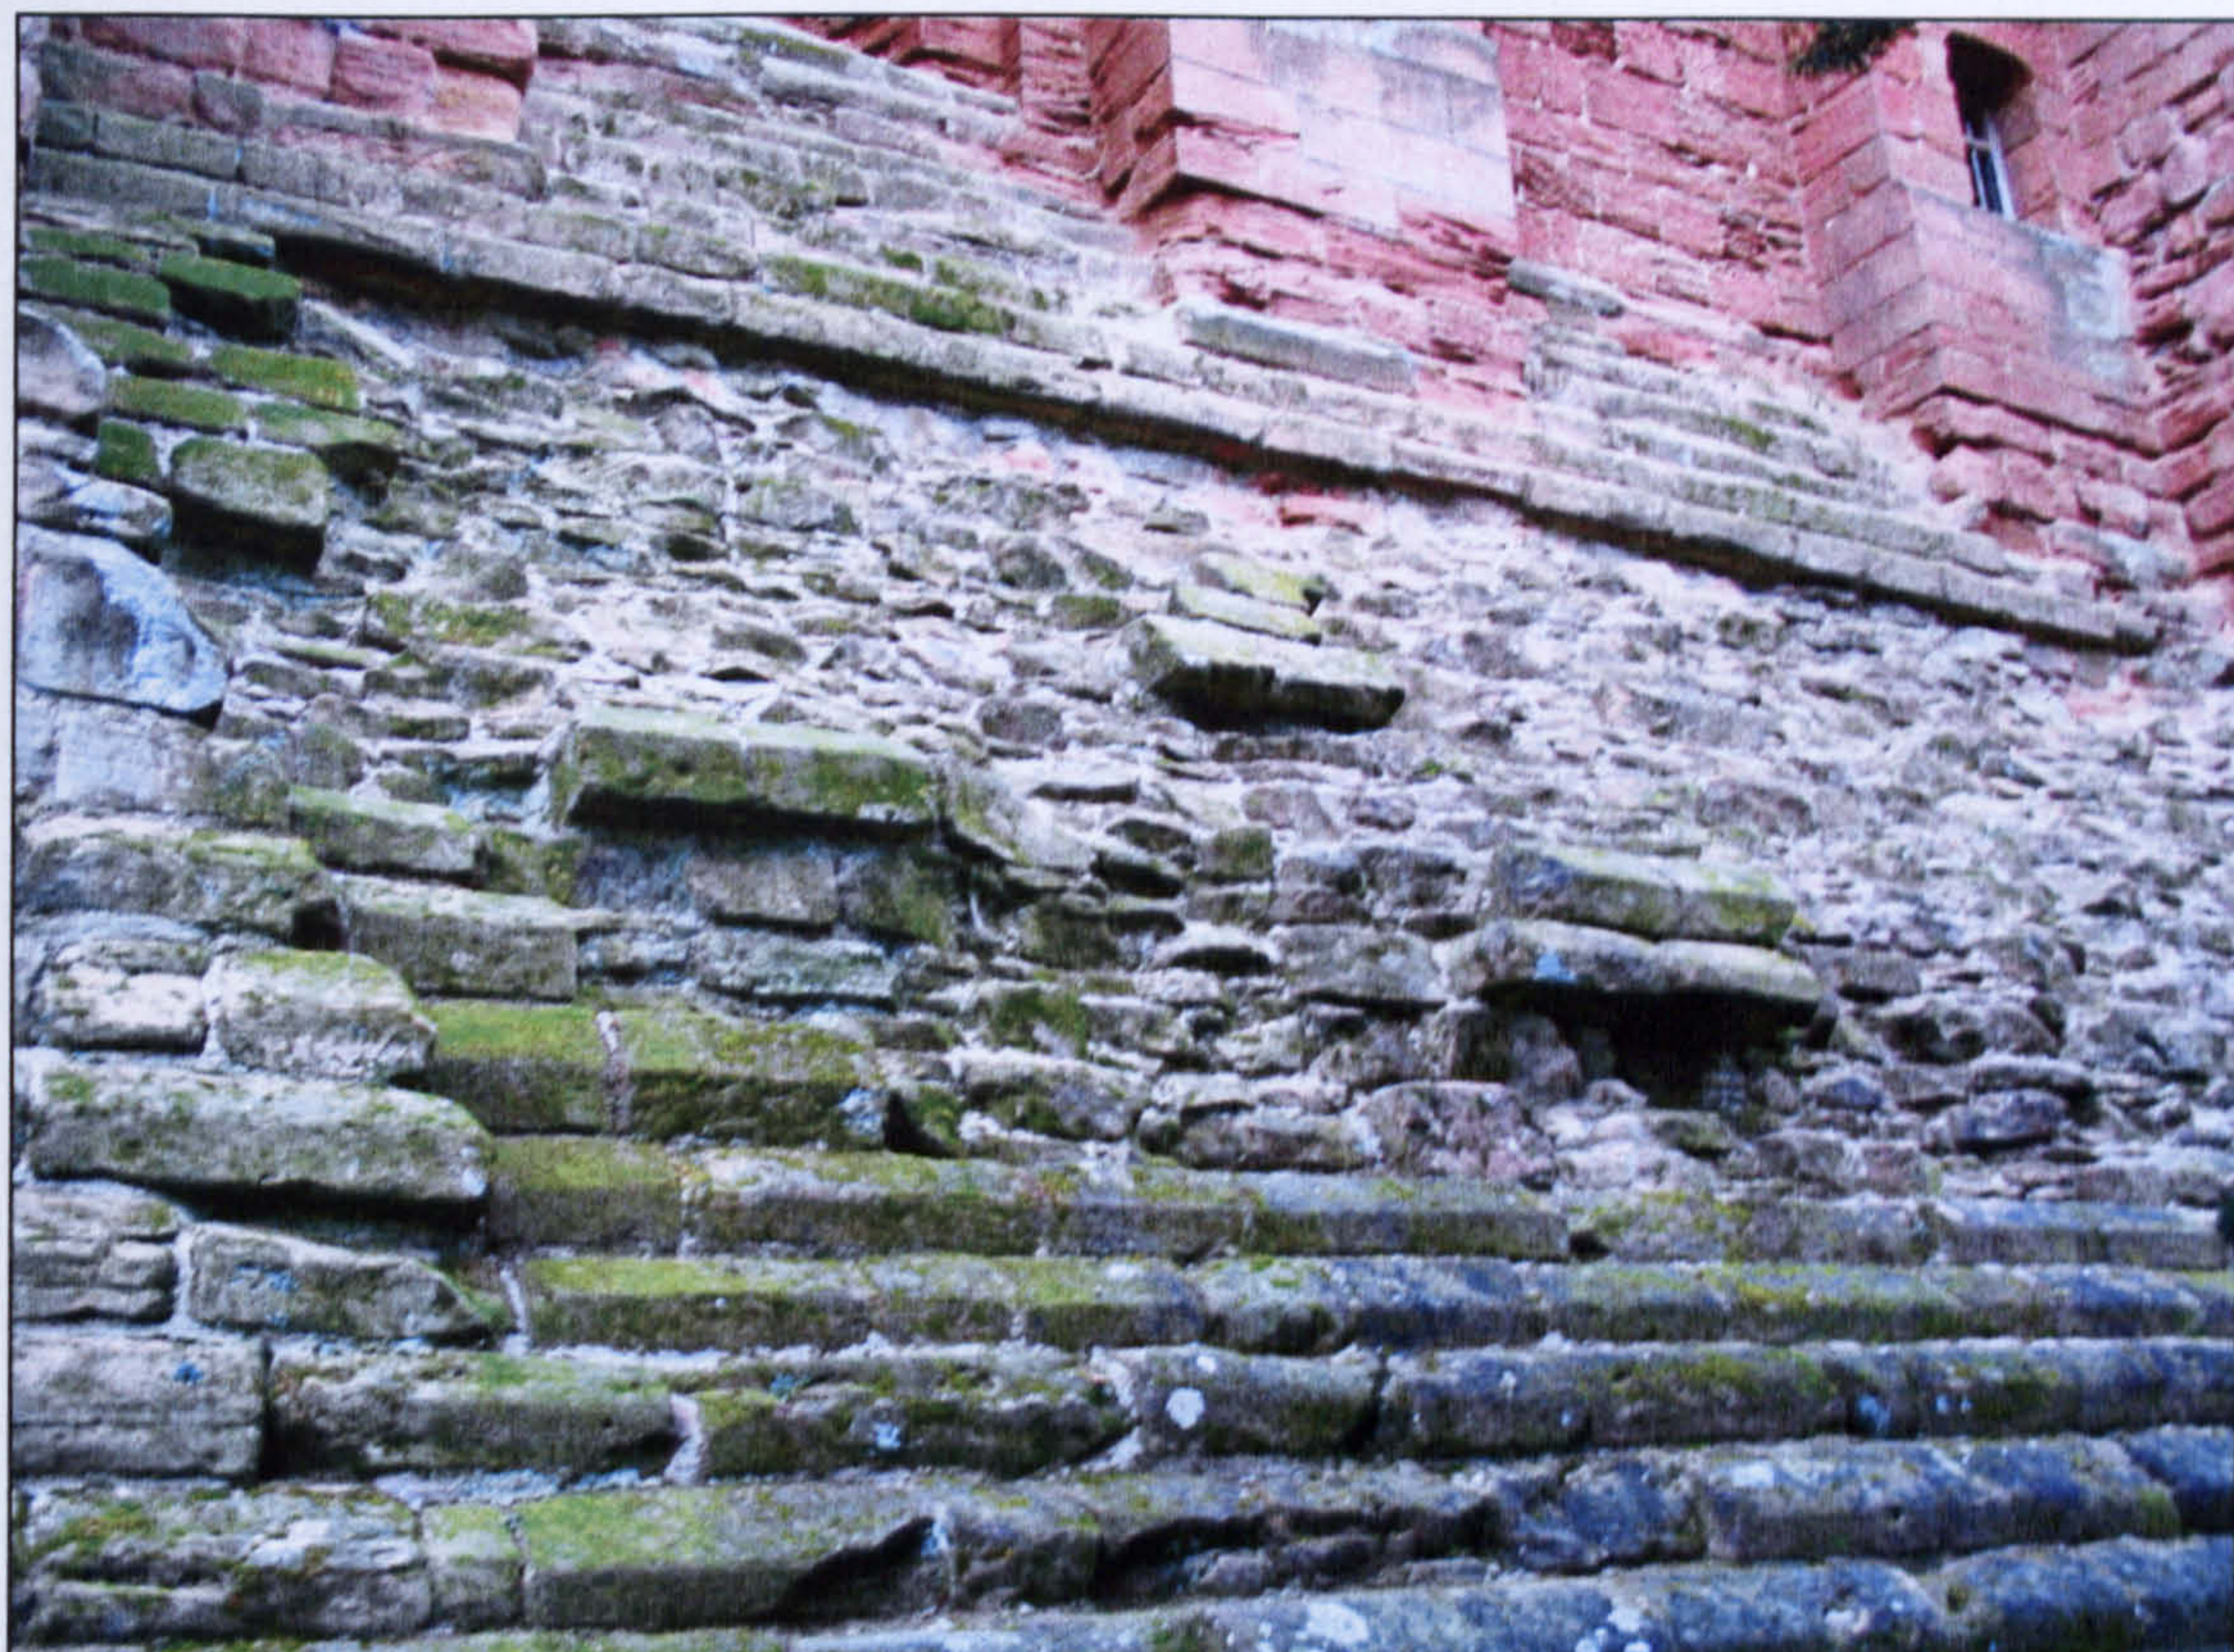
Figure 6.27 Close-up of the plinth on the east elevation, showing considerable damage to its upper courses.

Figure 6.27 Close-up of the plinth on the eastern elevation, showing considerable damage to its upper courses.

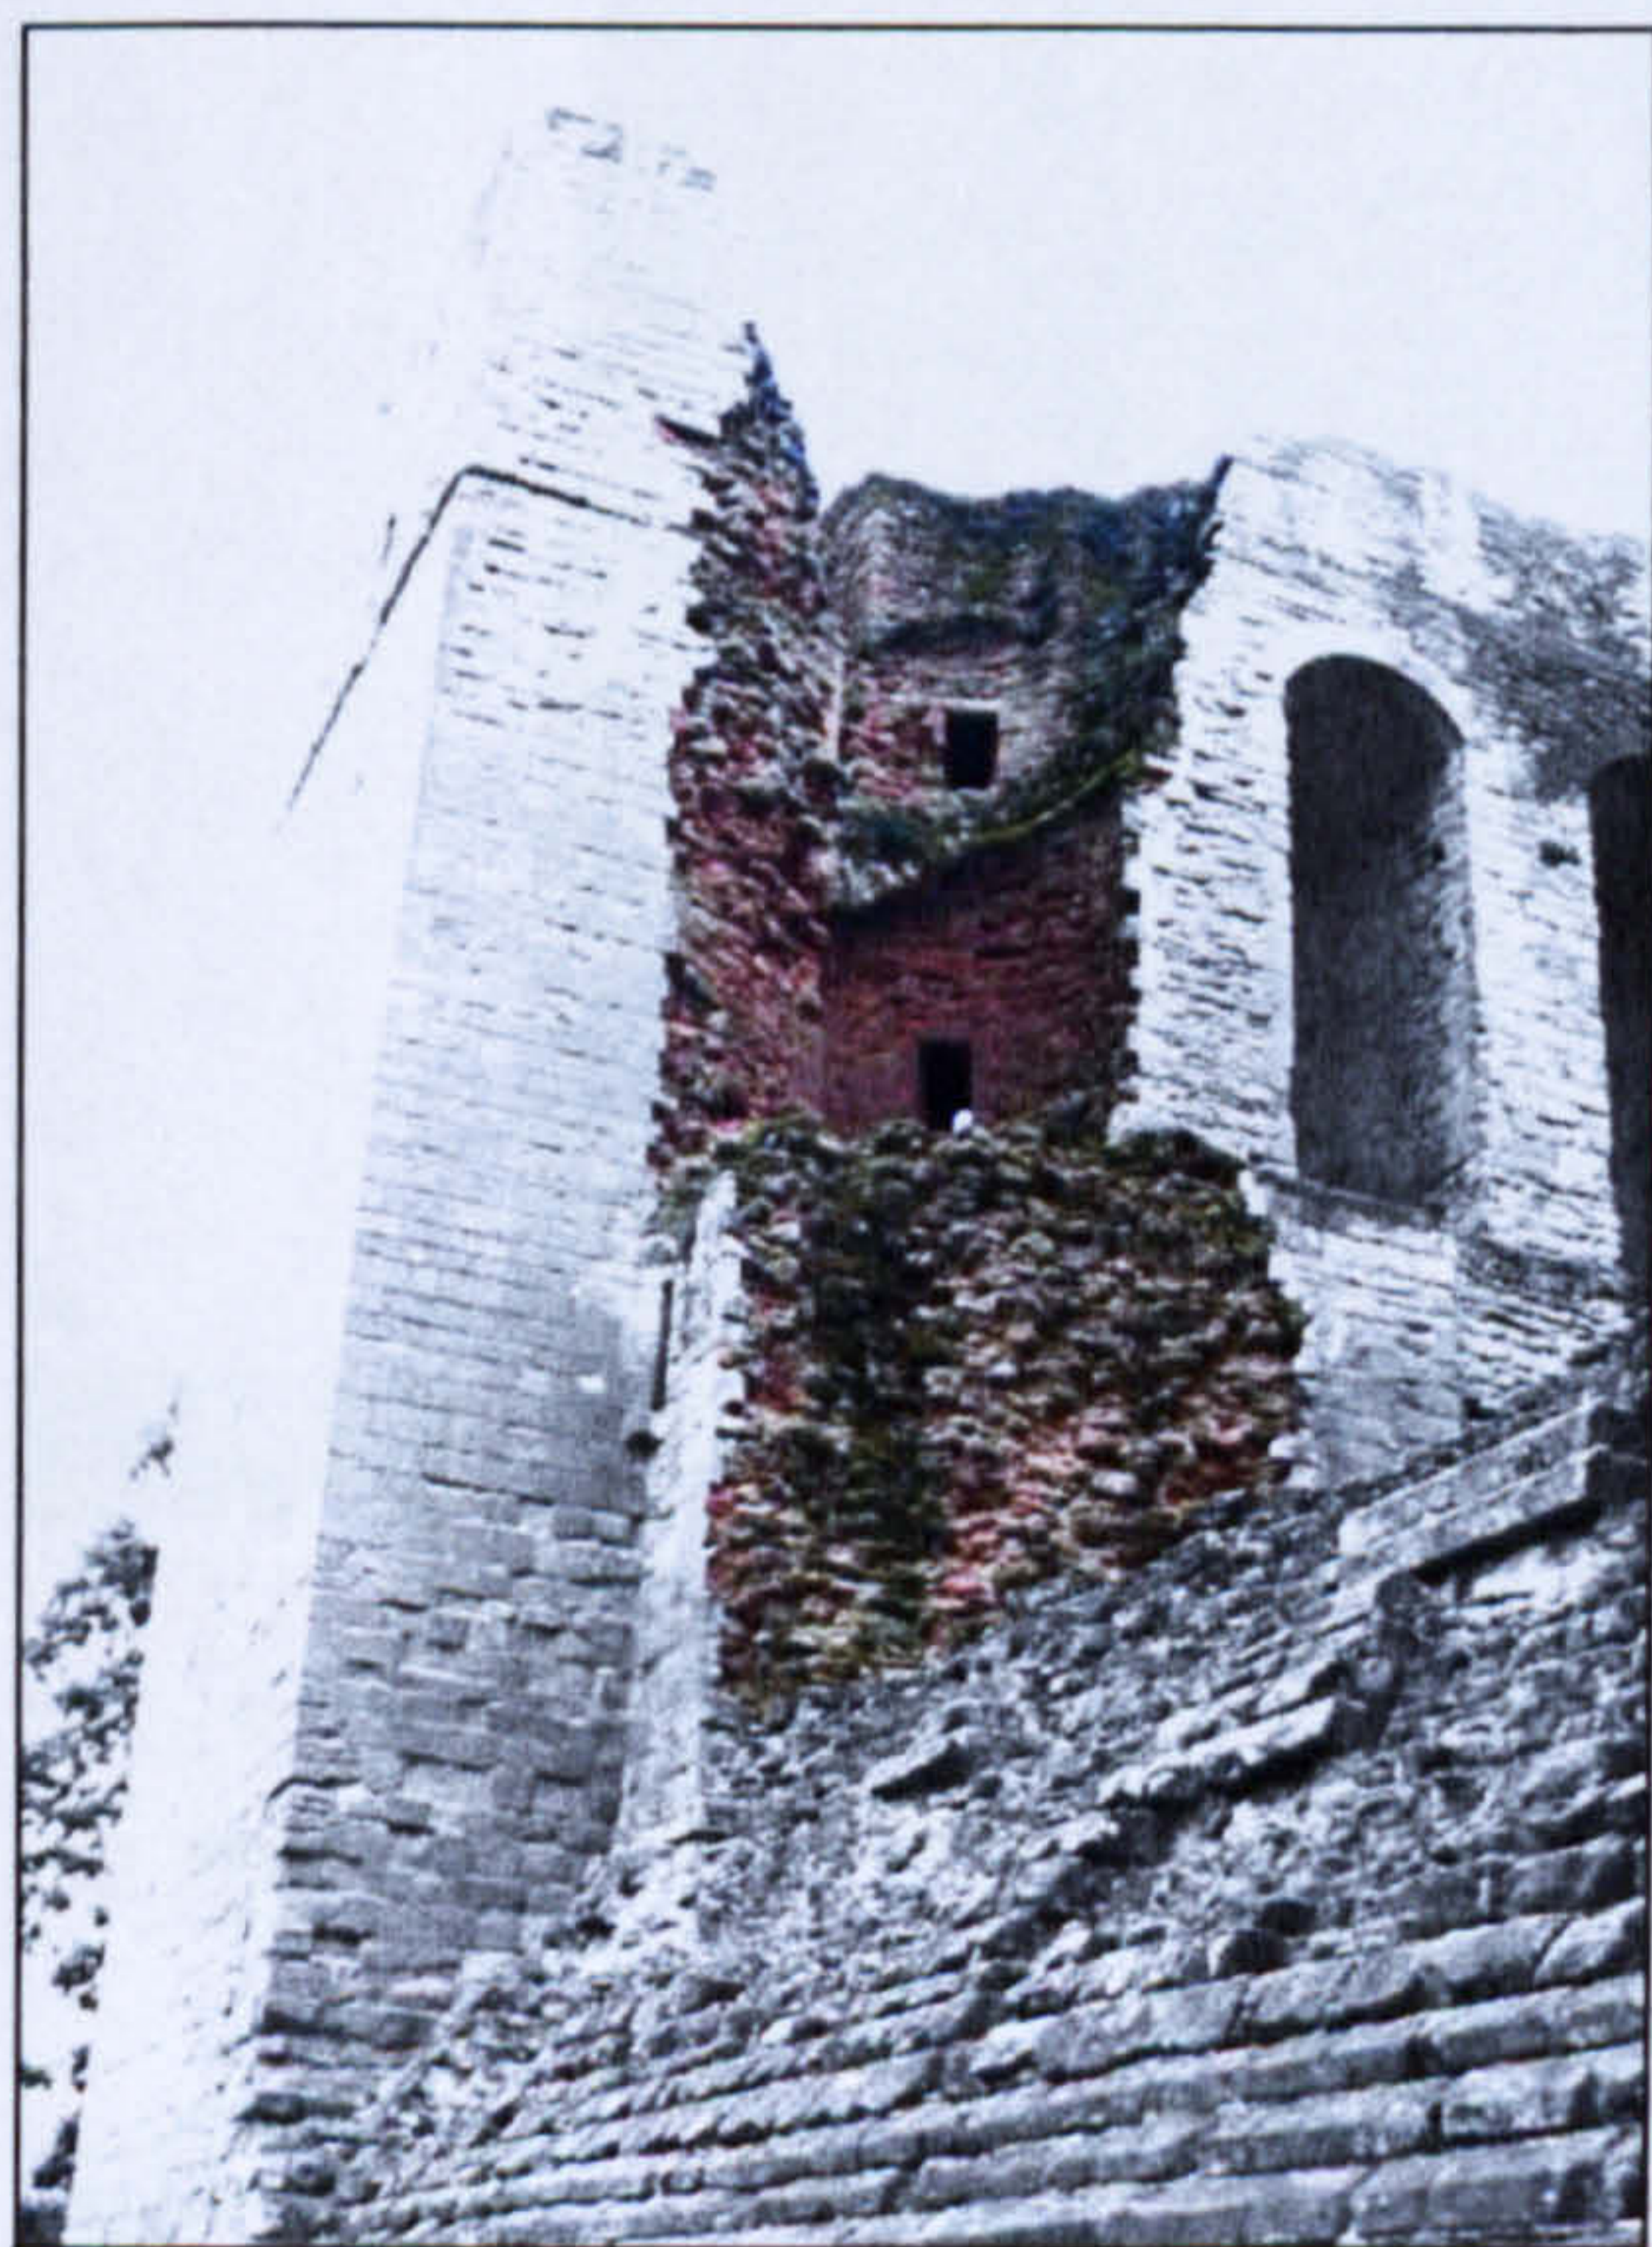
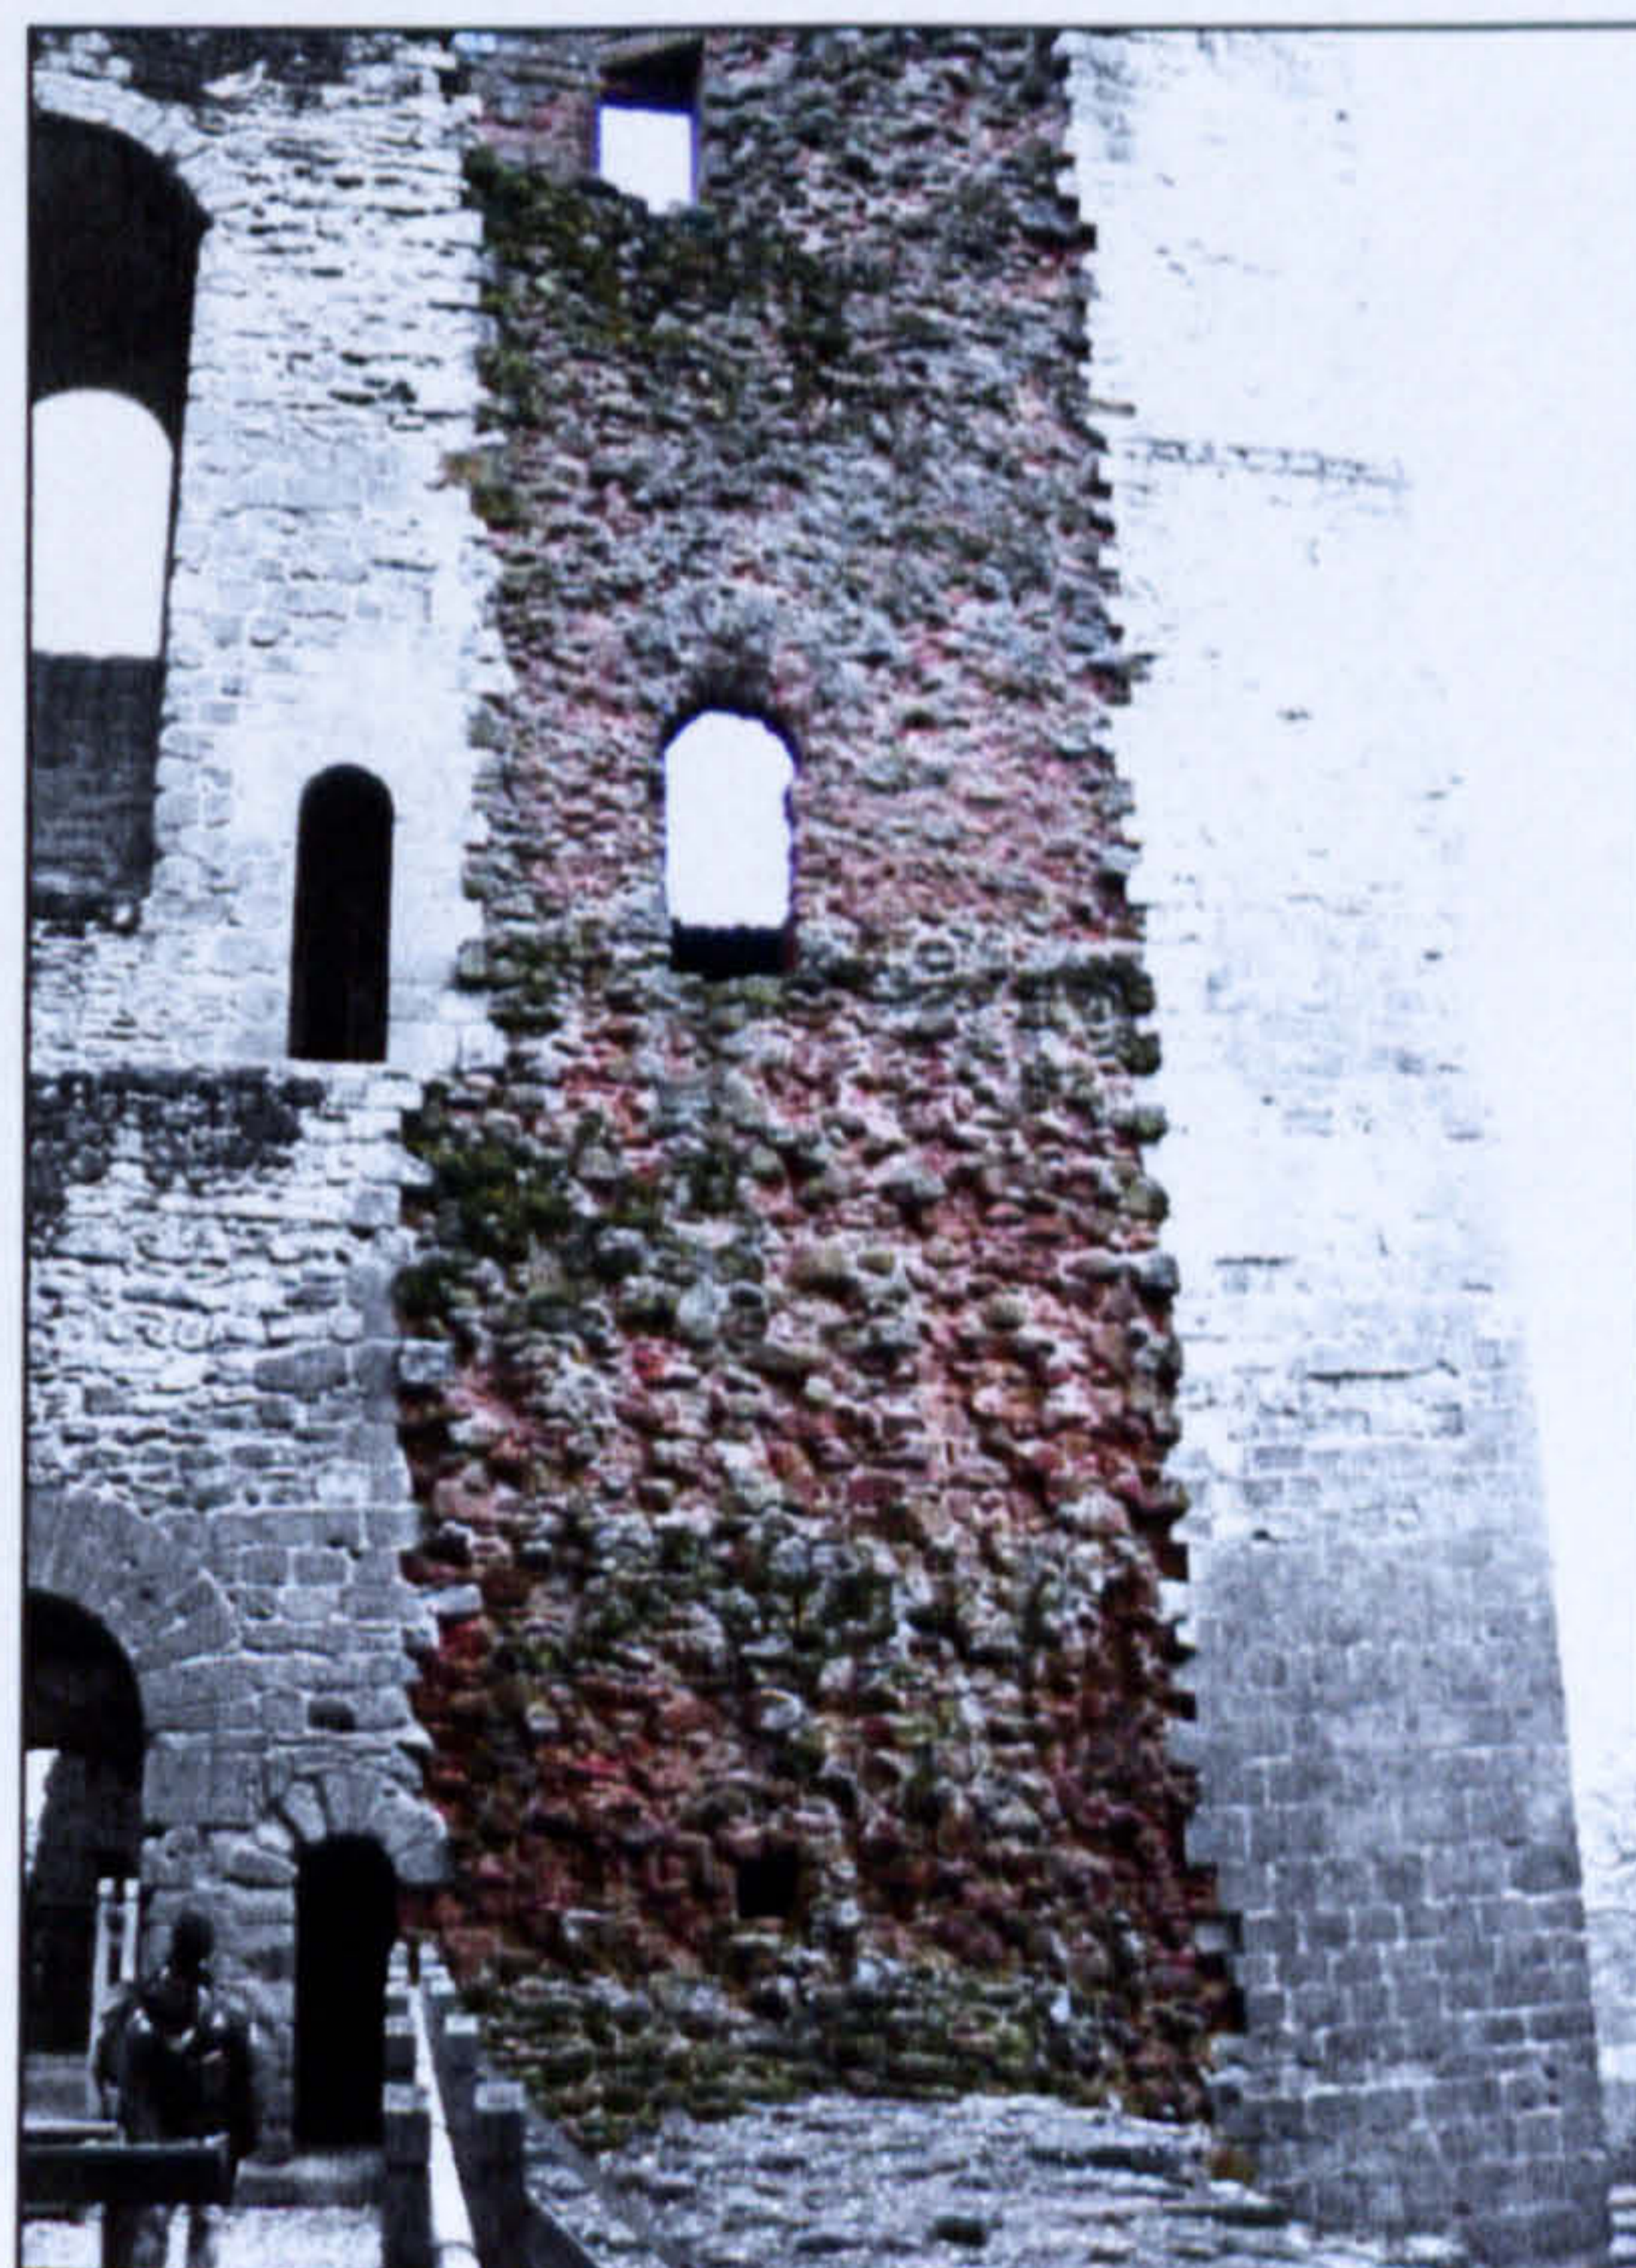
Figure 6.28 *Left:* The linear pattern of the exposed rubble core, northeast corner. *Right:* The linear pattern of the exposed rubble core, northwest corner.

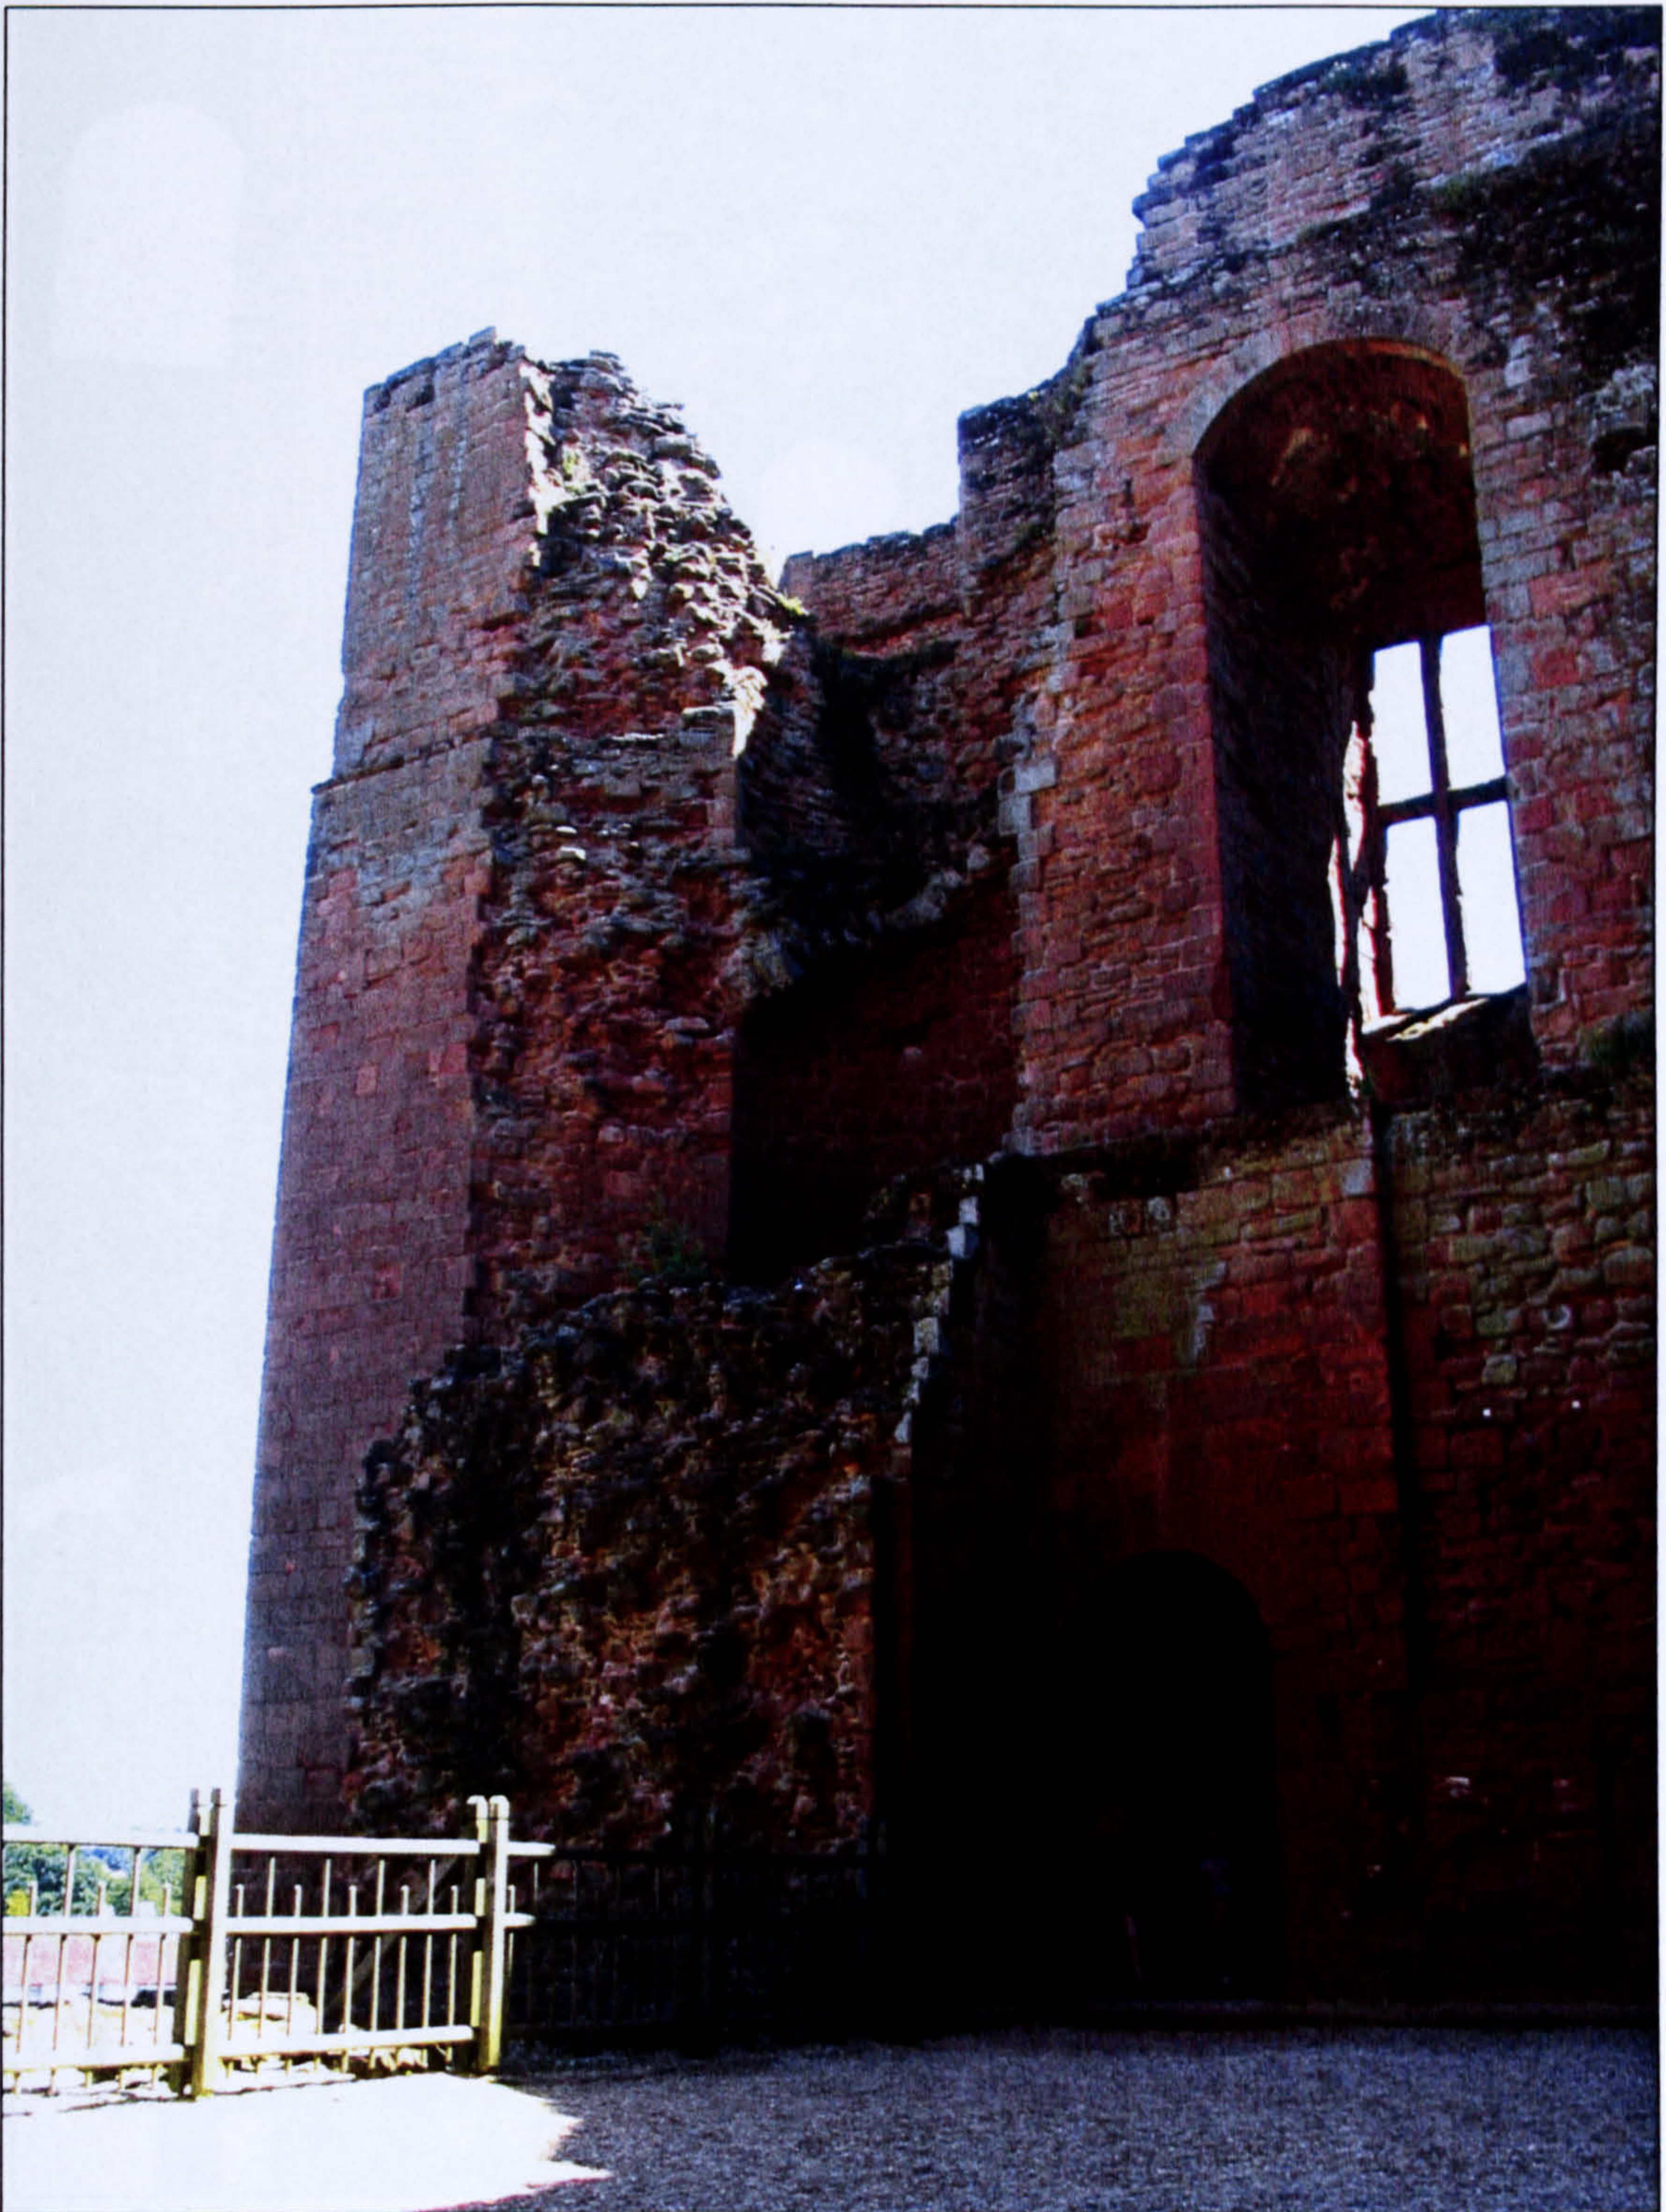
Figure 6.29 The northeast corner of the keep, showing the remnants of an upper floor stairwell.

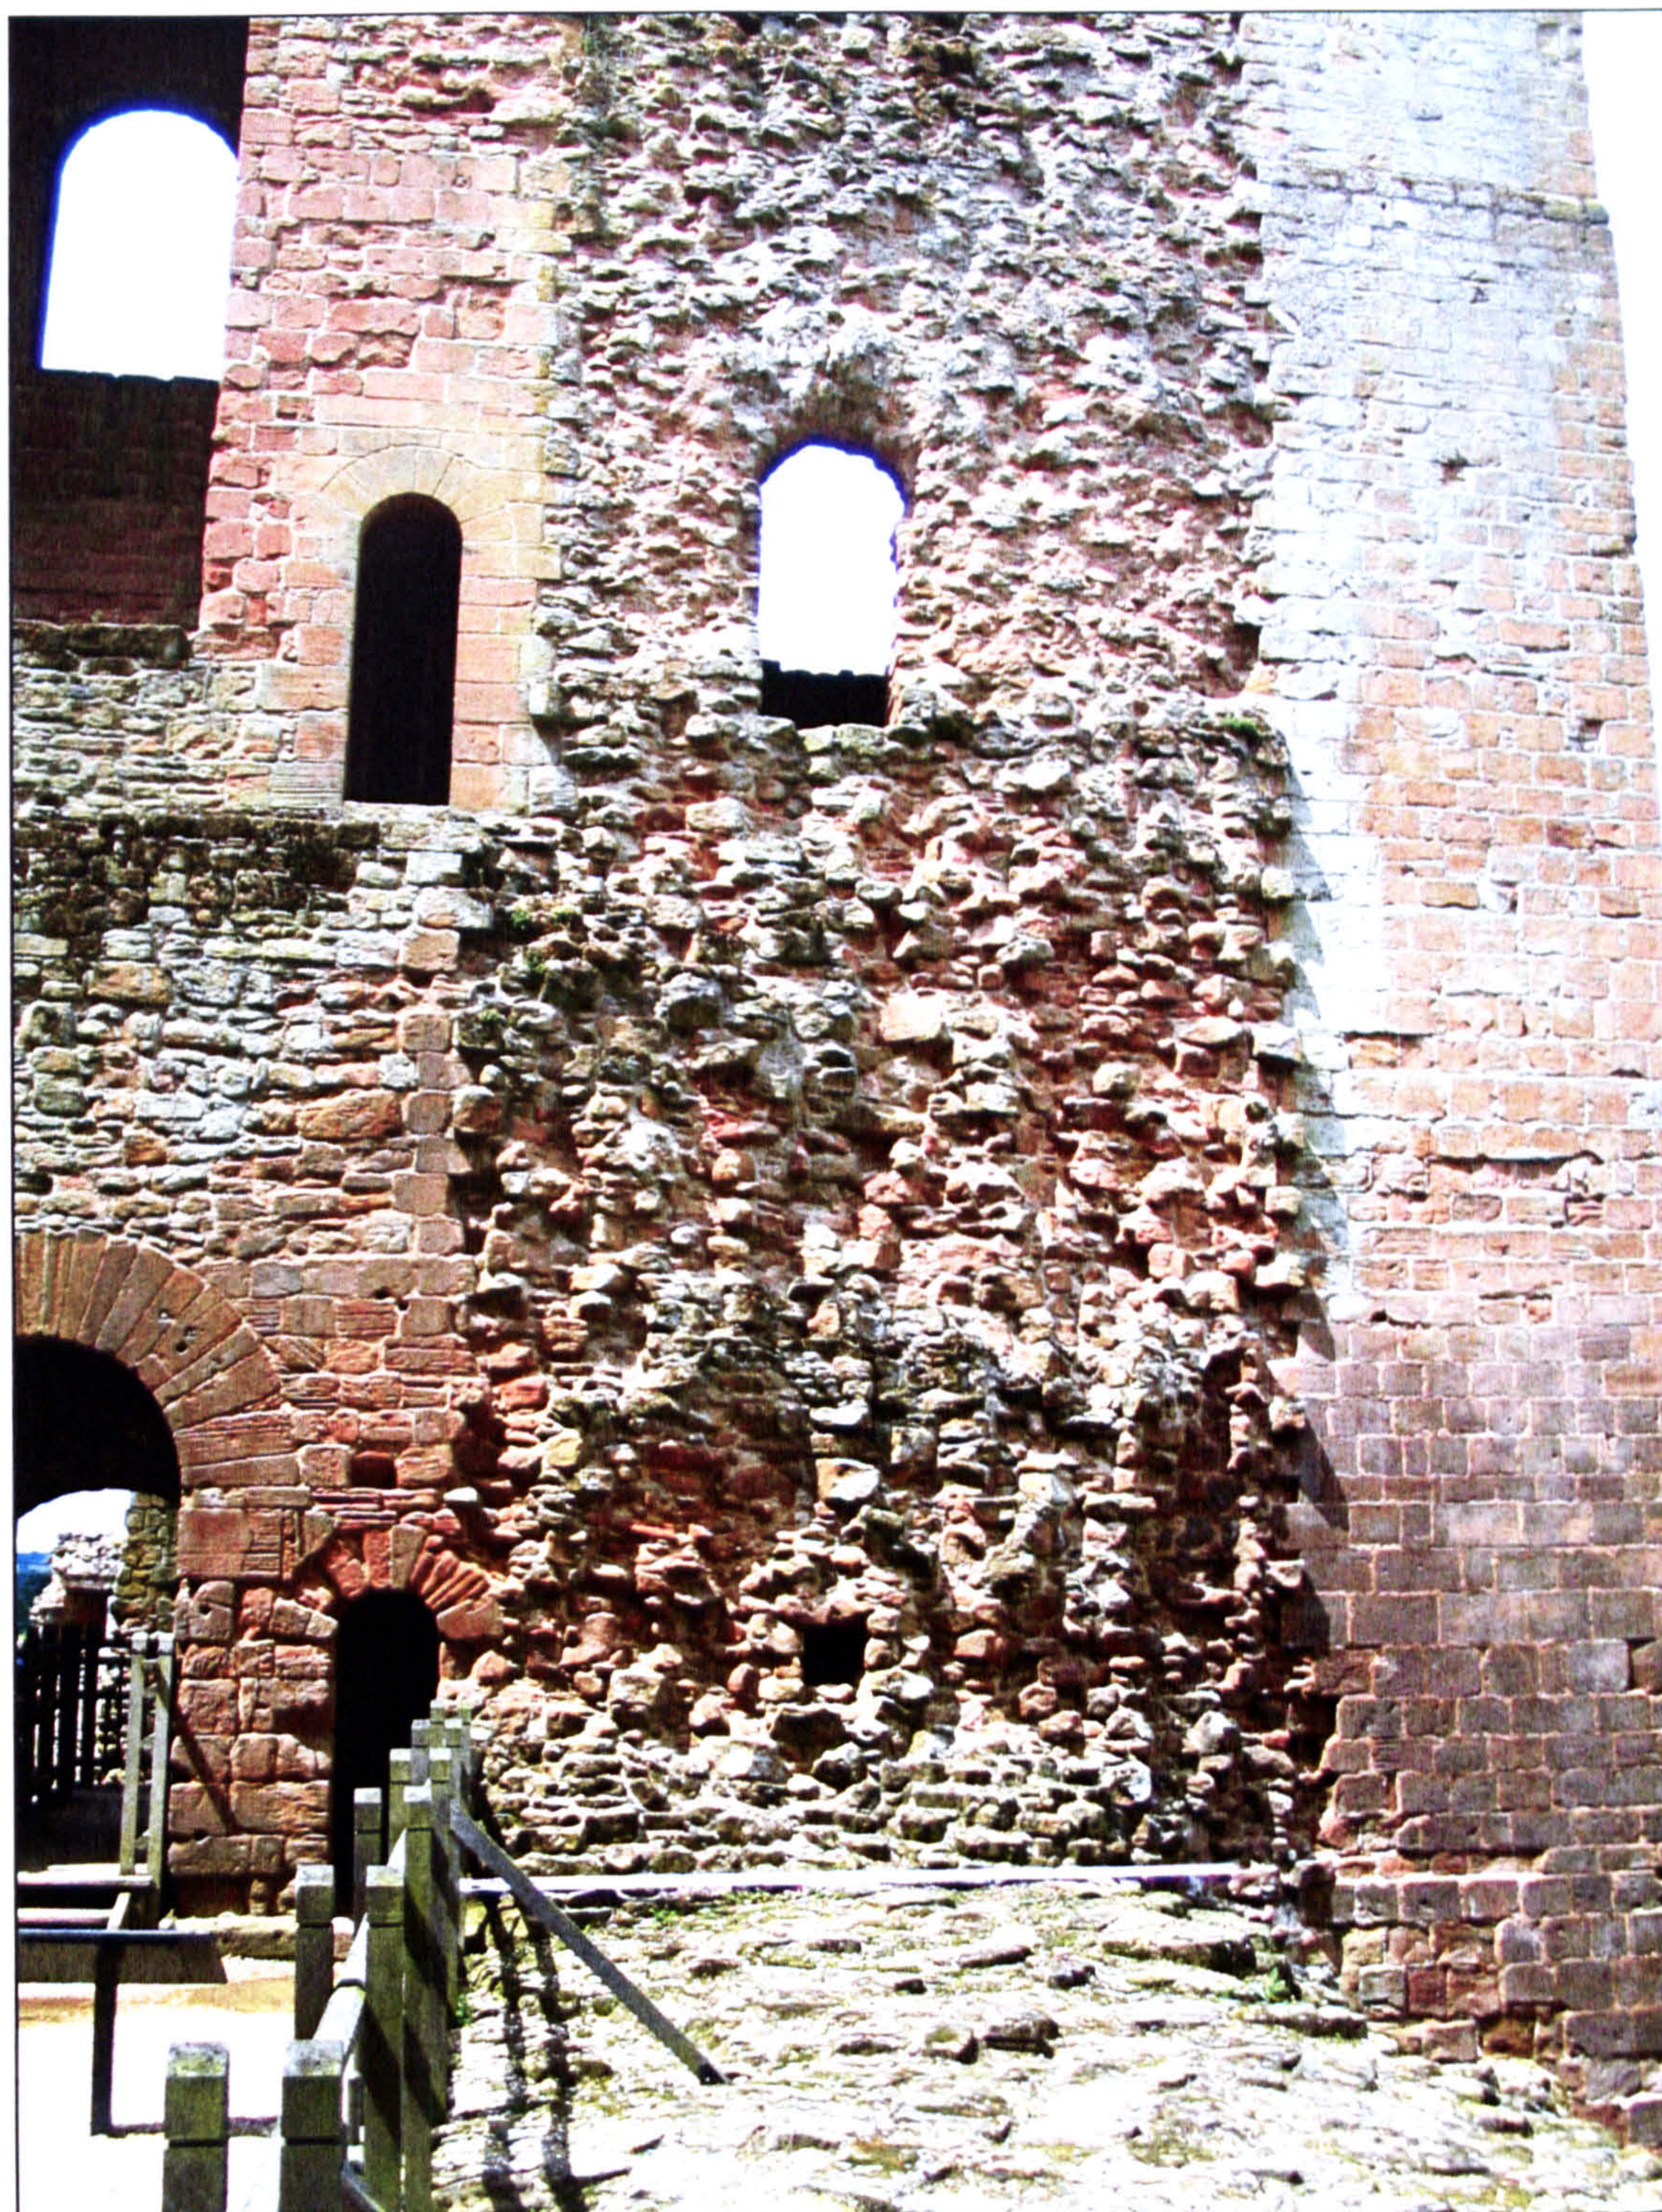
Figure 6.30 The northwest corner of the keep and its distinctive destruction pattern.

In contrast, the evidence pattern in the northwest corner presents a far more complex picture (Figure 6.30). The almost sharp demarcation lines and tidiness of the exposed rubble core prompted the Victorian G. T. Clark (1884, 133) to hypothesise that the north wall had ‘...been removed with some care, its junction with the north-west turret being cut smooth’. The lack of ‘overhanging’ rubble core and relative ‘flatness’ of its vertical surface area—from a structural perspective—does at first seem to indicate that the wall *was* picked apart course by course⁷, although an alternative explanation does exist (see below). Such an endeavour would have been

These weaknesses might explain how the north wall was undermined. By selectively removing stonework between the arches—through the buttresses—the ability of the lower wall to support the load from above could have been fatally compromised. All things being structurally equal, the part of a wall least able to weather a change in static conditions is the part farthest from other structural 'supports' (such as other walls). In practical terms, this usually translates into the middle or centre of a wall, largely because the load has nowhere else to go. At Kenilworth, however, the area that in theory should be the strongest—the points of contact with the east and west walls—in practice are not because they share so little wall mass in common. As Figure 6.34 shows, the windows on both floors are nearly flush with their respective adjacent walls, which means that very little of the south wall (and by comparison, the north wall) was bonded enough to receive any practical, lateral support. The areas that *did* receive direct structural support were compromised by the poor quality of construction on the upper floors, as evidenced by the smaller stones and greater use of mortar (Figures 6.30 and 6.31). In short, the northeast and northwest corners might
