ARCHAEOLOGY OF DESTRUCTION

A REINTERPRETATION OF CASTLE SLIGHTINGS IN THE ENGLISH CIVIL WAR

Thesis submitted for the degree of
Doctor of Philosophy
University of York
Department of Archaeology

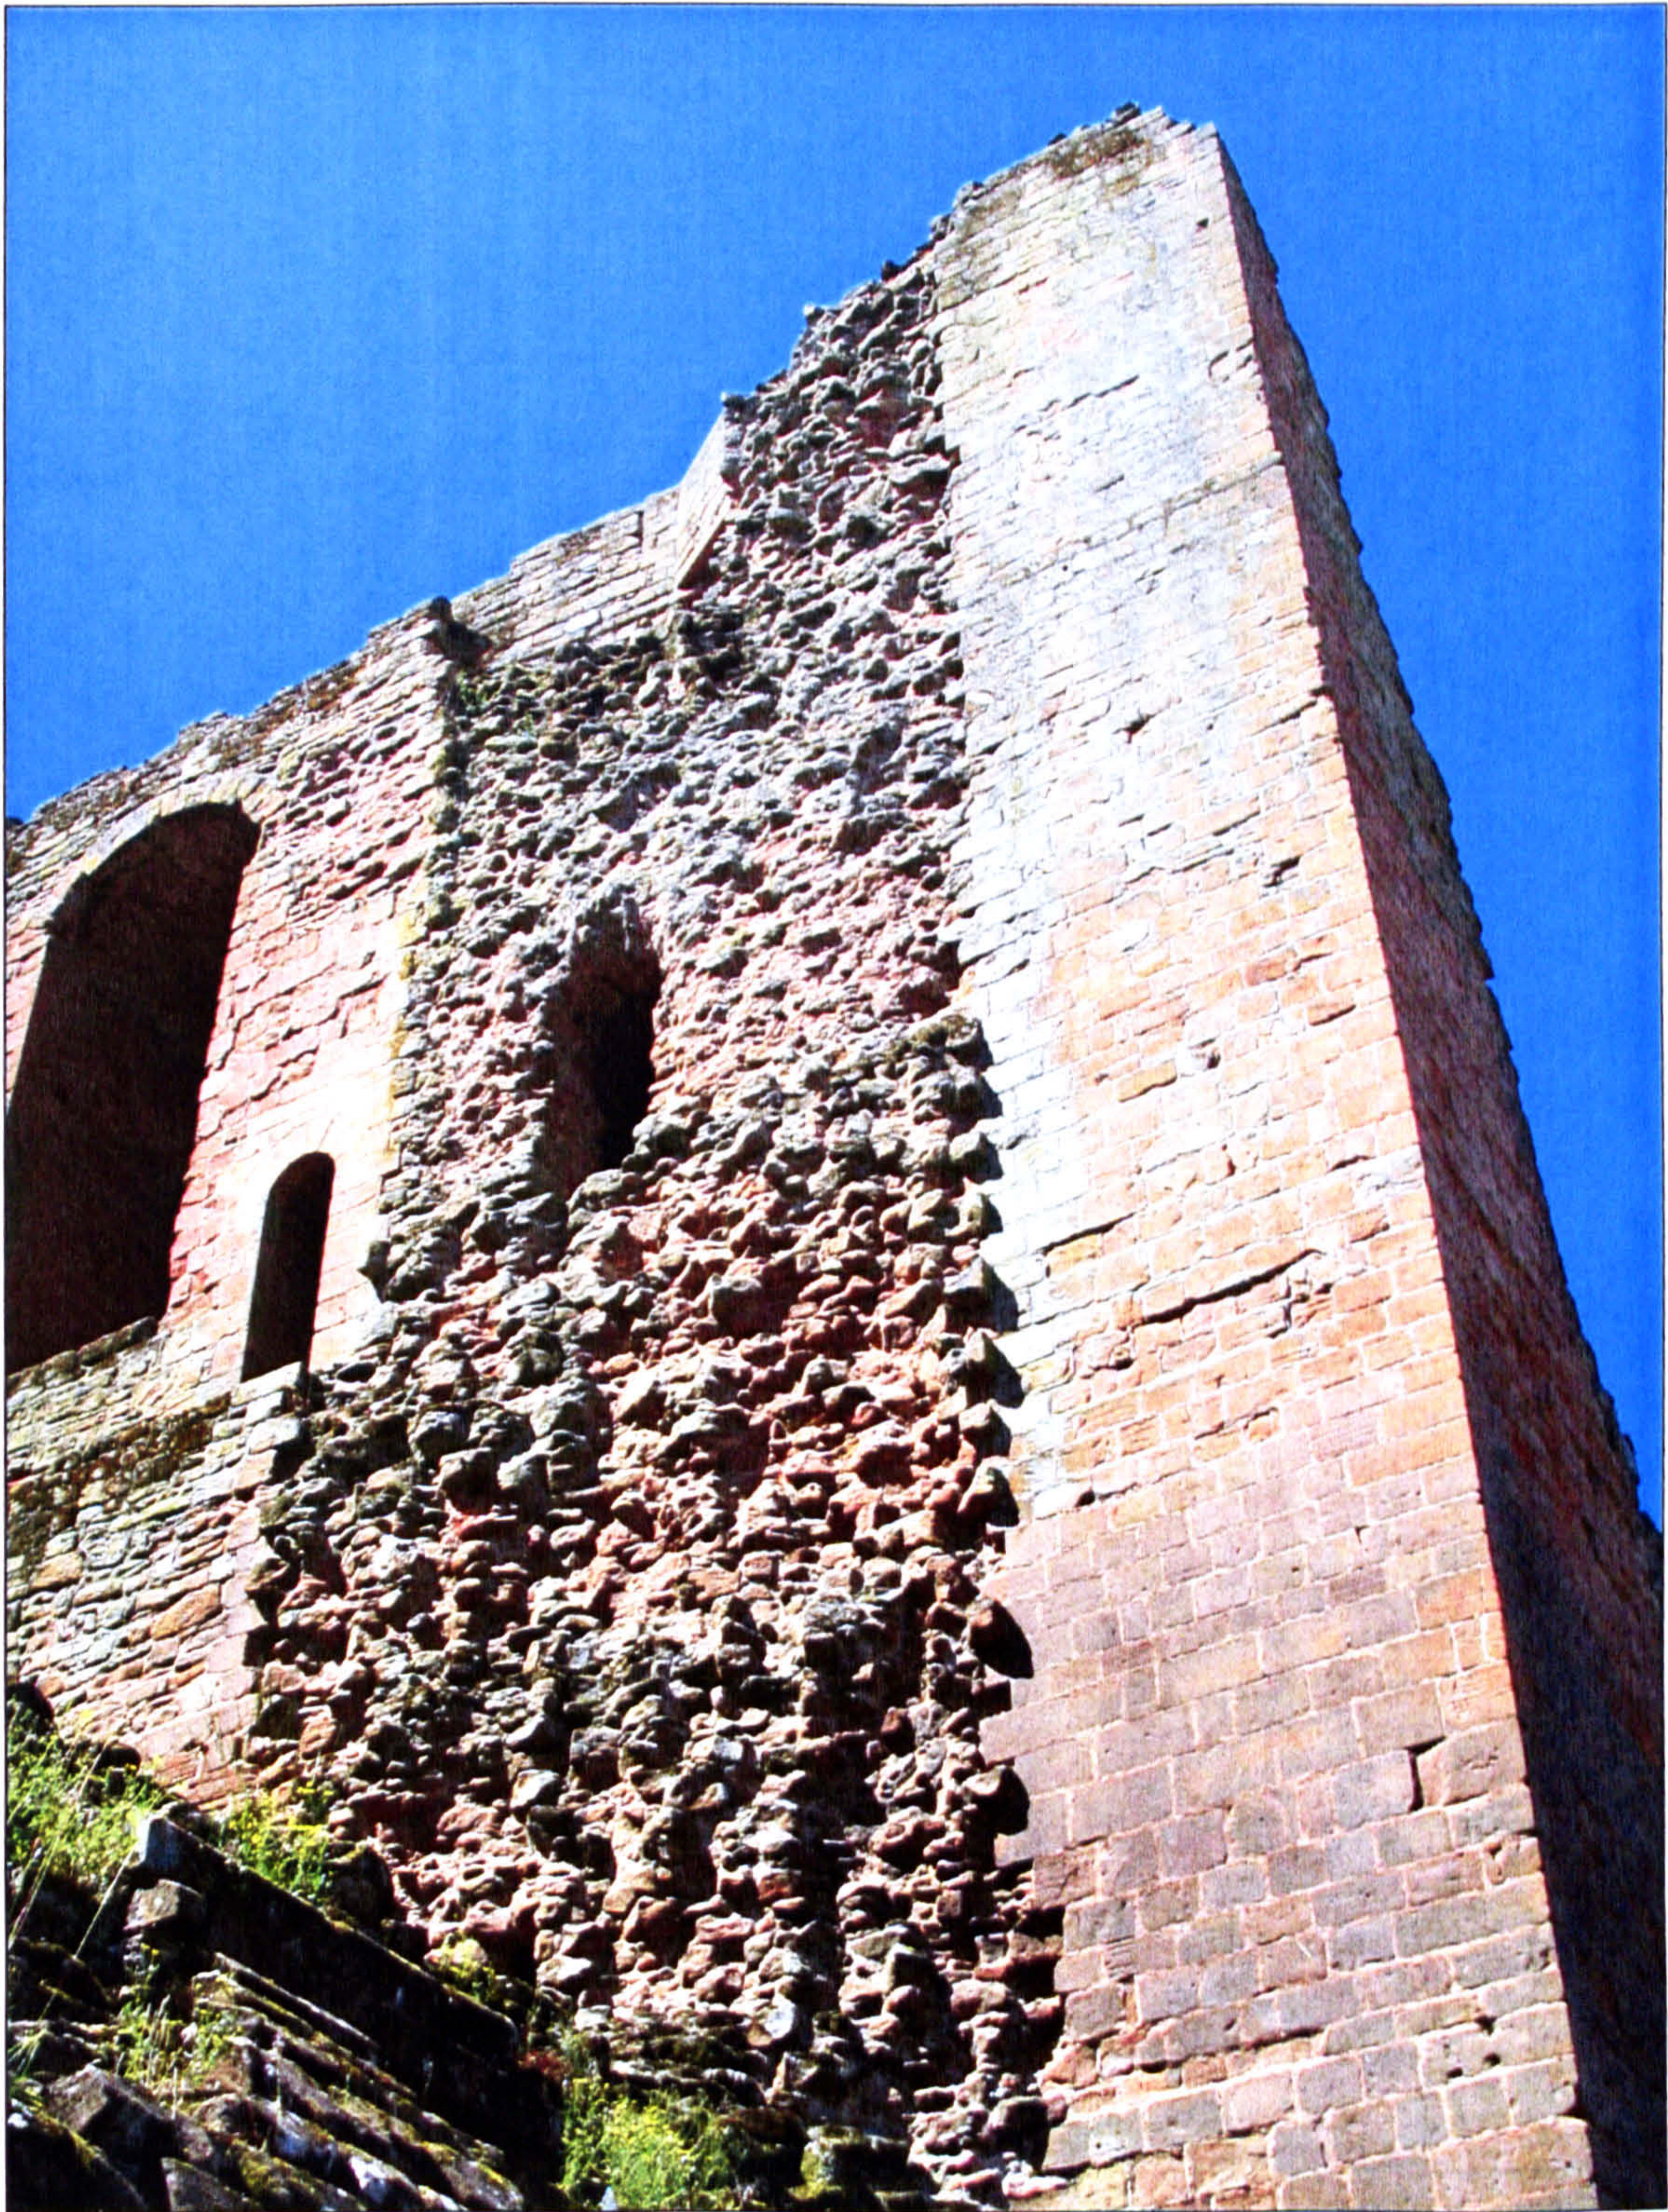
Figure 6.31 A view of the northwest corner and its exposed rubble core, showing the difference in construction quality between the upper and lower sections of the wall.

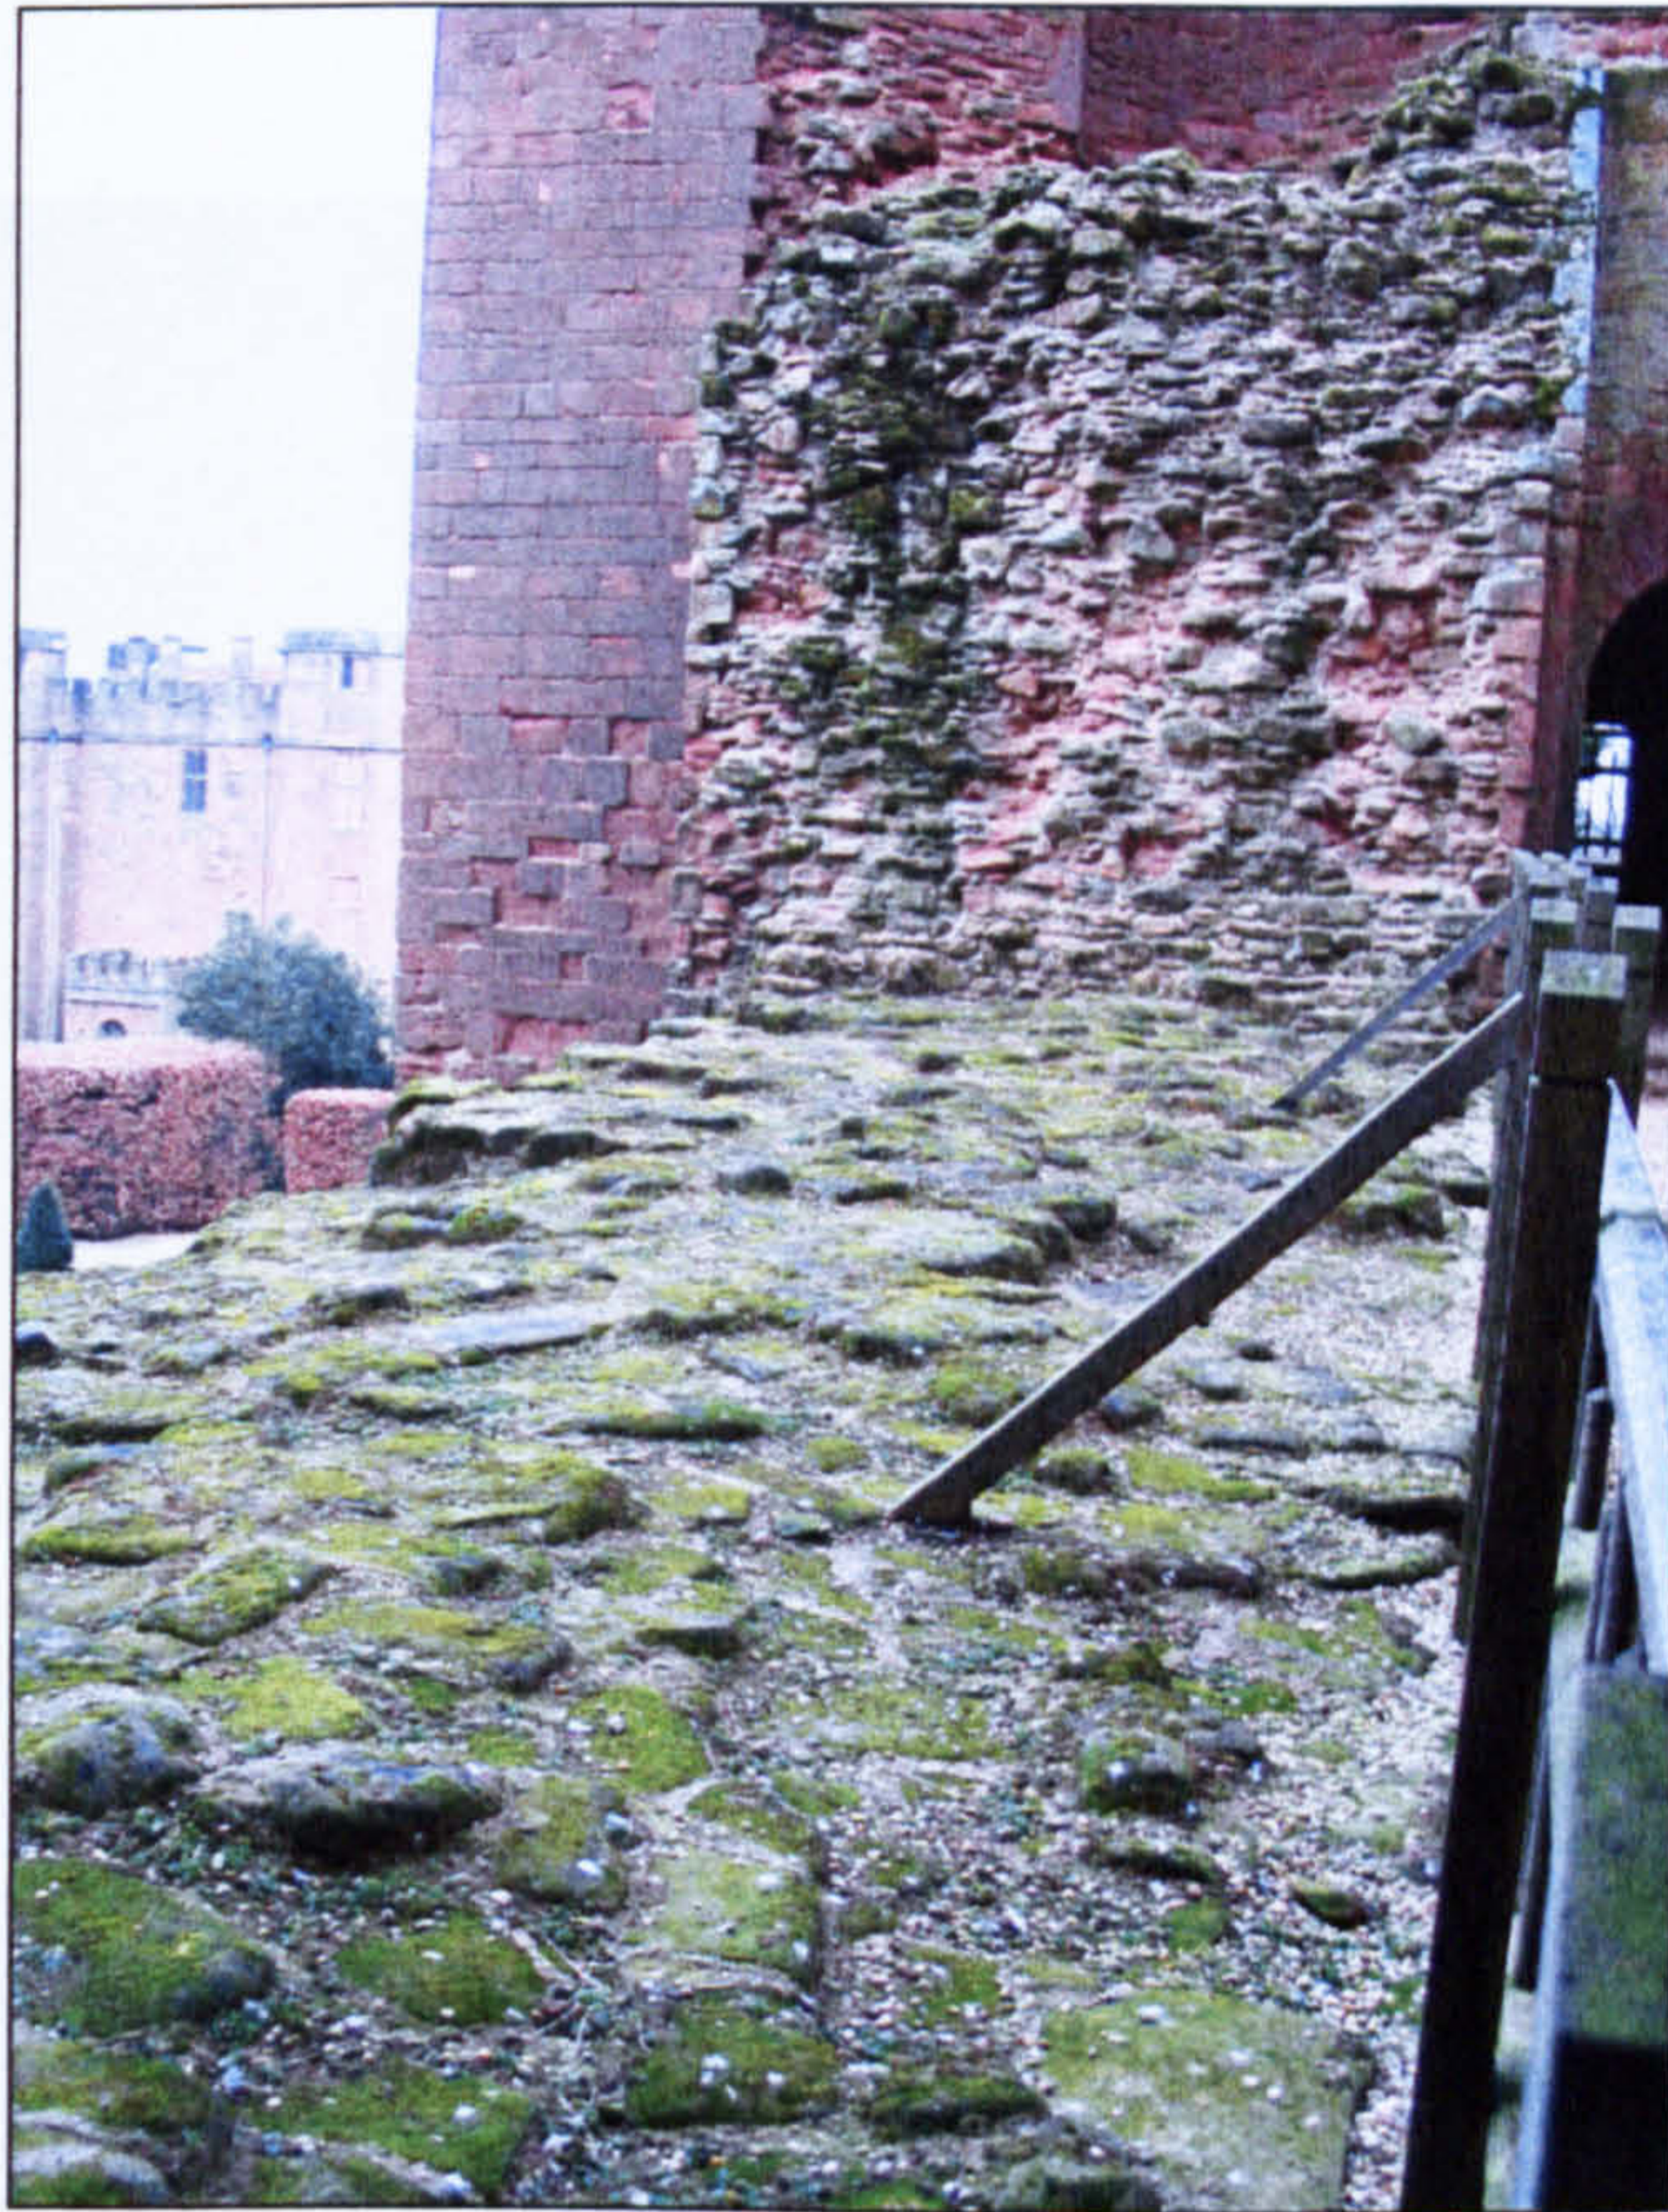
Figure 6.32 The base of the ten foot north wall.

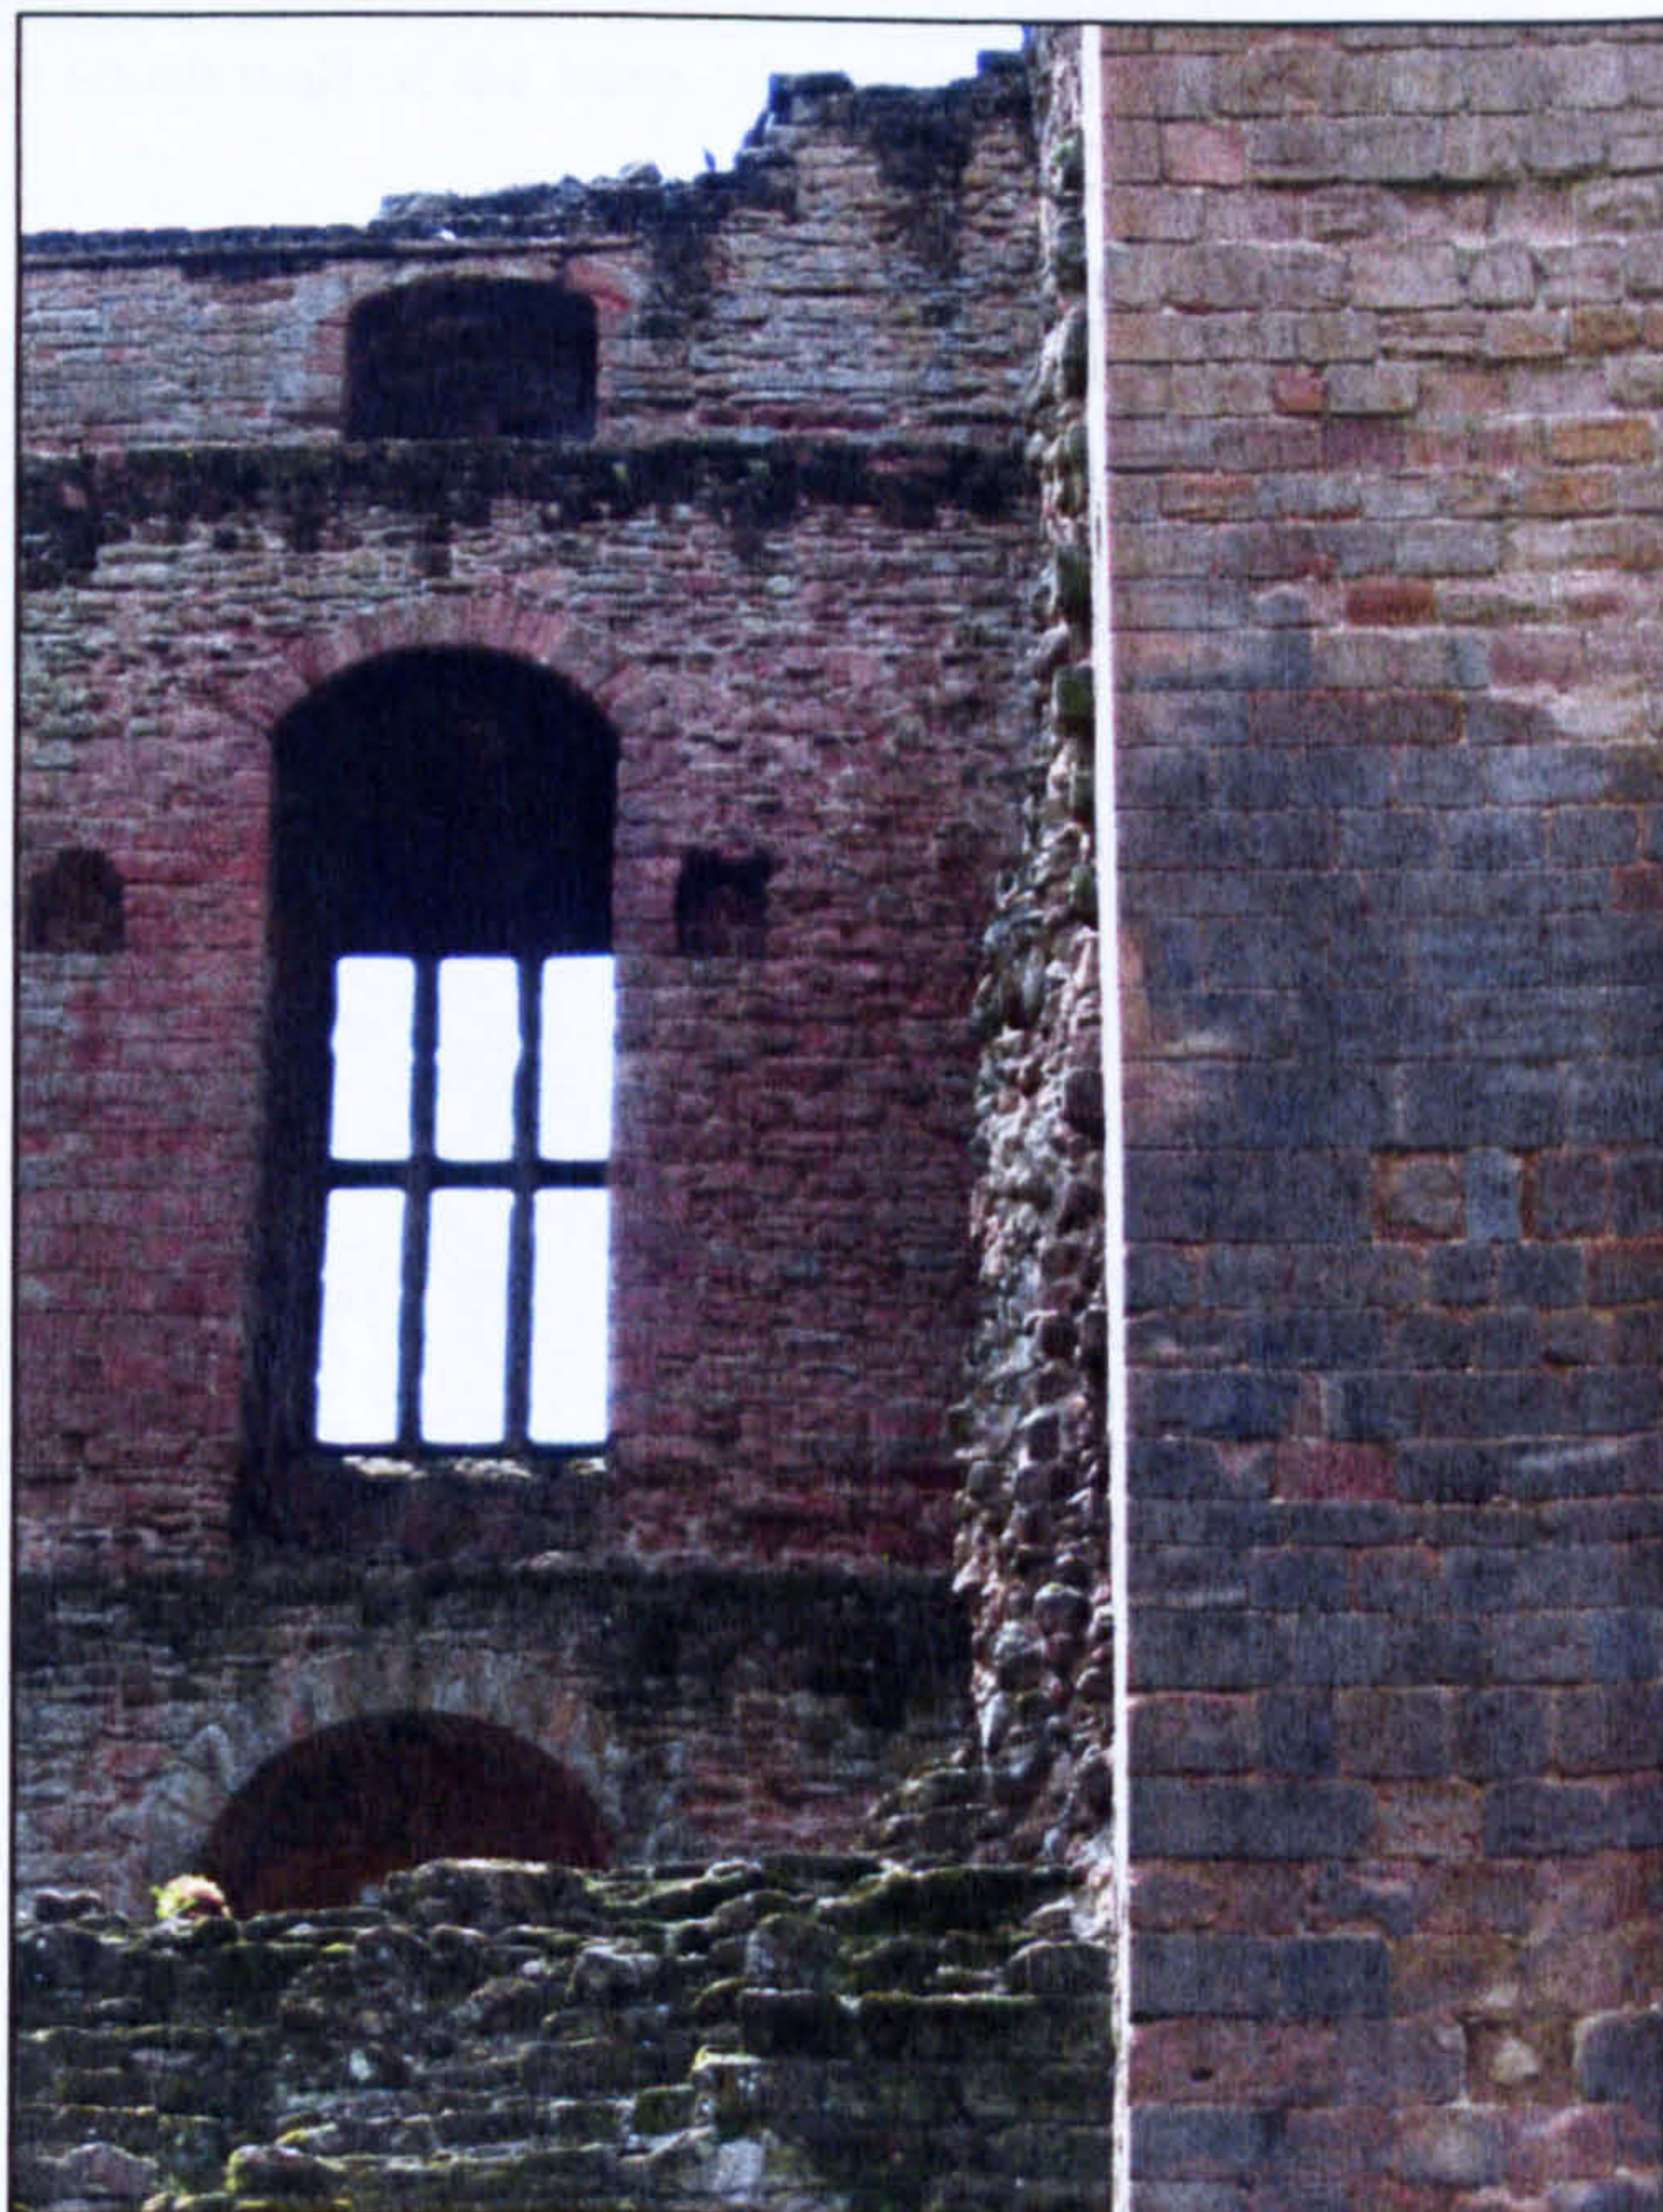
Figure 6.33 The northwest corner, looking south. Although some rubble core stands out, the right angle of the profile clearly shows that—if picked—the north wall was picked completely down to base level.

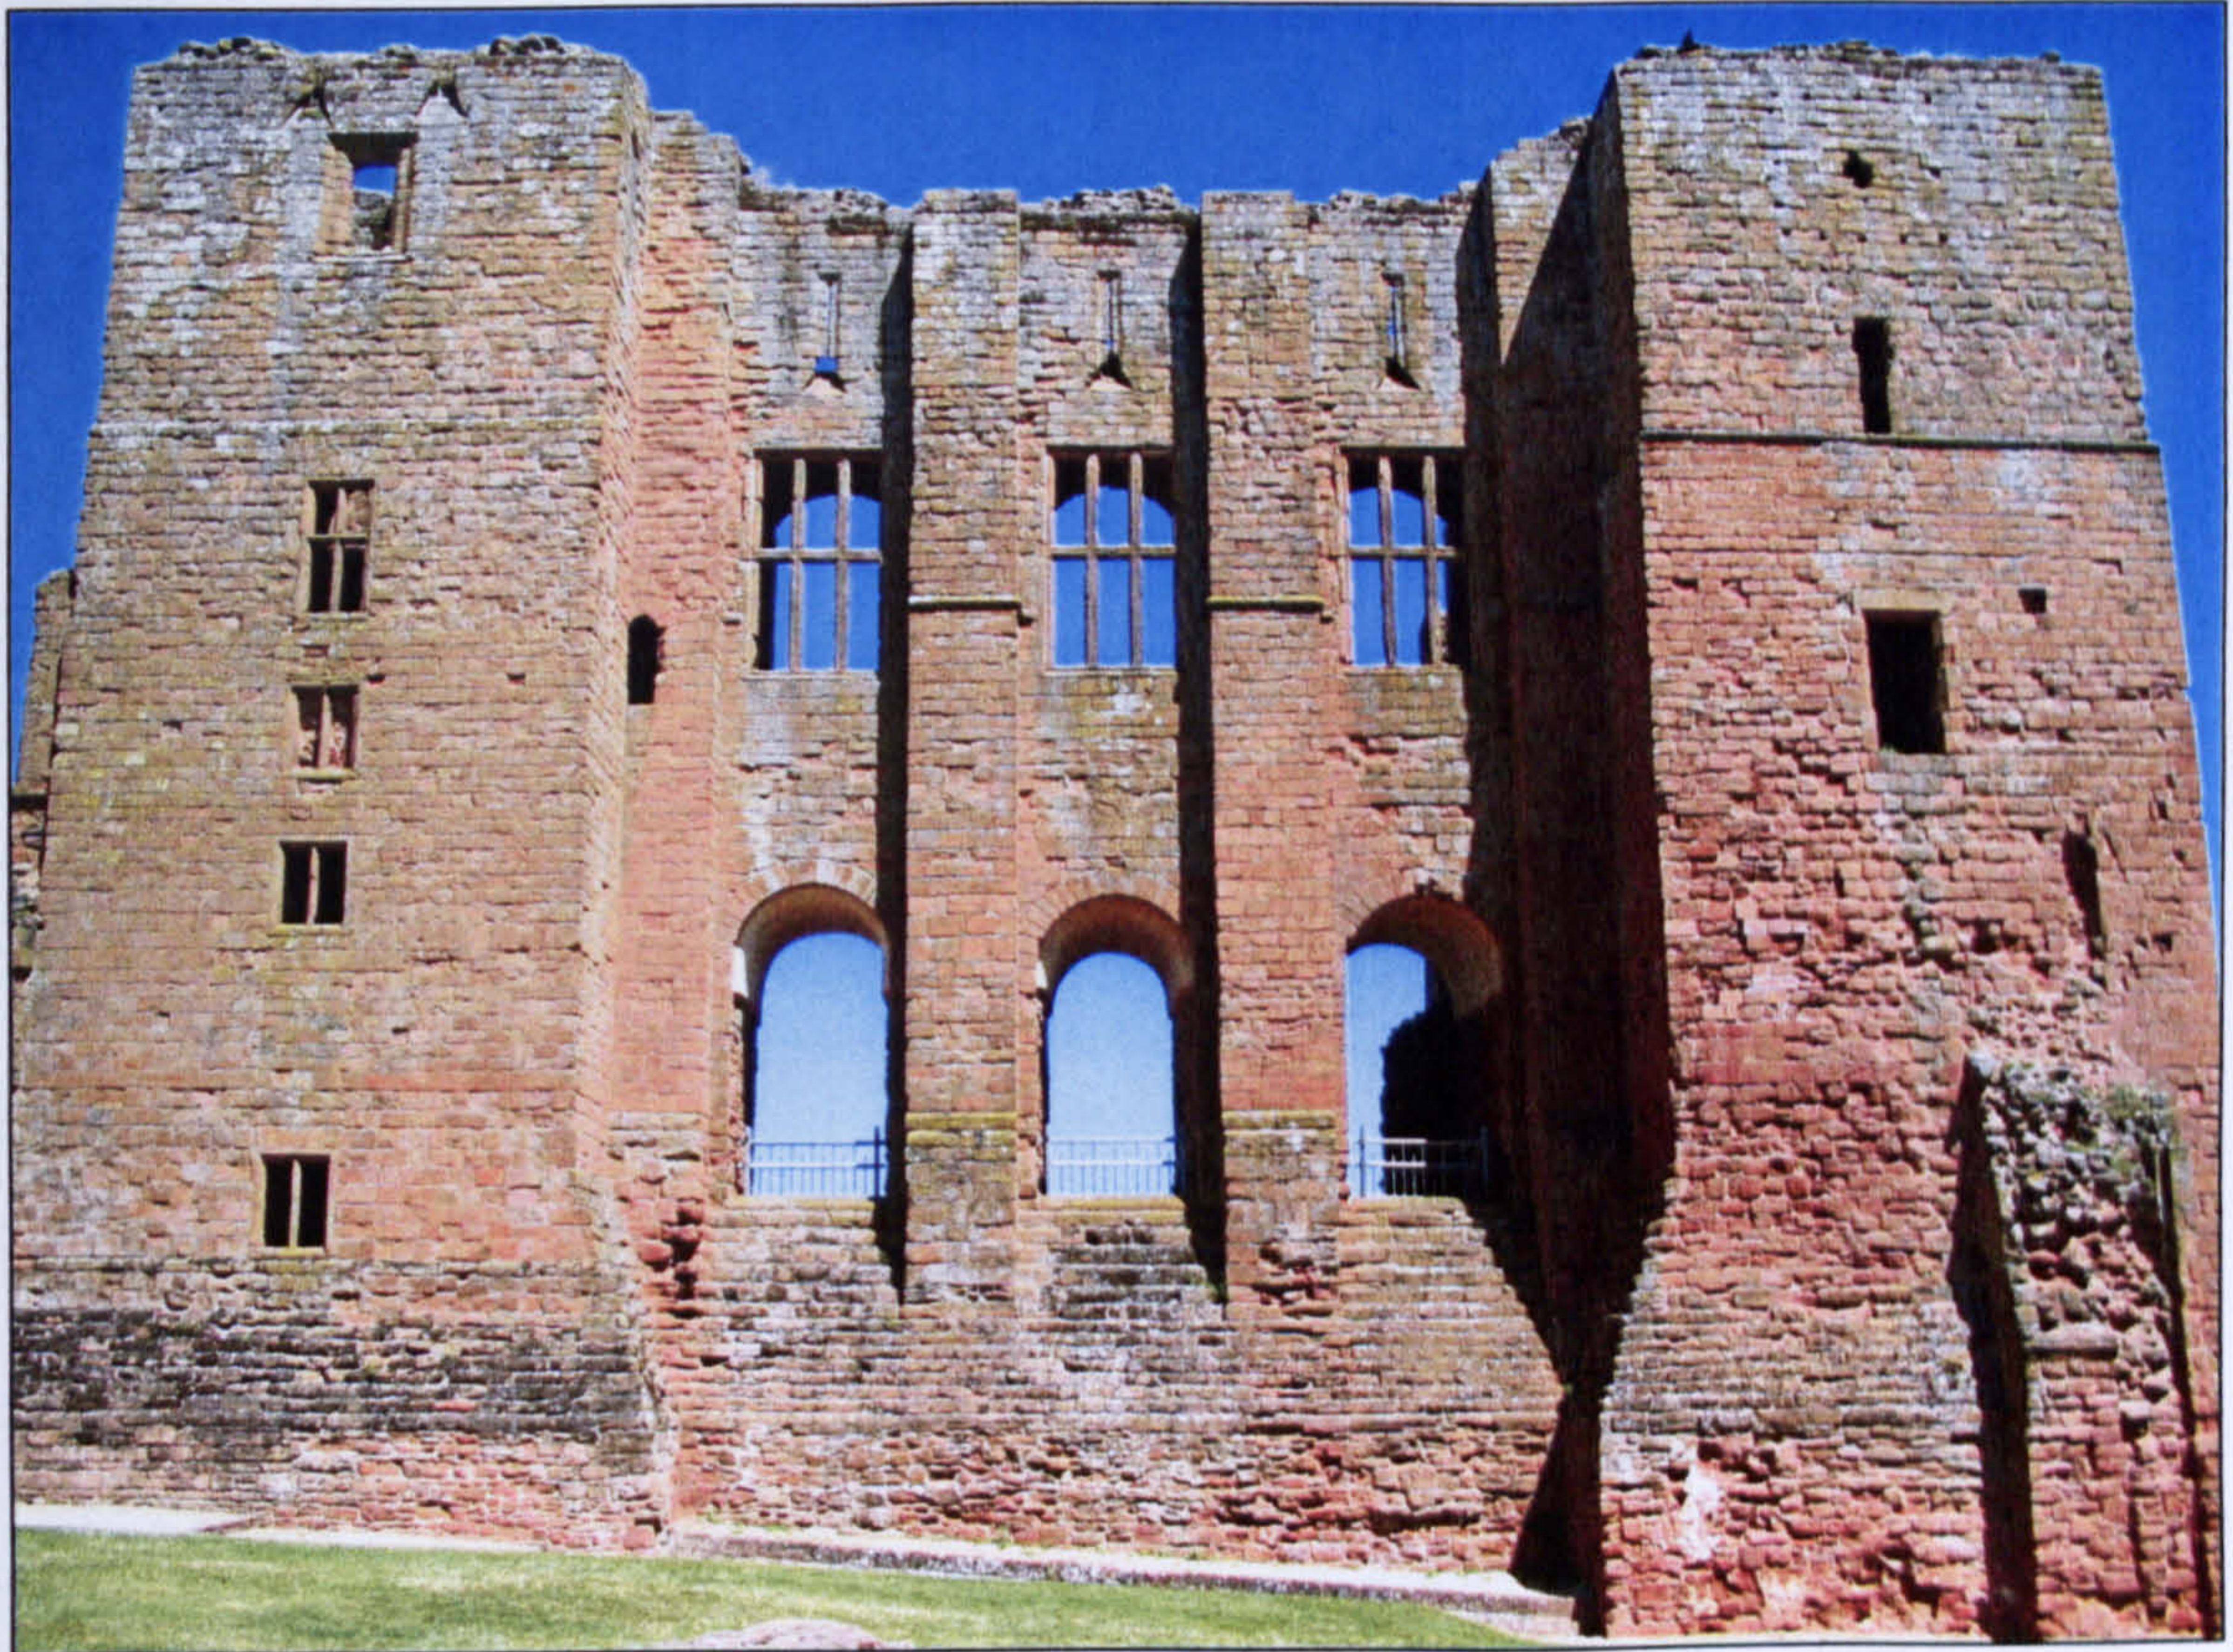
Figure 6.34 The intact south wall of the keep, showing Leicester's inserted Tudor windows.

With the north wall no longer extant, structural clues about how its undermining might have occurred must be found elsewhere. One option is to analyse the intact south wall (Figure 6.34) in order to understand the structural composition of the original parallel north and south walls. It becomes immediately obvious that the main structural weakness is the low percentage of wall mass that resulted from Leicester's sixteenth century inserted windows. Each window is about twelve feet in height and situated in a wall that stands over eighty feet (Clark 1884, 132-4), significantly reducing the original thickness of the medieval wall. The extra load from the roof would have put an enormous strain on all four walls, but in particular the north and south ones due to the greater number of windows located in both. These support issues appear to have been dealt with in the construction phase by utilising arches—which are naturally strong—and buttressing strips between them to add extra bulk in areas where it was needed (Figure 6.35).

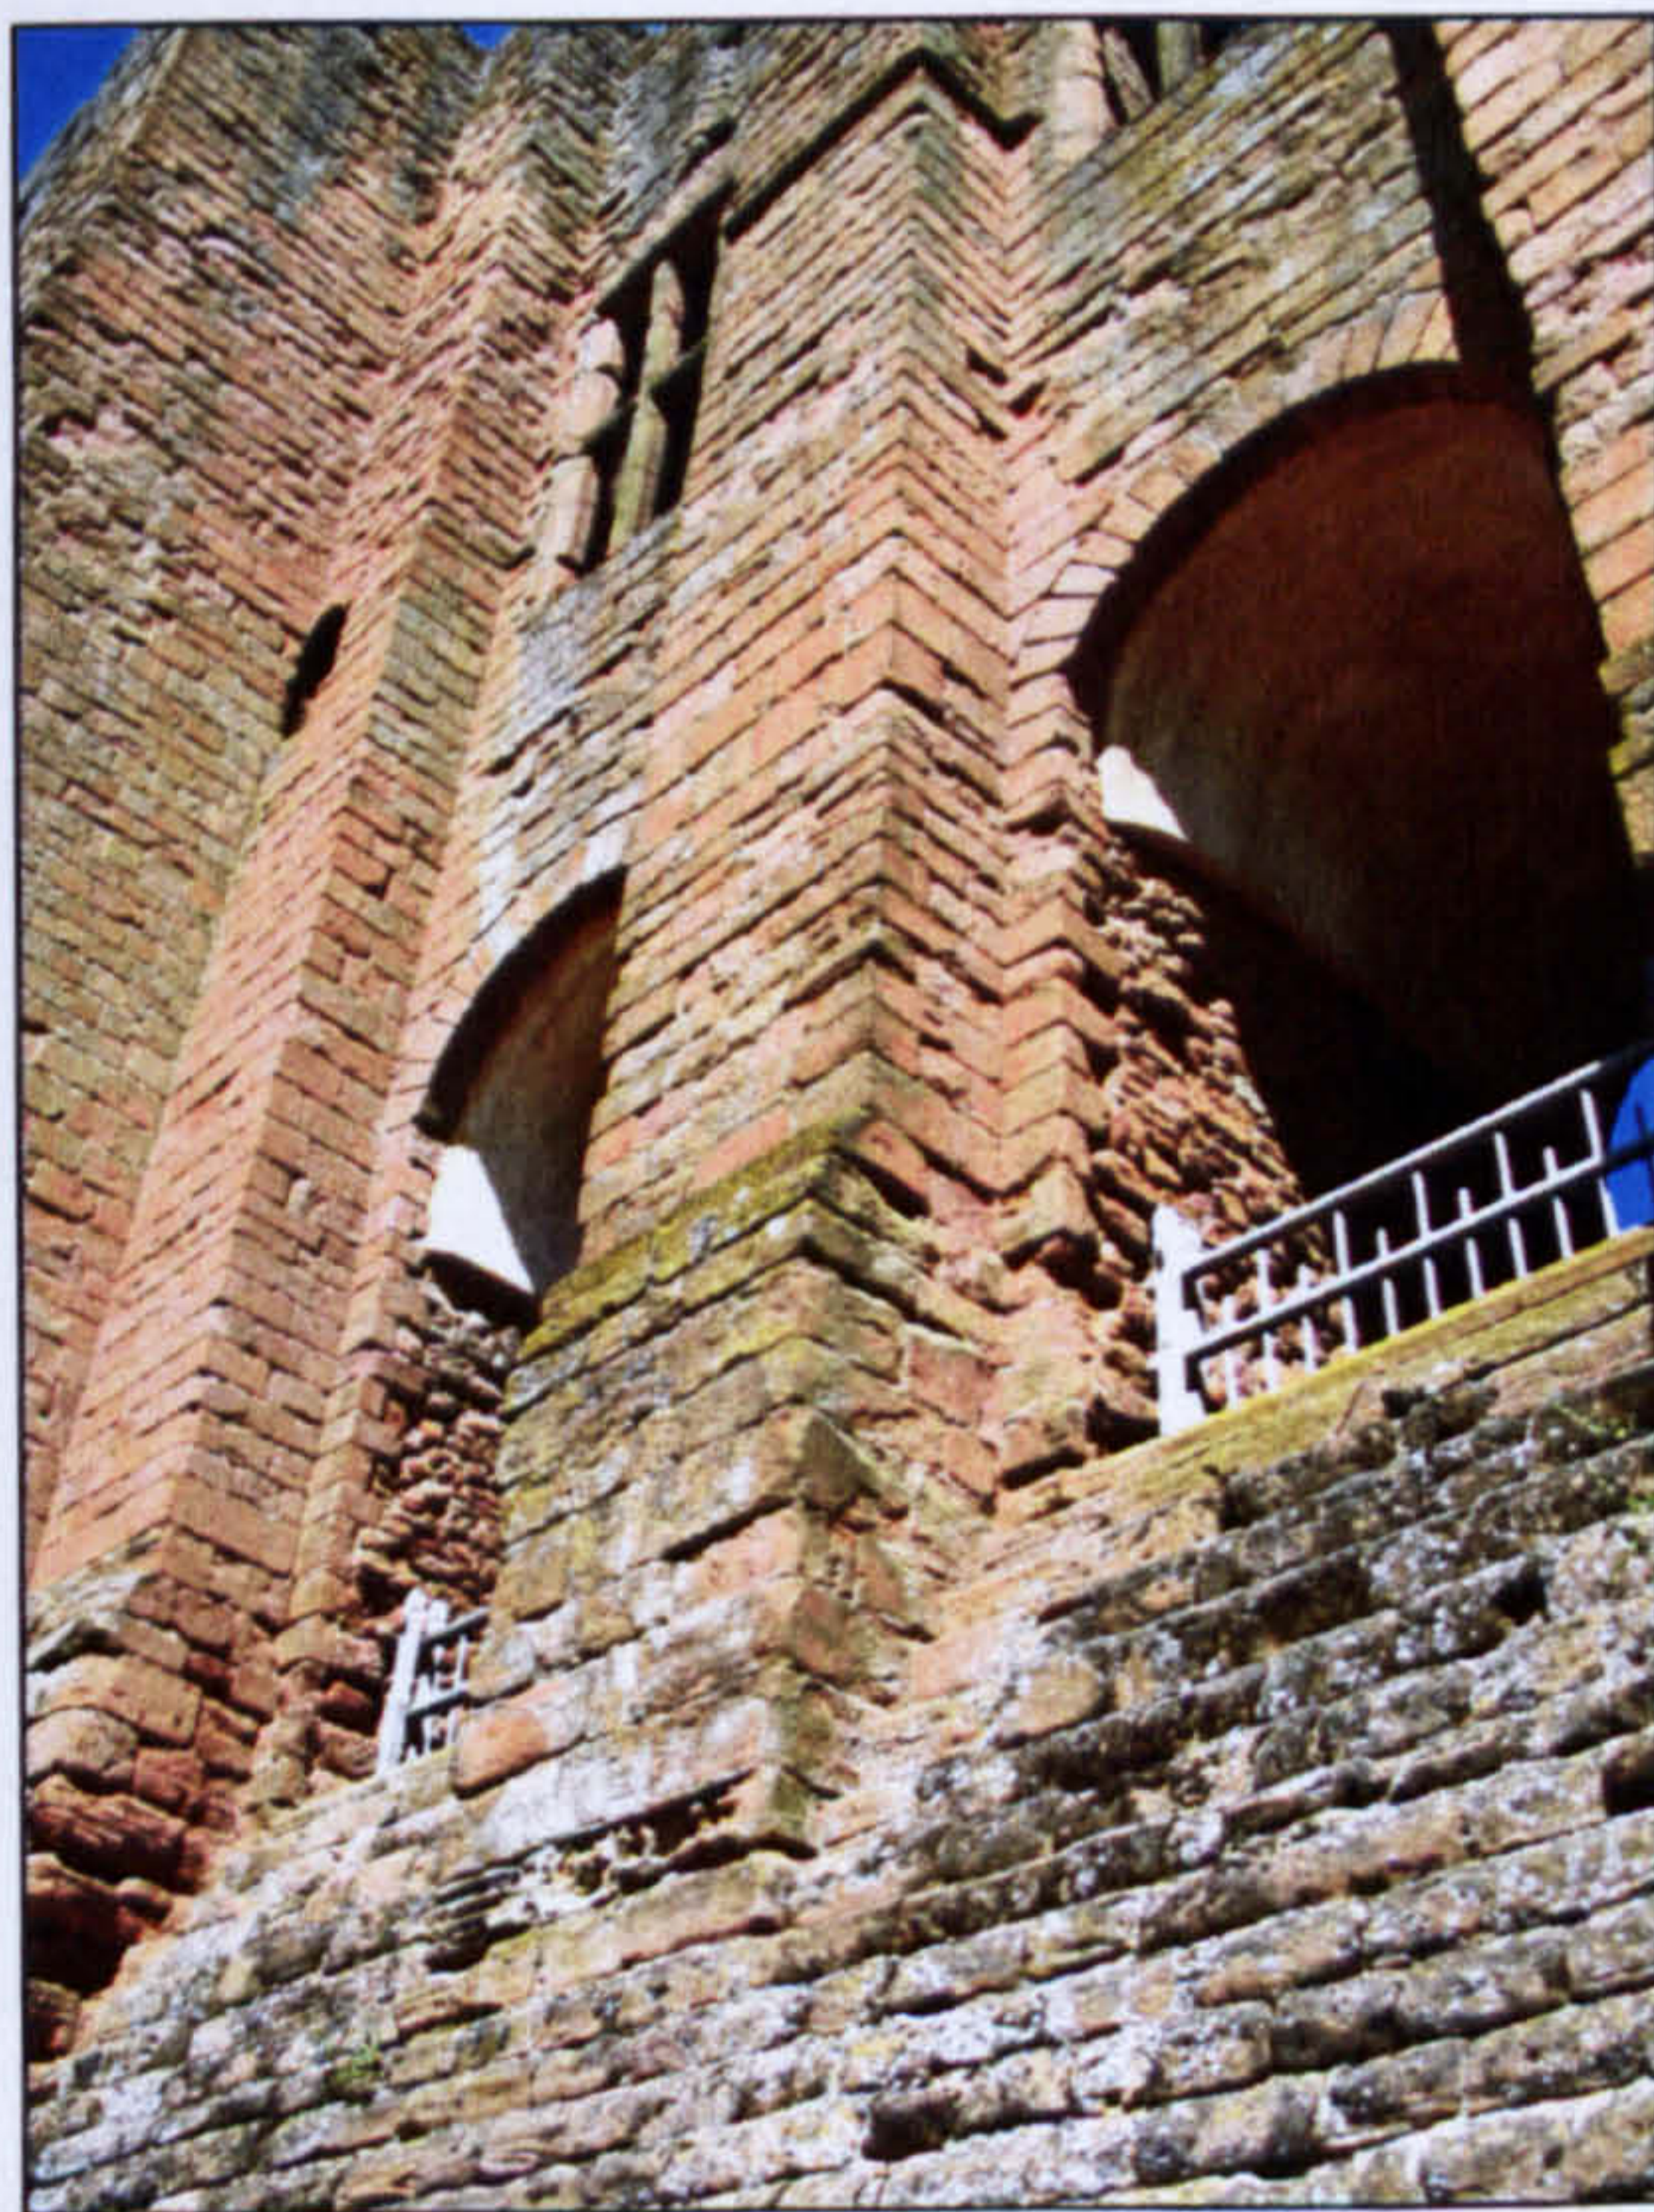
Figure 6.35 Close-ups of the west (left) and east (right) buttresses, south wall.
