An Experimental Investigation and Improvement of Insulated Rail Joints (IRJs) End Post Performance.

A thesis submitted for the degree of Doctor of Philosophy in the Faculty of Engineering of the University of Sheffield

by
Fathi A. Elshukri

Department of Mechanical Engineering
The University of Sheffield

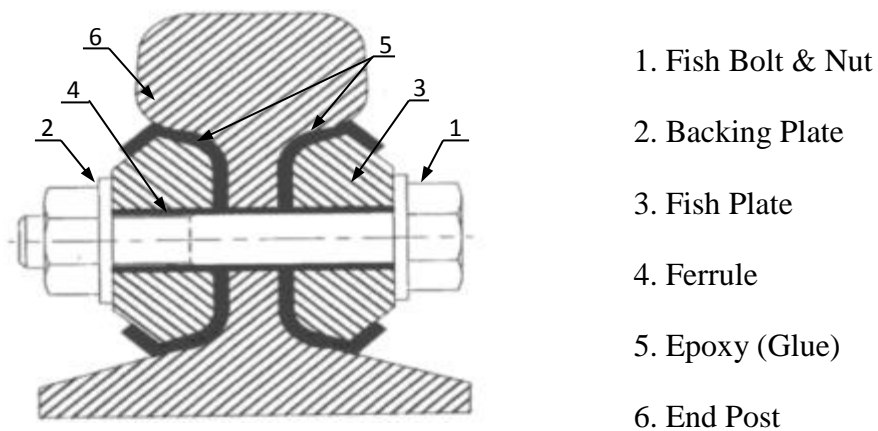
Fig. 1:12- Cross-Section of an Insulated Joint [21, 22].

IRJs are used to connect adjoining rails and provide a smooth surface for passage of train wheels on the railways as well as make the rail network electrically isolated. They preclude electrical current transfer between adjoining rails, thereby dividing a track circuit into circuit sections. IRJs employ insulating material between the rail ends (end posts). Insulated joints completely isolate the rails by insulating material placed between the fishplate and the rails and around the bolts. IRJs consist of the following components, as shown in Figure 1:12 [21, 22].

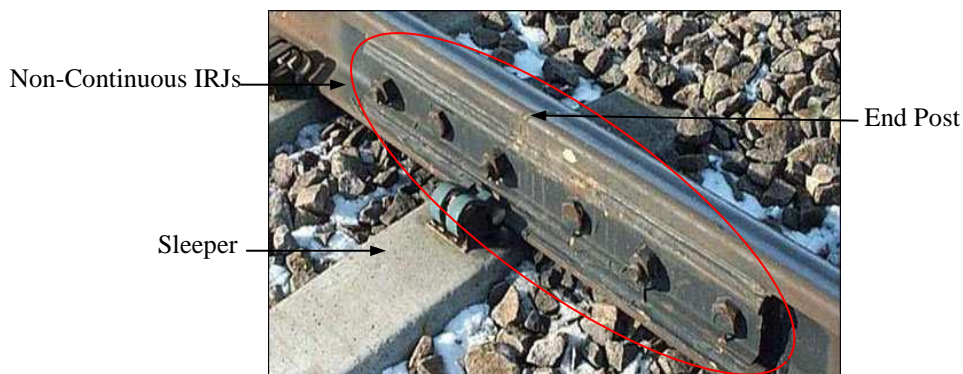
Fig. 1:18- Non-Continuous Supported IRJs [28].

In the non-continuous supported IRJs the end post is fixed immediately above a sleeper, as shown in Figure 1:18, which reduces the dipping of the rails, and thus relieves compression on the end post and prevents its cracking and fragmentation [27].

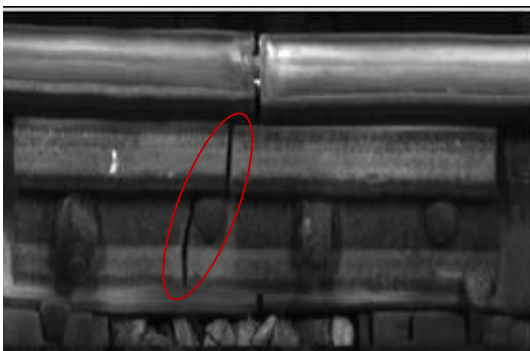
Fig. 1:19- Cracked Joint Bar [31].

The first type is mechanical failure; this type of failure affects steel parts, such as the rails, joint bars and bolts. All the steel parts in the track are subjected to static and dynamic loads and fatigue. The first type of mechanical failure is broken joint bar failure due to excessive load and high impact forces at the IRJs as shown in Figure 1:19.

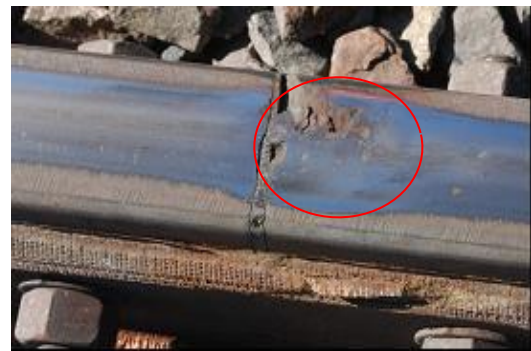
Fig. 1:20- Rail End Battering [32].

The second type of mechanical failure is “battered” rail end. The influence of running wheels causes the rail end to be flow downwards and become flattened. These flattened rail ends are called “battered” or “crippled” rail ends. This happens when the gap between adjoining rails is excessive and fish plates do not fit snugly because of the lack of strong support at the ends of the rails (see Figure 1:20). It is measured by comparing the height of the rail at the rail end and at a point 300 mm away from the rail end. Rail end battering up to 2 mm is accepted and 3 mm is critical.

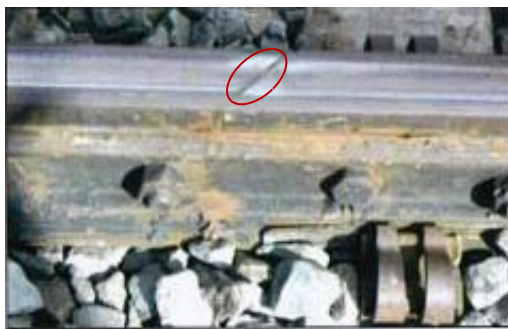
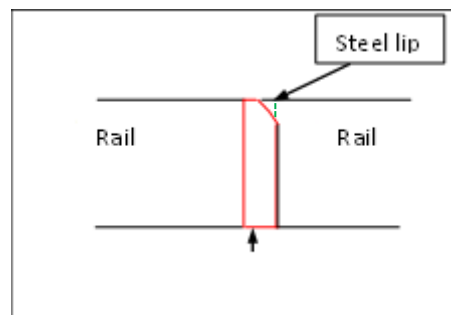
The first reason that leads to electrical failure in IRJs is “Lipping”, which is flow of rail head material due to high wheel loads and traction. When the train wheels pass over the rail head near the gap between adjoining rails at an IRJ, the steel of the rail can deform over time. After a period of time, the gap between rails will close and the adjoining rail comes into contact and an electrical short occurs (see Figures 1:21 and 1:22).

Fig. 1:21- Rail End Metal Flow [27].

Fig. 1:22- Schematic Diagram of Rail End Metal Flow.

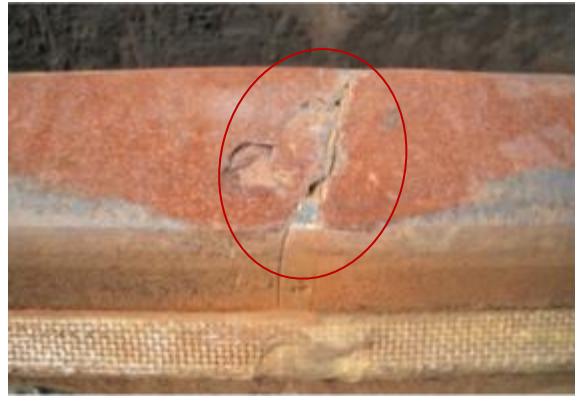
Fig. 1:23- Rail Head Metal Spalling in the Gap between Adjoining Rail at IRJs [27].

It can lead to the development of further damage such as spalling as shown in Figure 1:23. Key factors associated with this type of failure are rolling contact fatigue and the associated loading rate dependent metal plasticity as the wheel load exceeds the material yield point at the point of contact.

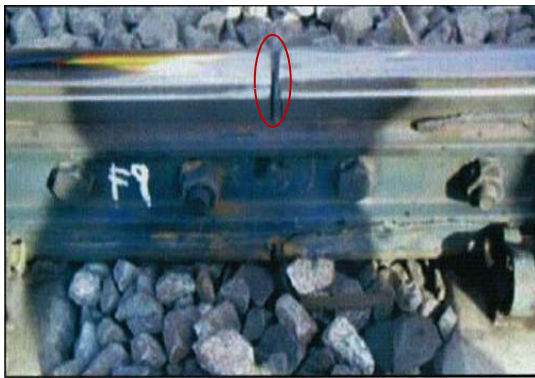
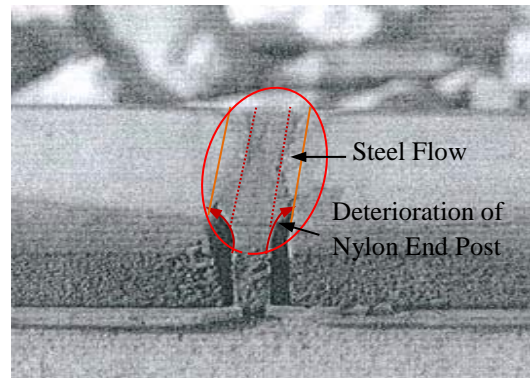
Fig. 1:24- IRJ with End Post Crushed [27]. Fig. 1:25- Plastic Deformation of Rail End with Deterioration of End Post [33].

Another method of electrical failure is a failure of the insulating end post of the joint. The end post may crack and come out of the space between the rails in the joint which may allow the rails to touch when they are extended or when the joint is loaded this is due to thermal effects and higher impact forces at IRJs (see Figures 1:24 and 1:25). Damage or loss of the end post can allow water in the joint and thus allow the passage of electrical current.

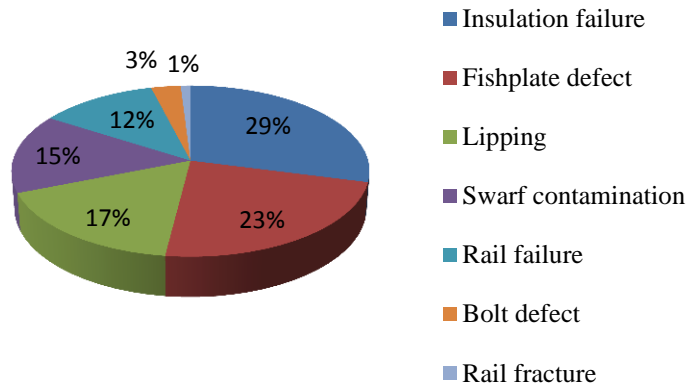
Fig. 1:26- Percentage Split of IRJ Failures (Data from [11]).

To improve and develop IRJs, understanding of their failure mechanisms is firstly required. There are several types of insulated rail joint failures related to various design of IRJs. In the UK, the main failure mode as shown in Figure 1:26 is insulation failure 29%, fishplate

defect 23%, lipping 17%, swarf contamination 15%, rail failure 12%, bolt defect 3% and rail fracture 1% [11].

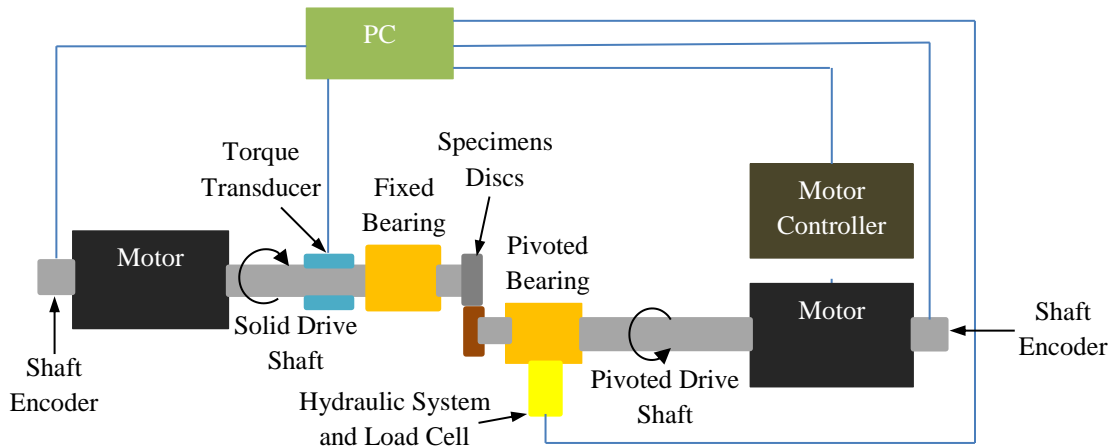
Fig. 3:2- Twin-Disc Test Machine Schematic.

discs together (see Figure 3:3) and they are driven at controlled speed by two separate electric motors with the relative slip ratio adjusted using the rotational speeds. A load cell is fixed below the hydraulic jack and a torque transducer is contained in one of the drive shaft. A PC is used to record all data and for load and speed control. This machine has been employed for rotating wear tests and the partial slip lipping test (see Sections 3.4.3 & 3.4.2.2).

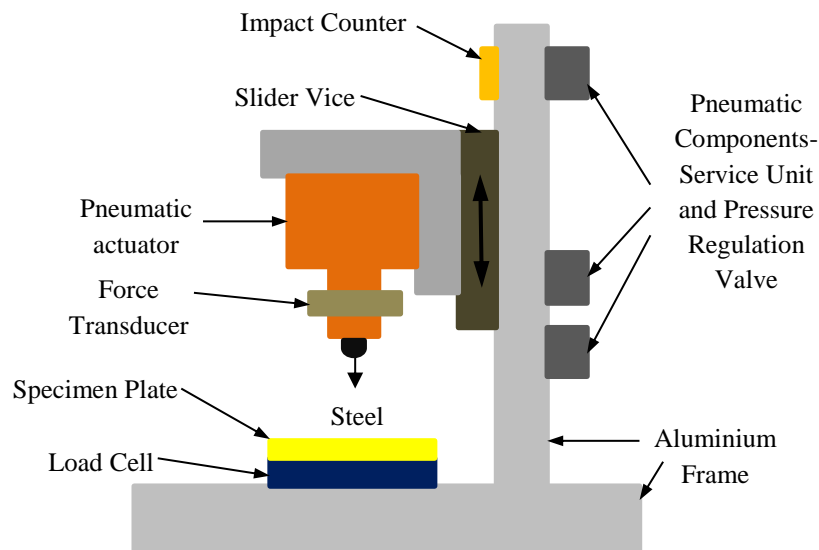
Fig. 3:4- Schematic of the Pneumatic Ball-on-Plate Tester.

applications relating to impact wear resistance and deformation of coatings are tested by ball-on-plate rigs [77-82]. The pneumatic ball-on-plate rig is an appropriate way of simulating the impact wear located in an end post. The test apparatus design was explained previously [76, 83, 84]. The pneumatic ball-on-plate rig, as shown in Figure 3:4, uses a pneumatic actuator to move an impact head assembly holding a 6mm diameter ball in a cyclic down and up motion against a specimen plate (see Figure 3:5) with an impact frequency of 8-10Hz. The load cell under the specimen plate is used to measure the impact load. The distance between the steel ball and specimen plate is 15 mm. 500N is the maximum impact load that can be used. The test duration is controlled by computer [85]. This was used for dry and wet impact wear tests (see Section 3.4.4).

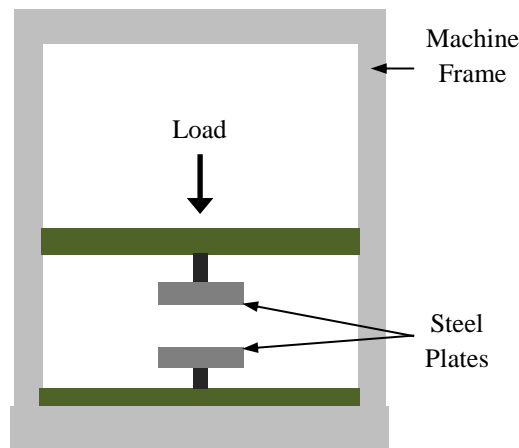
Fig. 3:6- Schematic of Tinius Olsen-H25kN

One standard way to perform a compressive static load test is with a Tinius Olsen-H25kN machine (see Figure 3:6). The machine has been used widely in the field of static load compressive tests [85-87]. The Tinius Olsen-H25kN machine is an appropriate way of simulating damage caused by compressive static load located in the end post. The test machine specification was explained in [88]. Figure 3:6 shows the Tinius Olsen-H25kN machine. The maximum load that can be used on the machine is 25 kN.

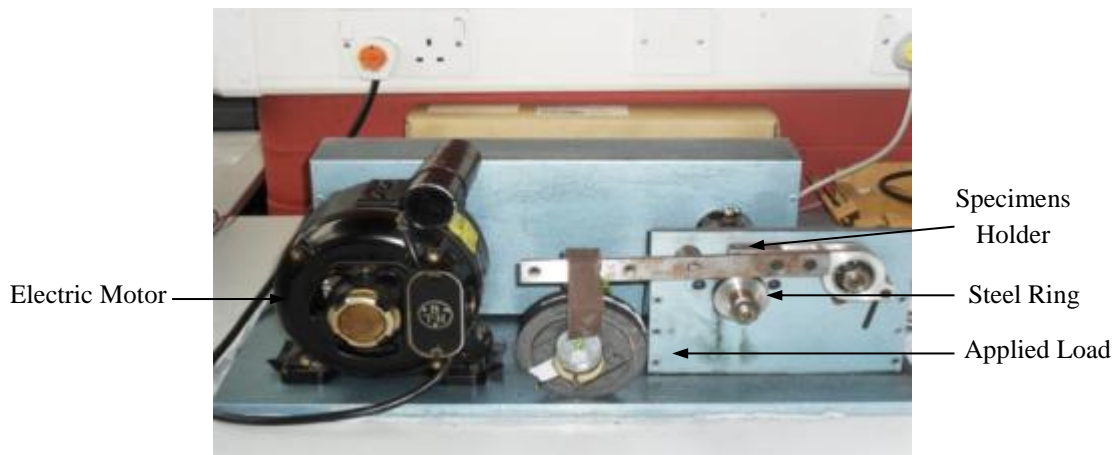
Fig. 3:13- Block-on-Ring Test.

An overview photo of the test set-up can be seen in Figures 3:13.

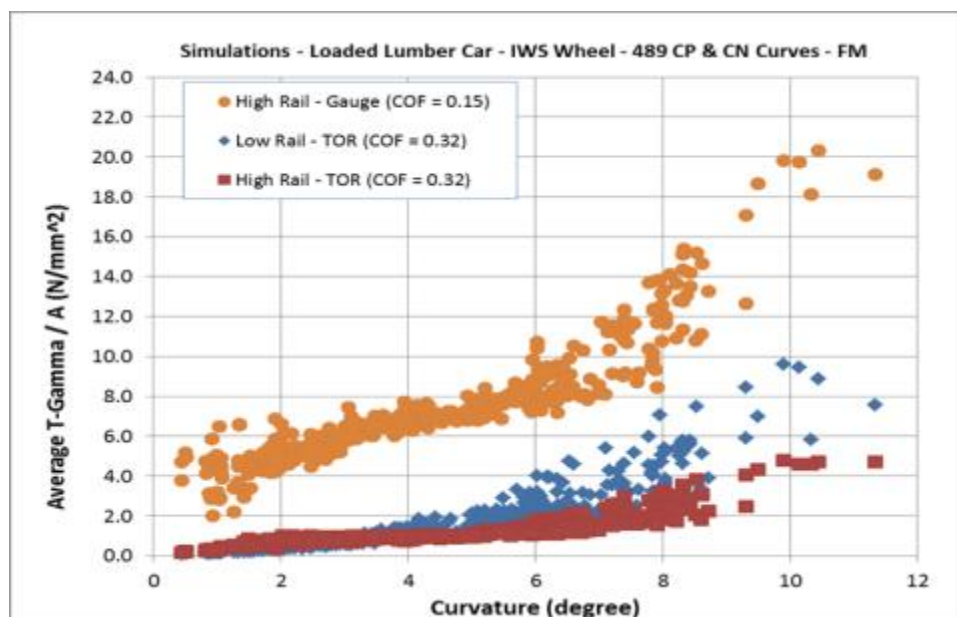
One way of comparing test conditions to those in the field is via the energy within the contact. In this case it can be calculated as $T\gamma$ (normal force x friction coefficient x slip in the contact) and scaled via the contact area (see Appendix A). For the Block-on-Ring $T\gamma/A$ values of 0.084 to 6.20 were calculated (using μ values from tests described in section 3.5.1.1). Typical field values for $T\gamma/A$ are shown in Figure 3:14; the Block-on-Ring tests are in the right regime. Because there is not a suitable reference for the energy within the contact for the UK network, energy within the contact of a Canadian rail network was used for comparison (see Figure 3:14). This shown that the $T\gamma/A$ for the Block-on-Ring tests was in the right regime.

Fig. 3:14- Data for NRC Modelling of Wheel/Rail Contact Using Multi body Dynamics Software [Informal Communication with Eric Magel, NRC, Canada].

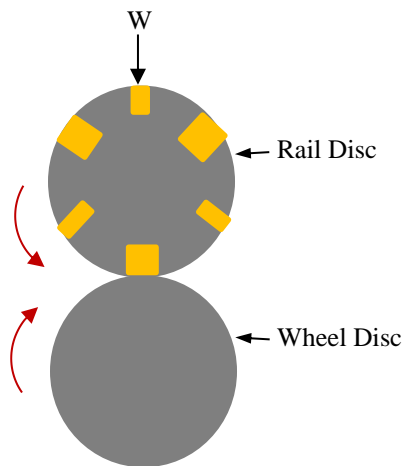
Fig. 3:22- Schematic of 1% Partial Slip Specimens.

- ii) The disc was machined with 3 grooves, 0.5mm x 10mm x 3mm, and 3 grooves, 1mm x 10mm x 3mm.
- iii) The end post material Epoxy Glass (EG) was cut into blocks 1mm x 10mm x 3mm, and 0.5mm x 10mm x 3mm in size and then glued in the grooves, then cleaned and dried.
- iv) The wheel steel disc was machined into a cylindrical shape with 46 mm diameter and 10mm thickness with surface roughness of $R_a \cong 1 \mu\text{m}$.
- v) The disc specimens were cleaned and mounted into a holder.
- vi) The tests were performed at rotating speeds of 400 rpm [97] slip 1%, contact pressures of 900 MPa, and 1500 MPa (typical actual contact pressure) [96], and for 2000 and 20000 cycles (see Figure 3:22).

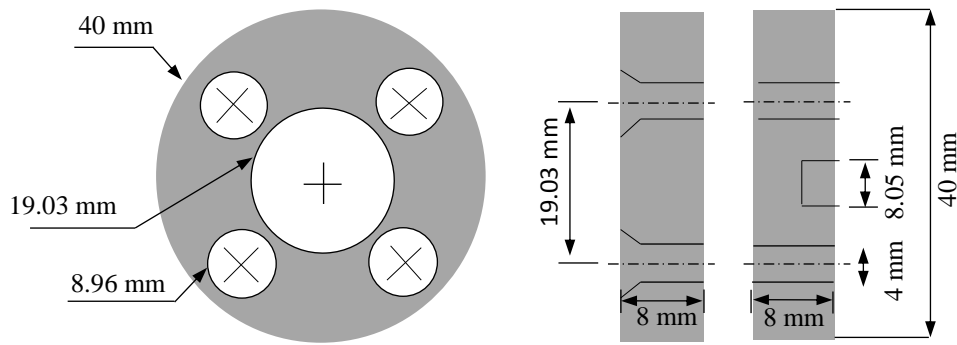
Fig. 3:23- Twin-Disc Machine End Post Specimen Holder.

- i) The specimen holder was designed and manufactured in the Mechanical Engineering department workshop (see Figure 3:23).

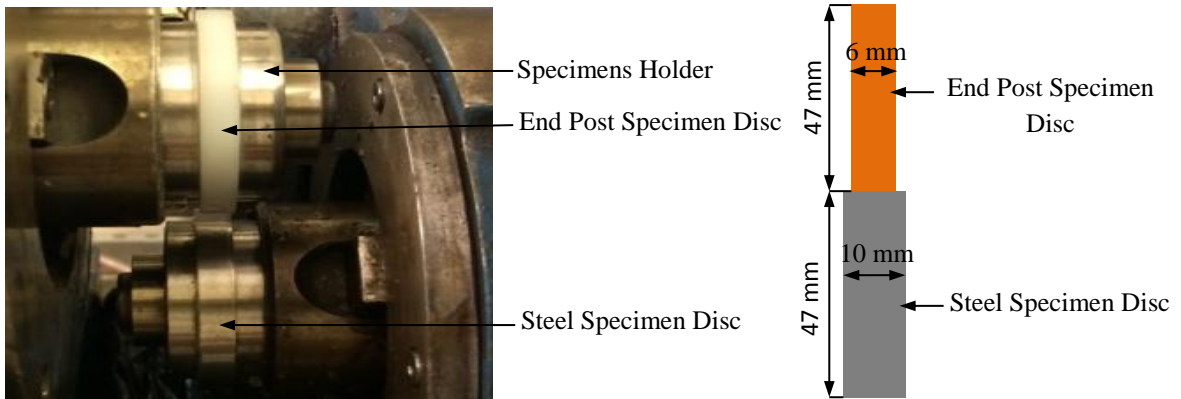
The tests were achieved employing the end post disc as the breaking disc and the steel wheel disc as the driving disc (see Figures 3:24 and 3:25). The tube at the top of the machine was used to drip in the water in the case of the wet test condition. The tests were carried out at a rotational speed of 400 rpm, a slip of 1% and a contact pressure of 200 MPa (see Figure 3:26) which is similar to the real wheel/end post contact [96]. Contact calculations are shown in Appendix A. The tests were first run dry, then wet with water (rain water was used). The water was applied at two drops per second (that is enough to make the disc specimens completely wet through the period of testing) [97]. Air cooling was used in this test.

Fig. 3:24- Twin-Disc Test Specimens Set-up Fig. 3:25- Schematic of Steel Disc and End Post Disc Contact.

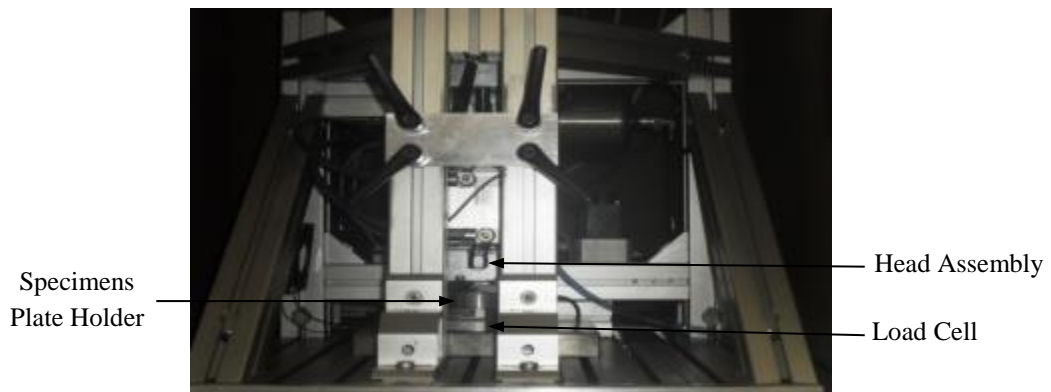
Fig. 3:27- Pneumatic Ball-on-Plate Apparatus.

One of the ways that can be used to test the wear caused by impact is a “Pneumatic Ball-on-Plate Impact Tester” (see Figure 3:27). This test technique characterises the behaviour of materials when subjected to cyclic impacts.

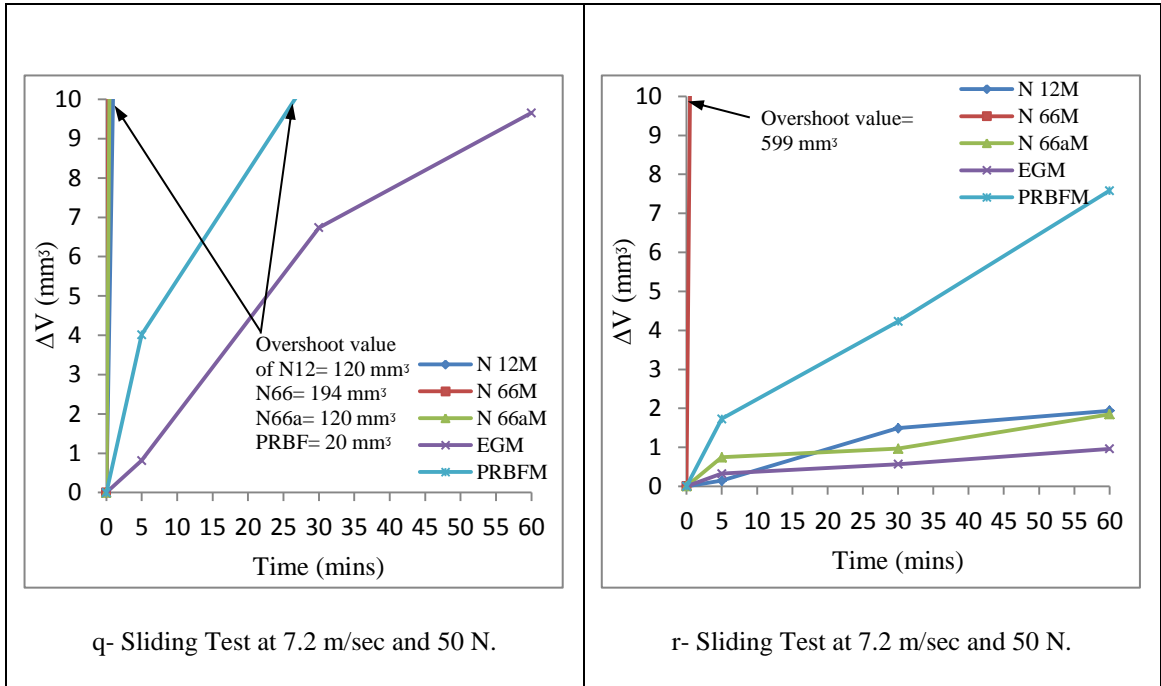
values of sliding velocities and loads as indicated in the figures. It can be seen from the figures that value of sliding velocity has an expected effect on the volume loss of the studied end post materials at different applied loads. (V_{ij} = the volume loss from specimens; $i=1,2,\dots,5$ and $j=1,2,\dots,9$).

Fig. 4:1- Volume Loss of End Post Materials in Dry and Wet Sliding Tests.

In contrast, in the case of wet tests condition, as can be observed in Figures 4:1 b, d, f, h, j, l, n, p and r, there was a positive effect of water on material wear resistance, this appears in the amount of material loss through the tests compared with dry tests condition. This is because the water acted as a lubricant and reduced contact temperature which led to a rise the material wear resistance and increased material service life. The rubbing surface was more smoothed as shown in Figure 4:5 f, cracks were observed and scratches existed on the surface parallel to the orientation of sliding (see Figures 4:11 hh, kk and ll).

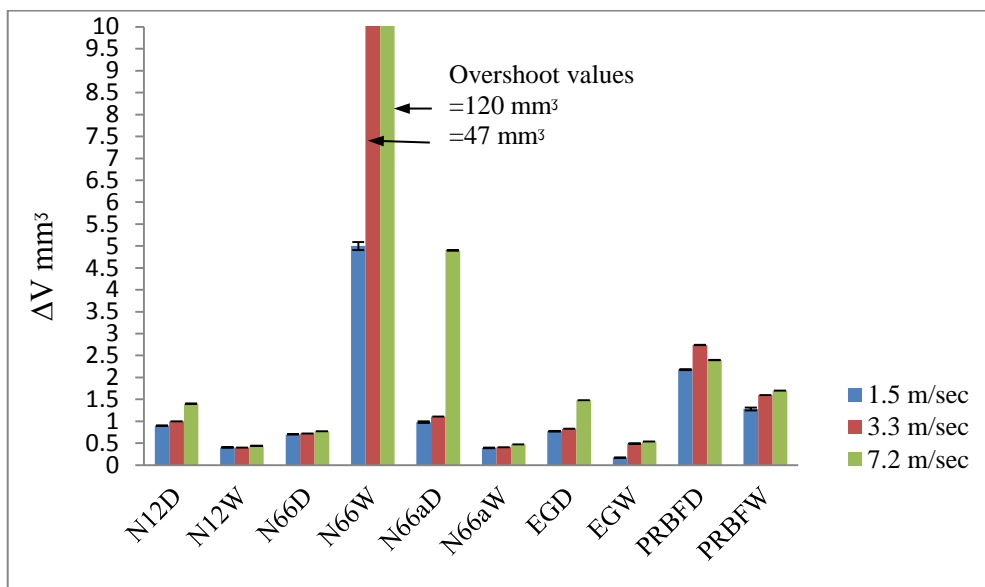
Figures 4:2 to 4:4 summarise the volume loss of Nylon 12, Nylon 66, Nylon 66a, Epoxy Glass and Phenolic Risen Bonded Fabric materials in dry and wet conditions at sliding speeds of 1.5 m/sec, 3.3 m/sec and 7.2 m/sec and applied loads of 10 N, 30 N and 50 N.

Fig. 4:2- Sliding Tests for All End Post Materials in Dry and Wet Test Conditions at an Applied Load of 10 N and Sliding Speeds of 1.5 m/sec, 3.3 m/sec and 7.2 m/sec.

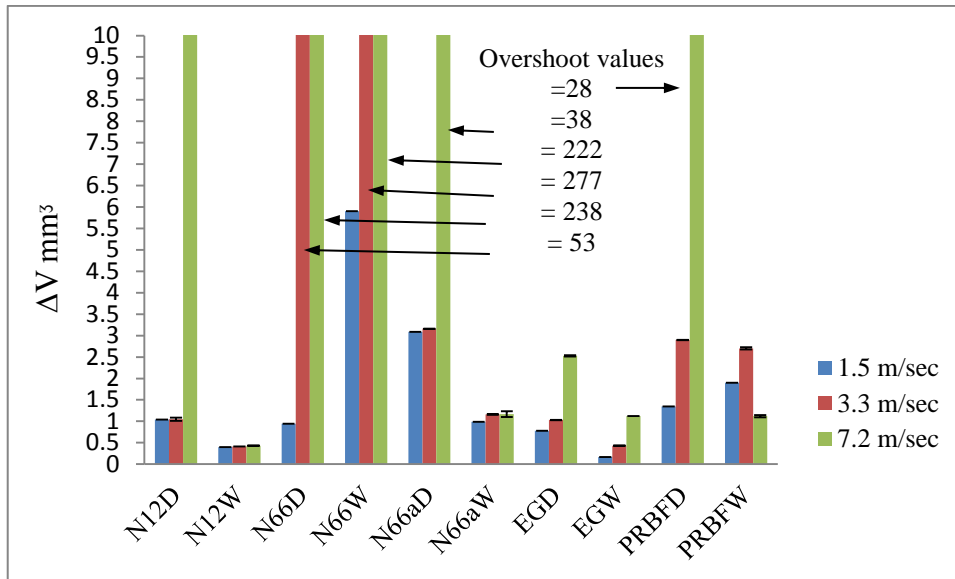
Fig. 4:3- Sliding Tests for All End Post Materials in Dry and Wet Test Conditions at an Applied Load of 30 N and Sliding Speeds of 1.5 m/sec, 3.3 m/sec and 7.2 m/sec.

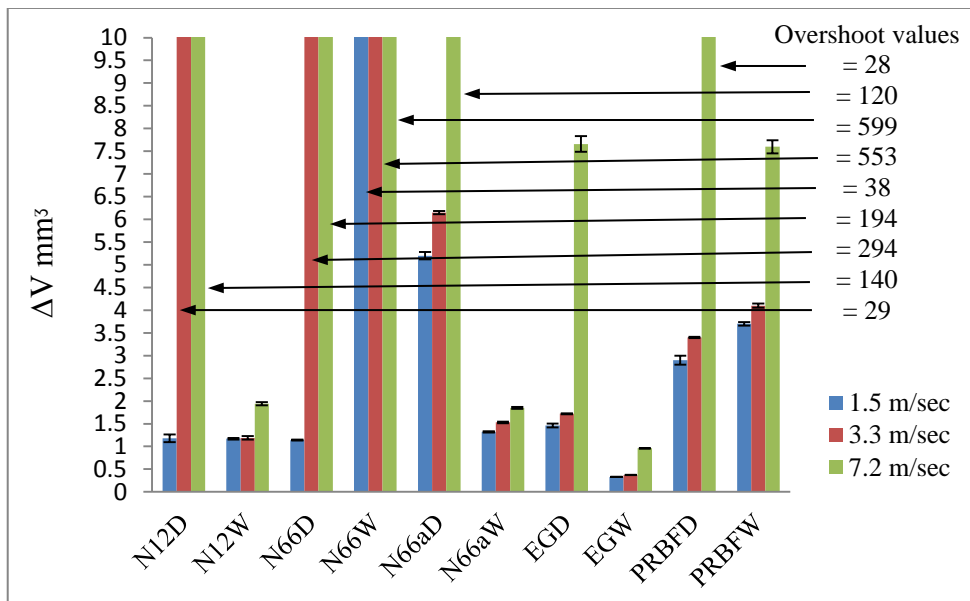
Fig. 4:4- Sliding Tests for All End Post Materials in Dry and Wet Test Conditions at an Applied Load of 50 N and Sliding Speeds of 1.5 m/sec, 3.3 m/sec and 7.2 m/sec.

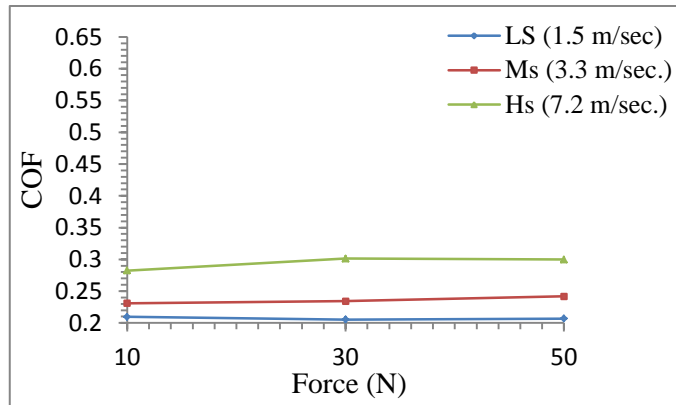
Figures 4:6 to 4:10 show the coefficients of friction for the five studied end post materials at the same sliding velocities used in the dry sliding wear experiments (1.5 m/sec, 3.3 m/sec, and 7.2 m/sec), which correspond to rotating velocities of 568 rpm, 1261 rpm, and 2764 respectively and also at the same applied loads.

Fig. 4:6- Coefficient of Friction of (N12) at Sliding Velocities of 1.5 m/sec, 3.3 m/sec, and 7.2 m/sec and Applied Loads of 10 N, 30 N, 50 N.

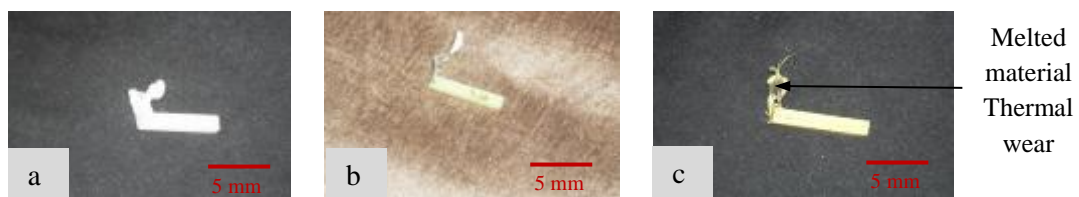
Fig. 4:13- Photos of Melted Materials of (a) Nylon 12, (b) Nylon 66 and (c) Nylon 66a.

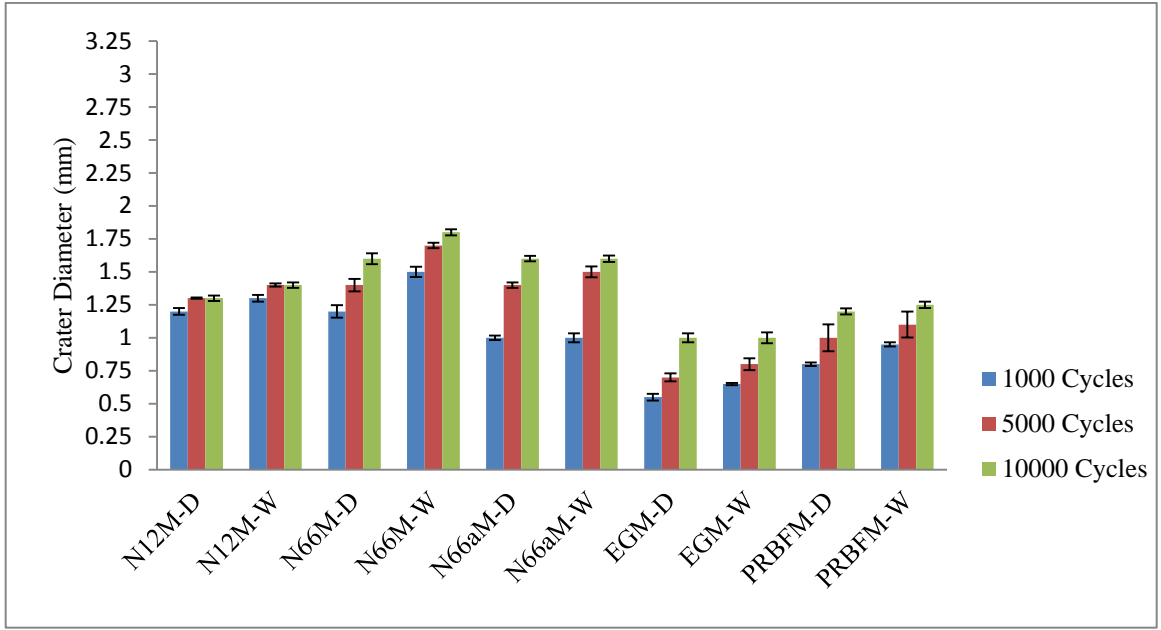
Fig. 5:2- Impact Test for All End Post Materials in Dry and Wet Conditions at an Applied Load of 100 N and 1000 Cycles, 5000 Cycles and 10,000 Cycles.

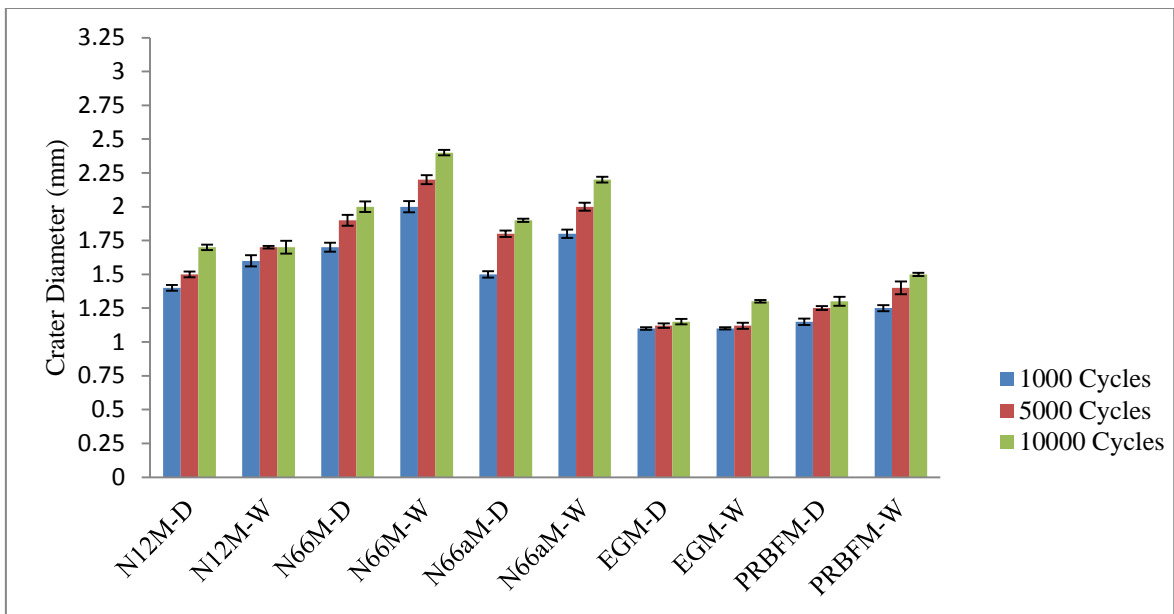
Fig. 5:3- Impact Test for All End Post Materials in Dry and Wet Conditions at an Applied Load of 300 N and 1000 Cycles, 5000 Cycles and 10,000 Cycles.

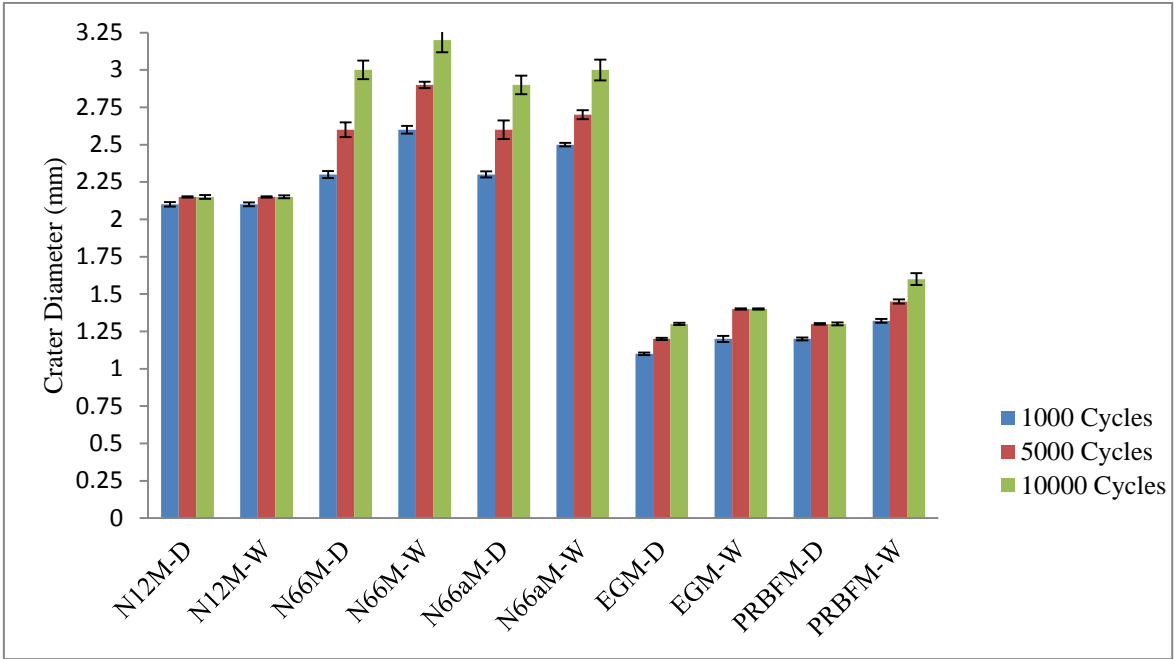
Fig. 5:4- Impact Test for All End Post Materials in Dry and Wet Conditions at an Applied Load of 500 N and 1000 Cycles, 5000 Cycles and 10,000 Cycles.

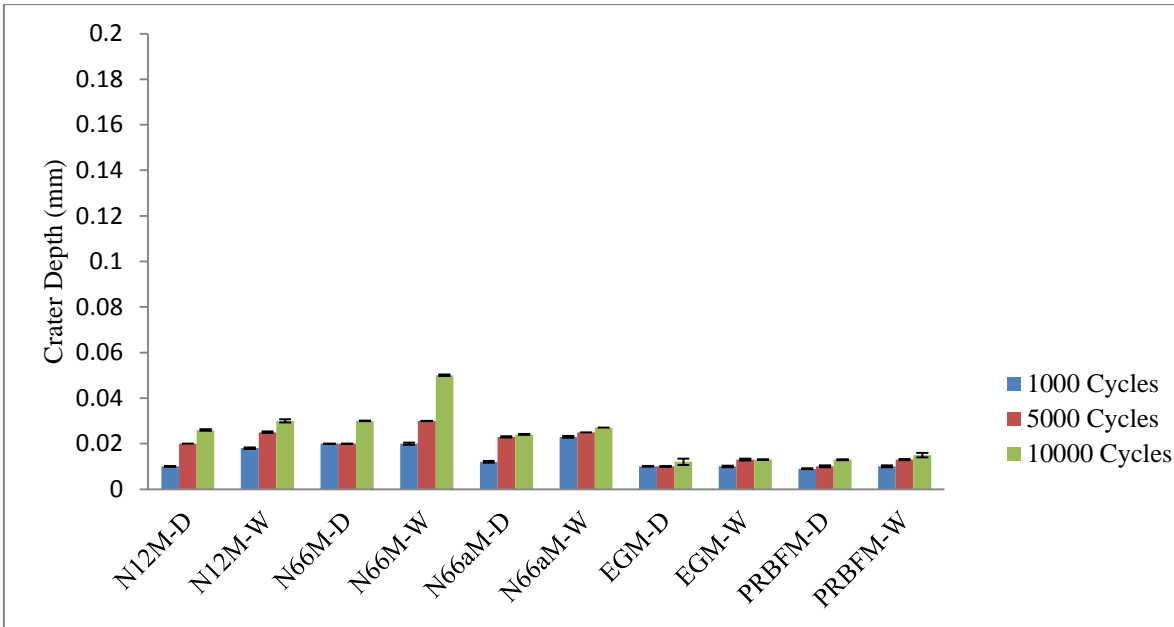
Figure 5:6- Impact Test for All End Post Materials in Dry and Wet Conditions at an Applied Load of 100 N and 1000 cycles, 5000 cycles and 10,000 cycles.

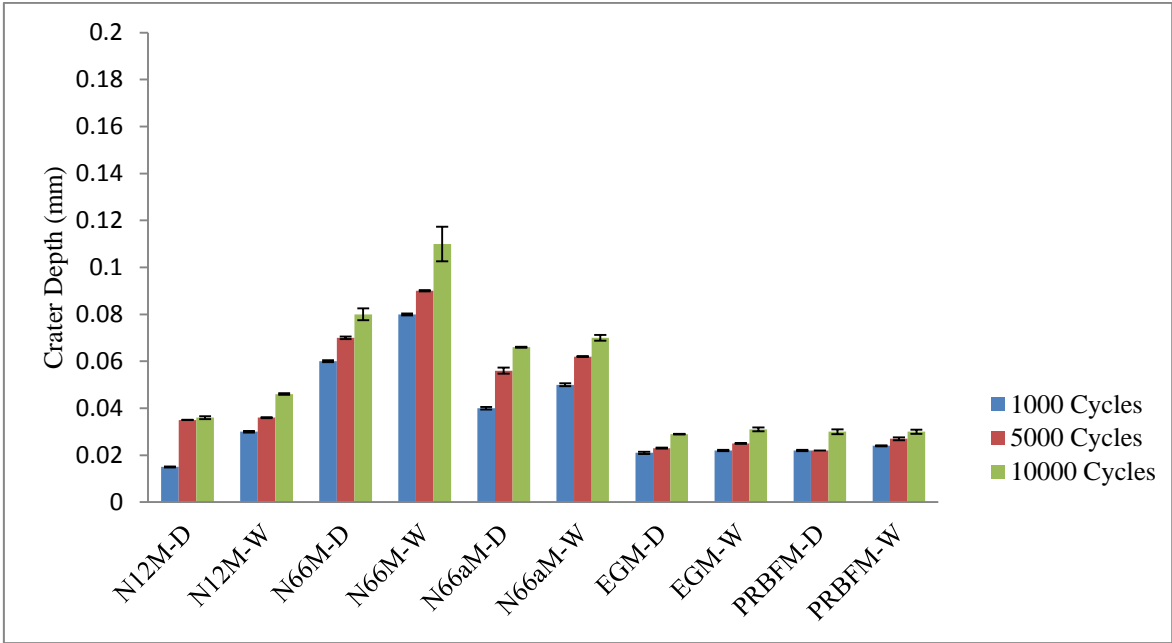
Figure 5:7- Impact Test for All End Post Materials in Dry and Wet Conditions at an Applied Load of 300 N and 1000 cycles, 5000 cycles and 10,000 cycles.

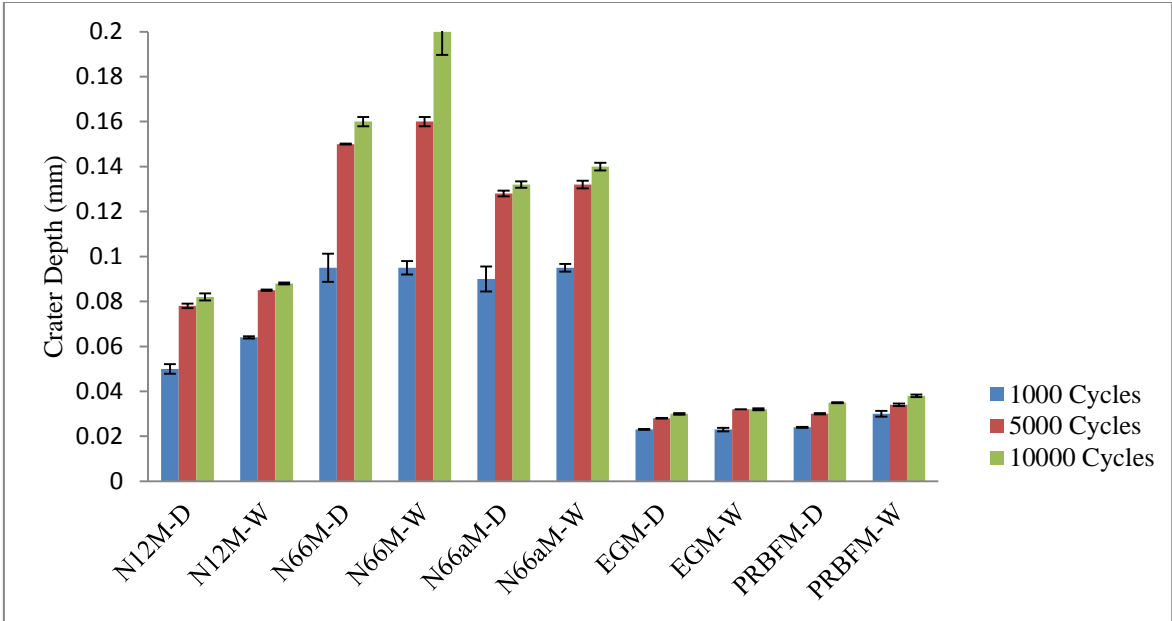
Figure 5:8- Impact Test for All End Post Materials in Dry and Wet Conditions at an Applied Load of 500 N and 1000 cycles, 5000 cycles and 10,000 cycles.

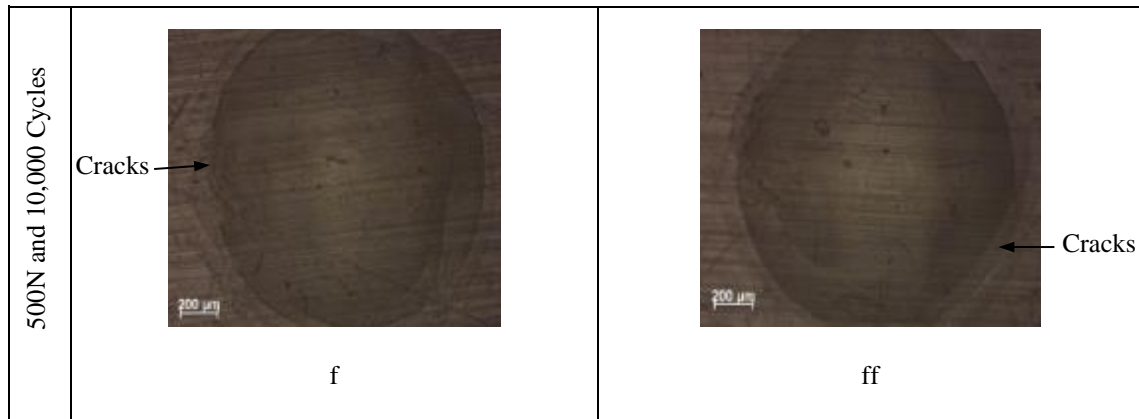
Figure 5:11- Wear Images of Phenolic Resin Bonded Fabric Material at Forces of 100 N, 300 N and 500 N and 1000 Cycles and 10,000 Cycles in both Dry and Wet Conditions.

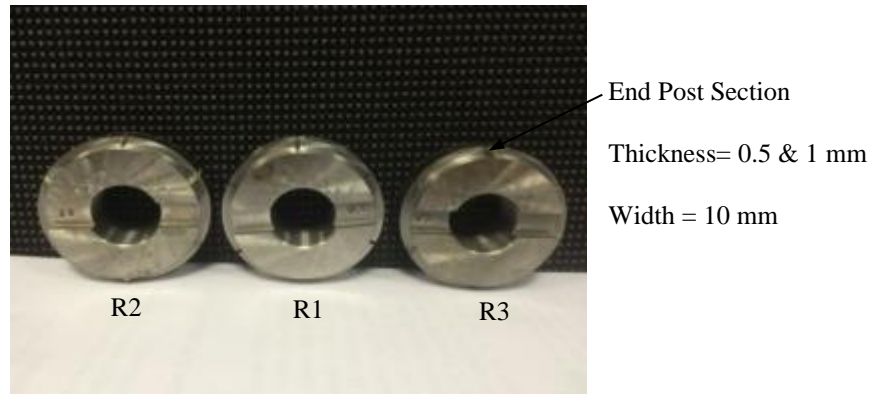
Fig. 6:1- Rail Steel Disc and Epoxy Glass End Post Materials (R1, R2 and R3).

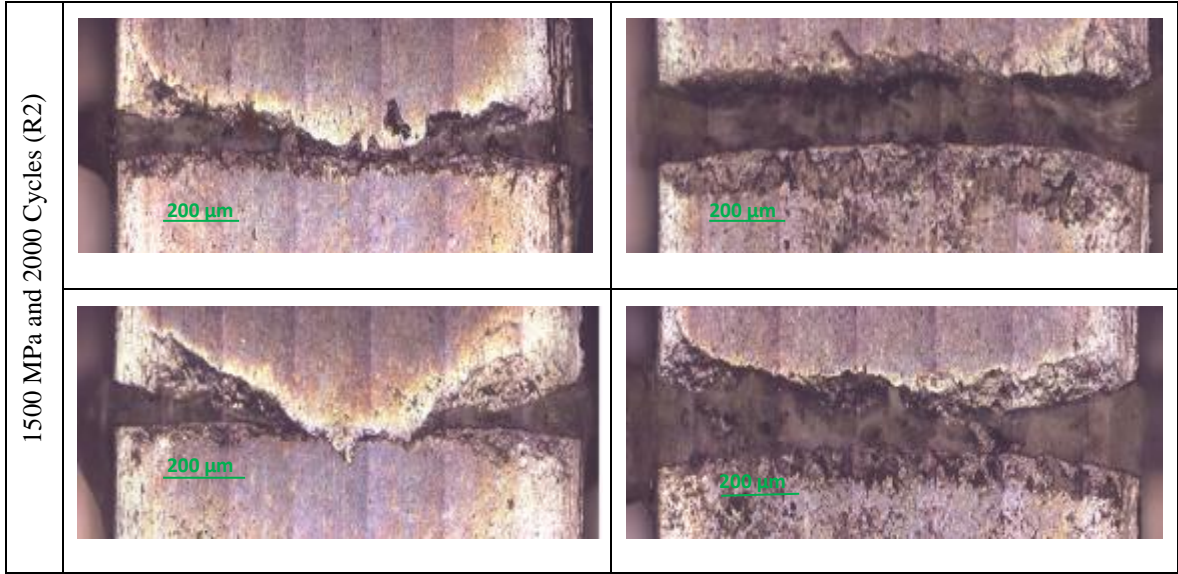
Fig. 6:6- Gaps Length Images after the Test.

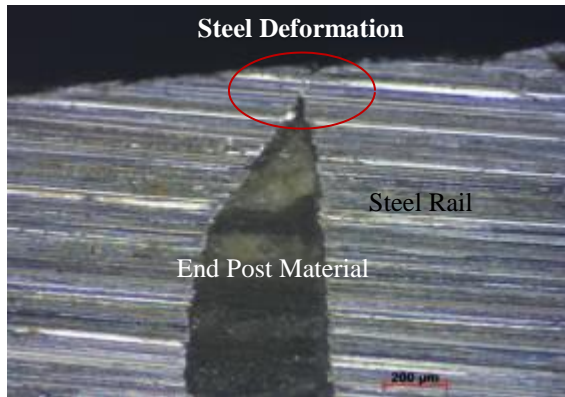
Fig. 6:8- R3 Specimen Imitating Rail Head Deformation over the Insulating End Post (0.5 mm)

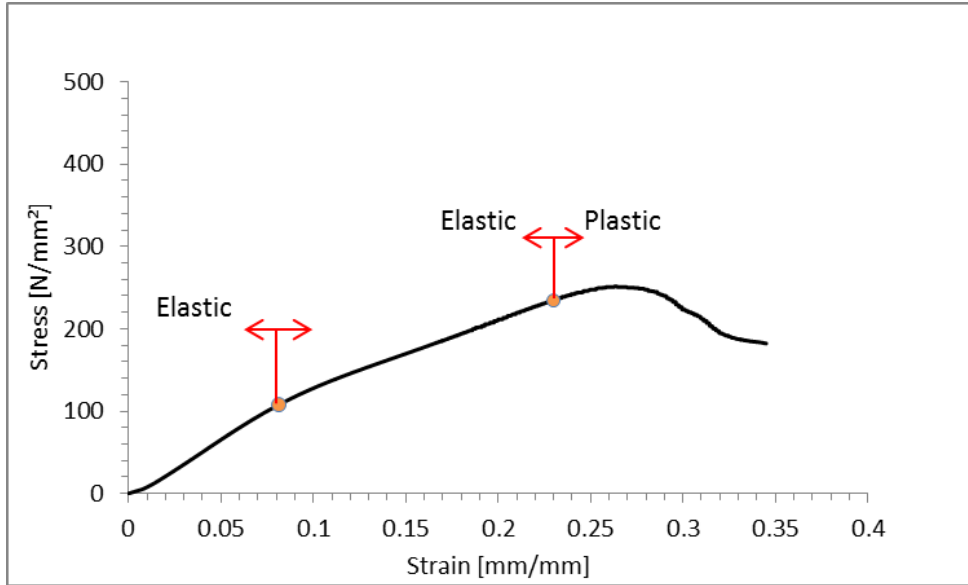
Fig. 8:7- Phenolic Resin Bonded Fabric Stress vs Strain.

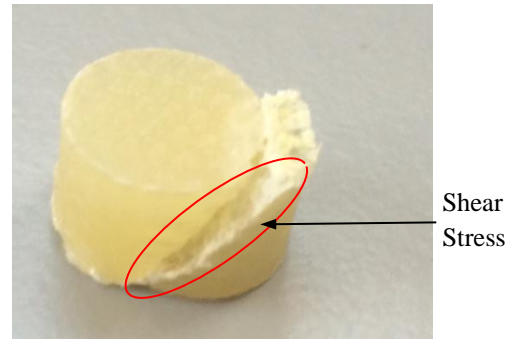
Fig. 8:13- Epoxy Glass Specimen Fracture Surface Image

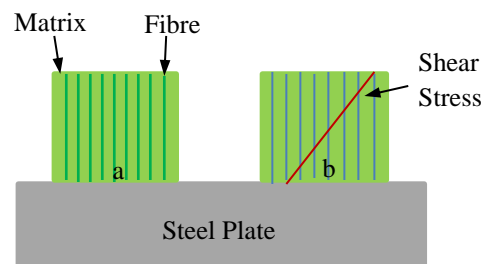
Fig. 8:14- Schematic Diagram of Epoxy Glass (a) before Test (b) after Test.
