Department
Of
Mechanical
Engineering.

Analysis of the Premature Failure of Wind Turbine Gearbox Bearings

**A thesis submitted in partial fulfilment of the
requirements for the degree of
Doctor of Philosophy**

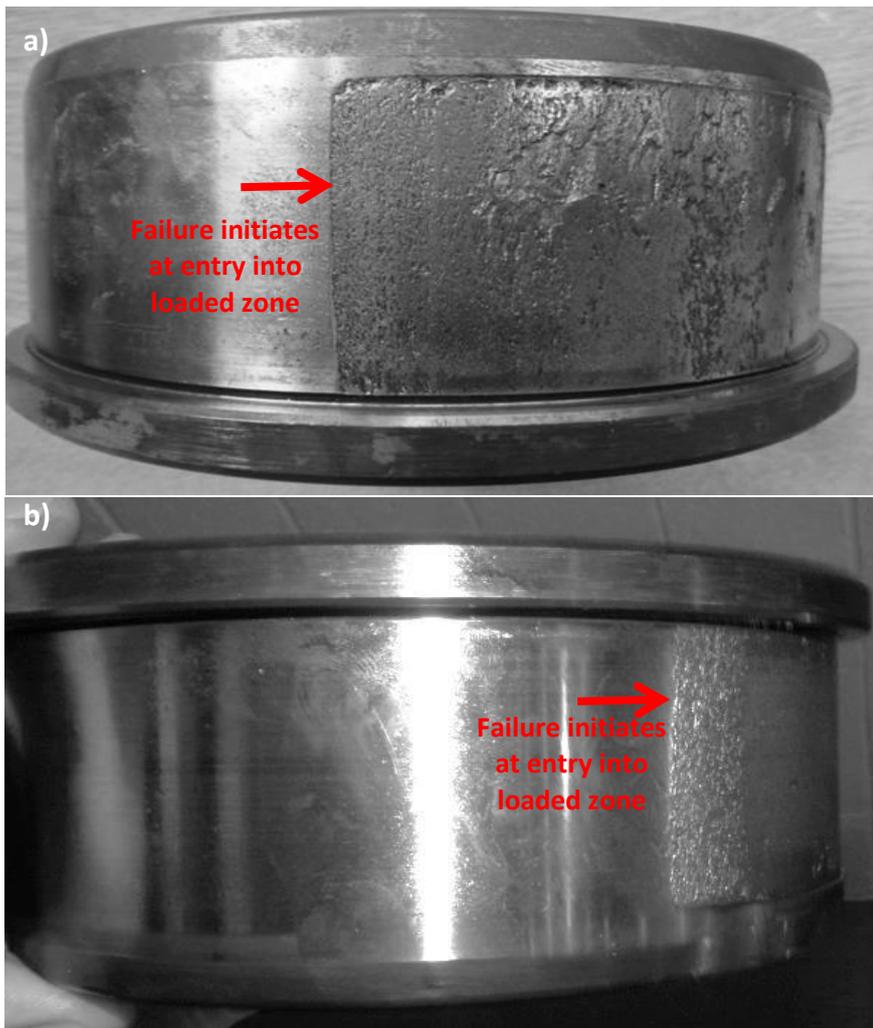
Figure 2-4: Failed planetary bearing inner raceways from a 600 kW turbine: a) upwind bearing, b) downwind bearing

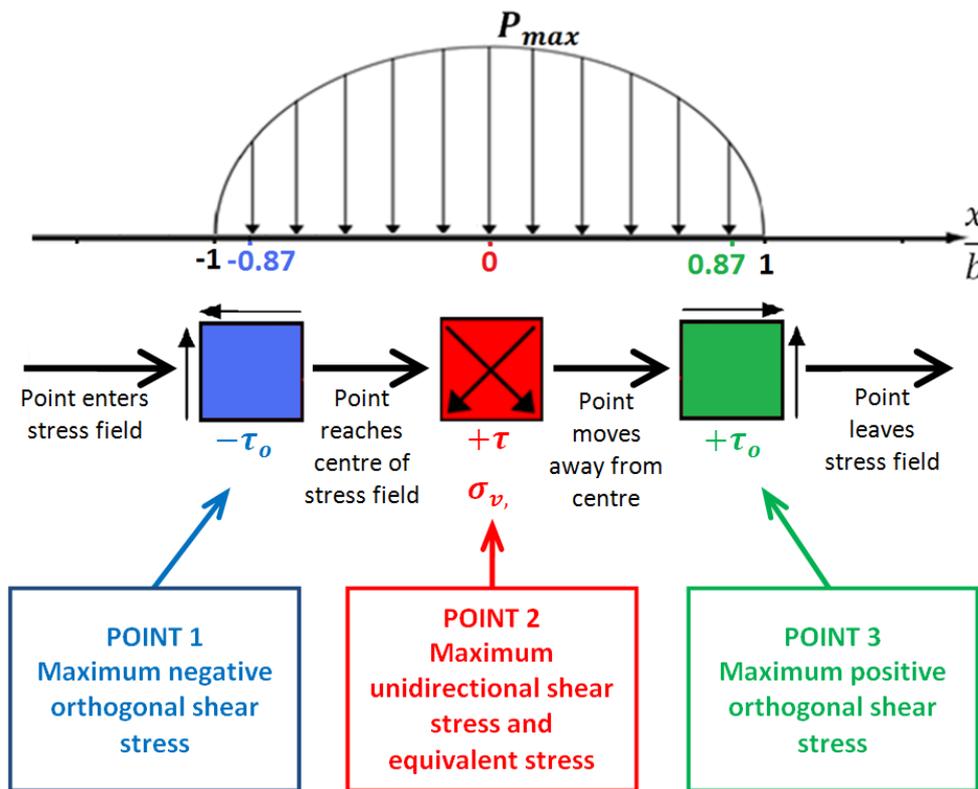
Any point at or close to the material surface of a rotating body under Hertzian loading will suffer repeated loading and unloading cycles, creating a much more complex situation than in static contact. Considering a point beneath the surface of the inner raceway of a CRB highlights the extreme loading conditions experienced by the bearing steel. As this point moves from left to right through the stress field illustrated in Figure 2-8, it will first experience the peak value of negative orthogonal shear stress, then move into an area of peak normal stress and peak unidirectional shear stress as the orthogonal shear stress magnitude decreases to zero, before experiencing an unloading of normal stress and orthogonal shear stress along with a load cycle of positive orthogonal shear. This rather complex description is illustrated in Figure 2-9. Loading extremities of points at key depths in the shear stress field are shown in Table 2-3, which highlights that the range of orthogonal shear stress is twice its magnitude since it experiences both a positive and negative maximum.

Figure 2-9: Stresses experienced by a point moving through a Hertzian stress field during rolling contact fatigue (note that the distances -0.87 and 0.87 are true for a point at depth $z = 0.5b$)

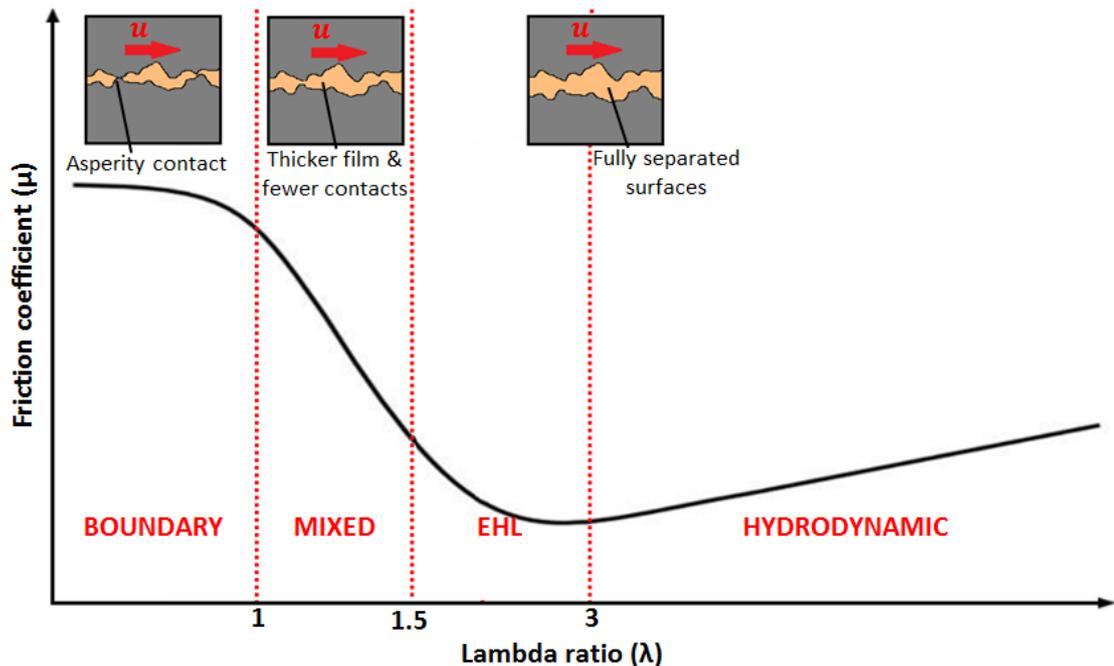
- **Hydrodynamic lubrication** ($\lambda > 3$) is formed due to a combination of the surfaces being inclined at some angle to each other, the fluid viscosity being high enough and the surfaces moving with sufficient velocity to generate a lubricant film that is able to support the contact load. Friction and wear levels drop to their lowest at first, but as fluid pressures increase, friction begins to increase due to fluid drag [19].

Figure 2-13: Stribeck curve illustrating lubrication regimes (not to scale). u indicates the direction of the movement.

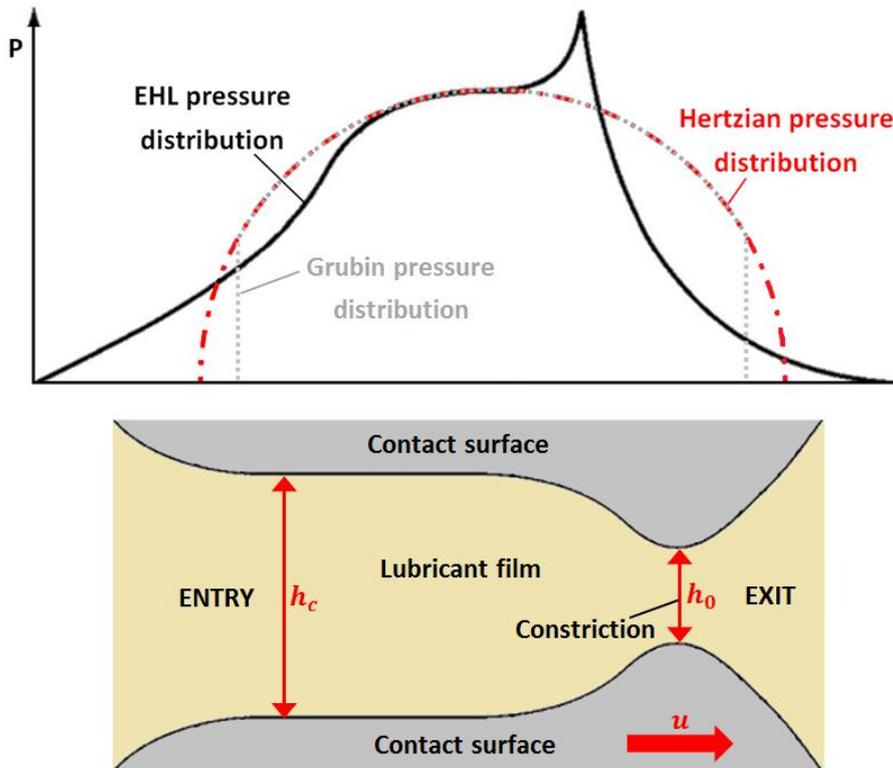
exit. On exit, a constriction is created, to compensate for this loss of viscosity and to maintain the lubricant flowrate through the contact region. It is at this constriction that the minimum film thickness h_0 is found [19].

Figure 2-14: Elastohydrodynamic pressure distribution showing contact geometry with comparison to Hertzian and Grubin pressure distributions; h_c is the central film thickness and h_0 is the minimum film thickness. Adapted from [19].

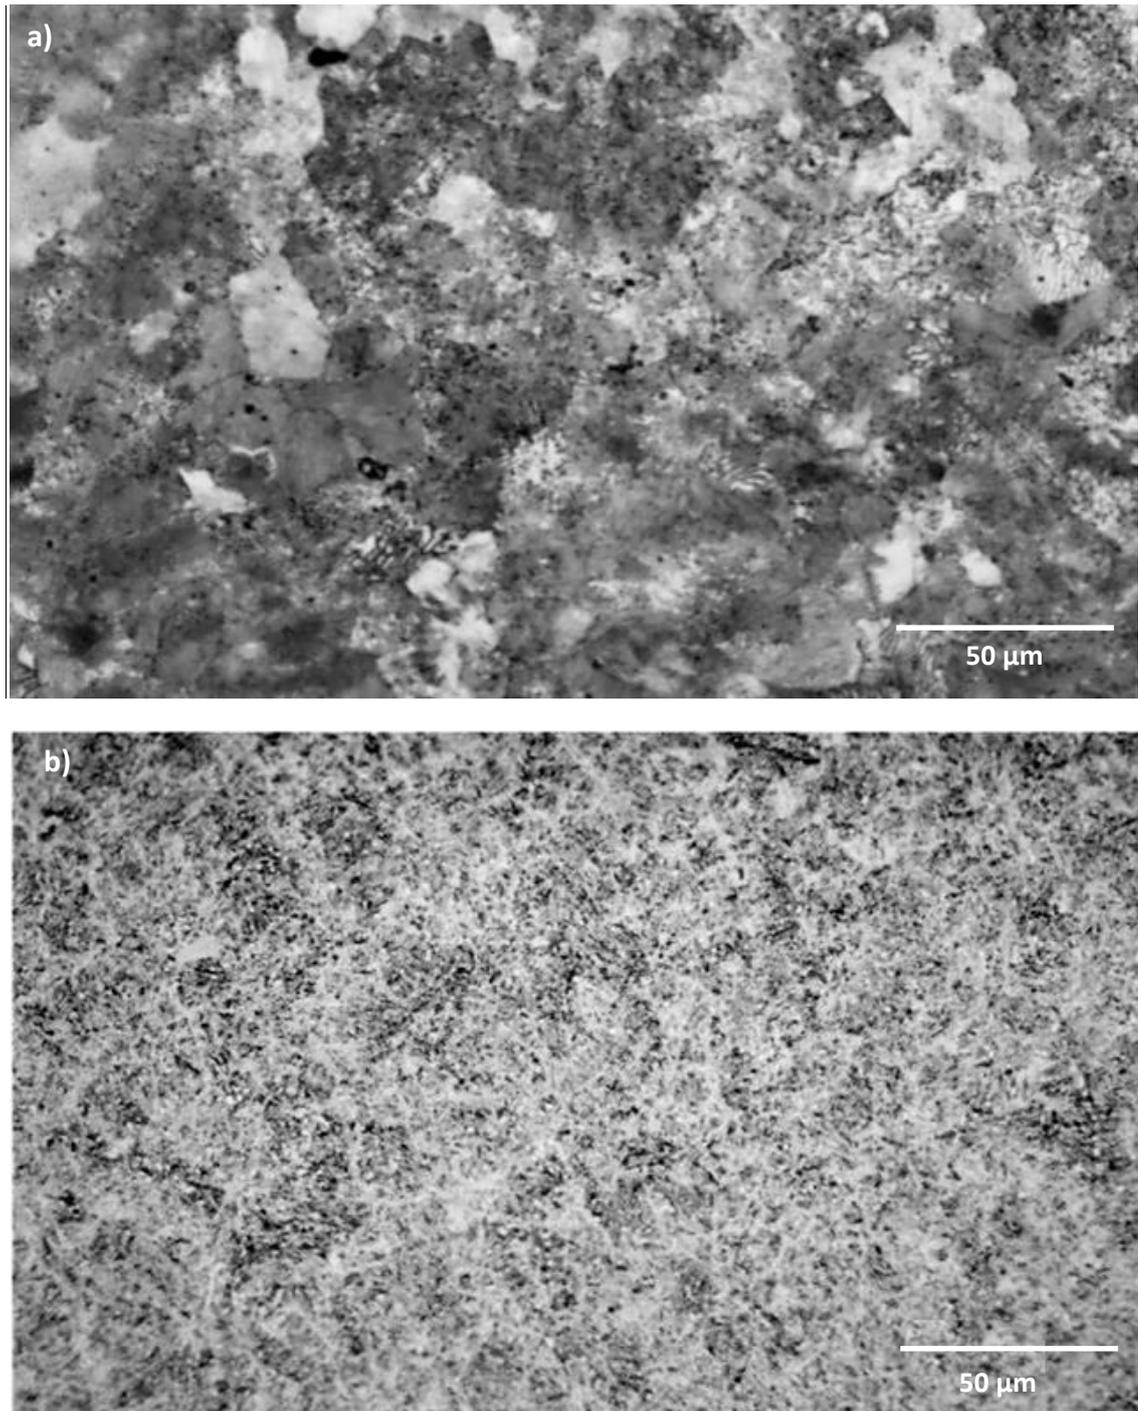
The through-hardening heat treatment of bearing steel takes place over three stages: austenitisation, quenching, and then tempering. The steel is held at austenitisation temperature for around 30 minutes, which is typically at around 840 °C. During austenitisation, the steel structure changes from a body-centred-cubic (BCC) ferrite structure to face-centred-cubic (FCC) austenite. Cementite is dissolved, with small percentages remaining, depending on the austenitisation temperature and time [26]. It is desirable for cementite levels to be low, since its presence has been shown to reduce RCF life [69]. Quenching is the rapid cooling of the steel from the austenitisation temperature and results in a hard, crystalline martensitic structure, with typically around 6-15 volume percentage (vol%) retained austenite [70, 71, 72, 73, 74] and 3-5 vol% uniformly distributed M_3C carbides around 0.4-0.6 μm in size, that remained after austenitisation [22, 26], although these percentages can vary depending on the austenitisation and quenching processes [26]. The "M" in M_3C represents a combination of iron and chromium atoms (as well as minor amounts of some other alloying elements) and consequently such carbides are sometimes denoted $(\text{Fe,Cr})_3\text{C}$ [23, 75, 76, 77]. After quenching, the steel is held at around 160 °C in a process called tempering, which causes the decomposition of some of the retained austenite and the precipitation of a variety of temper carbides (also called ϵ -carbides) [26]. Figure 2-15b shows the steel microstructure after heat treatment, using an image taken of the microstructure of the WTGB described in Chapter 5, prepared for metallurgical observation using the process discussed in section 4.1. The resulting, rather complex microstructure, contains martensite, retained austenite, ferrite, temper carbides and undissolved M_3C carbides left over from austenitisation [23, 26]. This microstructure is examined in more detail in section 4.3.2. It has been claimed that if at least 20% austenite remains after heat treatment, the bearing may be immune to the WEC failure mode [13]. However, a low level of retained austenite is desirable as it helps to keep the bearing raceway dimensionally stable [27].

Figure 2-15: Bearing steel microstructure: a) before heat treatment, b) after martensitic heat treatment

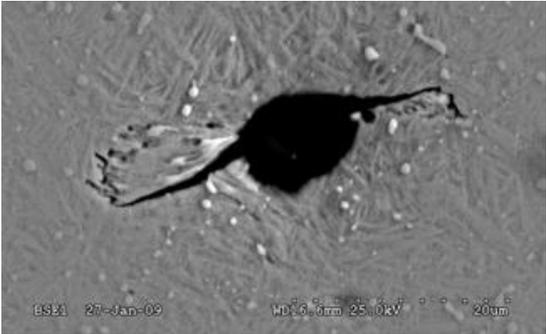
<p>3. Irregular white etching area (IrWEA)</p>	<p>A network of WECs and possibly butterflies that has developed into an irregular shape (not a single long and thin straight crack)</p>	
<p>4. Butterfly crack</p>	<p>A region of WEA that has the appearance of a butterfly, with up to four white etching microstructure “wings” at angles of between 30 to 50° and 130-150° from the over-rolling direction. They may or may not have a central initiating defect.</p>

Table 2-8: Clarification of the different stages and forms of the white etching microstructural change in steel. Images reproduced with thanks from [48], with permission from SAGE publishing.

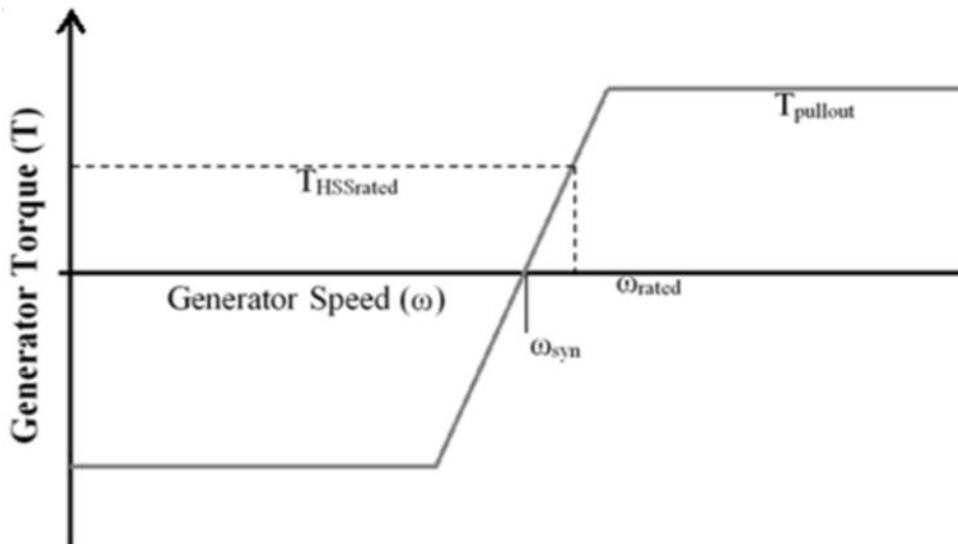
Using these values, a simple generator resistance torque curve can be calculated for any conventional wind turbine, as shown in Figure 2-22.

Figure 2-22: Simple induction generator resistance torque curve (adapted from [17])

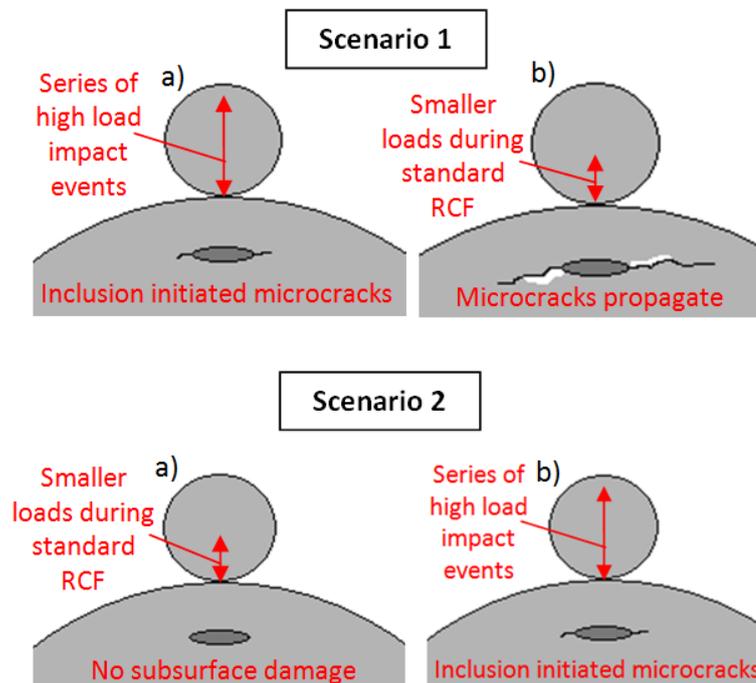
One of the key flaws in the Lundberg-Palmgren method is that it does not consider the order of loading events. It is hypothesised that this is a vitally important factor that is investigated in Chapter 7 of this thesis. Figure 2-29 describes a hypothesis, showing that if a high load event happens prior to a series of lesser load events, then the damage is more serious than that if these events occur in the reverse order.

Figure 2-29: Importance of the order of loading events (not to scale). Scenario 1 shows a high load impact event a) that initiates subsurface microcracking, which is then propagated by stresses induced by standard RCF loading in b). Scenario 2 shows that when these event occur in reverse, the damage would be far less severe.

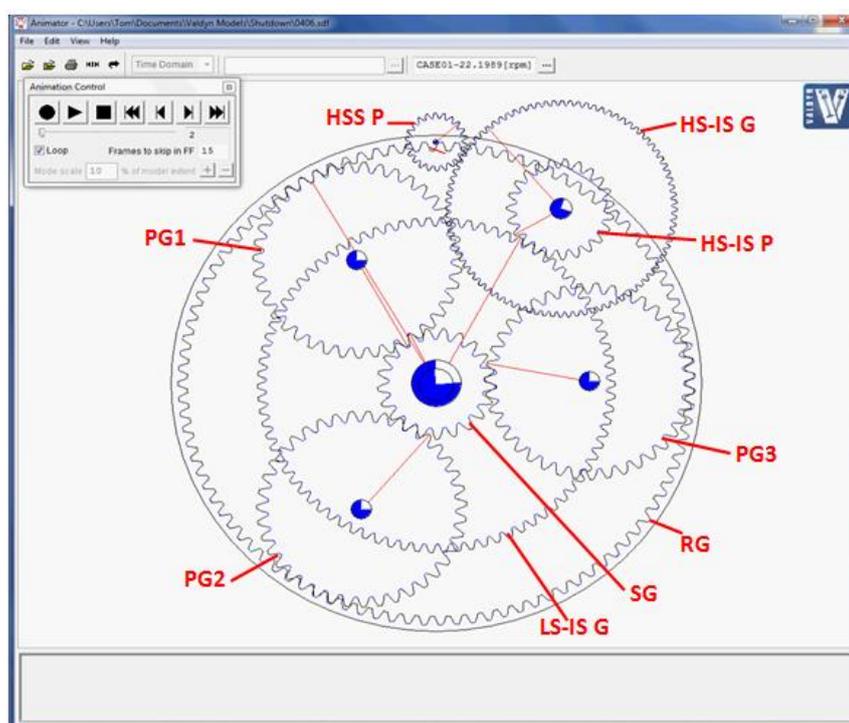
The appearance of the model on the VALDYN user interface is presented in Appendix B, with the various gearbox stages, the rotor, the generator and the gearbox casing labelled. When viewed in the VALDYN kinematic simulation interface, that allows the motion of the model to be viewed, the gearbox appears as shown in Figure 3-3.

Figure 3-3: Gearbox model viewed in VALDYN kinetic simulation interface

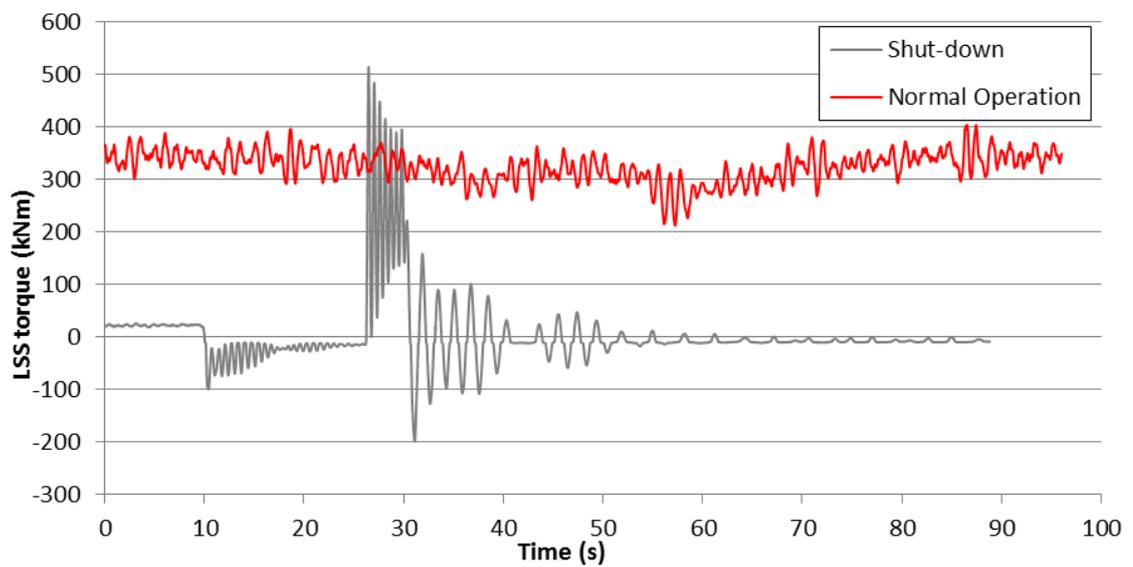
Figure 3-5 shows the LSS input torque for the two operating conditions that were investigated further by the developed dynamic model.

Figure 3-5: Input torque for normal operation and shutdown events

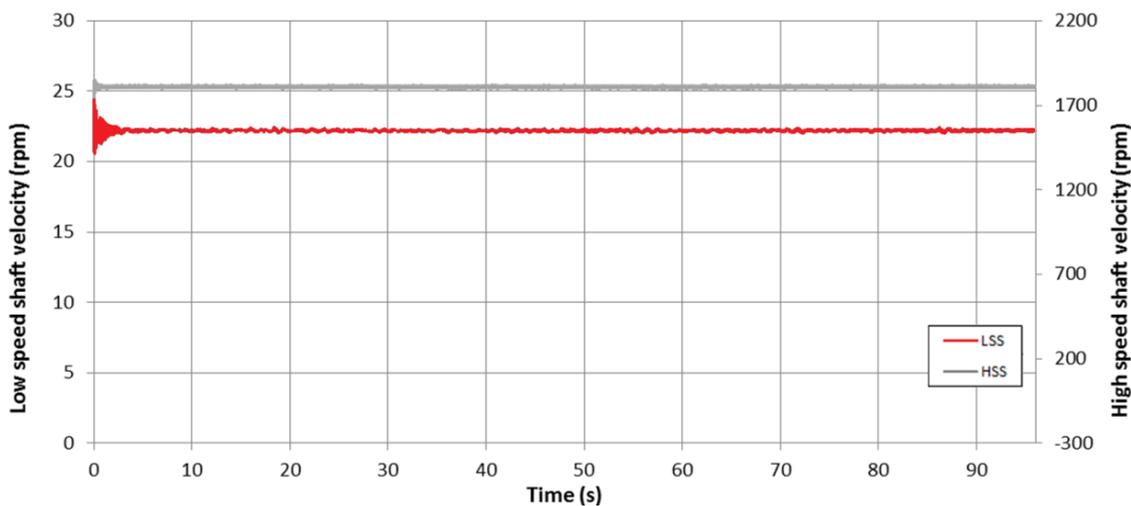
Figure 3-6 displays the LSS and HSS velocities over the 96 second simulation period. Ignoring oscillations caused by initial system unbalance in the first 5 seconds, LSS speed oscillation magnitudes of approximately 0.8 rpm compare well with NREL measured data, and the average velocity of the simulated LSS signal was 0.13 % different from NREL measured data. No comparison data was available for the HSS velocity, which oscillates either side of the generator rated speed of 1809 rpm by approximately +/-5 rpm.

Figure 3-6: LSS and HSS velocity during normal operation

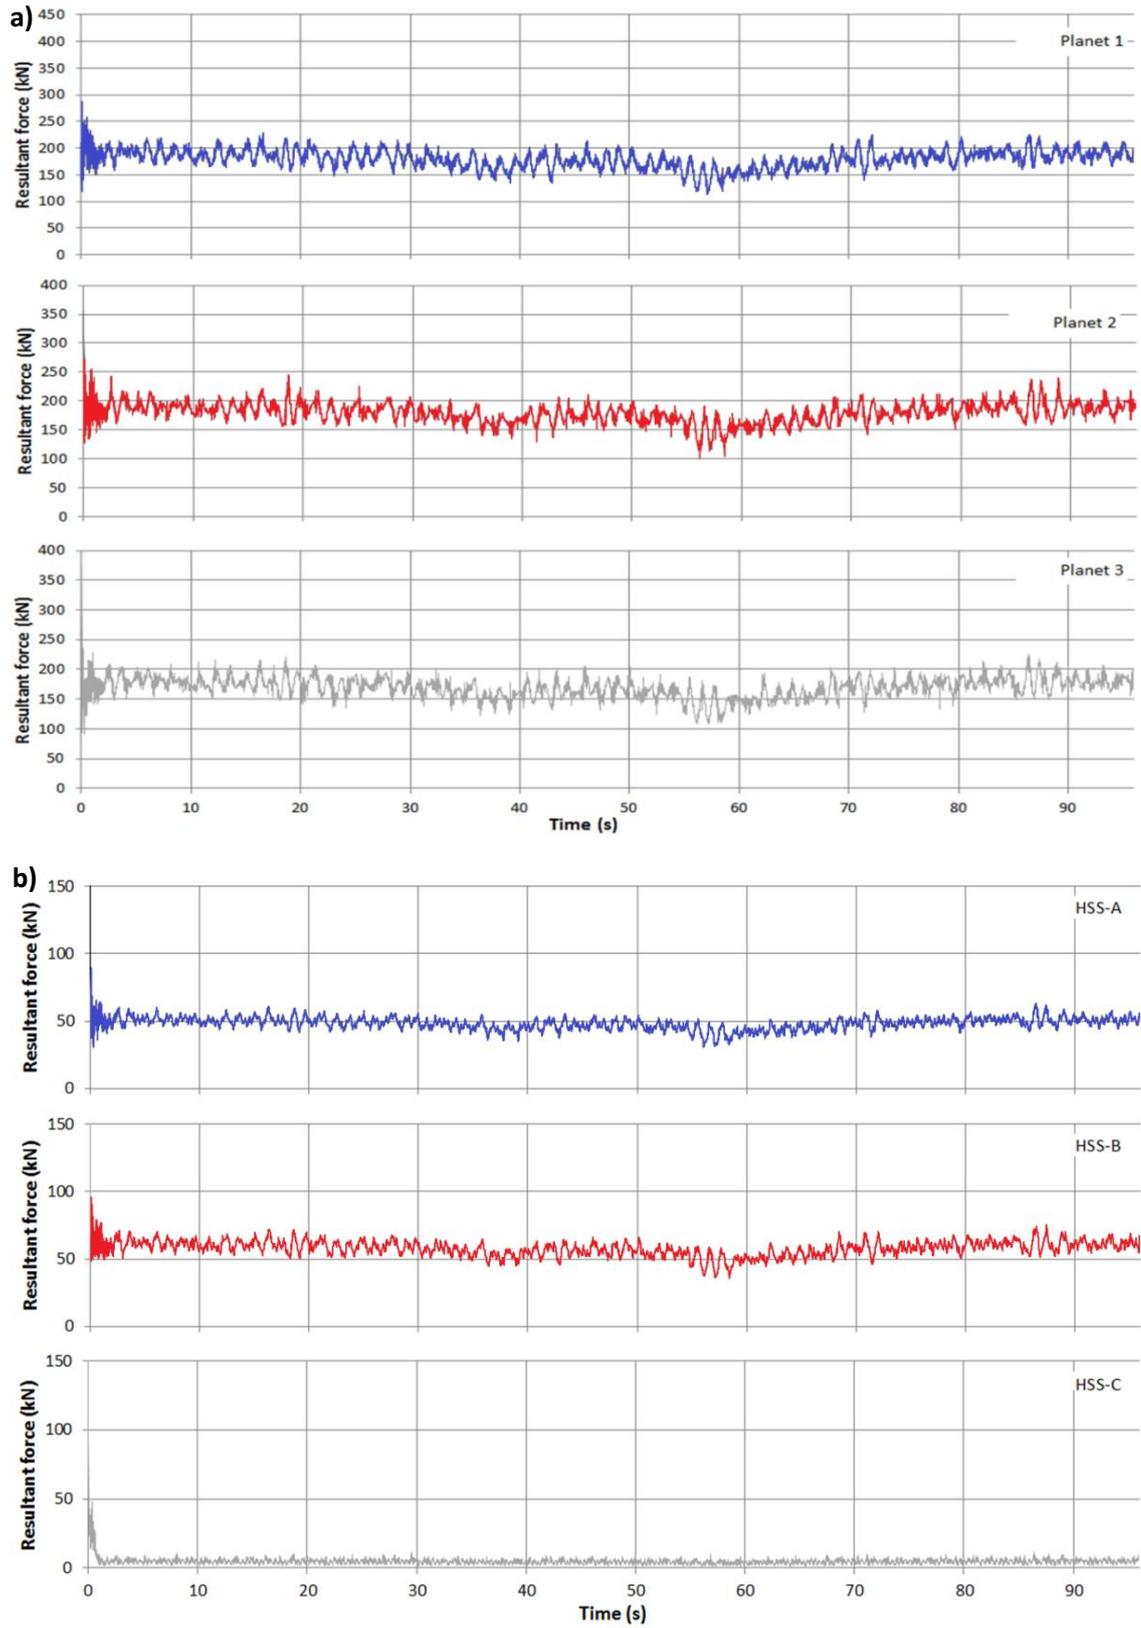
Figure 3-7: Resultant forces acting on bearings roller/raceway contacts during normal operation for: (a) Planetary bearings (b) High speed shaft bearings

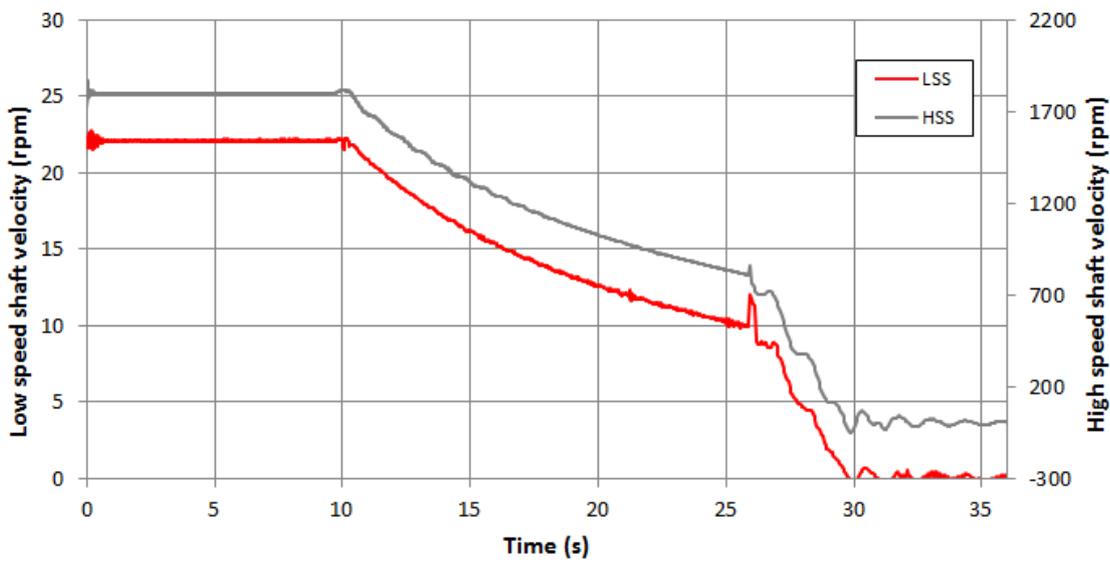
The LSS and HSS velocities during the shut-down event are shown in Figure 3-8. The simulation was stopped after 36 seconds as the rotor velocity was oscillating either side of zero and maximum bearing loading had been experienced. Figure 3-9a shows the planetary bearing loading in the X and Y directions. The resultant load peaks after 10 seconds, when the generator is switched offline, then a higher loading peak of 358 kN is experienced when the disc brake is engaged at 26 seconds. Figure 3-9b shows that the HSS bearings experience maximum resultant force magnitudes of 110 kN for *HSS-A*, 102 kN for *HSS-B* and 63 kN for *HSS-C* under braking.

Figure 3-8: LSS and HSS velocity during shut-down

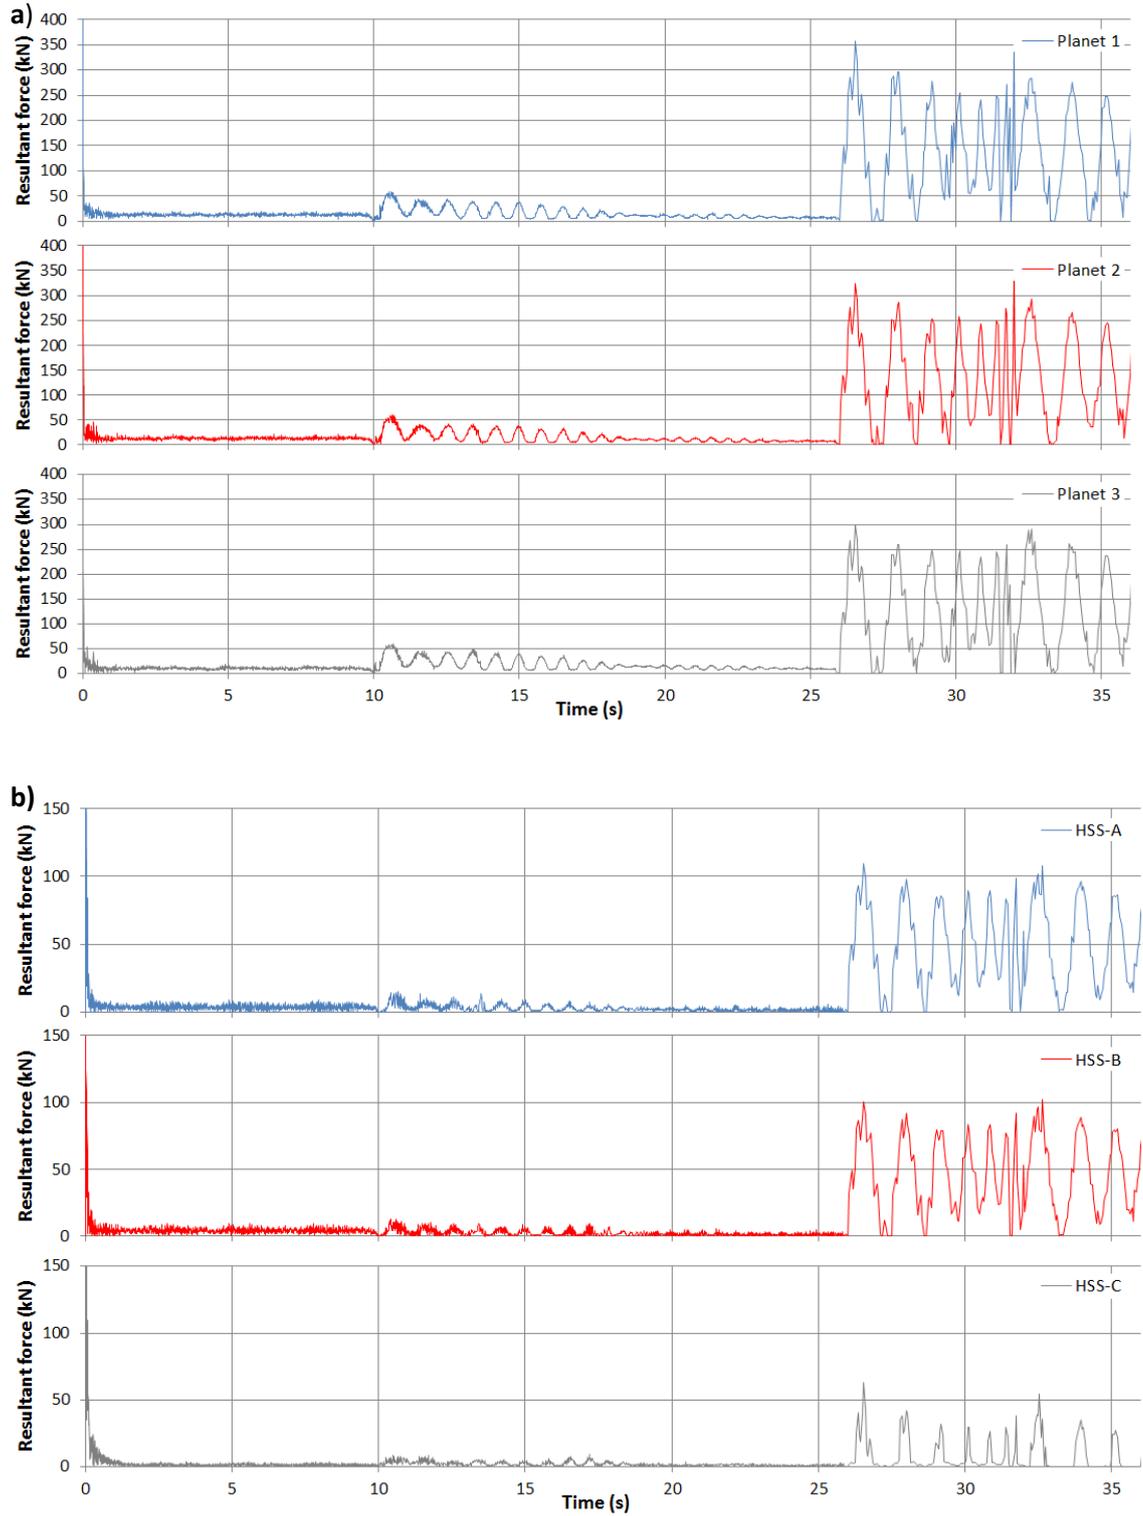
Figure 3-9: Resultant forces acting on planetary bearings roller/raceway contacts during shut-down for: (a) Planetary bearings (b) High speed shaft bearings

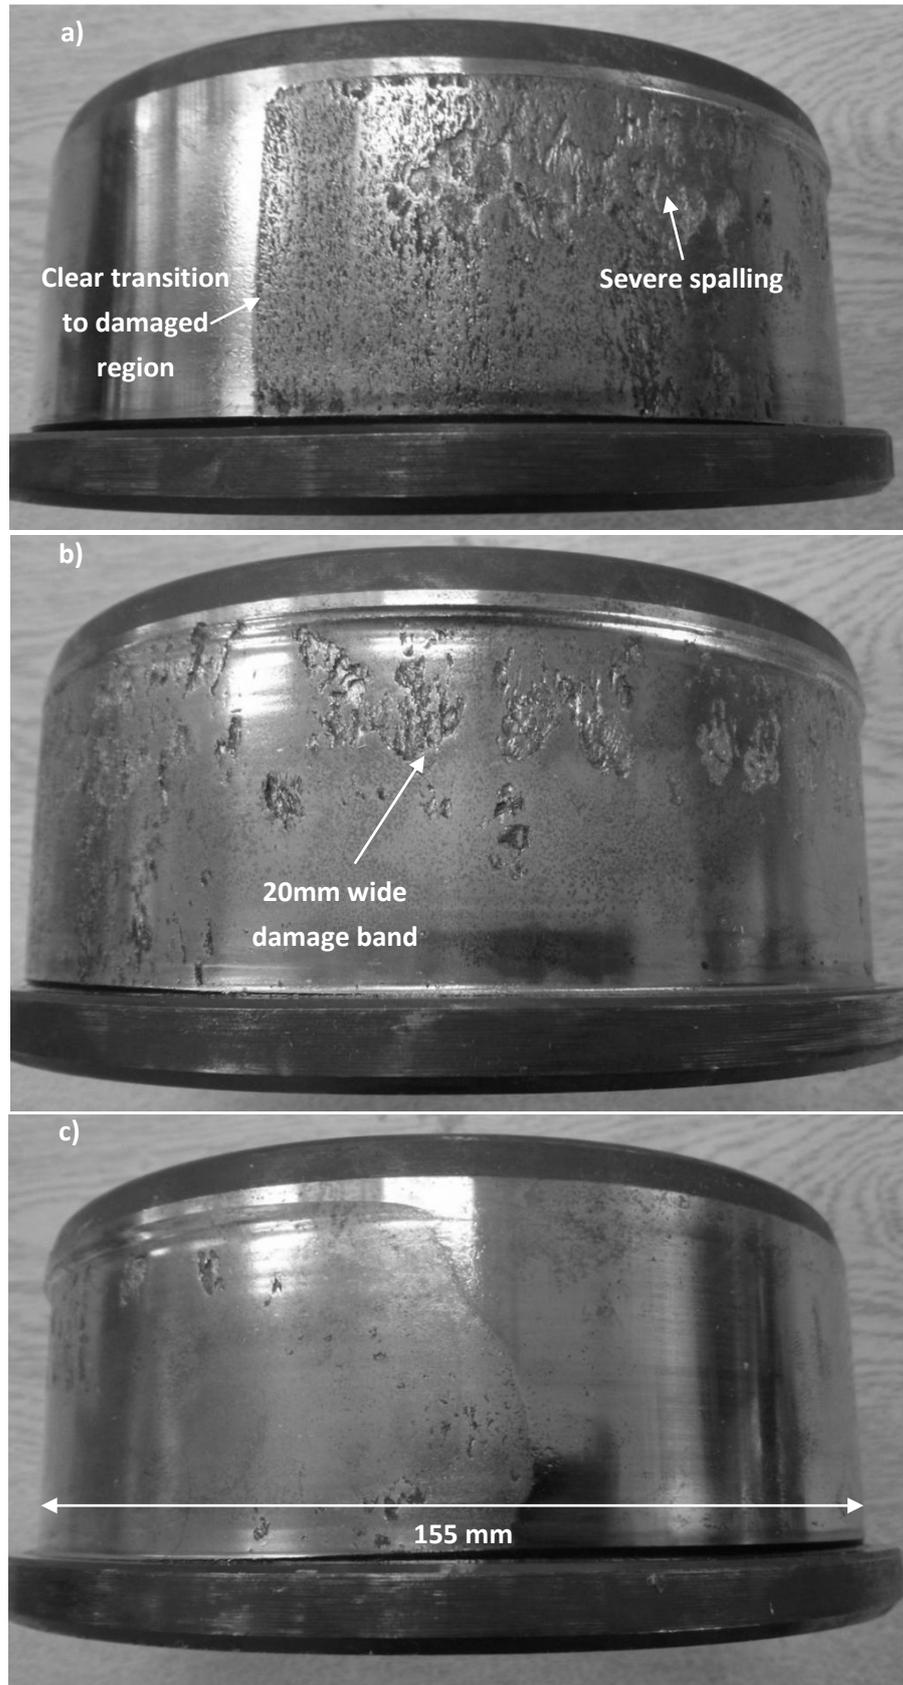
Figure 4-6: Photographs of raceway damage a) Zone 3 b) Zone 2 c) Zone 1

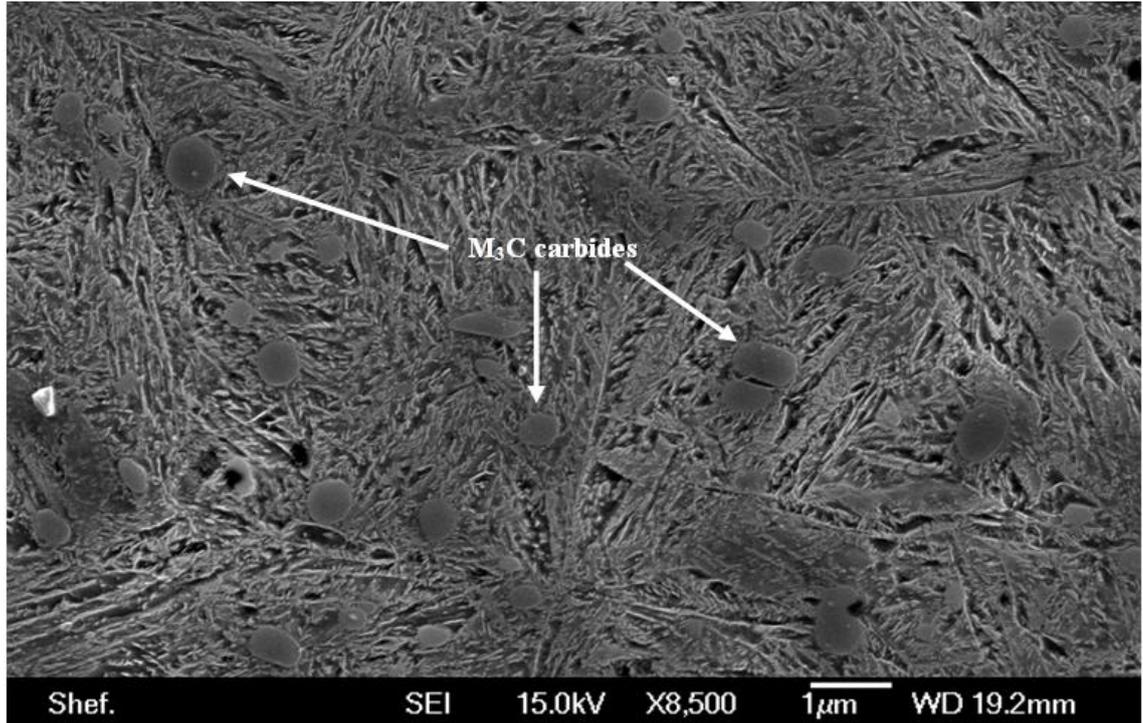
Figure 4-7: Bearing steel microstructure highlighting spheroidal iron-chromium (M_3C) carbides

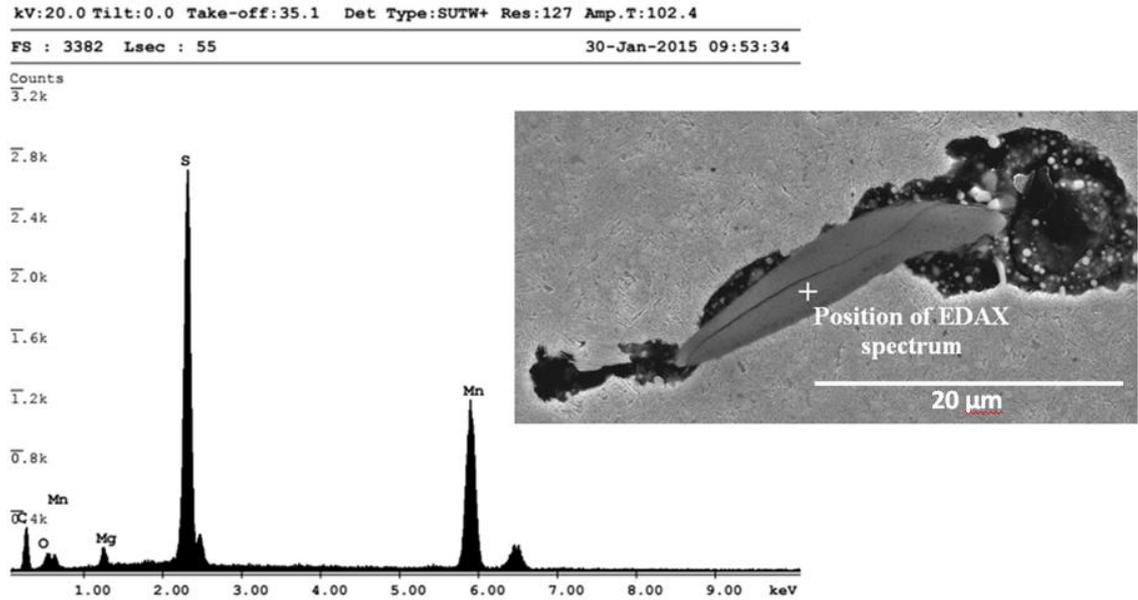
Figure 4-8: EDAX spectrum showing chemical composition of MnS inclusion

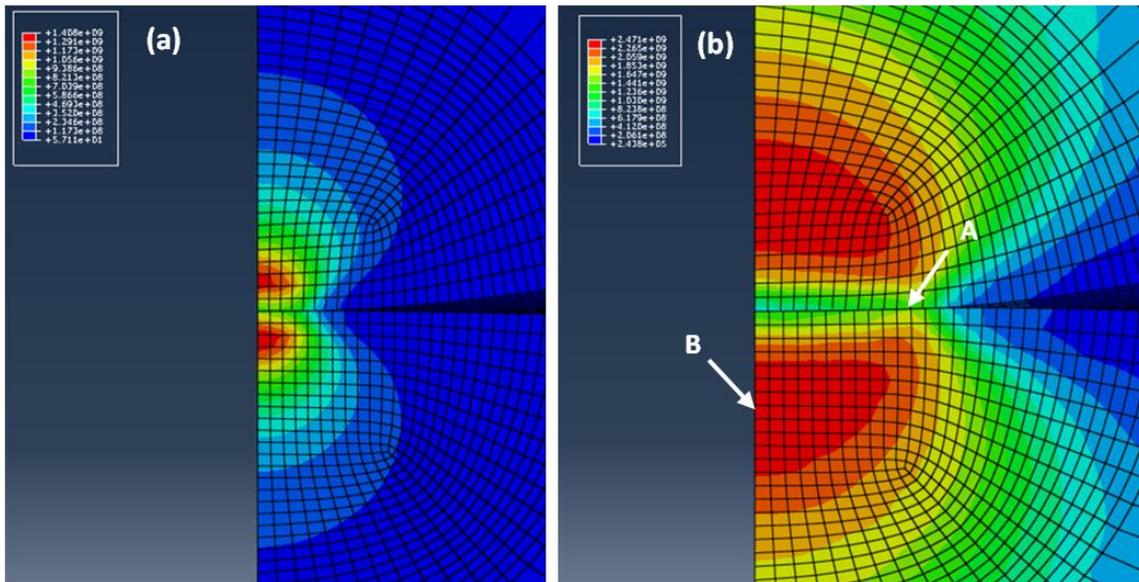
Figure 4-21: Equivalent stress distribution for 0.4 m/s impact velocity at (a) initial contact (b) max loading showing the approximate positions of maximum surface equivalent stress (A) and subsurface equivalent stress (B)

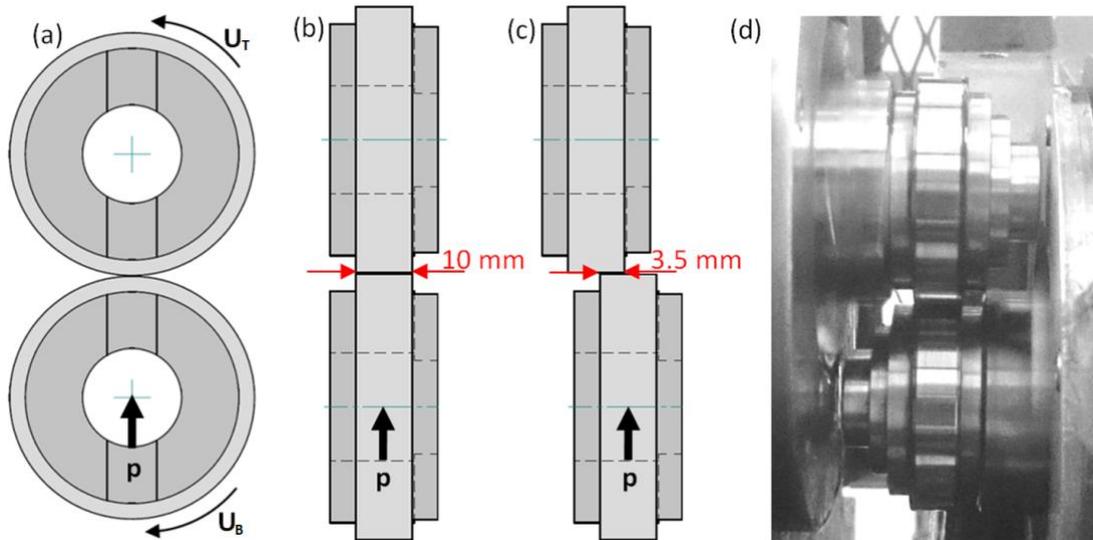
Figure 4-23: Twin disc testing specimen position (a) standard test (b) 10mm line contact (c) 3.5 mm line contact (d) 10 mm SUROS test. U_T = top disc velocity, U_B = bottom disc velocity, p = hydraulic load pushing up bottom disc.

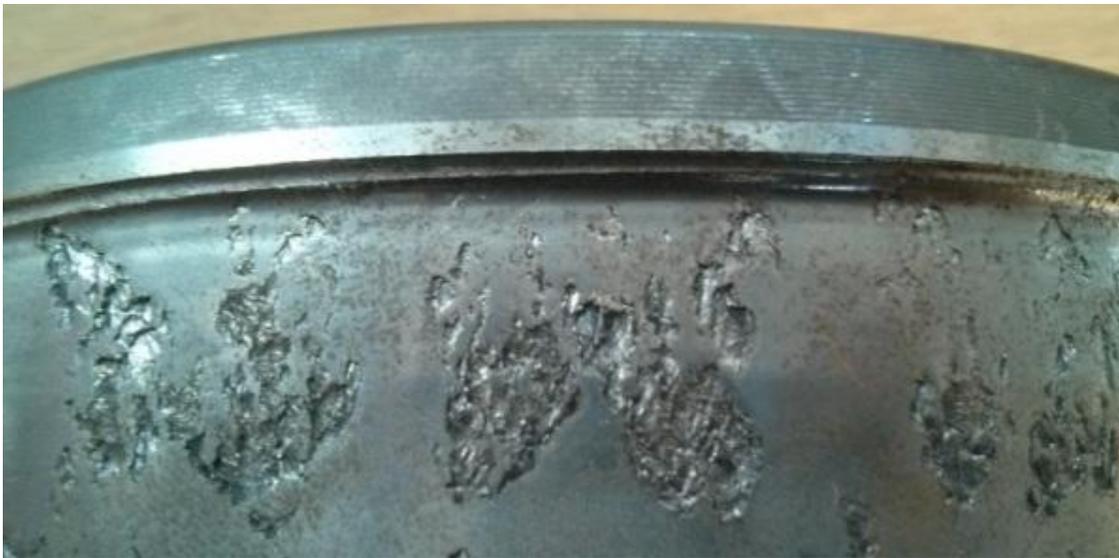
Figure 5-2: Spalling on the raceway surface in Zone 2

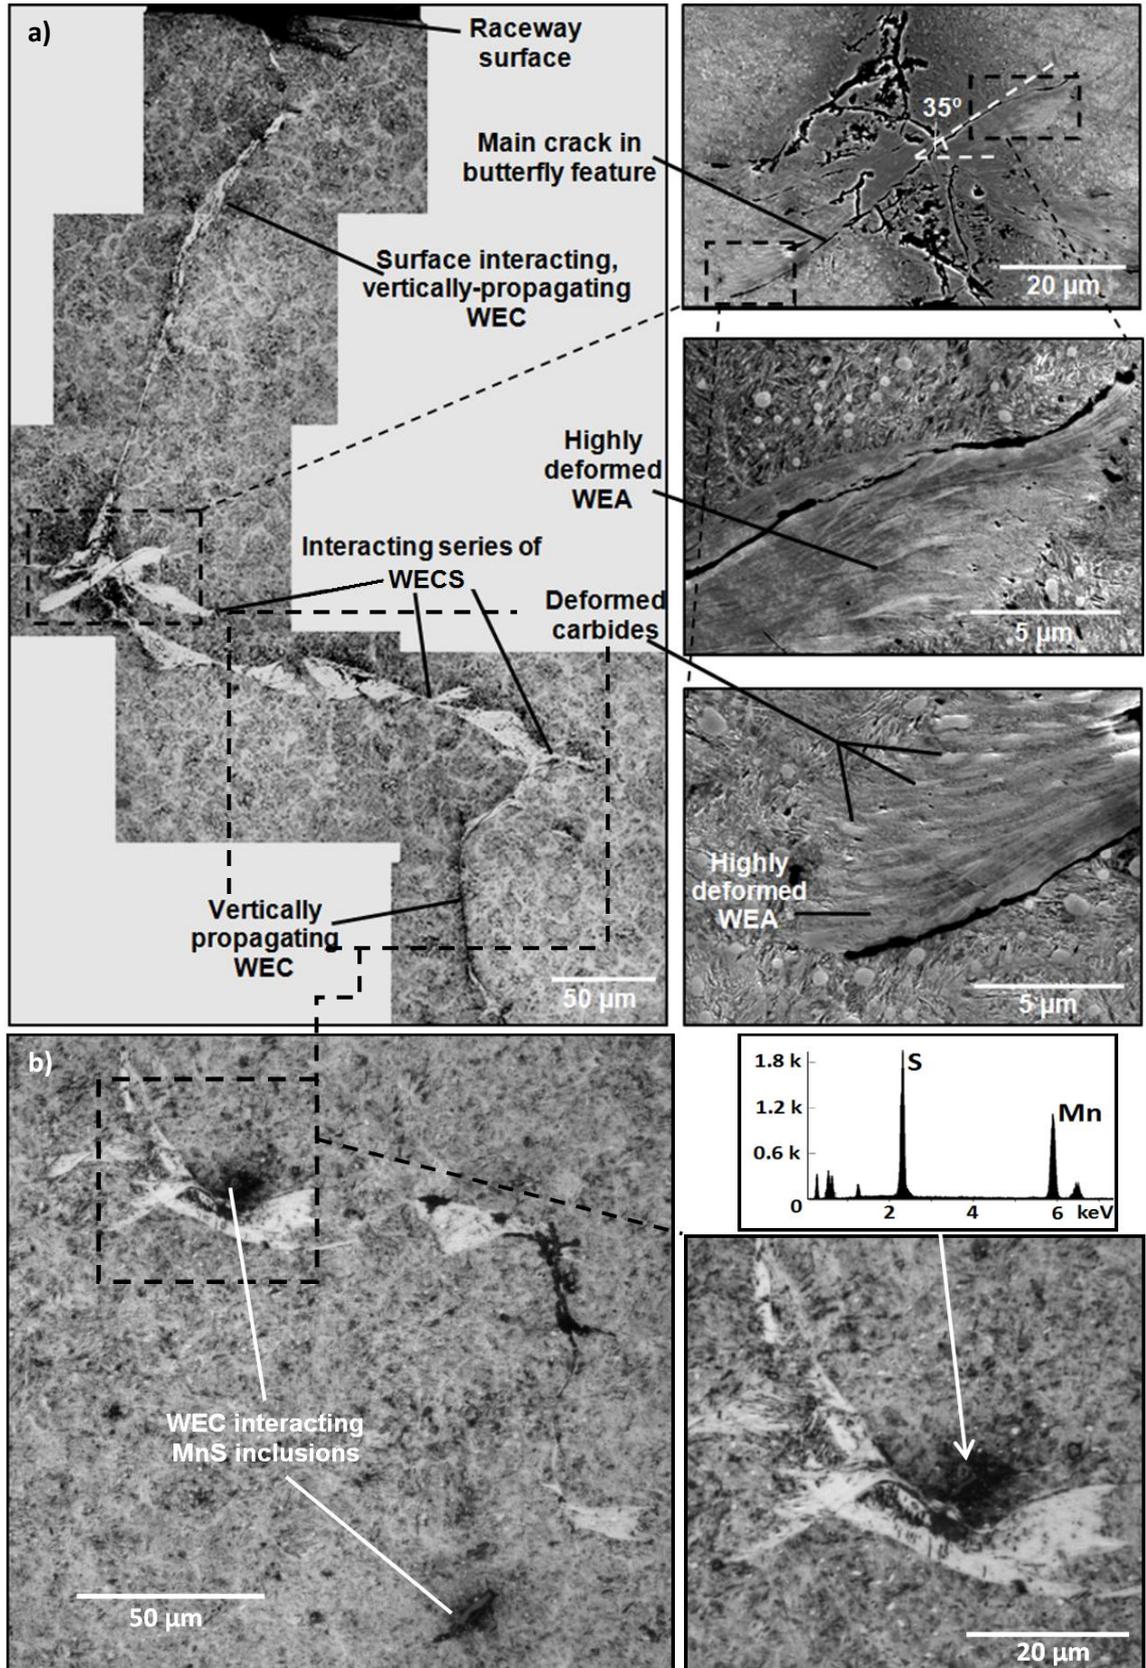
Figure 5-4: Series of butterflies and connected WECs in circumferential section a) first section observed b) second section observed approximately 20 μm below first section.
