Department
Of
Mechanical
Engineering.

Analysis of the Premature Failure of Wind Turbine Gearbox Bearings

**A thesis submitted in partial fulfilment of the
requirements for the degree of
Doctor of Philosophy**

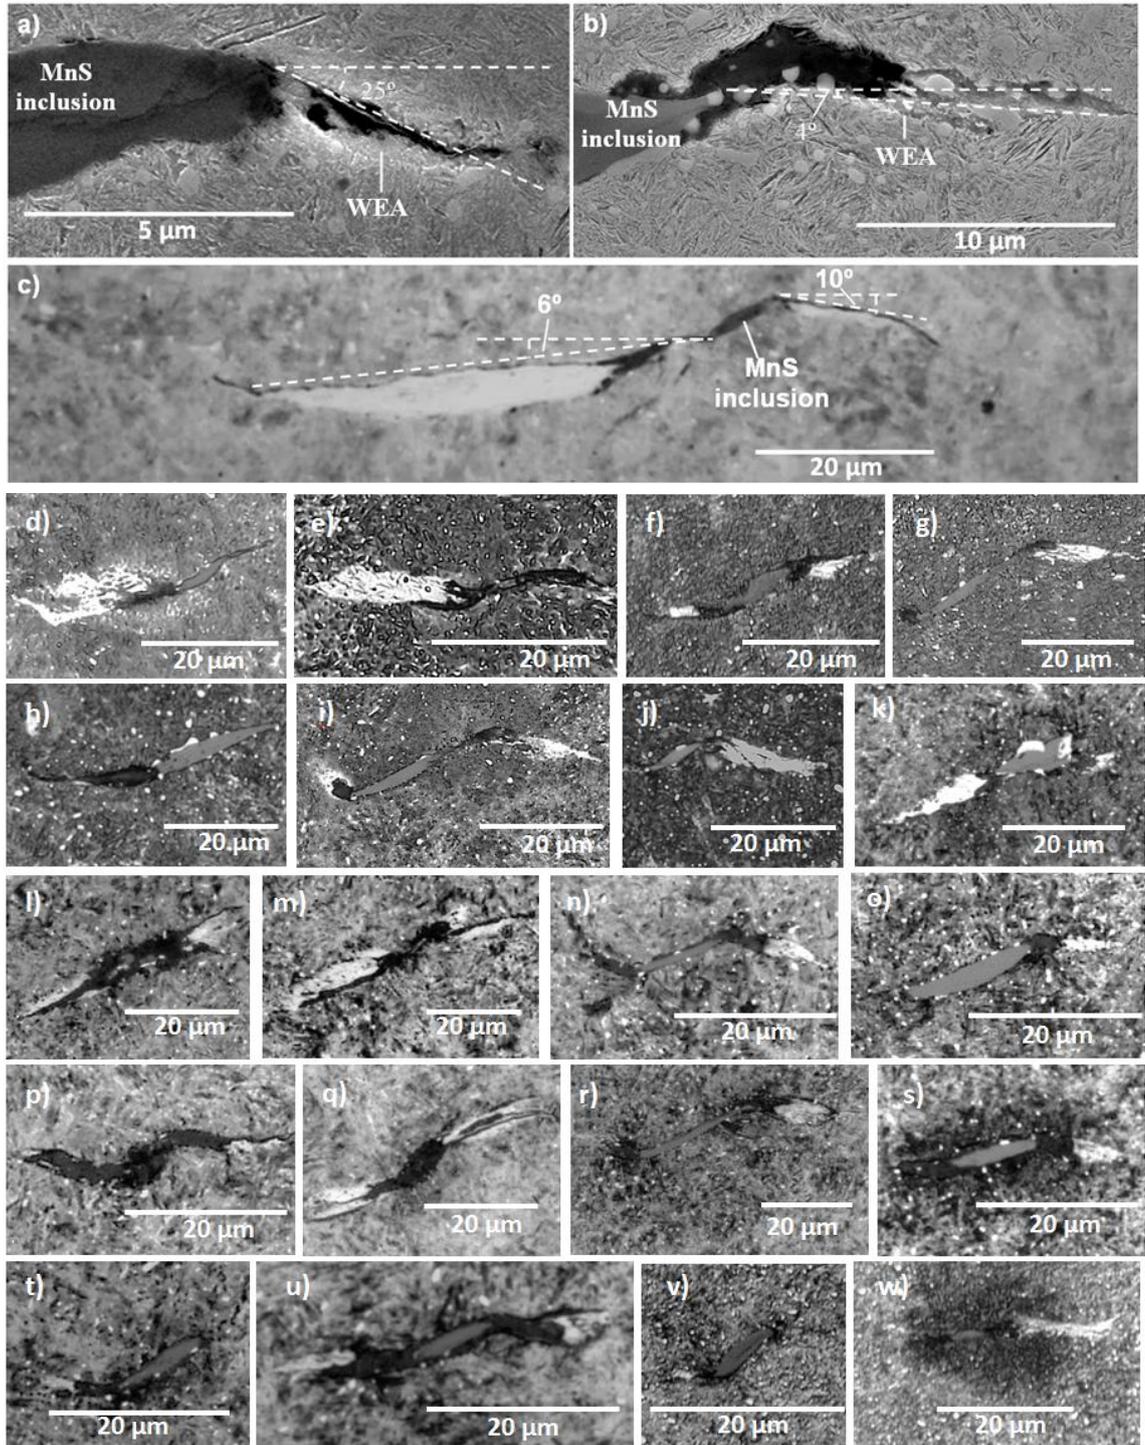
Figure 5-5: Examples of WEA-interacting MnS inclusions (circumferentially sectioned specimens)

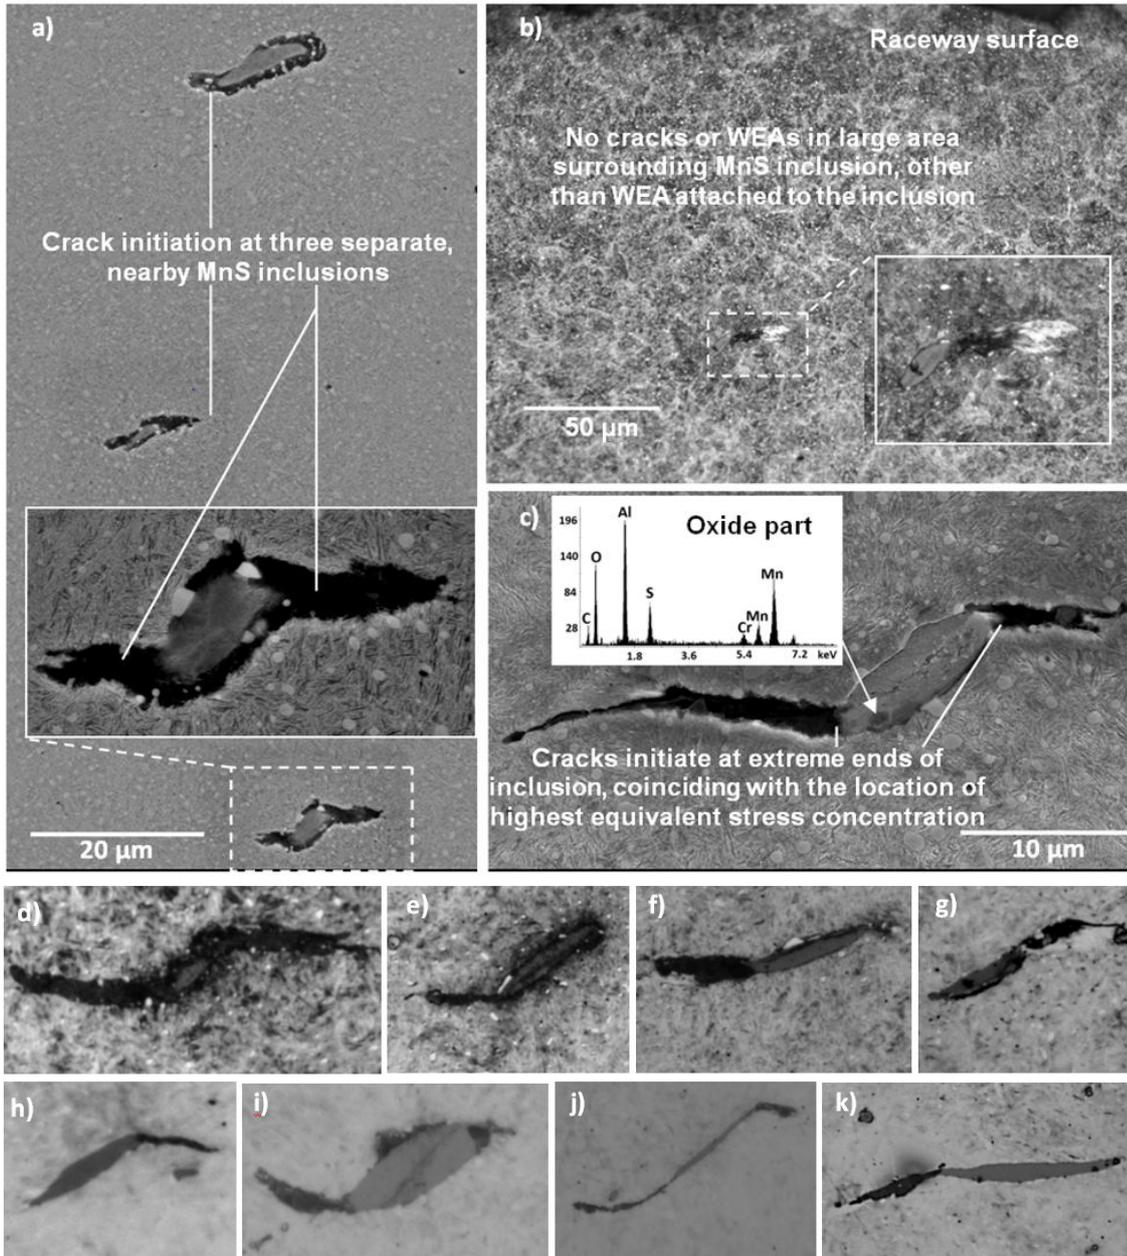
Figure 5-9: Evidence supporting subsurface crack and WEA initiation at MnS inclusions

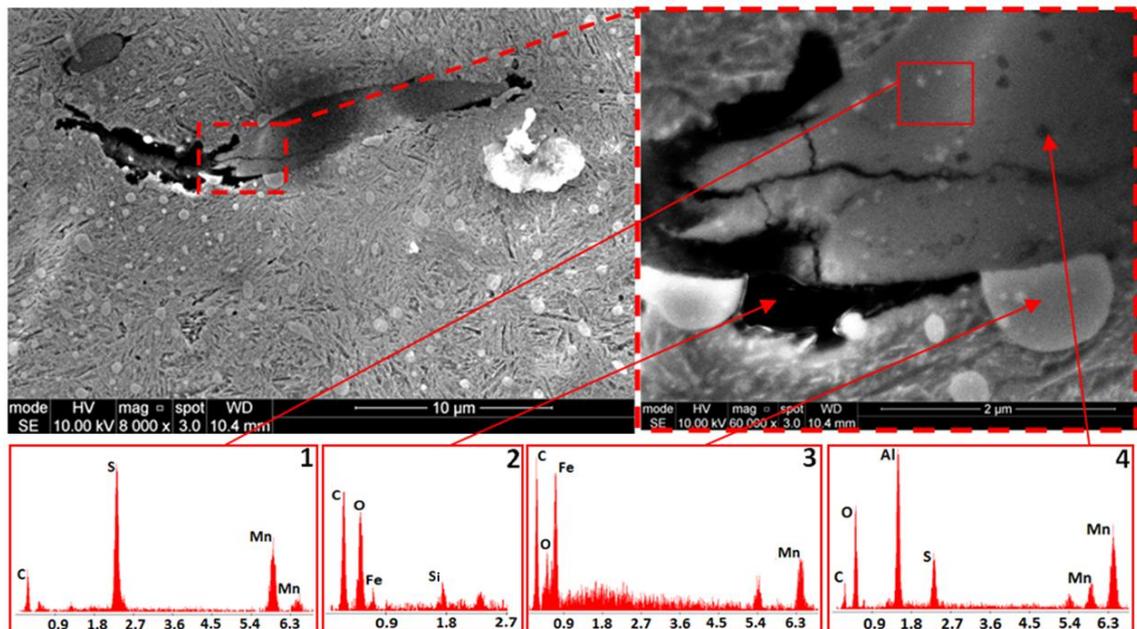
Figure 5-10: MnS inclusion and adjacent separation from the steel matrix with EDAX of features: 1. MnS inclusion main body; 2. Void at point of separation; 3. Temper carbide (M_3C) adjacent to inclusion; 4) Alumina part of inclusion

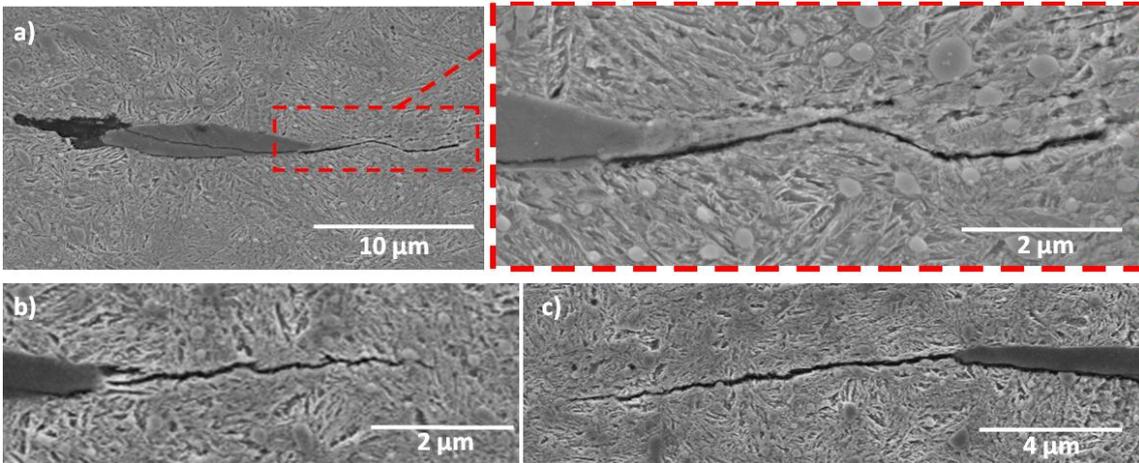
Figure 5-11: Internally cracked MnS inclusion initiated cracks with no interacting oxide part at inclusion tip (axially sectioned inclusions)

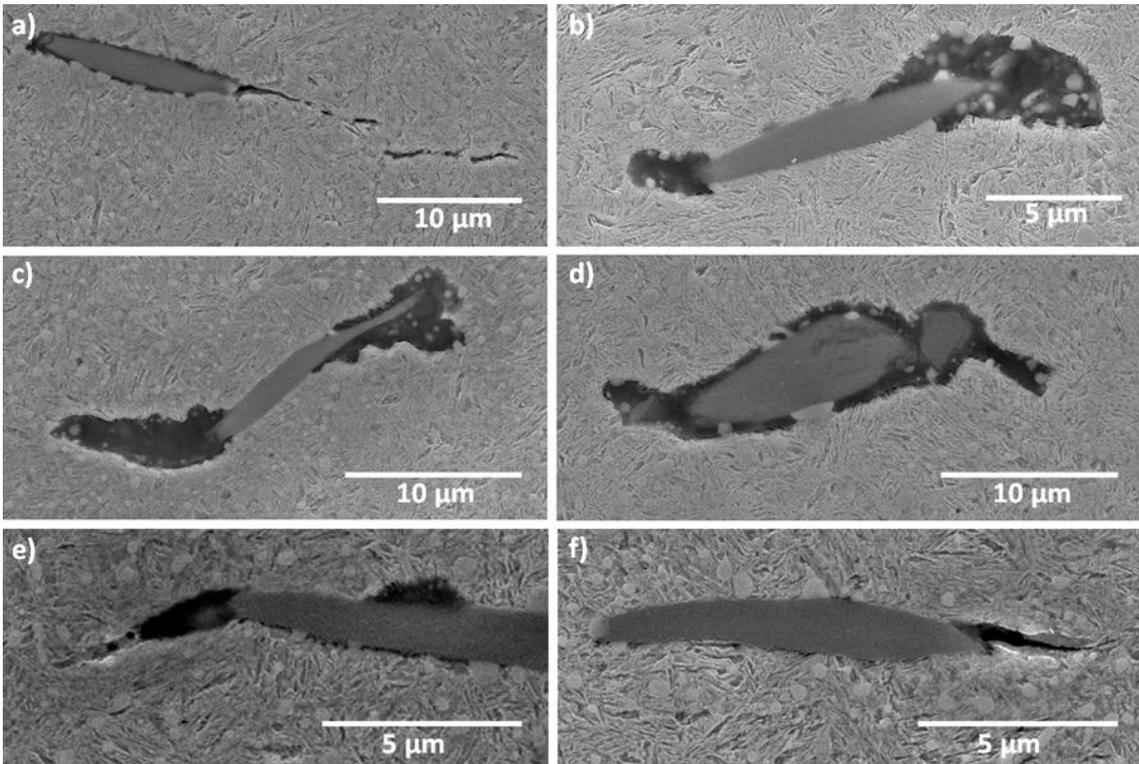
Figure 5-12: Evidence suggesting internal cracking of MnS inclusions is not necessary (inclusions do not appear to have oxide parts near inclusion tips).

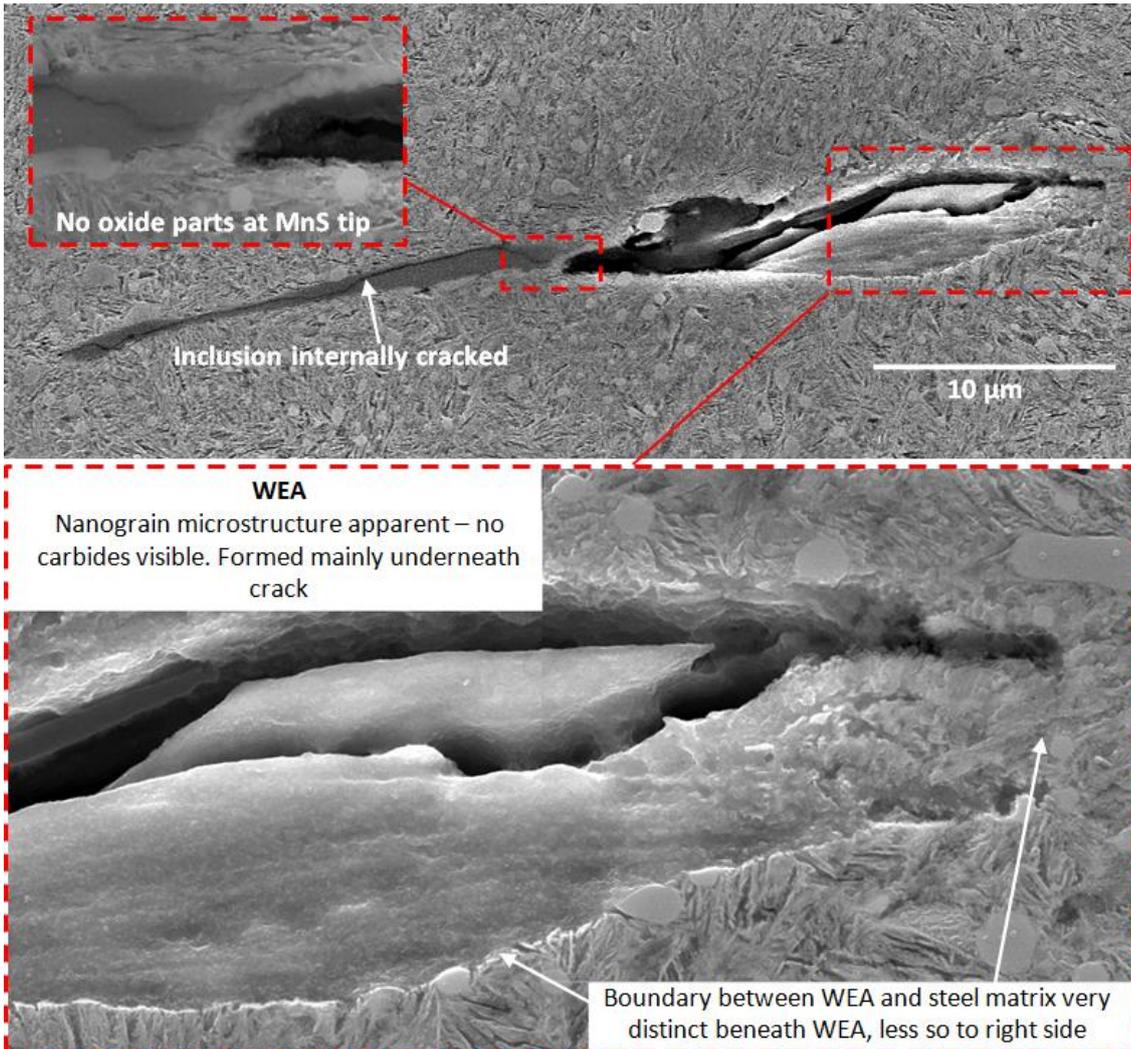
Figure 5-14: MnS inclusion initiated WEA detail

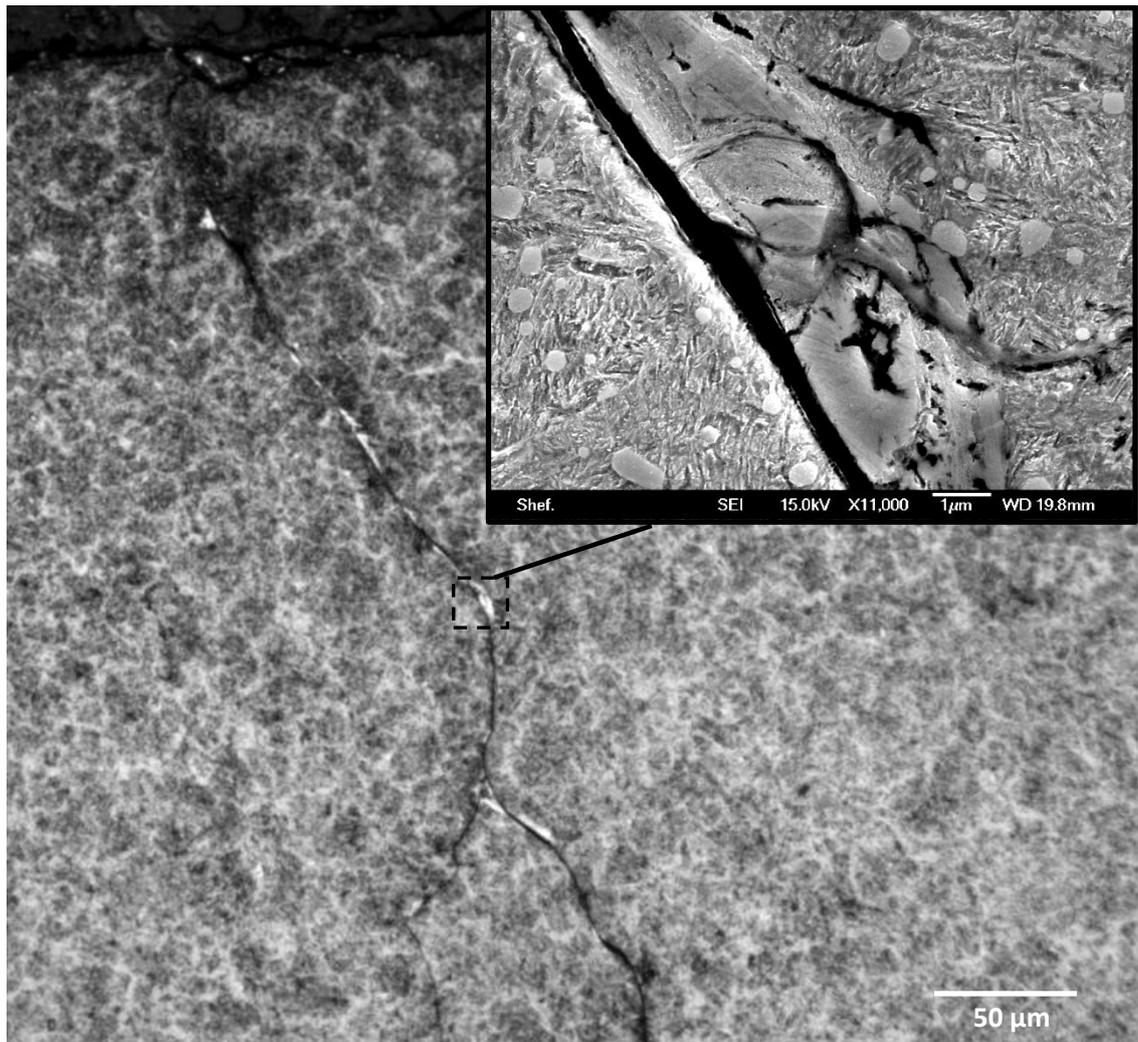
Figure 5-15: Extended surface breaking WEC network (circumferential section, phase 2 damage)

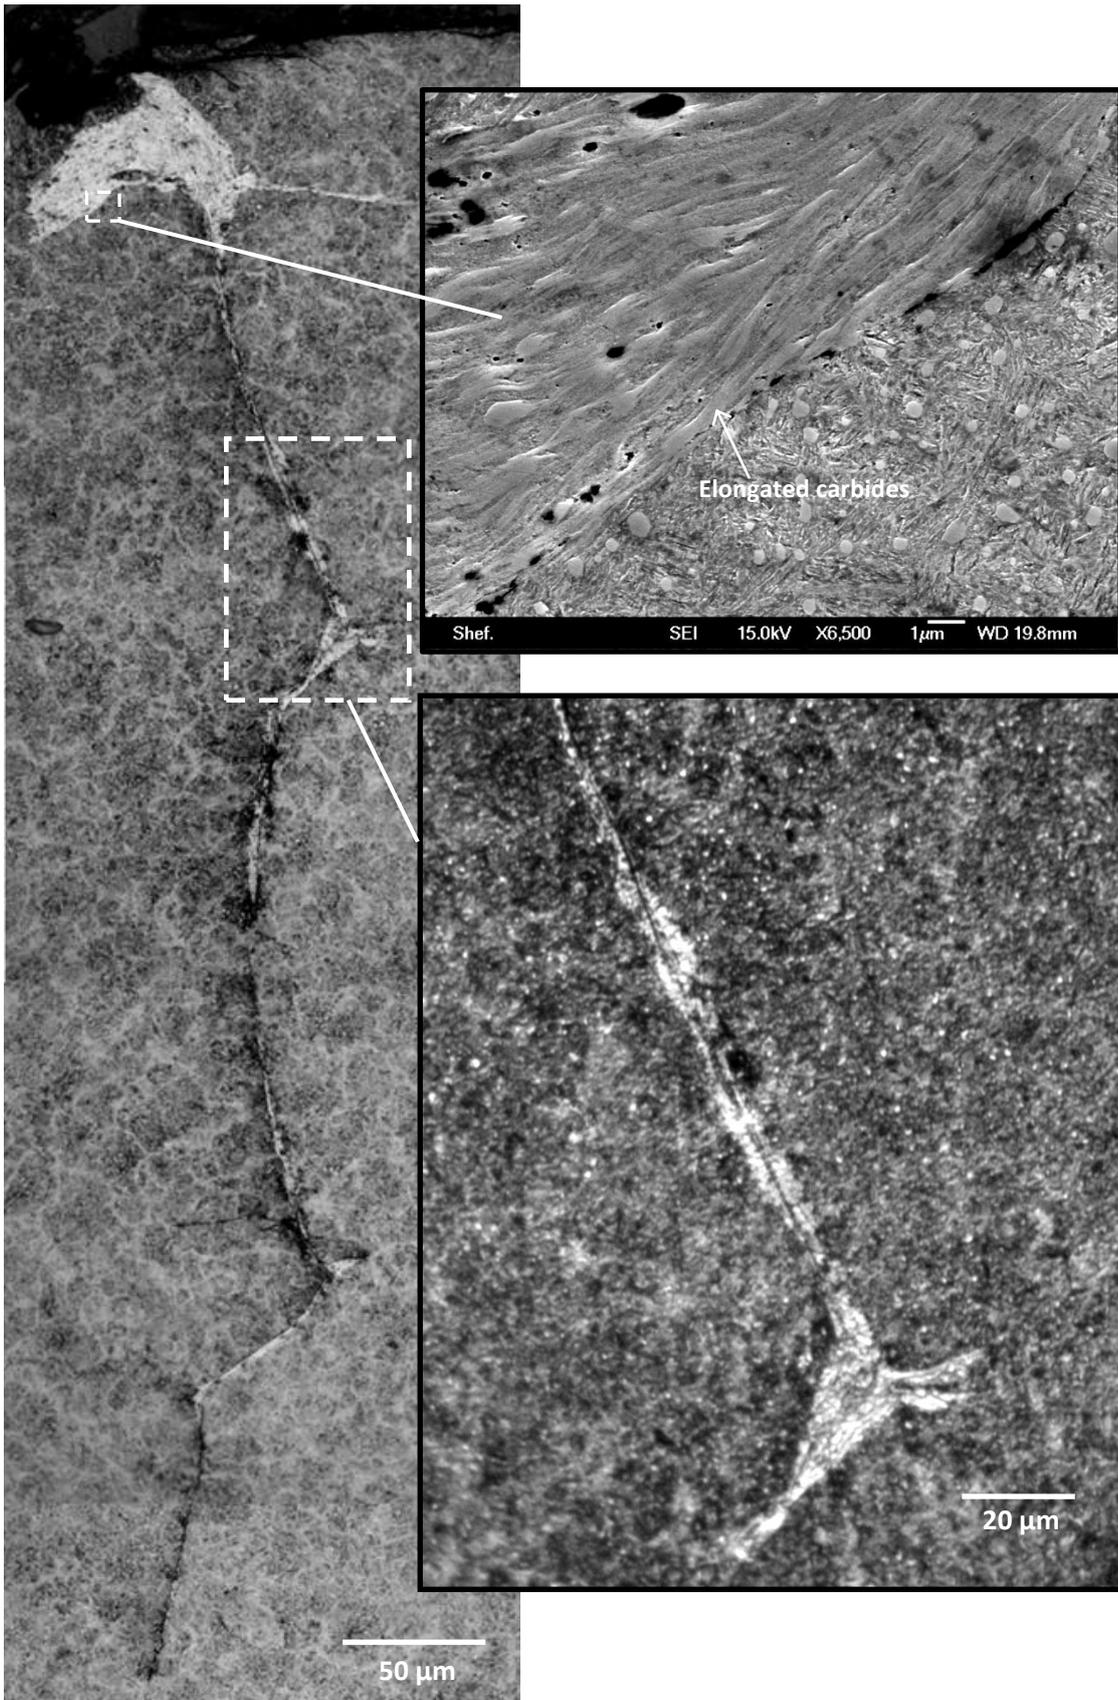
Figure 5-16: Large surface breaking, vertically propagating WEC (circumferential section, phase 2 damage)

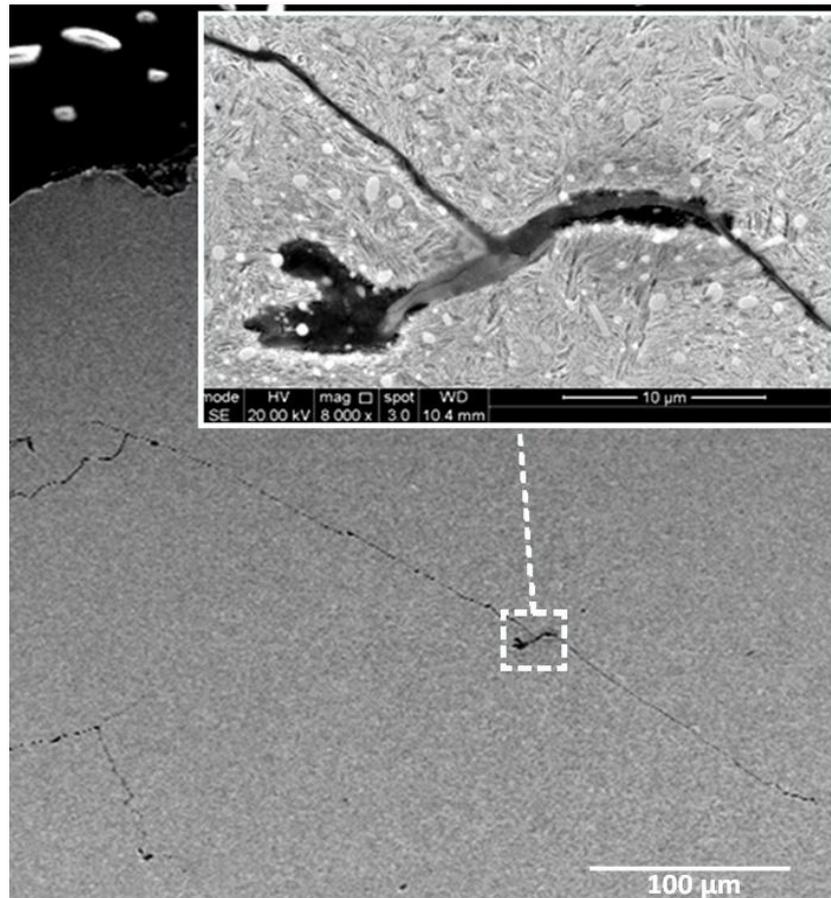
Figure 5-17: Axially propagating crack surface linked crack deflection by MnS inclusion

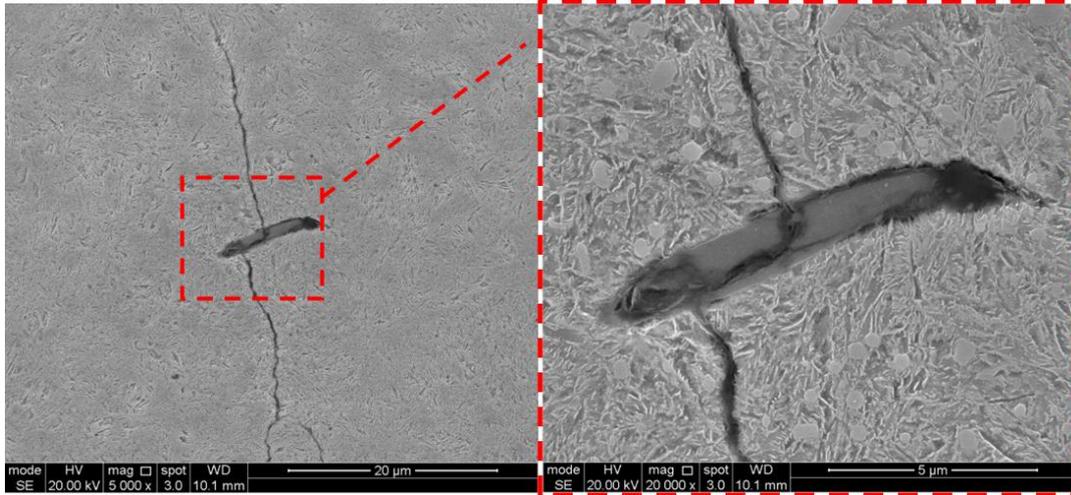
Figure 5-18: Vertically propagating surface linked crack deflection by MnS inclusion

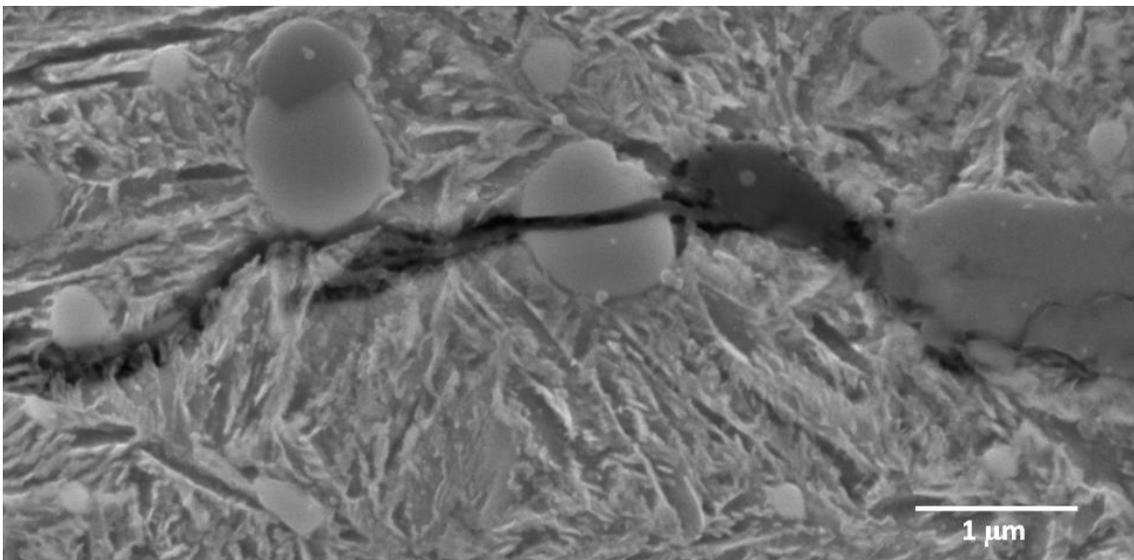
Figure 5-19: Crack propagation through an M_3C carbide

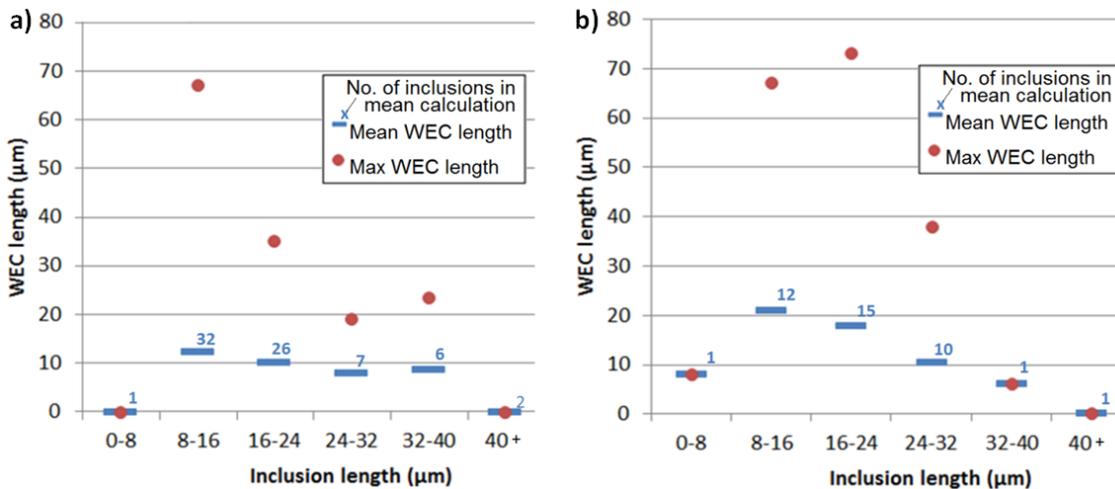
Figure 5-26: Variation of mean and max WEC length with MnS inclusion length in: a) circumferentially sectioned specimens, b) axially sectioned specimens

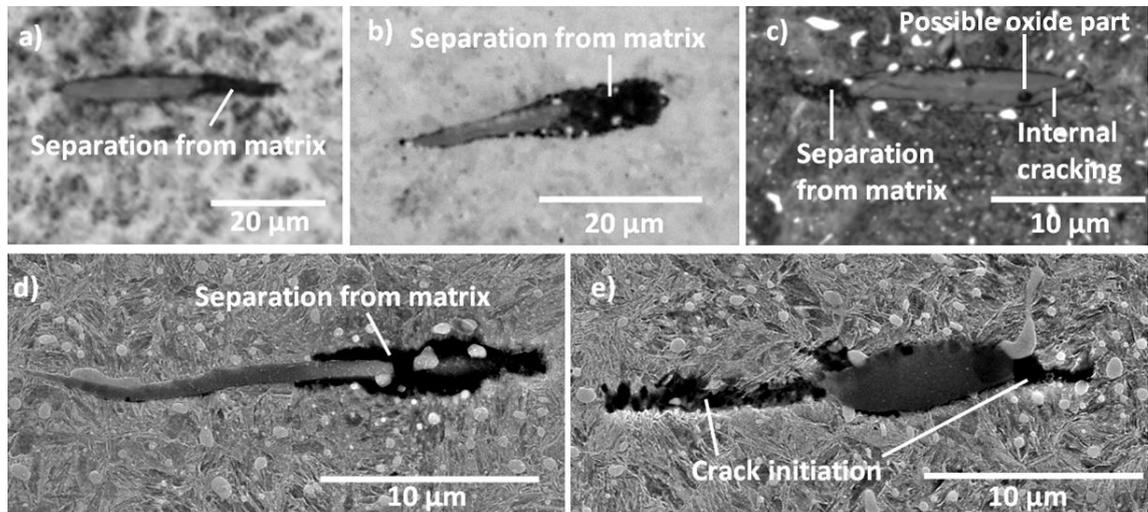
Figure 6-4: Examples of damage at MnS inclusions during varying number of impact tests a) 50,000 b-c) 100,000 d-e) 200,000

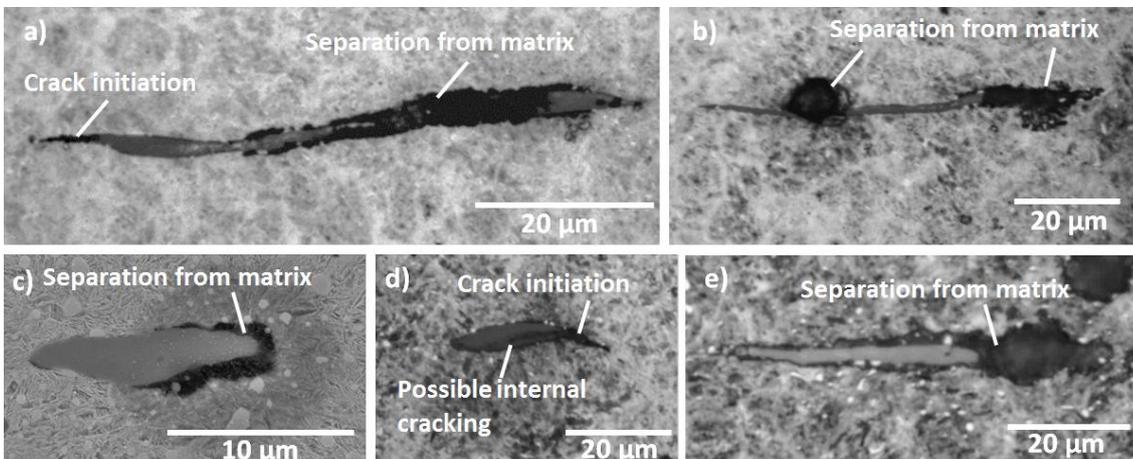
Figure 6-6: Example of damage at MnS inclusions during tests when subsurface stress was altered (a) 2.48 GPa (b) 2.60 GPa. c-e) 2.56 GPa

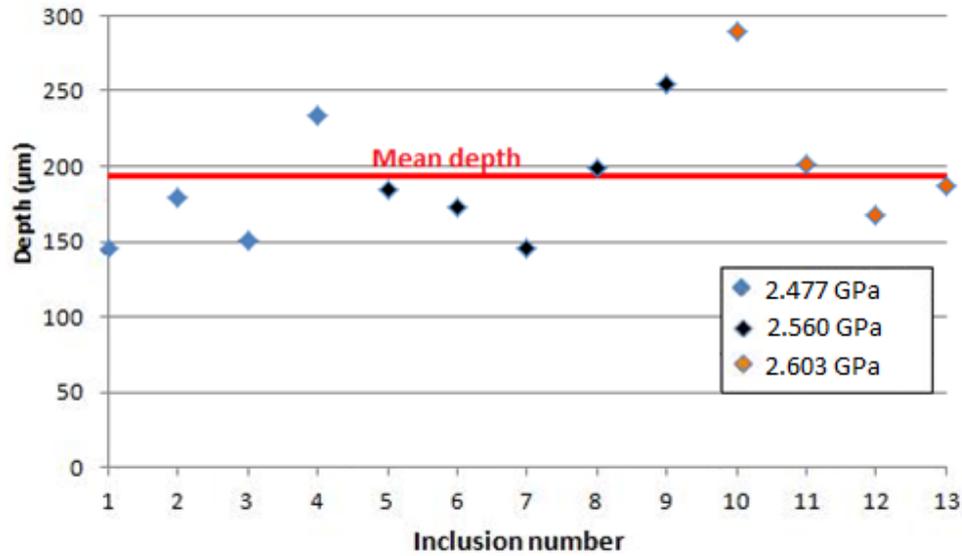
Figure 6-7: Depths of damage initiating inclusions found in varying contact pressure impact tests (specimen 12 - 2.477 GPa, specimen 13 - 2.560 GPa, specimen 14 - 2.603 GPa).

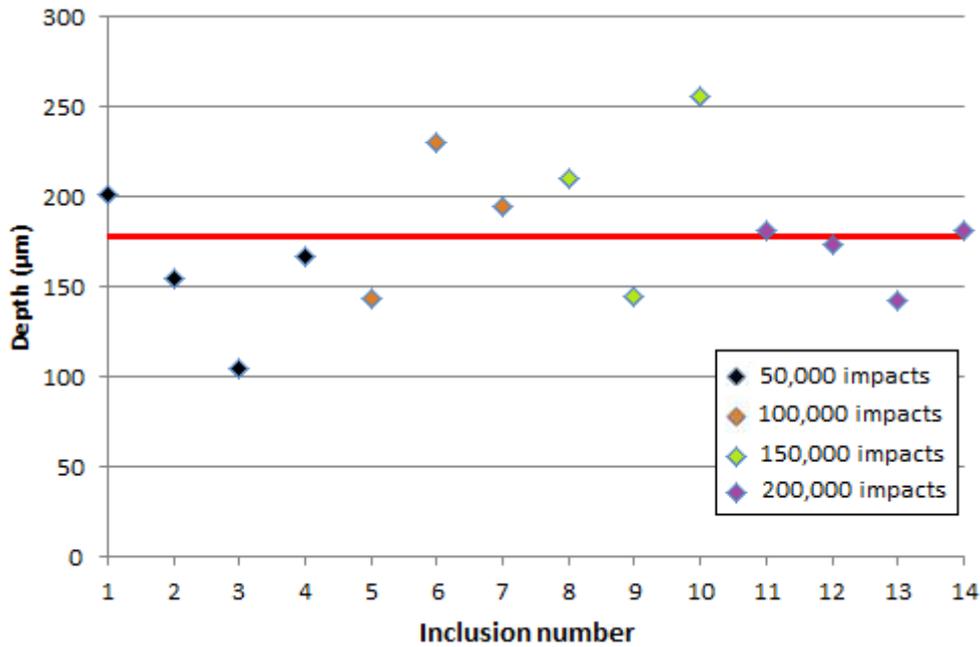
Figure 6-9: Depths of damage initiating inclusions found in varying number of impacts testing at 2.477 GPa (50,000 – specimen 17, 100,000 – specimen 18, 150,000 – specimen 19, 200,000 – specimen 20).

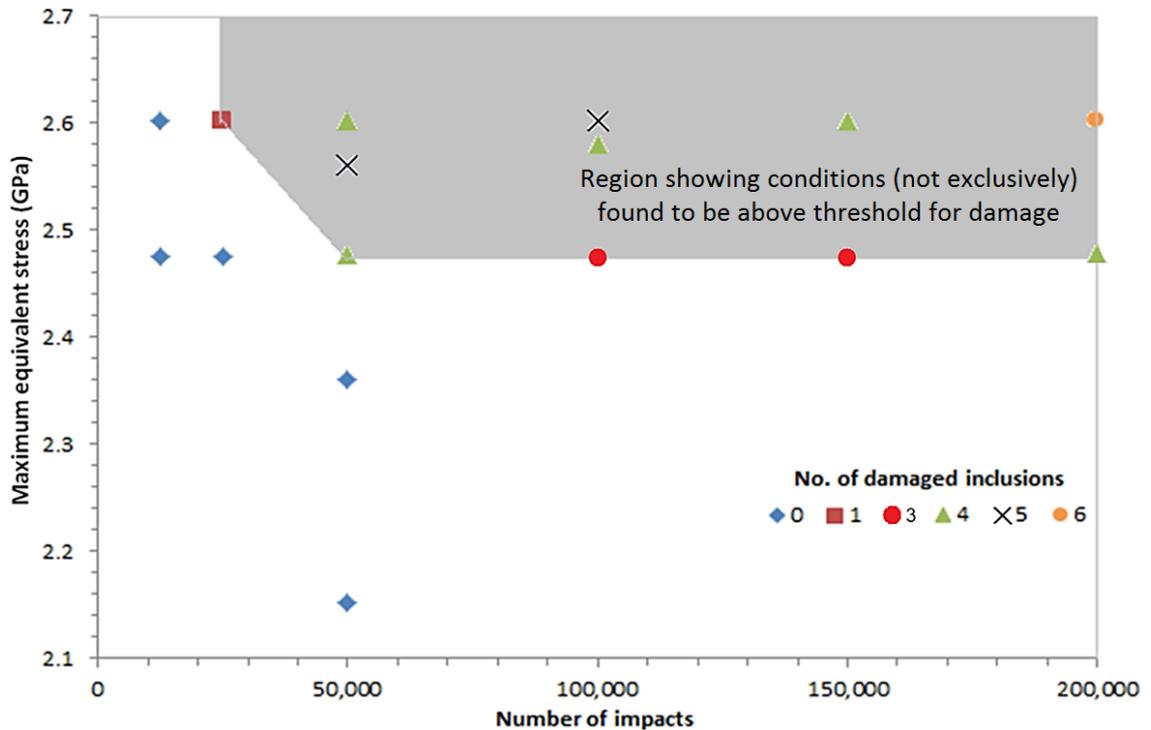
Figure 6-10: Number of damaged inclusions for each test when subjected to various testing conditions (note value of 4 damaged inclusions for initial tests is a mean of the 12 damaged inclusions from three specimens – plotted at 100,000 impacts and 2.560 GPa)

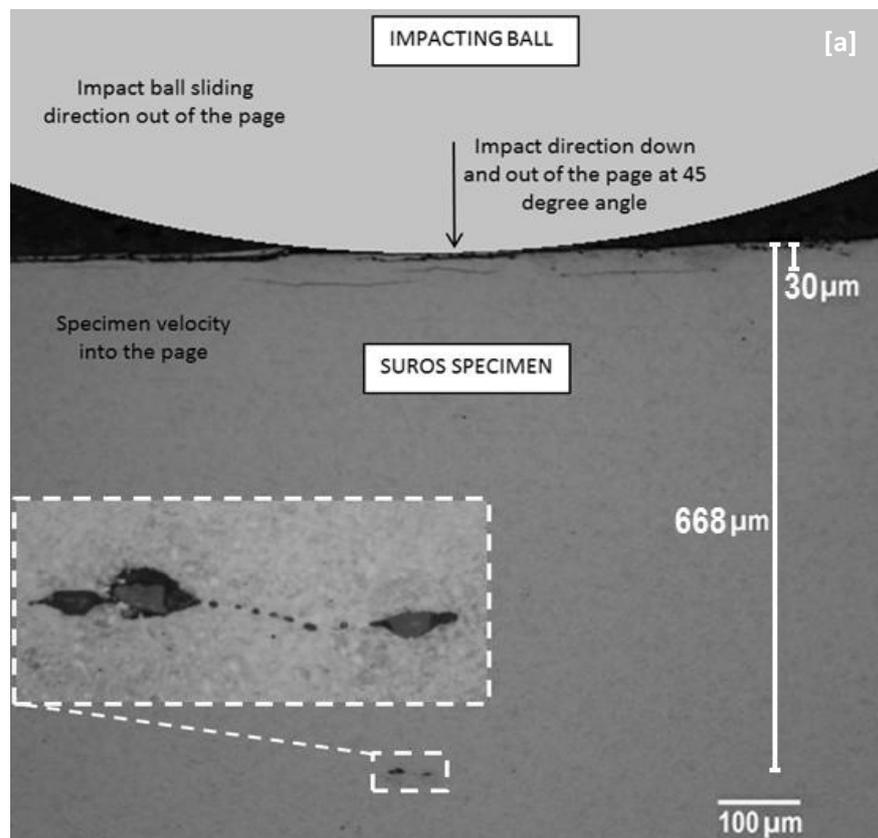
Figure 7-2: Subsurface cracks beneath impact zone of specimen 11, with approximate position of impacting ball superimposed

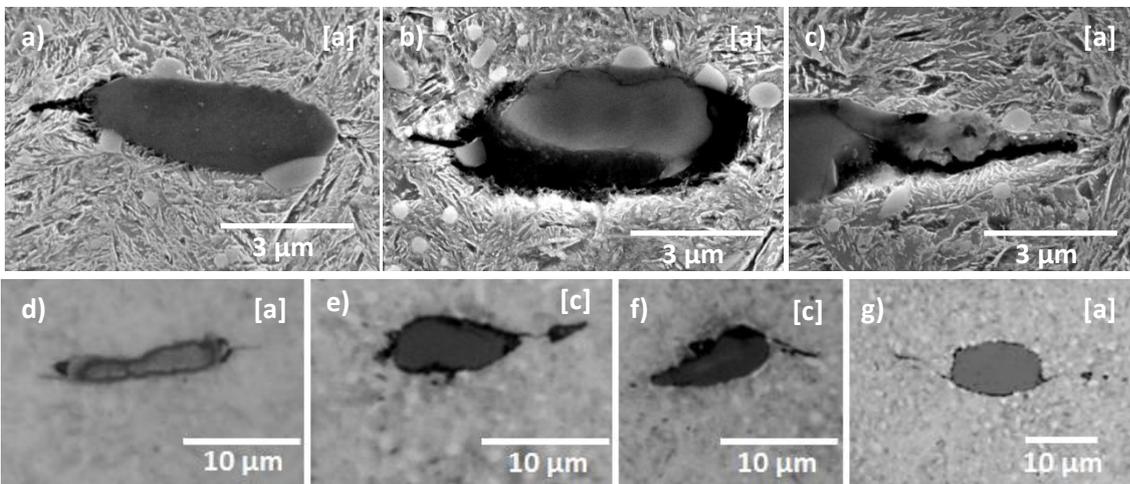
Figure 7-8: Cracking from MnS inclusion tips in: a-b) disc 11* c) disc 10* d-e) disc 7 f) disc 8 g) disc 12. *specimens affected by impact loading.

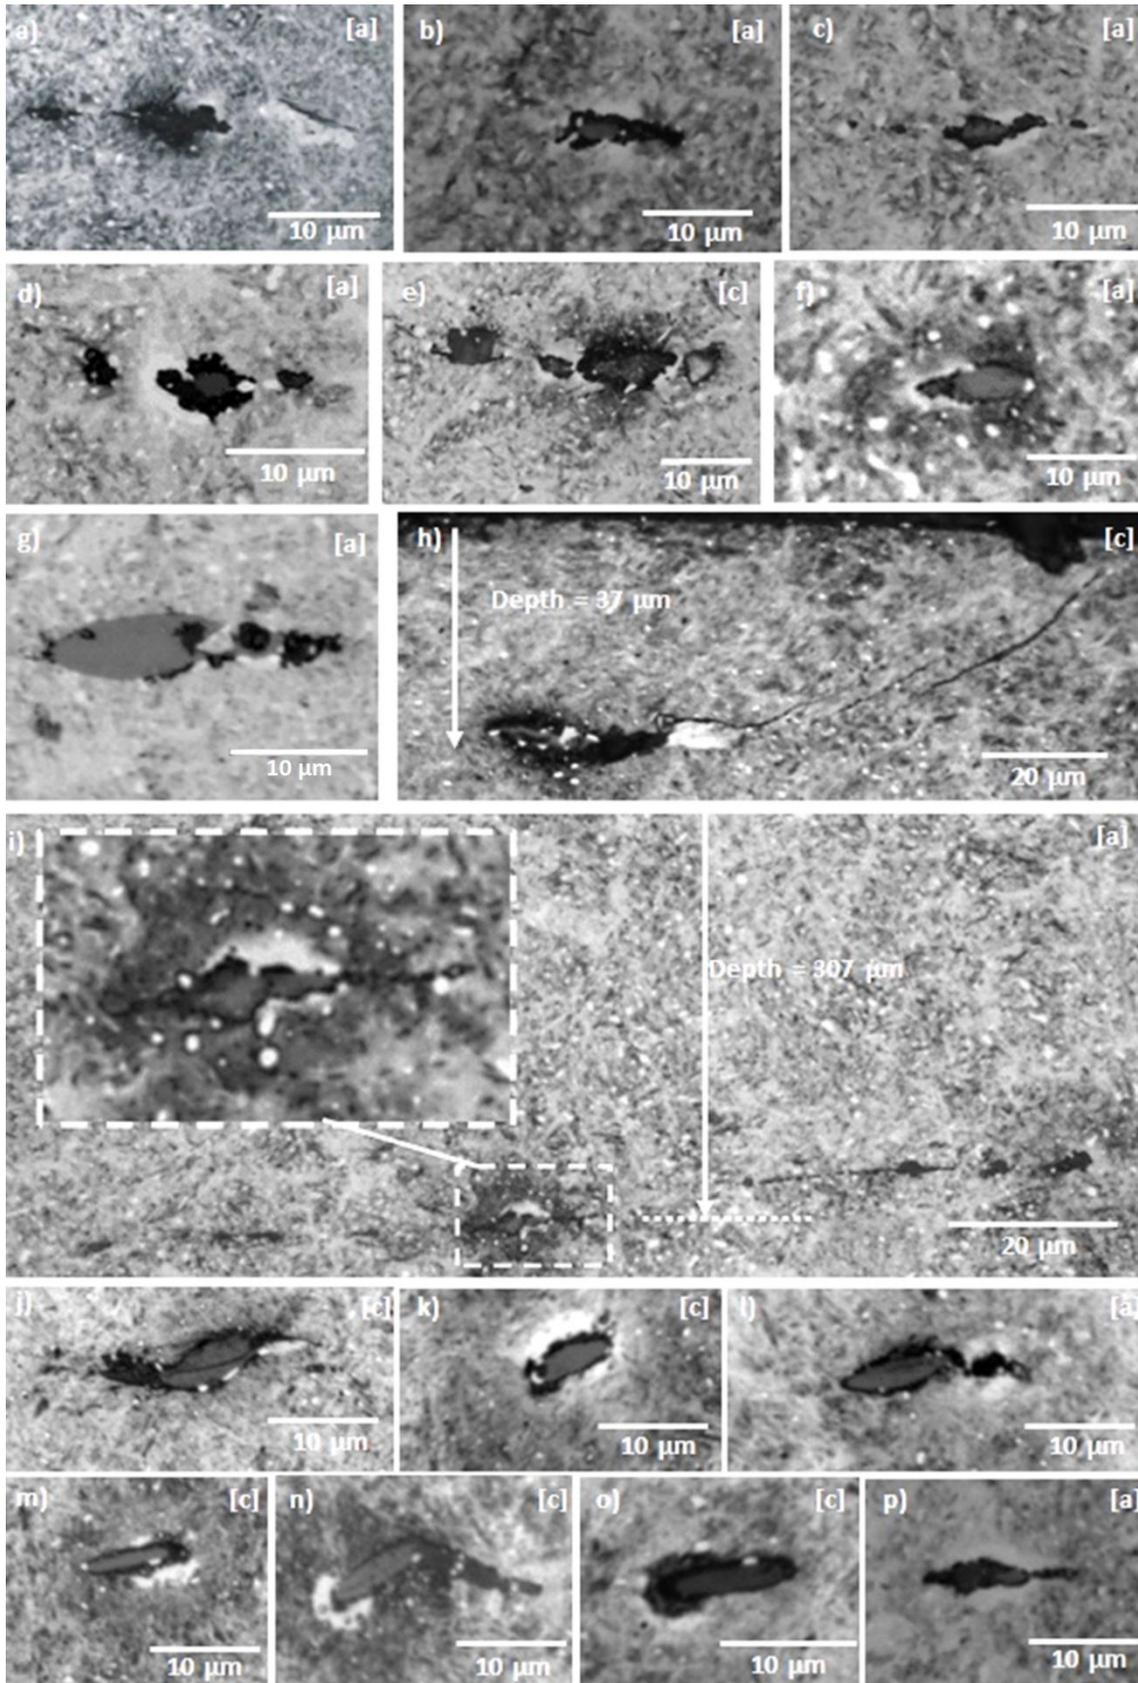
Figure 7-10: WEAs initiated at MnS inclusions in: a-b) disc 7*, c) disc 8, d) disc 7, e) disc 8*, f) disc 9*, g) disc 10*, h) disc 12*, i-k) disc 10 l-m) disc 11 n) disc 10* o) disc 12 p) disc 11*. *specimens affected by impact.

Figure 7-22: Depths of WEA initiated in twin disc testing with comparison to depths of maximum stress concentrations (inclusion ID letters correspond with image labels in Figure 7-10).

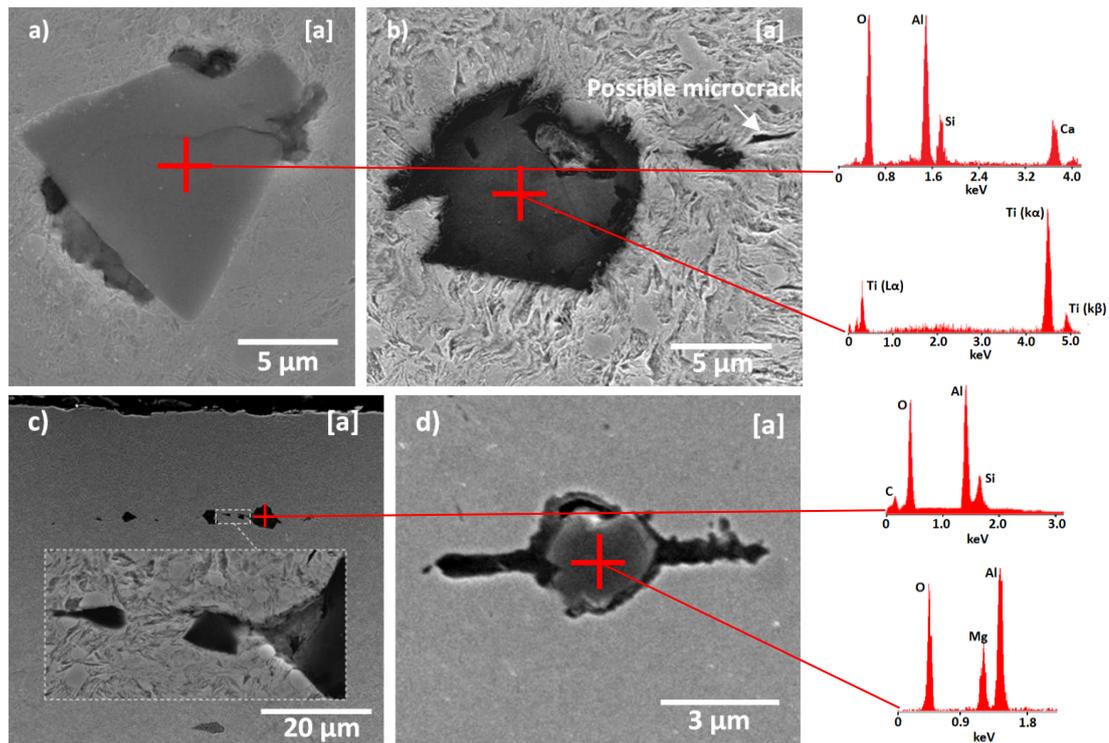
Figure 7-11: Damage at other inclusion types: a) internal cracking of alumina inclusion b) external microcrack connected to titanium inclusion* c) possible damage at alumina inclusion d) microcracks either side of alumina inclusion. *specimen affected by hammering impact.

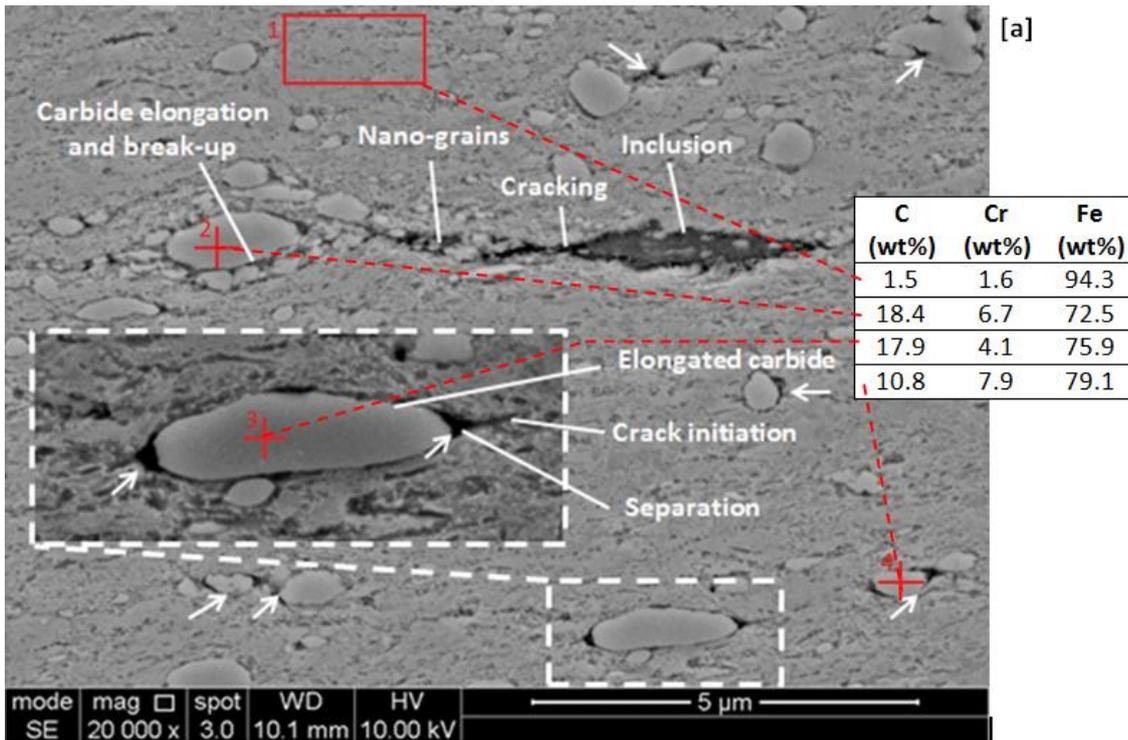
Figure 7-12: Damage at carbides in specimen 8

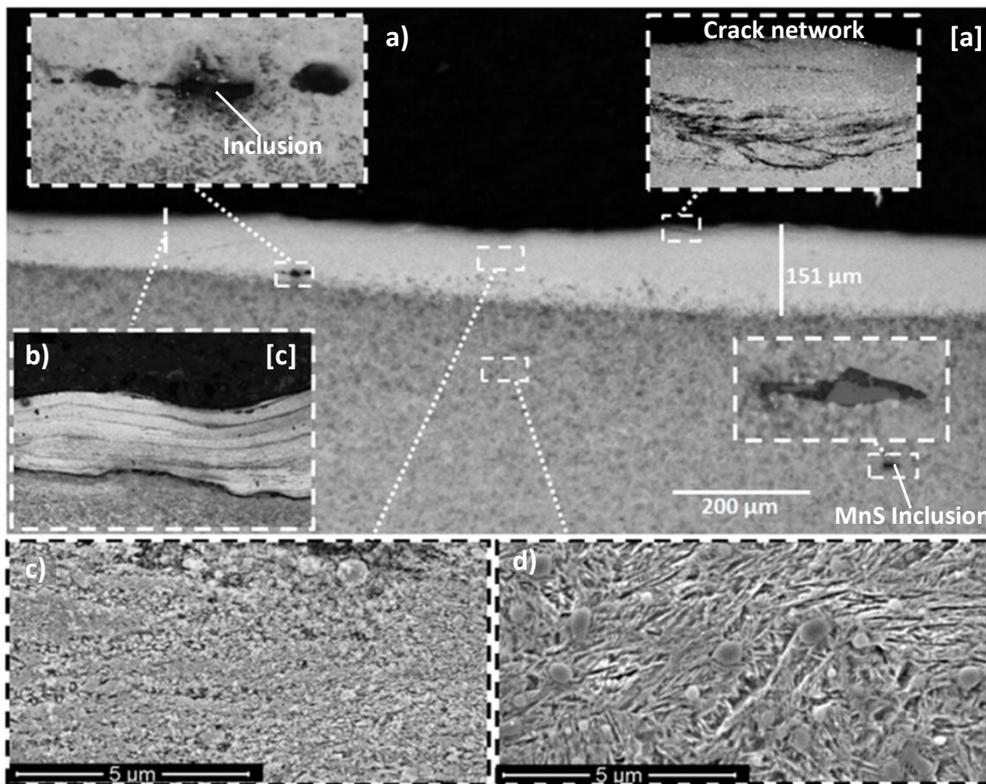
Figure 7-17: WEL formed in failed test showing a) axial section through disc b) circumferential section through disc (location in relation to axial section not accurate - only shown for illustrative purposes) c) WEA microstructure d) martensitic 100Cr6 steel microstructure

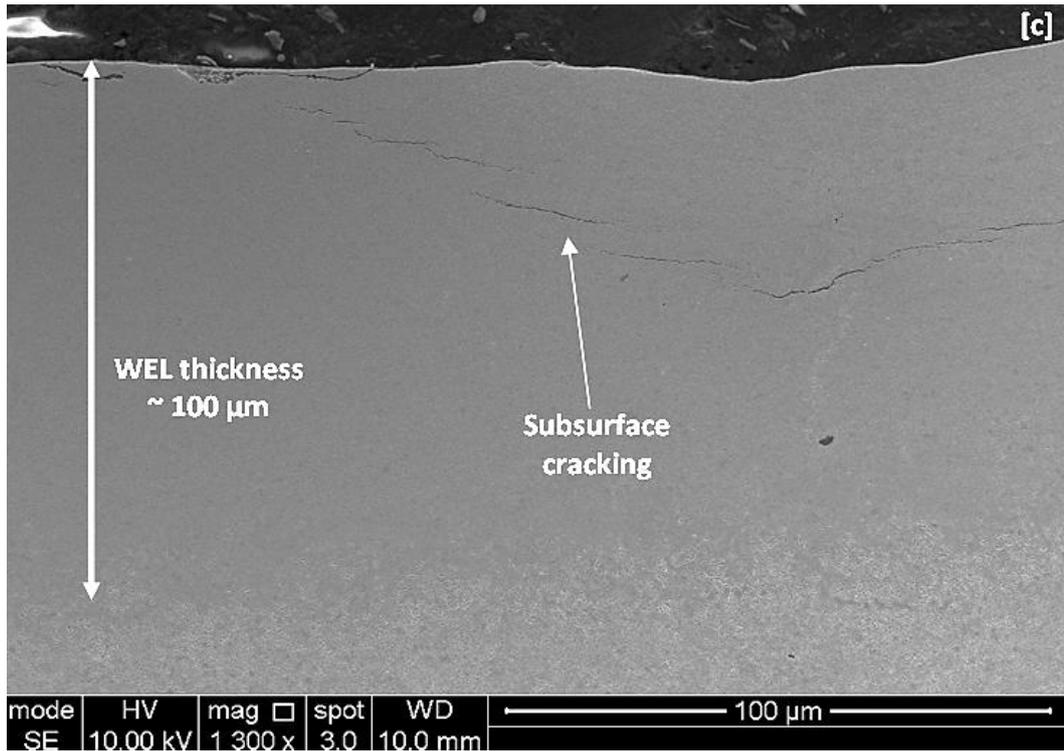
Figure 7-18: Cracking within WEL
