Department
Of
Mechanical
Engineering.

Analysis of the Premature Failure of Wind Turbine Gearbox Bearings

**A thesis submitted in partial fulfilment of the
requirements for the degree of
Doctor of Philosophy**

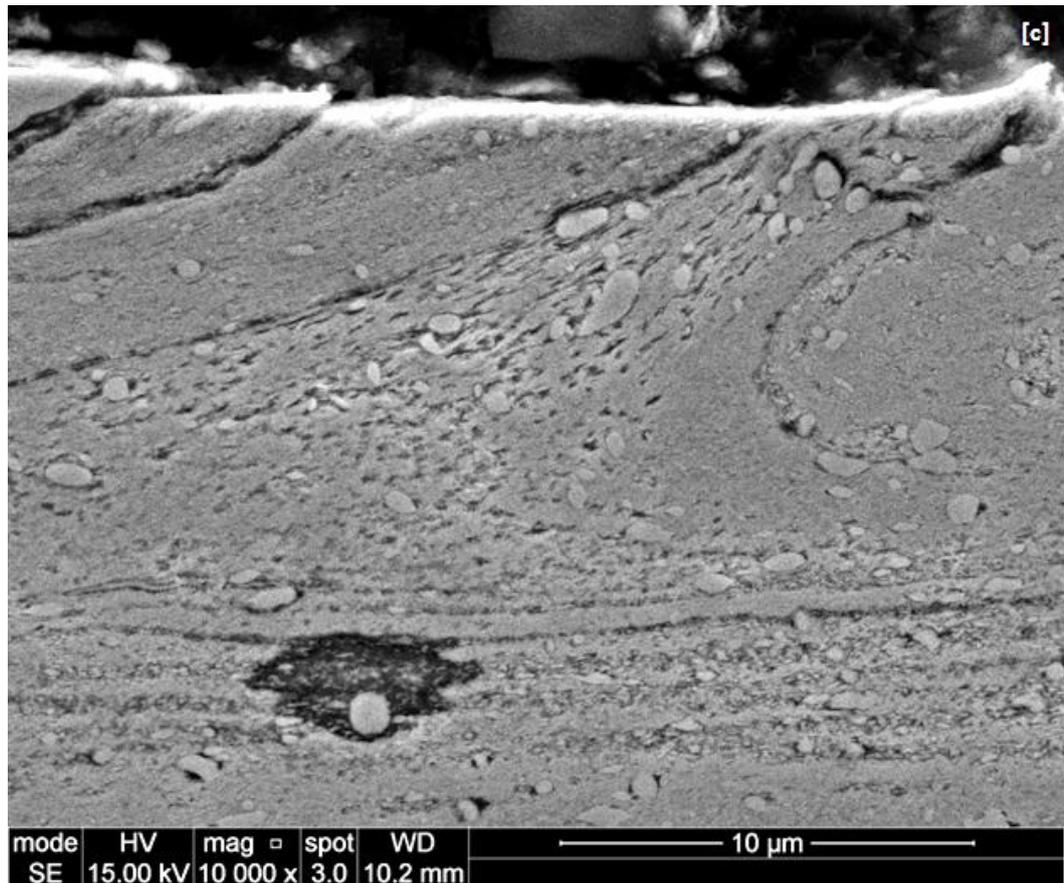
Figure 7-19: Variation of carbide size within WEL

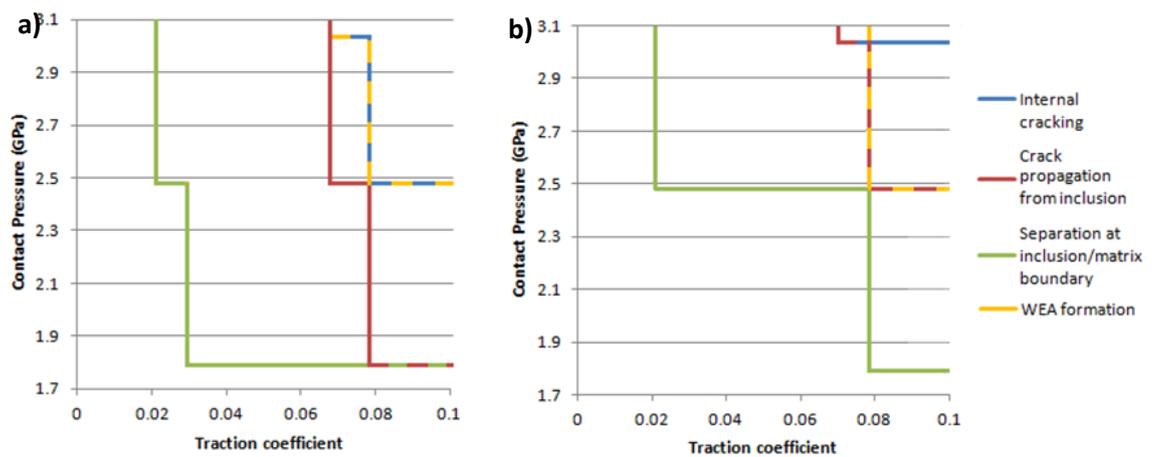
Figure 7-21: Contact pressure and traction coefficient threshold identification for different forms of MnS inclusion initiated damage for: a) specimens pre-damaged with hammering impact loading b) specimens with no pre-seeded damage (overlapping thresholds indicated by dashed two-colour lines).

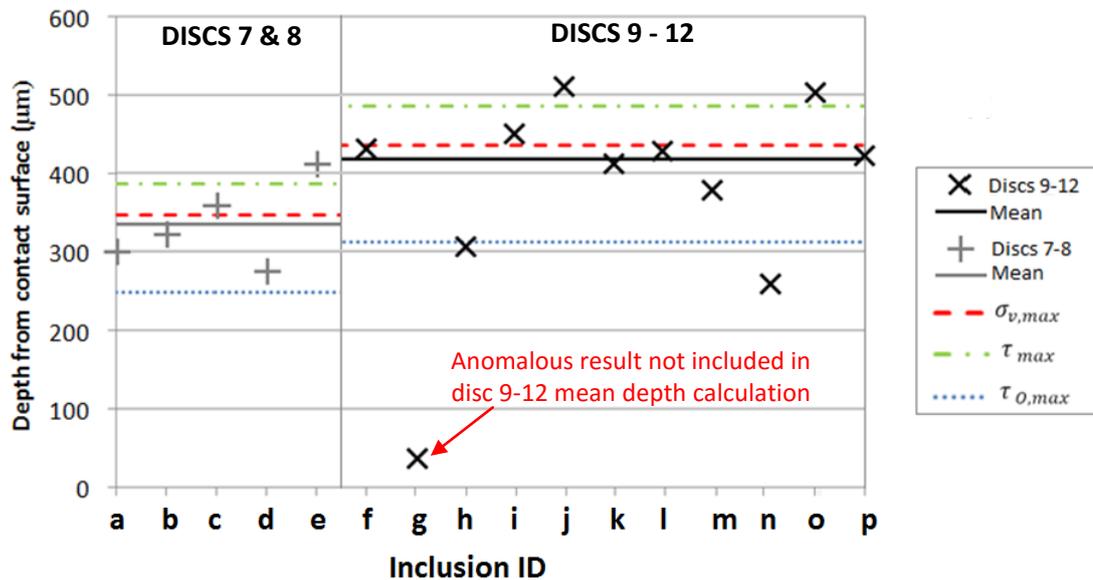
Figure 7-22: Depths of WEA initiated in twin disc testing with comparison to depths of maximum stress concentrations (inclusion ID letters correspond with image labels in Figure 7-10).

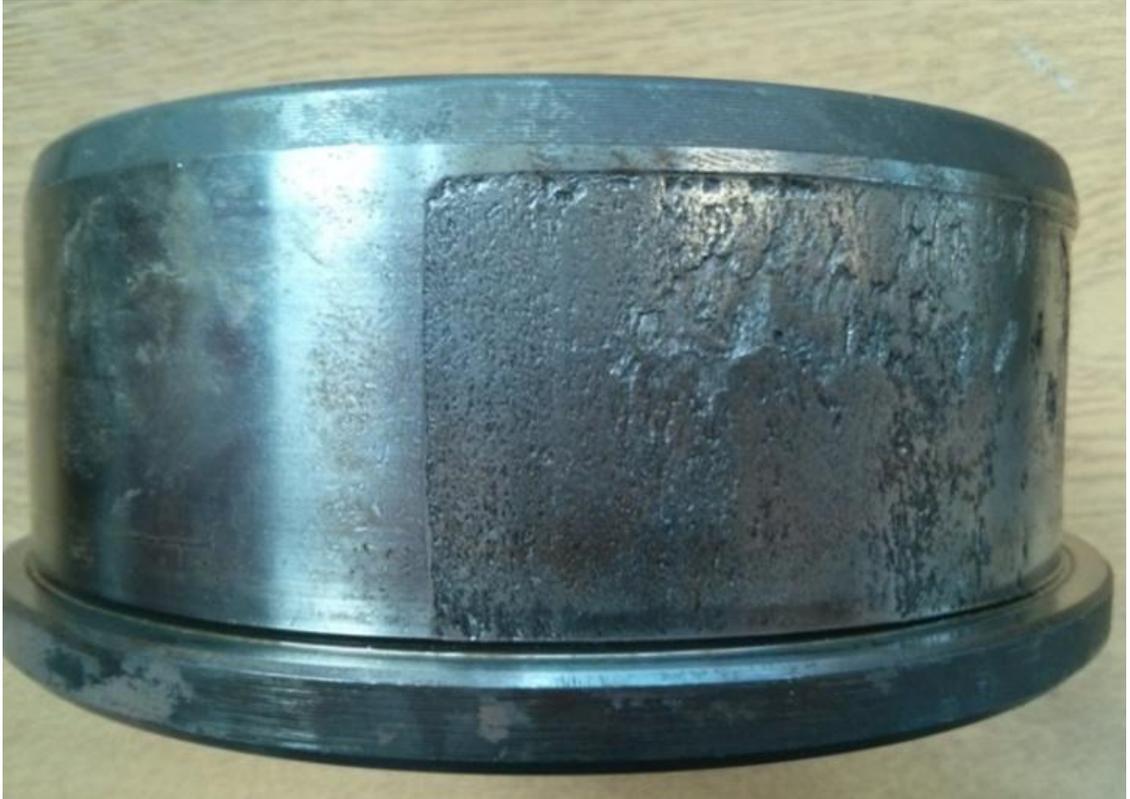
Figure 9-8: Image showing surface damage and clear transition from undamaged to damaged region

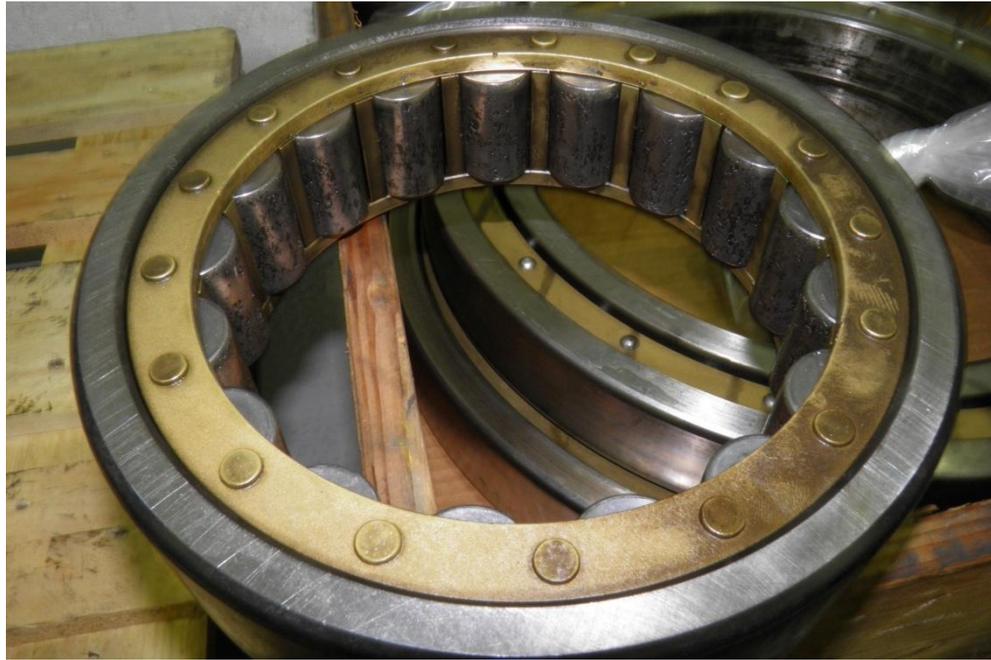
Figure 9-12: Outer race, cage and rolling elements of failed planetary gear bearing

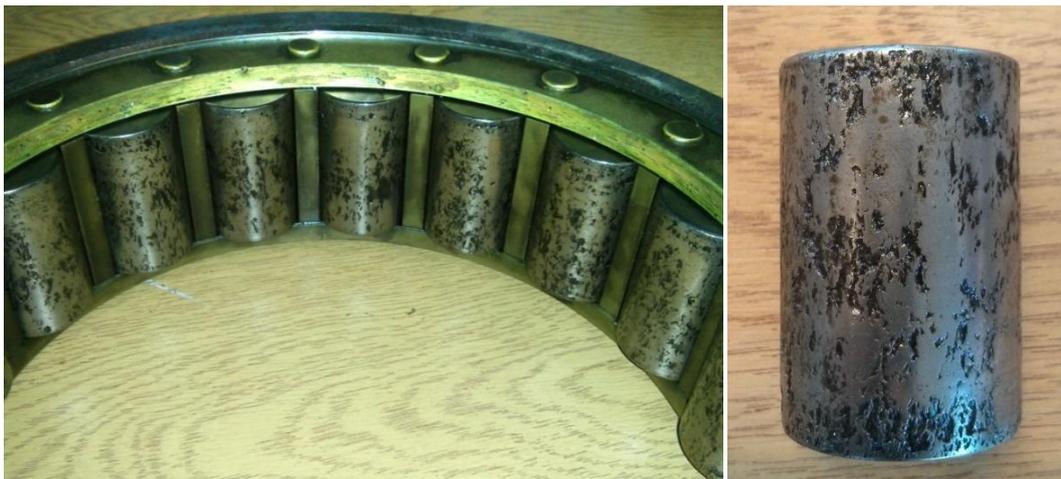
Figure 9-13: Wear scars observed on cylindrical rollers

The operating conditions for the bearing are summarised in Table 4-2. Approximate depths of maximum Hertzian stresses τ_{max} , $\tau_{O,max}$ and σ_v,max have been calculated using equations 2.1-2.3 followed by the approximations listed in section 2.1.3.2 and are presented in Table 4-2 based on the bearing dimensions (presented in Figure 9-7 in Appendix E) and the recommended maximum contact pressure for planetary WTGBs (1,500 MPa) listed in the wind turbine design standard IEC 61400-4 [18] and confirmed in Chapter 3 and [98]. Photographs of the bearing and other components from the same gearbox are presented for interest in Figure 9-8 - Figure 9-17 in Appendix E.

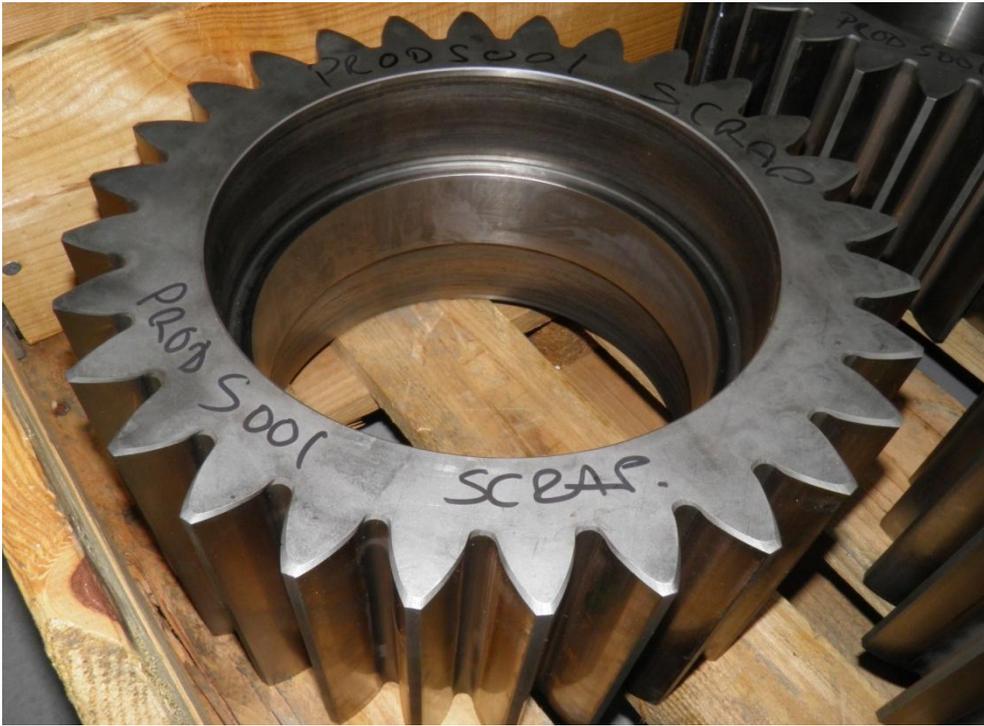
Figure 9-15: Failed planetary gear

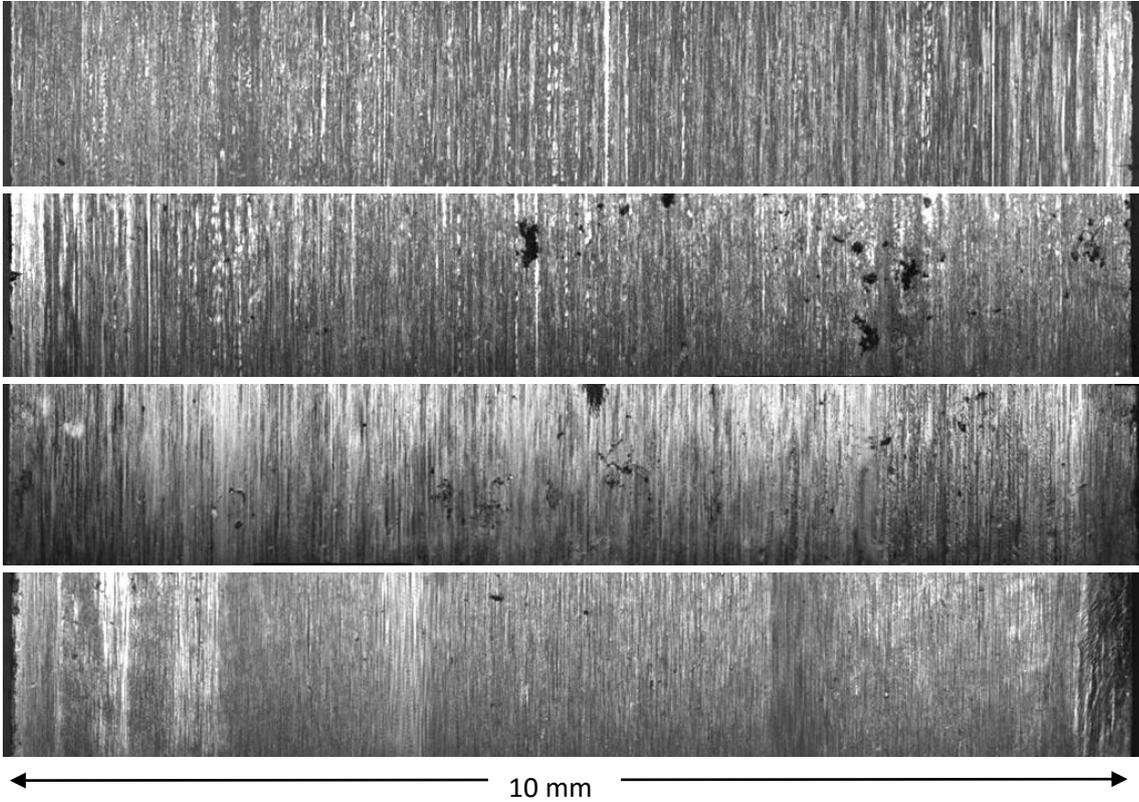
Figure 9-18: Wear tracks from SUROS discs 1-4

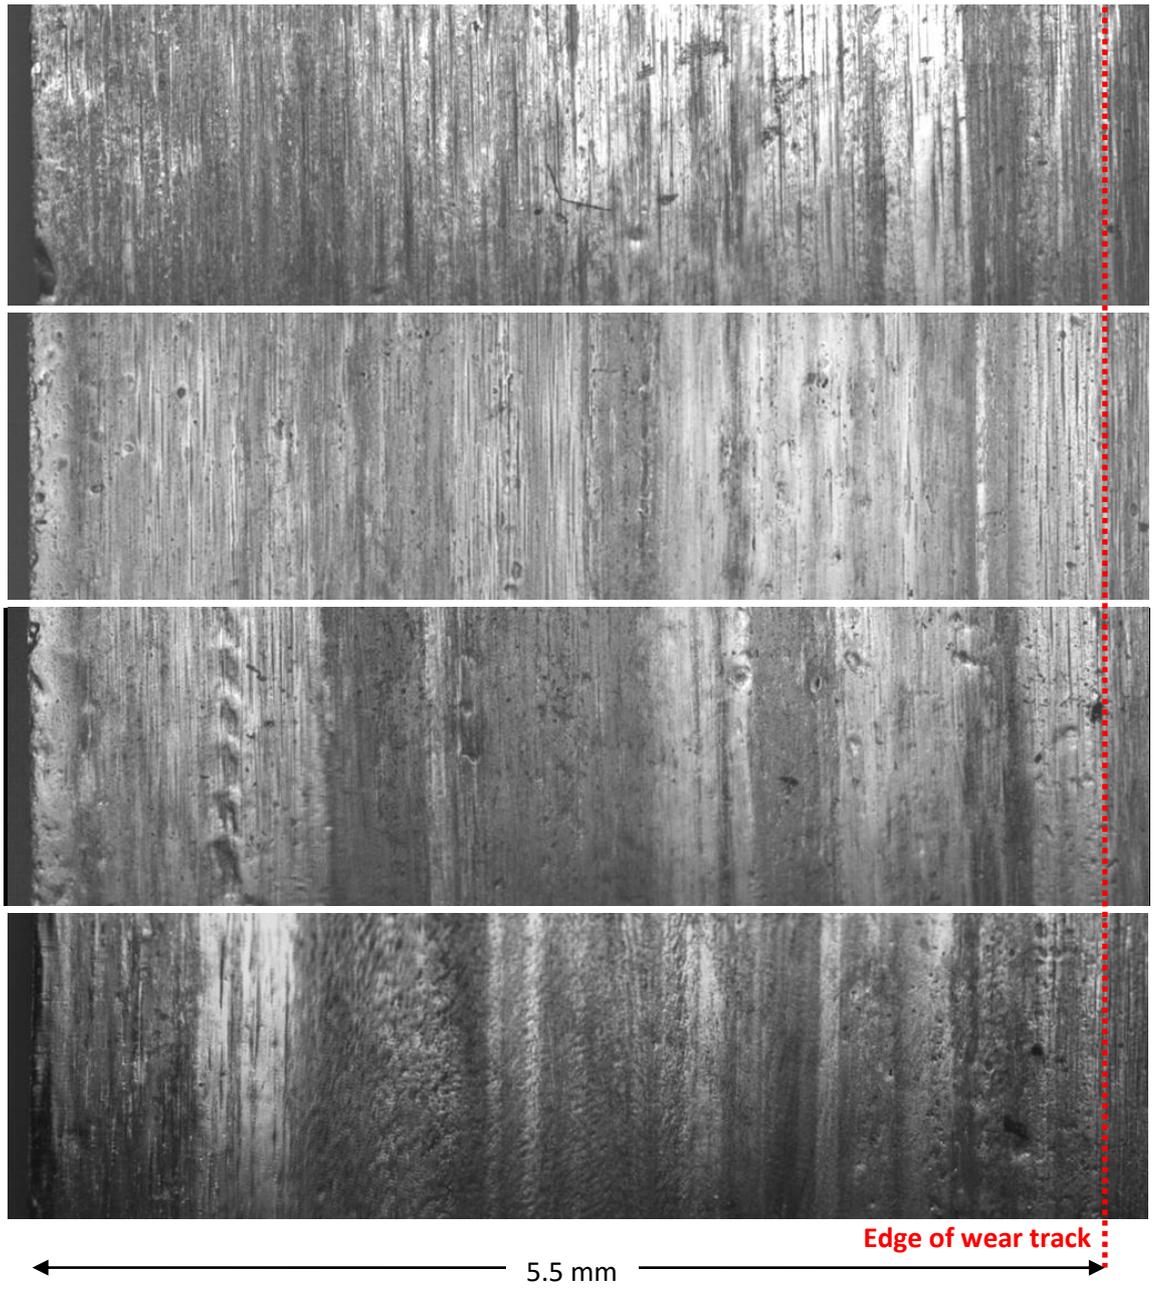
Figure 9-19: Wear tracks from SUROS discs 5-8

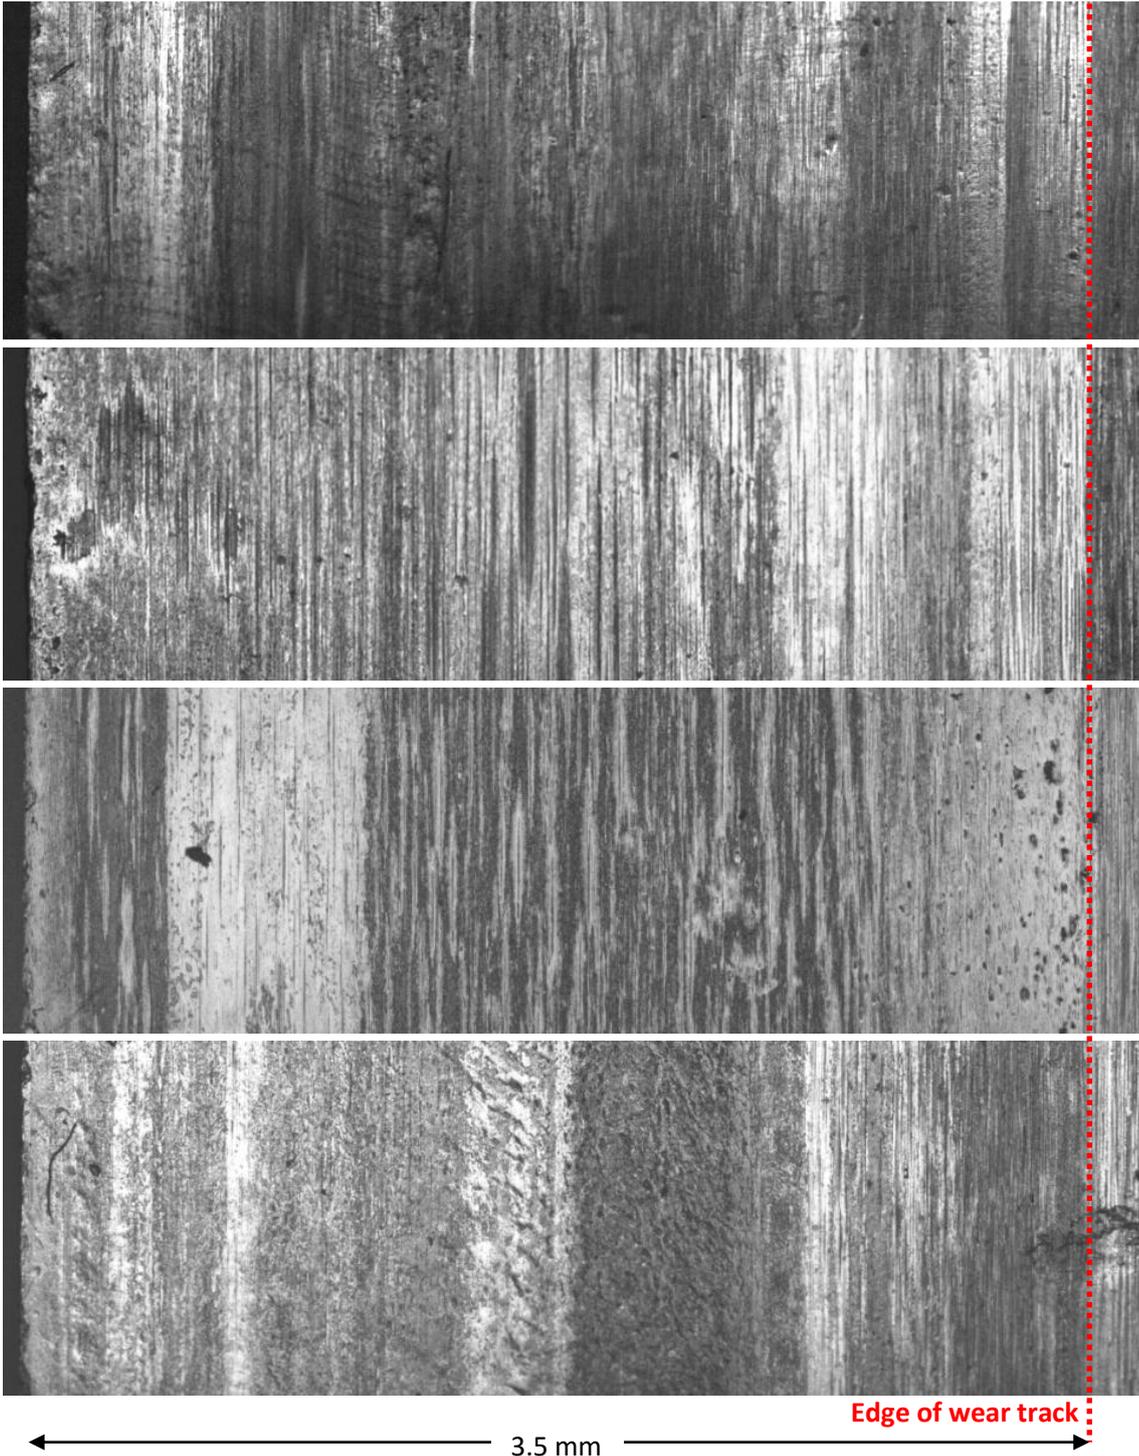
Figure 9-20: Wear tracks from SUROS discs 9-12
