“The Effect of Low Velocity Impact Damage on the Performance of a Woven CFRP”

**Thesis submitted to the University of Sheffield for the Degree of Doctor of
Philosophy in the Faculty of Engineering and Materials.**

**Department of Mechanical and Process Engineering,
University of Sheffield,
Mappin Street,
Sheffield,
S1 3JD.**

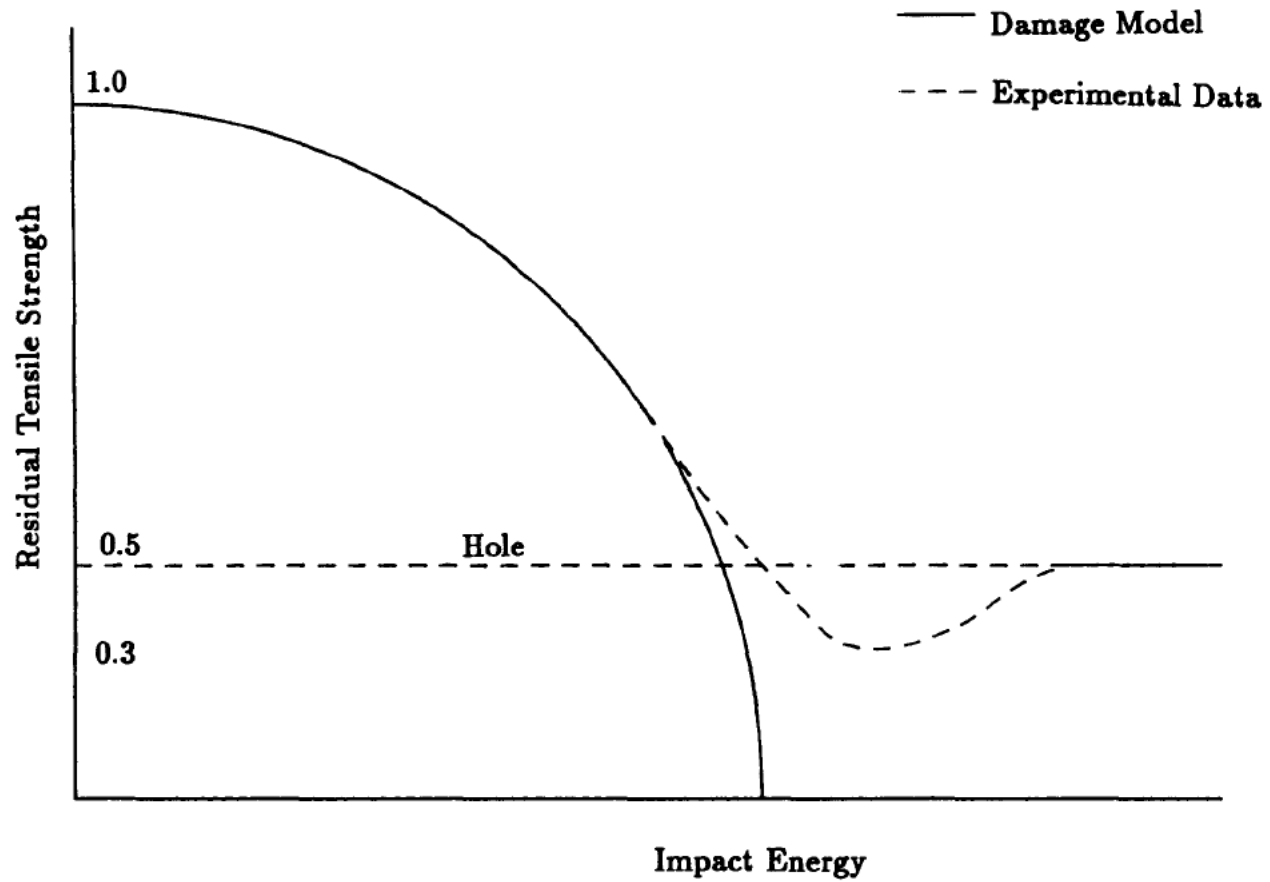
Figure 2.2. Residual Static Strength as a Function of Impact Energy [78].

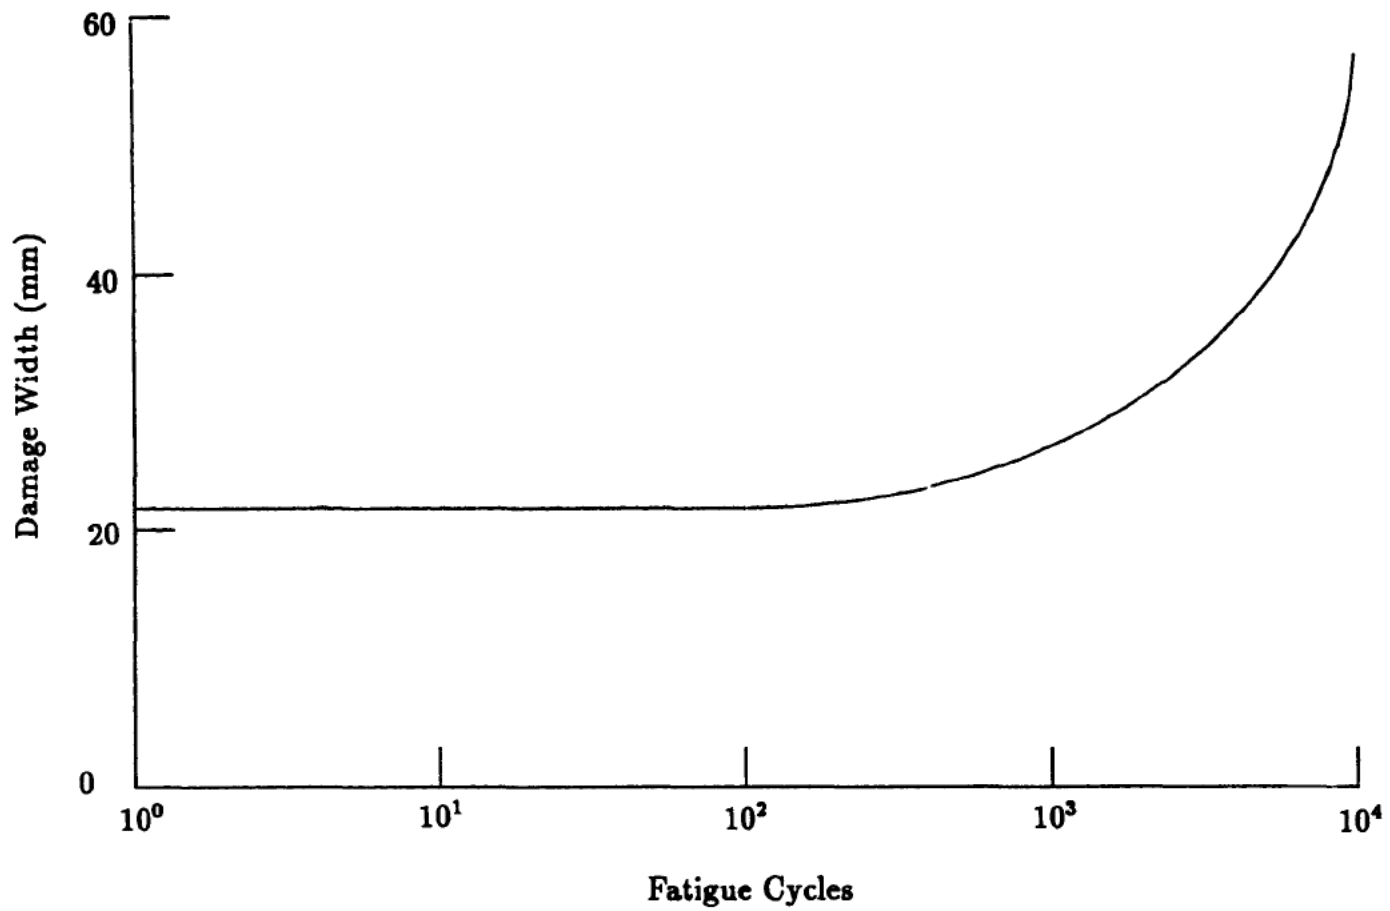
Figure 2.3. Lateral Growth of Damage under

Compressive Fatigue [55].

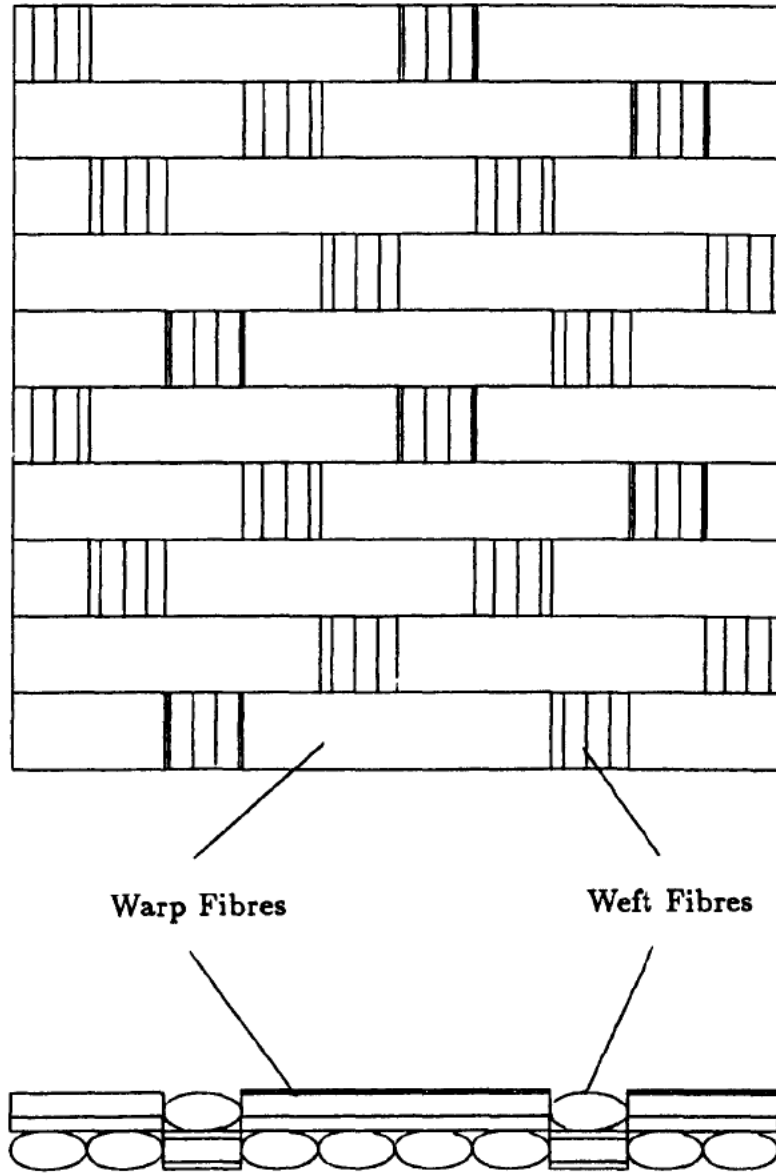
Figure 3.1. Weave Style of
 Five - Harness - Satin Woven CFRP.

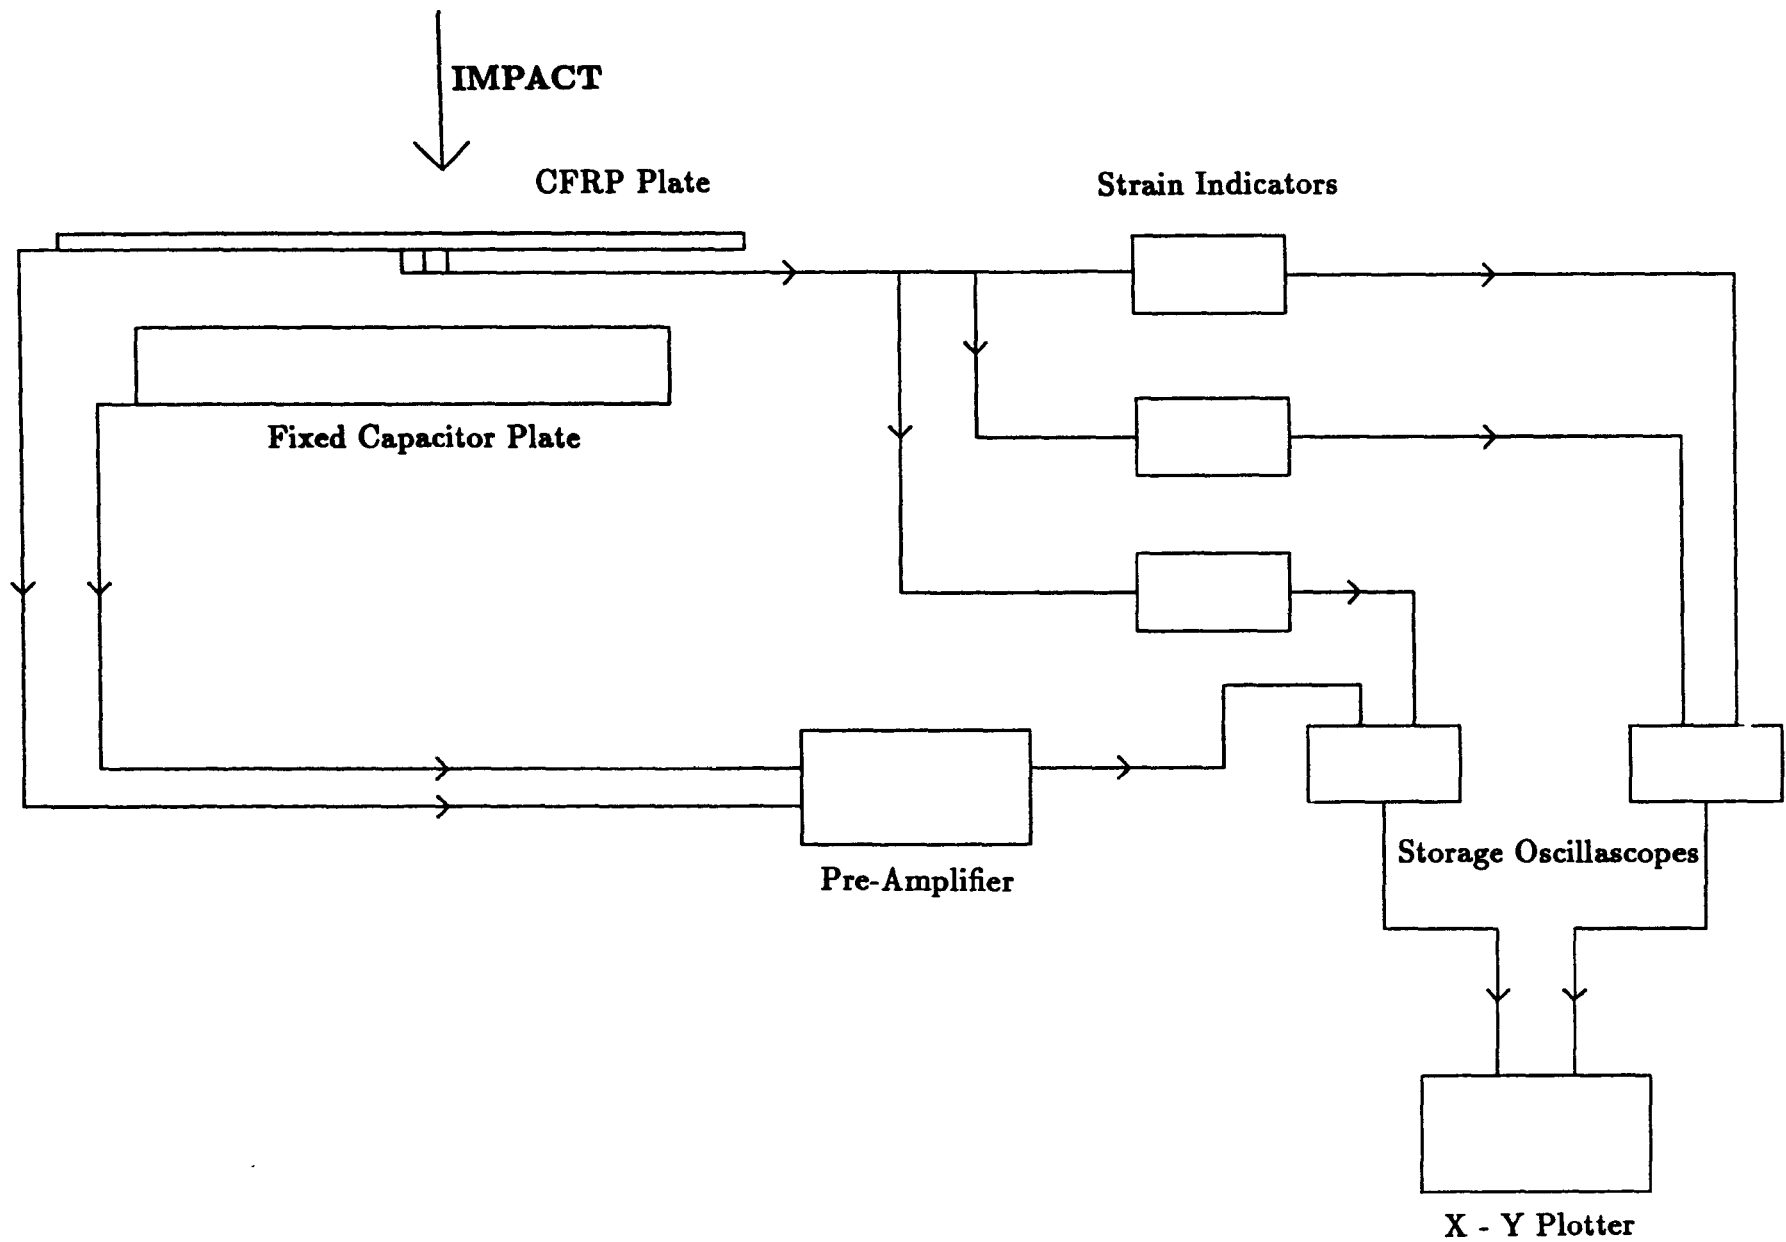
Figure 3.6. Schematic Representation of Instrumentation
for Impacting CFRP Laminates.

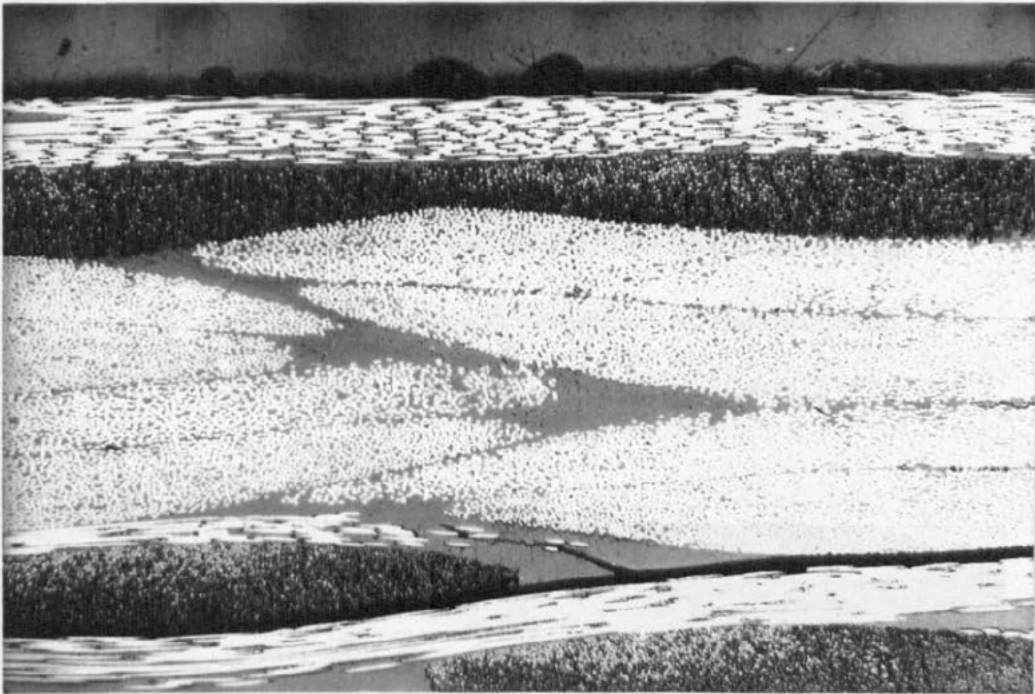
Figure 5.18. 2.94J Impact. The Influence of Tow
Cross-Overs in Deflecting Delaminations to
Adjacent Interfaces.

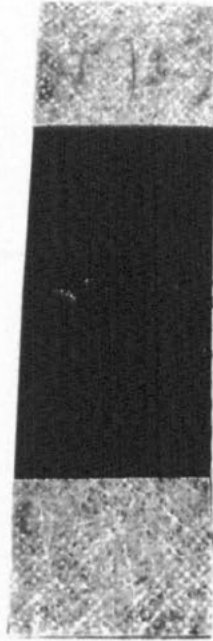
Figure 6.23. Typical Compressive Failure for 8.83J
Impacted Specimen. LE6169/A1/B1/11.

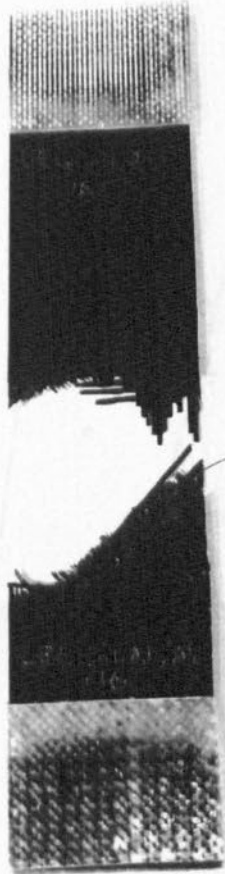
Figure 7.4. Typical Low Stress/High Cycle Zero-Tension Fatigue Failure. Specimen LE6169/A1/A2/16, 0J,

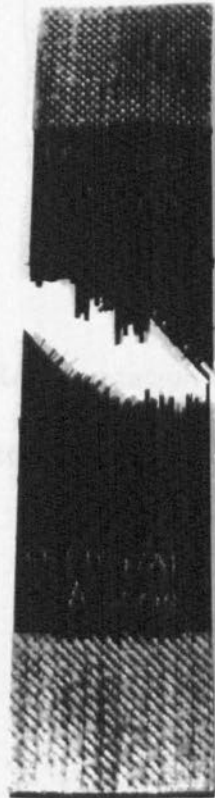
Figure 7.27. Typical High Stress/Low Cycle Zero-Tension

Fatigue Failure. Specimen LE6169/A1/B2/14, 2.94J,

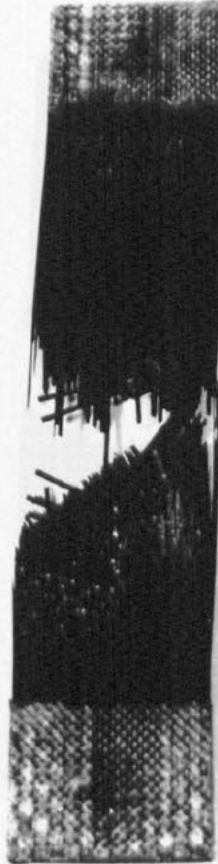
Figure 7.30. Typical Low Stress/High Cycle Zero-Tension
Fatigue Failure. Specimen LE6169/A1/B2/2, 2.94J,

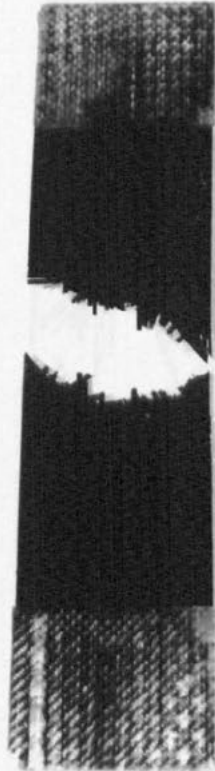
Figure 7.31. Typical High Stress/Low Cycle Zero-Tension
Fatigue Failure. Specimen LE6169/A1/B2/7, 6.87J,

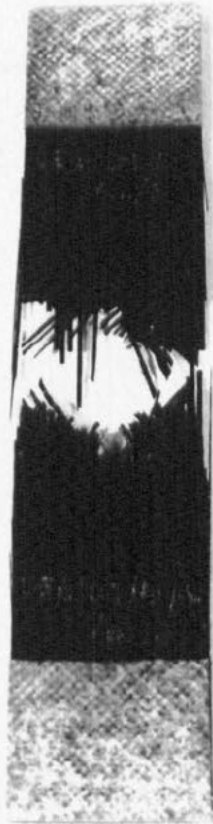
Figure 7.32. Typical Low Stress/High Cycle Zero-Tension
Fatigue Failure. Specimen LE6169/A1/A2/6, 6.87J,
