**MECHANISM OF FRETTING CORROSION AT THE MODULAR  
TAPER INTERFACE OF HIP PROSTHESIS**

**Abimbola Oluwawemimo Oladokun**

Submitted in accordance with the requirements for the degree of  
Doctor of philosophy

The University of Leeds  
School of Mechanical Engineering  
Leeds, UK

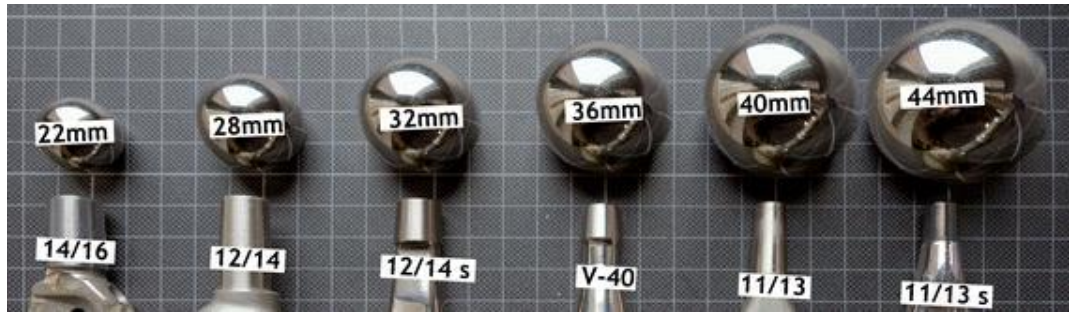
Figure 3-3 is a depiction of increasing head sizes from left to right and decreasing taper sizes in the same direction. The Euro – 12/14 is the most widely used amongst various companies while the other two are specific to a company; its dimensions are 12 mm proximal diameter and 14 mm distal diameter. The tolerance and taper surface morphology of these taper differs between companies; some models have smooth finish while others have grooves of varying pitches and depths. For this reason, mixing and matching of components from different manufacturers is generally advised against [57, 58]. A recent study [59], found that the choice between smooth or grooved male taper affects the taper strength as their study reported a higher taper strength when smooth tapers are used compared to grooved tapers. Although, the grooved tapers are necessary for securing ceramic bearings onto the male taper as the grooves deform against the ceramic when the taper is assembled with an impaction force thus creating an interference fit. The multifactorial challenges encountered at the head-neck modular interface are discussed in greater detail later in this chapter.

**Figure 3-3 – Increasing bearing sizes from left to right and decreasing taper sizes in the same direction [57].**

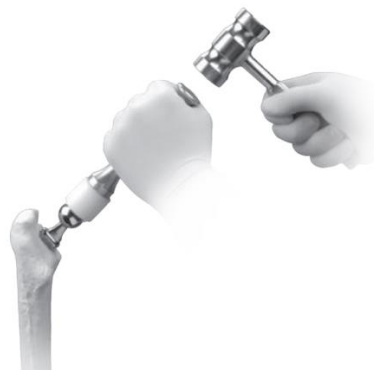
Bi-modular tapers such as the Zimmer M/L Taper with Kinetiv® Technology prescribes only a single strike using the head impactor to secure both head-neck and neck-stem tapers [62] however multiple impaction may be necessary to ensure the tapers are well fixed. Indeed, a number of studies are advocating the need for larger impaction forces to reduce fretting at the taper interface [59, 63, 64]. In a study by Rehmer et al [65] which focused on the Morse taper connection, it was demonstrated that the taper strength increases linearly with increase in assembly force while multiple impaction force had no effect. However, the ability to separate the tapers by the application of turn-off moments varied correspondingly to material combination and assembly force [59, 65]. In the case of the tri-modular tapers, Figure 3-2 shows how the design allows for various lengths of the stem to be fastened using a screw and once secure, the femoral head is subsequently impacted onto the neck component.

**Figure 3-4 – Fixation of both head–neck and neck–stem [62]**

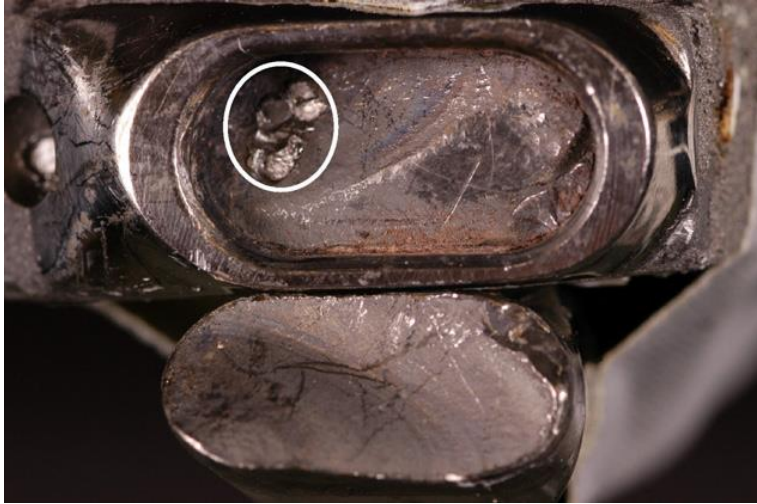
*In-vivo* fracture of the neck component had been a serious problem observed in at neck-stem interface. This is due to various causes but the most important is the use of titanium alloy as neck component [54]. Dangles and Altstetter [81] reported a fracture of the modular neck in an obese middle-aged man, Figure 3-9 shows the fractured neck with the other half still fixed within the stem bore. In their study, the cause of fracture was proposed to be a result of increase in offset and crevice corrosion, other fractures reported by Skendzel [82] were suggested to be related to the use of long varus style modular neck which is said to increase bending moment by 32.7% compared to short varus stems. The study also concluded that the stem design played a significant role in fracture of the neck. Ti6Al4V alloy necks have been shown to be more prone to fracture than CoCrMo alloy and a study by Nganbe et al [83] gives a good reason through their result which shows that CoCrMo alloy has a 38% higher load-bearing capacity and 1000 times longer fatigue life than Ti6Al4V. This explains why CoCrMo is a better material choice for the neck component.

**Figure 3-9 – Fracture of the neck component at the neck-stem interface  
[81]**

However, considering the deleterious consequence of adding another CoCrMo component to the hip prosthesis i.e. the risk of increased Co and Cr ions release into the peri-prosthetic tissues; such compromise is a rather difficult one to justify. Nevertheless, it proves a better decision than risking *in-vivo* fracture. In addition, it has been reported that Ti6Al4V alloy is more susceptible to a cold welding phenomena – a solid state joining process occurring without heat at the interface. This has led to several reported cases of damage of the neck component and difficulty in disengaging the neck from the stem component [55, 84].

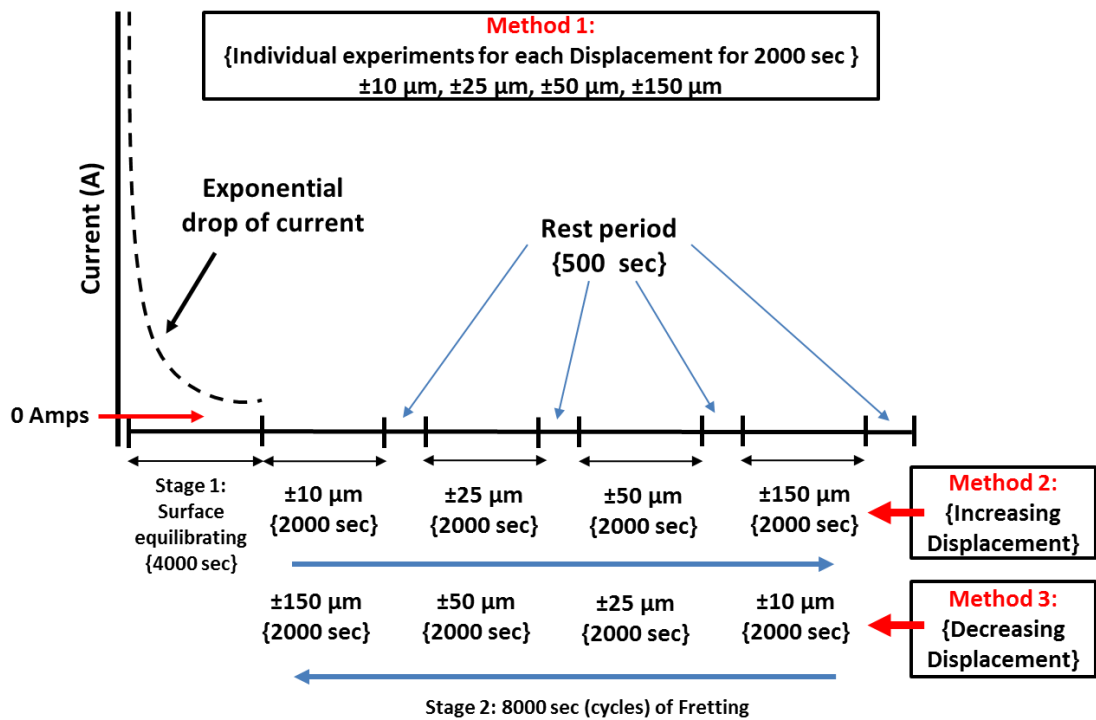
**Figure 4-5 – Schematic diagram of potentiostatic fretting corrosion protocol**

- In 'Method 1' 2000 cycles of fretting (1 Hz) were carried out for each displacement amplitude ( $\pm 10 \mu\text{m}$ ,  $\pm 25 \mu\text{m}$ ,  $\pm 50 \mu\text{m}$  and  $\pm 150 \mu\text{m}$ ). Prior to each test, 4000 seconds of equilibrating period was permitted in order to allow the current transient to be as close to '0 amps' as possible.
- In 'Method 2', the tests were conducted for the same displacements as in method 1. However, in this case, the tests were performed in series, in the increasing order of  $\pm 10$ ,  $\pm 25 \mu\text{m}$ ,  $\pm 50 \mu\text{m}$ ,  $\pm 150 \mu\text{m}$  with an incorporated rest period of 500 seconds after each displacement amplitude.
- 'Method 3' follows the same process as method 2, however, in this case the tests were conducted in a decreasing order ( $\pm 150$ ,  $\pm 50 \mu\text{m}$ ,  $\pm 25 \mu\text{m}$ ,  $\pm 10 \mu\text{m}$ ).

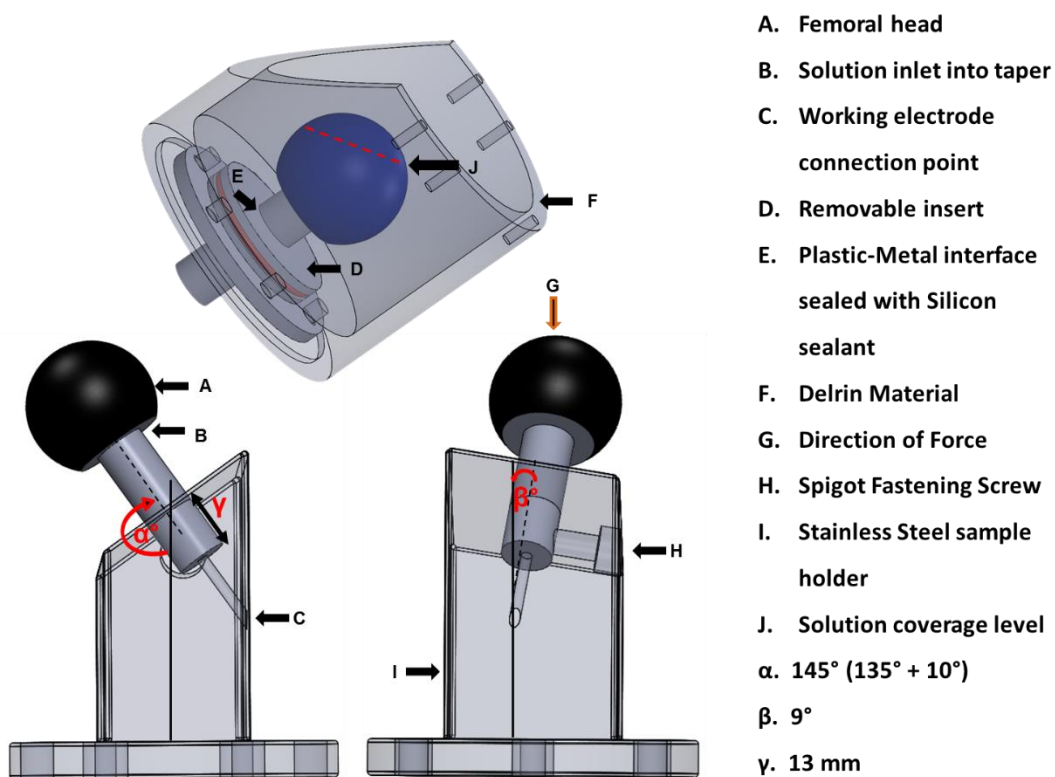
**Figure 4-7 – 3D representation of the fatigue set-up for assessing fretting corrosion of realistic taper geometry.**

The assembled taper interface was exposed to 85 mL solution which covered the femoral head up to the line denoted 'J'. The plastic-metal interface identified as 'E' was isolated from the physiological solution by the use of silicon sealant. The test was conducted at room temperature ( $20\pm 2^\circ\text{C}$ ) which minimised the amount of solution evaporated over the 2.5 days of dynamic loading. The WE for the electrochemical connection was taken from the bottom of the male spigot 'C' and both RE and CE were suspended in the solution in close proximity to the taper interface 'B' thus ensuring accurate electrochemical measurements.

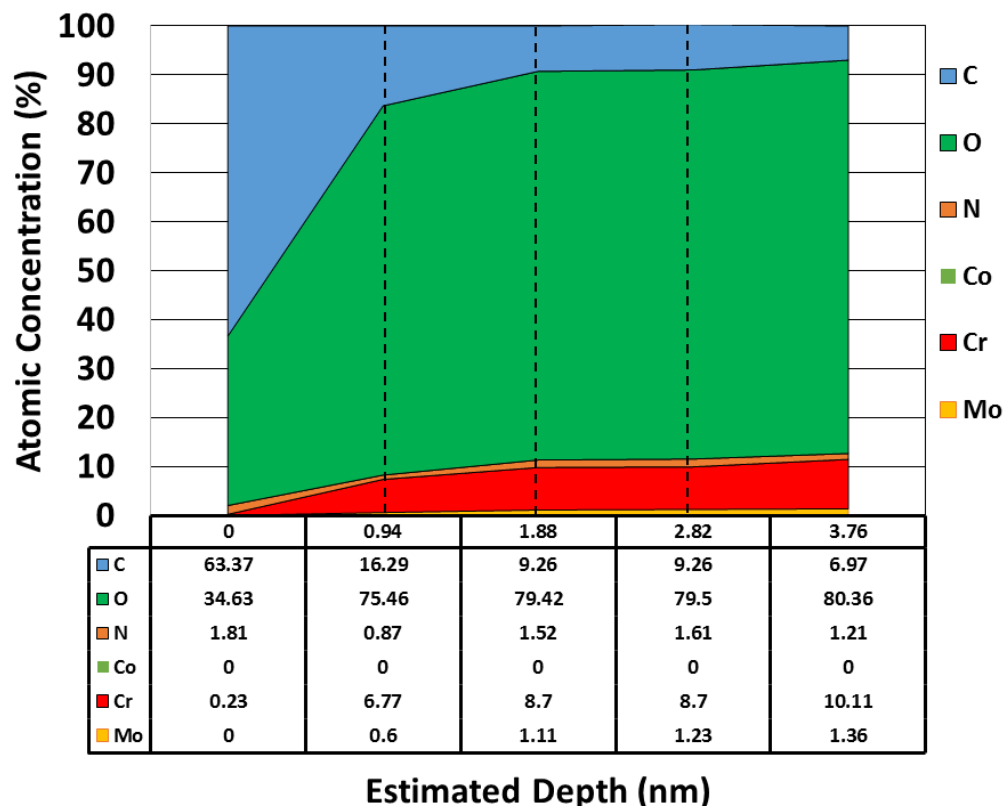
**Figure 5-8 – XPS Depth profile analysis of CoCrMo passive film**

179]. A sharp increase in the O content between the first and second levels corresponds to the increase in Cr and Mo, this is indicative of the two main metallic elements that contribute to the protective layer. However, the abundance of Cr compared to Mo was seen to be roughly 8:1 ratio across the depths beyond the first level confirming that Cr is the dominant metallic element in the protective layer [180]. Furthermore, no evidence of Co was observed throughout the 5 levels of the depth profile analysis which suggests that the bulk surface of the alloy was not reached. More so, the absence of any oxides of Co is likely due to an observation made in the study referenced already [180] where it is noted that Co-oxide exist deeper within the protective layer – interfacing with the bulk metal.

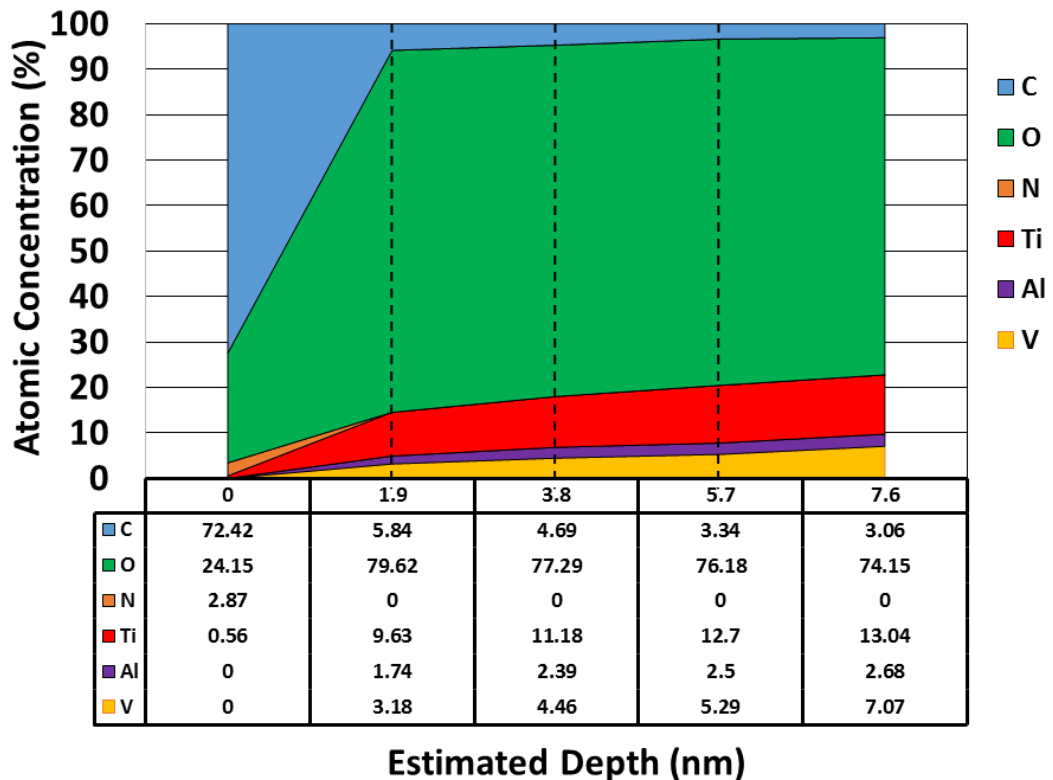
**Figure 5-10 – XPS Depth profile analysis of Ti6Al4V passive film**

Figure 5-10 shows the concentration of the elements assessed on the Ti6Al4V surface. Similar to the CoCrMo surface, the uppermost surface of the Ti6Al4V alloy also composed of C, O and N and a small proportion of the most reactive metal in the alloy – Cr in the case of CoCrMo and Ti in Ti6Al4V alloy. The proportion of O, C and Ti on the Ti6Al4V follow a similar pattern with O, C and Cr contents as described for the CoCrMo. However, the proportion of Ti in the Ti6Al4V protective layer is seen to be higher than that of Cr in the CoCrMo layer for all levels. Interestingly, the concentration of V was higher in proportion to Al for all levels beyond the uppermost surface.

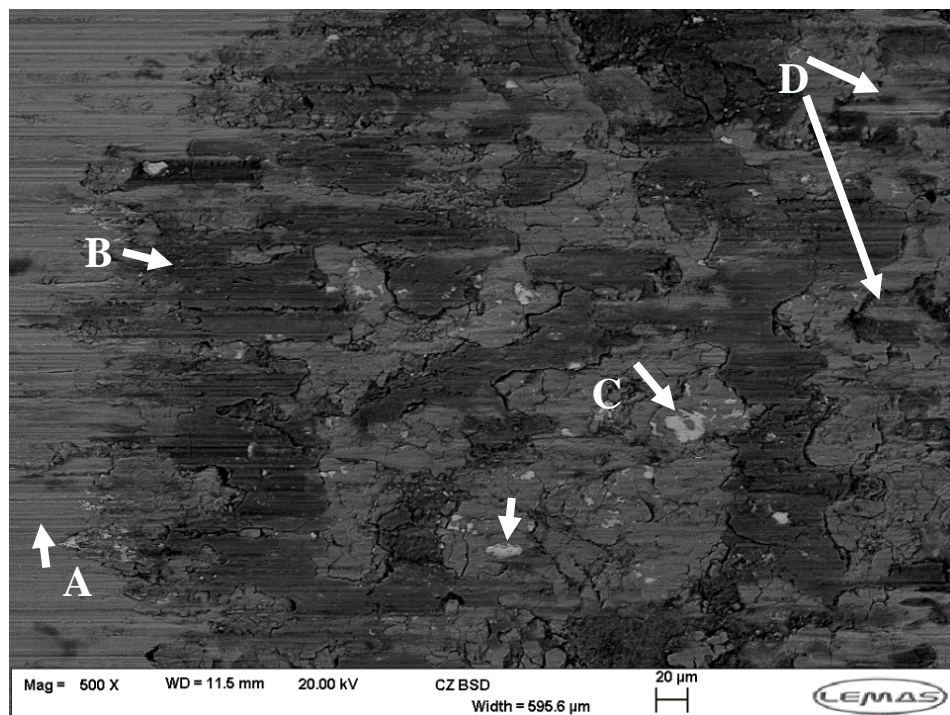
**Figure 6-12 – Back scatter-SEM of Ti6Al4V flat from the CoCrMo – Ti6Al4V interface at  $\pm 50 \mu\text{m}$  under OCP conditions.**

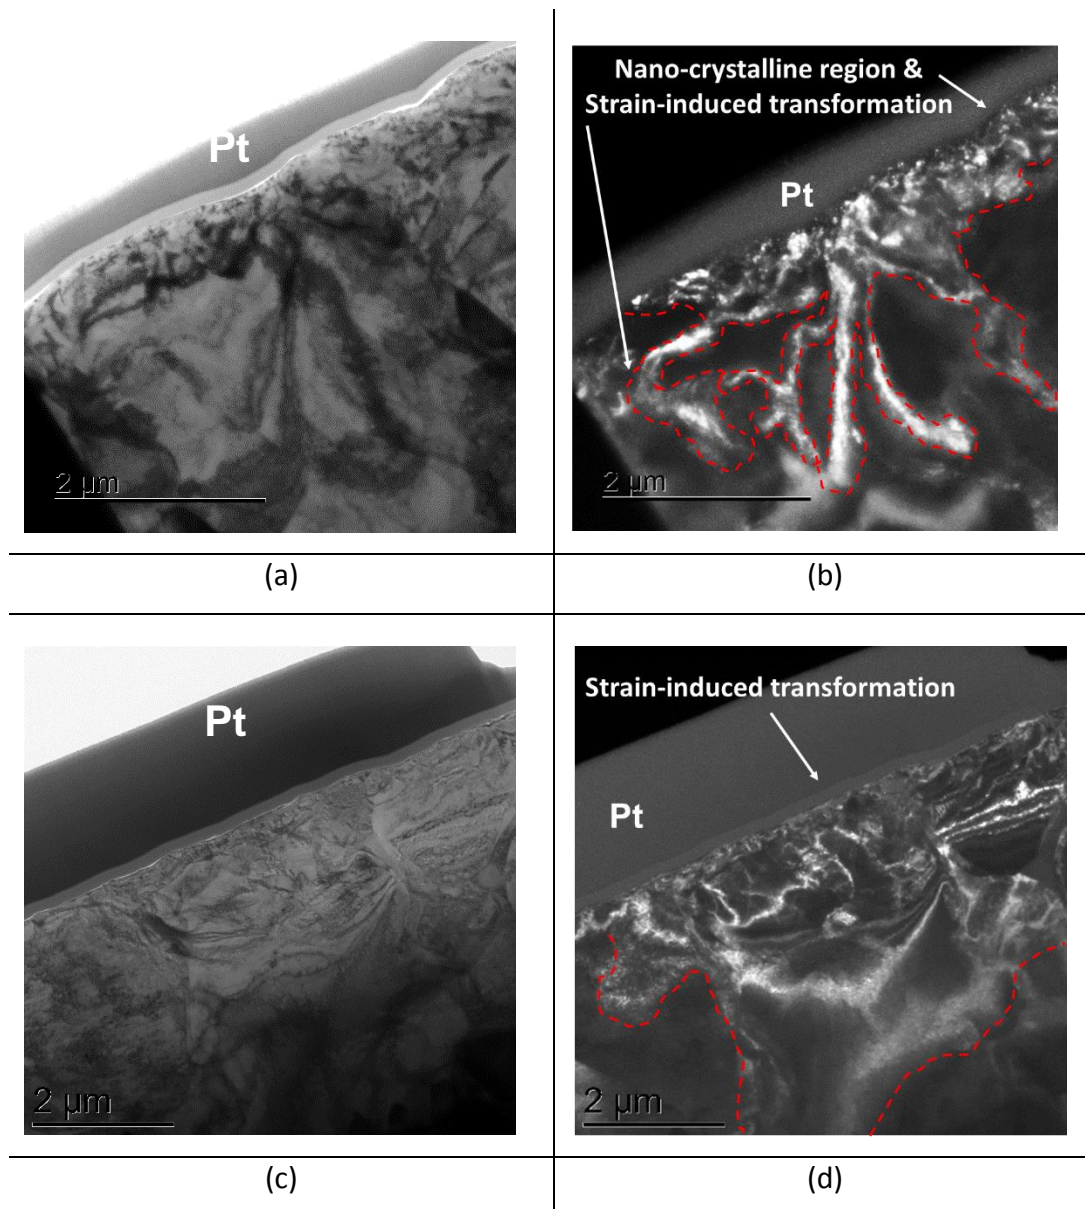
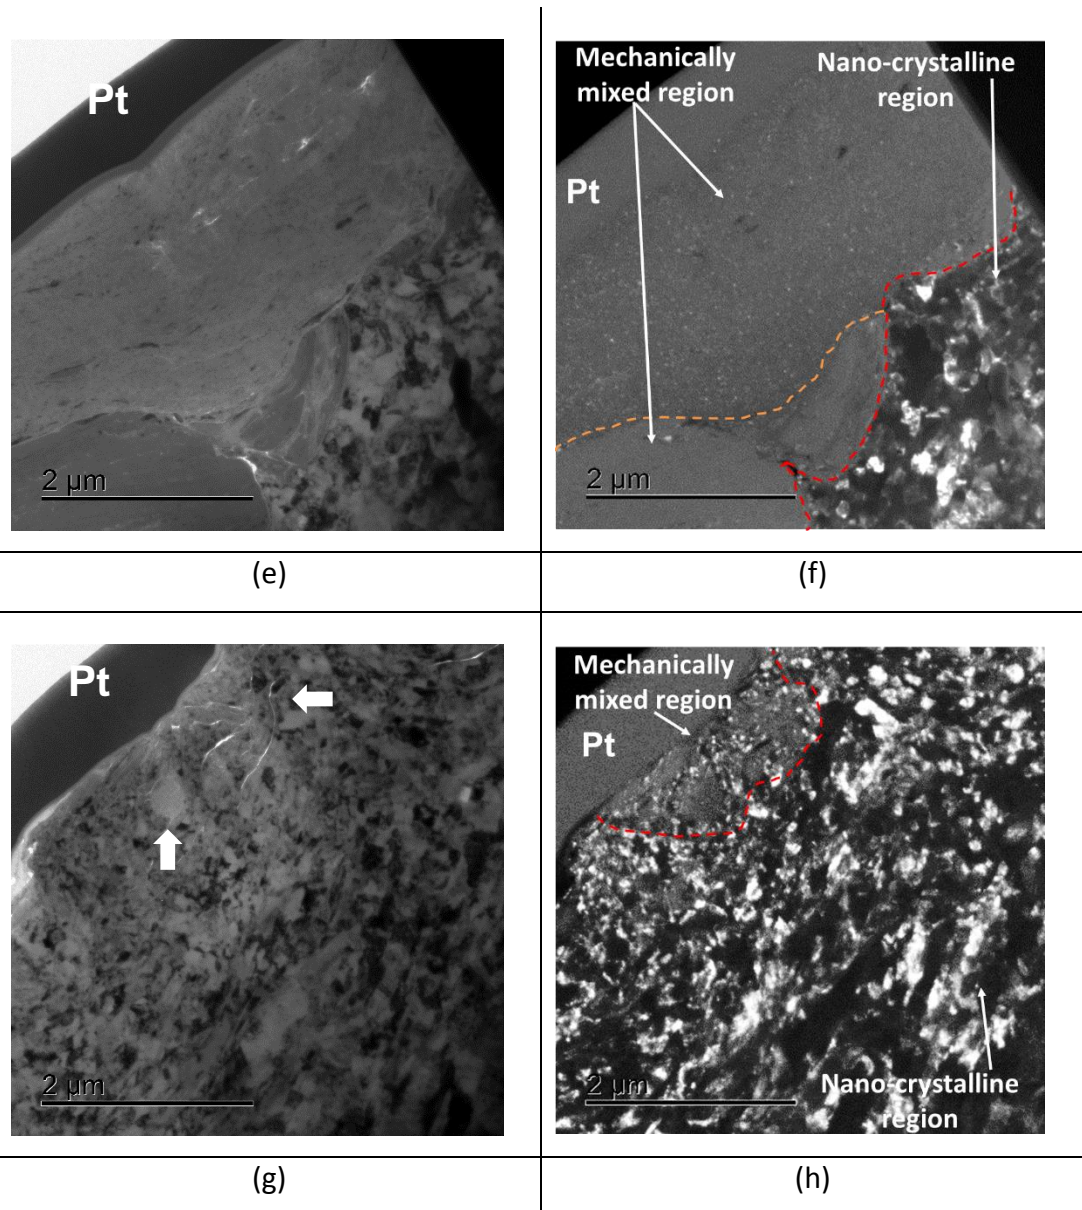
**Figure 6-19 – TEM bright and dark field micrographs of Ti6Al4V flat component from CoCrMo – Ti6Al4V interface at  $\pm 10 \mu\text{m}$  (a & b),  $\pm 25 \mu\text{m}$  (c & d),  $\pm 50 \mu\text{m}$  (e & f),  $\pm 150 \mu\text{m}$  (g & h).**

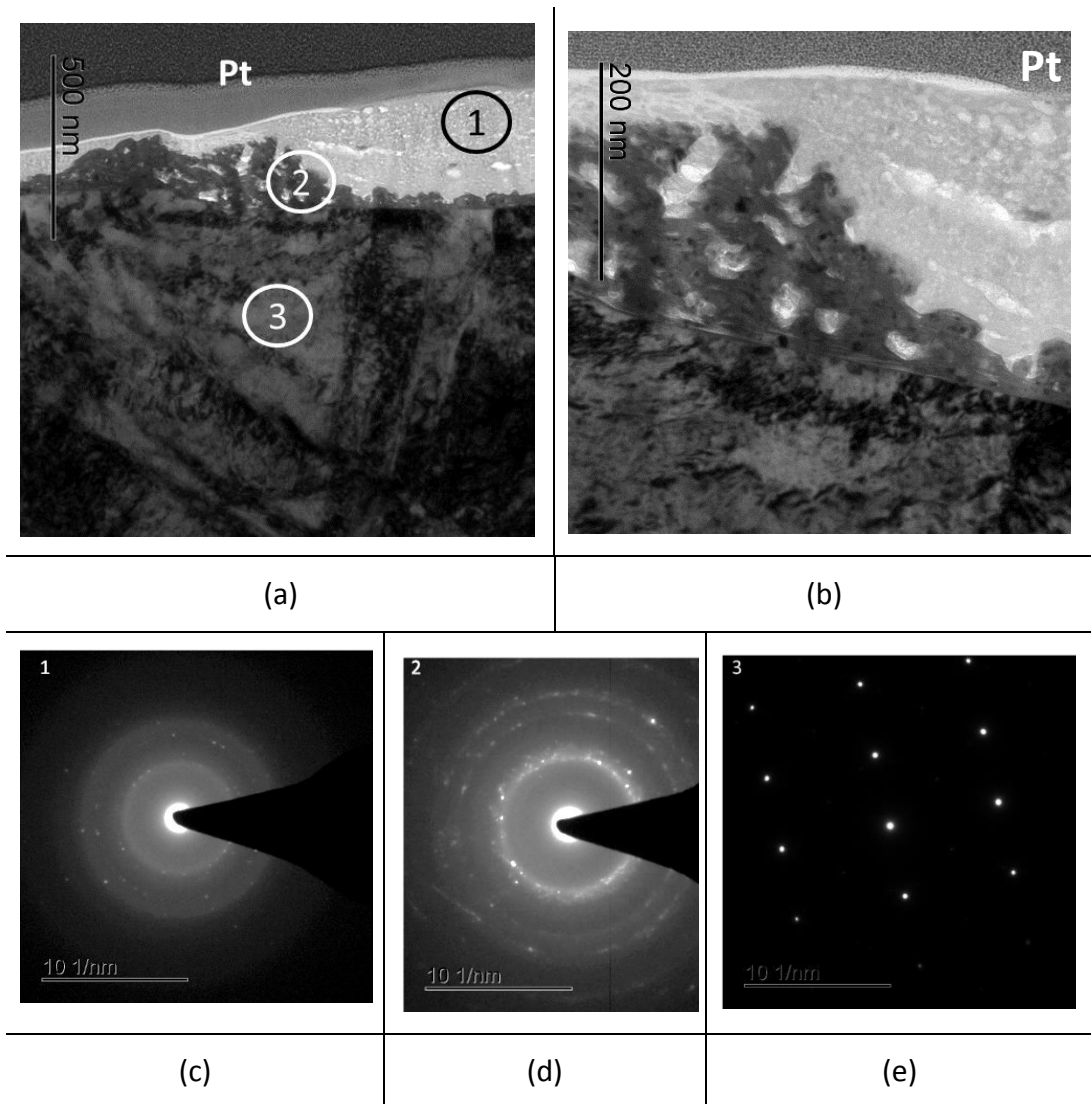
**Figure 6-20 – TEM and SAED of CoCrMo – CoCrMo at  $\pm 150 \mu\text{m}$ : a) Bright field TEM micrograph of CoCrMo subsurface b) Close-up image of tribochemical products on surface c) SAED of structure 1 d) SAED of structure 2 e) SAED of CoCrMo bulk.**

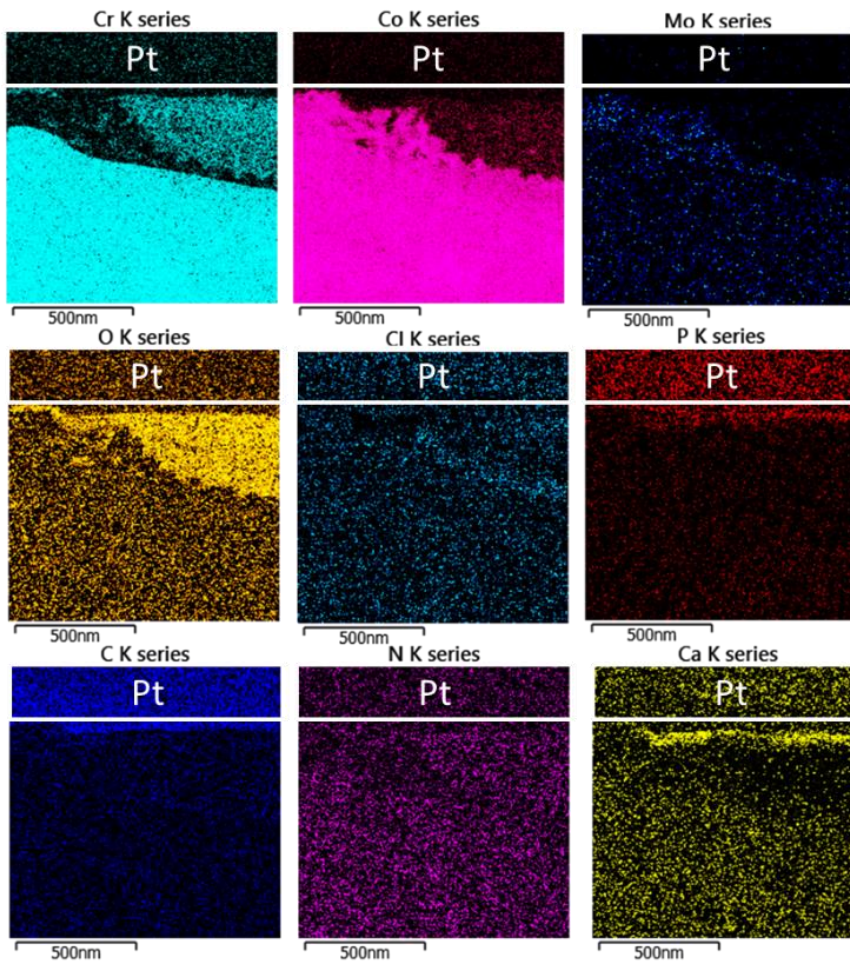
Figure 6-21 – TEM-EDS map of CoCrMo – CoCrMo flat surface at  $\pm 150$   $\mu\text{m}$

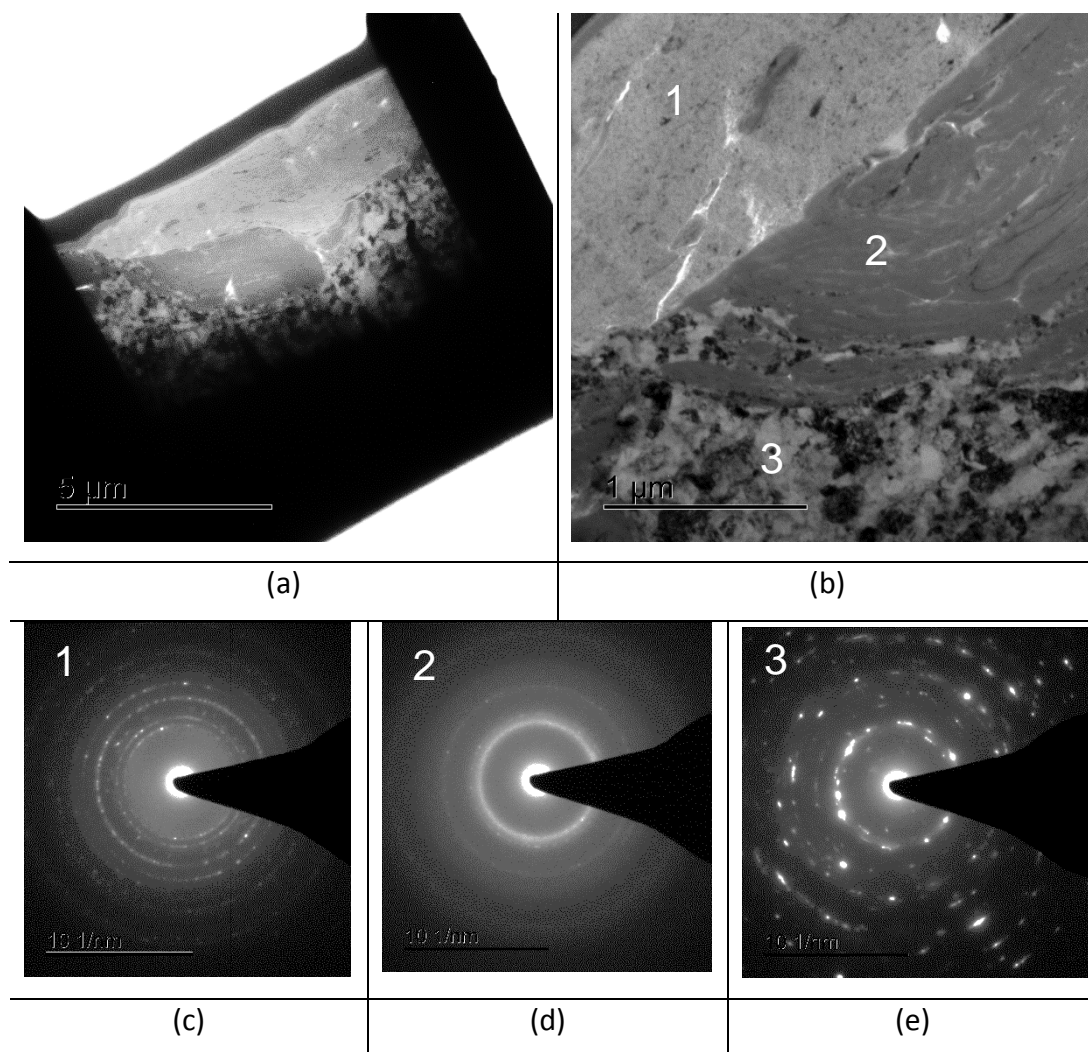
**Figure 6-23 – TEM and SAED of mechanically mixed layers on Ti6Al4V alloy: a) TEM micrograph of Ti6Al4V subsurface b) high-resolution micrographs of the subsurface structures c) SAED of the mechanically mixed layer d) SAED of mechanically mixed Ti6Al4V structures e) SEAD of Ti6Al4V nano-crystalline structure.**

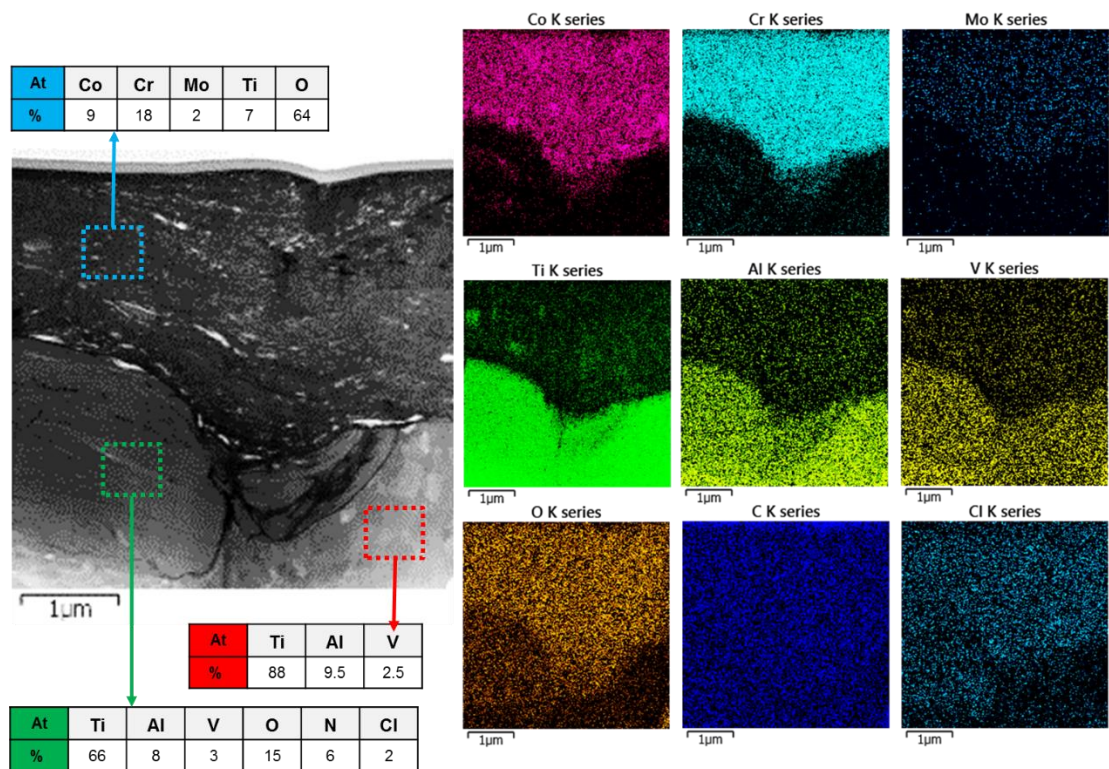
**Figure 6-24 – TEM-EDS map of the mechanically mixed layer and transformed Ti6Al4V alloy from CoCrMo – Ti6Al4V interface.**

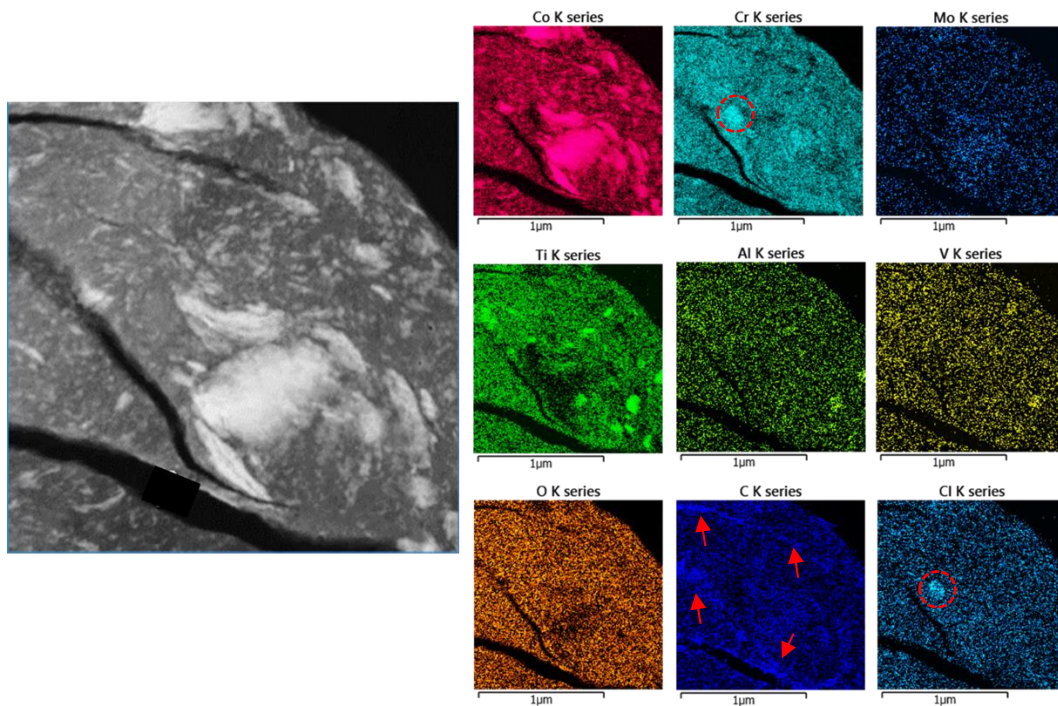
**Figure 6-26 – TEM-EDS map of the Ti6Al4V flat at the mechanically induced crack region of the CoCrMo – Ti6Al4V interface.**

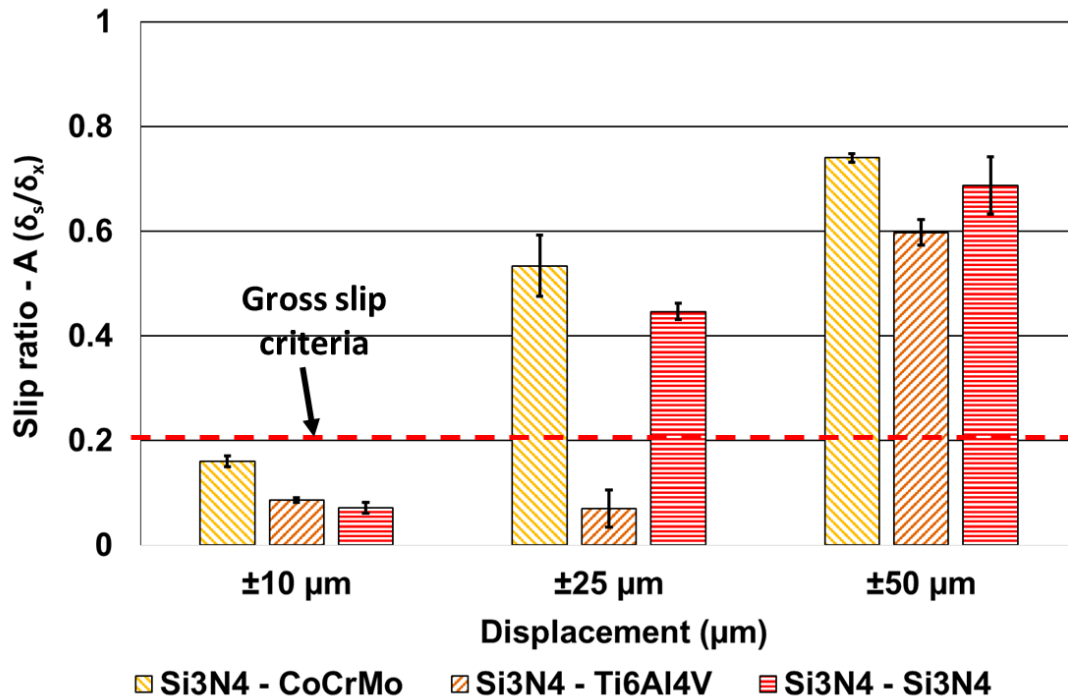
**Figure 7-3 – Slip ratio of Si<sub>3</sub>N<sub>4</sub> – CoCrMo, Si<sub>3</sub>N<sub>4</sub> – Ti6Al4V and Si<sub>3</sub>N<sub>4</sub> – Si<sub>3</sub>N<sub>4</sub> under OCP conditions for ±10, ±25 ±50 μm displacements.**

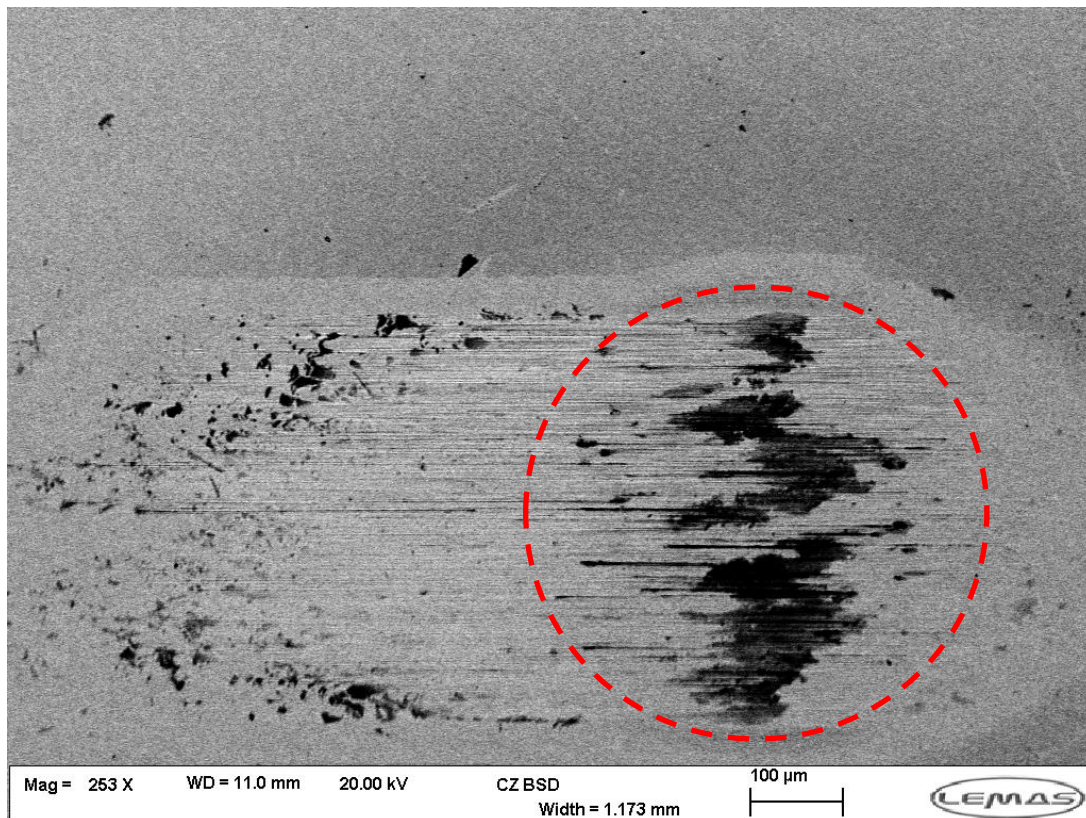
**Figure 7-15 – Back scatter-SEM micrograph of CoCrMo flat from the fretting against  $\text{Si}_3\text{N}_4$  ball at  $\pm 50 \mu\text{m}$ .**

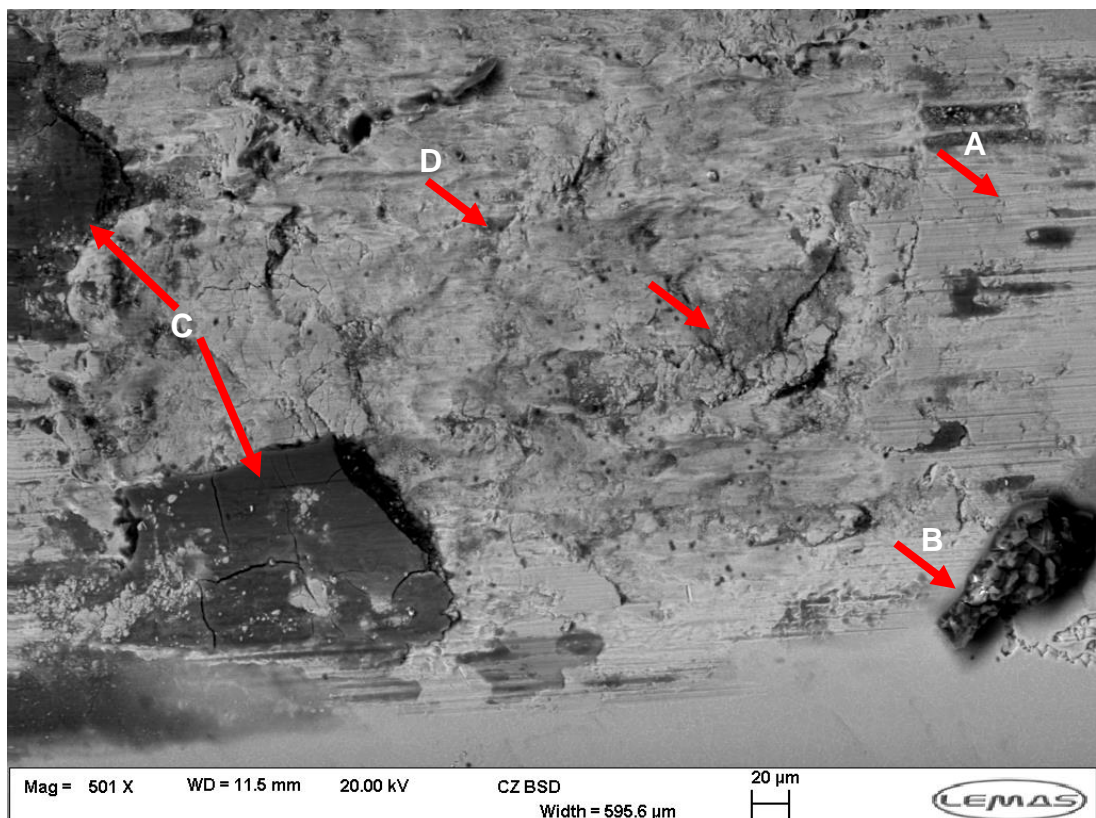
**Figure 7-16 – Back scatter-SEM micrograph of Ti6Al4V flat fretted against Si<sub>3</sub>N<sub>4</sub> ball at ±50 μm.**

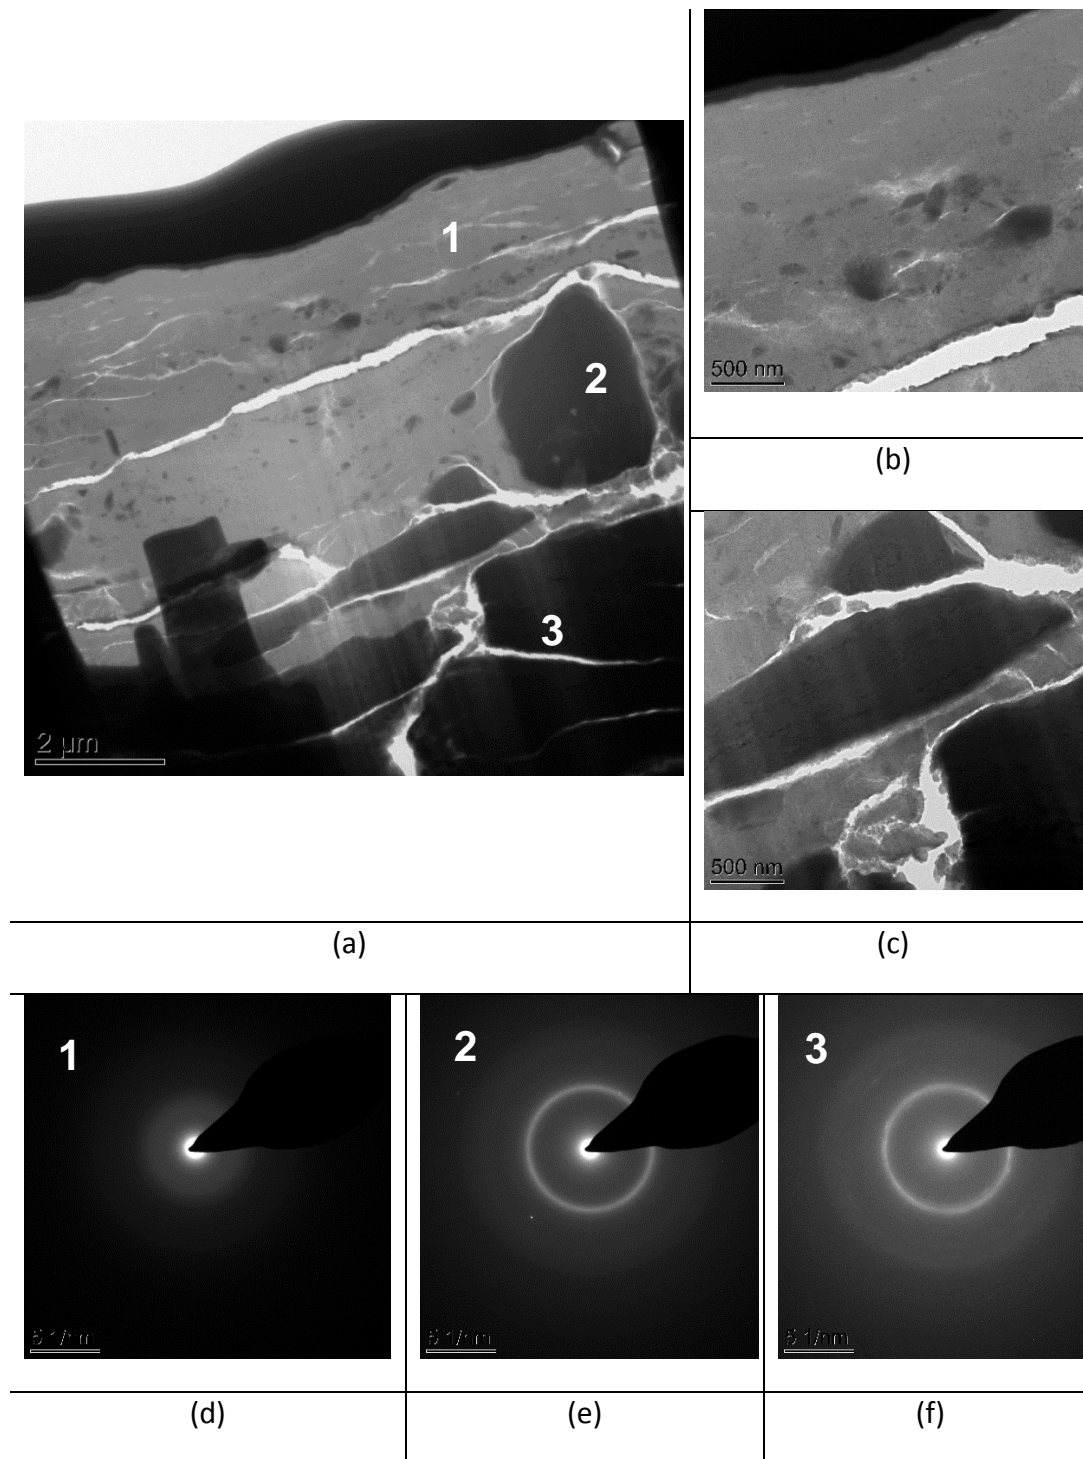
**Figure 7-24 – TEM and SAED of Ti6Al4V from the Si<sub>3</sub>N<sub>4</sub>– Ti6Al4V combination (region of mechanically mixed layer): a) TEM micrograph of the Ti6Al4V subsurface b) high resolution image of the mechanically mixed layer c) high resolution image of the transformed amorphous Ti6Al4V structure d) SAED of the mechanically mixed layer e) SAED of the suspending large particle f) SAED of fractured region.**

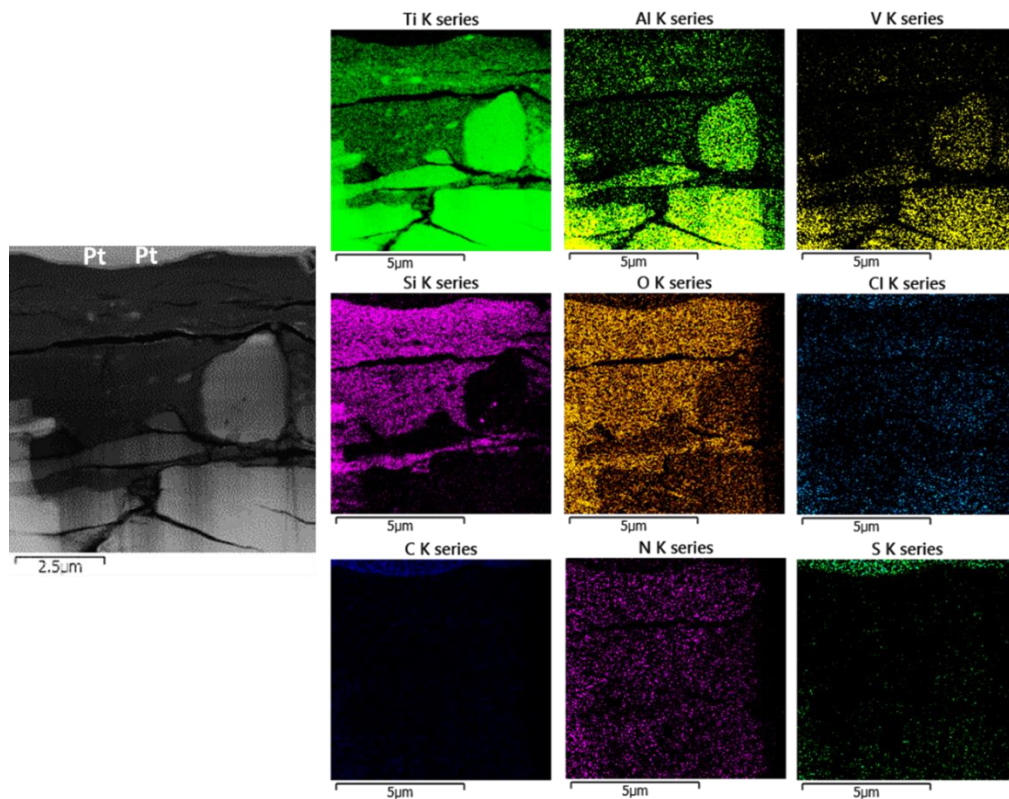
**Figure 7-25 – TEM-EDS map of the Ti6Al4V subsurface from the Si<sub>3</sub>N<sub>4</sub> – Ti6Al4V material combination – region of mechanically mixed layer.**

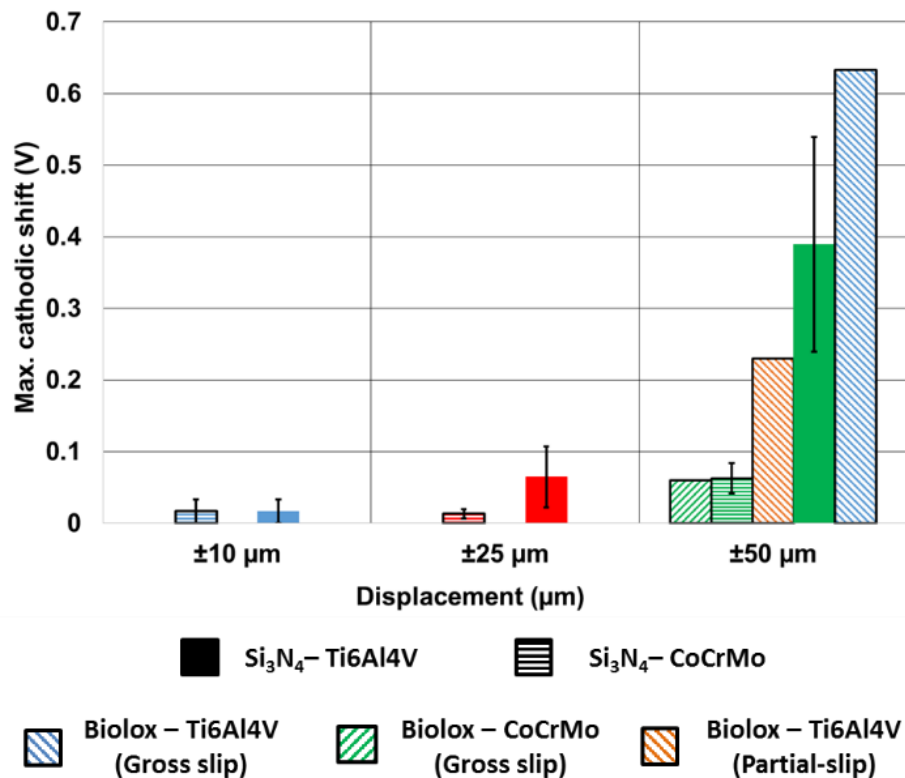
**Figure 7-38 – Comparing Max. cathodic shift in ceramic – metal combinations.**

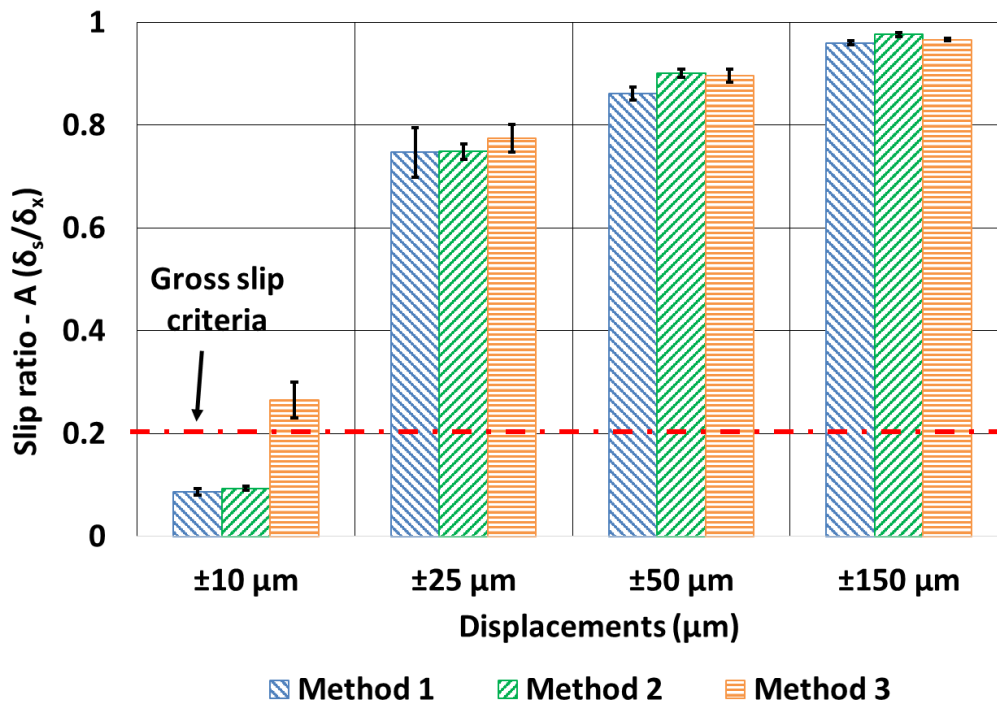
**Figure 8-2 – Slip ratio of CoCrMo – CoCrMo under potentiostatic conditions for  $\pm 10 - \pm 150 \mu\text{m}$  in ‘Methods 1 – 3’.**

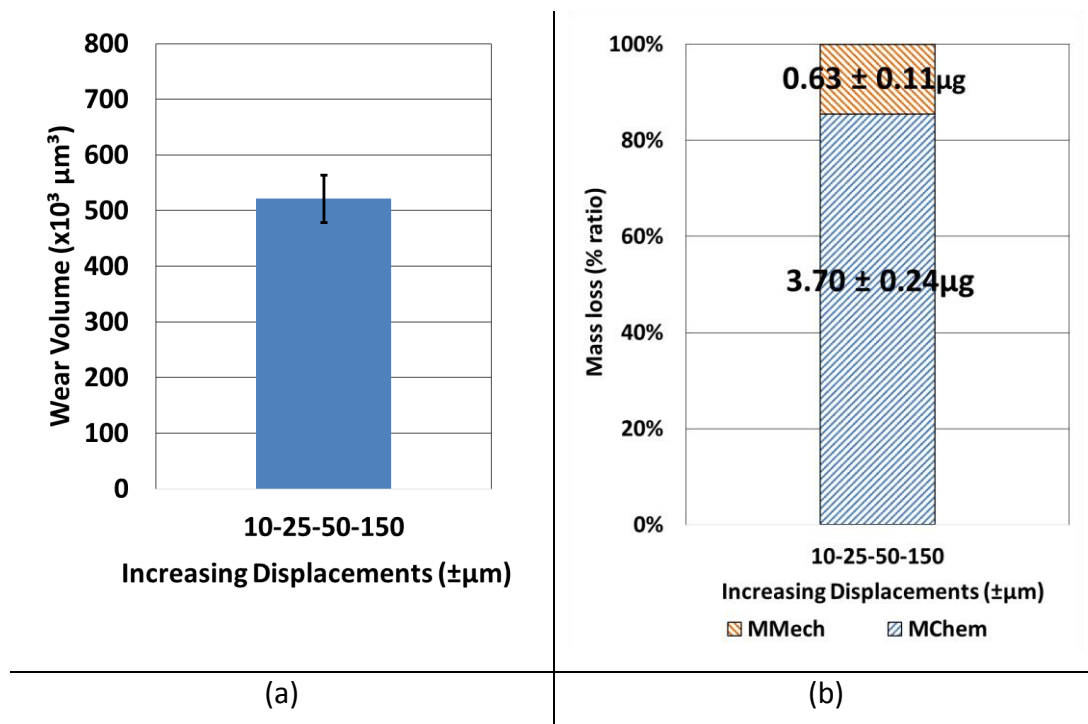
**Figure 8-11 – Method 2: tribocorrosion mass loss; a) Wear volume; b) Mass loss as a proportion of  $M_{\text{mech}}$  and  $M_{\text{chem}}$ .**

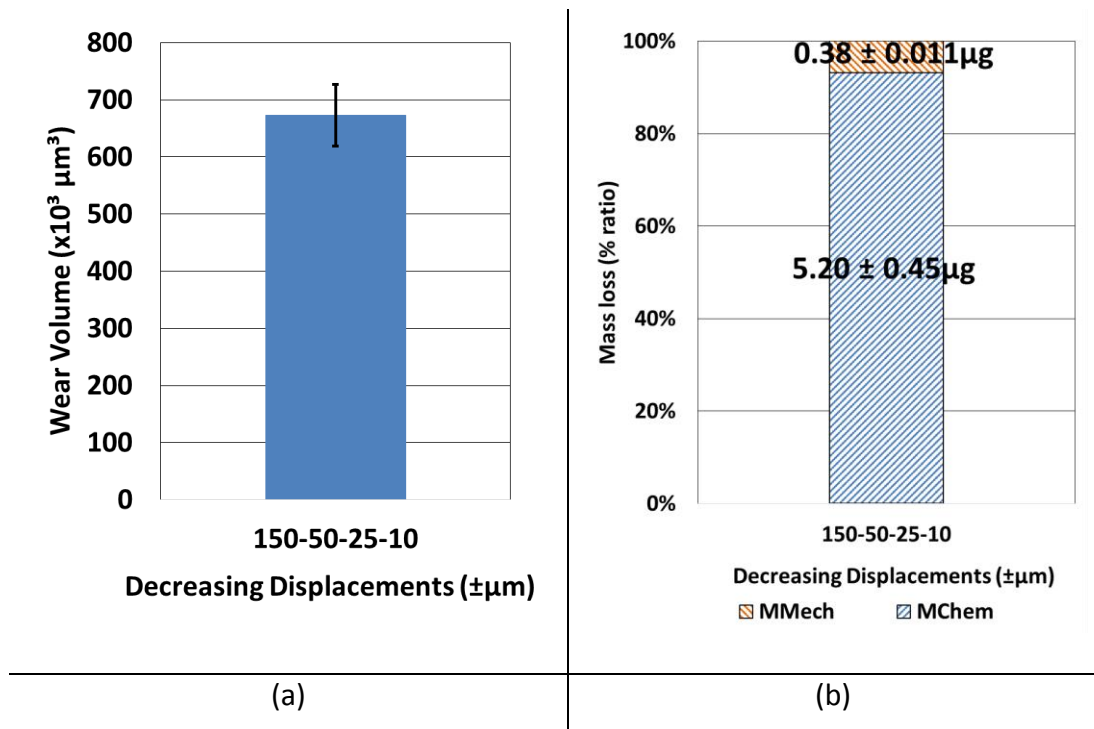
**Figure 8-15 – Method 3: tribocorrosion mass loss; a) Wear volume; b) Mass loss as a proportion of  $M_{mech}$  and  $M_{chem}$ .**
