**MECHANISM OF FRETTING CORROSION AT THE MODULAR  
TAPER INTERFACE OF HIP PROSTHESIS**

**Abimbola Oluwawemimo Oladokun**

Submitted in accordance with the requirements for the degree of  
Doctor of philosophy

The University of Leeds  
School of Mechanical Engineering  
Leeds, UK

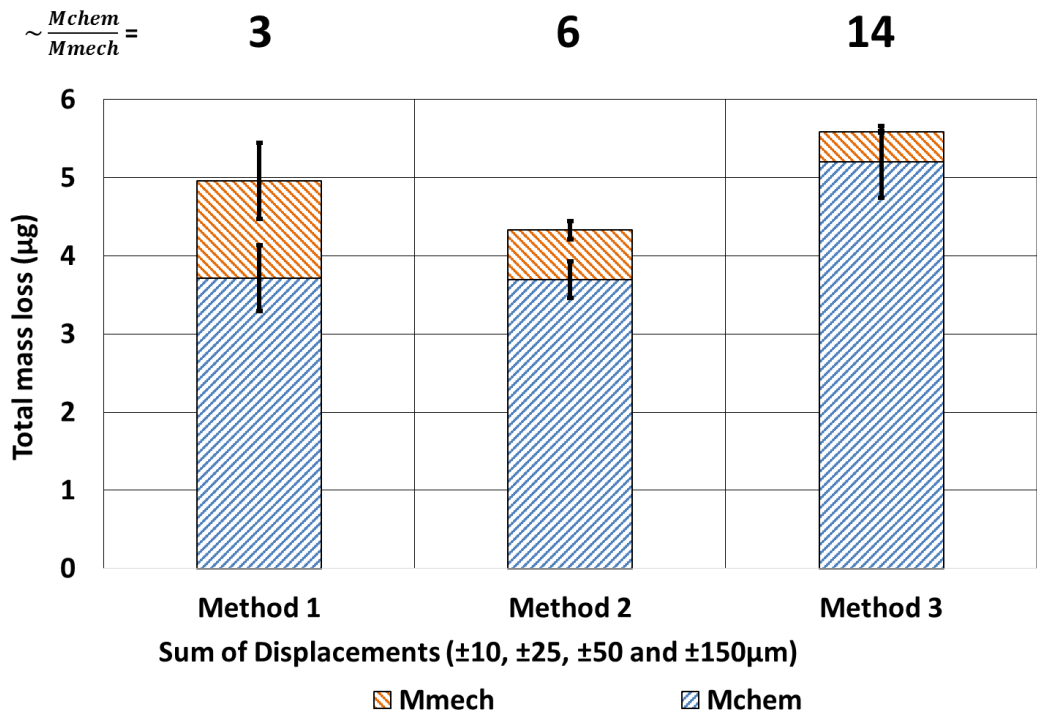
**Figure 8-16 – The sum of  $M_{mech}$  and  $M_{chem}$  for all displacements in the three methods of assessment. The  $M_{chem}/M_{mech}$  ratio for each method is also shown above.**

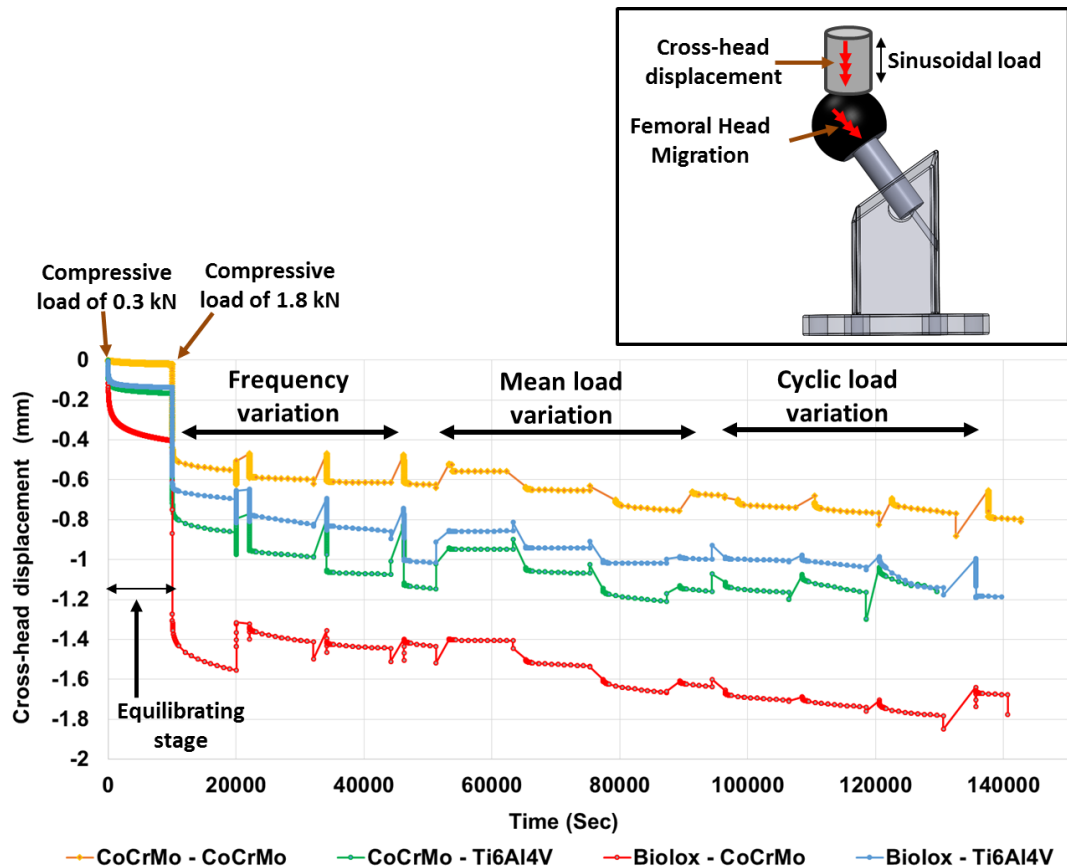
**Figure 9-9 – Cross-head displacement vs. Time graph. Each data point for all material combinations during the dynamic stages represents a point every 1000 seconds of the cross-head position. At the top right corner, a schematic of the cross-head displacement is shown.**
