Amorphous Carbon Coating Systems for Pressurised Water Reactor Tribological Applications

Nuclear Engineering Doctorate

Department of Materials Science and Engineering, University of Sheffield

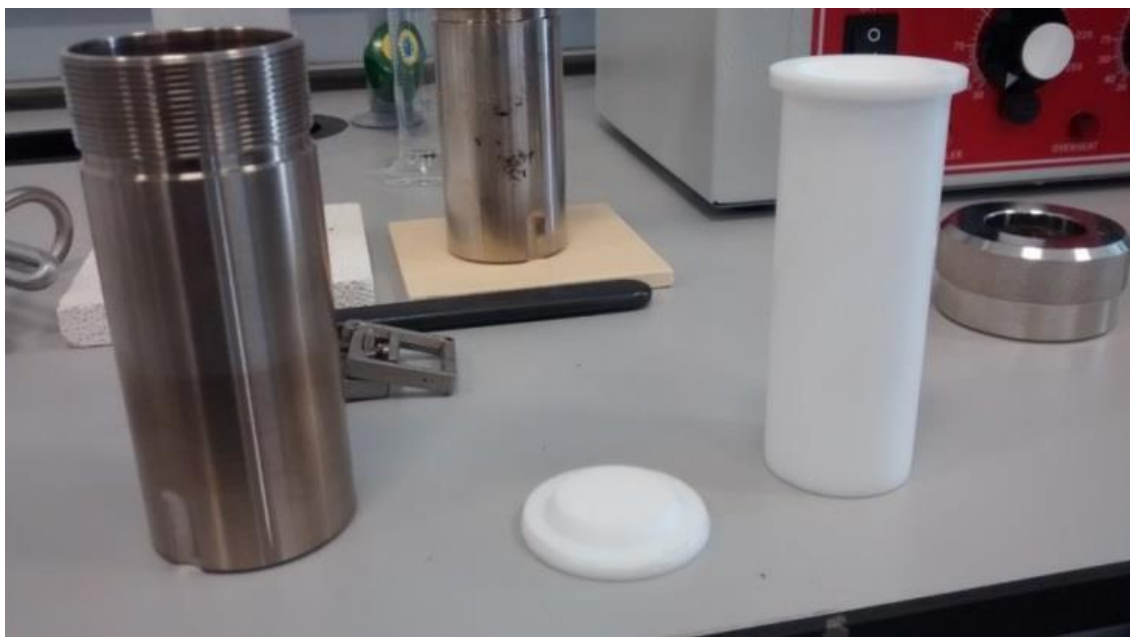
Figure 2.10 4744 45ml general purpose acid digestion Parr bomb.

The vessel used in these experiments was the 4744 45ml general purpose acid digestion Parr bomb from the Parr Instrument Company [93]. The equipment consists of a thick-walled PTFE cup with a volume of 45mL as shown in the right side of Figure 2.10. This PTFE vessel then sits inside a broad flange sealed stainless steel vessel on the left in Figure 2.10. The Parr bomb was designed to operate at temperatures of up to 250°C. The vessel has a built in mechanical fuse in the form of a rupture disc between the

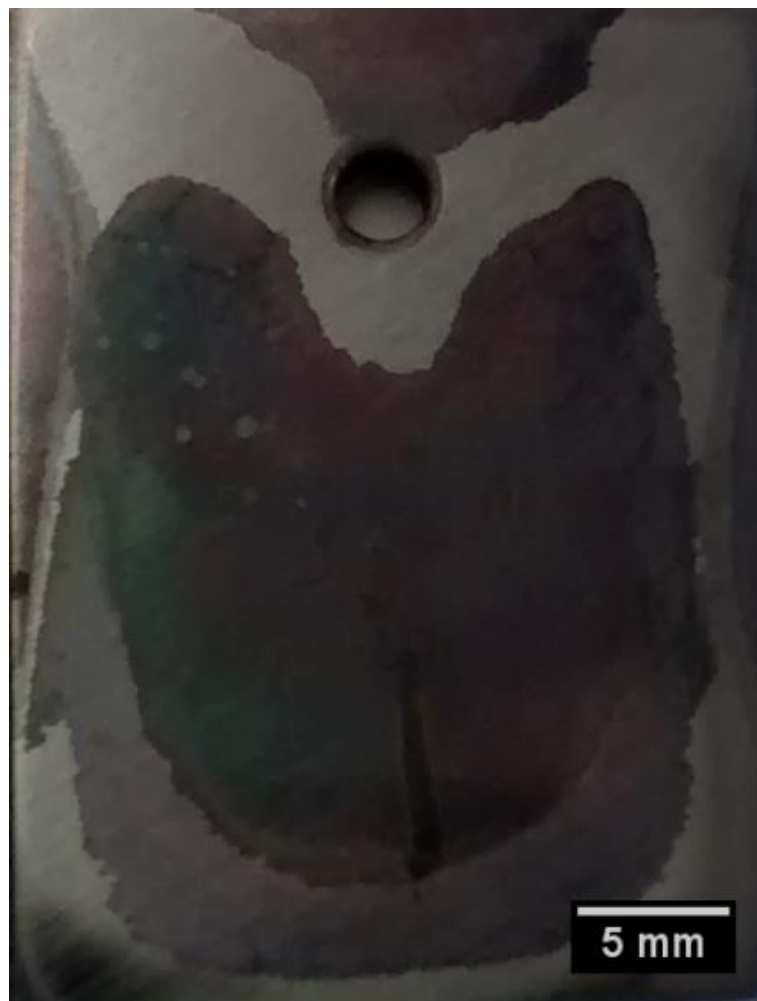
Figure 2.12 Partially spalled surface of Coating Type A after 2 year CAPCIS autoclave test for Rolls-Royce.

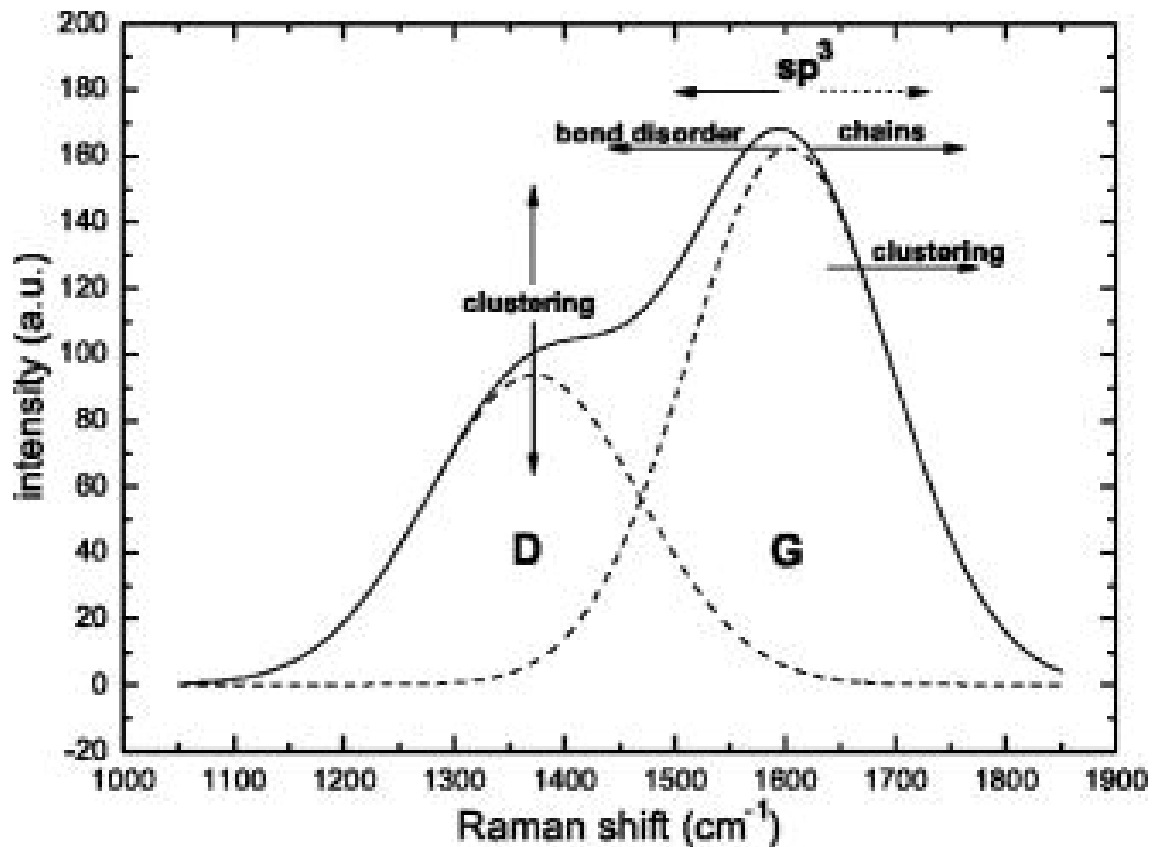
Figure 2.16 A schematic diagram of the D and G Raman peaks in a typical amorphous carbon film [105].

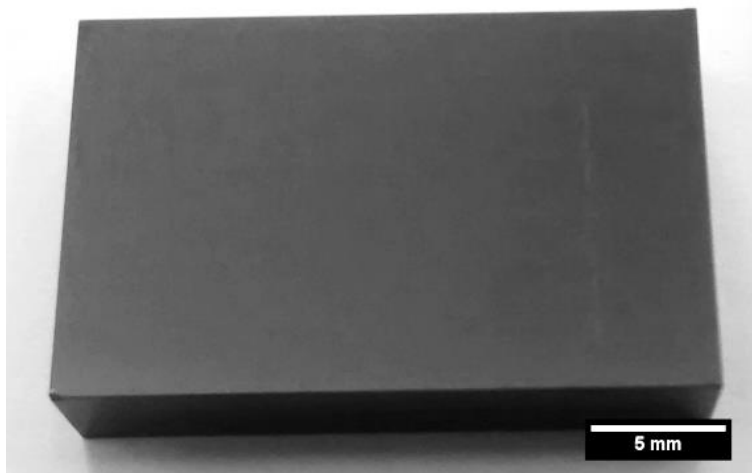
Figure 3.1 Coating Type A before the 24 hour Parr bomb experiment.

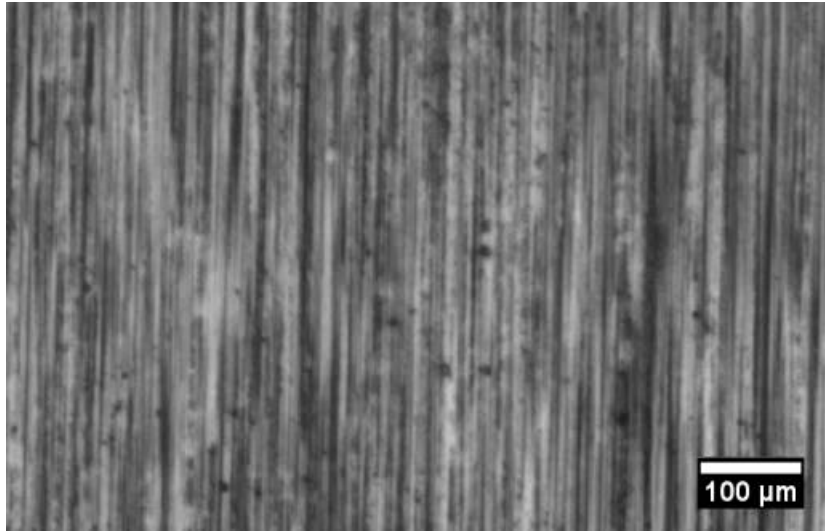
Figure 3.5 An optical micrograph of the surface of Coating Type A after the 7 day hour Parr bomb experiment.

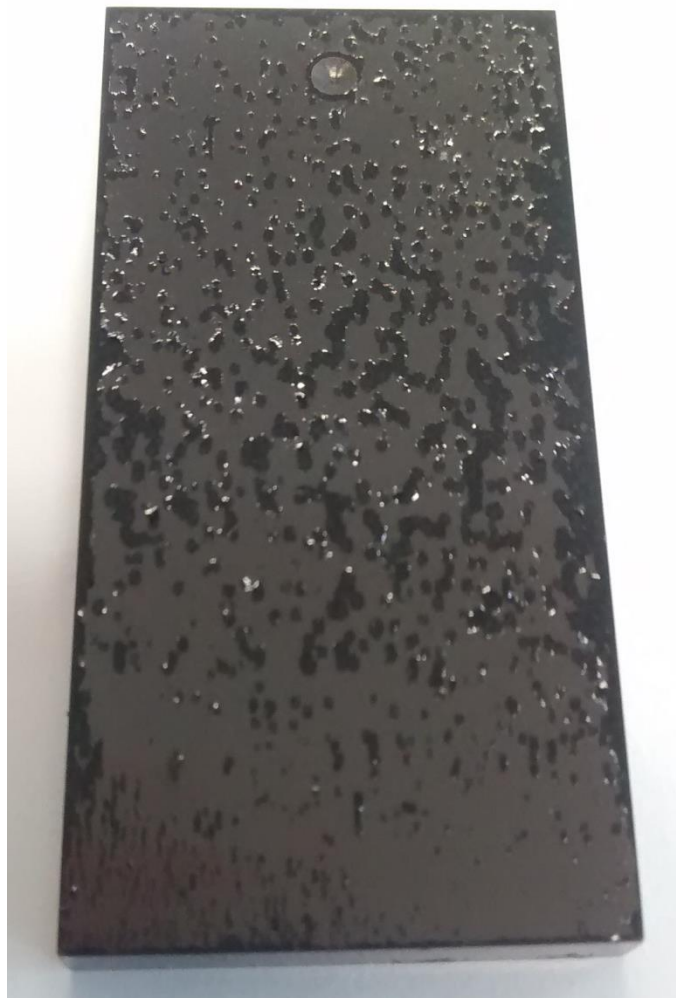
Figure 3.9 Partially spalled surface of Coating Type A after the 7 day autoclave test.
