The Interaction of Automatic Transmission Fluid Additives with Copper

Submitted in accordance with the requirements for the degree of
Doctor of Philosophy

THE UNIVERSITY OF LEEDS
School of Mechanical Engineering

September 2018

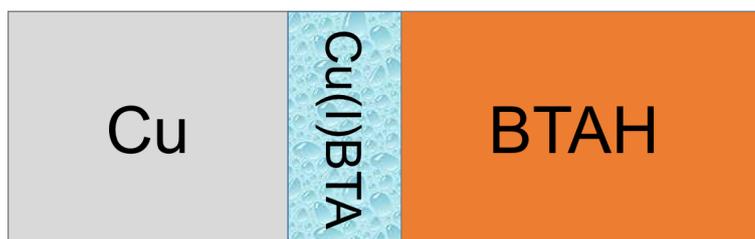
Figure 3.18: Schematic illustration of outer layer growth of BTAH film on inner layer of Cu(I)BTA complex [97]

Cu(I)BTA complex, a slower second period of growth was attributed to growth of BTAH on top of this complex until a plateau was reached, as indicated in Figure 3.18.

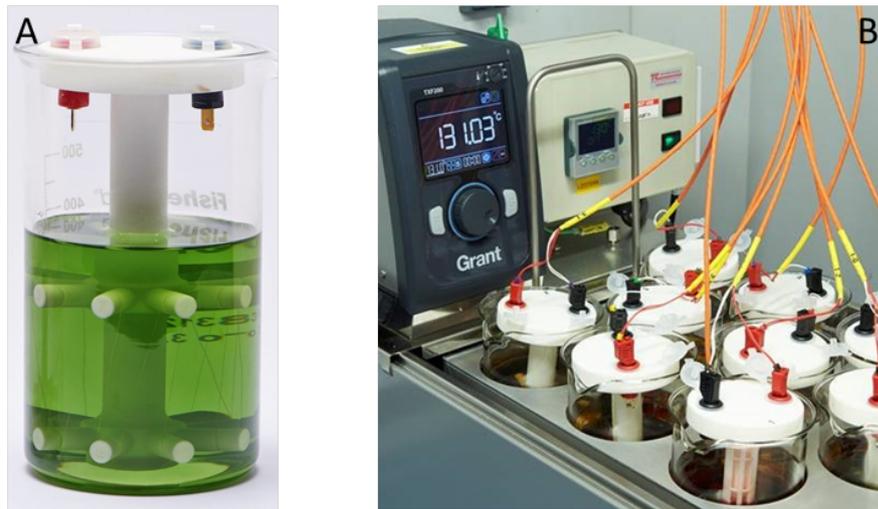
Figure 4.2: (A) Copper wire wrapped around former; (B) Beakers in bath connected to control system

them, the wire was passed back up through the hollow shaft and soldered to the other connector. This allowed approximately 1 metre of wire to be held securely. The wire was always threaded by myself to allow consistency and was never pulled tightly in order to minimise any tension. An image of a wired former in fluid can be seen in Figure 4.2a.

1 m of copper wire was wound around a nylon former, as described above in section 4.3.1. A wired former was placed into a clean beaker containing approximately 400 mL of the test fluid. An image of the prepared former can be seen in Figure 4.2a.

The beakers containing test fluid and a wired former were placed into a metal rack that held nine beakers, allowing them to be placed into the oil bath at the same time. After placing the beakers in the rack the connection points at the top of each former were attached to a control system which passed 1 mA of current through the wire and measured its resistance. The control system was capable of monitoring nine different wires at once; an image of the oil bath setup can be seen in Figure 4.2b.

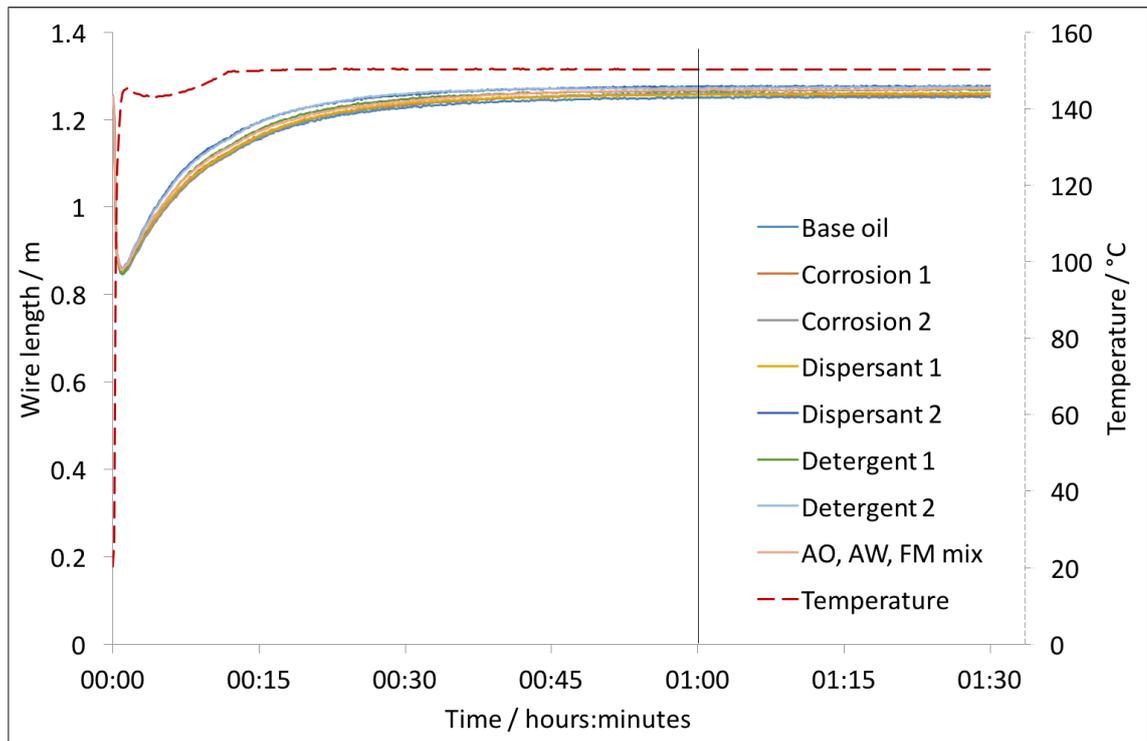
It can be seen that the temperature begins at 20°C and then rises rapidly to around 145°C , after which there was a slight dip followed by a gradual increase to 150°C ; the temperature at which the experiment was conducted.

Figure 4.3: Graph showing temperature of oil and length of wires immersed in different additives with time

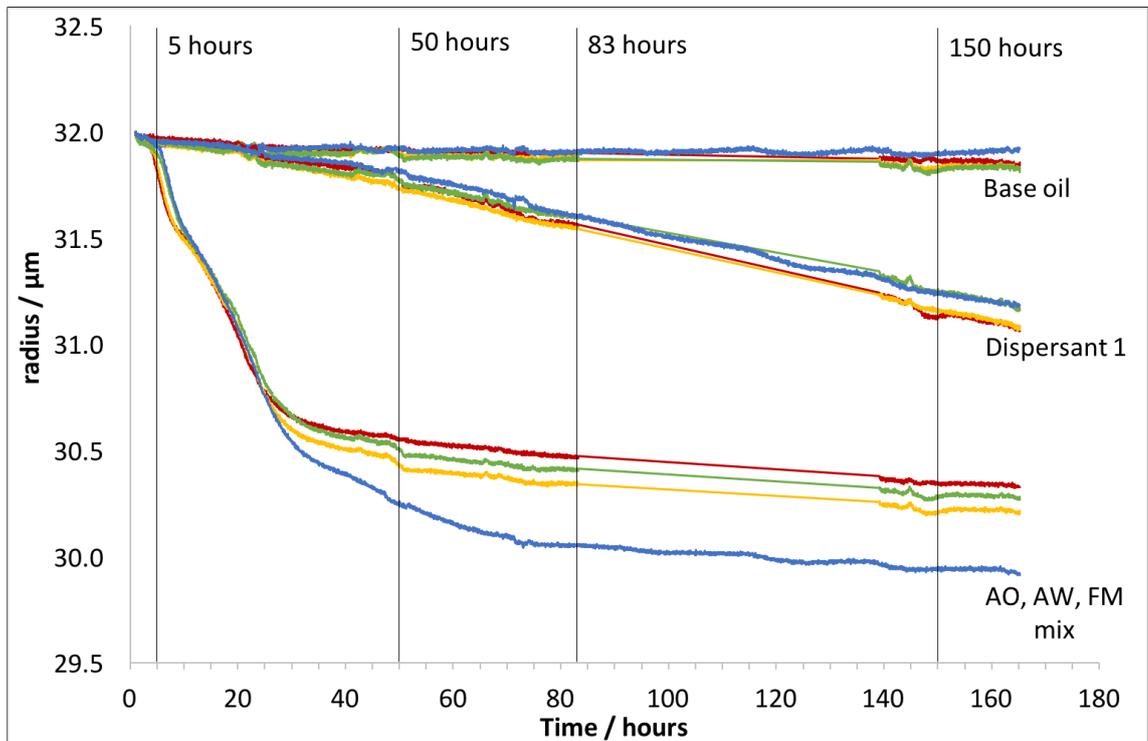
The greatest standard deviation value is 0.159 (AO, AW, FM mix; 50 hours) making the repeatability 0.446. This means that for any test carried out under these conditions there should be no change greater than 0.446 from the measured value. It is likely that the repeatability is better than this, as the average standard deviation for base oil is 0.02, therefore repeatability is 0.06. For dispersant 1 the average standard deviation is 0.03, so

Figure 4.7: Radius changes of wires immersed in base oil, dispersant 1, or the AO, AW, FM mix, with lines denoting where standard deviation was calculated

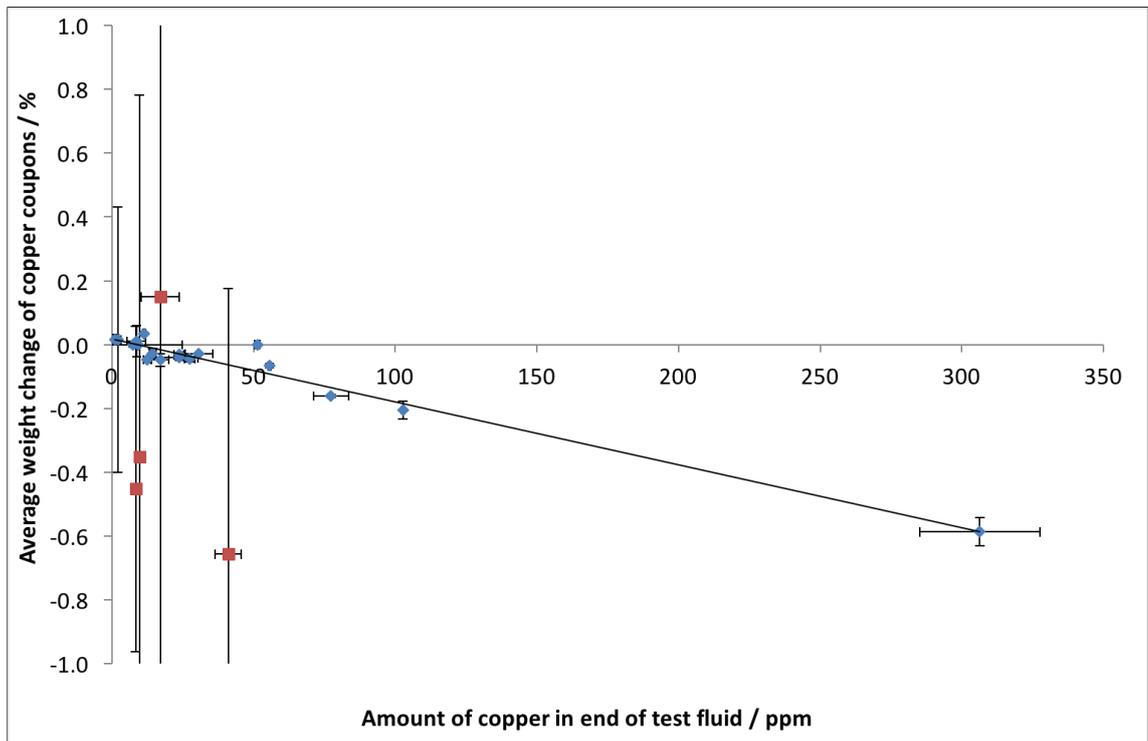
It would seem logical that the weight change of the copper coupons should relate to the amount of copper in the end of test fluid, with greater weight loss leading to more dissolved copper. This can be seen in Figure 5.4. It is possible to plot a trend line through the majority of the data with the exception of four data points, highlighted in red. On closer inspection, these four points showed very different values for the weight change of the copper squares for each of the three test runs, as indicated by the large error bars, and as such the weight change data for these samples could be considered anomalous.

Figure 5.4: Average weight change of copper coupon and amount of copper measured with ICP-AES in the end of test fluid

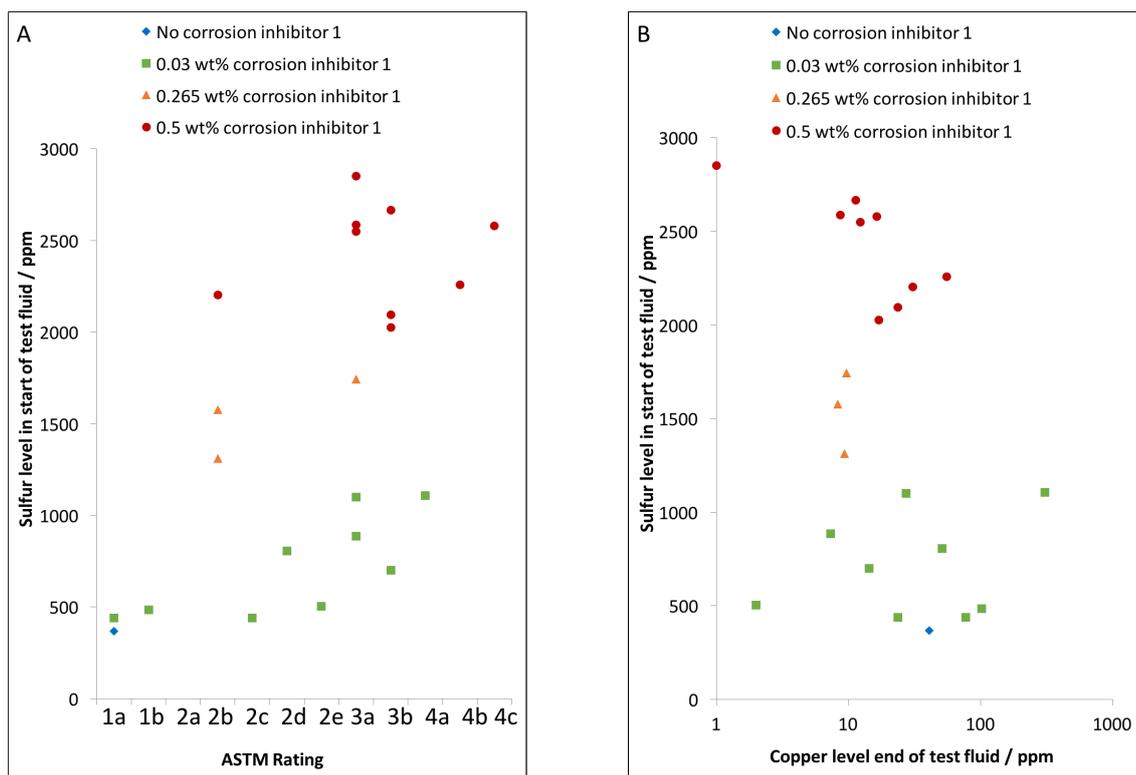
In order to test this theory the amount of sulfur in the start of test fluid was measured using ICP-AES for each formulation, this was then plotted on two separate graphs against the ASTM rating and the amount of copper in the end of test fluid. In order to tell if the different additives were showing any correlations the graphs were coloured by the concentration of additive present. Figures 5.5, 5.6 and 5.7 show the plots highlighting the sulfur contribution from corrosion inhibitor 1, dispersant 2 and dispersant 1 respectively.

Figure 5.5: Sulfur level in each formulation plotted against (A) ASTM rating of the copper square, and (B) the copper level in the end of test fluid, highlighting the level of corrosion inhibitor 1

No correlations were found for any of the additives; all that can be concluded is that the majority of the sulfur contribution comes from corrosion inhibitor 1, Figure 5.5.

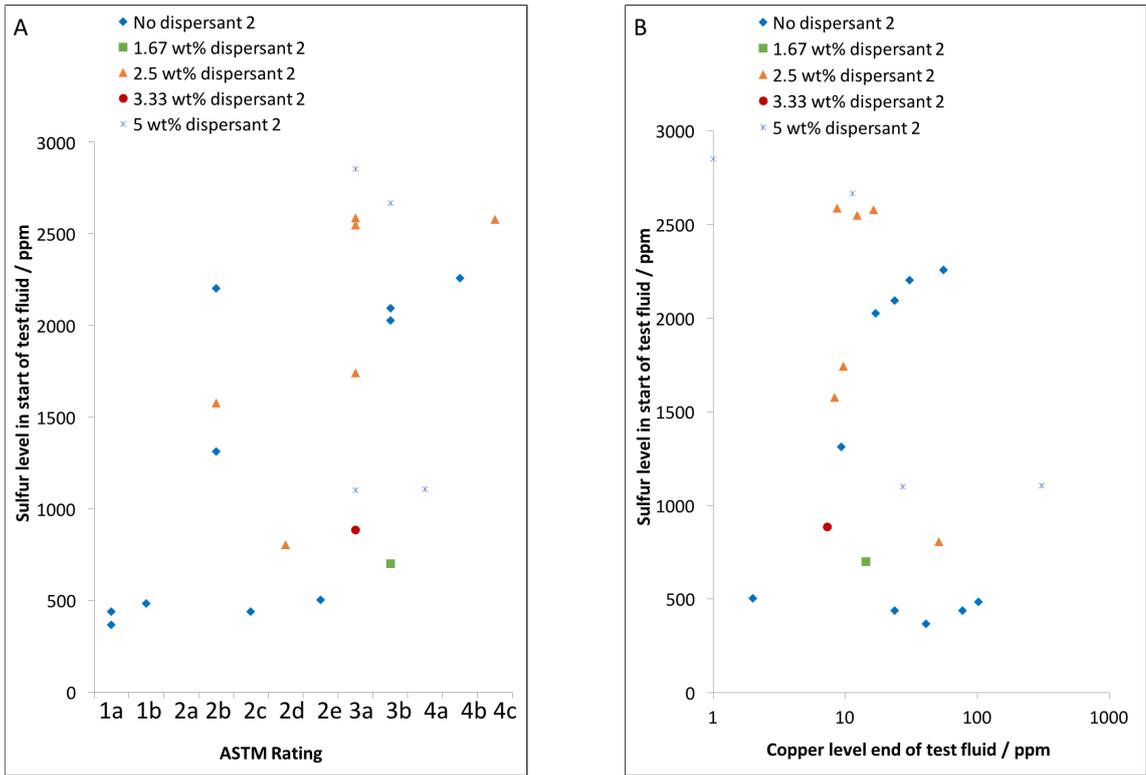
Figure 5.6: Sulfur level in each formulation plotted against (A) ASTM rating of the copper square, and (B) the copper level in the end of test fluid, highlighting the level of dispersant 2

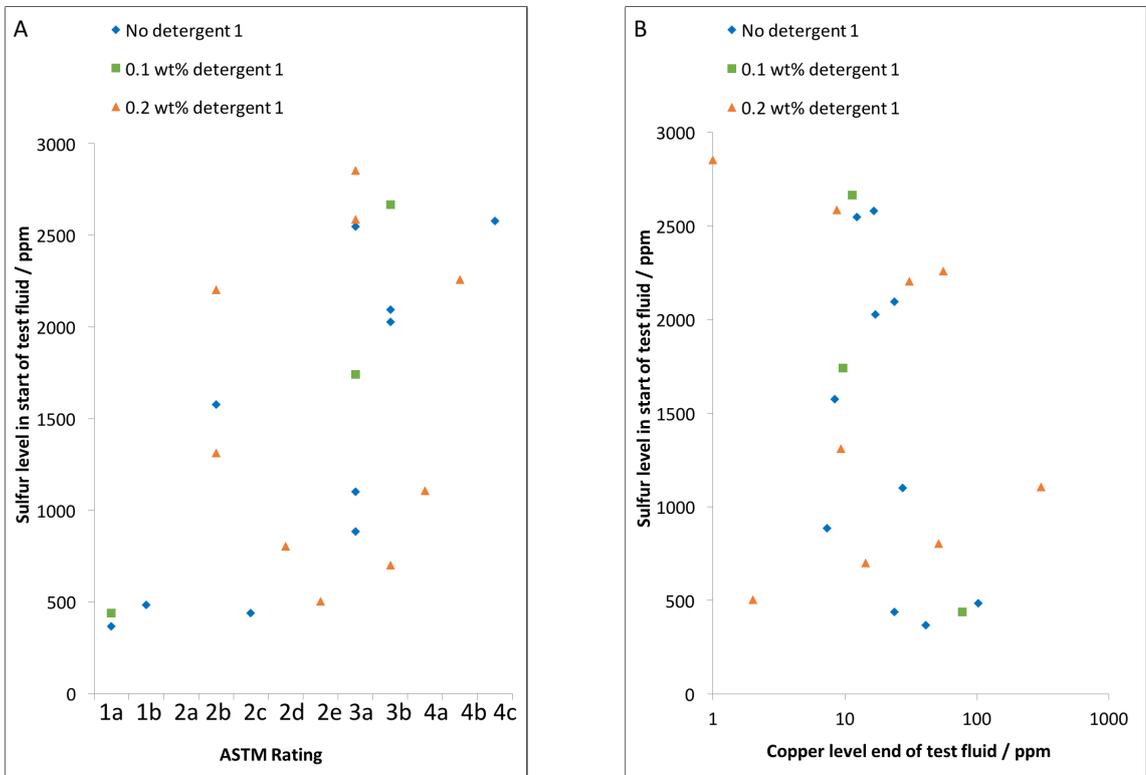
Figure 5.7: Sulfur level in each formulation plotted against (A) ASTM rating of the copper square, and (B) the copper level in the end of test fluid, highlighting the level of dispersant 1

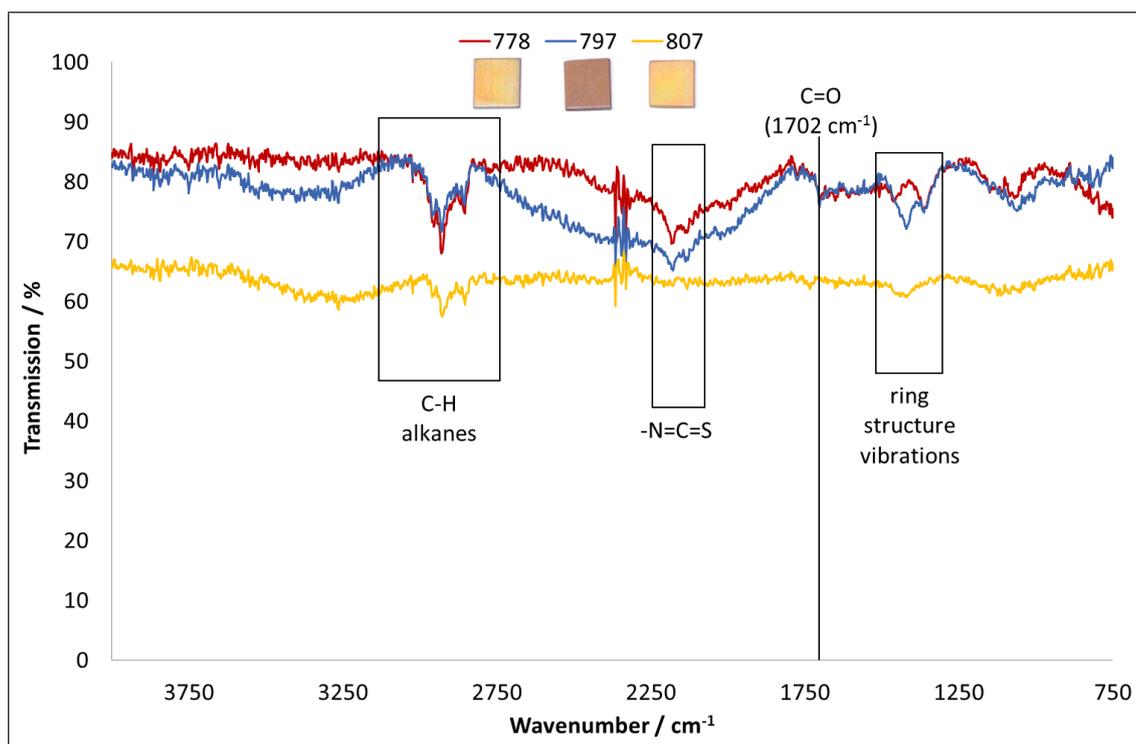
Figure 5.9: FTIR spectra and images for coupons -778, -797, and -807

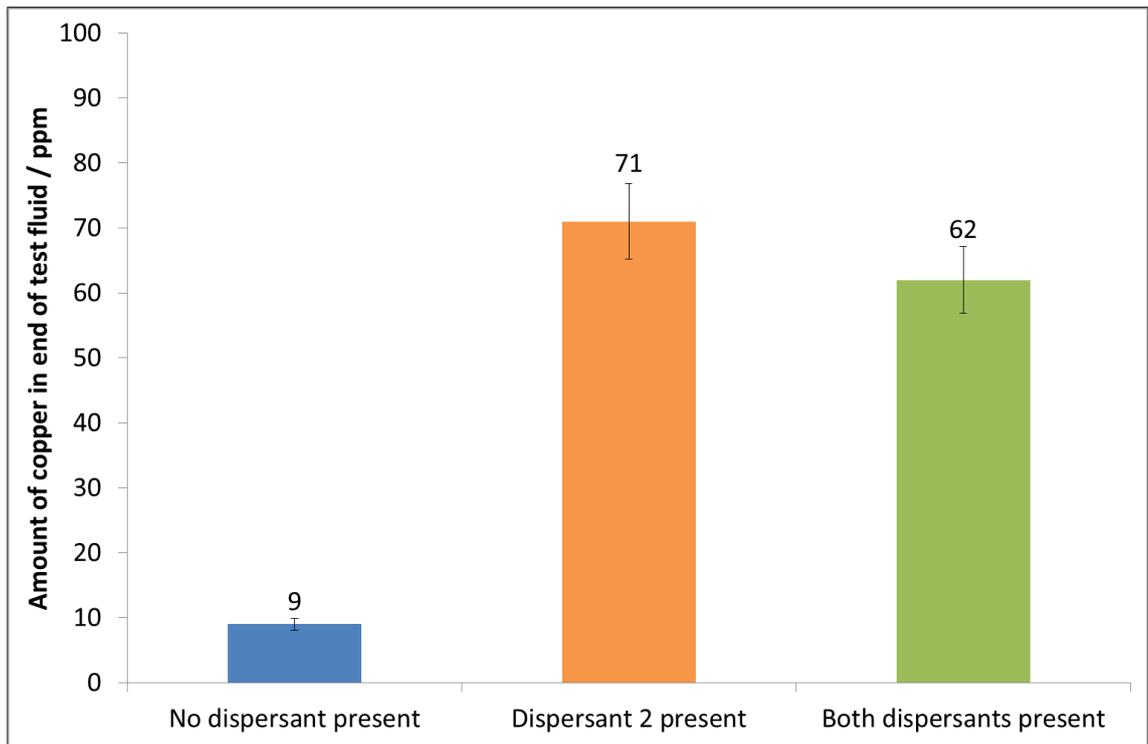
Figure 5.21: Amount of copper in the end of test fluid as determined by ICP-AES for dispersant variations based on the full formulation -794

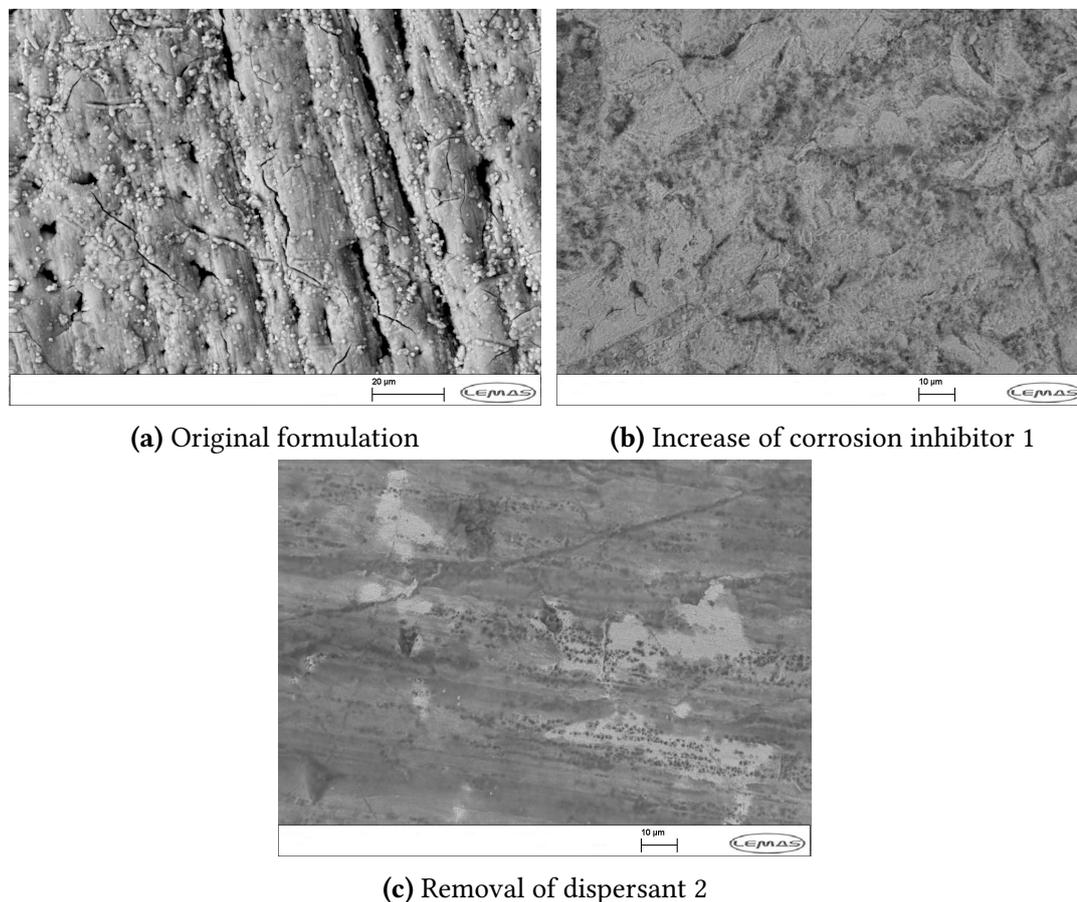
Figure 5.24: BSE images of the surfaces of samples immersed in variations of the full formulation -776

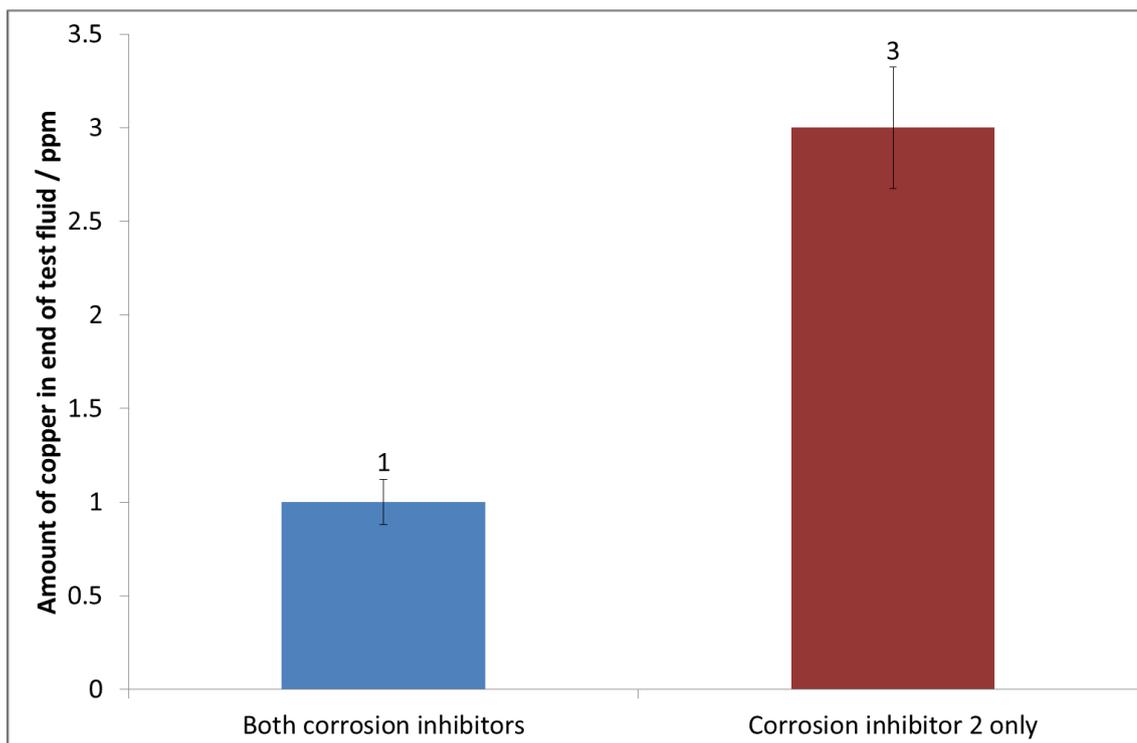
Figure 5.27: Amount of copper in end of test fluid for formulation -810, and corrosion inhibitor variation

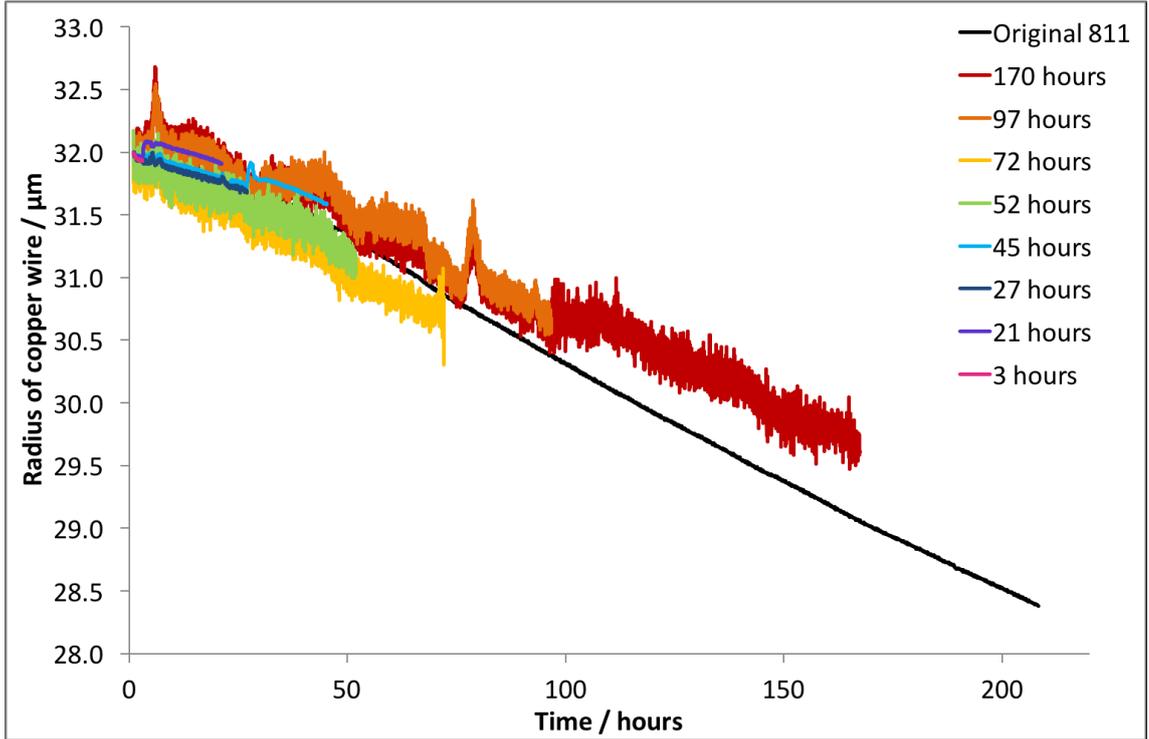
Figure 6.3: Change of radius of a copper wire at 130 °C immersed in 811, stopped at various time points

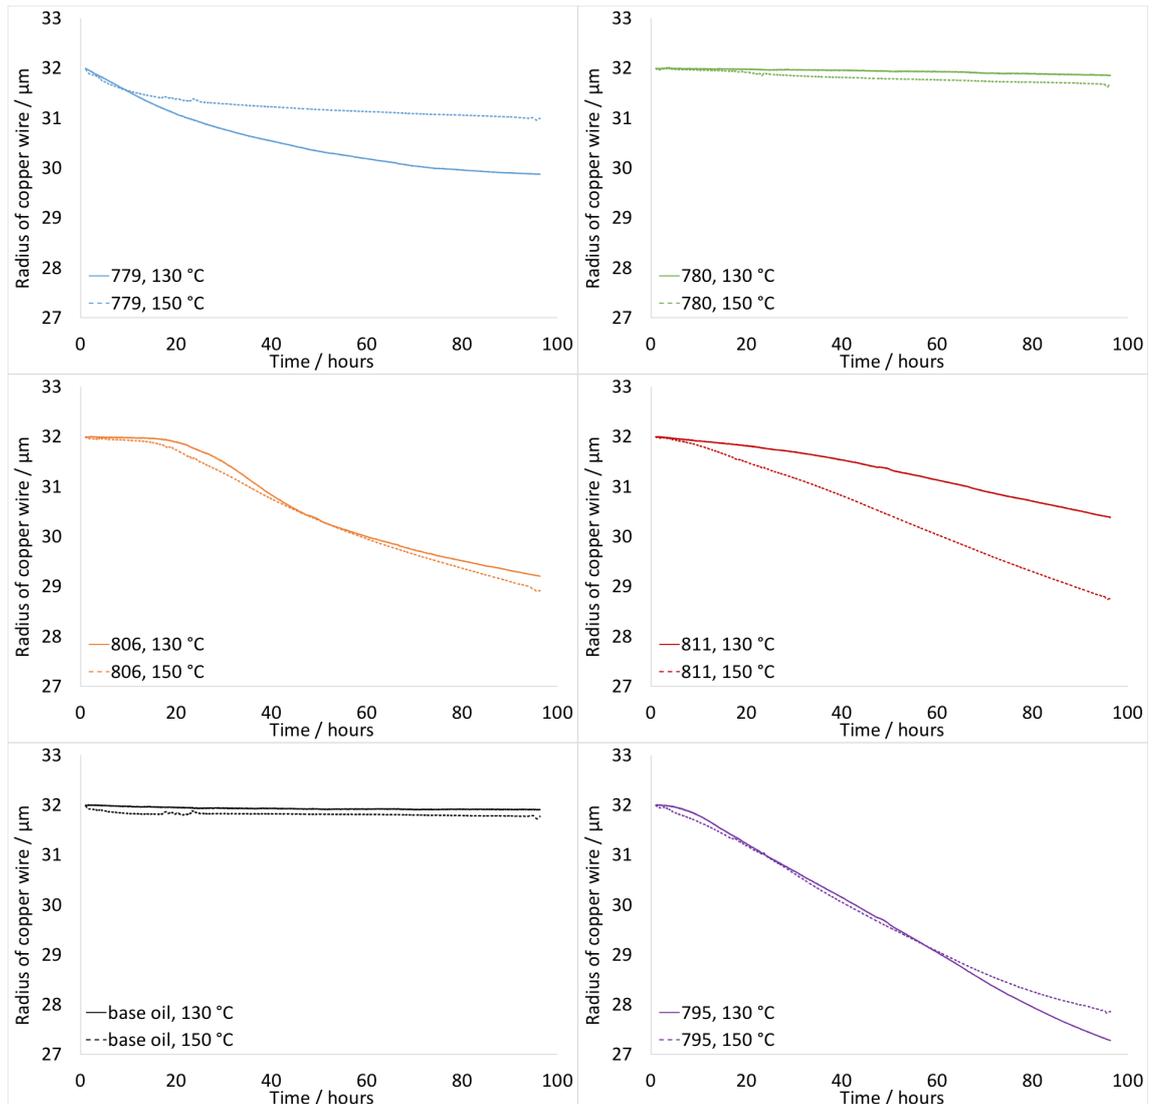
Figure 6.9: Differences in the change in radius for formulations run at different temperatures

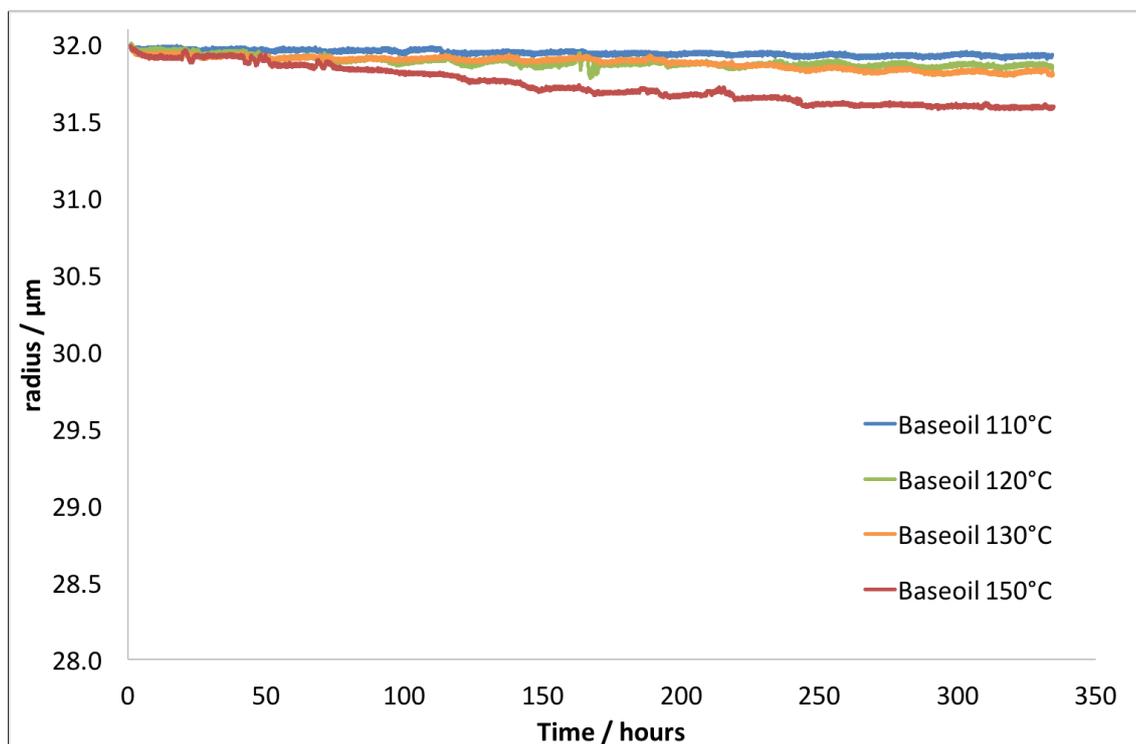
Figure 7.3: Change in radius of copper wires immersed in base oil at 110 °C, 120 °C, 130 °C and 150 °C

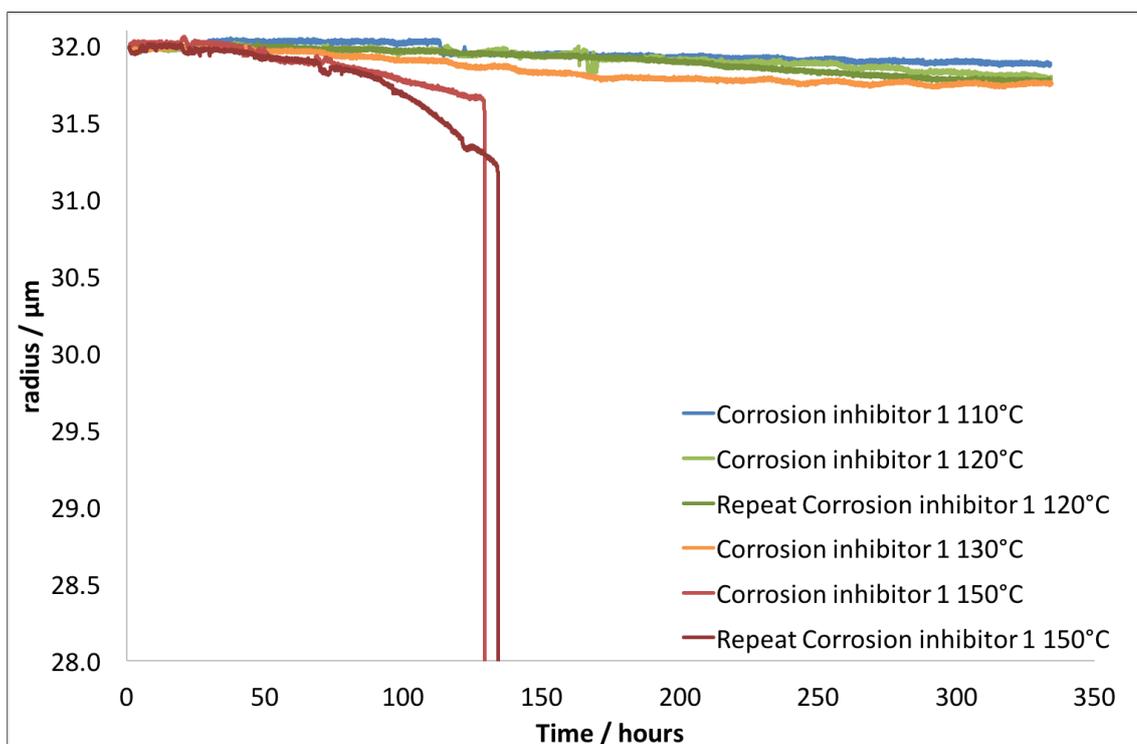
Figure 7.8: Radius change of copper wires immersed in 0.5 wt% corrosion inhibitor 1 at 110 °C, 120 °C, 130 °C and 150 °C, including repeats at 120 °C and 150 °C

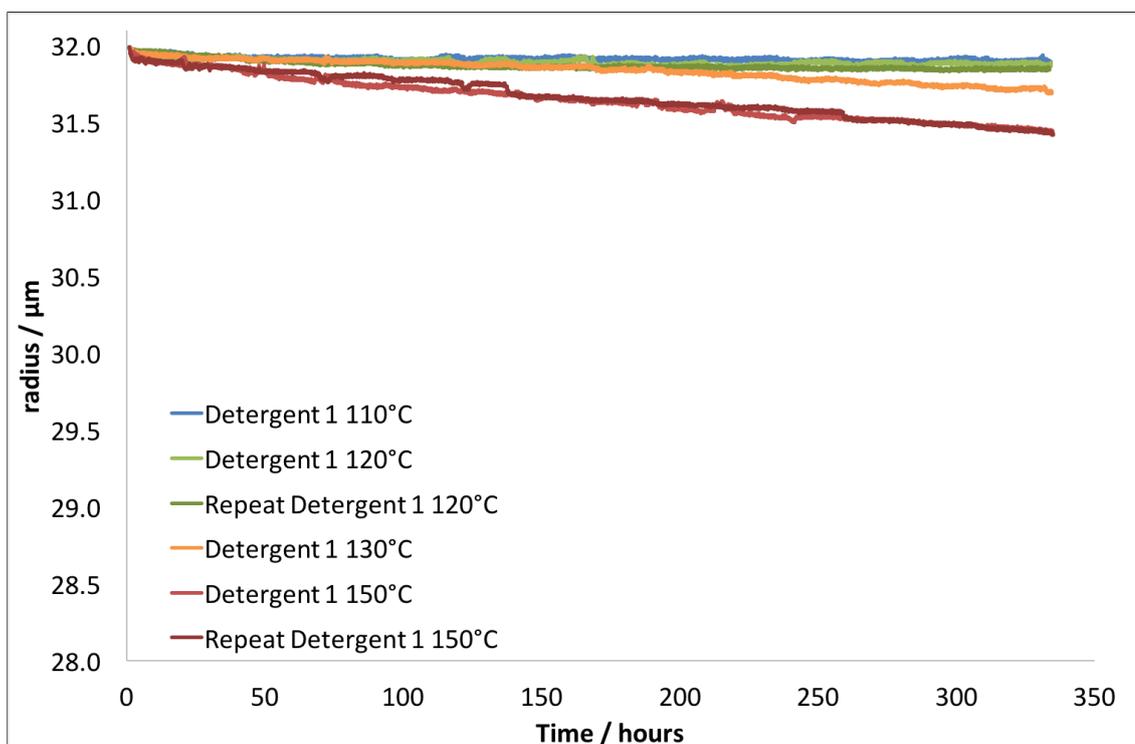
Figure 7.28: Radius change of copper wires immersed in 0.5 wt% detergent 1 at 110 °C, 120 °C, 130 °C and 150 °C, including repeats at 120 °C and 150 °C

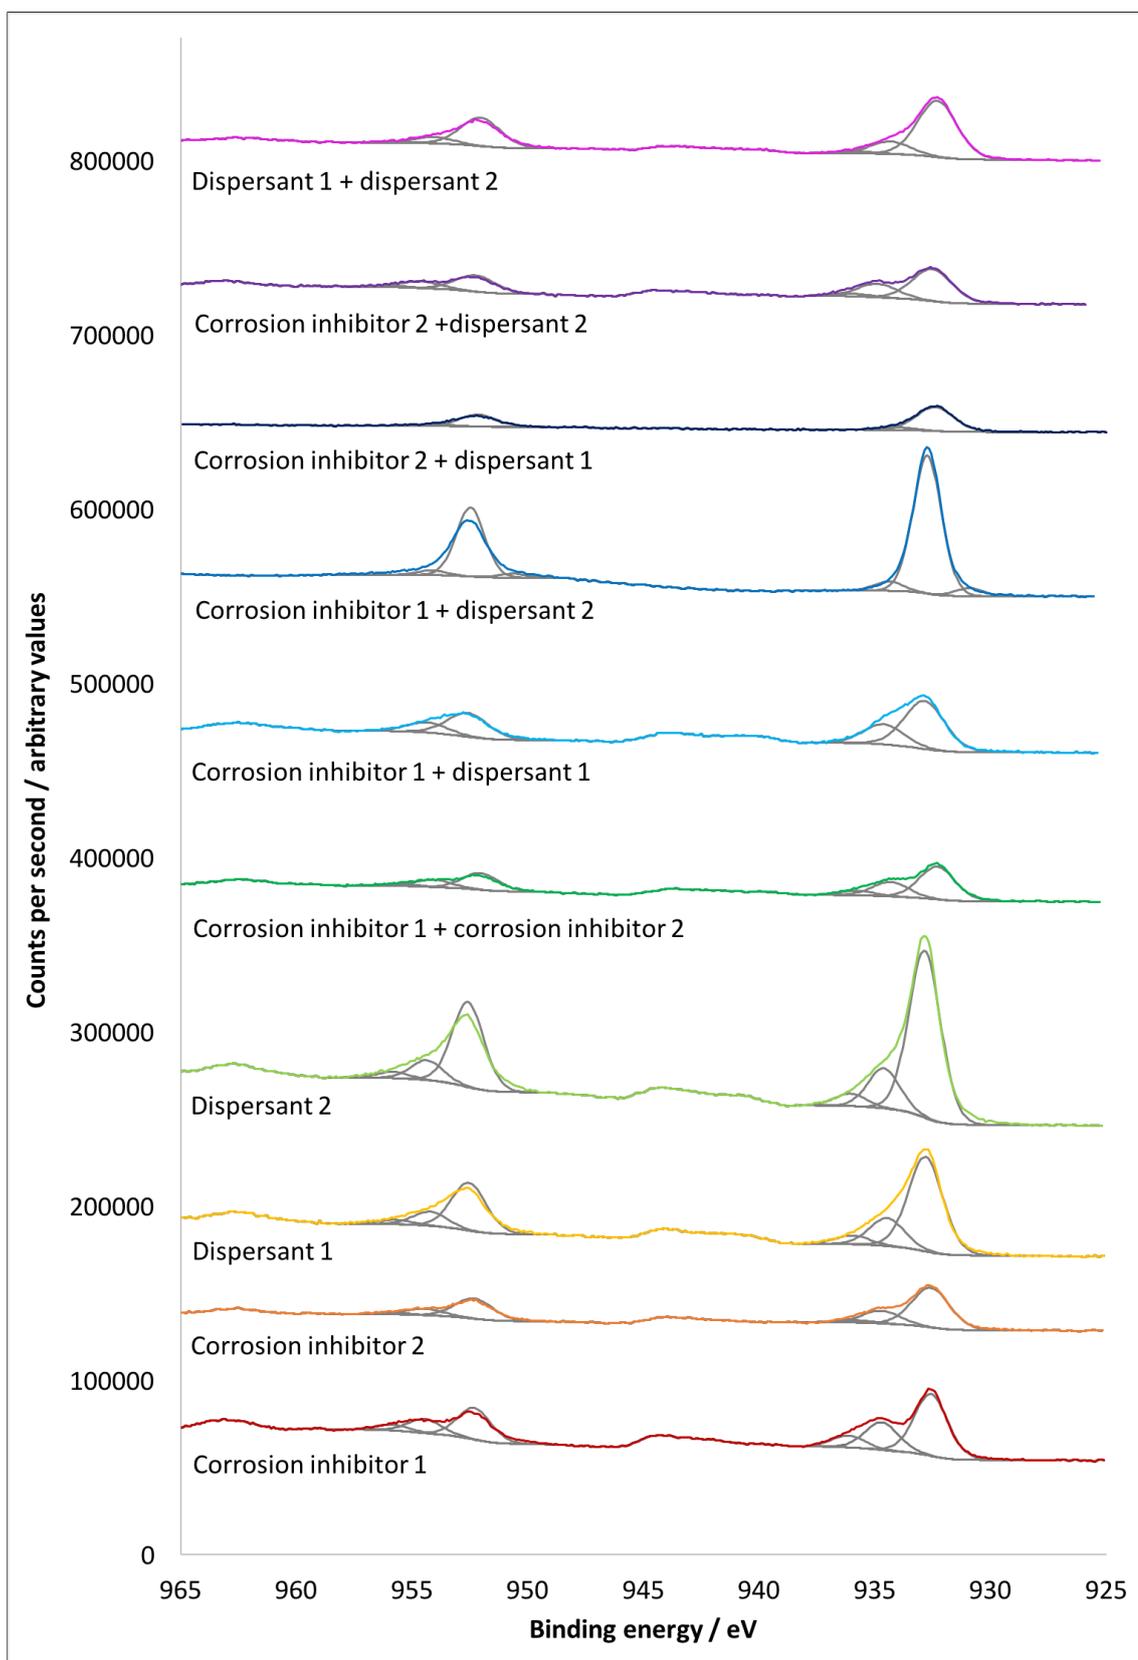
Figure 8.5: High resolution XPS copper scans for samples run at 120 °C containing corrosion inhibitor 1, corrosion inhibitor 2, dispersant 1, and dispersant 2

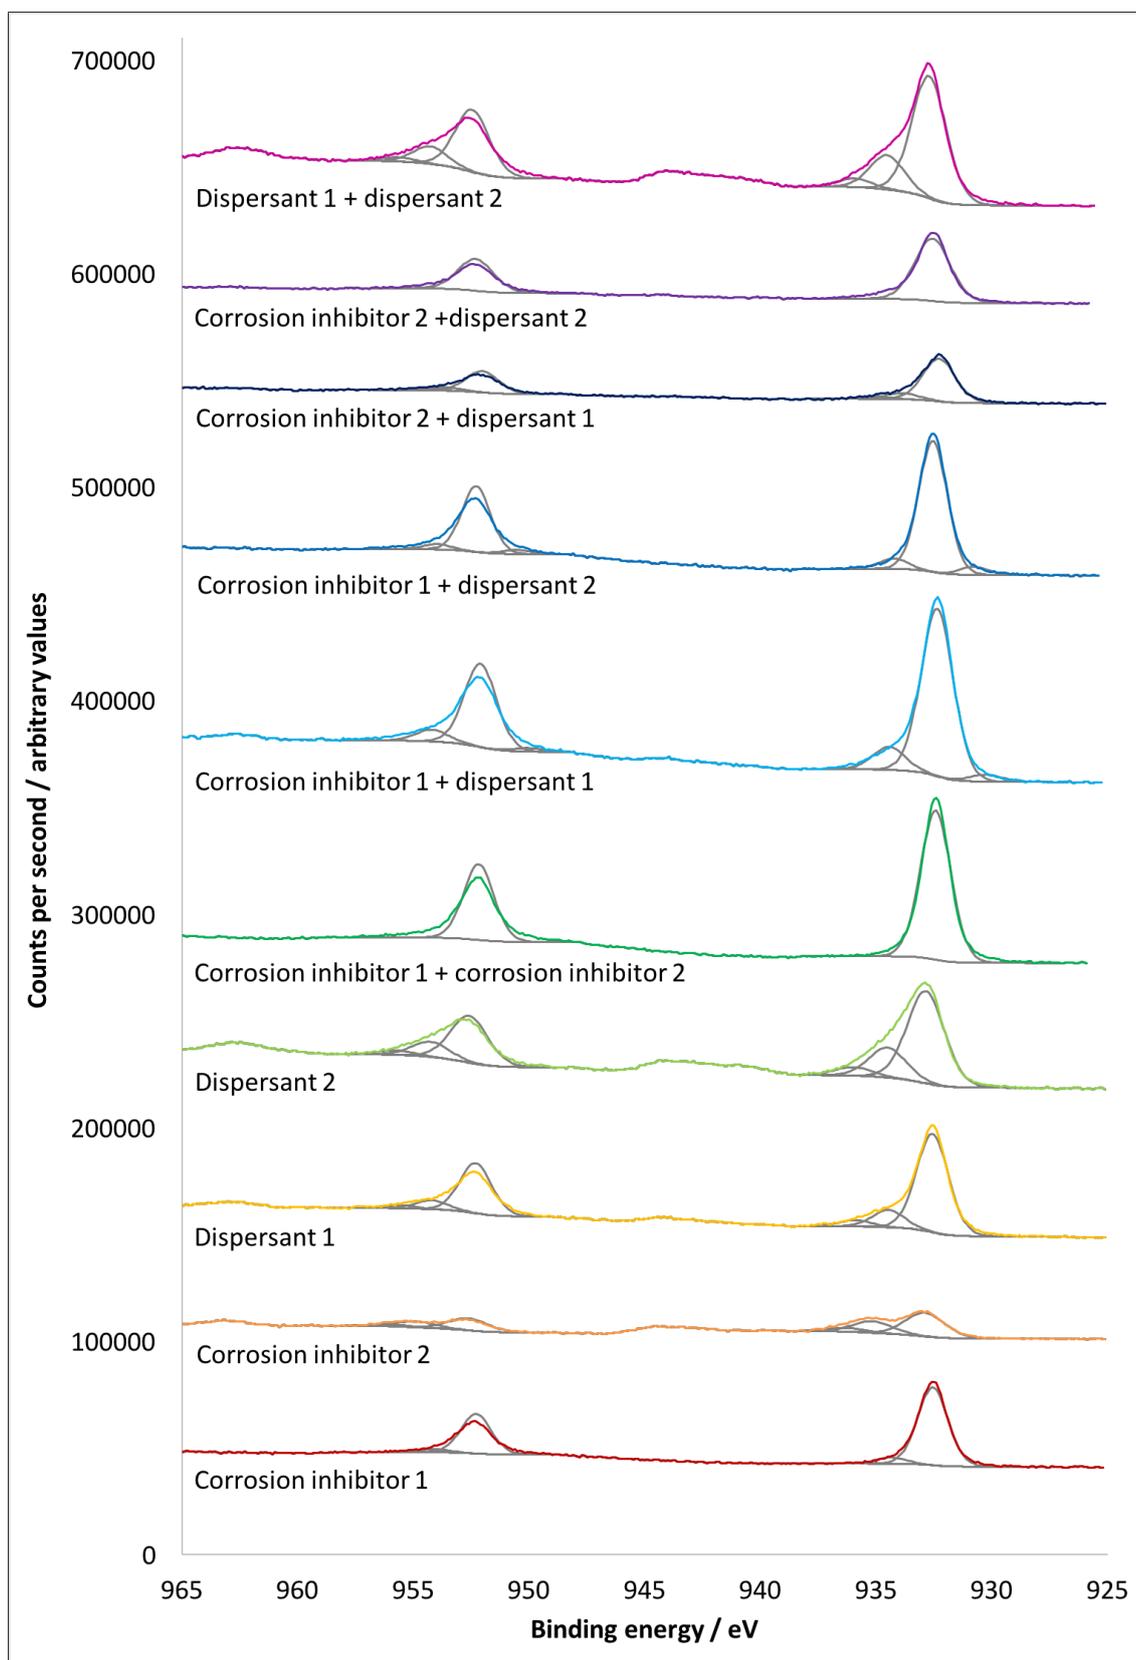
Figure 8.9: High resolution XPS copper scans for samples run at 150 °C containing corrosion inhibitor 1, corrosion inhibitor 2, dispersant 1, and dispersant 2

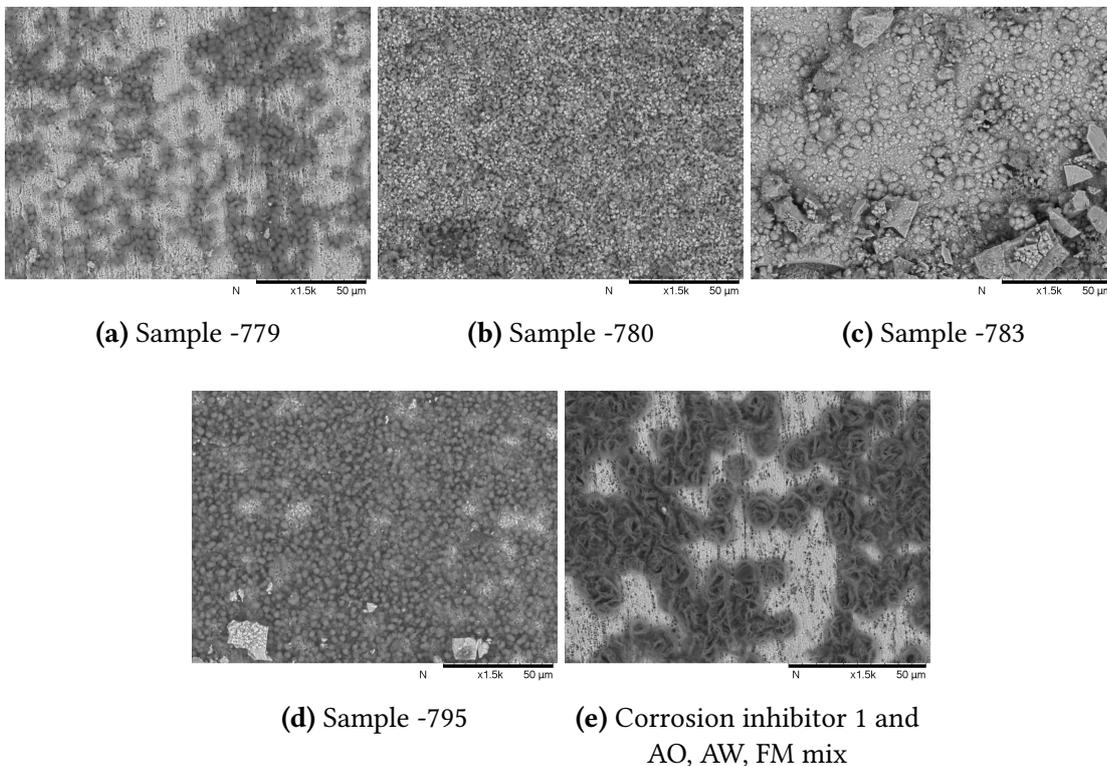
Figure 10.1: SEM images of full formulation samples showing spheres on the surface along with the corrosion inhibitor 1 and AO, AW, FM mix sample surface

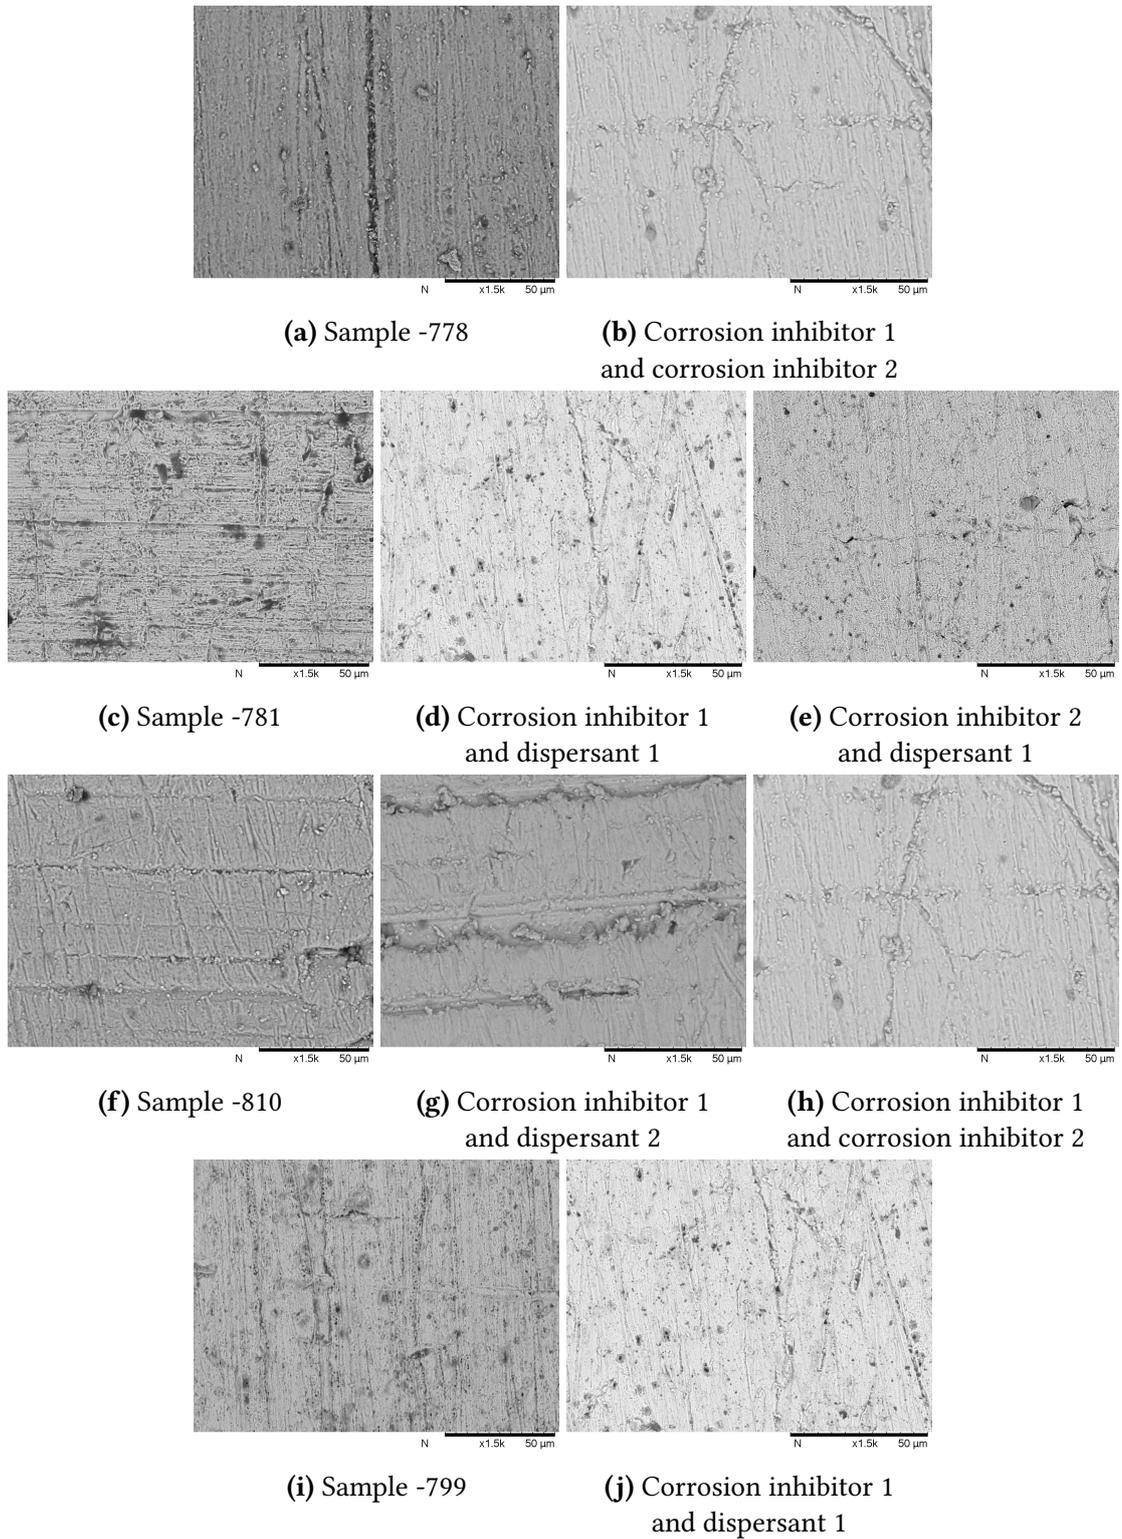
Figure 10.2: SEM images of the surfaces of full formulation samples and simple additive combination samples which contained corrosion inhibitor 1 at 0.5 wt%

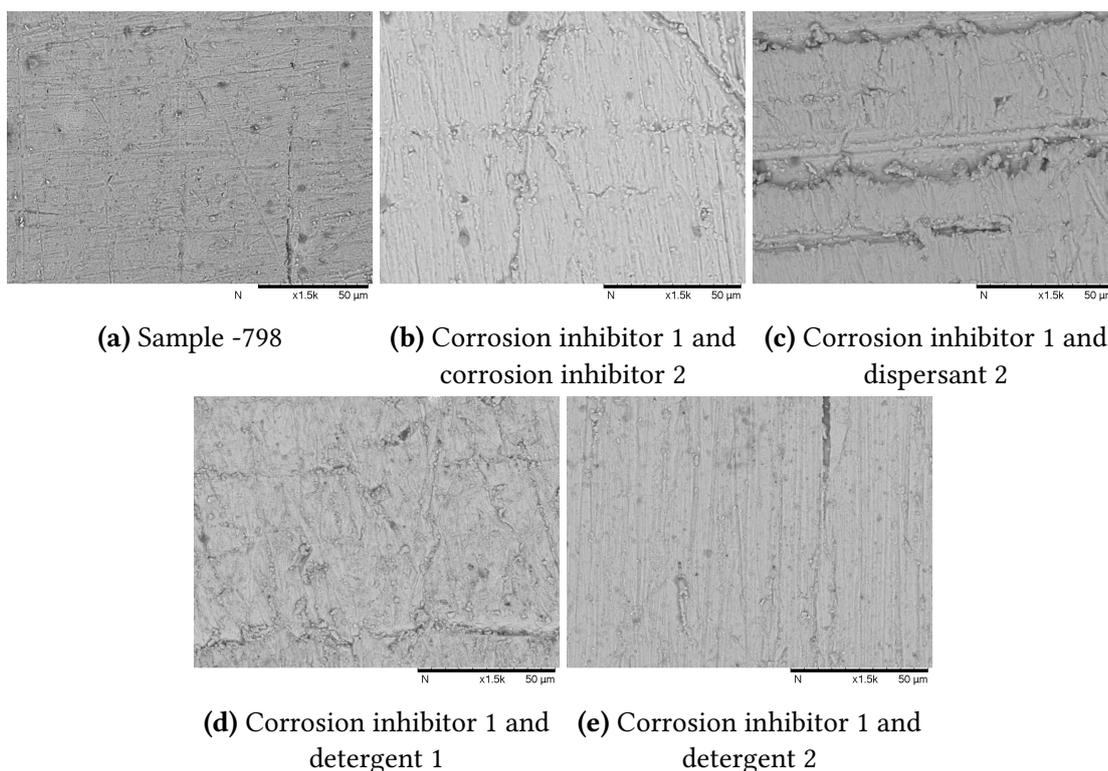
Figure 10.5: SEM images of sample -798 and all the simple additive mixtures it was matched with
