The Interaction of Automatic Transmission Fluid Additives with Copper

Submitted in accordance with the requirements for the degree of
Doctor of Philosophy

THE UNIVERSITY OF LEEDS
School of Mechanical Engineering

September 2018

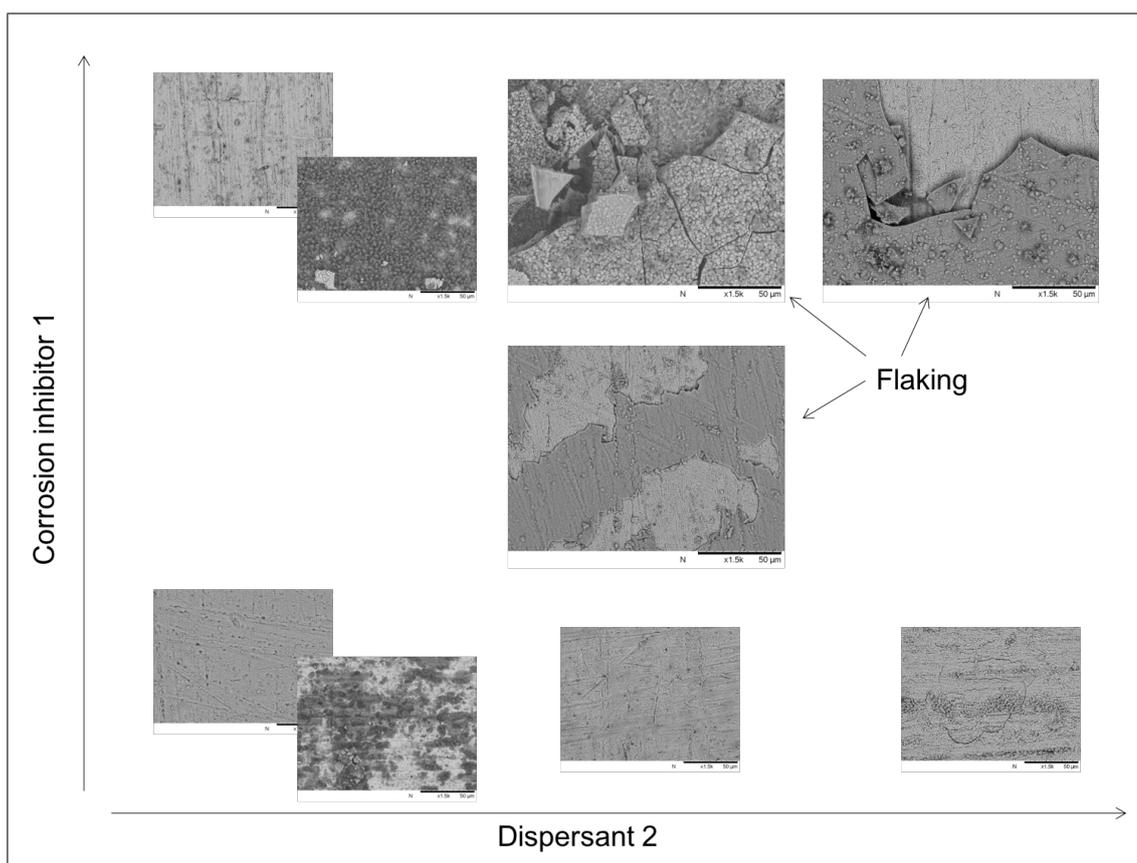
Figure 11.3: Schematic of samples containing no corrosion inhibitor 2 and their corresponding levels of corrosion inhibitor 1 and dispersant 2 showing that higher levels of corrosion inhibitor 1 and dispersant 2 lead to flaking of the surface film on the sample

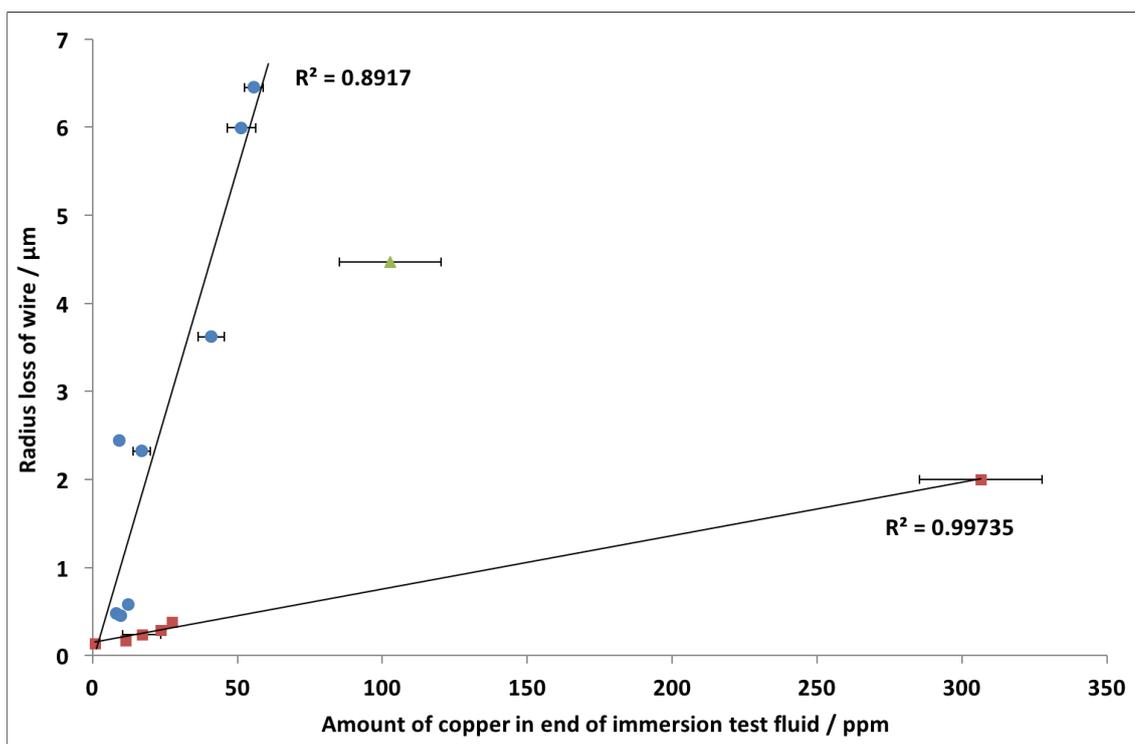
Figure 11.5: Radius loss of copper wire plotted against the amount of copper measured at the end of the coupon immersion test for full formulation fluids

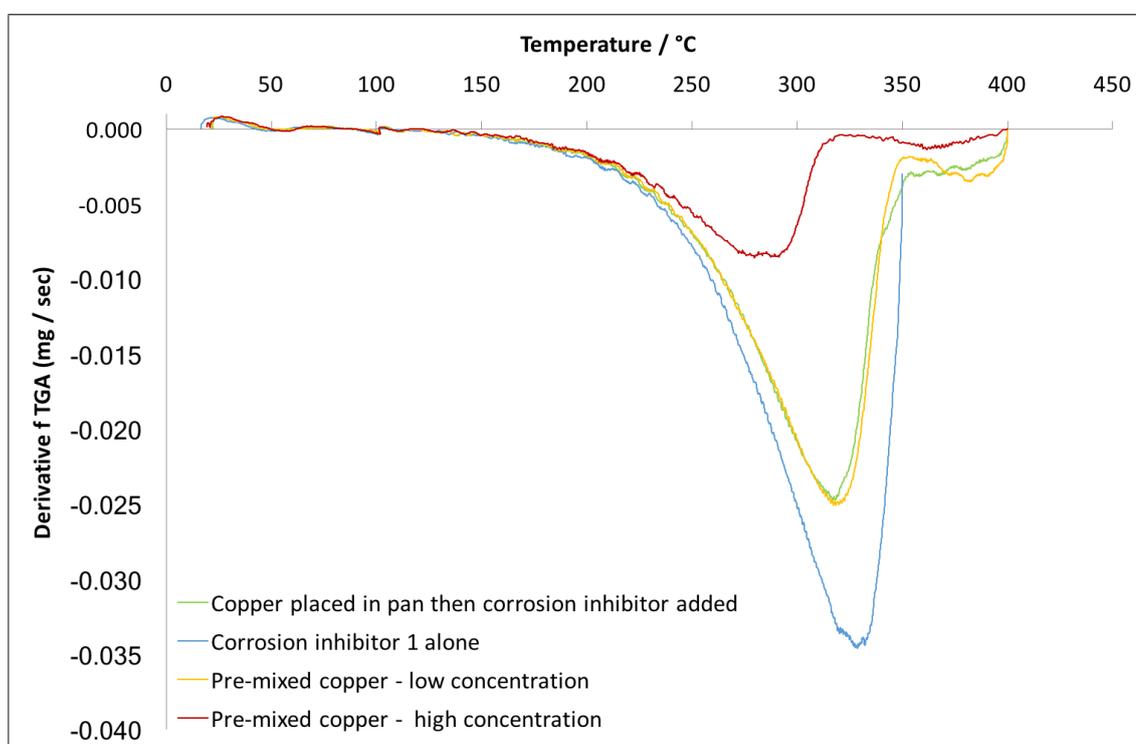
Figure 11.23: First derivative of TGA against temperature for corrosion inhibitor 1 with and without the presence of copper

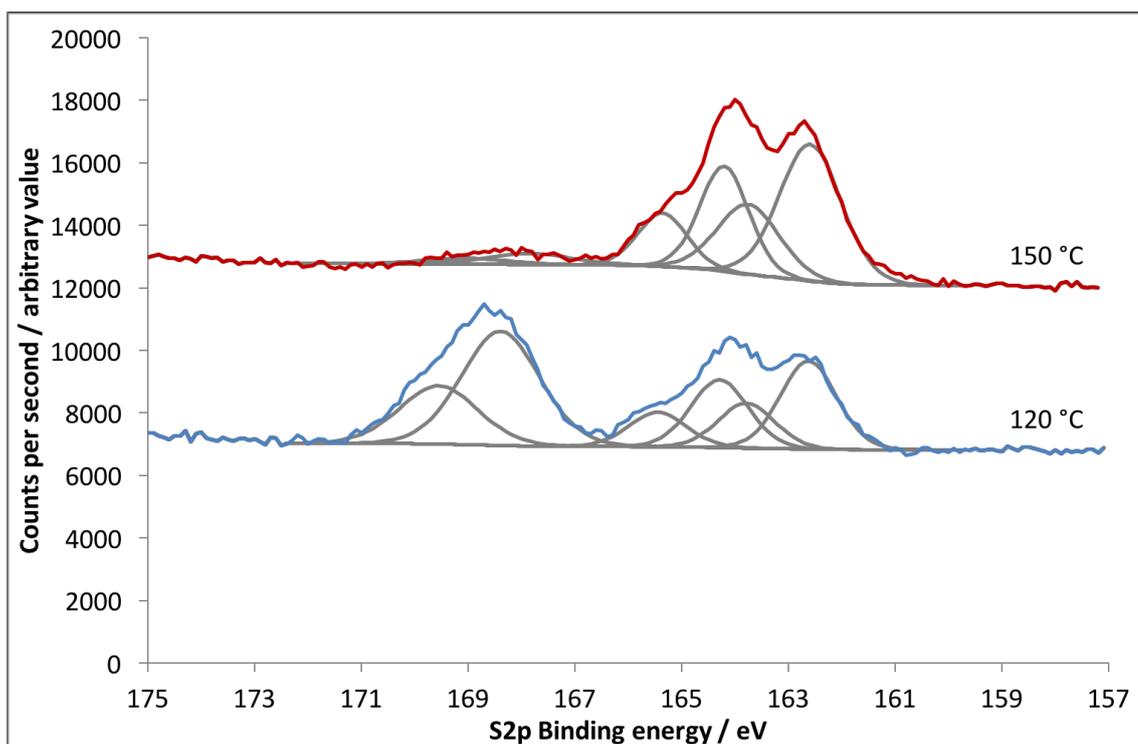
Figure 11.24: Corrosion inhibitor 1 sulfur XPS spectra at 120 °C and 150 °C

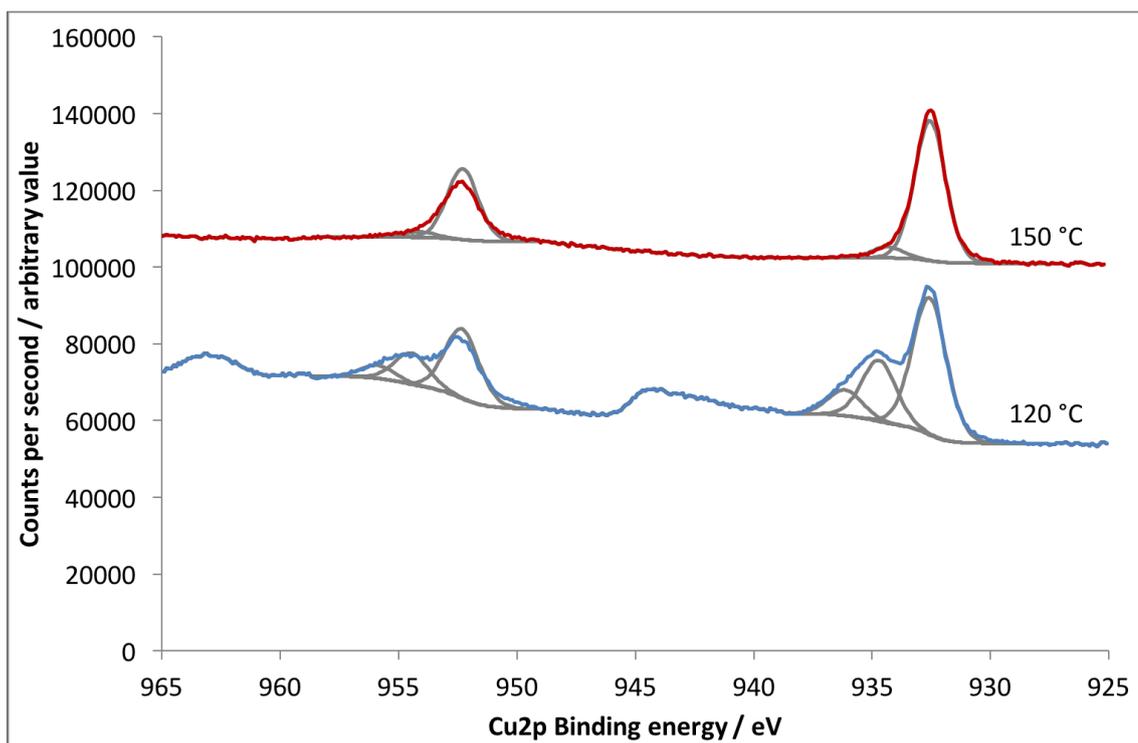
Figure 11.25: Corrosion inhibitor 1 copper XPS spectra at 120 °C and 150 °C
