Fracture of Automotive High Strength Steels

A thesis submitted in partial fulfilment of the requirements for the degree
of
Doctor of Philosophy

The University of Sheffield
Faculty of Engineering
Department of Mechanical Engineering

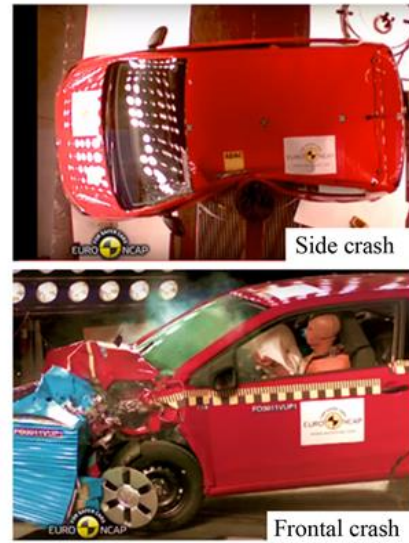
Figure 1-1 (Left) An example of a city car which utilises the various grades of AHSS aiming at lighter and safer cars (Euro NCAP, 2011). (Top right) Crash test showing a collision impact from the side affecting the passenger compartment and (bottom right) is an example of impact collision to test the car frontal crumple zone (Wagner et al., 2016).

Figure 1-1 shows an example of a commercial car that utilizes combination of the steels from the AHSS group which is aimed towards weight reduction whilst maintaining passengers' safety. Development of future cars incorporates the utilisation of the AHSS depending on the steel grades. Stronger steels with high yield strength are used for the body panels of passenger compartments to prevent deformation or intrusion during crash impact. While in the car crumple zone, steels with high work hardening, good ductility and good strength are used for a better crashworthiness due to high energy absorption over a distance during collision (Keeler and Kimchi, 2015).

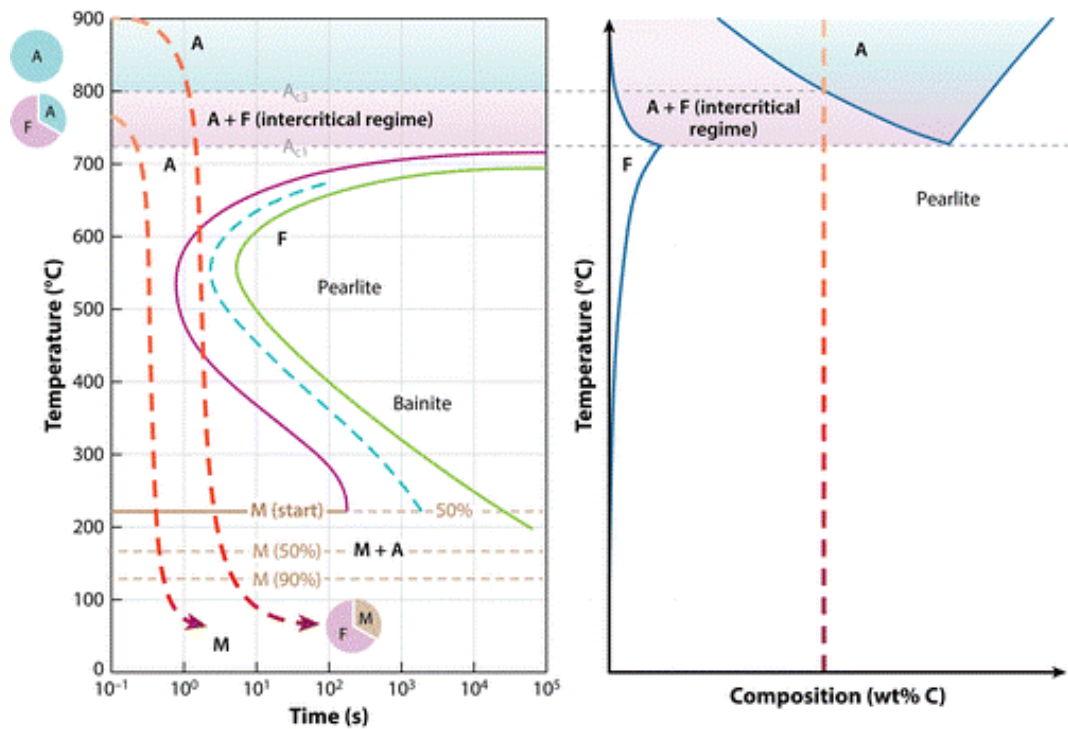
Figure 2-2 The schematic diagram show the heat treatments procedure to obtain the dual-phase microstructure. On the left shows the TTT (time-temperature-transformation) diagram and on the right is the iron-carbon equilibrium diagram. (Abbreviation used are A: austenite phase, F: ferrite phase and M: martensite phase). (Tasan et al., 2015)

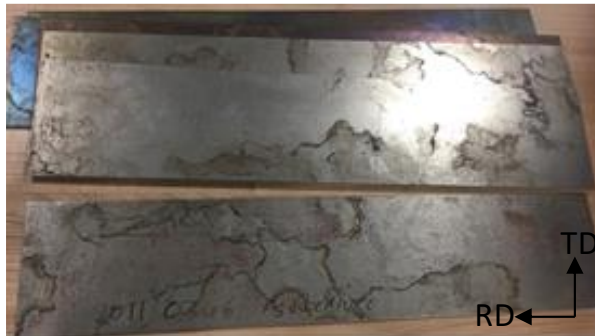
Figure 3-1 DP1000 sheet steels which are being used as research material in this study. Samples for every tempering conditions samples are received in sets of four with an approximate size of 120mm x 550mm x 1.6mm (width x length x thickness).

For each condition, four pieces of DP1000 sheet steel samples are supplied with their width and length measuring 120mm by 550mm, respectively. Figure 3-1 shows several DP1000 steels sheet where they are cut shorter (width) in the transverse direction and the longer (length) side is following the rolling direction during the material's

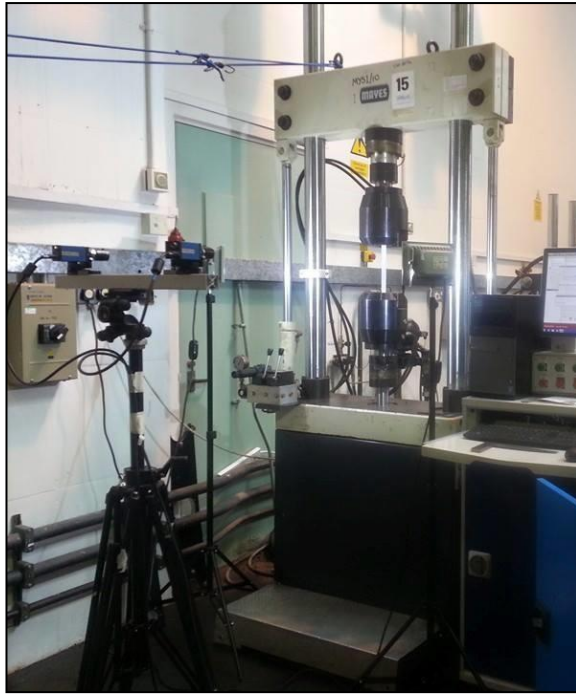
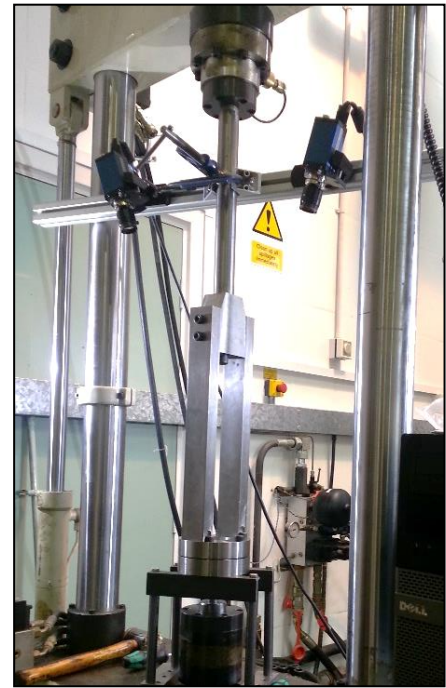
Figure 3-7 3D DIC set up for standard tensile test (left) and 3D DIC set up for a forming/punch test (right).

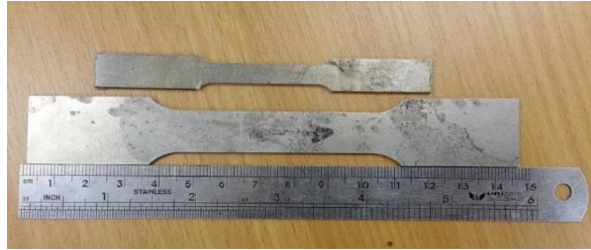
Figure 3-8 Example of two tensile specimen geometries after being cut using the EDM. At the bottom is the 12.5mm width standard specimen and the top (smaller) one is the 6mm wide subsize specimen.

As explained earlier in the material section, the receive DP material has a 1.6 mm thickness. The most suitable way to test this DP sheet-type steels is by referring the ASTM Standard E8/E8M Standard Test Methods for Tension Testing of Metallic Materials (ASTM Standard, 2011). Crucial information on the material properties such as the Ultimate Tensile Strength (UTS), strain corresponding at UTS (ϵ_{UTS}), strain at fracture (ϵ_f), Young's Modulus (E) can be obtained from performing this standard method. Preferably, it is chosen the 12.5mm nominal width tensile specimen geometry for all tests conducted to standardize this investigation. However, the total length required for a 12.5mm width standard geometry can only be tested in rolling directions due to the as-received sheet steels samples size limitation. 12.5mm width specimen geometry has an overall length which exceeded the as-received sheet steels width of 120mm. To overcome this problem, a smaller 6mm width subsize specimen geometry is chosen for testing the DP1000 materials in all three directions (RD, TD, 45°) and this is done for the as-quenched type only. An example of a 6mm subsize specimen and 12.5mm standard is shown in Figure 3-8 and their geometries are presented in Figure 3-9. The 12.5mm width standard geometry will be used on all material types, but only in the rolling directions.

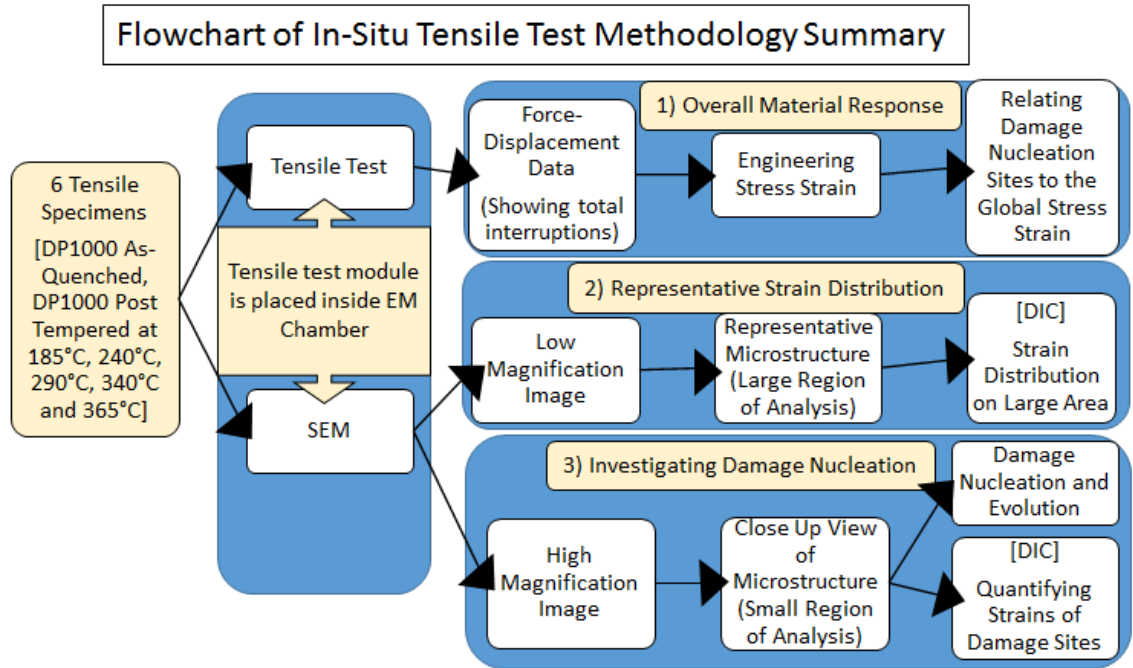
Figure 3-18 Experimental procedures being used to conduct the in-situ tensile test that is summarized in a flowchart.

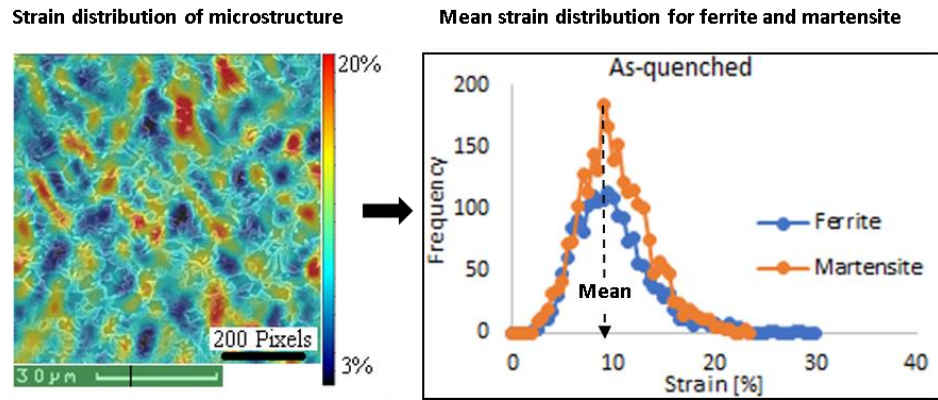
Figure 3-22 DIC strain map (left) provides the strain distribution for the analysed microstructure and frequency distribution plot (right) shows the average strain values in ferrite phase and martensite phase separately.

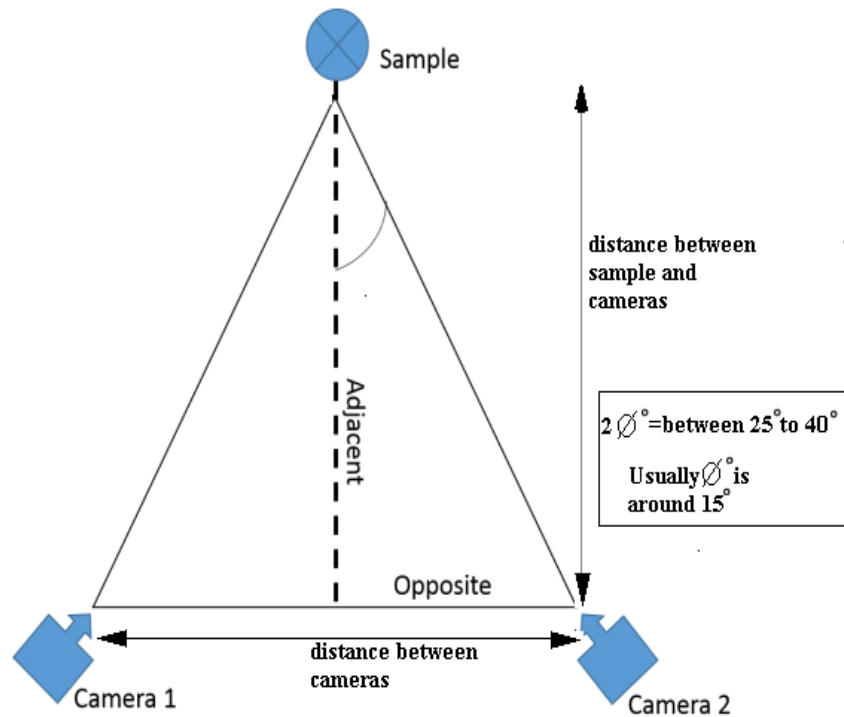
Figure 3-23 Schematic diagram of 3D DIC cameras set up which require the cameras to be placed at a certain angle and distance.

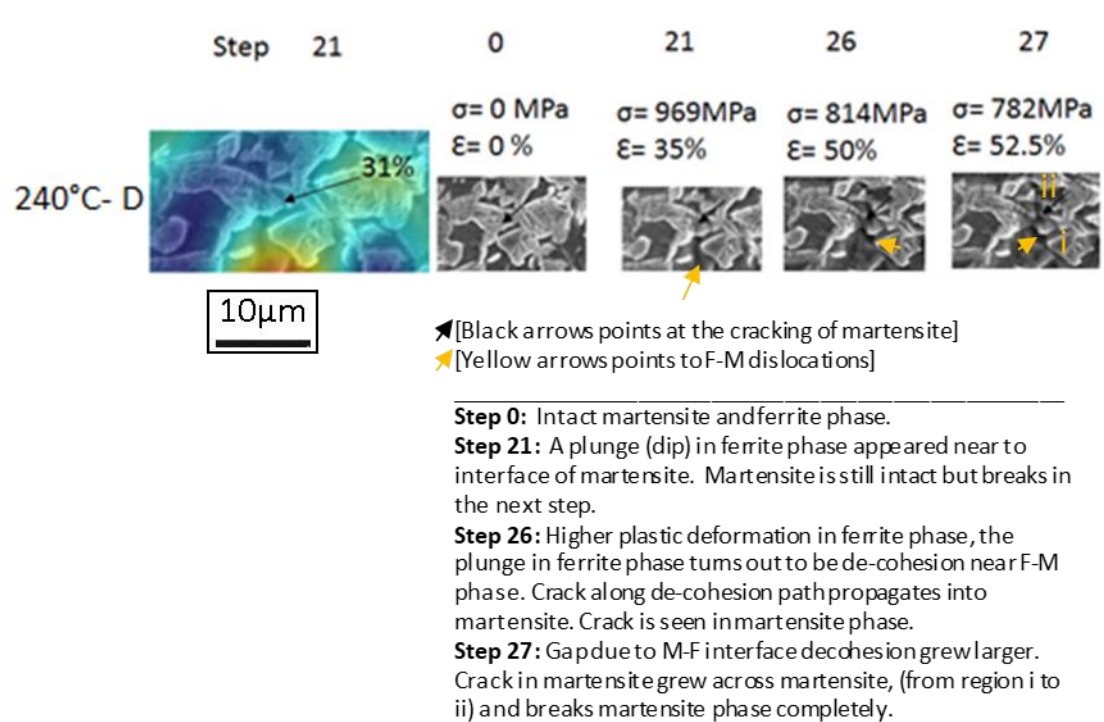
Figure 4-17 An example of de-cohesion near ferrite-martensite interface that propagates into the martensite phase observed in specimen 240°C.

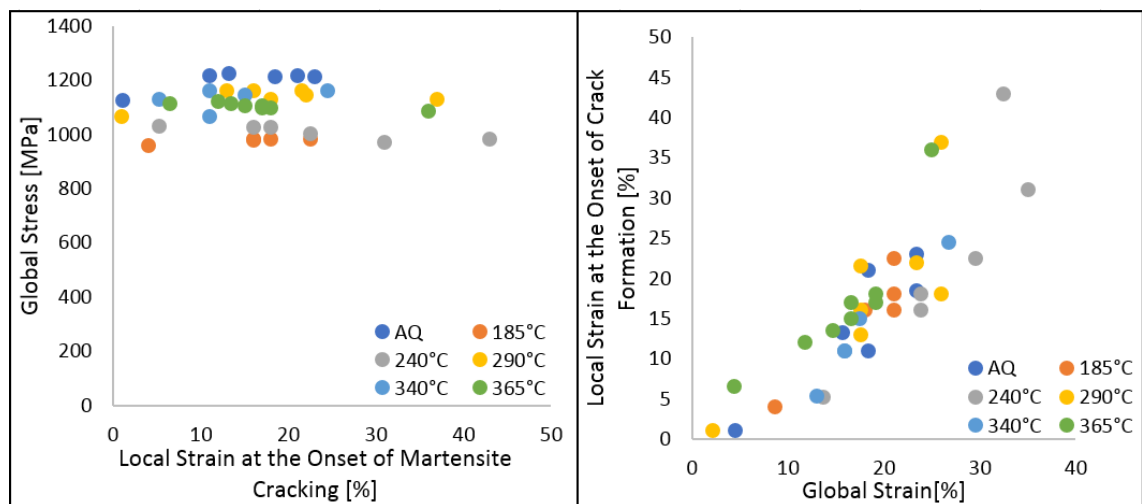
Figure 4-20 Graph showing the relationship of the strain during the onset of crack development in martensite and their overall specimens' stress-strain states.

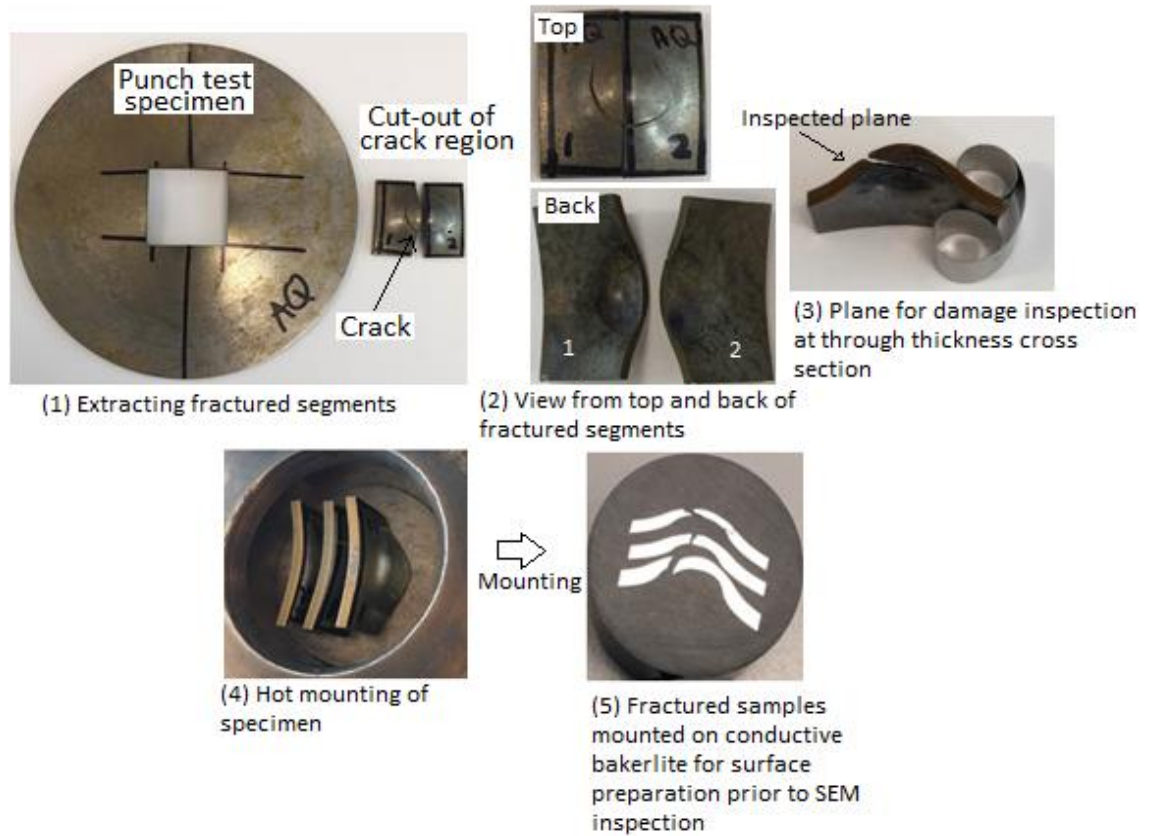
Figure -5-14 Centre region of a failed punch test specimen is extracted out and later is cut in half to reveal the cross-section profile of a failed punch test specimen.
