CERTIFICATE OF ANALYSIS OF A MORTAR SAMPLE FOR DETERMINATION OF MIX COMPOSITION BINDER TYPE

Project Reference	:	Stonehouse, Brook Lane, Thornton Dale, North Yorkshire
Sample Description	:	Pointing mortar to a Clay/Lime Mortared masonry Wall
Date Received	:	27 th November 2018
CMC Sample Ref	:	SR 2662 – S1
Date Analysed	:	3 rd 20 th & 27 th December 2018 and 3 rd January 2019
Method of Test	:	Binder type and presence of reaction products by X-Ray Diffraction, with Mix Composition by Modal Analysis and examination of a Petrographic thin section following standard procedures.

Earth, Stone & lime Company.
Stonehouse, Brook Lane, Thornton Dale,
North Yorkshire
Examination and Analysis of a Pointing Mortar sample.

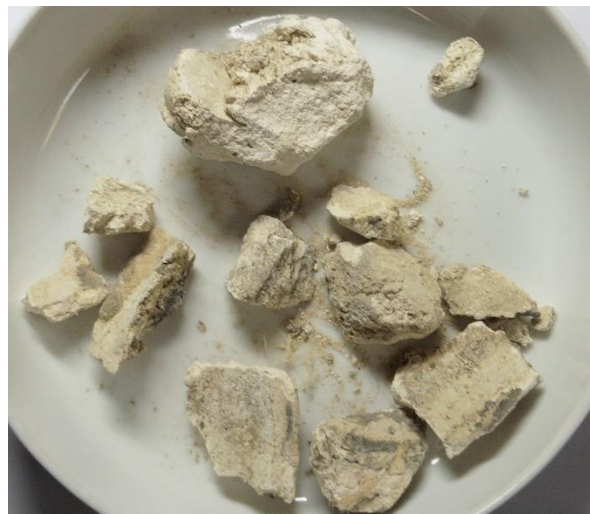
Plate No. 1: The above plate shows the intact pieces of mortar as received, which was found to consist of twelve mortar fragments and a small quantity of fines.

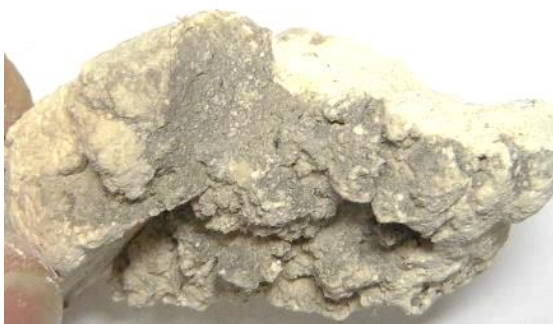
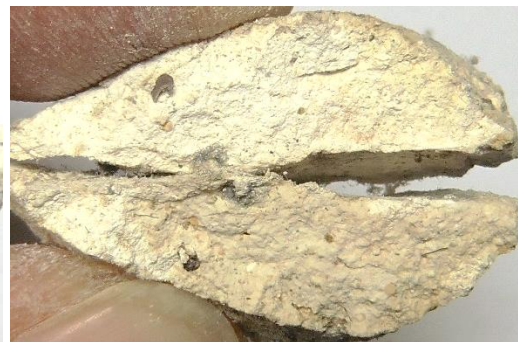
Plates No. 2 & 3: The left plate shows a close-up of a soiled surface within a void in the mortar, where water percolation with the deposition of both transported debris and redeposited leached lime were both apparent. The right plate shows a freshly fractured surface through the thickness of the pointing, with “aggregates” apparent along with lime inclusions and hair fibres. Tests on the fractured surfaces with a phenolphthalein indicator solution confirmed that the mortar was fully carbonated.

The mortar was well compacted and moderately hard although the intact pieces could be broken under moderate to firm finger pressure and once disrupted the mortar could be powdered under moderate finger pressure. The mortar, although well compacted, was noted to contain a few irregular shaped voids, which appeared to be placing features with soiling of the surfaces exposed within the voids inferring that water percolation through the pointing had occurred locally.

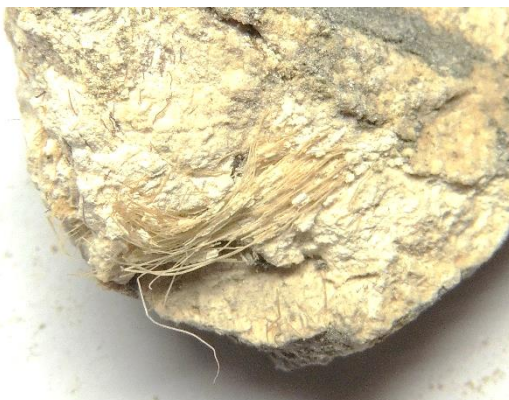
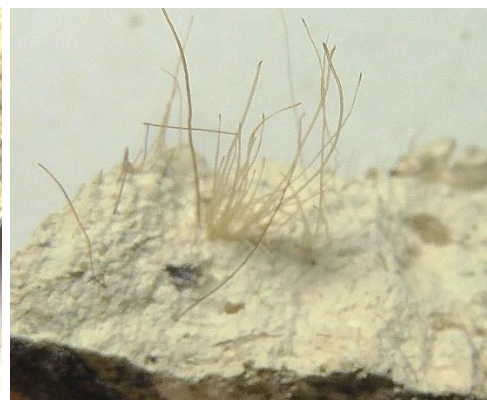
Plates No. 4 & 5: The above plates show fractured surfaces in which an abundance of fibre can be seen, with hair fibre occurring as clumps, poorly separated fibres, and as individual hair fibres. The hair ranged in colour from white, light and dark brown to red, with the fibres being of animal hair, possibly horse body hair.

A proportion of animal hair was observed within the mortar, with the hair being typical of that obtained from horse body hair, though this would require further analysis to confirm. The hair is in sufficient proportion to infer that it was purposely added as a reinforcement.

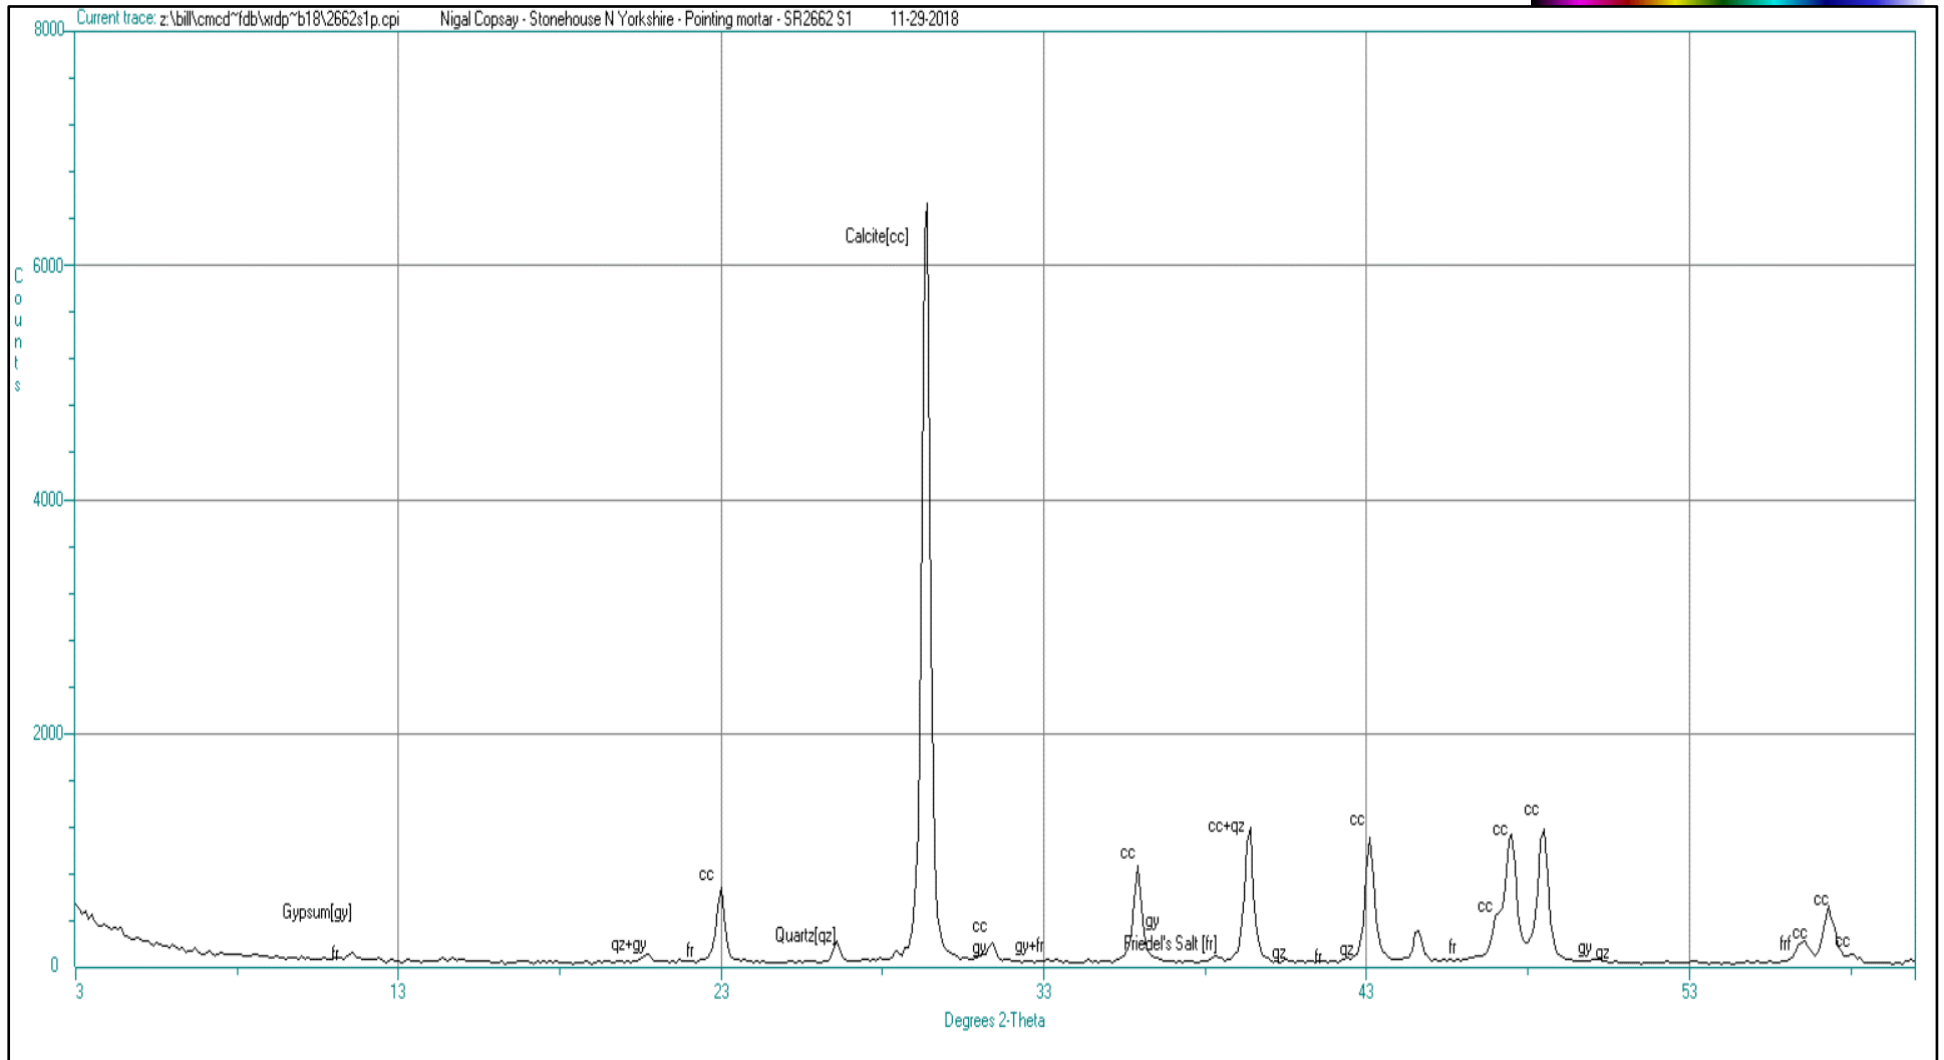
Figure No. 1: Sample SR2662-S1, Powdered sample of Pointing mortar, ex the Stonehouse.

- cc** = Calcite (CaCO_3) calcium carbonate, carbonated lime from lime binder, or limestone,
- qz** = Quartz (SiO_2) dominant component of the sand aggregate in the mortar,
- fr** = Friedel's Salt ($\text{Ca}_4\text{Al}_2\text{O}_6\text{Cl}_2\cdot 10\text{H}_2\text{O}$) Calcium Aluminium Oxide Chloride Hydrate, Hydration product, possibly from a minor pozzolanic reaction with ash in feed stock,
- gy** = Gypsum ($\text{CaSO}_4\cdot 2\text{H}_2\text{O}$) Calcium Sulphate Hydrate, reaction product between lime in binder and environmental sulphates.

Component	Proportion (% by Mass)
Sample:	Mortar sample
Calcite	96.0
Quartz	2.1
Friedel's Salt	1.0
Gypsum	<u>0.9</u>
Total	100.0

Based on the XRD analysis, it is indicated that the mortar is essentially a high calcium lime mortar mix, with a trace proportion of quartz. The latter is likely to have been present as a contaminant in the feedstock rather than a purposefully added component.

Minor reaction products were detected in the sample analysed, with two forms detected, Friedel's Salt which is a hydration reaction product, which may infer a very minor proportion of pozzolanic material in the ash, or the presence of potentially hydraulic component from within some of the overburnt lime inclusions, such as aluminates in the limestone, i.e. from feldspar or clay minerals. The second reaction product is in the form of Gypsum, and this is likely to be indicative of a post placement reaction with environmental sulphates, from contaminants rather than infer that a low proportion of gypsum had been added to the mortar at time of mixing.
