# **AN APPRAISAL OF THE PERFORMANCE OF A 'GREEN' OFFICE BUILDING**

Submitted in accordance with the requirements for the degree of  
**Doctor of Philosophy**

The University of Leeds  
School of Civil Engineering

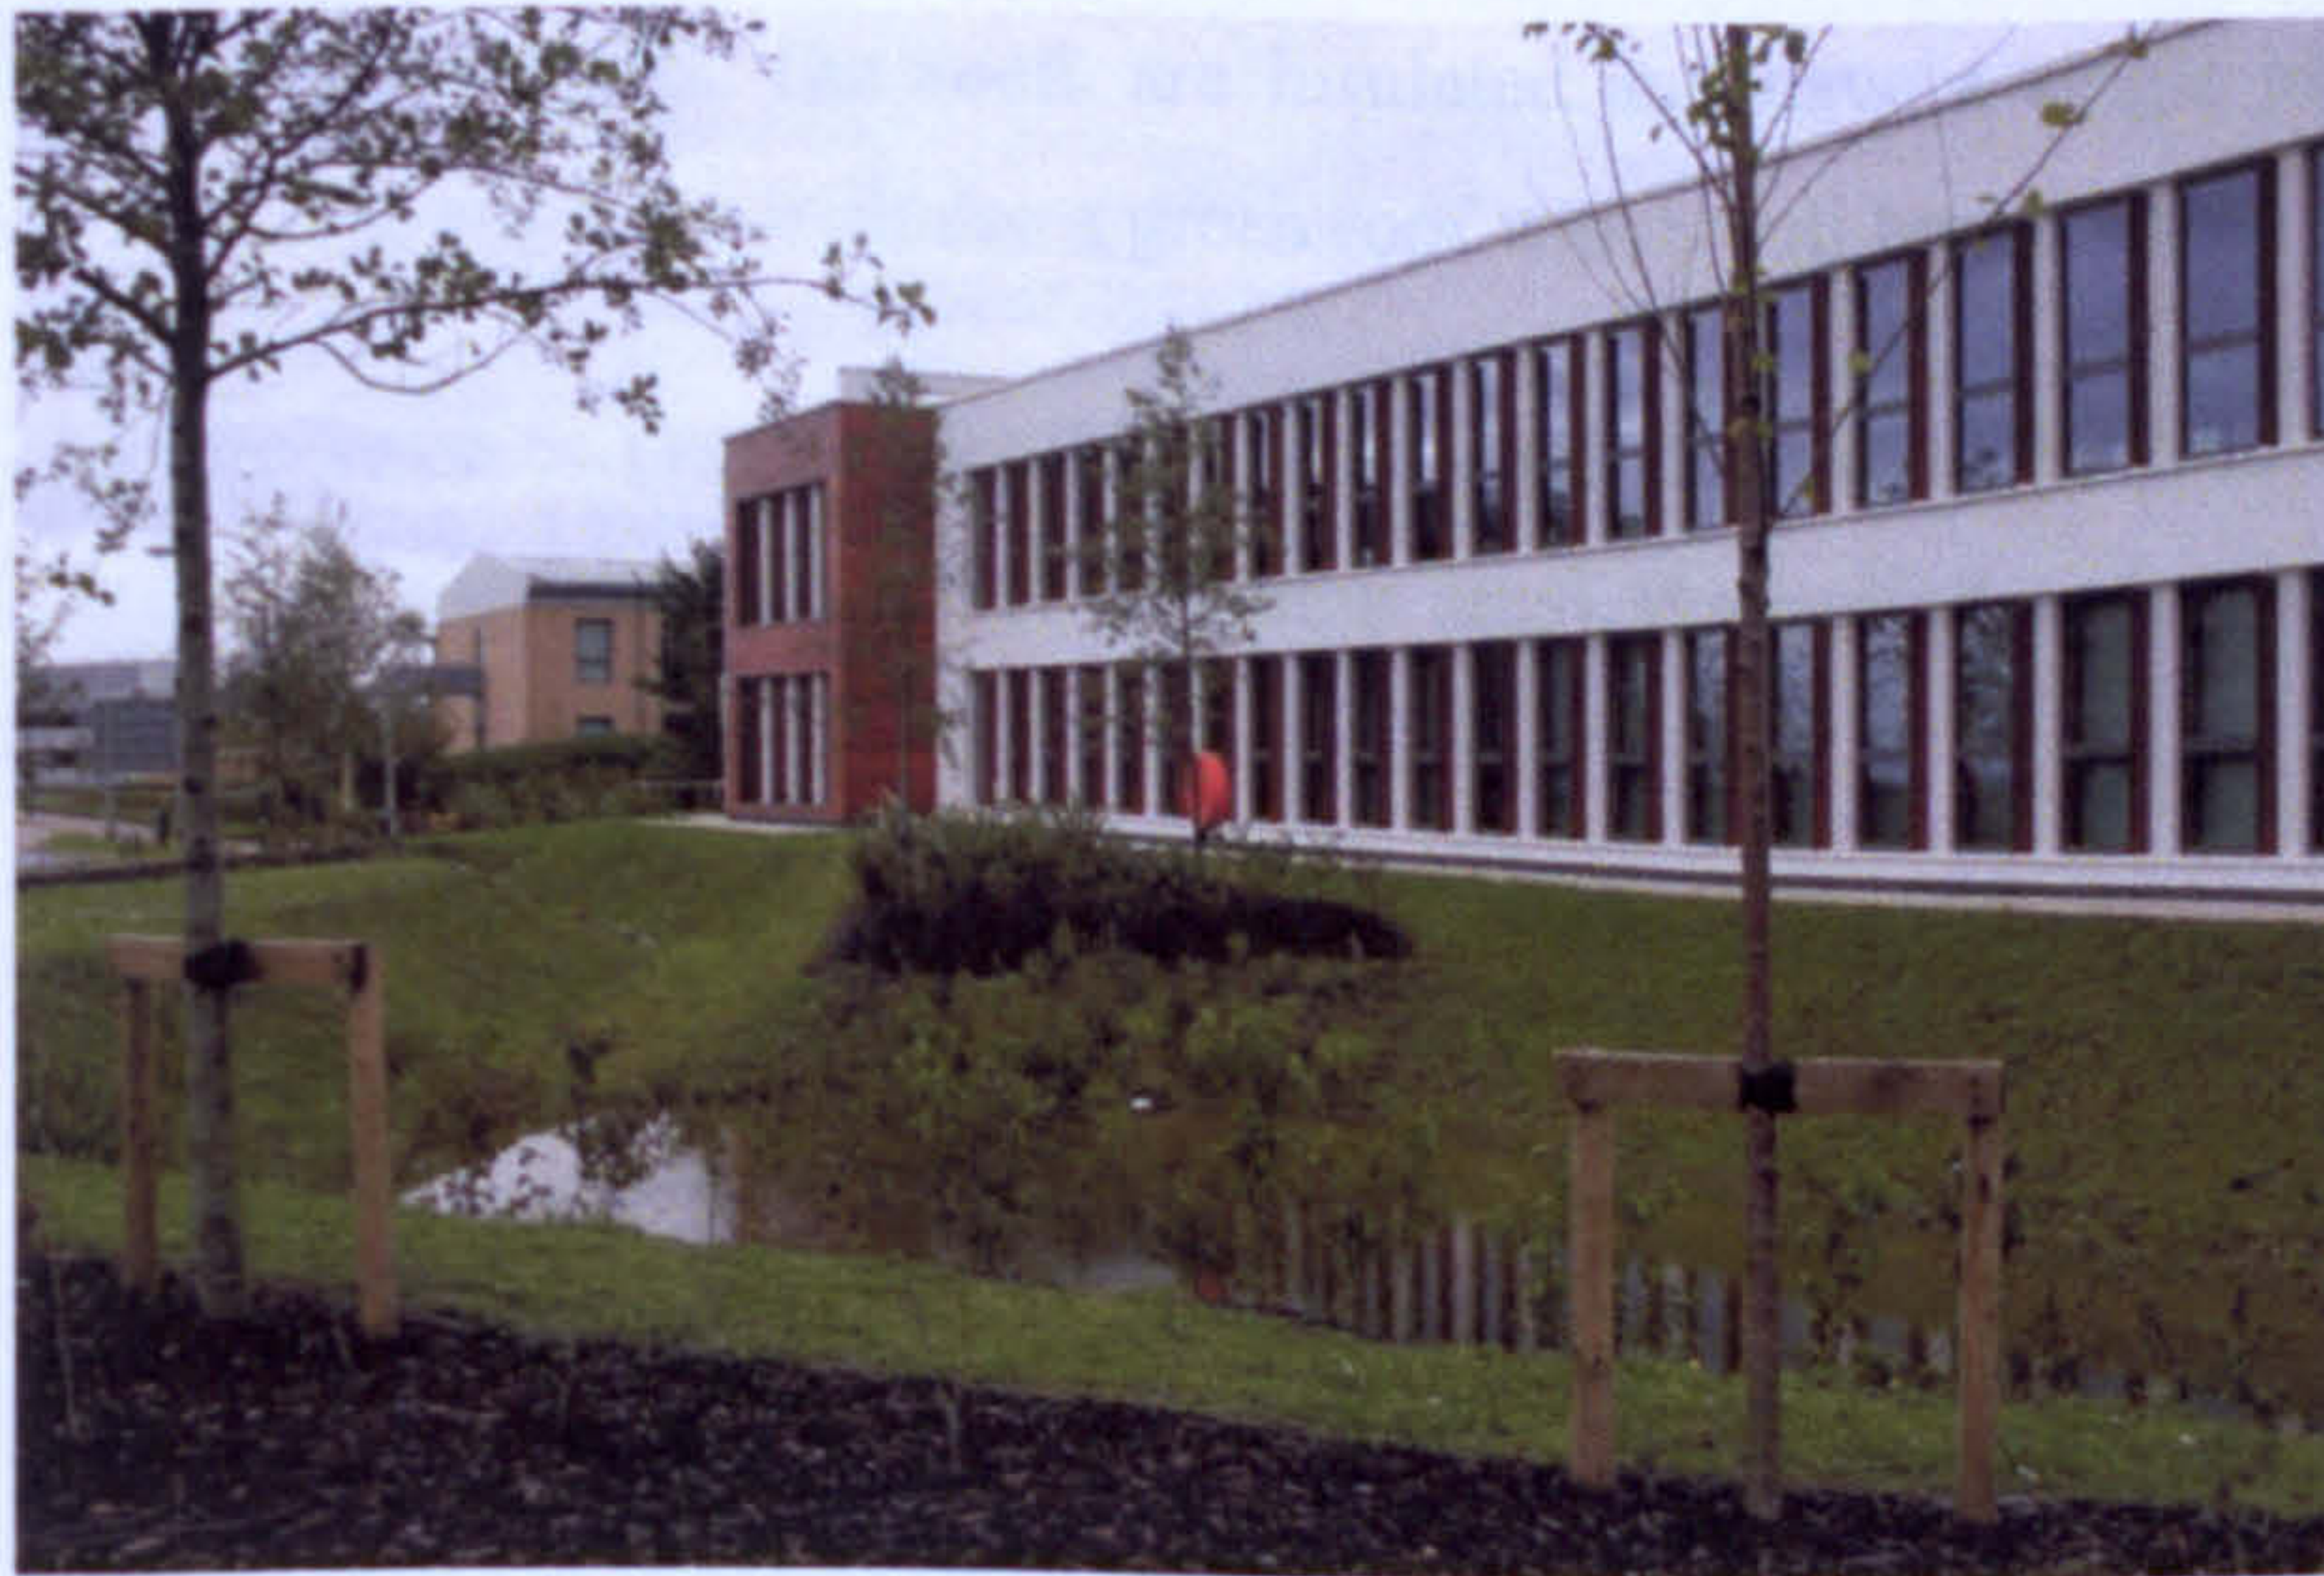
Figure 3-1: Case study office building

The building that was available for the case study and subjected Post Occupancy Evaluation (POE) is an award winning BREEAM 'Excellent' office building (shown in Figure 3-1) located approximately six miles east of Leeds city centre in the UK. The building location can be seen in relation to the proximity of Junction 46 on the M1 in Figure 3-2.

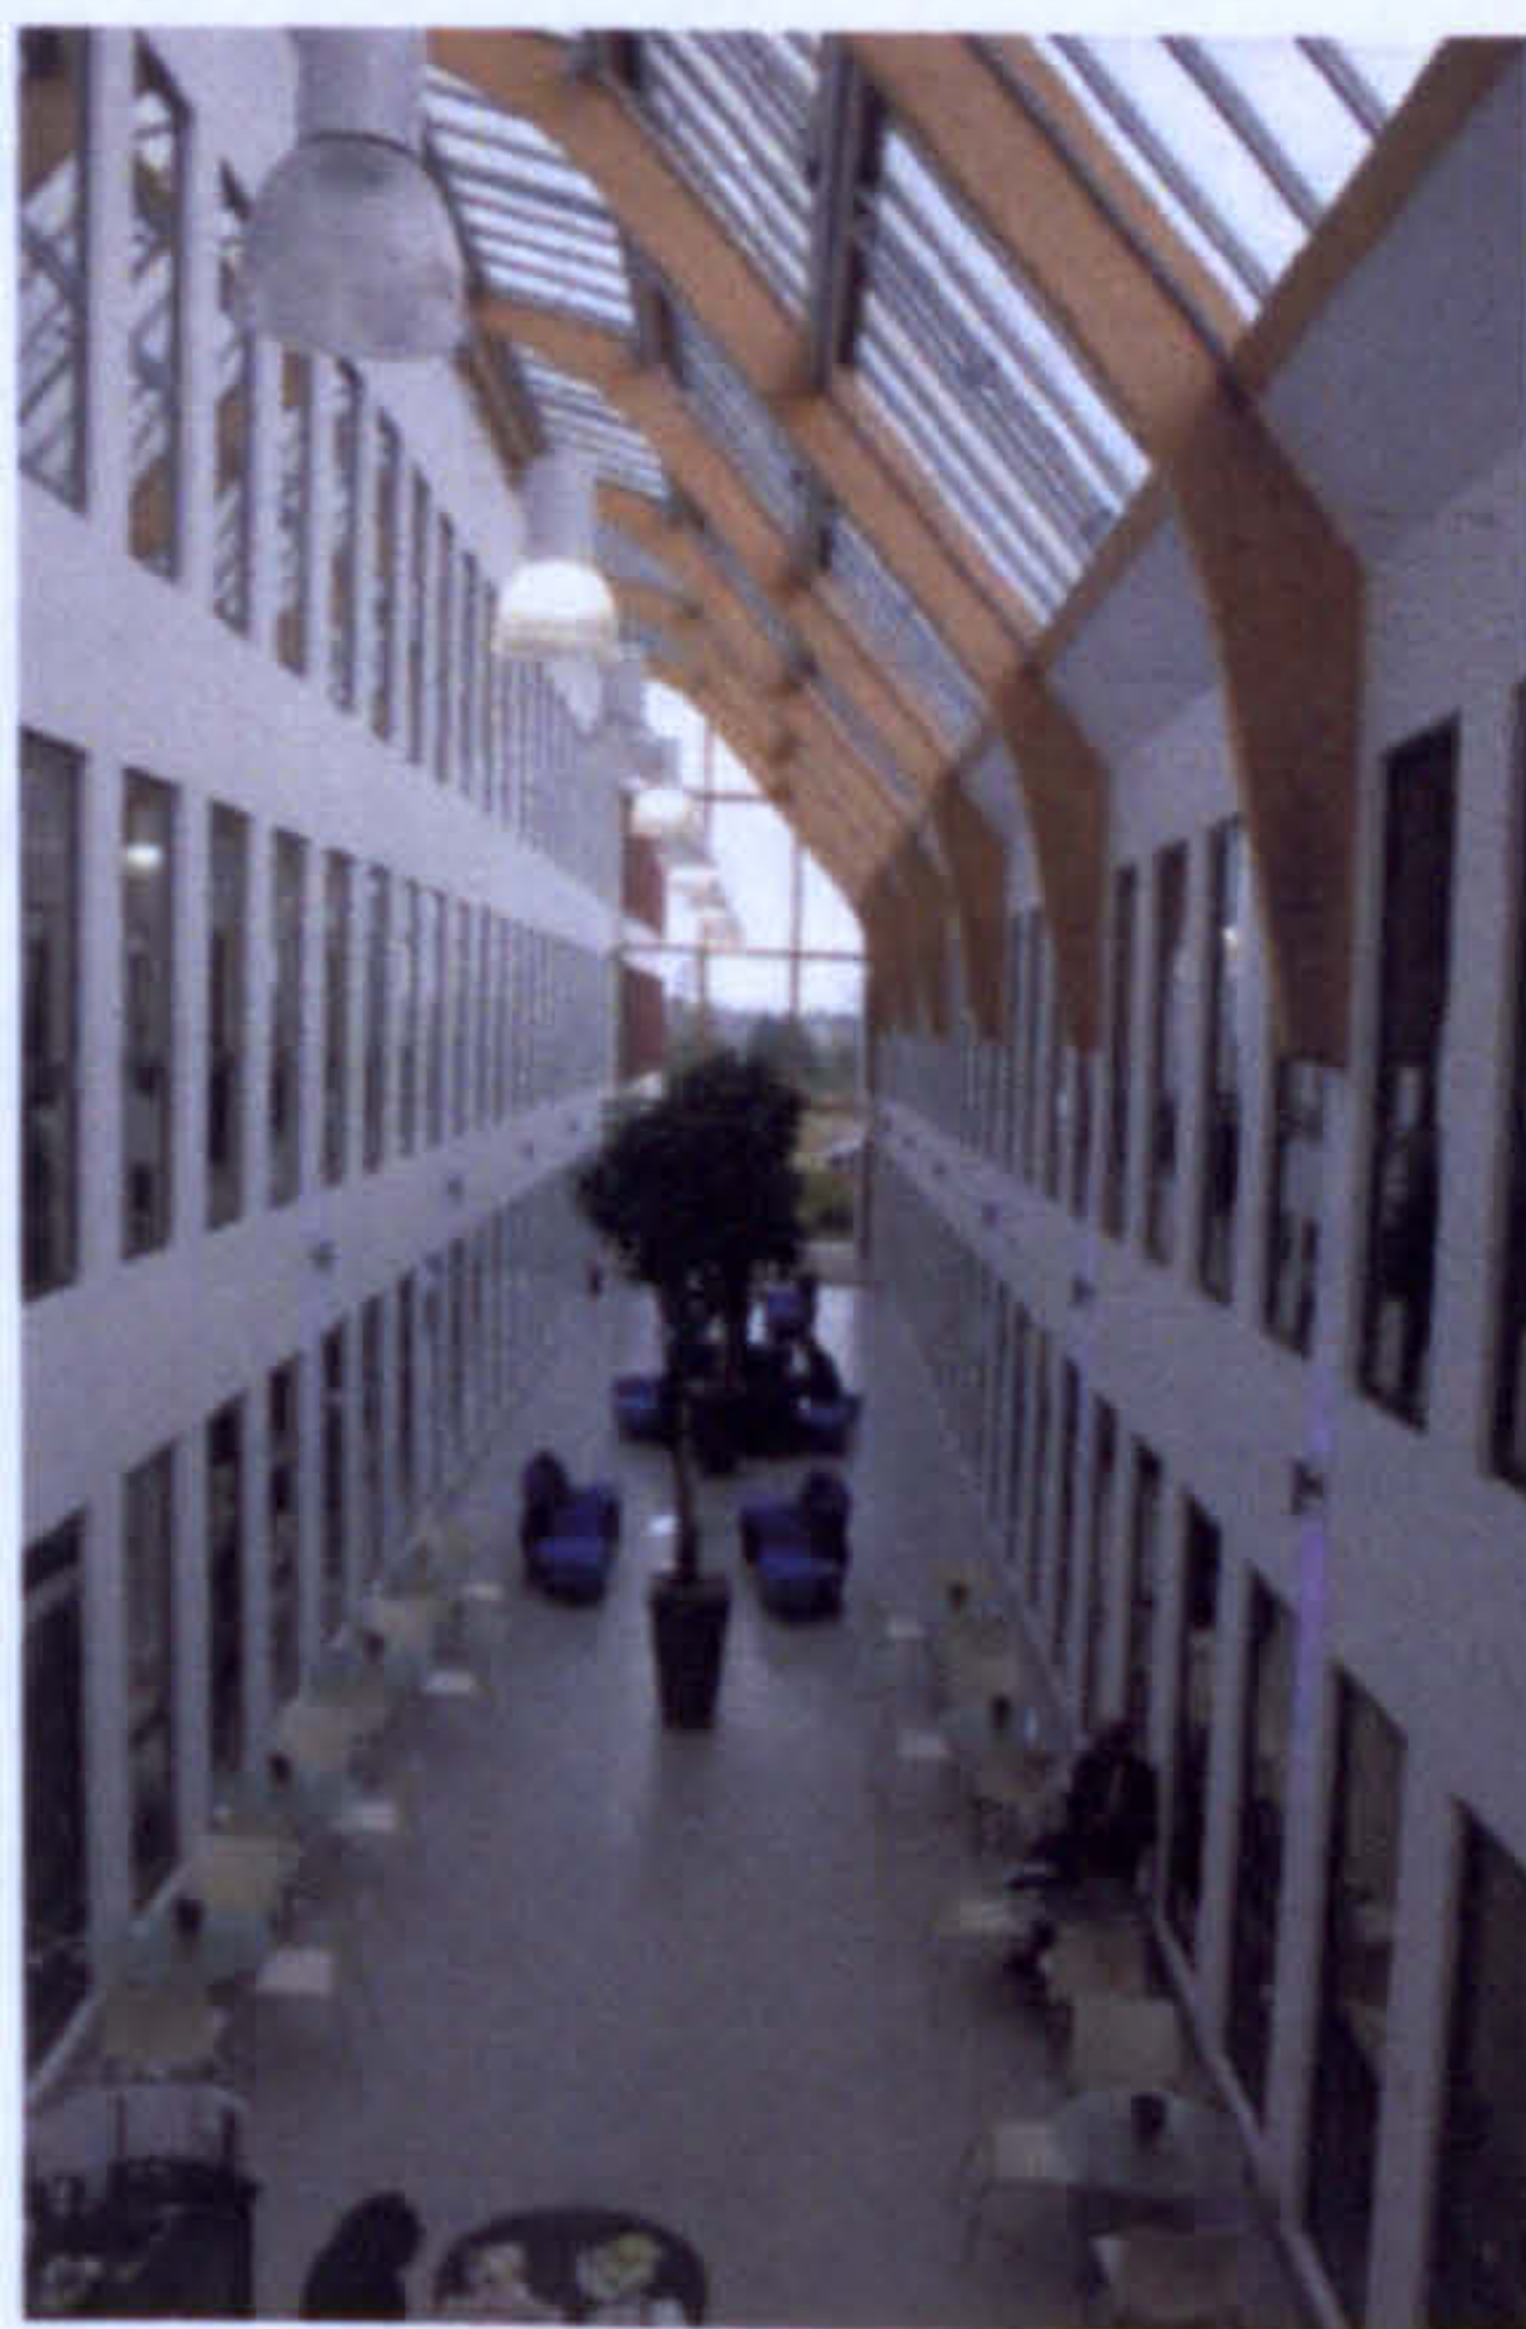
Figure 3-8: Atrium, known as “The Street”

The building is glazed on the east and west facades, and orientated in such a way that the offices are subjected to direct sunshine in the morning and late afternoon. The central atrium, shown in Figure 3-8, allows for additional daylight to penetrate into the office wings.

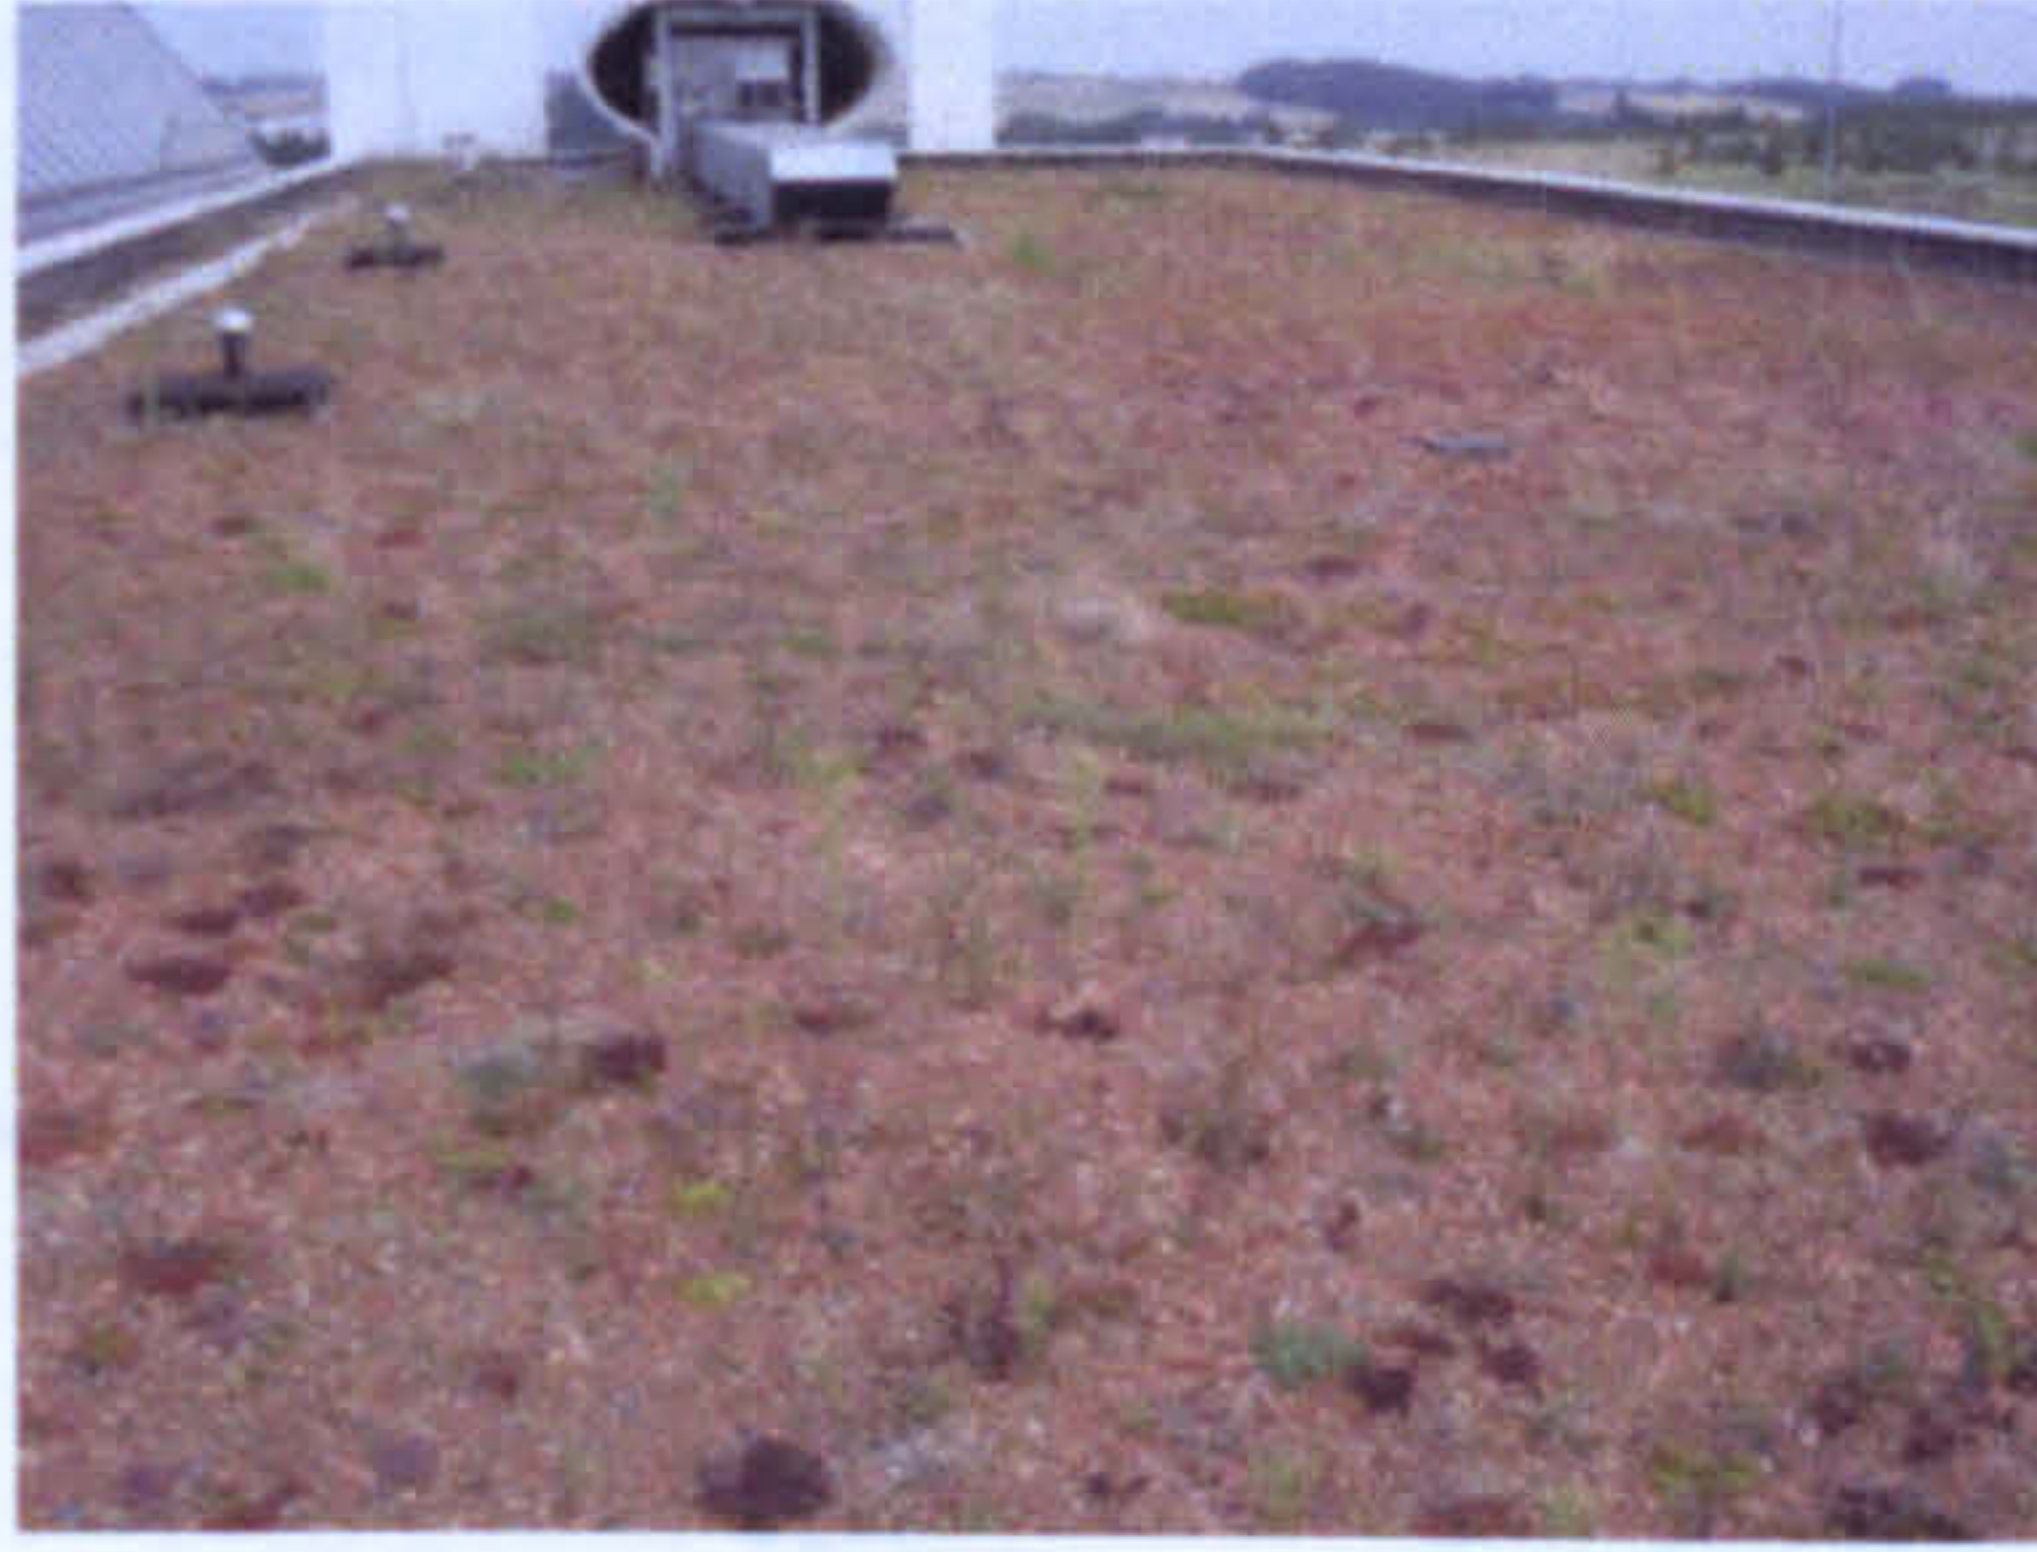
**Figure 3-9: Sedum green roof on the roof of the east wing block**

An extensive, sedum green roof is installed on the east wing roof (shown in Figure 3-9). These types of green roof require low levels of maintenance. Incorporating a green roof has restored the grass area originally removed when the building was constructed, therefore improved the bio-diversity and re-created the wildlife habitat.

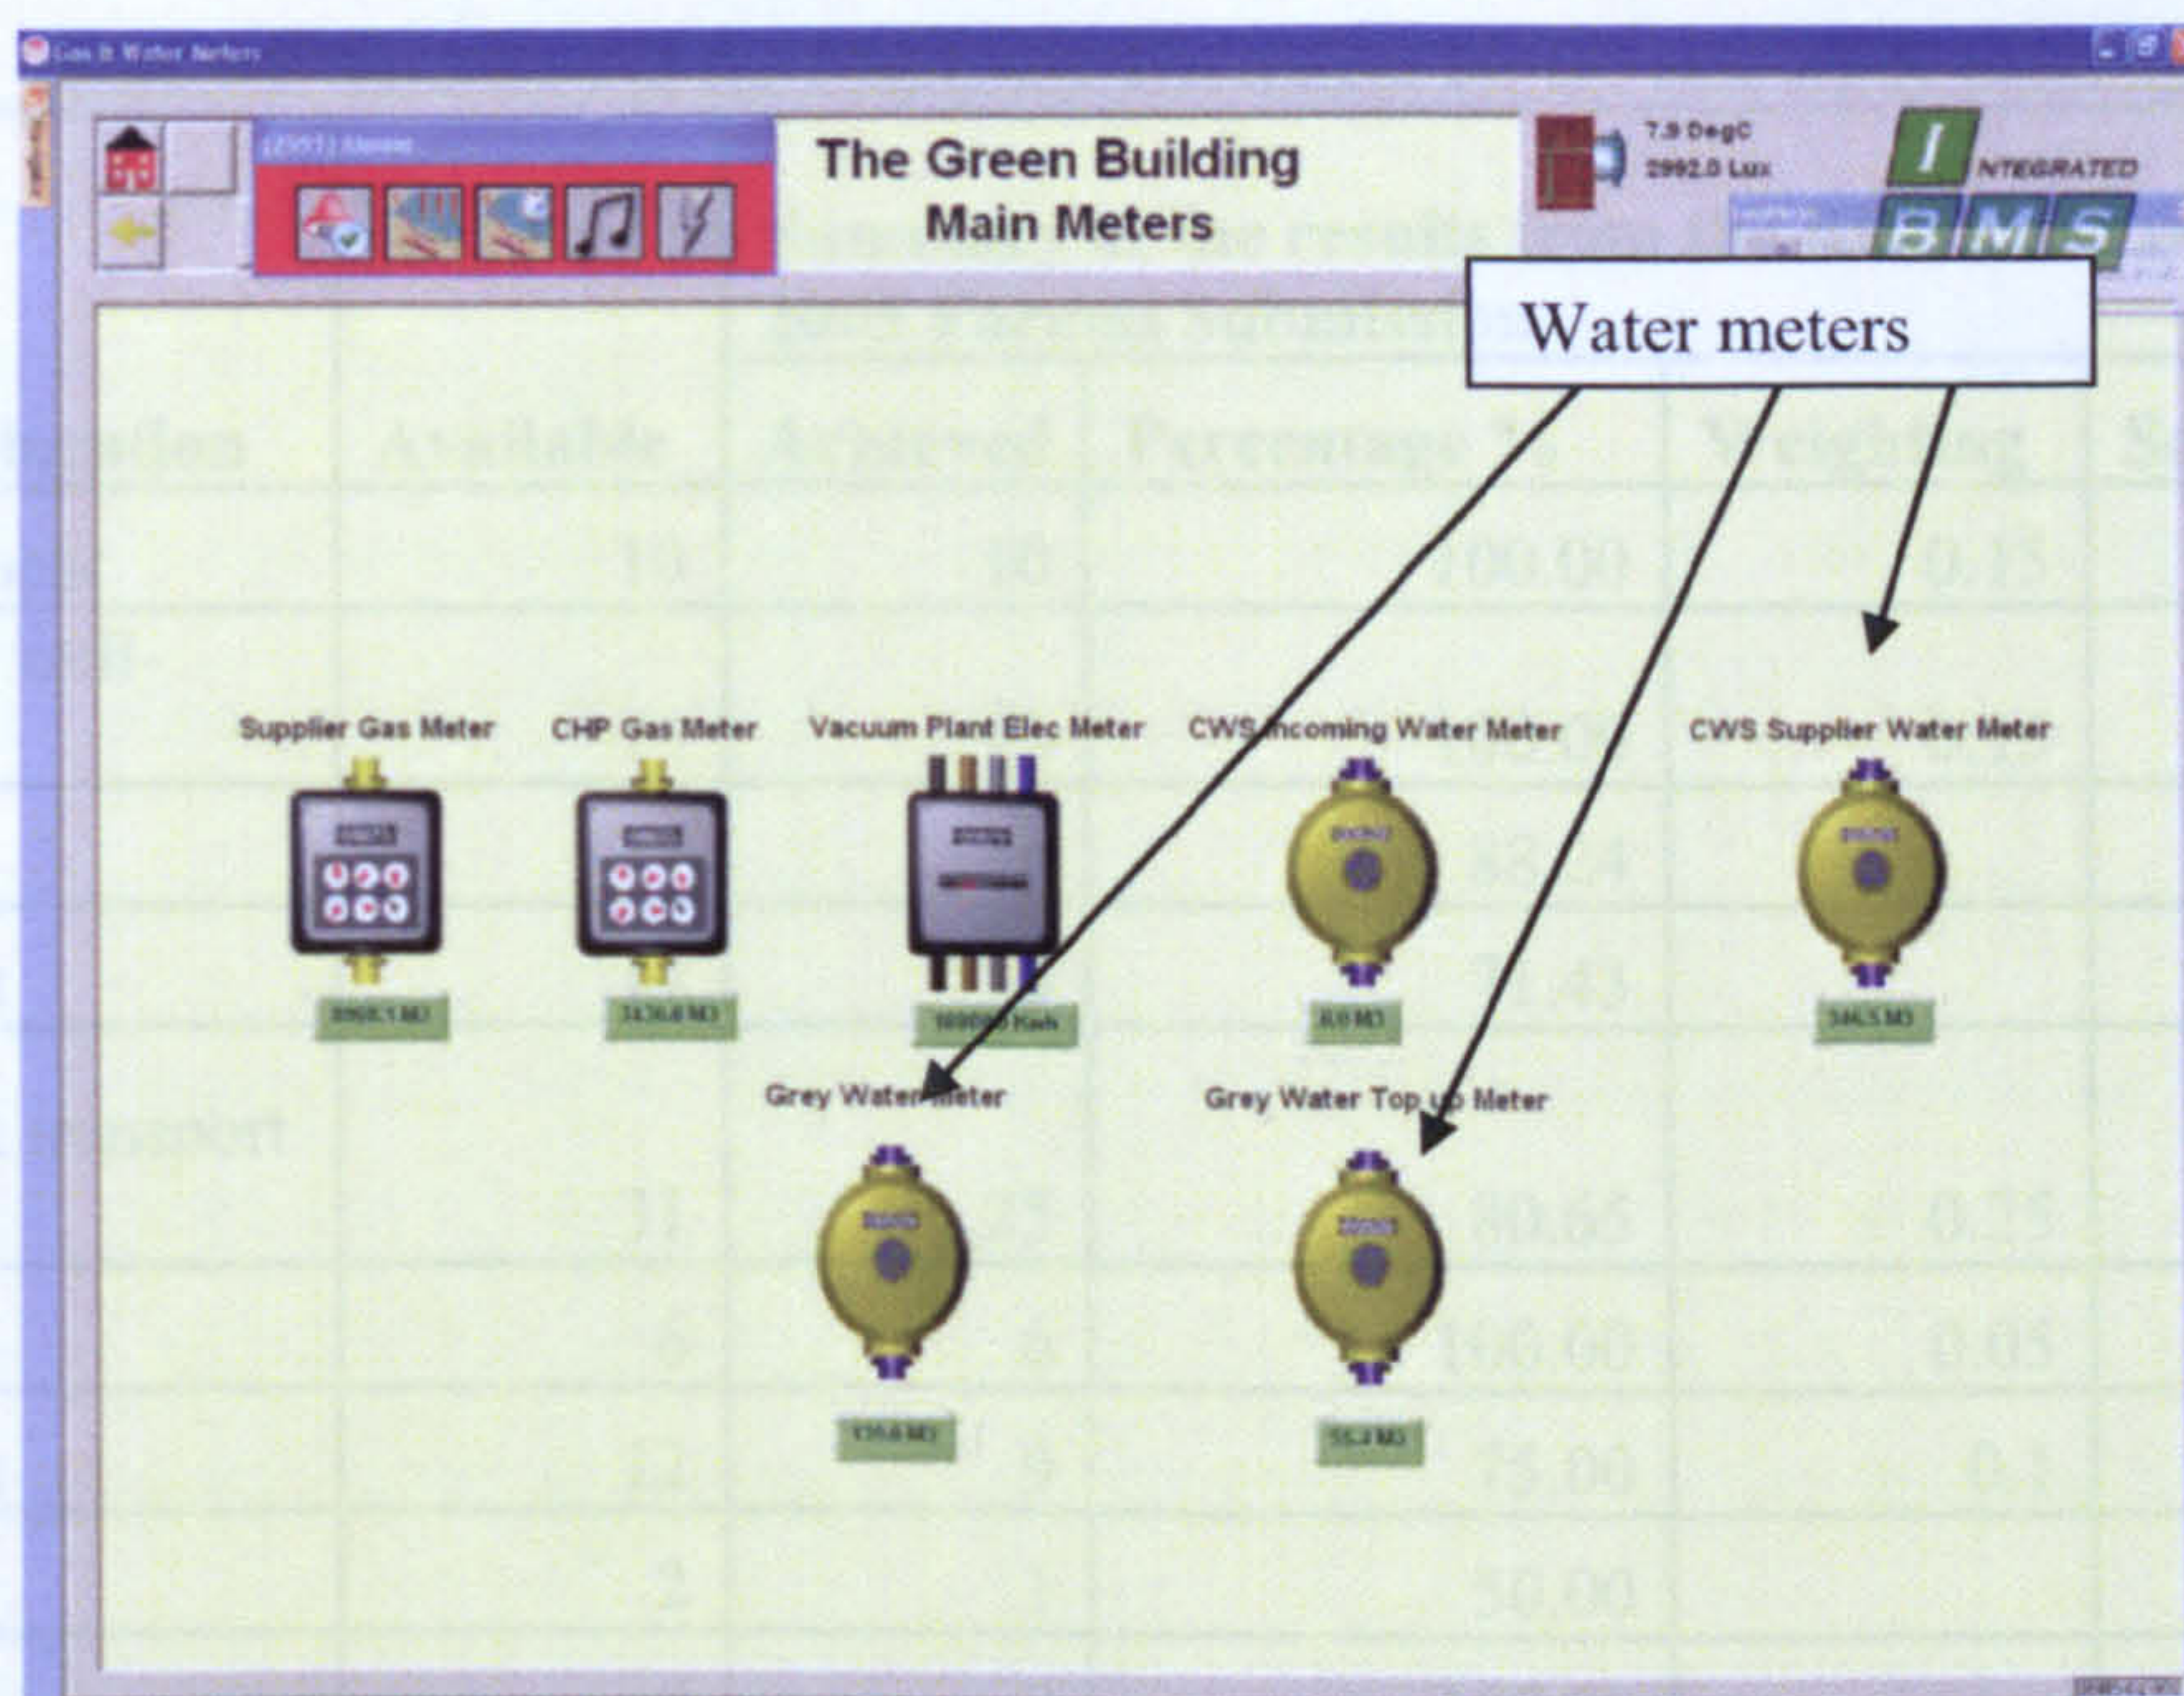
Figure 3-10: Water consumption logged on the BMS

The water consumption for mains water, grey water (harvested rain water) and mains 'top up' water are all logged on the BMS (see Figure 3-10).

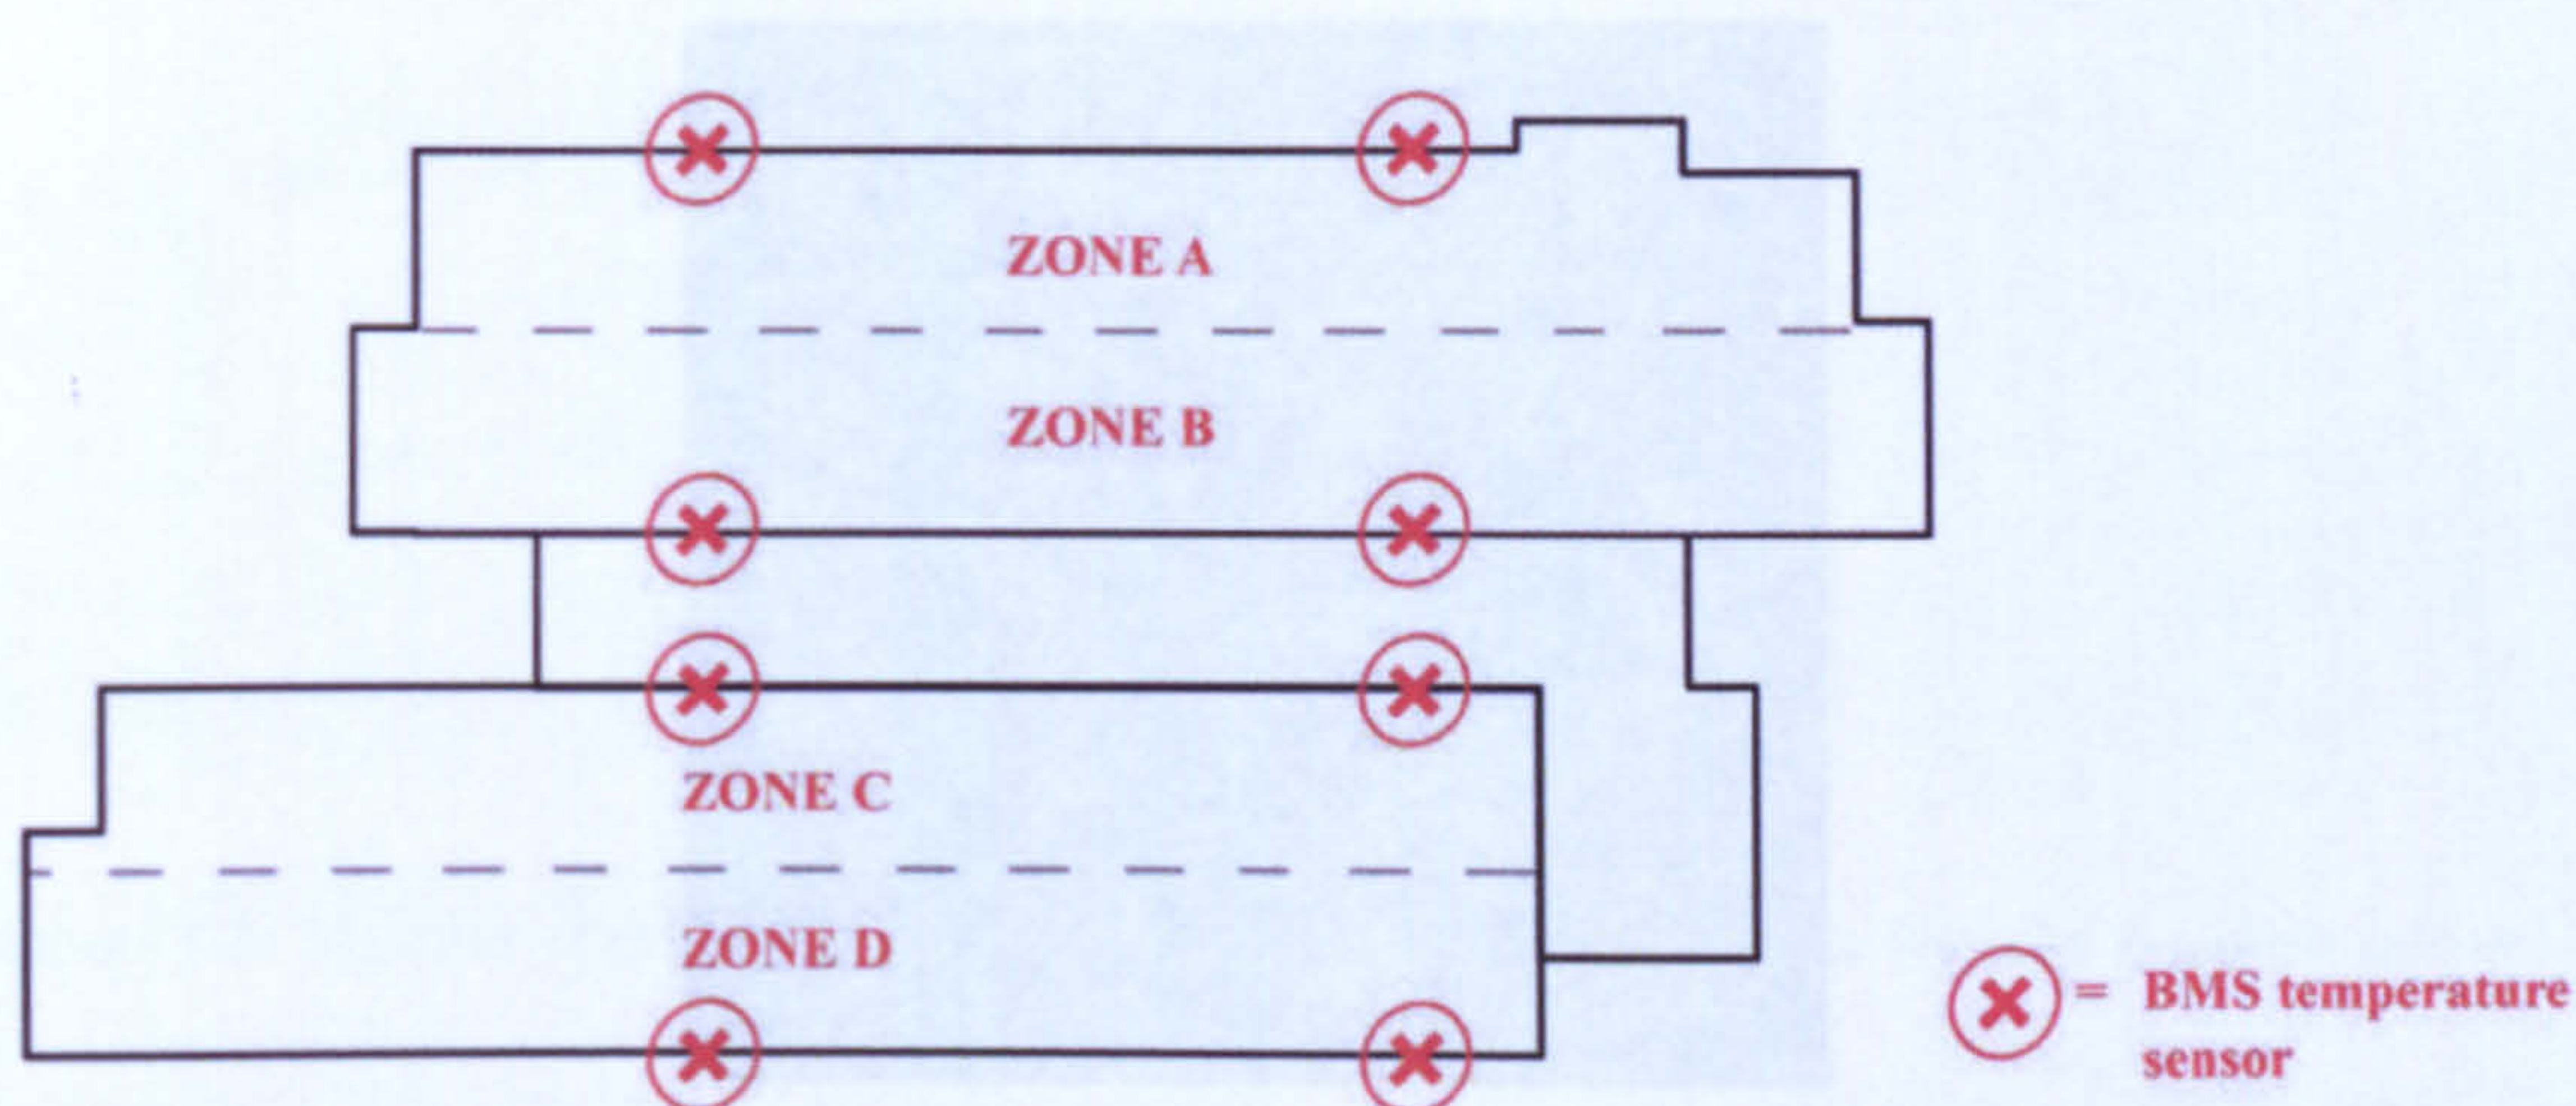
Figure 4-6: The typical locations of BMS temperature sensors

Each zone has two BMS sensors located within it (i.e. Space 1 sensor and Space 2 sensor). These sensors are only positioned in two offices per zone in the building. Figure 4-6 shows the typical positions of the BMS temperature sensors.

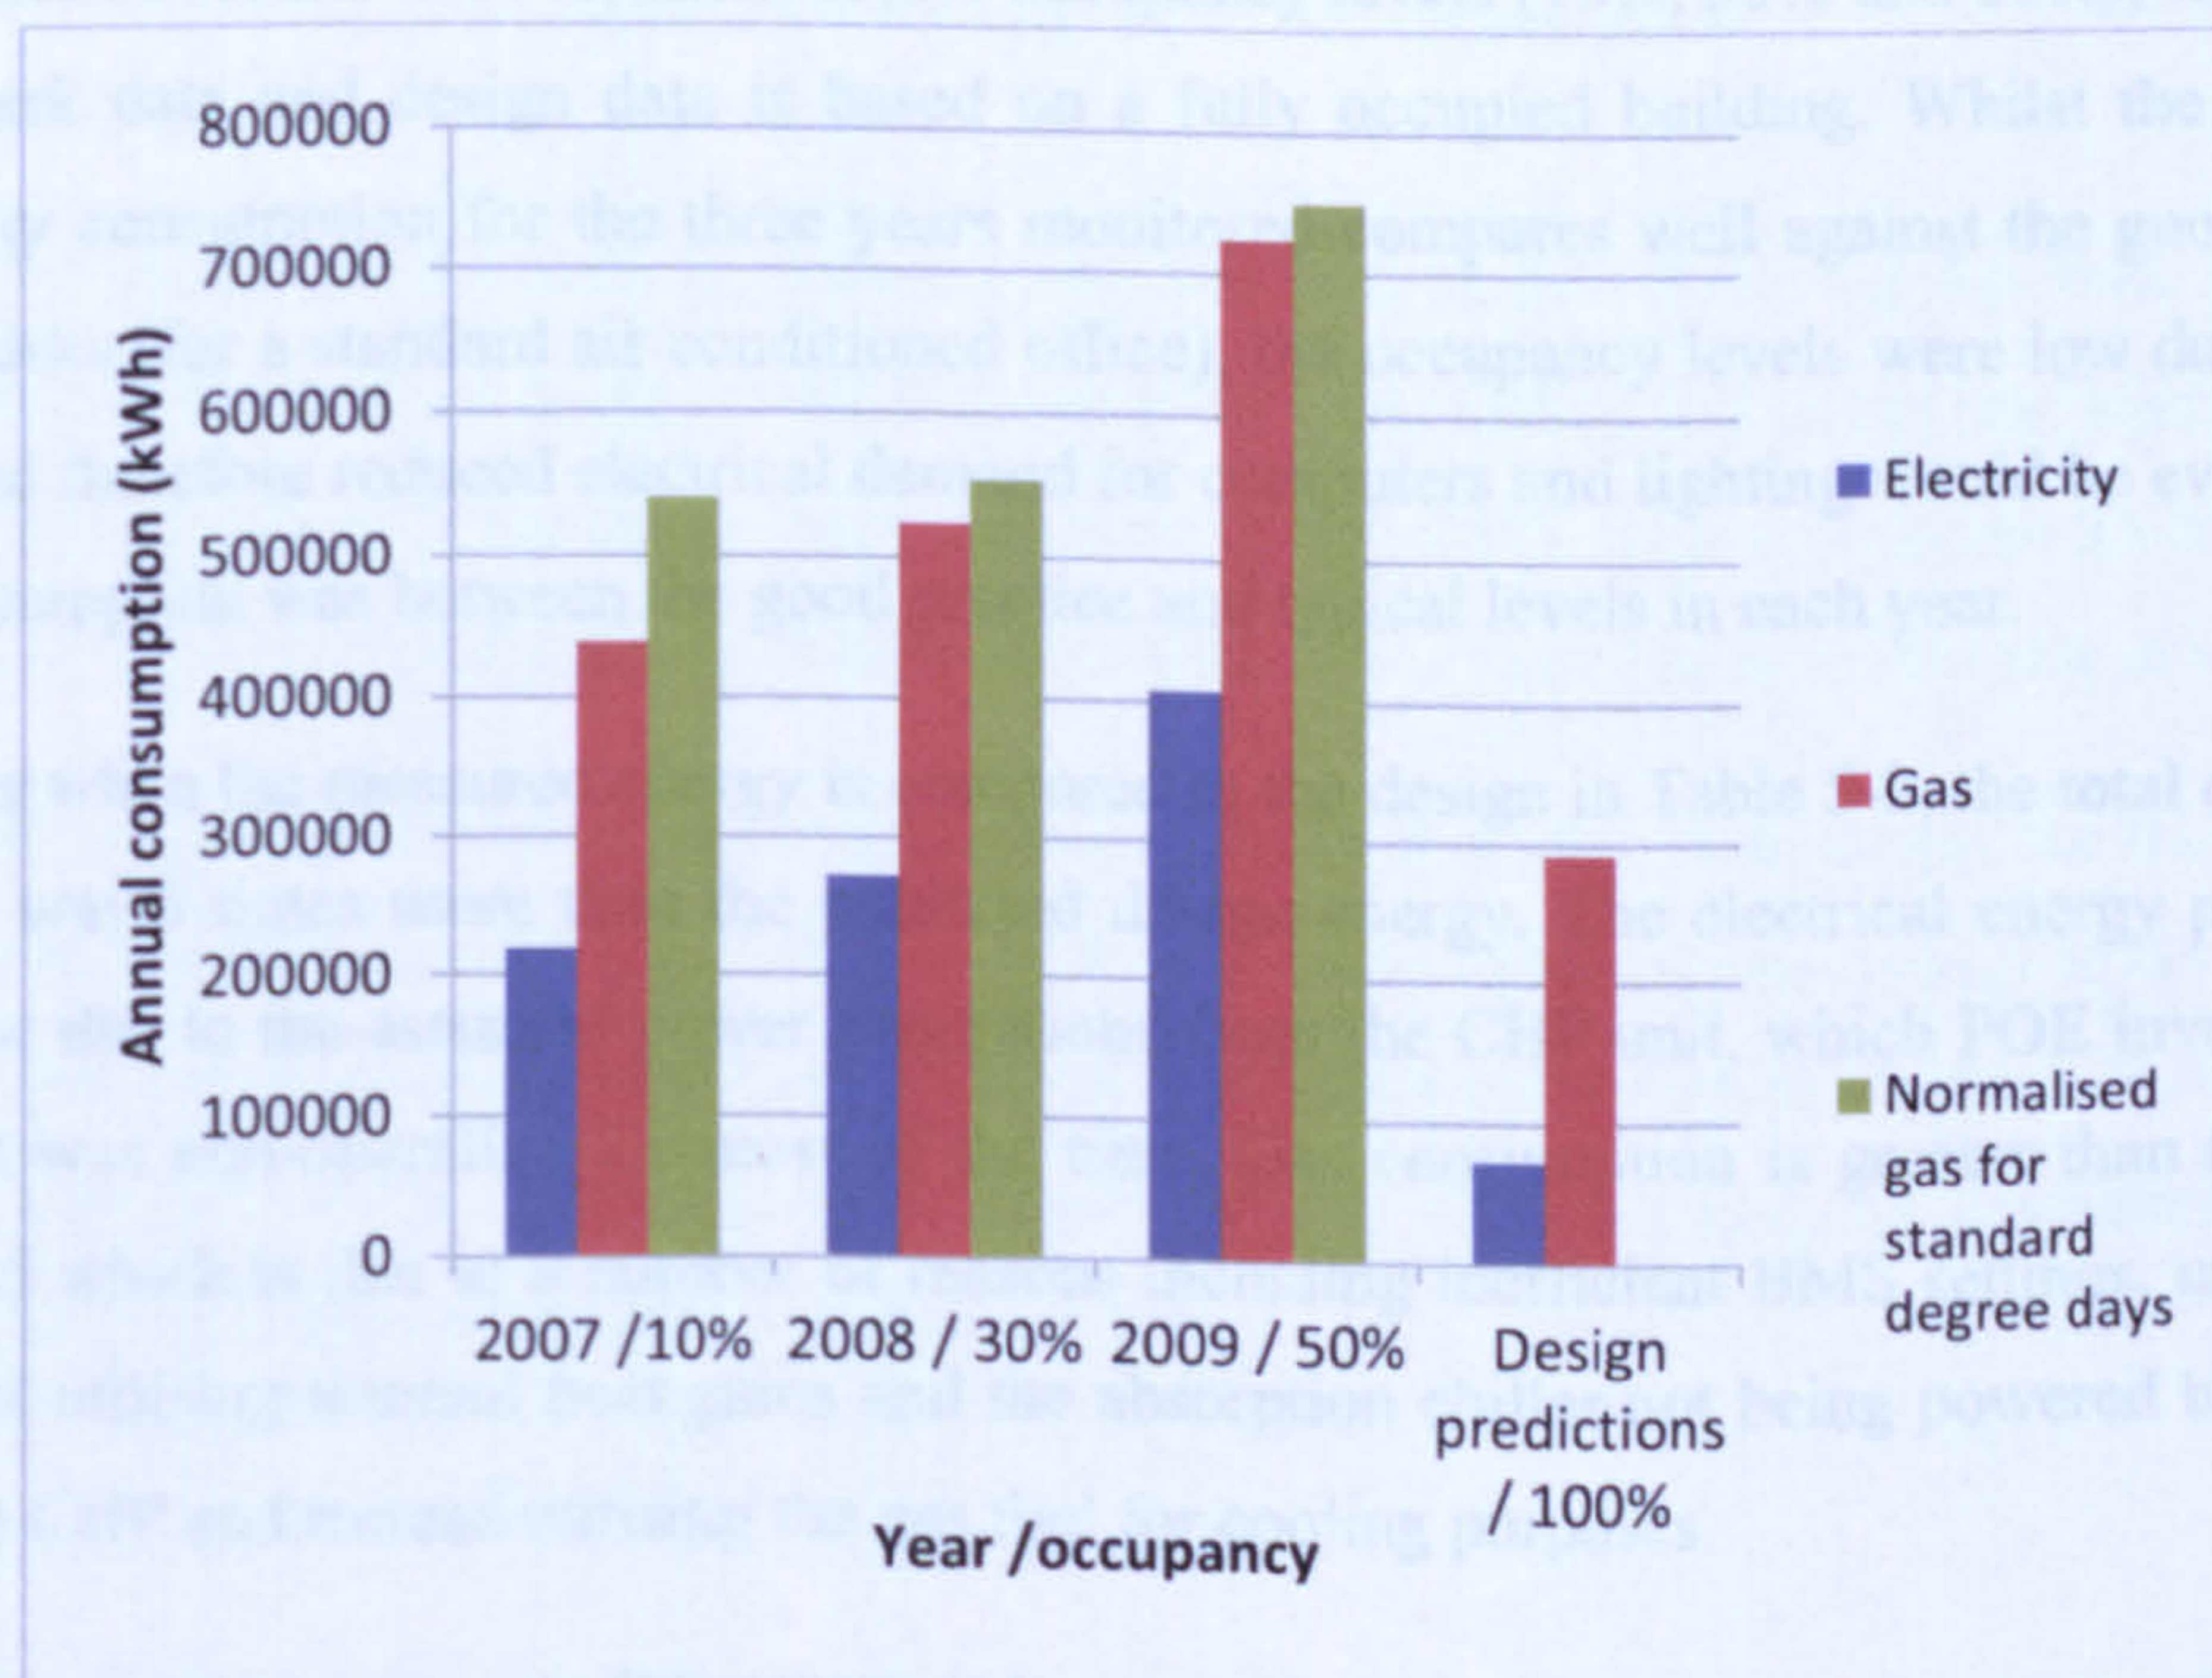
**Figure 5-2: Electricity and gas consumption for 2007, 2008 and 2009**

The measured electricity, gas and normalised gas (Vesma 2011) consumptions for 2007, 2008 and 2009 are shown with the design consumptions in Figure 5-2. The annual heating degree days for the West Pennine area for 2007, 2008 and 2009 were 2033, 2329 and 2378 respectively. Note the design energy consumptions did not include the consumptions for small power.
