# **AN APPRAISAL OF THE PERFORMANCE OF A 'GREEN' OFFICE BUILDING**

Submitted in accordance with the requirements for the degree of  
**Doctor of Philosophy**

The University of Leeds  
School of Civil Engineering

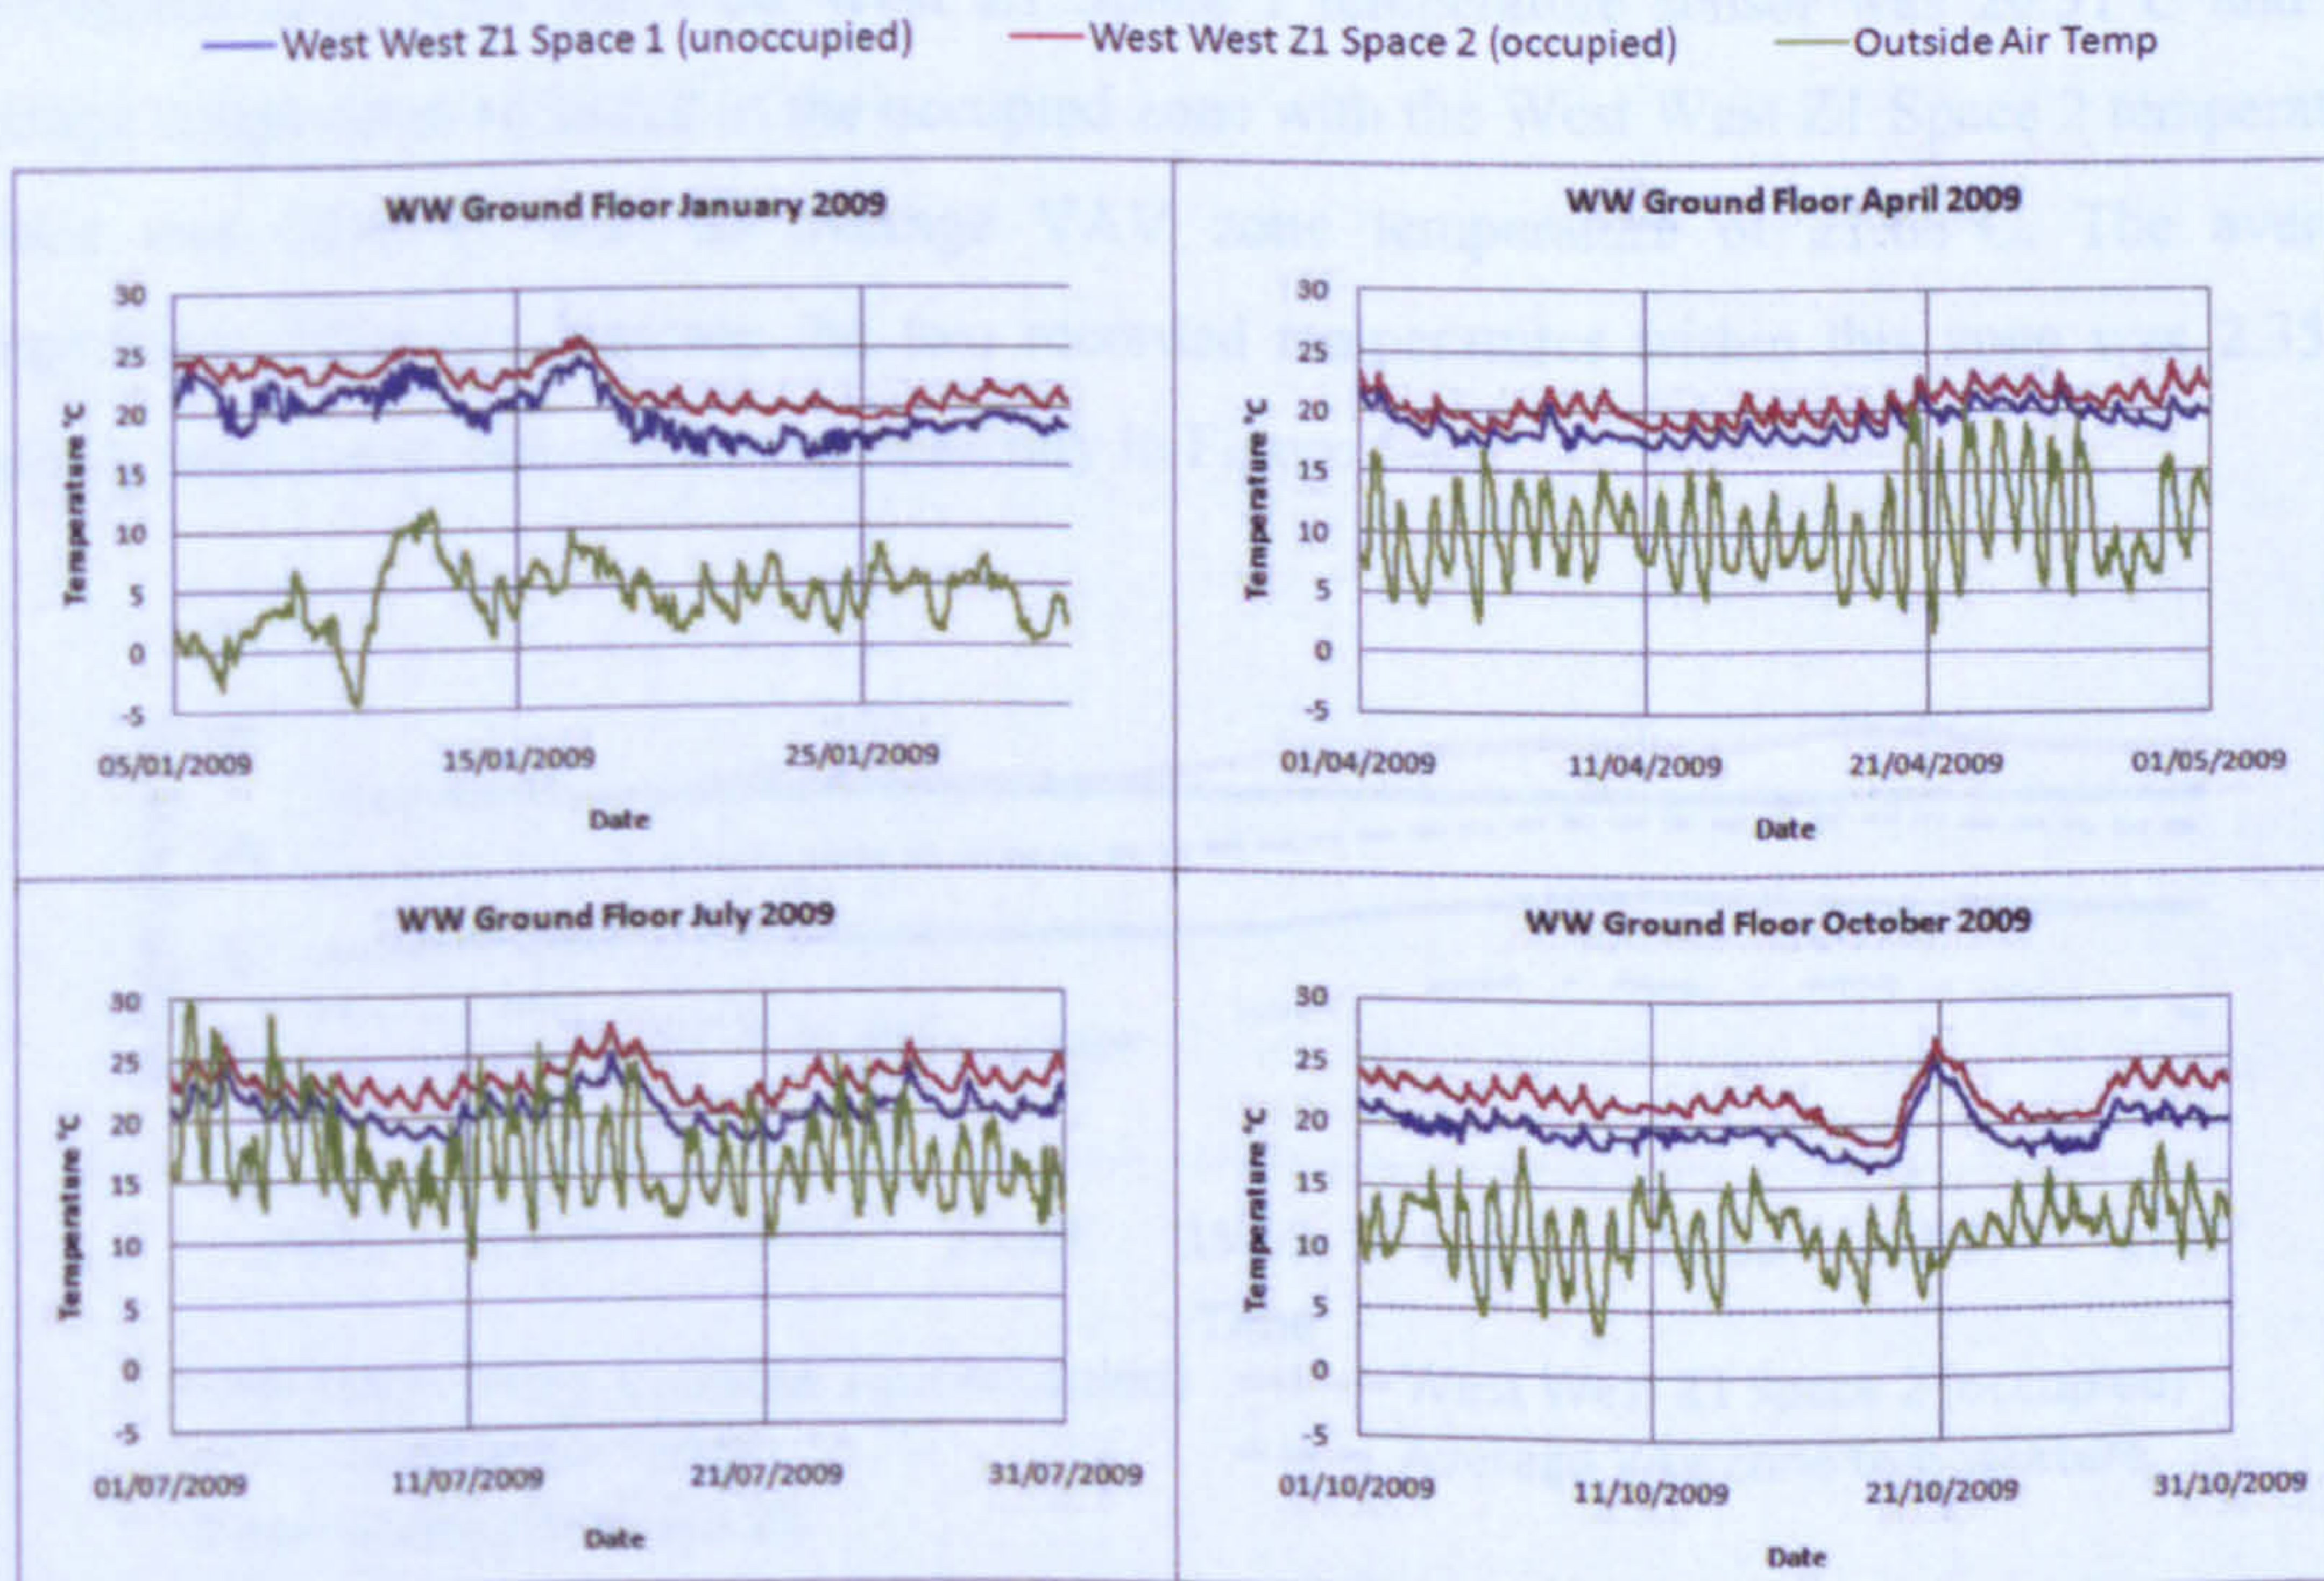
**Figure 5-23: WW Ground Floor VAV group, recorded sensor temperatures and outside temperature**

As an example, in the west west zone on the ground floor the WW Z1 Space 1 sensor is located in a meeting room which is unoccupied apart from occasional use and the WW Z1 Space 2 sensor is located in an occupied office. The BMS calculates an average from these two temperature sensors and responds in such that it will provide heating or cooling if required. The graphs shown in Figure 5-23 show the measured temperatures for January, April July and December 2009.

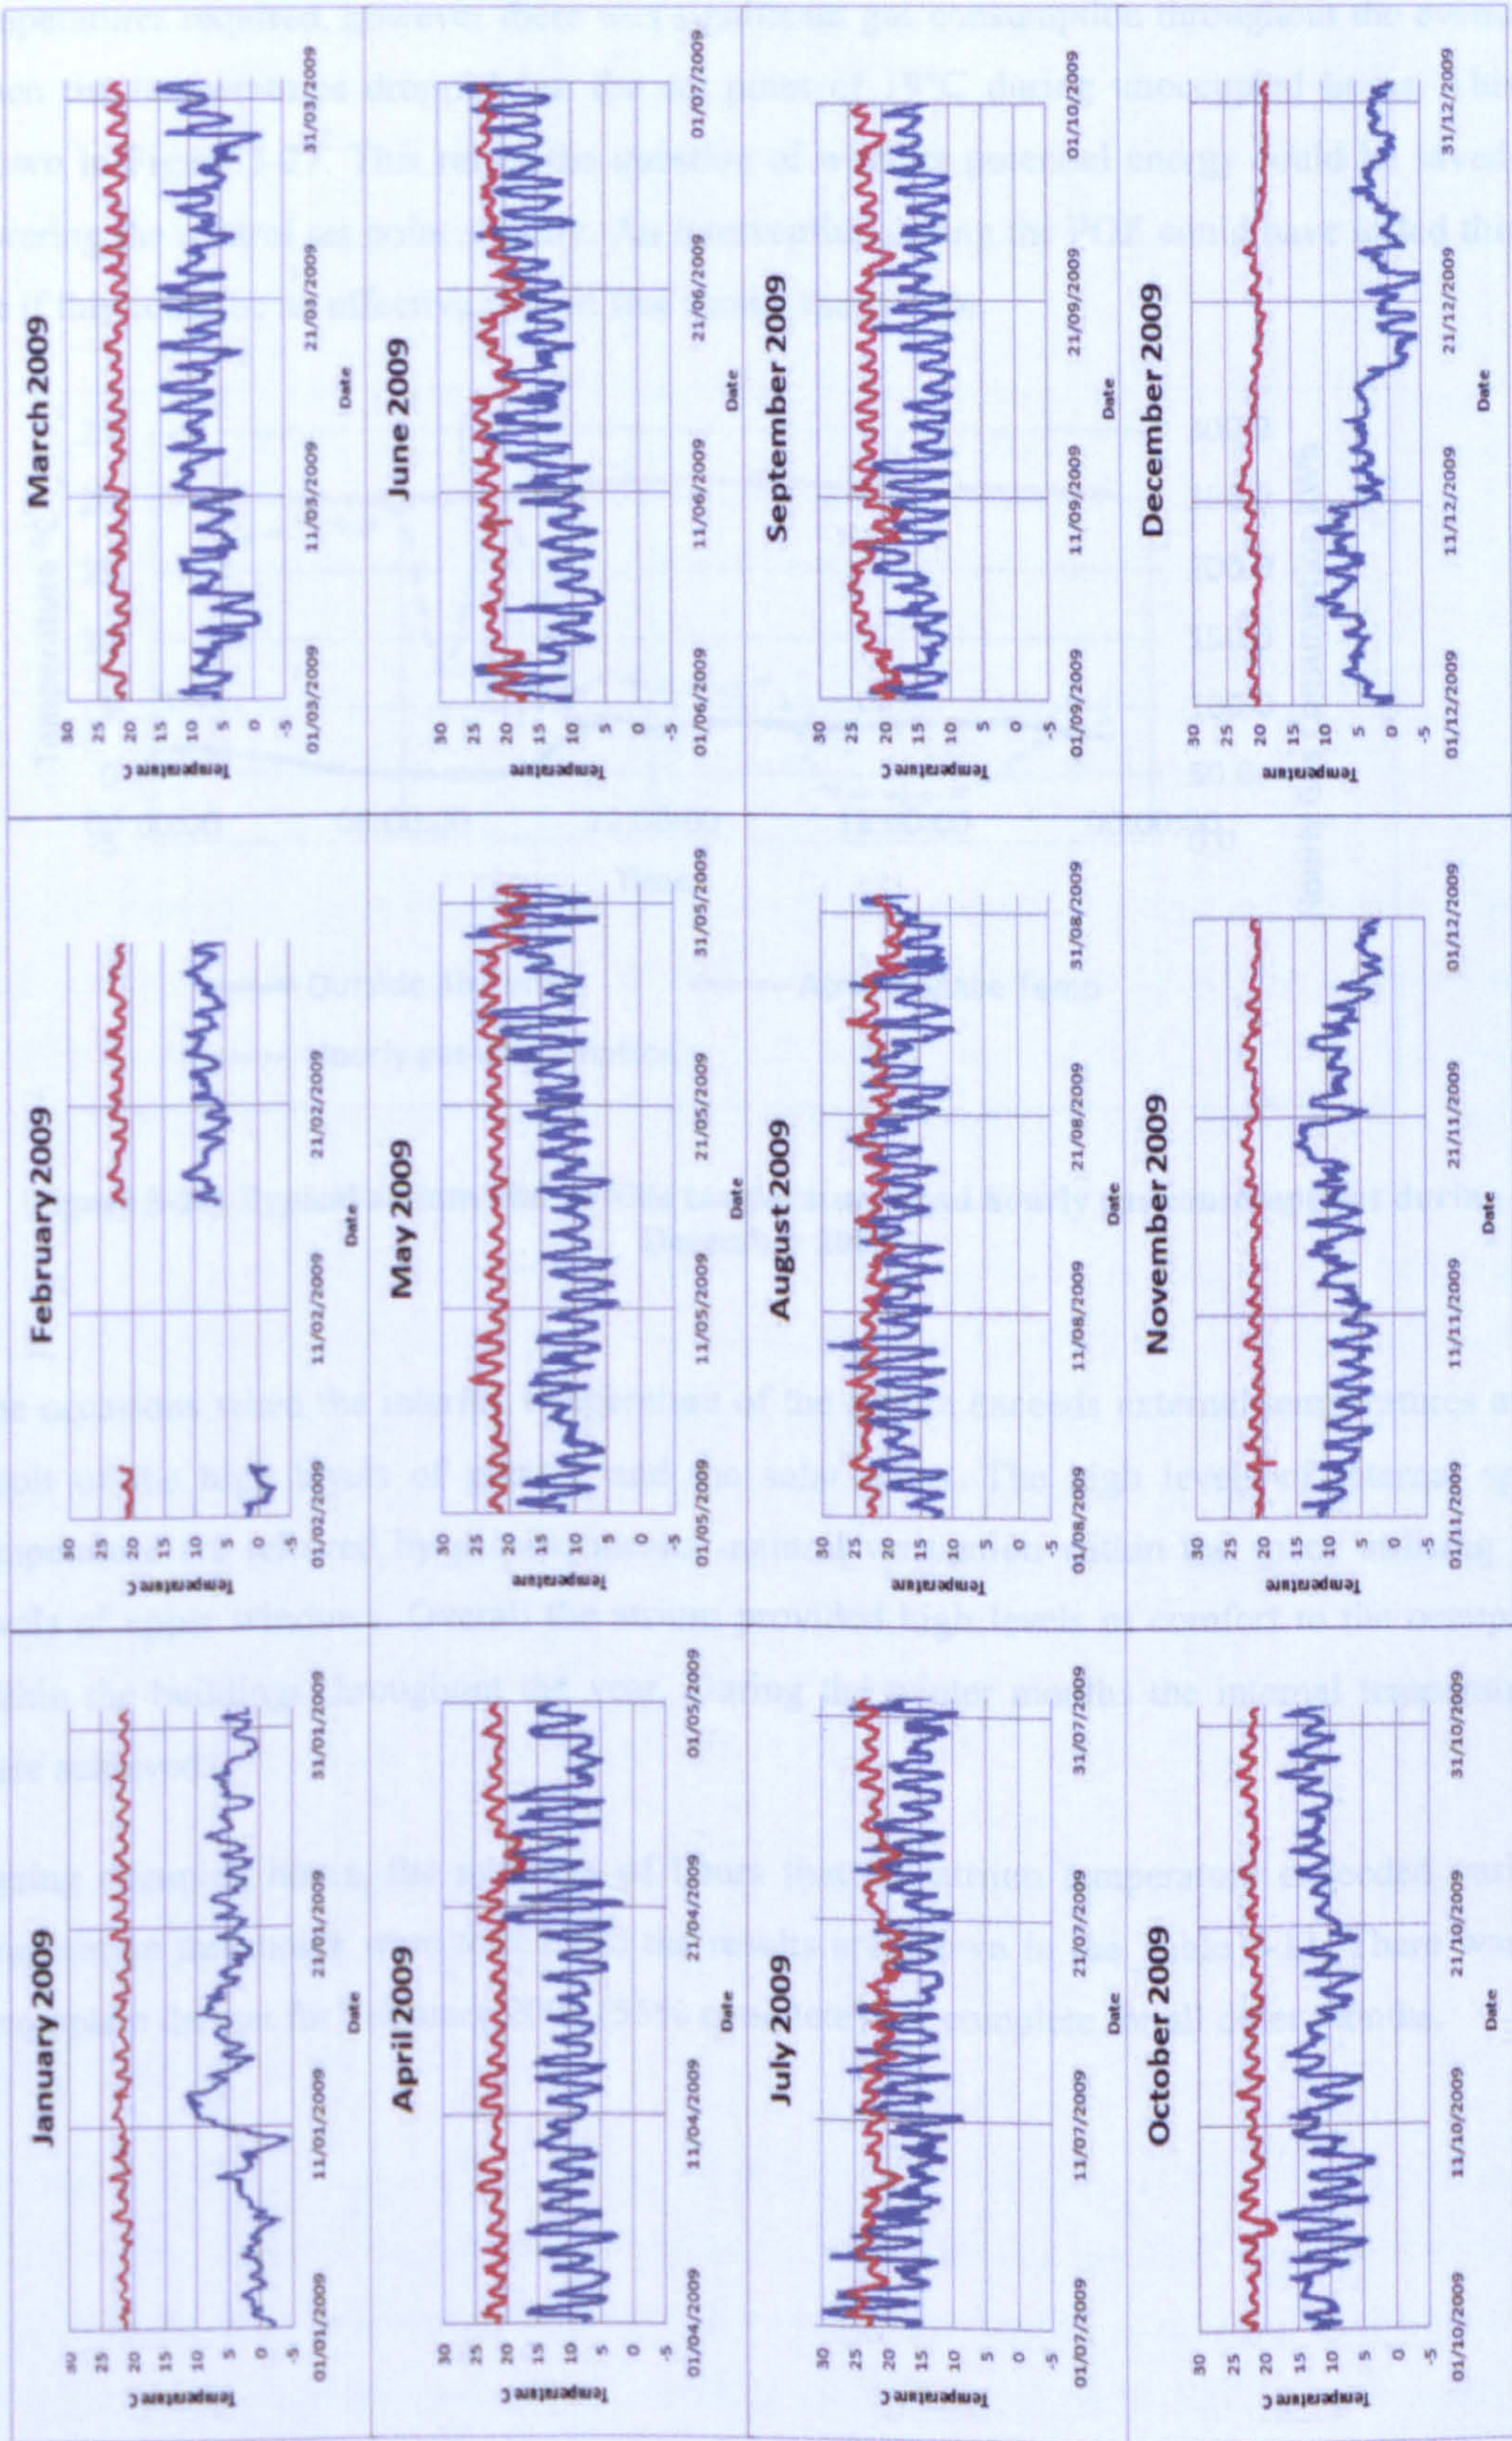
Figure 5-26: Monthly atrium and external temperatures (January 2009 to December 2009)

The atrium is a highly glazed area and there are significant amounts of heat loss through the roof. The control strategy set out to aim for an internal temperature of 21°C during occupied hours and 19°C during unoccupied hours. Constant operation of these types of underfloor heating systems is common as it can take a long time to warm up the space. Maintaining these temperatures, particularly during the night when there is significant heat losses due to the highly glazed atrium roof, results in a high boiler demands and therefore high energy consumption. The graphs in Figure 5-26 present the measured external temperature (shown as the blue line) and the internal space temperatures of the atrium (indicated by the red line).

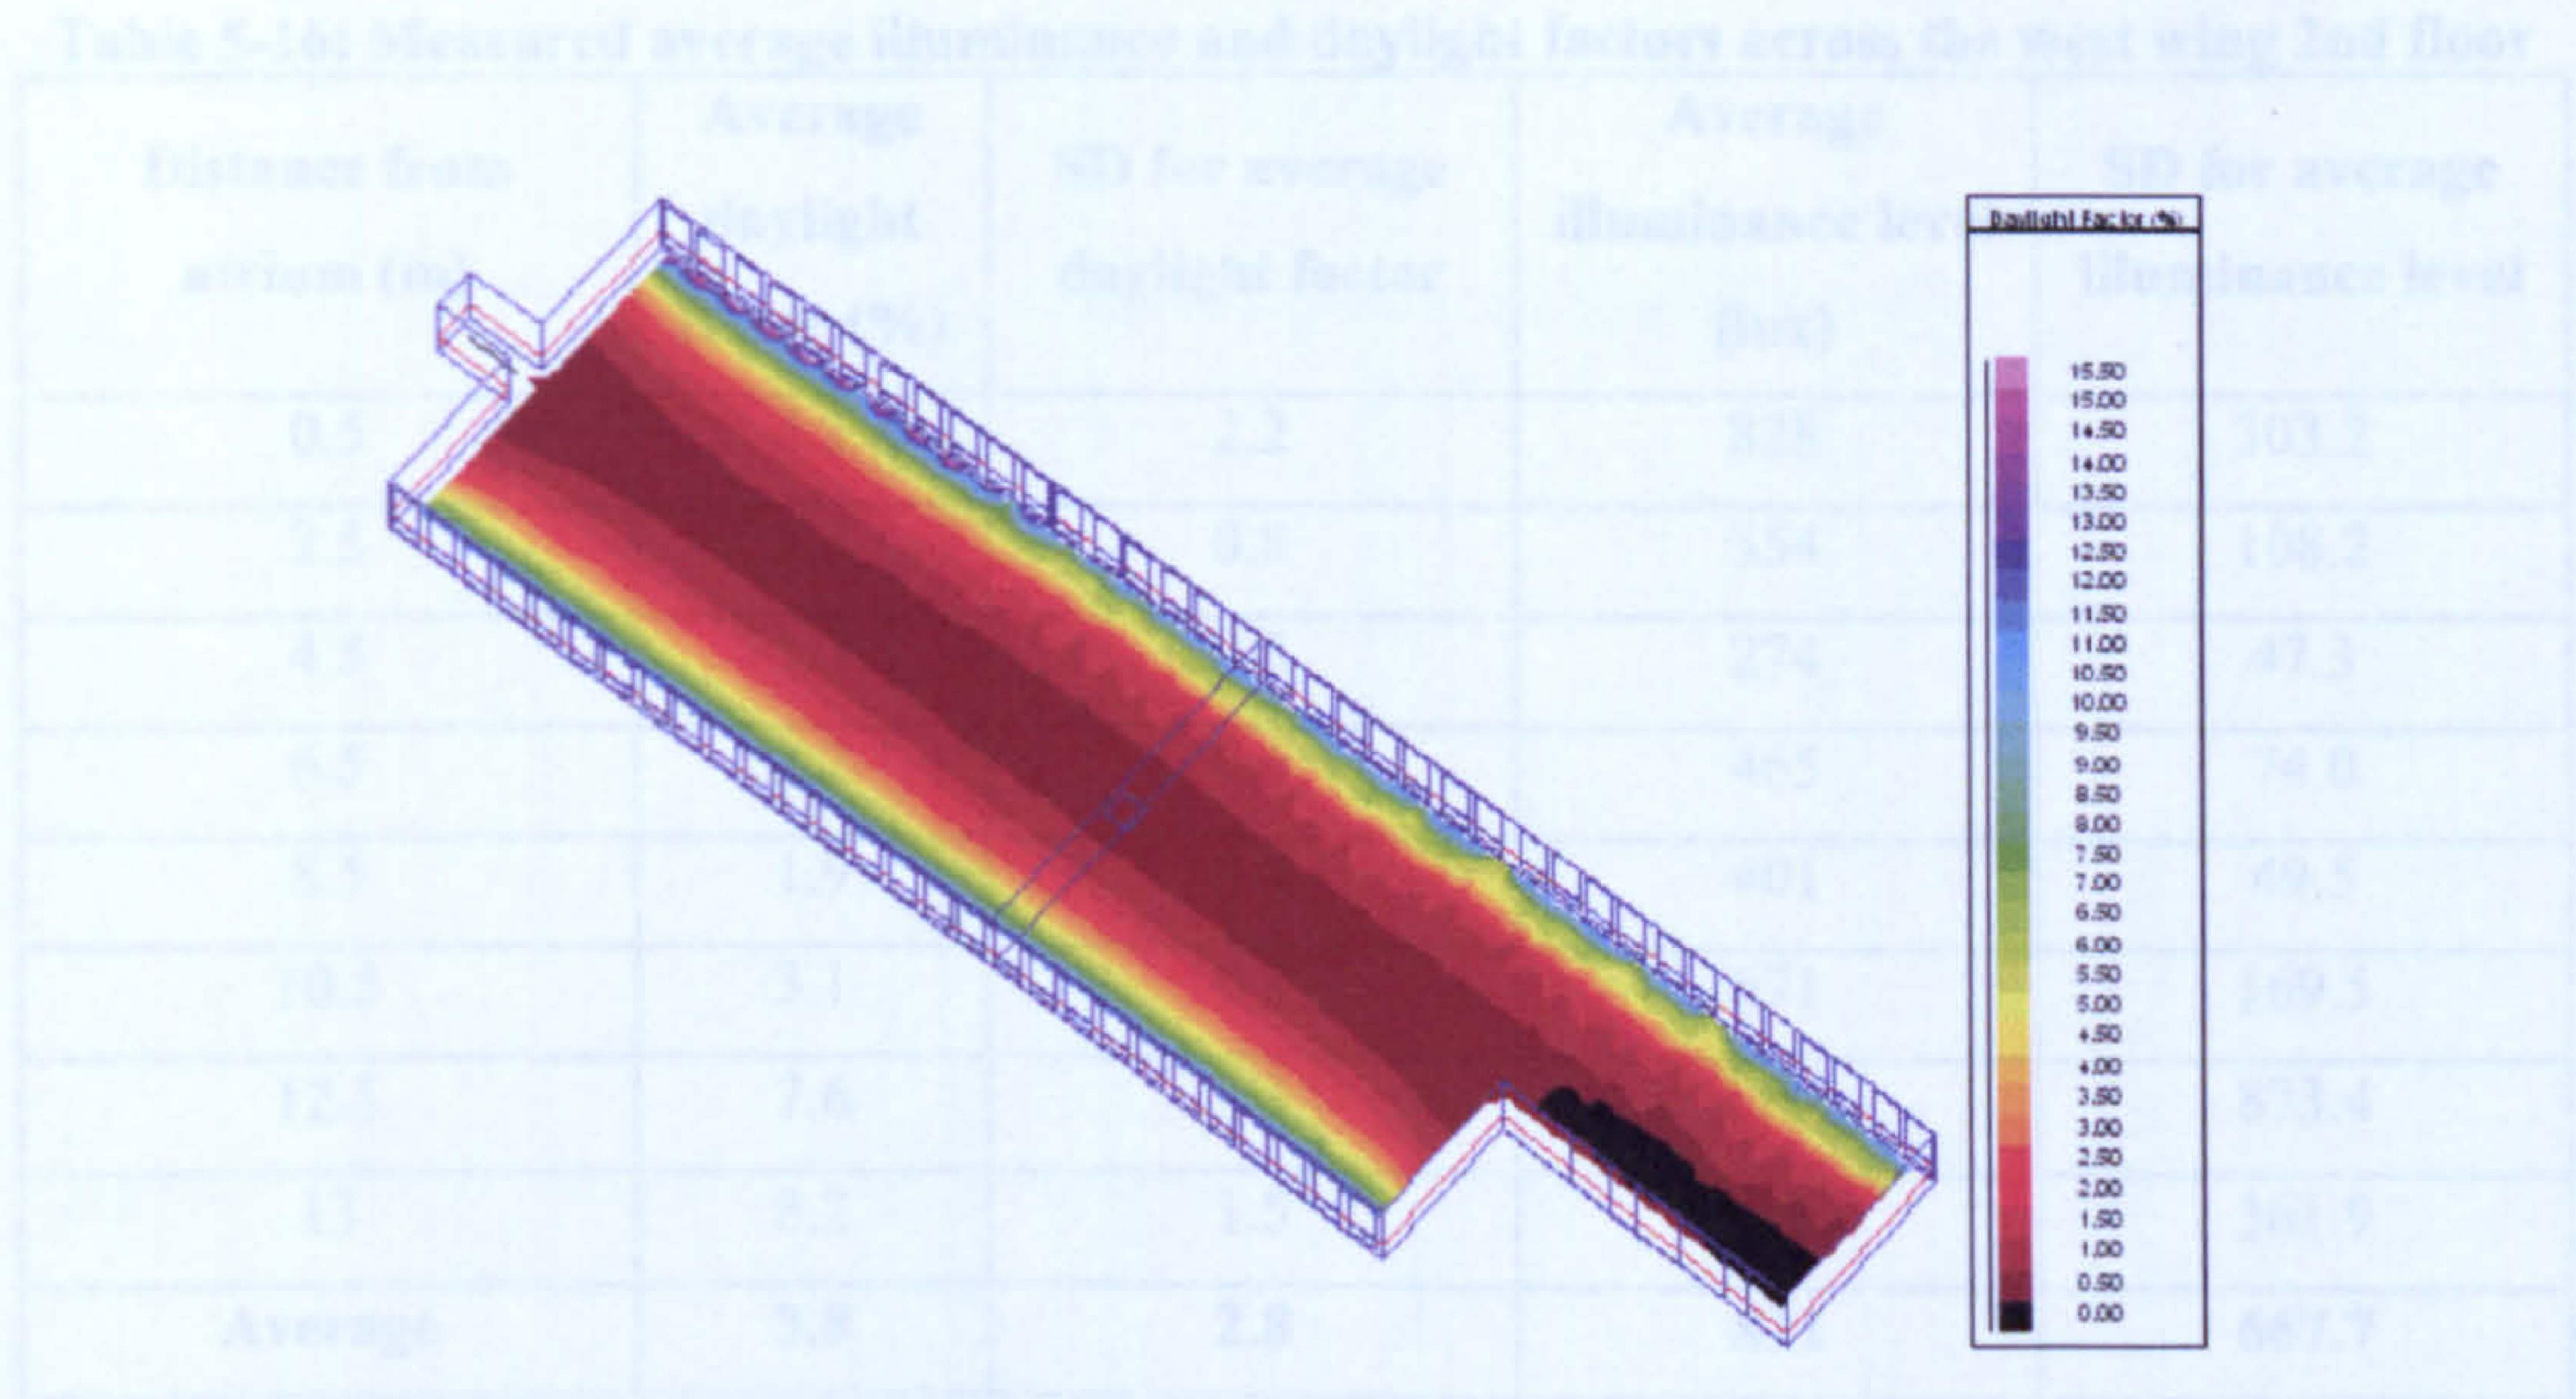
Figure 5-30: Simulated daylight factors for the west wing 2<sup>nd</sup> floor

The simulated average daylight factor for the west wing 2<sup>nd</sup> floor was calculated to be 3.1%, with an average illuminance of 374 lux. The daylight factors were simulated for September to be comparable with the measurements taken.

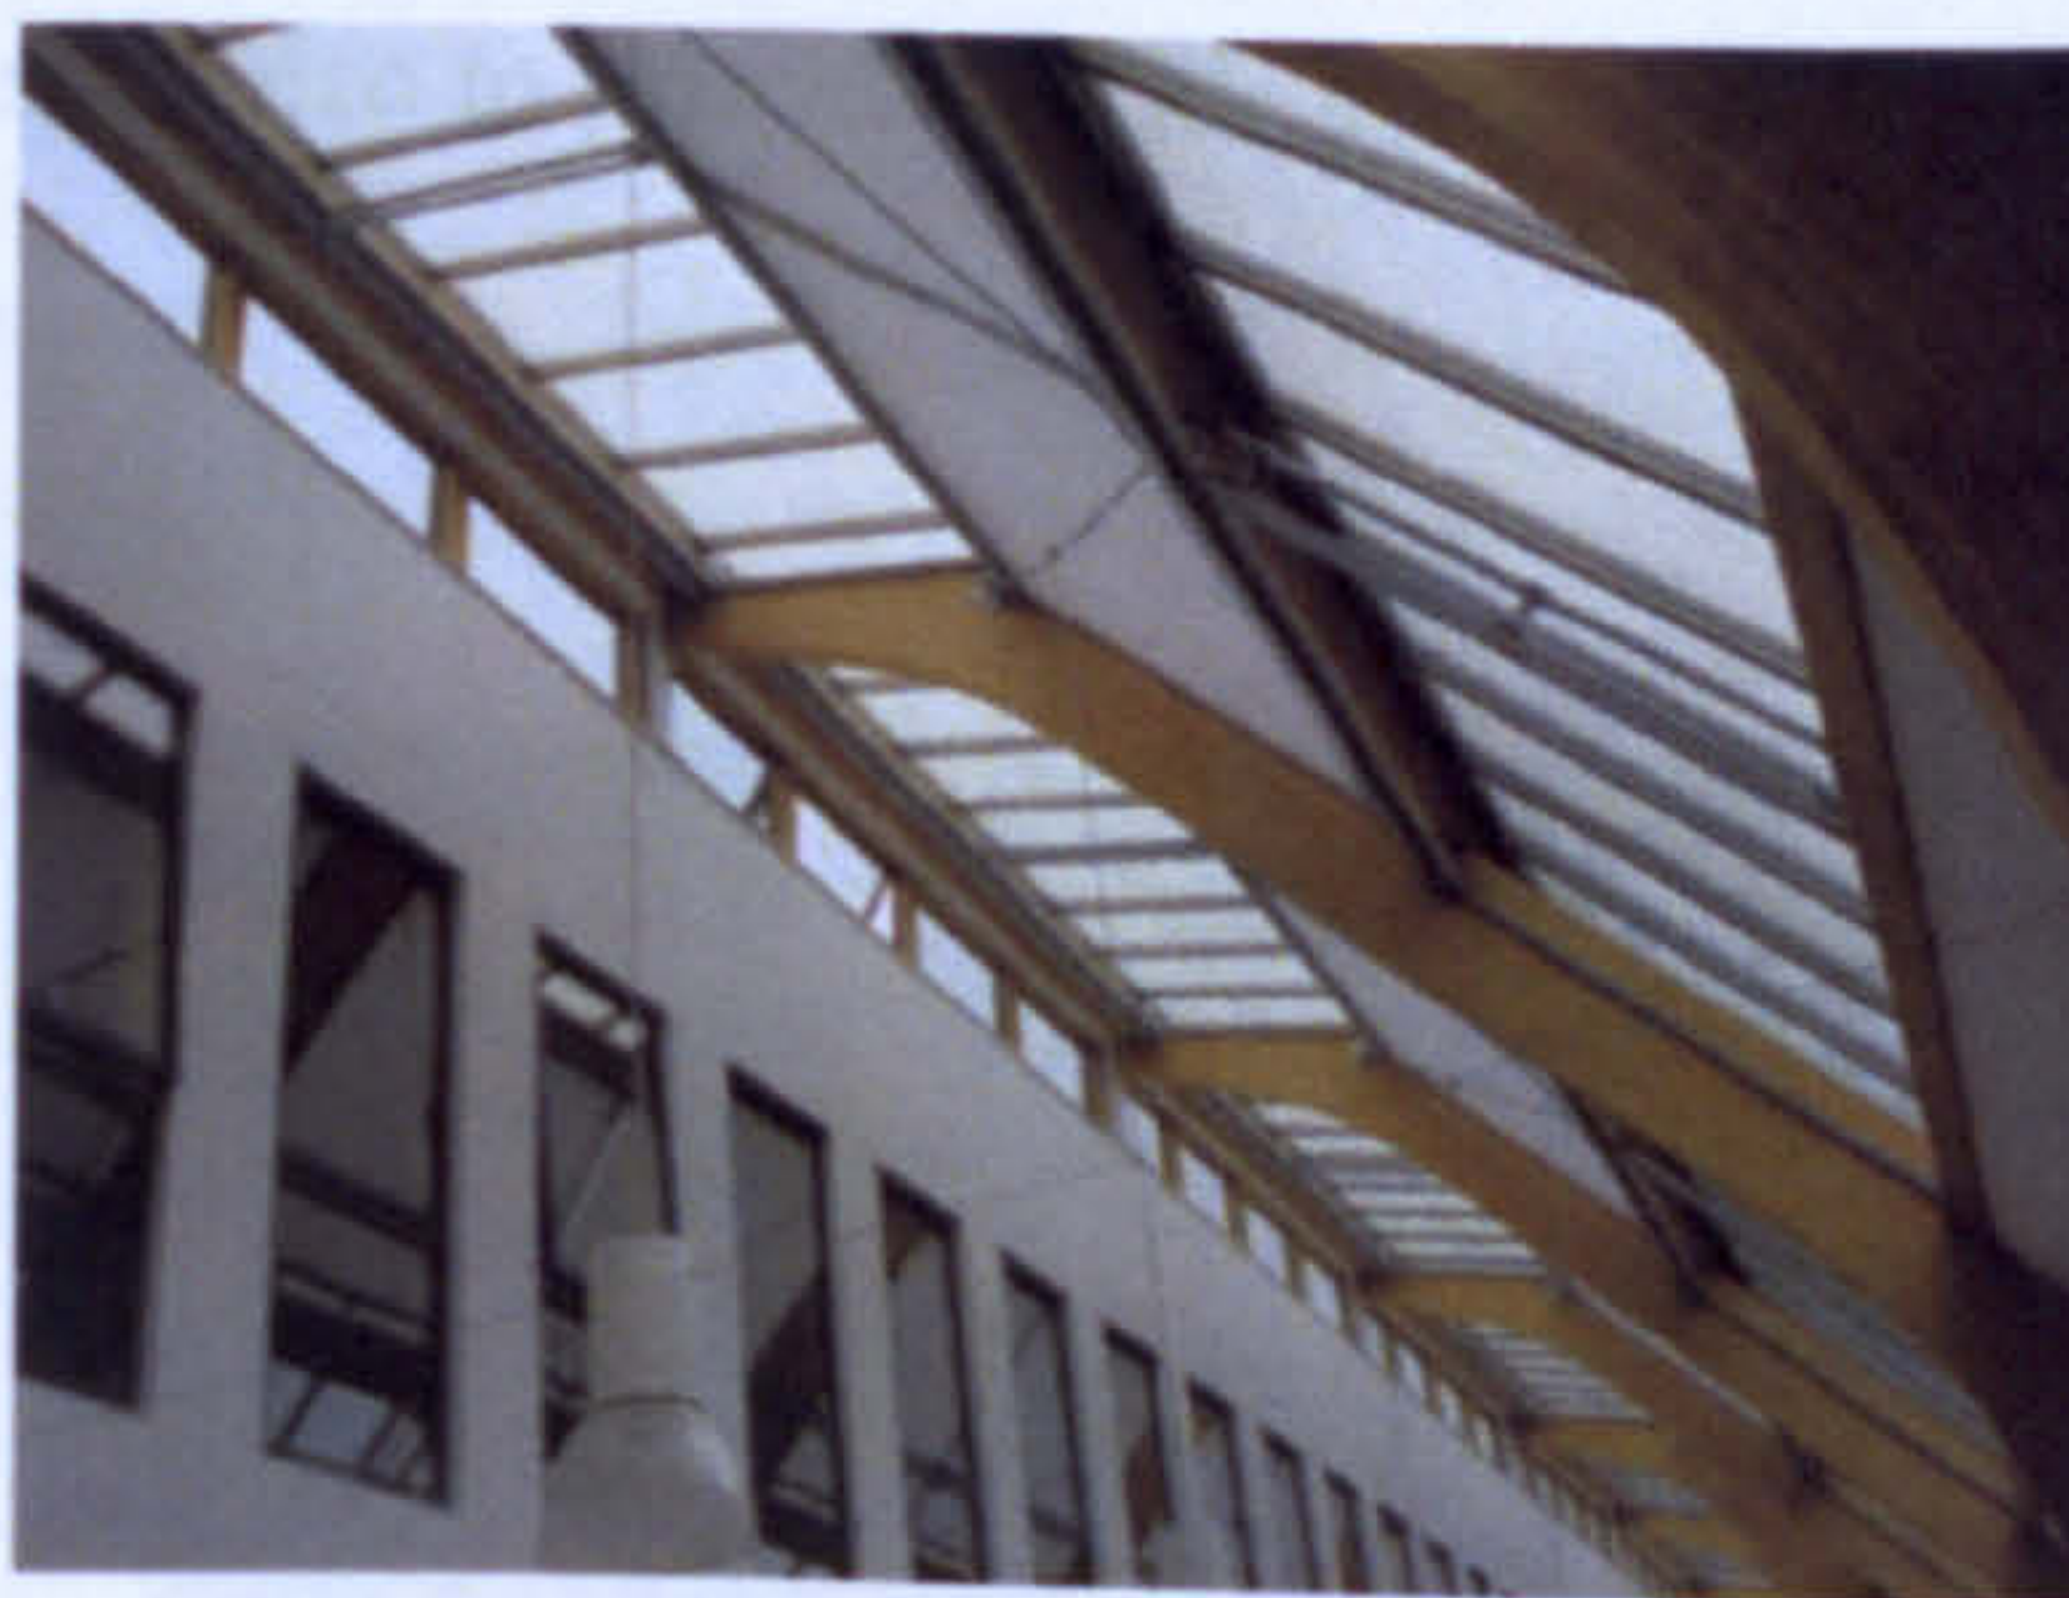
**Figure 5-33: Broken actuators in the natural ventilation strategy within the atrium**

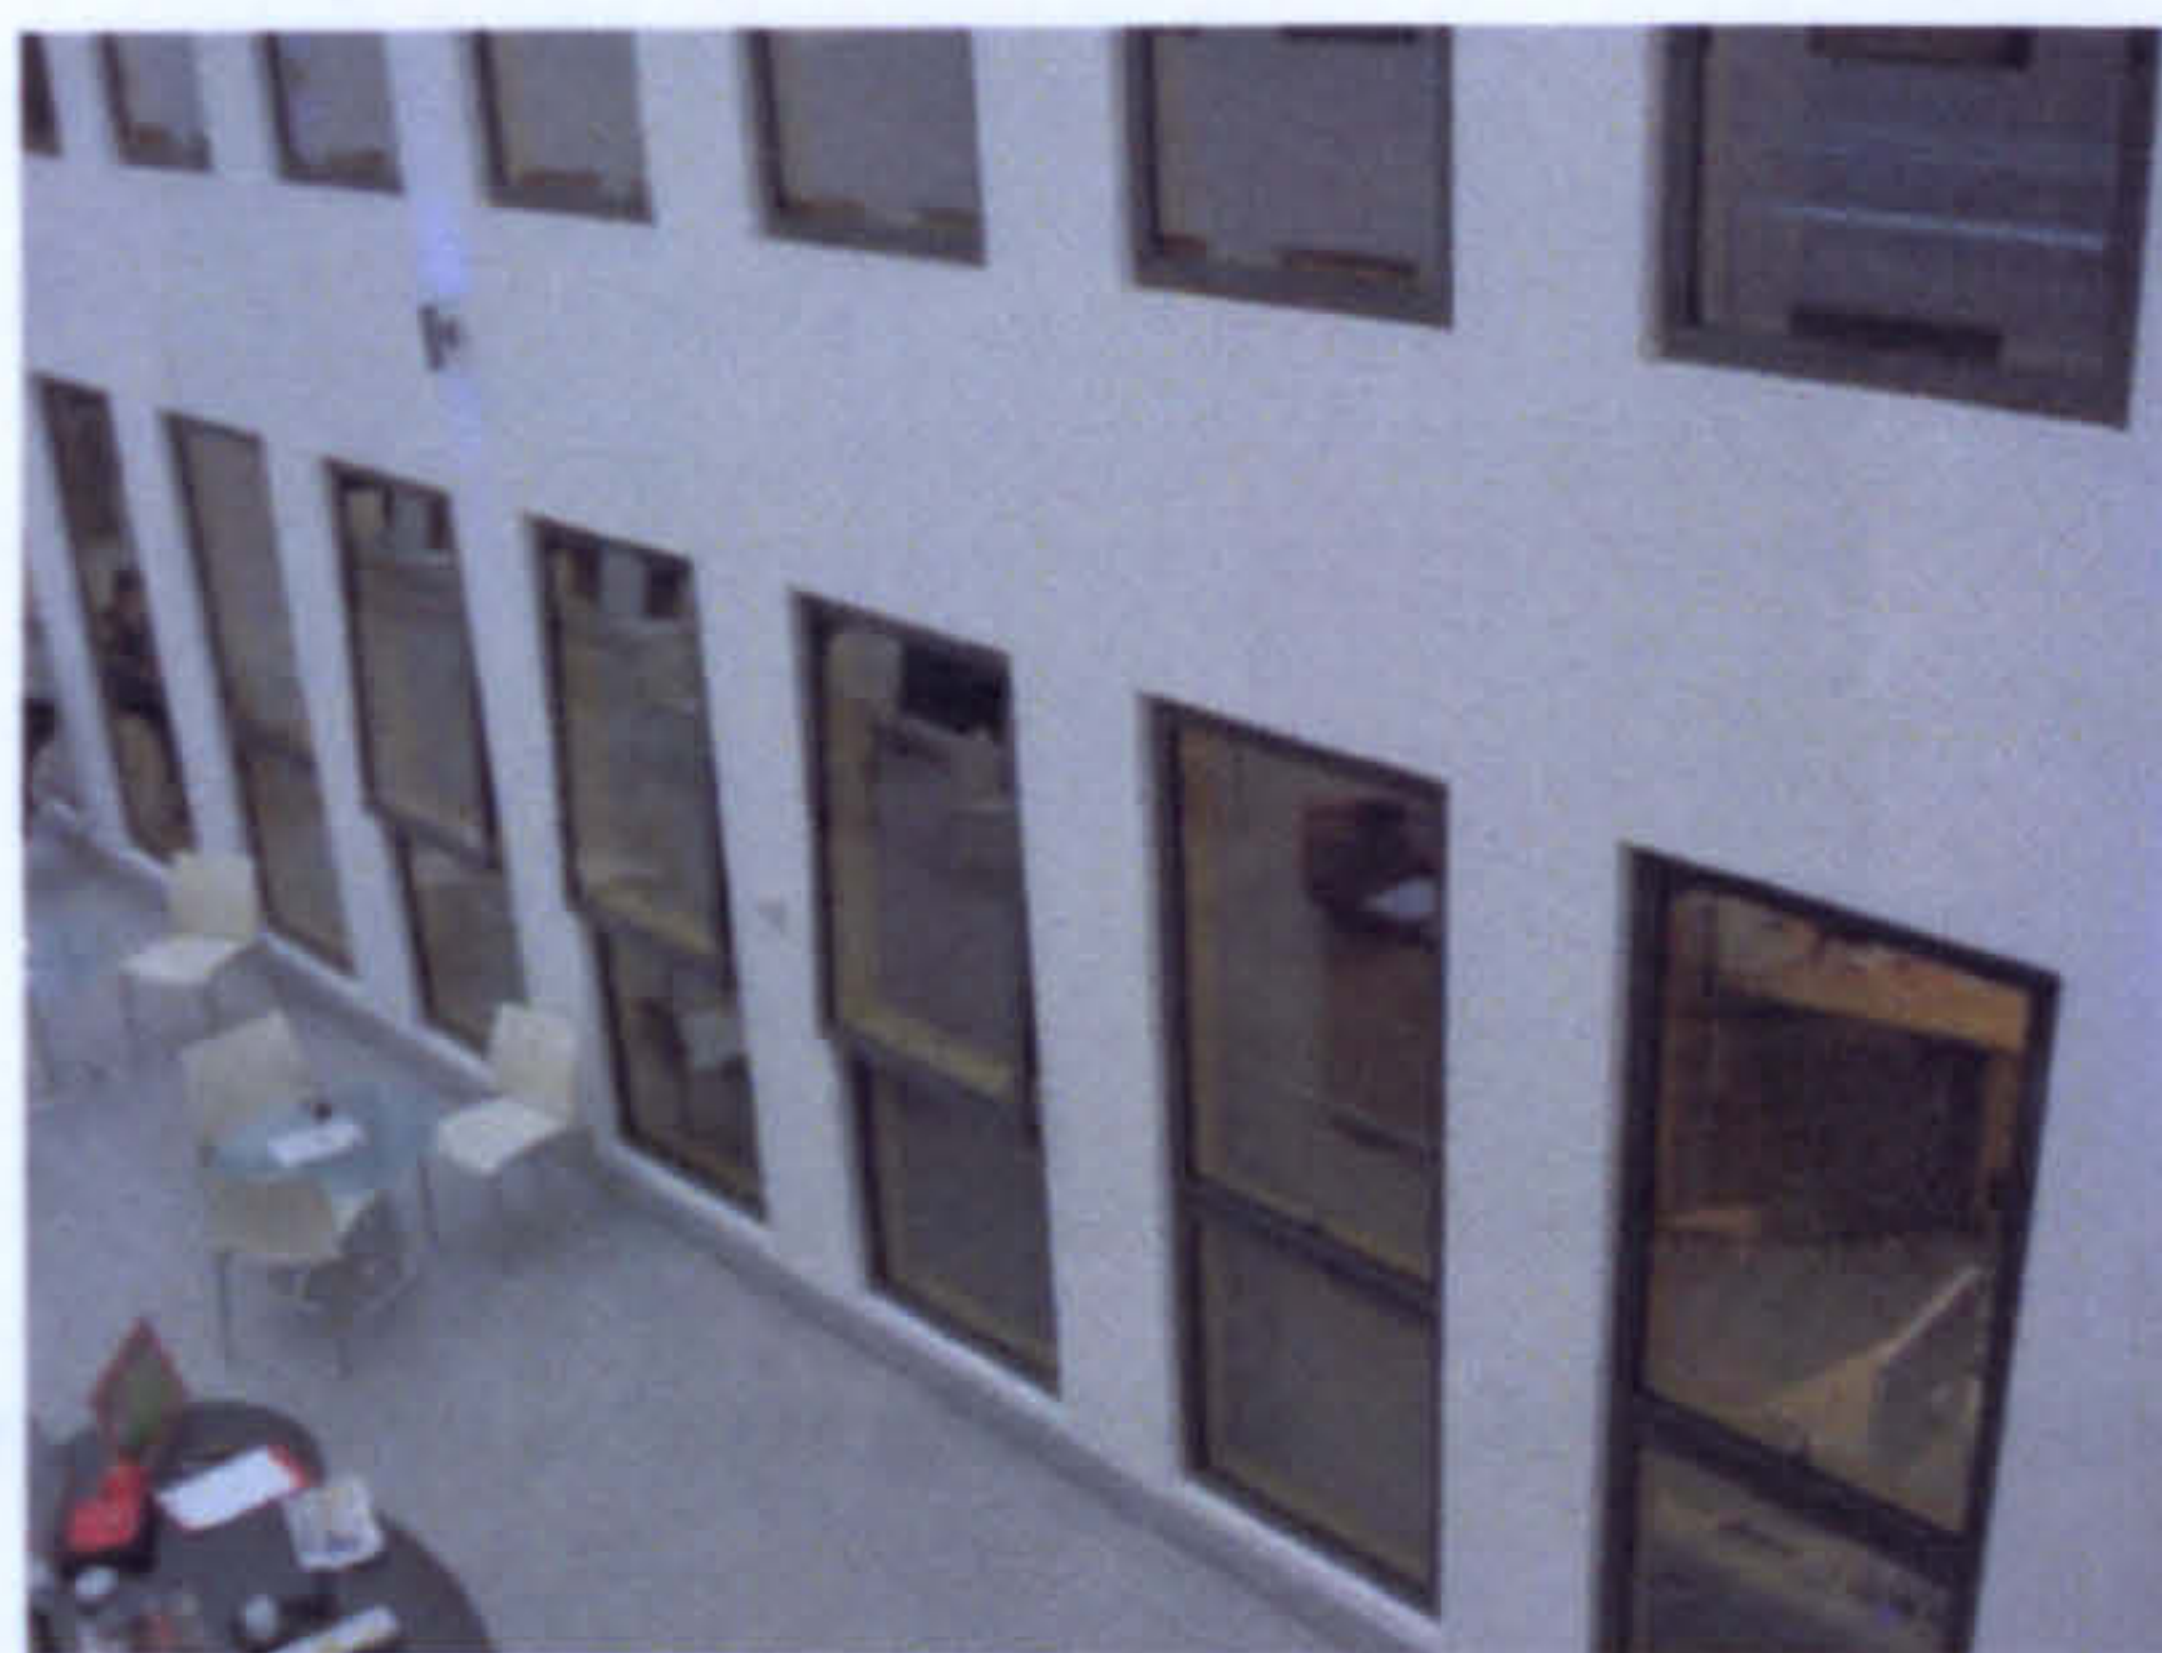
**Figure 5-34: Offices adjacent to the atrium with closed blinds**

2. Blinds were often down in the offices over-looking the atrium (as shown in Figure 5-34), presumably as a means of providing additional privacy. However, actions like these would have an adverse effect on the lighting consumption

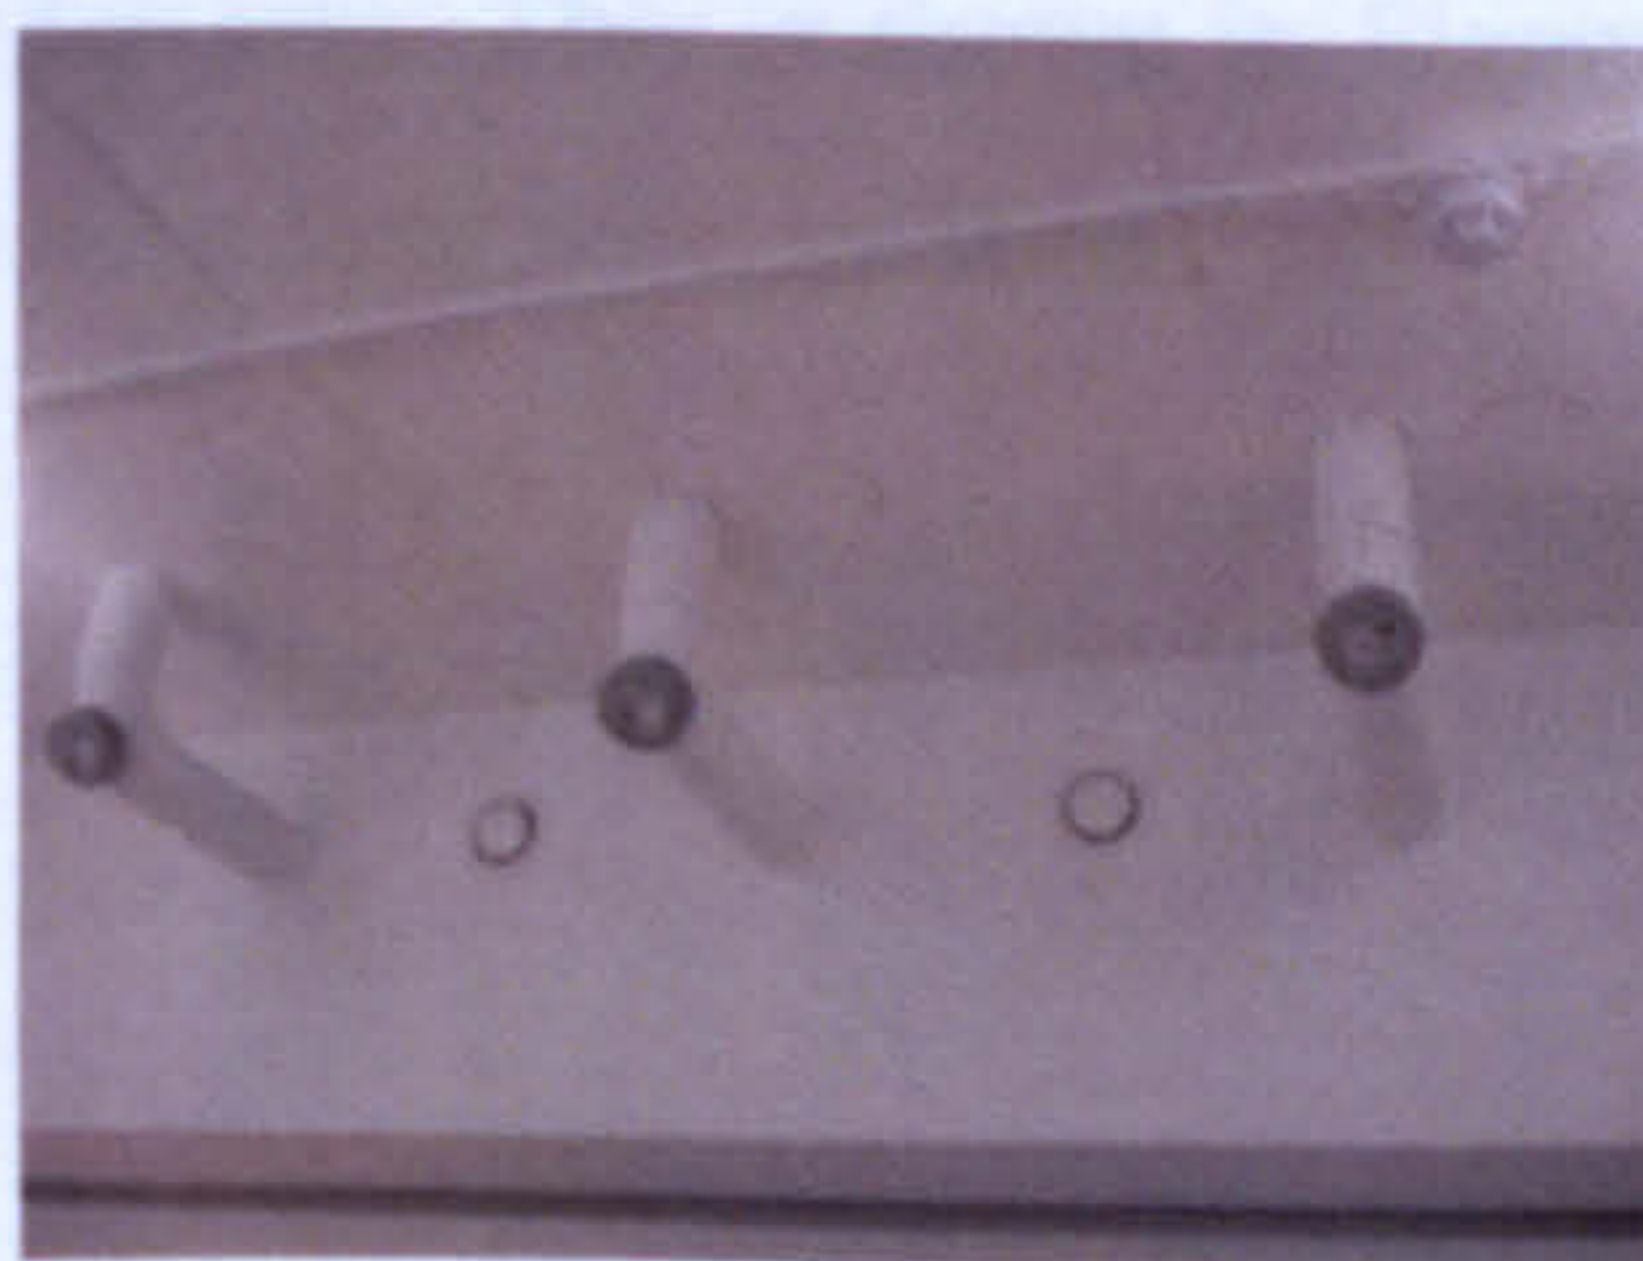
**Figure 5-35: Ventilation extract**

4. Partitioning issues: The impacts caused by partitioning were not thought-out effectively. Partitioning has carried out without seeking advice from a Termodeck Engineer; this has resulted in some offices having an imbalanced ventilation system. The open office layout relies on the central corridor space for ventilation extract, therefore when partitioning takes place extraction holes need to be drilled into the bulk head of the individual office to provide the air extraction. These extraction holes can be seen in Figure 5-35.

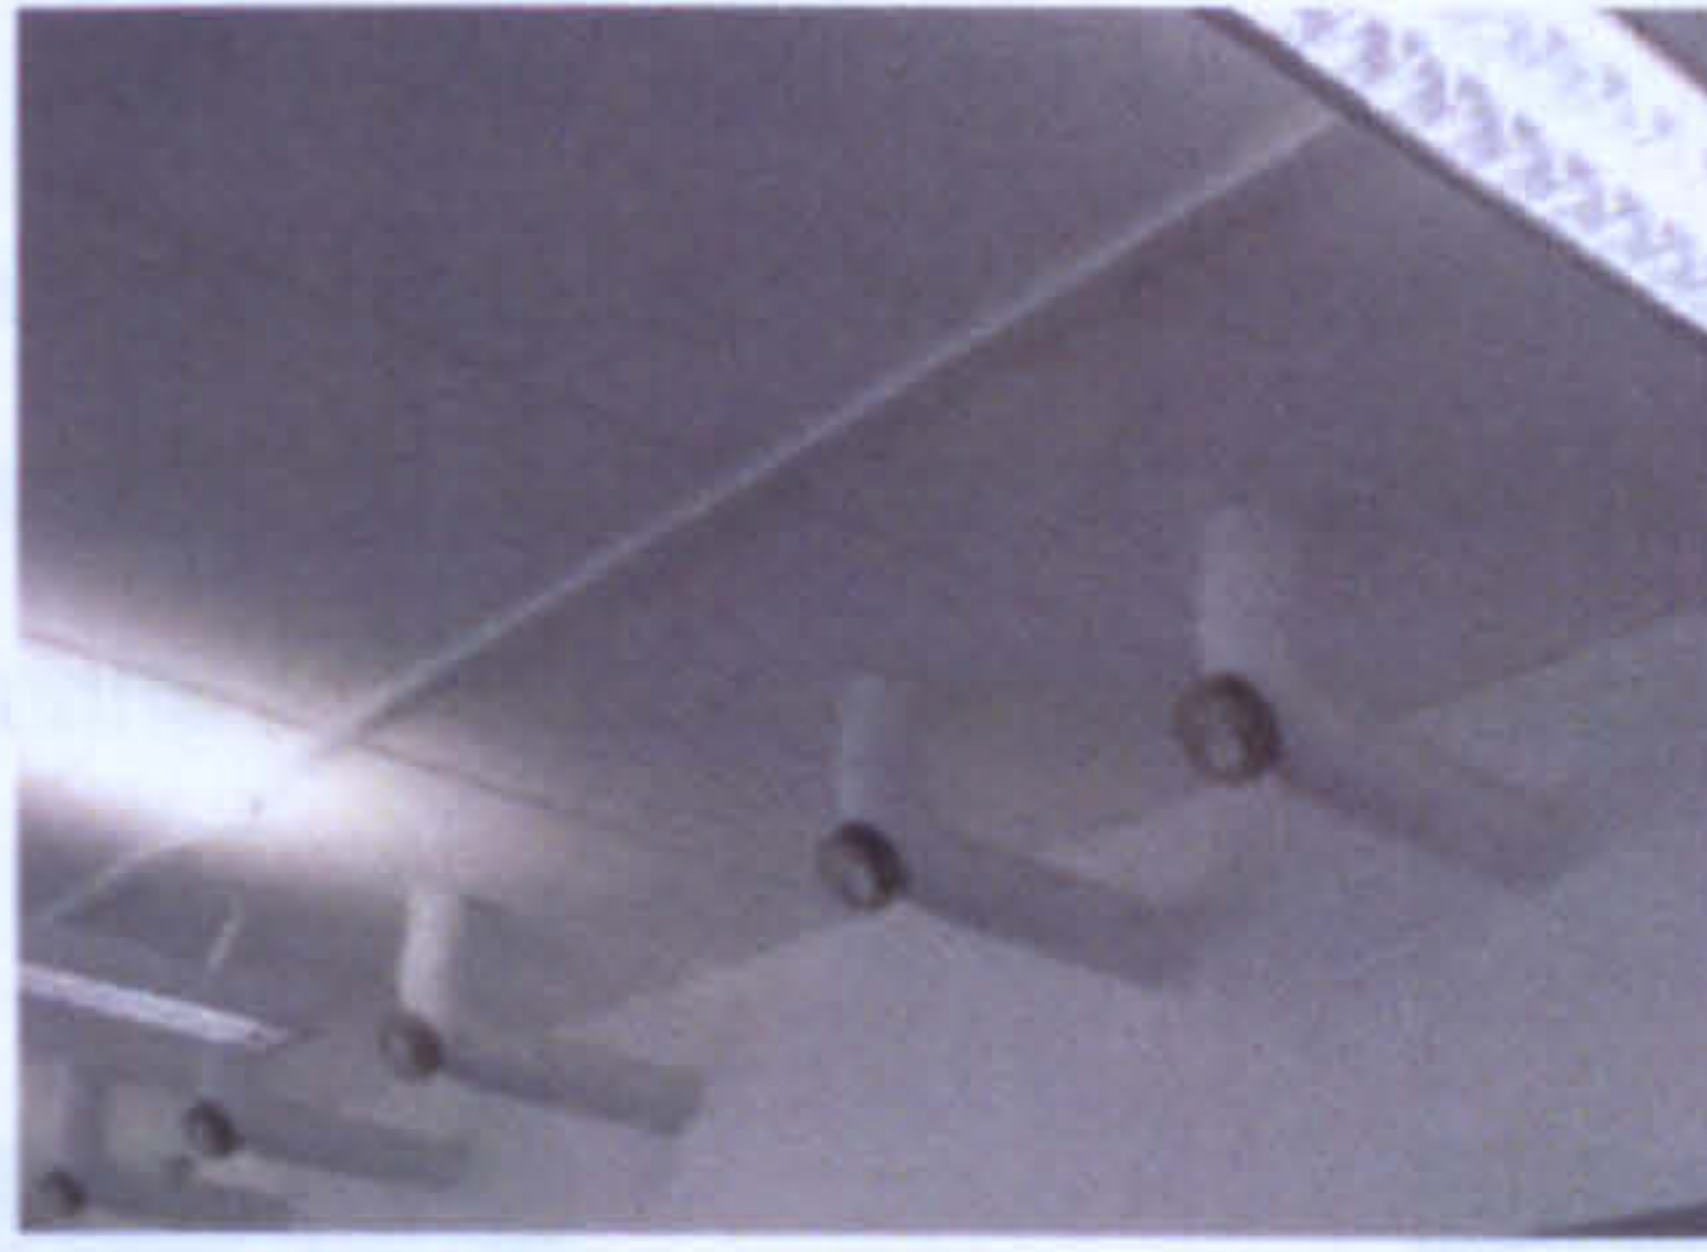
**Figure 5-36: No extract vents within the cellular office**
