# **AN APPRAISAL OF THE PERFORMANCE OF A 'GREEN' OFFICE BUILDING**

Submitted in accordance with the requirements for the degree of  
**Doctor of Philosophy**

The University of Leeds  
School of Civil Engineering

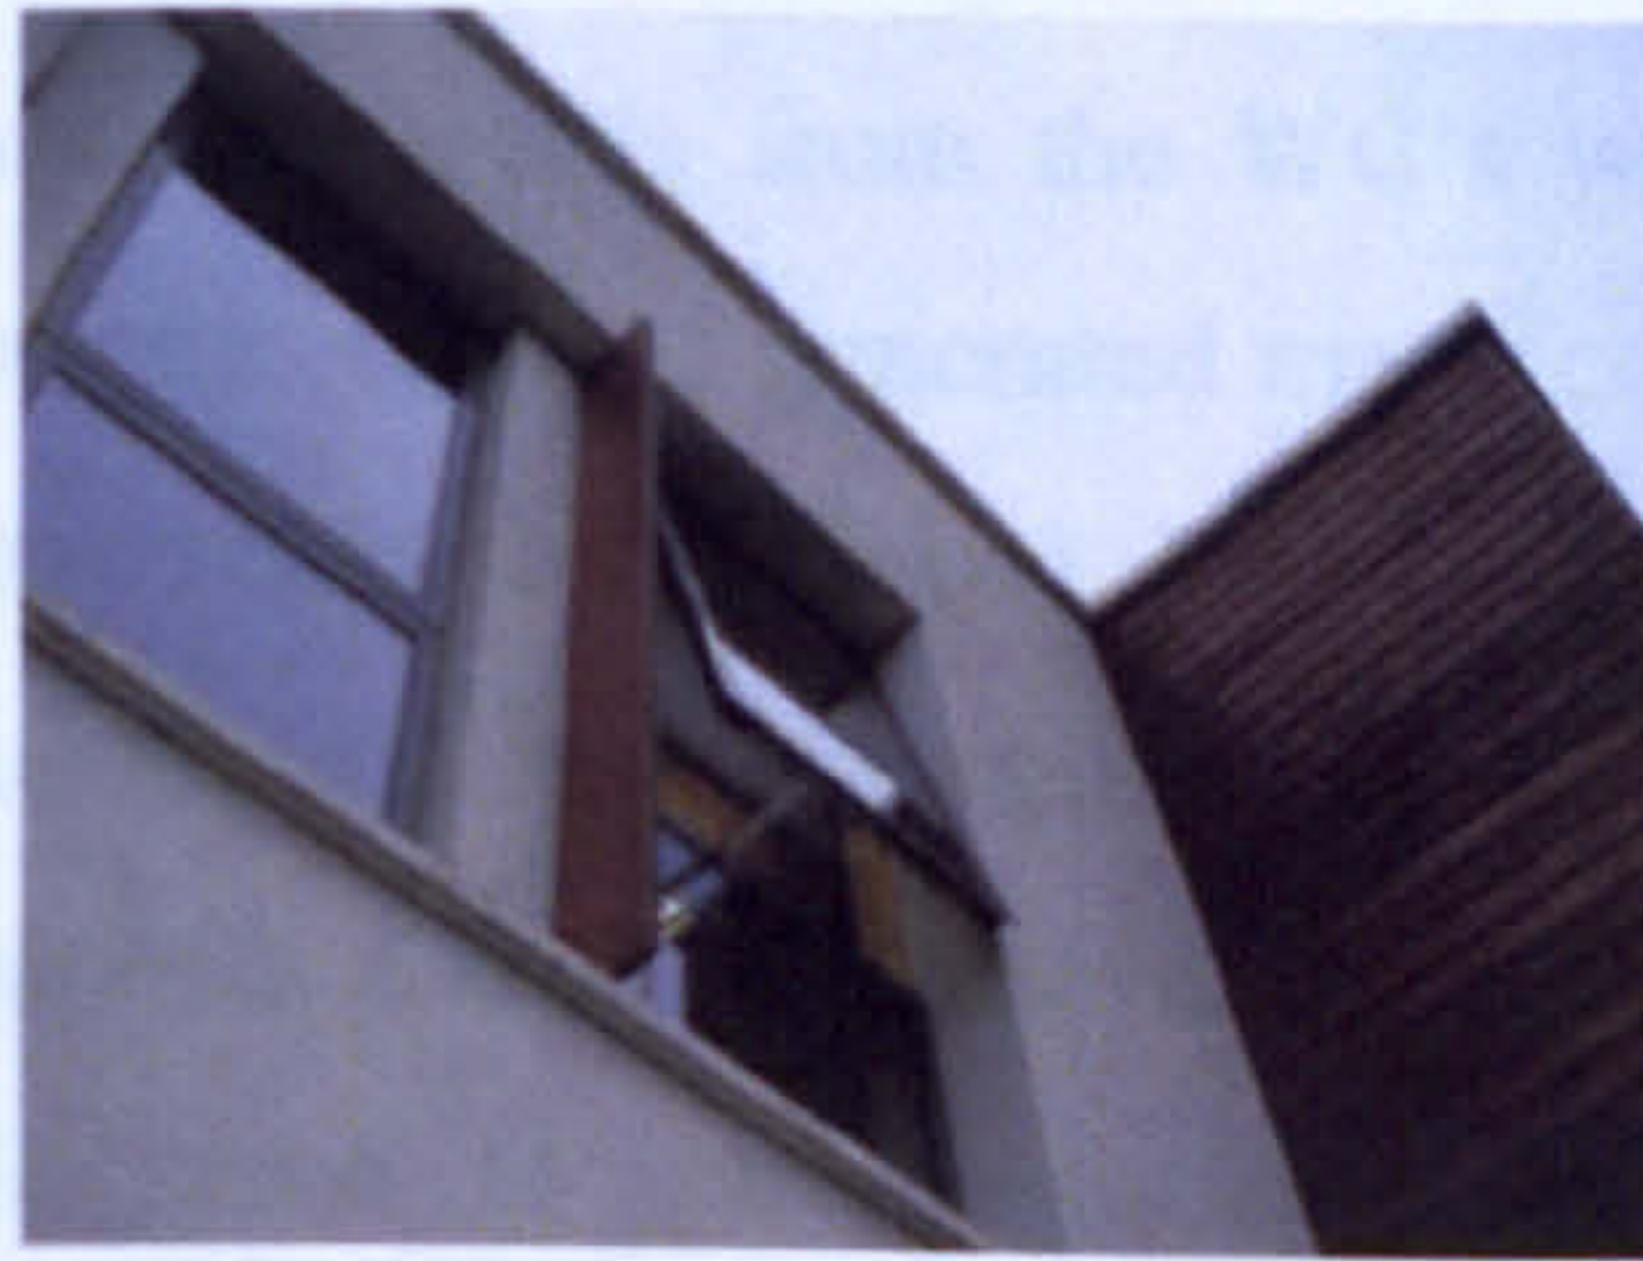
**Figure 5-37: Temporary solution by user**

The extent of the problems and the issues became evident as the occupants soon started to complain about the temperature and air conditions in these spaces and upon investigation it was found that there was no extraction within some offices (see Figure 5-36). As a means of coping with the discomfort the occupiers were using a ruler to prop open the window. This is shown in Figure 5-37.

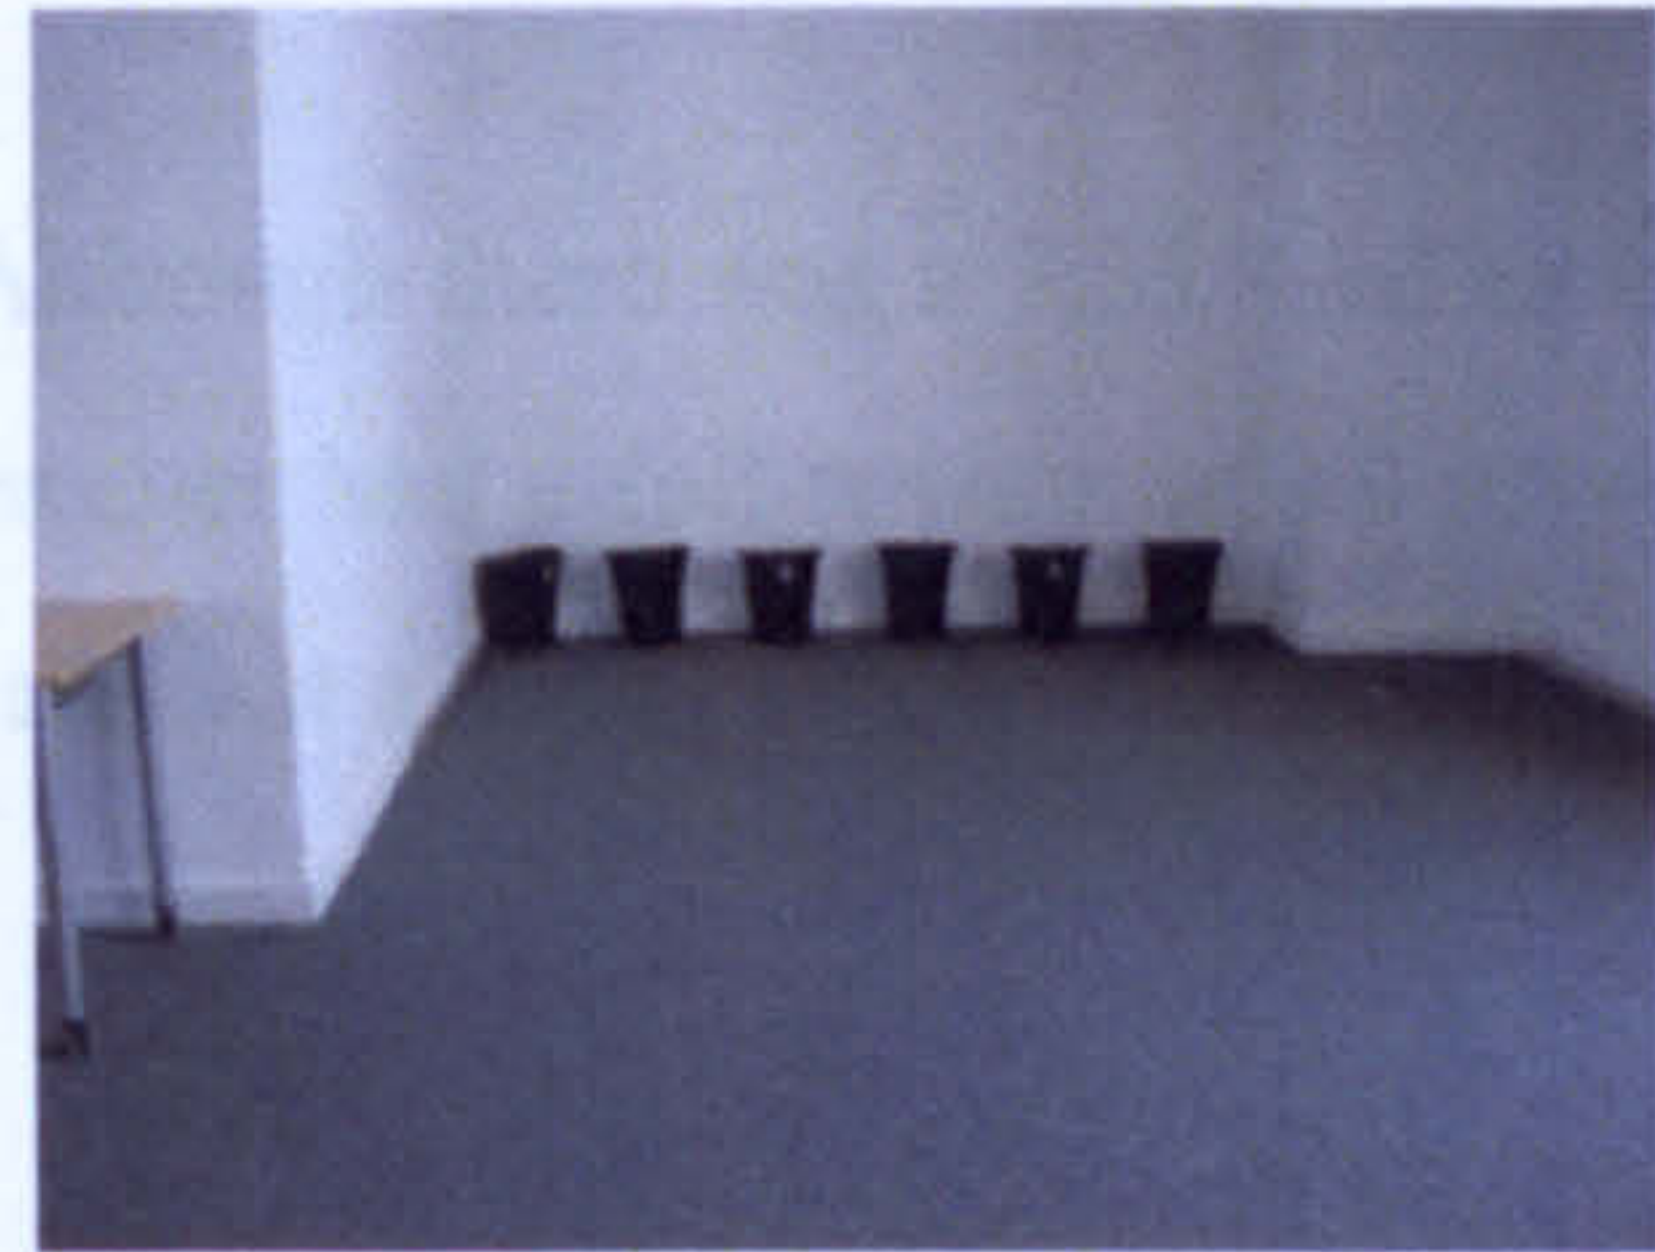
**Figure 5-40: Temporary measure**

5. On both wings there were issues with roof leaks. The leaking was initially identified during visits when thermal imaging was conducted. The leaking caused considerable damage to walls (Figure 5-39) and the carpets within the buildings and has also caused some of the lighting units to rust. As a temporary measure buckets were positioned to reduce the damage to the fabrics (see Figure 5-40).

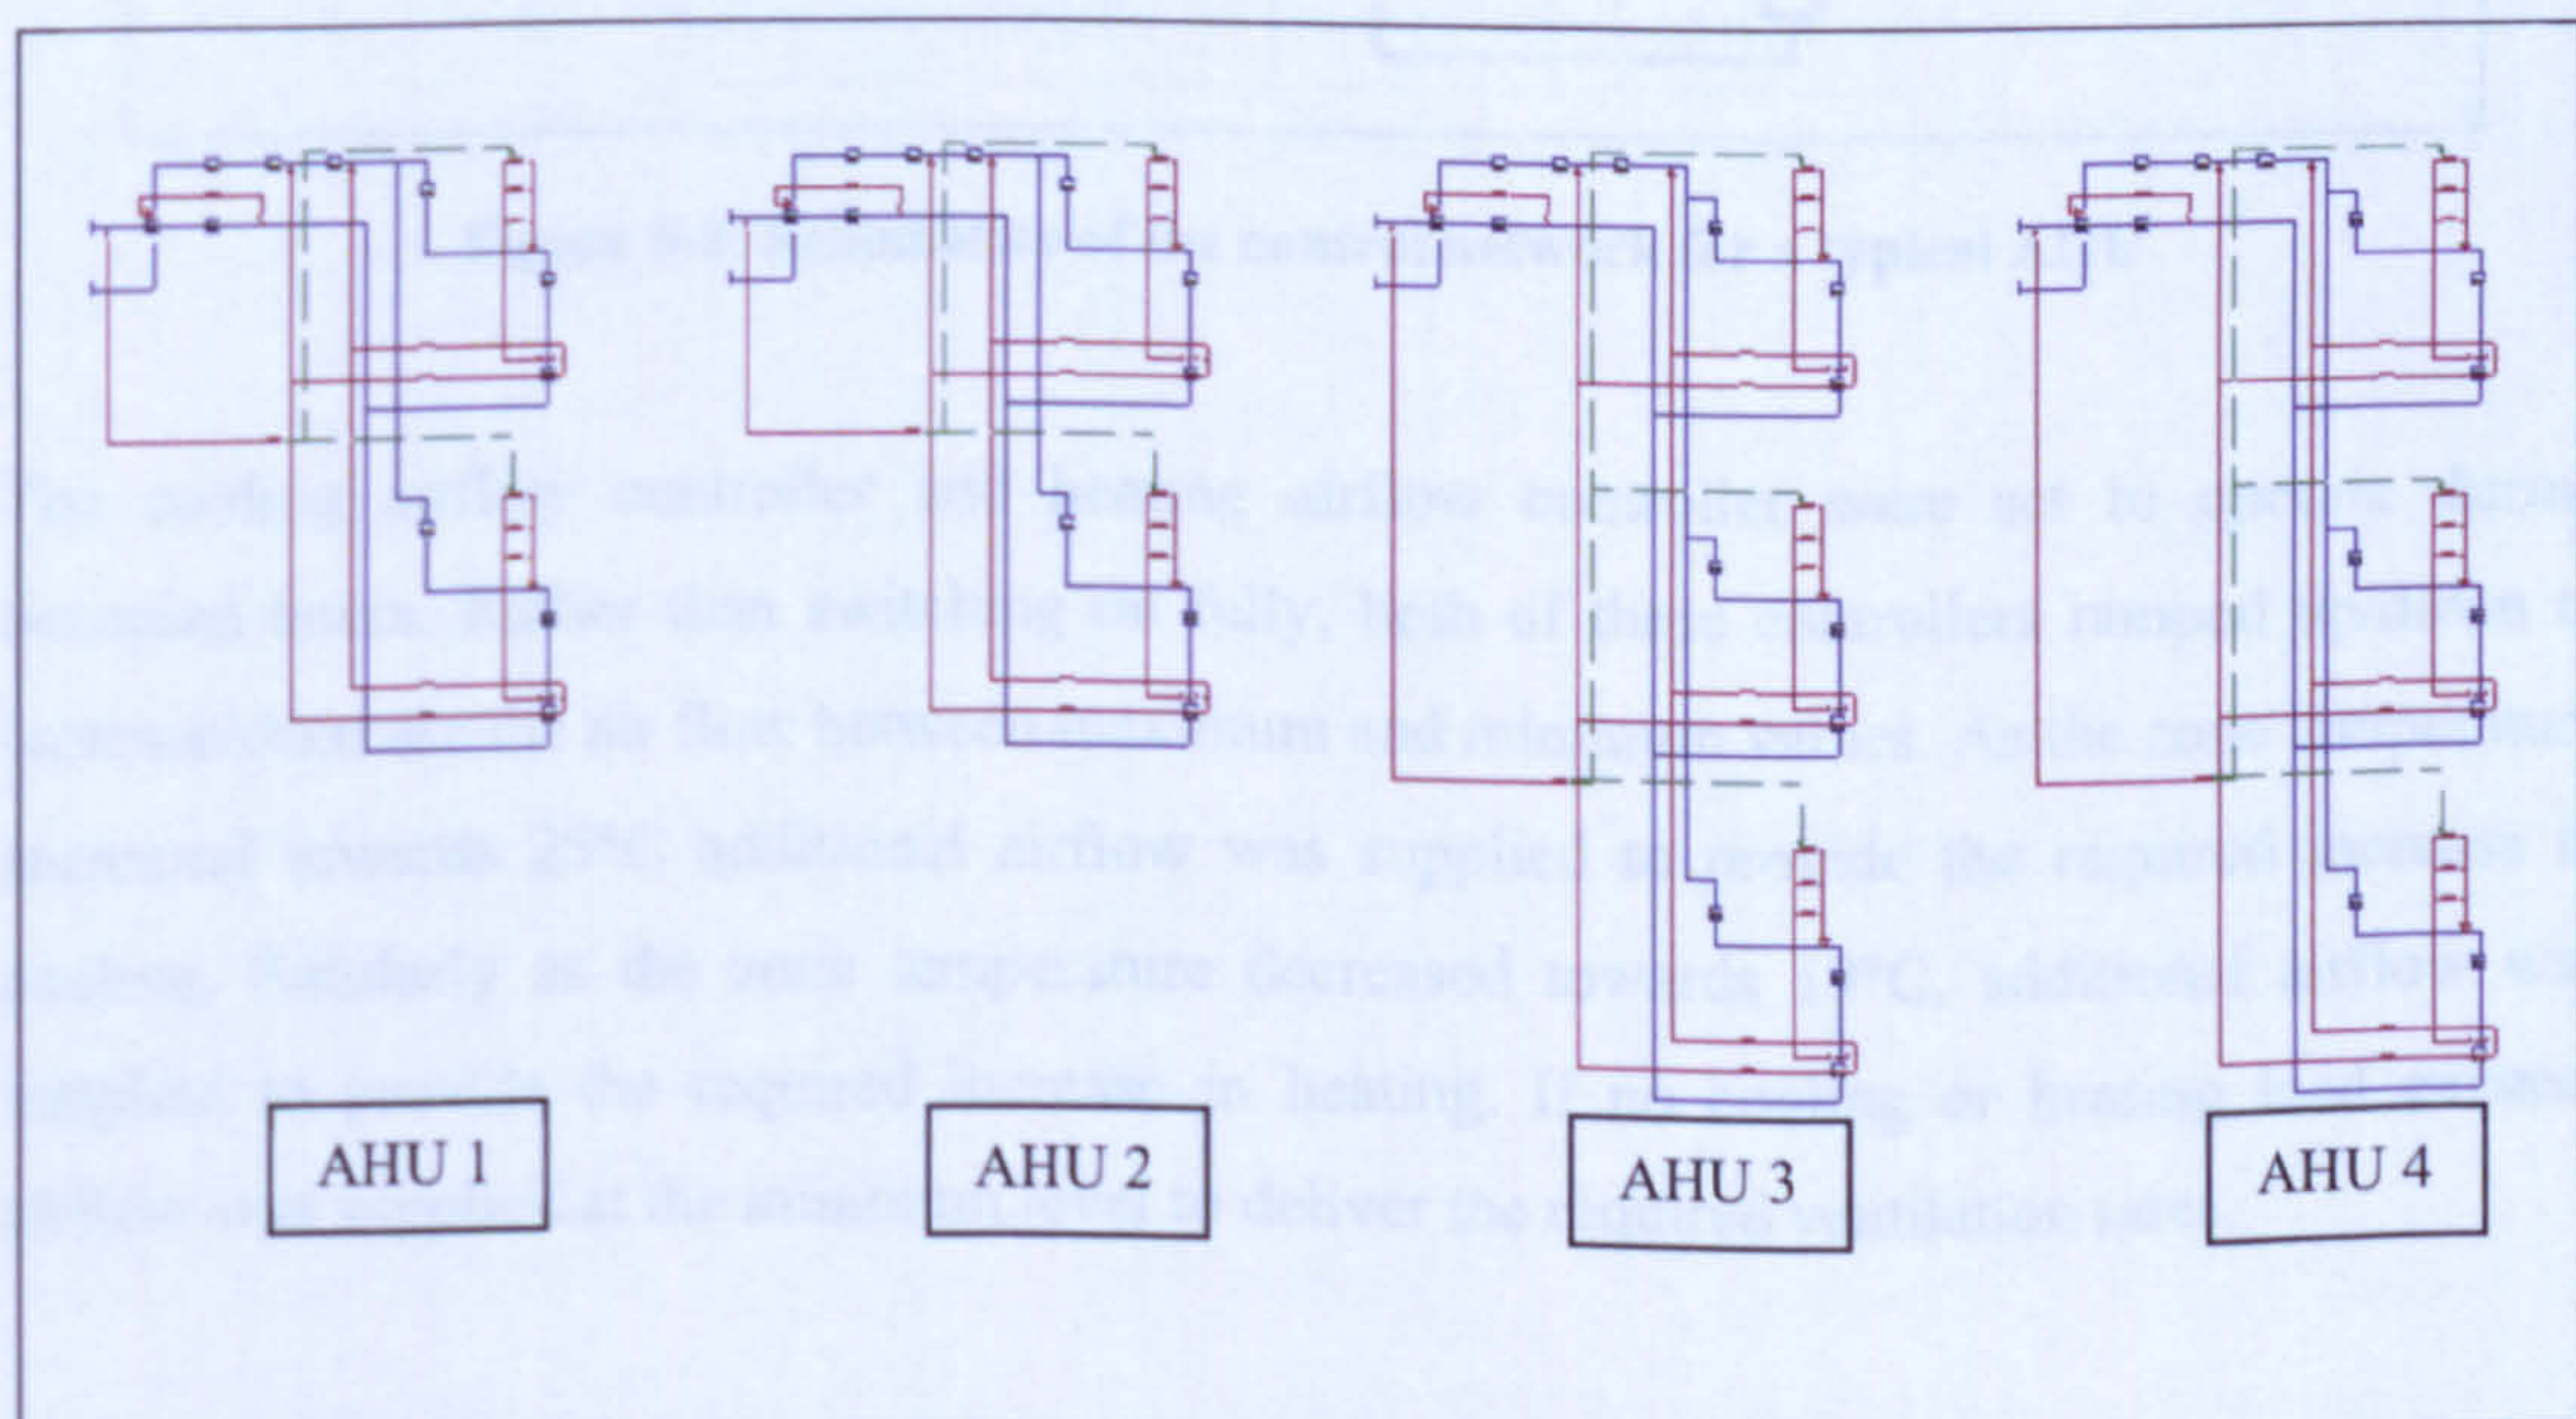
Figure 6-1: The IES ApacheHVAC network created to mimic the installed building systems

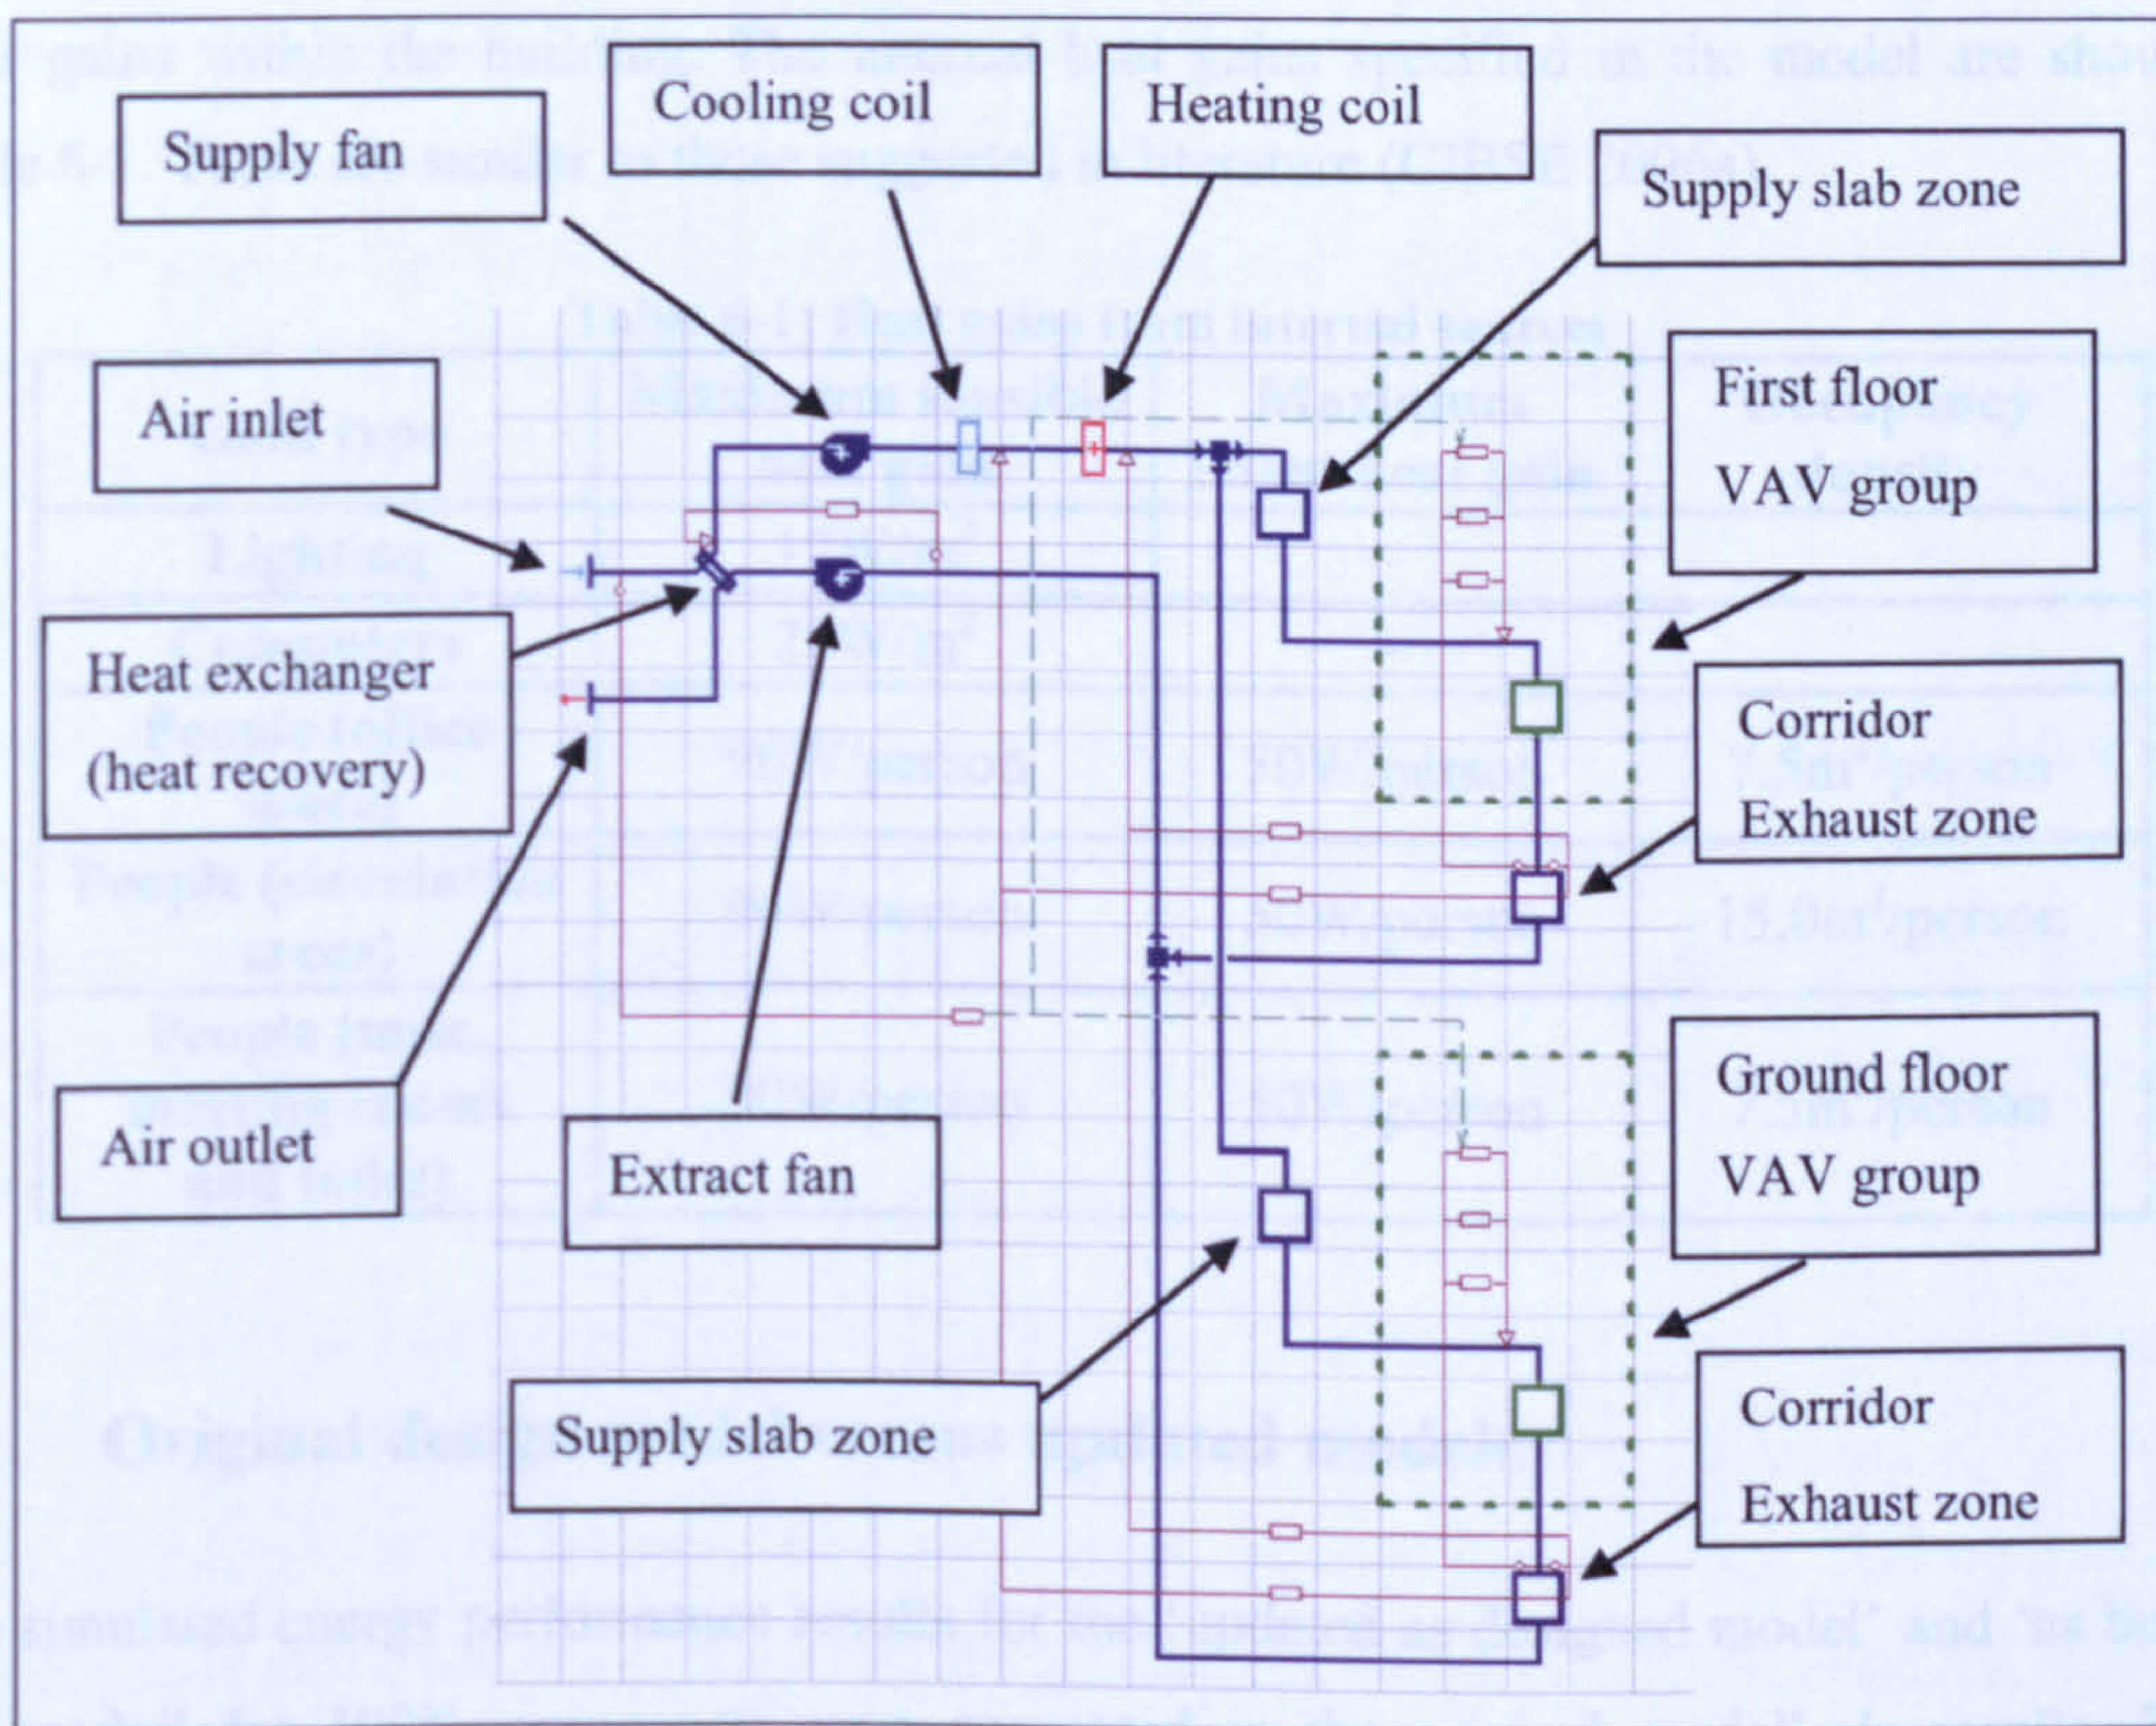
**Figure 6-2: Schematics of the control network for a typical AHU**

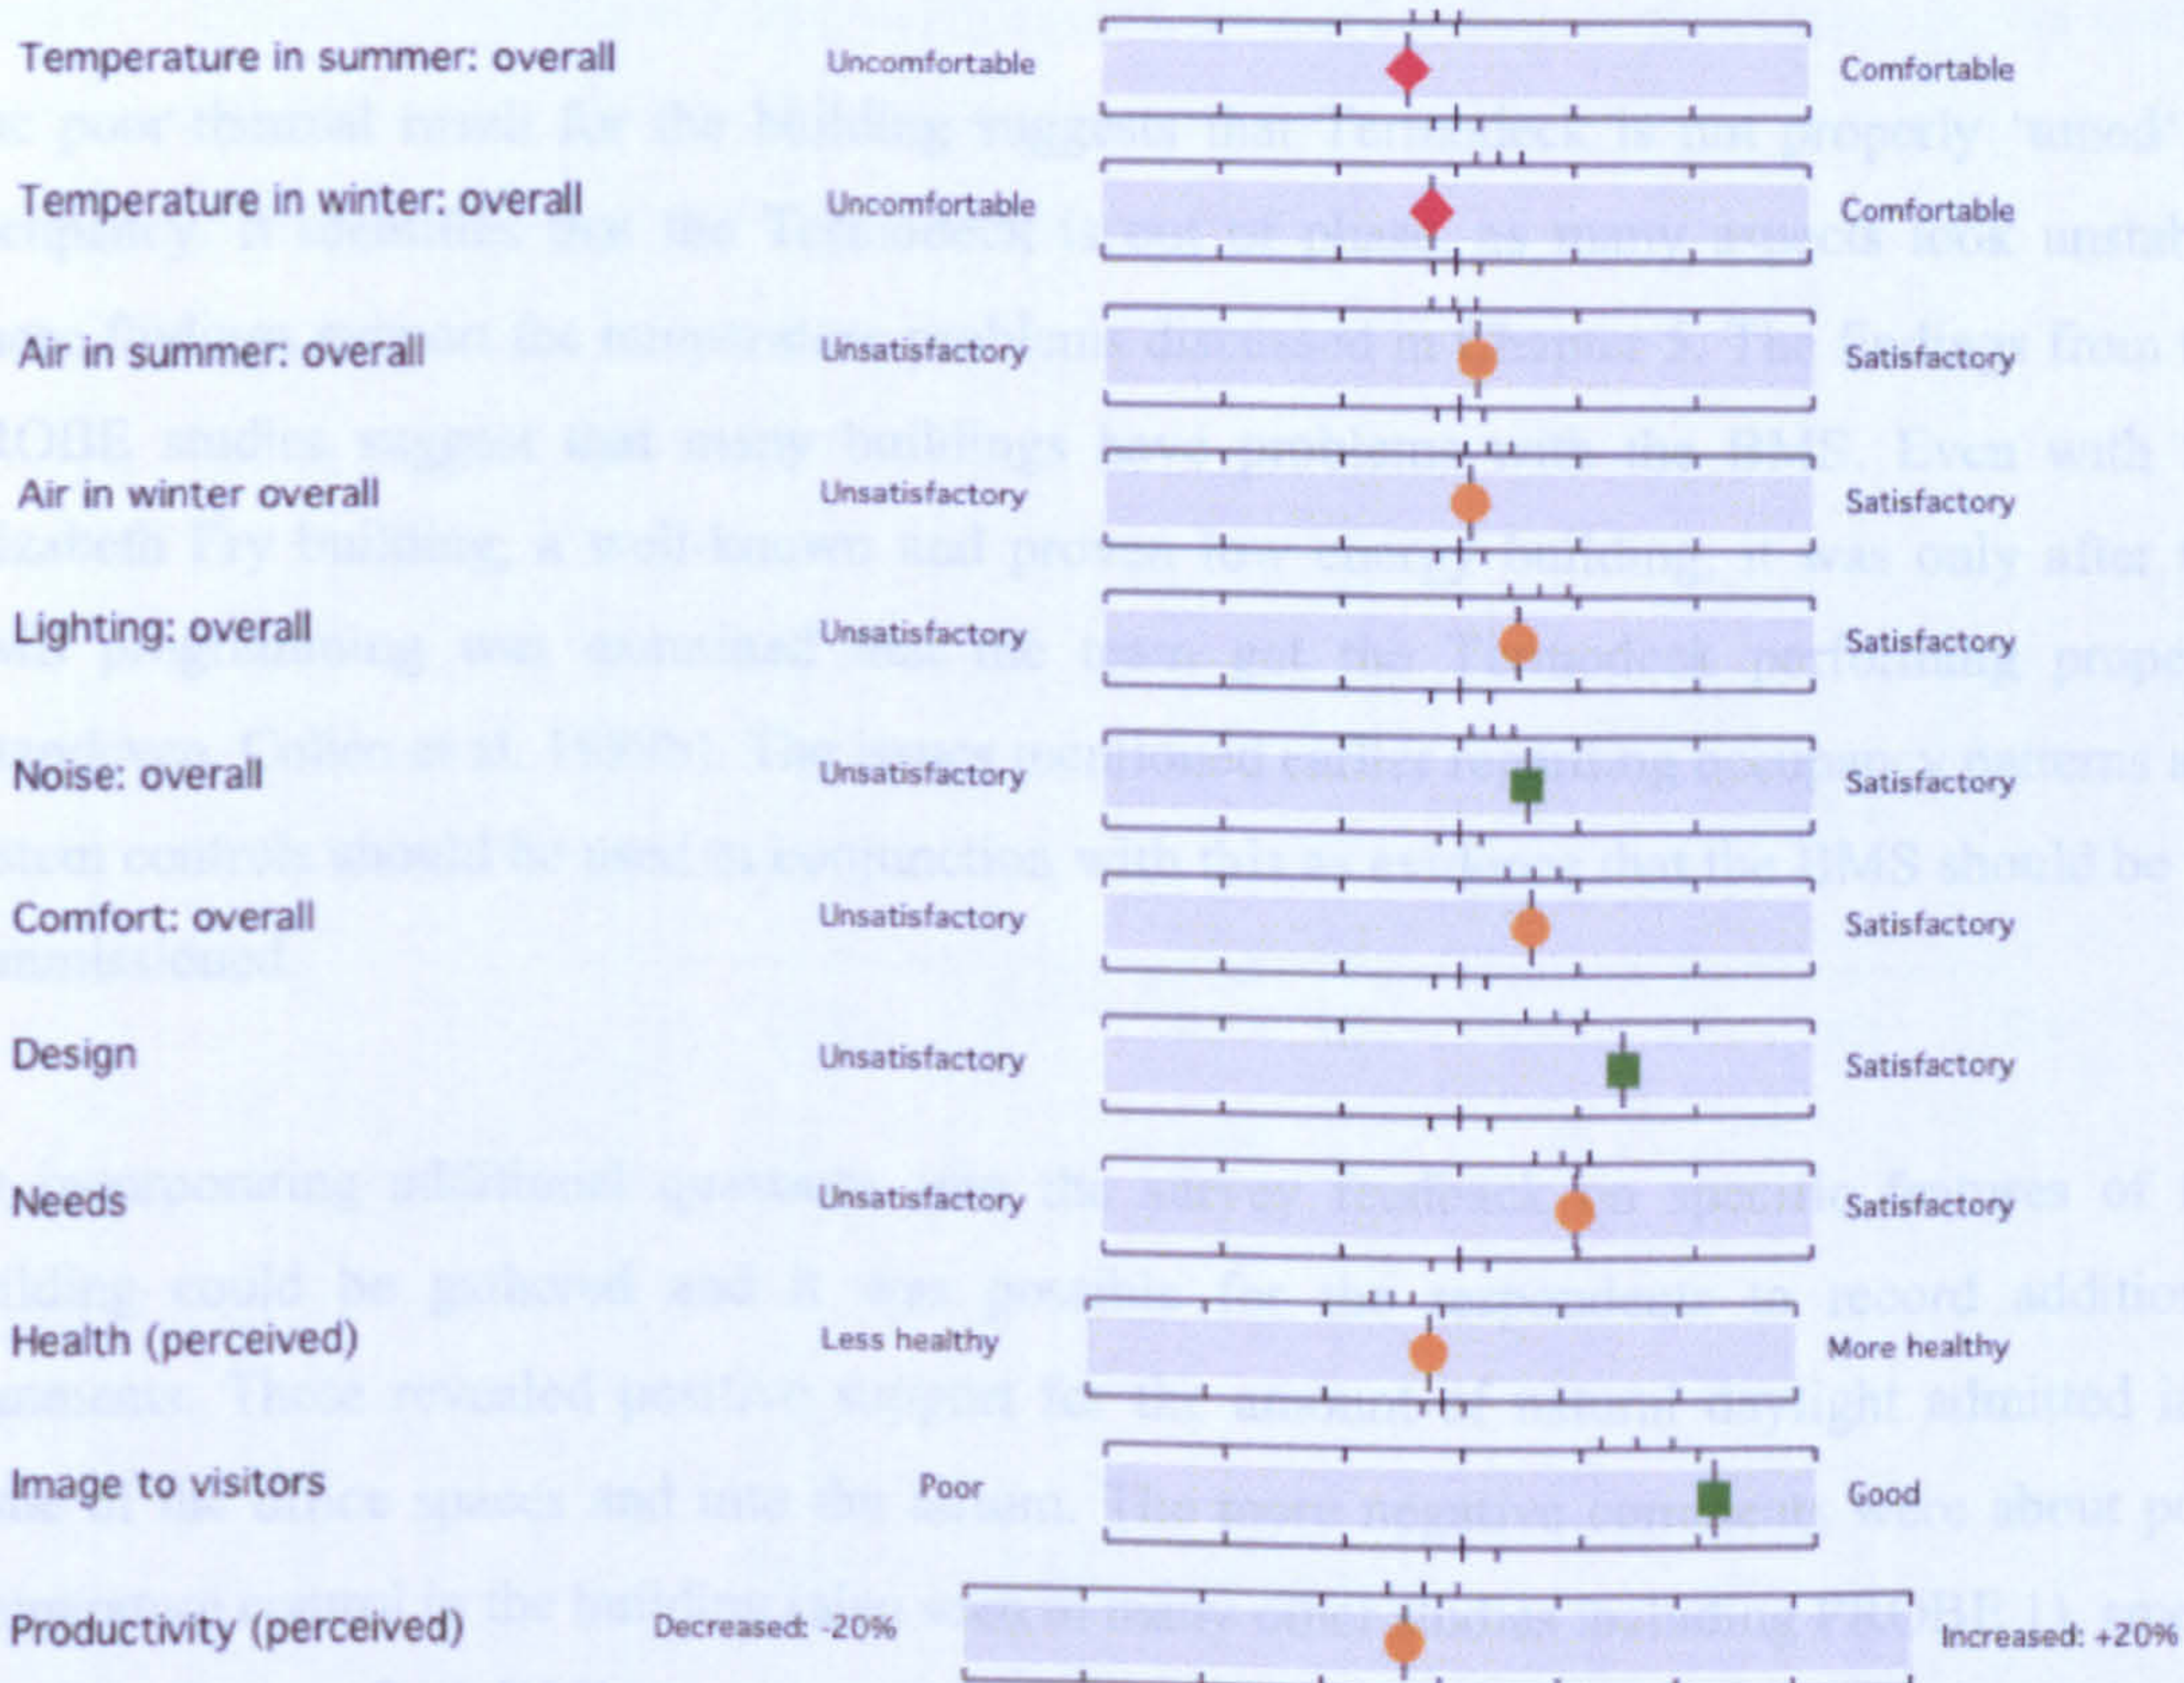
**Figure 8-1: BUS survey results, overall variables (Building Use Studies 2009)**

In Figure 8-1, the overall variables results of the survey are shown on the 7 point scale either by a diamond shape (indicating an aspect that performed considerably worse than the BUS benchmark score), a circle (indicating an aspect that performed similar to the BUS benchmark score) or a square (indicating an aspect that performed considerably better than the BUS benchmark score).

Temperature was the most disappointing and problematic aspect revealed from the overall variables of the building. The building is automatically controlled by the BMS and the occupants have little control over the internal environment other than being able to open windows and control the window blinds within their office space.
