The
University
Of
Sheffield.

Department
Of
Mechanical
Engineering.

EFFECT OF COMPRESSION, IMPACT AND SLIPPING ON ROLLING CONTACT FATIGUE AND SUBSURFACE MICROSTRUCTURAL DAMAGE

**A thesis submitted in partial fulfillment of the
requirements for the degree of**

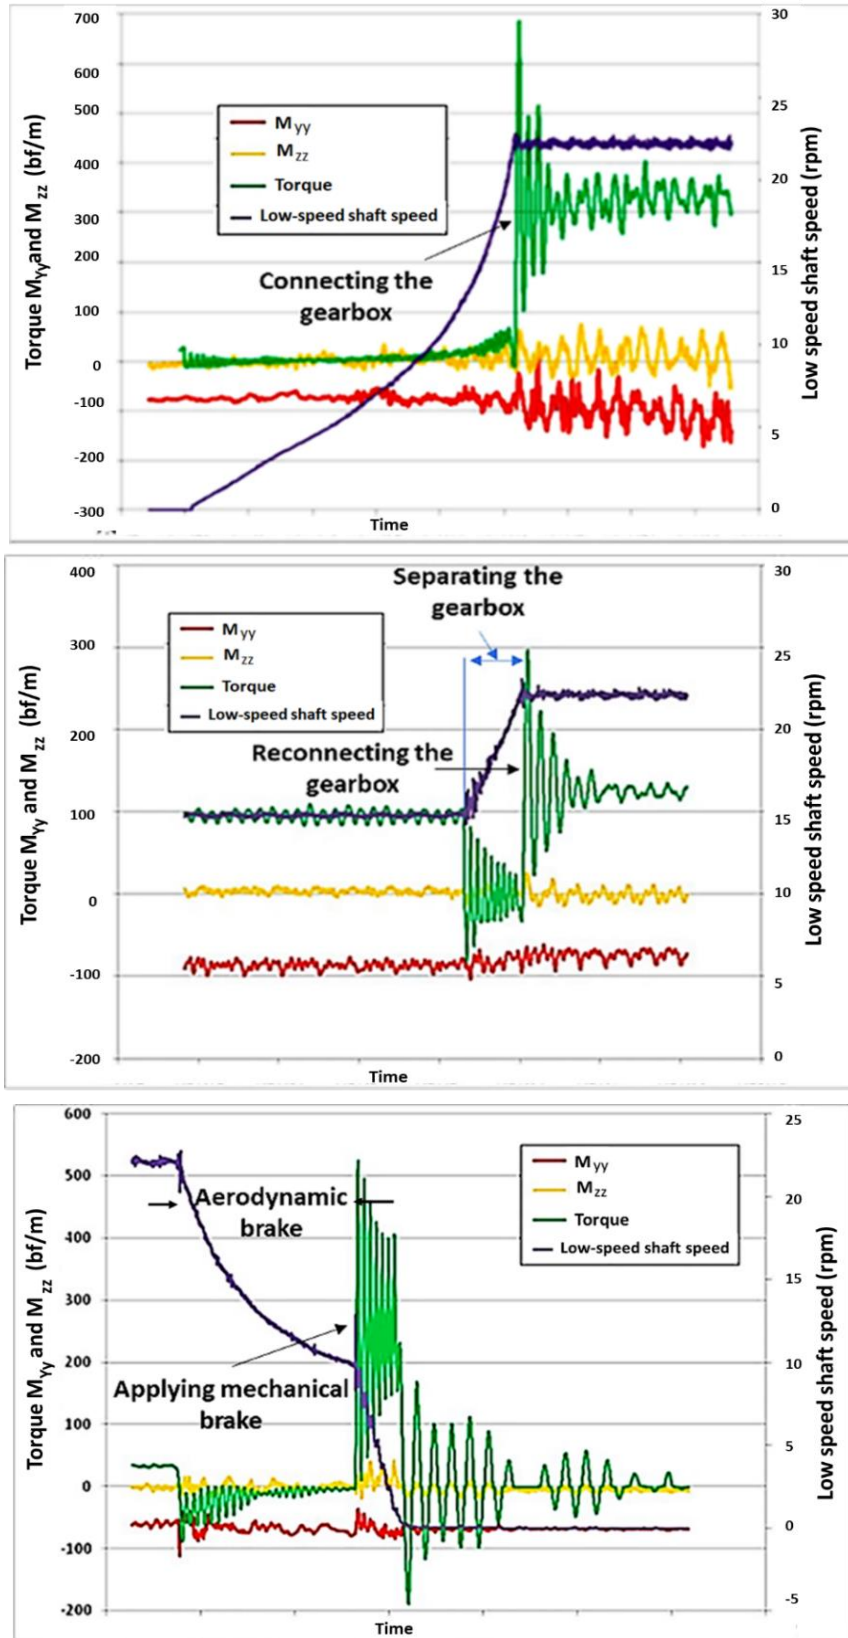
Figure 1-3: Rotor torque and speed variations with time during three operating events, start-up (upper), speed up (middle) and normal shutdown [36].

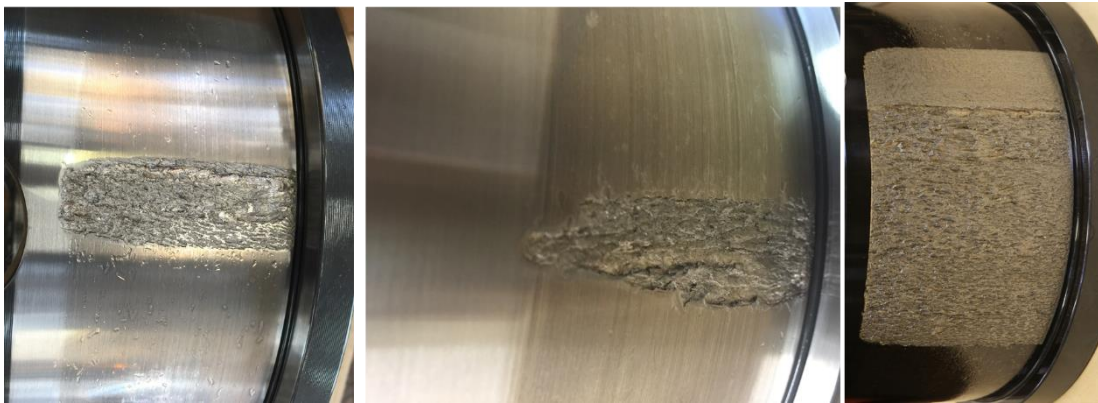
Figure 2-1: Examples of failed inner races of wind turbine gearbox bearings by flaking.

RCF is studied in terms of loading (contact stress), damage features (Microcracks, damaged nonmetallic inclusions and microstructural alterations), lubrication, surface and subsurface properties variation and fatigue life. Investigating the failed WTGBs by flaking (removal of material from the contact surfaces) showed different damage distributions on the inner race contact surfaces as can be seen in [Figure 2-1](#). In the subsurface of the flaking, different microstructural damage features were observed including damaged nonmetallic inclusions, cracks and microstructural alterations.

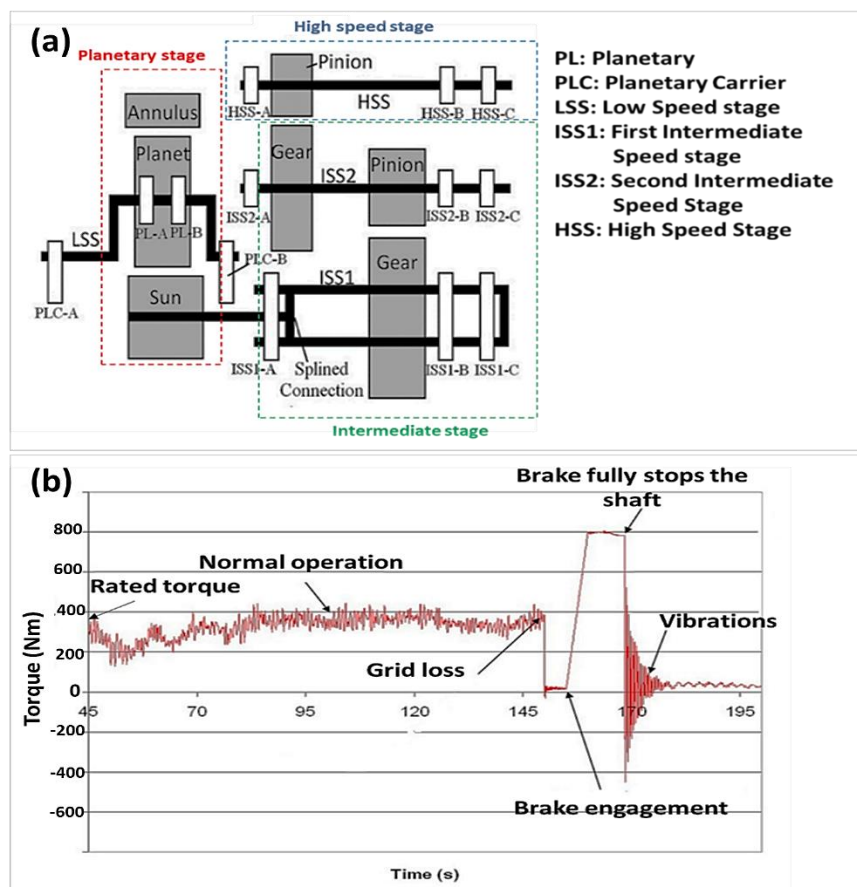
Figure 2-4: (a) Typical gearbox consists of one planetary stage showing the bearings locations (b) torque variation during grid loss and braking events [21].

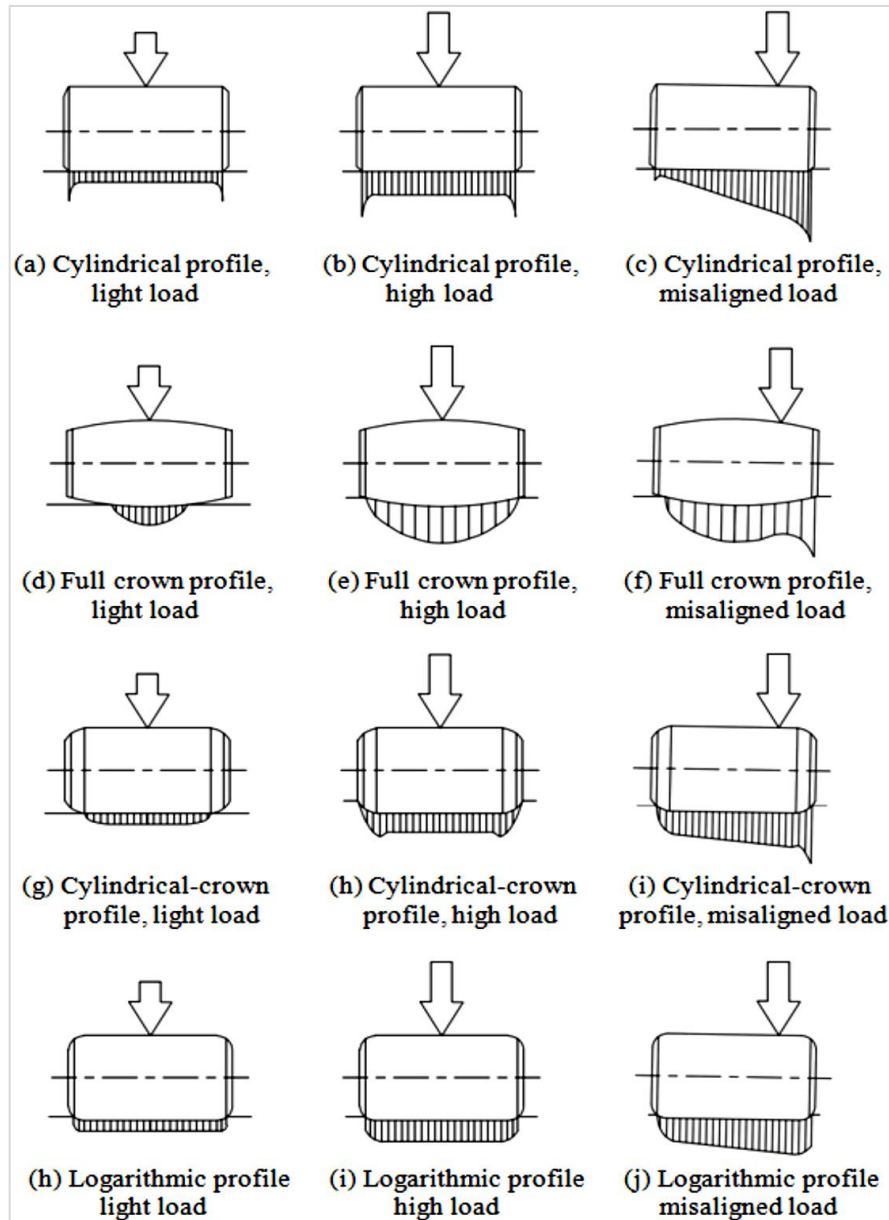
Figure 2-5: Contact stress distribution under different roller types and contact stresses [25].

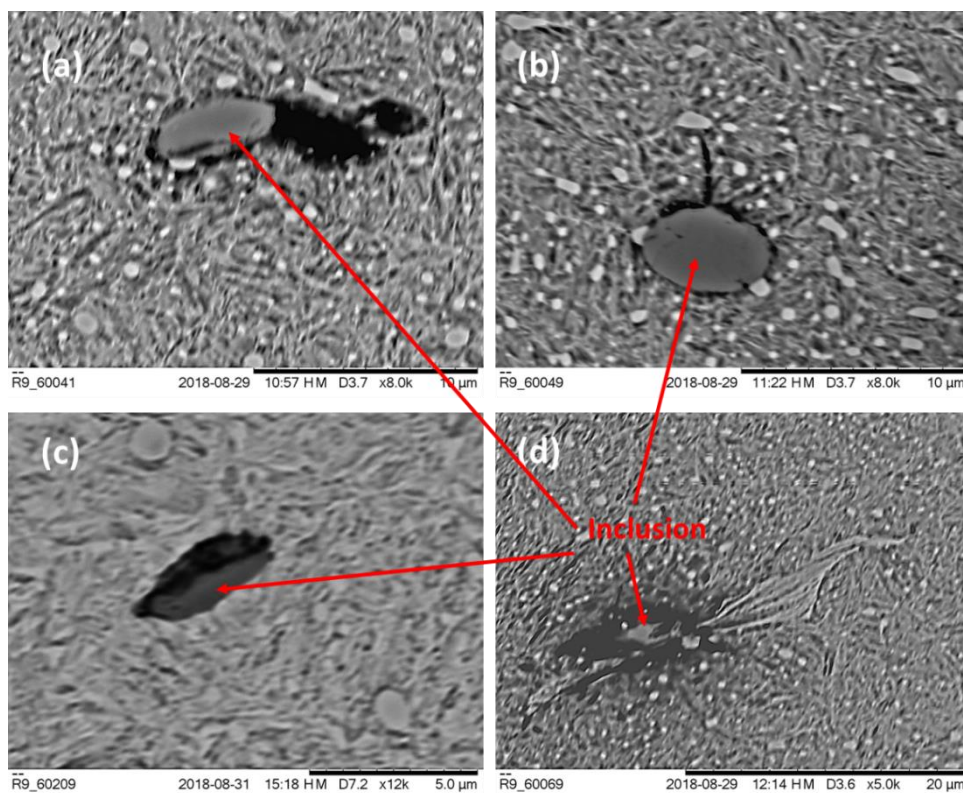
Figure 2-8: Examples of damaged inclusions (a) side separation damage; (b) crack initiated from an inclusion; (c) internally cracked inclusion; (d) inclusion associated with butterfly wing damage feature.

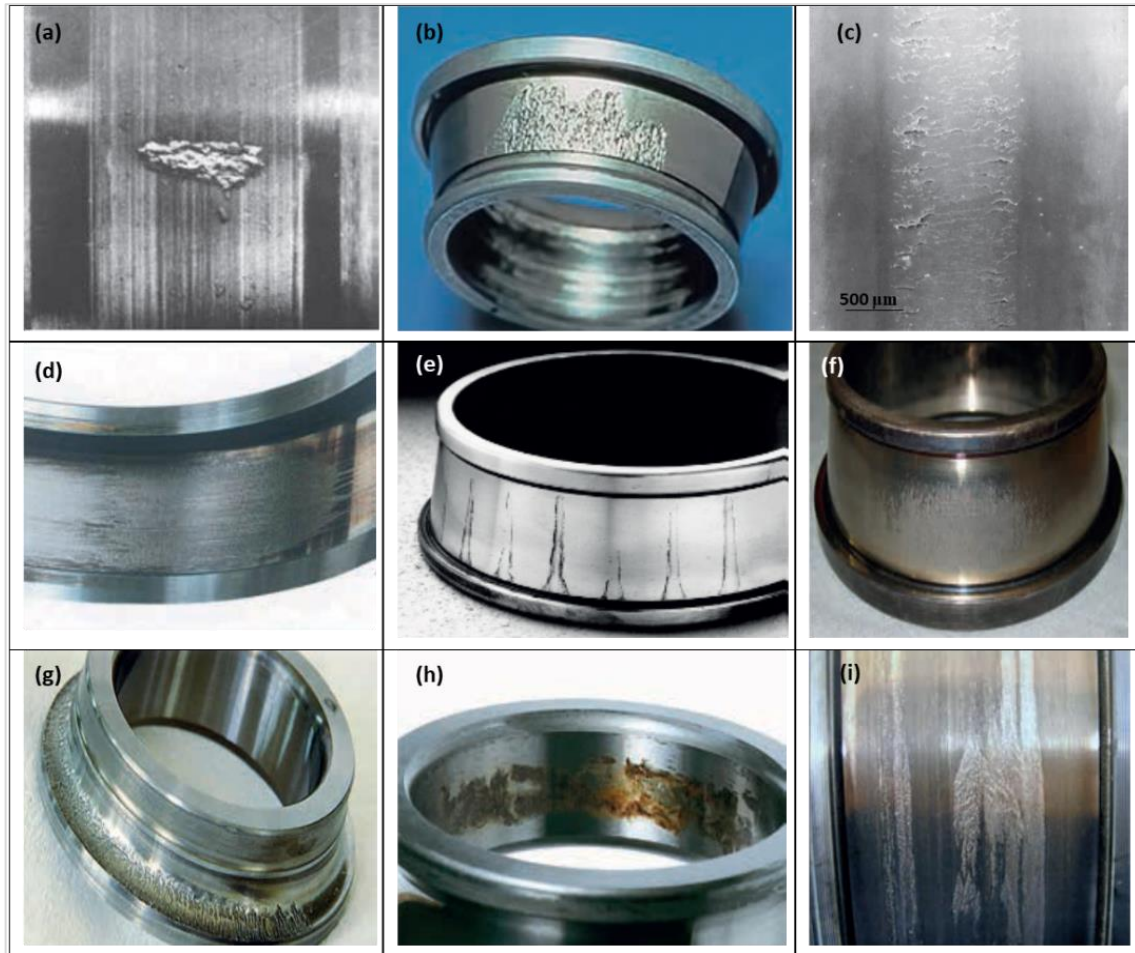
Figure 2-13: Examples of bearing inner race failures [148]. (a) Spalling in early-stage; (b) Spalling in advanced stage; (c) micro-spalls; (d) Smearing; (e) contact corrosion; (f) surface-initiated micro-spalls; (g) surface-initiated spalling; (h) fretting; (i) smearing and skidding.

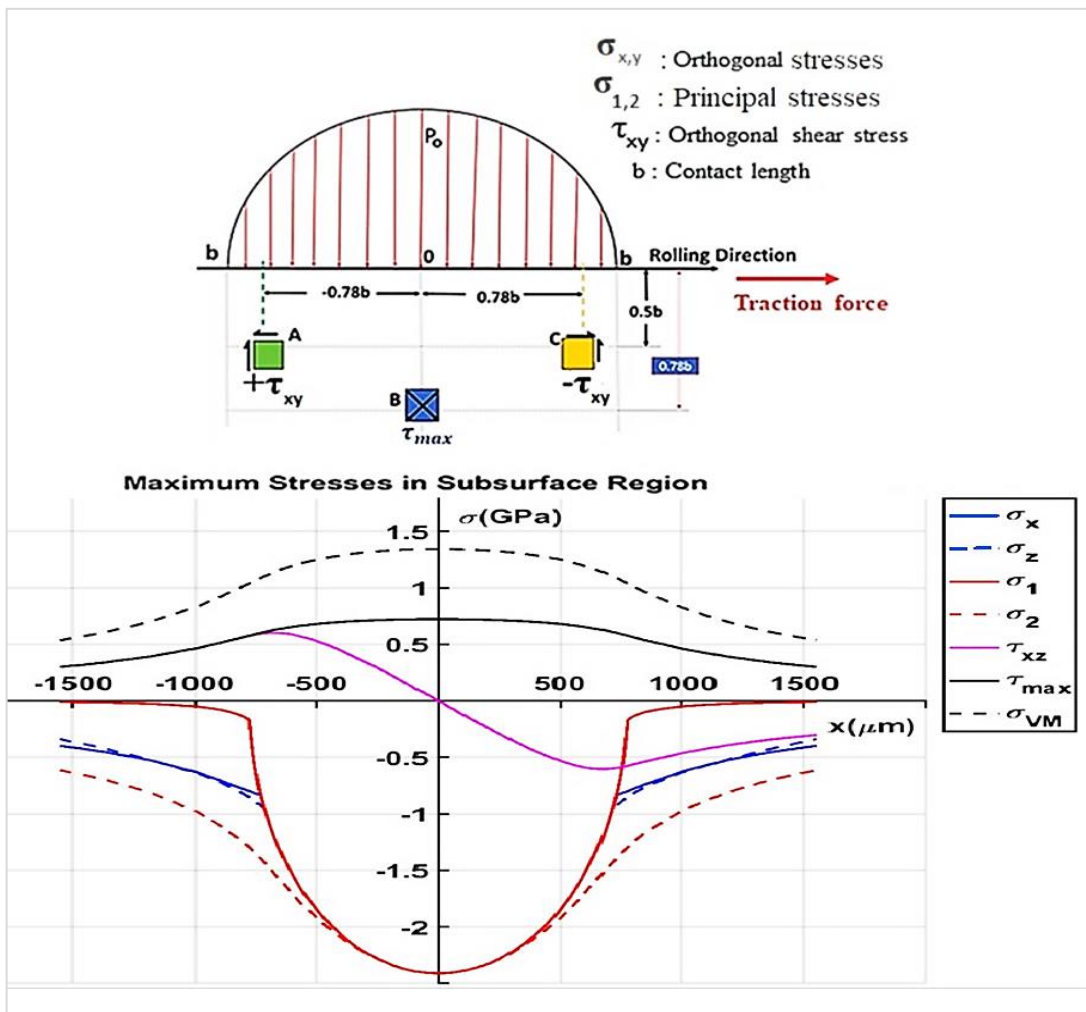
Figure 2-14: Pressure distribution and maximum stresses in the contact region under Hertzian contact pressure of 2.4 GPa on a typical 2 MW planetary bearing.

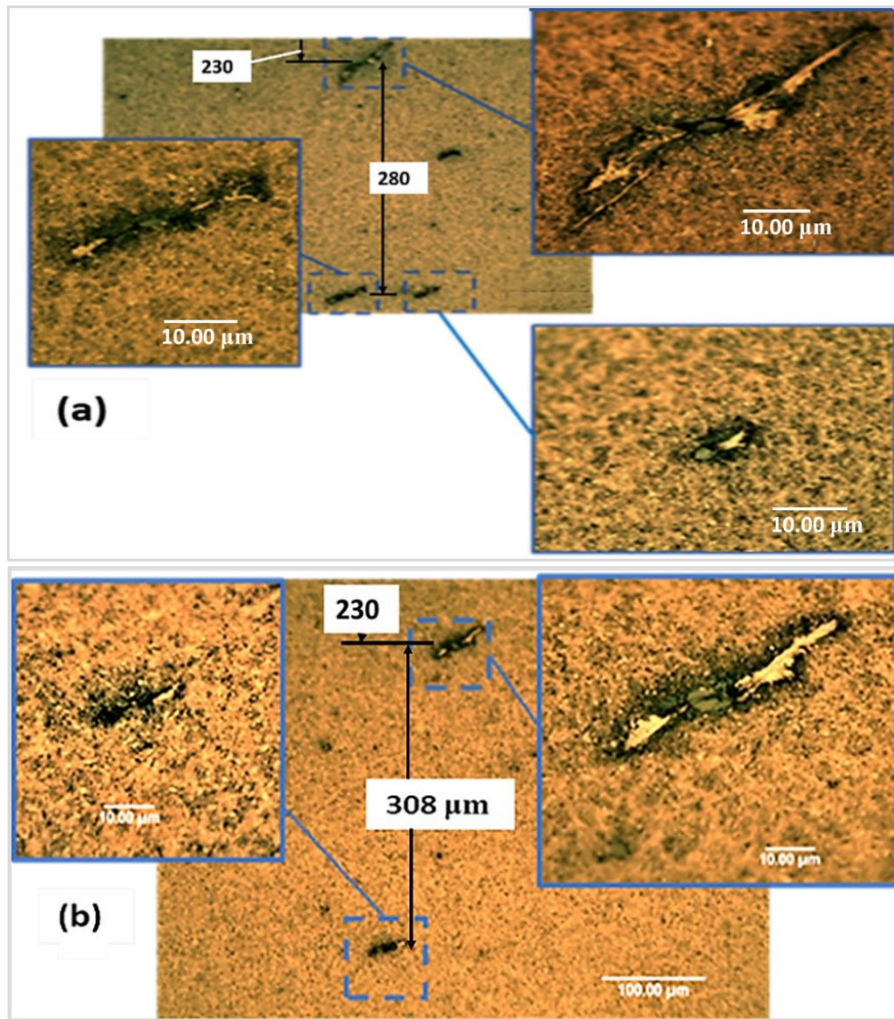
Figure 3-26: Double and single butterfly wings (a) double and upper butterfly wings depth $\sim 220\mu\text{m}$; (b) double and upper butterfly wings depth $\sim 230\mu\text{m}$ (from the circumferential specimen 6 UW bearing).

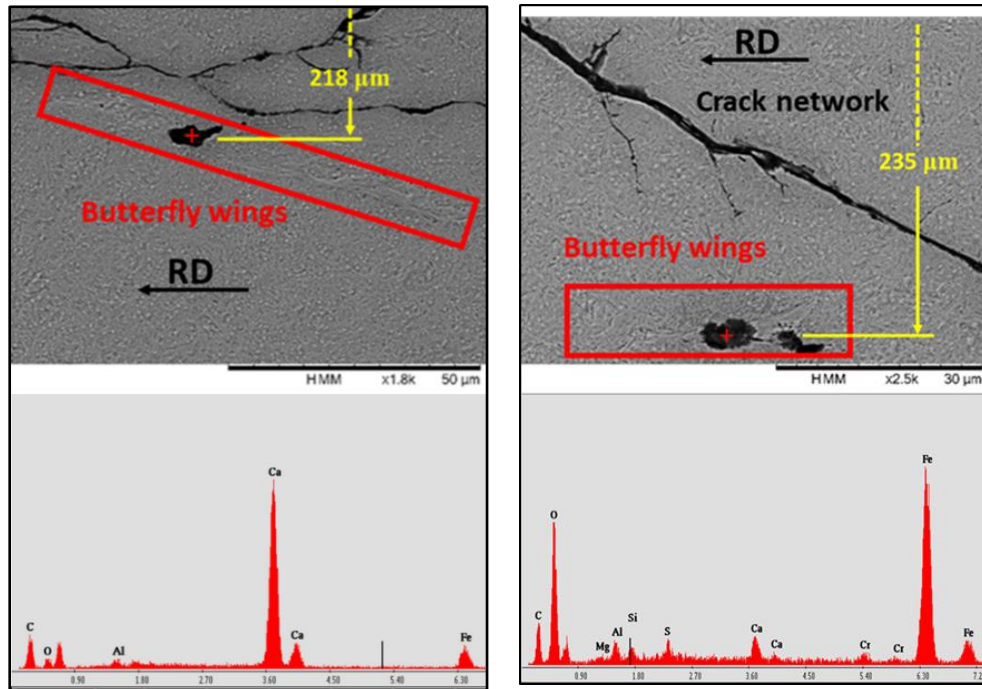
Figure 3-29: Two butterfly wings close to cracks, but not connecting with the crack network (from the circumferential specimen No. 2 UW bearing).

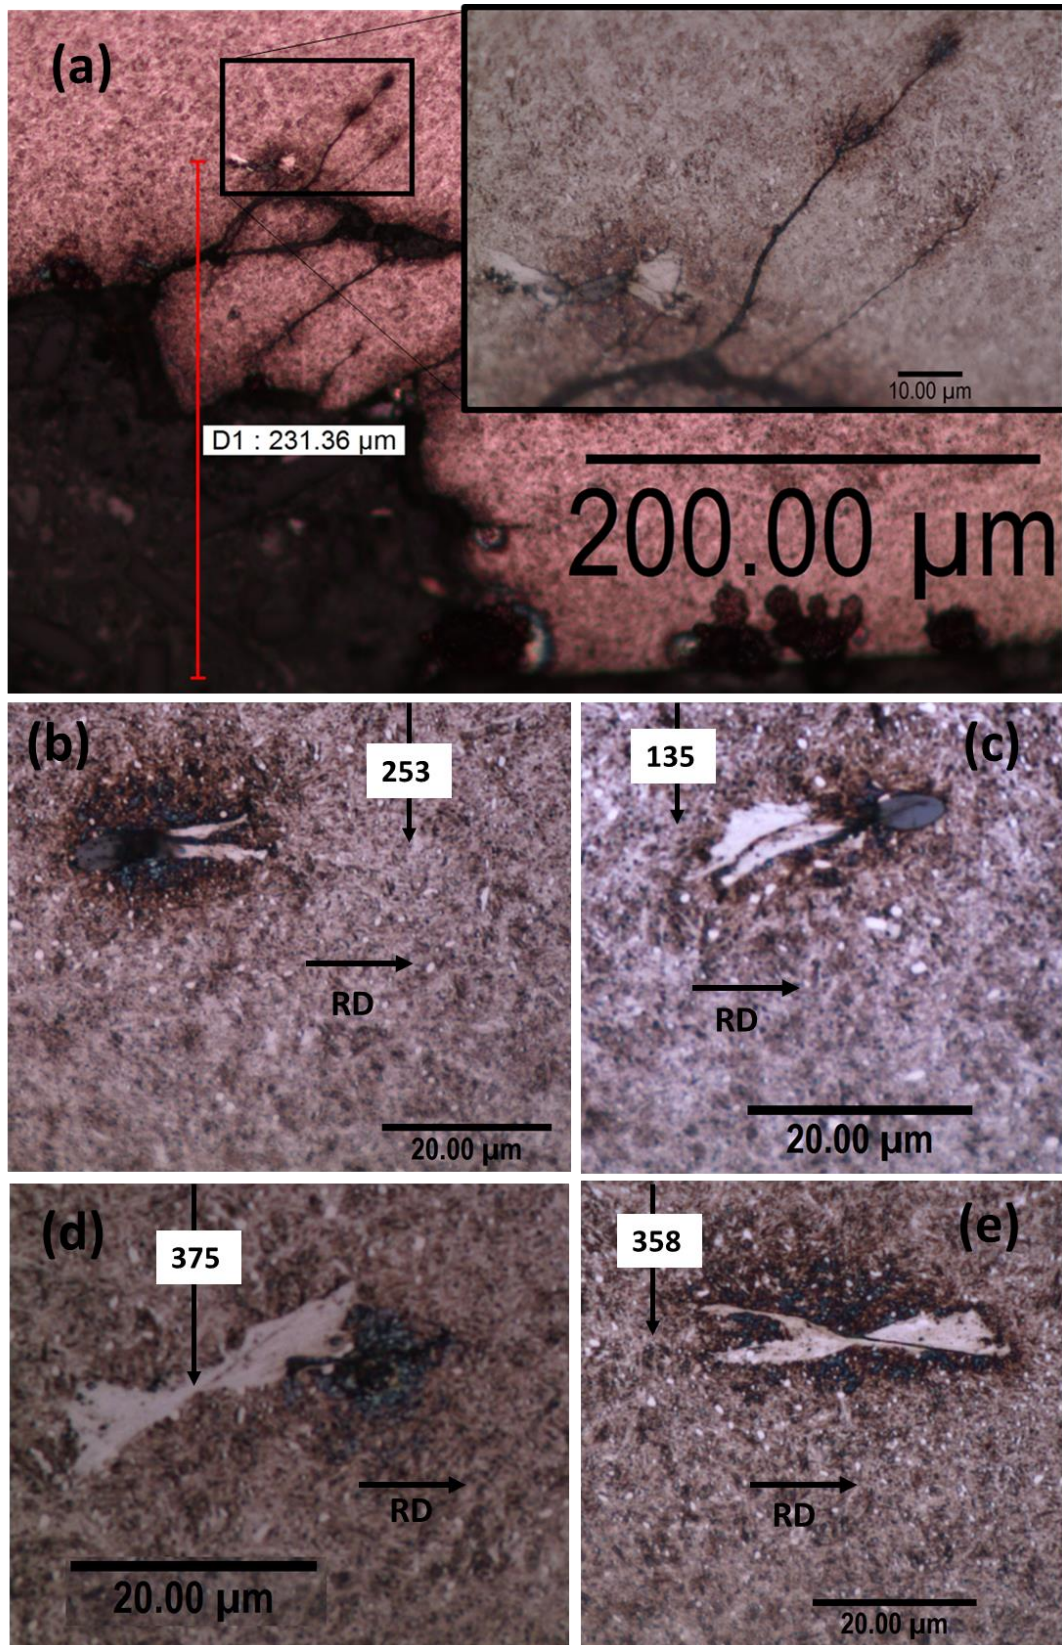
Figure 3-32: (a) butterfly wings not connected to the crack network causing flaking; (b) and (c) two features with double wings on each side; (d) and (e) two butterfly wings without central inclusion.

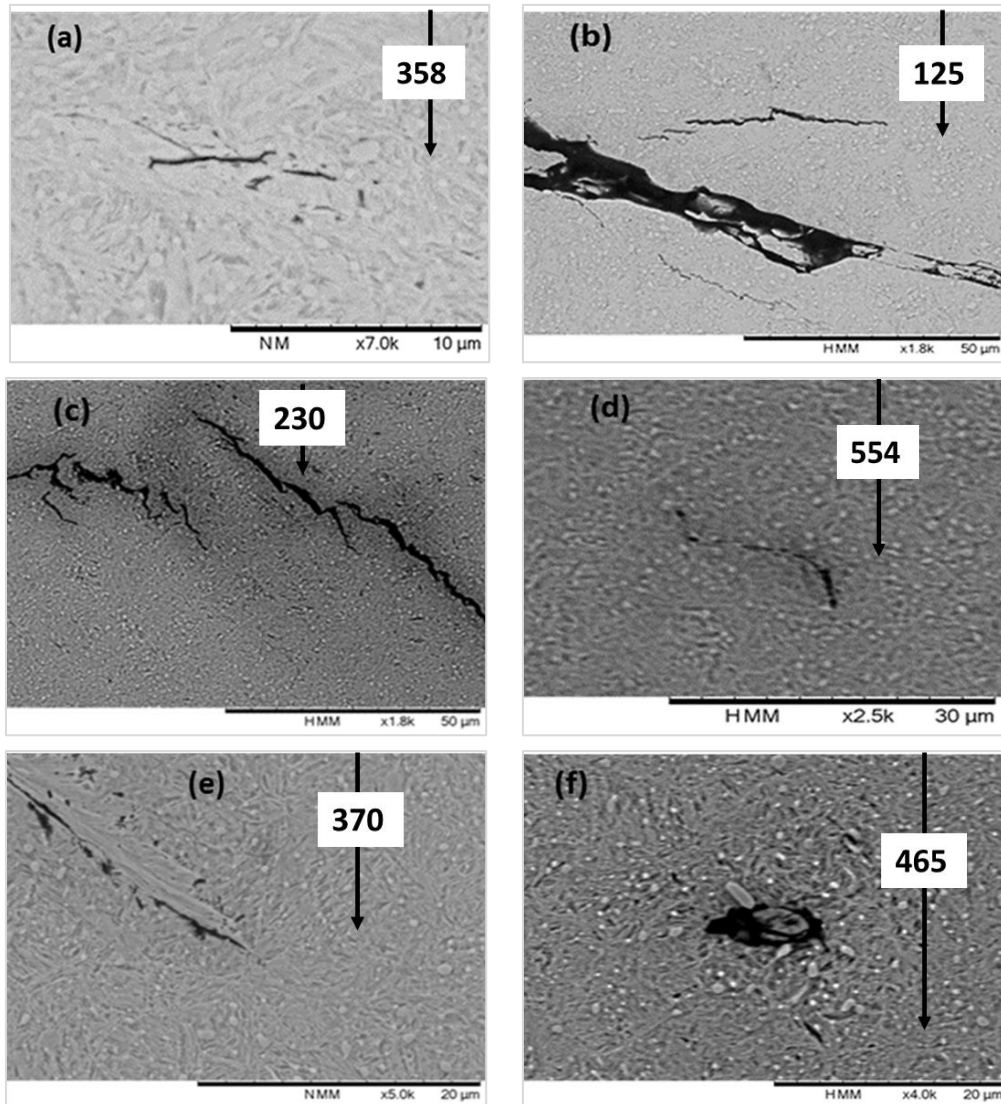
Figure 3-34: SEM images showing microcracks initiated in the subsurface region without inclusion.

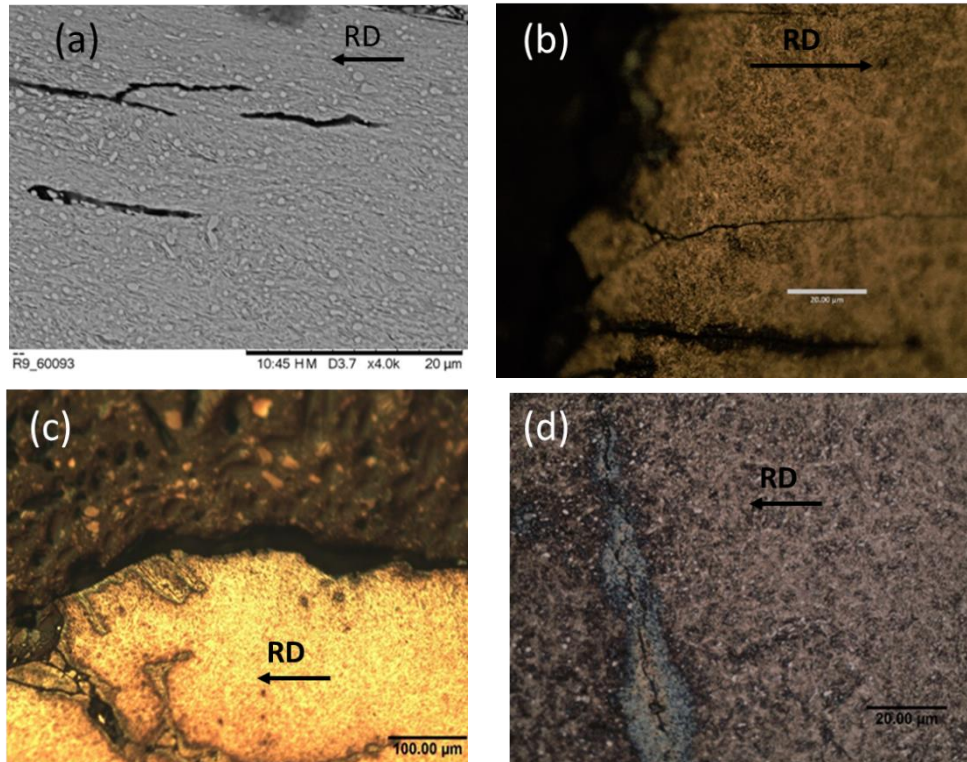
Figure 3-36: Crack orientation in axial and circumferential sections (a) and (b) axial sections; (c) and (d) circumferential sections.

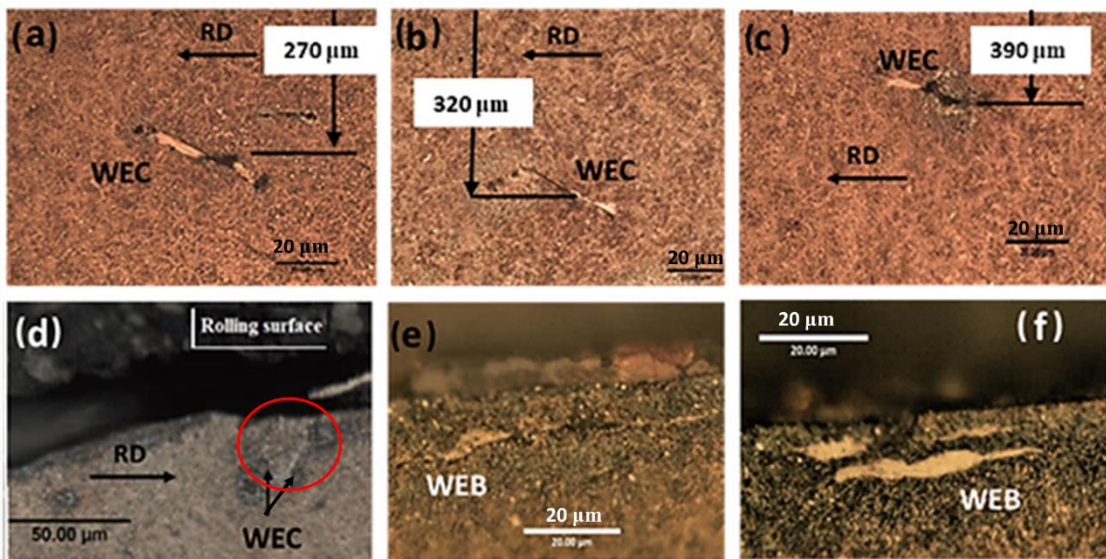
Figure 3-37: Microstructural alteration features; (a), (b) and (c) WEAs in axial section; (d) WECs in circumferential direction; (e) and (f) WEB in the axial direction.

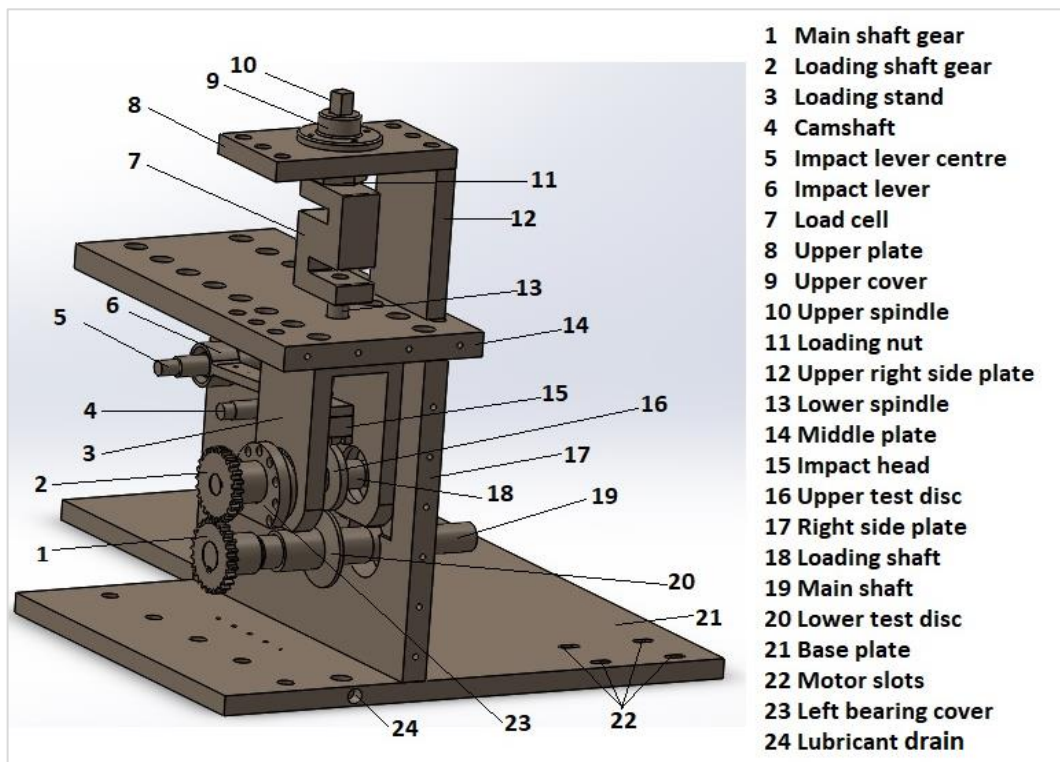
Figure 4-6: Schematic diagram showing the main parts of the designed test rig.

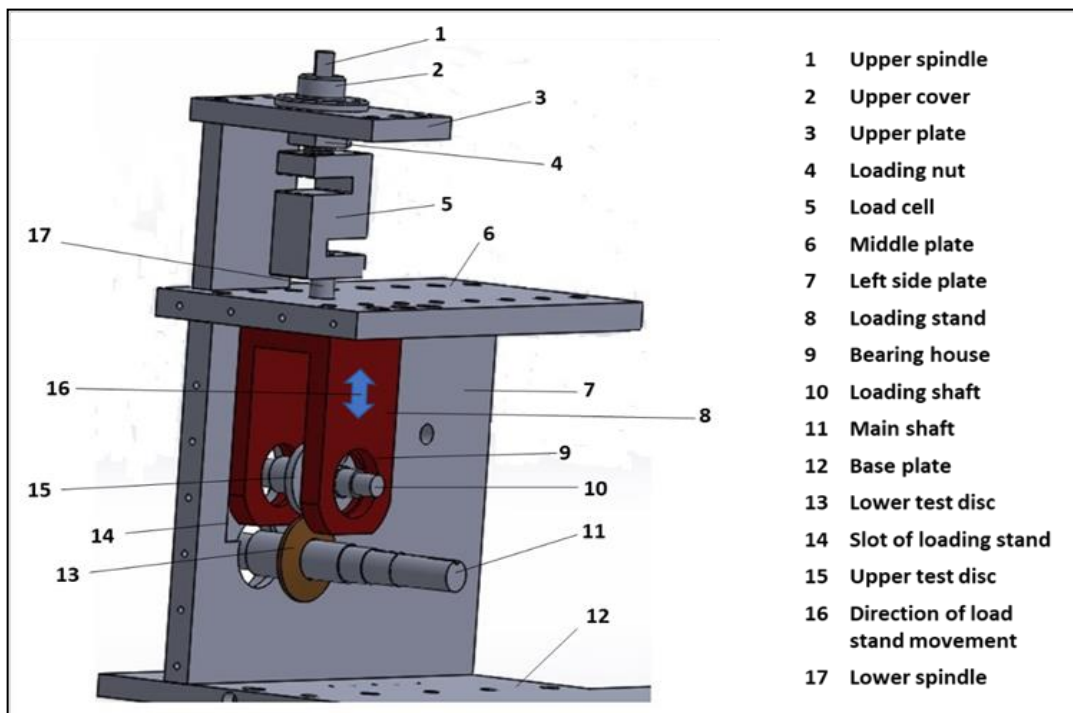
Figure 4-7: Main components of the compression mechanism.

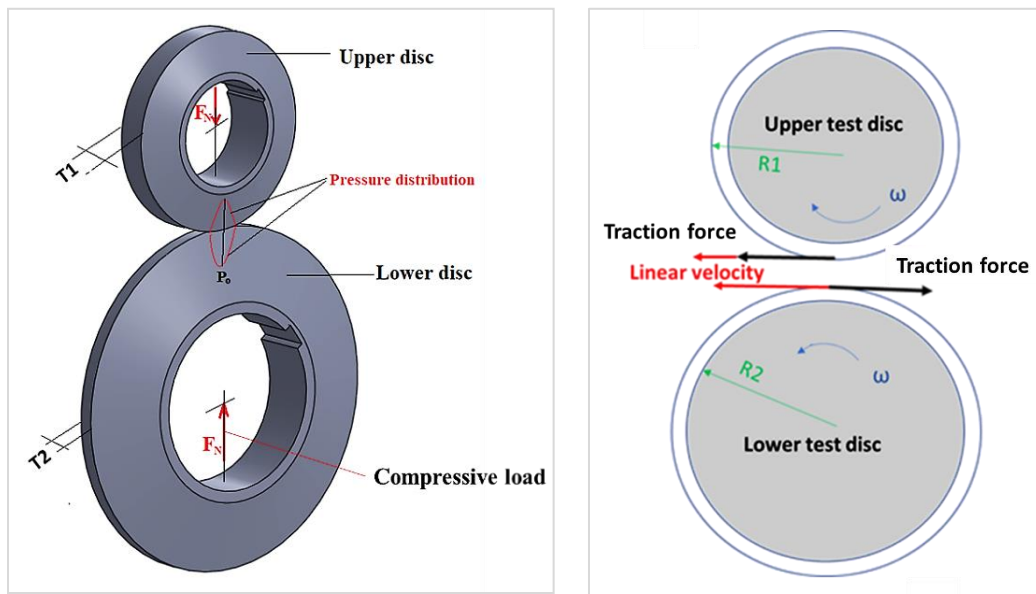
Figure 4-10: Test discs contact showing compression force and pressure distribution (left) and, velocity and traction force (right).

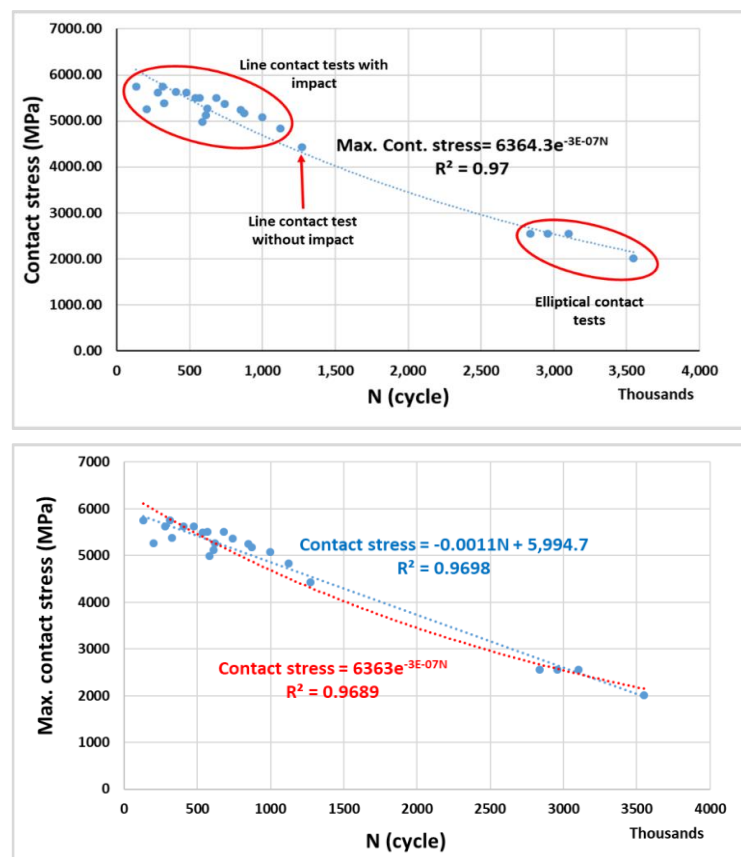
Figure 5-19: Modified S-N curve of the test disc material using linear and exponential approximations.

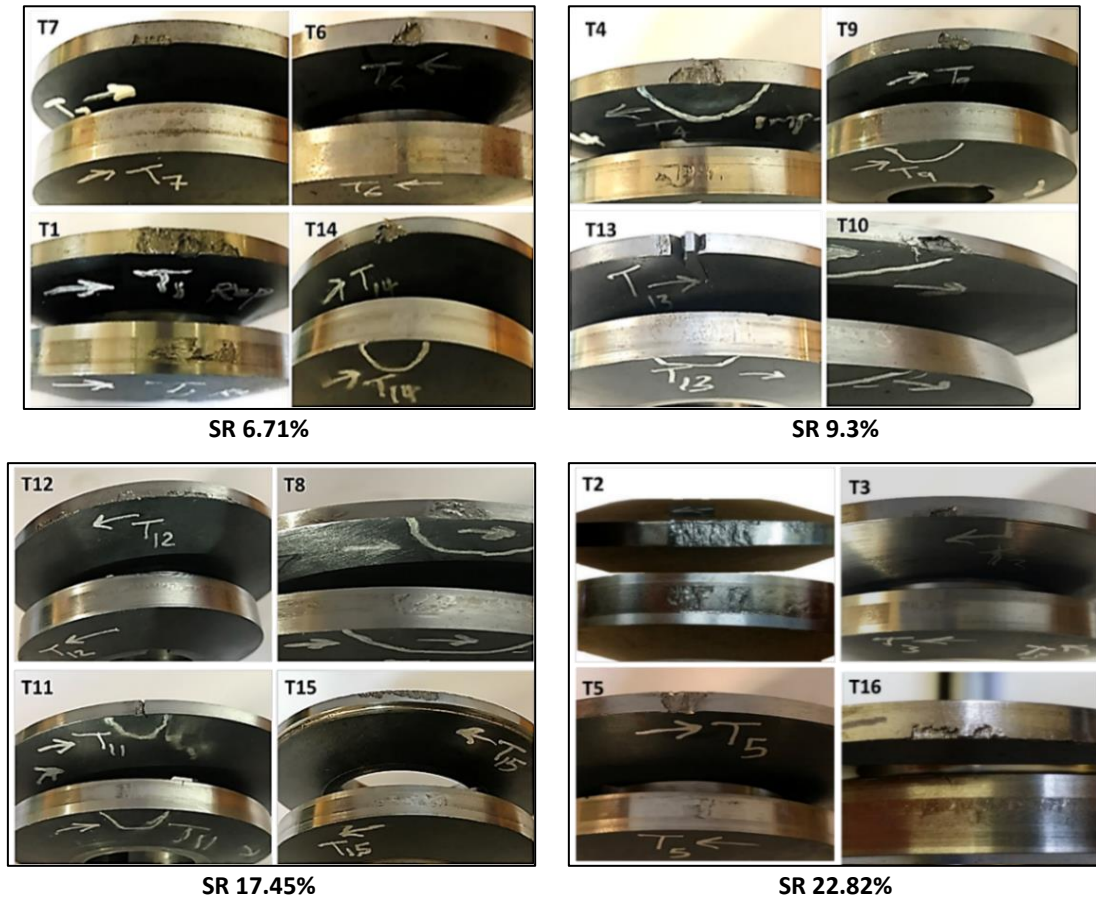
Figure 7-2: Failed upper and lower test discs classified into four groups depending on the SR.

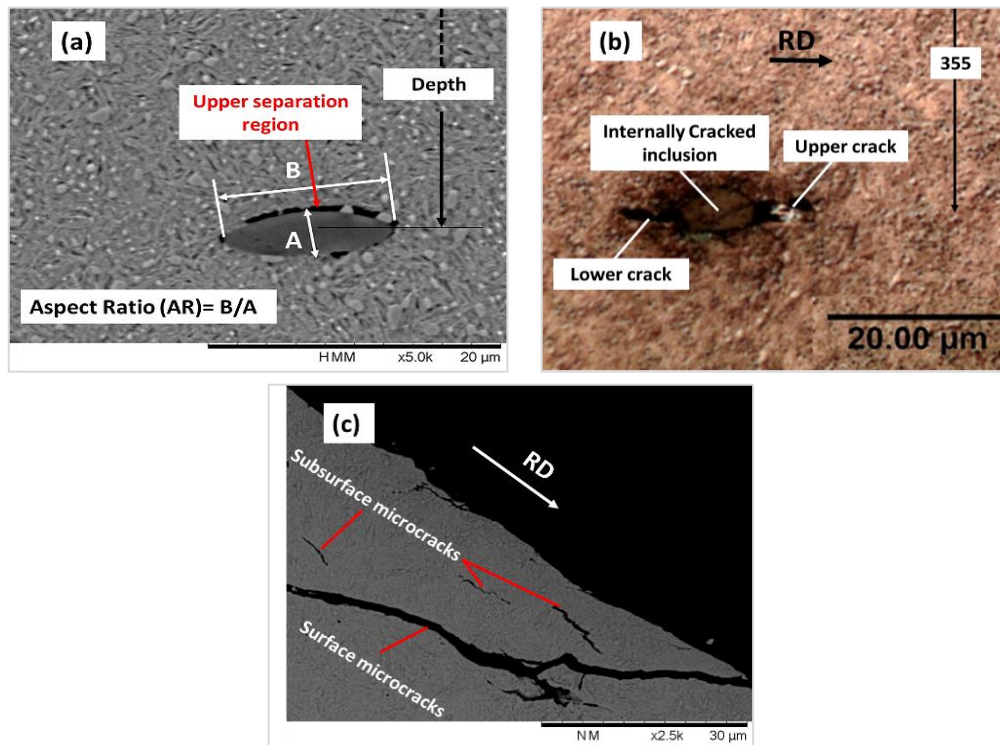
Figure 7-13: Examples of damage features observed (a) inclusion damaged by upper separation (observed in T4); (b) inclusion damaged by cracking (observed in T6); (c) surface and subsurface microcracks (observed in T5).

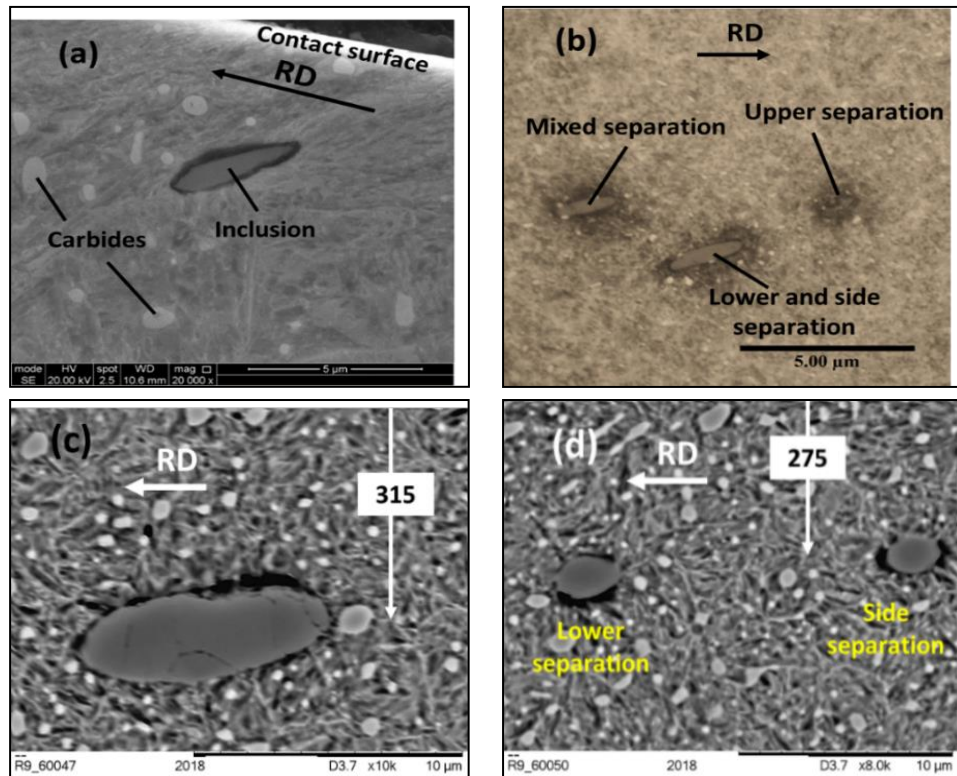
Figure 7-17: Damaged inclusions by separation (a) near the spalling area (front T1); (b) different separations at the same depth (from T4); (c) upper separation (from T6A); (d) Lower and side separation (from T7).

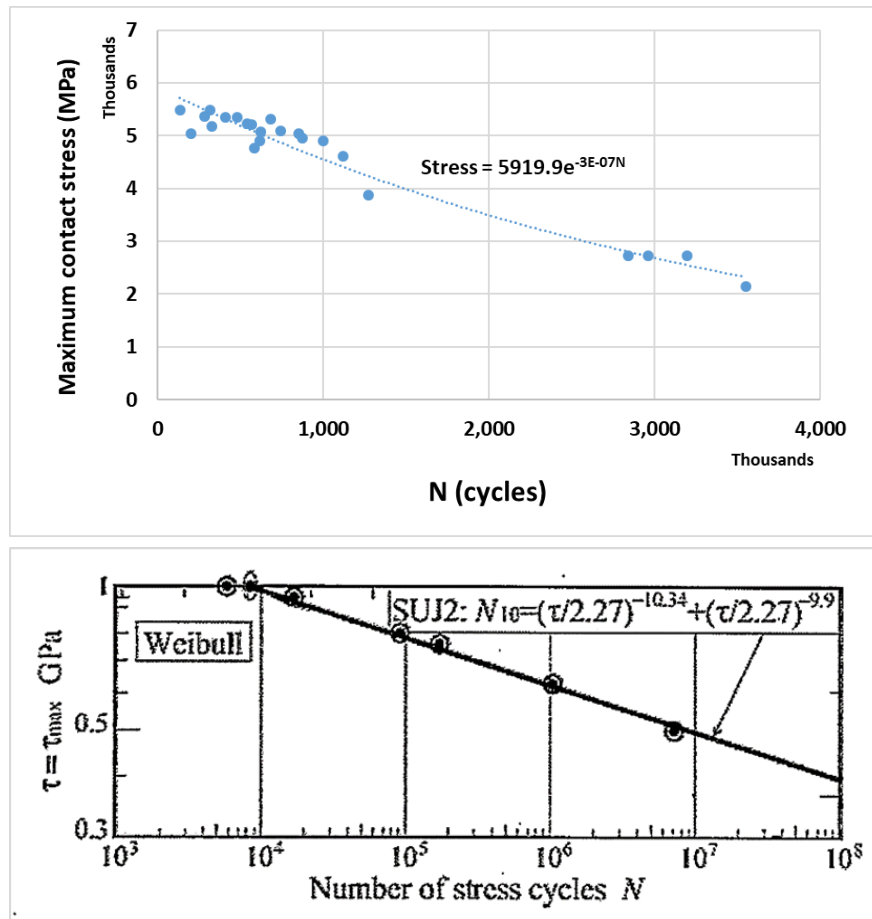
Figure 7-45: S-N curves of the test disc material (top) and the real bearing material (down) [258].

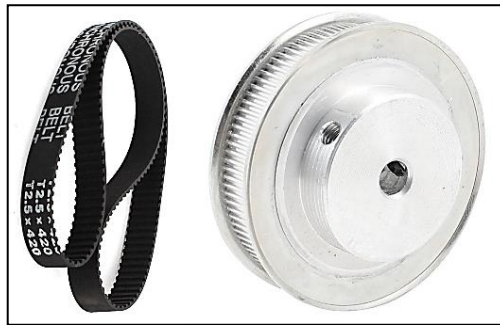
Figure G- 1: Flanged groove synchronous timing pulley and belt.

Using two grooved flange pulleys with speed ratio 1:1 and a timing belt as shown in [Figure G- 1](#), will improve the test rig camshaft-driving mechanism by preventing any slipping in addition to reduce the load on the camshaft bearings.
