## **Characterisation and Modelling of Normal and Compound Impact Wear in Common Engineering Alloys**

A thesis submitted to the University of Sheffield  
for the degree of Doctor of Philosophy in the Faculty of Engineering

Author: Mohanad Qasim Zalzalah  
Date: June 2021  
Supervisors: **Dr. Tom Slatter**  
**Prof. Roger Lewis**

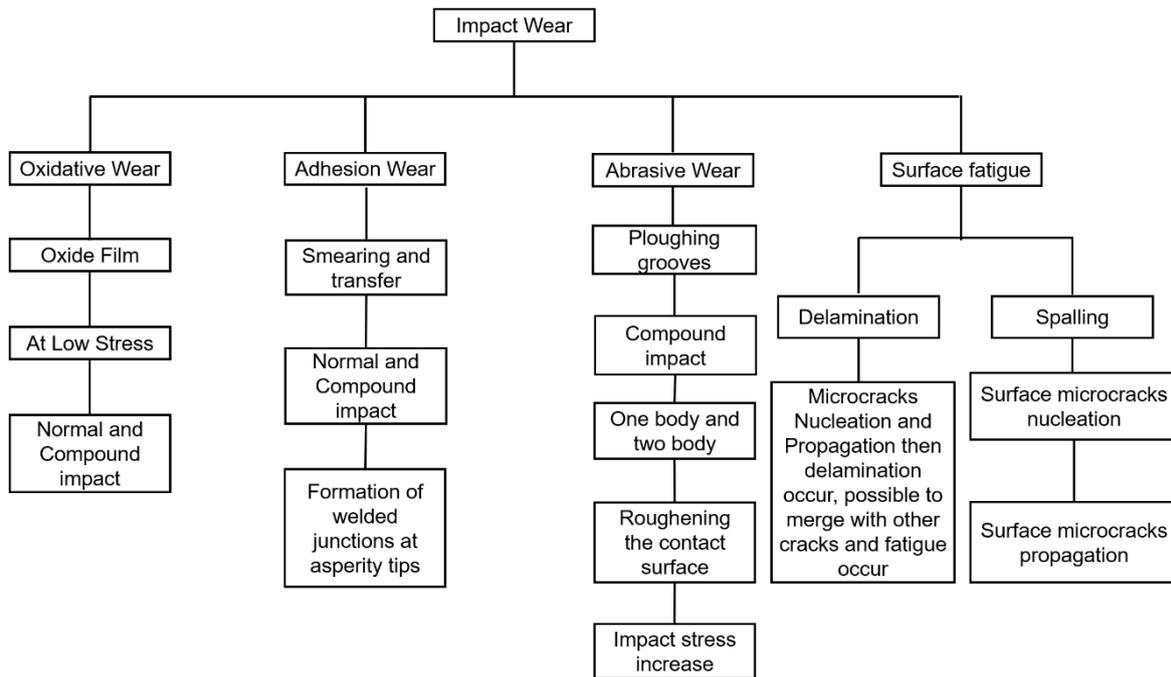
Figure 2.1 Impact Wear Mechanisms

The impact wear mechanisms are summarised in Figure 2.1.

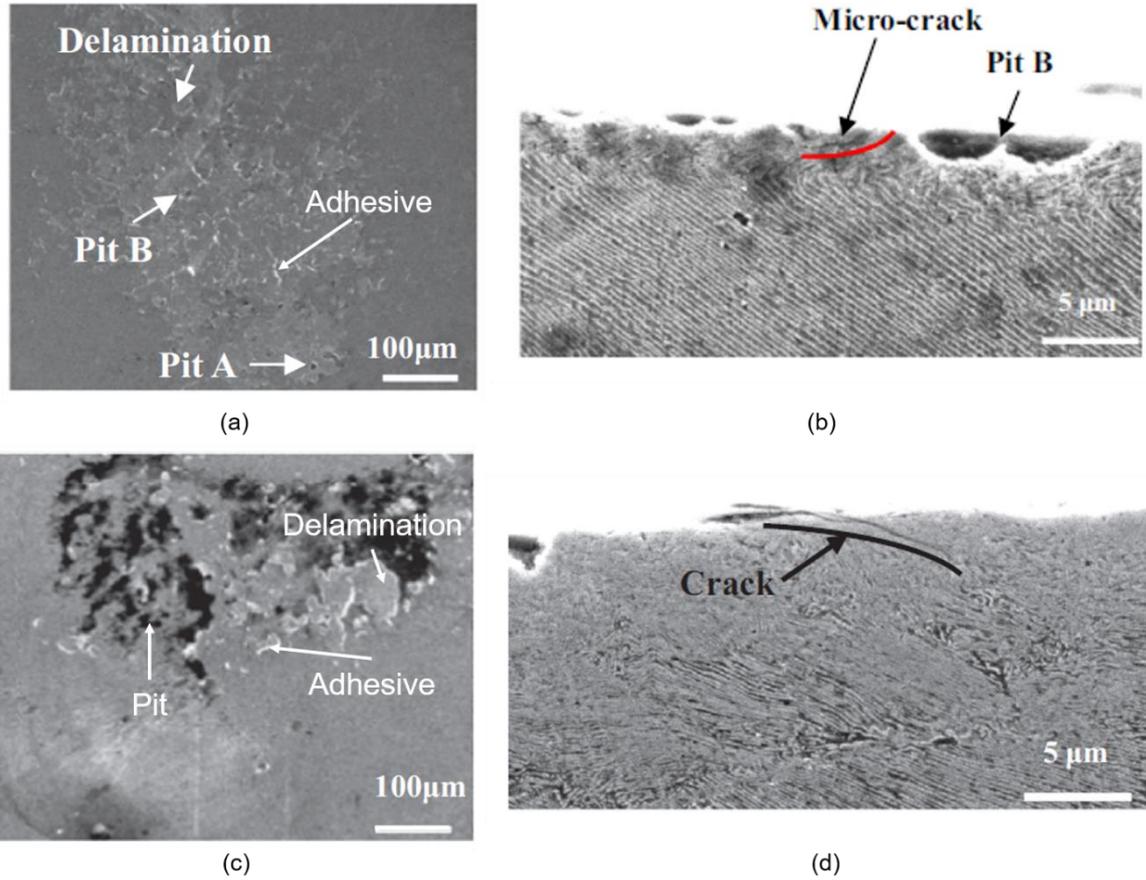
Figure 2.3 SEM image for surface and subsurface deformation of both rail material (a, b) and weld joint material (c, d) showing the delamination on surface (a, c) and crack propagate parallel to surface (b, d) after 10,000 cycles with normal impact force of 200 N extracted from [15]

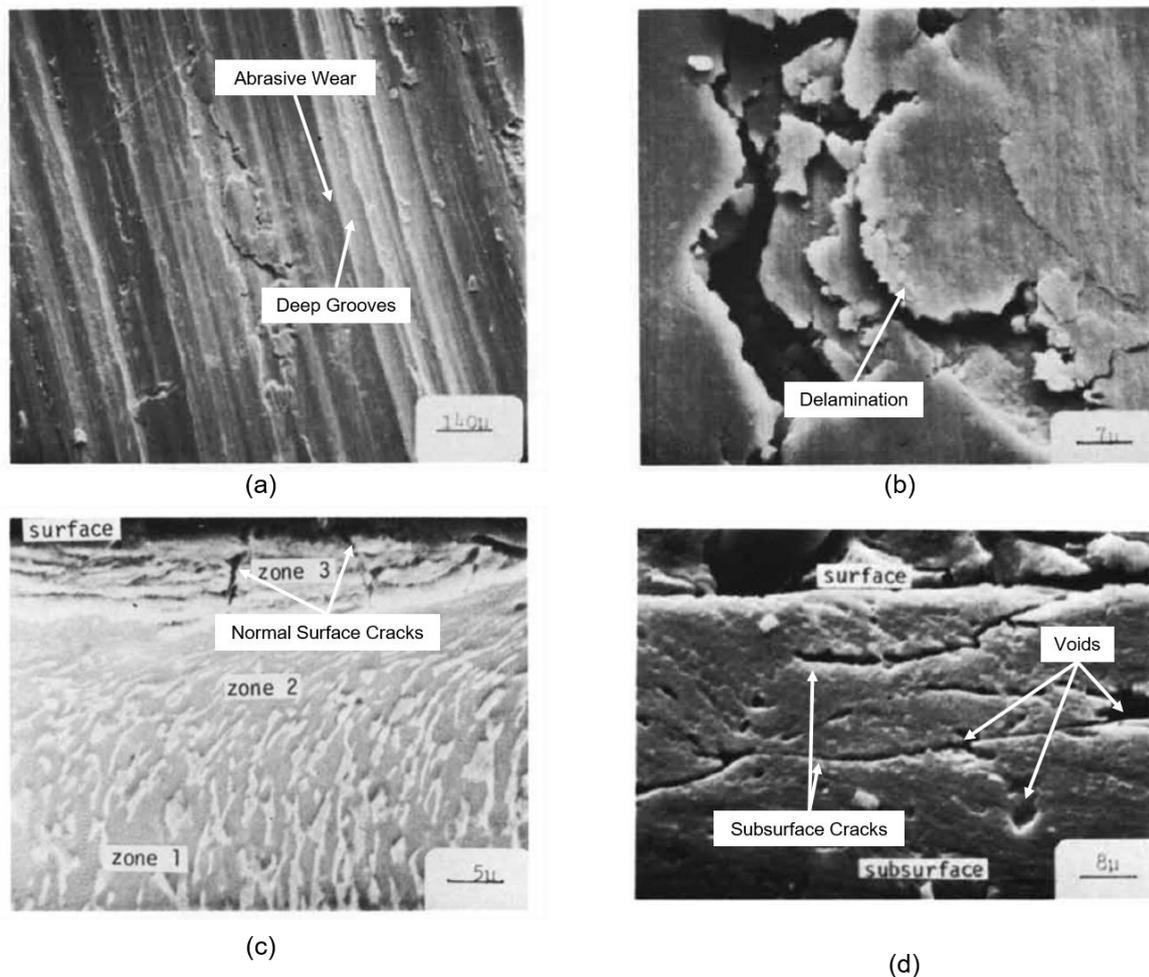
Figure 2.10 SEM morphology of aluminium specimen where (a) and (b) shows the surface damage while (c) and (d) revealed the subsurface damage extracted from [25]

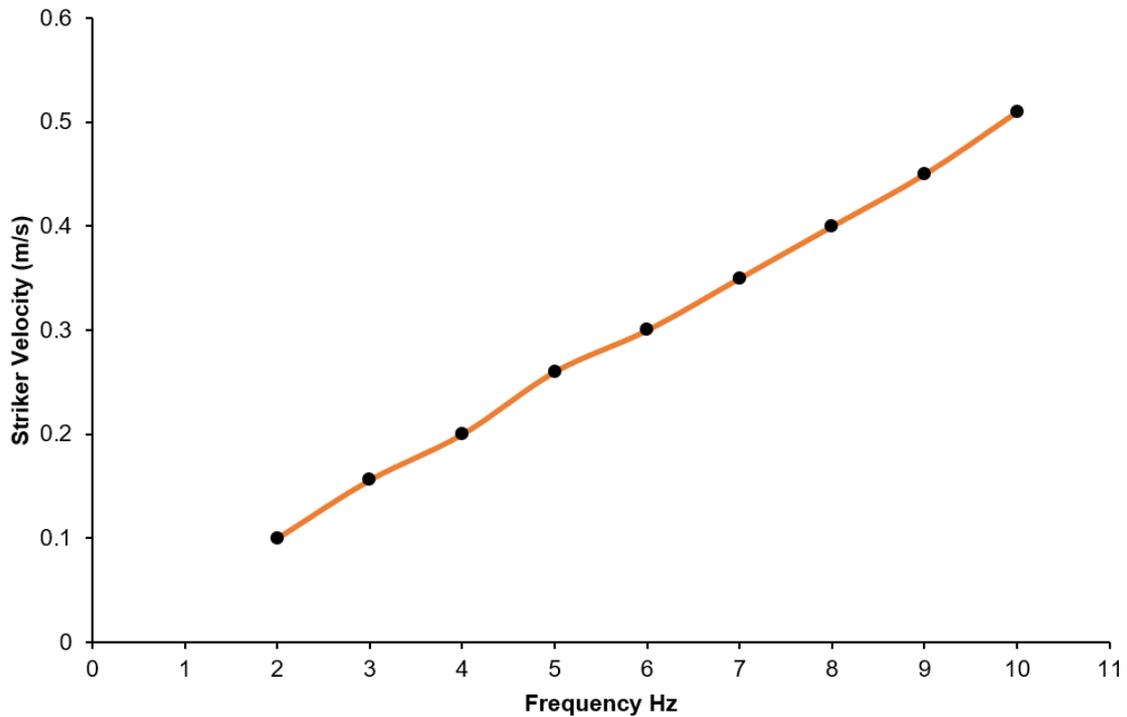
Figure 3.5 Correlation between the theoretical velocity of impact and rig frequency

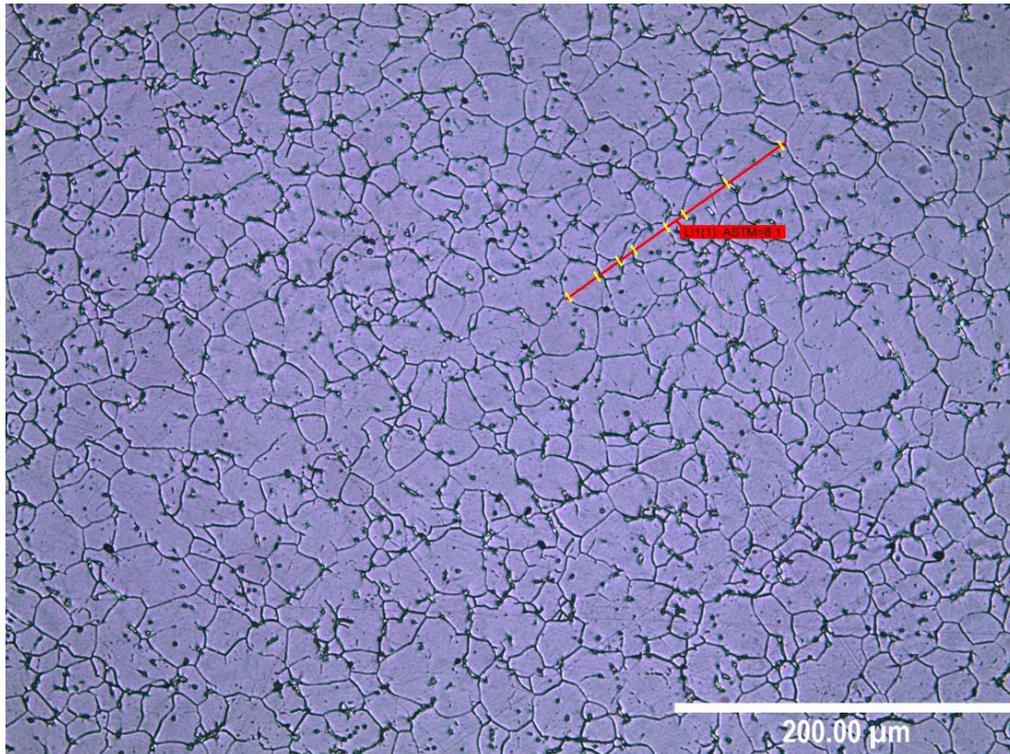
Figure 3.15 ASTM E112 for grain size of AISI 304 before impact

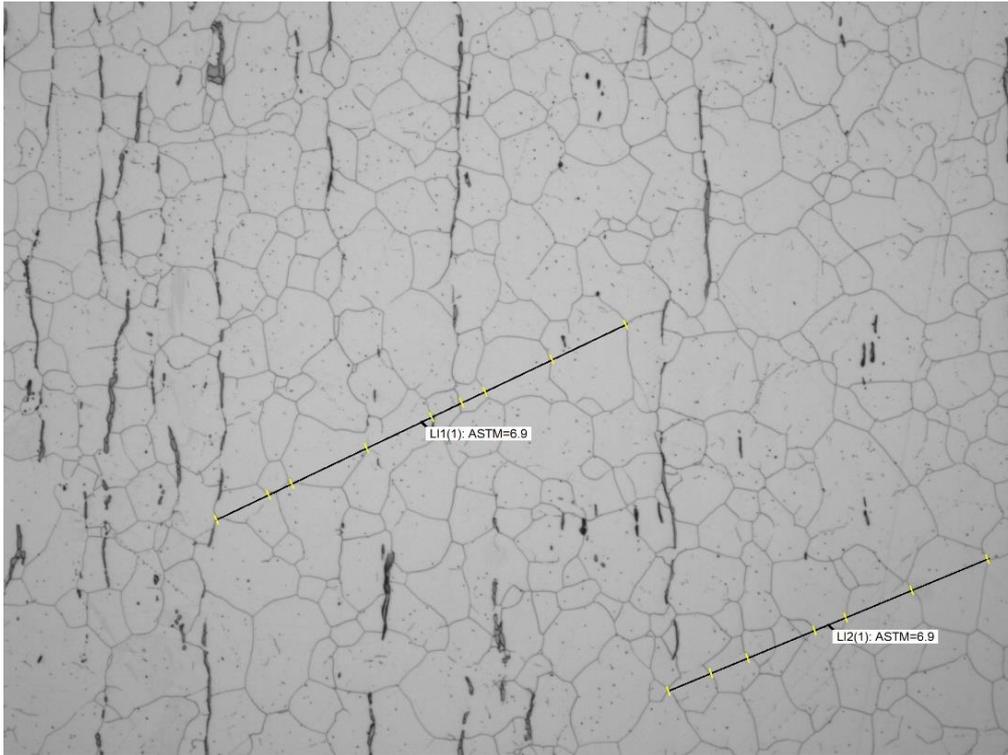
Figure 3.16 ASTM E112 for grain size of AISI 316 before impact

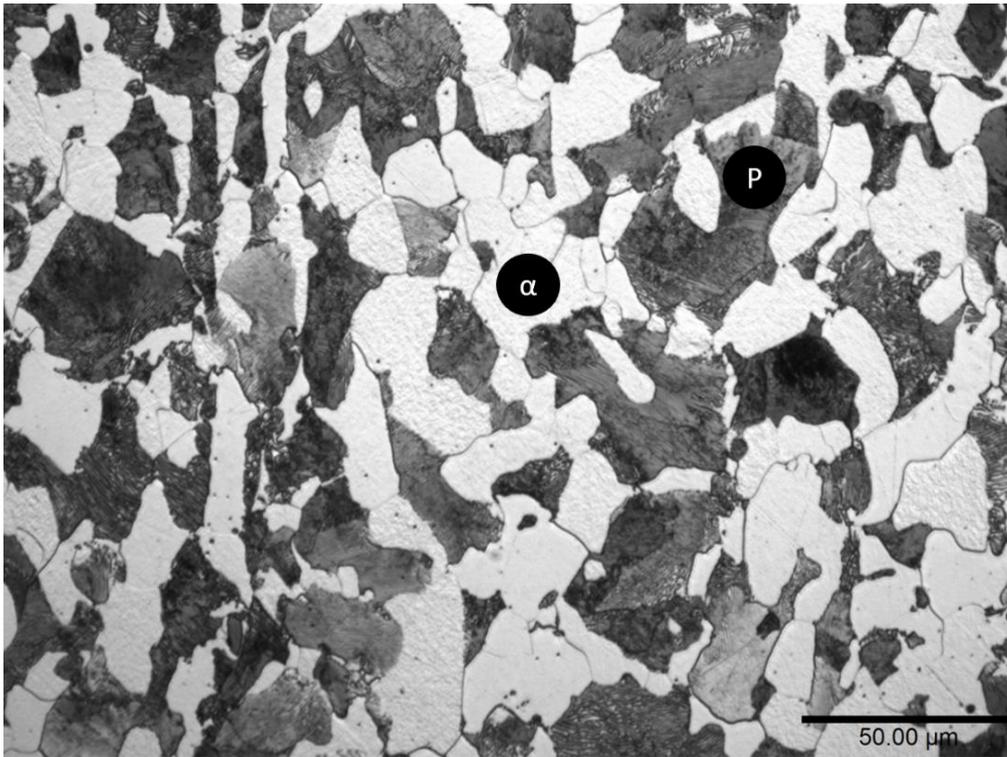
Figure 3.17 Microstructure of EN8 showing both unimpacted phases, pearlite (P) and ferrite ( $\alpha$ )

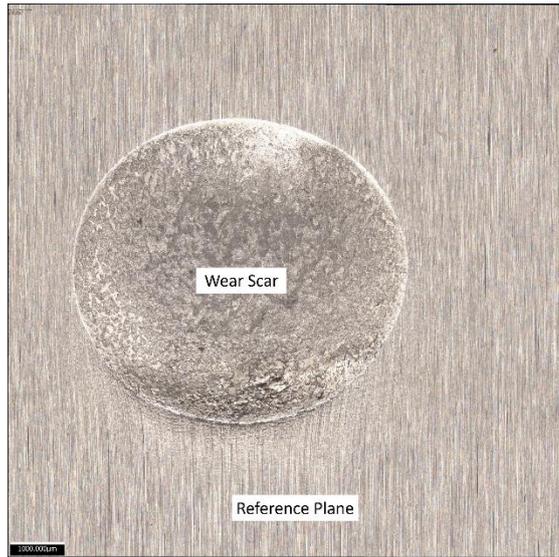
Figure 3.18 Volume measurements of typical impact wear scar of AISI 304 with impact angle 60° after 72,000 cycles by 3D non-contact profilometer shows (a) the impact wear scar and the reference plane while (b) the distortion outside the wear scar edges and (c) the volume of the wear scar

For volume measurements (Figure 3.18 (a)), a reference plane must be created first, to achieve this, three points must be selected, the first point is the reference plane point and it is outside the wear scar (typically 2-3) mm away from the edges of the wear scar. Using profile measurements method by 3D non-contact profilometer revealed that the maximum distance that the edges of the wear scar can be extruded outside the impact region above the reference plane is 1mm as shown for example in Figure 3.18 (b). Then two further points must be selected, one above the reference plane from one of the top wear scar edges and the other one below the reference plane from the other opposite bottom of the wear scar. The maximum height of the plastic flow for all the tested specimens is 770 $\mu$ m while the maximum depth of the wear scar is 572 $\mu$ m. Based on that, these two points were out of focus by 2mm to ensure that all volumes are included in the scanned region and ensure that there was no distortion of the sample outside of the impact area.

Image field measurement option was used to generate the volume for all specimens due to the large size of the wear scar, this option enables the specimen stage to move horizontally and vertically to scan the three selected point and create a 3D image as shown in Figure 3.18 (c). The original points of the 3D non-contact profilometer moved to the reference plane to get accurate measurements, both rectangular and circular scan options were used and the results are the same every time. No filters were used during this procedure and both auto exposure and autofocus options were used during this procedure.

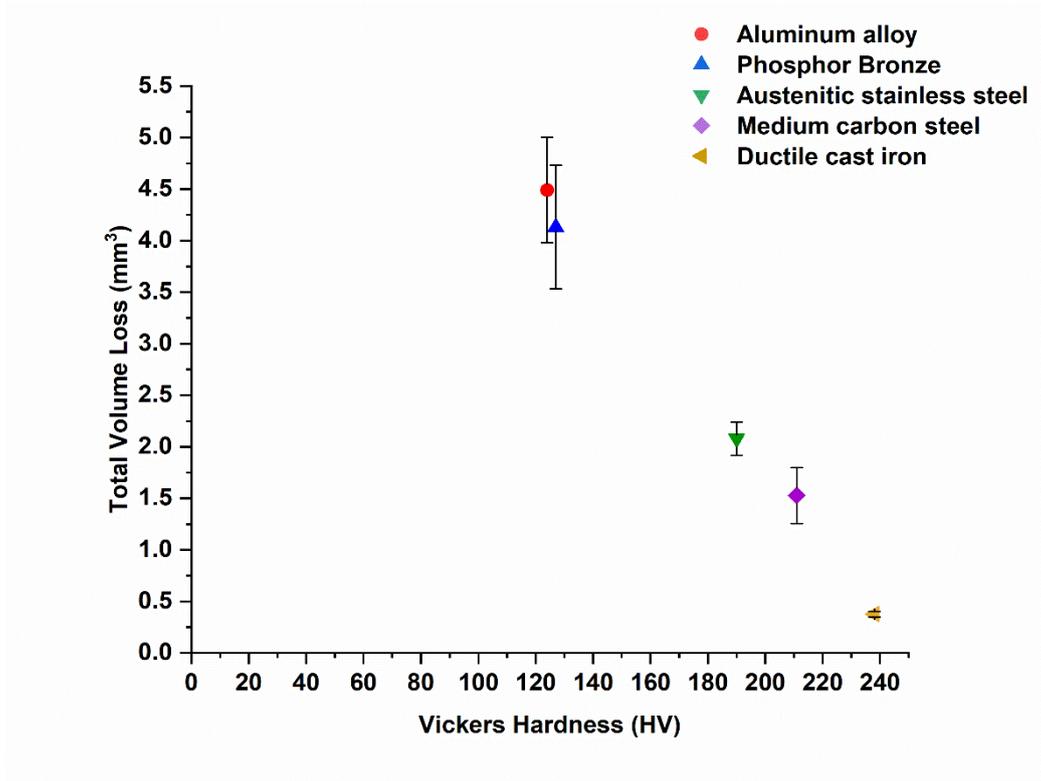
Figure 4.6 Total volume loss of materials after 36,000 cycles

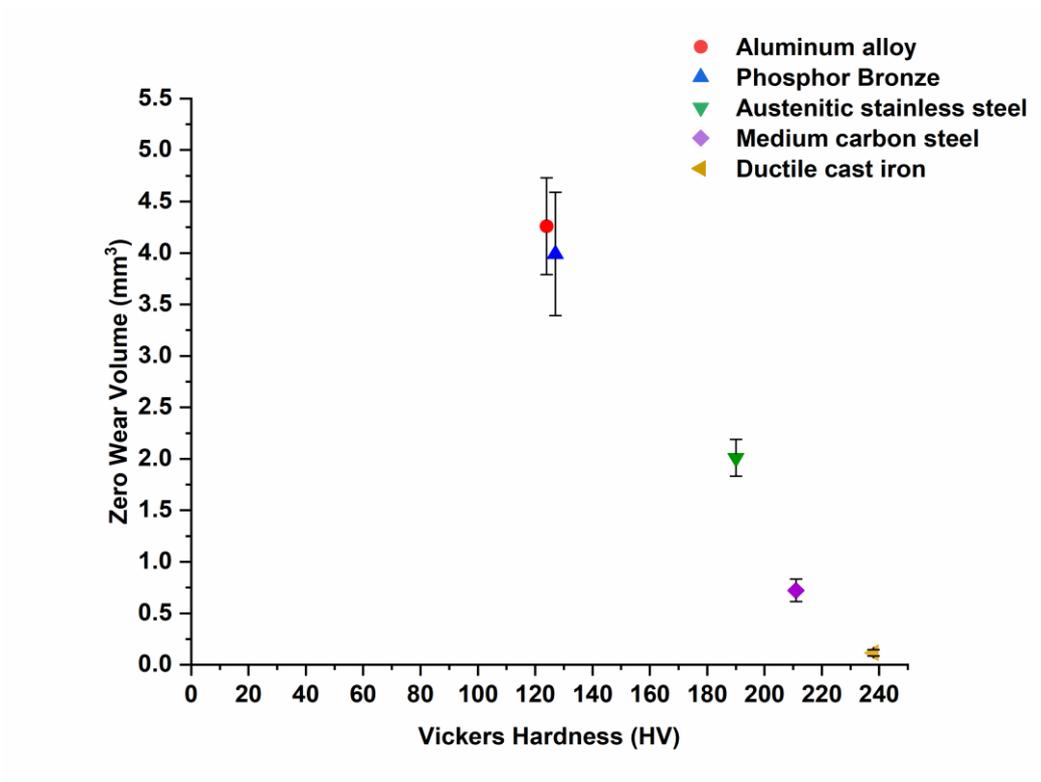
Figure 4.7 Zero wear volume loss of materials after 36,000 cycles

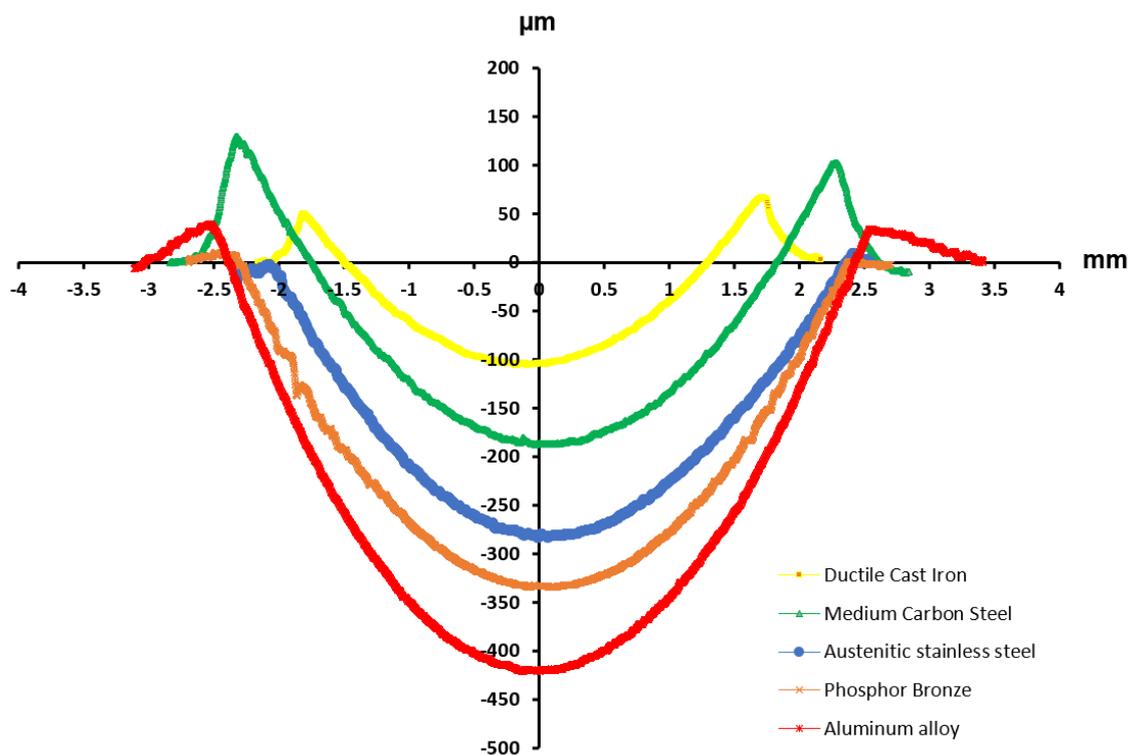
Figure 4.10 Typical wear scar profile after 36,000 cycles for each material tested.

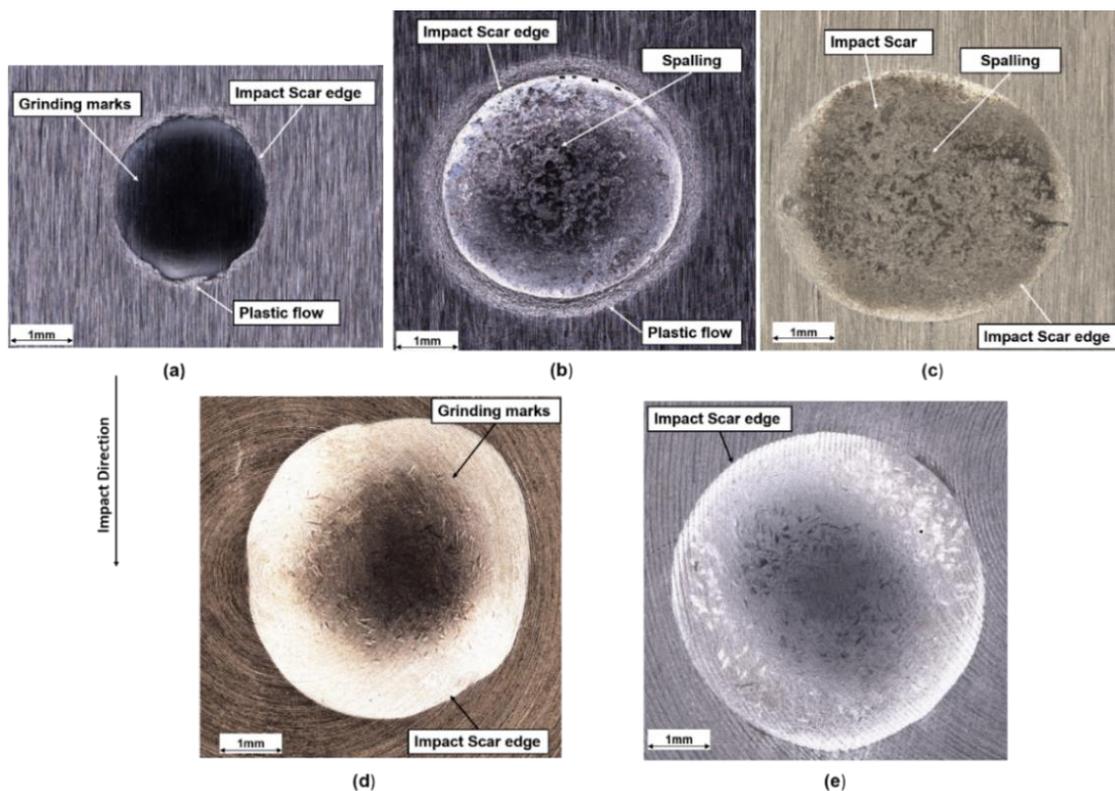
Figure 4.12 Typical impact wear scar for tested materials after 36,000 cycles for (a) ductile cast iron, (b) EN8, (c) AISI 304, (d) phosphor bronze and (e) aluminium alloy

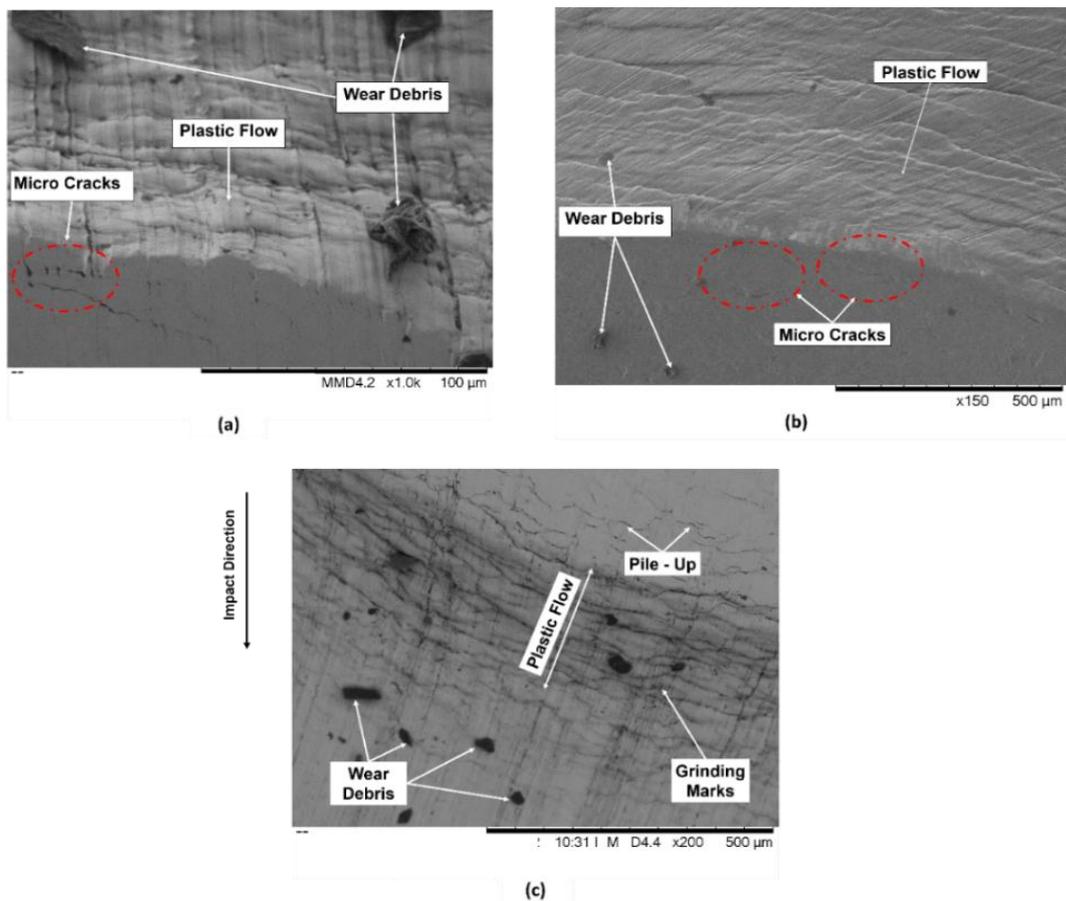
Figure 4.14 Plastic flow formation on the edges and micro-cracks after 36,000 cycles for (a) ductile cast iron, (b) aluminium alloy and (c) EN8

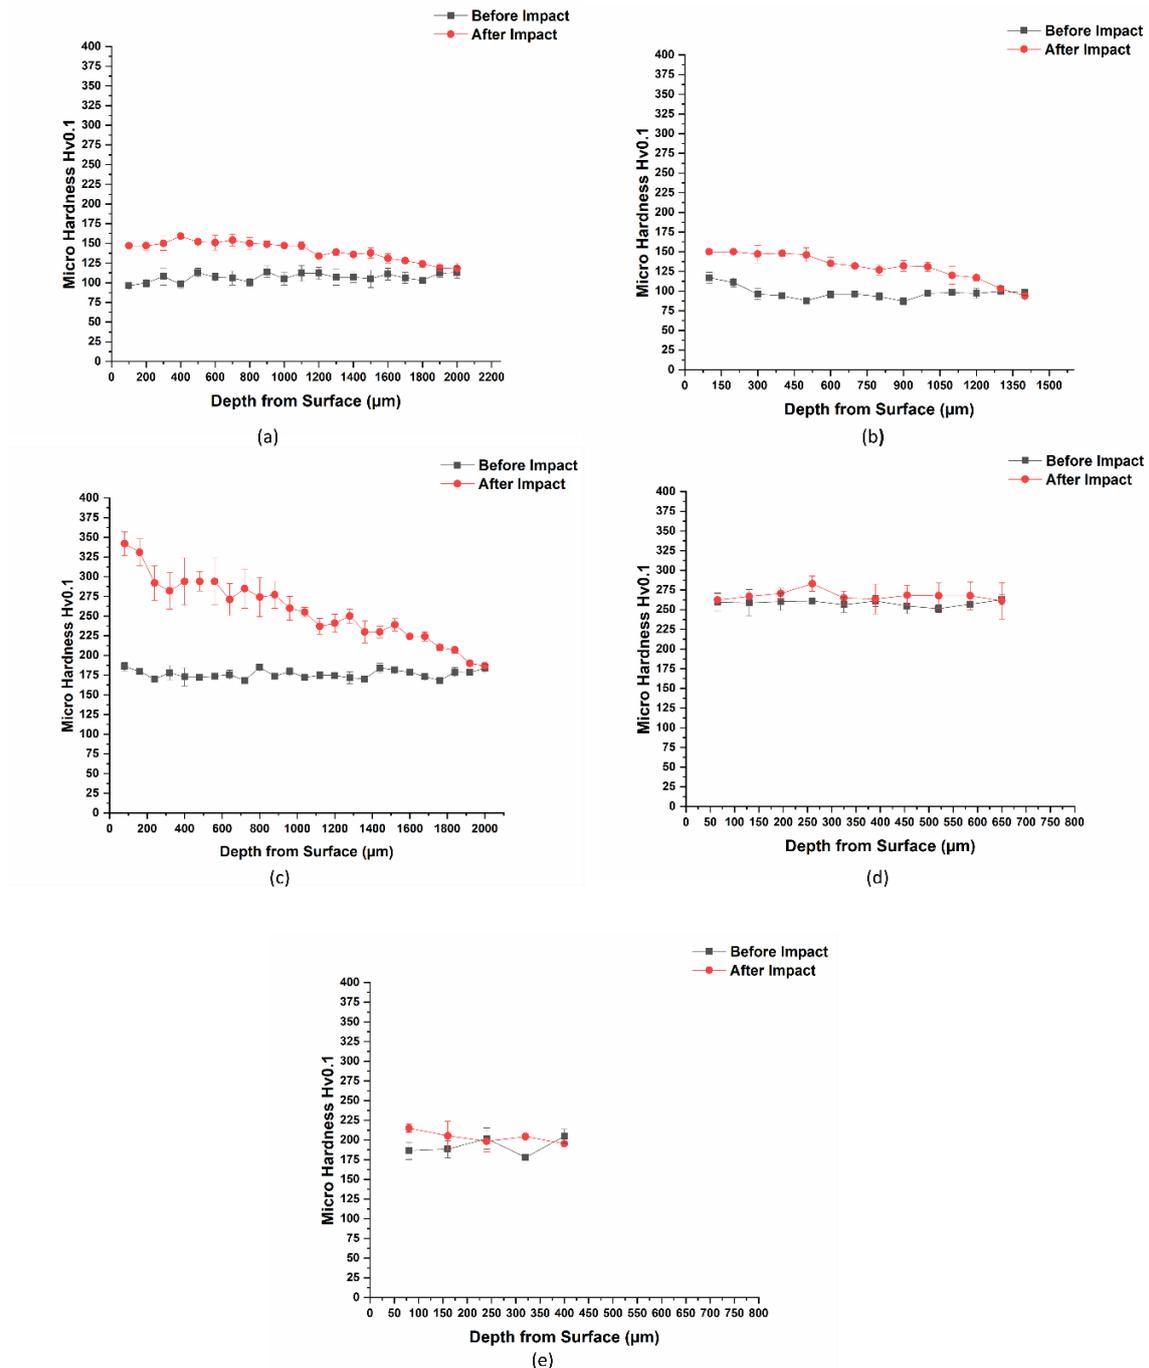
Figure 4.15 Microhardness measurements under normal impact for (a) aluminium alloy, (b) phosphor bronze, (c) AISI 304, (d) ductile cast iron and (e) EN8 after 36,000 cycles

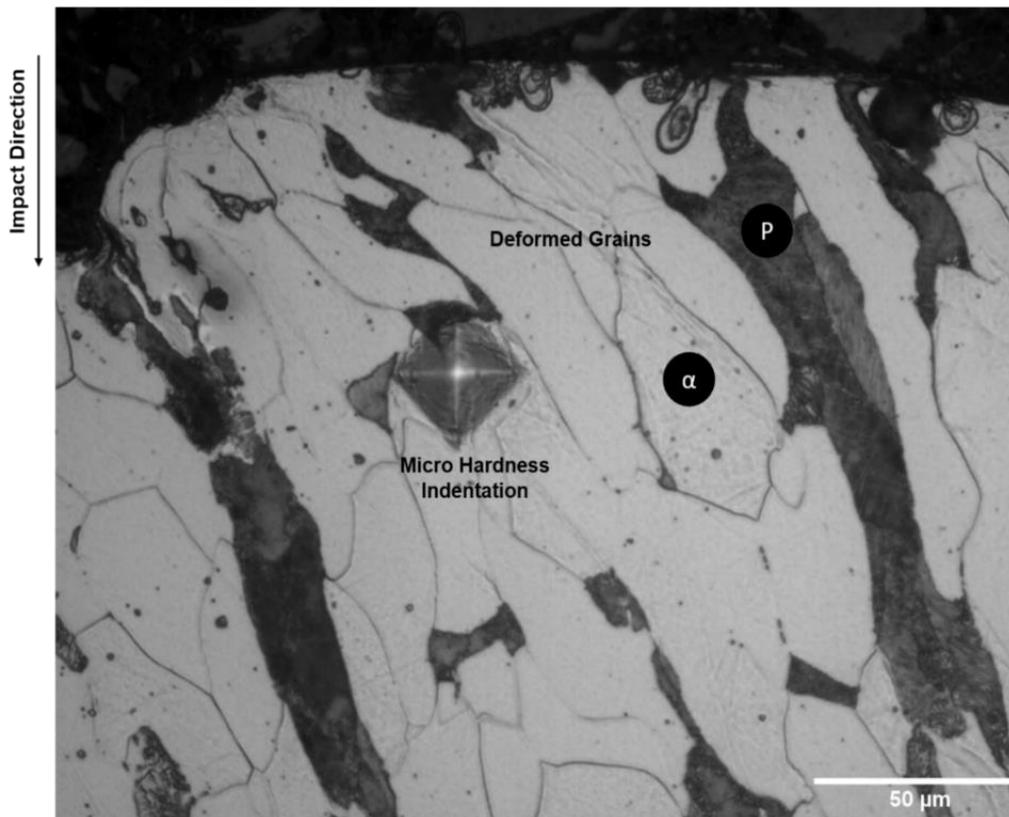
Figure 4.16 Microhardness indentation of EN8 below the bottom edge of wear scar after 36,000 cycles

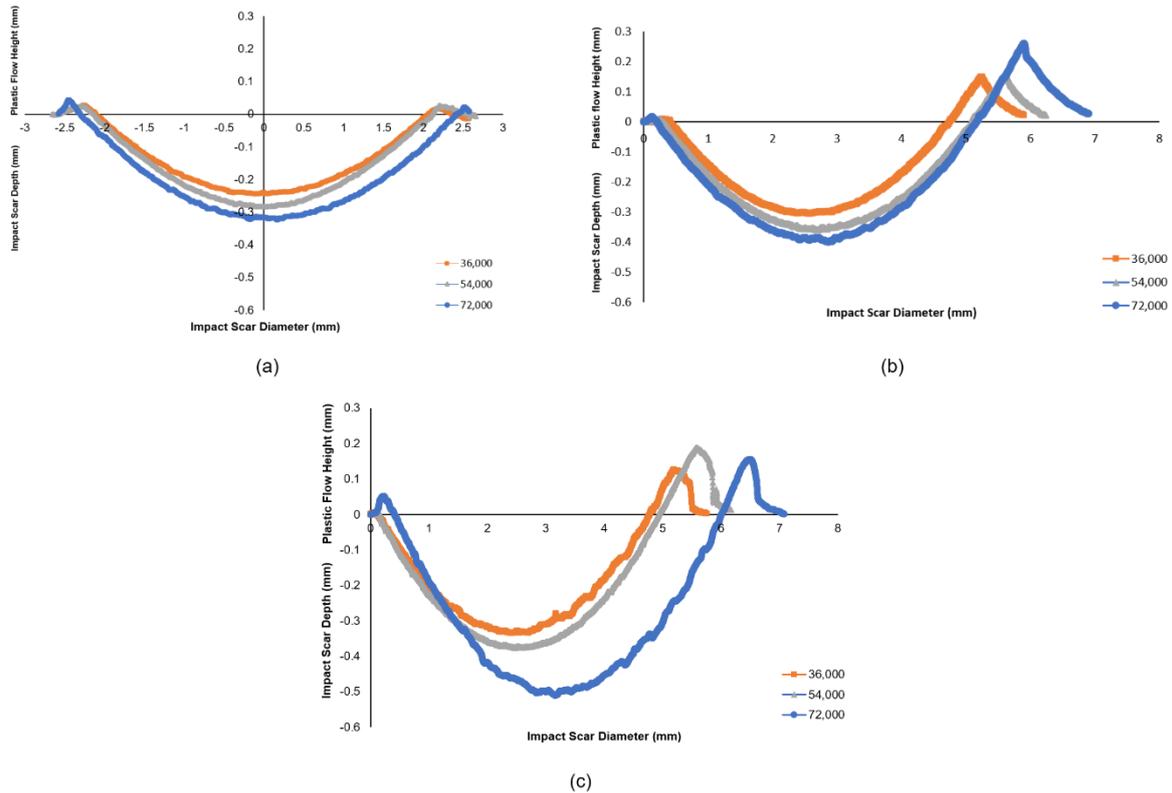
Figure 5.7 Typical diametric and depth of the wear scar with different cycles for AISI 304 under (a) normal impact, (b) compound impact 60° and, (c) compound impact 45°

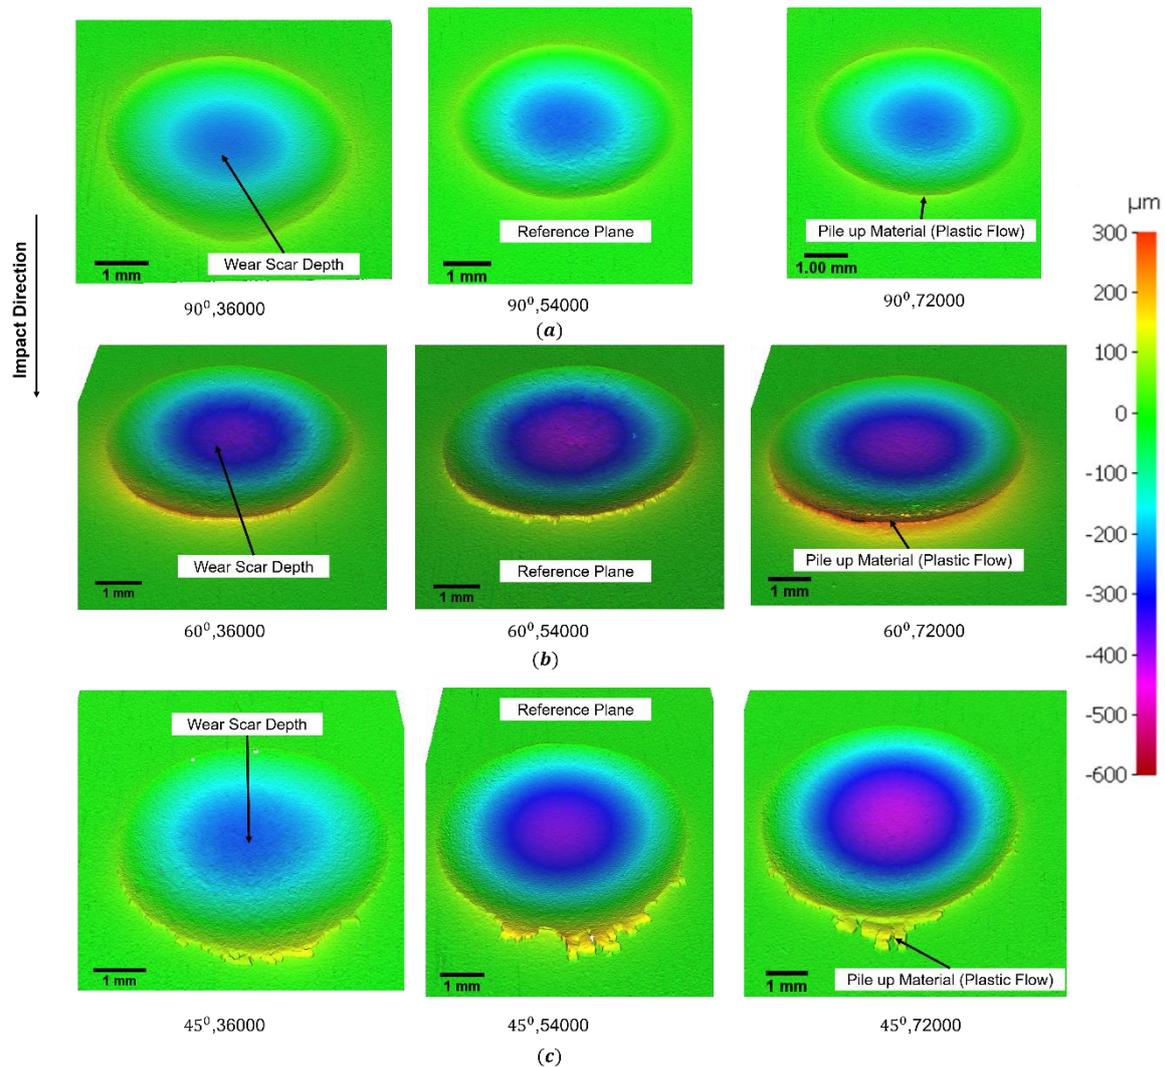
Figure 5.8 3D Image of typical depth and pile up profile of impact scars for material with different impact conditions: (a) under normal impact  $90^\circ$ , (b) with impact angle  $60^\circ$ , (c) with impact angle  $45^\circ$

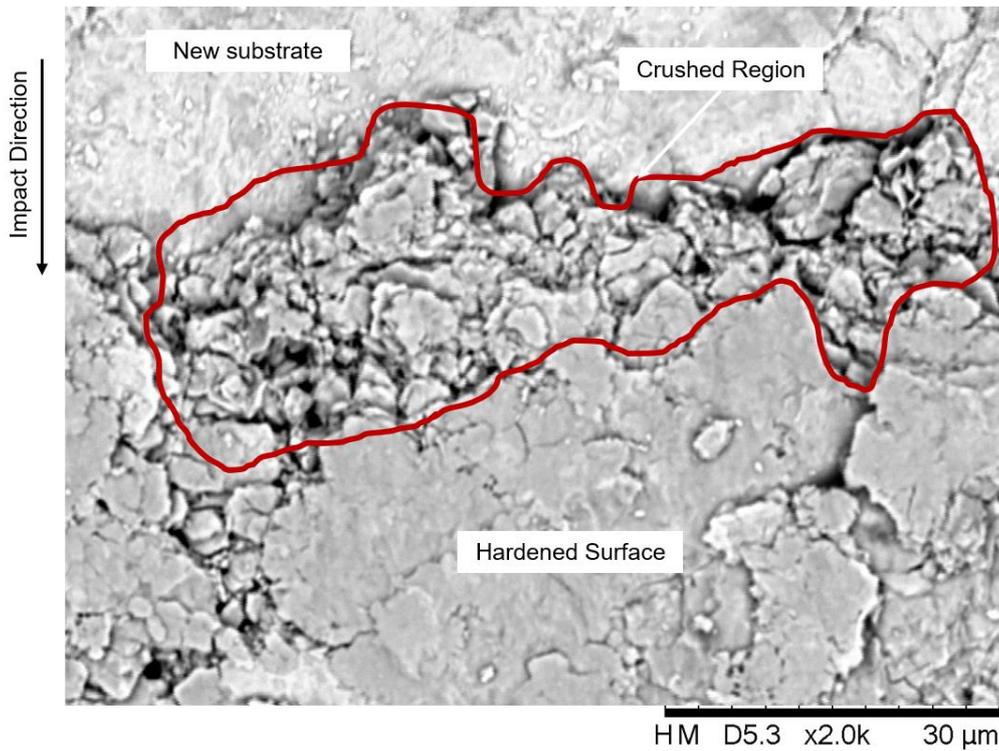
Figure 5.11 Crushed region between the hardened surface and new substrate in the centre of impact wear scar for material after 54,000 cycles

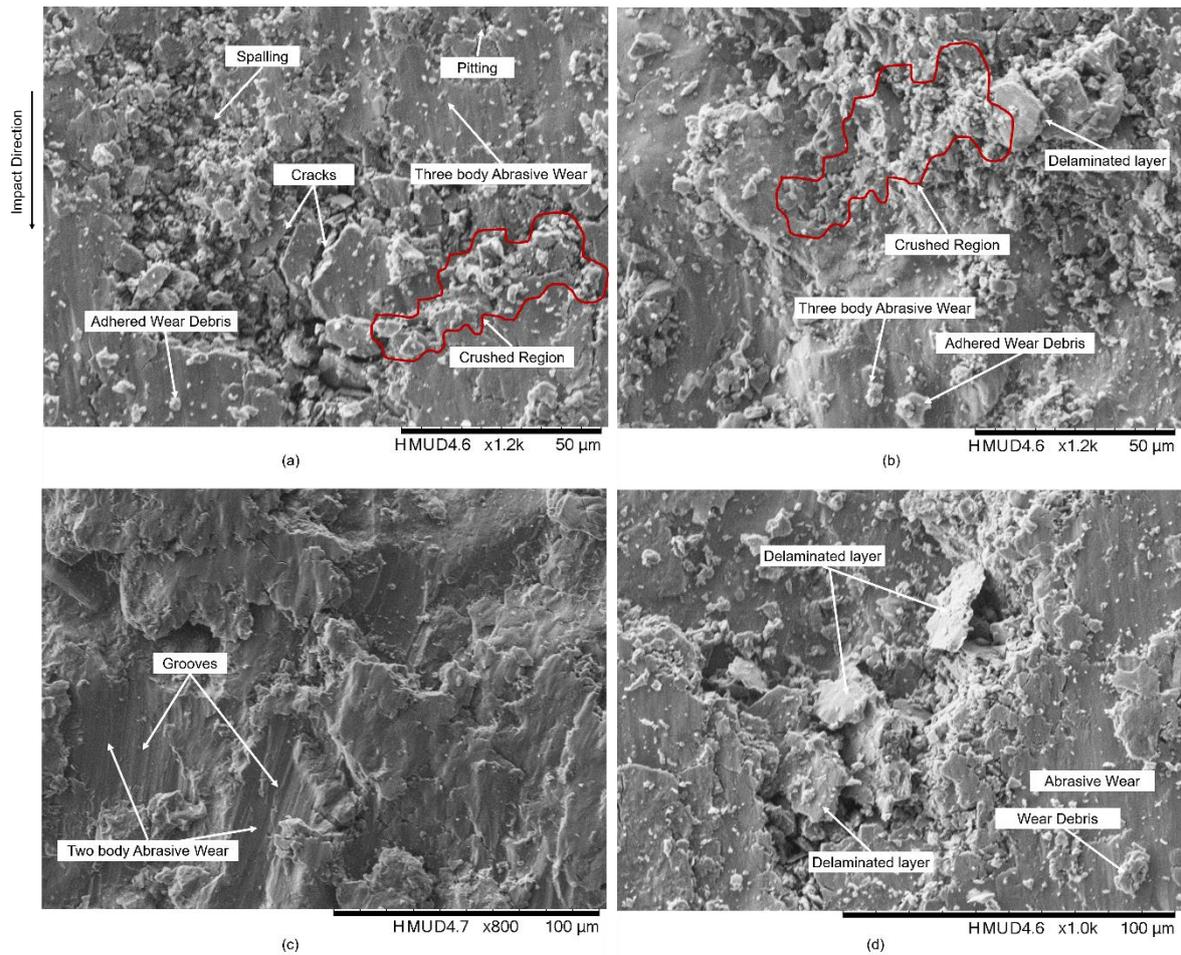
Figure 5.14 Wear damage mechanism for the centre of wear scar for material after 36,000 cycles under compound impact  $60^\circ$  where (a) and (b) show the abrasive wear and the crushed region, (c) and (d) show the ploughing process due to abrasive wear

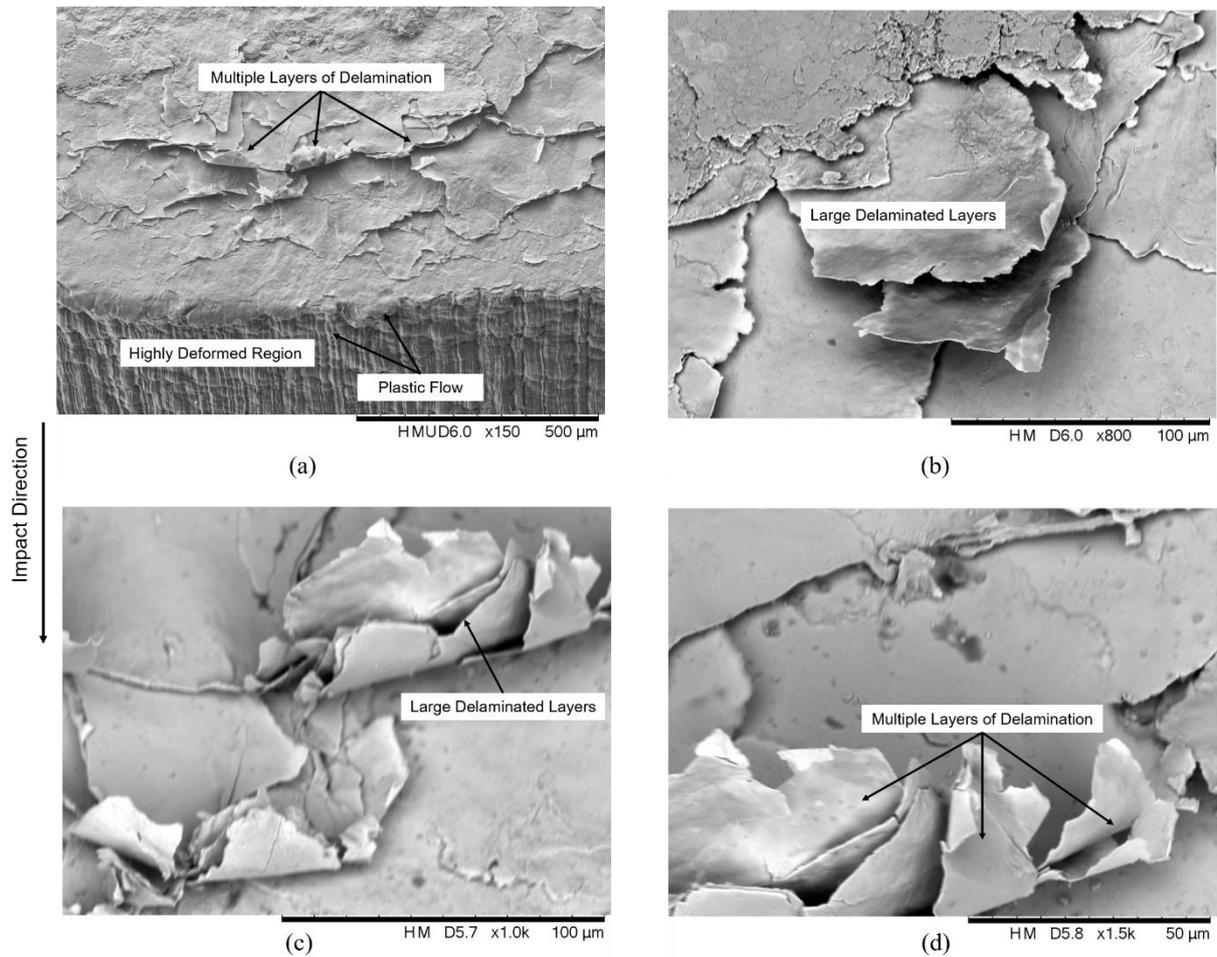
Figure 5.18 Multiple layers of delamination near the bottom of the wear scar for material after 72,000 cycles under compound impact  $60^\circ$  with different magnifications

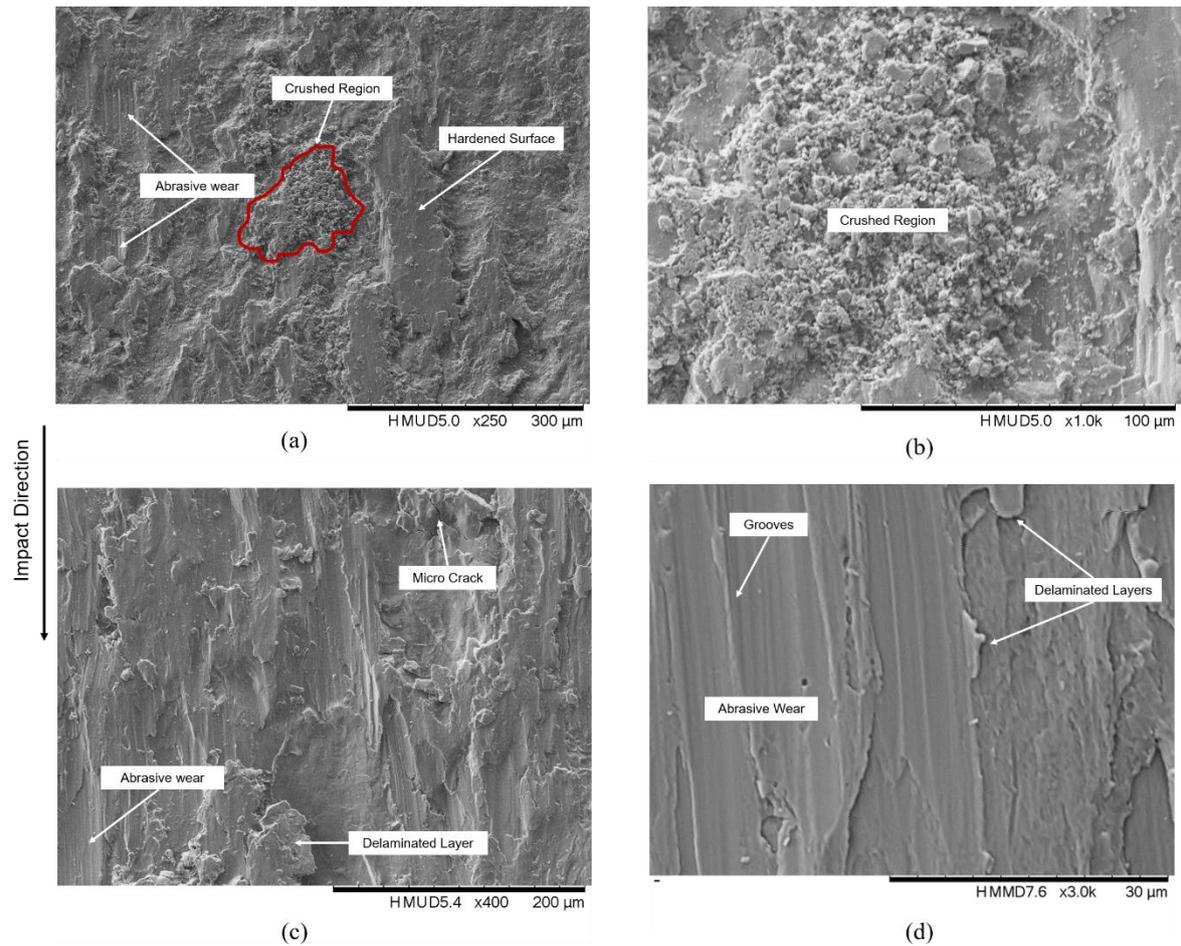
Figure 5.19 SEM micrographs of worn surface for material after 36,000 cycles under compound impact  $45^\circ$  revealing the different wear damage mechanisms for the centre of wear scar where (a) and (b) shows the crushed particles while (c) and (d) reveals the abrasive wear and grooves

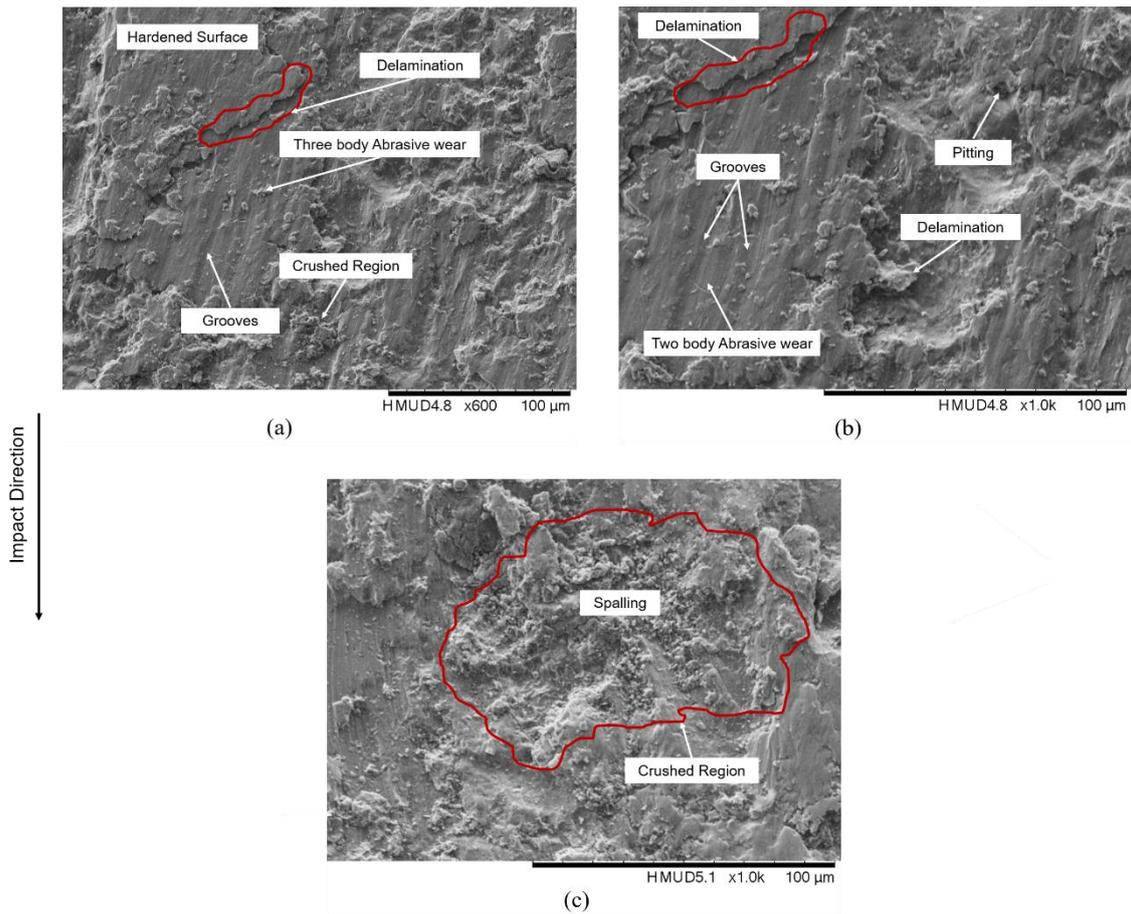
Figure 5.21 SEM micrograph of worn surface for material after 54,000 cycles under compound impact 45° revealing different wear damage mechanisms for the centre of wear scar

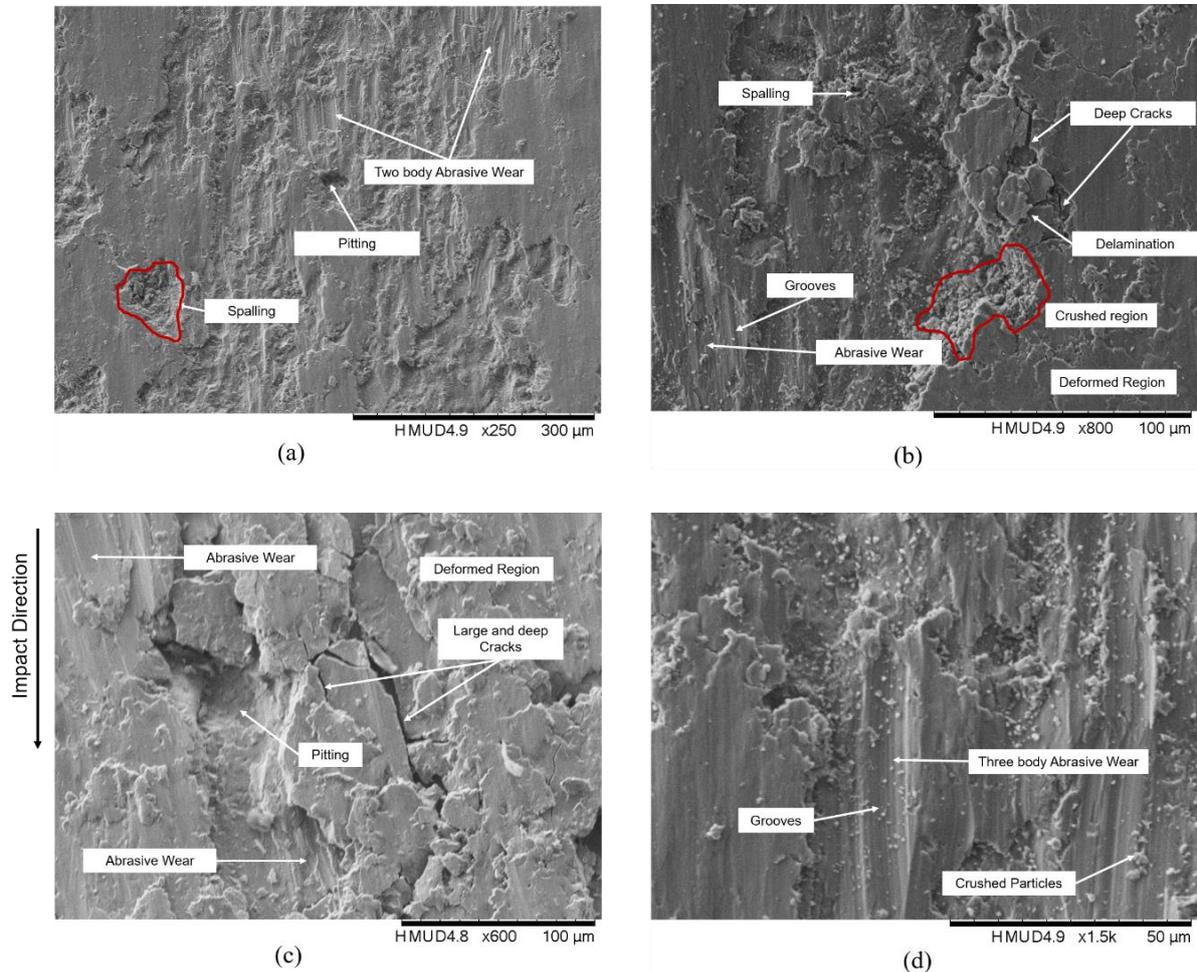
Figure 5.23 showing wear damage mechanism for the centre of wear scar of for material after 72,000 cycles under compound impact 45° where (a) shows pitting and two body abrasive wear, (b), (c) and (d) shows an obvious multiple cracks, crushed particles and abrasive wear with grooves
