## **Characterisation and Modelling of Normal and Compound Impact Wear in Common Engineering Alloys**

A thesis submitted to the University of Sheffield  
for the degree of Doctor of Philosophy in the Faculty of Engineering

Author: Mohanad Qasim Zalzalah  
Date: June 2021  
Supervisors: **Dr. Tom Slatter**  
**Prof. Roger Lewis**

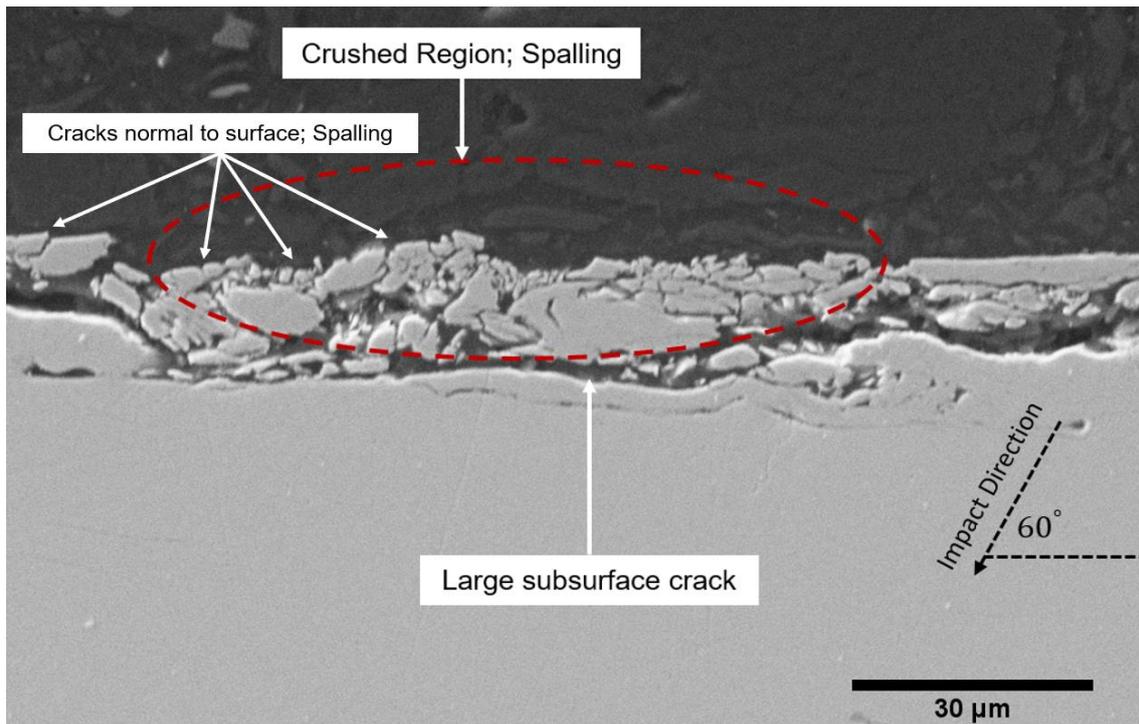
Figure 5.26 SEM image of subsurface damage for material after 72,000 cycles under compound impact  $60^\circ$  showing the crushed region in the centre of the wear scar

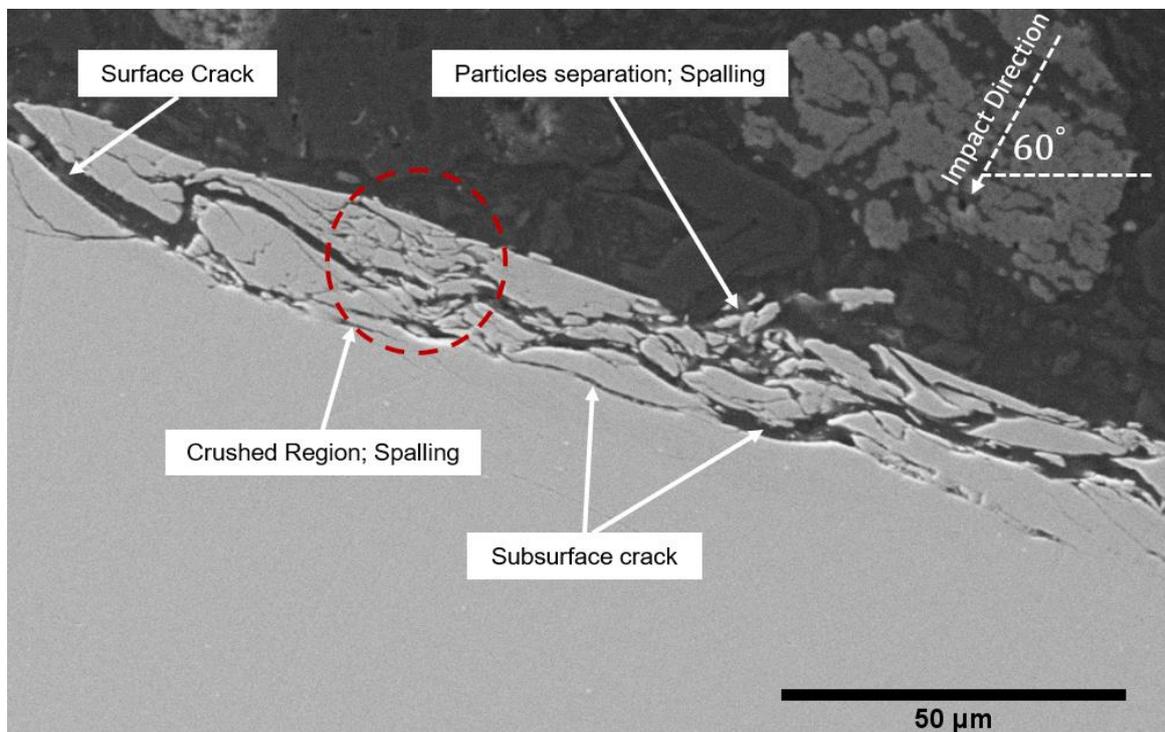
Figure 5.27 SEM image of large delamination layer due to subsurface crack for material after 72,000 cycles under compound impact  $60^\circ$  with crushed particles

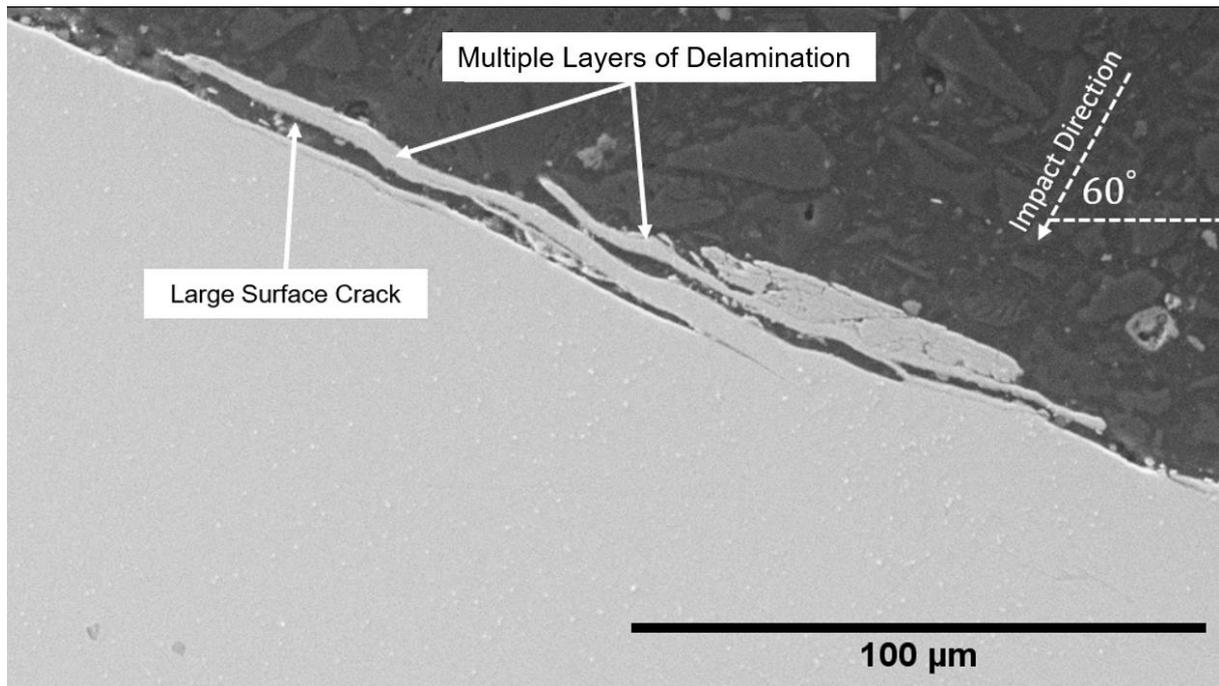
Figure 5.28 SEM image showing multiple layers delamination for material after 72,000 cycles under compound impact  $60^\circ$  near the bottom edge

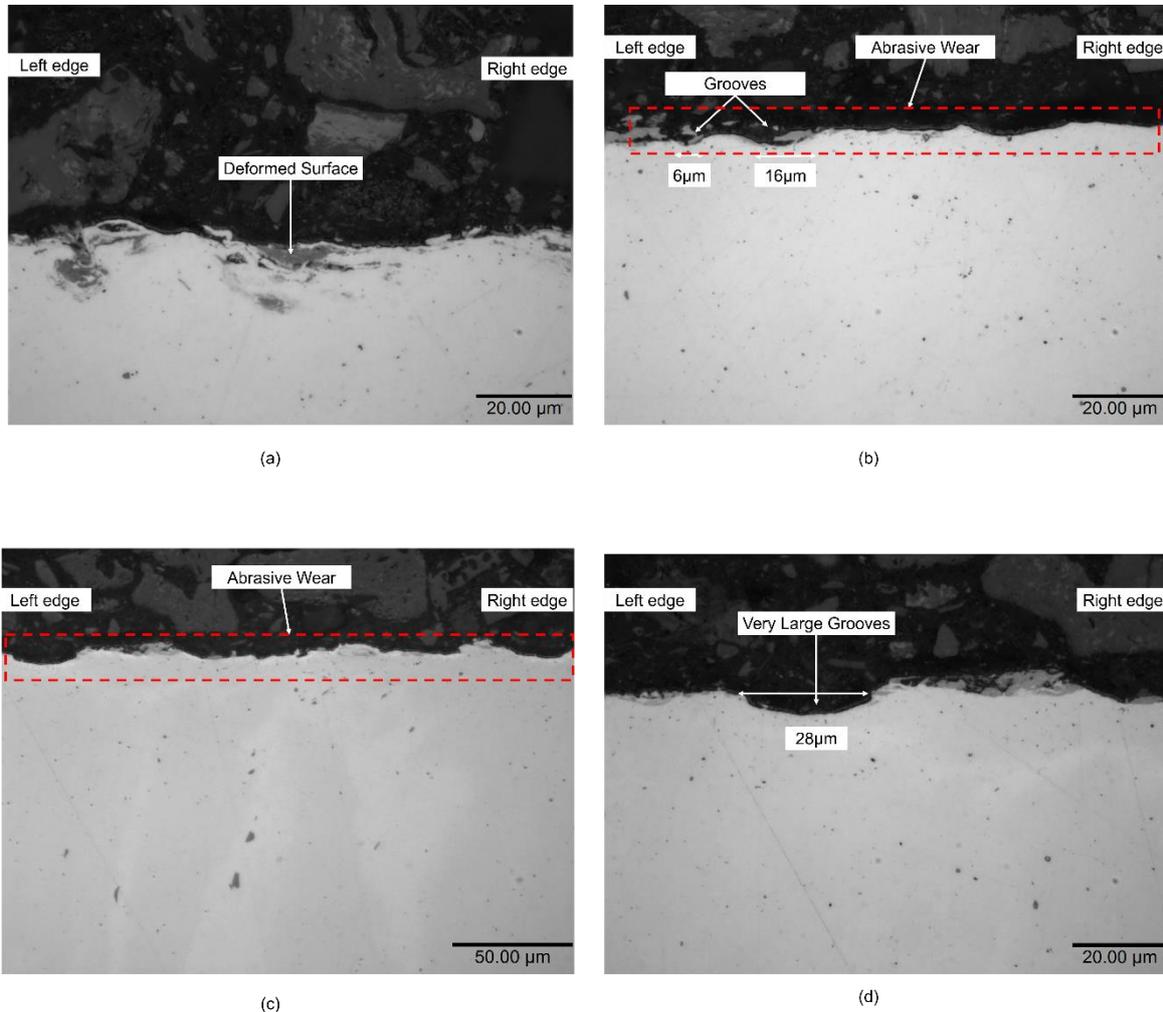
Figure 5.32 Optical microscope images with perpendicular sectioning to the impact direction for the centre of wear scar of three specimens showing the wear damage at: (a) normal impact  $90^\circ$ , (b) compound impact  $60^\circ$ , (c) and (d) compound impact  $45^\circ$  after 72,000 cycles

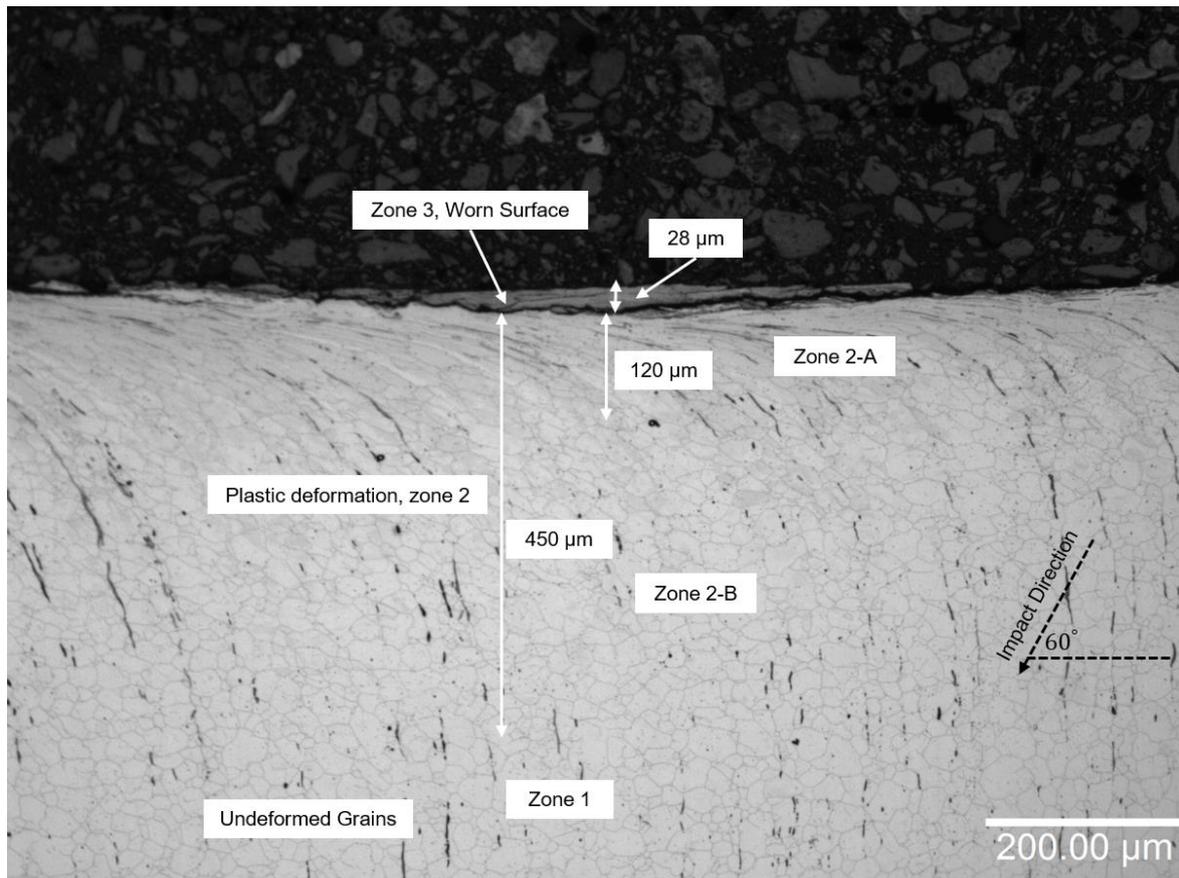
Figure 5.35 Optical microscope image of electro etching for material under compound impact  $60^\circ$  showing the centre of the wear scar after 72,000 cycles showing the impact wear zones

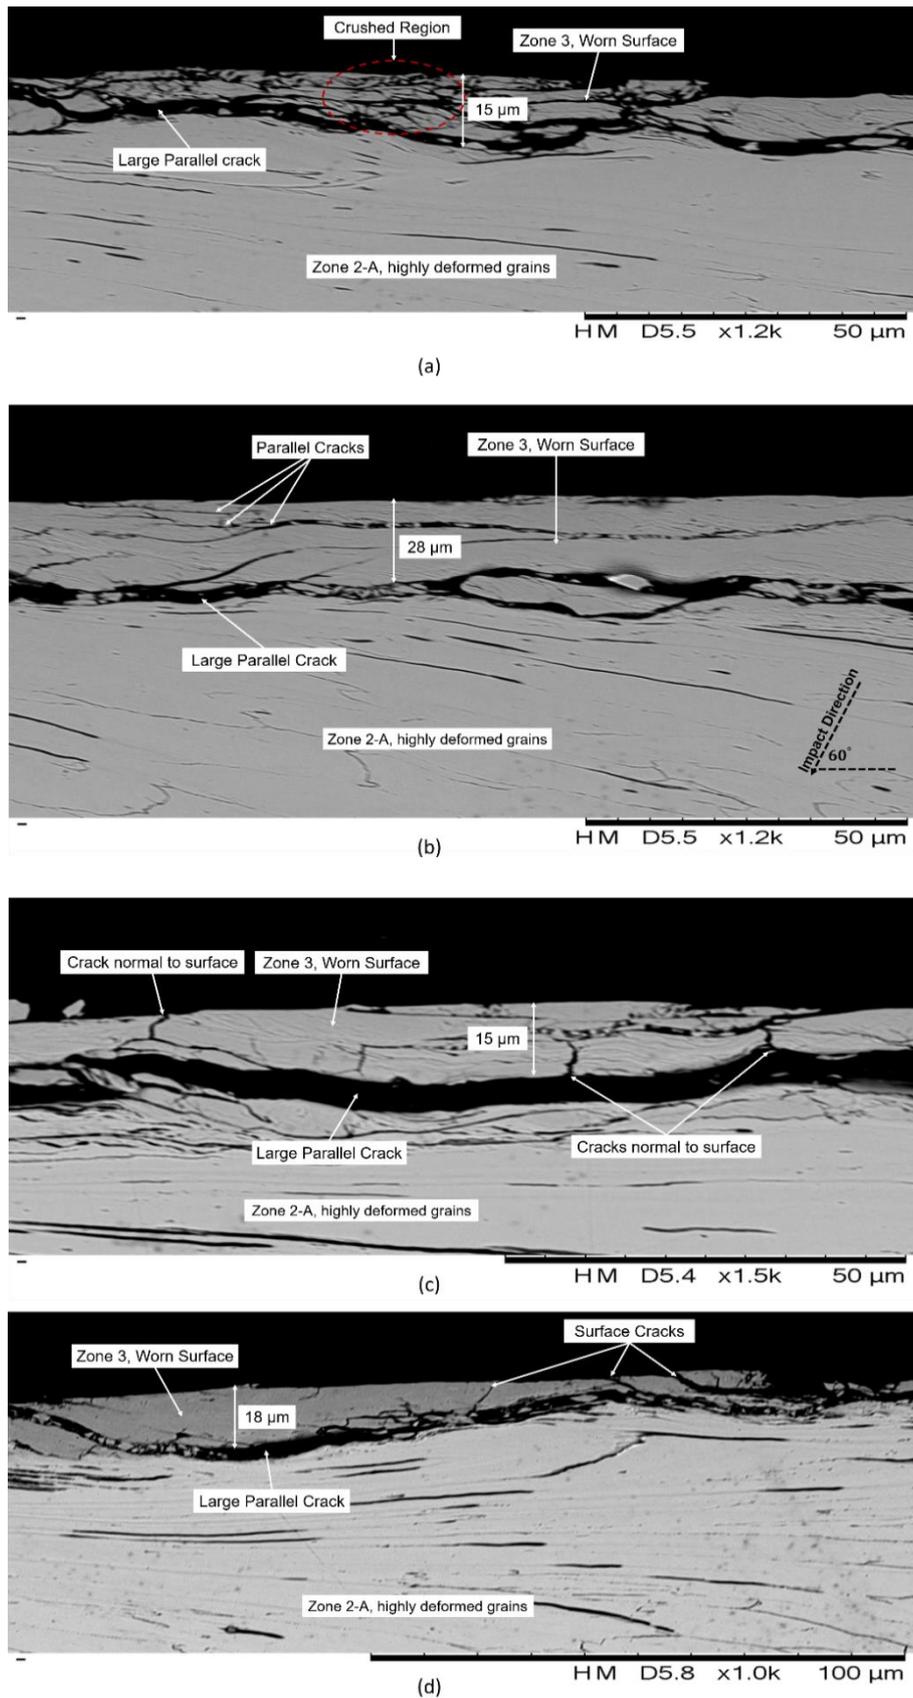
Figure 5.36 SEM images revealing wear damage mechanisms affecting the worn surface layer (zone 3) for material under compound impact 60° where (a) shows the crushed region, (b) reveals the parallel cracks while (c) shows cracks normal to the surface and (d) shows the large parallel crack that separate the worn layer

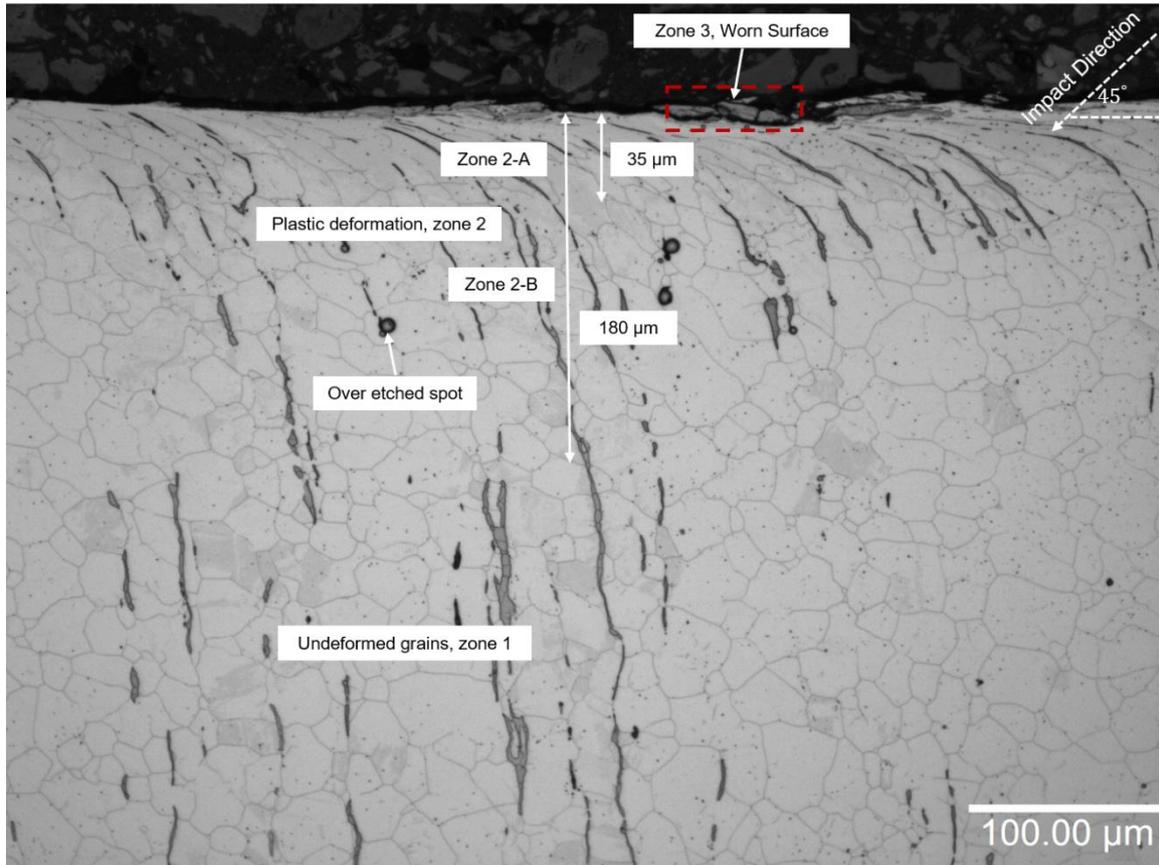
Figure 5.39 Optical microscope image of electro etching for material under compound impact  $45^\circ$  for the centre of wear scar after 72,000 cycles showing the impact wear zones

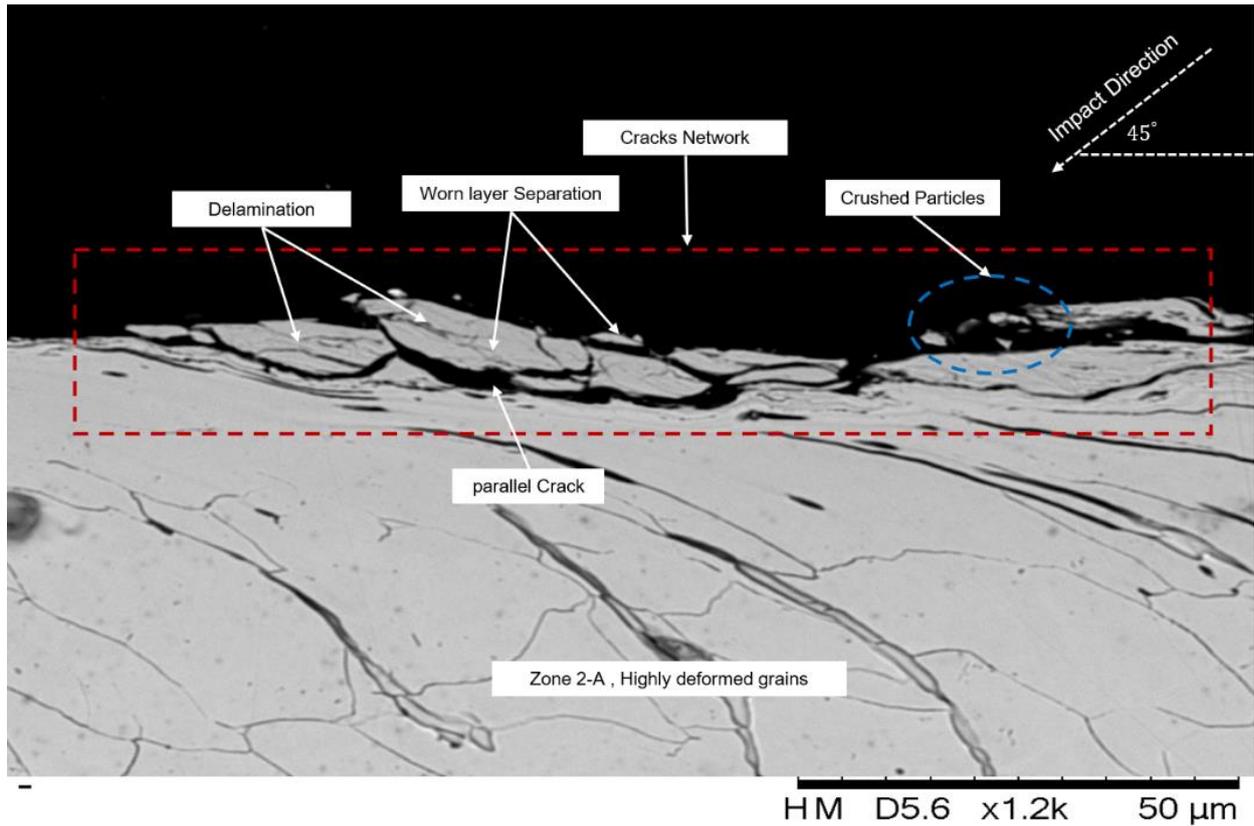
Figure 5.40 SEM image reveals the wear damage mechanisms occurring in the worn surface layer for material after 72,000 cycles under compound impact  $45^\circ$

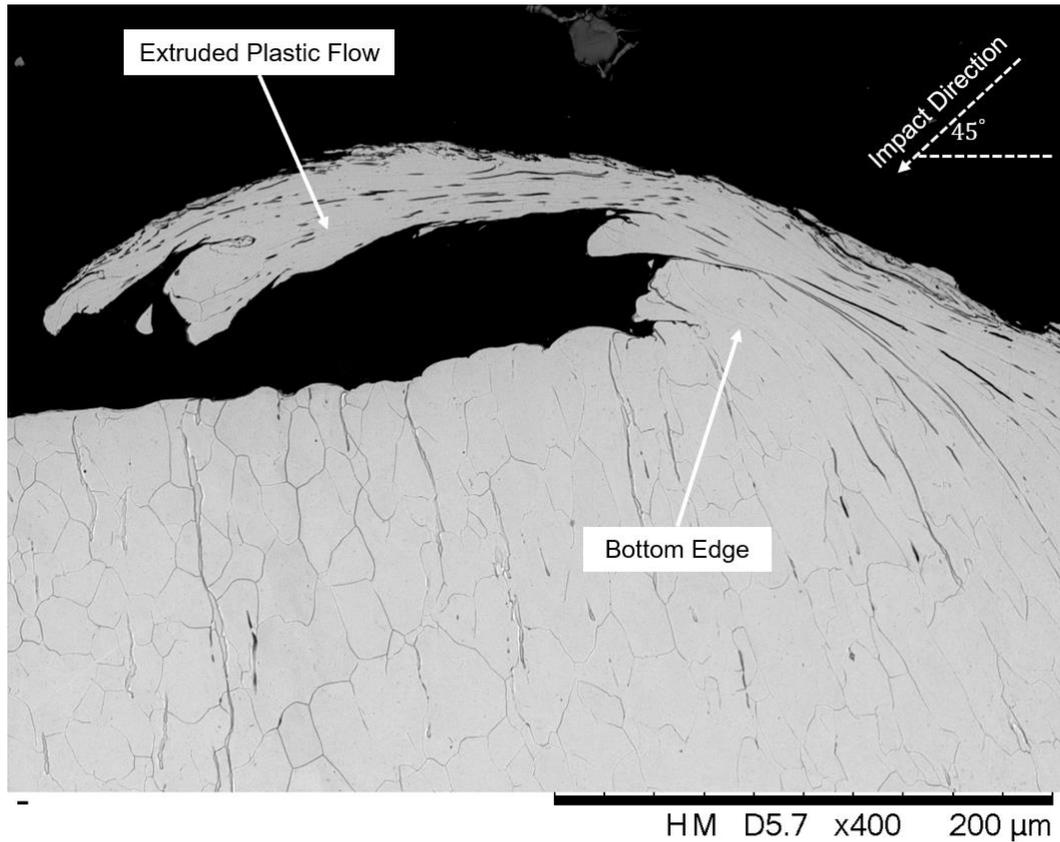
Figure 5.41 SEM image after electro etching for material reveals the deformed grains on the bottom edge and the extrusion of pile up materials outside the wear scar of specimen after 72,000 cycles under compound impact  $45^\circ$

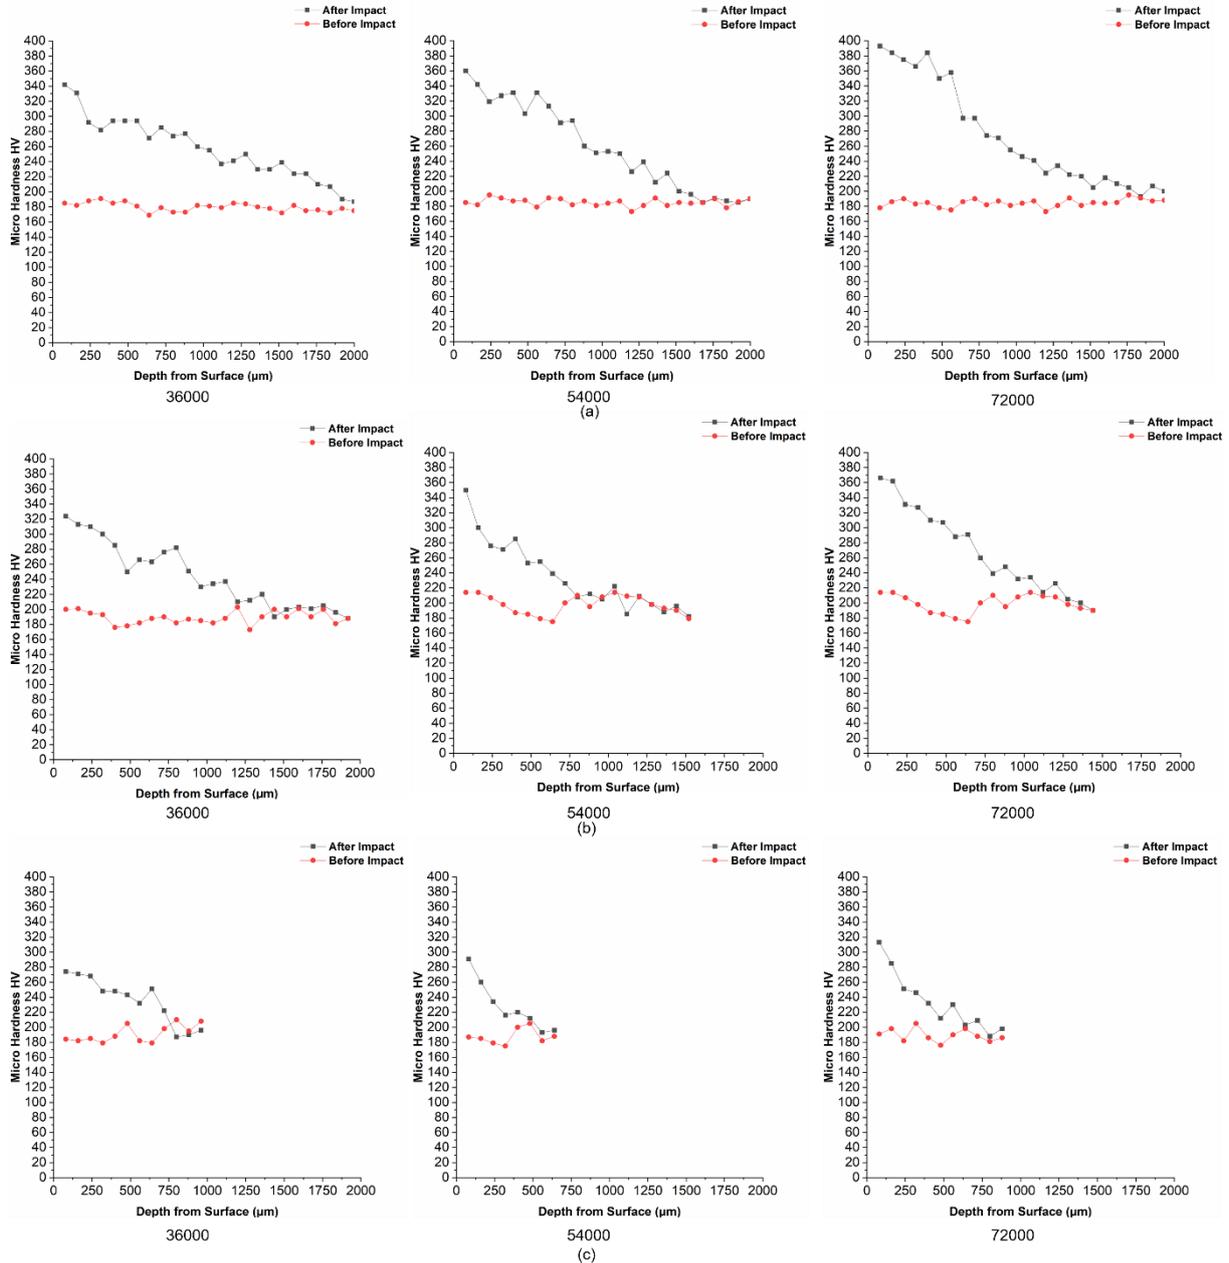
Figure 5.42 Microhardness profile of original and impacted austenitic stainless steel samples at impact force of 3476 N with different impact conditions where (a) is normal impact  $90^\circ$ , (b) is compound impact  $60^\circ$  and (c) is compound impact  $45^\circ$

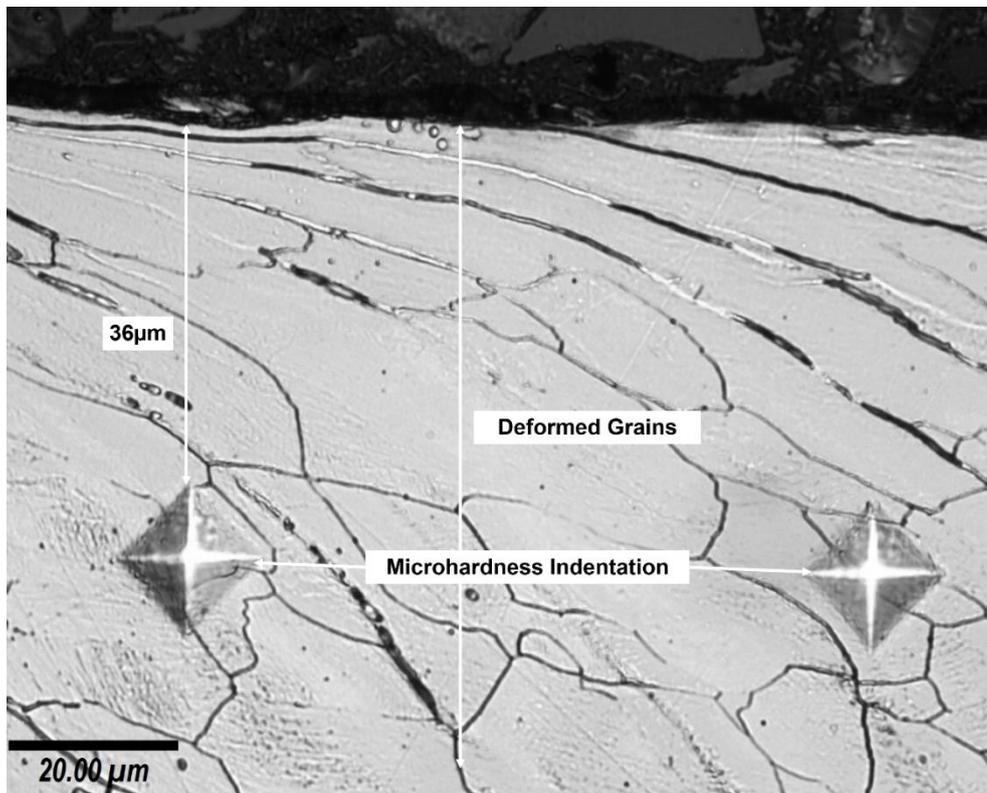
Figure 5.43 Optical microscope image for the microhardness indentation inside the deformed grains of austenitic stainless steel 304 for compound impact 45° after 54,000

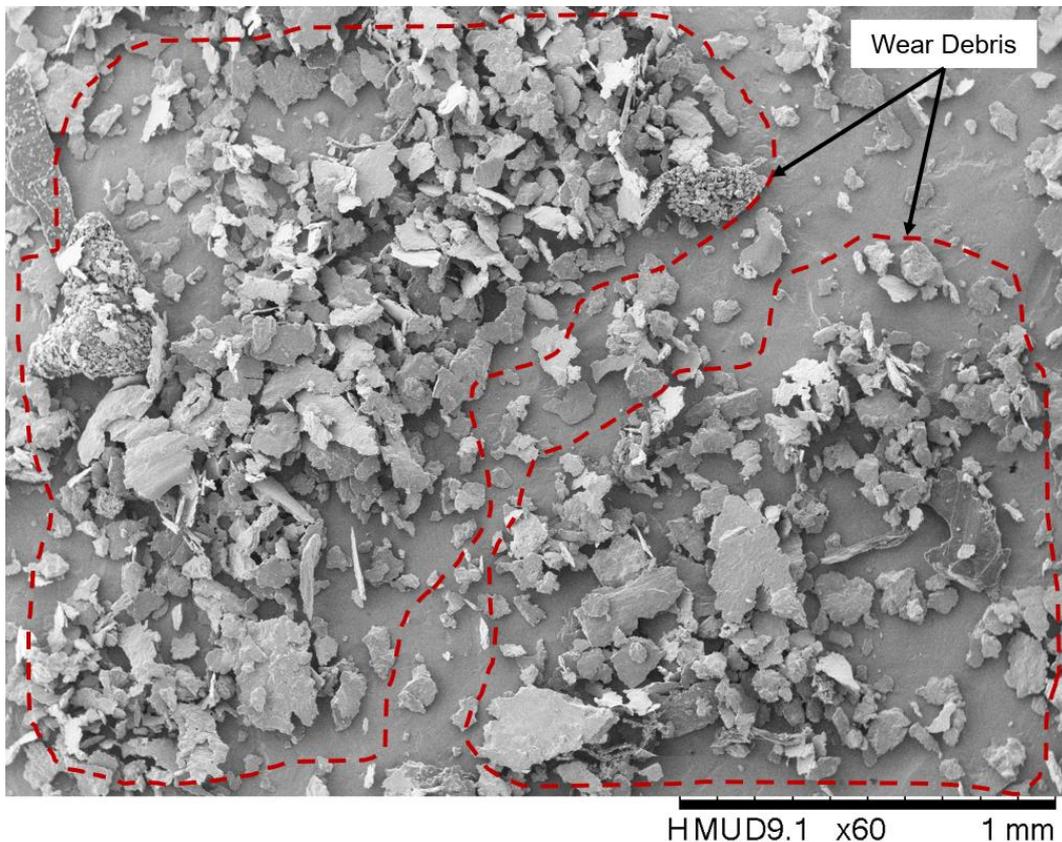
Figure 5.50 Collected wear debris from worn surface for material under compound impact  $45^\circ$  after 72,000 cycles

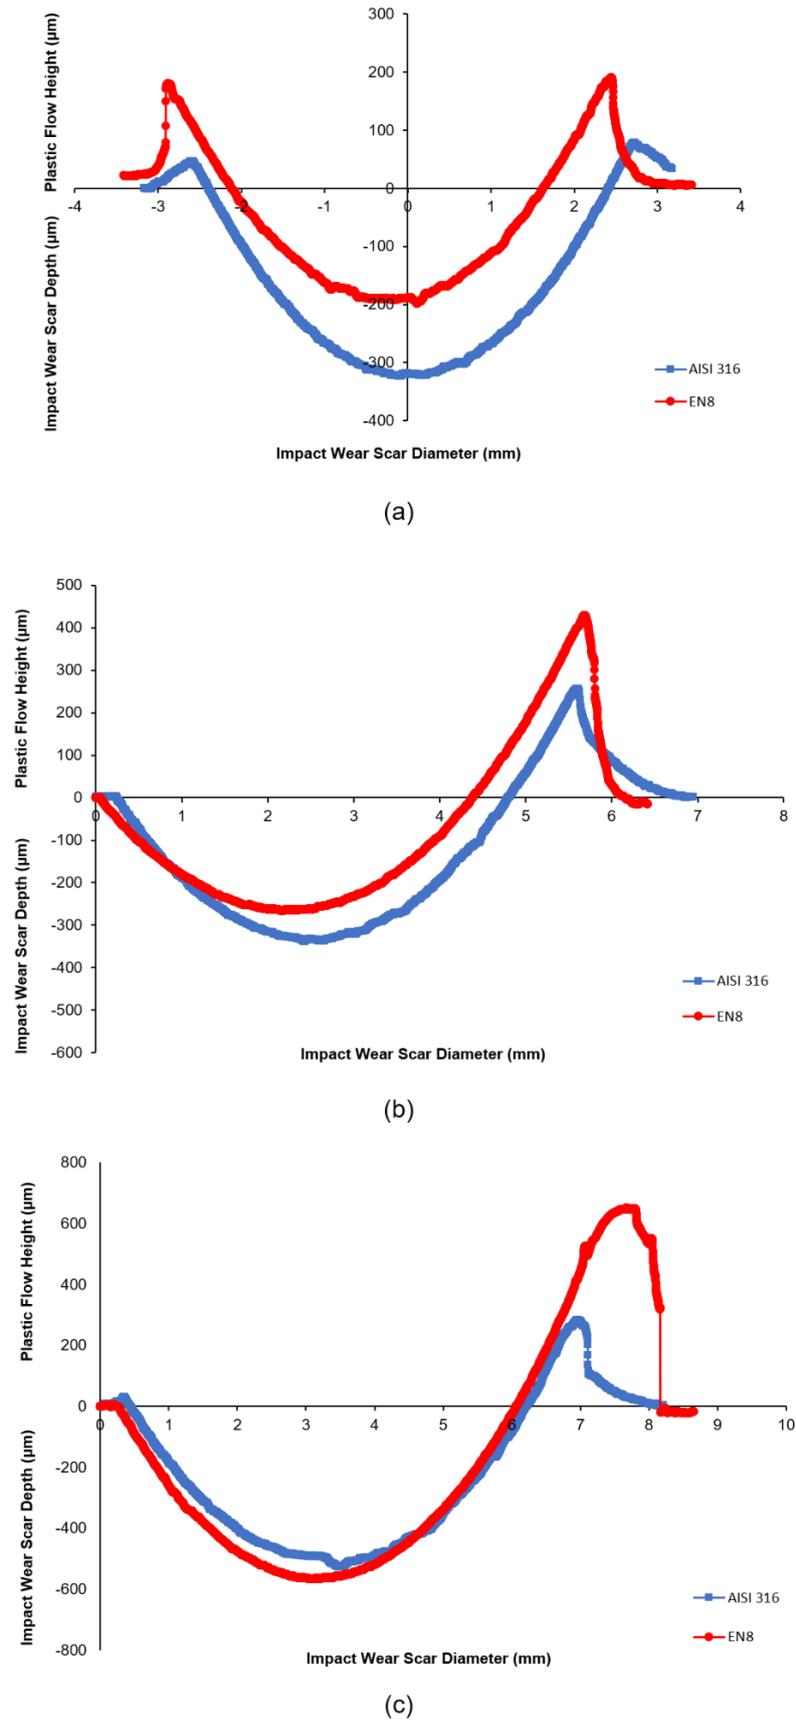
Figure 6.6 Typical diameter and depth of the wear scars for AISI 316 and EN8 after 54,000 cycles under (a) normal impact, (b) compound impact 60°, and (c) compound impact 45°

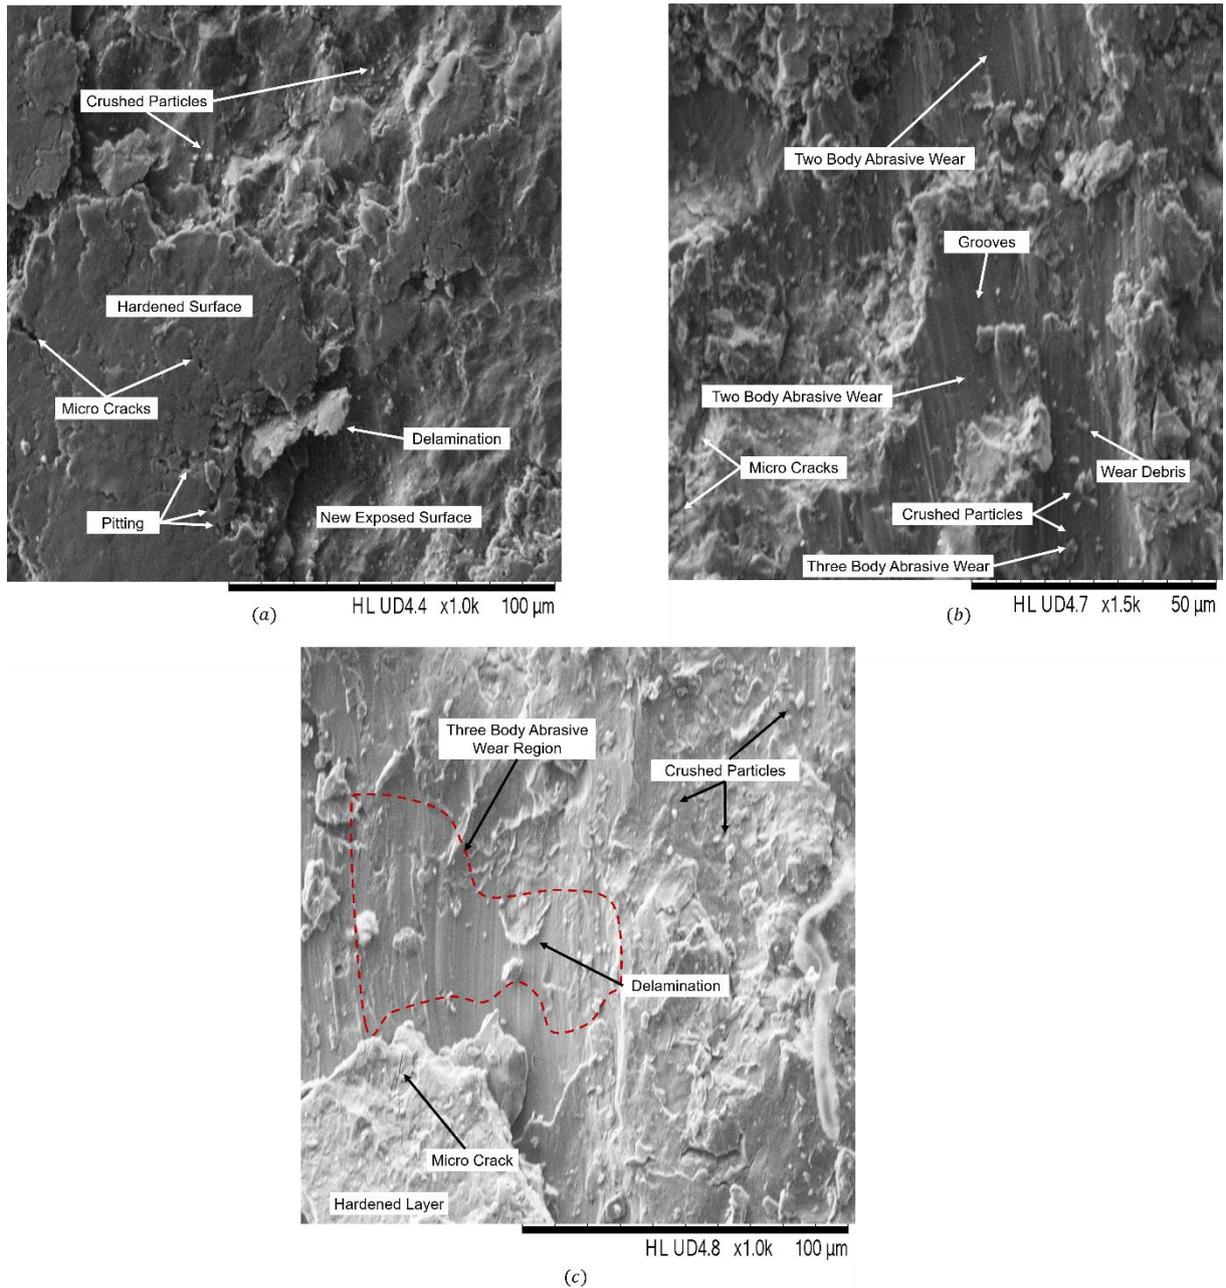
Figure 6.7 SEM image of the worn surface of AISI 316 showing the wear damage mechanism in the centre of the scar after 54,000 cycles under: (a) normal impact  $90^\circ$ , (b) impact angle  $60^\circ$  and (c) impact angle  $45^\circ$

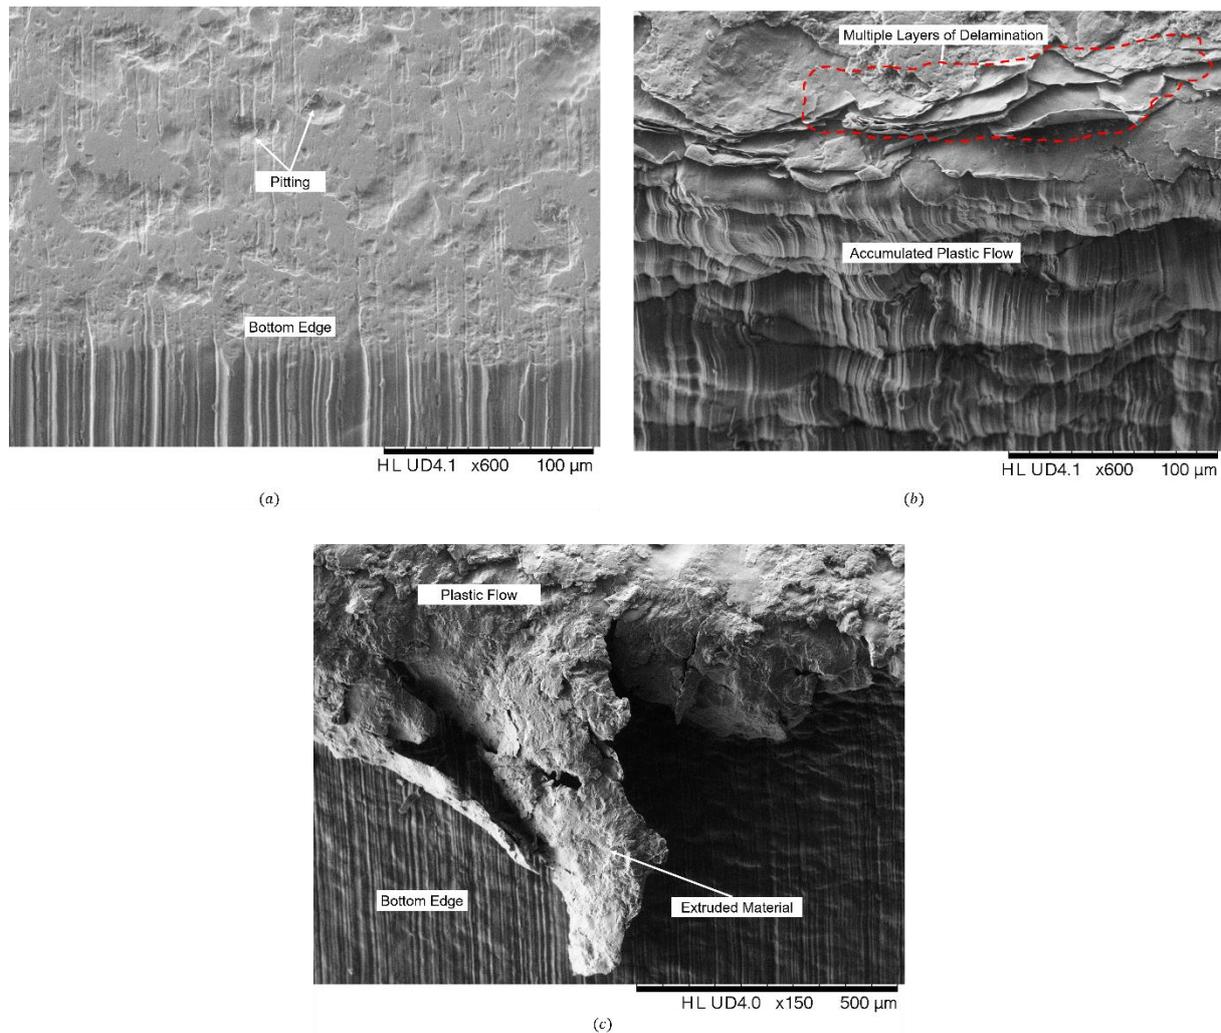
Figure 6.9 SEM image for the bottom of the wear scar for AISI 316 after 54,000 cycles showing the accumulation of plastic flow materials on or outside the bottom edge under: (a) normal impact  $90^\circ$ , (b) impact angle  $60^\circ$ , and (c) impact angle  $45^\circ$

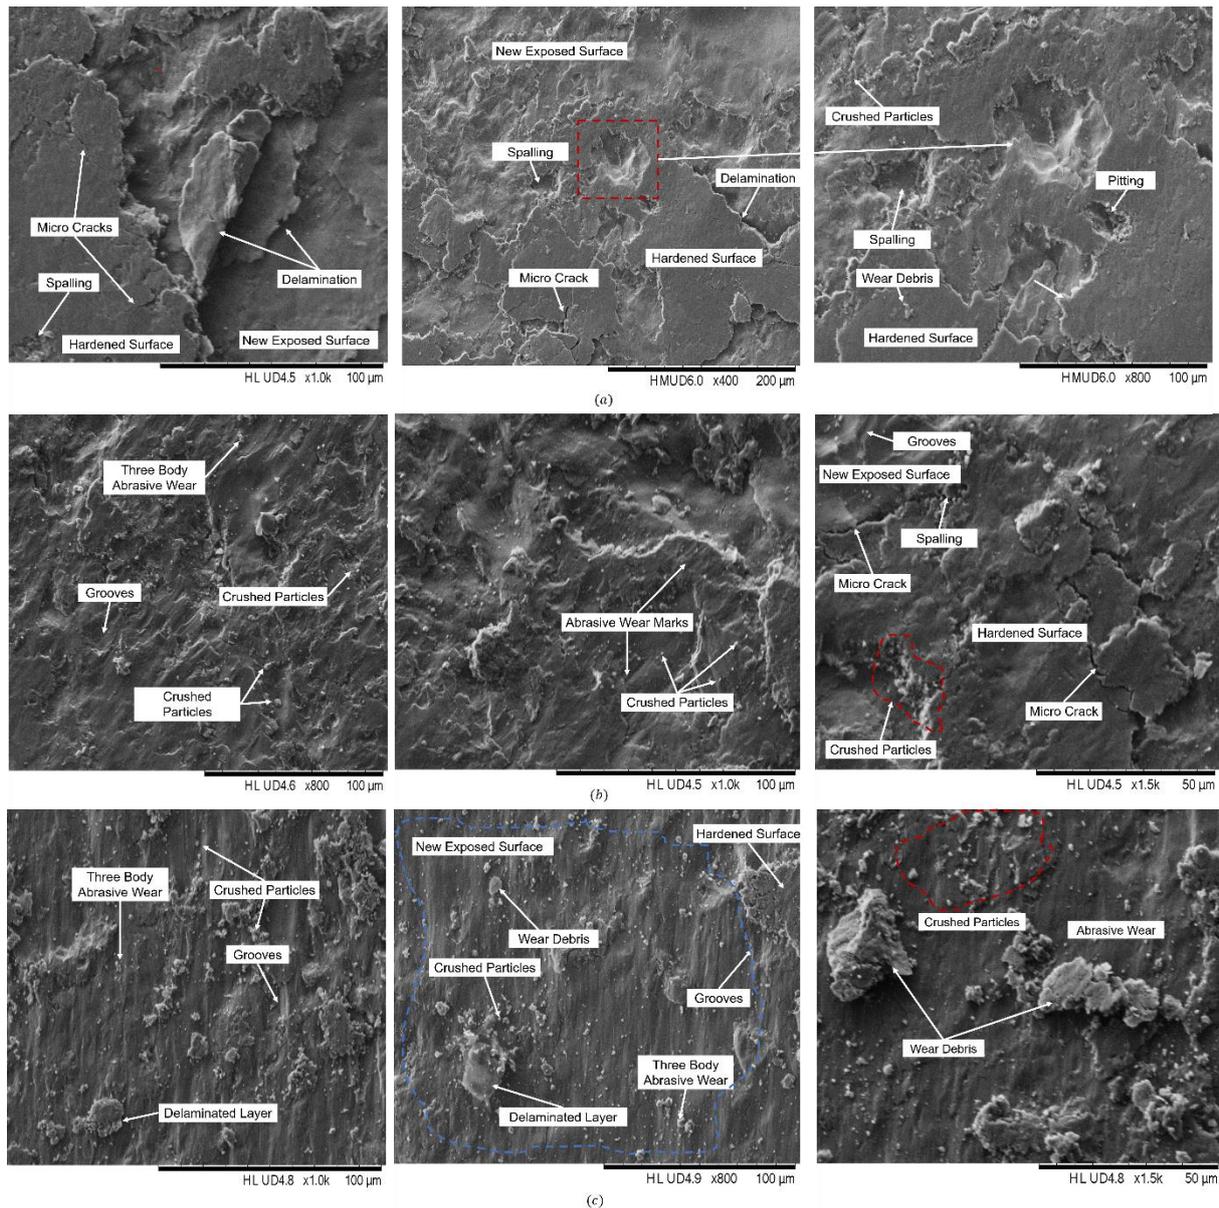
Figure 6.10 SEM images of the worn surface for EN8 showing the wear damage mechanism in the centre of the scar after 54,000 cycles under: (a) normal impact  $90^\circ$  showing the delamination and pitting, (b) impact angle  $60^\circ$  showing the abrasive wear, crushed particles and micro crack, and (c) impact angle  $45^\circ$  showing the abrasive wear, crushed particles and adhered wear debris

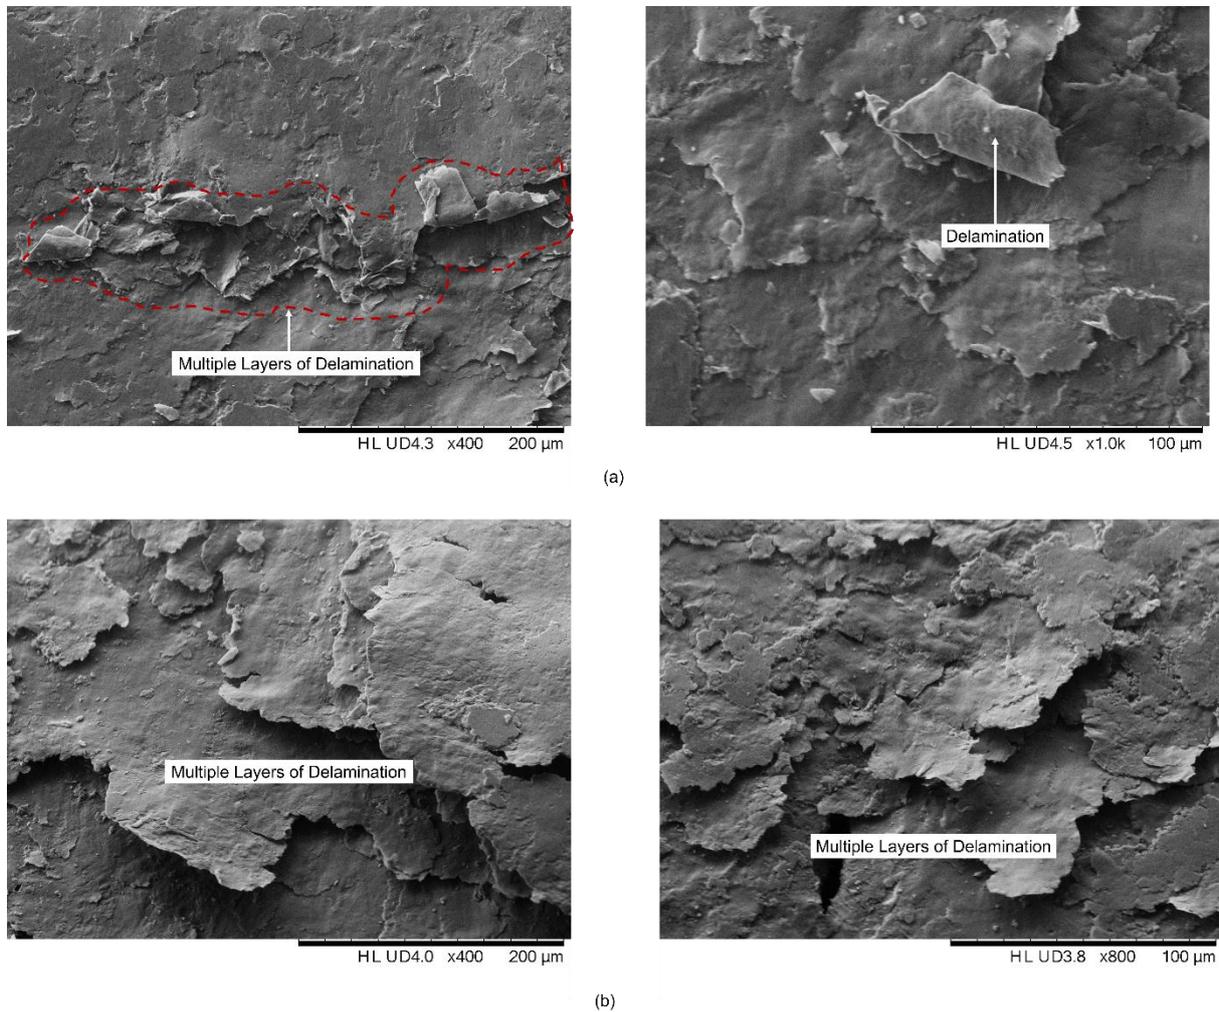
Figure 6.11 Multiple layers of delamination of the wear scar for EN8 after 54,000 cycles near the bottom edge under: (a) impact angle 60° and (b) impact angle 45°

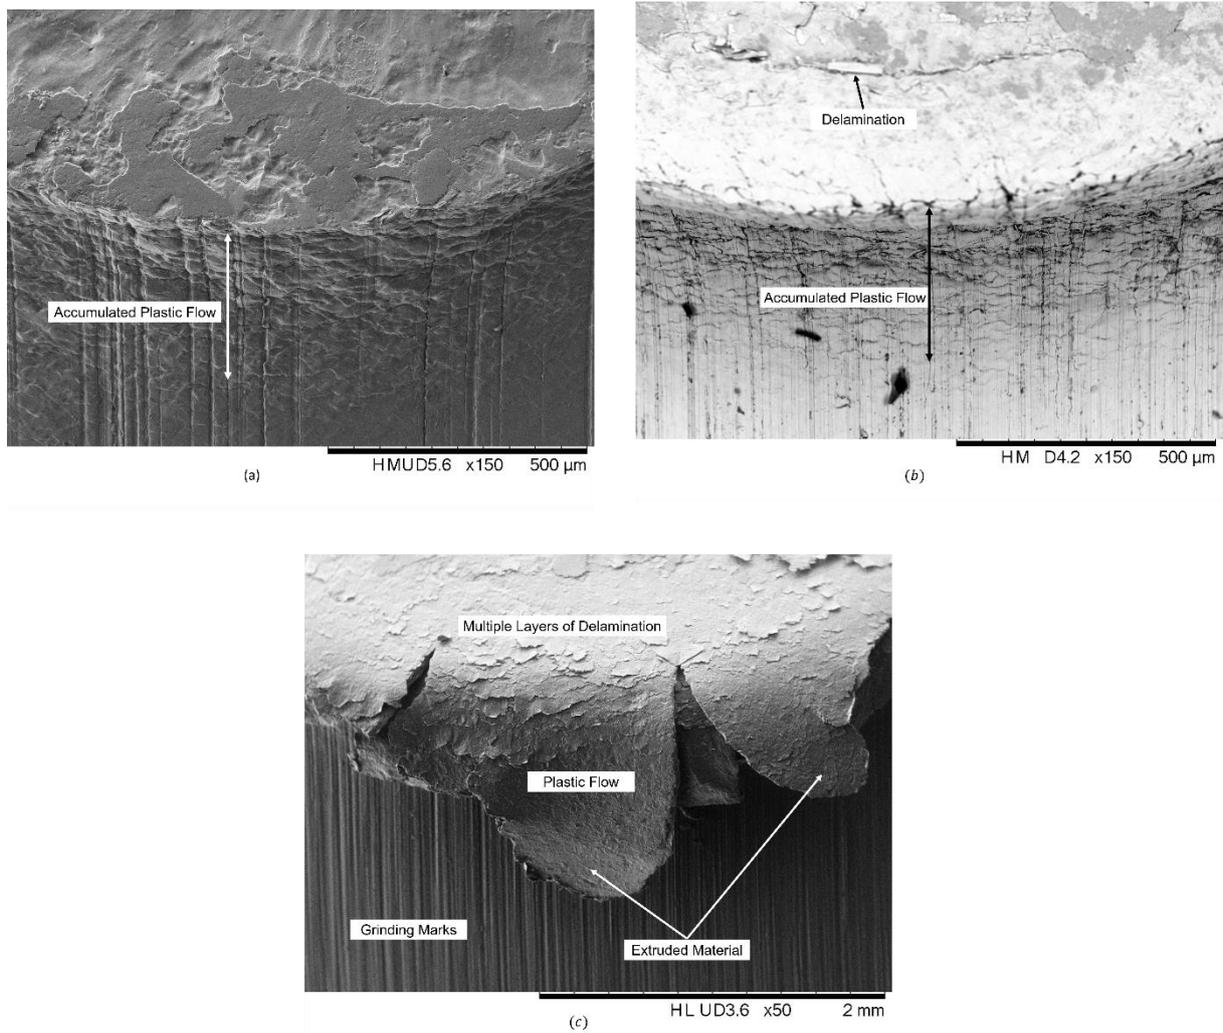
Figure 6.12 SEM image for the bottom of the wear scar for EN8 after 54,000 cycles showing the accumulation of plastic flow materials on or outside the bottom edge under: (a) normal impact 90°, (b) impact angle 60°, and (c) impact angle 45°

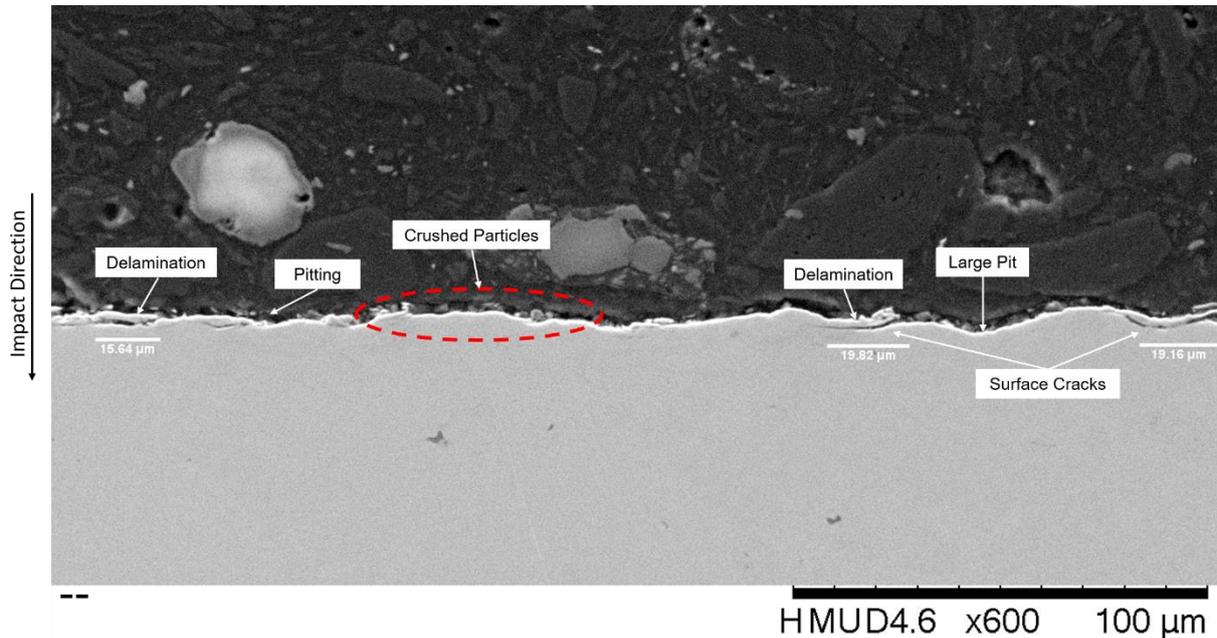
Figure 6.13 SEM image for AISI 316 after 54,000 cycles under normal impact
