## **Characterisation and Modelling of Normal and Compound Impact Wear in Common Engineering Alloys**

A thesis submitted to the University of Sheffield  
for the degree of Doctor of Philosophy in the Faculty of Engineering

Author: Mohanad Qasim Zalzalah  
Date: June 2021  
Supervisors: **Dr. Tom Slatter**  
**Prof. Roger Lewis**

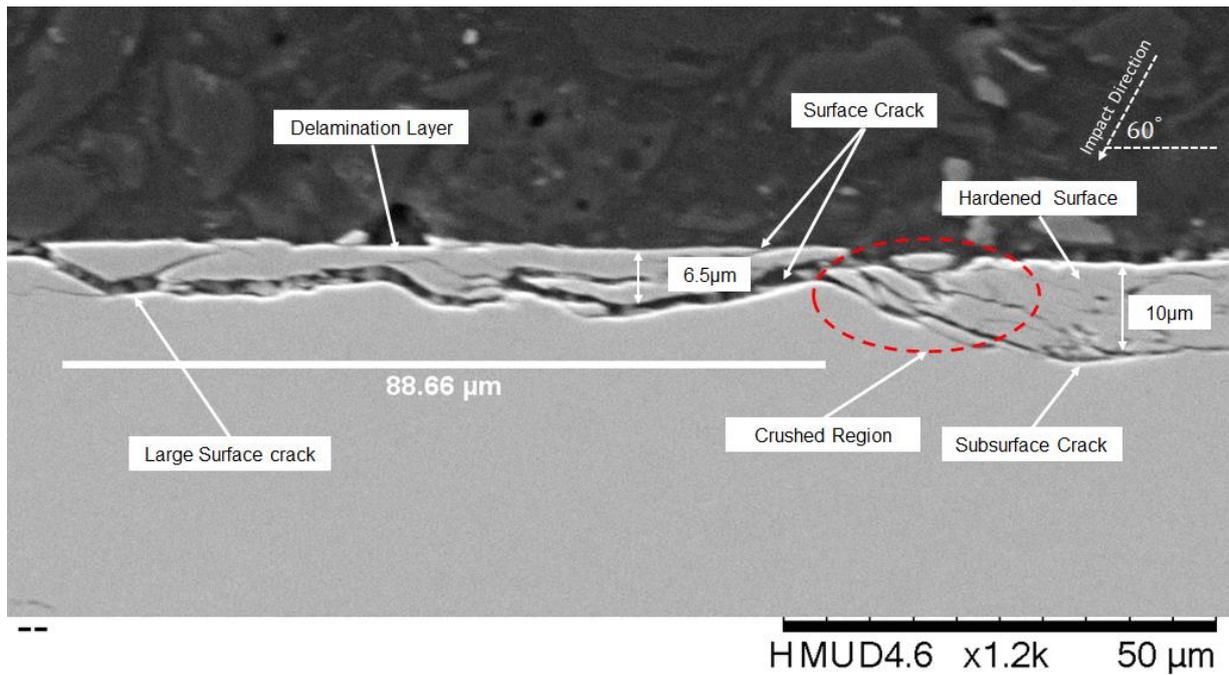
Figure 6.14 SEM image of subsurface damage for AISI 316 after 54,000 cycles under compound impact 60°

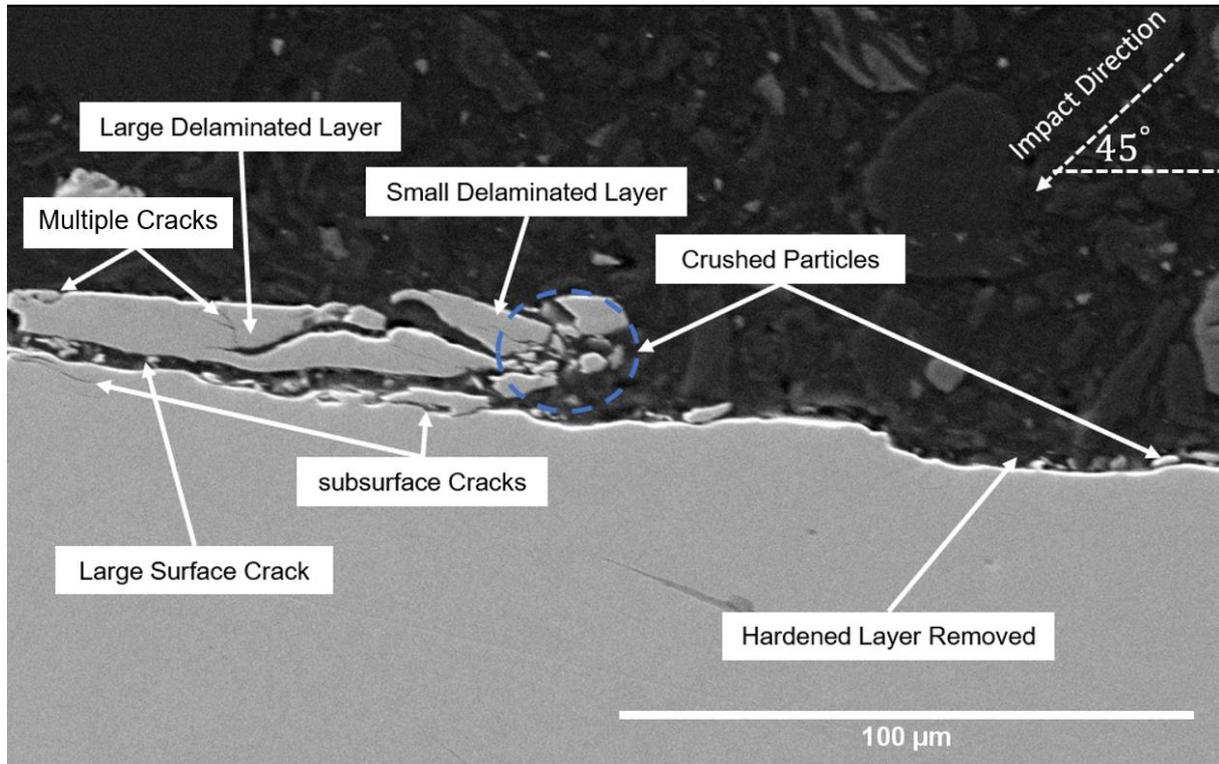
Figure 6.16 SEM image showing large subsurface cracks inside the worn surface for AISI 316 after 54,000 cycles under compound impact  $45^\circ$

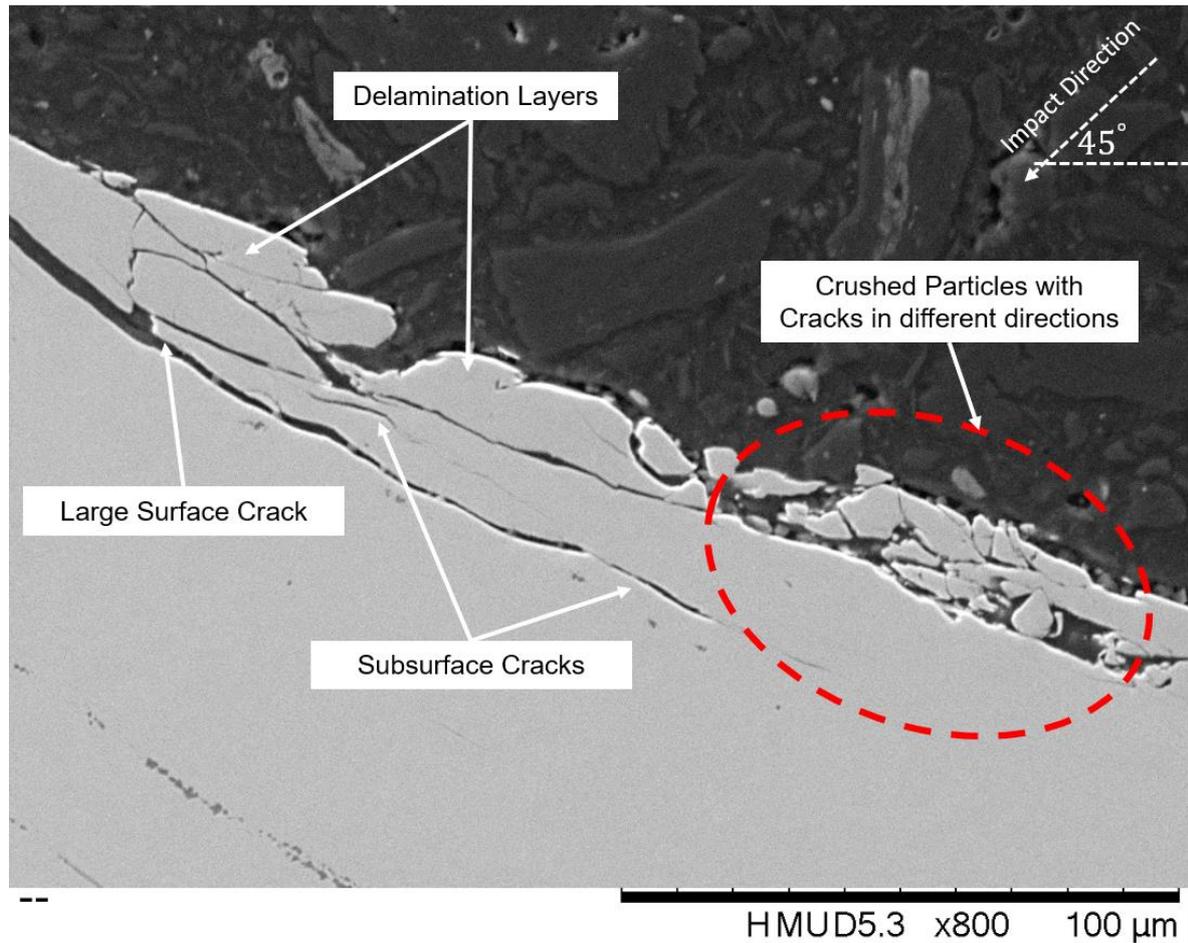
Figure 6.17 SEM image of large delamination layer due to surface and subsurface cracks in AISI 316 after 54,000 cycles under compound impact  $45^\circ$ , with crushed particles to the right side of the image

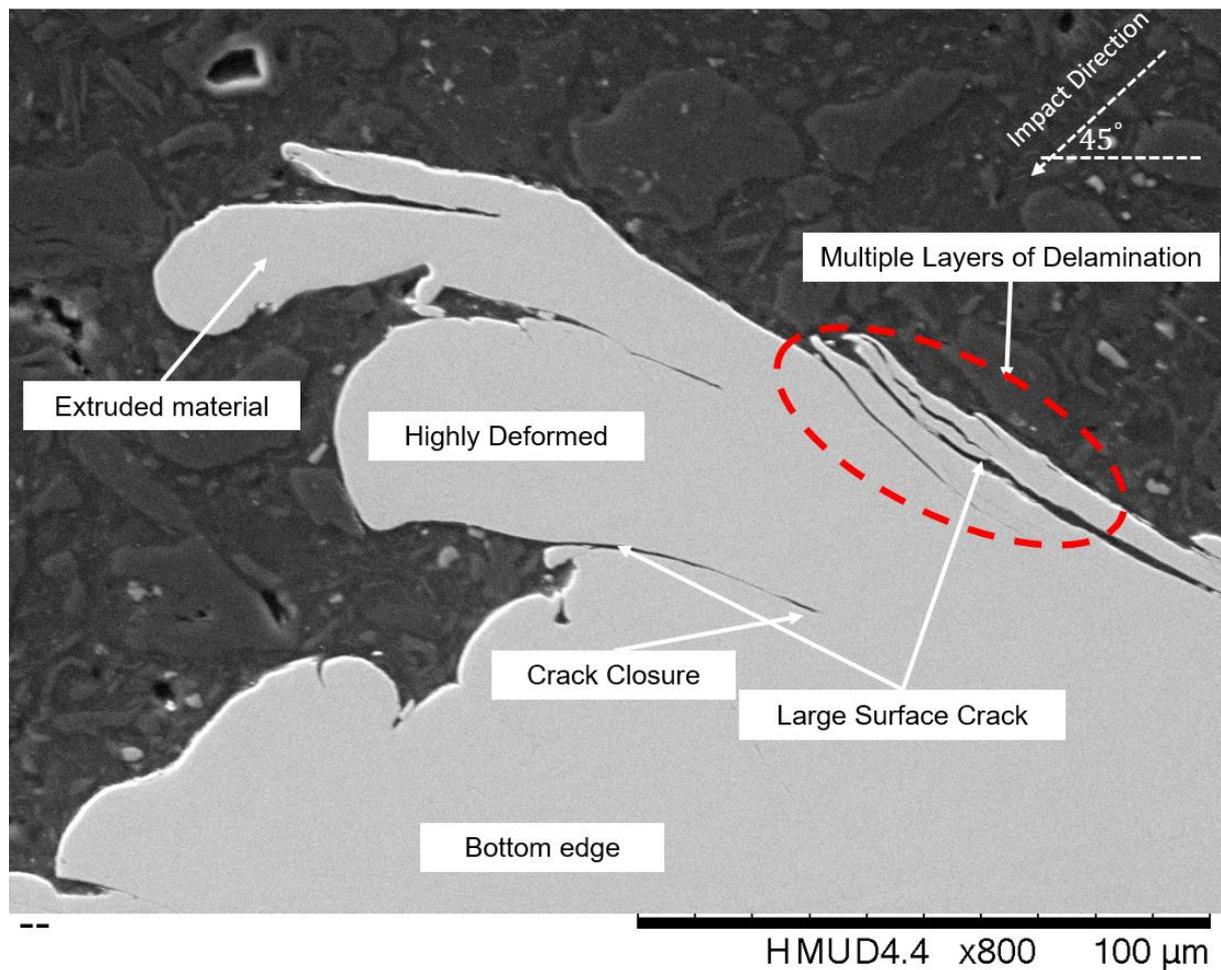
Figure 6.18 SEM image of pile up materials extruded outside the impact scar of AISI 316 after 54,000 cycles under compound impact  $45^\circ$

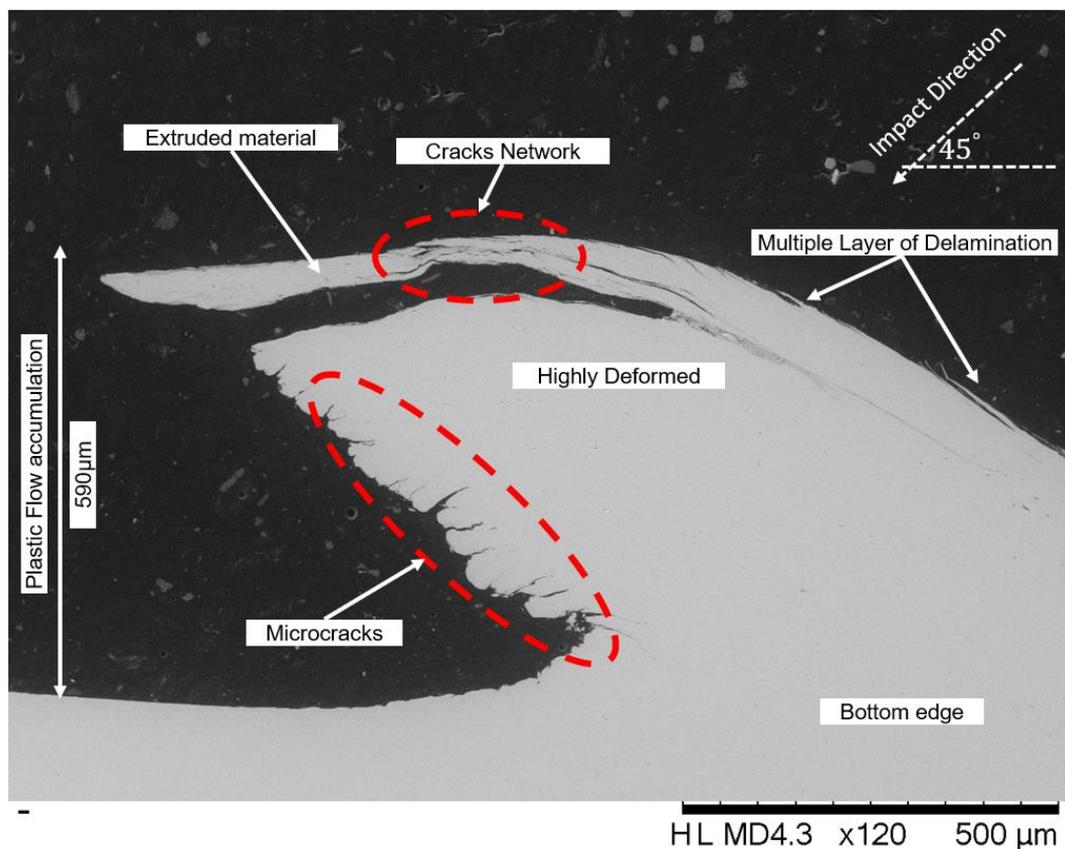
Figure 6.25 SEM image of pile up materials extruded outside the impact scar in EN8 after 54,000 cycles under compound impact  $45^\circ$

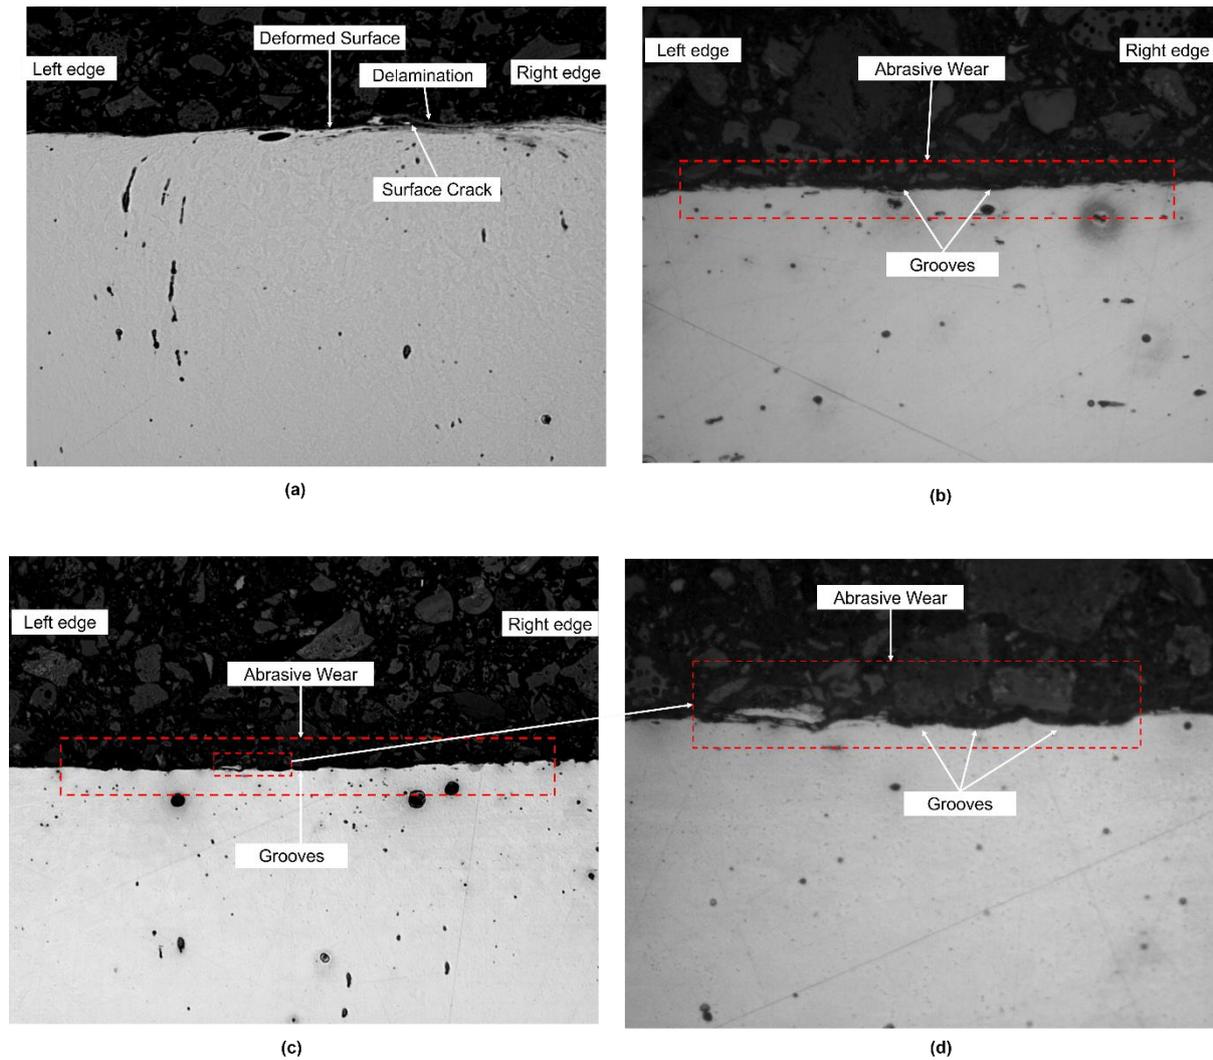
Figure 6.26 Optical images with perpendicular sectioning to the impact direction for the centre of the impact scar for EN8 showing the wear damage under: (a) normal impact  $90^\circ$ , (b) compound impact  $60^\circ$ , and (c) and (d) compound impact  $45^\circ$  after 54,000 cycles

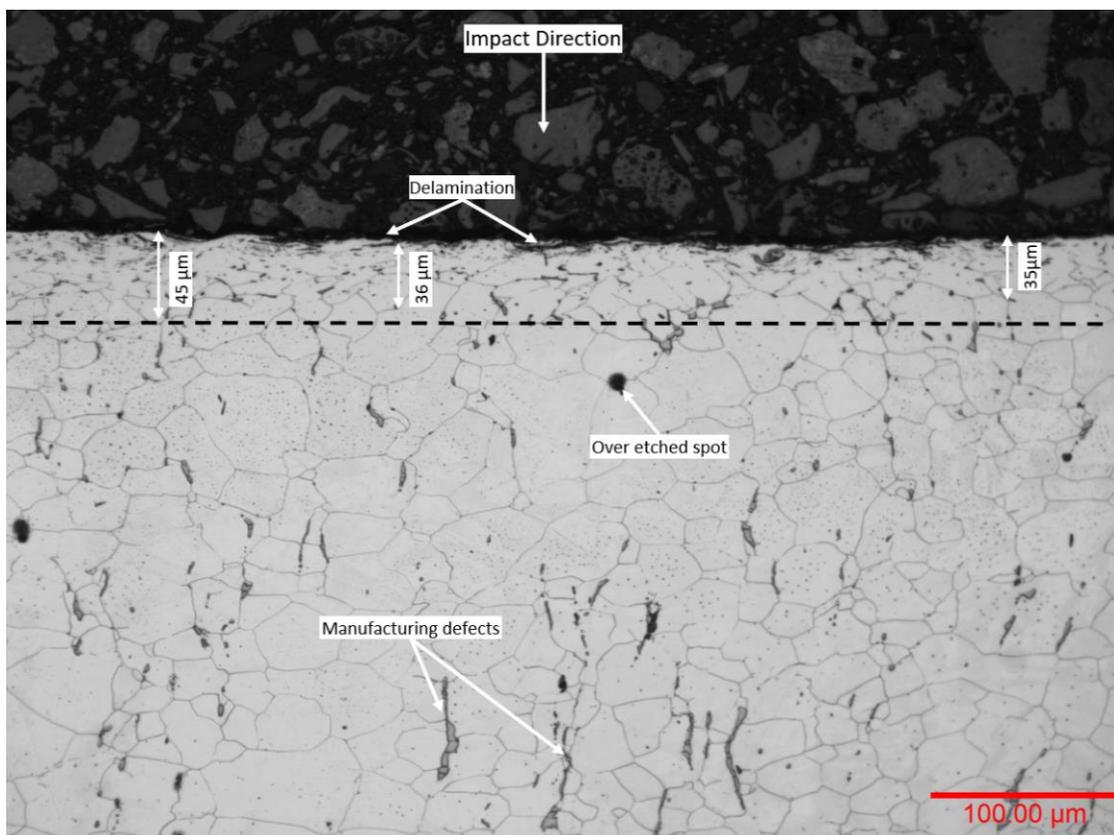
Figure 6.28 Optical microscope image of electro etching for AISI 316 under normal impact for the centre of the wear scar after 54,000 cycles showing the deformed and undeformed grains

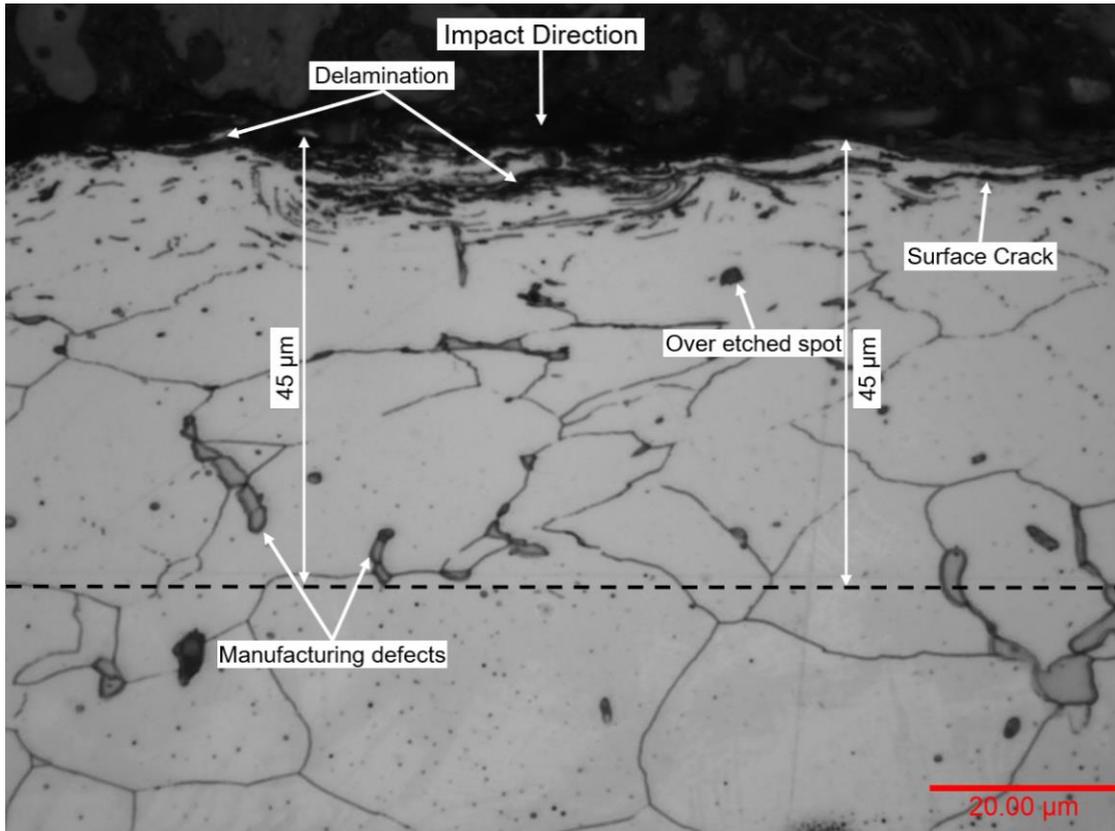
Figure 6.29 Higher magnification of optical microscope image of electro etching for AISI 316 under normal impact for the centre region of the wear scar after 54,000 cycles showing the deformed and undeformed grains

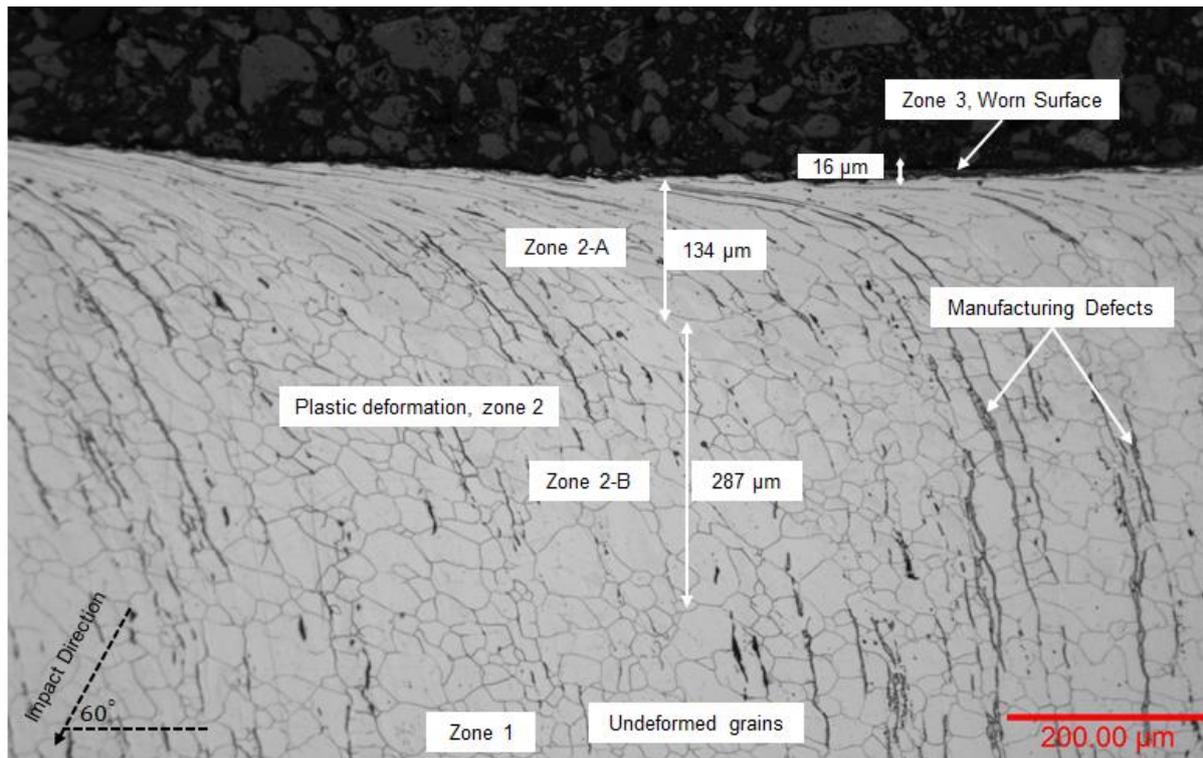
Figure 6.31 Optical microscope image of electro etching for AISI 316 steel under compound impact  $60^\circ$  for the centre of the wear scar after 54,000 cycles showing the deformed zones

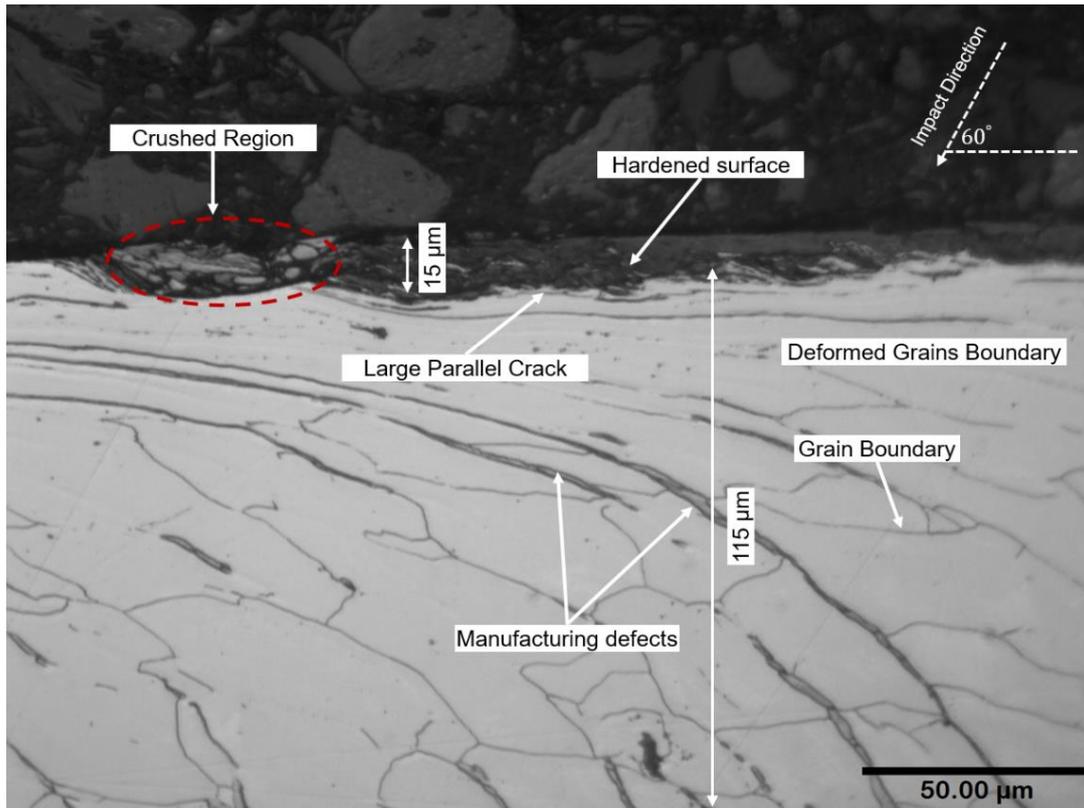
Figure 6.32 Higher magnification for the centre region of the impact wear scar for AISI 316 after 54,000 cycles with impact angle 60° showing the highly deformed grains beneath the worn surface (zone 3)

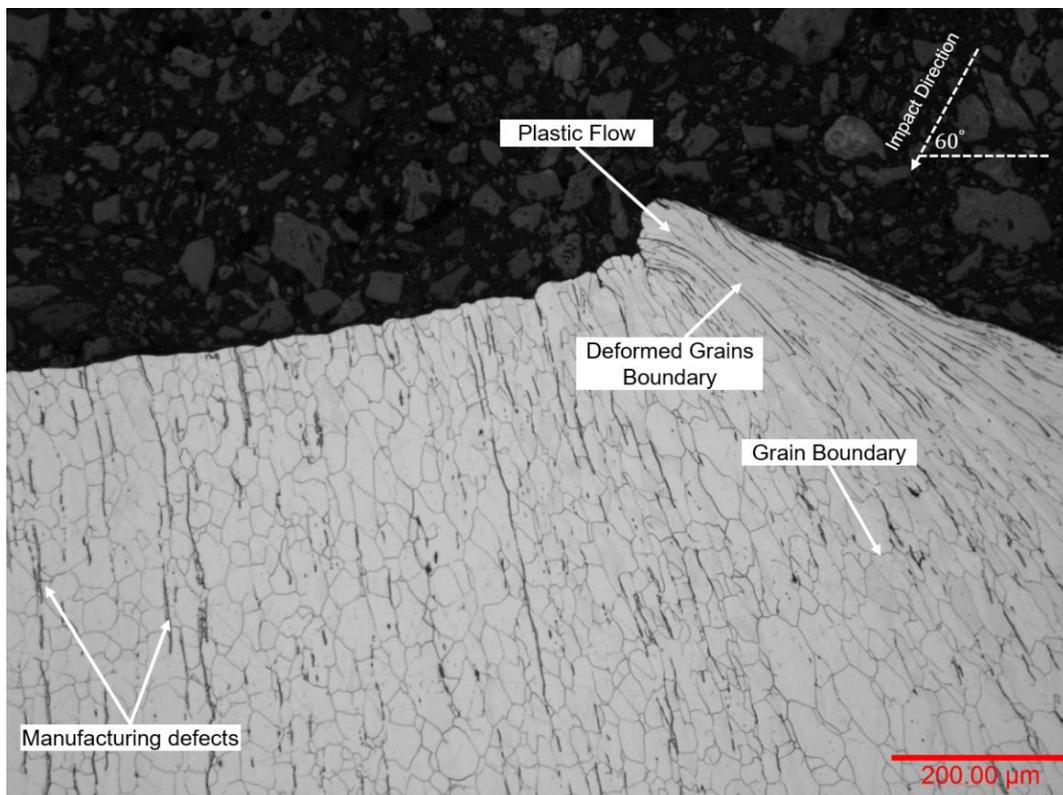
Figure 6.33 OM image of pile up materials for AISI 316 on the bottom edge after 54,000 cycles under compound impact 60° as revealed by electro etching

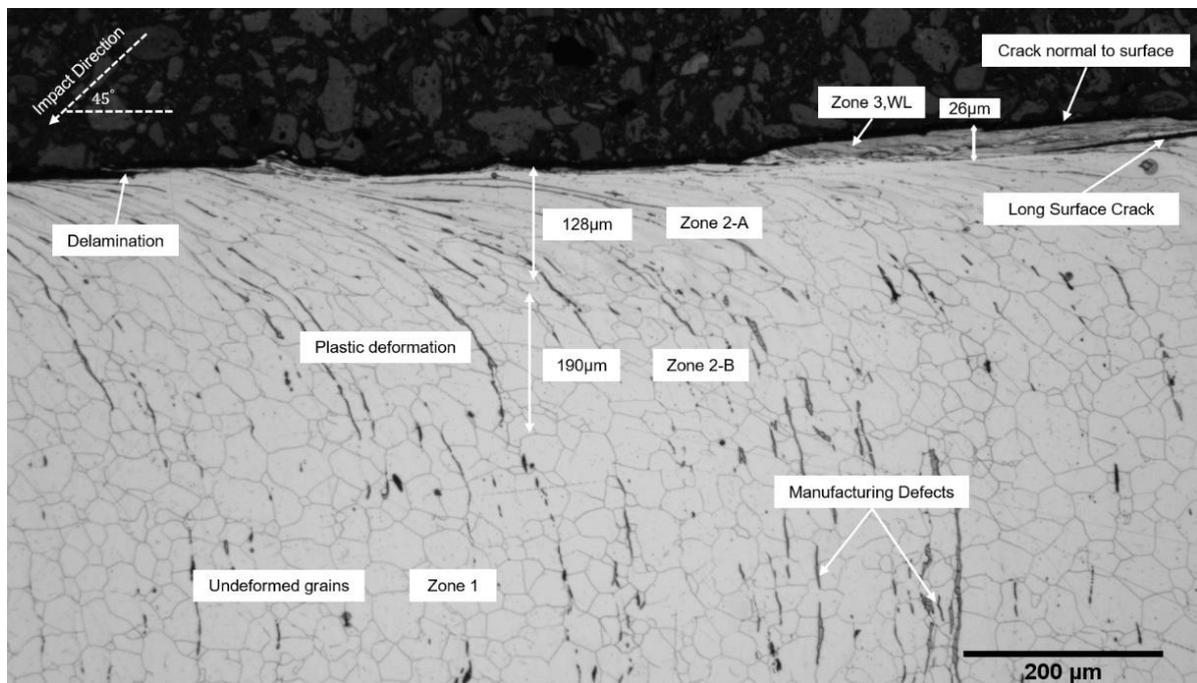
Figure 6.35 Optical microscope image of electro etching for AISI 316 under compound impact  $45^\circ$  for the centre of the wear scar after 54,000 cycles showing the deformed zones

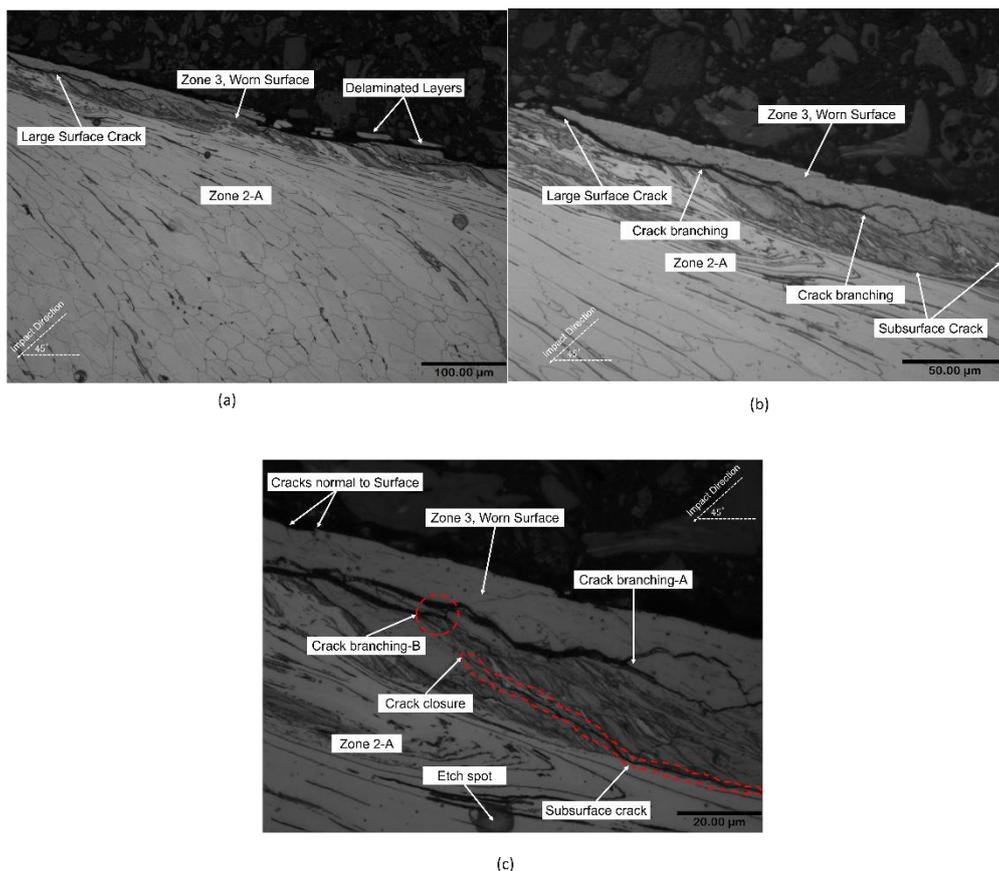
Figure 6.37 Optical microscope images revealing wear damage mechanisms that have occurred in the worn surface layer for AISI 316 after 54,000 cycles with impact angle 45°

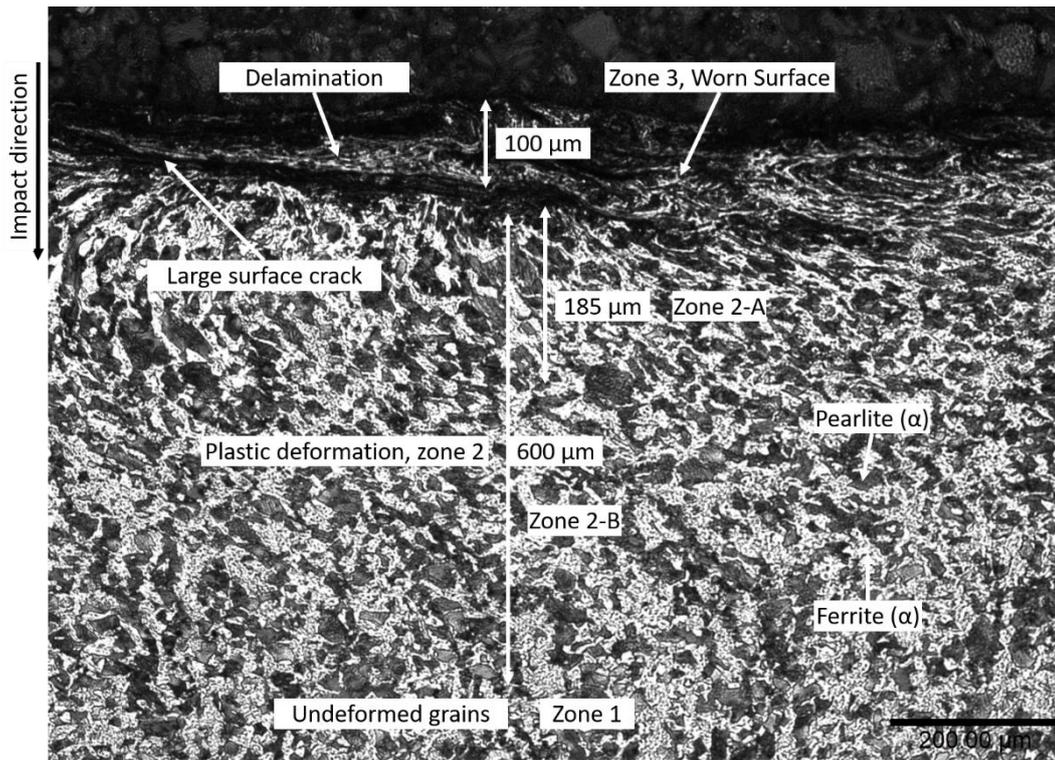
Figure 6.40 Optical microscope image of chemical etching for EN8 under normal impact for the centre of the wear scar after 54,000 cycles

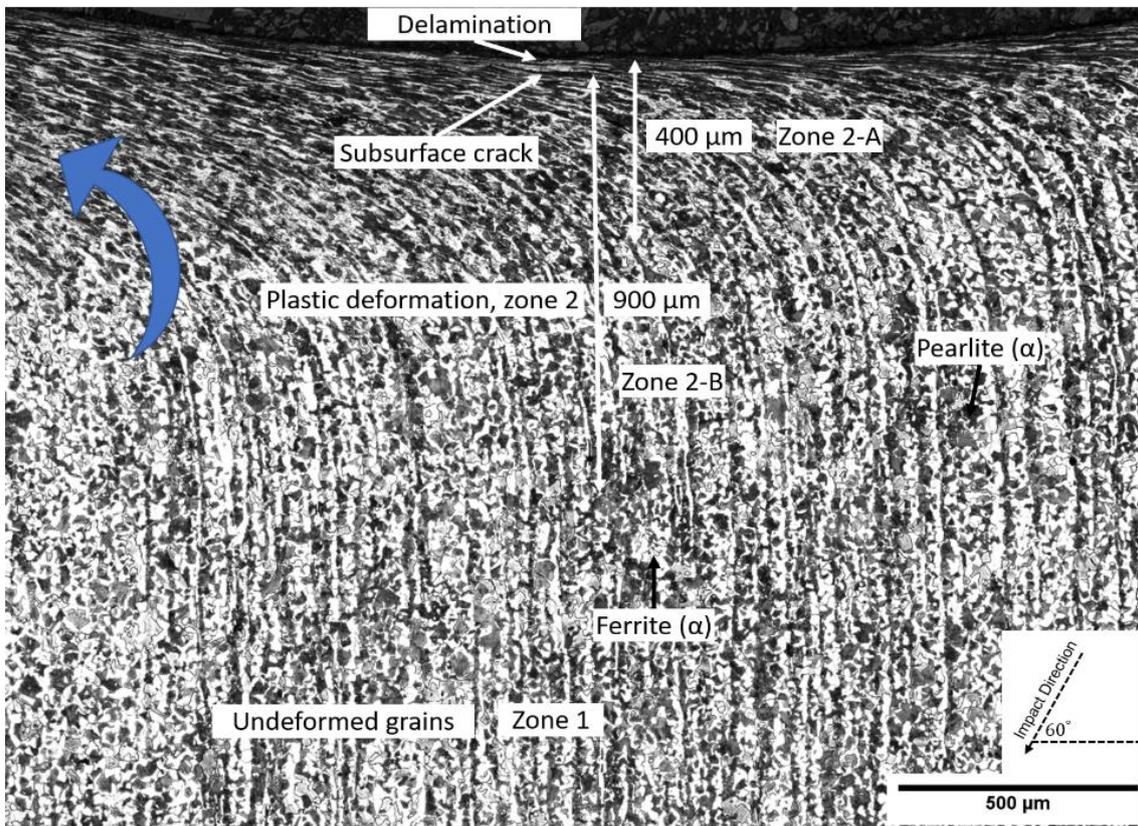
Figure 6.43 Optical microscope image of chemical etching for EN8 with impact angle  $60^\circ$  for the centre of the wear scar after 54,000 cycles showing the deformed zones

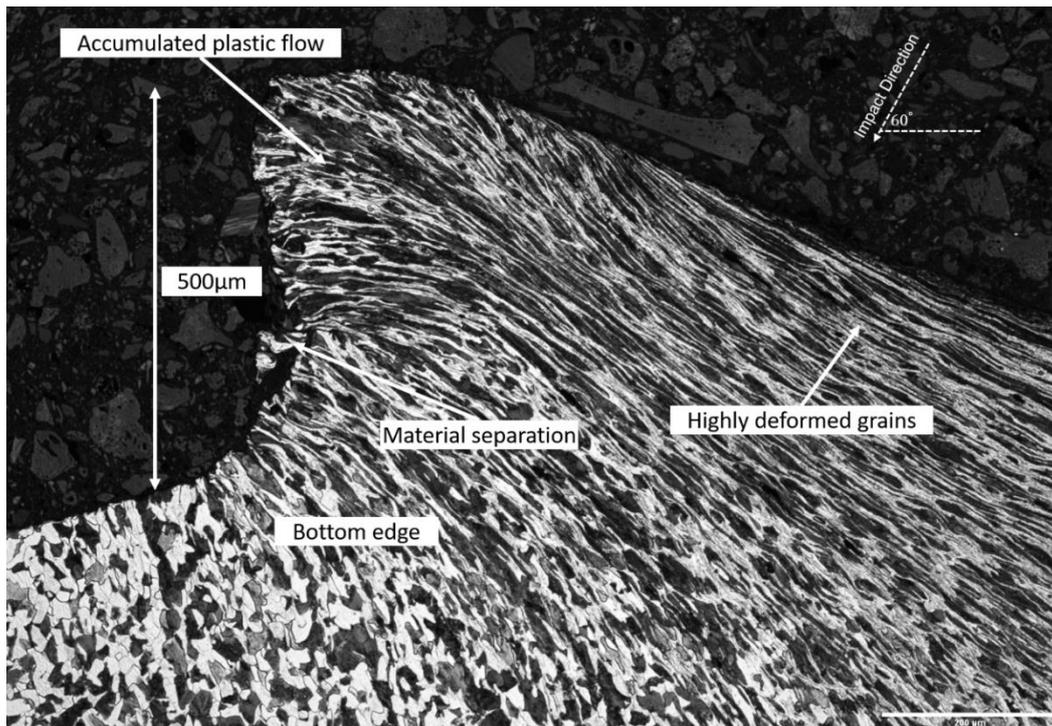
Figure 6.44 Optical microscope image of pile up materials on the bottom edge for EN8 after 54,000 cycles under compound impact  $60^\circ$  as revealed by chemical etching

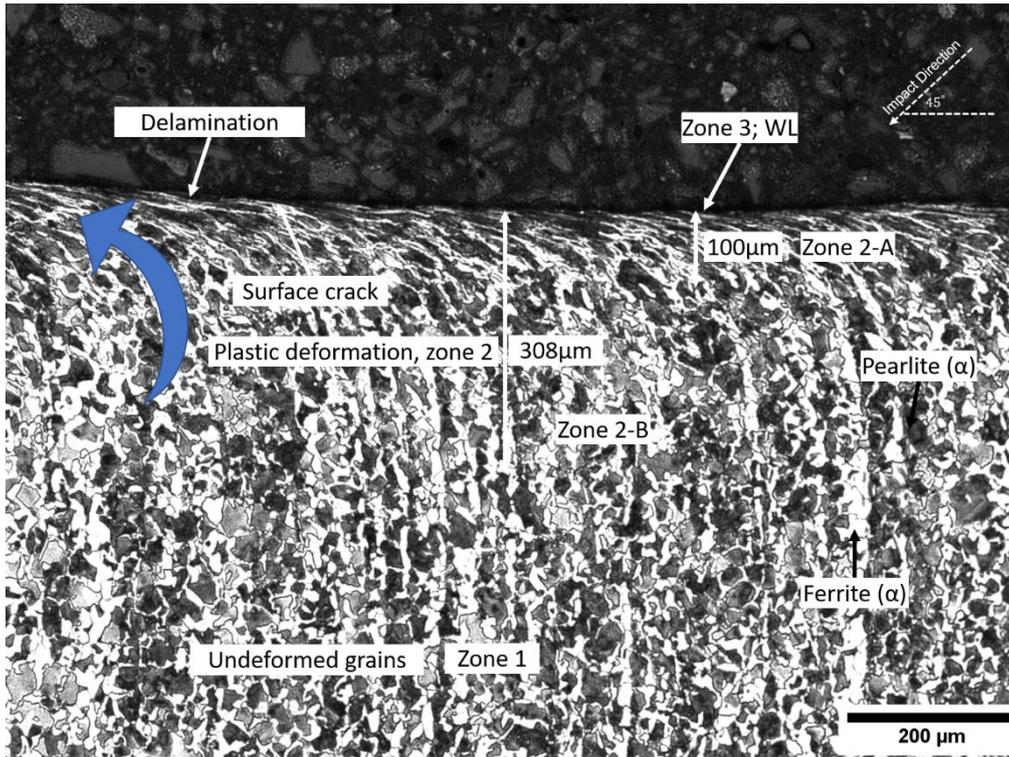
Figure 6.46 Optical microscope image of chemical etching for EN8 with impact angle 45° for the centre of the wear scar after 54,000 cycles showing the deformed zones

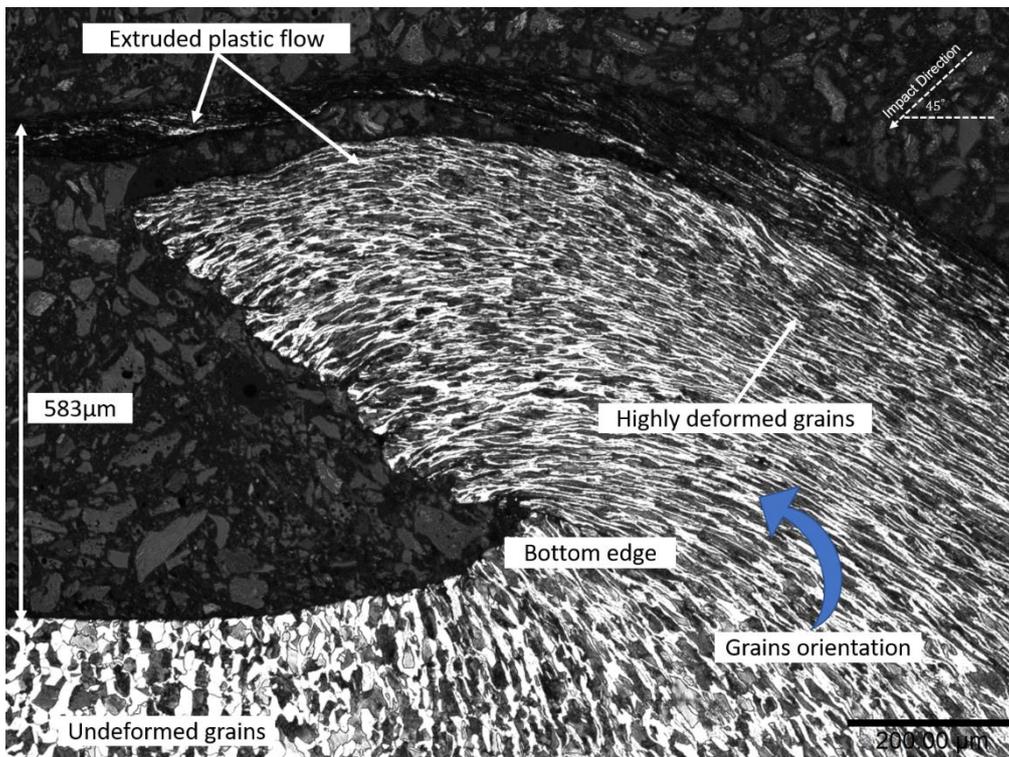
Figure 6.47 Optical microscope image of extruded materials near the bottom edge for EN8 after 54,000 cycles under compound impact 45° as revealed by chemical etching

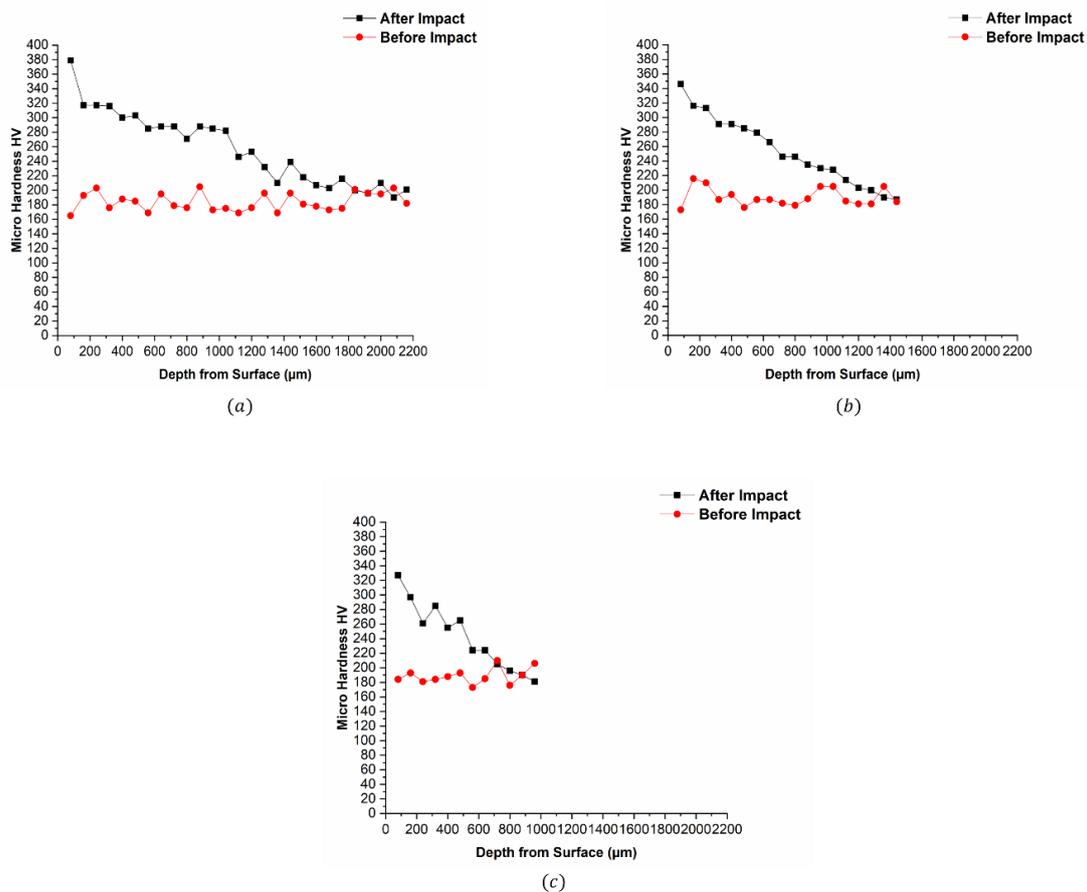
Figure 6.48 Microhardness profile of original and impacted regions of tested specimens for AISI 316 at impact force of 3476 N where (a) normal impact, (b) impact angle 60°, and (c) impact angle 45°

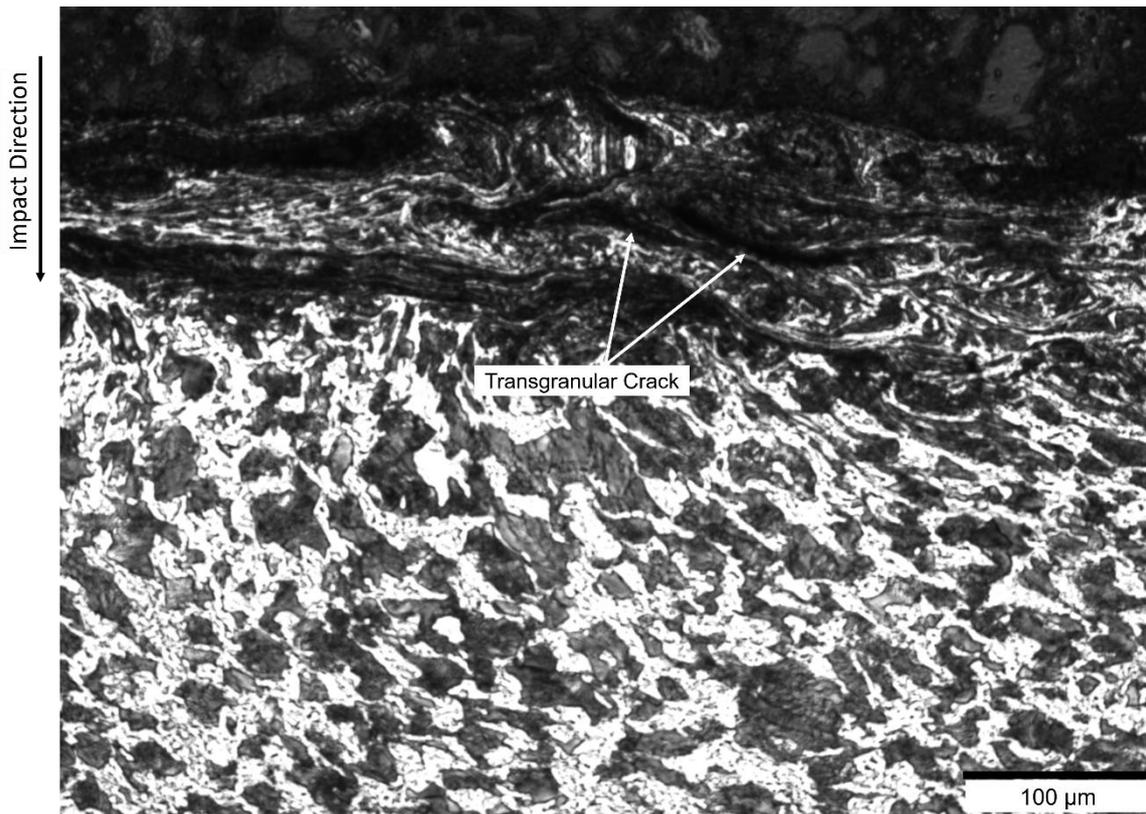
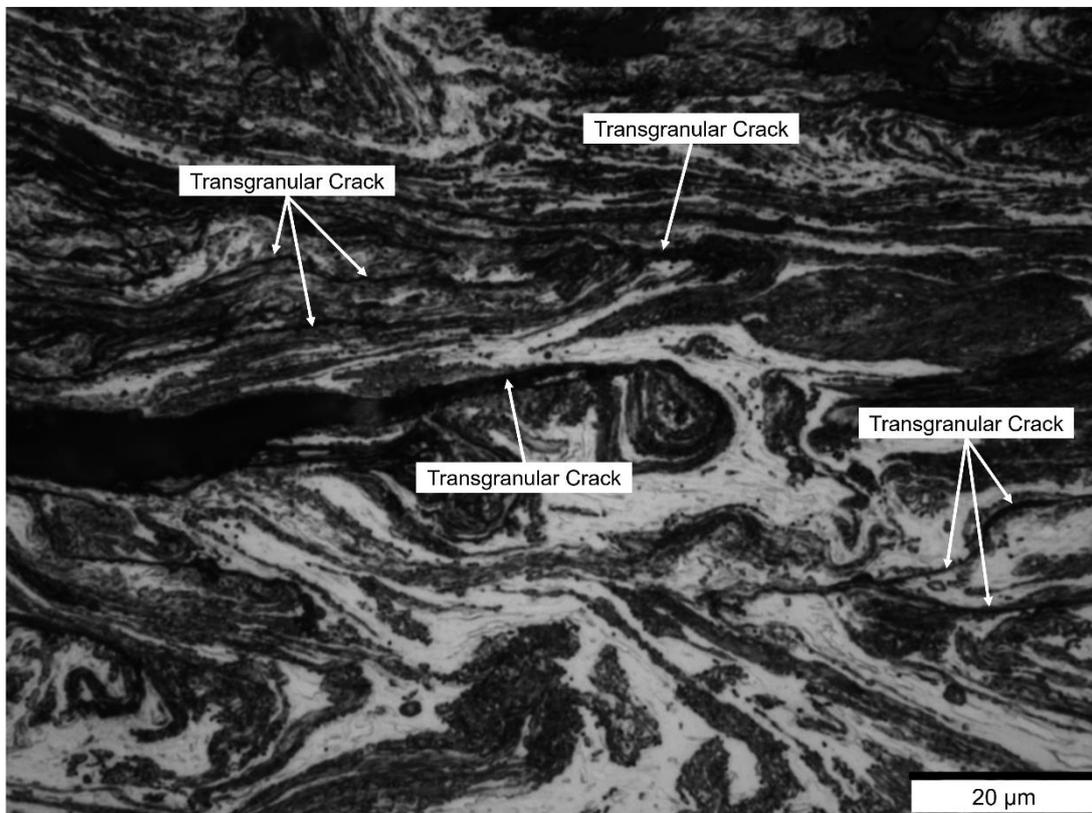
Figure 6.52 Optical microscope image showing both transgranular and intergranular cracks propagation inside and within the grains for EN8 after 54,000 cycles under normal impact angle  $90^\circ$

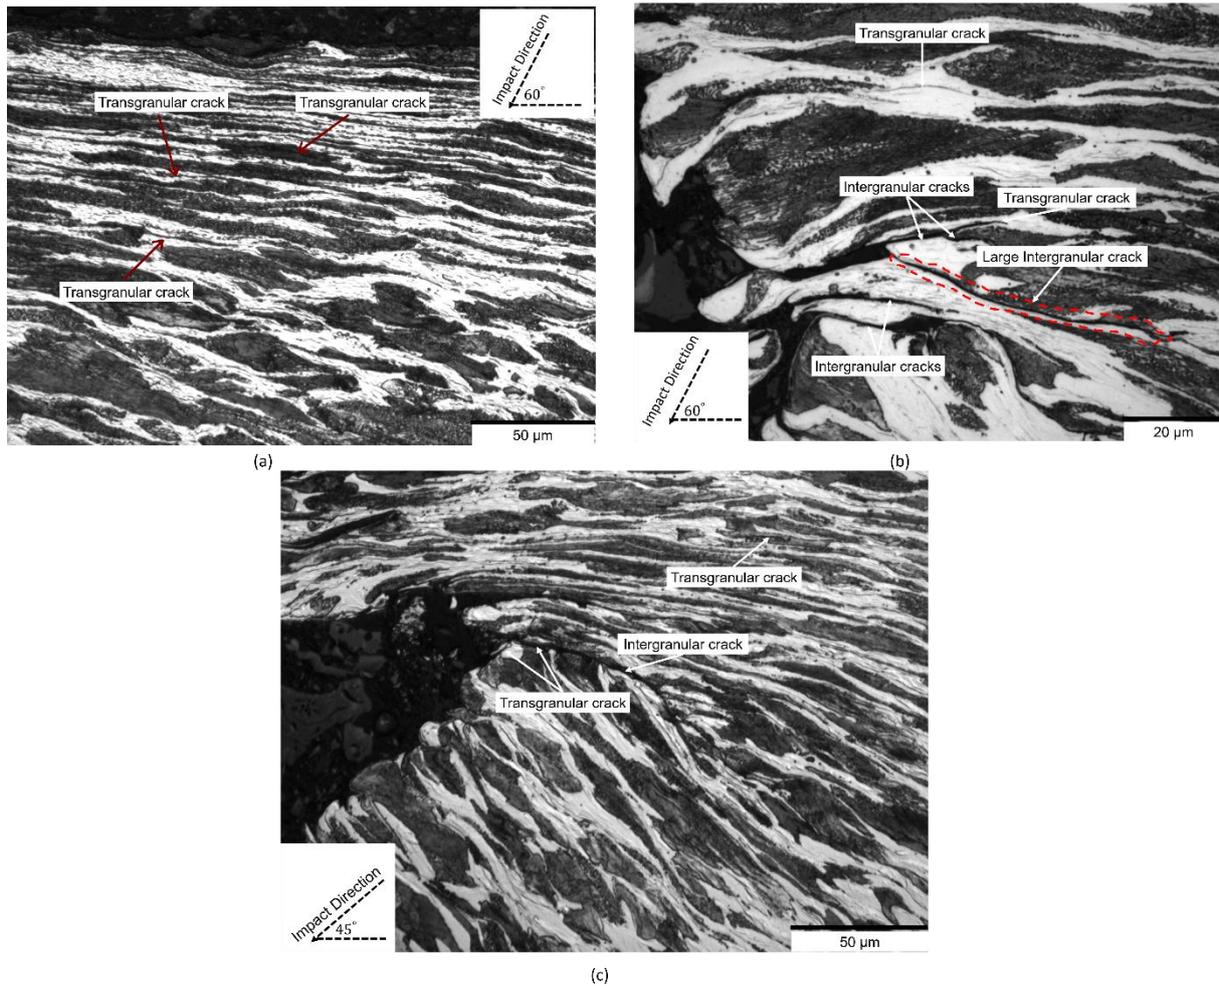
Figure 6.53 Optical microscope image showing both transgranular and intergranular cracks propagation inside and within the grains for EN8 after 54,000 cycles under: (a) and (b) compound impact  $60^\circ$ , and (c) impact angle  $45^\circ$

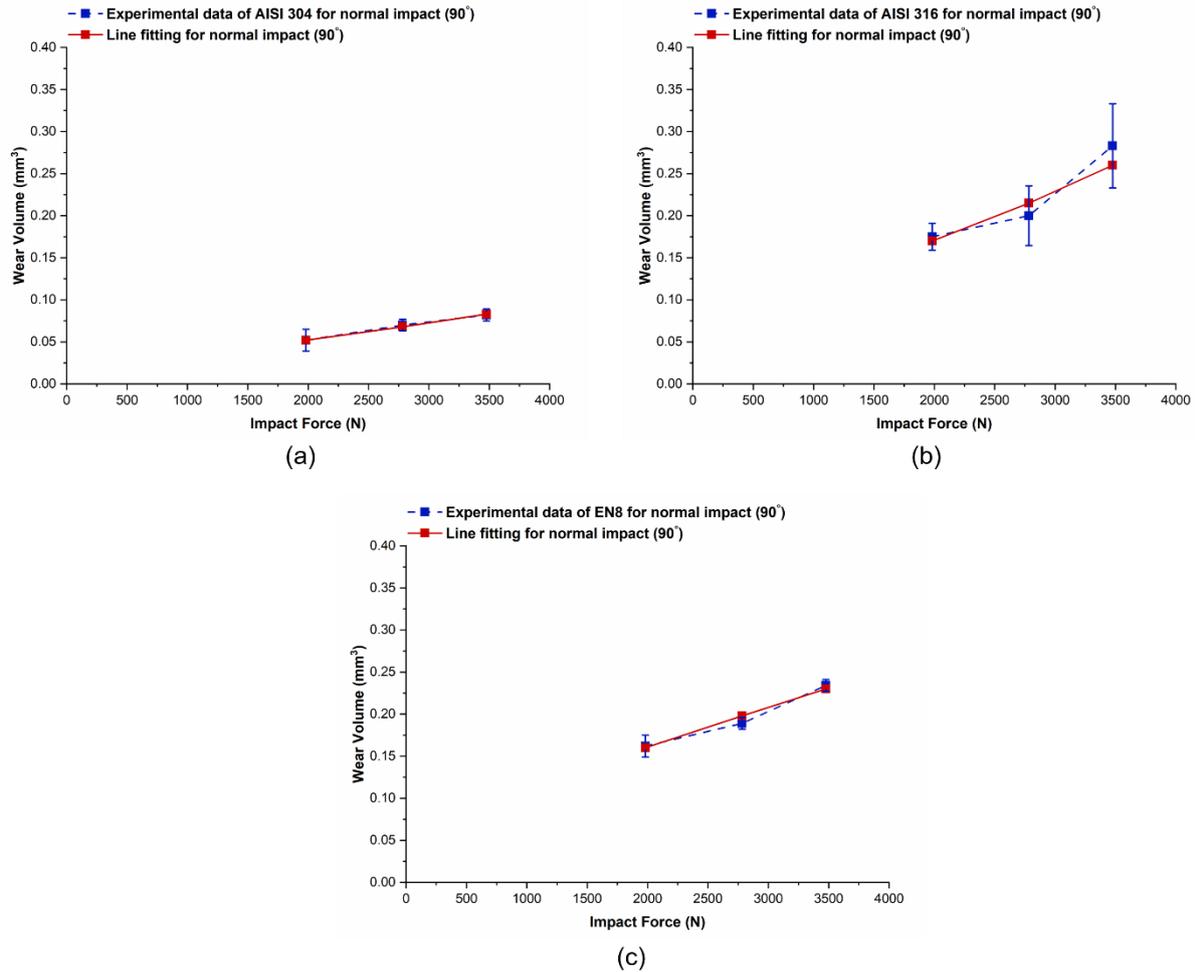
Figure 7.1 Line fitting from the experimental data of (a) AISI 304, (b) AISI 316 and (c) EN8 under normal impact after 54,000 cycles
