## **Characterisation and Modelling of Normal and Compound Impact Wear in Common Engineering Alloys**

A thesis submitted to the University of Sheffield  
for the degree of Doctor of Philosophy in the Faculty of Engineering

Author: Mohanad Qasim Zalzalah  
Date: June 2021  
Supervisors: **Dr. Tom Slatter**  
**Prof. Roger Lewis**

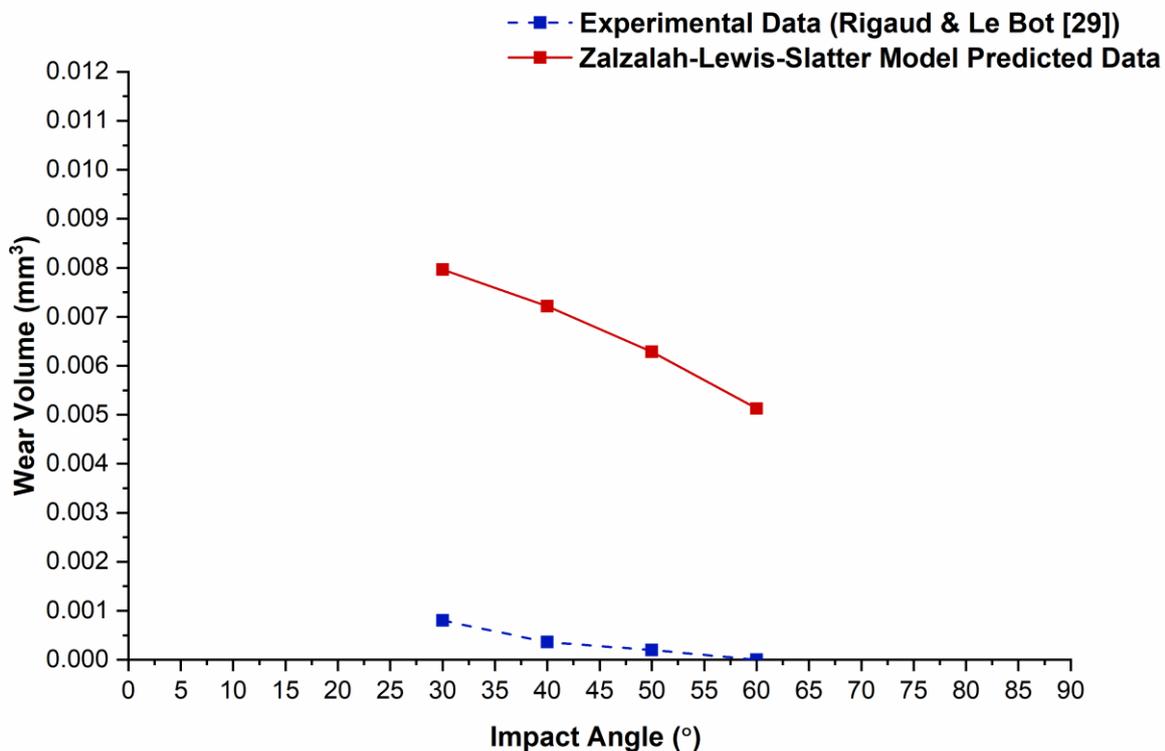
Figure 7.2 Experimental data of Rigaud & Le Bot [29] compared with the Zalzal-Lewis-Slater model data.

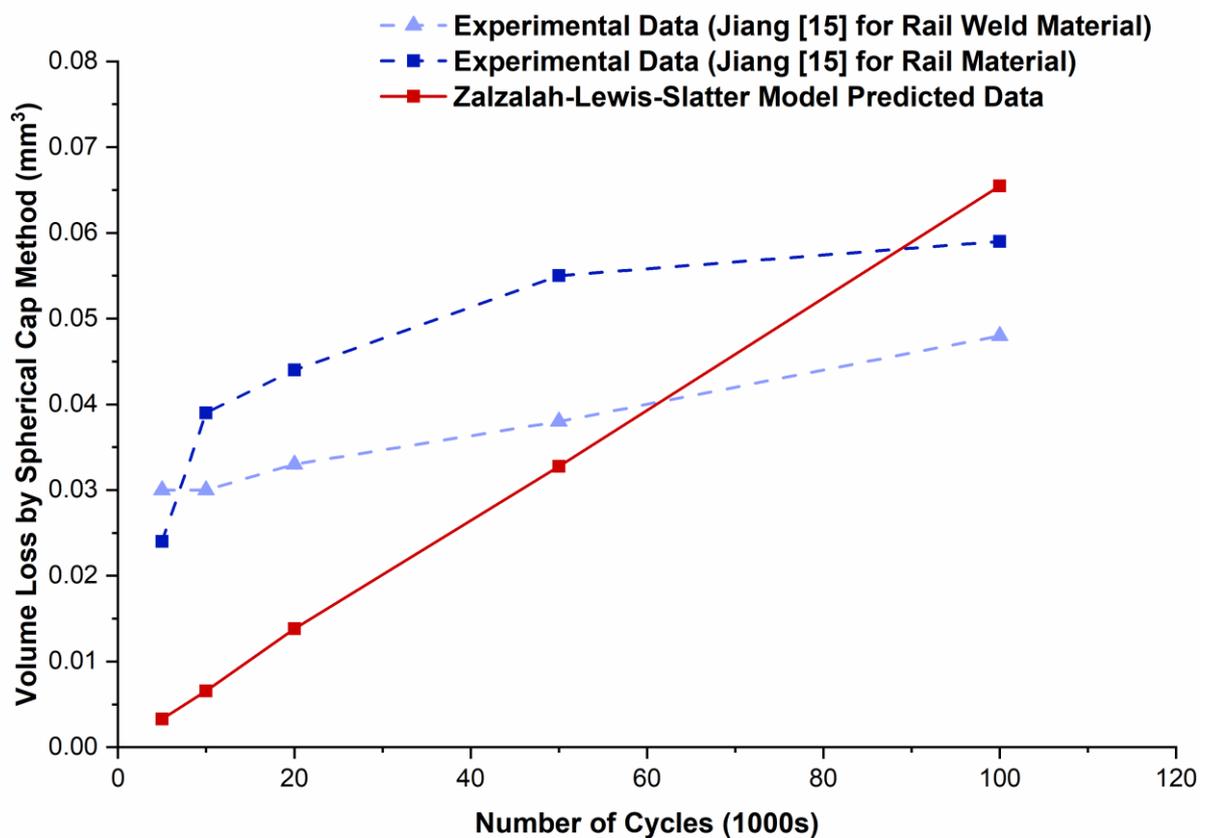
Figure 7.4 Comparison between the experimental data of Jiang et al. [15] for steel of rail material and rail weld joint material and data from Zalzalal-Lewis-Slatter model data.
