The
University
Of
Sheffield.

Department
Of
Mechanical
Engineering

Investigating Fundamental Processes in Erosive Wear of Titanium Alloys by Water Droplets

Thesis submitted to The University of Sheffield for the degree of
Doctor of Philosophy

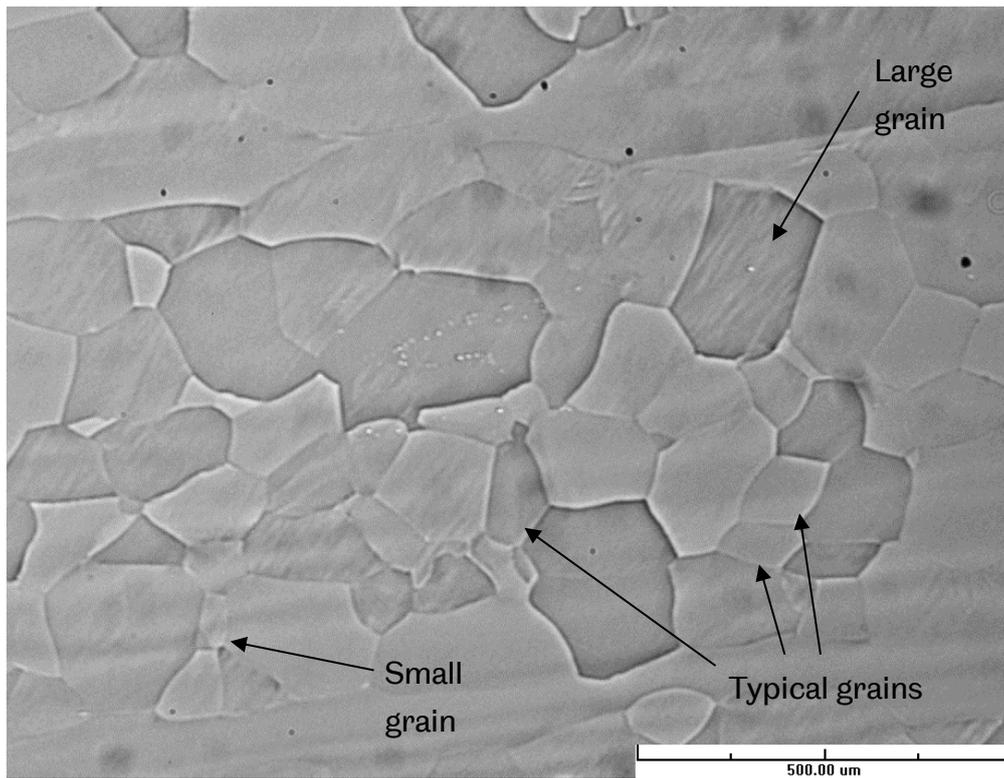
Ti-15Mo provided by TIMET was prepared for metallography and the microstructure imaged with white light microscopy. Figure 2.3 shows the grain size is around 100 μm .

Figure 2.3 – As-received Ti-15Mo under low magnification light microscopy, with 500 μm scale bar.

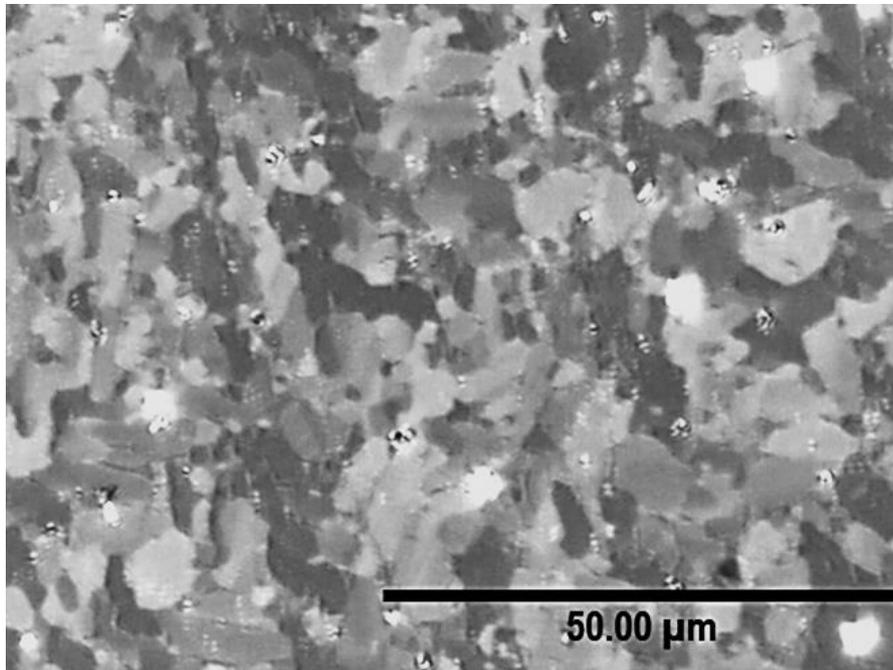
Aerospace grade Ti-6Al-4V bar was supplied by TIMET. The as-received microstructure, imaged with a white light microscope, is shown in Figure 2.4 below. The alpha grain size is approximately 5 μm , observed by utilising a polarising filter with contrast enhanced and brightness reduced.

Figure 2.4 – As-received microstructure of Ti-6Al-4V at under high magnification light microscopy.

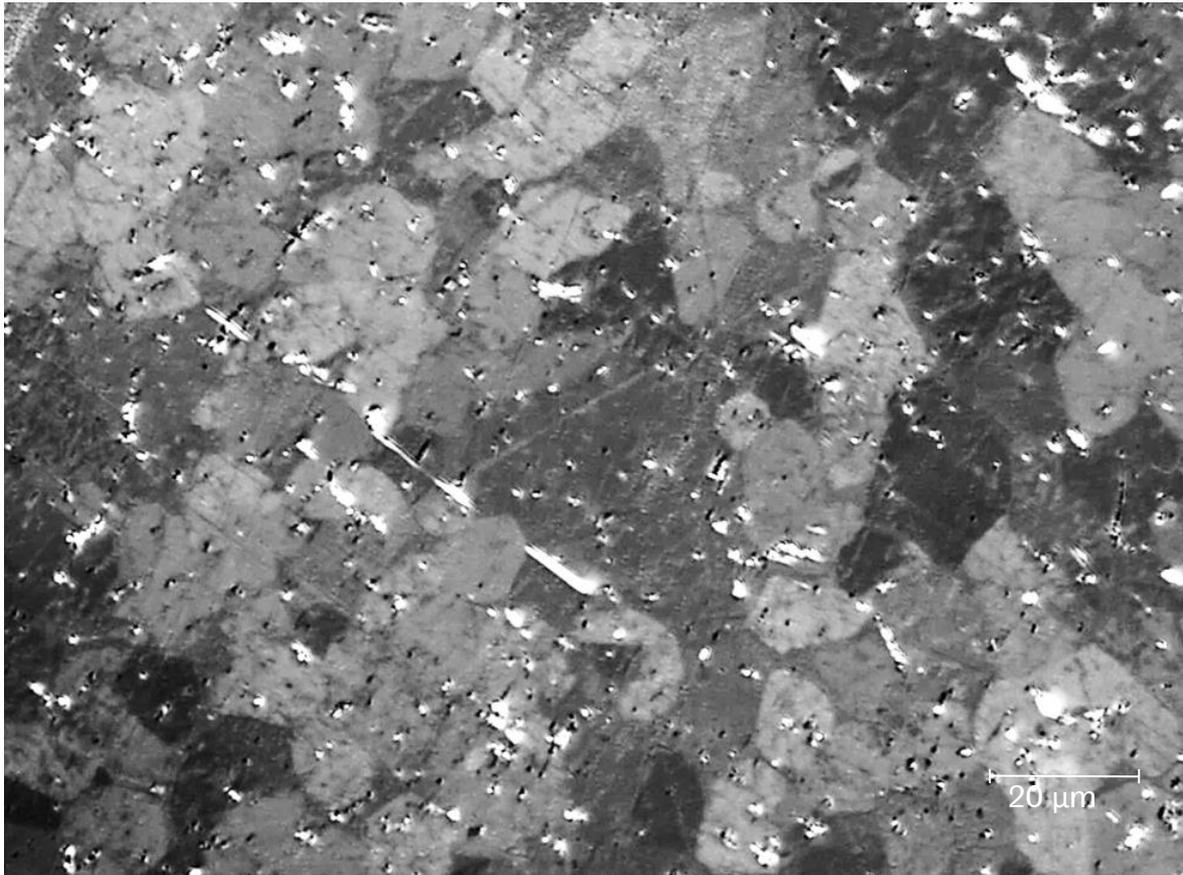
Figure 2.5 shows a typical 900 °C anneal and furnace cool microstructure.

Figure 2.5 – Ti-6Al-4V annealed at 900 °C for 4 hours then furnace cooled. High magnification light microscope with 20 μm scale bar. N.B. the white flecks are artefacts; colloidal silica polishing compound which has not fully cleaned off.

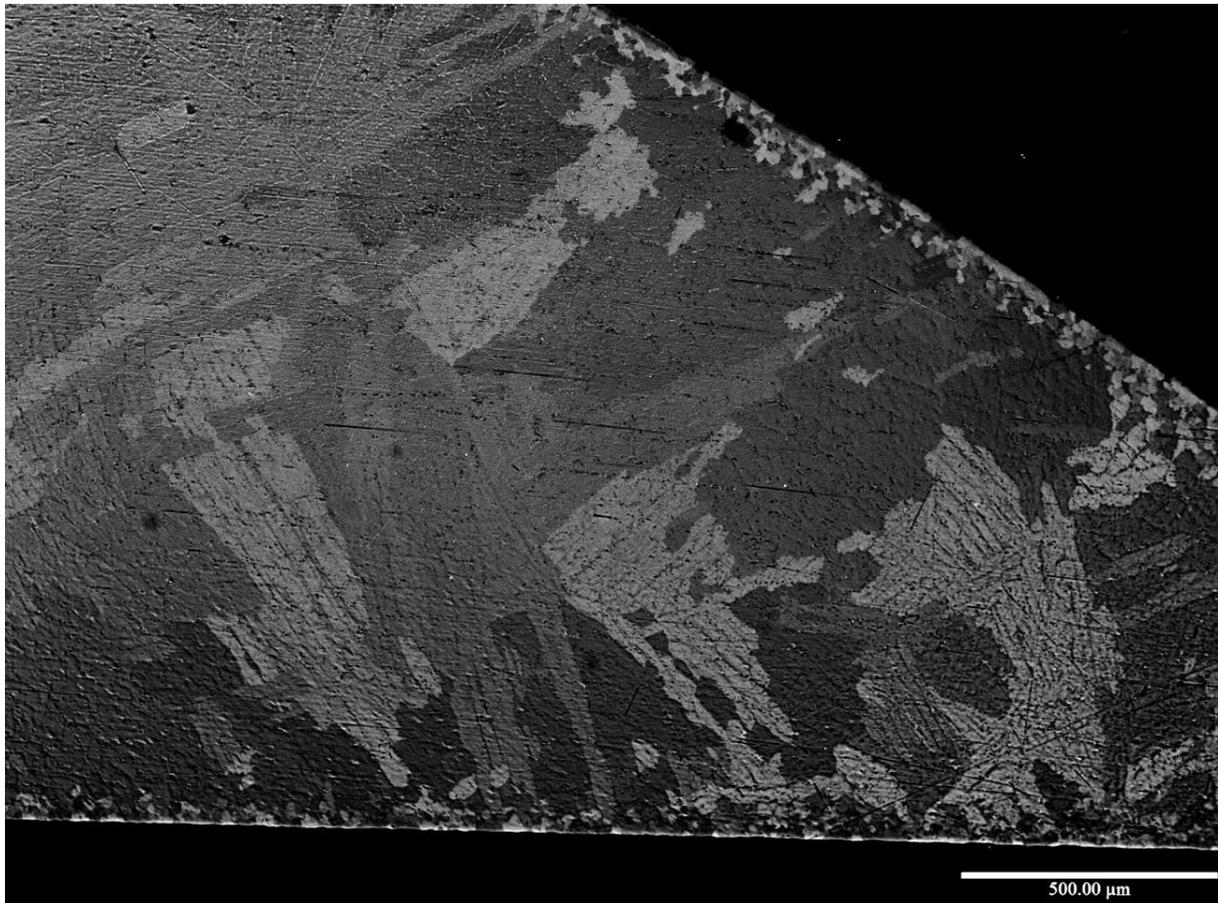
By consulting titanium experts, it became clear that a super β -transus anneal followed by a sub β -transus hold would be required. This would transform primary α grains to large β phase colonies, which can then transform back to α phase in the sub β -transus hold. Figure 2.6 shows the microstructure from such a procedure, the primary α colonies are many 100's of micrometres in size.

Figure 2.6 – Ti-6Al-4V annealed at 1100 °C for 2 mins, then held at 960 °C for 1 hour then furnace cooled. High magnification light microscopy with 500 μm scale bar.

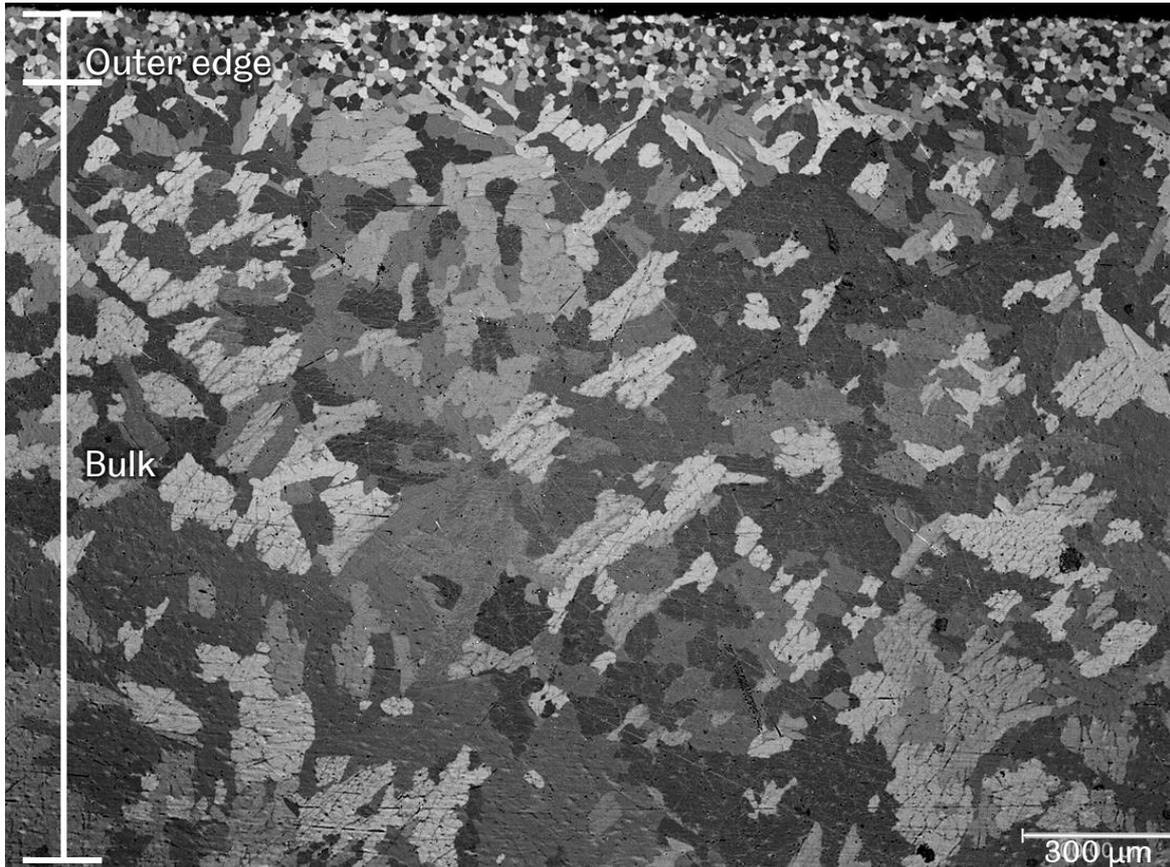
By changing the super β -transus annealing temperature and hold time it was possible to produce a nearly equiaxed microstructure of large primary α colonies, comparable to the size of the as-received Ti-15Mo β grains. Figure 2.7 shows the microstructure following annealing just above the β -transus for 5 minutes, followed by a hold just below the β -transus for an hour, then furnace cooling. The finer microstructure at the surface would be machined off in sample manufacturing.

Figure 2.7 – Ti-6Al-4V annealed at 1050 °C for 5 mins, then held at 960 °C for 1 hour, then furnace cooled. Low magnification light microscopy with 300 μm scale bar.

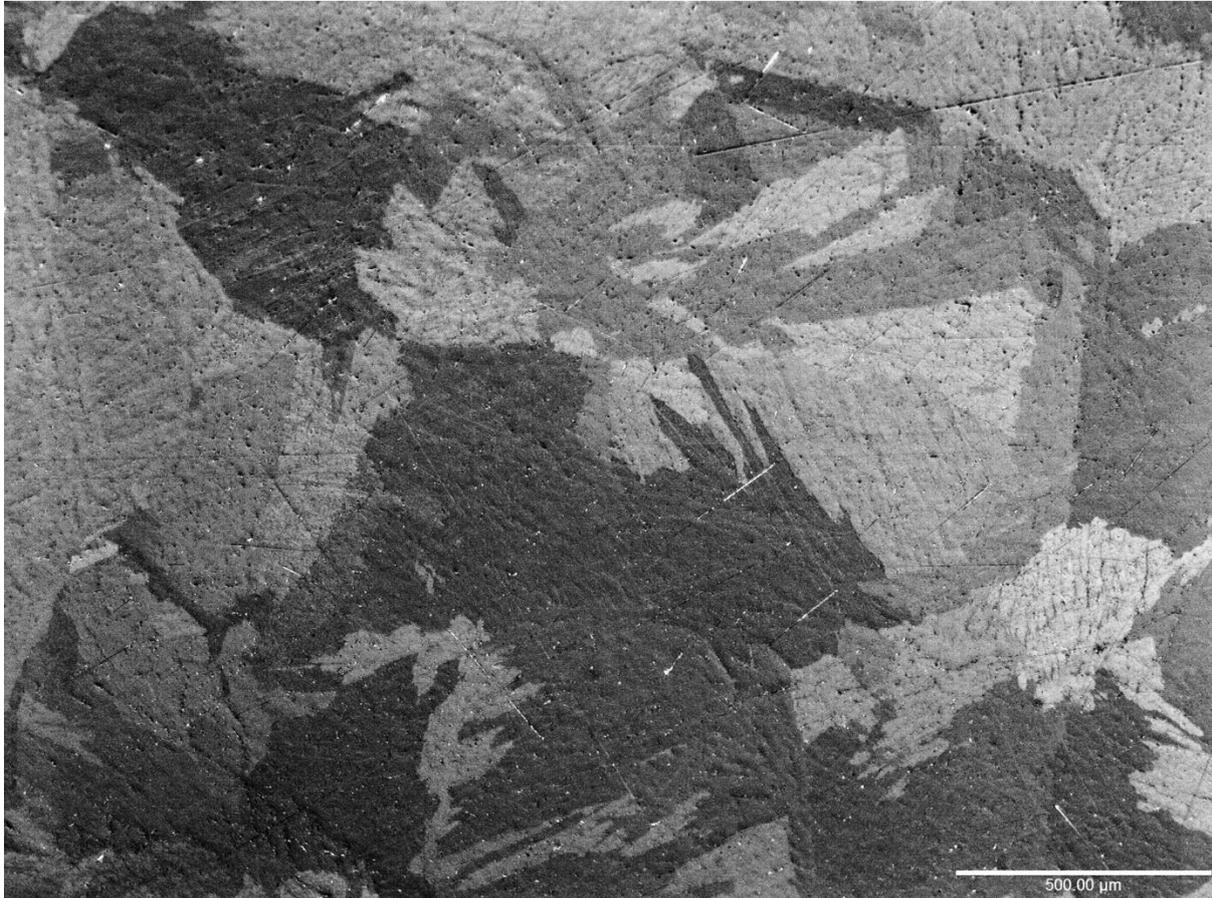
Finally, a batch of as-received Ti-6Al-4V was annealed at these parameters, though unknowingly this was done in a different, larger furnace which appears to have had different characteristics. The final microstructure produced by the batch anneal resulted in colonies of lamellar α laths $\sim 500 \mu\text{m}$ in size, much larger than planned, as illustrated in Figure 2.8.

Figure 2.8 – Ti-6Al-4V annealed at 1050 °C for 5 mins, then held at 960 °C for 1 hour, then furnace cooled. Low magnification light microscopy with 500 μm scale bar.

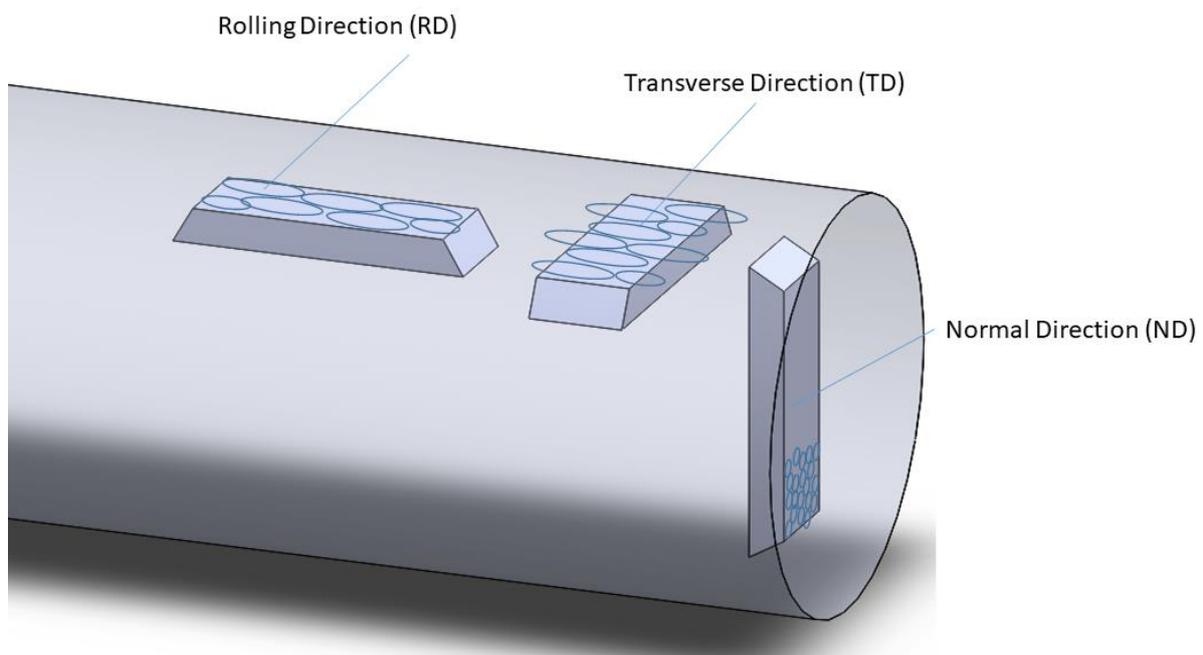
Figure 2.10 demonstrates how processing direction can affect microstructure. Grains viewed in the normal direction (ND) are typically smaller, having been forged or rolled tightly together [44], [45]. Examining coupons taken in the rolling direction (RD) or transverse direction (TD) reveals grains are typically elongated in the processing direction.

Figure 2.10 – Coupon orientations and grain orientations relative to bar processing direction.

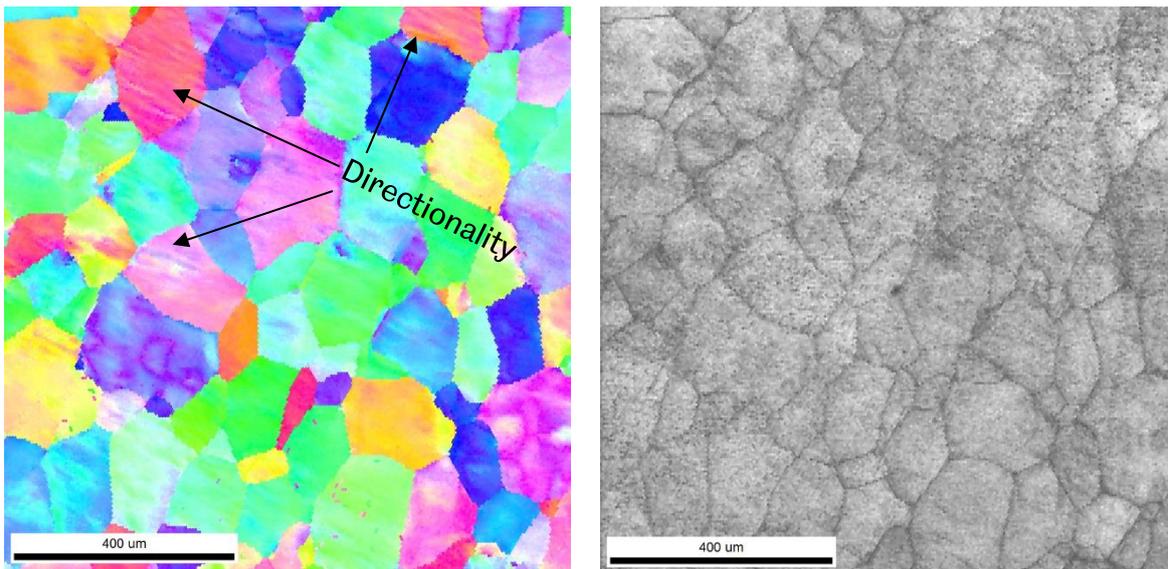
Figure 2.11, below, shows an Inverse Pole Figure (IPF) for Ti-15Mo in the ND plane. From Figure 2.11, average grain size is around 100 μm . The IPF also highlights an underlying directionality in the microstructure. This may be from the manufacturing route, likely rolling or forging. It is useful to characterise the alloys before later testing, to help clarify whether microstructural anomalies are caused by testing or are residual from manufacturing.

Color Coded Map Type: Inverse Pole Figure [001]

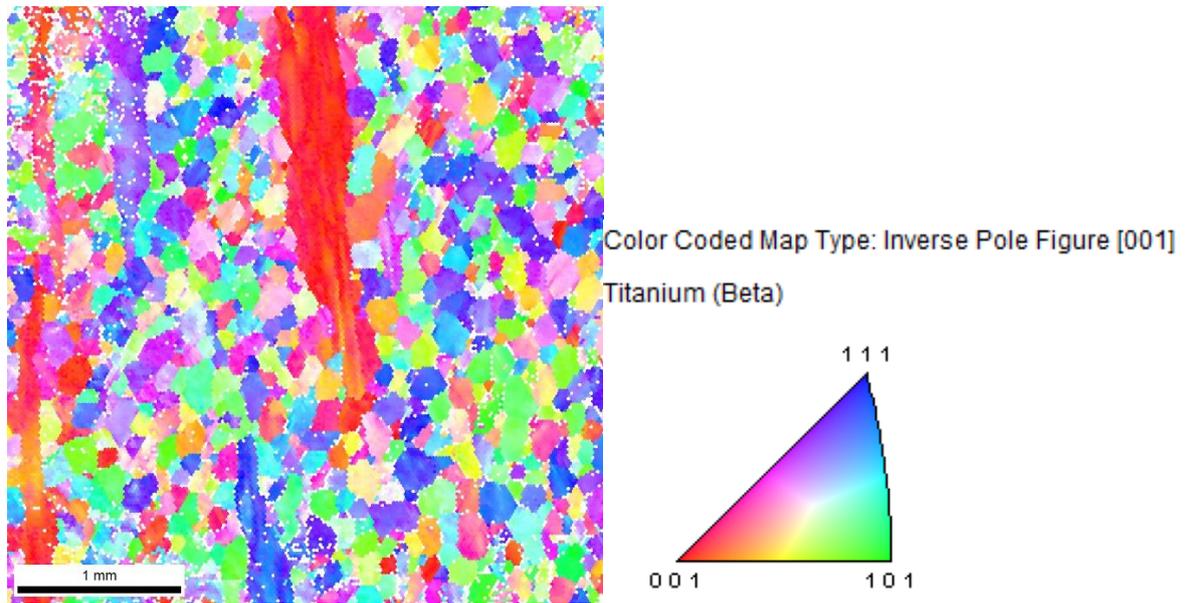
A larger scale scan taken at a lower magnification in Figure 2.13 reveals that the microstructure also has very large laths running through it.

Figure 2.13 – IPF of Ti-15Mo ND. Scanned with a 2x2 binning rate and a step size of 20 μm . Grains of size less than 2 pixels removed.

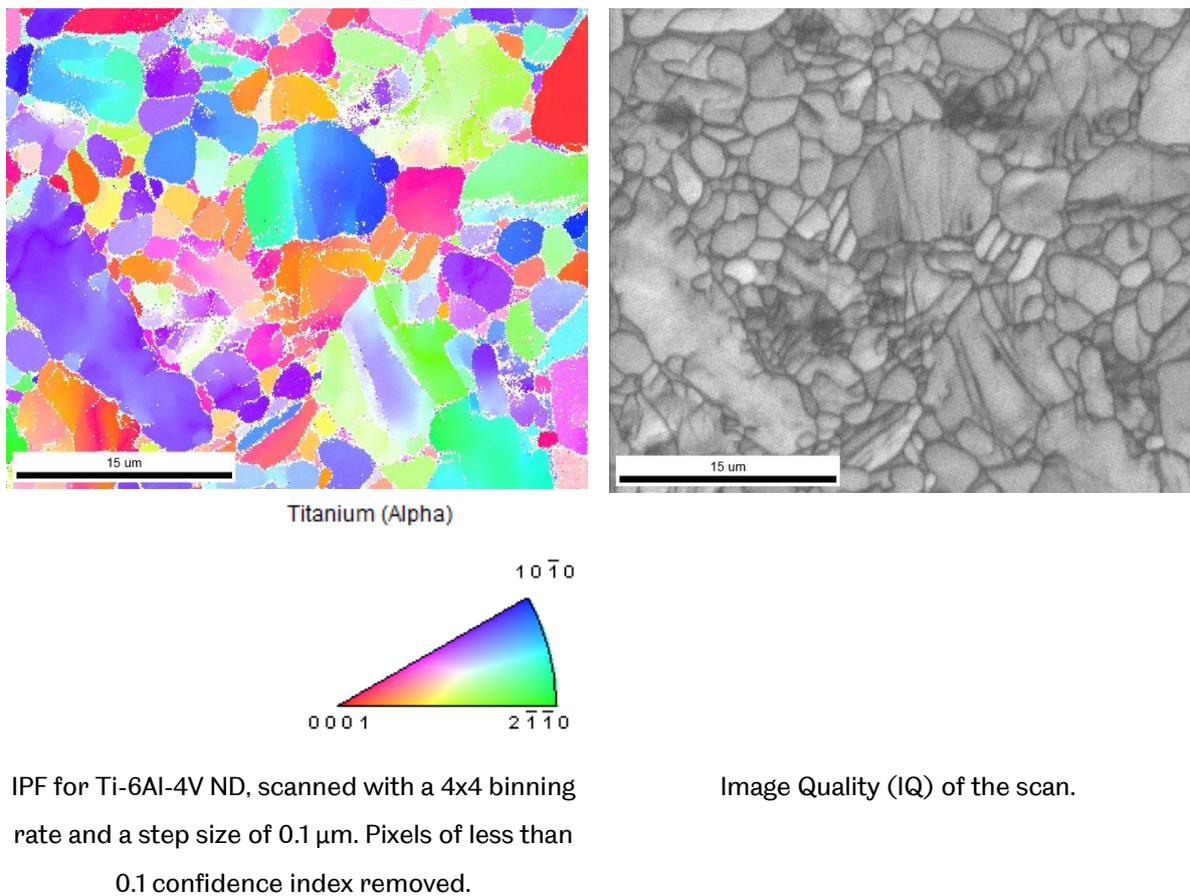
Figure 2.14 shows a high resolution EBSD scan of the as-received Ti-6Al-4V microstructure. The image quality (IQ) map is produced from band contrast. High contrast indicates high confidence in indexing, darker areas indicate poor indexing in regions such as grain boundaries, contamination from dirt, polishing scratches or other deformation. The IQ map therefore serves as a useful way of seeing grain boundaries. The IPF indicates some large grains are actually made up of several orientations, and some small grains may in fact be similarly orientated to each other.

Figure 2.14 – IPF and IQ maps for as-received Ti-6Al-4V (ND).

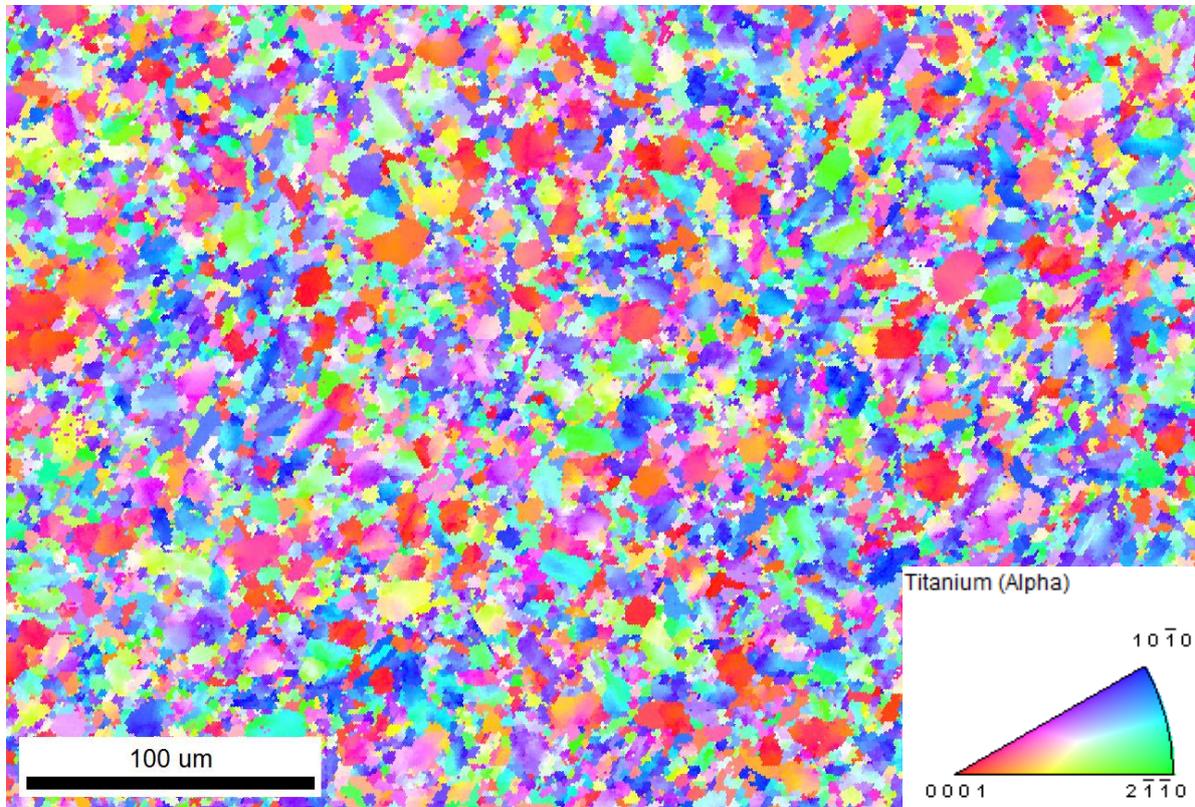
Figure 2.16 – IPF of as-received Ti-6Al-4V (ND). Scanned with a 4x4 binning rate and a step size of 1 μm . Grains of size less than 2 pixels removed. Data cleaned up by Kuwahara filter applied to first neighbour for one iteration.

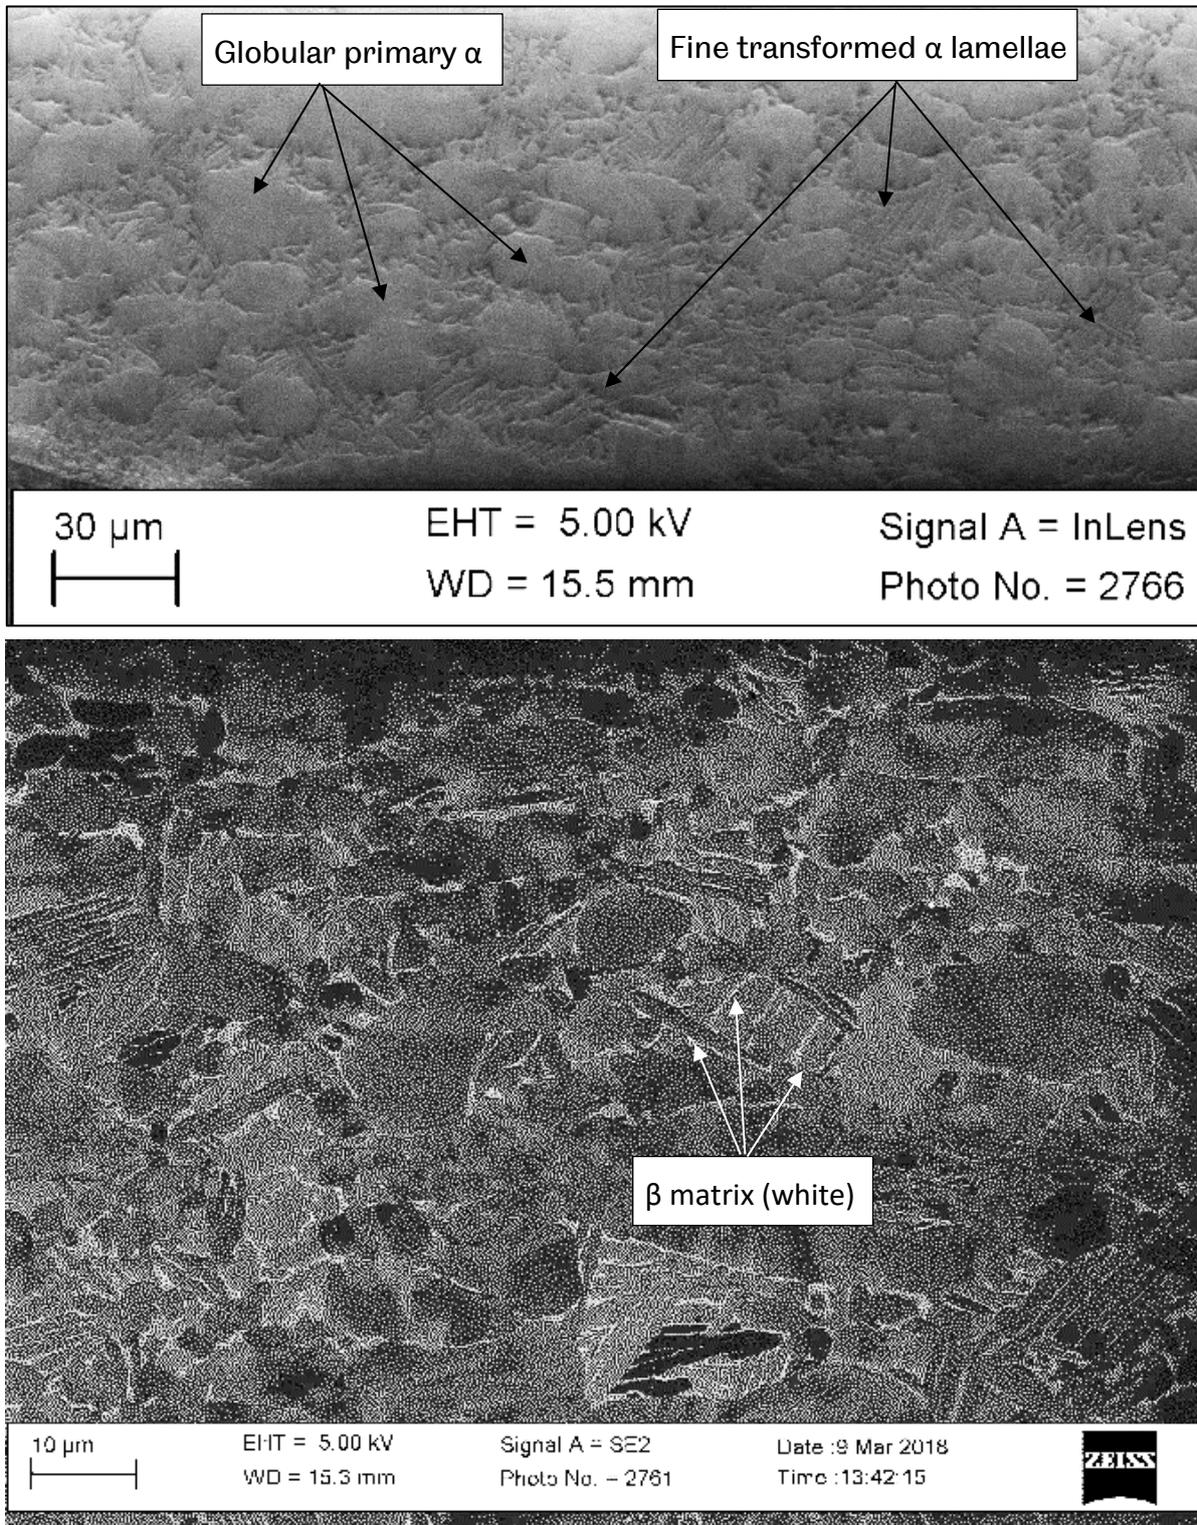
SEM is also useful for viewing the microstructure. Figure 2.17 shows an equiaxed duplex structure of globular and fine transformed lamellar primary α in prior β grains, typical of a Ti-6Al-4V alloy forged just below the $\alpha+\beta$ transus then air cooled.

Figure 2.17 – SEM images of the as-received Ti-6Al-4V (RD) microstructure, showing the duplex globular and lamellar α phase embedded in a β phase matrix.

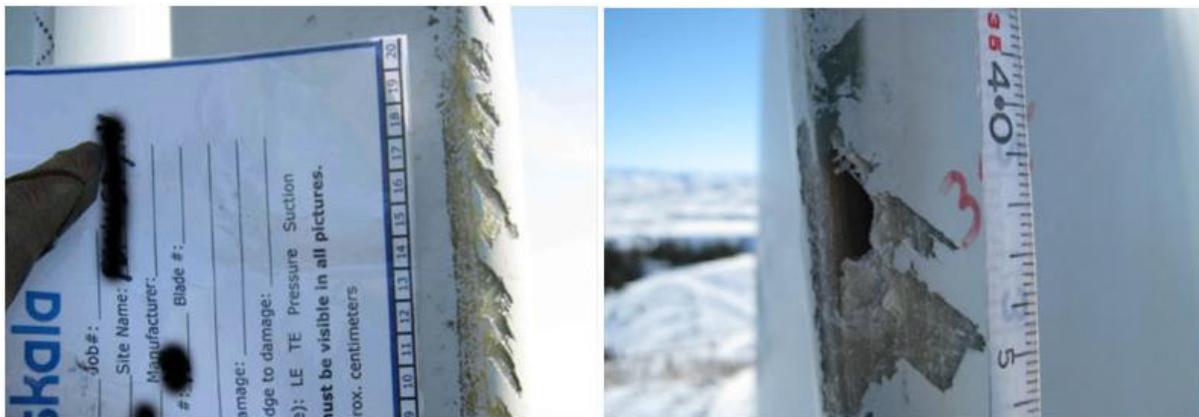
Figure 3.1 – Erosion on the leading edge of wind turbine blades [18].

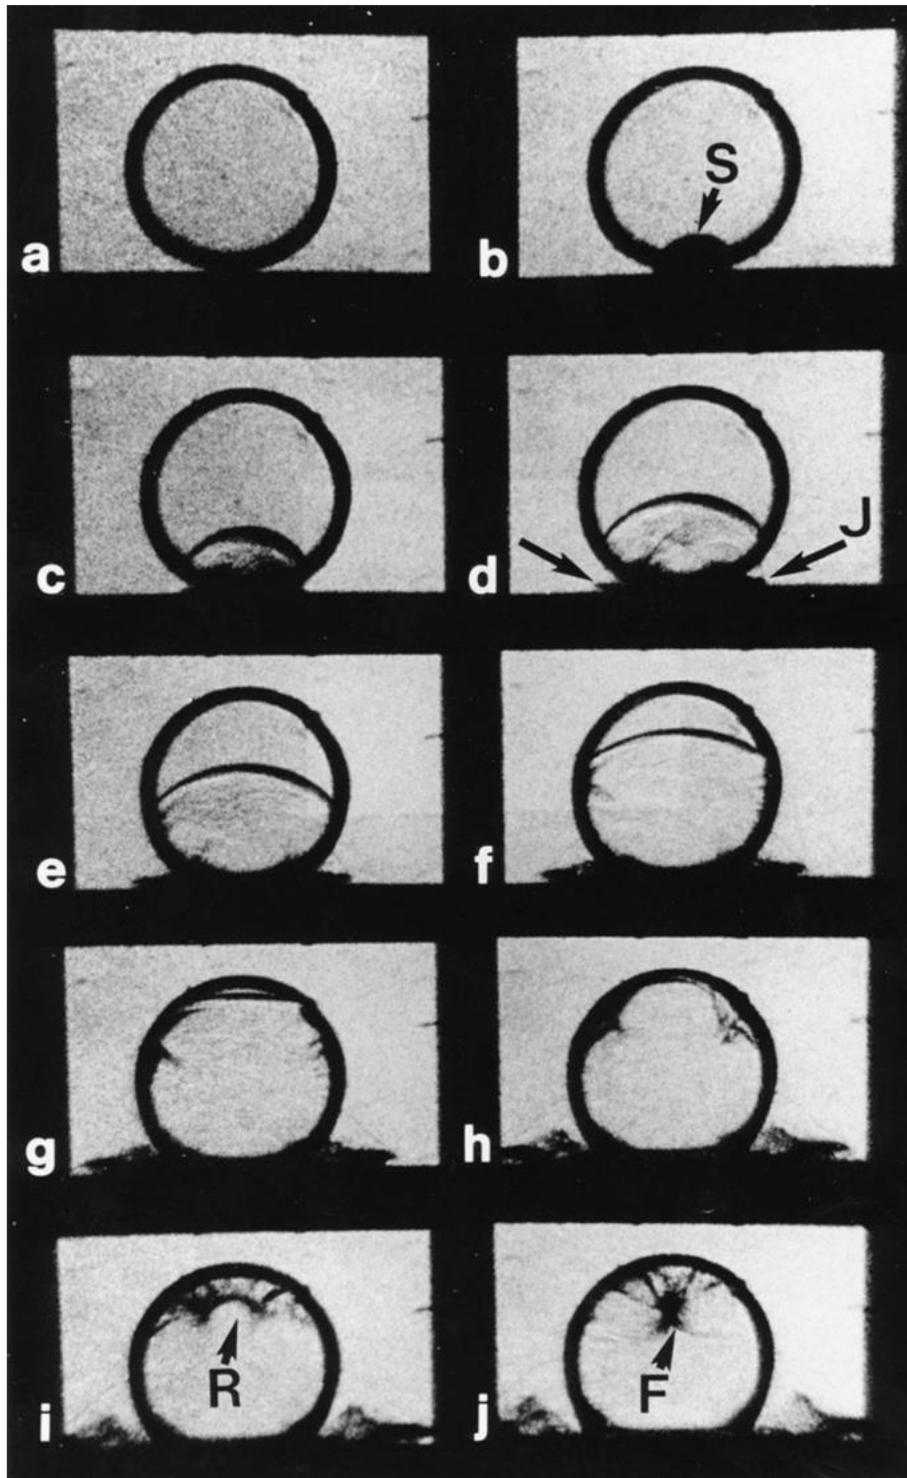
Field, Dear and Ogren [16] photographed a timeseries of an impacting droplet in Figure 3.5 below. A compressive shockwave, S, travels up the droplet, then reflects from the top surface as expansive waves, R. These meet at a focussing region, F, to produce cavities.

Figure 3.5 – A 10 mm droplet impacted by a metal slider at $110 \text{ m}\cdot\text{s}^{-1}$. Interframe time $1 \mu\text{s}$ [16].

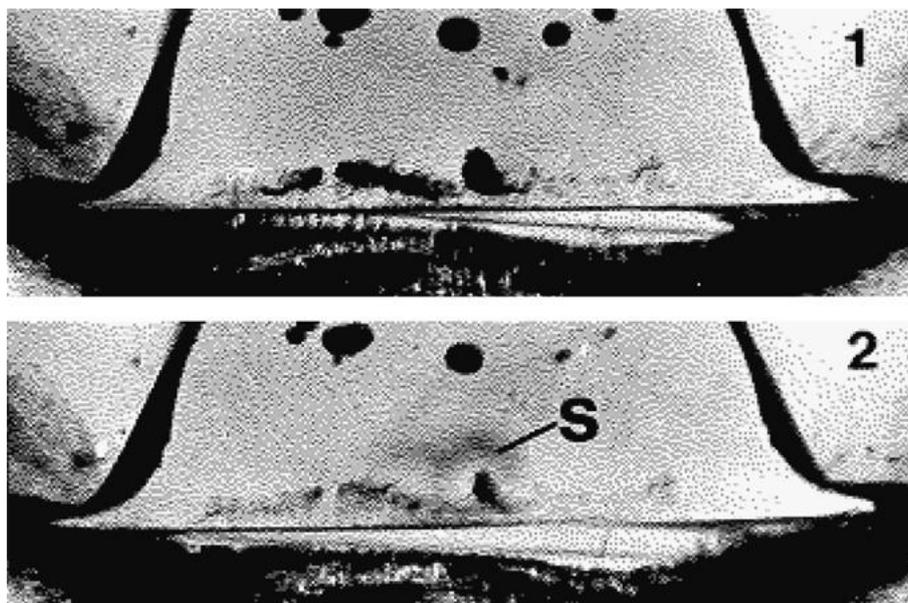
Cavitation closer to the material surface has also been observed, such as the cavities photographed by Camus [53] in Figure 3.8, one of which collapses and produces a shockwave, labelled S in the second frame.

Figure 3.8 – A 5 mm droplet impacted at $60 \text{ m}\cdot\text{s}^{-1}$ [53].

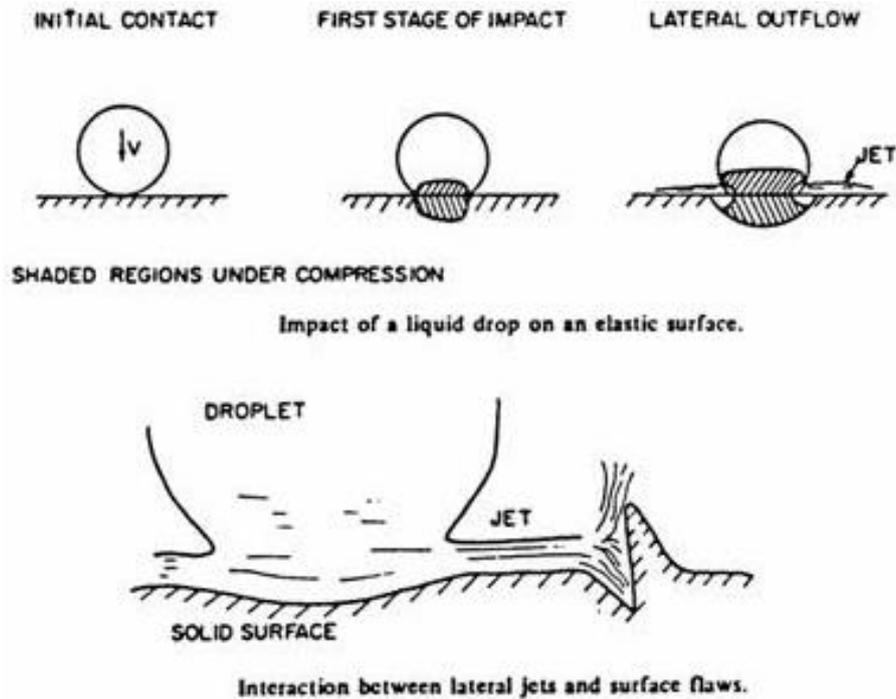
Springer's schematic in Figure 3.11 shows how lateral outflow jets produced by a water droplet impact would interact with surface flaws and cause damage [54].

Figure 3.11 - Springer's schematic of a lateral outflow jet interacting with surface roughness [54].

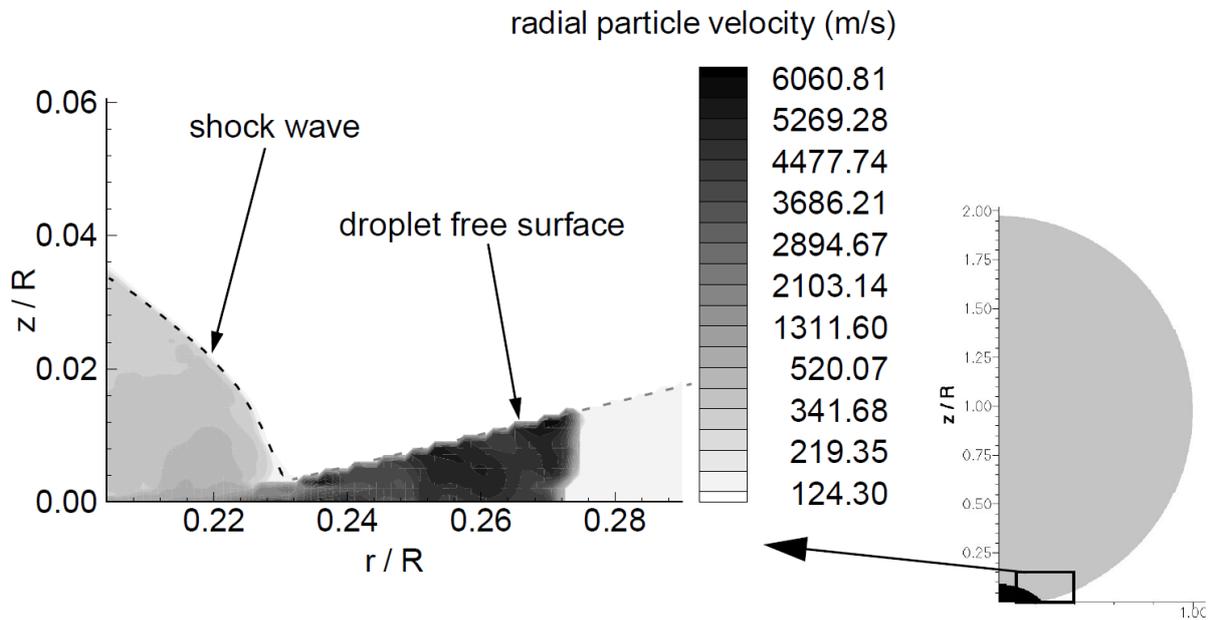
Figure 3.13 – $100 \mu\text{m}$ diameter water droplet impacting at $500 \text{ m}\cdot\text{s}^{-1}$. Left: enlarged detail of the lateral jets produced when the shockwave overtakes the contact patch area. Right: the entire model, illustrating the region of interest [13].

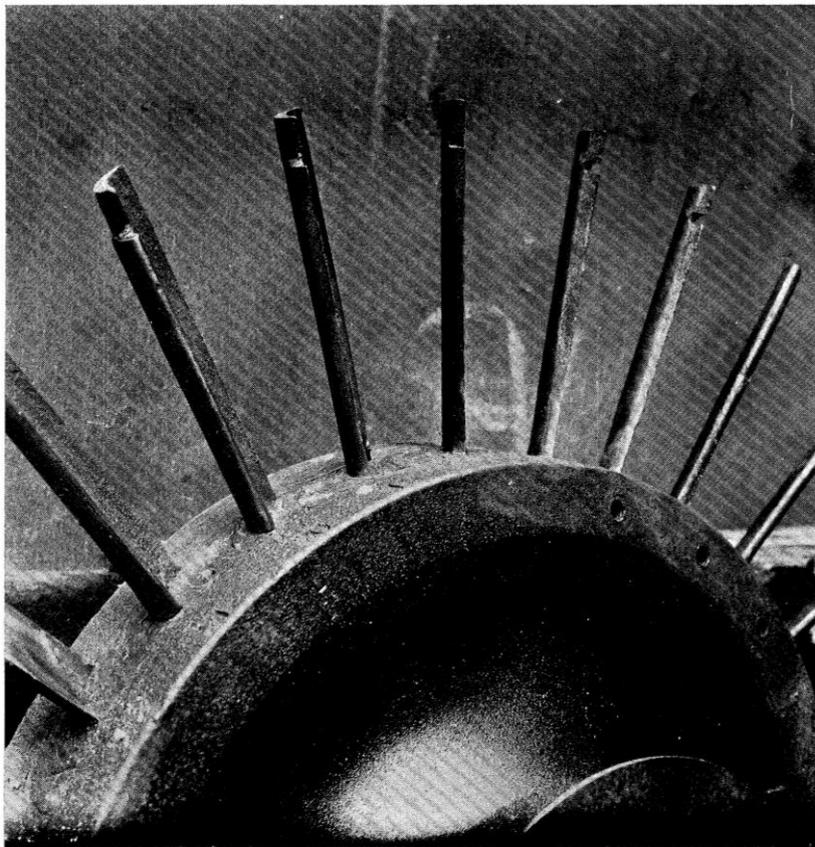
Figure 3.15 – The rotating sample set-up which Cook utilised [33].

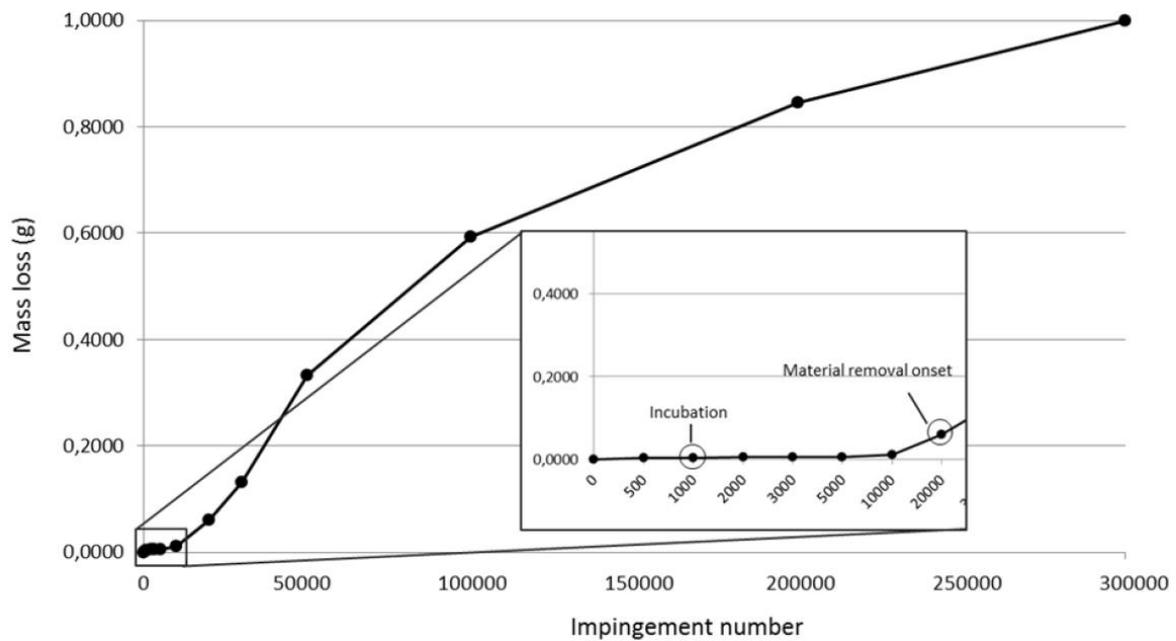
Figure 3.18 – Mass loss with “impingement number” (number of revolutions) for a whirling arm water droplet erosion test of Ti-6Al-4V at 350 m·s⁻¹ impact velocity [57].

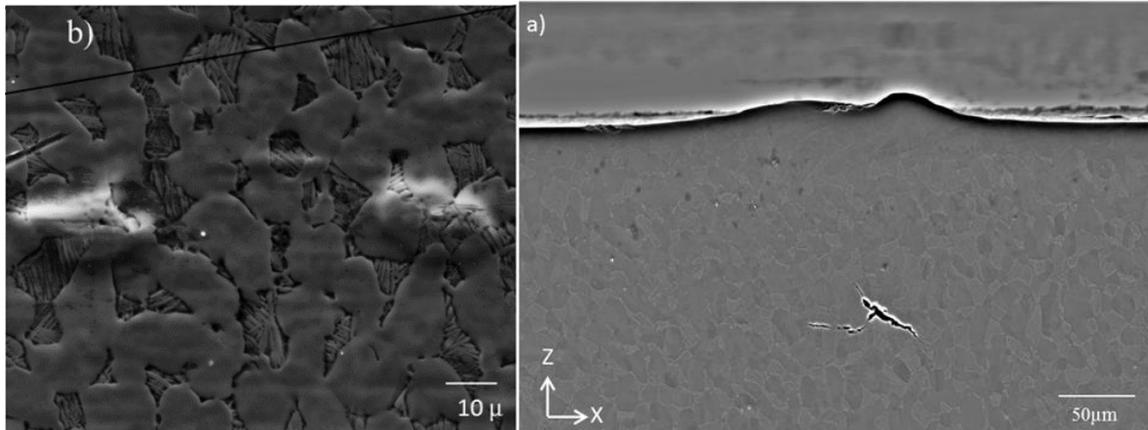
Figure 3.19 – Raised features on a Ti-6Al-4V surface after 1,000 revolutions through a water droplet stream and a subsurface crack found when FIB sectioning one [57].

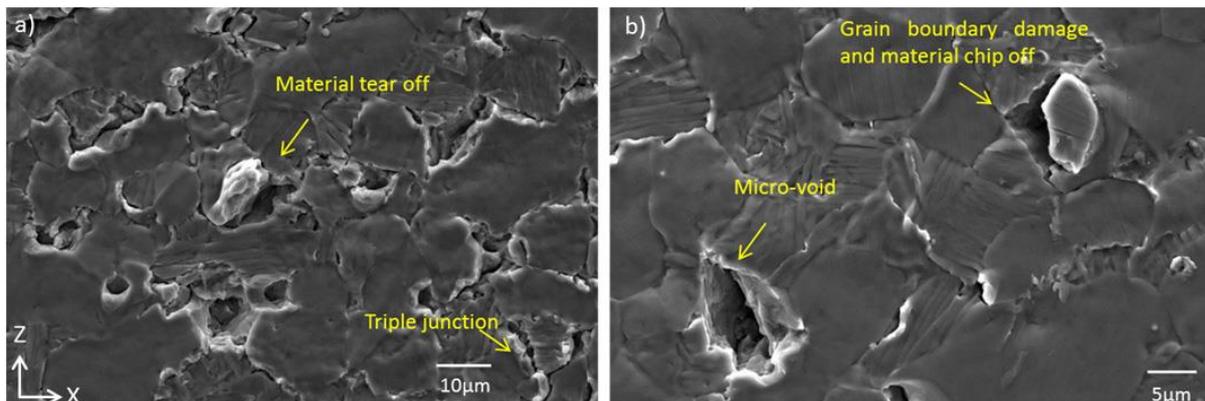
Figure 3.22 – As cracks propagate and join, small chunks of material begin to tear off leaving micro-voids [57].

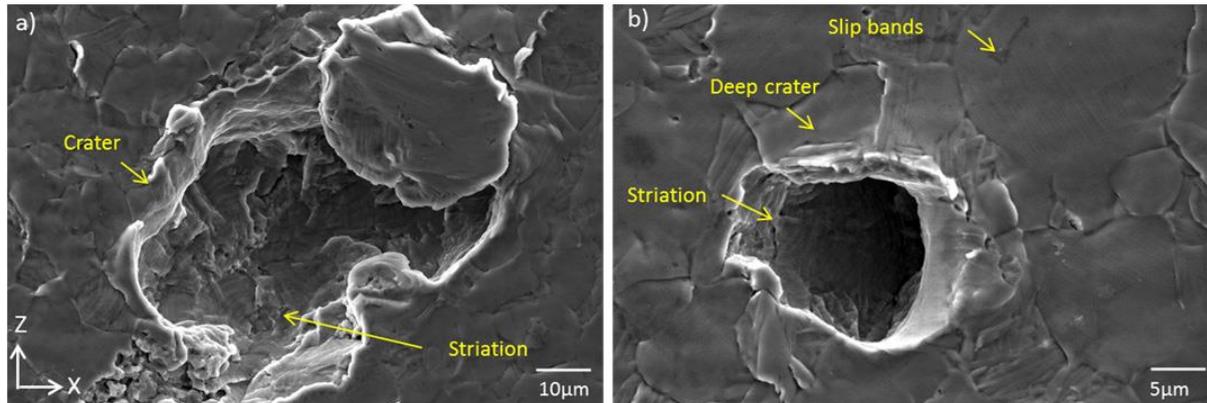
Figure 3.23 - Deep craters are formed as hydraulic penetration forces material to detach from the bulk [57].

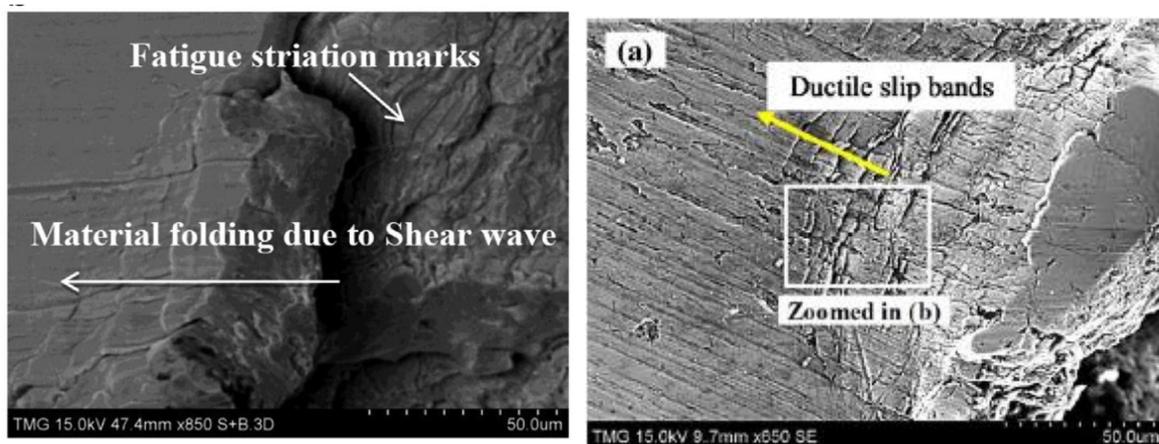
Figure 3.24 – (Left) the edge of an eroded crater in Ti-6Al-4V [75]. (Right) slip bands at the edge of an erosion crater during advanced erosion of untreated Ti-6Al-4V [48]

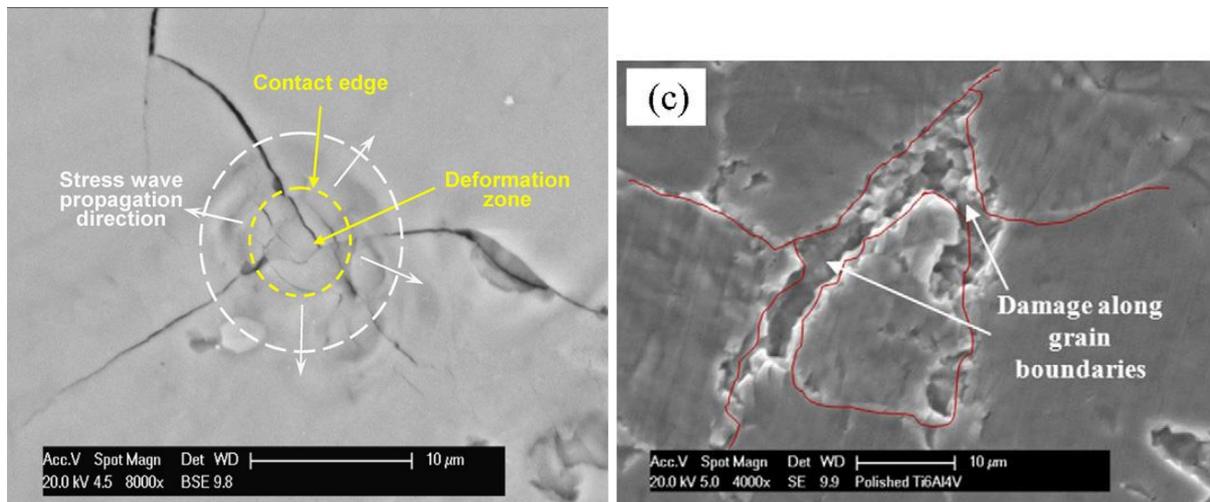
Figure 3.27 – (Left) γ -TiAl after a single pass of a 730 MPa jet [76]. (Right) Ti-6Al-4V after three passes of a 940 MPa jet [9].

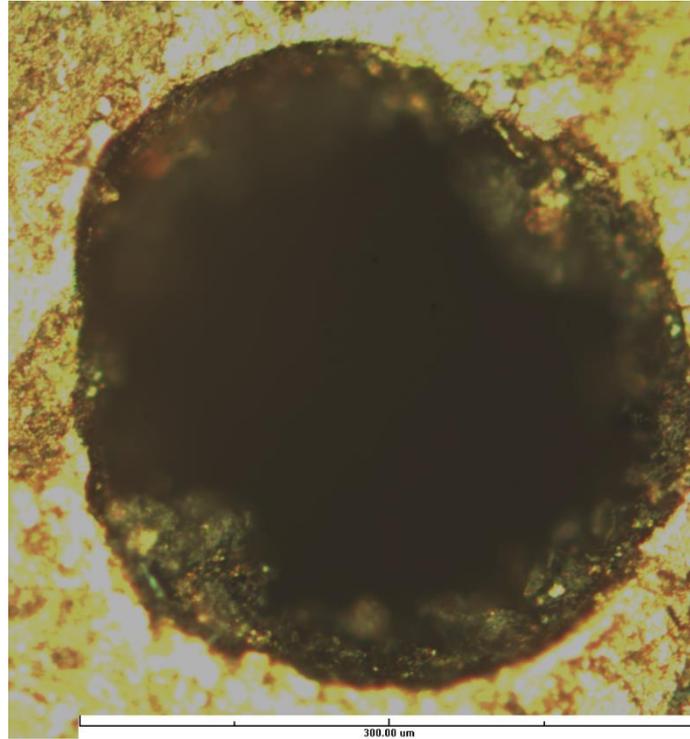
Figure 3.32 – Original brass nozzle with some corrosion product or other debris inside the bore (300 μm scale bar).

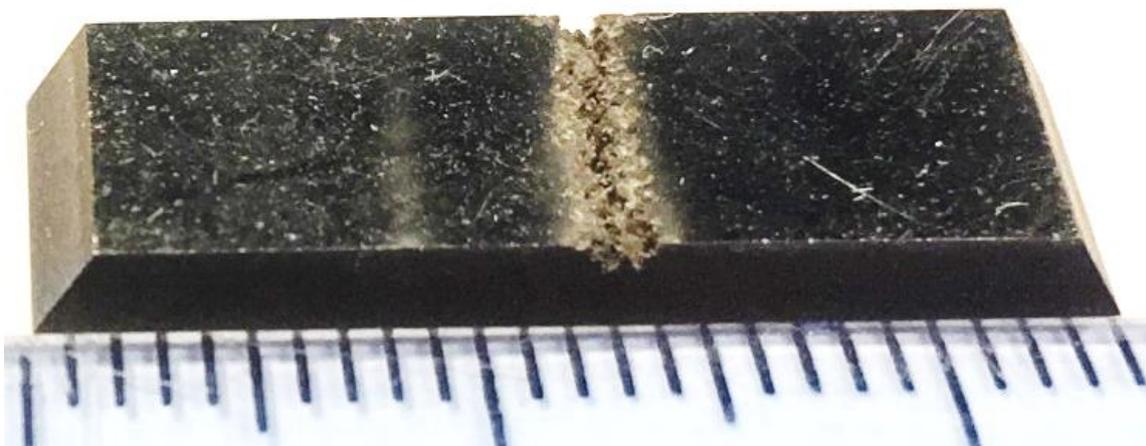
Figure 3.36 Photograph of as-received Ti-6Al-4V after 36 hours of exposure to WDE, with millimetre graduated ruler.
