The
University
Of
Sheffield.

Department
Of
Mechanical
Engineering

Investigating Fundamental Processes in Erosive Wear of Titanium Alloys by Water Droplets

Thesis submitted to The University of Sheffield for the degree of
Doctor of Philosophy

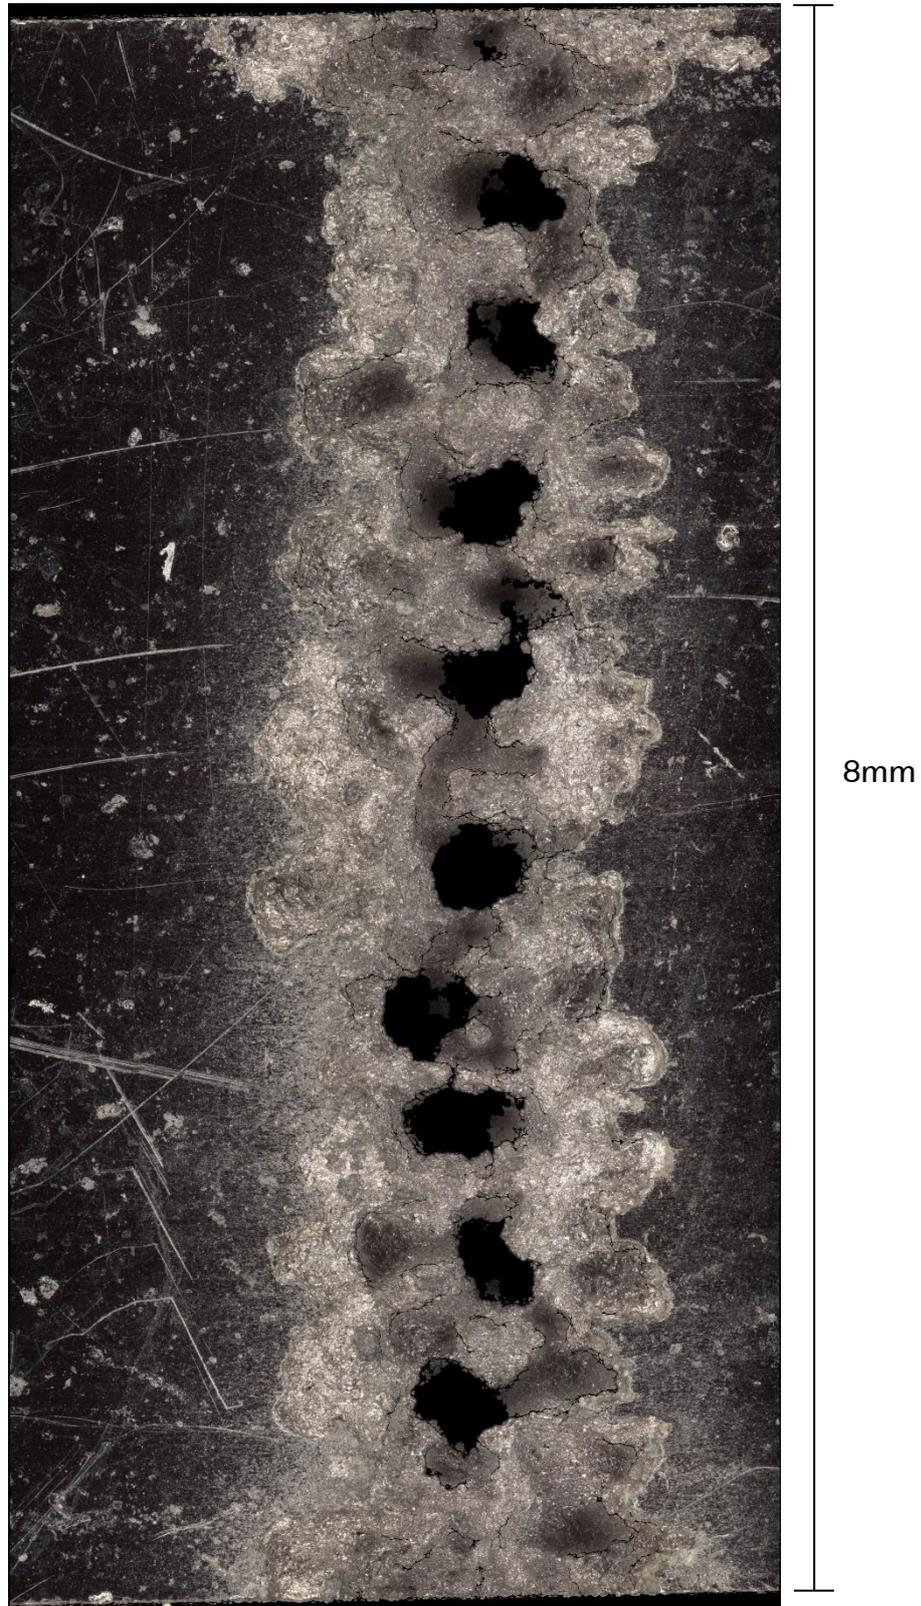
Figure 3.37 – Alicona image of as-received Ti-6Al-4V after 36 hours of exposure to WDE. The image is across the entire 8 mm coupon width.

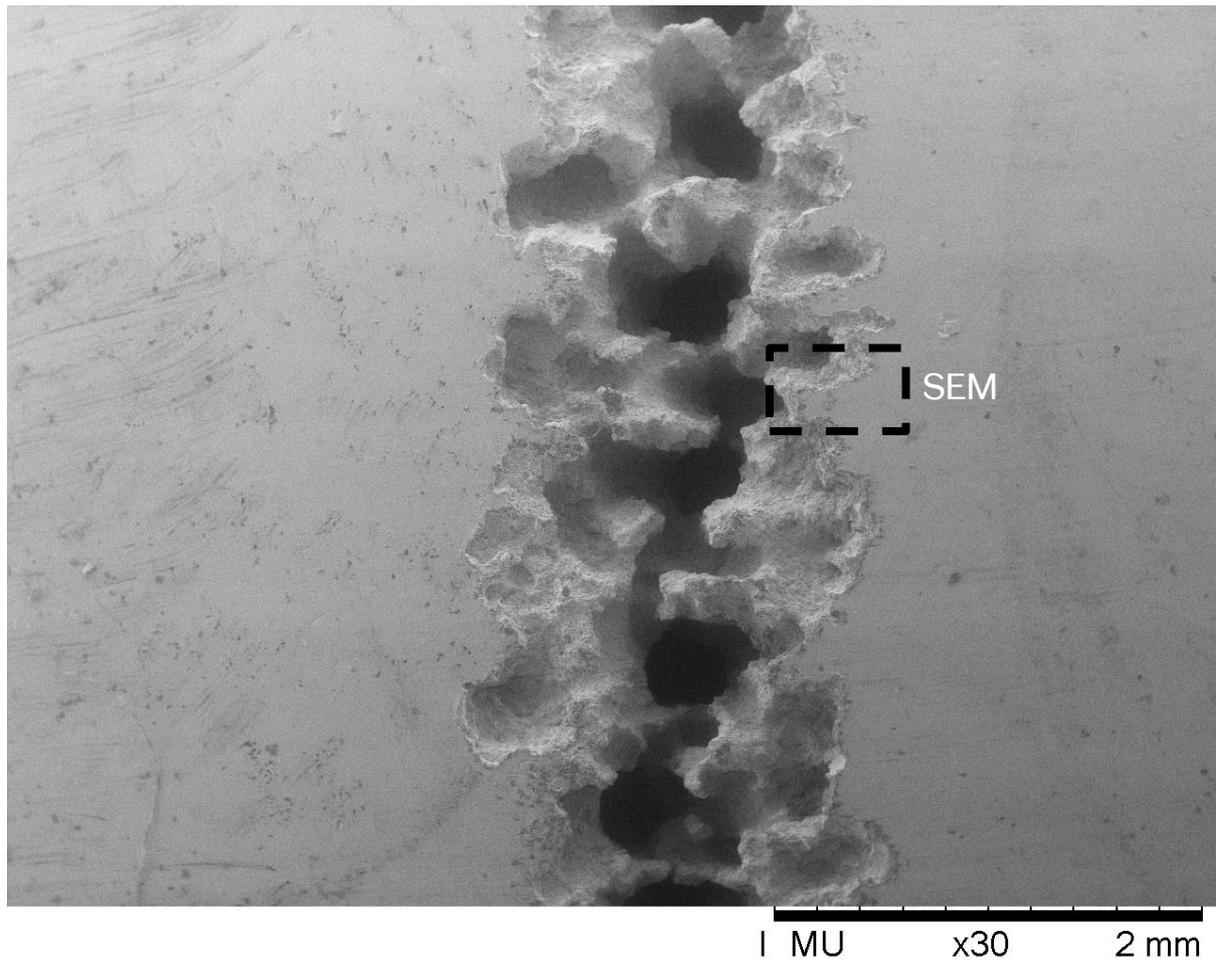
Figure 3.38 is a SEM image of the erosion scar in Ti-6Al-4V following the 36-hour test.

Figure 3.38 – SEM image of as-received Ti-6Al-4V after 36 hours of exposure to WDE. An area is circled where higher magnification analysis was investigated further.

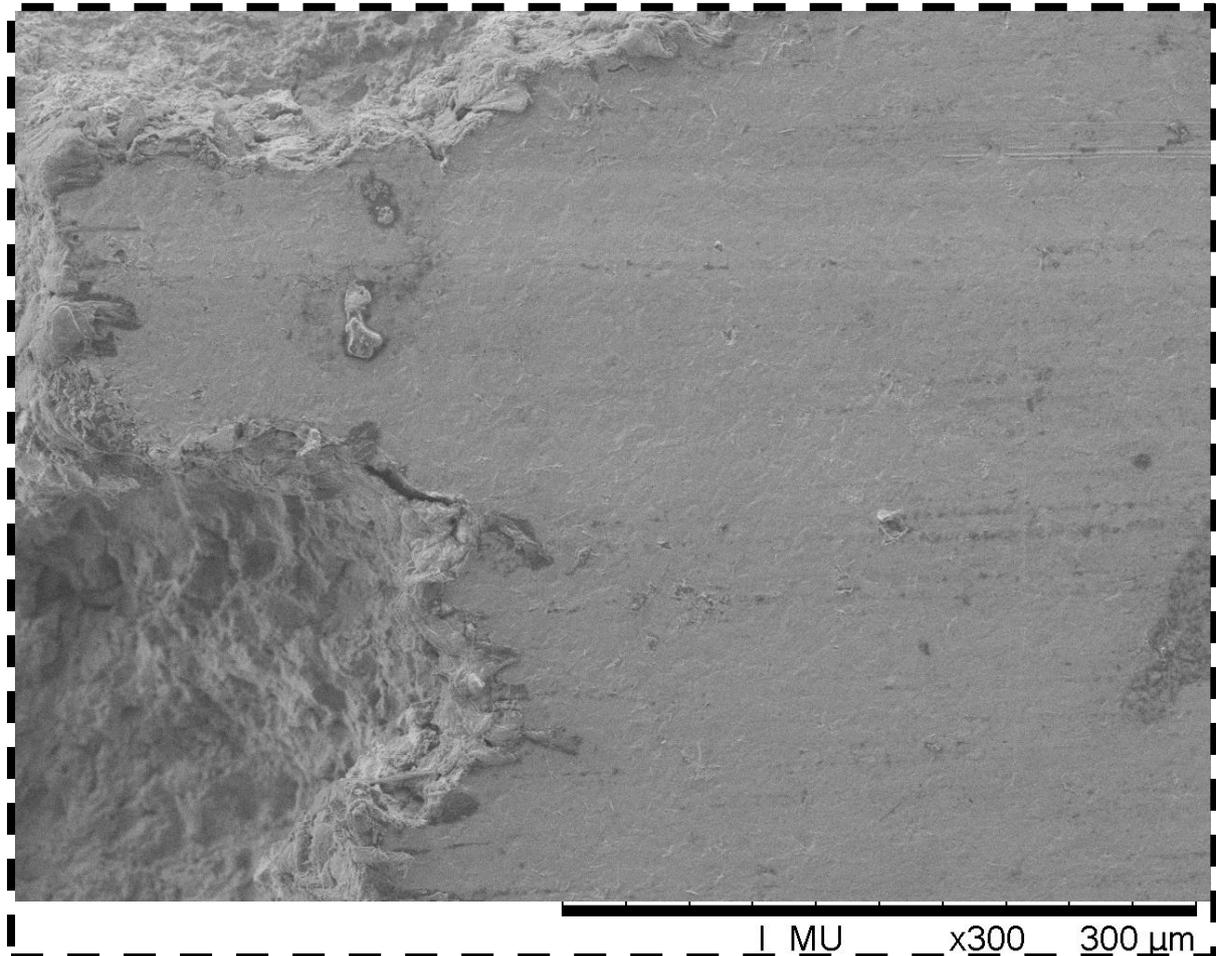
Figure 3.39 – SEM image of as-received Ti-6Al-4V after 36 hours of exposure to WDE.

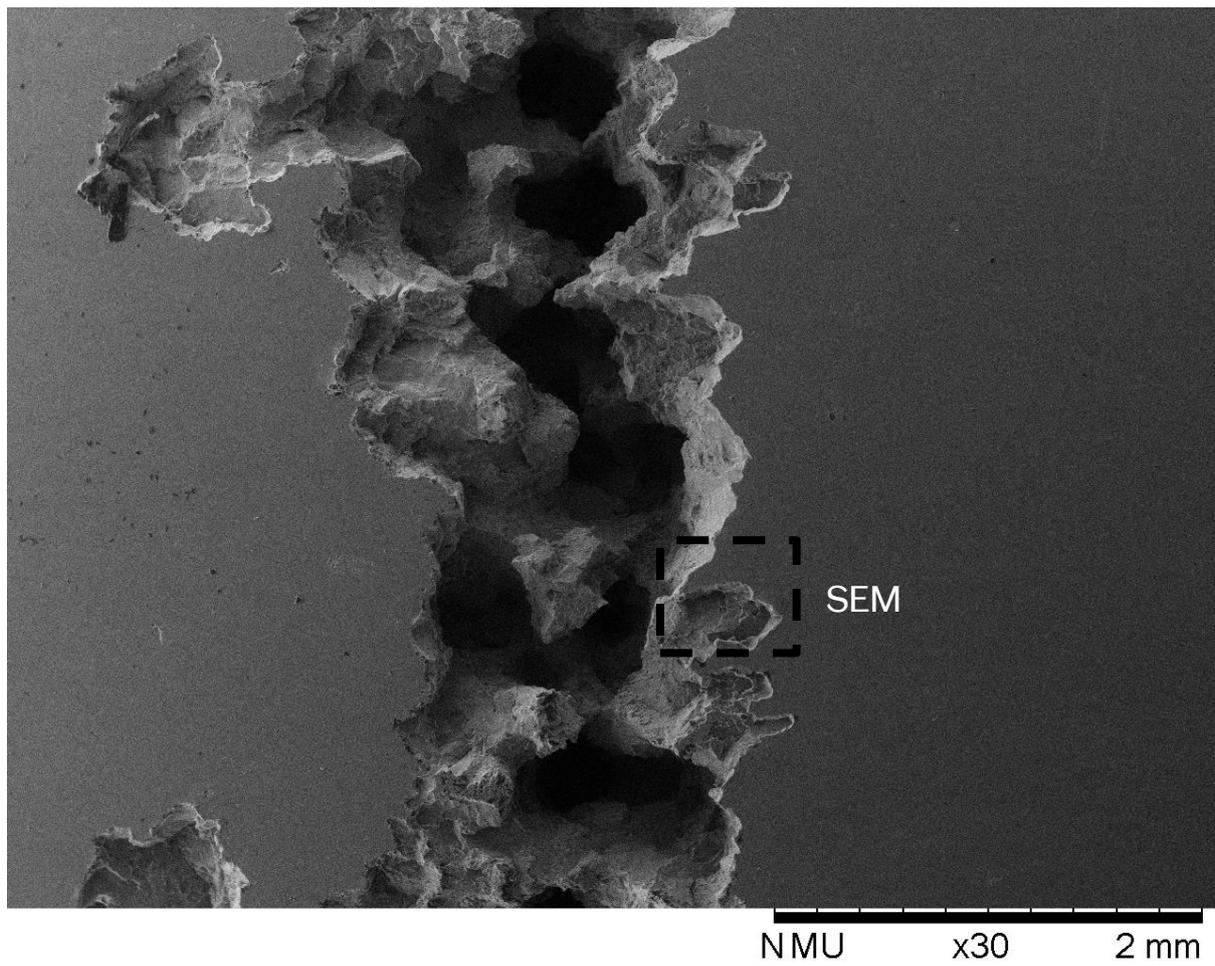
Figure 3.41 – SEM image of as-received Ti-15Mo after 36 hours of exposure to WDE. An area is marked where higher magnification was conducted.

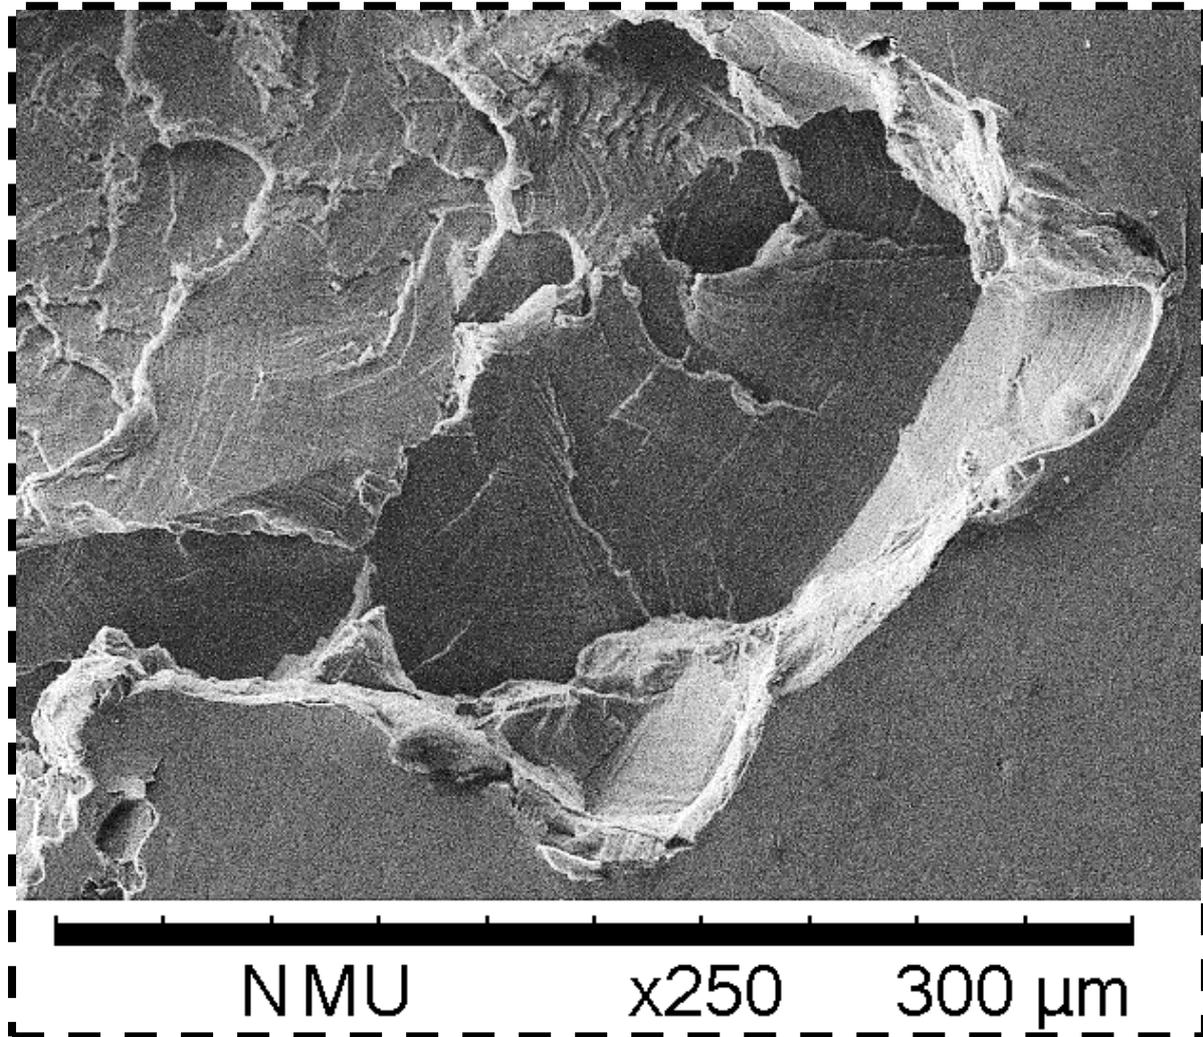
Figure 3.42 – SEM image of as-received Ti-15Mo after 36 hours of exposure to WDE.

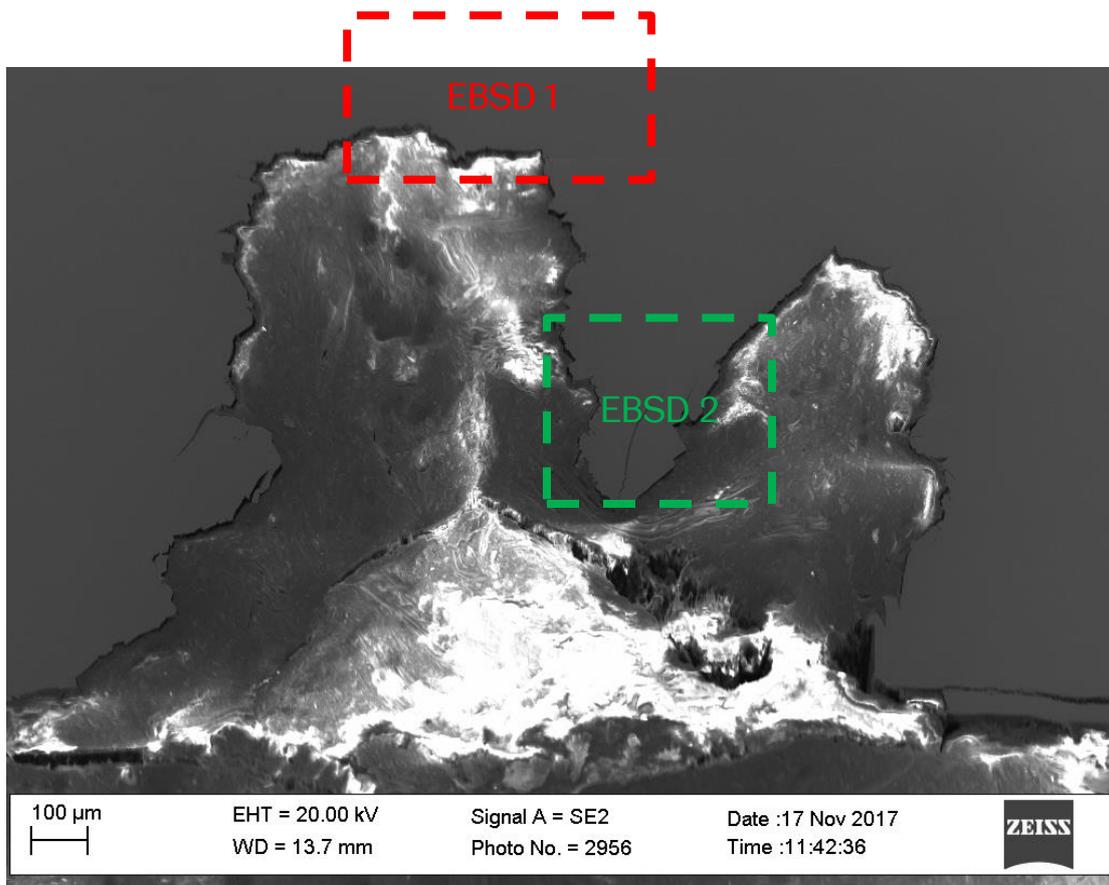
Figure 3.44 – SEM image showing EBSD scan regions of 36-hour WDE Ti-15Mo sample.

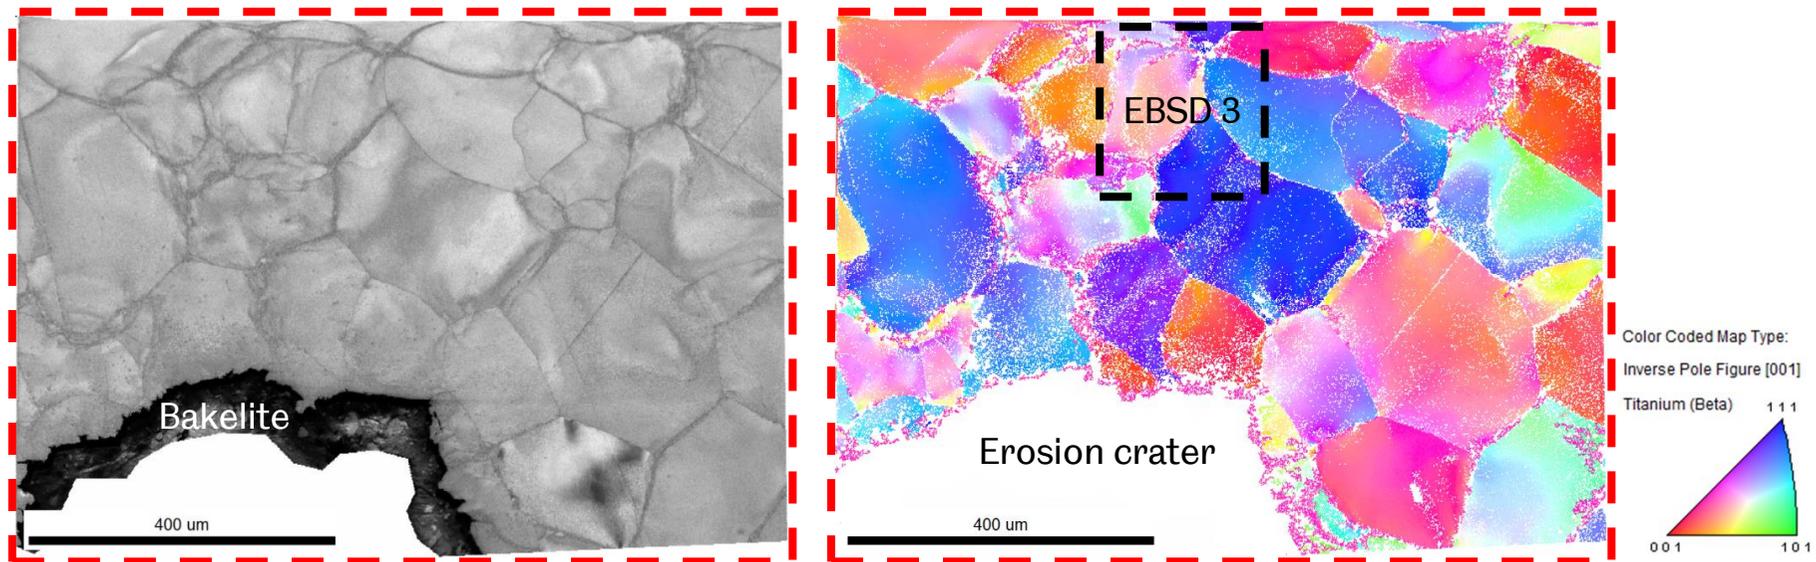
Figure 3.45 – IQ and IPF for 36-hour WDE Ti-15Mo sample, scanned with a 4x4 binning rate and a step size of 1.5 μm . Grains of less than 2 pixels removed.

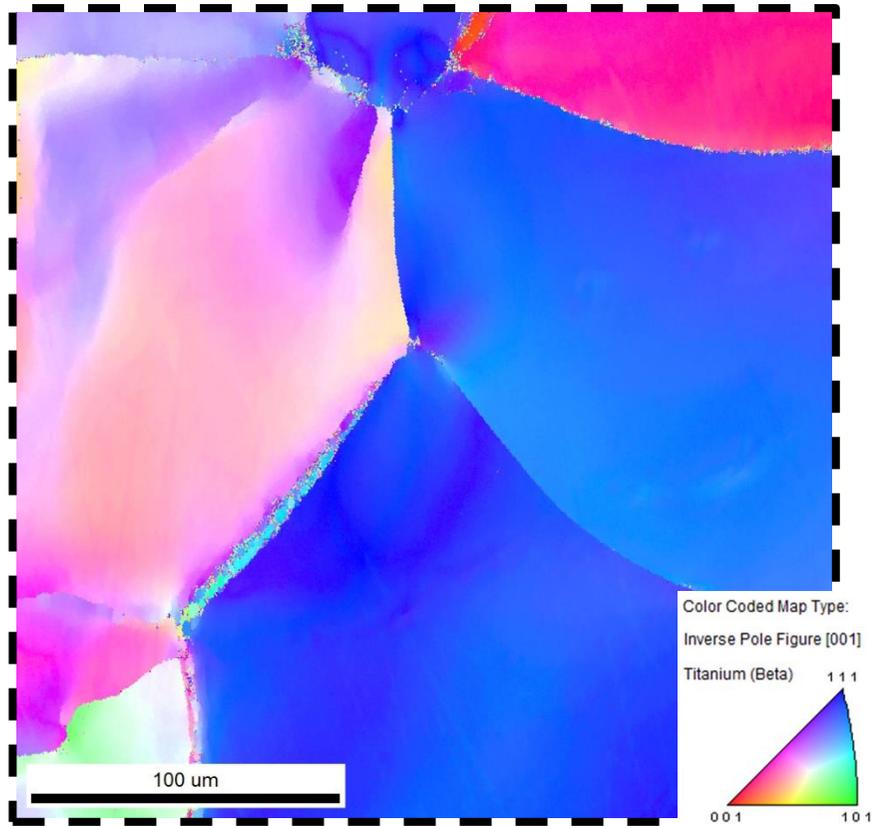
Figure 3.46 – IPF and Misorientation map for 36-hour WDE Ti-15Mo sample, scanned with a 2x2 binning rate and a step size of 0.5 μm.

The results of a higher resolution scan of the “EBSD 3” region from Figure 3.45 are shown in Figure 3.46. The IPF and misorientation map show sub-grains and misorientation, particularly at grain boundaries, but these are common in the untested as-received Ti-15Mo.

In the advanced erosion crater in Figure 3.45 there is limited evidence of localised deformation such as twinning or slip at the sectioned crater surface. Figure 3.46 shows there is little subsurface deformation, apart from cracks which appear to originate from the surface such as in Figure 3.47. This is in-line with theory; that advanced erosion is mechanically driven – hydraulic penetration forcing cracks wider and driving crack growth. This occurs rapidly and leads to material loss before other mechanisms can begin to cause other microstructural deformation. The analysis of eroded surfaces in this level of detail, in particular with EBSD, has not been researched elsewhere.

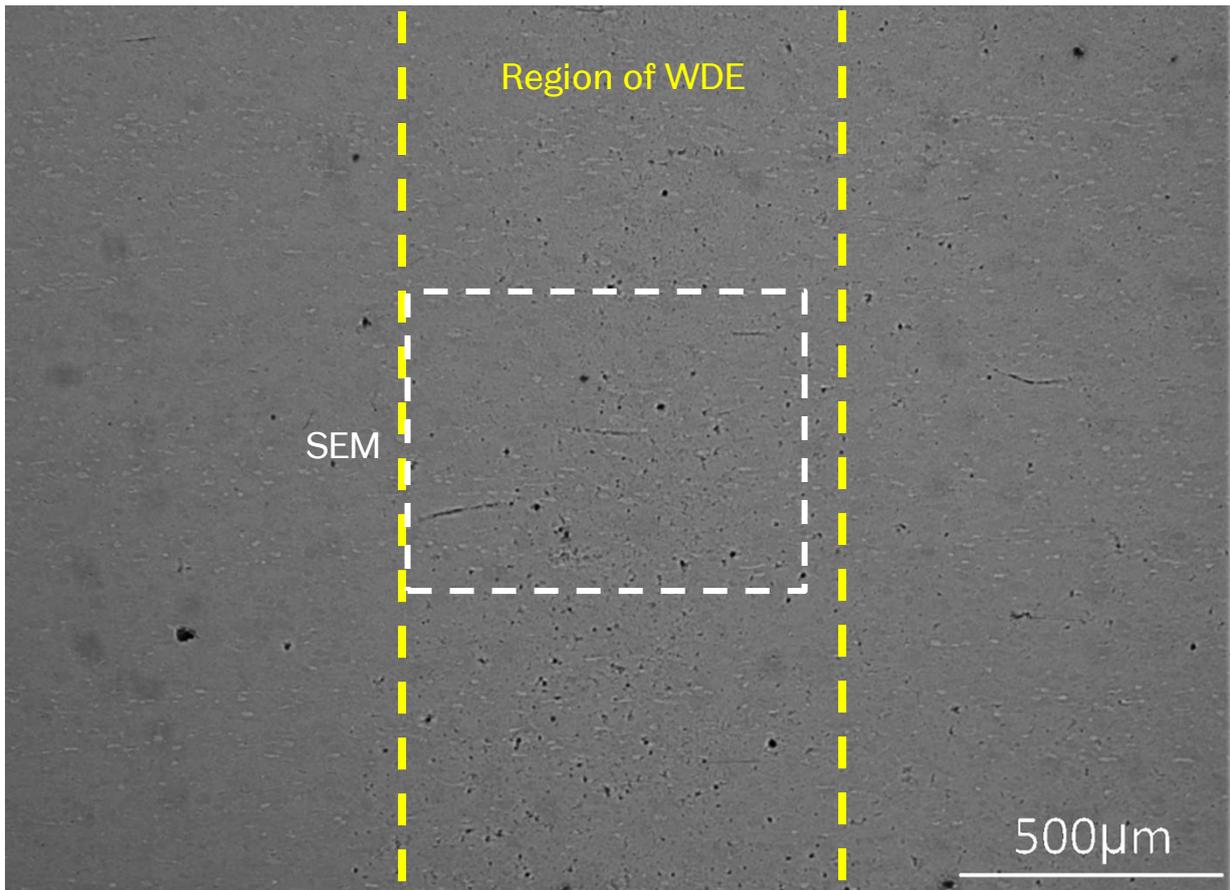
Figure 3.50 – Erosion wear scar in as-received Ti-6Al-4V RD following 10 s exposure to WDE.

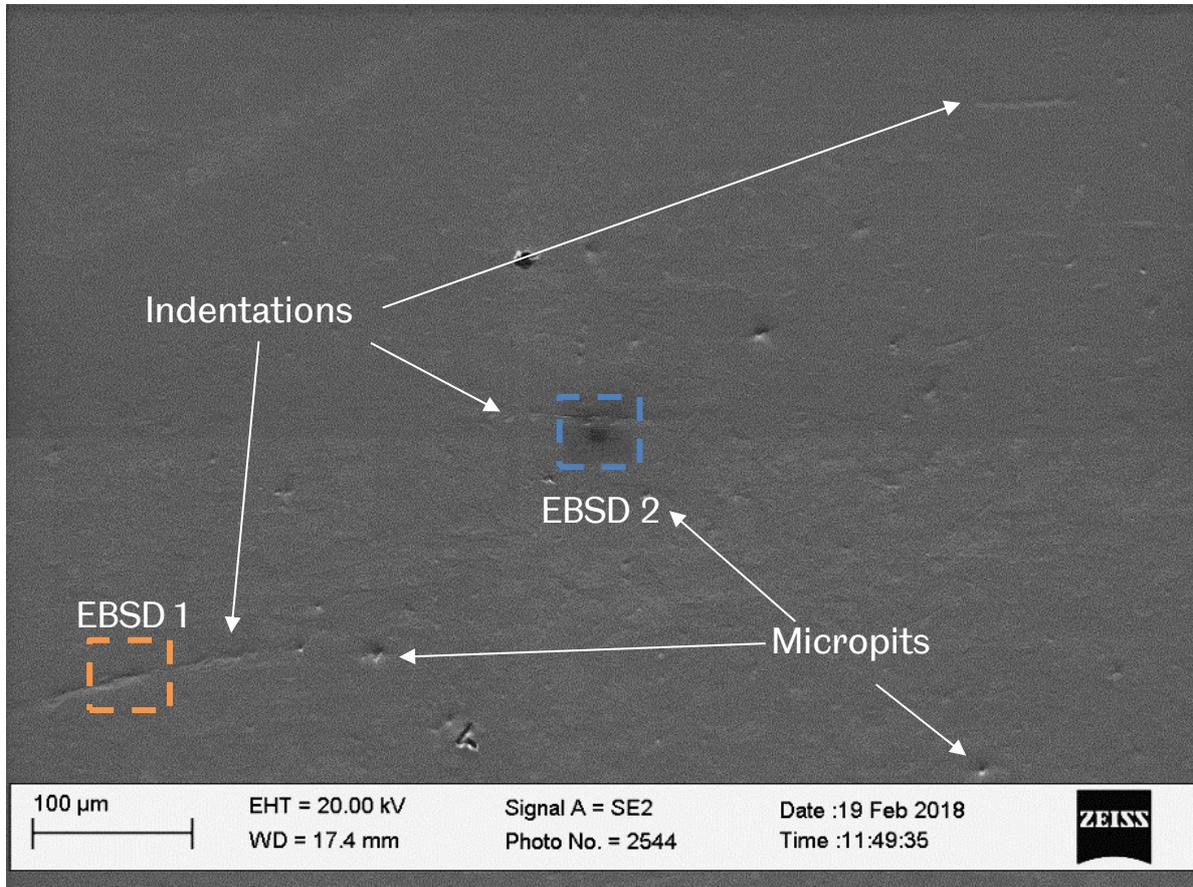
Figure 3.51 – SEM image of deformation features in erosion wear scar in as-received Ti-6Al-4V RD following 10 s exposure to WDE. .

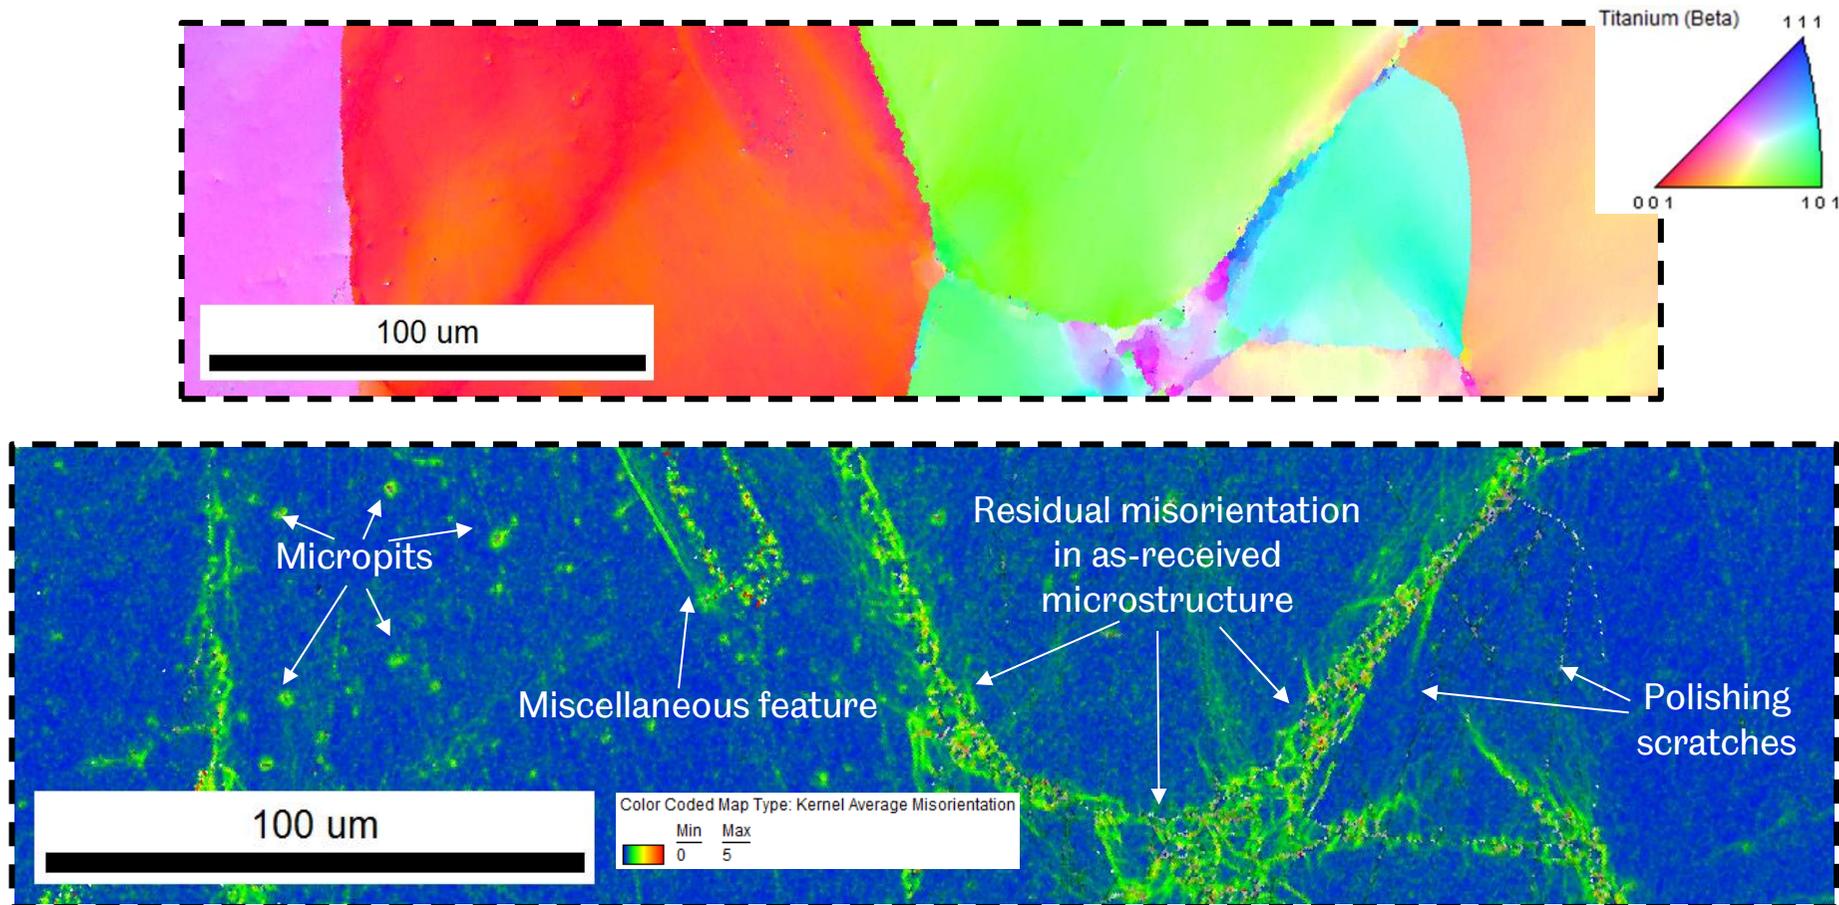
Figure 3.65 – Ti-15Mo TD after 5 minutes WDE. EBSD results with 2x2 binning rate, step size 0.5 μm. Top: IPF. Bottom: Misorientation map of the scan using Kernel Average 1st neighbour. Overlaid on IQ map.

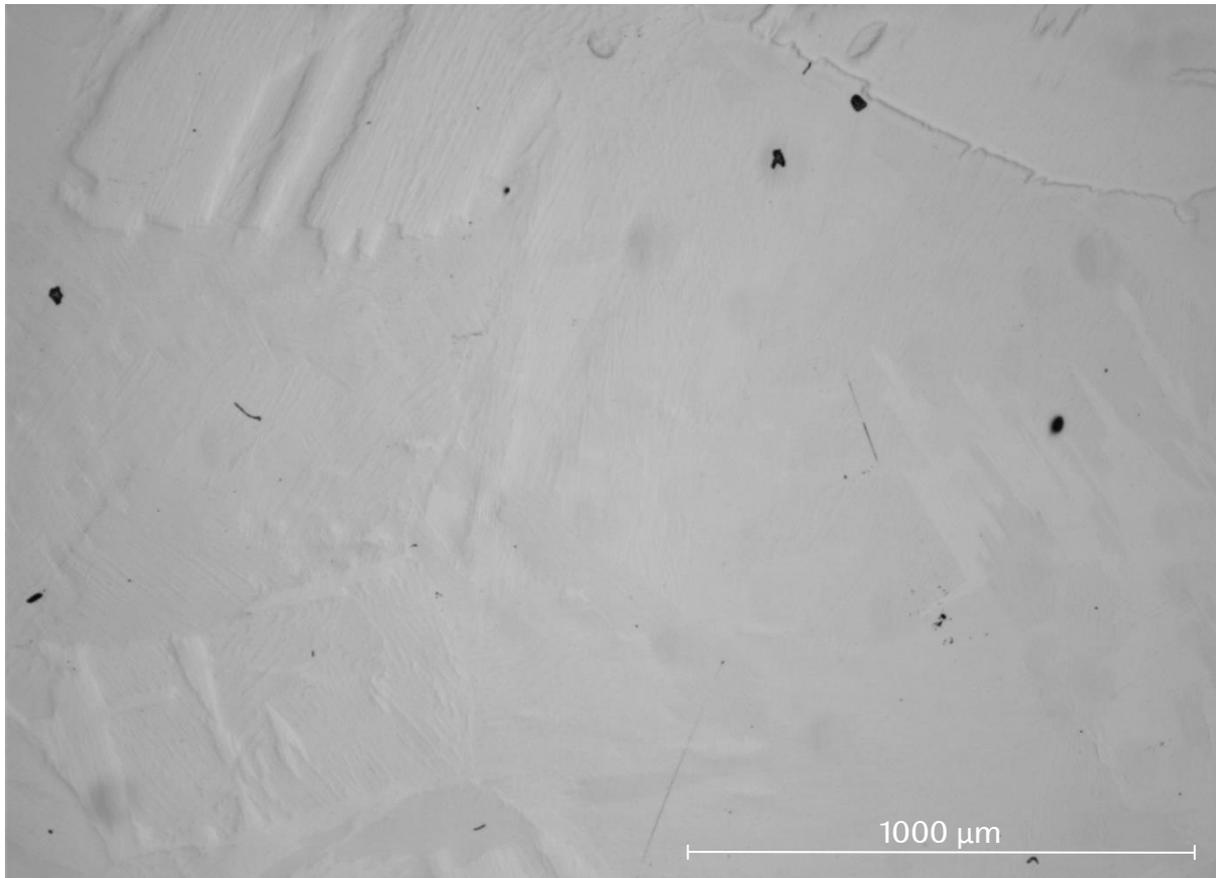
Figure 3.68 – Mid-section of coupon, 3 mm from edge nearest to nozzle. Annealed Ti-6Al-4V RD before WDE testing.

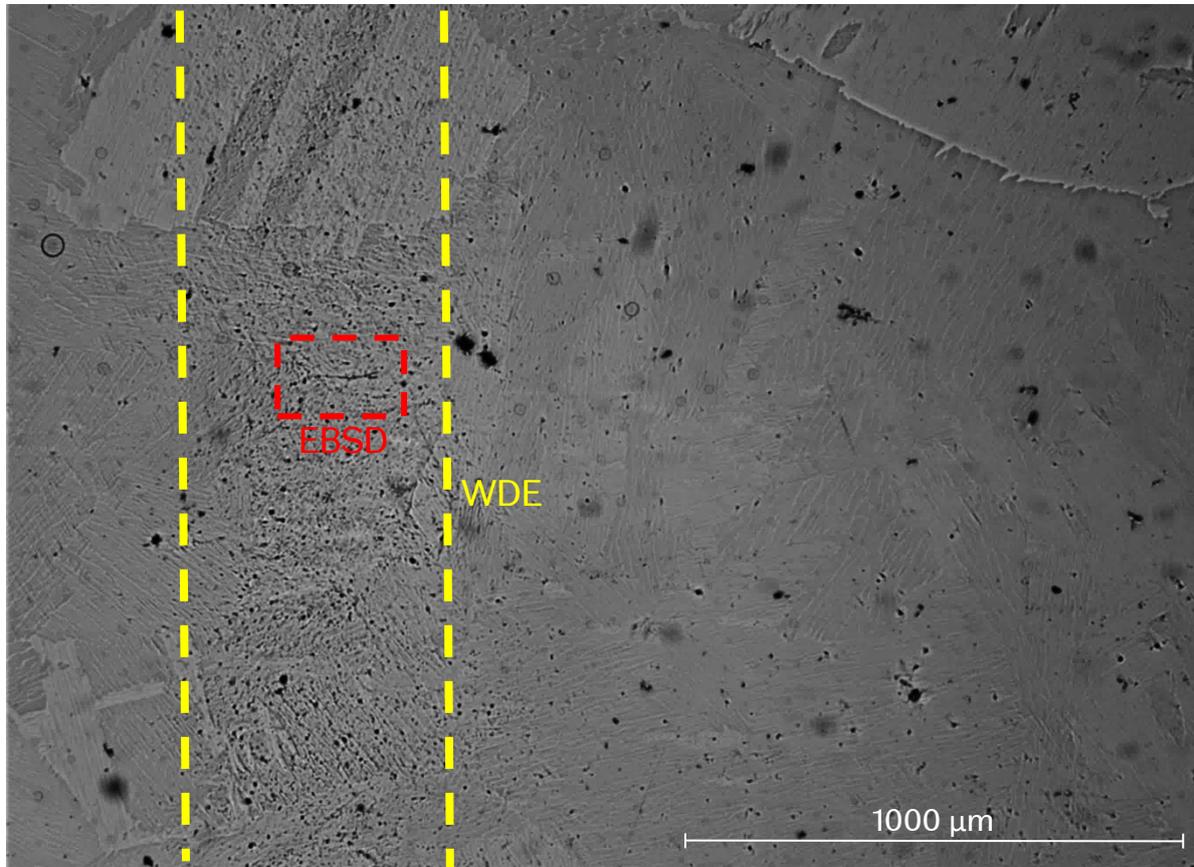
Figure 3.69 – Mid-section of coupon, 3 mm from edge nearest to nozzle. Annealed Ti-6Al-4V RD after 5 minutes WDE testing. Light microscope at low magnification. Scale bar is 1000 μm.

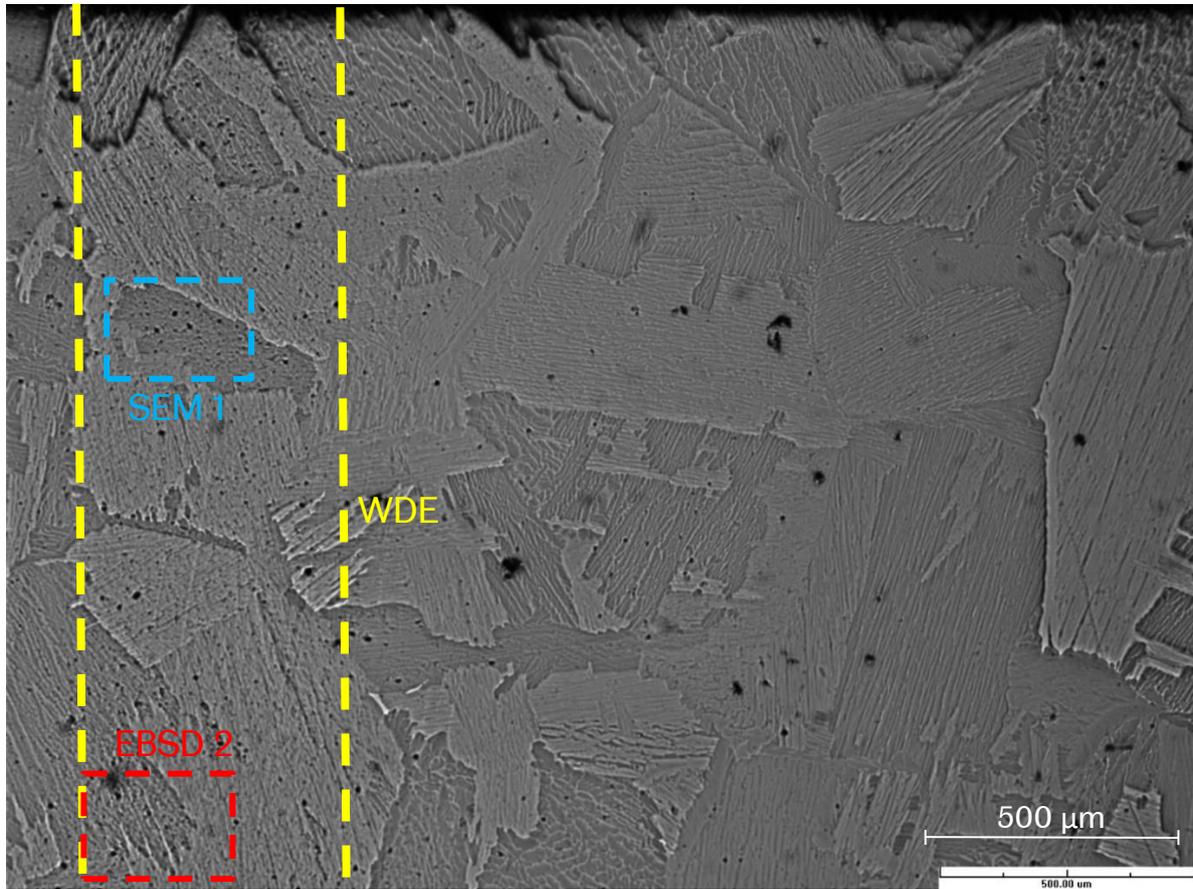
Figure 3.73 – Mid-section of coupon, edge nearest to nozzle. Annealed Ti-6Al-4V RD 10 minutes after WDE testing.

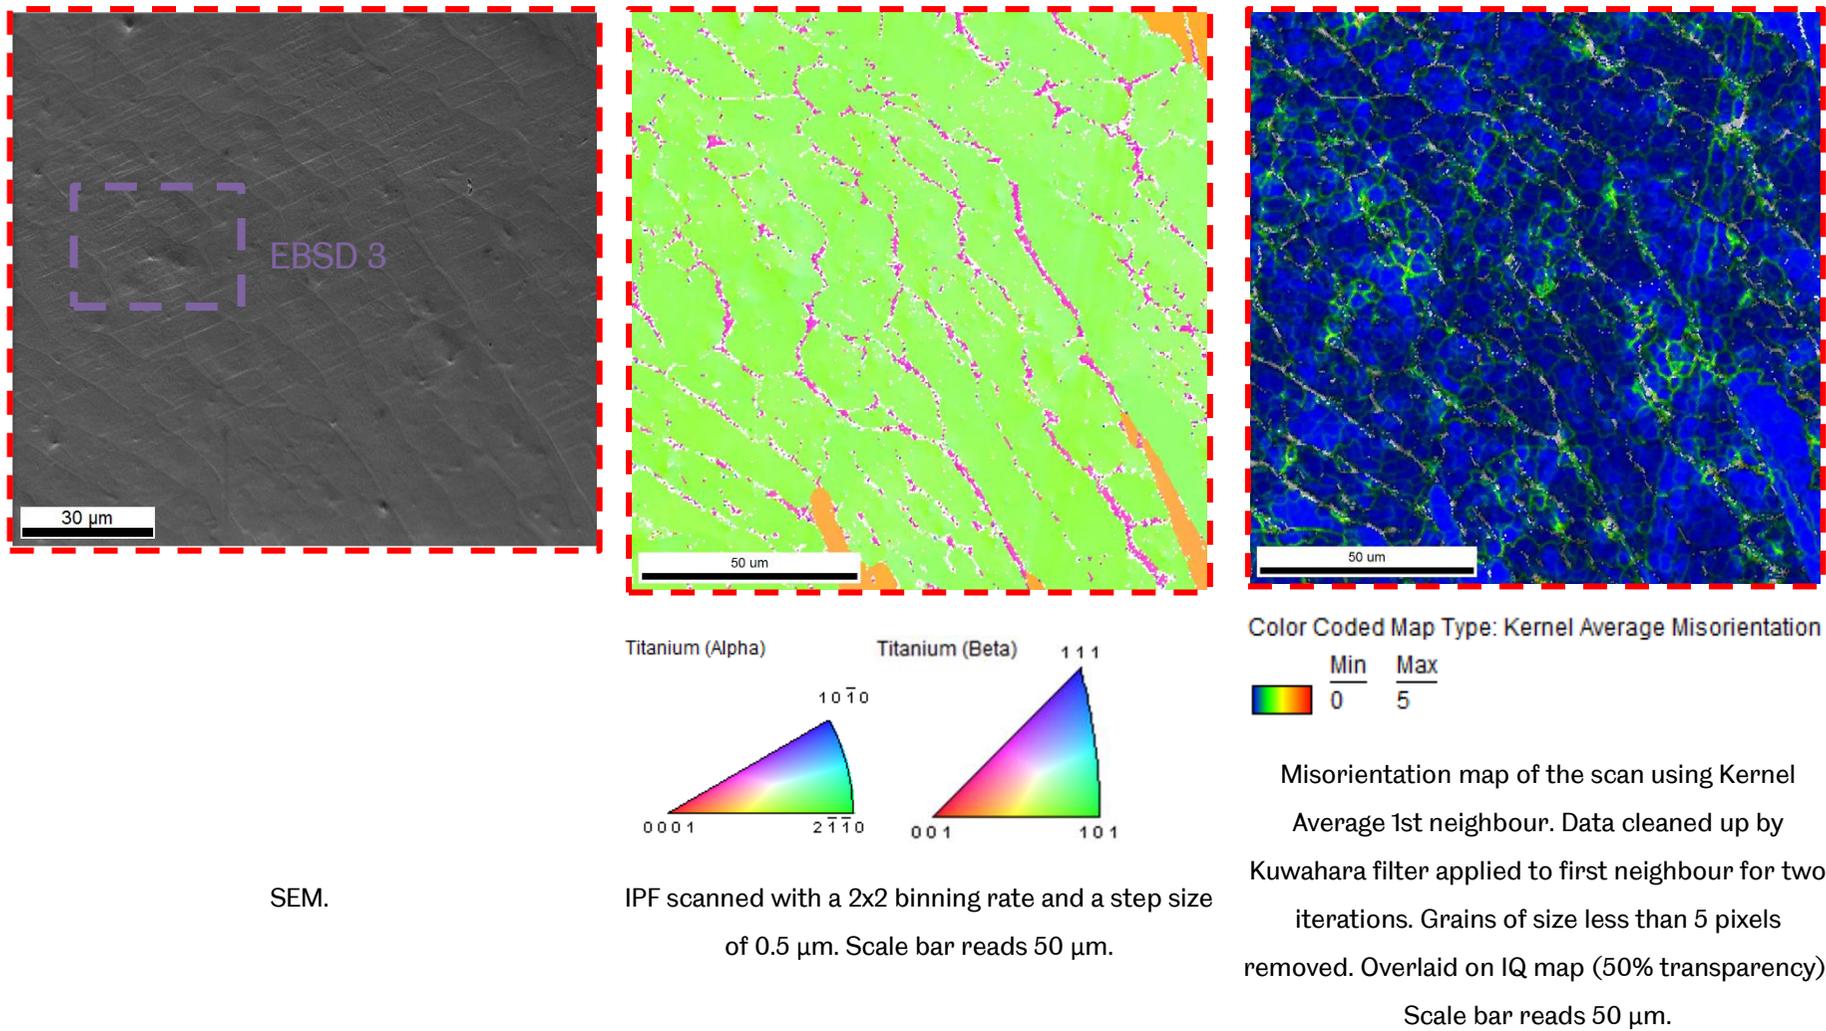
Figure 3.76 – SEM & EBSD images from “EBSD 2” region of Figure 3.73. Approximately 2.5 mm from the edge of the coupon. Annealed Ti-6Al-4V RD 10 minutes after WDE testing.

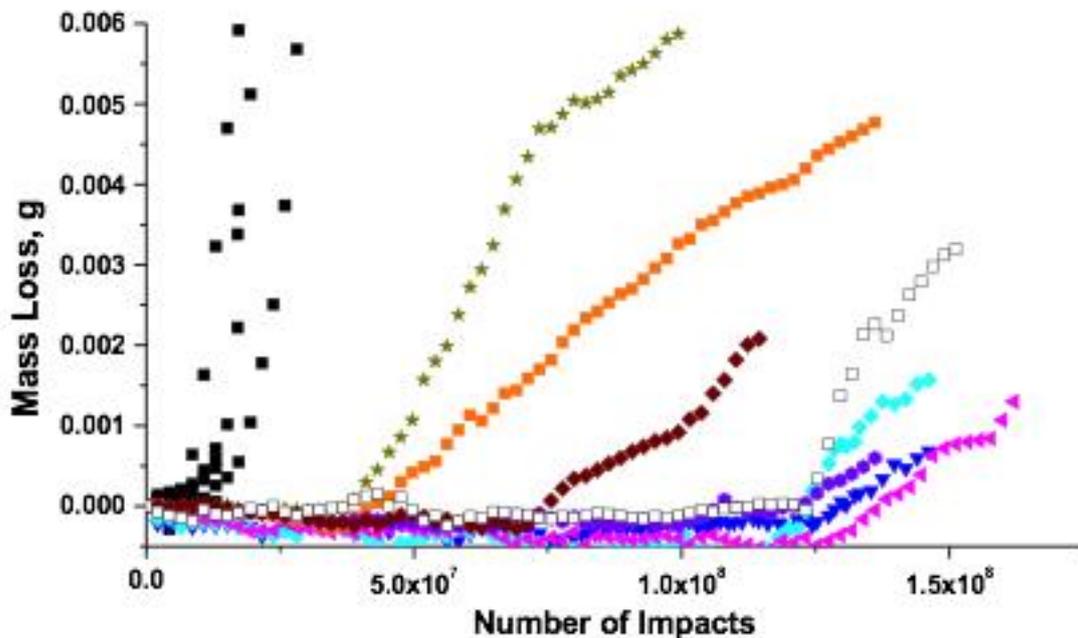
Figure 3.79 – Mass loss curves for various materials [77].

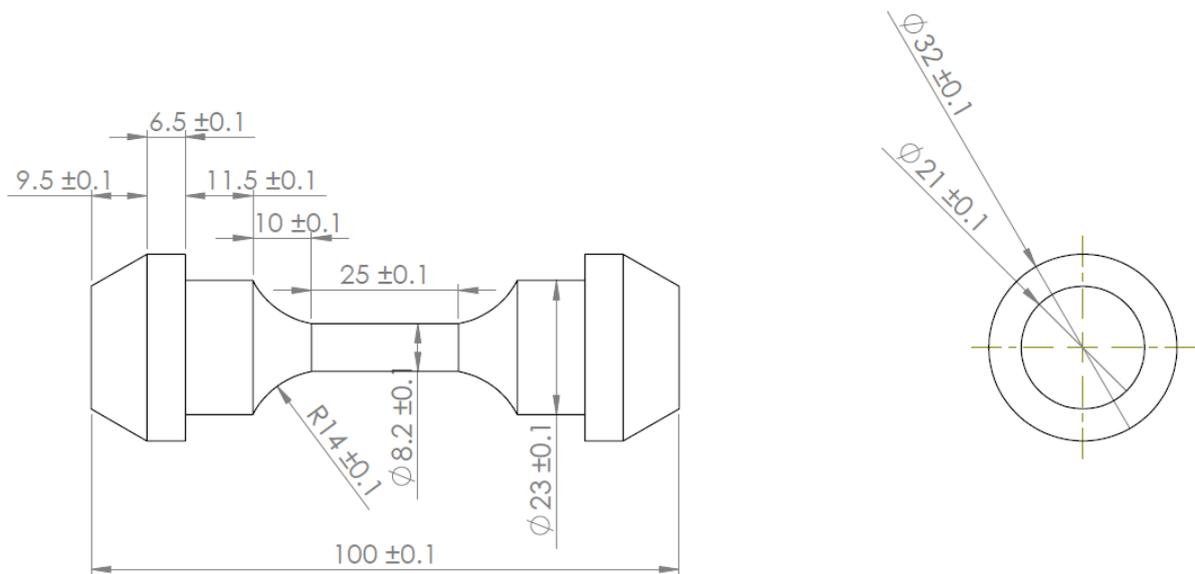
Figure 4.1 – Dimensions of the tensile test and low cycle fatigue test specimens (in mm).

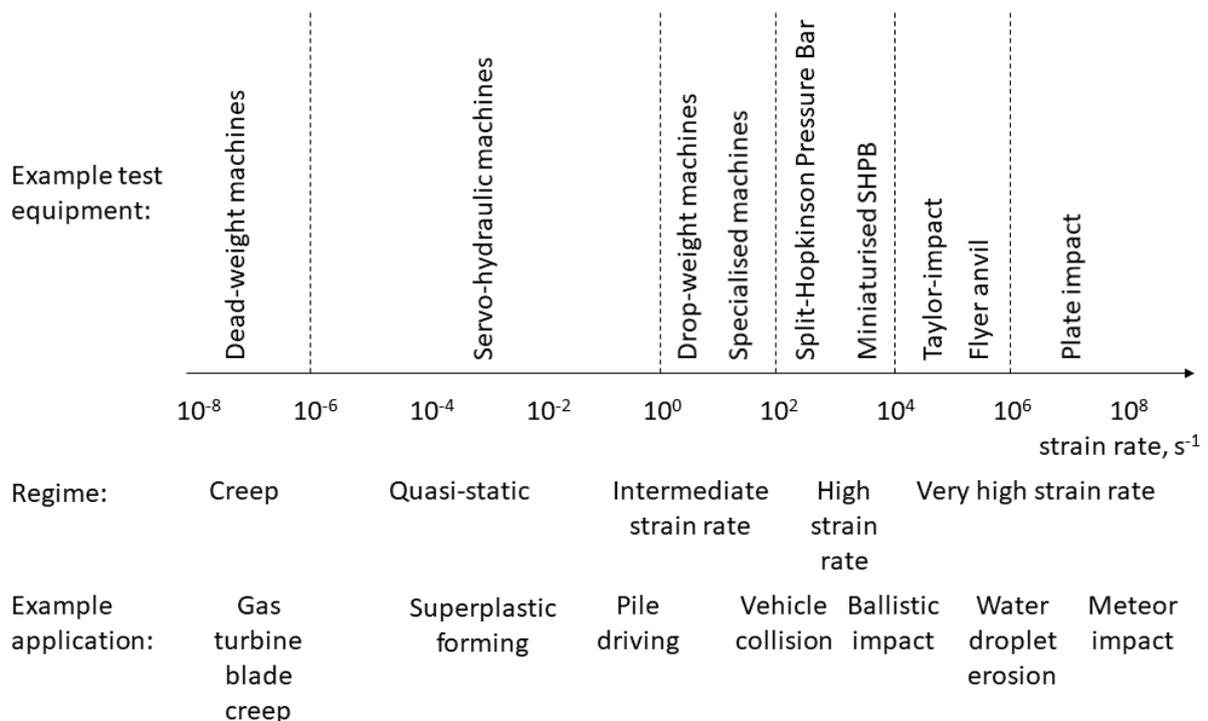
Figure 5.1 – Varying strain rate regimes, typical tests, and typical examples [83]–[85].

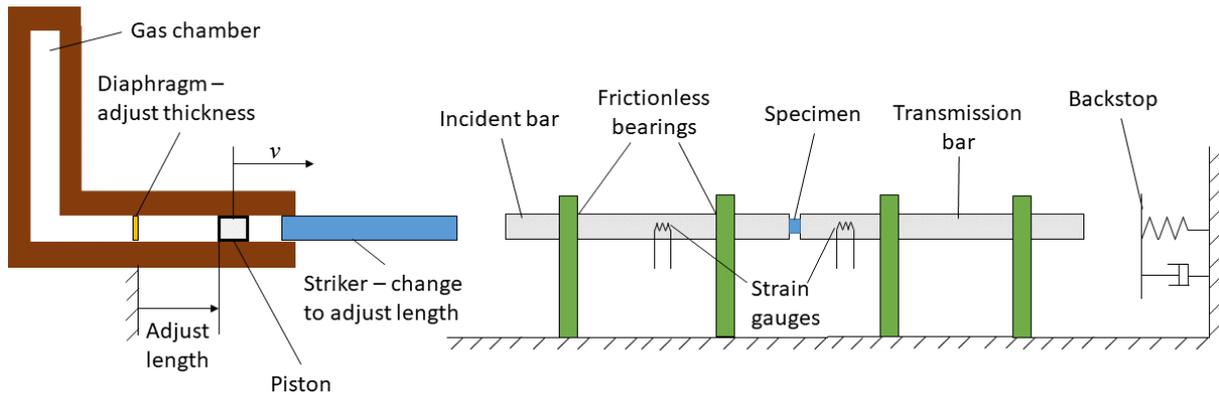
Figure 5.5 – Compressive Split Hopkinson Bar set-up.

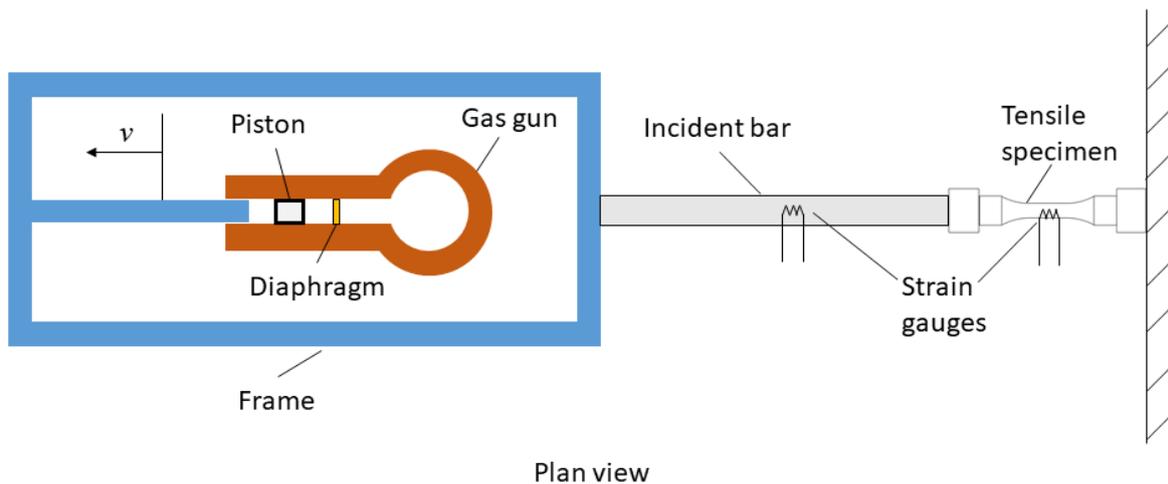
Figure 5.6 – Tensile SHPB set-up.

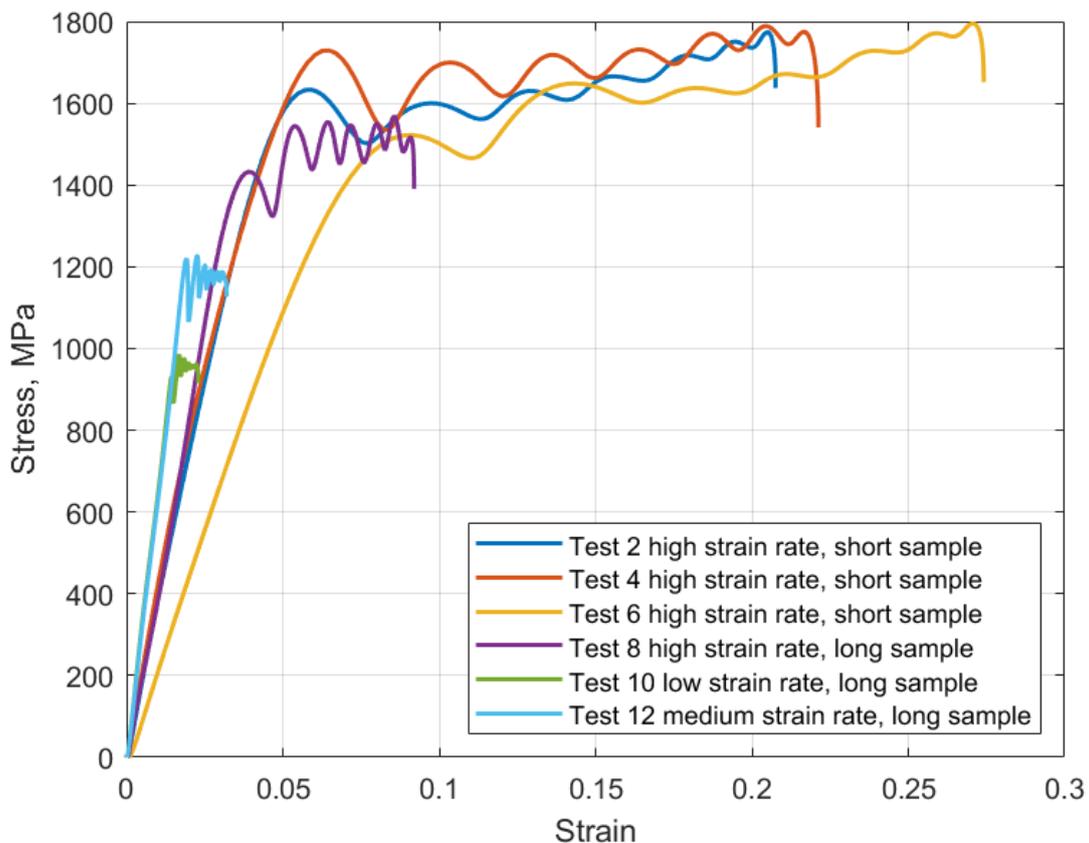
Figure 5.10 – Ti-15Mo samples tested at various strain rates.
