The
University
Of
Sheffield.

Department
Of
Mechanical
Engineering

Investigating Fundamental Processes in Erosive Wear of Titanium Alloys by Water Droplets

Thesis submitted to The University of Sheffield for the degree of
Doctor of Philosophy

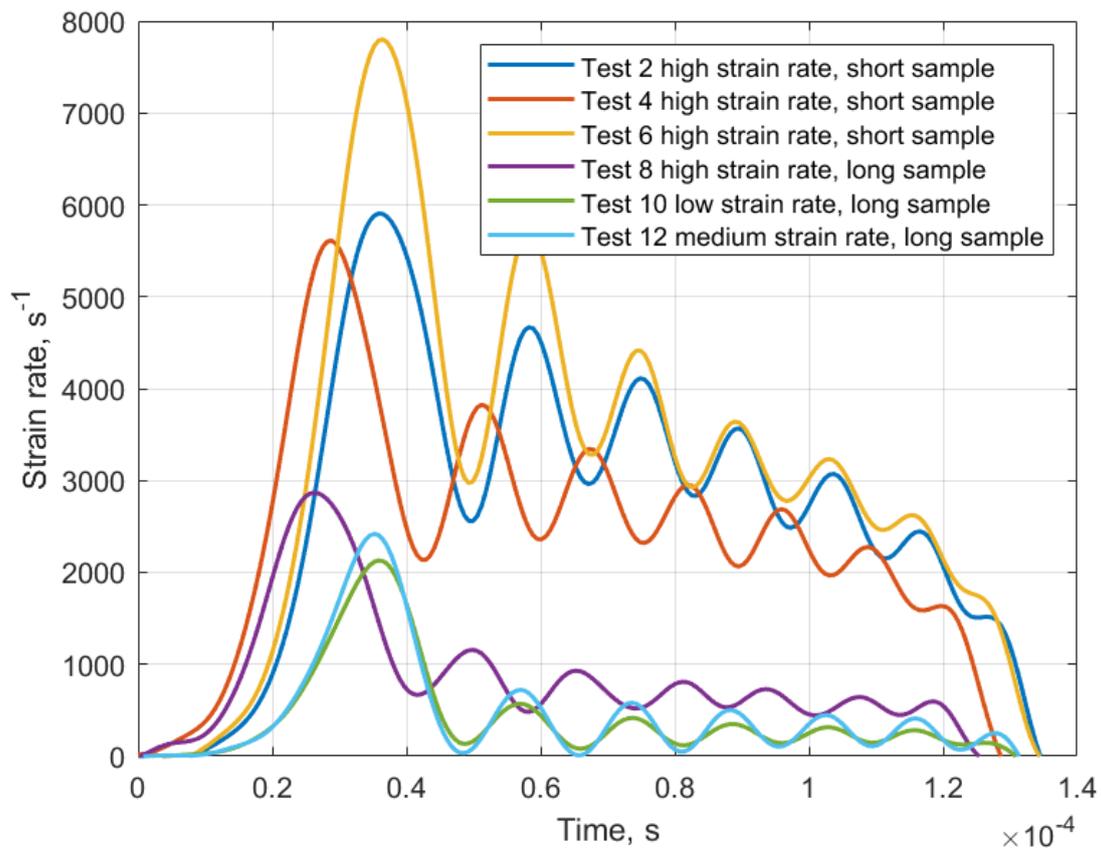
Figure 5.11 – Strain rate with time for the Ti-15Mo samples.

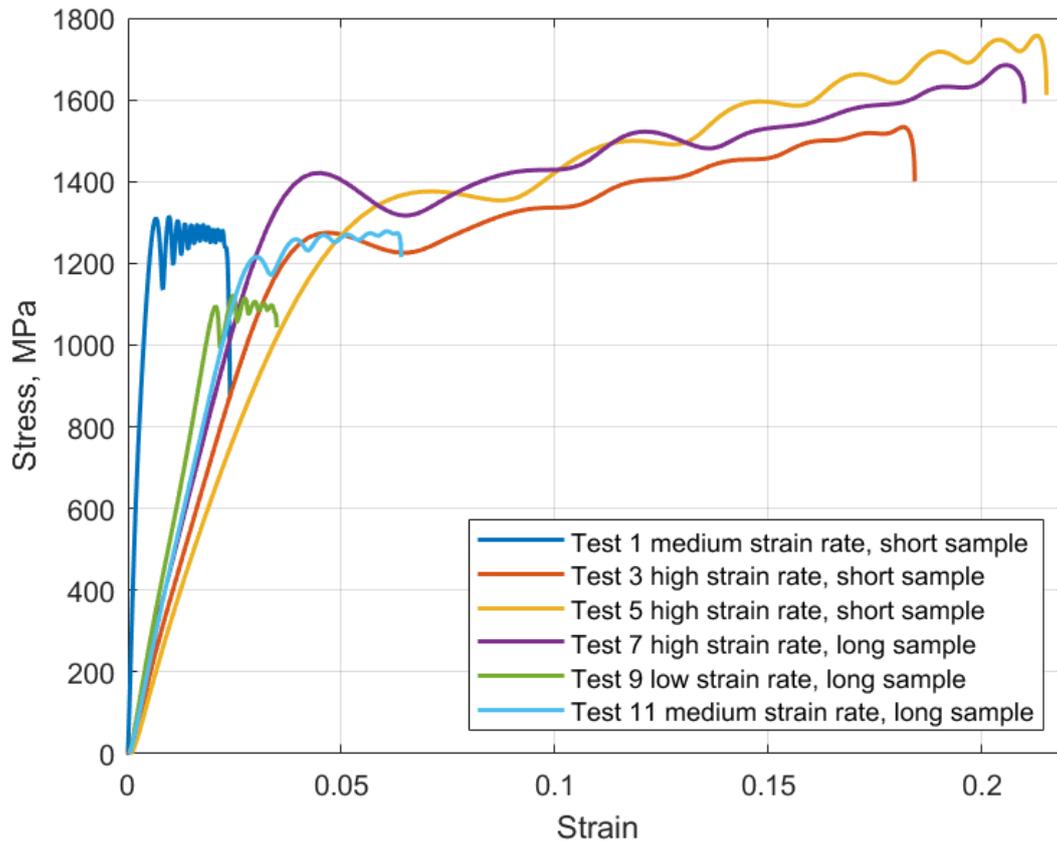
Figure 5.12 – Annealed Ti-6Al-4V samples tested at various strain rates.

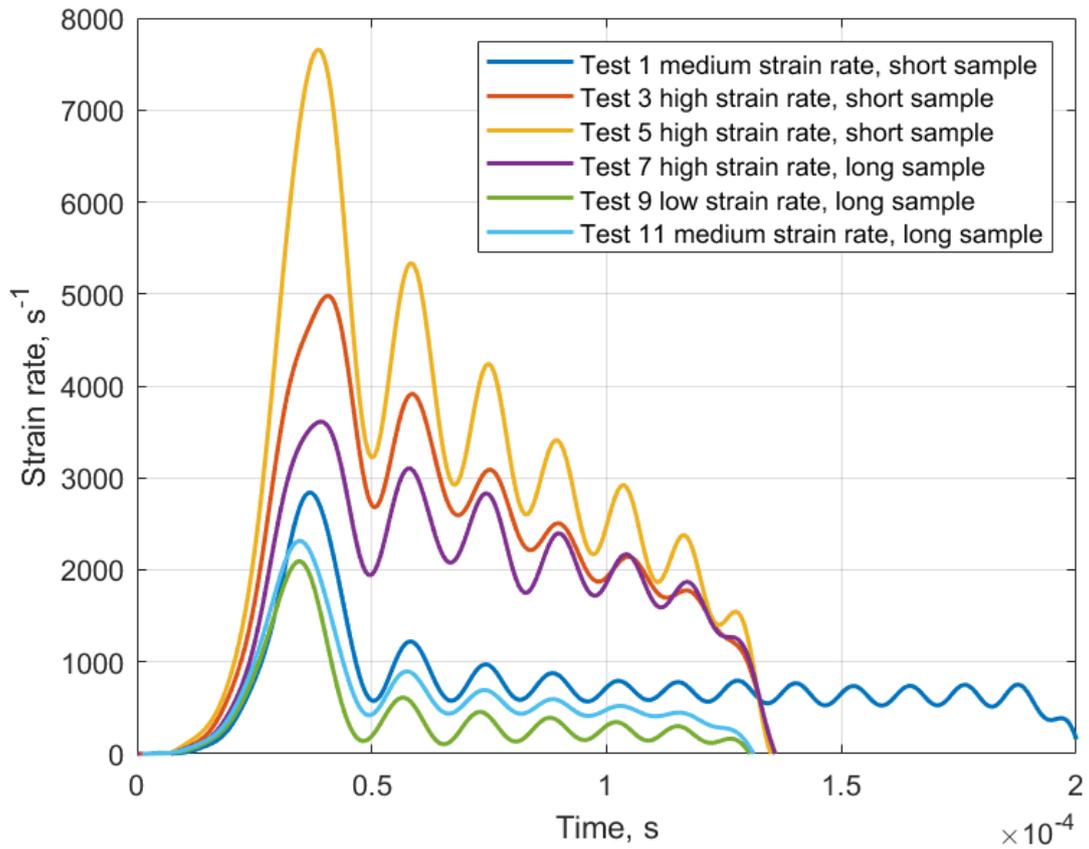
Figure 5.13 – Strain rate with time for the annealed Ti-6Al-4V samples.

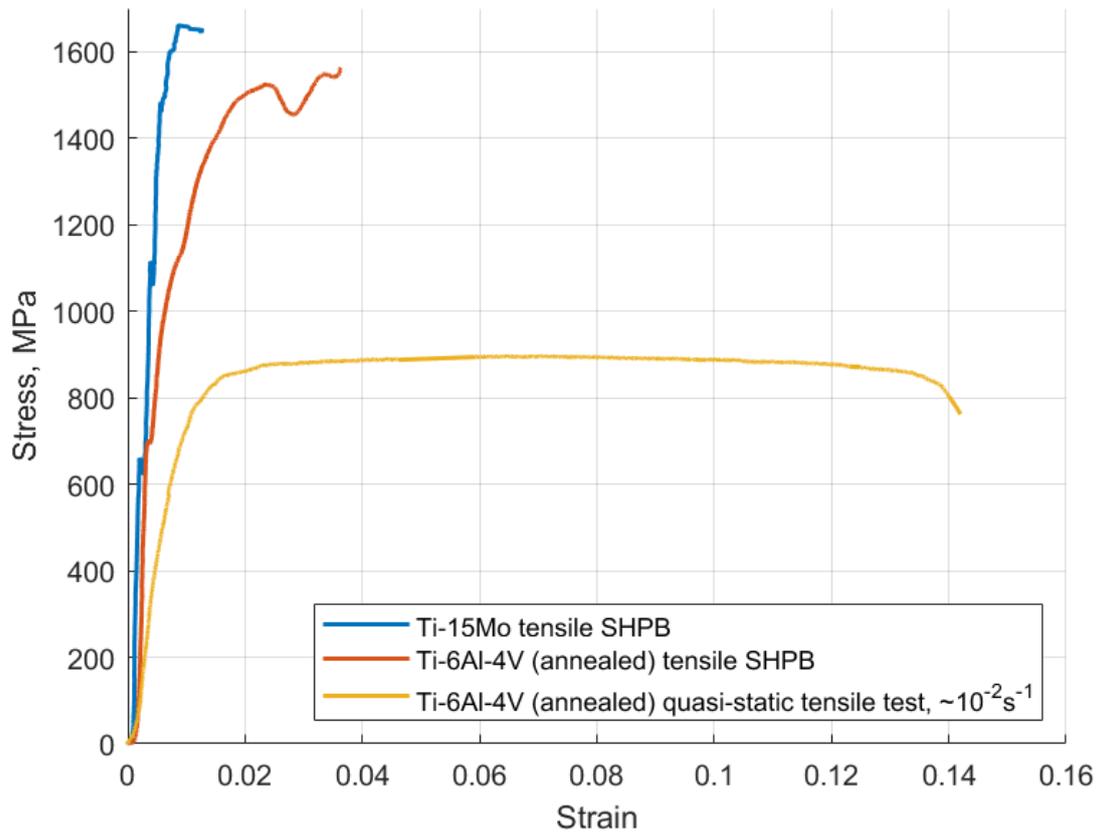
Figure 5.14 – Annealed Ti-6Al-4V and Ti-15Mo tested in tensile Split Hopkinson Pressure Bar. The result of the quasi-static tensile test is also included for comparison.

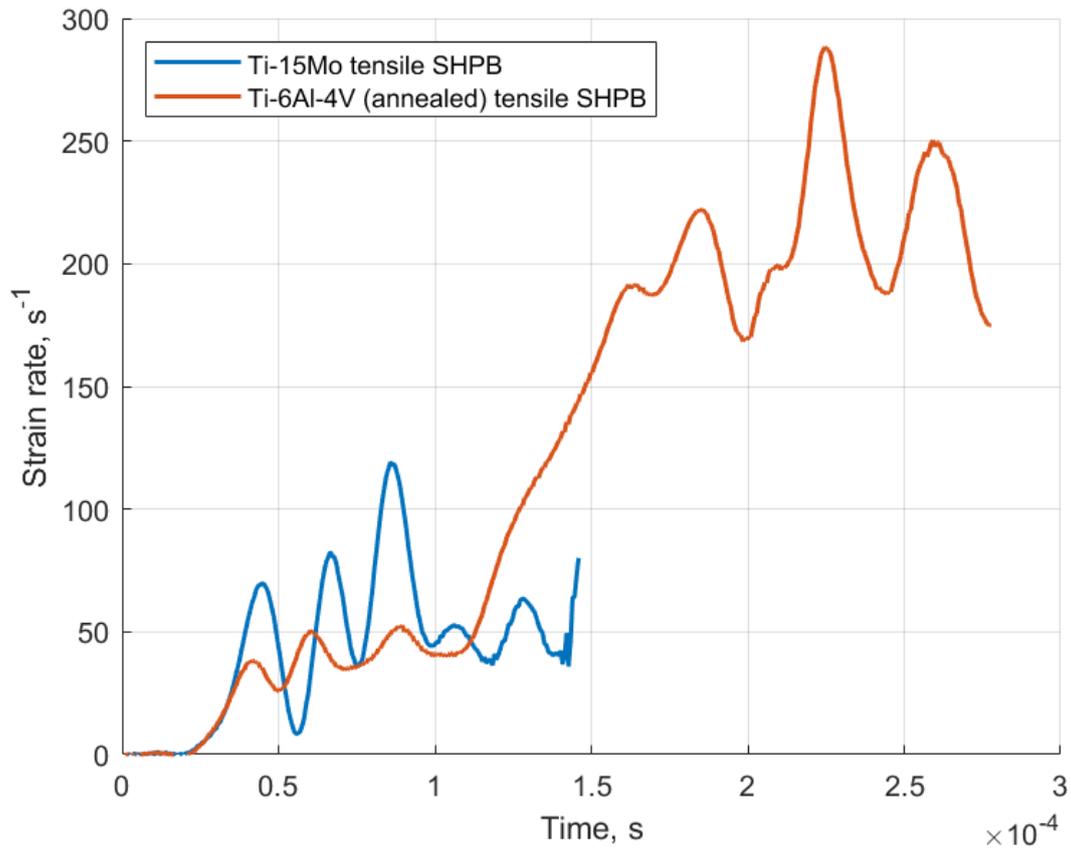
Figure 5.15 – Strain rate with time for the Ti-15Mo and annealed Ti-6Al-4V tensile SHPB tests.

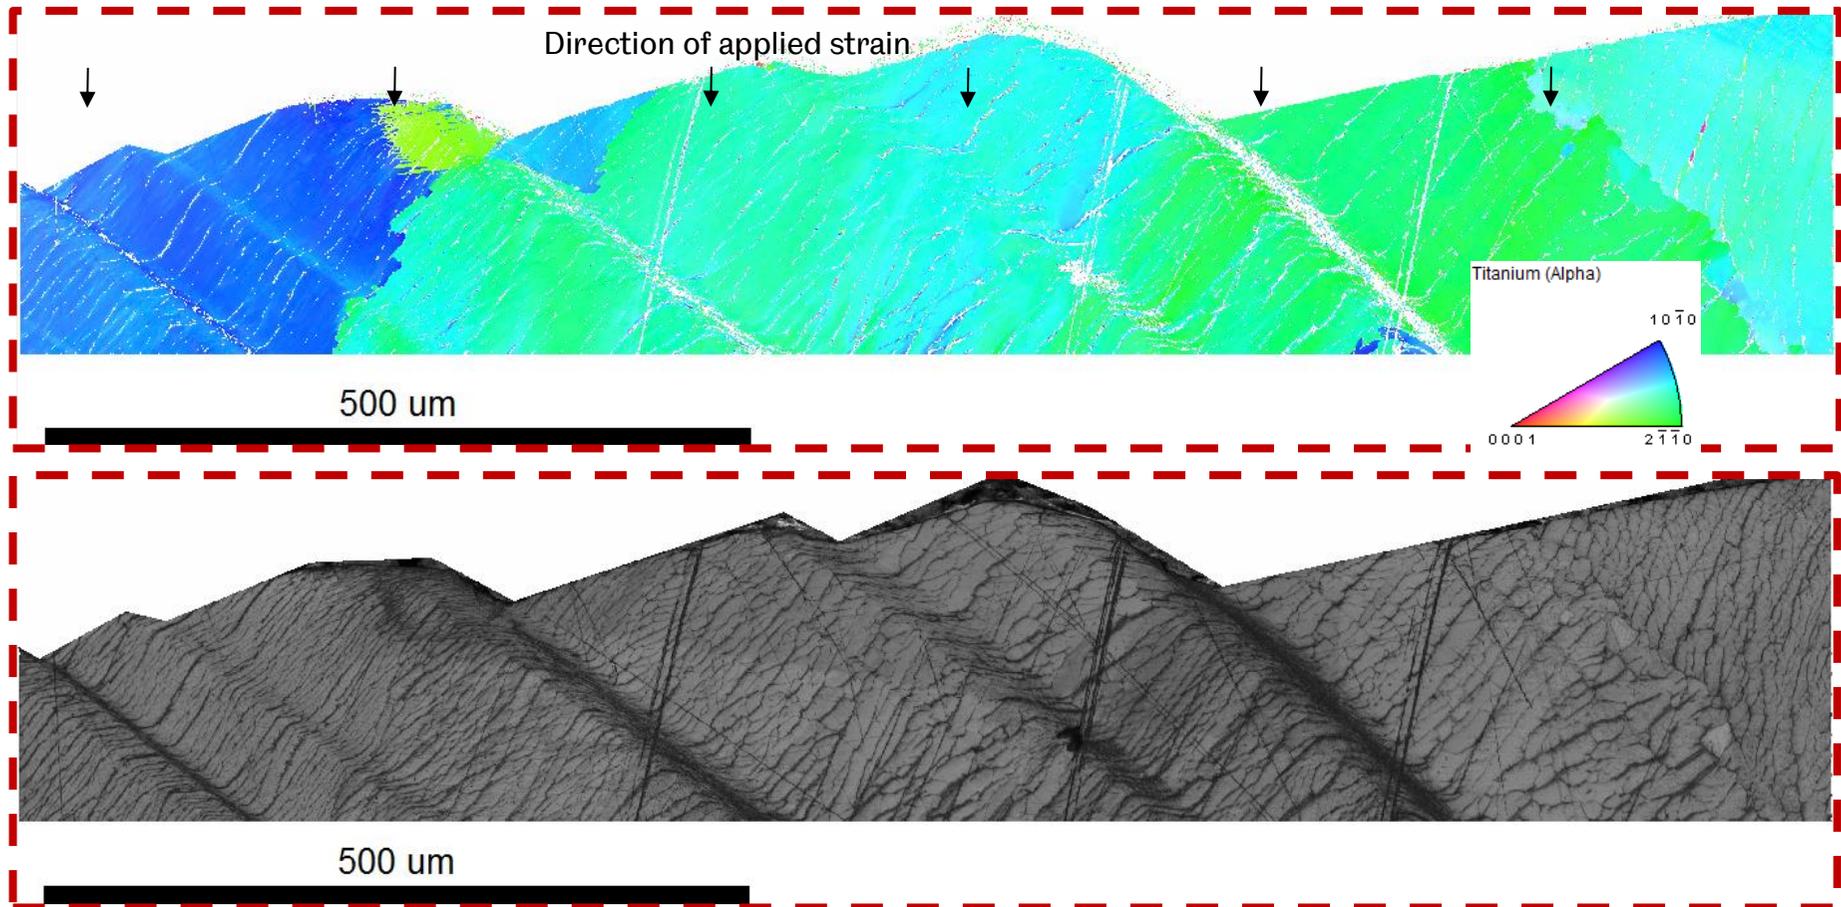
Figure 5.22 – IPF and IQ maps of “front” face of test number 5. Annealed Ti-6Al-4V tested at a peak strain rate of 7700 s^{-1} . Scanned with a 2×2 binning rate and a step size of 0.5 μm . Grains of less than 2 pixels size removed from the IPF.

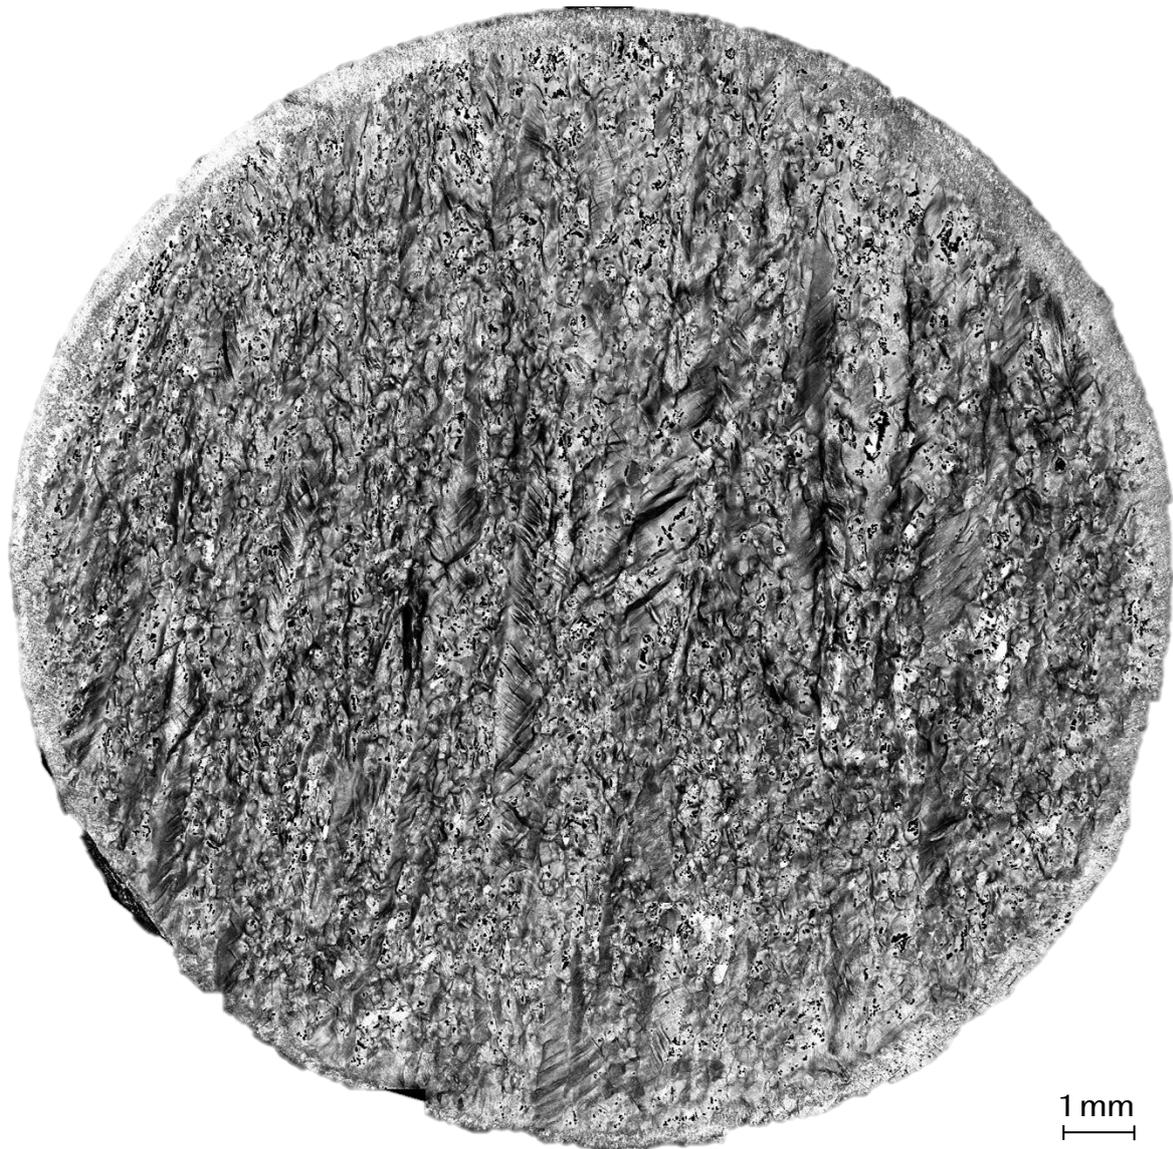
Figure 5.28 – Alicona image of side 1 of test number 6. As-received Ti-15Mo tested a peak strain rate of 7800 s^{-1} . Peak strain 27 %. Peak stress 1800 MPa.

Confocal microscopy was also used to characterise the surface. Figure 5.28 shows side 1, which appeared to be the more deformed side.

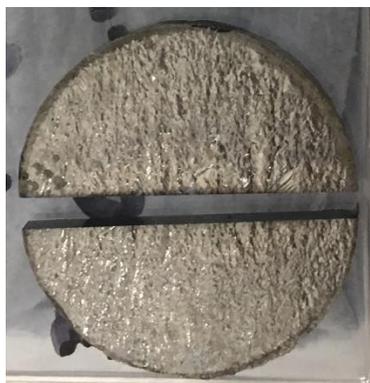
Figure 5.29 – Photographs & SEM images of test number 6 sectioned. As-received Ti-15Mo tested at a peak strain rate of 7800 s^{-1} .

The sample was sectioned in two, mounted and polished for EBSD analysis. This is illustrated in Figure 5.29. SEM images in Figure 5.29 also show where EBSD analysis was conducted.

Side 1 face. Sample sectioned across predominant lines of macrozones.

Figure 5.30 shows the IPF maps generated from EBSD scans in the regions highlighted in Figure 5.29. The large macrozones already exist in the untested alloy. However there appear to be new features in some grains which may be twins, so this region (outlined in Figure 5.30) was investigated further with a higher resolution EBSD scan.

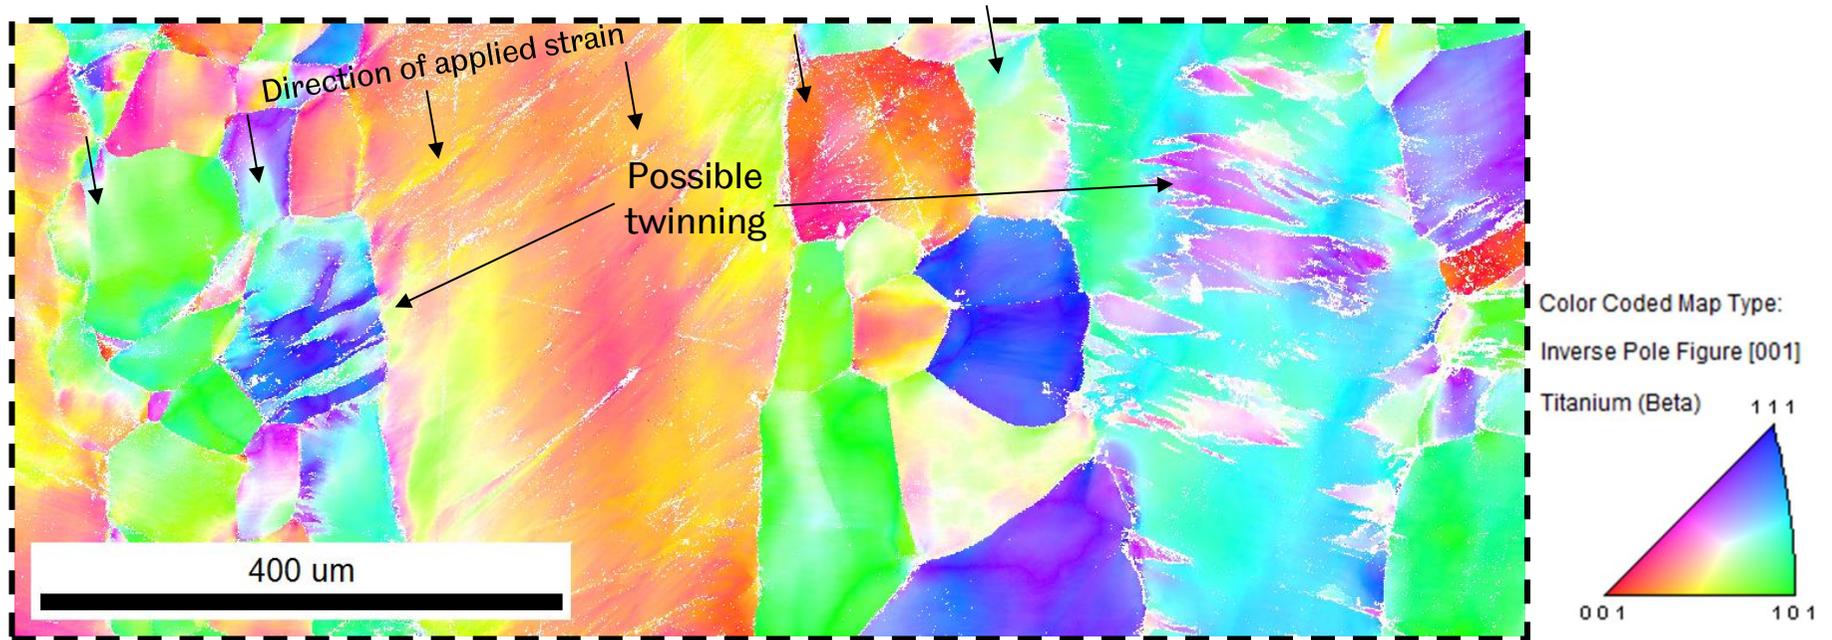
Figure 5.31 – IPF scanned with a 2x2 binning rate, step size 0.7 μm. Pixels of less than 0.1 confidence index removed. Test number 6 - as-received Ti-15Mo tested at a peak strain rate of 7800 s⁻¹.

Figure 5.31 is the resulting IPF from a smaller step size scan of the area highlighted in Figure 5.30. It shows what appears to be twinning.

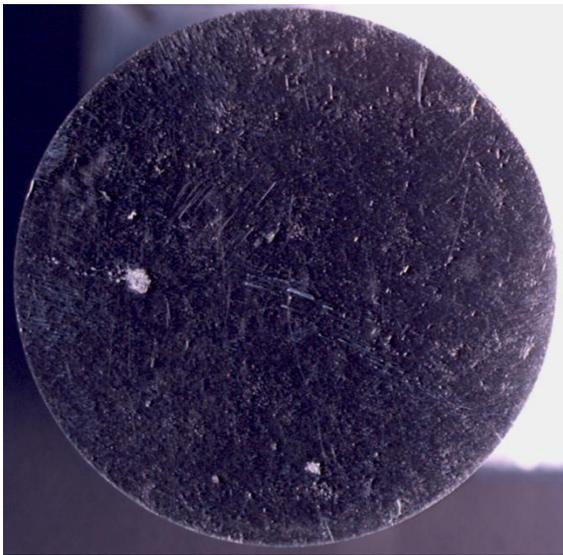
Figure 5.34 – Photographs of test number 10. As-received Ti-15Mo tested at a peak strain rate of 2000 s^{-1} . Peak strain 2.5 %. Peak stress 1000 MPa.

Photographs of the incident face of test 10 are shown in Figure 5.34 below, a 5 mm length Ti-15Mo sample, tested at the lowest achievable strain rate. There is an indentation in a ring shape on this specimen which is visible when the light source is at a slight angle to the specimen. The ‘long’ (5 mm) sample experienced a lower strain rate than ‘short’ (2.5 mm) specimens. The test was also set up to produce the lowest strain rate possible with the available test equipment. The lower strain rate resulted in less visible deformation, so the ring features are more obvious in the lower strain rate tests.

Front face.

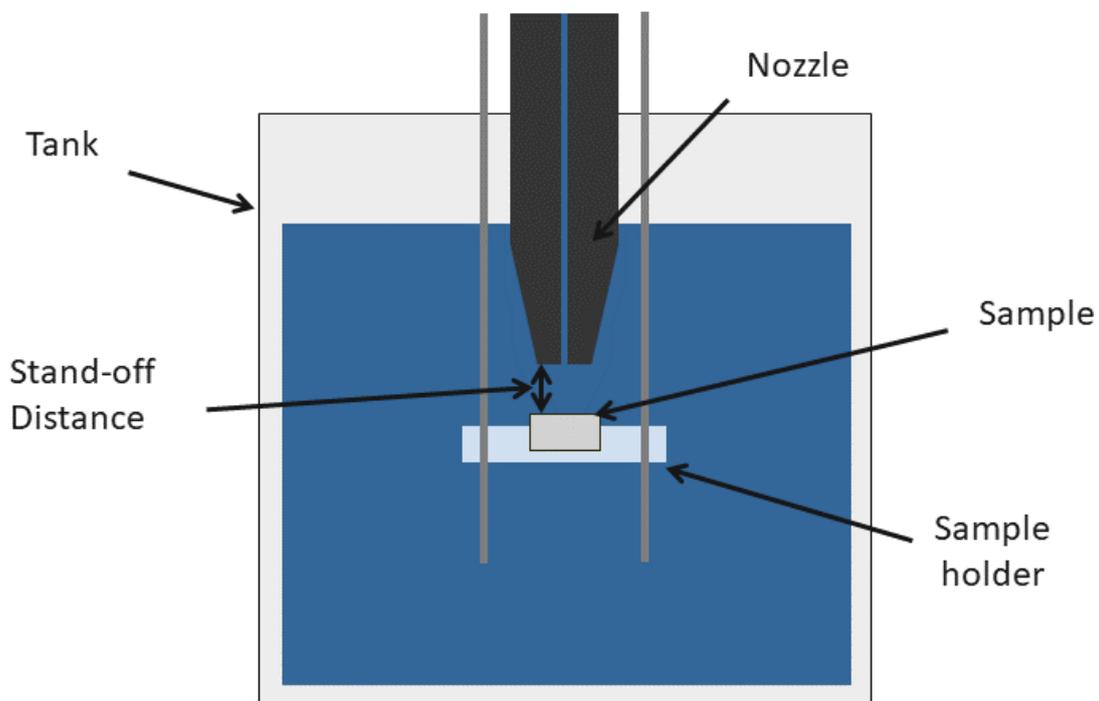
Figure 6.1 – Schematic of the submerged impingement jet (SIJ) rig.

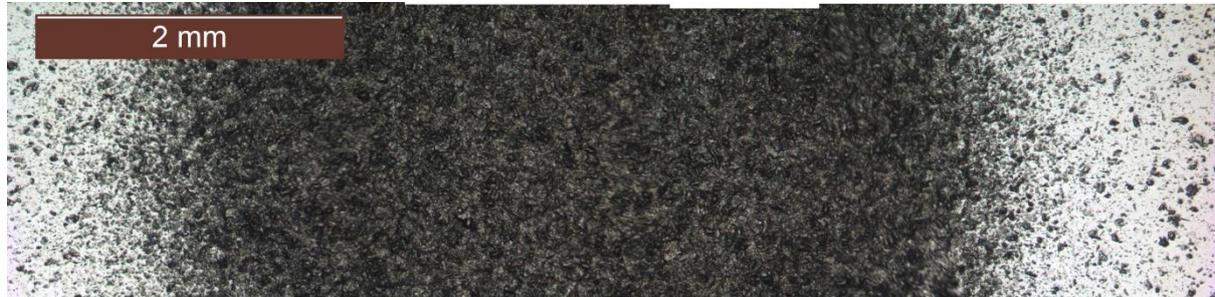
Figure 6.2 – Light microscope images stitched together of a stainless steel sample after 30 min in SIJ rig.

The effectiveness of the SIJ rig was initially checked with a stainless steel sample. The sample was prepared for testing by metallographic polishing. Figure 6.2 shows part of the circular wear scar resulting from a 30 minute test, imaged by a light microscope. There was no measurable difference in mass loss when using the laboratory's $\pm 10^{-5}$ g precision mass balance.

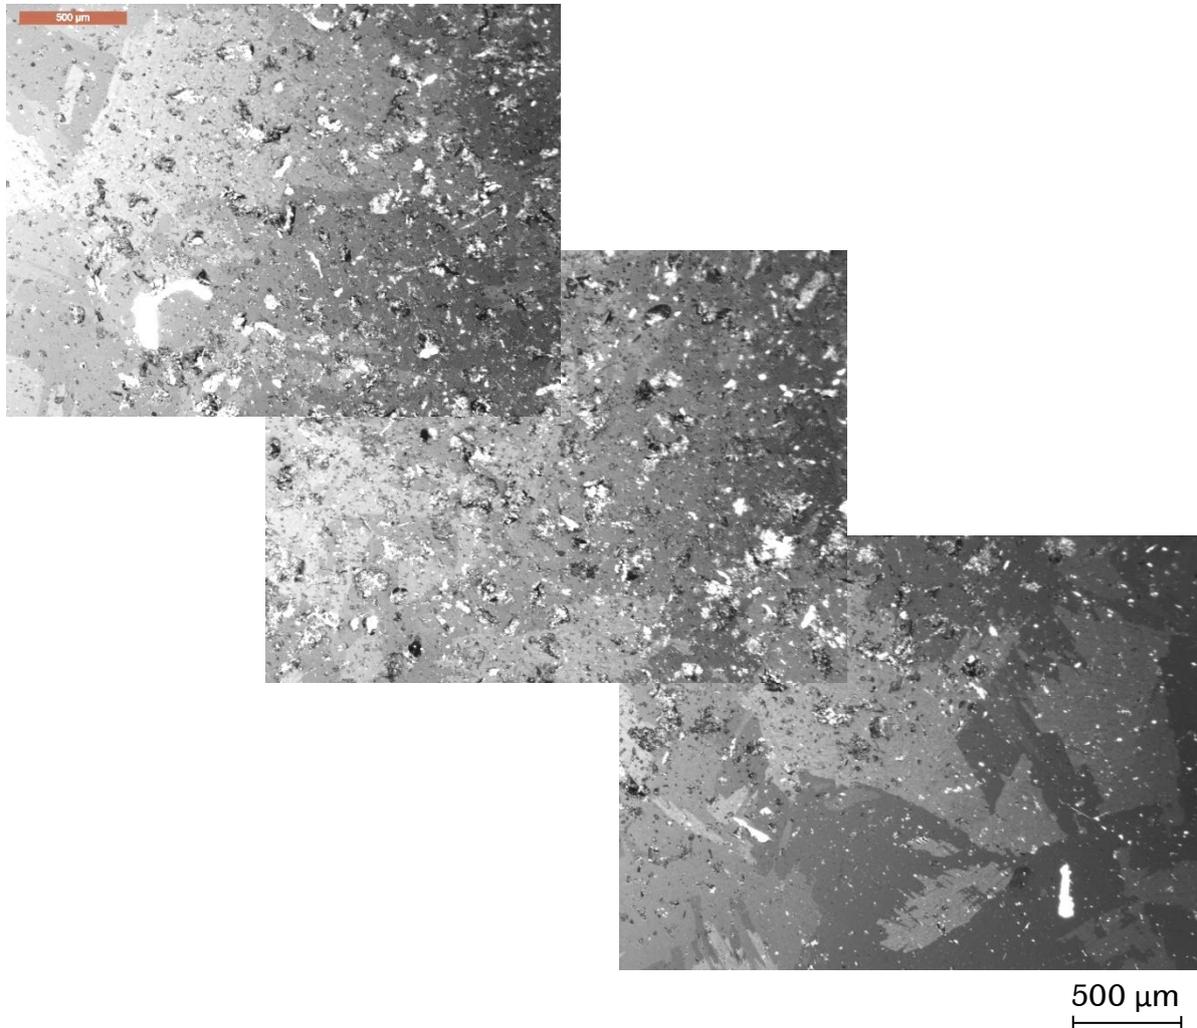
Figure 6.3 – Annealed Ti-6Al-4V after 10 minutes in SIJ rig. Wear scar is approximately 4 mm in diameter.

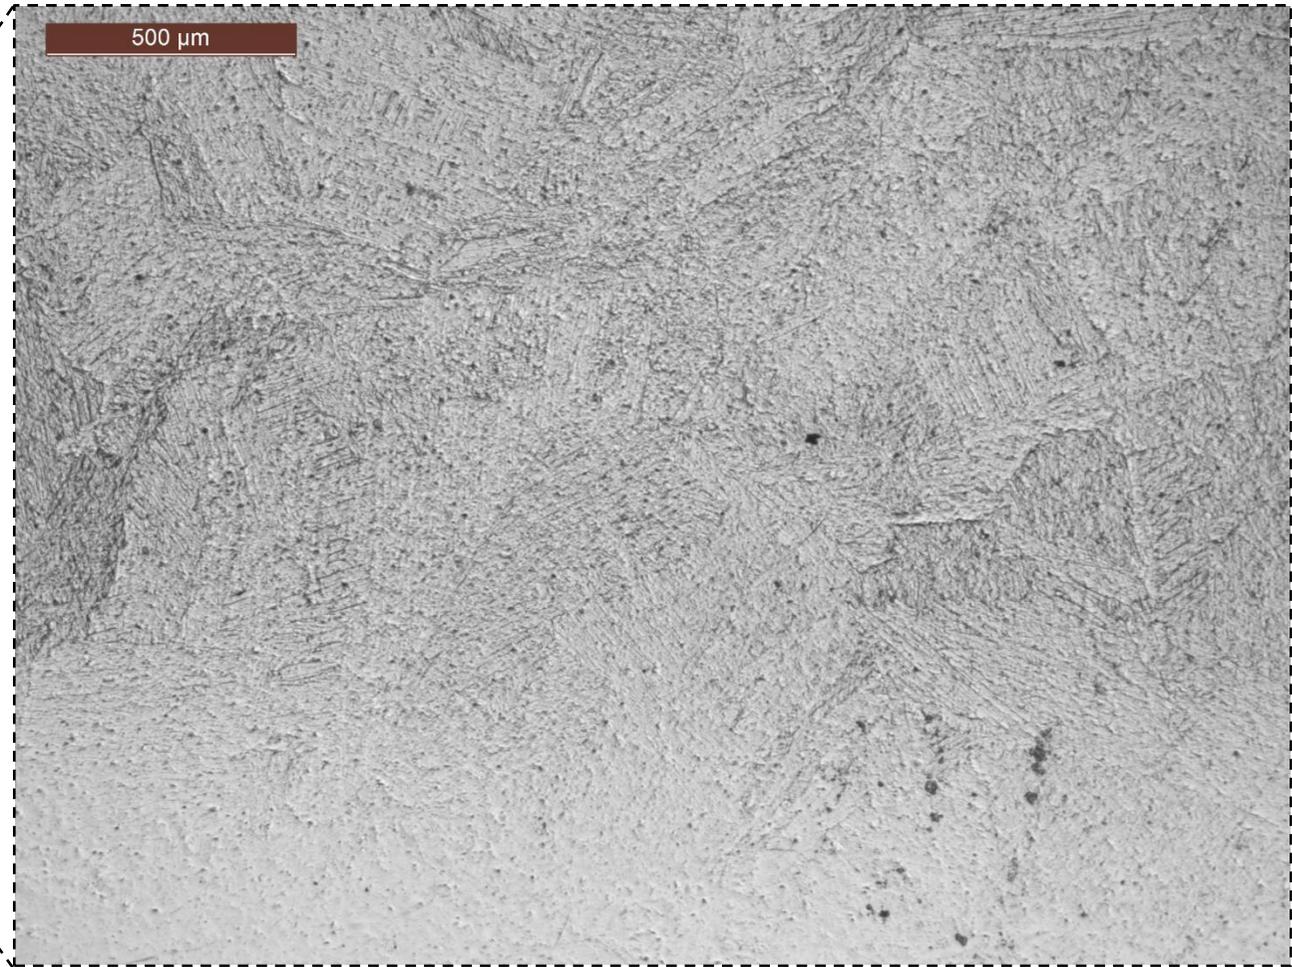
Light microscope image. Taken at the edge of the damaged region, the bottom is outside the region where cavitation occurred.

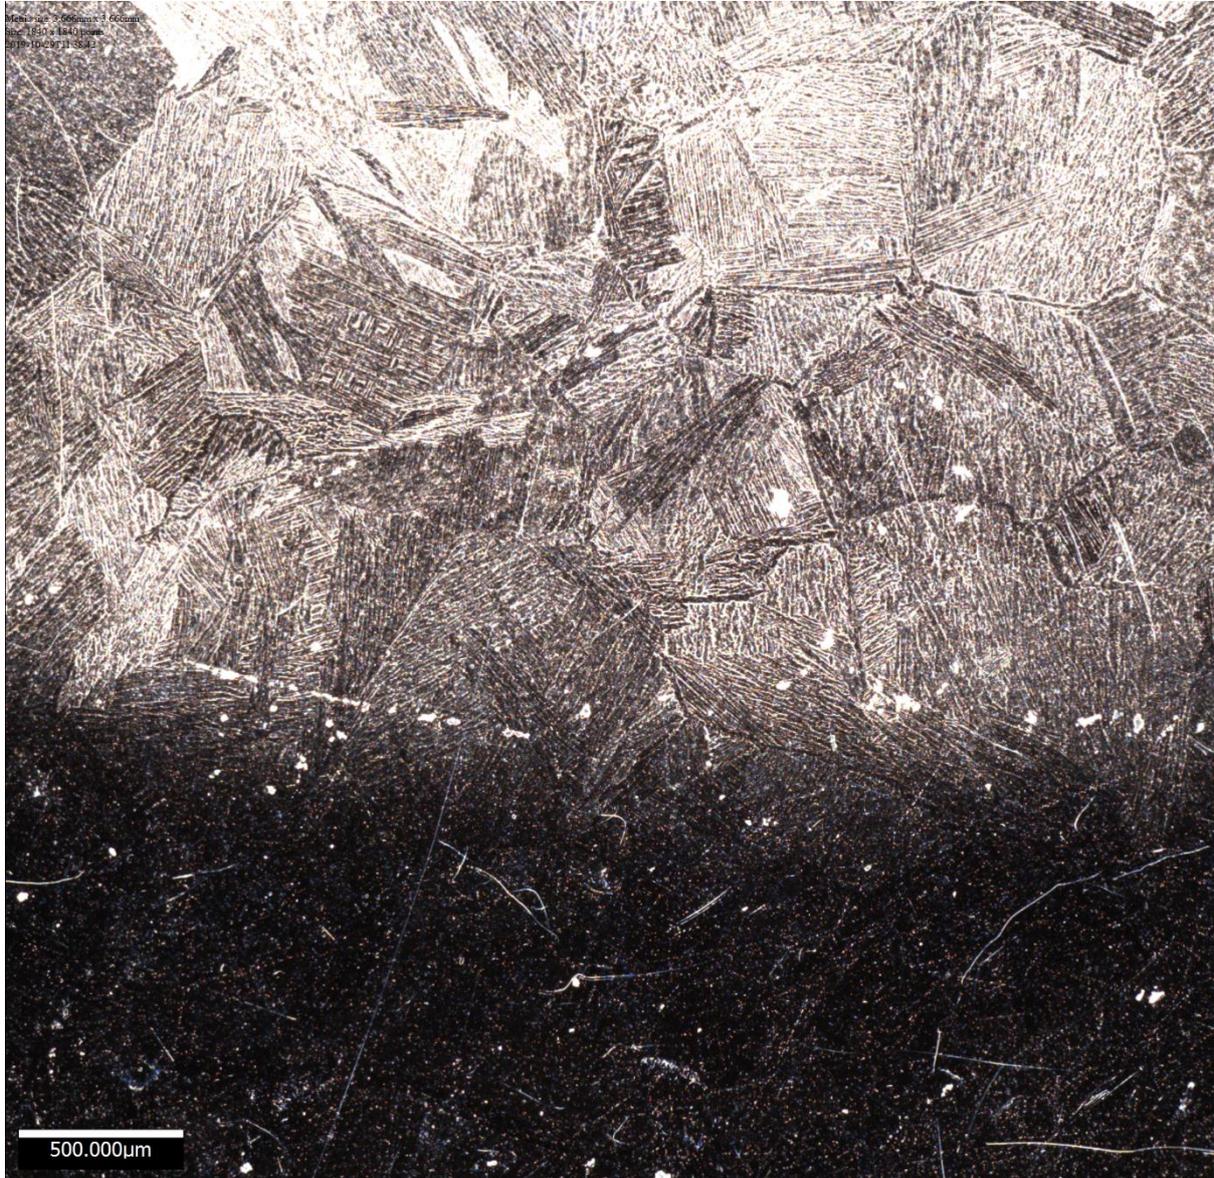
Figure 6.6 – Alicona image of annealed Ti-6Al-4V sample after 1 hour in cavitating sonotrode rig.

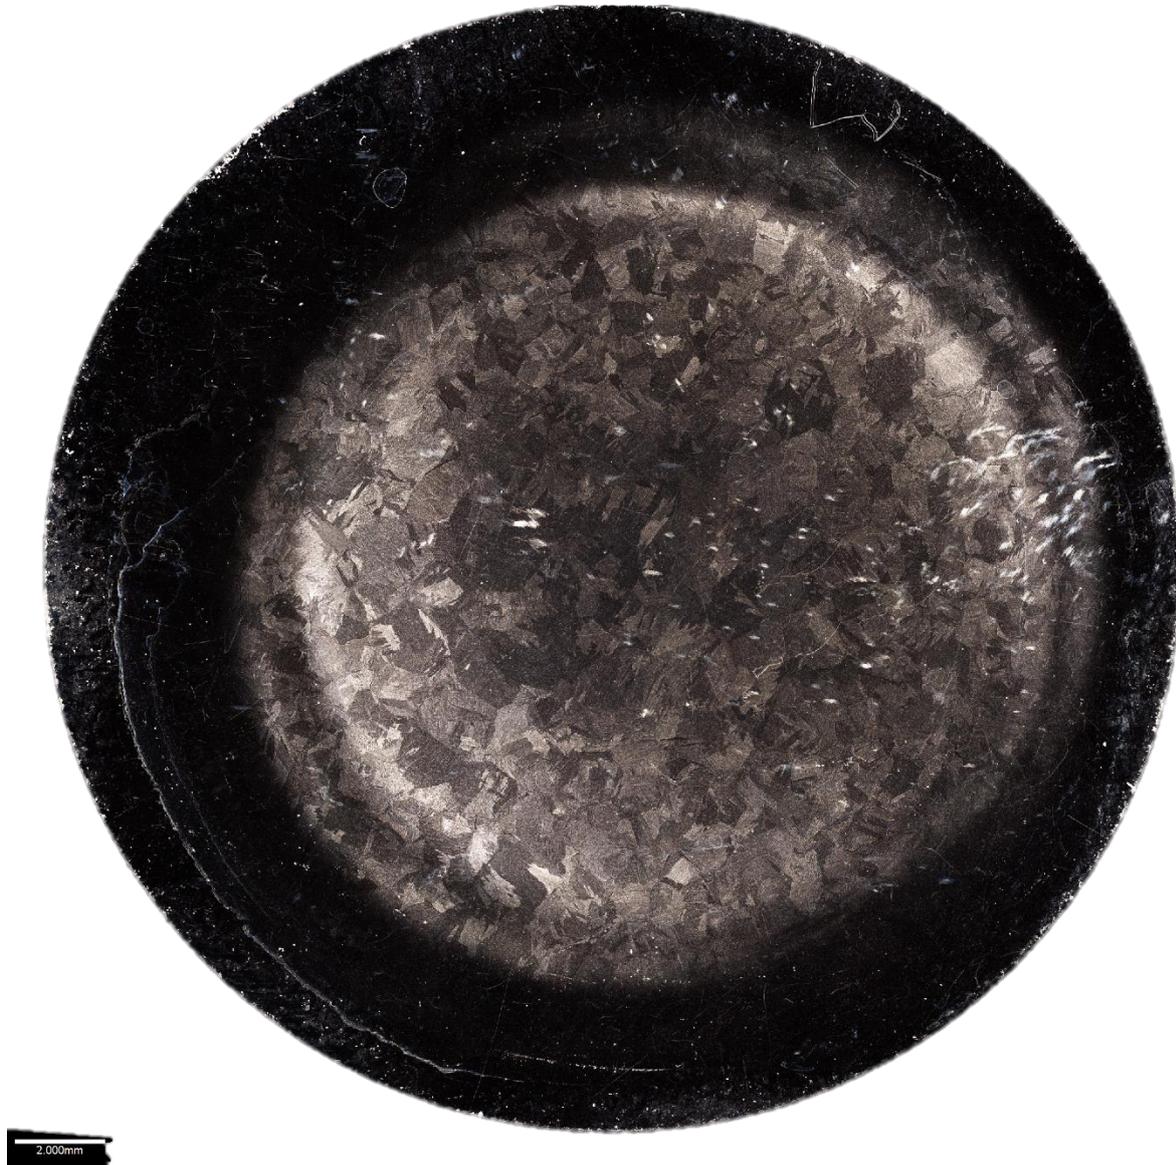
Figure 6.7 – Alicona image of annealed Ti-6Al-4V sample after 2 hours in cavitating sonotrode rig. 2mm scale bar.

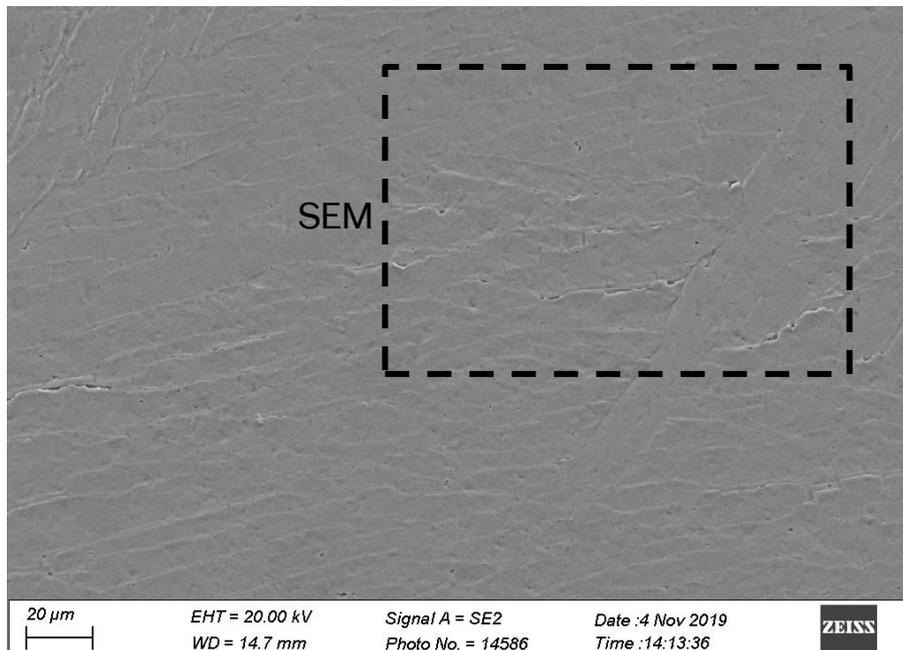
Figure 6.8 – SEM image of annealed Ti-6Al-4V sample after 2 hours in cavitating sonotrode rig.

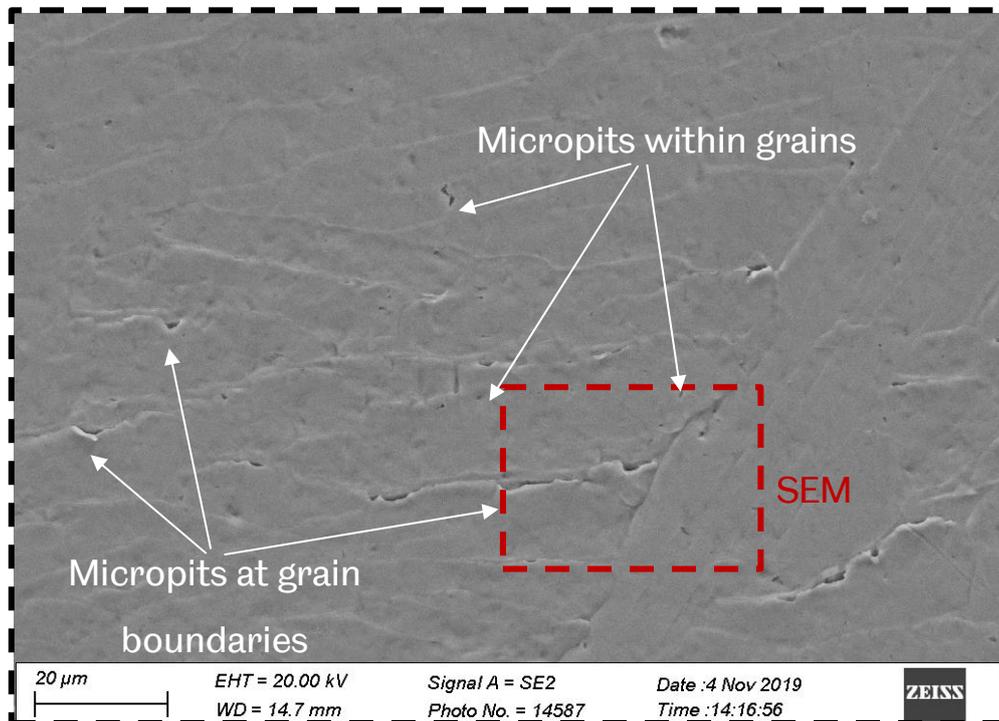
Figure 6.9 – SEM image of annealed Ti-6Al-4V sample after 2 hours in cavitating sonotrode rig.

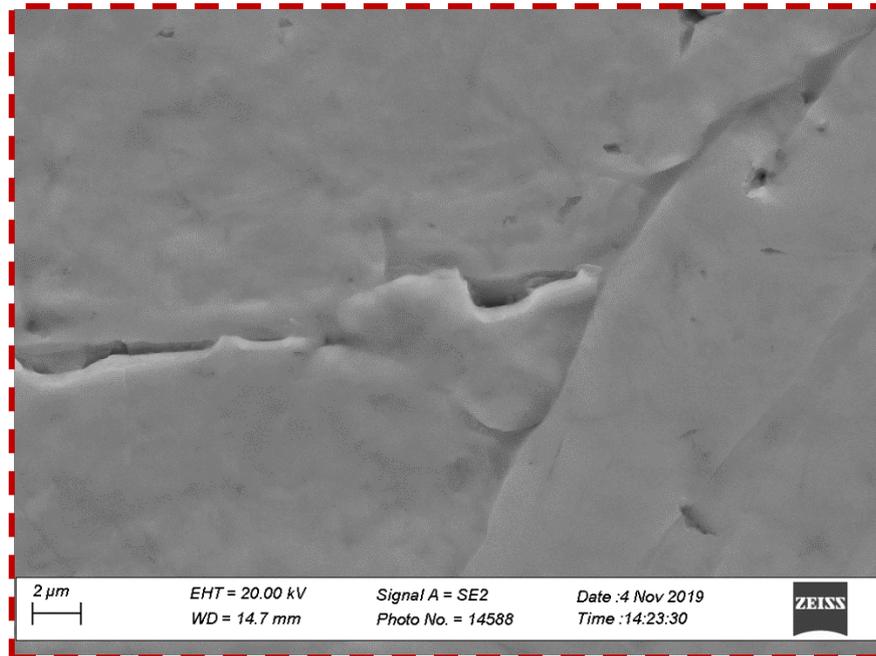
Figure 6.10 – SEM image of annealed Ti-6Al-4V sample. 2 hours in cavitating sonotrode rig.
