A STUDY OF RESIDUAL SHEAR STRENGTH OF NAMURIAN
SHALES IN RESPECT OF SLOPES IN NORTH DERBYSHIRE.

VOL II

Thesis submitted in fulfilment of the requirements for the
Degree of PH.D.

Department of Geology
University of Sheffield

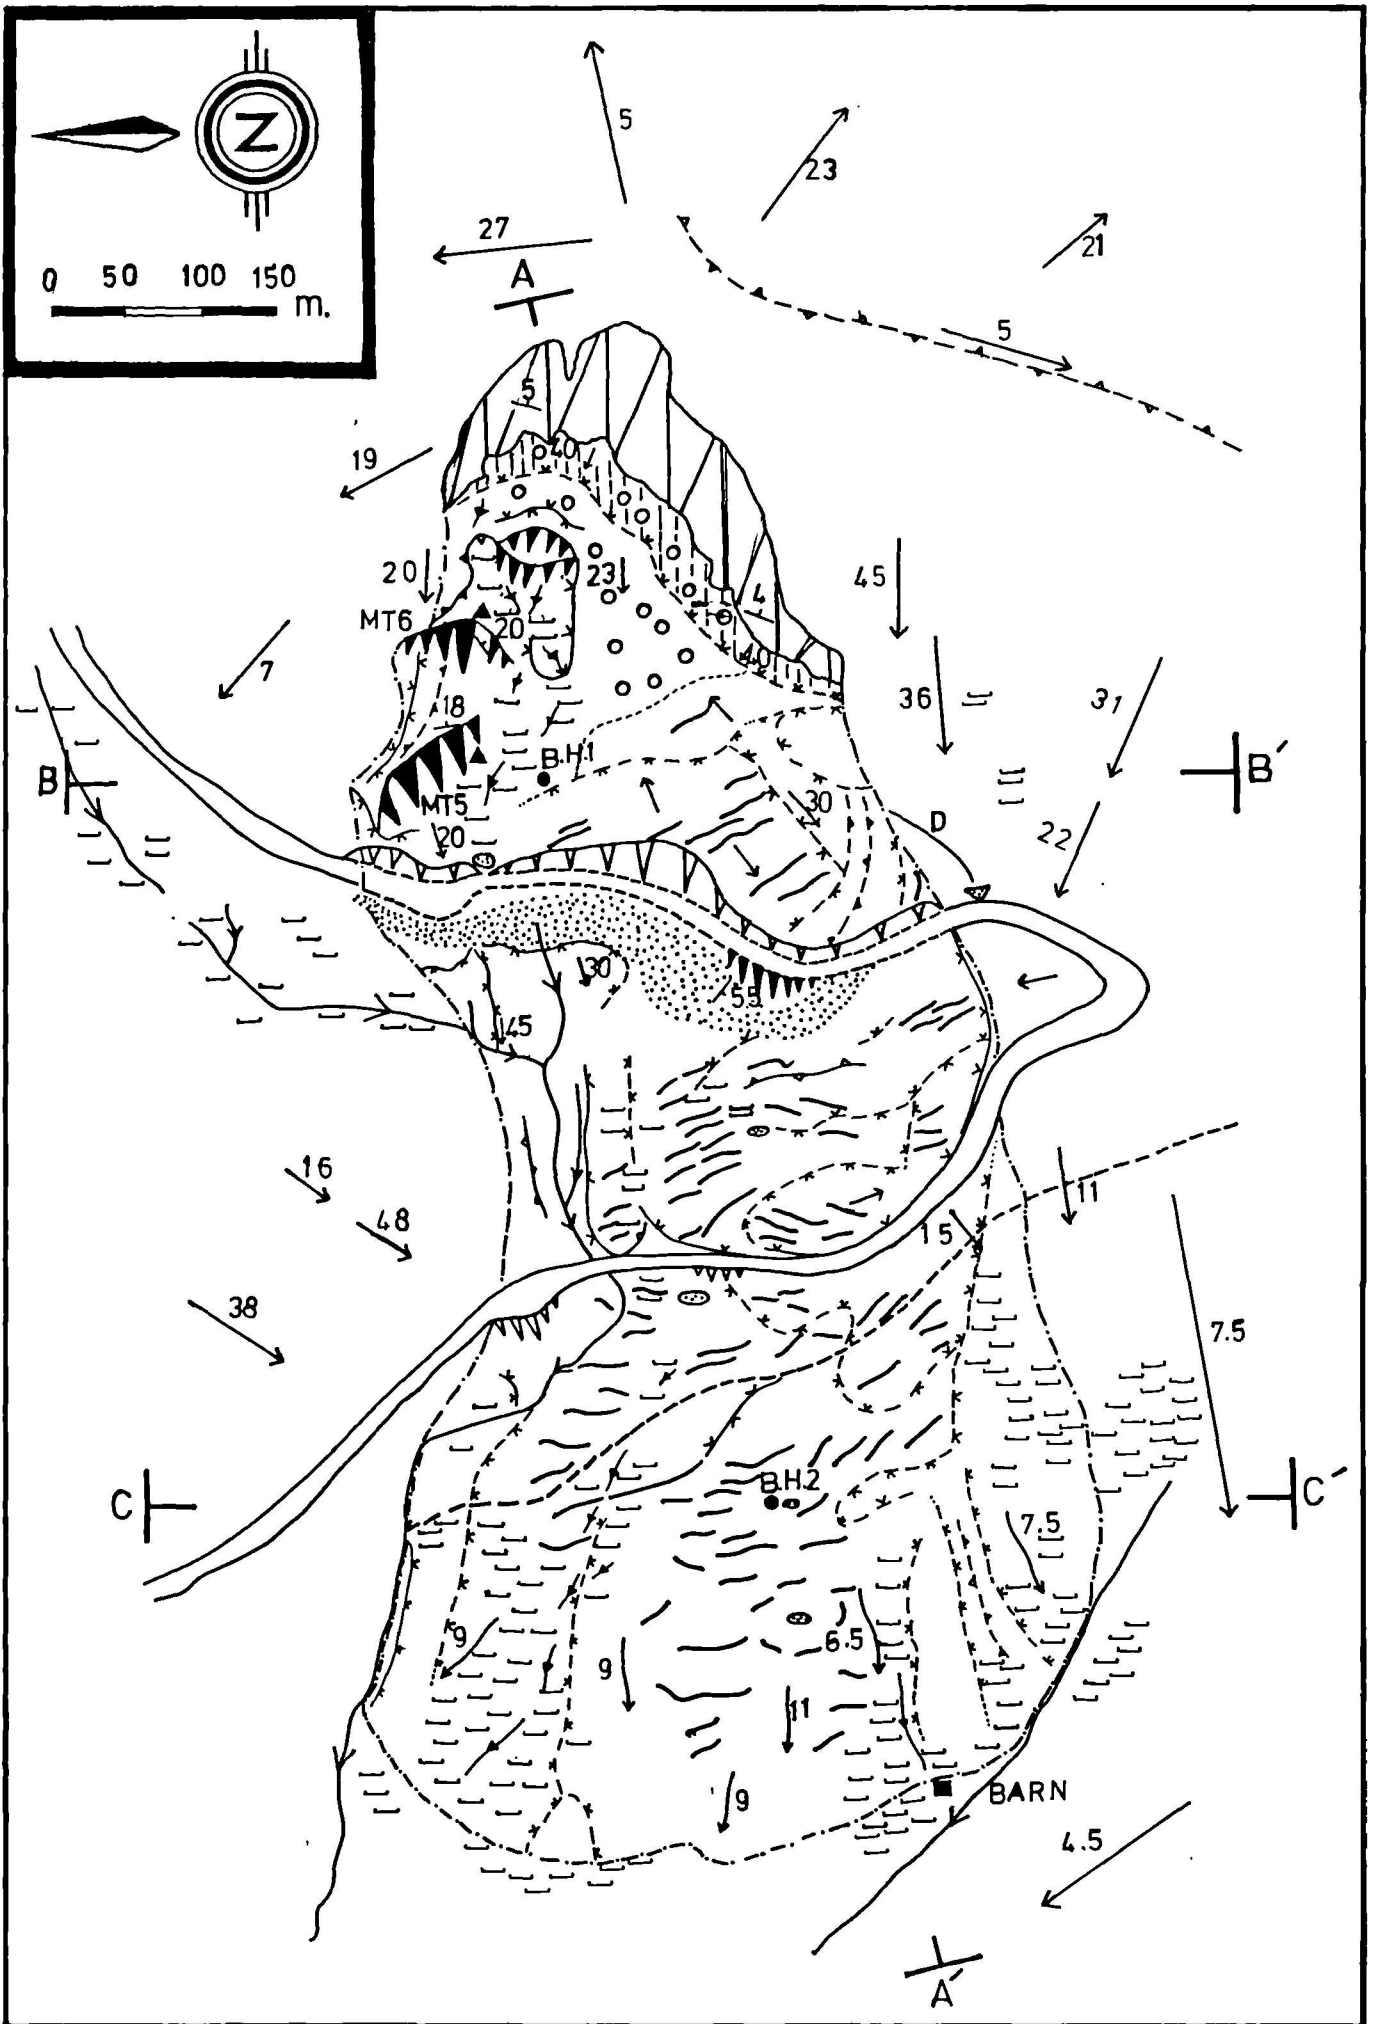
FIG. 7.3 GEOMORPHOLOGICAL MAP OF MAM TOR LANDSLIP.

The Mam Tor landslip, shown in map Fig. 7.3 and Plates 7.1 and 7.2, may be divided into two main parts. The main unit consists of a non-circular rotational slip stretching from the back scarp to near the lower loop of the road. A translational flow slide stretches from the toe of the main slide to the furthest edge of the instability. According to Skempton and Hutchinson's (1969) classification the slide is a complex type with a 500m. long by 300m. wide main unit, and a translational toe of 400m. length and 450m width.

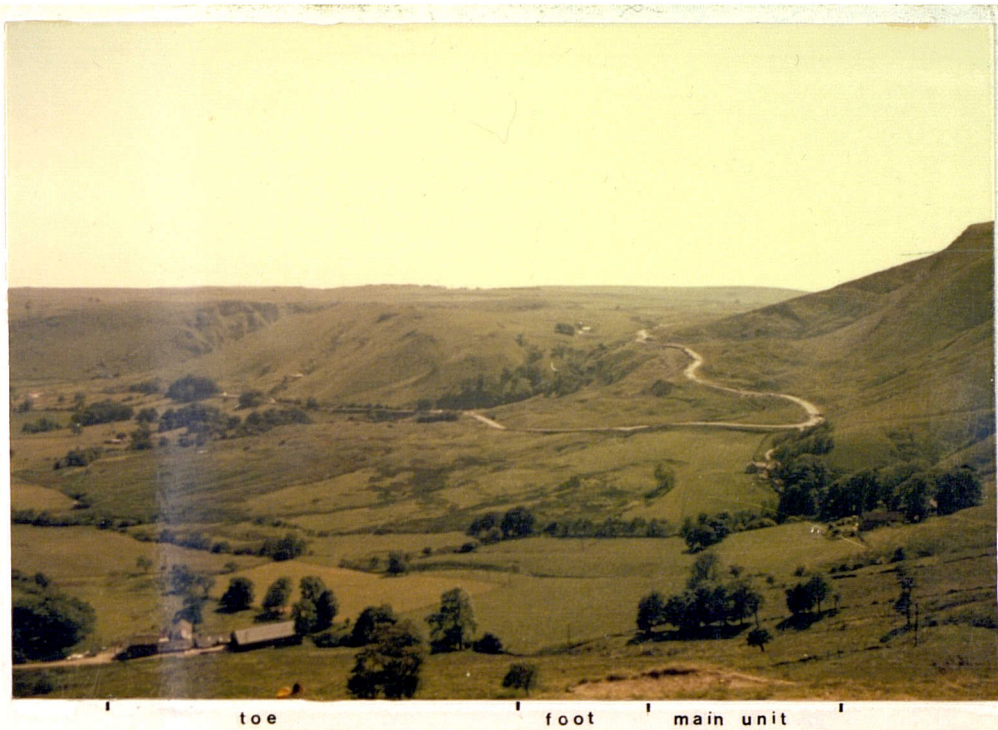
Plate 7.2 General view of Mam Tor landslip in a southerly direction. Note the contrast in the character of the ground surface between the toe and other parts of the landslip. August 1983.

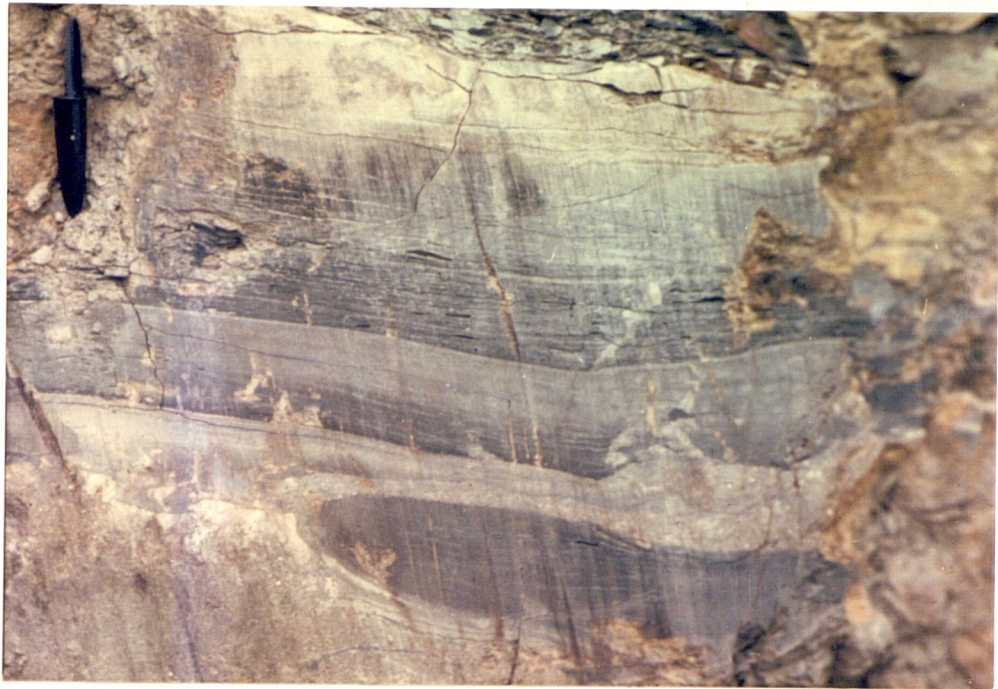
Plate 7.4 Slickensided, back scarp surface at Mam Tor.

- iv. Beds, in particular sandstone in the main unit, have suffered distortion.
- v. The back scarp is a free face subject to not infrequent rock-fall instability which together with smaller talus flows contribute to the 40° scree slope shown in Plate 7.3. The slickensided failure surface photographed in Plate 7.4 is preserved beneath talus at the top of the scree slope. This surface which dips at an angle of about 85° becomes exposed when the rate of downward movement of scree exceeds the rate of scree debris accumulation.

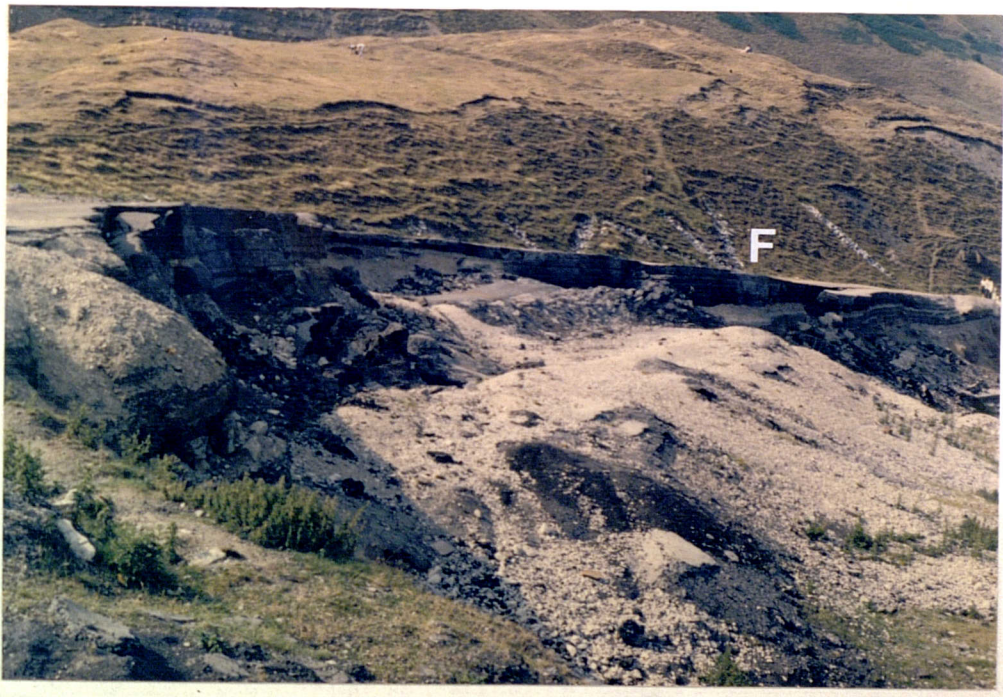
Plate No. 7.5 Damage at the upper road at Mam Tor. Note that successive layers of road surfacing material have been applied in an attempt to maintain the road. French drains on main unit of Mam Tor landslide 'F'.

- xi. As indicated in Plates 7.5 and 7.6 the upper part of the road has been seriously damaged by the instability and in some places several metres of vertical and horizontal movement prevent the passage of wheeled traffic. The upper road is mainly damaged at the edge of unstable area, where downward movement shown in Plate 7.5 is evident.

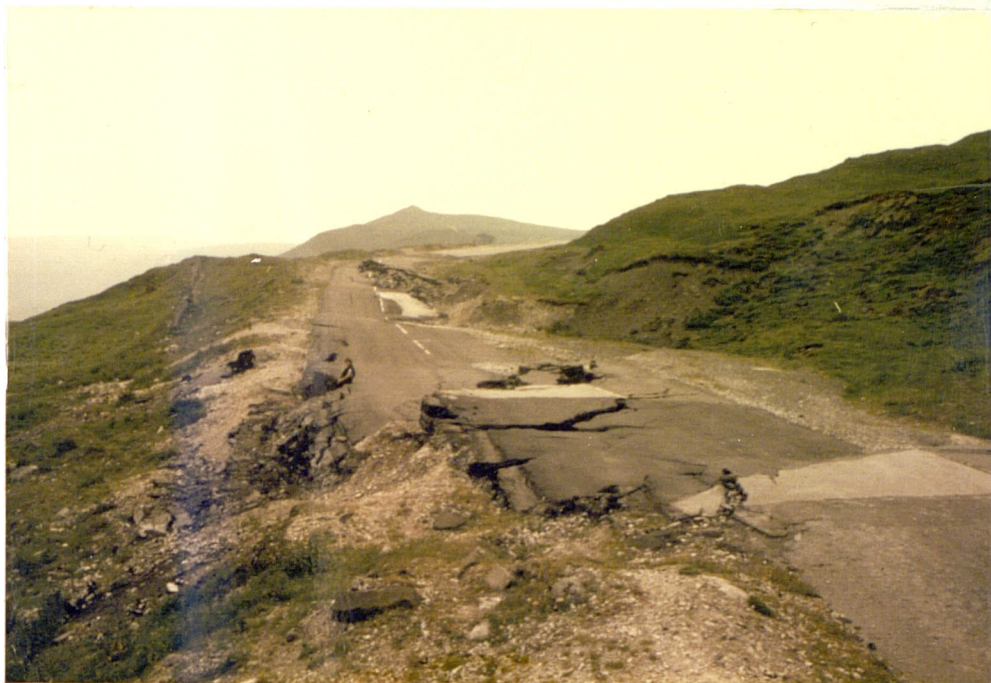
Plate No. 7.6 Damage of the upper road at Mam Tor. Note that the recent instability has caused a downward movement with lateral displacement.

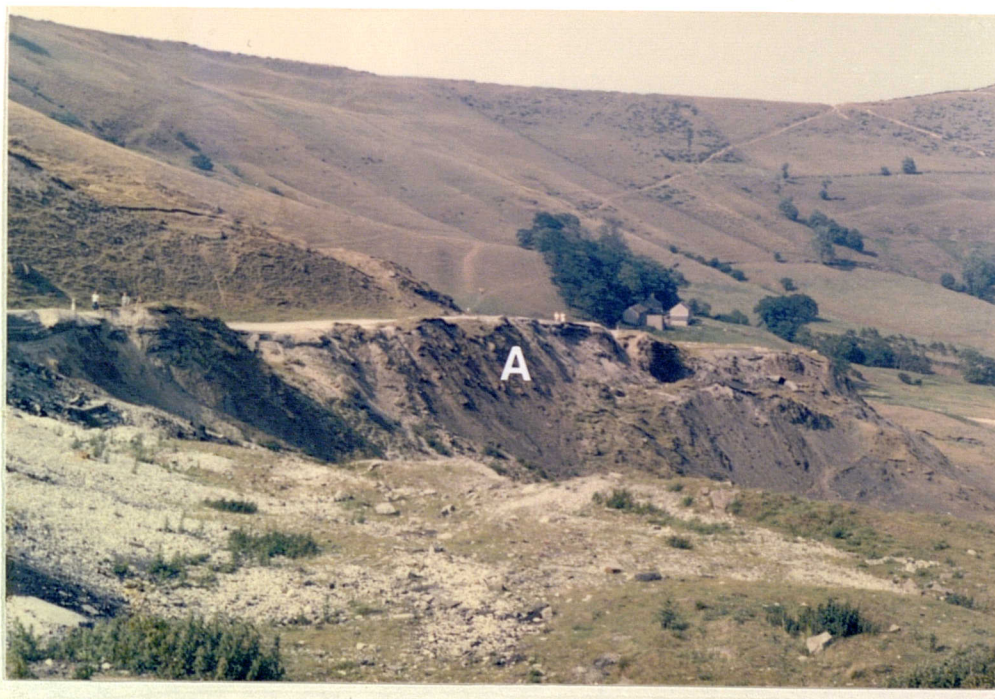
Plate No. 7.7 Minor scarp at little Mam Tor 'A'.

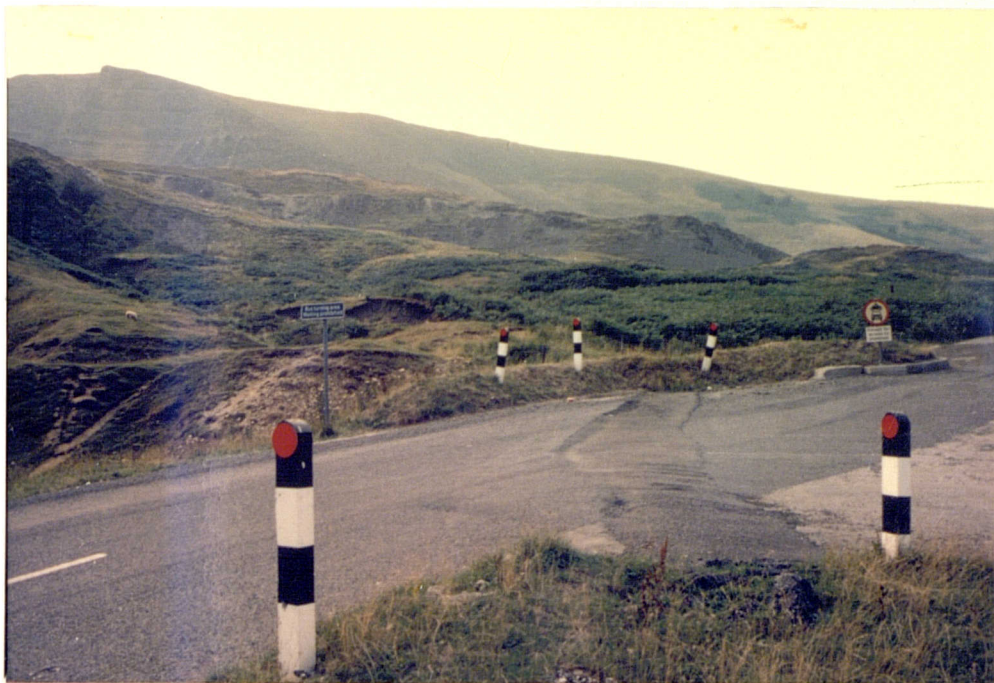
Plate No. 7.8 Hummocky ground at the foot of main unit. Recent downward movement of lower southern edge of the road in January 1983.

- xii. A series of minor scarps shown in Plate 7.7 also affect the upper road for most of its transverse across the displaced ground.
- xiii. The foot of the main unit is characterized by hummocky ground with a system of linear ridges and hollows running in SE-NW and NNE-SSW, directions. These are illustrated in Plate 7.8.

- xv. The lower road has also been damaged by the movement with the upward movement shown in Plate 7.9 and Fig. 7.4 at the northern margin while at the southern margin the horizontal translation and vertical movement shown in Plate 7.8 are evident.

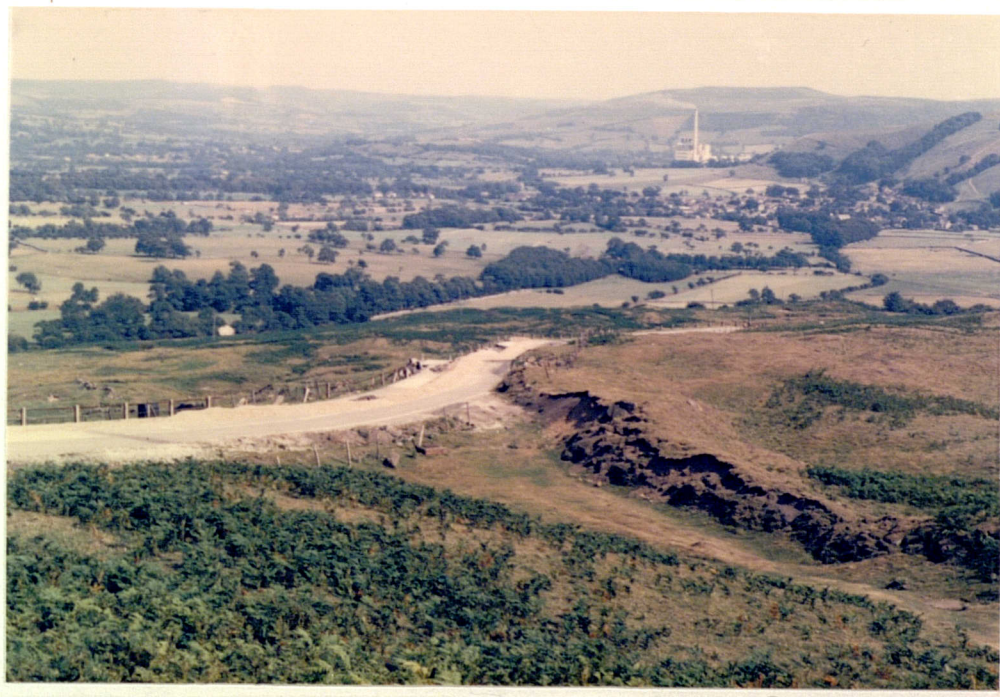
Plate No. 7.9 Heave movement at northern part, Lower road.

The diversion in the direction of the movement at the foot of the main unit and the lower road may be due to the resistance offered by the stable area on the southern flank which also causes the heave in the northern part of the toe shown in Plate 7.9 and Fig. 7.4.

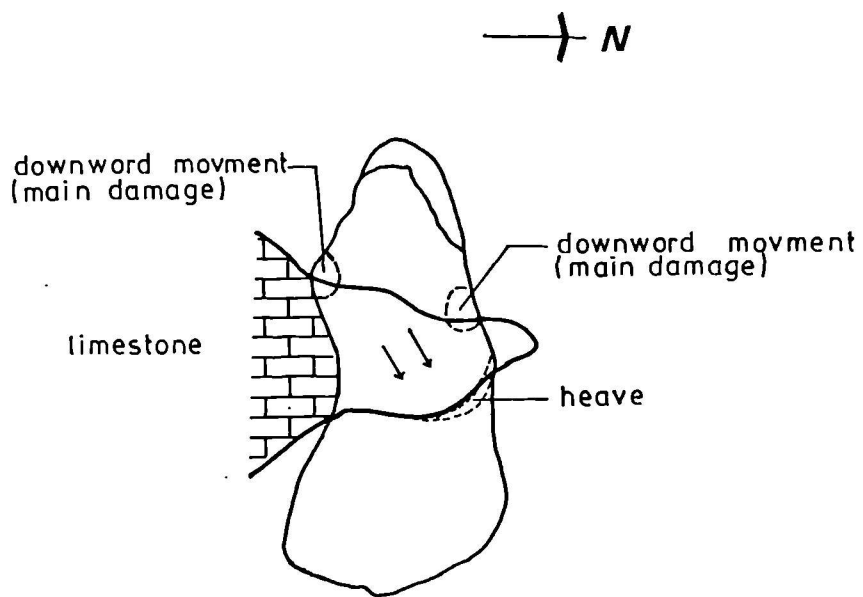
Fig. 7.4 Mam Tor landslip showing the main damage and the heave area.

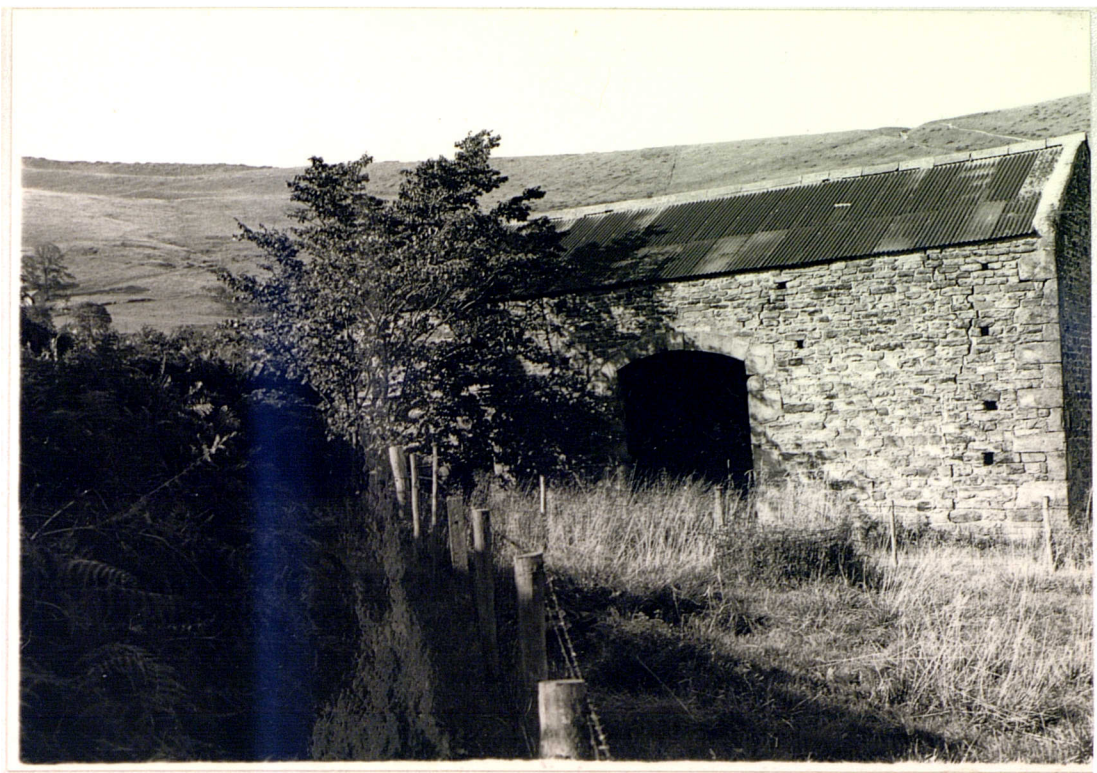
Plate No. 7.10 Blacketlay Barn before March 1983.

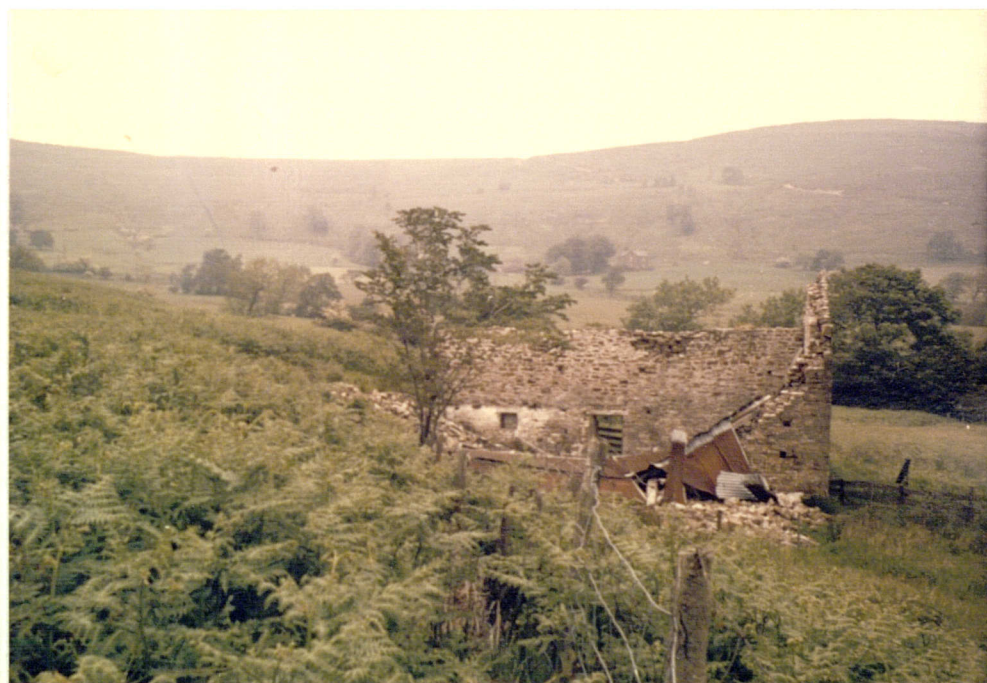
Plate No. 7.11 Destruction of Blacketlay Barn. March 1983. Note convex character of toe.

- i. Various seepages which occur in the locations indicated in map Fig. 7.3. Although these wet areas are marshy in part, they are also the sites of iron oxide precipitation which forms a hard crusty deposit.
- ii. The aerial photograph, Plate 7.1 indicates a system of linear ridges and hallows in this area.
- iii. As indicated by Plates 7.10 and 7.11 the toe of the slide is convex in profile and rises to height of average of 10m. above the original ground surface (See Fig. 8.5).
- iv. The toe of the slide is very active as evidenced by the destruction of Blacketlay barn in March 1983. Plate 7.10 shows the barn before its destruction whereas in Plate 7.11 it has been pushed over by advancing movement.

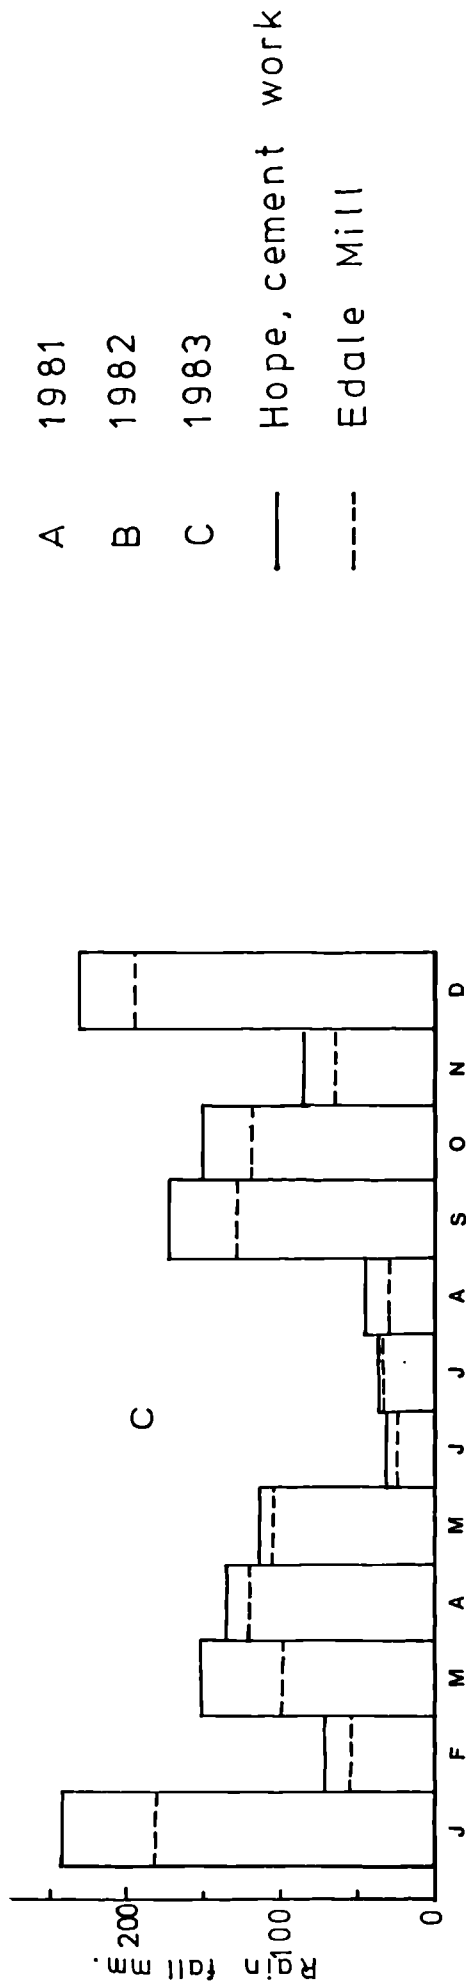
Fig. 7.6 Histogram of monthly rainfall of Edale Mill
 and Hope Cement Works. Years - 1981, 1982 and
 1983.

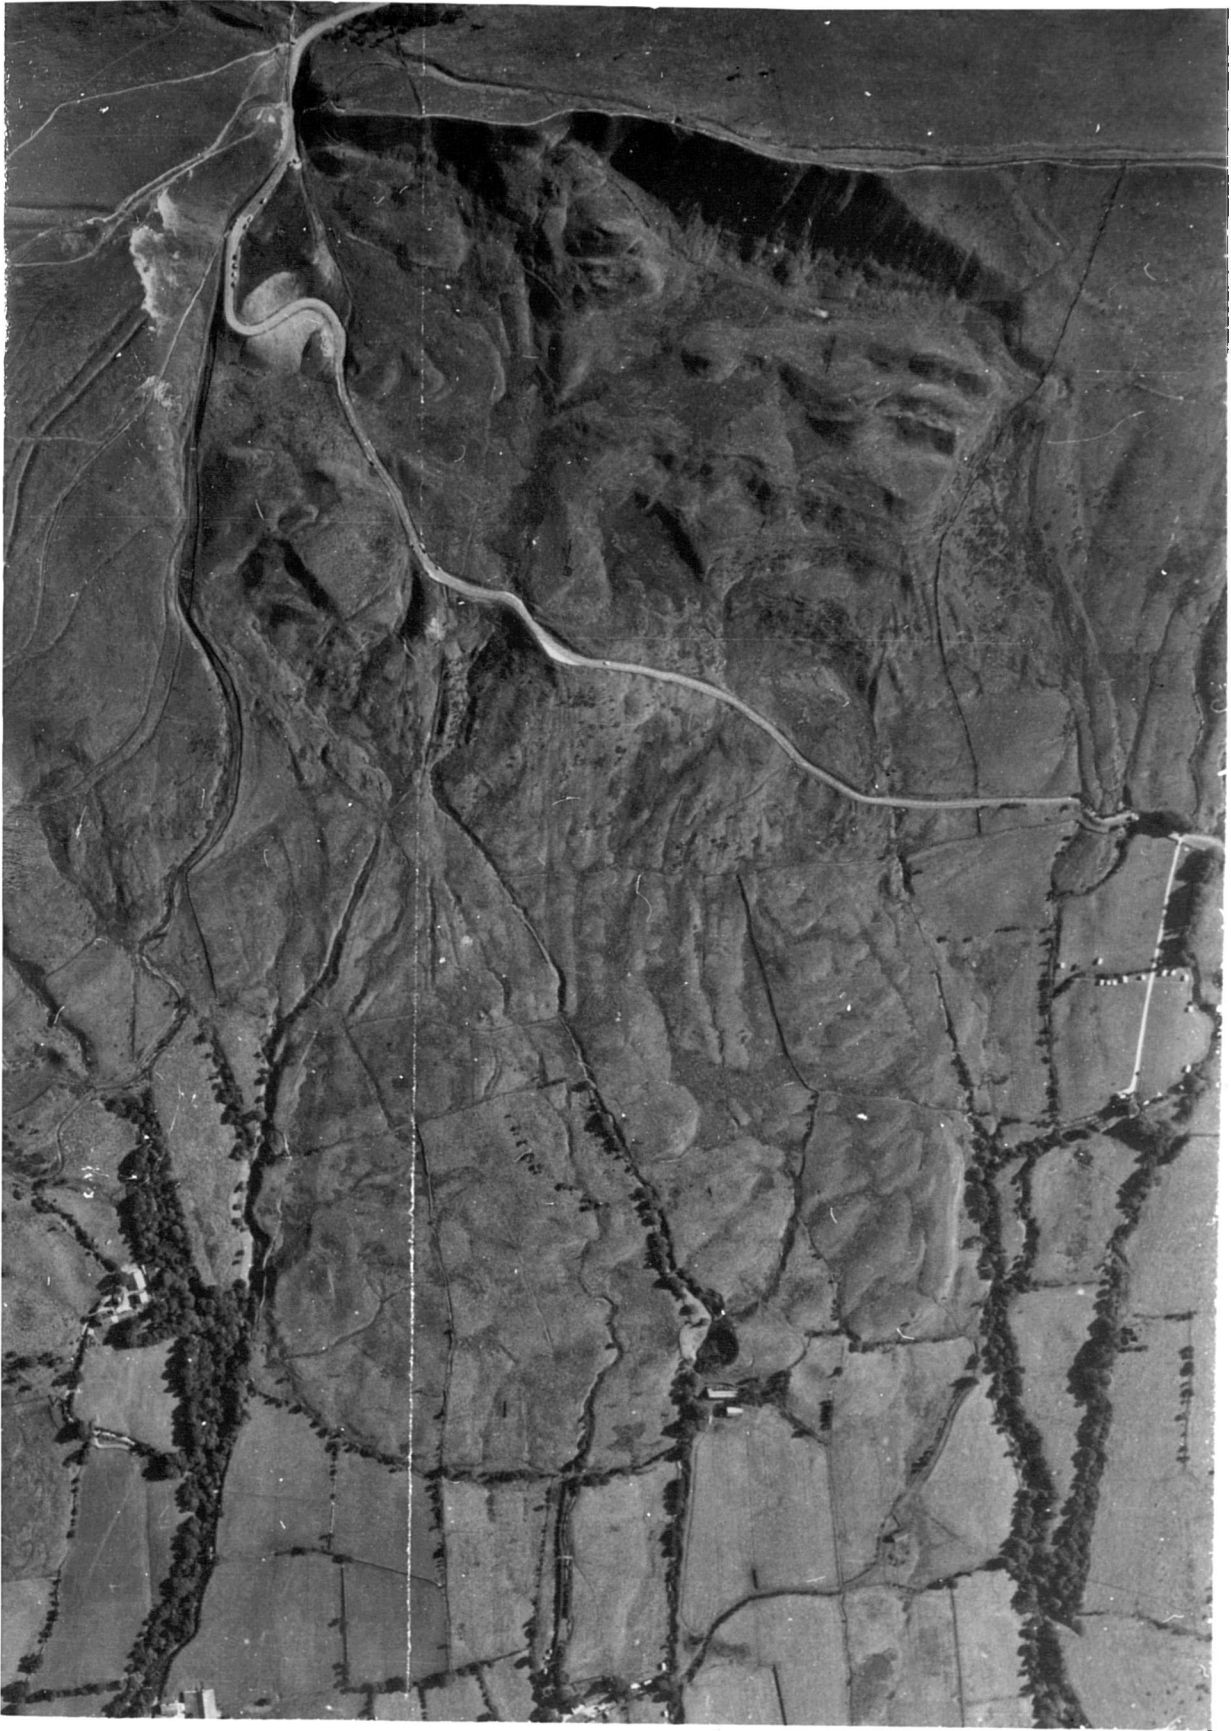
Plate No. 7.12 Aerial photograph of Rushup Edge landslip.
Scale: 1:6000

The landslide at Rushup Edge, near Mam-Nick is one of the most well-known landslips developed in the Millstone Grit Series rocks. As indicated in map Fig. 7.7 and Plate 7.12, in common with landslide at Mam Tor, it can be divided into two main parts. The upper part is characterized by a non-circular rotational slide with a translational slide or flowage forming the toe. According to Skempton and Hutchinson's (1969) classification the landslide is a complex type in which the rotational part measures 500m. long by 750m. wide while the translational part covers an area 600 m. long by 600m. wide.

- vi. The translational toe (See Plate 7.14) is also characterized by hummocky ground but of a less intense nature than that of the upper part.
- vii. The flanks of the landslip are clearly defined as in Plate 7.12.

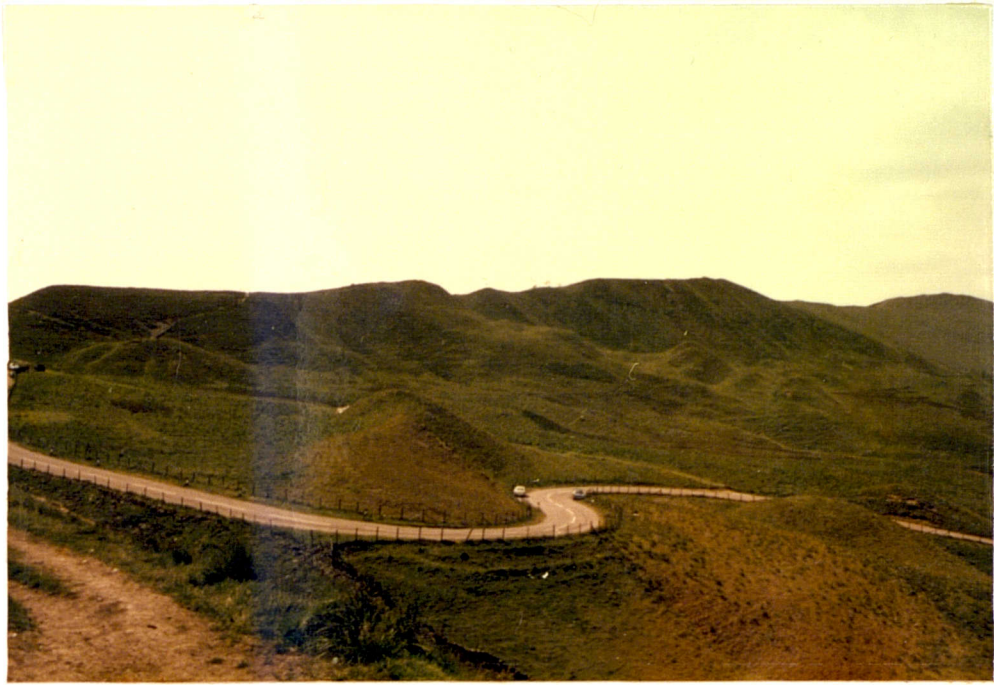
Plate No. 7.13 Main scarp and main unit landslip
at Rushup Edge.

- iii. The Minor scarp seen in Plate 7.13 form a series of NE-SW trending steps near to and below the head of the landslide. These are an indication of the rotational failure of the main unit.

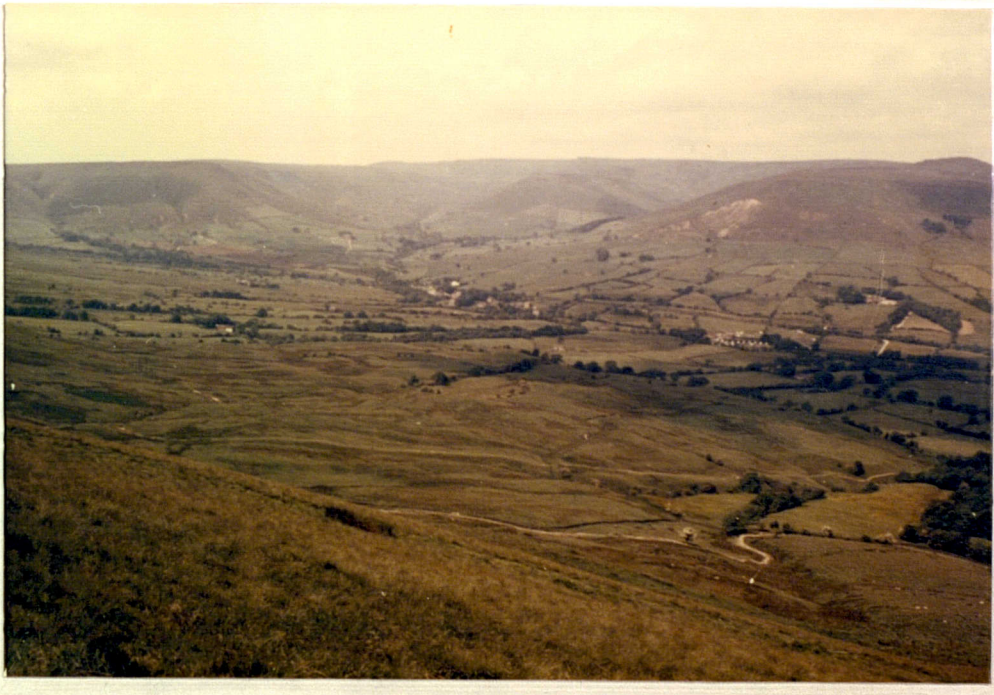
Plate No. 7.14 Toe of landslip at Rushup Edge.
Note the present of marshy areas.

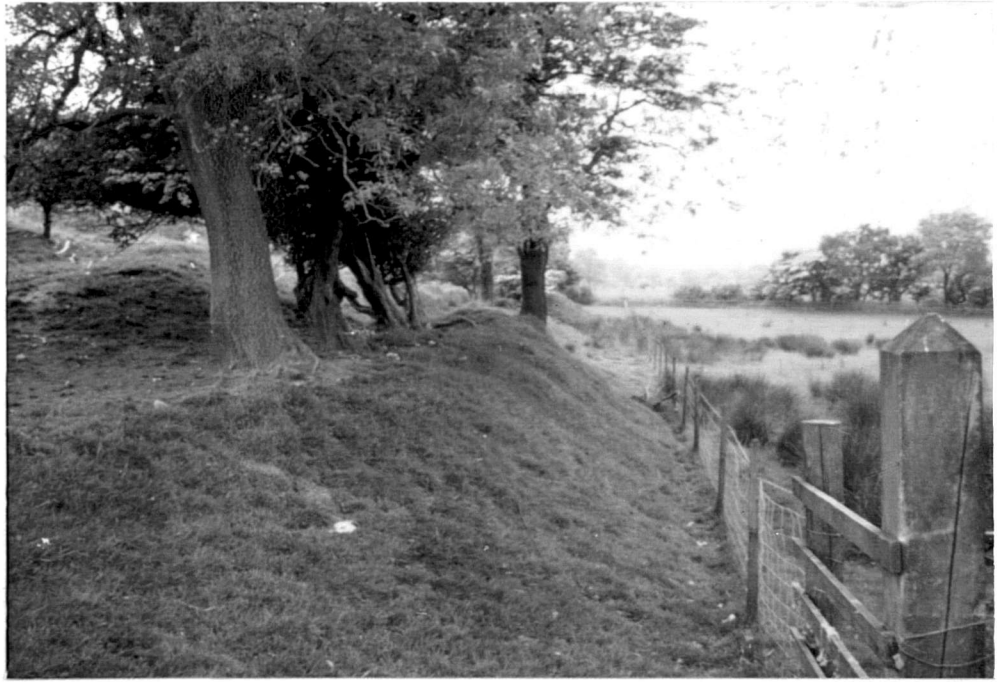
Plate No. 7.15 The convex margin of the toe of the landslide at Rushup Edge.

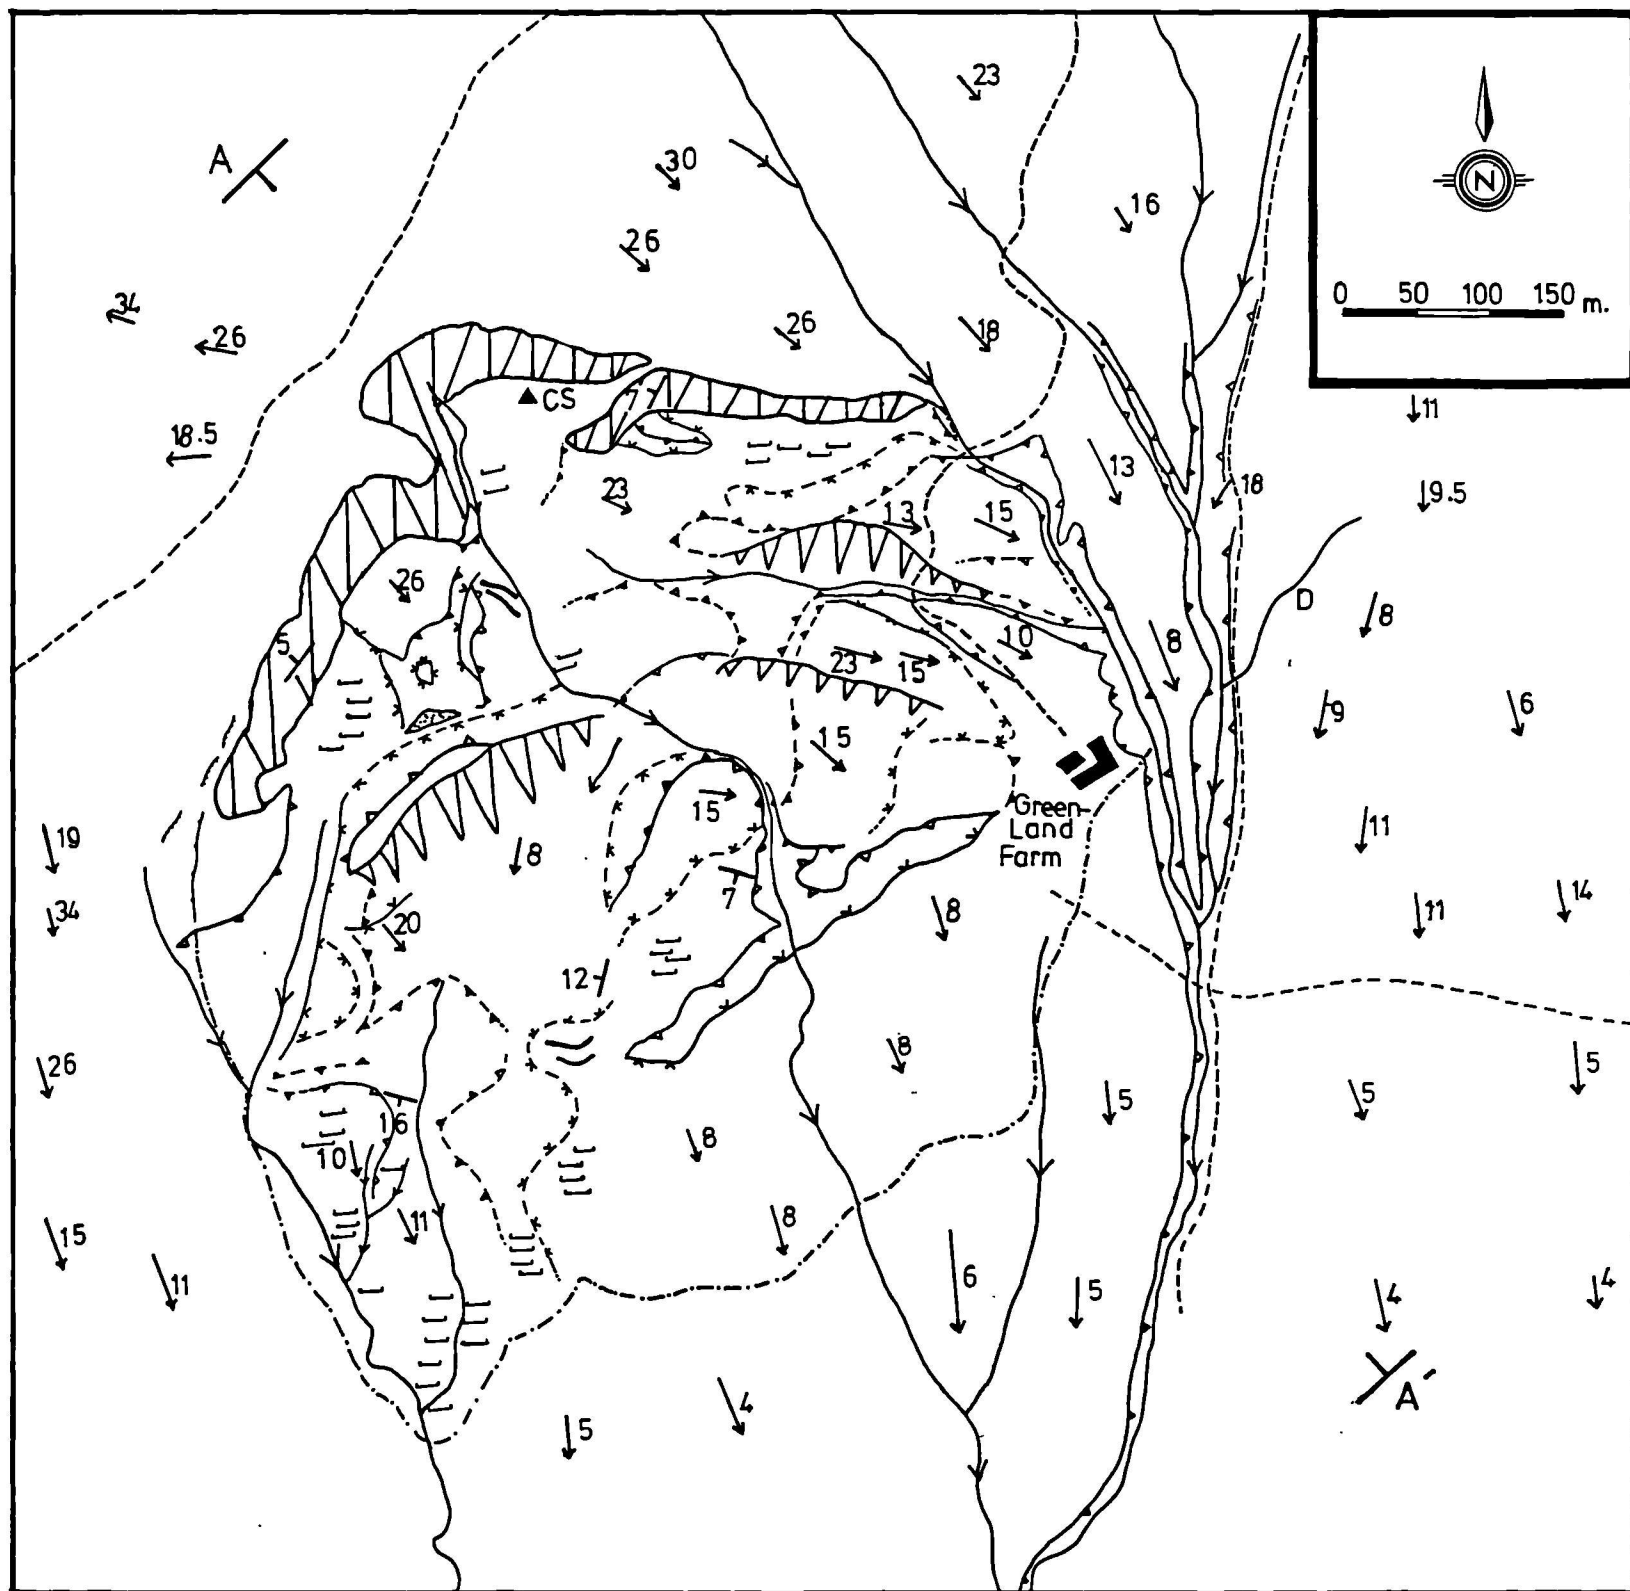
FIG. 7.8 GEOMORPHOLOGICAL MAP OF COLD SIDE LANDSLIP.

- i. The crown forms a 26° NE-SW trending slope on the valley side. Much of this area is vegetated although a small tension crack on the eastern margin of the main scarp provides evidence of recent instability.

- ix. At a number of locations, especially in the eastern sector, hollows contain accumulation of peat.
- x. The toe of the landslip shown in Plate 7.20 consists of a smooth 8° slope formed of landslip debris.

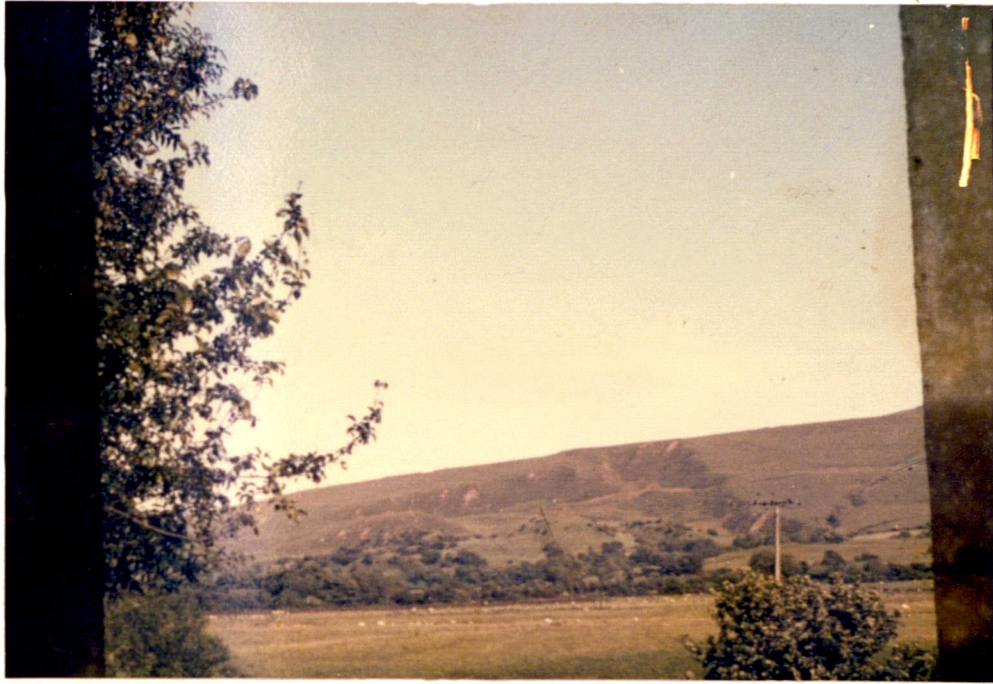
Plate No. 7.17 General view of Cold Side landslip.
Note the vegetated character and
change in direction of the minor
scarp.

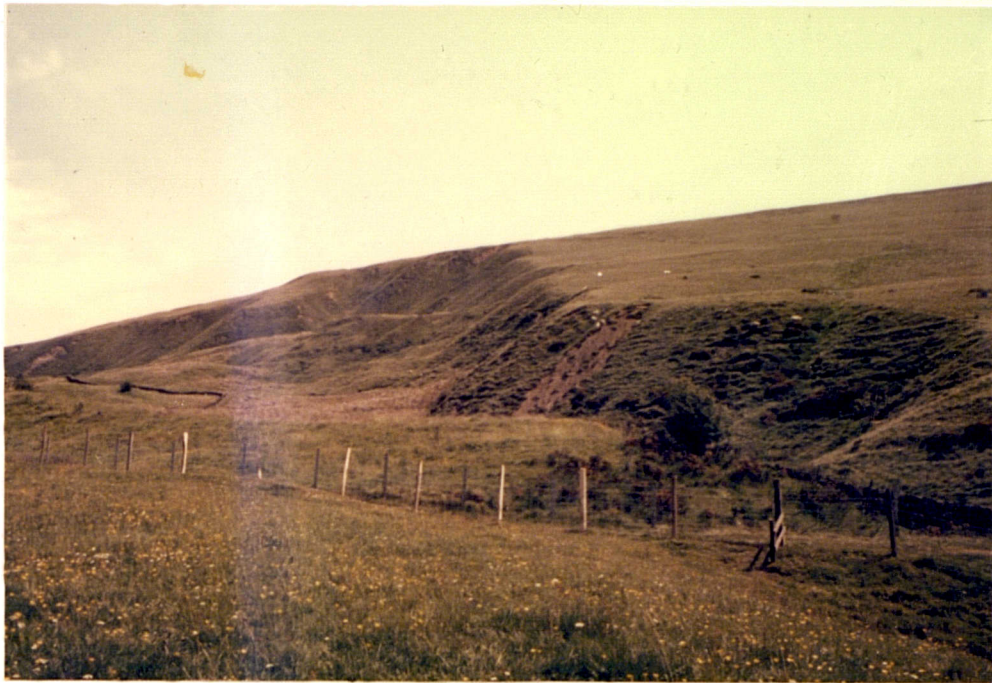
Plate No. 7.18 East-west part of the main scarp of the landslide at Cold Side.

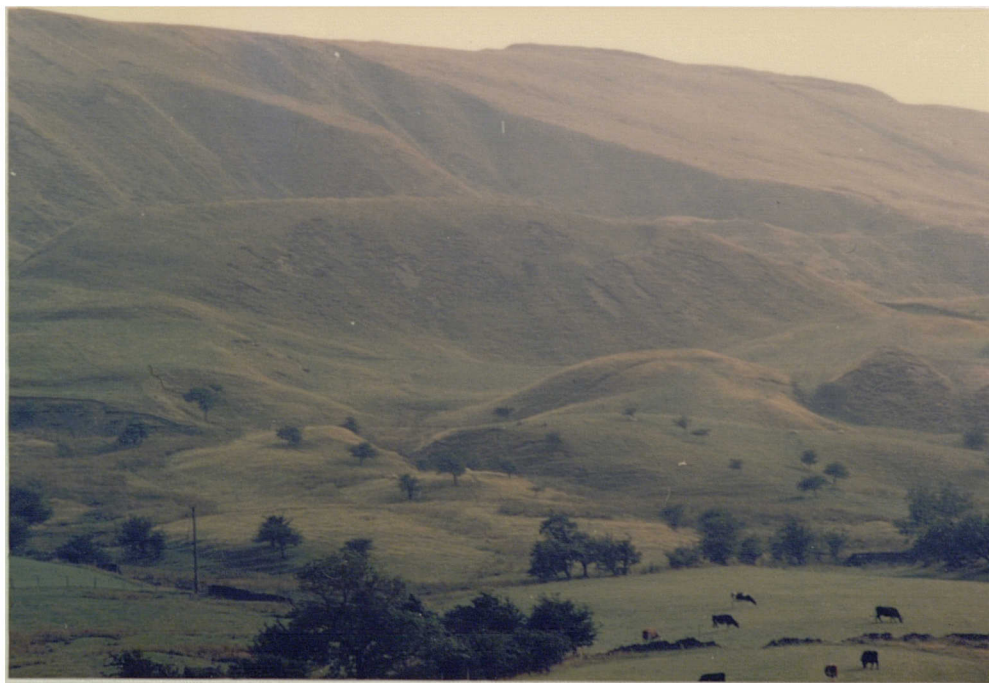
Plate No. 7.19 Minor scarps in the landslide at Cold Side, note that there are mostly grass covered.

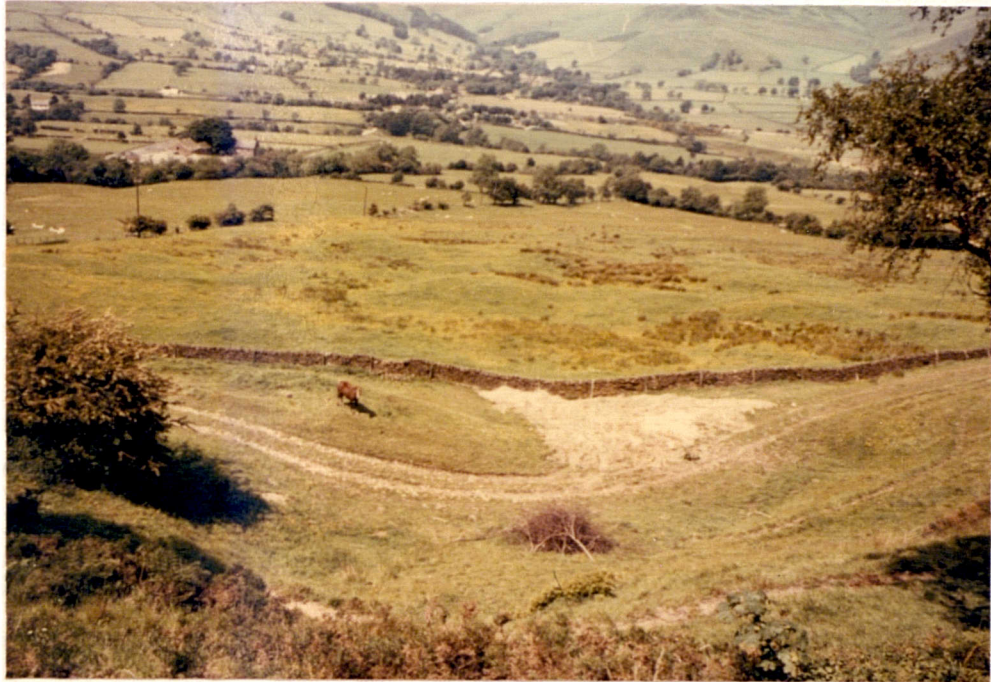
Plate No. 7.20 The toe of Cold Side landslide. Note the presence of marshy areas.

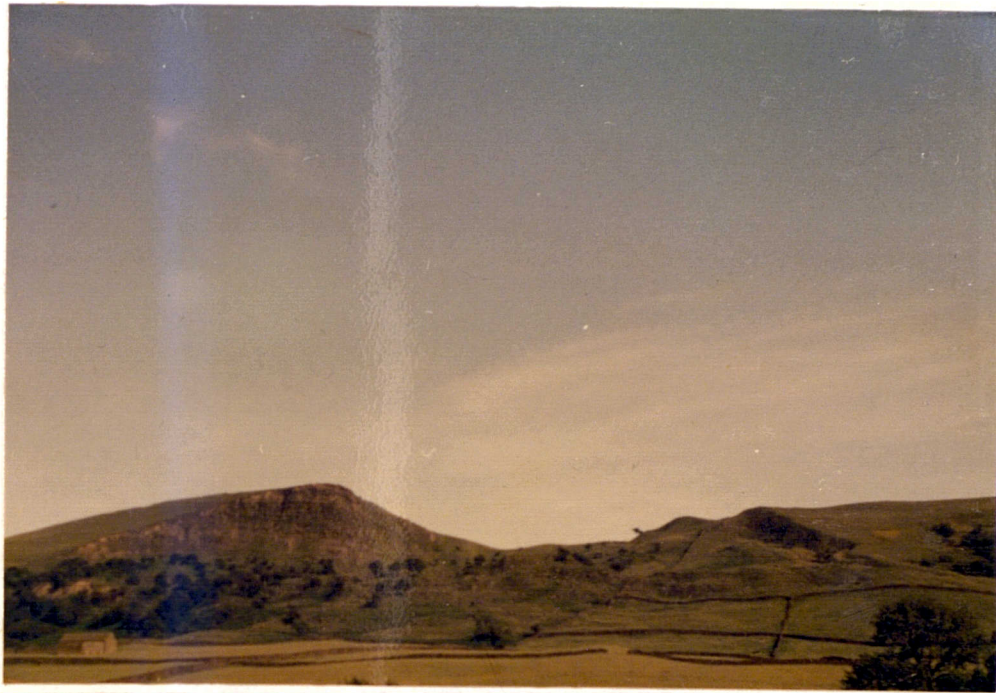
Plate No. 7.22 General view of Back Tor landslip.
Note the steep exposure of Shale
Grit and Mam Tor beds in the back
scarp.
