A STUDY OF RESIDUAL SHEAR STRENGTH OF NAMURIAN
SHALES IN RESPECT OF SLOPES IN NORTH DERBYSHIRE.

VOL II

Thesis submitted in fulfilment of the requirements for the
Degree of PH.D.

Department of Geology
University of Sheffield

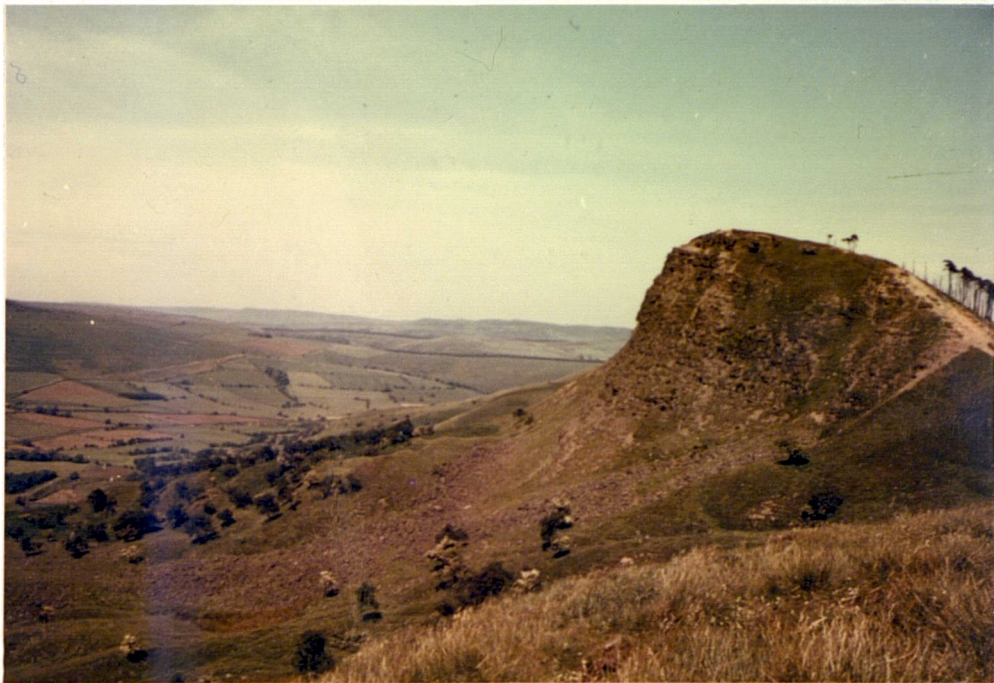
Plate No. 7.23 Eastern side of the main scarp of the landslip at Back Tor.

- iii. Movements in the eastern part are much greater than those of the western or middle parts. A well developed minor scarp occurs in the eastern part of the main unit of the landslip. This feature can be seen in Plate 7.23 and 7.21 and map Fig. 7.9, which also show the hummocky ground that comprises a series of generally NE-SW trending hollows and ridges in this area.

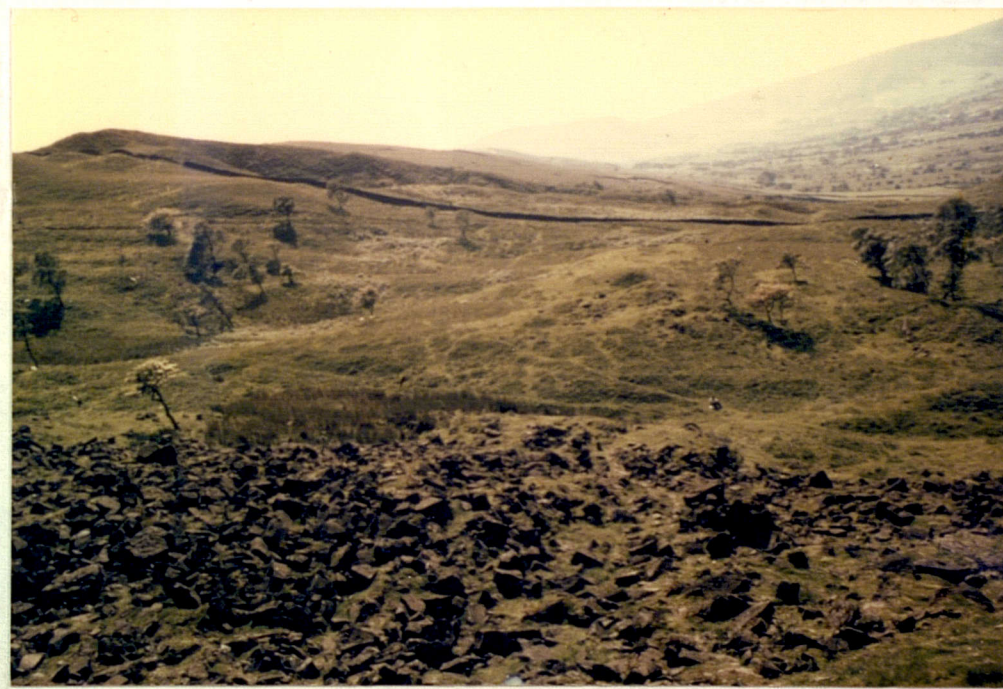
Plate No. 7.24 Western side of the main scarp of Back Tor landslip. Part of the main unit shows the hummocky ground with sandstone blocks below the main scarp.

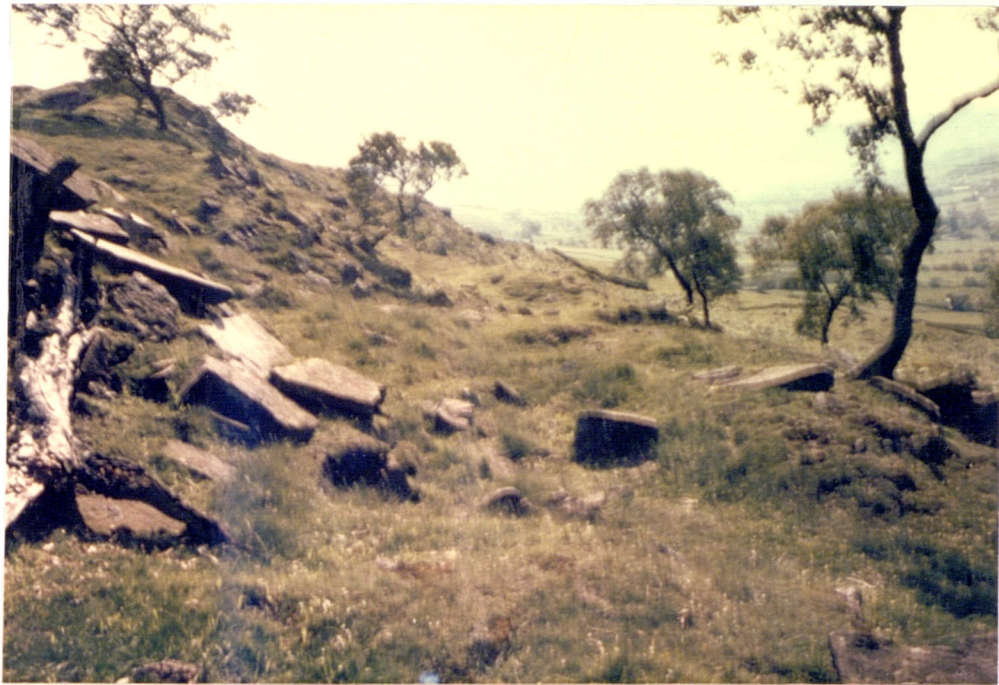
Plate No. 7.25 Minor scarp at foot of the main unit of Back Tor landslip.

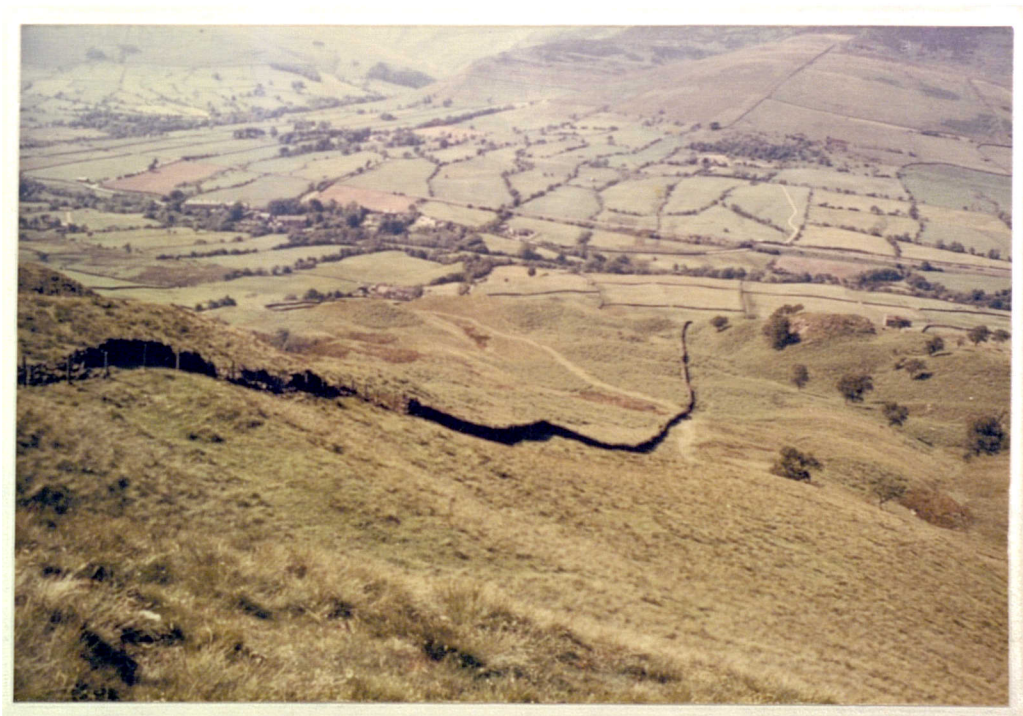
Plate No. 7.26 Part of the foot and toe of the landslip at Back Tor. Note the gentle slope of toe.

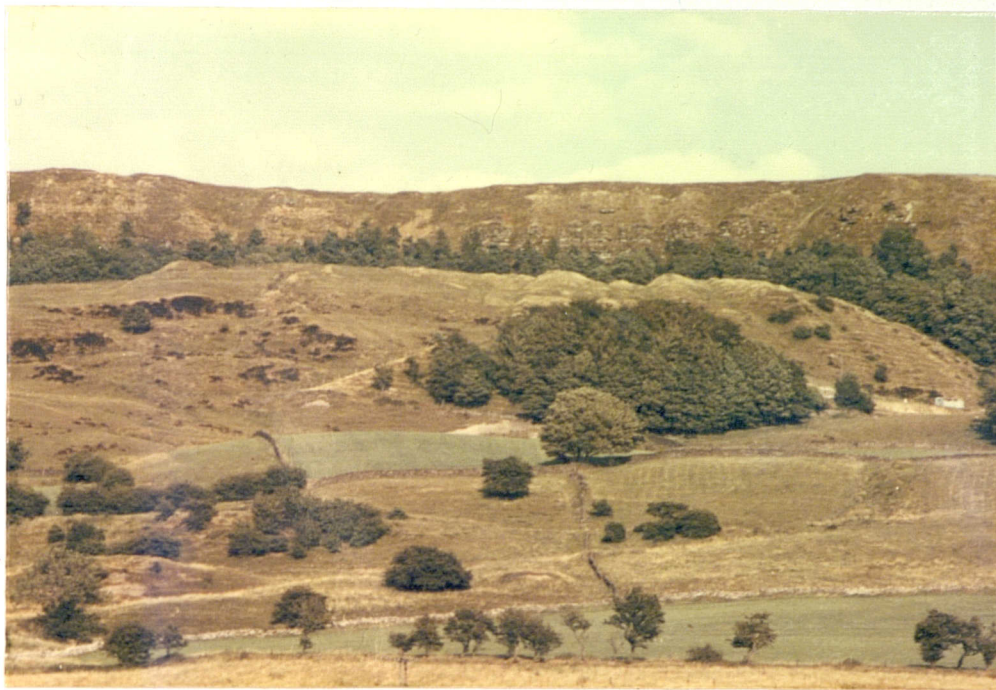
Plate No. 7.28 General view of landslip at Burr-Tor. Note the main scarp behind the belt of trees.

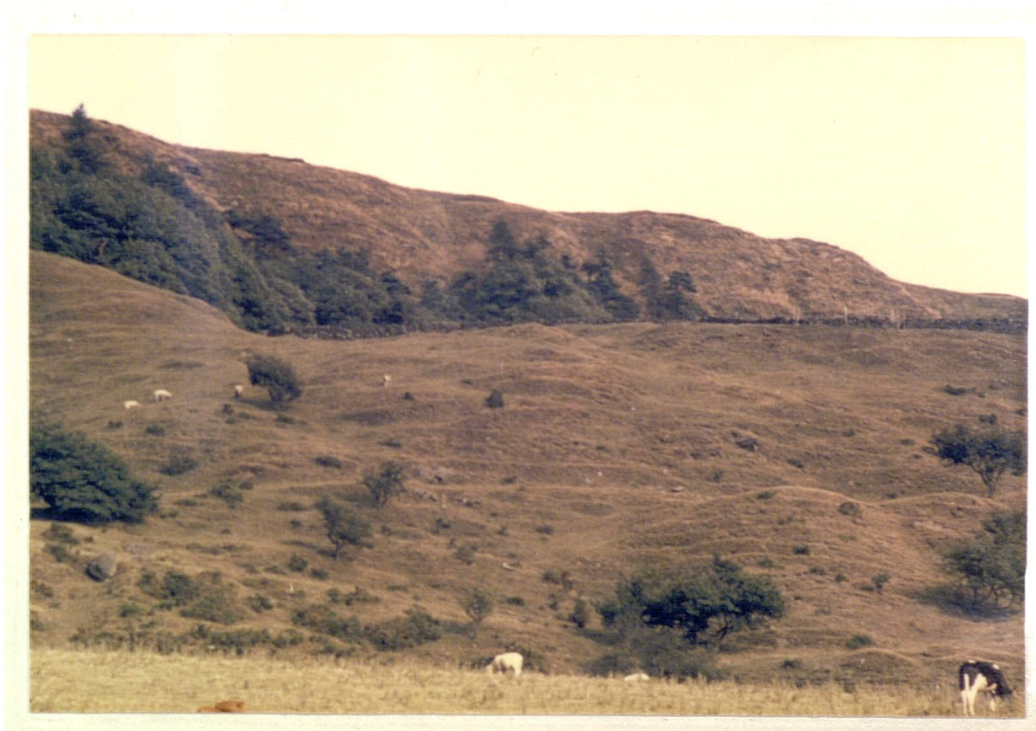
Plate No. 7.29 Main scarp of the landslip at Burr Tor. Note the steep exposure of sandstone of Shale Grit, and hummocky ground at the main unit.

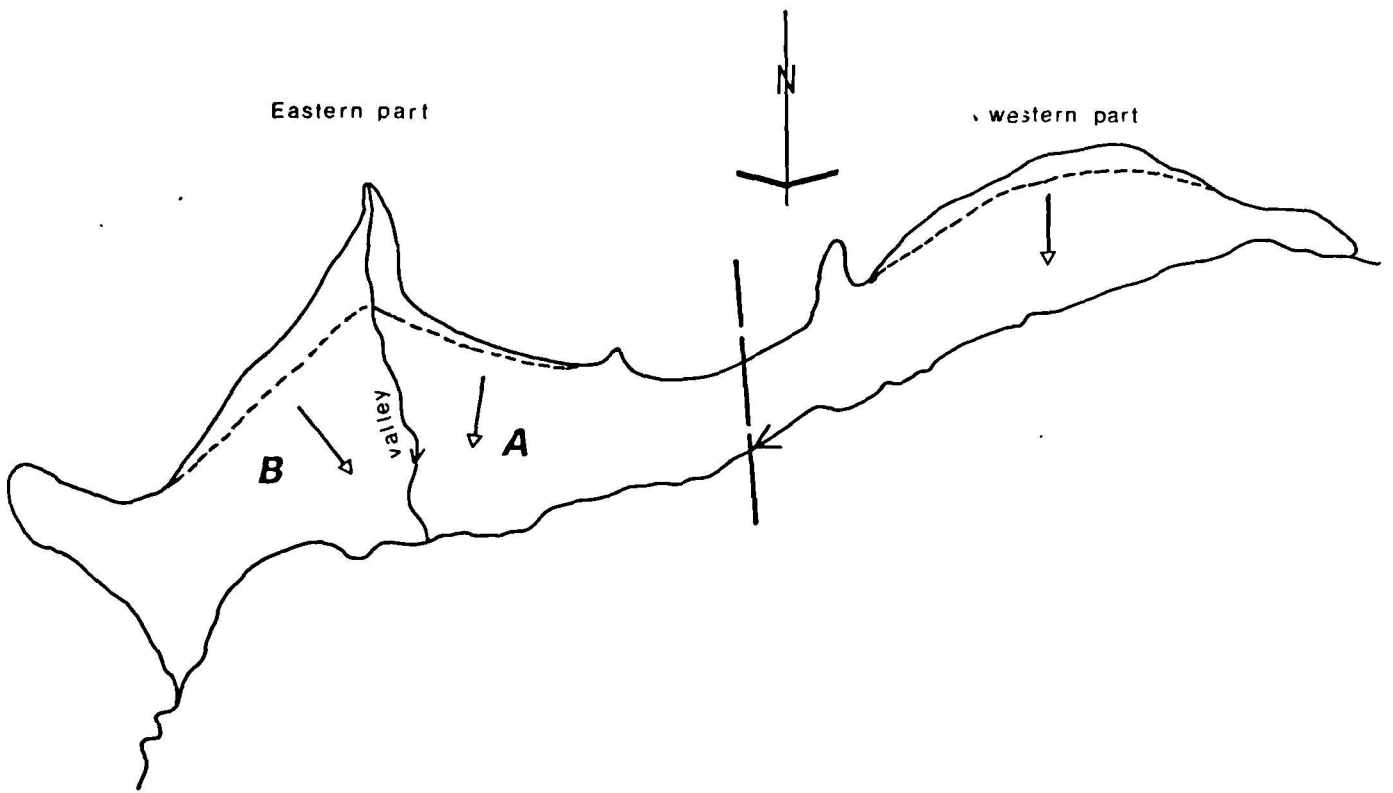
Fig. 7.11 A Sketch showing regional subdivisions of Bretton Clough landslip to which reference is made in the text.

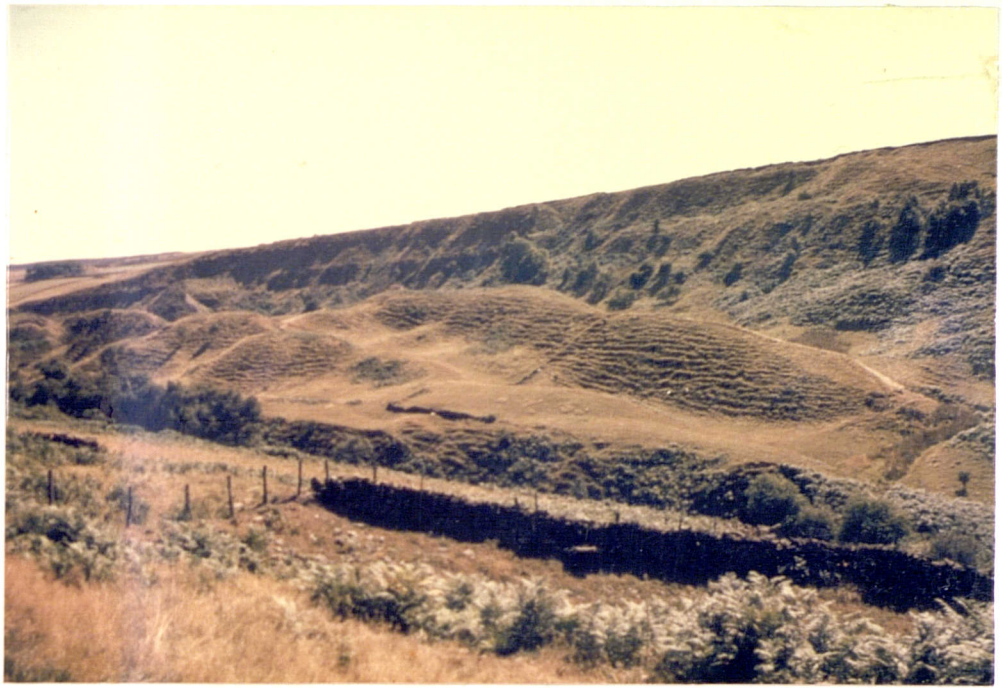
Plate No. 7.31 Western part of the landslip at Bretton Clough. Note ridged ground.

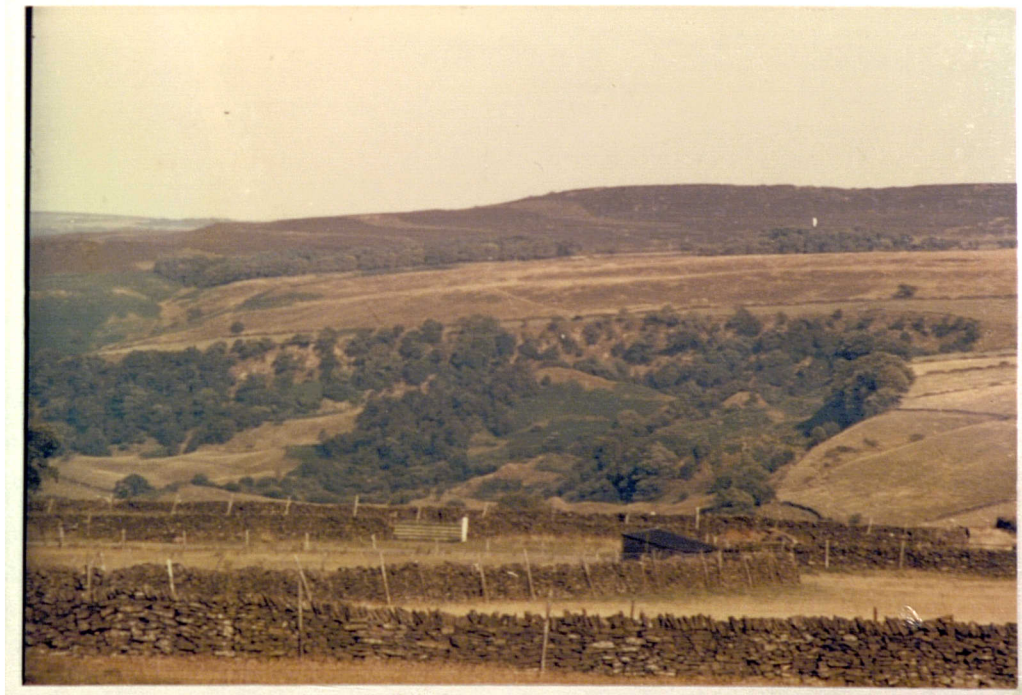
Plate No. 7.32 Eastern landslip at Bretton Clough - general view.

- ii. The main scarp shown in Plates 7.30 and 7.32 is well defined with a maximum height of 21.5m. This area is mostly vegetated.
- iii. A SW-NE trending ridge occurs at the top of the main unit of the landslip. An exposure of sandstone beds in the main unit dips 45° SE while the dip of the sandstone beds in the main scarp is 8° NE. Thus an outward rotation of 53° has occurred.
- iv. At the eastern end, that is at the extreme flank of the landslip, as shown in map Fig. 7.11, a minor scarp forms a series of NE-SW trending steps from the main unit to near the toe of the landslip. The minor scarp nearest to the toe shows recent instability since in Plate 7.34 trees have become bent towards the river.
- v. The toe in this area is not as well developed as the one in Part A.
- vi. Apart from the instability noted in the foot, there is no evidence of movements within the remaining area.

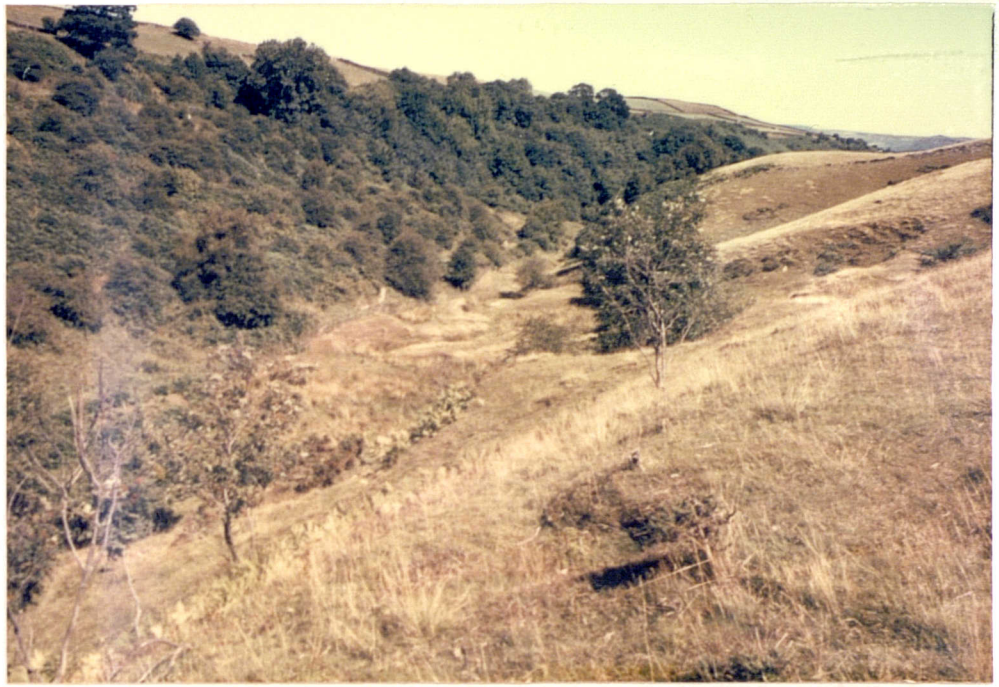
Plate No. 7.33 Part of the toe in the eastern part of landslide at Bretton Clough - Note the gentle slope towards the river.

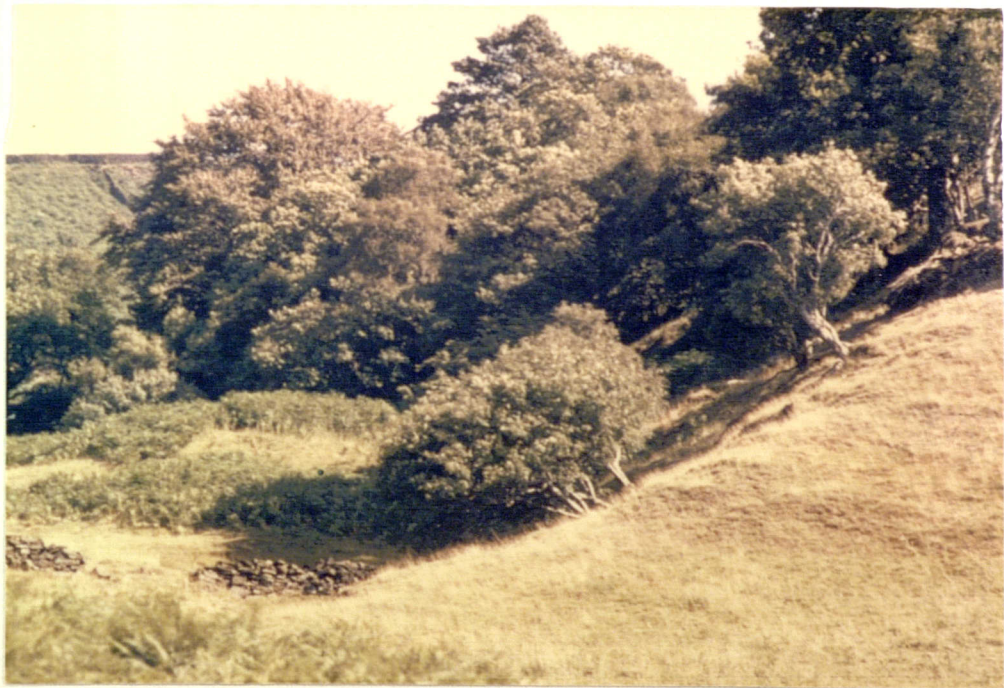
Plate No. 7.34 Minor scarp on the eastern side of Bretton Clough with evidence of recent instability

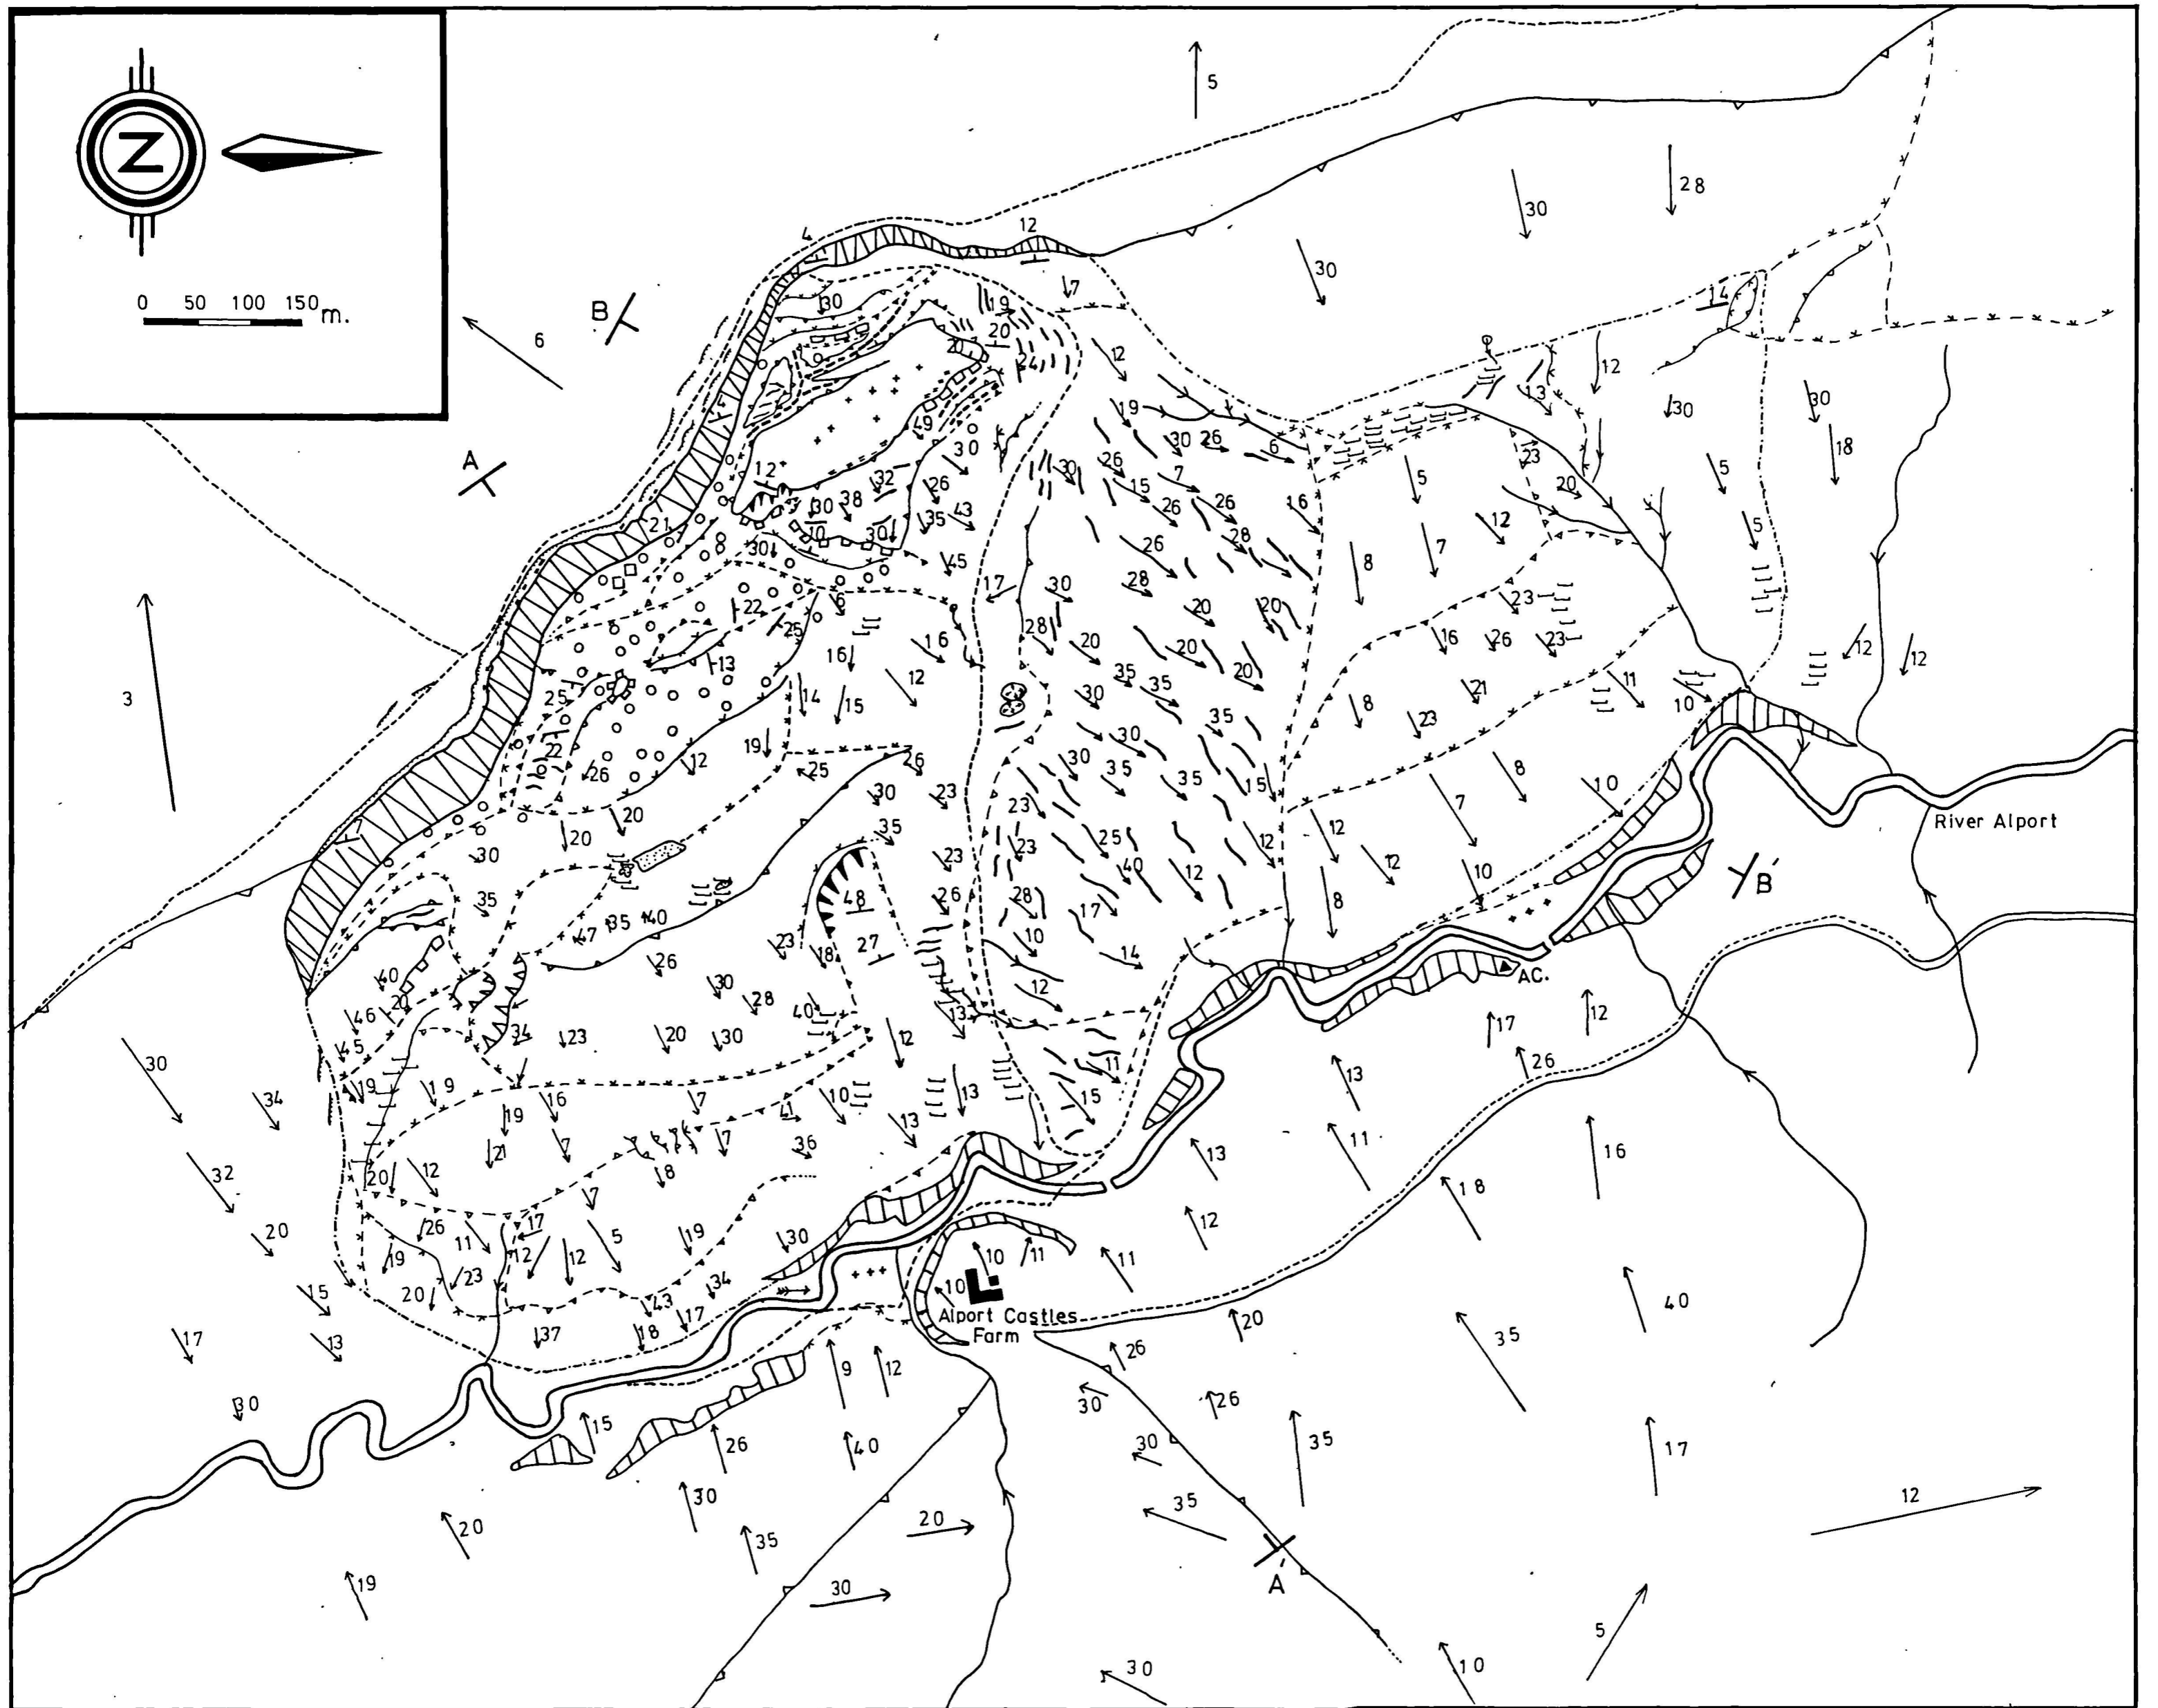
FIG. 7.12 GEOMORPHOLOGICAL MAP OF ALPORT CASTLES LANDSLIP.

Alport Castles, located in Fig. 2.1, is an area of landslip which is one of the most interesting cases of instability in the area studied. It is a complex type of failure with a maximum length 800m. and width 1500m. developed in Millstone Grit Series rocks. Many aspects of the landslip are illustrated on map Fig. 7.12 and Plates 7.35 and 7.36. The main features may be described as follows:

- i. As shown in map Fig. 7.12, the crown of the landslip slopes in the opposite direction to the main scarp. It is mostly vegetated and along the upper edge of the main scarp there are a number of 60-70 cm. deep trenches containing peat as shown in Plate 7.37.
- ii. A well developed main scarp up to 32m. high shown in Plate 7.38 exposes jointed sandstone in thick

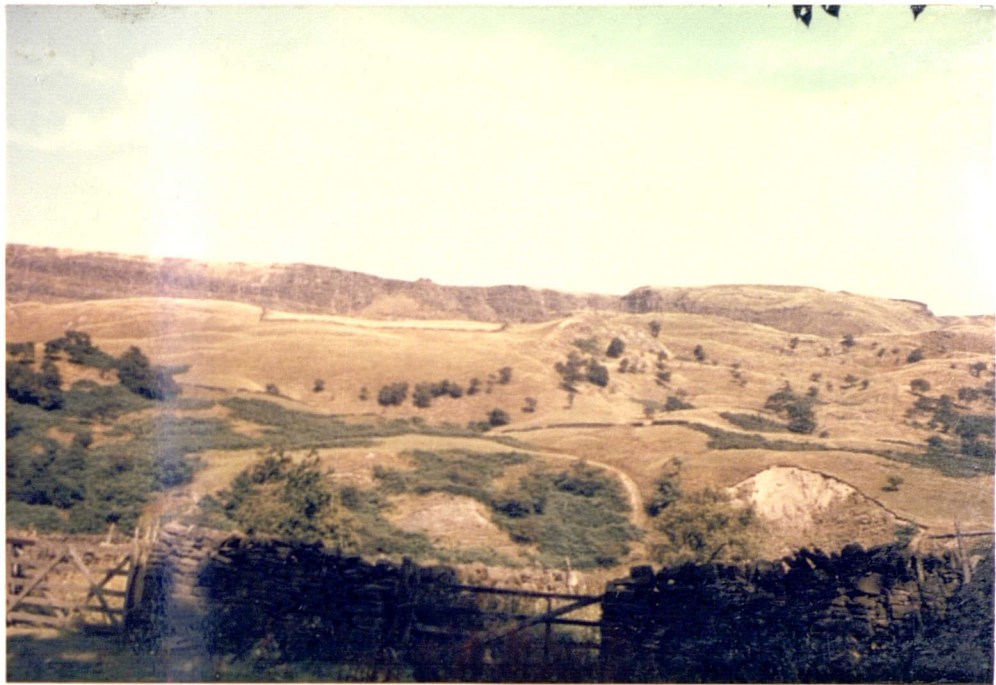
Plate No. 7.36 General view of the landslip at Alport Castles.

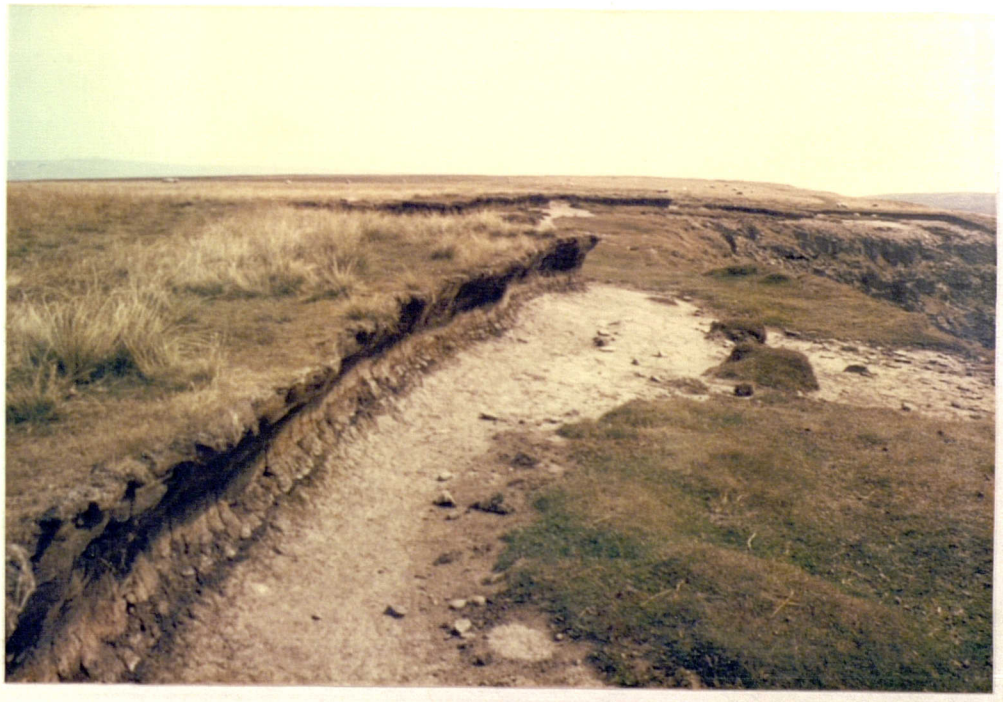
Plate No. 7.37 The crown of Alport Castles landslip. Note the trenches contain peat.

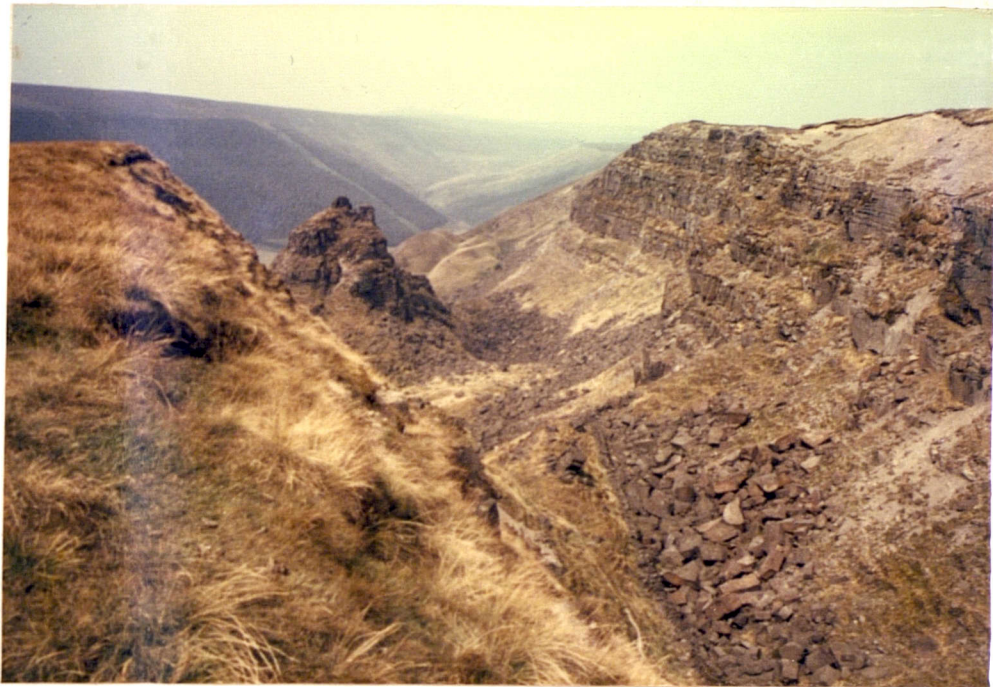
Plate No. 7.38 Main scarp of landslide at Alport Castles showing a recent rockfall. Note the detached of block of the main unit.

- beds. The slope of the main scarp decreases in a southerly direction into a vegetated 30° slope seen in Plate 7.39.
- iii. Instability in the form of rock falls shown in Plates 7.38 and 7.40 affects the main scarp where sandstone blocks form a scree slope.

- i. This area is dominated as a large block 250m. long by 75m. wide shown in Plate 7.35 and 7.41 which appears to have become detached from the large area of ground involved in the initial instability. As shown in Fig. 7.12 A and Plate 7.38, further detached

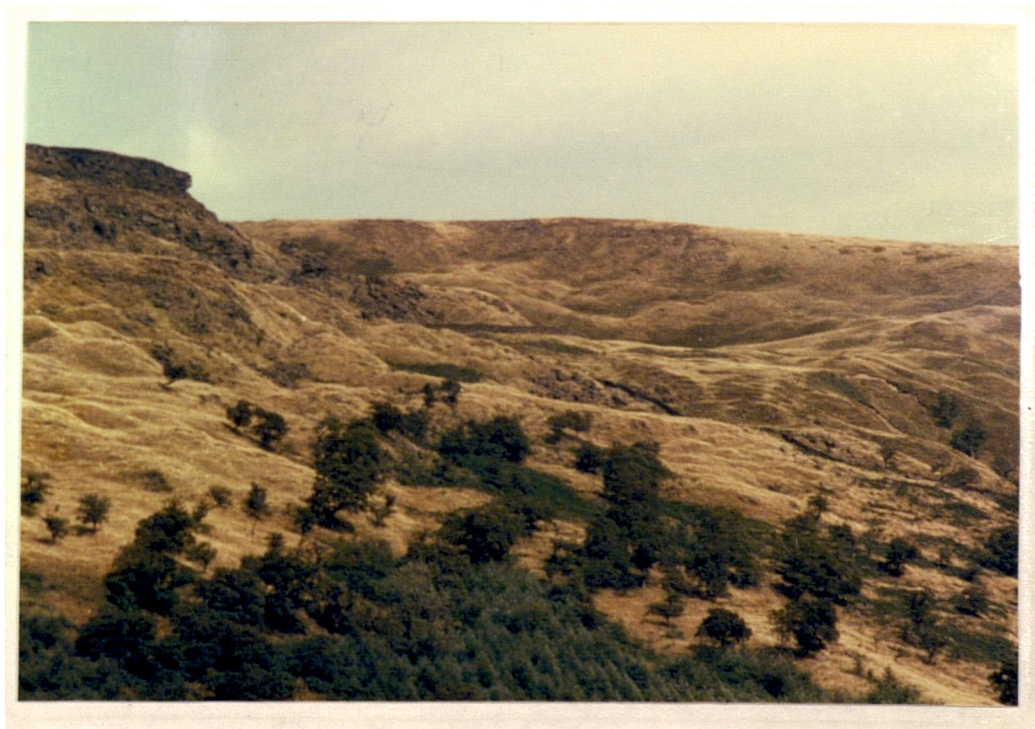
Plate No. 7.39 The main scarp at the southern side of Alport Castles landslide. Note the hummocky ground of the main unit.

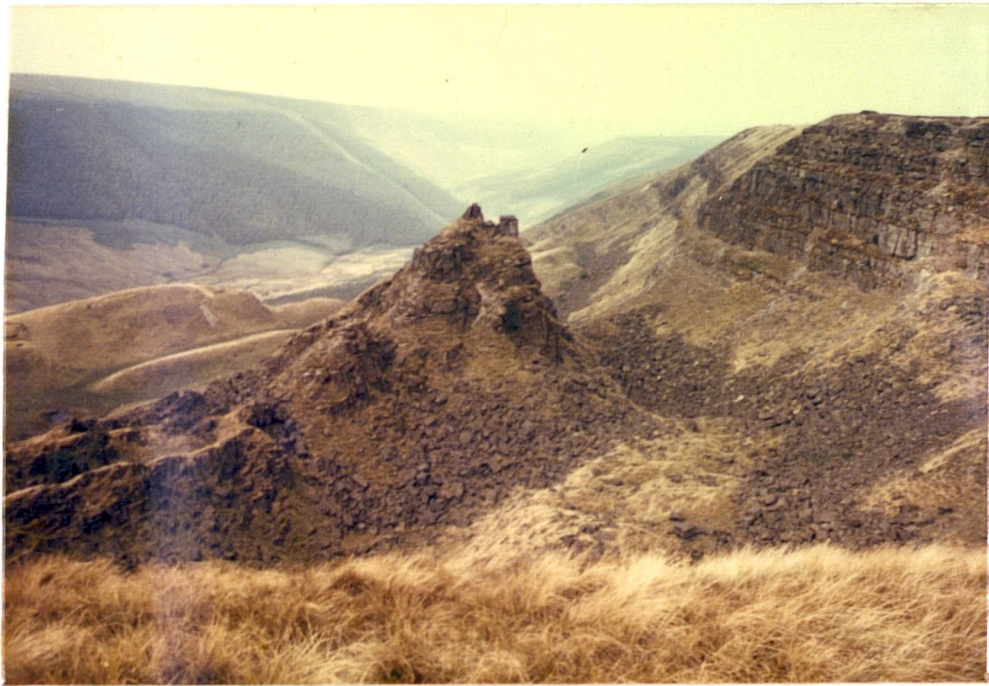
Plate No. 7.40 Scree formed by distribution of sandstone blocks in the main unit of landslip at Alport Castles with a detached block due to secondary movement. Note Back scarp of sandstone and shale beds of Shale Grit formation.

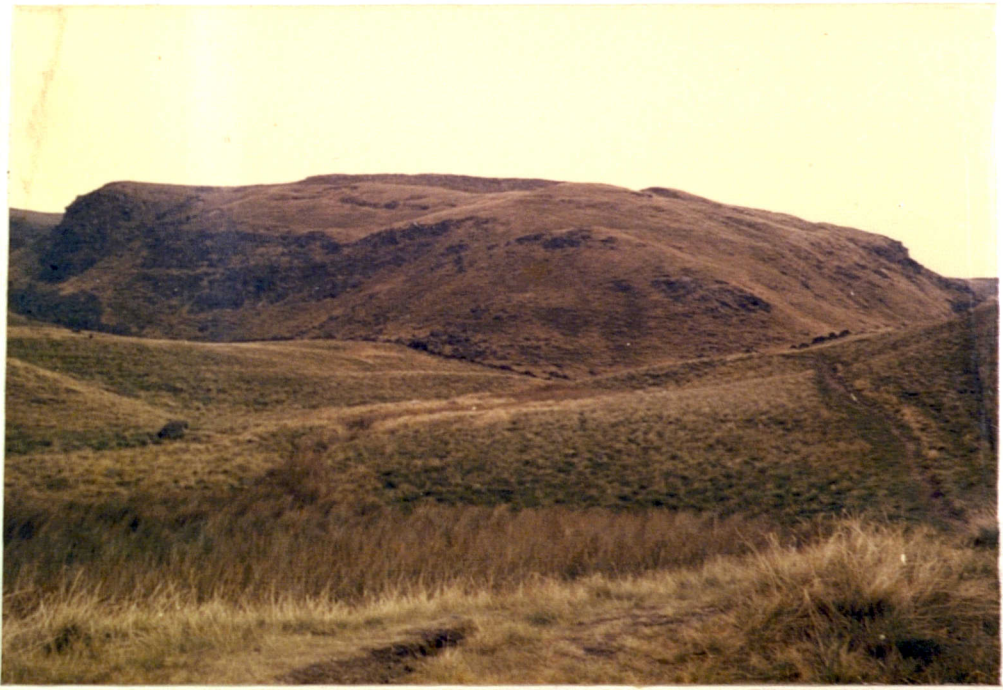
Plate No. 7.41 Part of the main unit of the landslip shows a block of 250 m. by 75 m. wide at Alport Castles landslip.

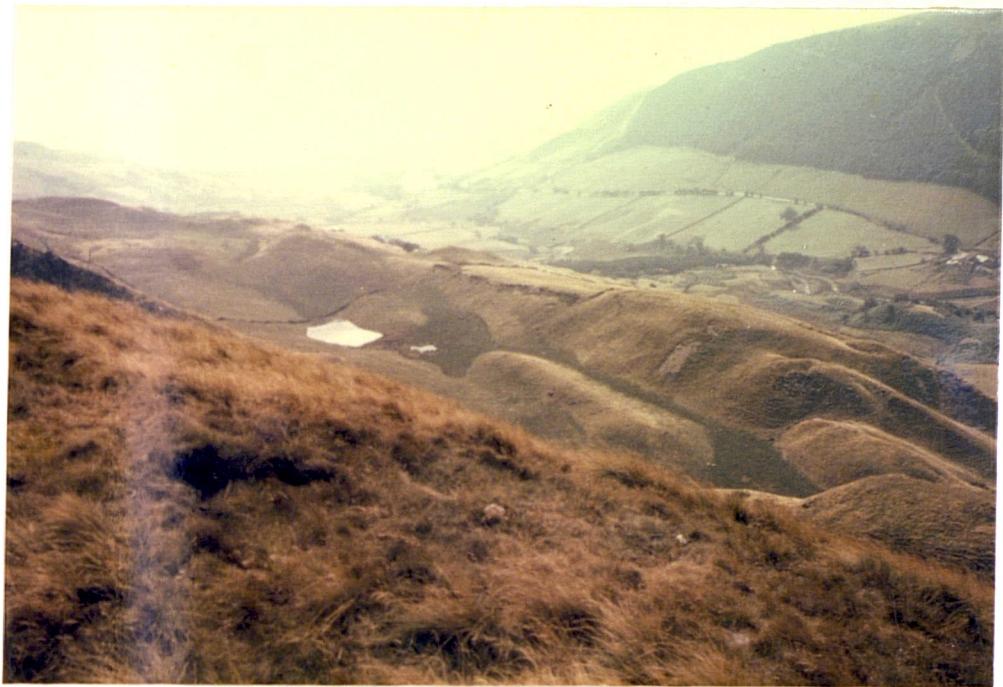
Plate No. 7.42 Northern side of the main unit of the landslip at Alport Castles. Note the ponding of water.

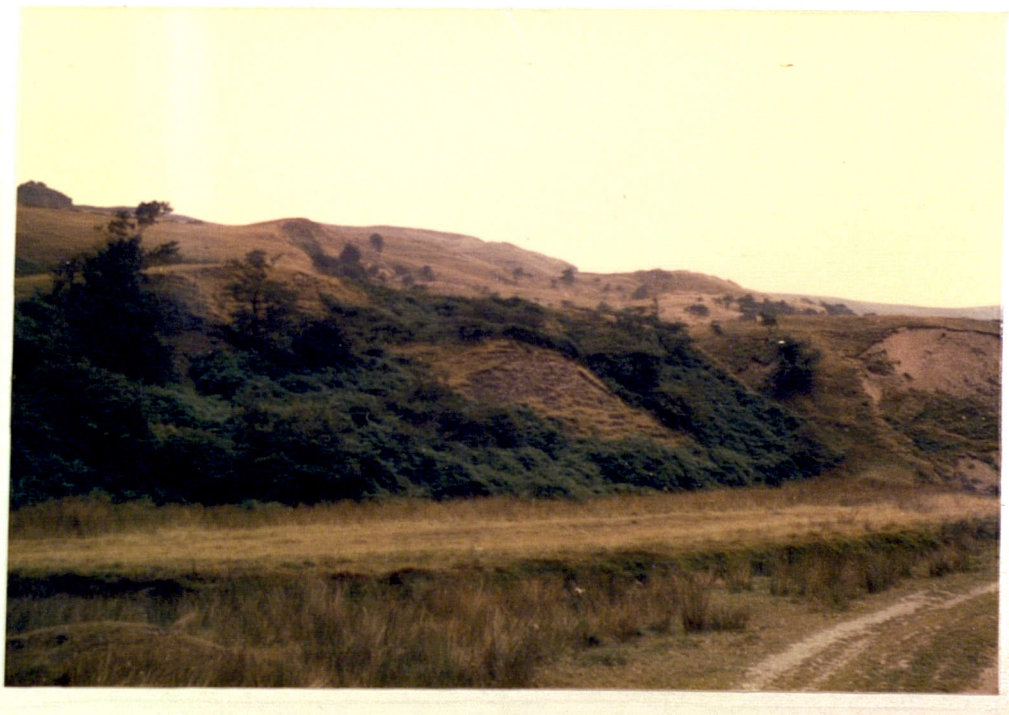
Plate No. 7.43 Part of the toe at landslip of Alport Castles forming minor scarp along flank of river Alport.

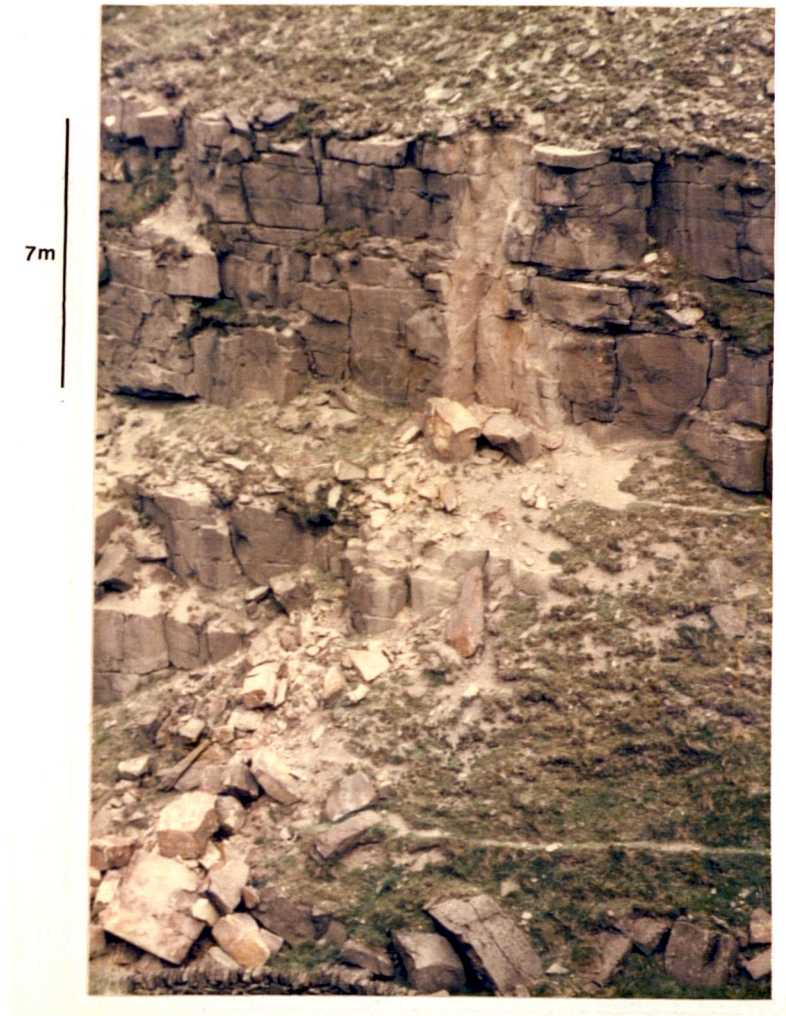
Plate No. 7.44 Recent rockfall in the main scarp
at Alport Castles. August 1982
Scale 1cm. = 0.5m.

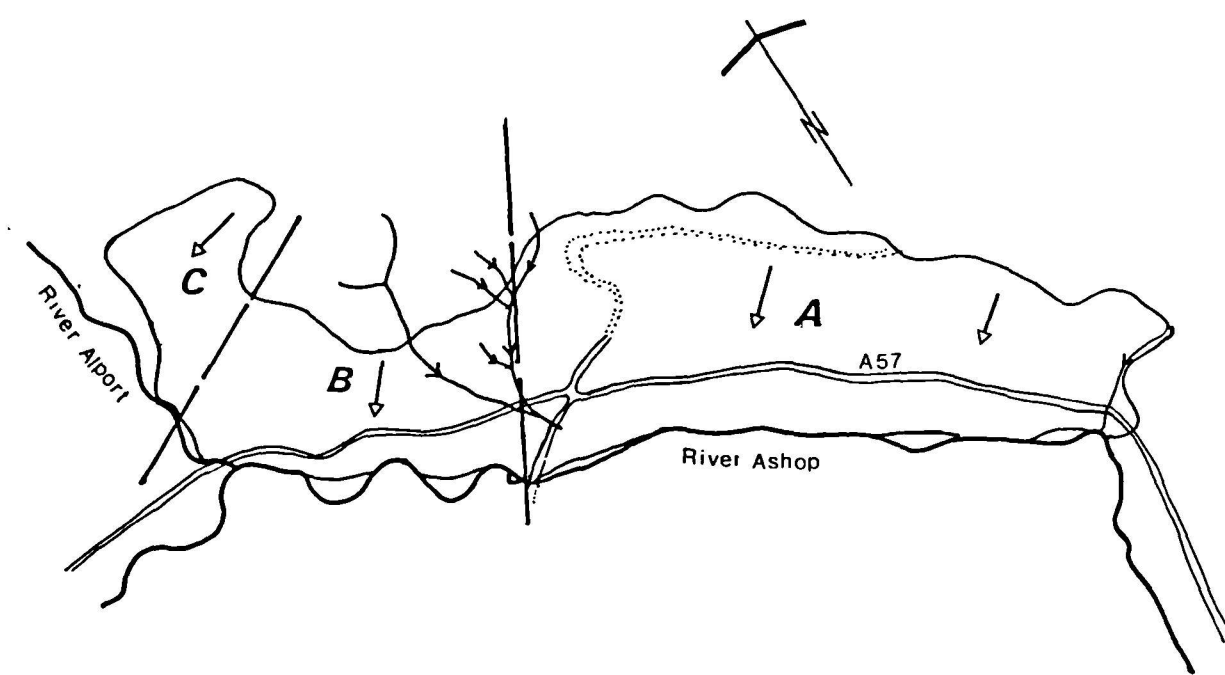
Fig. 7.13 A Sketch showing regional subdivisions of Rowlee Pasture landslip to which reference is made in the text.

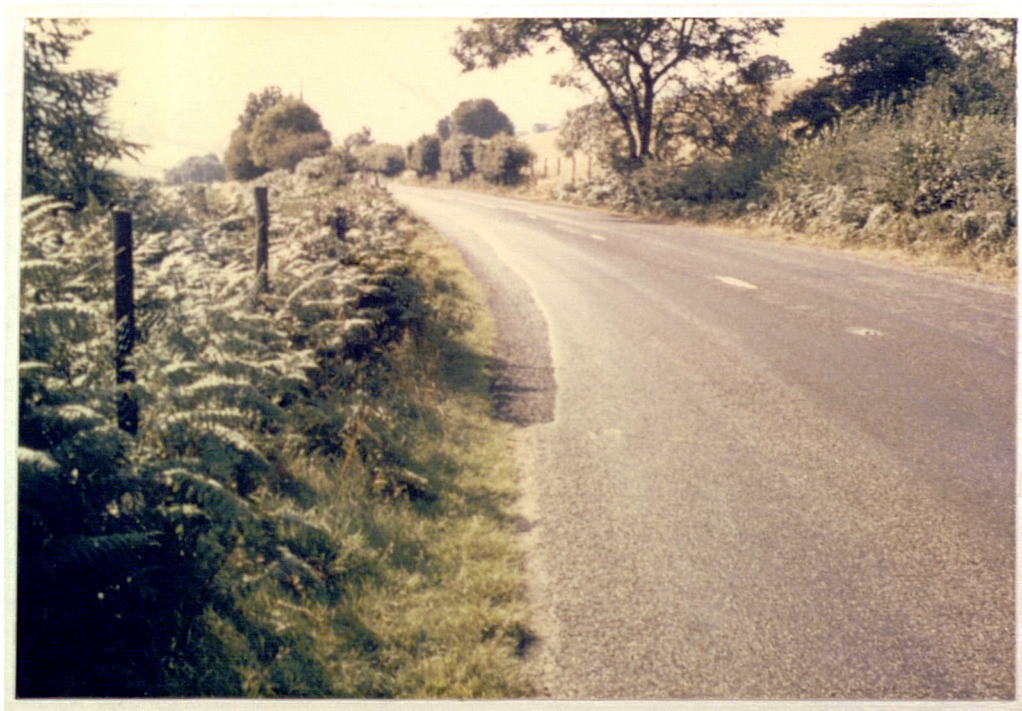
Plate No. 7.47 Repairs to the A57 road due to movements of the landslide at Rowlee Pasture.

Recent activity of this landslip is indicated along the A57 road and particularly in the area of the toe where fences and traffic signs have been displaced. The edge of the road shown in Plate 7.47 and 7.48 is subjected to fracturing and measures to prevent erosion of the toe of the landslip by the River Ashop include the construction of gabions and concrete walls, shown respectively in Plates 7.48 and 7.49. However, as indicated in Plate 7.50, these defences have not entirely prevented movement. No landslide activity was noticed in the remainder of area C.

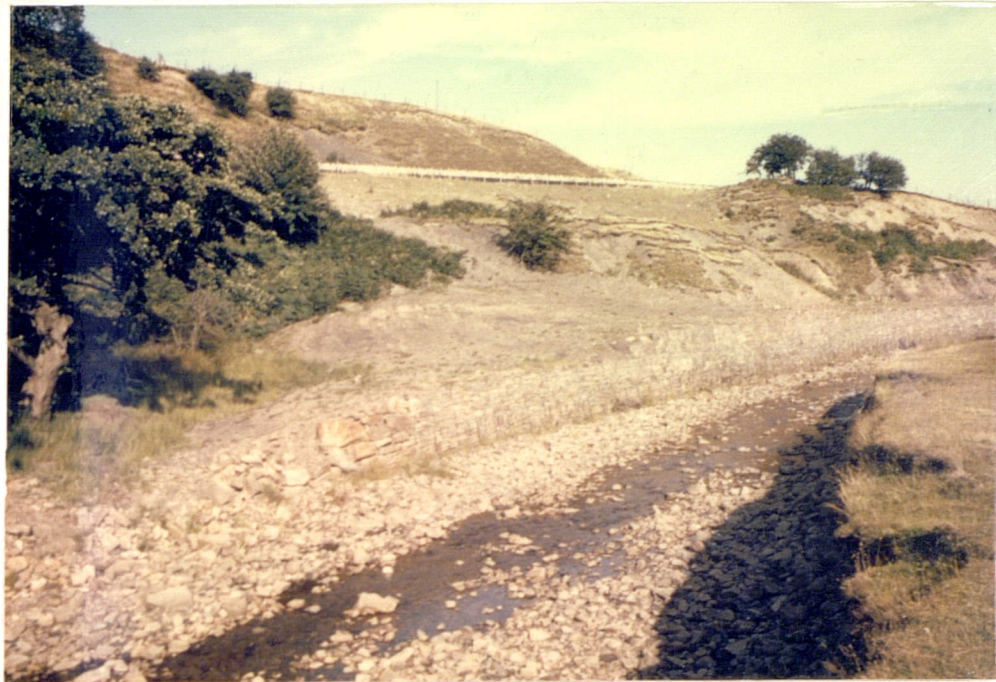
Plate No. 7.48 Gabbion wall to protect the toe of the landslip at Rowlee Pasture.

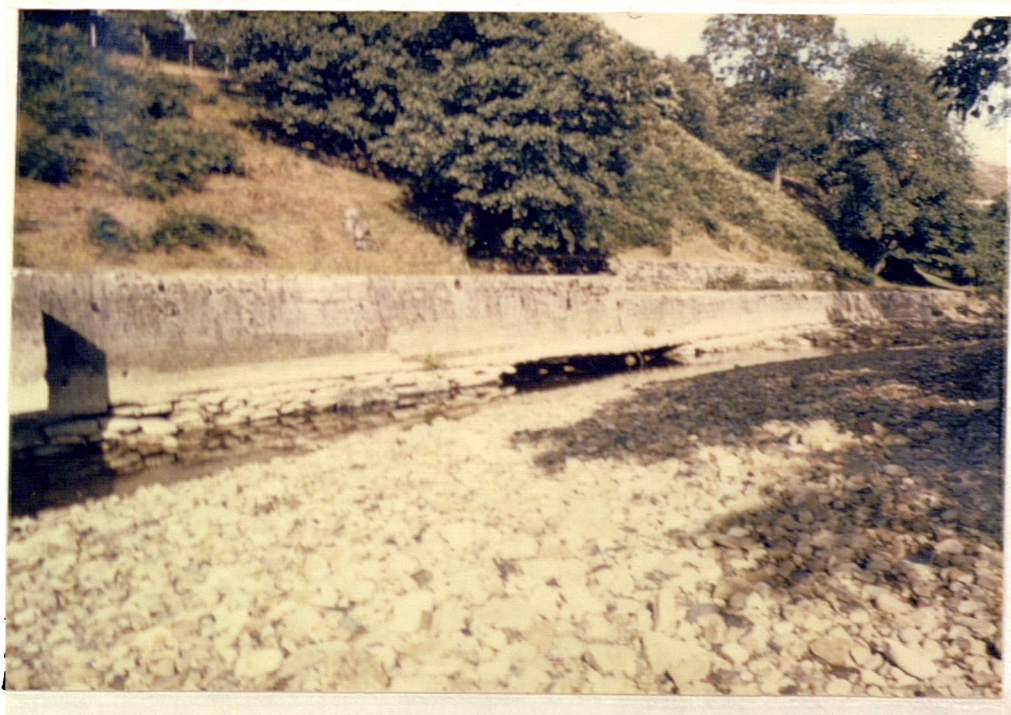
Plate No. 7.49 Concrete wall to protect the toe of the landslip at Rowlee Pasture.
