A STUDY OF RESIDUAL SHEAR STRENGTH OF NAMURIAN
SHALES IN RESPECT OF SLOPES IN NORTH DERBYSHIRE.

VOL II

Thesis submitted in fulfilment of the requirements for the
Degree of PH.D.

Department of Geology
University of Sheffield

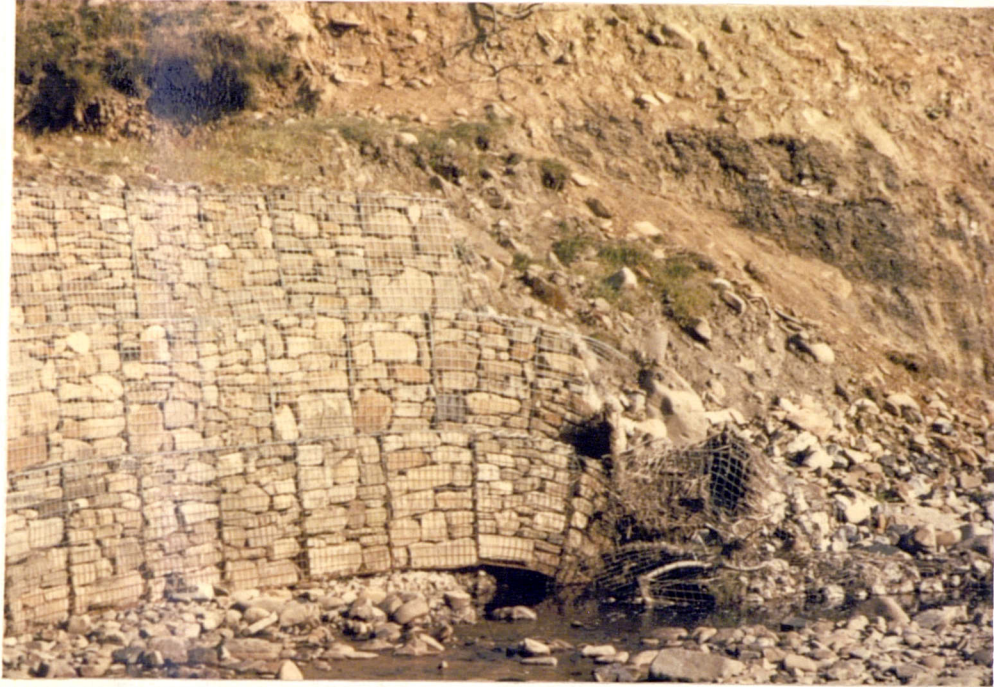
Plate No. 7.50 The gabbion protection has not entirely prevented movement of toe of the Rowlee Pasture landslide.

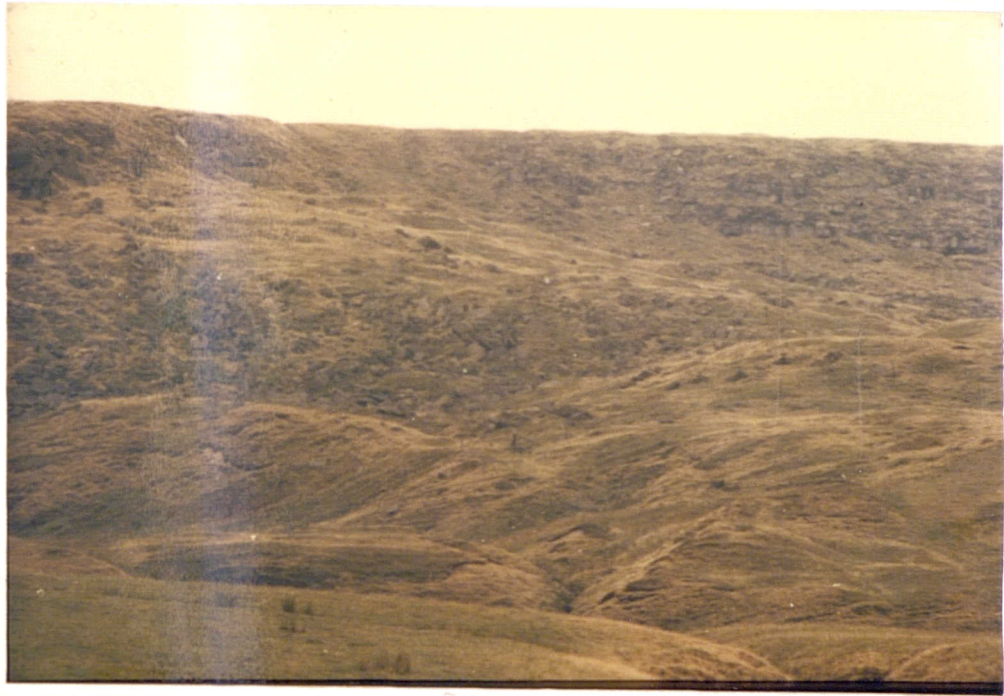
Plate No. 7.52 Main scarp and main unit of landslip at Cowms Moor. Note the exposure of sandstone of Shale Grit formation in the main scarp at 'A' and the fallen sandstone block in the main unit at 'B'.

- ii. A well developed main scarp that attains a maximum height of 39 m. and which decreases in steepness in a westerly direction as illustrated in Plate 7.52, consists of sandstone beds. Water seepages from joints in this area supply the streams flowing across the main unit.

- v. A number of fallen sandstone blocks are distributed over the main unit (See Plate 7.52).
- vi. Minor scarps clearly mark the eastern flank of the landslide as in map Fig. 7.14 but the western flank is less prominent. Plate 7.53 is a typical view of the hummocky ground of the main unit.

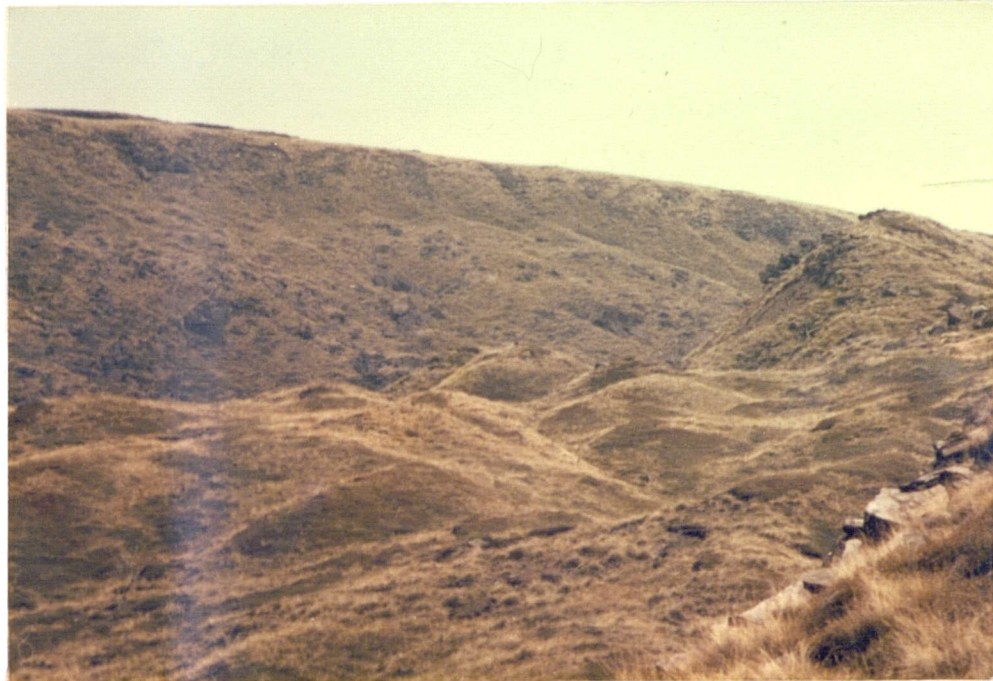
Plate No. 7.53 Hummocky ground in the main unit of landslide at Cowms Moor.

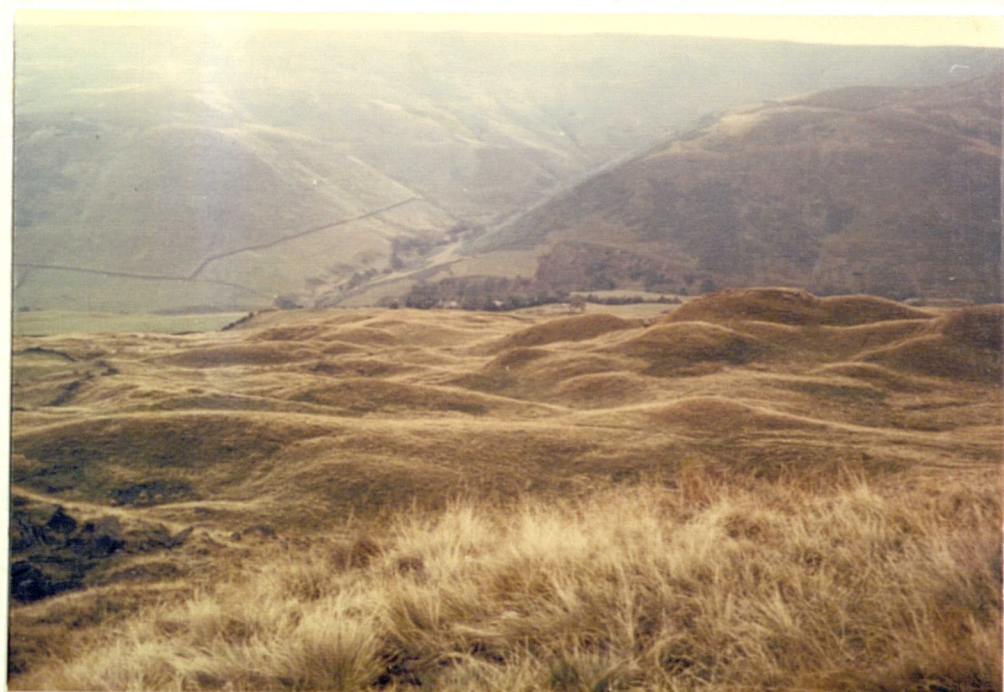
Plate No. 54 The main unit of the lower slip at Cowms Moor. Note the NW-SE ridges and hollows.

- ix. The eastern side of the main unit of the lower movement is characterized by differentiated NW-SE ridges and hollows as shown in Plate 5.54. Towards the west, and also in the middle part of the main unit, the ridges become less intensive.

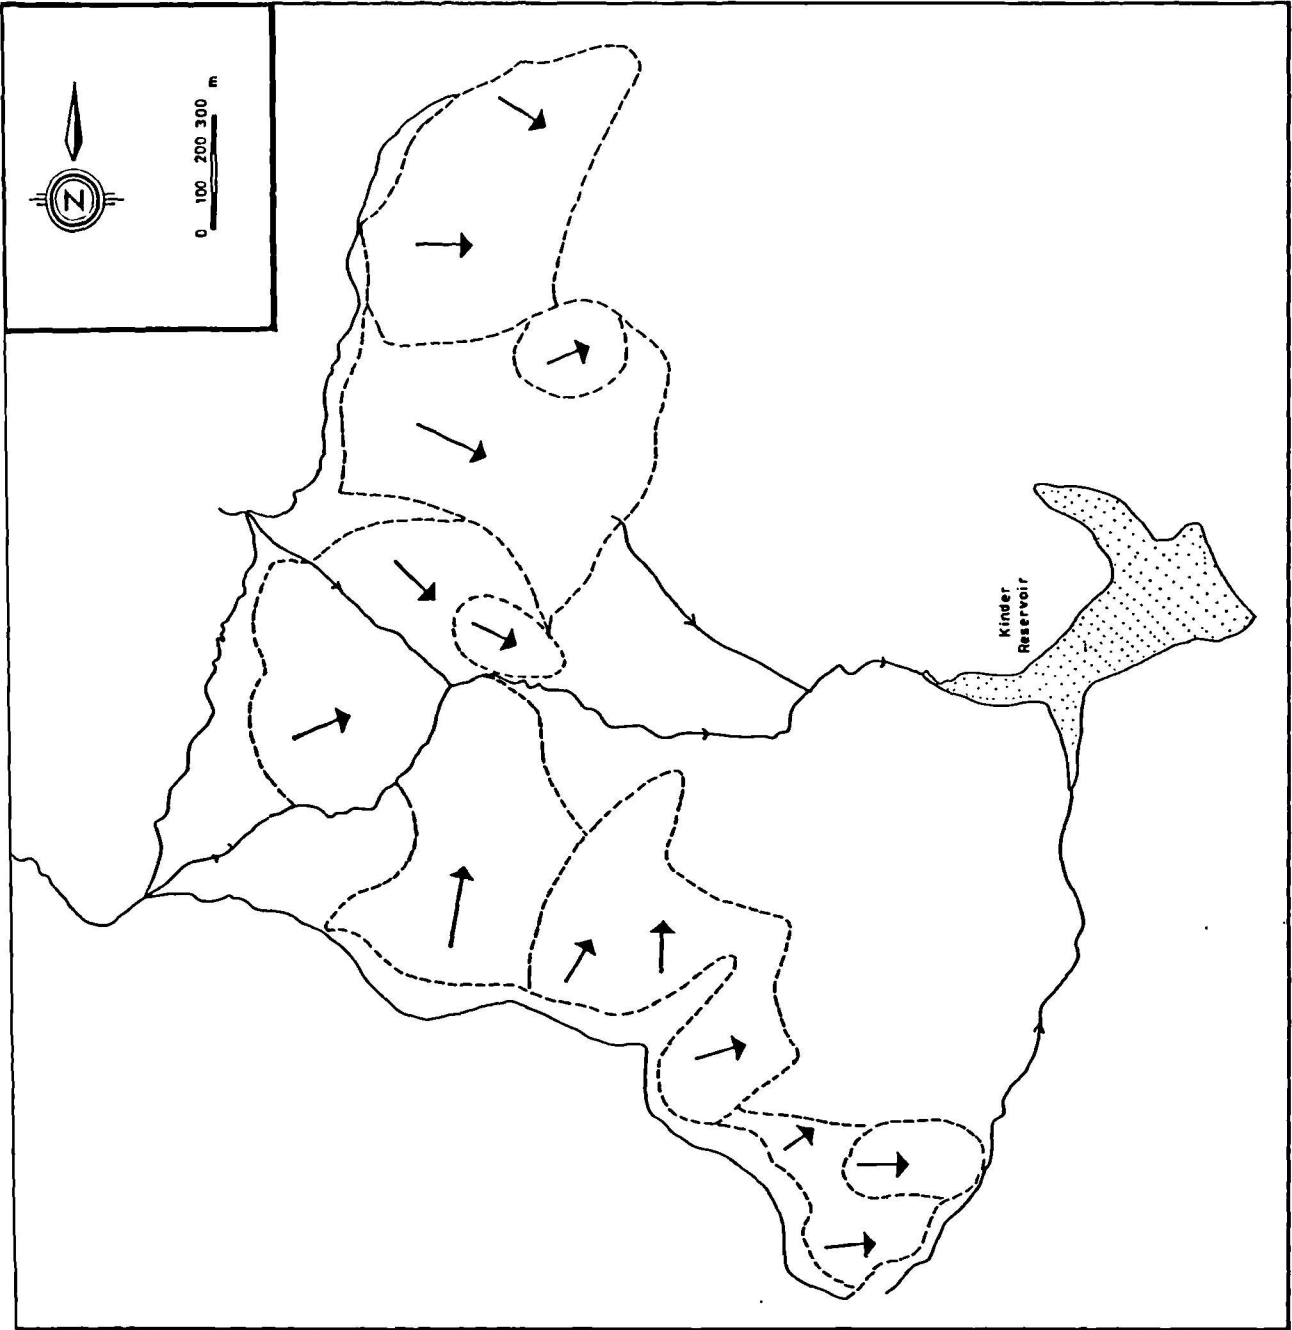
FIG. 7.16 AREAS OF INSTABILITY AND THE POSSIBLE DIRECTION OF MOVEMENT AT KINDER SCOUT.

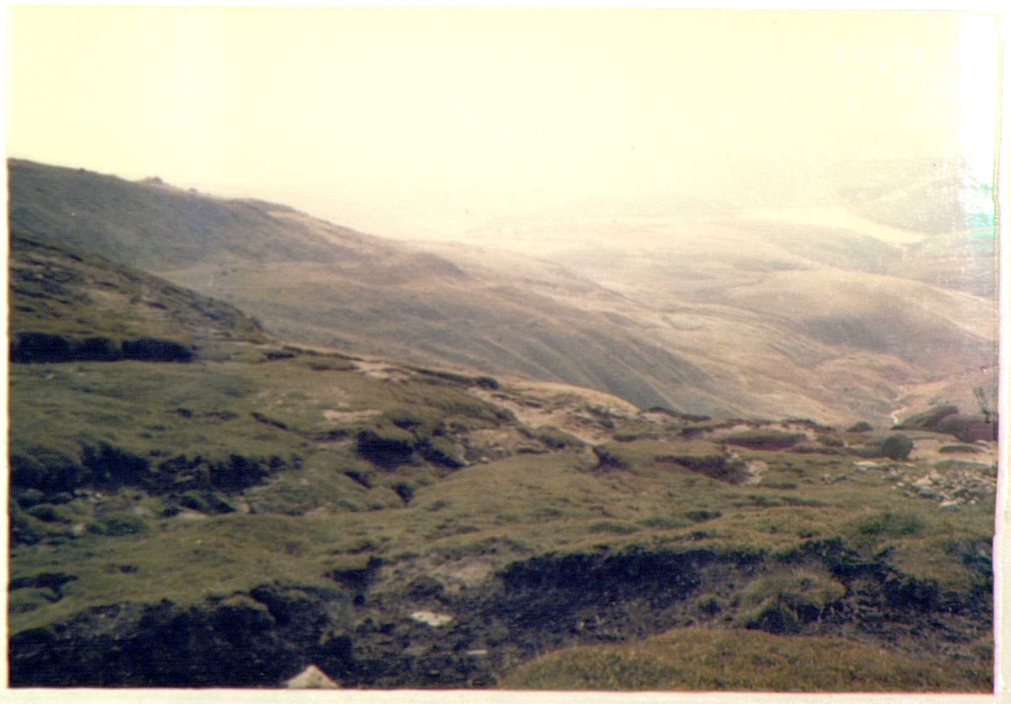
Plate No. 7.57 Crown of landslips at Kinder Scout showing the surface drainage.

- i. The crowns of the landslips are very nearly flat with some exposures of coarse feldspathic sandstone in thick exfoliating beds which are illustrated in Plate 7.56. Although the surface water drainage system shown in map Fig. 7.15 and Plate 7.57 is well developed over the whole of the crown with streams and ditches, the area is very wet with marshes in some places.

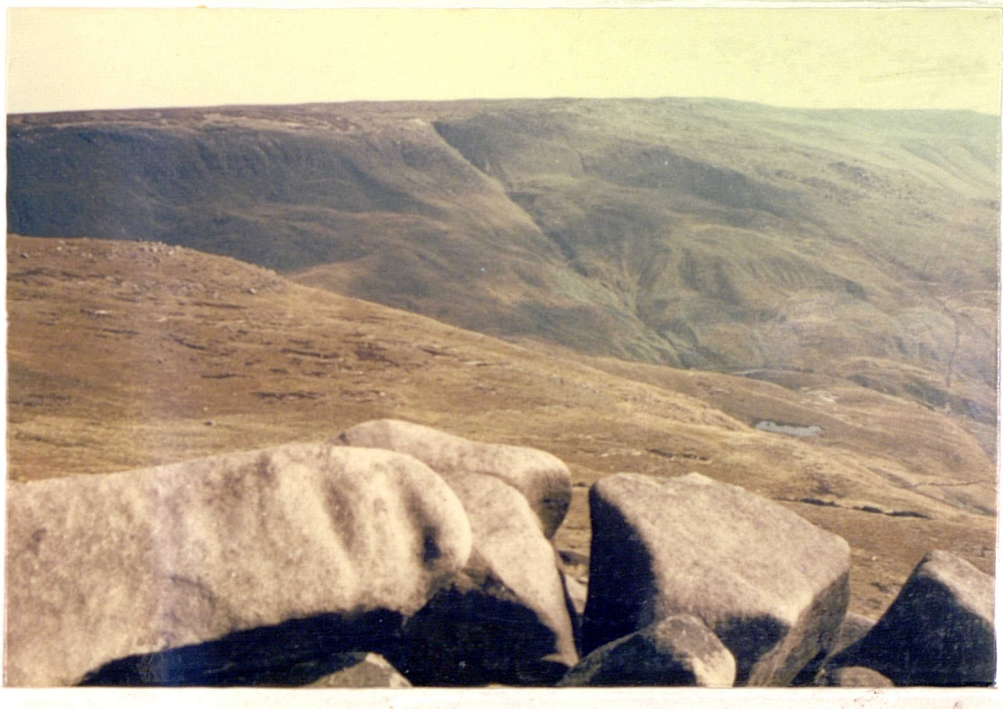
Plate No. 7.58 The landslide in the SW part of Kinder Scout. Note. Exposure of sandstone at the crown and the ponding water.

- ii. The main scarp of the landslide consists of two faces at right angles to each other with Kinder Downfall stream at the intersection. Plate 7.56 show NW area and the SW part is shown in Plate 7.58. The vertical back scar face occurs in Kinderscout Grit Sandstone and is shown in Plate 7.59.

- iii. The main units of the landslide exhibit different slopes as indicated in map Fig. 7.15. Plates 7.56 and 7.58. A number of fallen blocks of sandstone are distributed over the main unit which is mostly vegetated except for certain areas represented on map Fig. 7.15 by dip and strike readings.

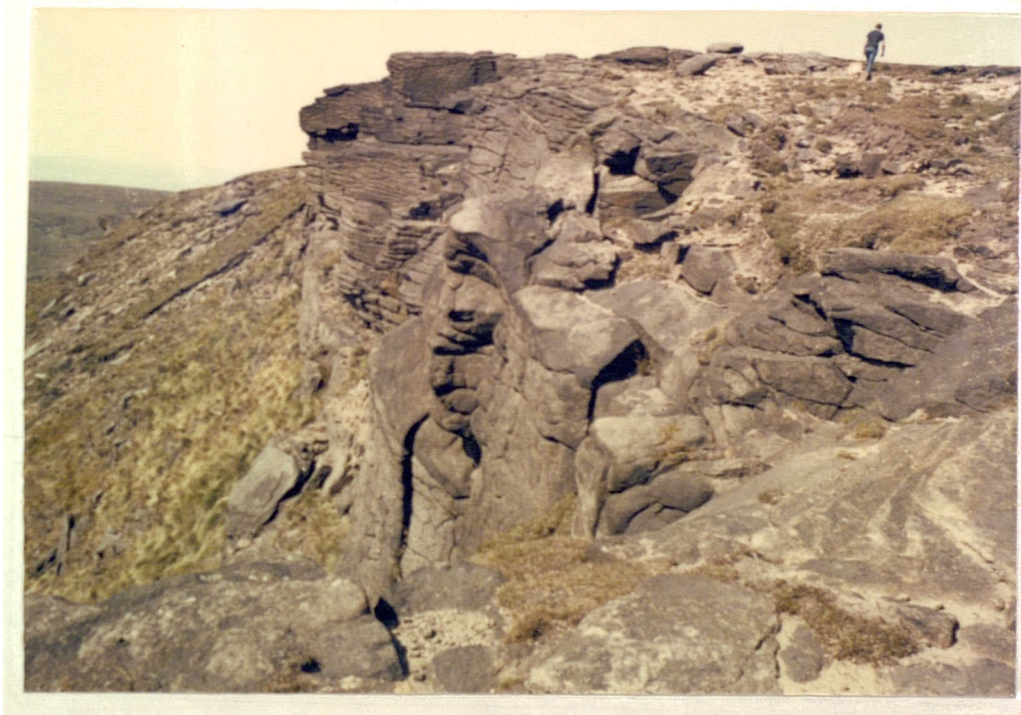
Plate No. 7.59 Kinder Scout sandstone cliff forming part of NW Main scarp.

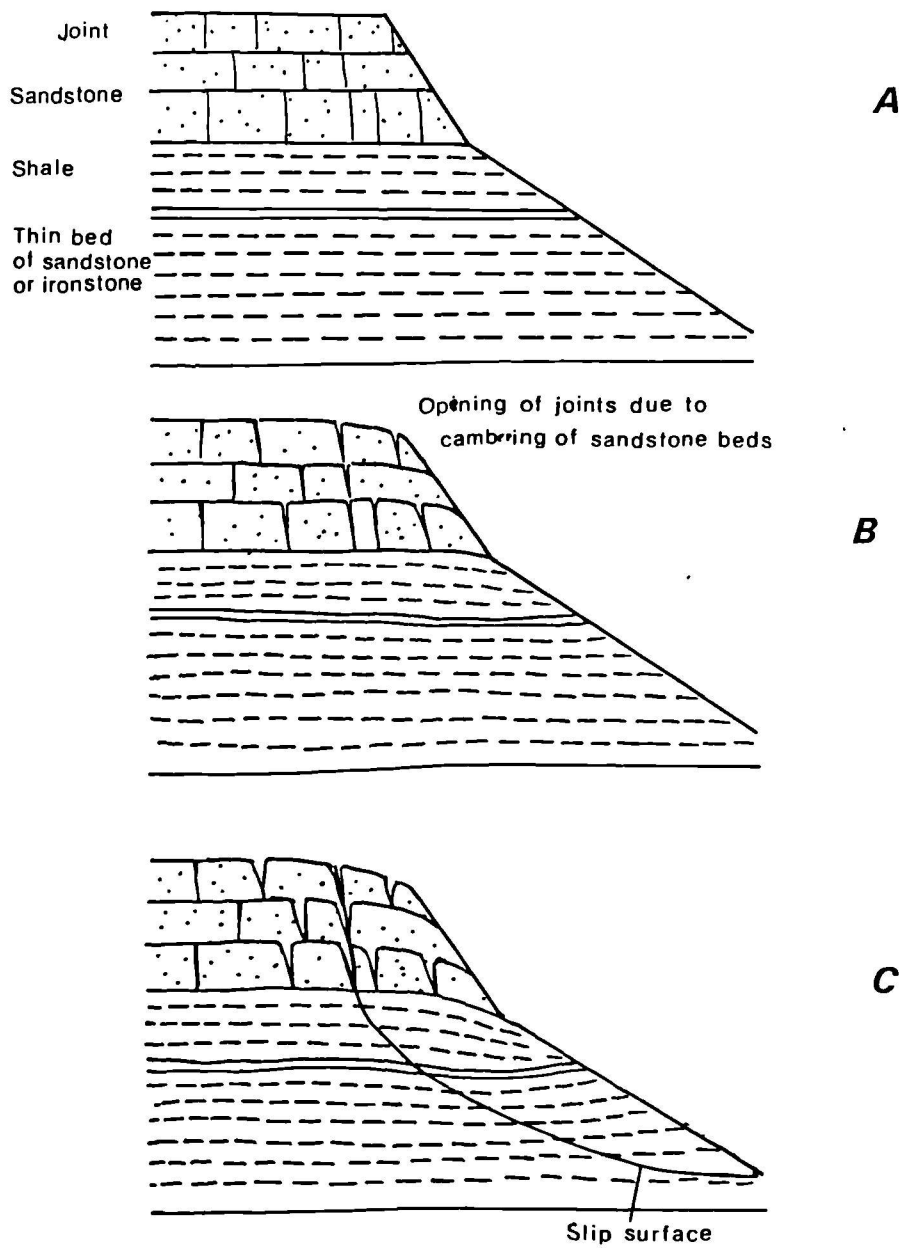
Thick beds of jointed sandstones of the Mam Tor Sandstone and also the Shale Grit Formation overlying relatively weak beds of shale. High load causes cambering of the sandstone beds over the shale which results in opening of joints as shown in fig. 7.17 A and B. The shale beneath the sandstone beds becomes deformed as shown in Fig. 7.17 C.

Fig. 7.17 Possible evolution of landslips.

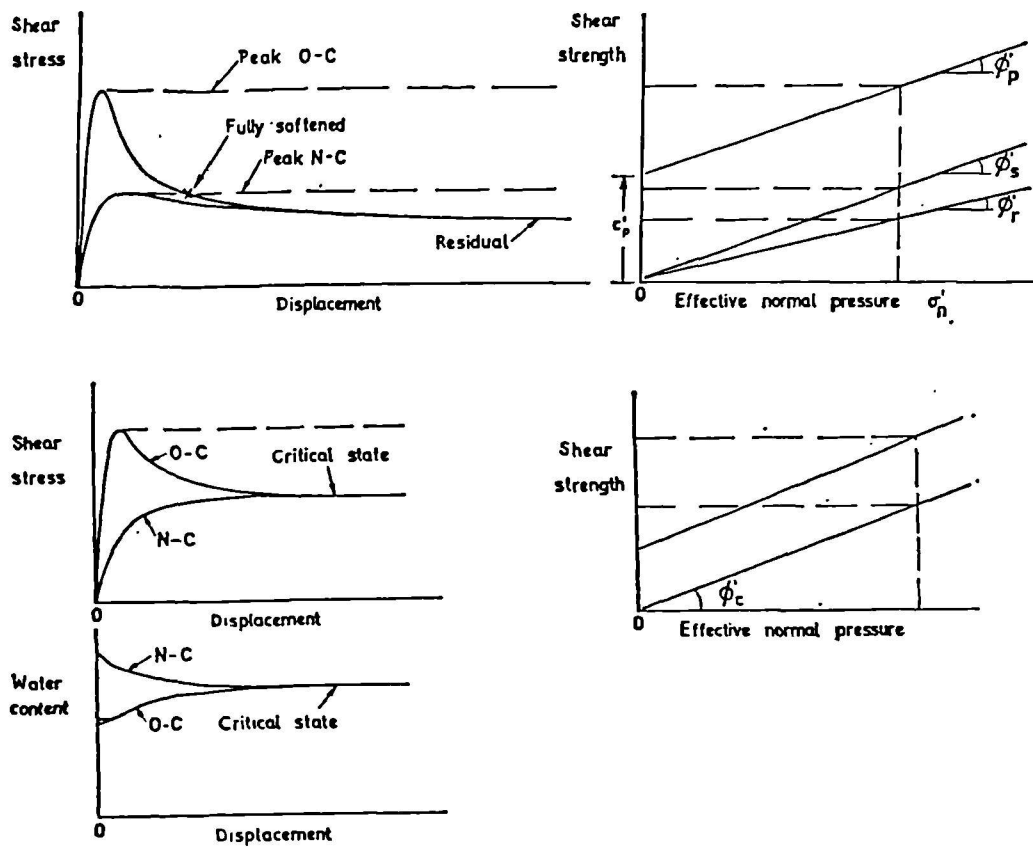
Fig. 8.1 Critical state for drained shear tests on ideal clay (After Skempton, 1970).

According to Skempton (1970) the stability of first-time slides in over-consolidated clay is controlled by the fully softened or remoulded strength and residual is appropriate to the analysis of over-consolidated clay with pre-existing failure planes. It is argued with reference to Fig. 8.1 that whatever the original condition of a clay, drained shear is accompanied by dilation in the case of over-consolidated clays and contraction in under-consolidated clays so that ultimately a condition of normal consolidation is attained during shearing. Roscoe et al (1958) define a critical condition after which further increments of shear distortion cause no change in water content, this is an equivalent condition to normal consolidation. Although Schofield and Wroth (1968) concluded that the peak strength of a normally-consolidated remoulded clay occurs just before the critical state is reached and he suggest a value of $\phi_c' = 22.5^\circ$ for London Clay compared with the remoulded peak strength of 20° found by Skempton (1970) for practical purpose, the critical condition strength is taken as being equal to the fully softened strength of an over-consolidated clay or the peak strength of remoulded normal consolidated sample.

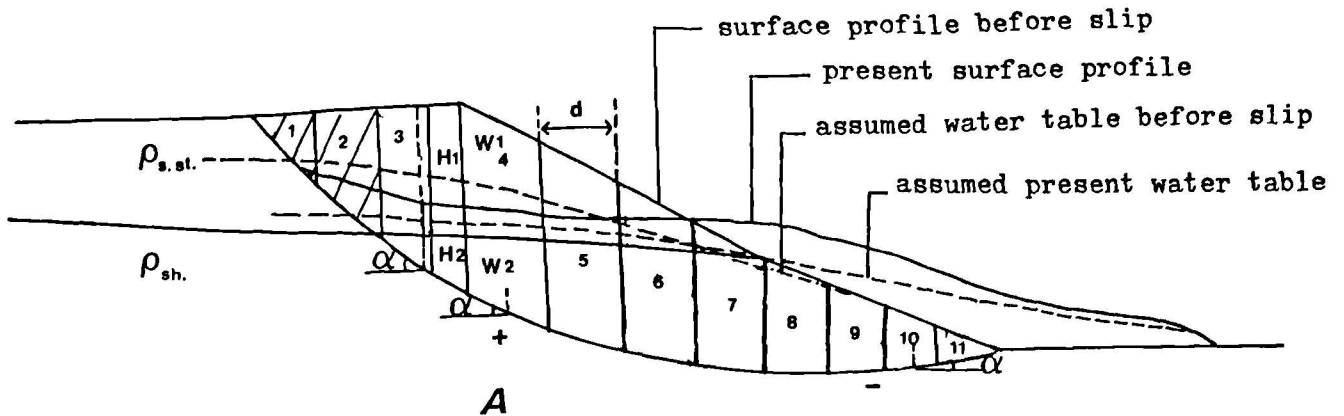
NOTE THAT: slices 1 - 8 the weight causes instability (+) whereas in slices 9 - 11 it contribute to stability (-).

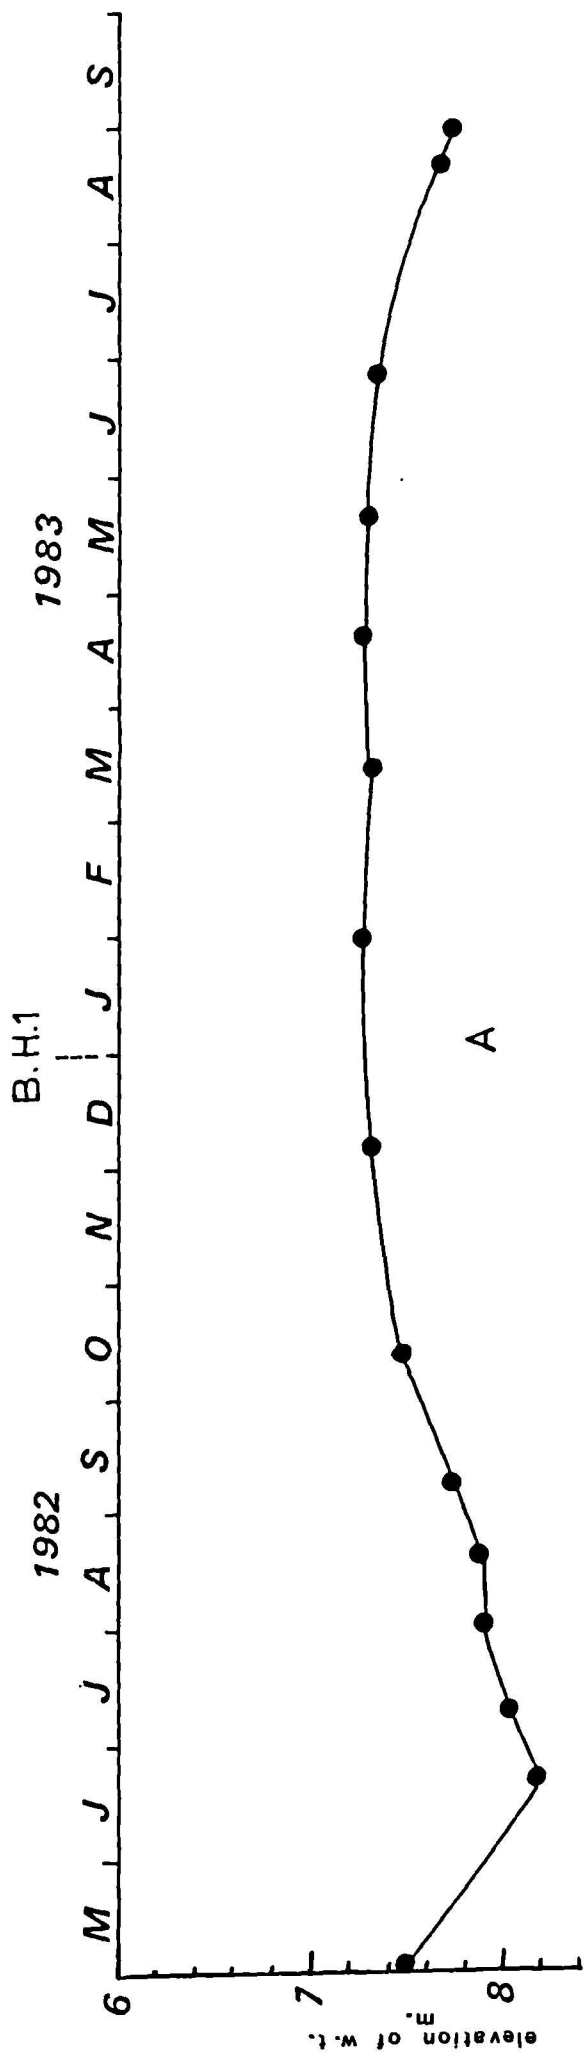
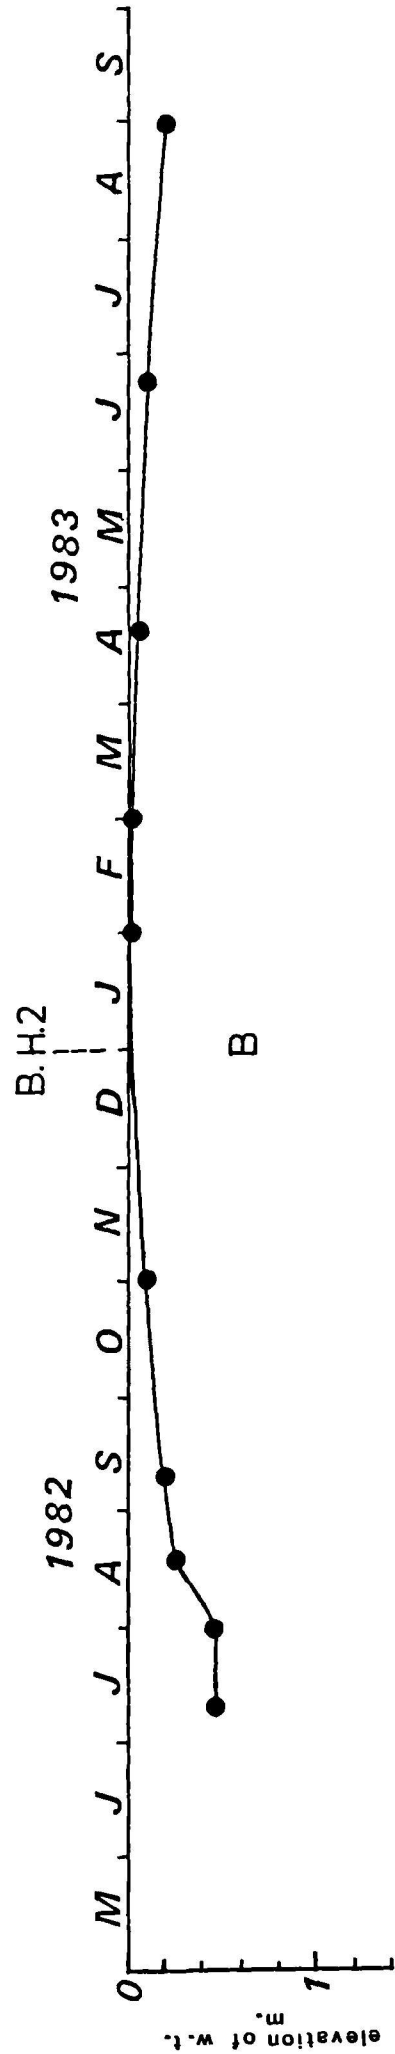
Fig. 8.4 Piezometers reading at Bore holes 1 and 2 (Mam Tor).

Finding a suitable position for the water table in the case of the post-failure analyses is much easier than for first-time sliding. At Mam Tor, the piezometers readings are available (See Fig. 8.4). However, since the cross section chosen for determination the stability of Mam Tor landslip does not pass through the measuring positions, the water table was extrapolated on a tranverse sections (See Map Fig. 7.3), again using a shape which reflects in a subdued manner the ground surface. For the other landslips for which no measurements of the elevation of water table are available, the elevation of water table has been estimated after considering the location of marshes and seepages. These were observed during geomorphological maps work. Again different heights of water table were tested by trial and error analyses, and the most satisfactory one was adopted.

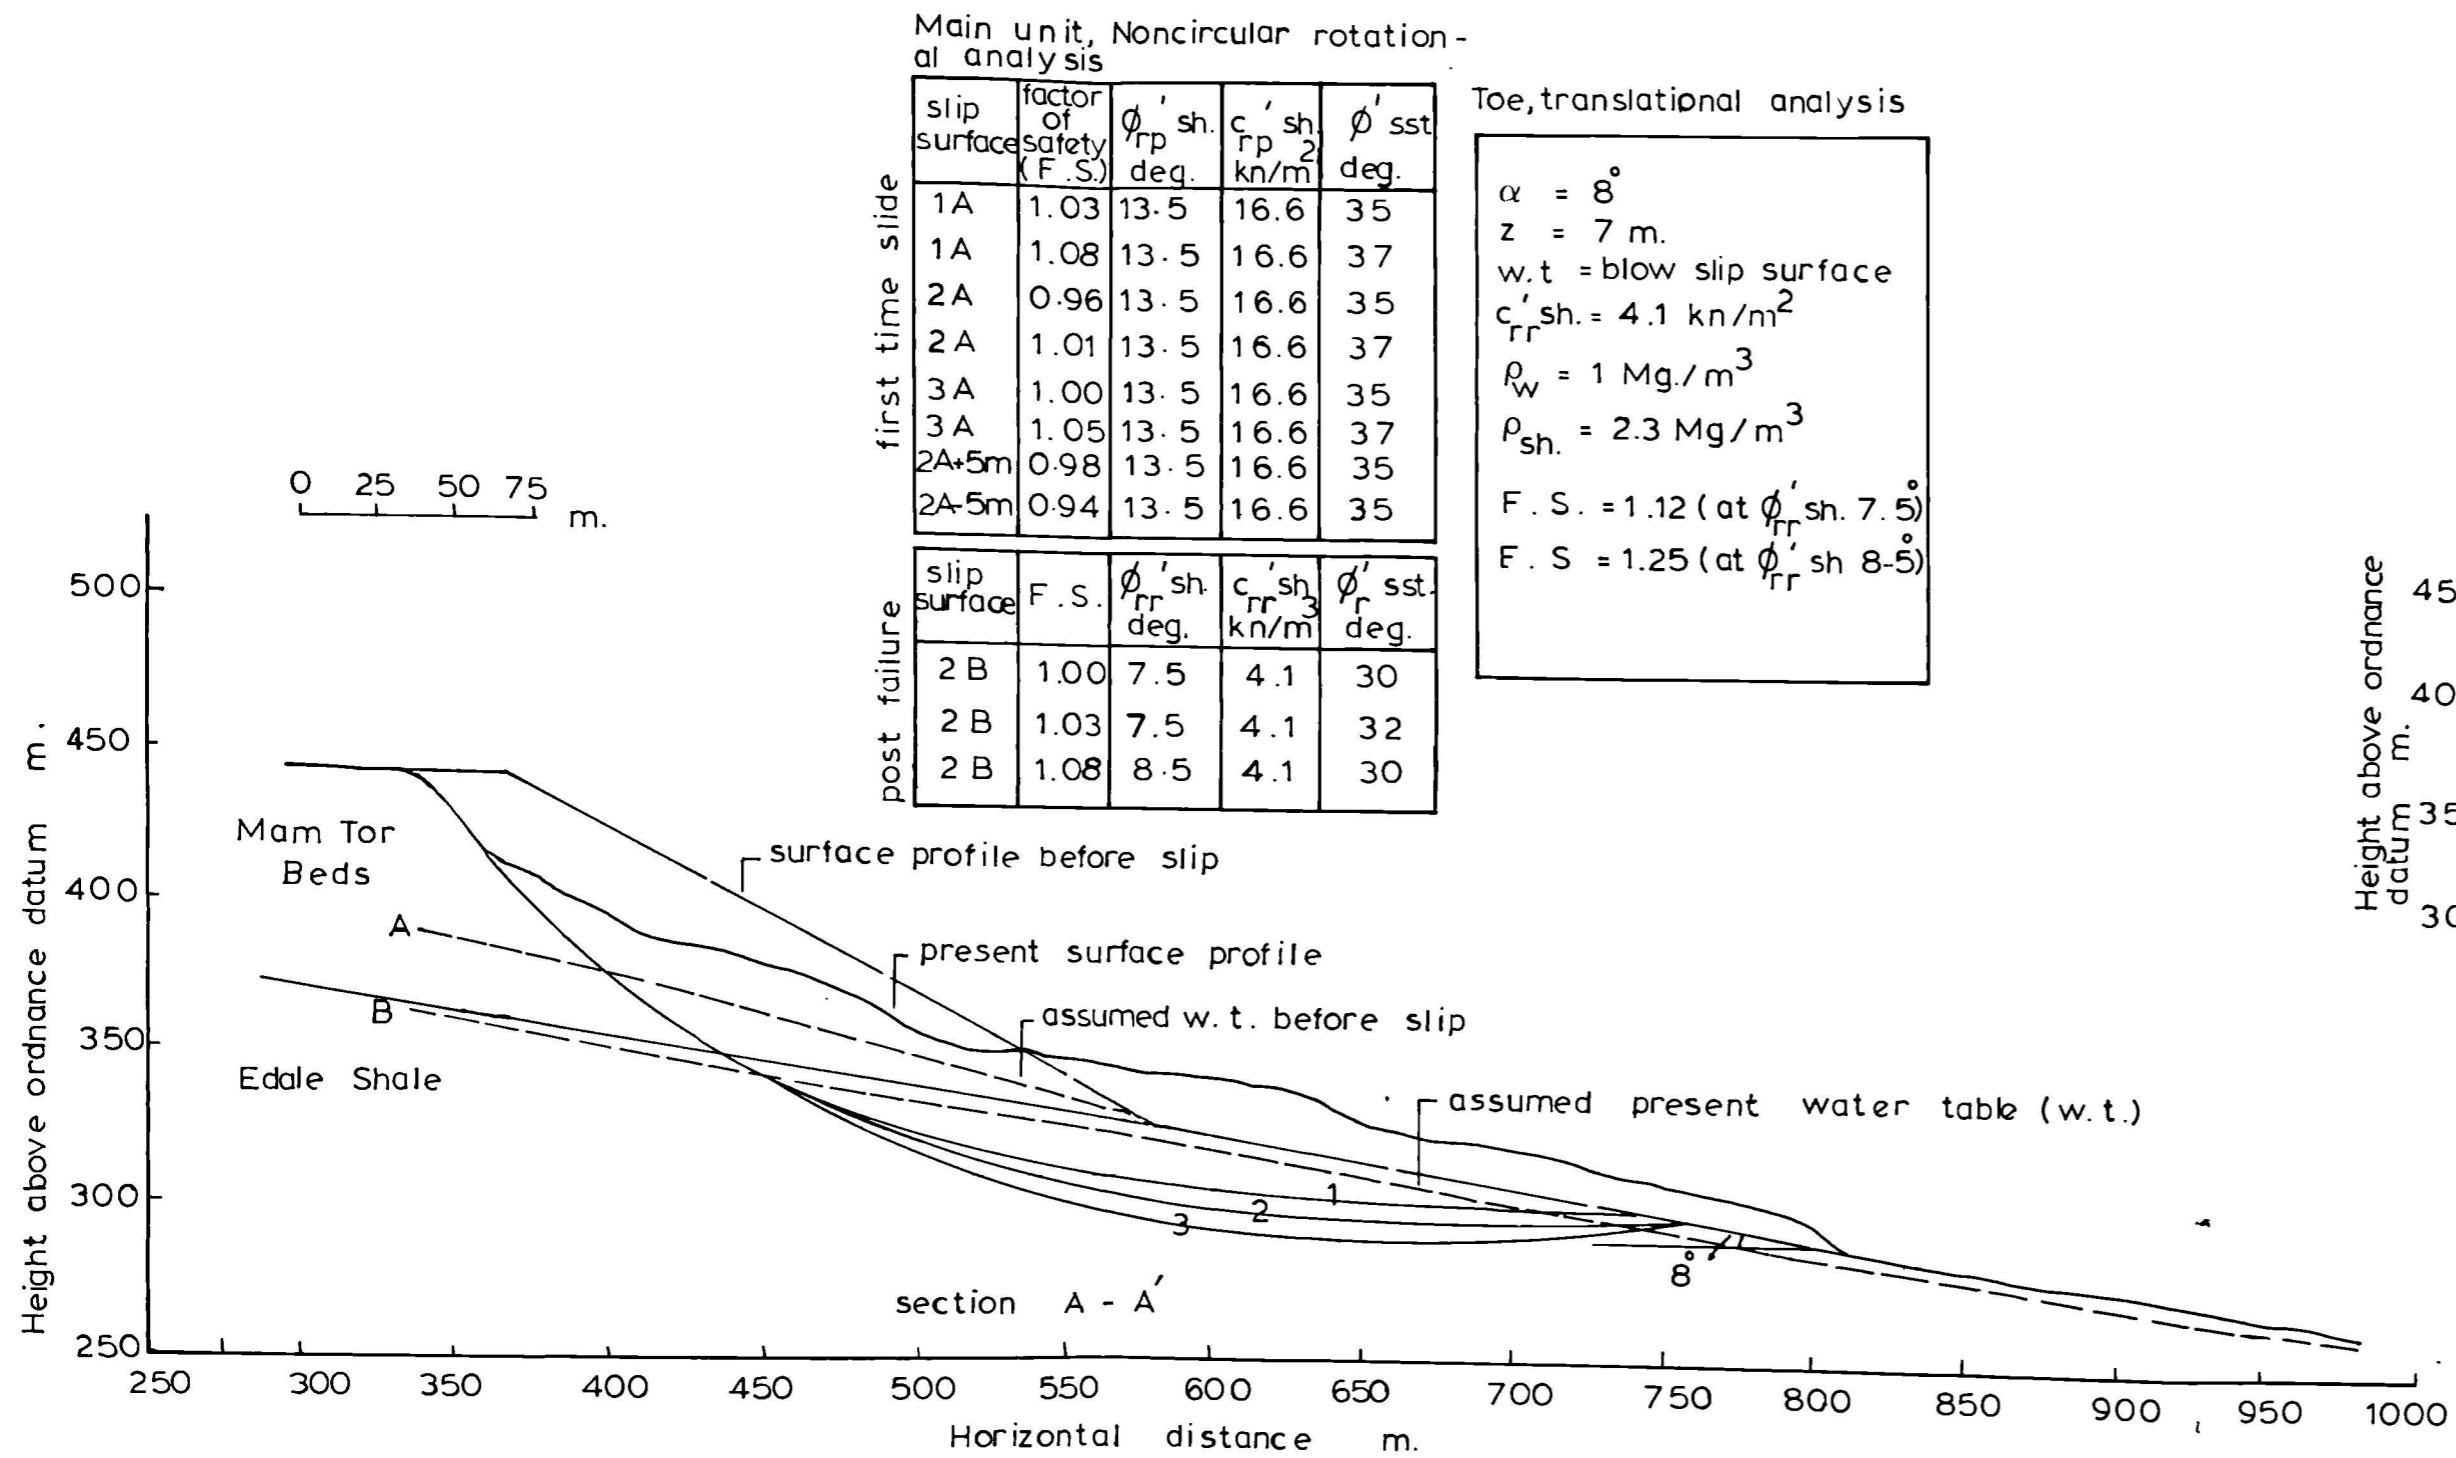
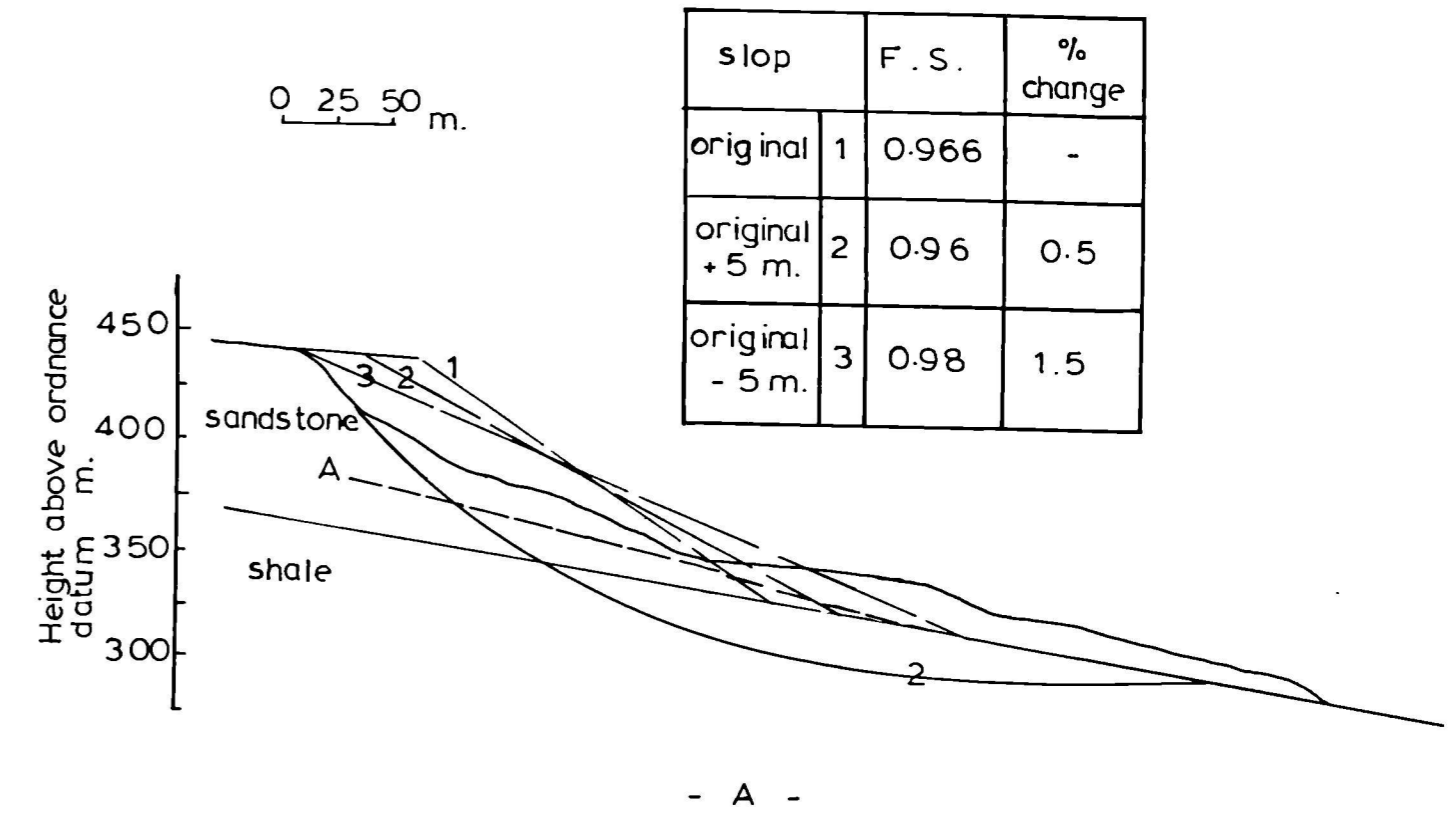
FIG. 8.7 STABILITY ANALYSIS FOR COLD SIDE LANDSLIP

The stability of the toe of the landslide was calculated as a flow of landslide material. The results shown

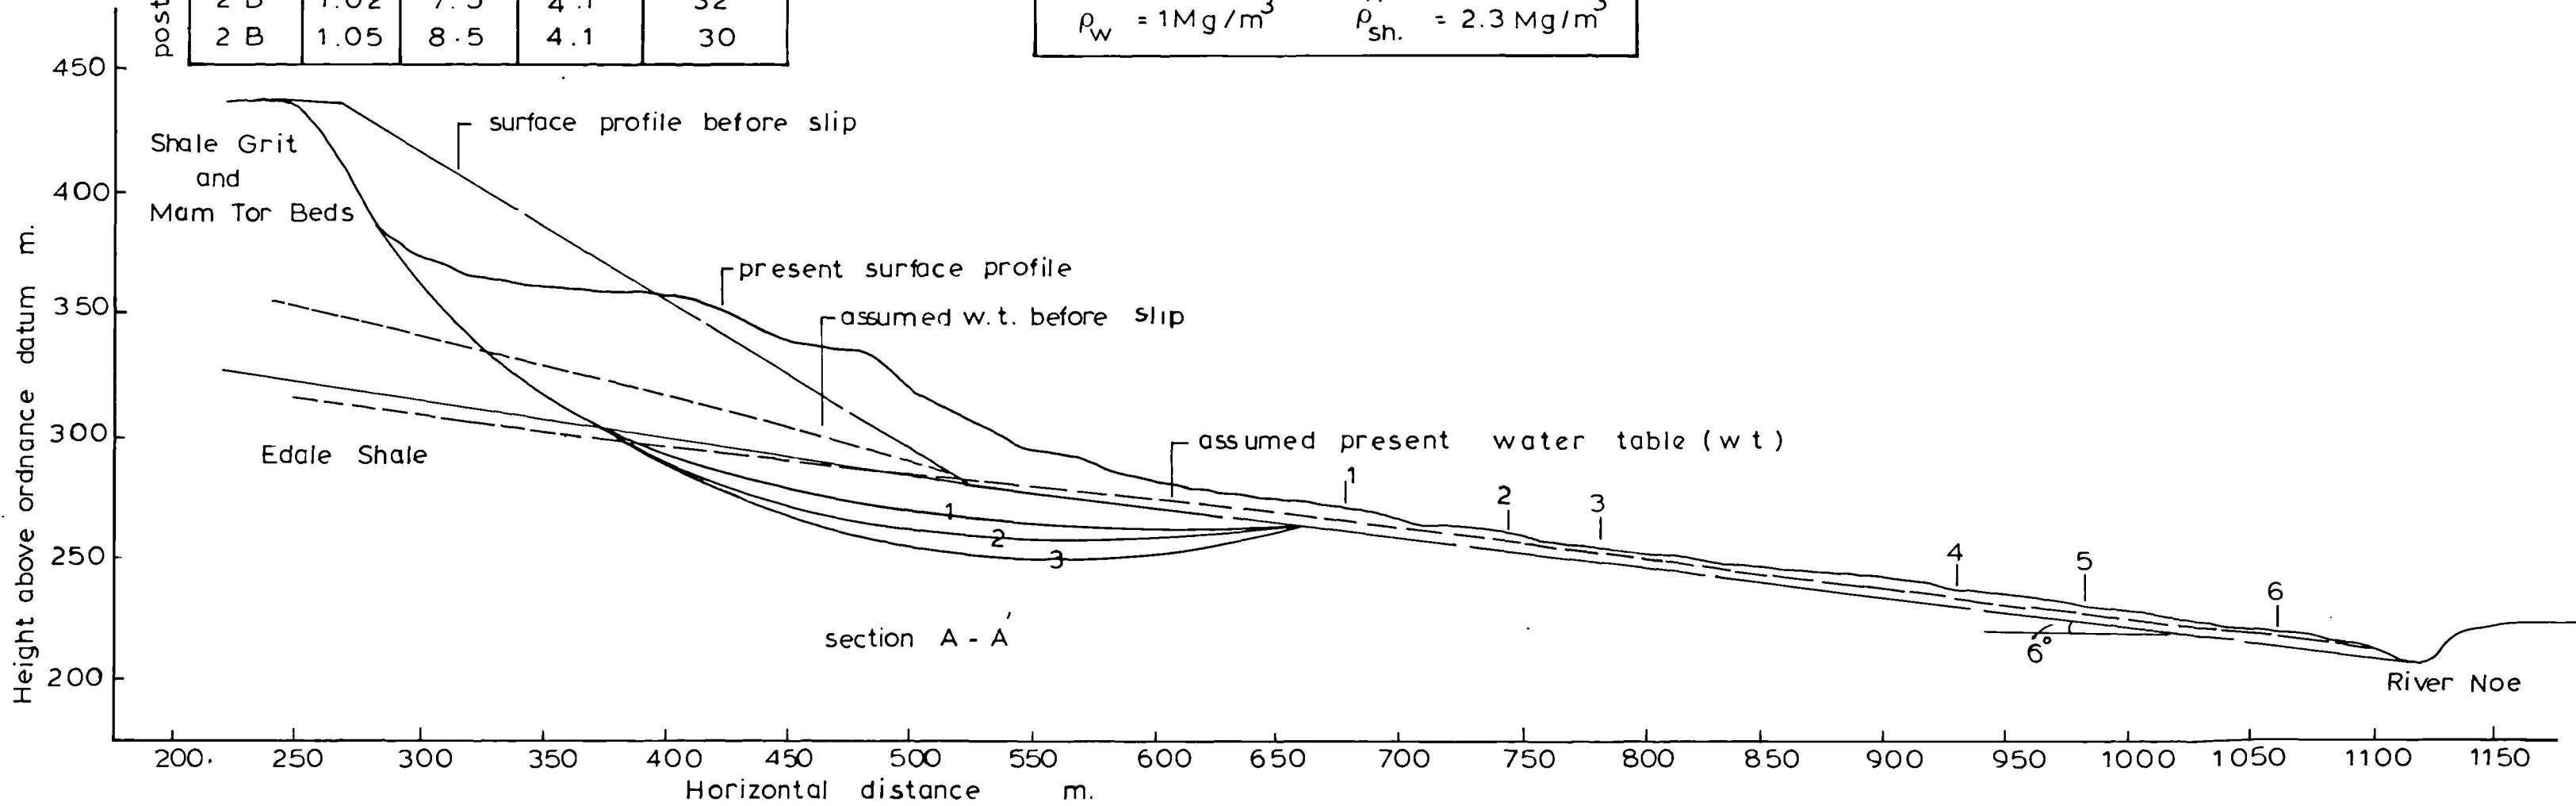
FIG. 8.8 STABILITY ANALYSIS FOR BACK TOR LANDSLIP

$\alpha = 6^\circ$ c'_{rr} sh. = 4.1 kn/m²
 $\rho_w = 1 \text{ Mg/m}^3$ $\rho_{sh.} = 2.3 \text{ Mg/m}^3$

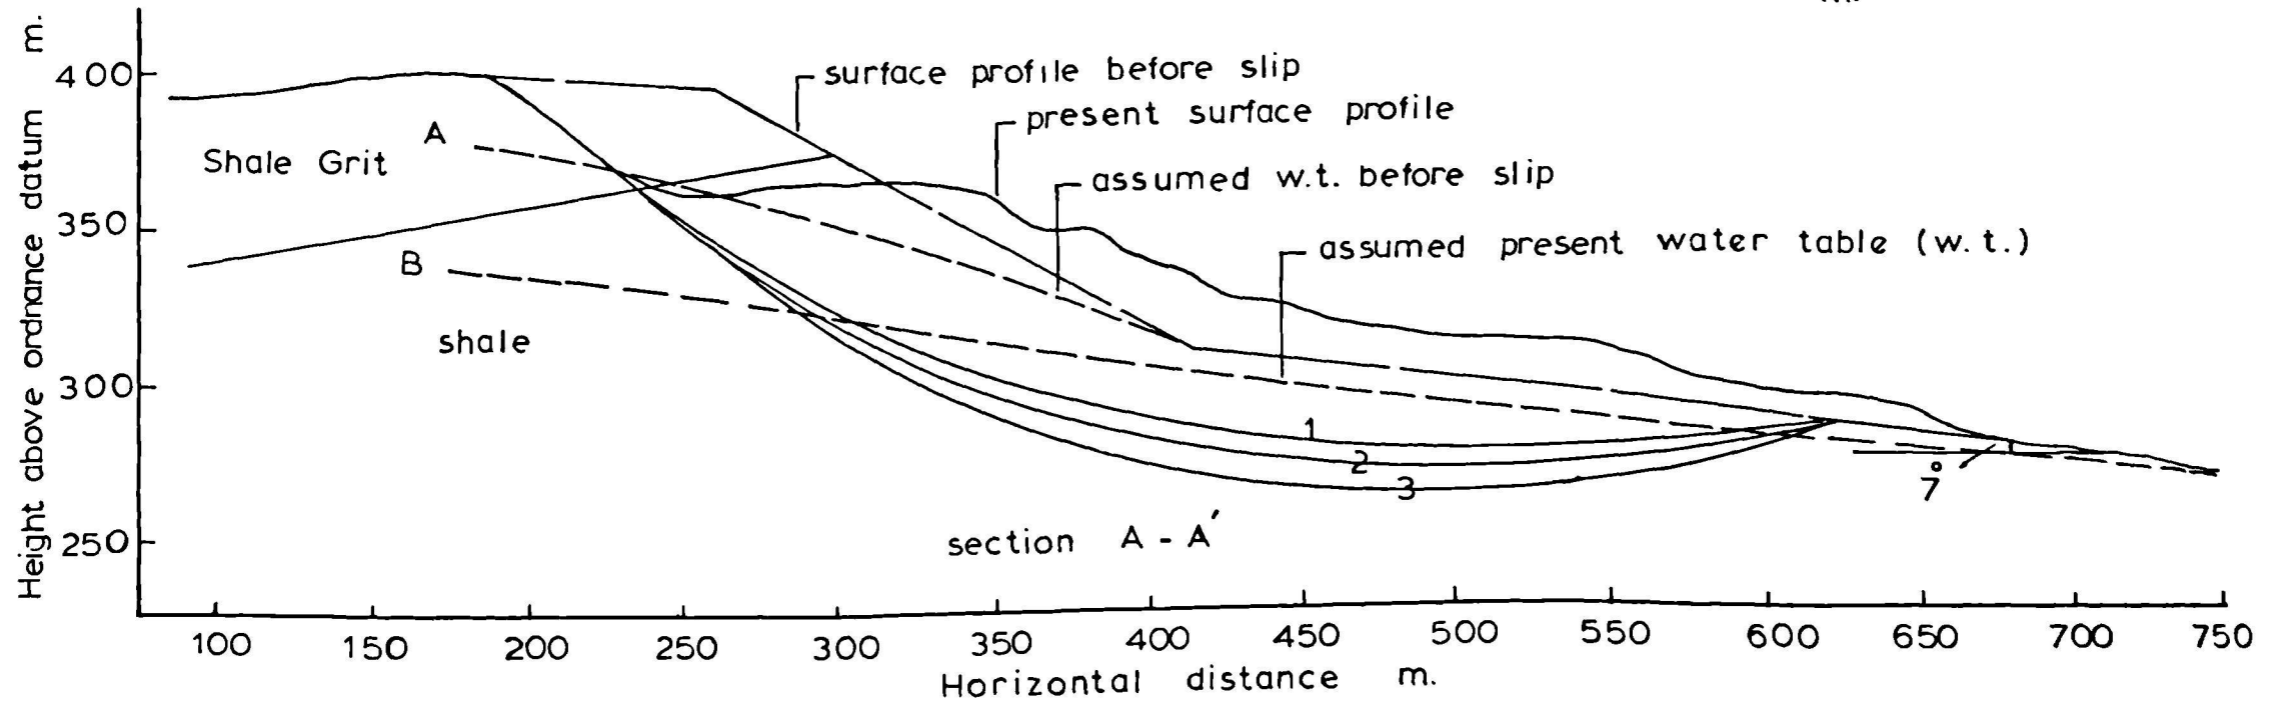
FIG. 8.9 STABILITY ANALYSIS FOR BURR TOR LANDSLIP

$\alpha = 7^\circ$
 $z = 9m.$
 $w.t. = 2m.$
 $c_{rr} sh = 7.6 kn/m^2$
 $\rho_w = 1 Mg/m^3$
 $\rho_{sh} = 2.3 Mg/m^3$
 $F.S. = 1.21$ (at $\phi'_{rr} sh 9.5$)
 $E.S. = 1.31$ (at $\phi'_{rr} sh 10.5$)
