A STUDY OF RESIDUAL SHEAR STRENGTH OF NAMURIAN
SHALES IN RESPECT OF SLOPES IN NORTH DERBYSHIRE.

VOL II

Thesis submitted in fulfilment of the requirements for the
Degree of PH.D.

Department of Geology
University of Sheffield

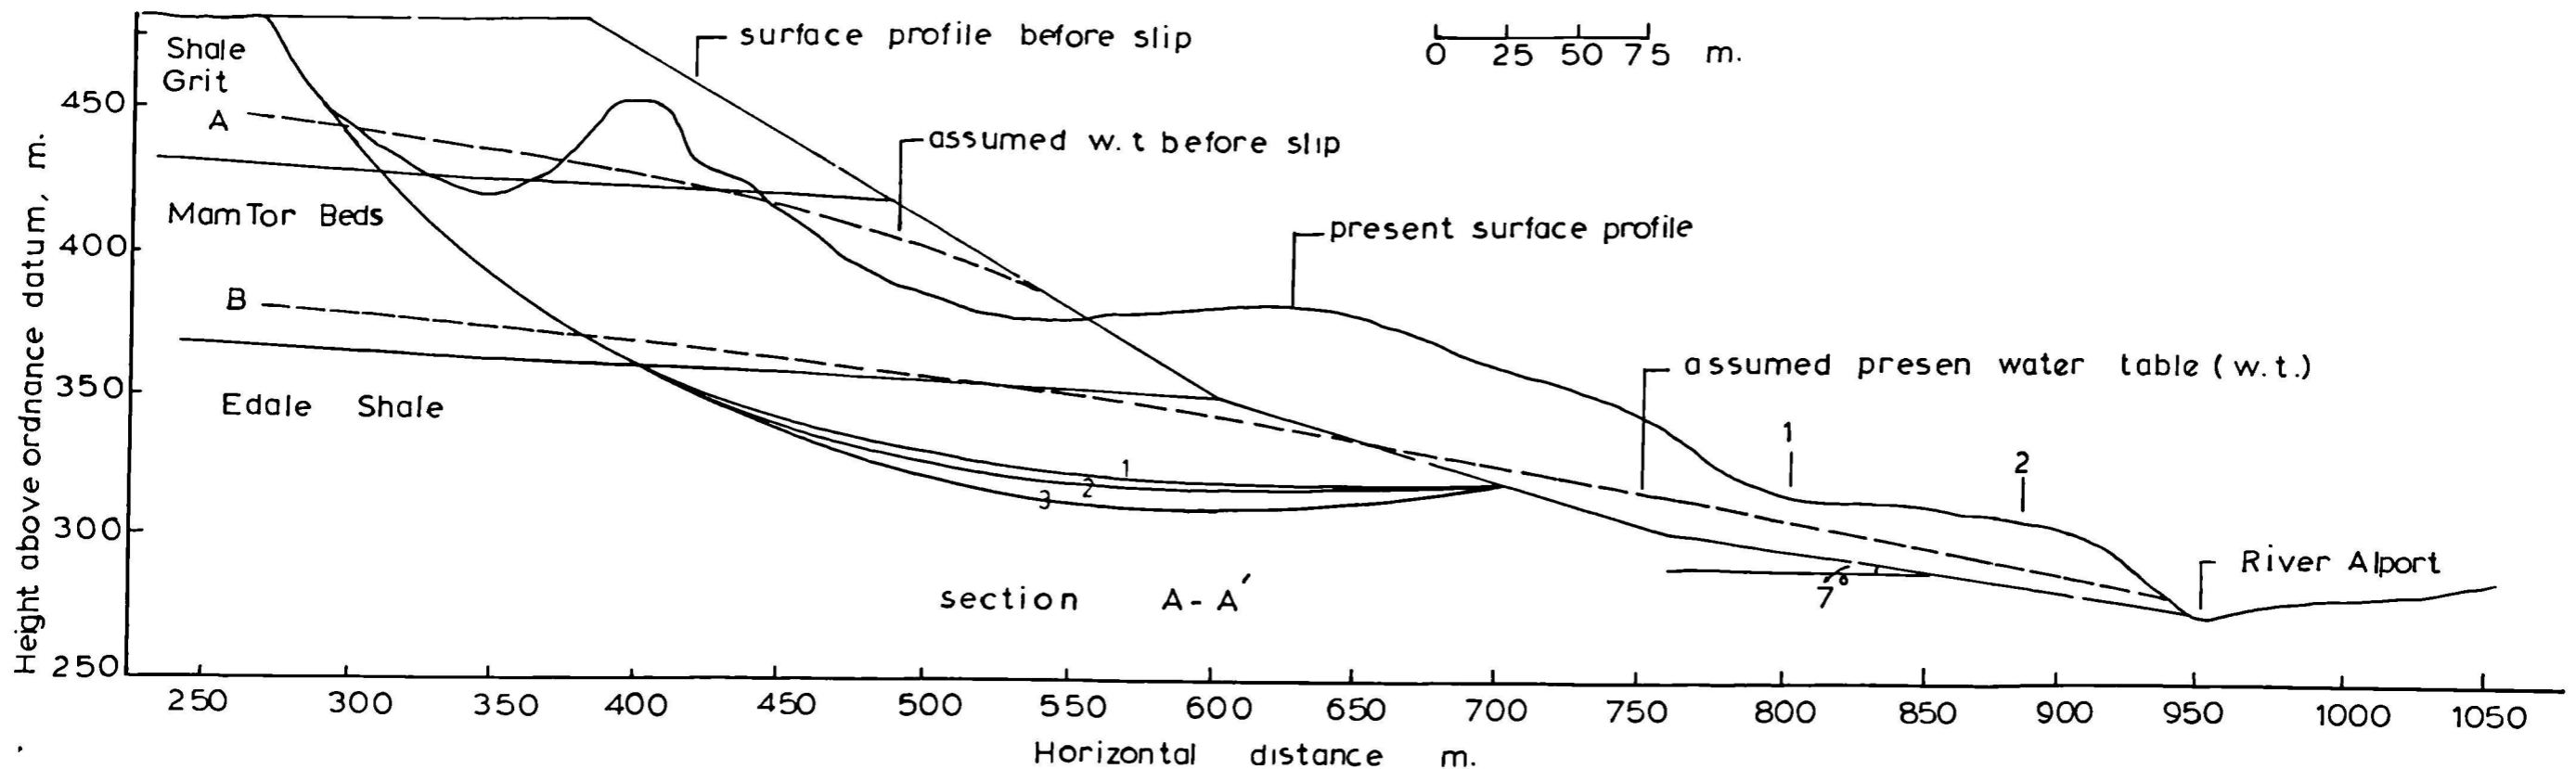
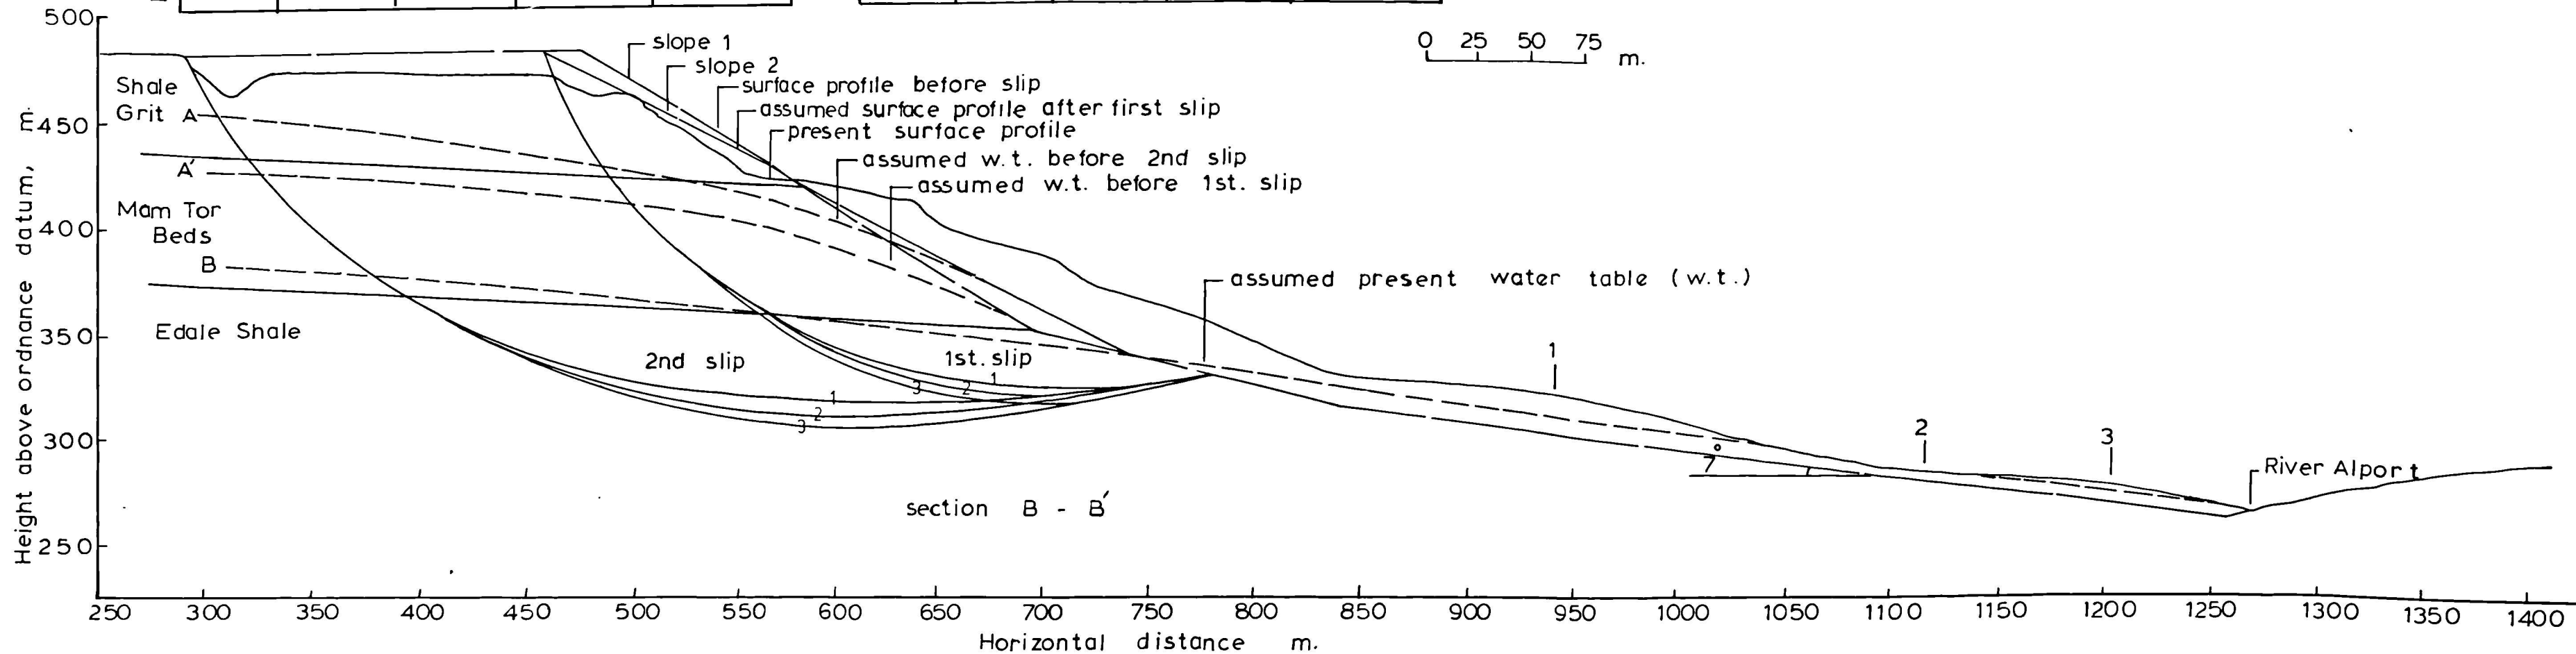
FIG. 8.11 STABILITY ANALYSIS FOR ALPORT CASTELS LANDSLIP

locations	depth to slip surface (z) m.	elevation of w. t. m.	F. S.	
			ϕ'_{m7°	ϕ'_{m8°
1	17	8	0.92	1.03
2	22	17	1.02	1.15
$\alpha = 7^\circ$ $c'_{sh} = 6.5 \text{ kn/m}^2$ $\rho_w = 1 \text{ Mg/m}^3$ $\rho_{sh} = 2.3 \text{ Mg/m}^3$

locations	depth to slip surface (z) m.	elevation of w. t. m.	F. S.	
			ϕ'_{rr} sh. 7.0	ϕ'_{rr} sh. 8.0
1	18	10	0.94	1.06
2	3	0	1.35	1.47
3	7	2	1.03	1.14
$\alpha = 7^\circ$		$c_{rr} = 6.5 \text{ kn/m}^2$		
$\rho_w = 1 \text{ Mg/m}^3$		$\rho_{sh} = 2.3 \text{ Mg/m}^3$

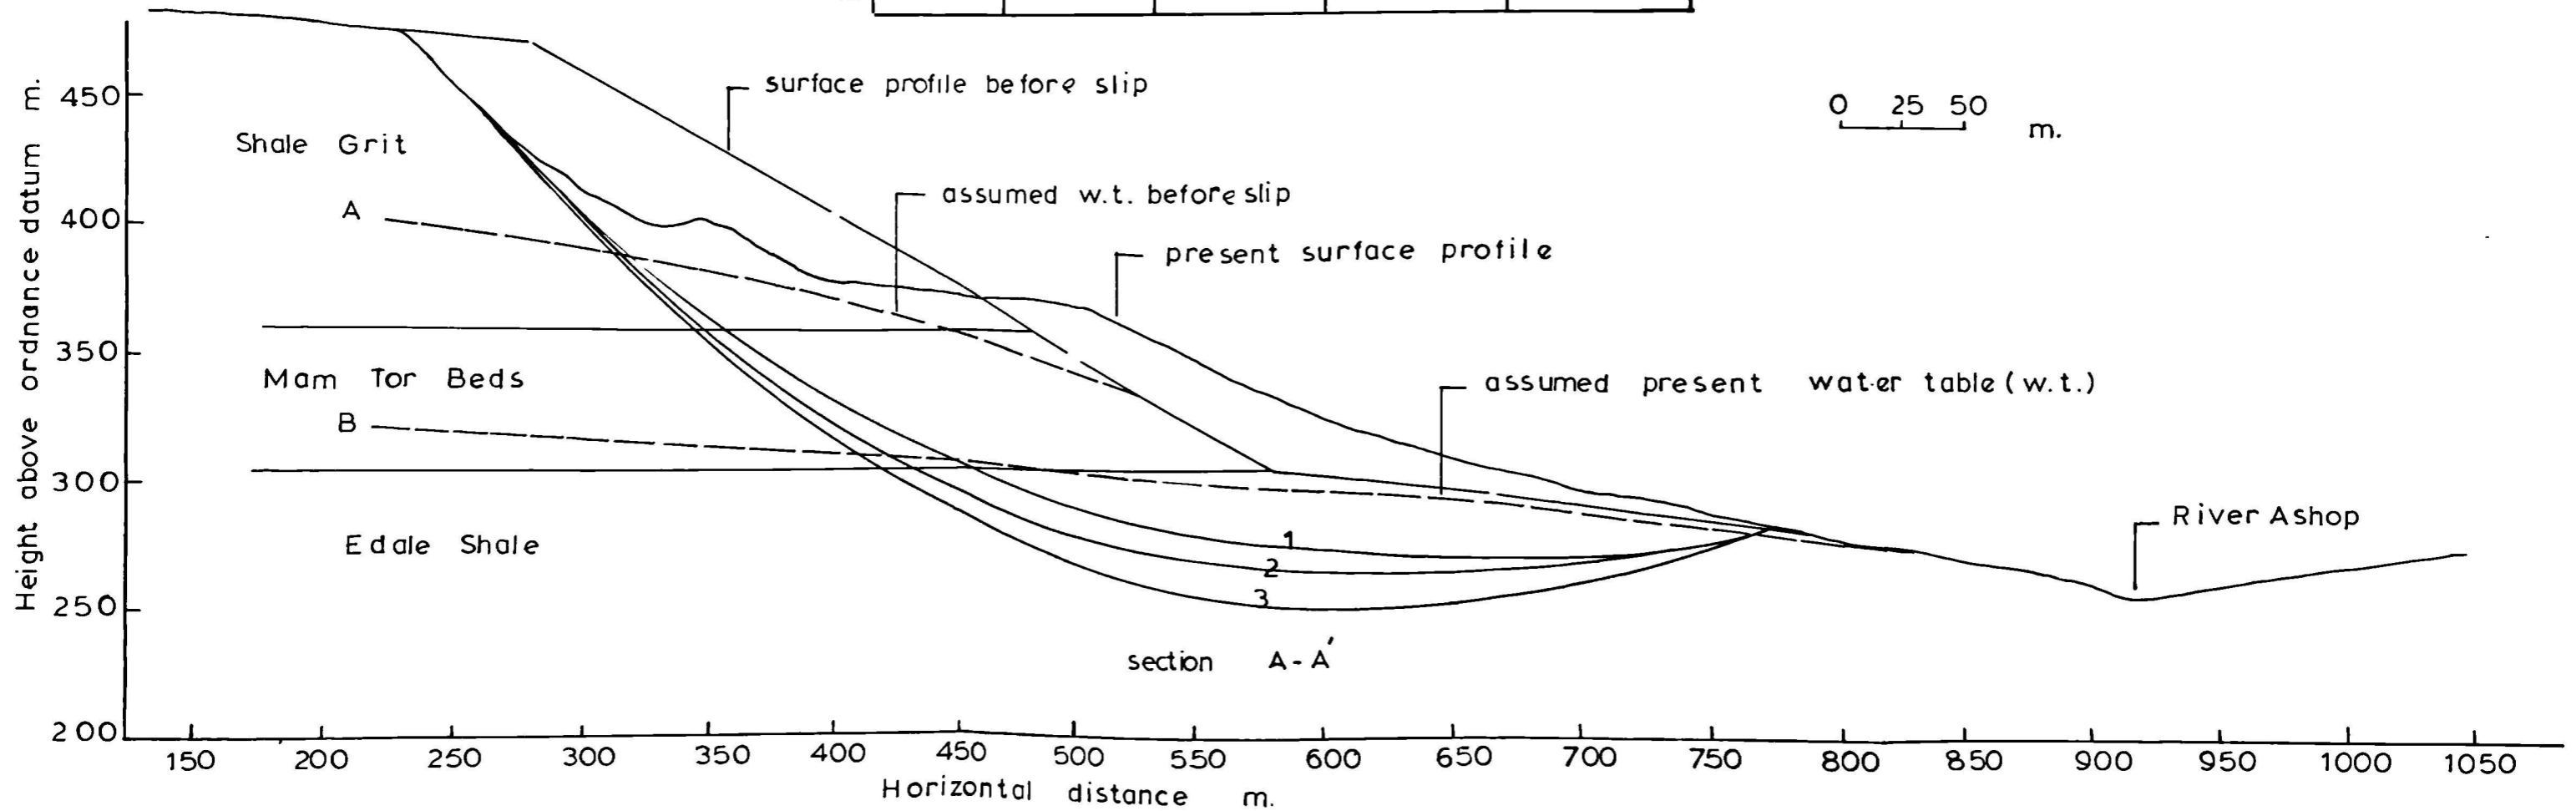
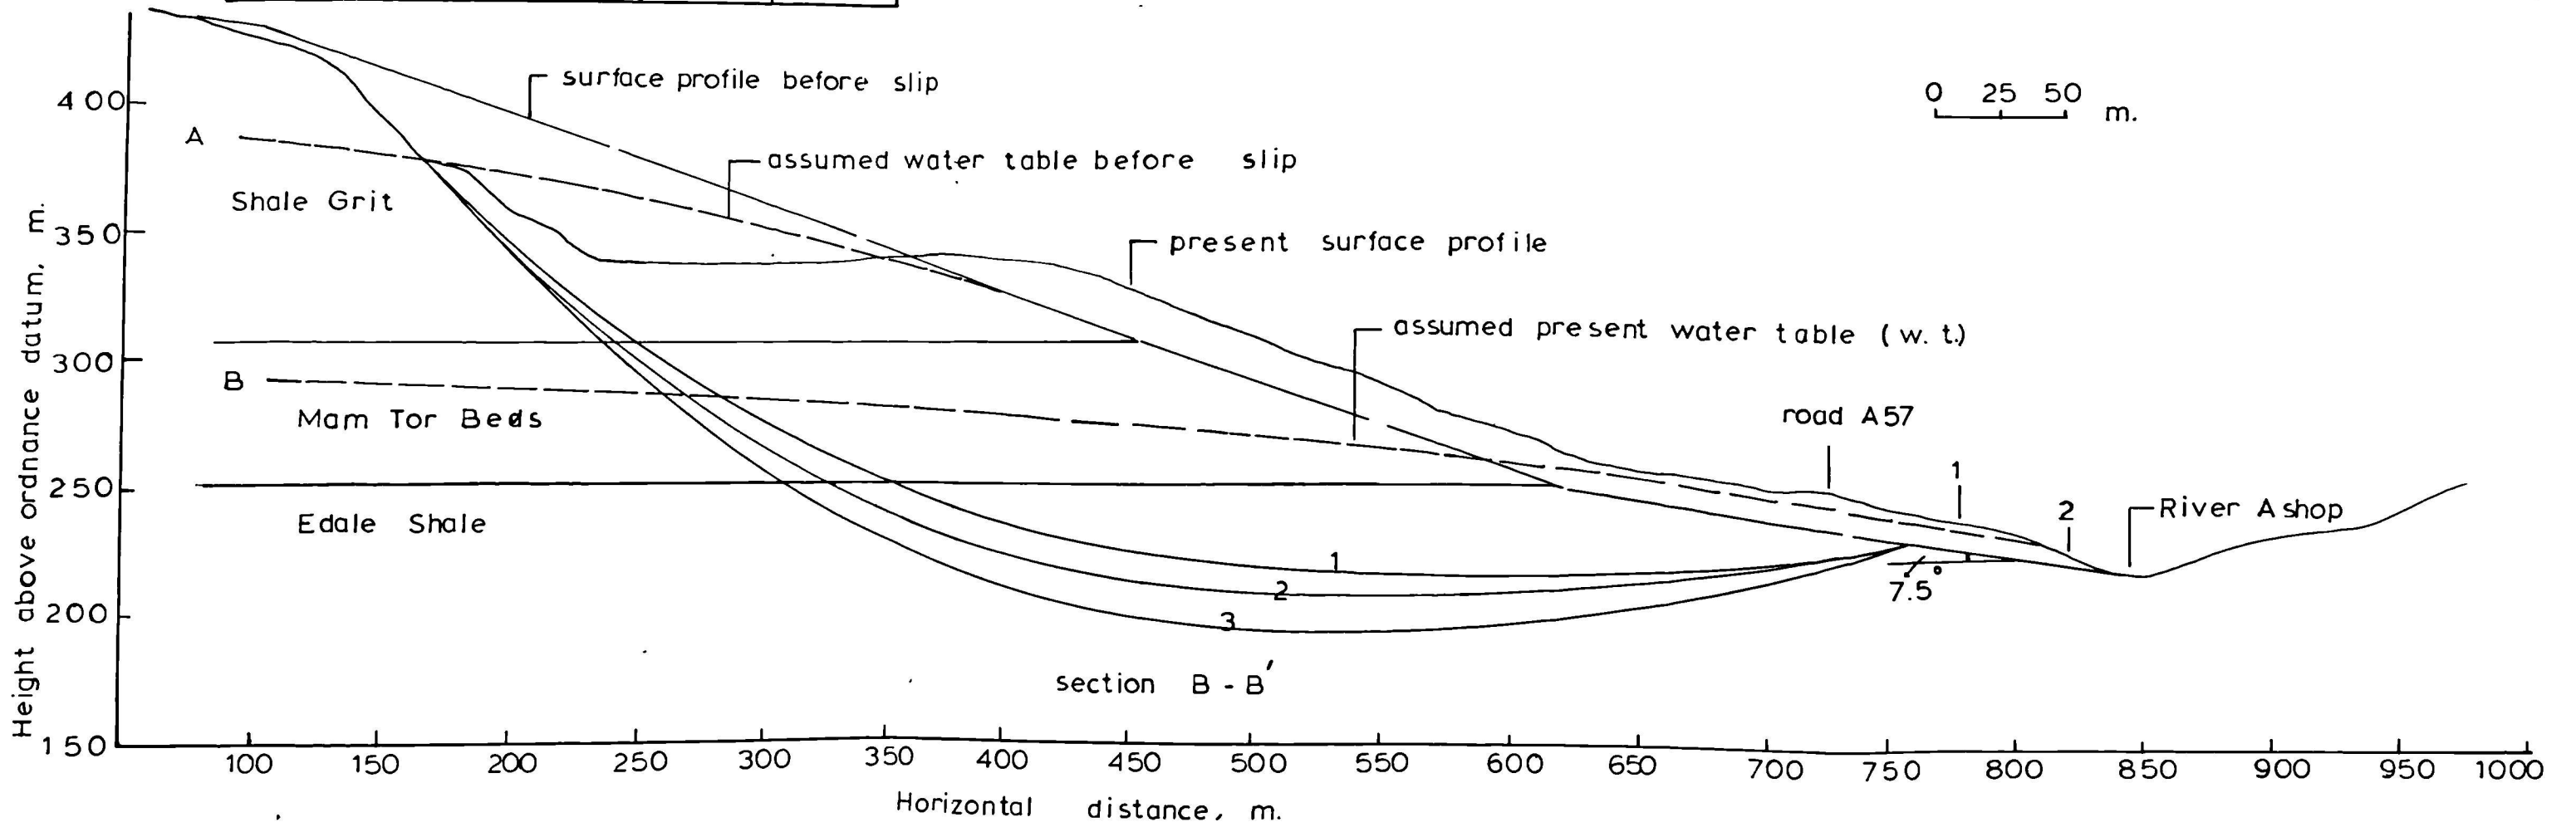
FIG. 8.12, STABILITY ANALYSIS FOR ROWLEE PASTURE LANDSLIP

slip surface	F. S.	ϕ'_{rr} sh. deg.	c'_{rr} sh. kn/m^2	ϕ'_{r} sst. deg.
2 B	0.98	7.5	4.3	30
2 B	1.02	7.5	4.3	32
2 B	1.04	8.5	4.3	30

$\alpha = 7.5^\circ$ $\rho_w = 1 Mg/m^3$
 $c_{rr} = 4.1 kn/m^2$ $\rho_{sh} = 2.3 Mg/m^3$

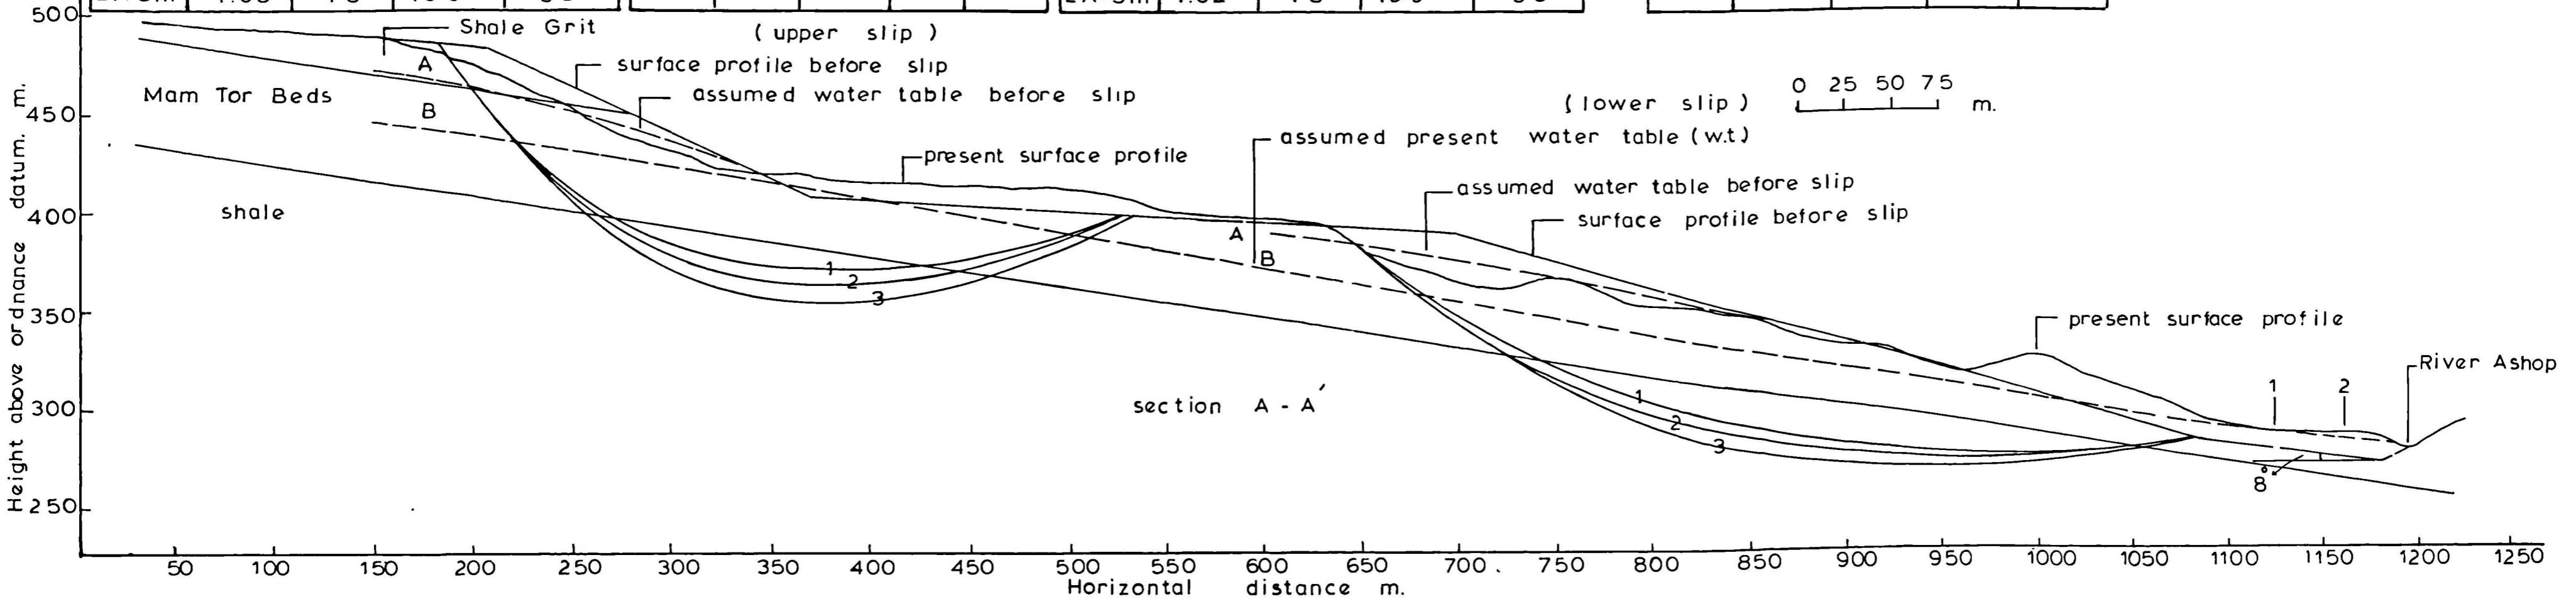
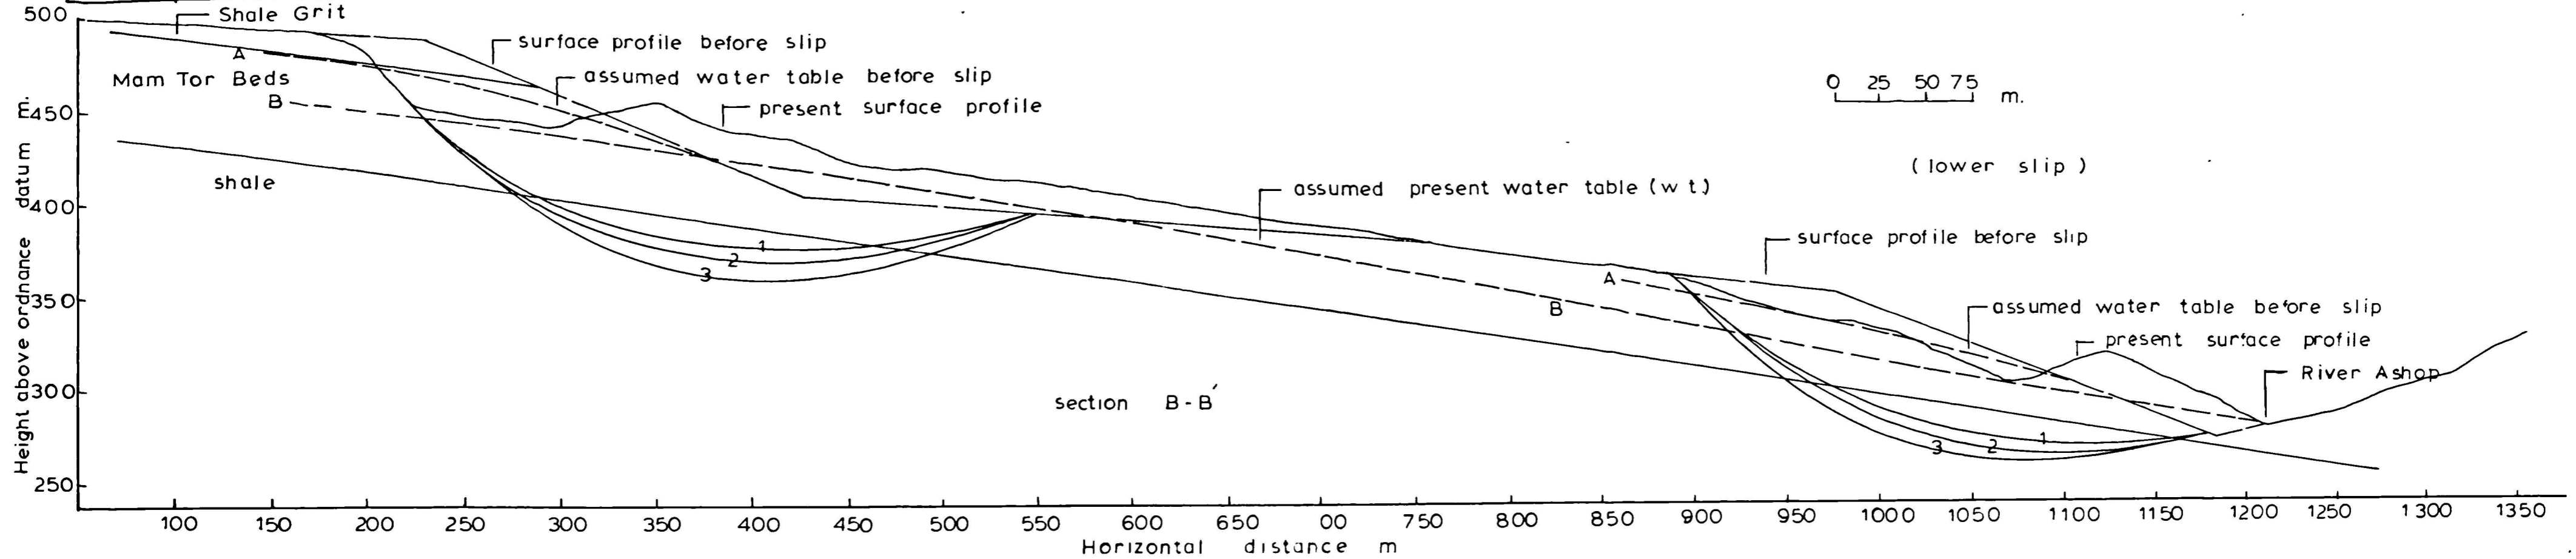
FIG 8.13 STABILITY ANALYSIS FOR COWMS MOOR LANDSLIP

$\alpha = 8^\circ$
 $c_r'_{sst} = 0$
 $\rho_w = 1 \text{ Mg/m}^3$
 $\rho_{sst} = 2.59 \text{ Mg/m}^3$

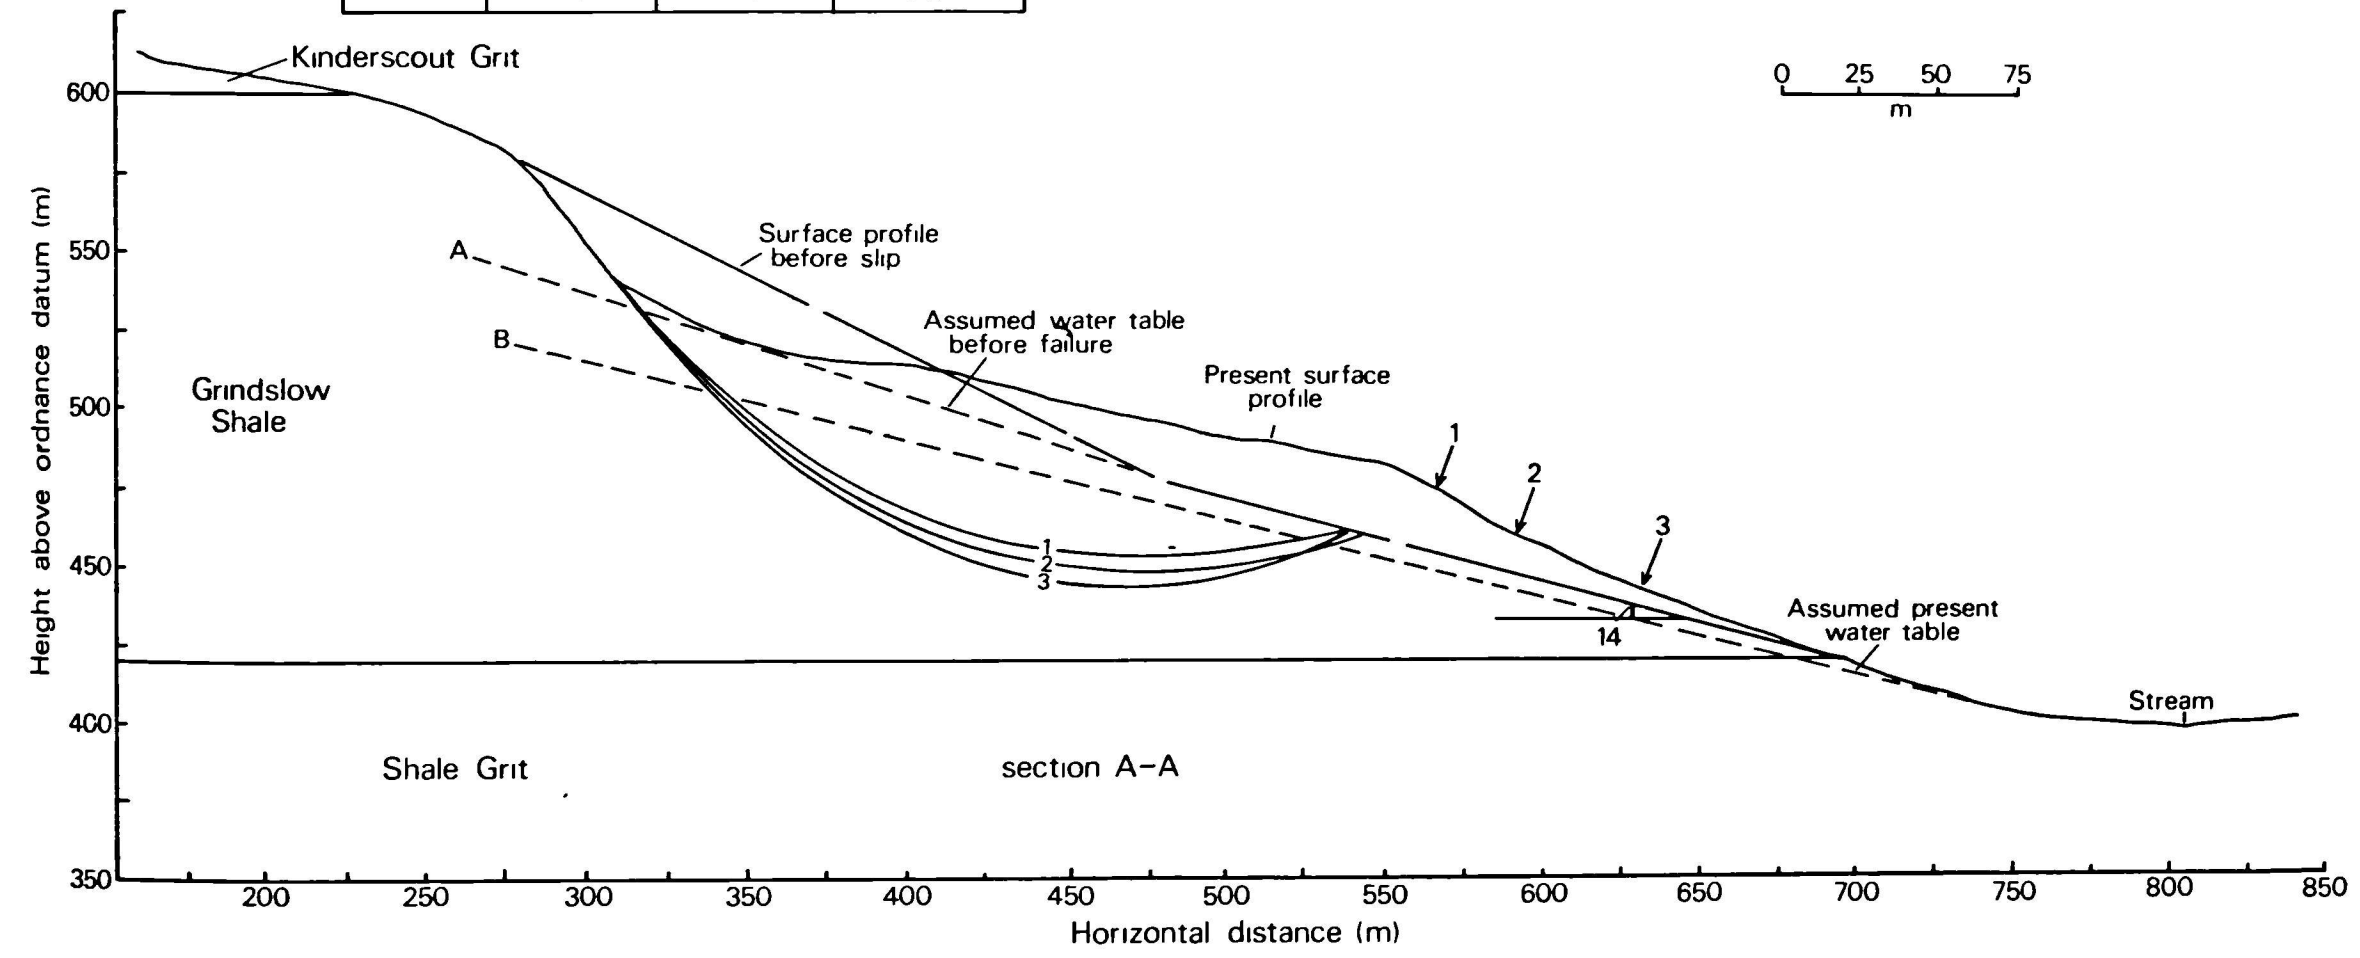
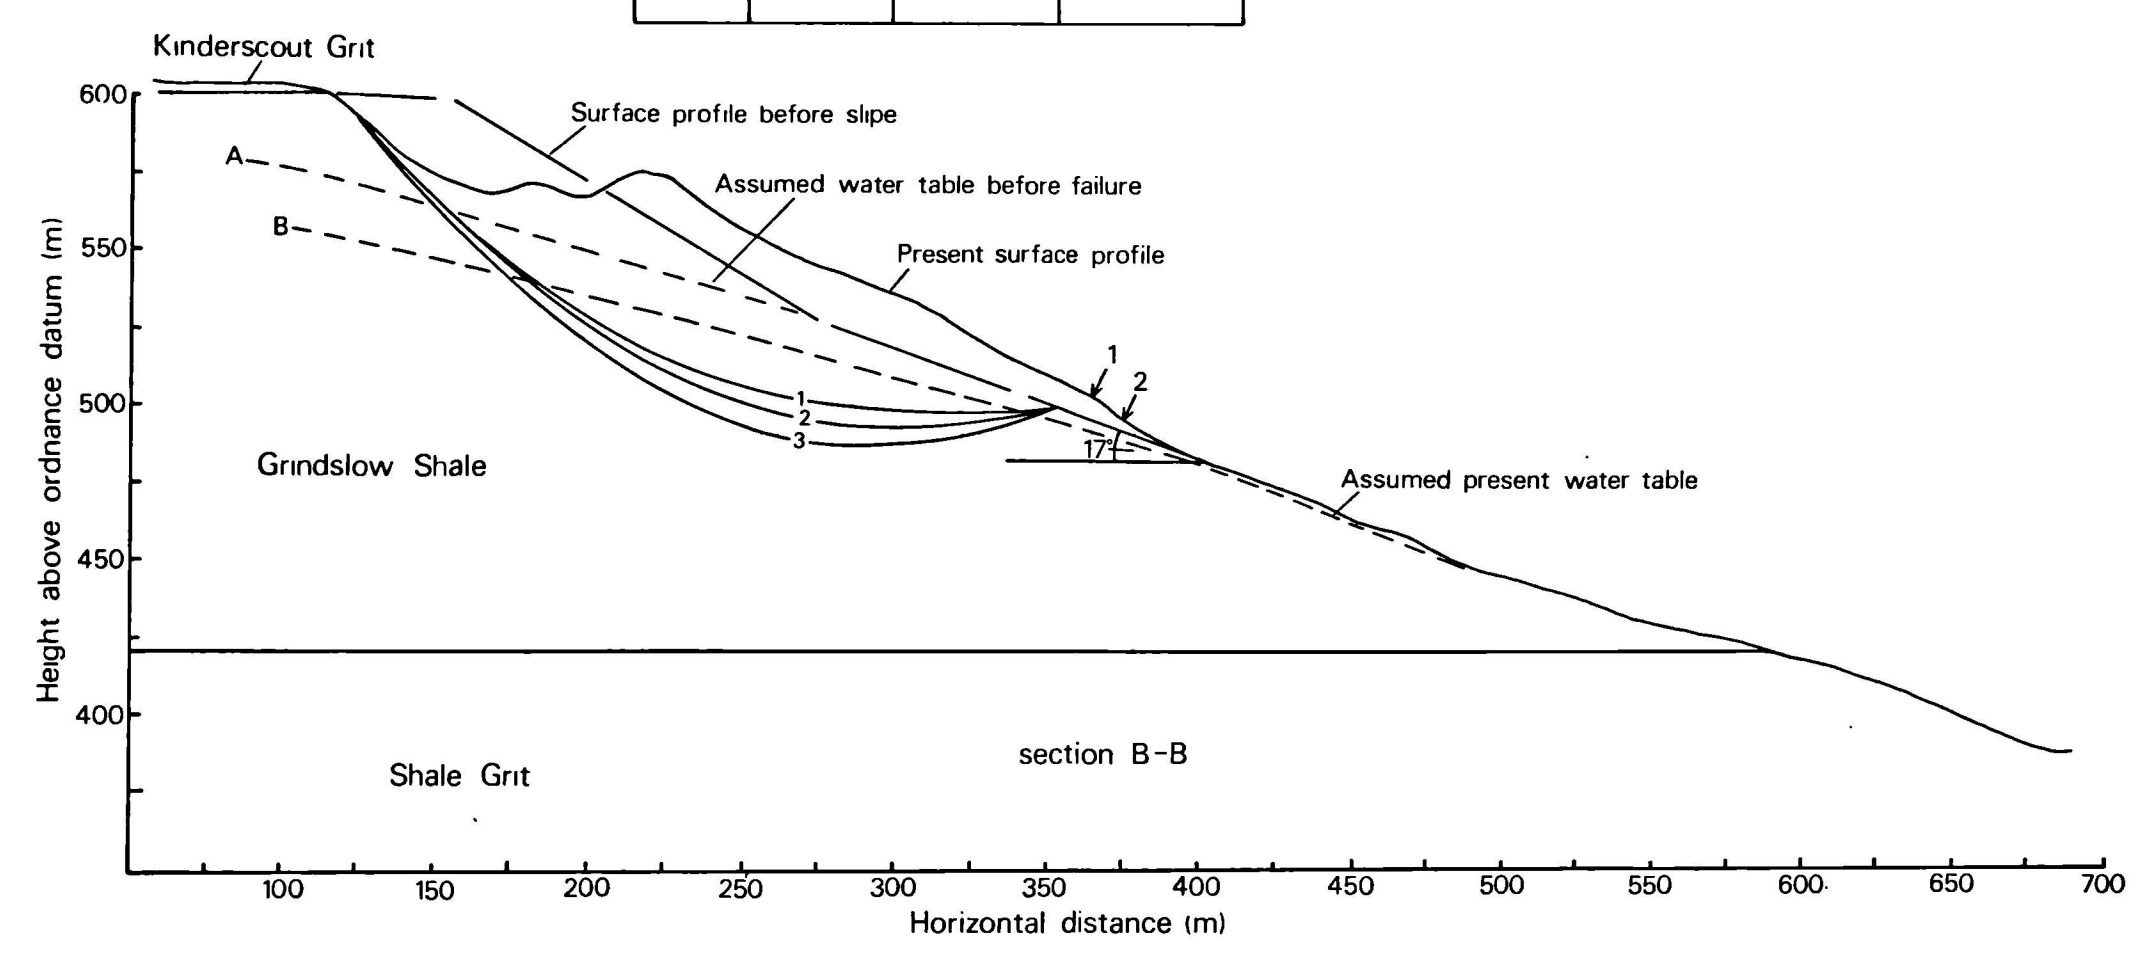
Fig. 8.14 STABILITY ANALYSIS FOR KINDER SCOUT LANDSLIP

Toe (Translation analysis)				
Location	Depth to slip surface 2 (m)	Elevation of water table (m)	Factor of safety	
			13°	14°
1	7	Below original slope	0.91	0.97
2	3		1.02	1.08
$\alpha = 17^\circ$ $C'_{rr} = 4.9 \text{ kN/m}^2$ $\rho_w = 1 \text{ Mg/m}^3$				
$\rho_{sh} = 2.3 \text{ Mg/m}^3$

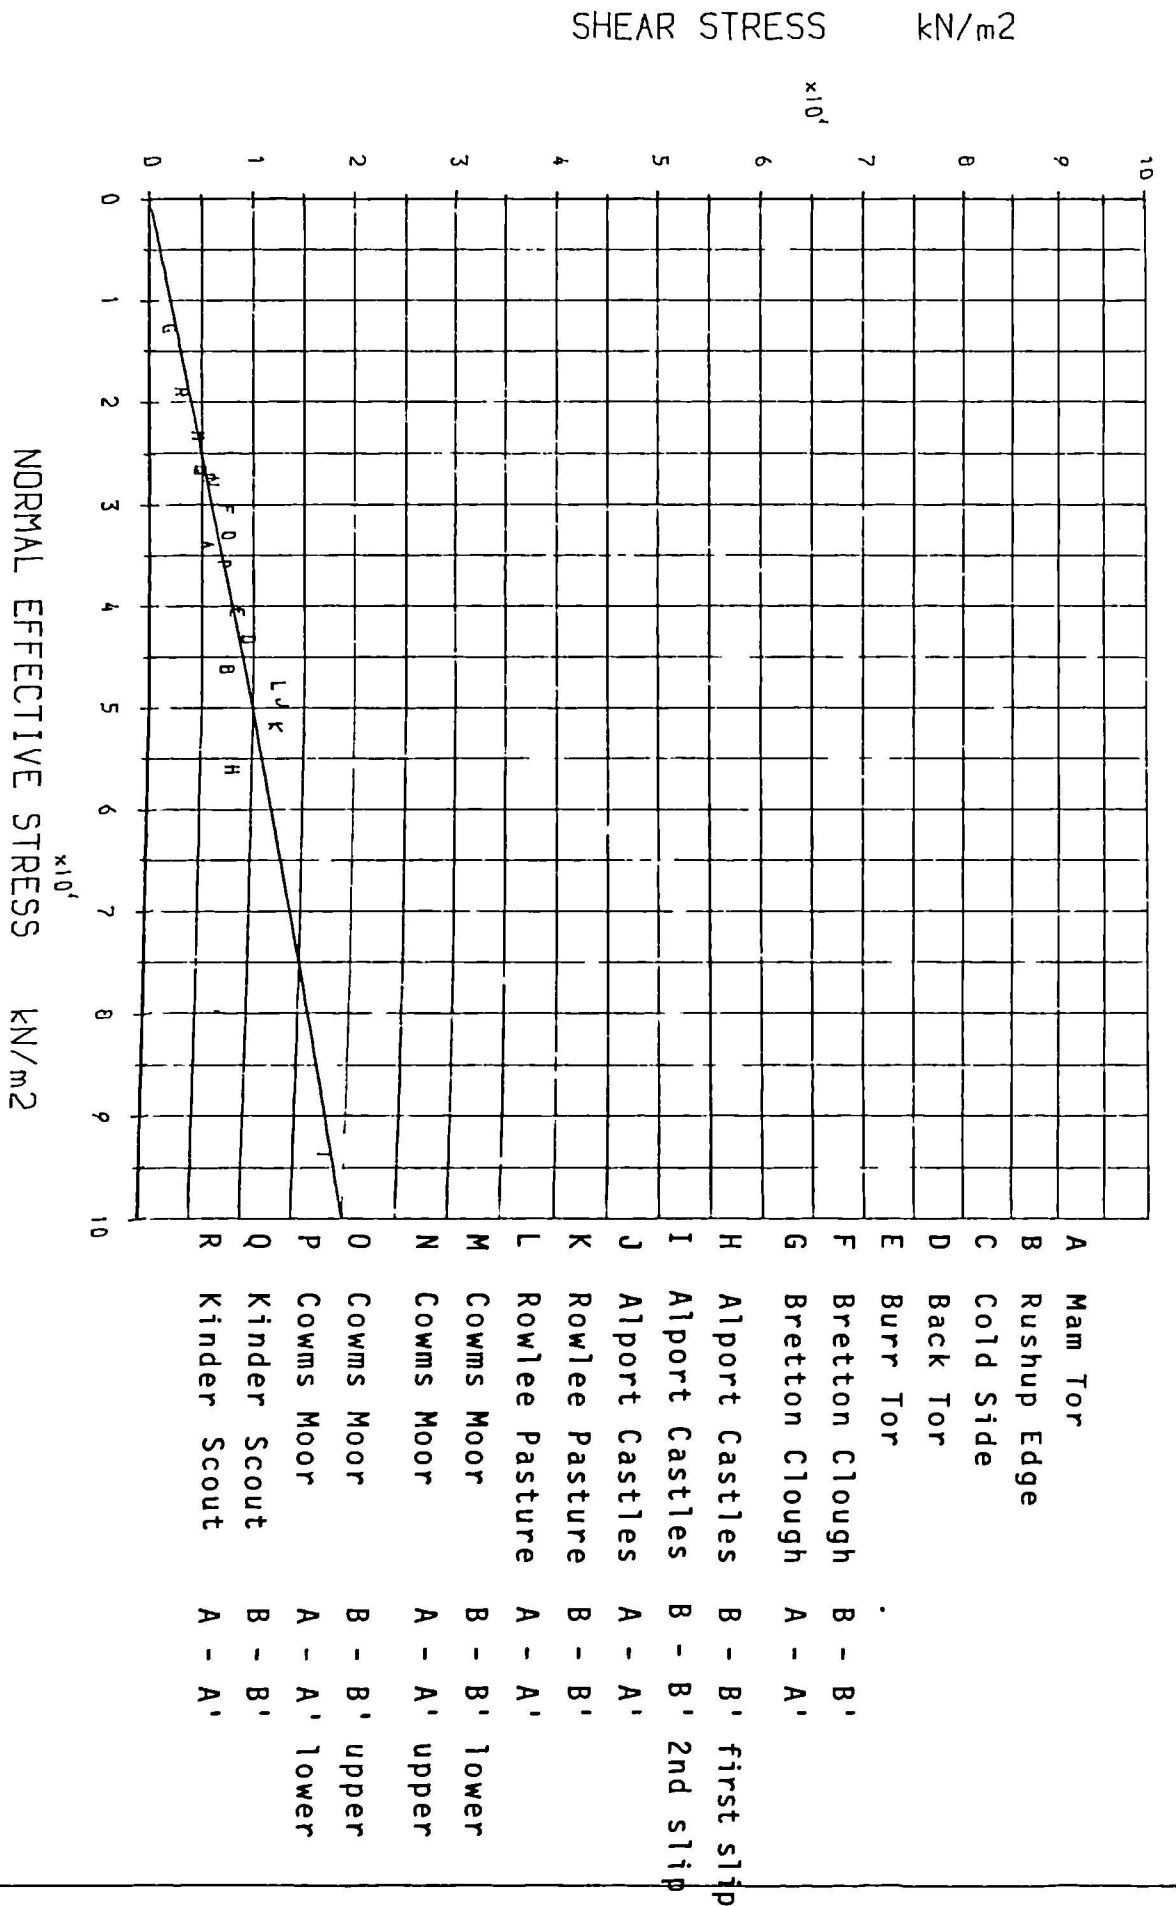
Fig. 9.1 Field residual shear strength

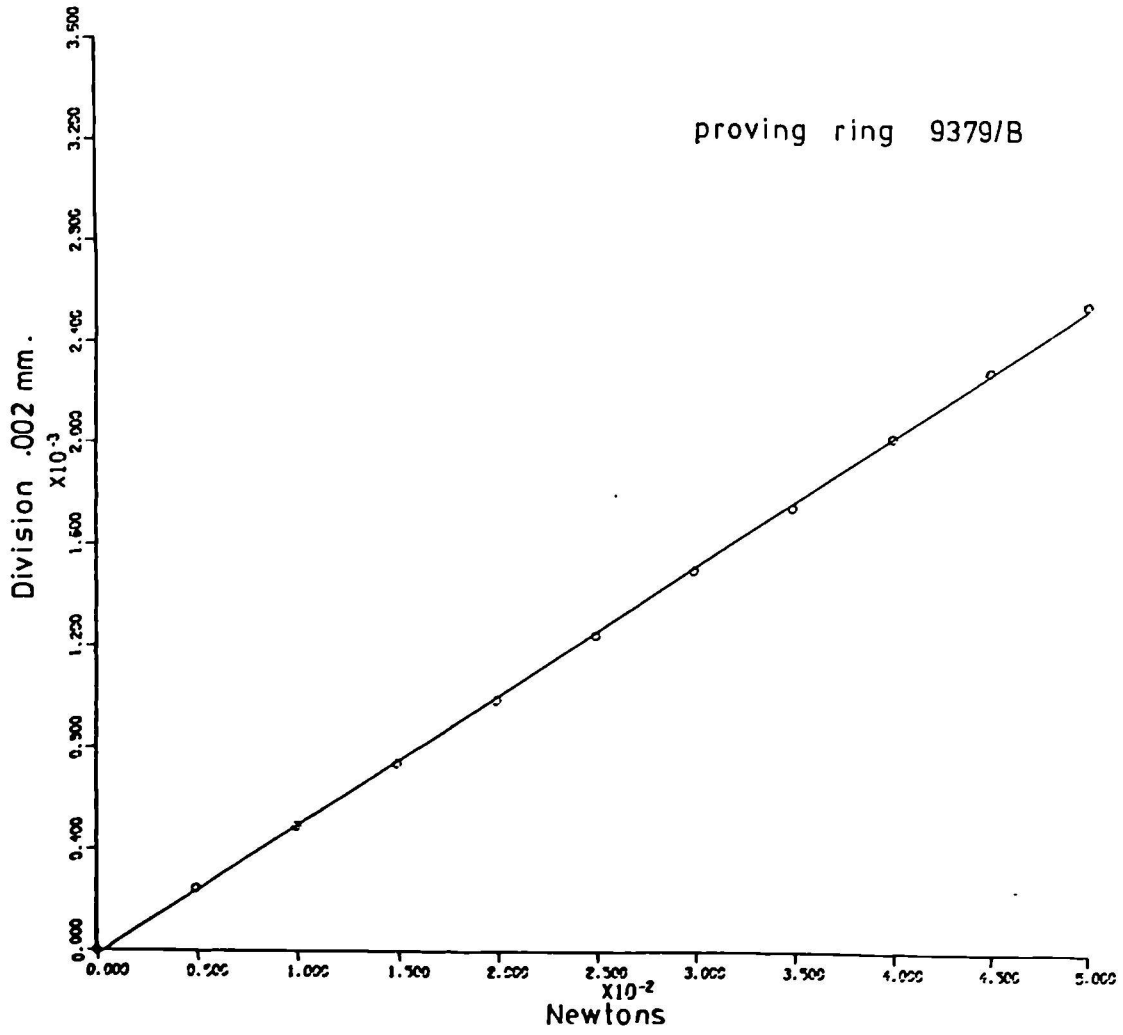
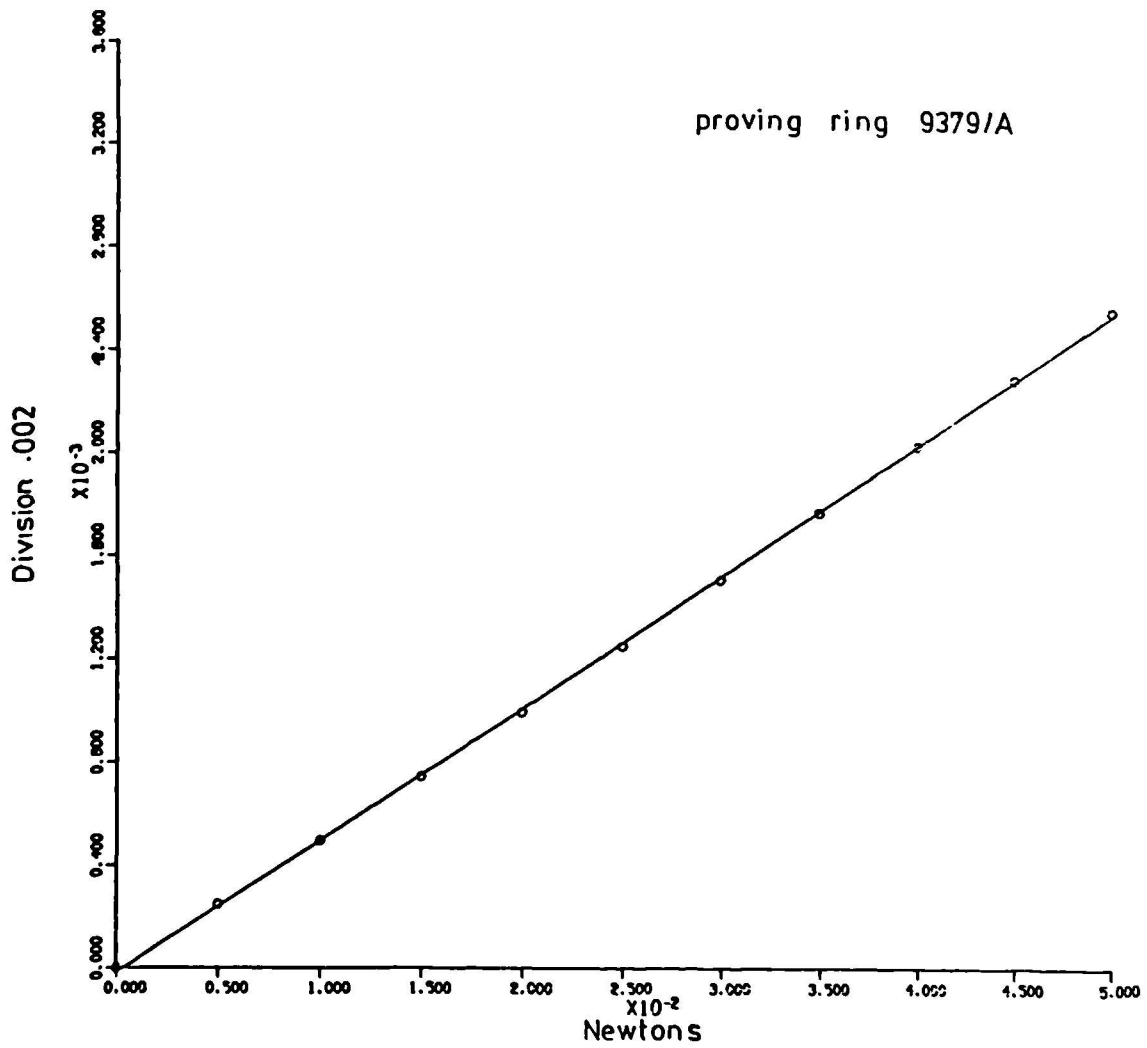
Fig. A.1 Calibration curve of proving rings for ring shear apparatus.

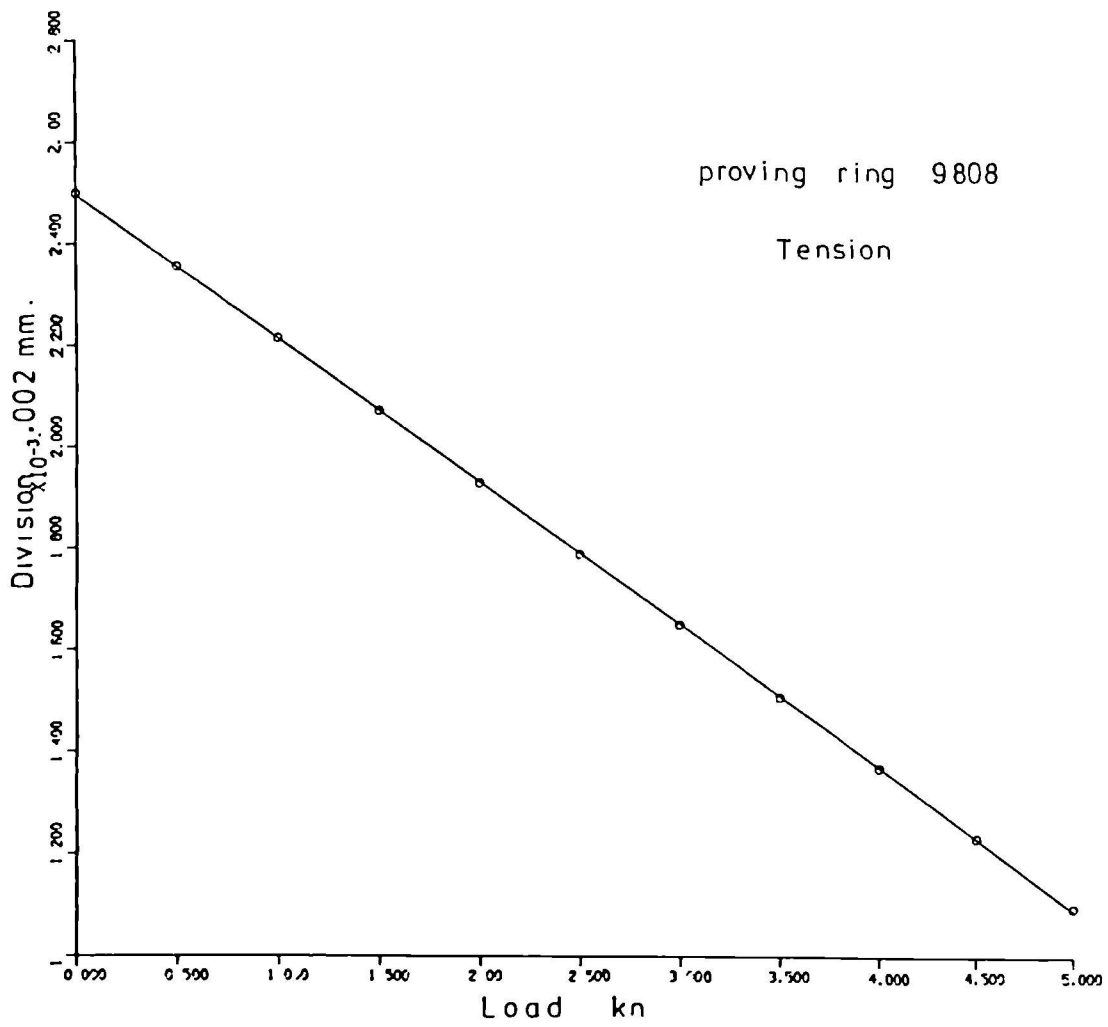
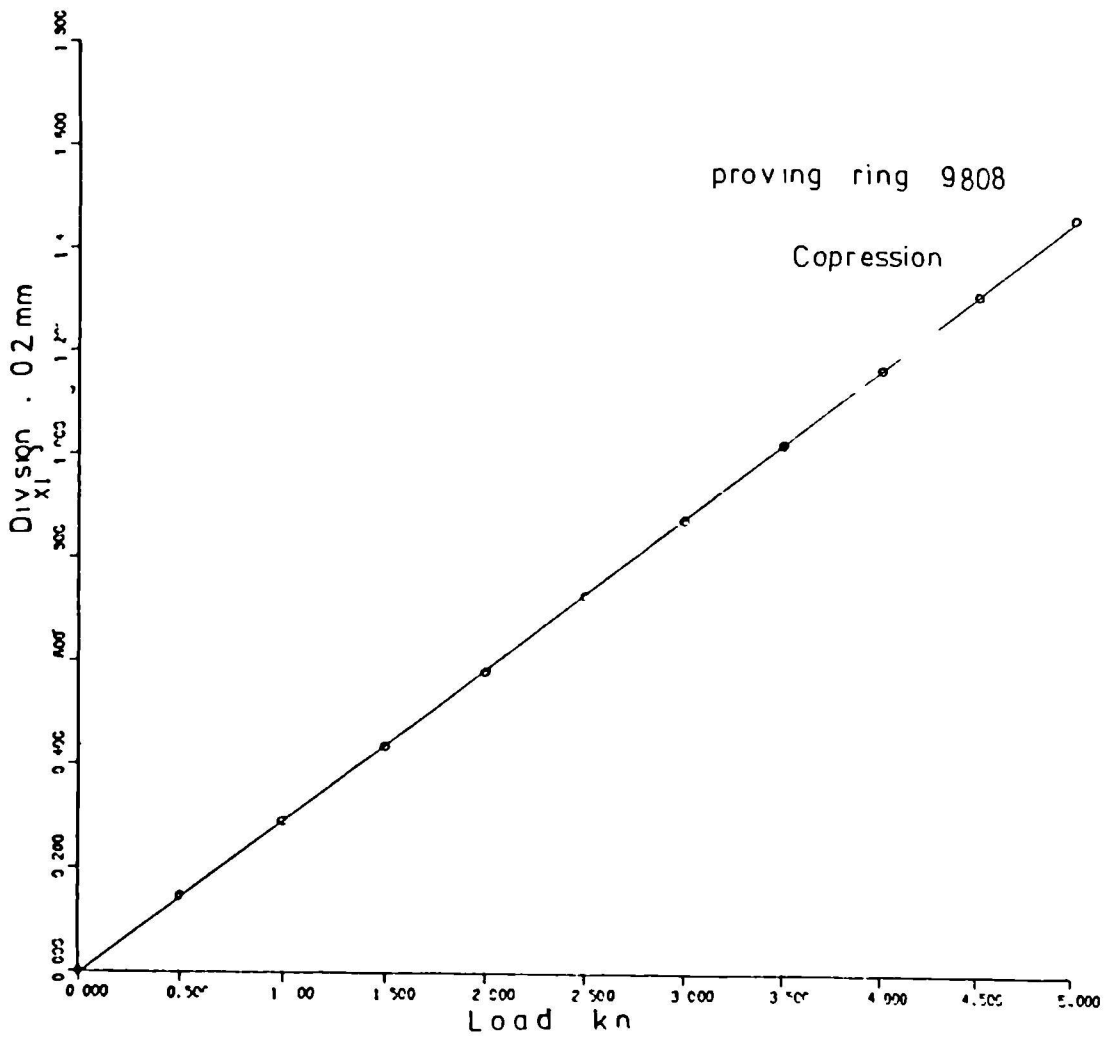
Fig. A.2 Calibration curve of proving ring for shear box apparatus.
