A STUDY OF RESIDUAL SHEAR STRENGTH OF NAMURIAN
SHALES IN RESPECT OF SLOPES IN NORTH DERBYSHIRE.

VOL II

Thesis submitted in fulfilment of the requirements for the
Degree of PH.D.

Department of Geology
University of Sheffield

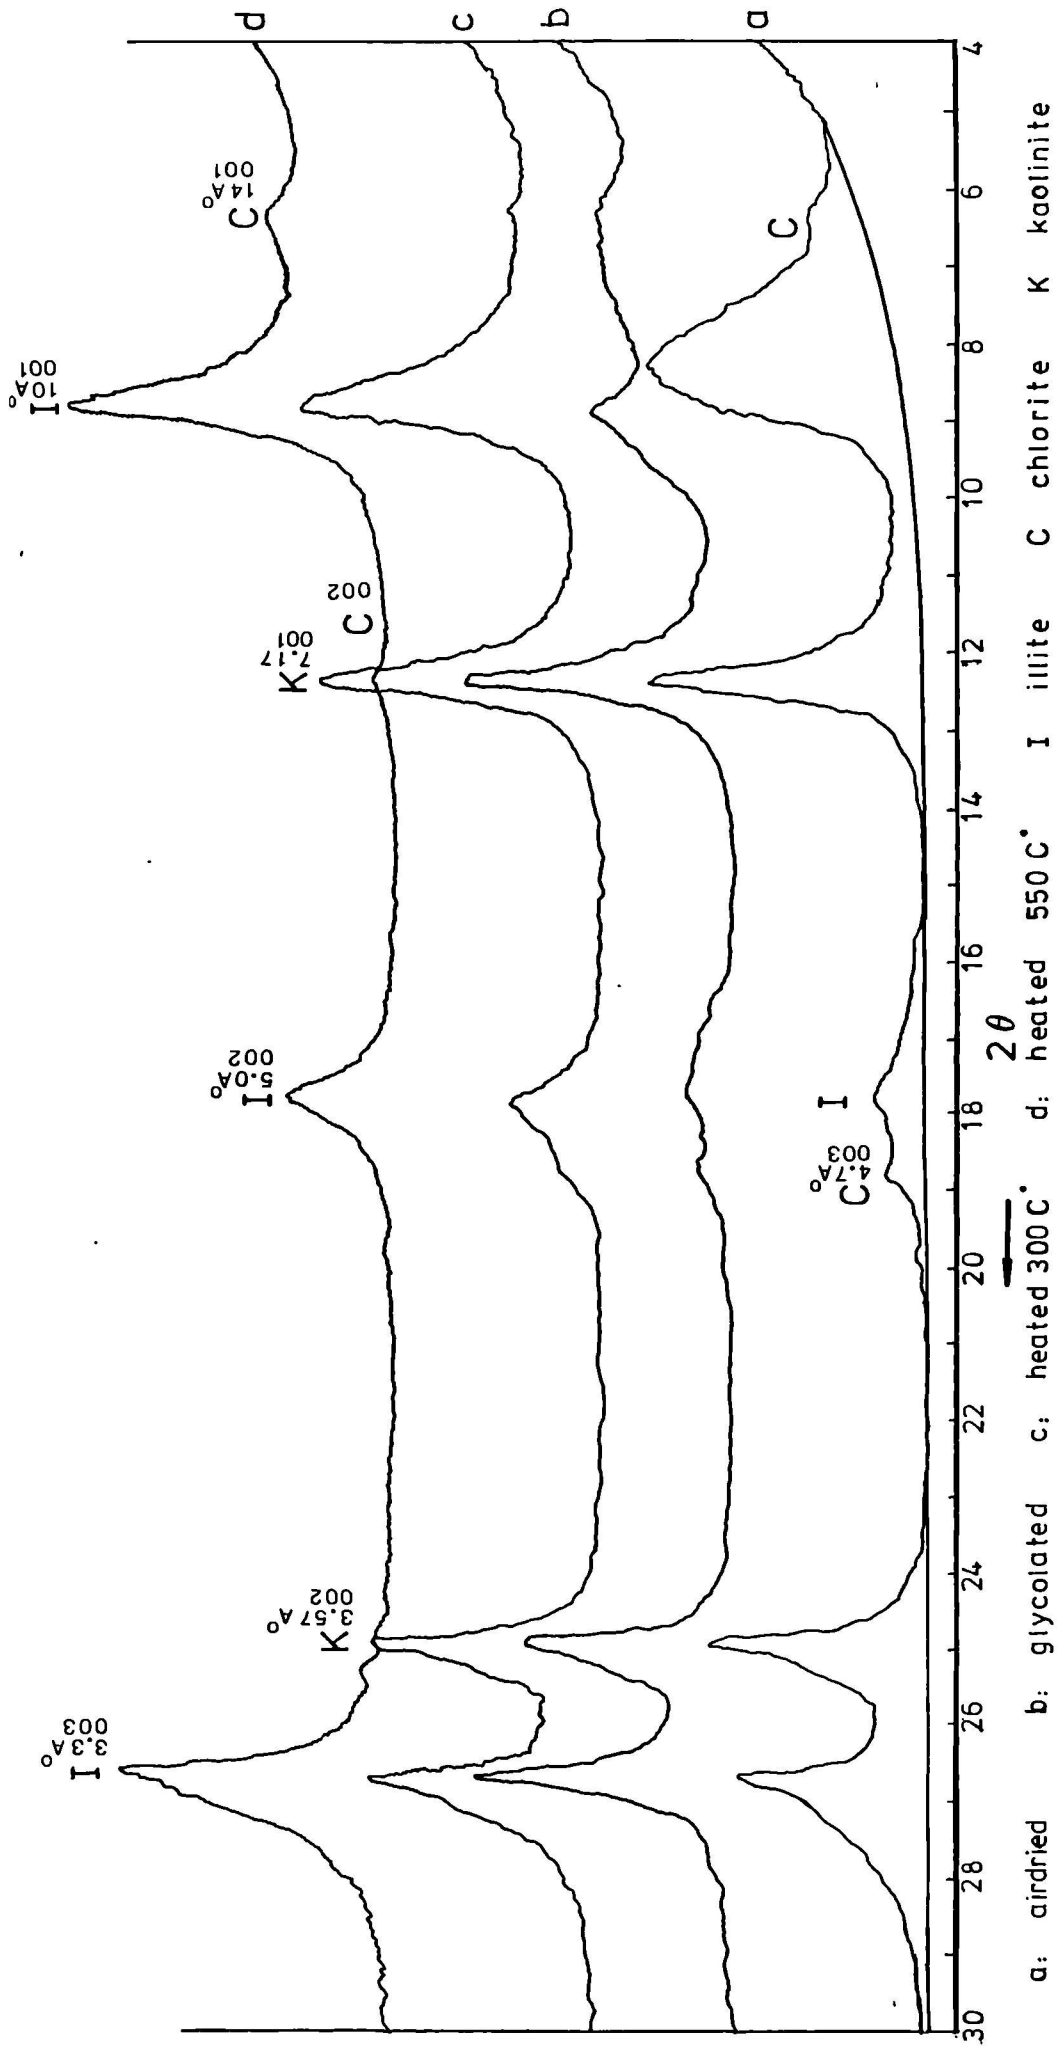
Fig. C.3 X-ray diffraction of orientated smear mounts of the $\leq 2 \mu\text{m}$ clay fraction after different treatments.

The illite peak and expandable clay reflections with basal d - spacings between 10 and 12 \AA (See Fig. C.3) were distinguished by glycolation and heating. When treated with ethylene glycol the d-spacing of the expandable clay increases to about $12 - 14 \text{ \AA}$. Heating the glycolated sample causes dehydration and collapse back to about 10 \AA . Therefore the difference in area between the glycolated 10 \AA peak and the one obtained after heating is usually taken as a quantitative measure of the proportion of expandable clay relative to illite.
