# **Multi-Scale Analysis of Deformation and Damage Development in DP1000 Automotive Steel**

A thesis submitted in partial fulfilment of the requirements for the degree of  
Doctor of Philosophy

The University of Sheffield  
Faculty of Engineering  
Department of Mechanical Engineering

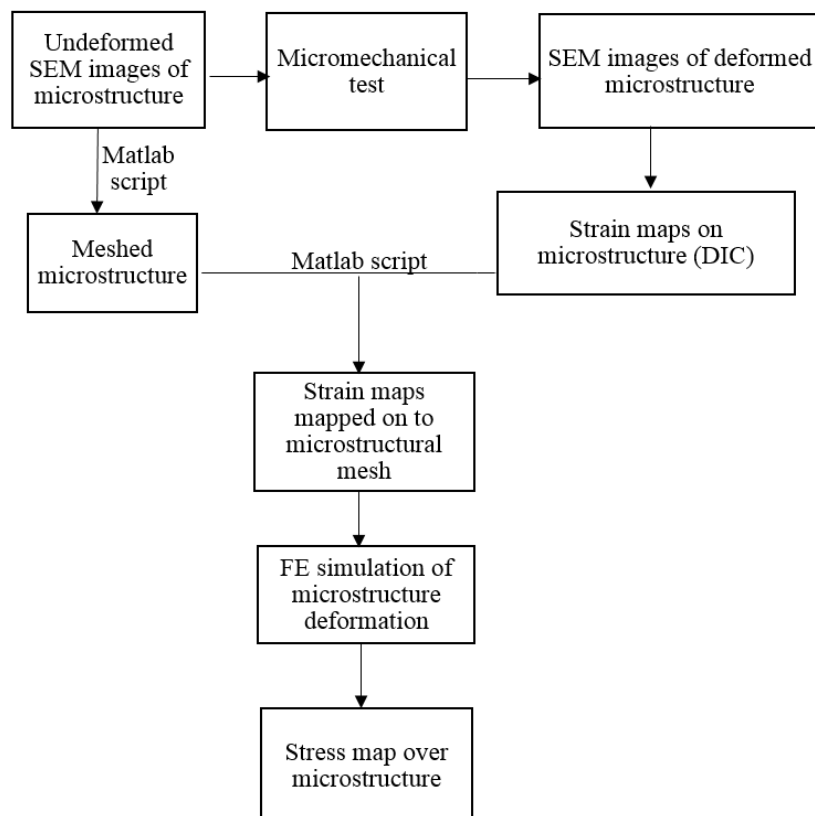
Fig. 4. 4 Flowchart detailing the production of stress maps over the deformed microstructure.

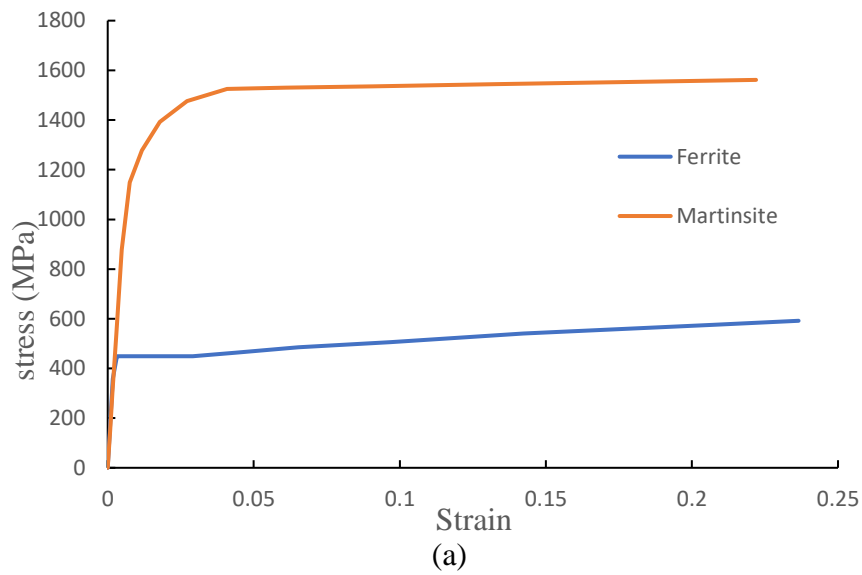
Fig. 6. 11 (a) Adjusted stress-strain curves for both phases from finite simulations of the microstructure, (b) Applied strain values selected for calculated errors reported in Table 6.2.
