DEPARTMENT OF MECHANICAL ENGINEERING
THESIS SUBMITTED FOR THE DEGREE OF DOCTOR OF PHILOSOPHY

**ADDITIVE MANUFACTURING FOR RAILWAY
TRACK COMPONENT LIFE EXTENSION WITH
PREMIUM LASER CLAD COATING**

KATHERINE TOMLINSON

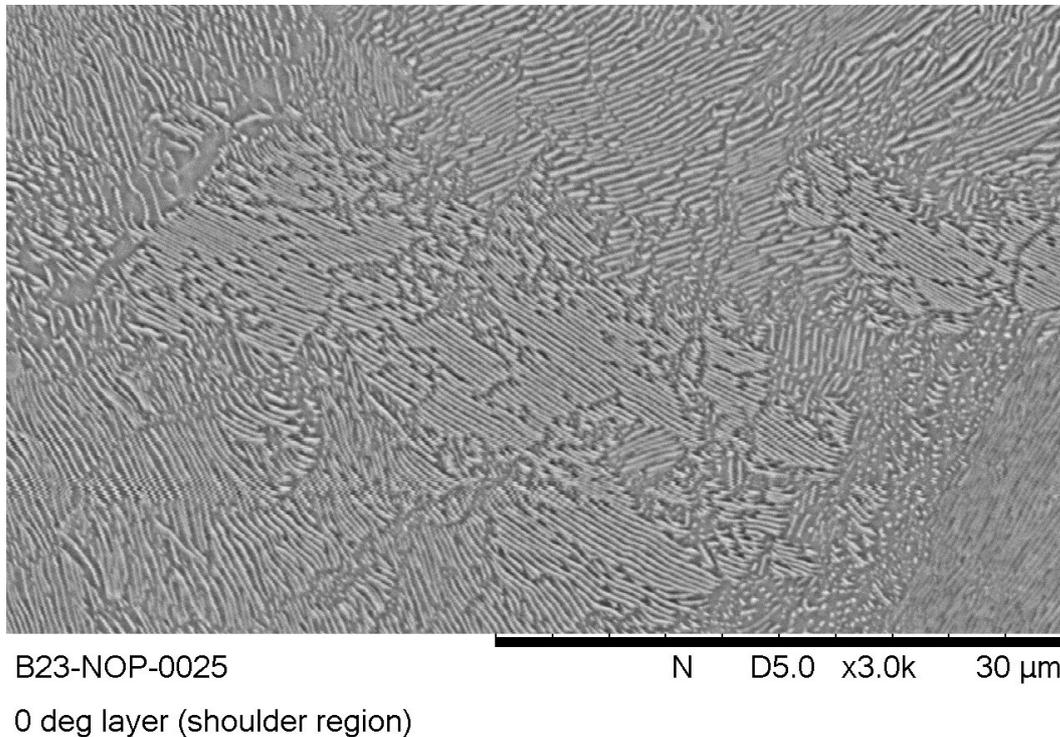
Figure 2.3: SEM image showing the two phased lamellar microstructure of pearlitic rail steel consisting of ferrite and cementite.

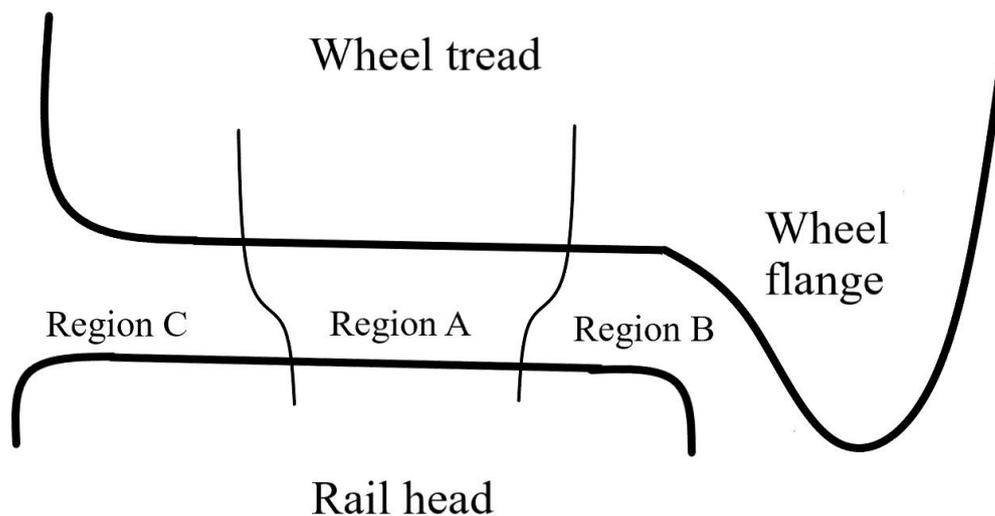
Figure 2.4: Simplified cross section of rail-wheel showing regions in which rail-wheel contact can occur.

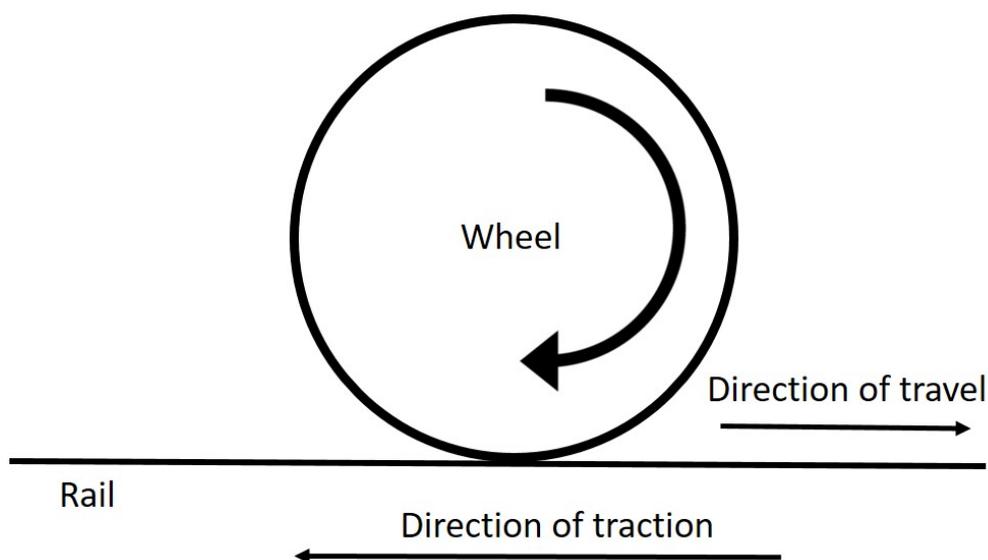
Figure 2.5: Direction of traction experienced by the rail opposed to the direction of travel of accelerating rolling stock.

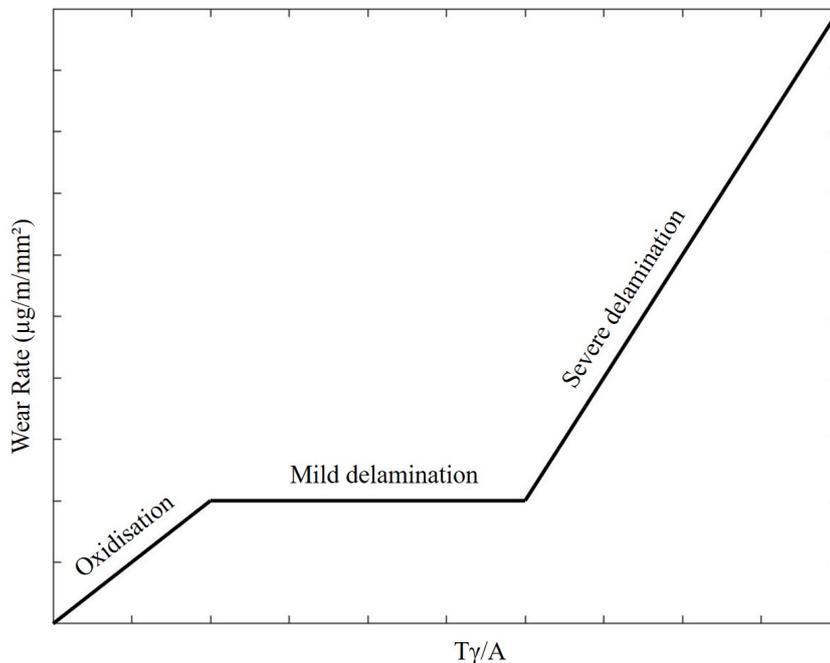
Figure 2.10: Schematic diagram of wear regimes and features.

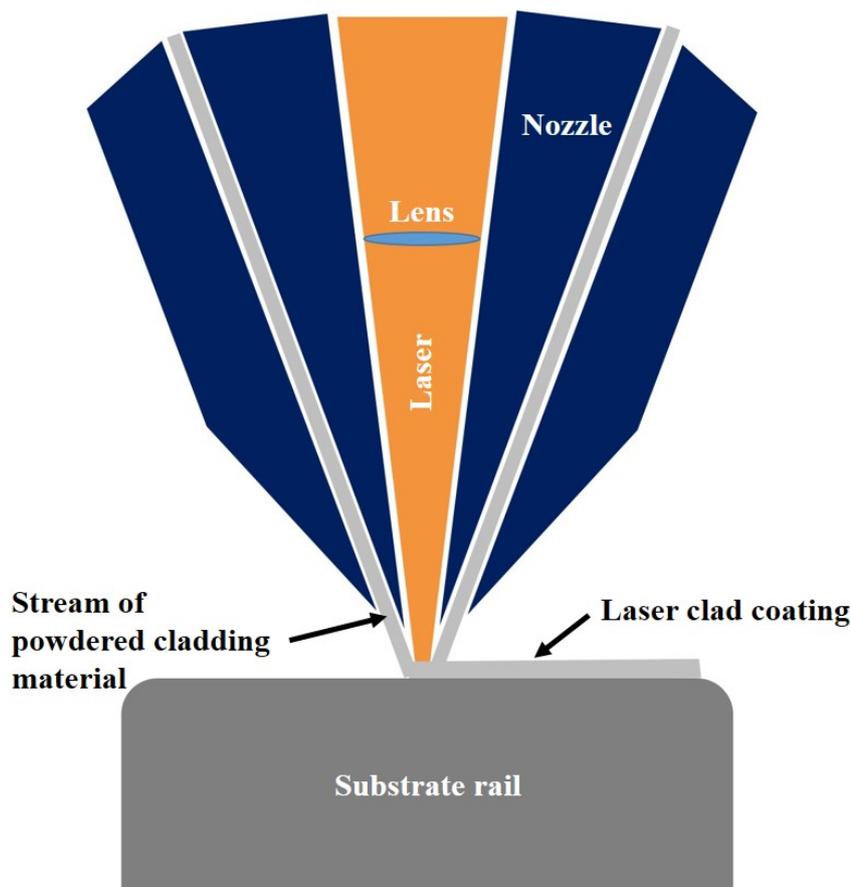
Figure 2.11: Schematic drawing of laser cladding process.

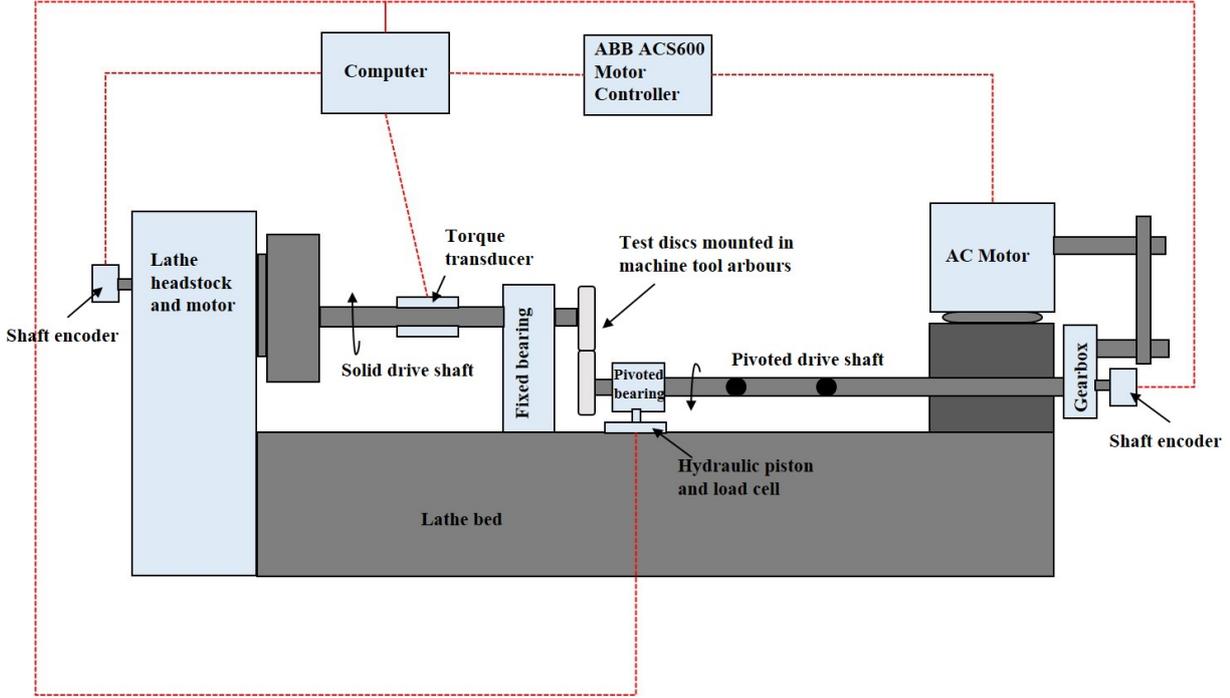
Figure 3.1: Schematic of Sheffield University Rolling Sliding (SUROS) twin disc test machine.

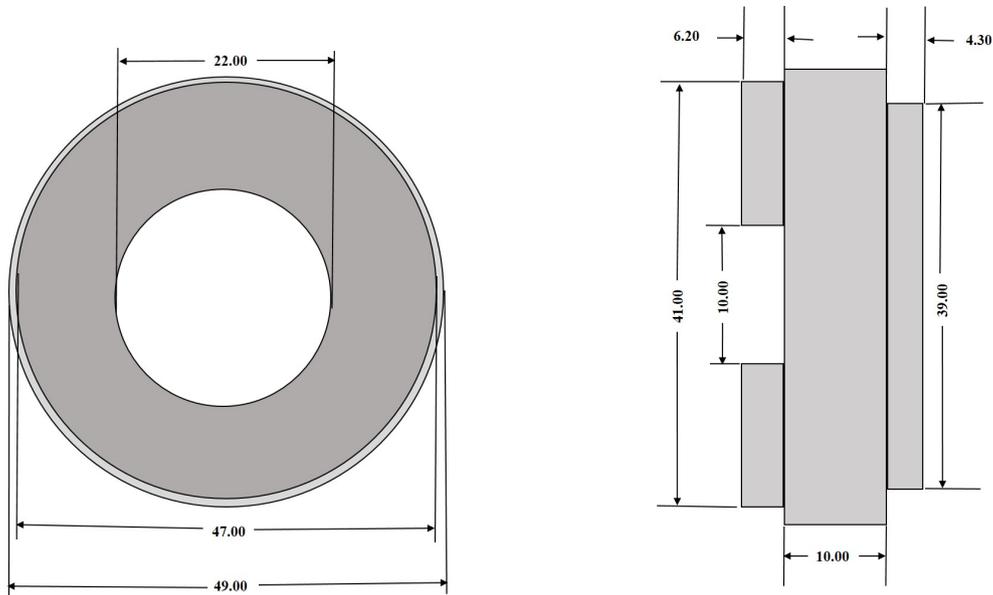
Figure 3.2: Standard dimensions of SUROS test disc specifications with the addition of a 1 mm laser clad coating.

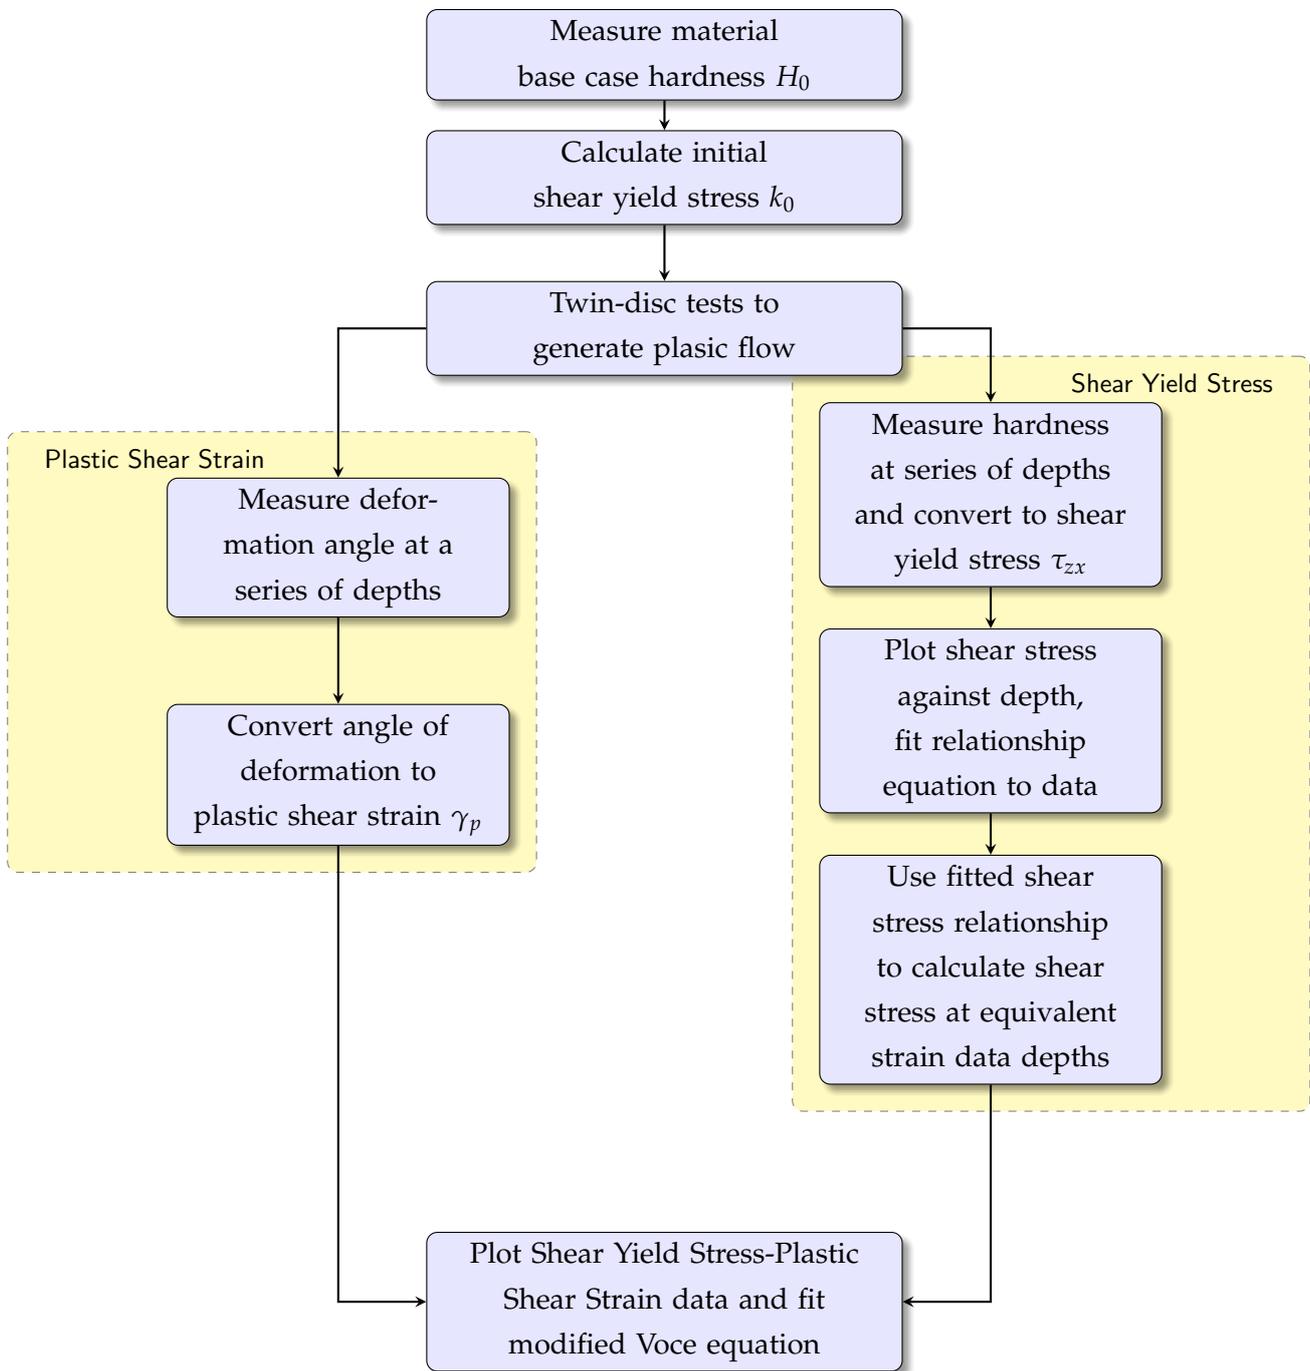
Figure 3.4: Analysis method for characterising Shear Yield Stress – Plastic Shear Strain relationship shown here in a flow chart. Illustrating the initial measurements required before twin-disc testing and the separate PSS and SYS analysis to be conducted before the final SYS-PSS curve is extracted.

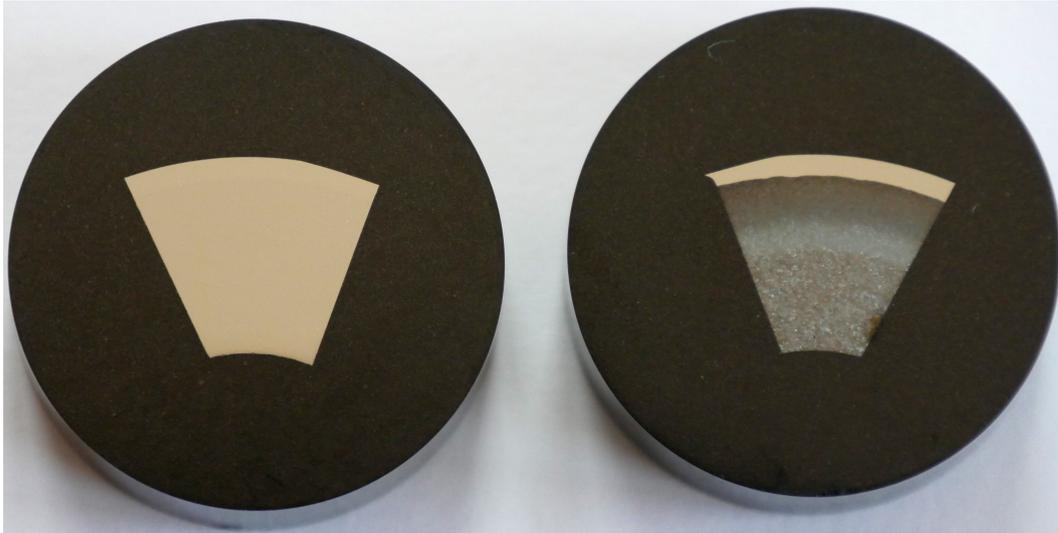
Figure 3.5: Polished (l) and etched (r) R260 grade SUROS with MSS laser clad coating samples

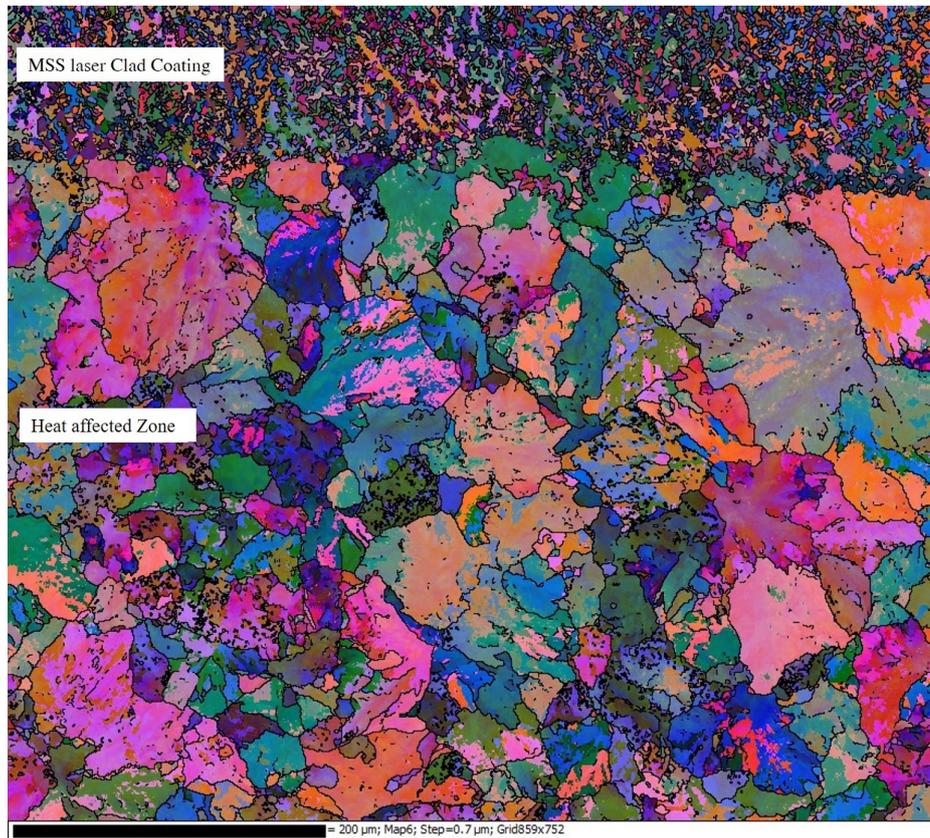
Figure 3.7: Electron Back Scatter Diffraction (EBSD) material observation of MSS laser clad coating on the Heat Affected Zone (HAZ) of the substrate R260 grade rail steel. Showing the comparison of grain structure in the MSS and R260 HAZ.

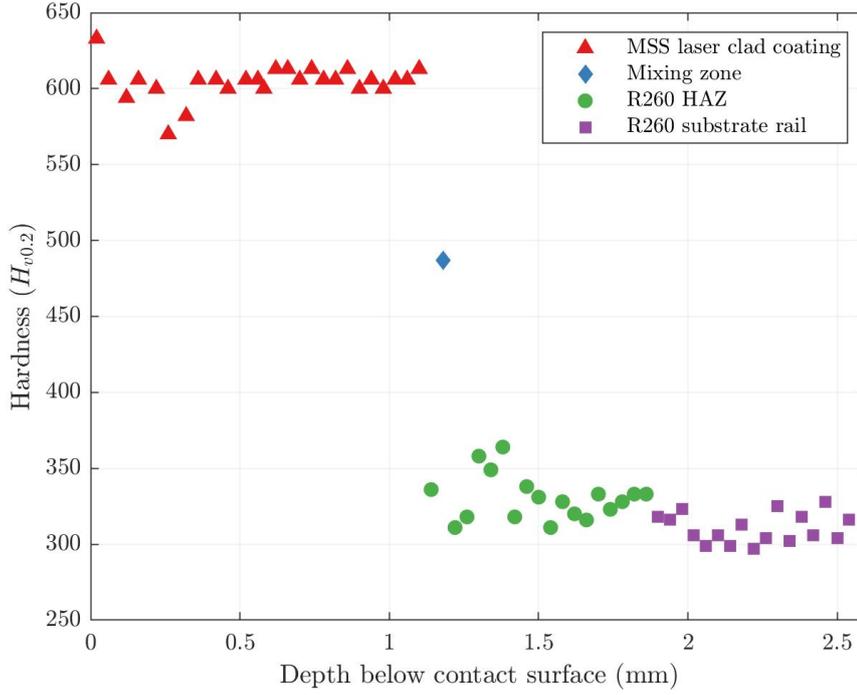
Figure 3.8: Vickers hardness $Hv_{0.2}$ through the vertical-longitudinal section of untested MSS laser clad coated R260 grade rail steel sample, showing the harder coating, the standard R260 substrate rail and the marginally hardened R260 Heat Affected Zone.

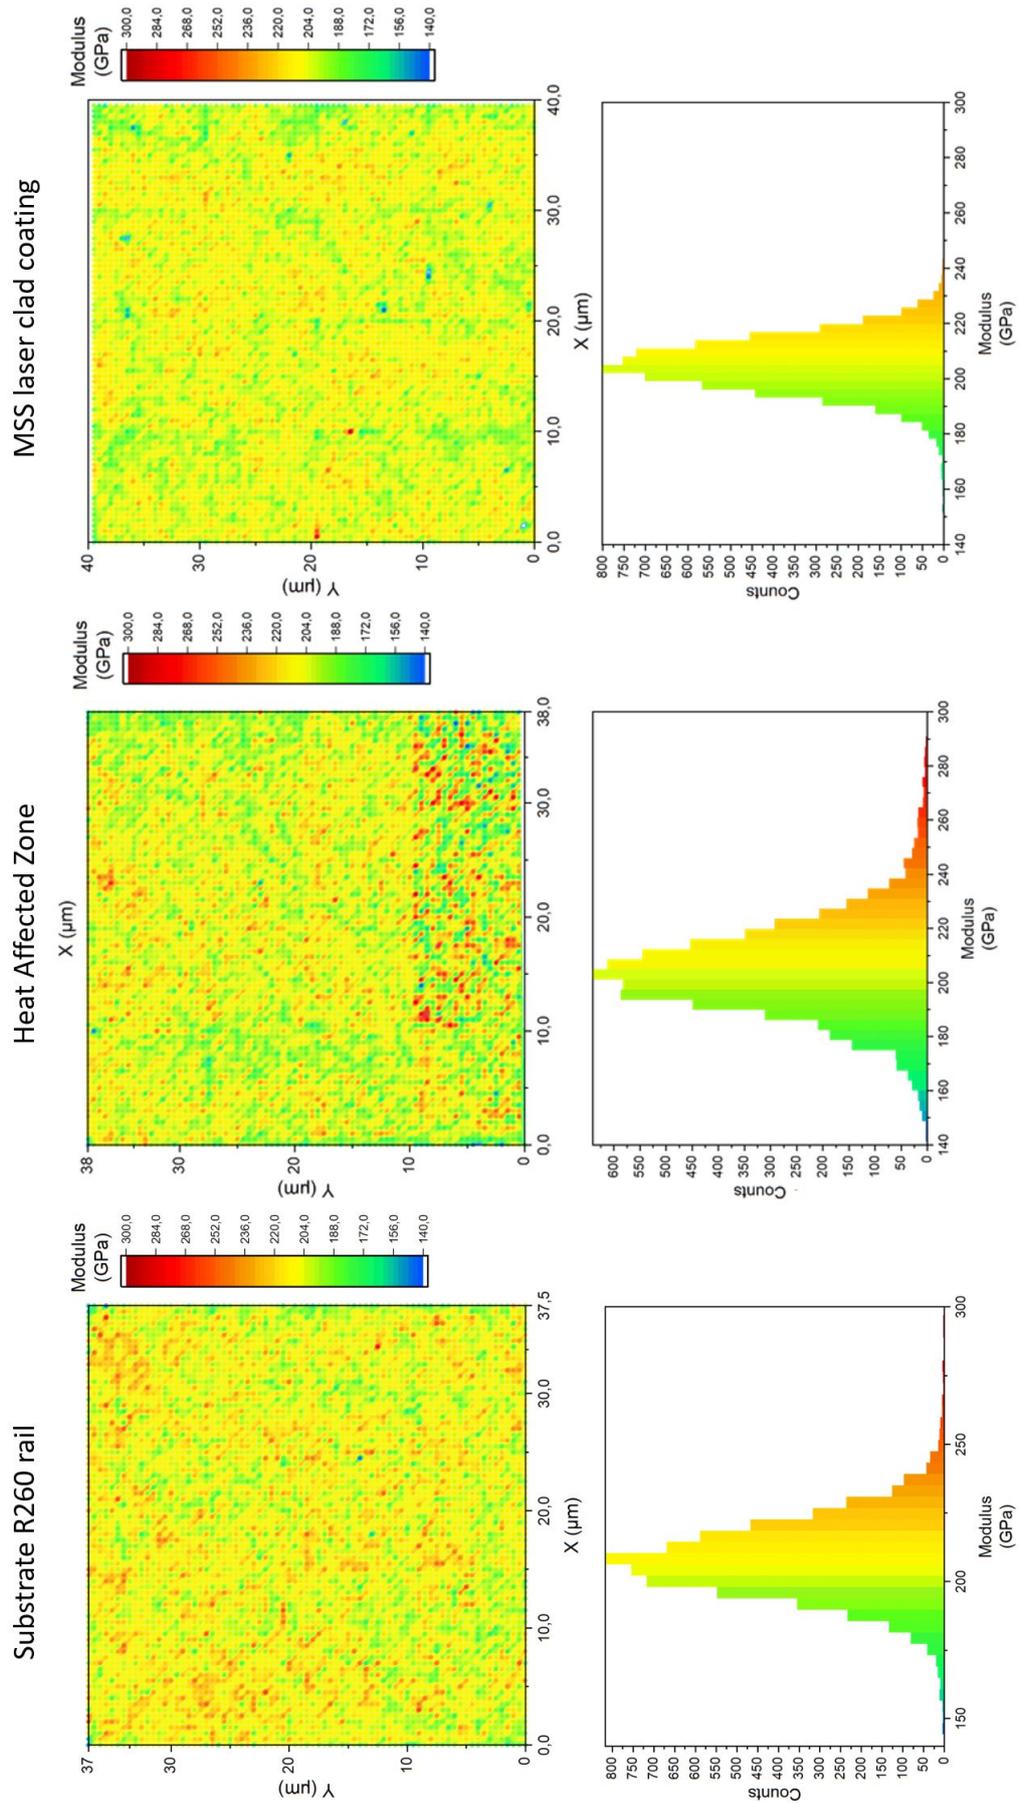
Figure 3.9: Nano-indentation mapping over $40\mu m^2$ area in R260 substrate rail, HAZ and MSS laser clad coating. Measuring the elastic modulus with 6400 indents, showing more variation across the microstructure of the pearlitic rail steel than the Martensitic Stainless Steel. [151]

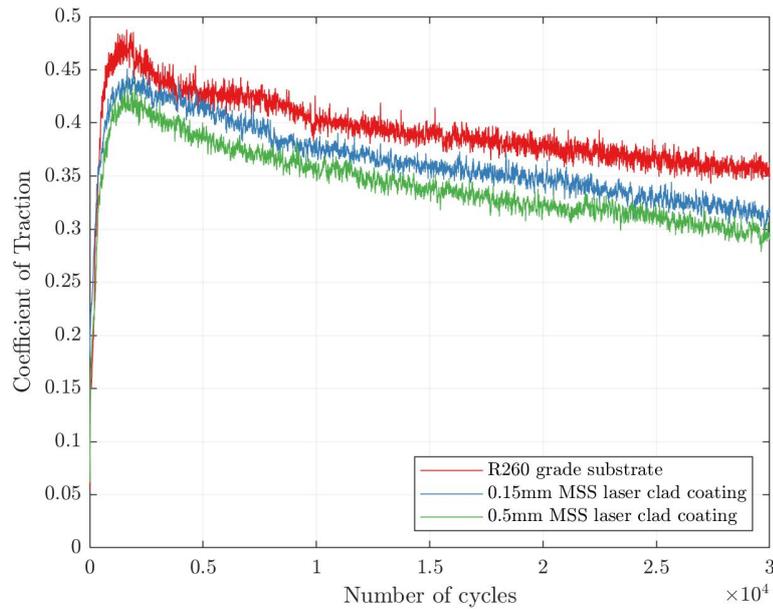
Figure 3.11: Twin-disc coefficient of traction (CoT) for R260, 0.5 mm and 0.15 mm MSS laser clad coatings when tested at 1500 MPa, -1% slip, 30,000 cycles. The peak CoT is 0.48 for R260, 0.44 for 0.15 mm MSS laser clad coating and 0.43 for 0.5 mm MSS laser clad coating.

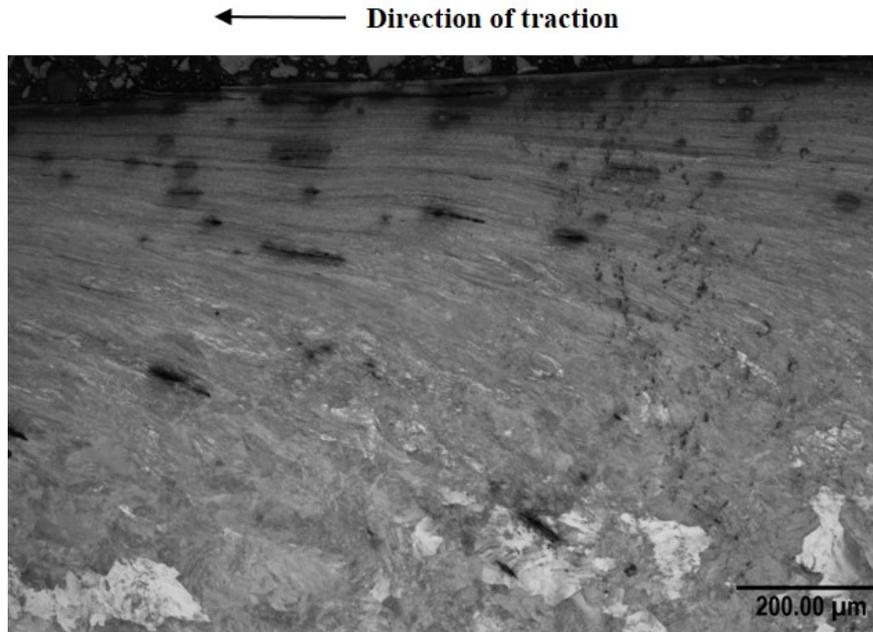
Figure 3.12: Sample 1: R260 steel alloy rail disc following testing at 1500 MPa, -1% slip for 30,000 cycles, with significant plastic deformation below the contact surface.

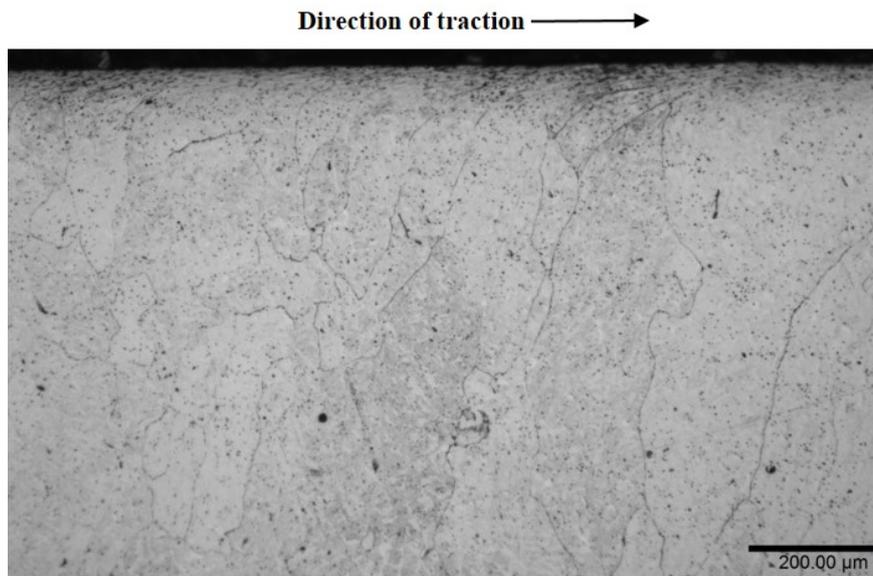
Figure 3.13: Sample 3: MSS laser clad coating following testing at 1500 MPa, -1% slip for 30,000 cycles, with minimal plastic deformation on the shallow surface only.

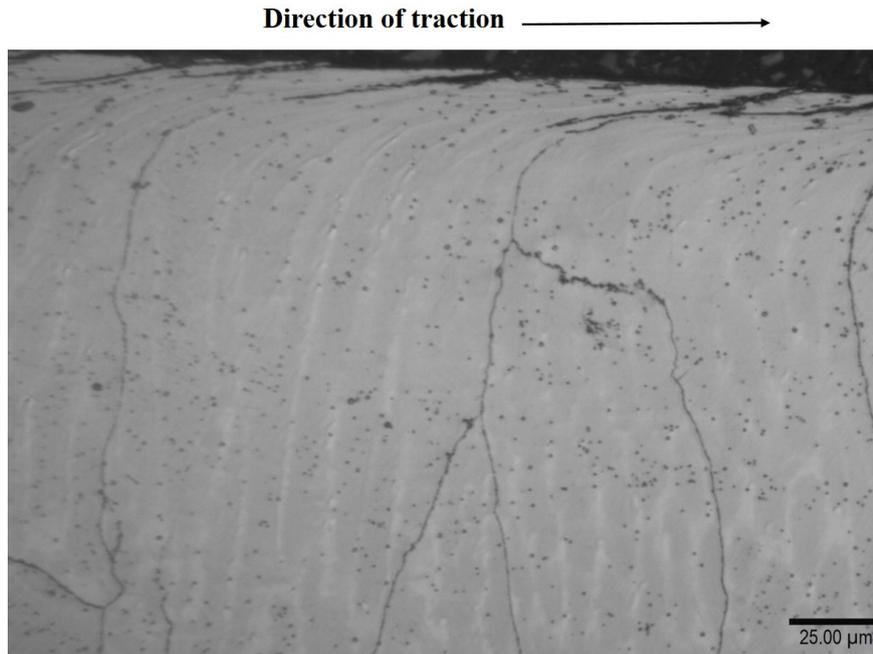
Figure 3.15: Sample 2: Thin 0.15 mm laser clad coating following testing at 1500 MPa, -1% slip for 30,000 cycles, with plastic ratcheting in the shallow surface depths. It should be noted that the strong etchant has caused surface marks and that the lines do not represent cracks.

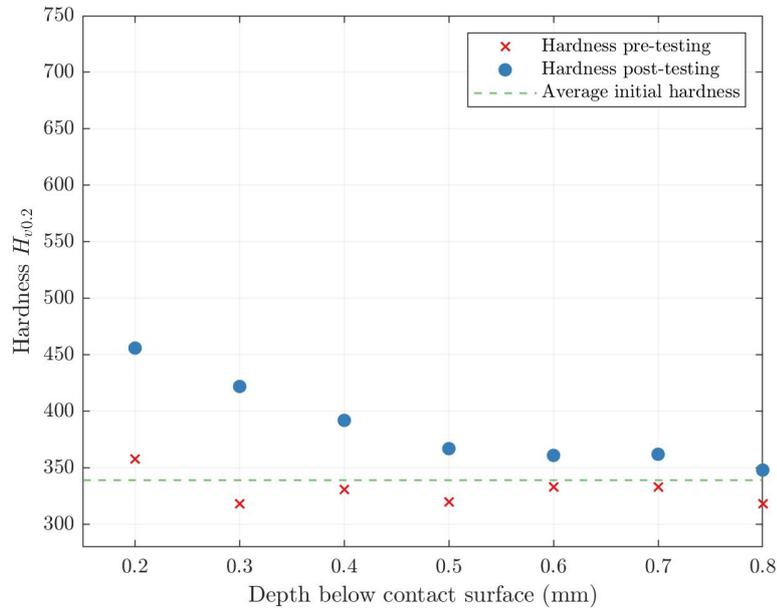
Figure 3.17: Sample 2: R260 HAZ. Slight increase in hardness after testing at 1500 MPa, -1% slip and 30,000 cycles compared with material hardness pre-testing.

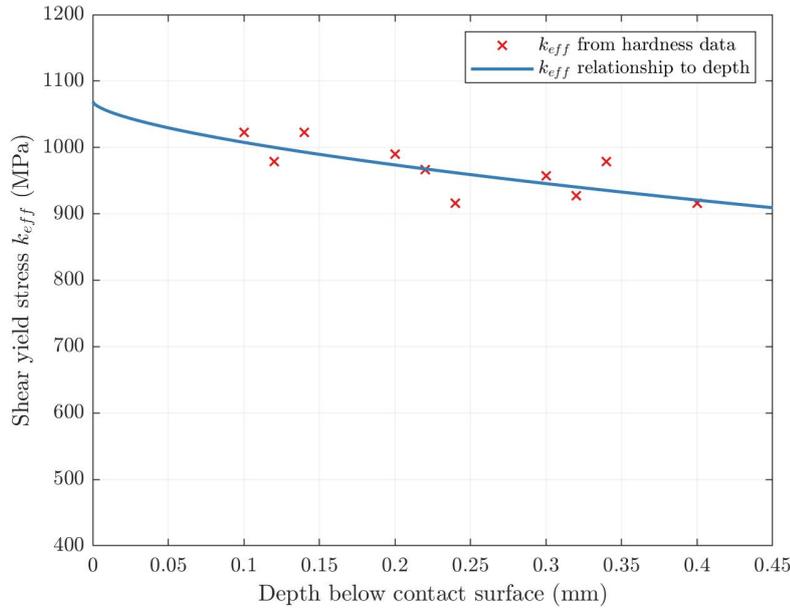
Figure 3.21: Sample 3: MSS laser clad coating, line of best fit showing the Shear Yield Stress relationship with depth x , $k_{eff} = -265.7x^{0.6367} + 1069$

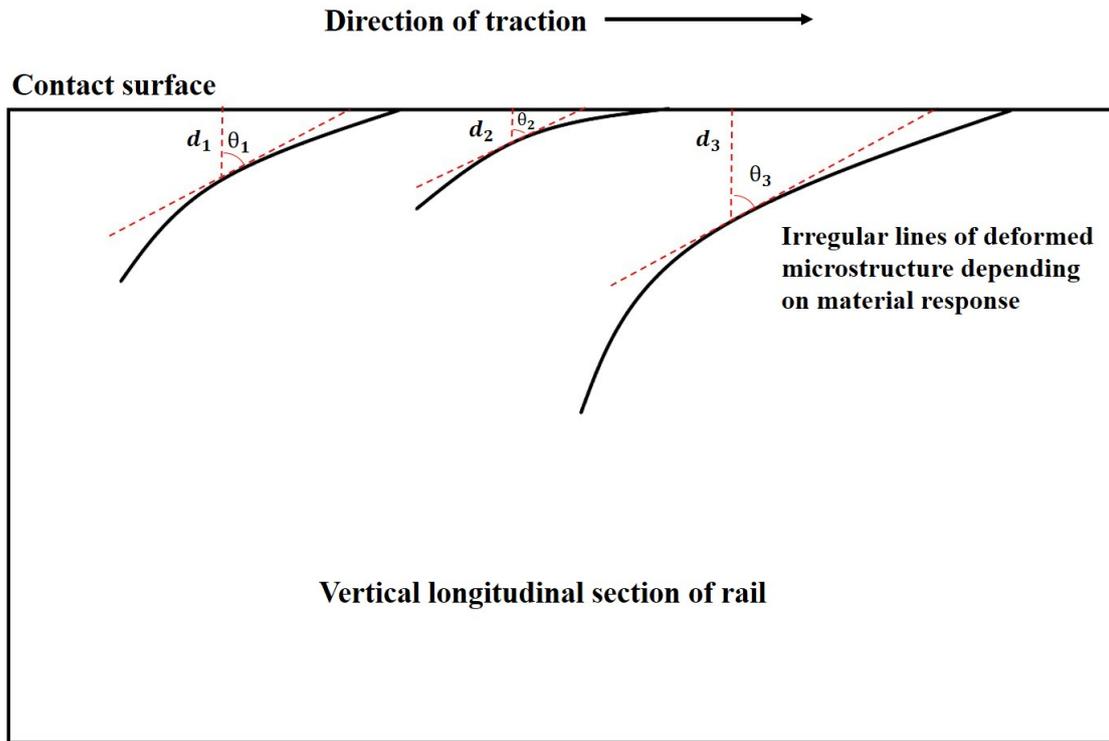
Figure 3.22: Developed method to measure Plastic Shear Strain. Angle of deformation θ measured at variable depths d and recorded as pairs of data to enable the calculation of Shear Yield Stress at the equivalent depths.

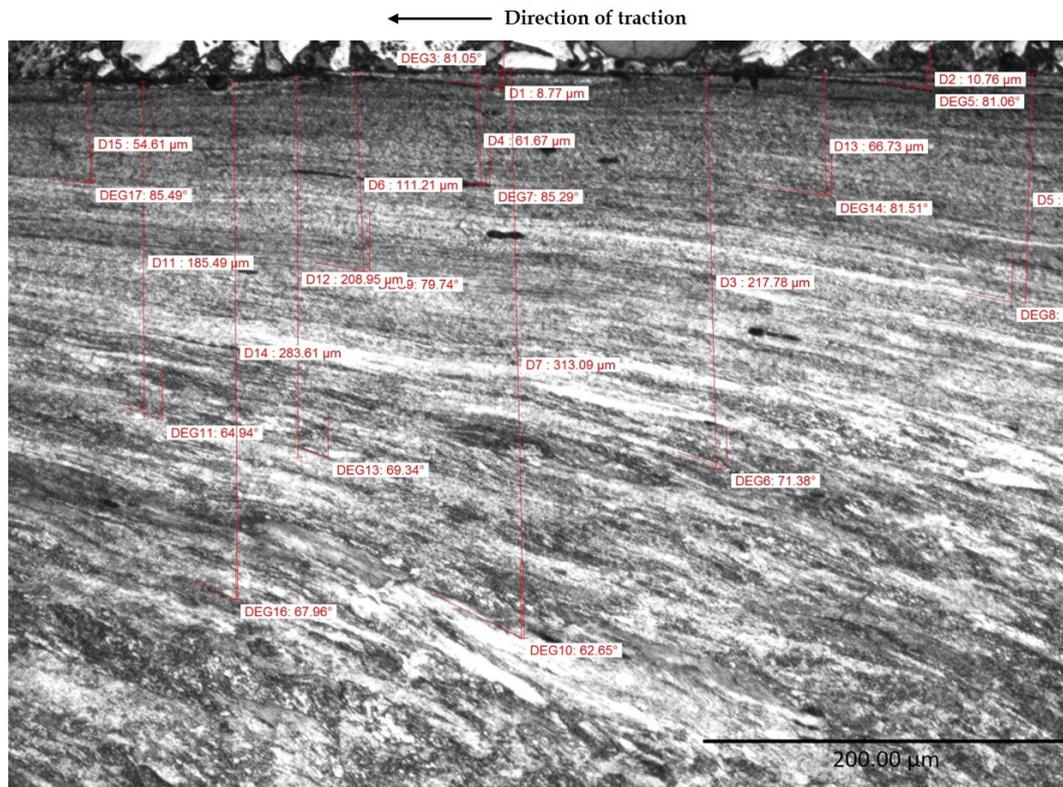
Figure 3.23: Sample 1: Image showing the measured angles of deformation and corresponding depth measurements within the R260 rail material. Measurements taken with Buehler Omnimet 9.5 software under optical microscopy and recorded in Table 3.7

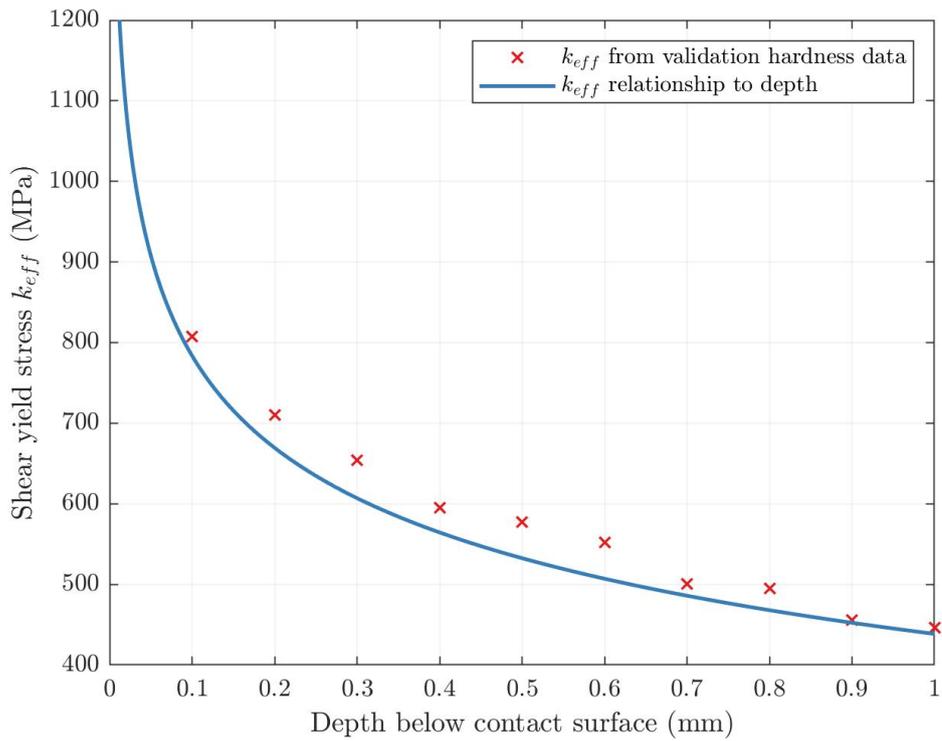
Figure 3.29: Sample 4 experimental data fit to the R260 equation of best fit for Shear Yield Stress relationship with depth shown in Table 3.6.

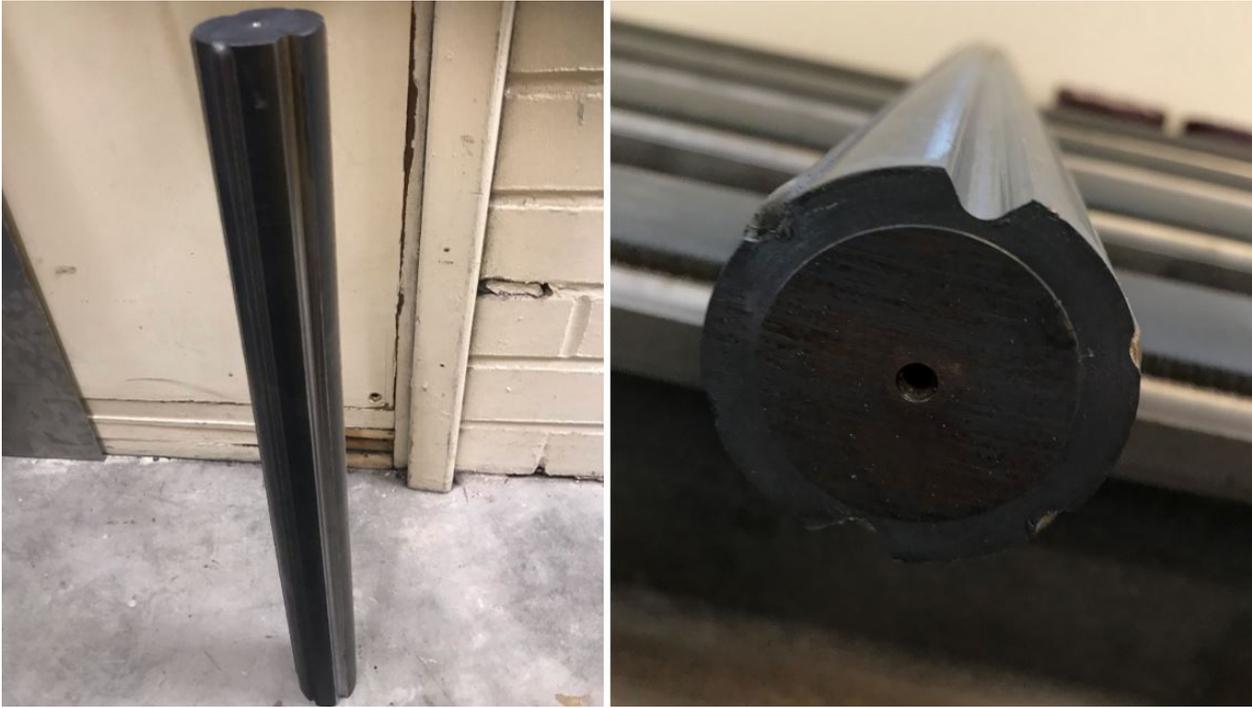
Figure 4.1: Photograph of the repair bar during the manufacturing process showing the wire eroded slots for the laser clad repairs.

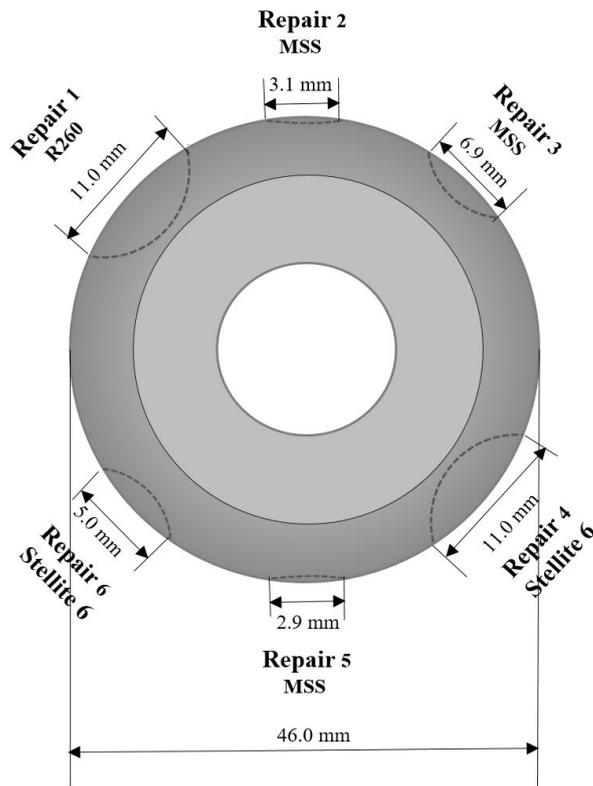
Figure 4.2: Sketch of the repair disc with the repair numbers, materials and width of each repair site.

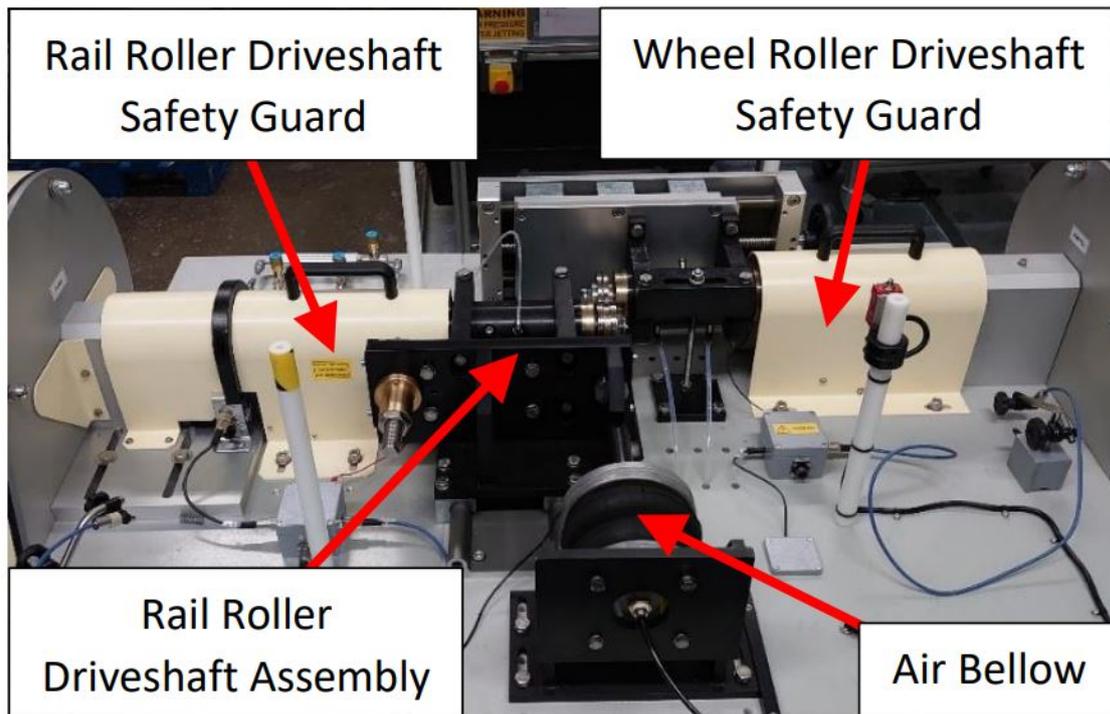
Figure 4.3: Image of new twin-disc test machine; SUROS 2 (TE 72 Two Roller Machine) used to replicate rail-wheel contact in the laboratory.

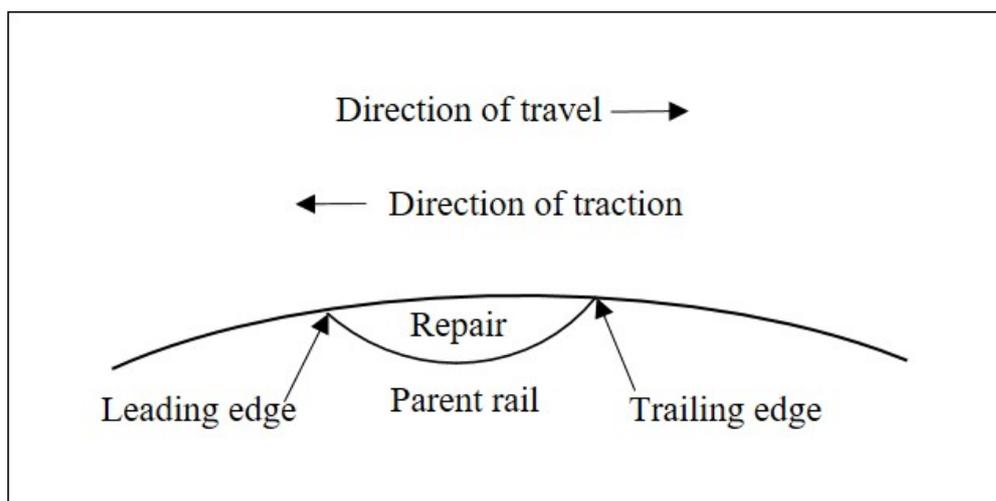
Figure 4.4: Illustration to demonstrate the leading edge and trailing edge of the repair site within the parent rail. The direction of travel and opposing direction of traction across the repair surface is also shown.

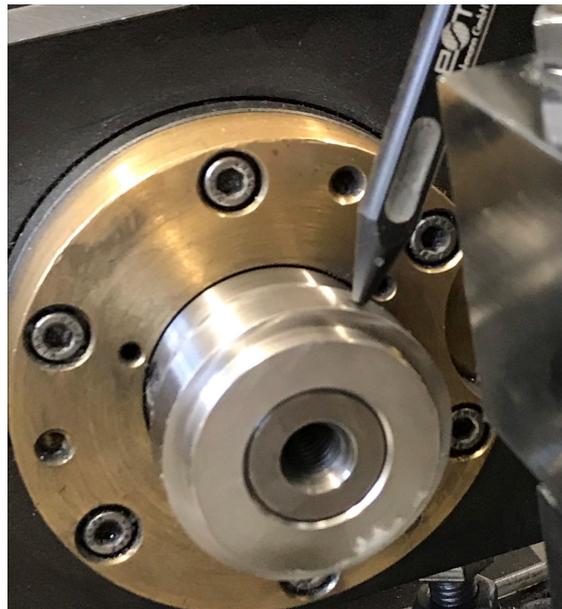
Figure 4.5: Position of KD21 Rohmann GmbH differential eddy current probe positioned over the R1 45 calibration disc.

A standard R1 45 calibration disc of R260 grade rail steel with a spark eroded slot of 3 mm wide and 100 μm at an angle of 45° was initially tested with the probe detecting the crack as expected. The resultant crack trigger of the calibration disc is set between the gates as shown in Figure 4.6a and the tests on the repair discs use this level for comparison. Eddy current testing has been conducted on a range of fully laser clad coated twin-disc samples by Lewis et al. [110] and Hiensch et al. [49] in which no cracks were detected. An untested R260 grade rail steel rail disc with the full surface laser clad with MSS was tested for comparison with this previous research and it can

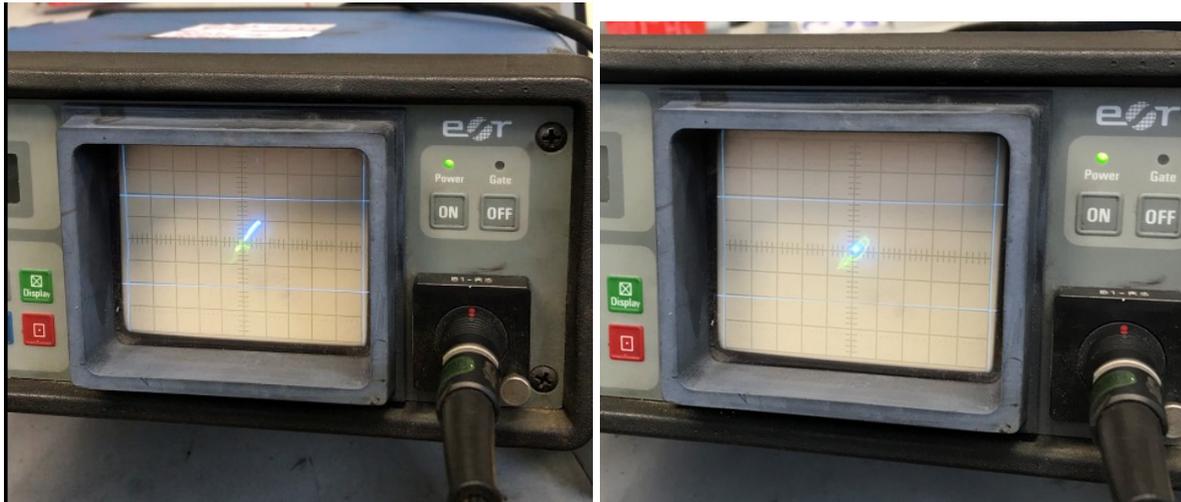
(a) Standard R1 45 calibration disc of R260 grade rail steel. (b) R260 grade rail steel rail disc with full MSS laser clad surface.

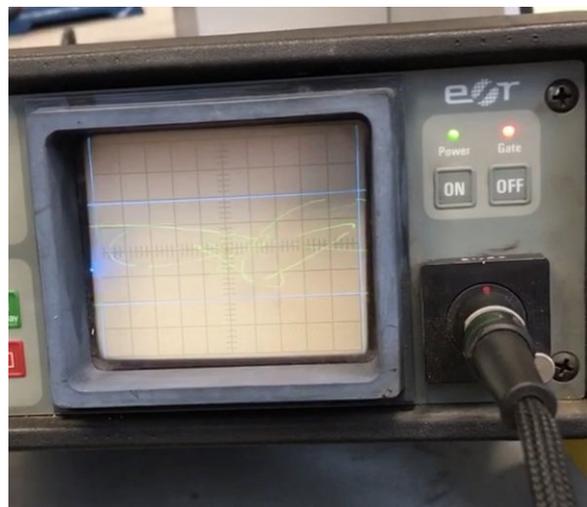
Figure 4.7: Eddy current detector signal over the untested repair disc, gates triggered at each joint between parent rail and repair.

The difference in this assessment of the method is the discontinuous composition of the repair disc which has the potential to trigger false or multiple readings. Assessing this non-destructive examination method for laser clad coating repairs will aid maintenance inspections in-situ. Testing an untested repair disc with the eddy current it can instantly be seen that the gate is triggered at every interface between parent rail and repair as shown in Figure 4.7.

Considering Figure 4.7 with an untested repair disc it is concluded that non-destructive eddy current testing is an unsuitable method for the detection of cracks in laser clad repairs. The method is not used in the RCF tests in this chapter and visual surface inspection with Alicona in combination with post-test destructive methods of microscopy observations are selected for analysis.

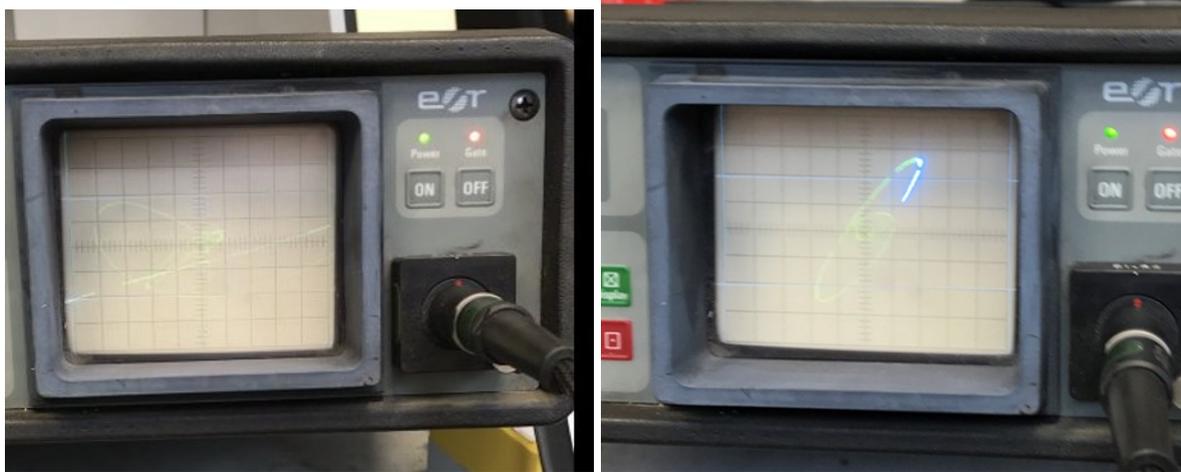
(a) Repair disc after testing for 5,000 cycles

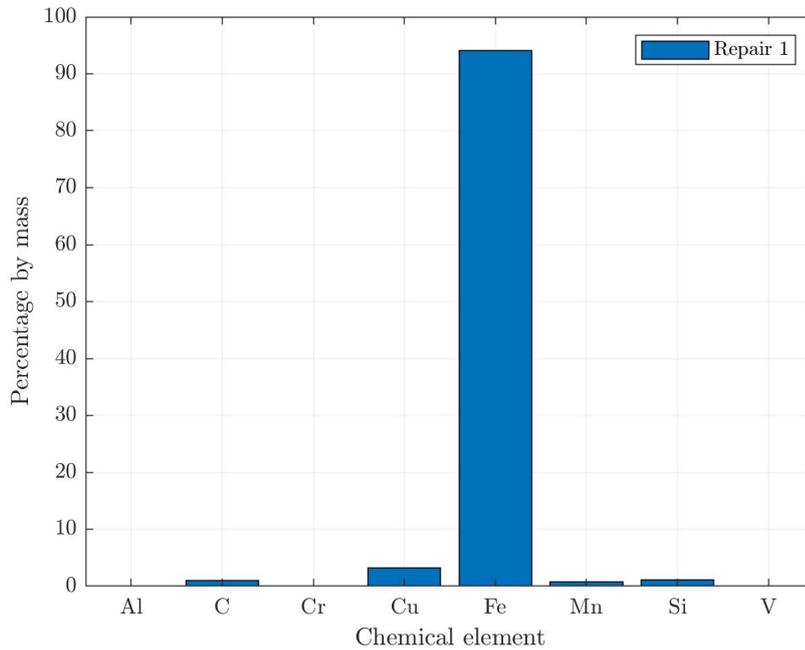
Figure 4.10: Chart showing the chemical element percentage mass of the R260 repair from the data gathered through LIBS analysis.

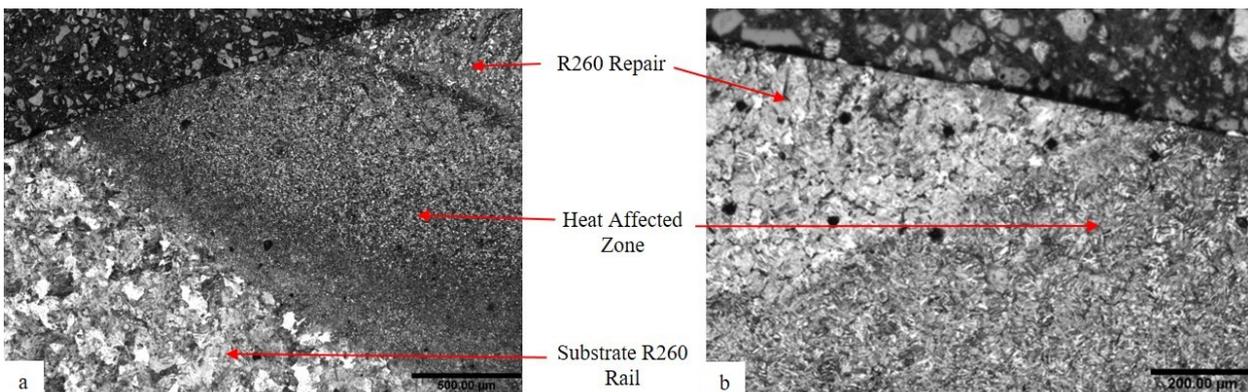
Figure 4.11: Repair 1: optical micrographs of the a) leading edge and b) trailing edge interface of the R260 repair with the R260 parent rail disc, showing the heat affected zone surrounding the repair.
