DEPARTMENT OF MECHANICAL ENGINEERING
THESIS SUBMITTED FOR THE DEGREE OF DOCTOR OF PHILOSOPHY

**ADDITIVE MANUFACTURING FOR RAILWAY
TRACK COMPONENT LIFE EXTENSION WITH
PREMIUM LASER CLAD COATING**

KATHERINE TOMLINSON

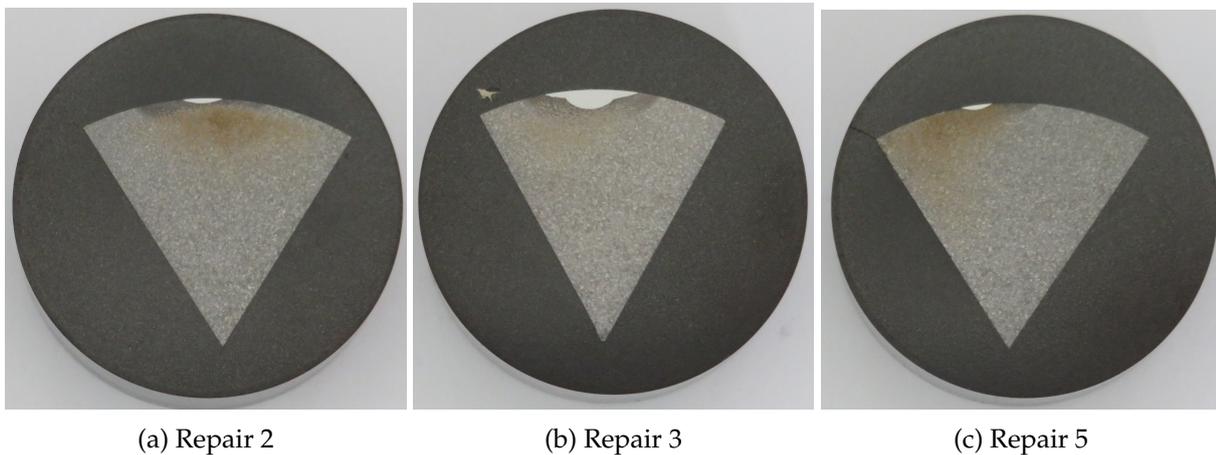
Figure 4.13: Repairs 2,3 and 5: MSS repair sites prior to testing. Etched parent rail reveals repair site and surrounding heat affected zone.

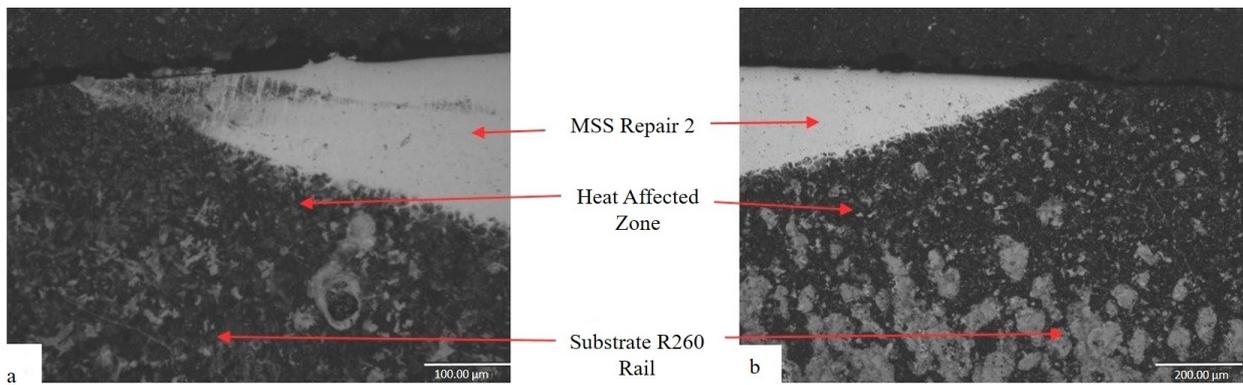
Figure 4.15: Repair 2: Optical micrographs of the a) leading edge and b) trailing edge of the MSS repair with the R260 parent rail disc, showing mechanical mixing at the interface.

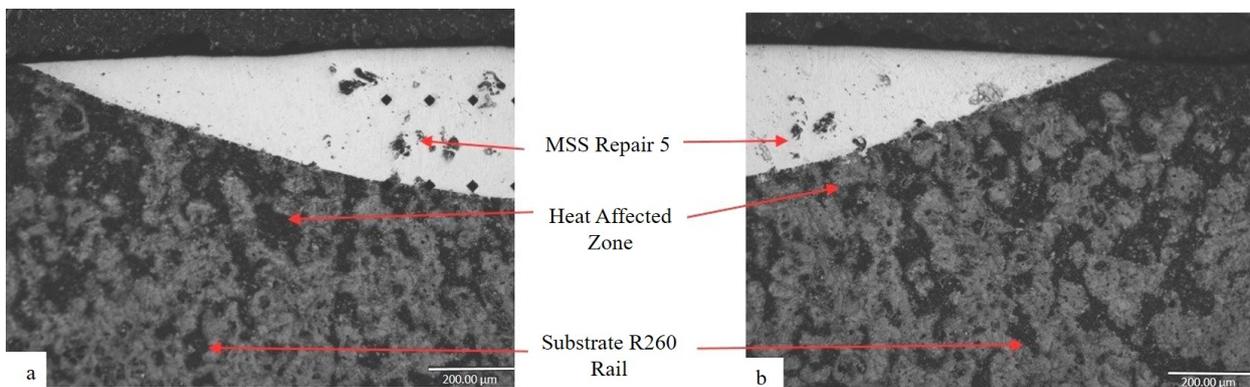
Figure 4.17: Repair 5: Optical micrographs of the a) leading edge and b) trailing edge of the MSS repair with the R260 parent rail disc, showing mechanical mixing at the interface.

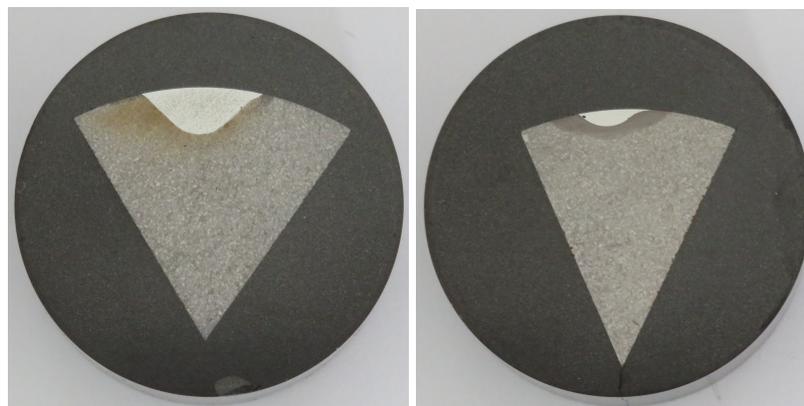
(a) Repair 4

(b) Repair 6

Figure 4.19: Repairs 4 and 6: Stellite 6 repair sites prior to testing. Etched parent rail reveals repair site and surrounding heat affected zone.

The cross section of 4.19a repair site 4 and 4.19b repair site 6 can be seen in Figure 4.19, after etching with 2% Nital which etches the substrate R260 material and reveals the repair site.

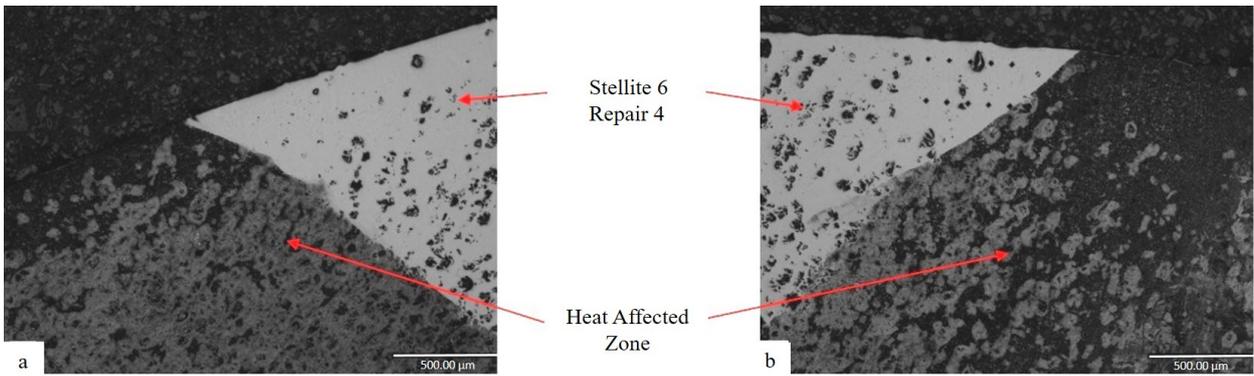
Figure 4.21: Repair 4: Optical micrographs of the a) leading edge and b) trailing edge of the Stellite 6 repair with the R260 parent rail disc, showing mechanical mixing at the interface.

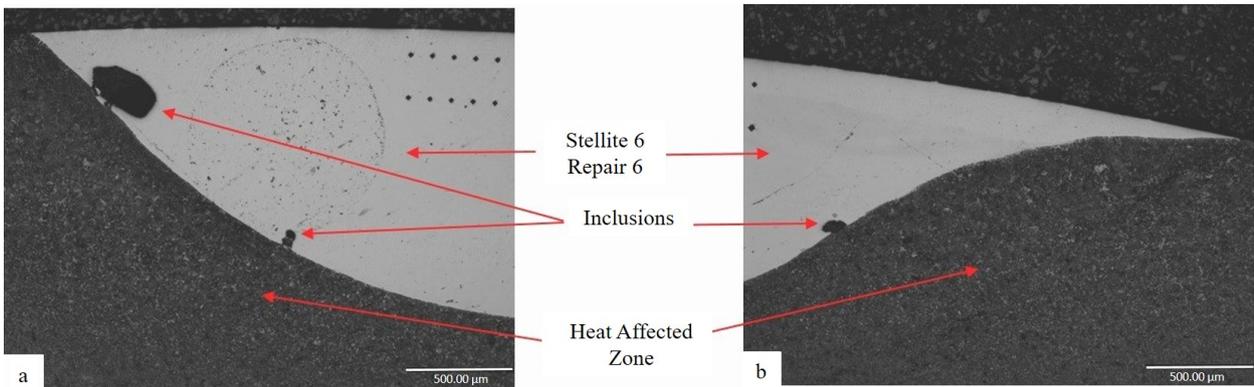
Figure 4.22: Repair 6: Optical micrographs of the a) leading edge and b) trailing edge of the Stellite 6 repair with the R260 parent rail disc, showing inclusions at the interface.

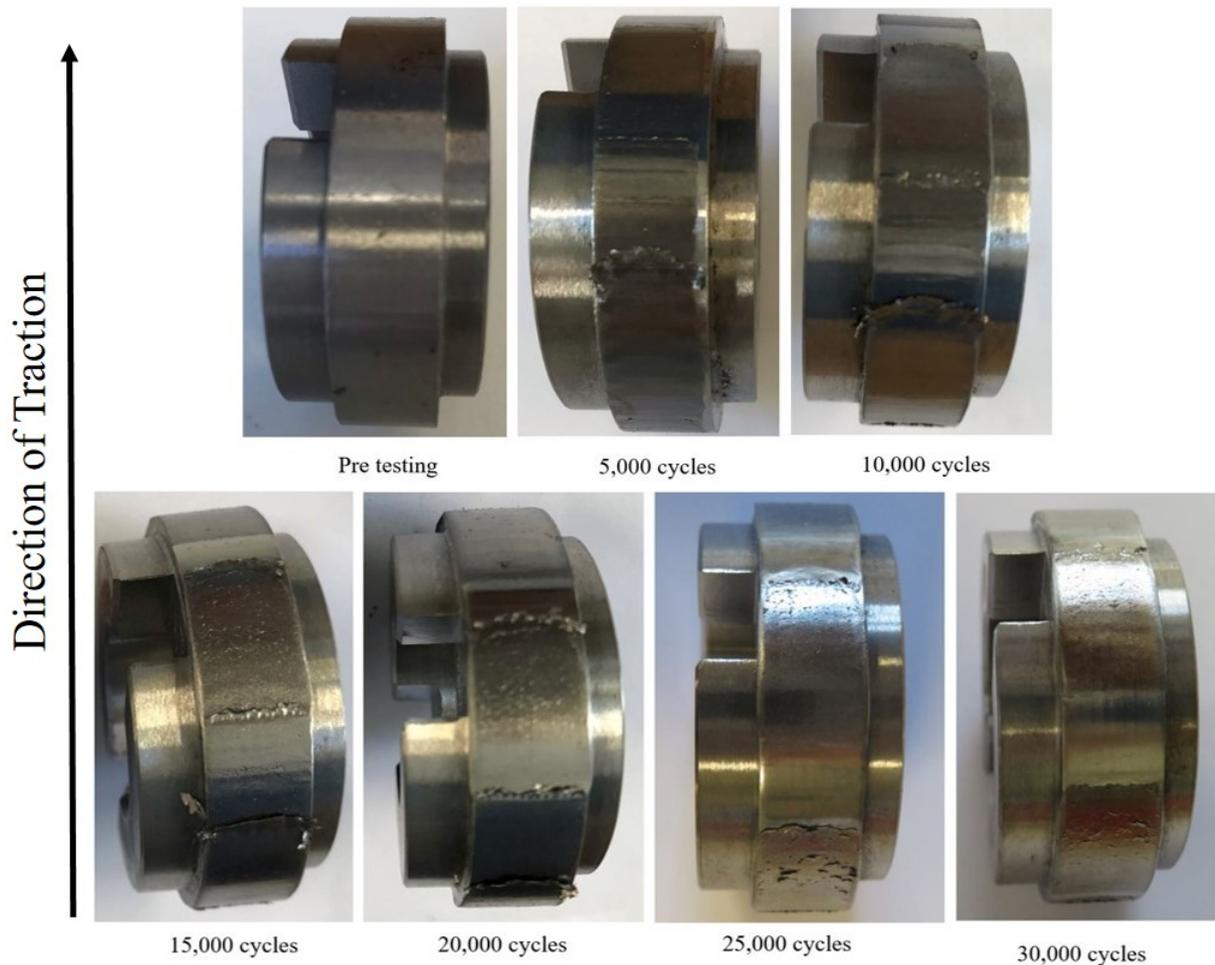
Figure 4.24: Visual observation of the progression of surface evolution on the repair disc at regular intervals in the unlubricated test. Material flow can be seen at the interface between the parent rail and repair sites.

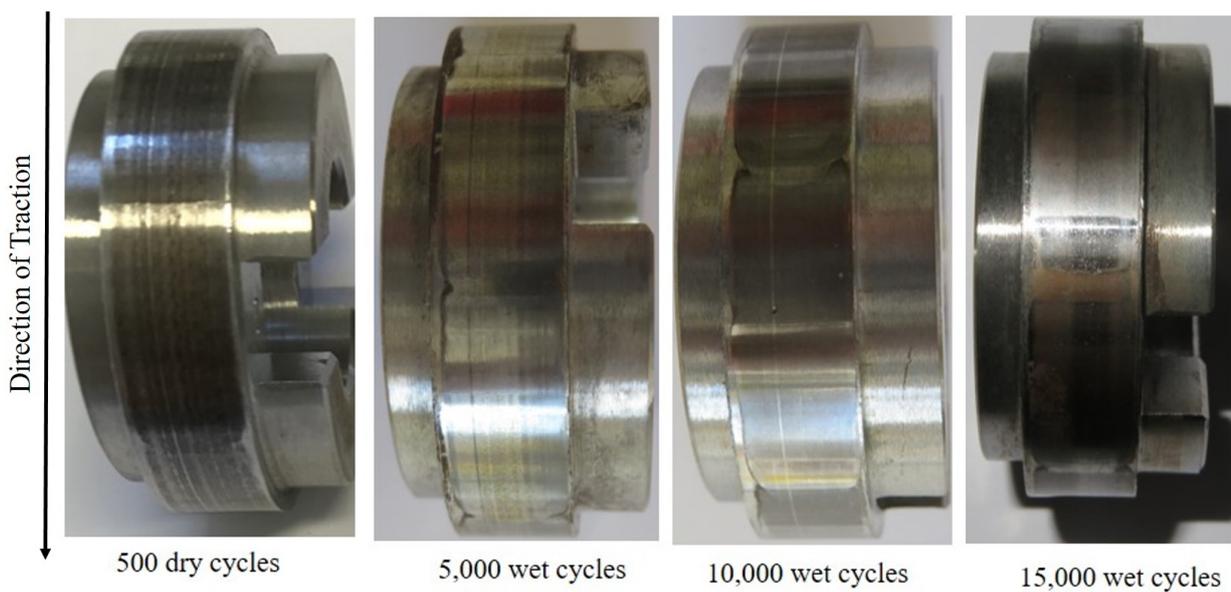
Figure 4.28: Surface appearance of the repair disc after testing for 500 dry cycles and 15,000 wet cycles, observed at regular intervals.

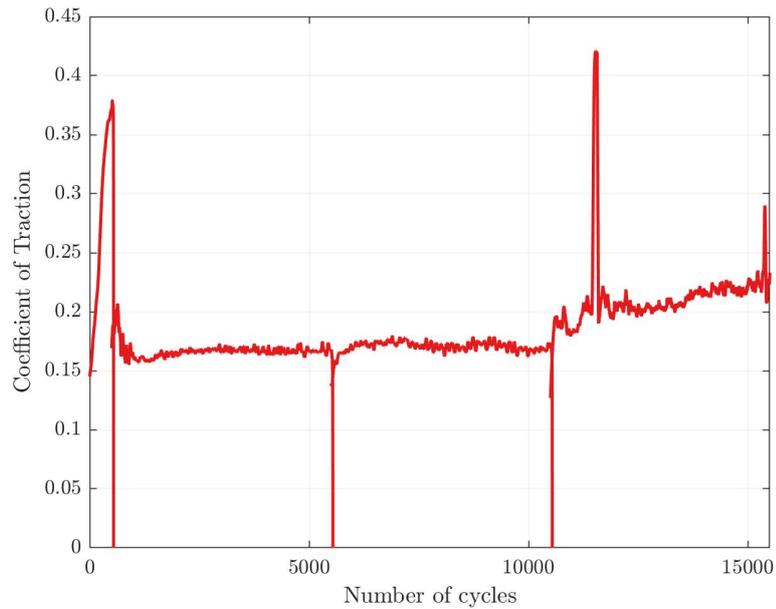
Figure 4.29: Twin-disc coefficient of traction (CoT) for RCF test on repair rail disc, tested at 1500 MPa, -1% slip, 500 dry cycles followed by 15,000 cycles. The peak CoT is 0.38 in the dry cycles and around 0.15 in the wet cycles.

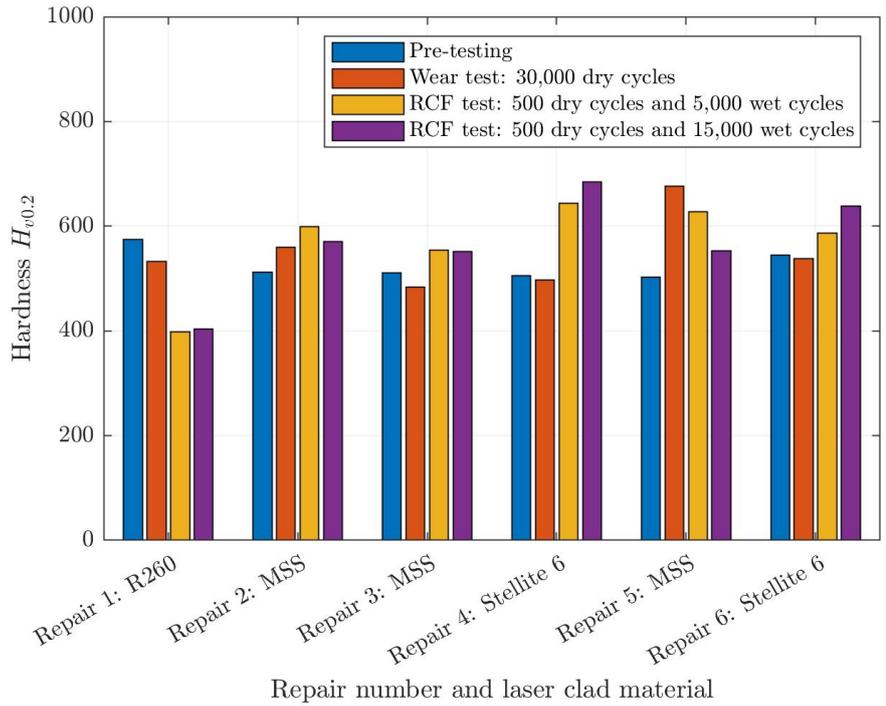
Figure 4.30: Average hardness of the repairs after each test measured on the longitudinal sub-surface cross-section using micro indentation with a 0.2 kg load.

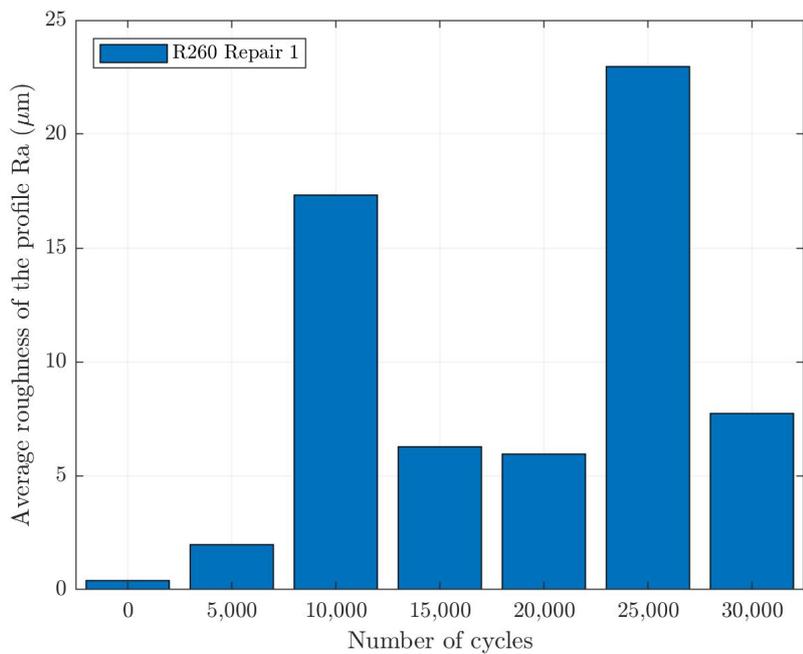
Figure 4.31: R260 repair: repair site 1. Roughness profile measurement R_a , taken at regular intervals throughout the unlubricated test (1500 MPa, -1% slip, 30,000 cycles).

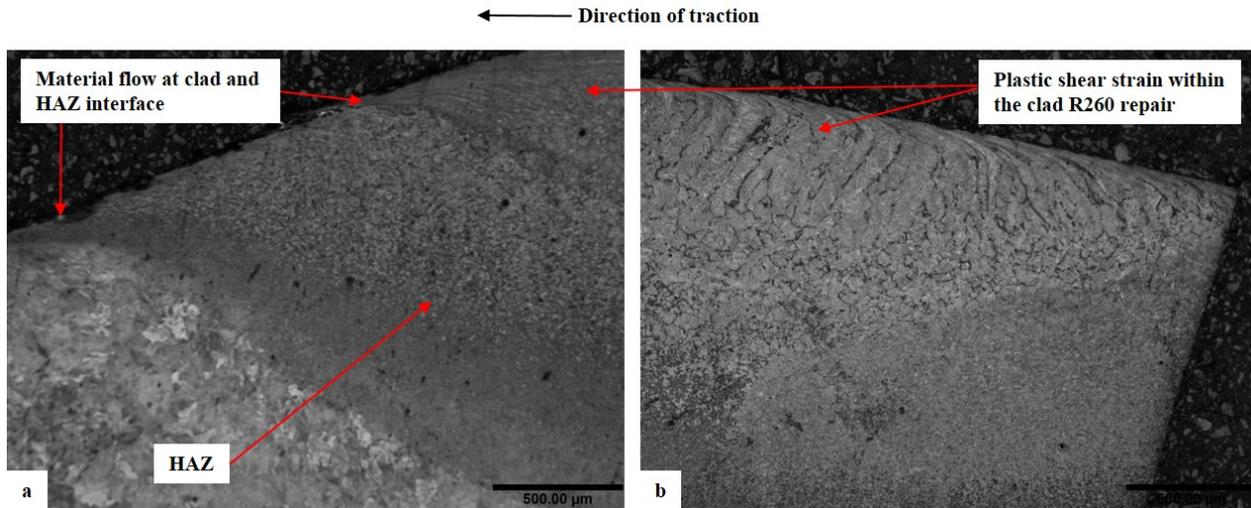
Figure 4.33: Repair 1: Optical micrograph showing material flow in the R260 repair and surrounding heat affected zone in the a) leading edge and b) trailing of repair site 1.

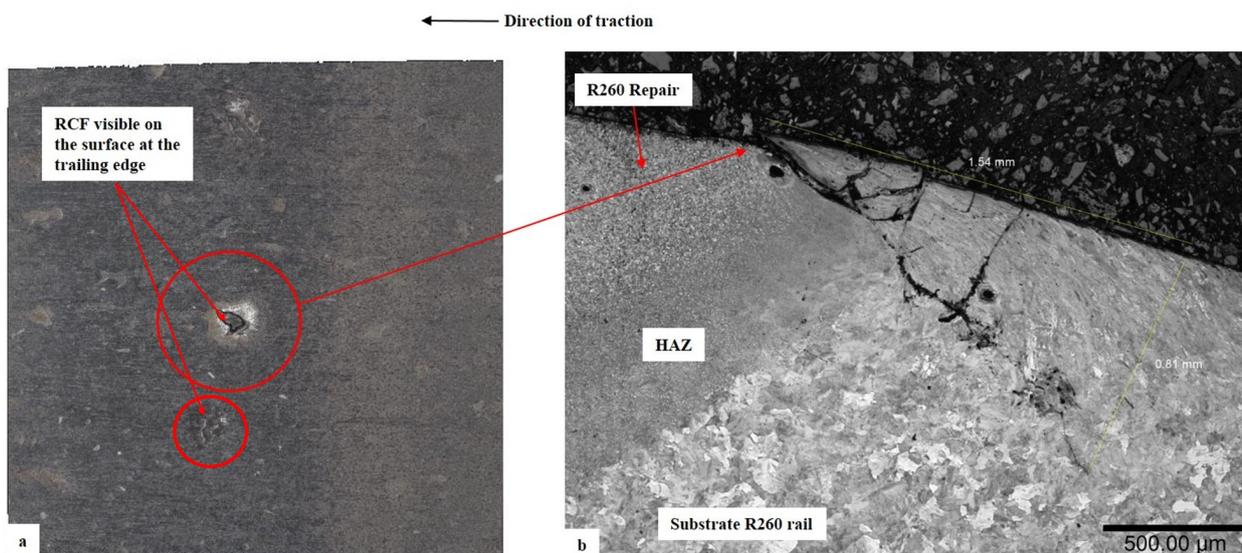
Figure 4.35: Repair 1: Trailing edge of R260 repair after RCF testing of 500 dry cycles followed by 5,000 water lubricated cycles. a) Alicona image showing sign of RCF on the surface and b) Optical micrograph showing network of cracks below the RCF seen on the surface.

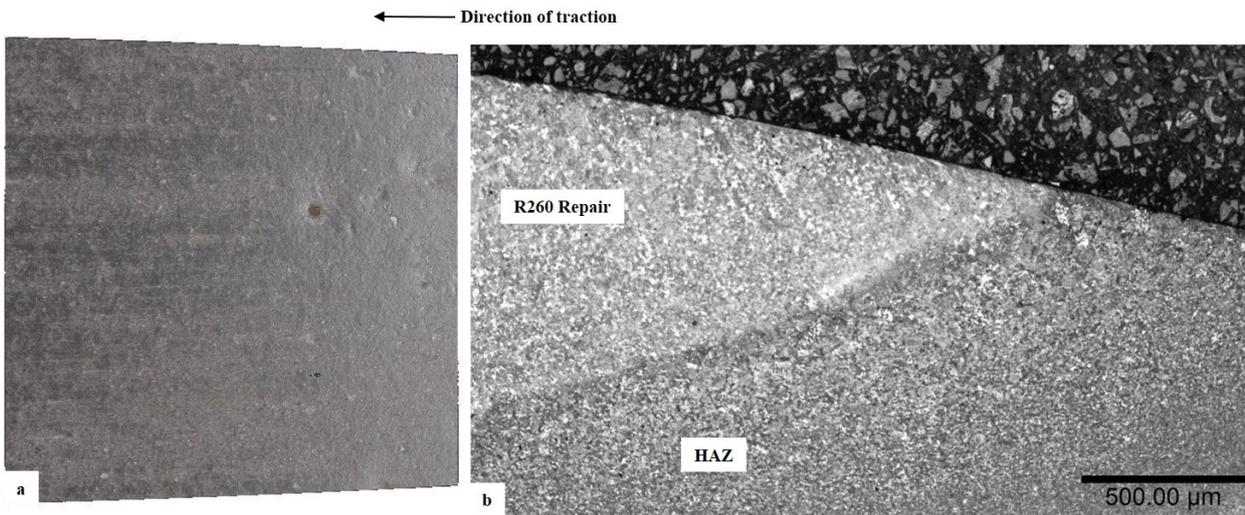
Figure 4.37: Repair 1: R260 repair trailing edge after RCF testing of 500 dry cycles followed by 15,000 water lubricated cycles. a) Alicona image showing little damage on the surface and b) Optical micrograph of the subsurface showing no sign of RCF.

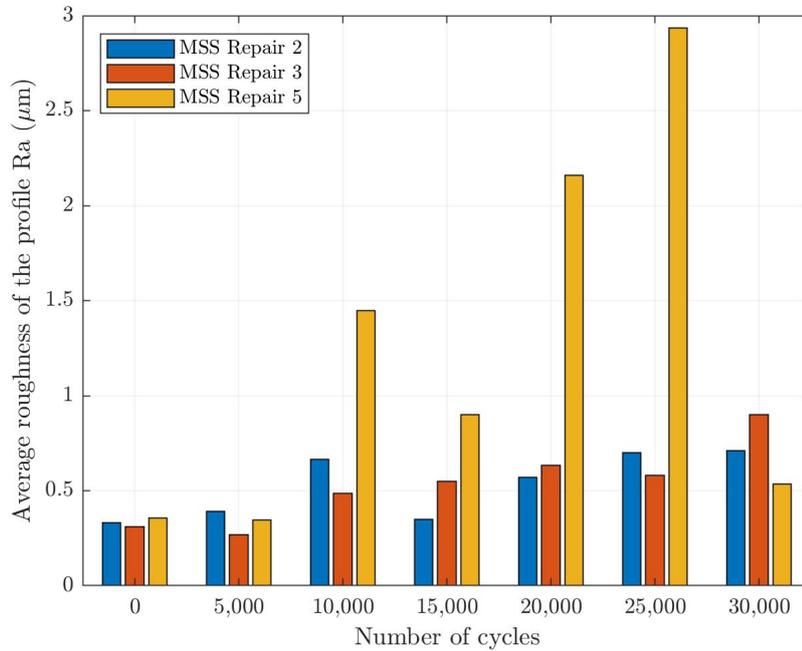
Figure 4.39: MSS repairs: repair sites 2, 3 and 5. Roughness profile measurement Ra, taken at regular intervals throughout the unlubricated test (1500 MPa, -1% slip, 30,000 cycles).

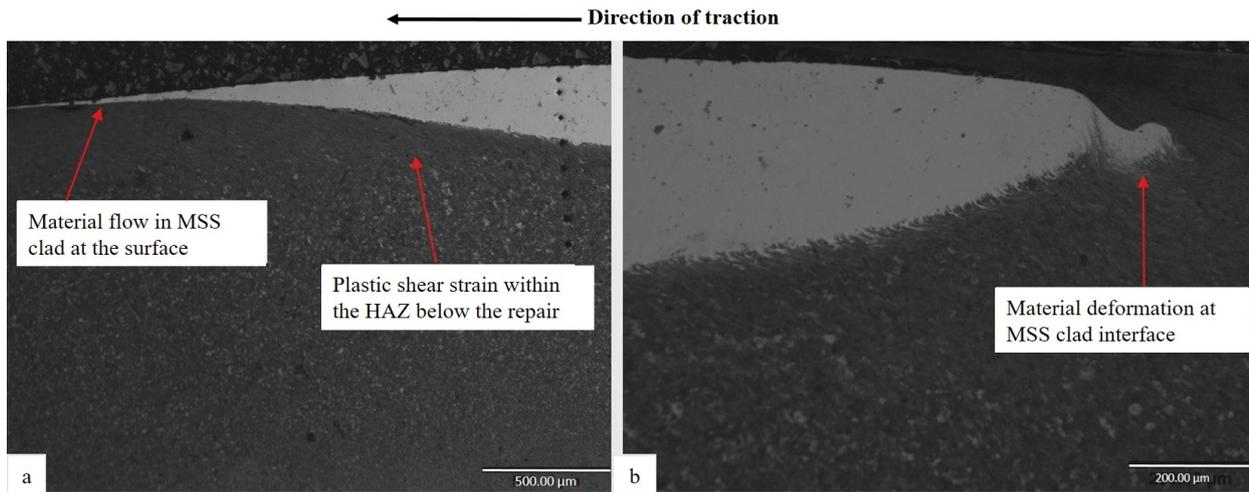
Figure 4.43: Repair 2: MSS repair after 30,000 dry cycles. Optical micrographs showing a) material flow in the leading edge of MSS repair and surrounding heat affected zone, and b) material deformation in the trailing edge.

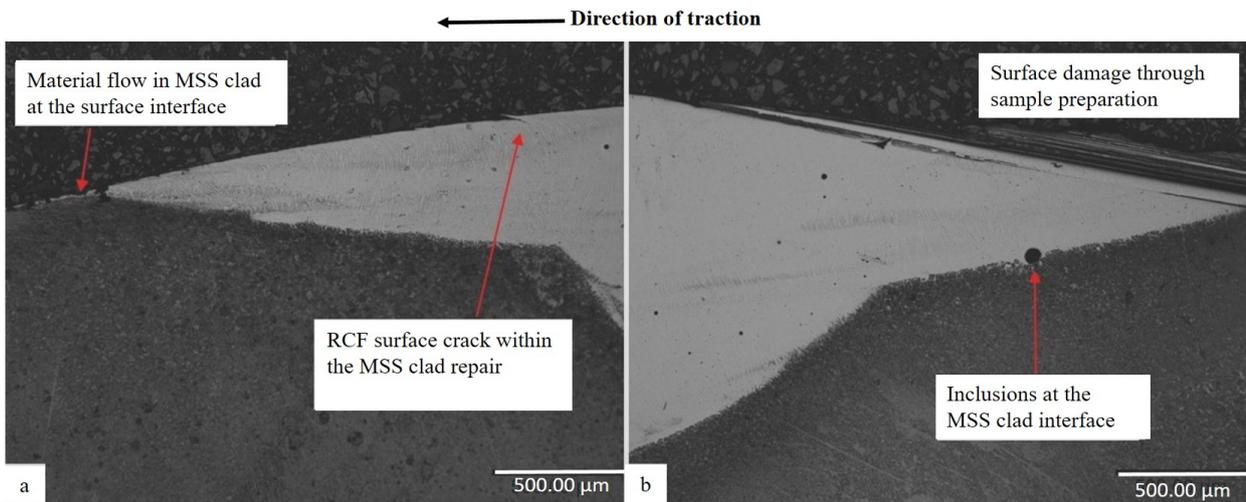
Figure 4.44: Repair 3: MSS repair after 30,000 dry cycles. Optical micrographs showing a) material flow and plastic shear strain at the surface of the leading edge of MSS repair, and b) the trailing edge with inclusion at the repair interface.

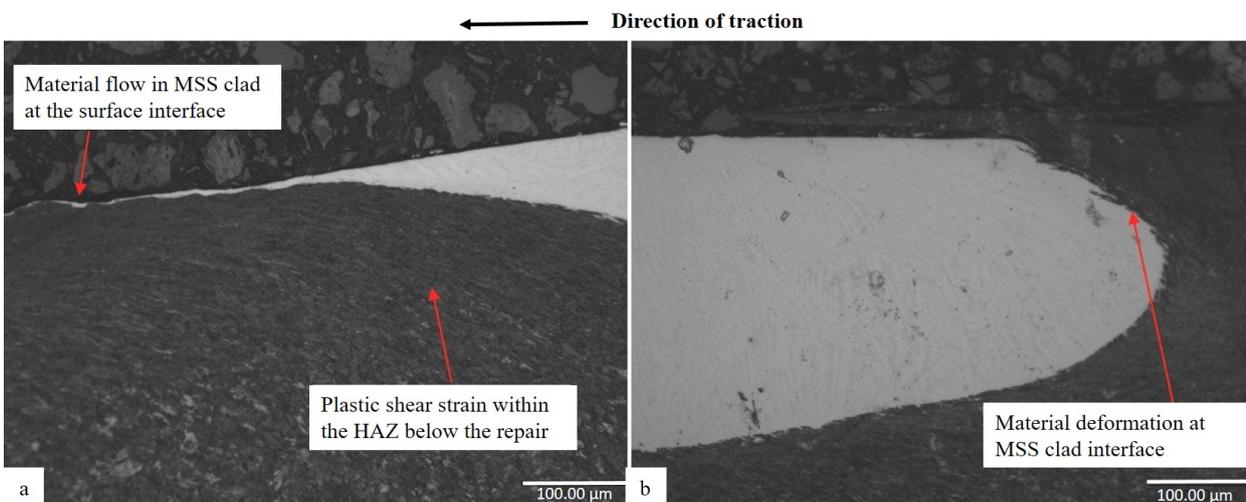
Figure 4.45: Repair 5: MSS repair after 30,000 dry cycles. Optical micrographs showing a) material flow in the leading edge of MSS repair and surrounding heat affected zone, and b) material deformation in the trailing edge.

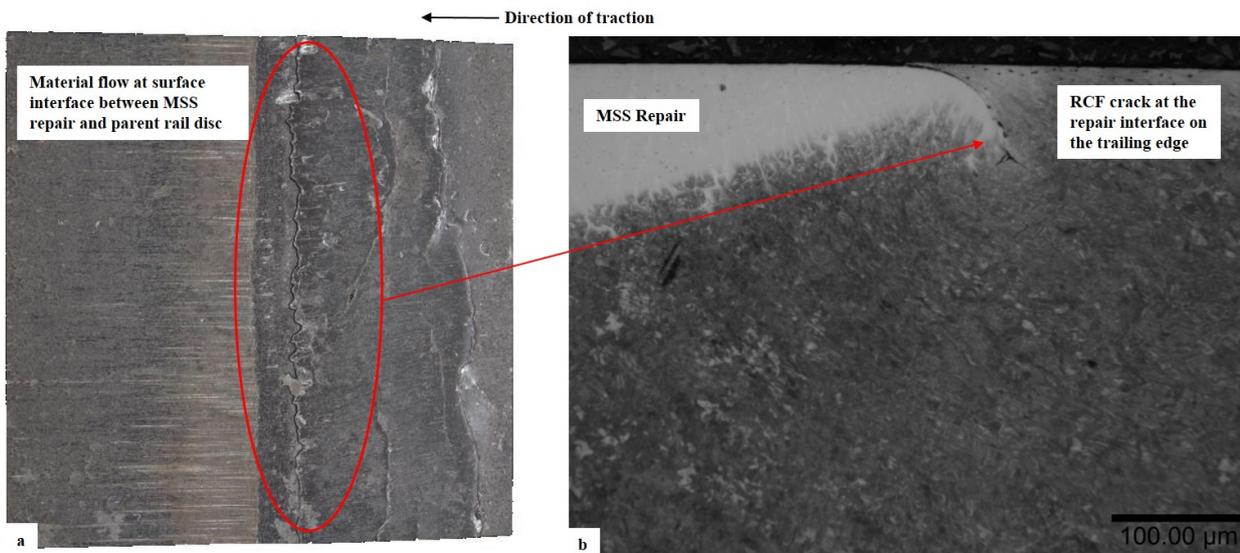
Figure 4.46: Repair 2: MSS repair trailing edge after RCF testing of 500 dry cycles followed by 5,000 water lubricated cycles. a) Alicona image showing material flow on the surface interface and b) optical micrograph showing RCF cracks below surface on the repair interface.

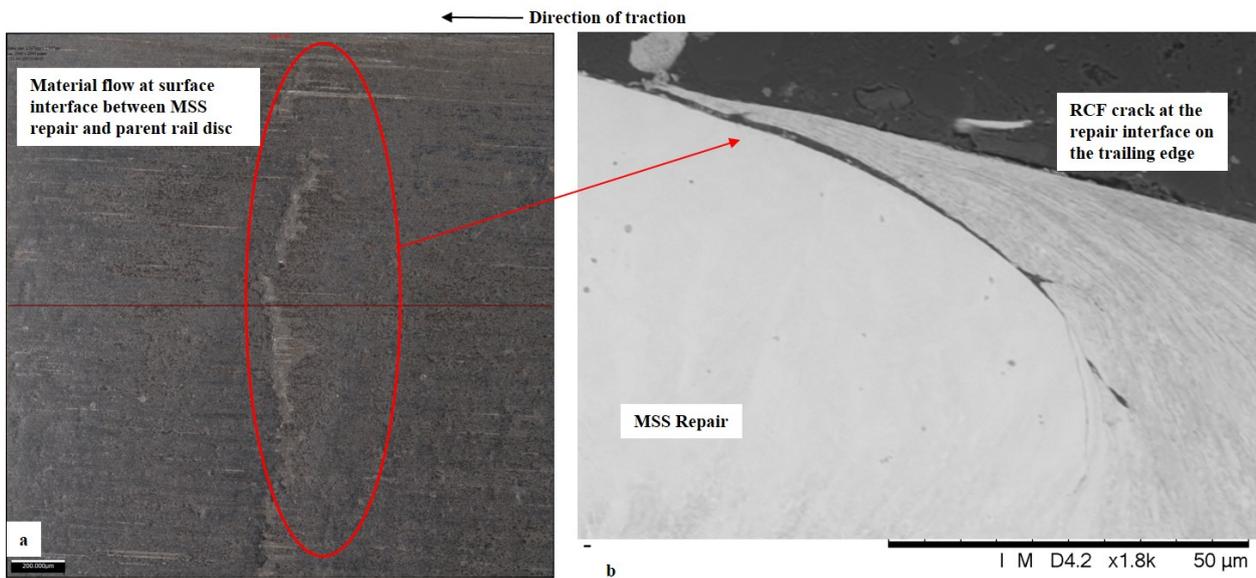
Figure 4.48: Repair 3: MSS repair trailing edge after RCF testing of 500 dry cycles followed by 5,000 water lubricated cycles. a) Alicona image showing material flow on the surface interface and b) SEM image of RCF cracks below surface on the repair interface.

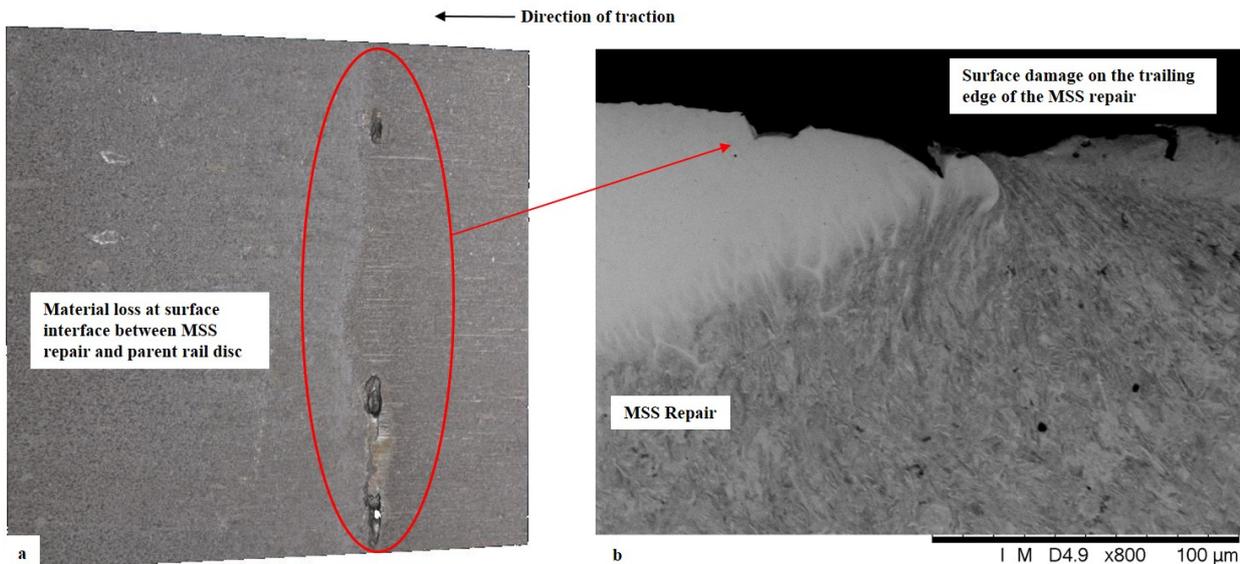
Figure 4.50: Repair 5: MSS repair trailing edge after RCF testing of 500 dry cycles followed by 5,000 water lubricated cycles. a) Alicona image showing damage on the surface interface and b) SEM image of material loss on the surface of the repair.

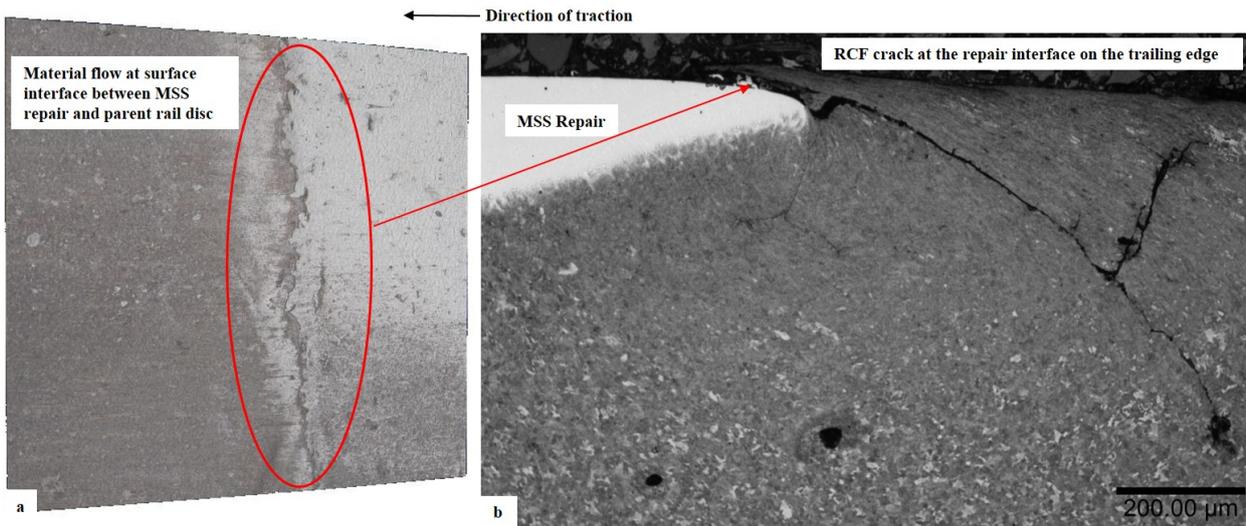
Figure 4.52: Repair 2: MSS repair trailing edge after RCF testing of 500 dry cycles followed by 15,000 water lubricated cycles. a) Alicona image showing material flow on the surface interface and b) Optical micrograph showing network of RCF cracks below surface on the repair interface.

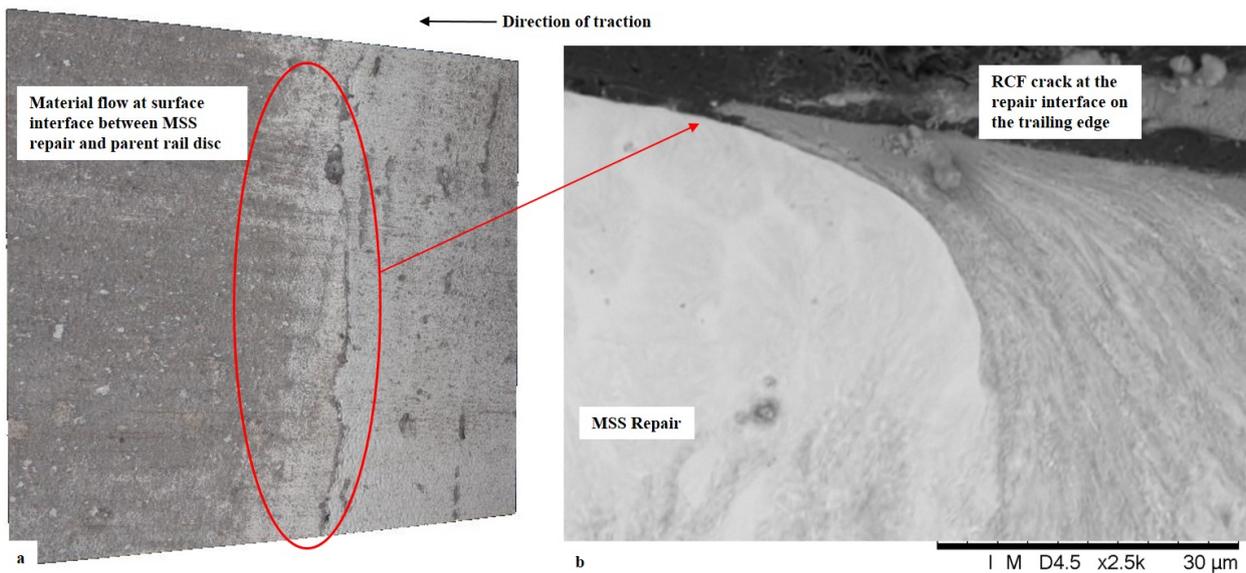
Figure 4.54: Repair 3: MSS repair trailing edge after RCF testing of 500 dry cycles followed by 15,000 water lubricated cycles. a) Alicona image showing material flow on the surface interface and b) SEM image of RCF crack below surface on the repair interface.

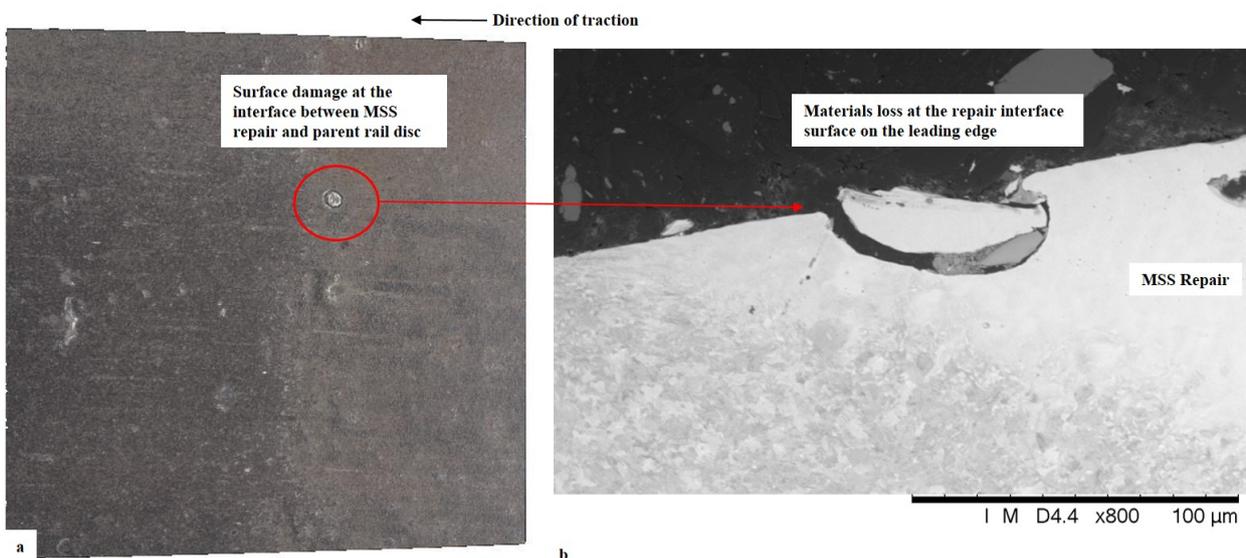
Figure 4.55: Repair 3: MSS repair leading edge after RCF testing of 500 dry cycles followed by 15,000 water lubricated cycles. a) Alicona image showing small hollow on the surface interface and b) SEM image of MSS repair fragment of material spalling from surface.

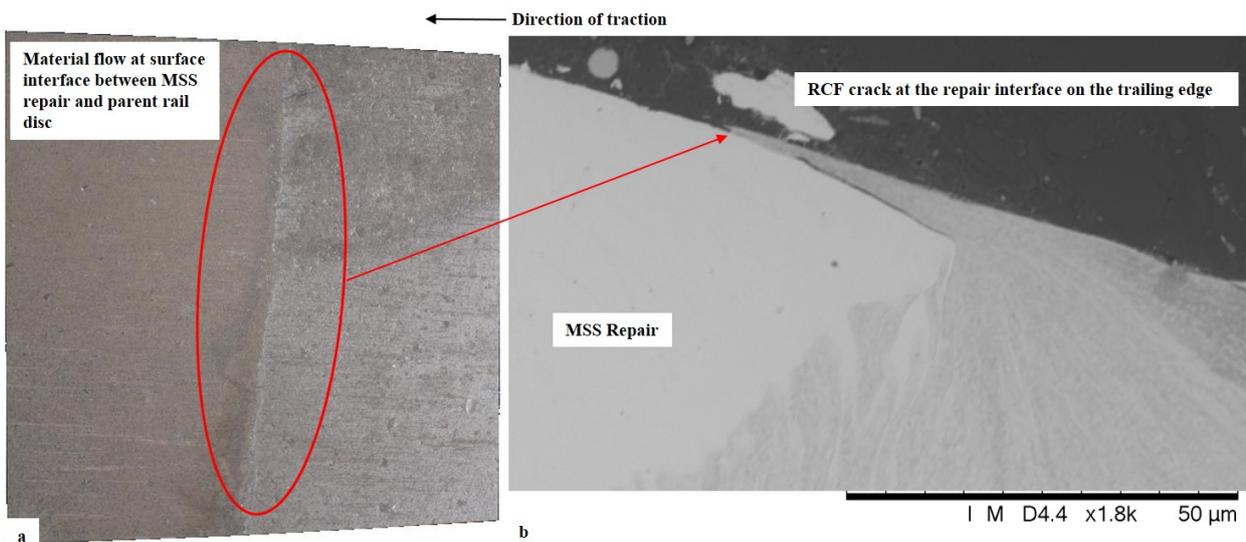
Figure 4.56: Repair 5: MSS repair trailing edge after RCF testing of 500 dry cycles followed by 15,000 water lubricated cycles. a) Alicona image showing small amount of material flow on the surface interface and b) SEM image of RCF crack below surface on the repair interface.

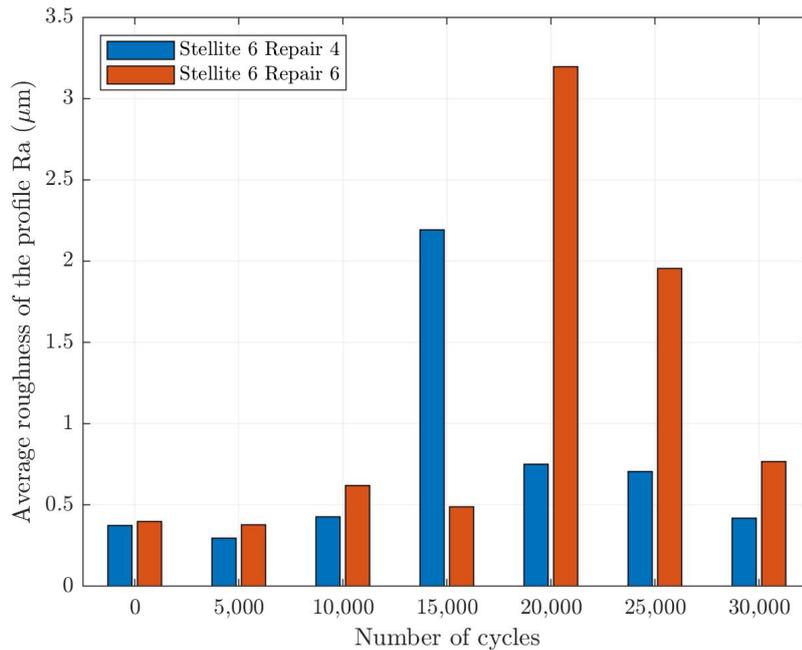
Figure 4.58: Stellite 6 repairs: repair sites 4 and 6. Roughness profile measurement Ra, taken at regular intervals throughout the unlubricated test (1500 MPa, -1% slip, 30,000 cycles).

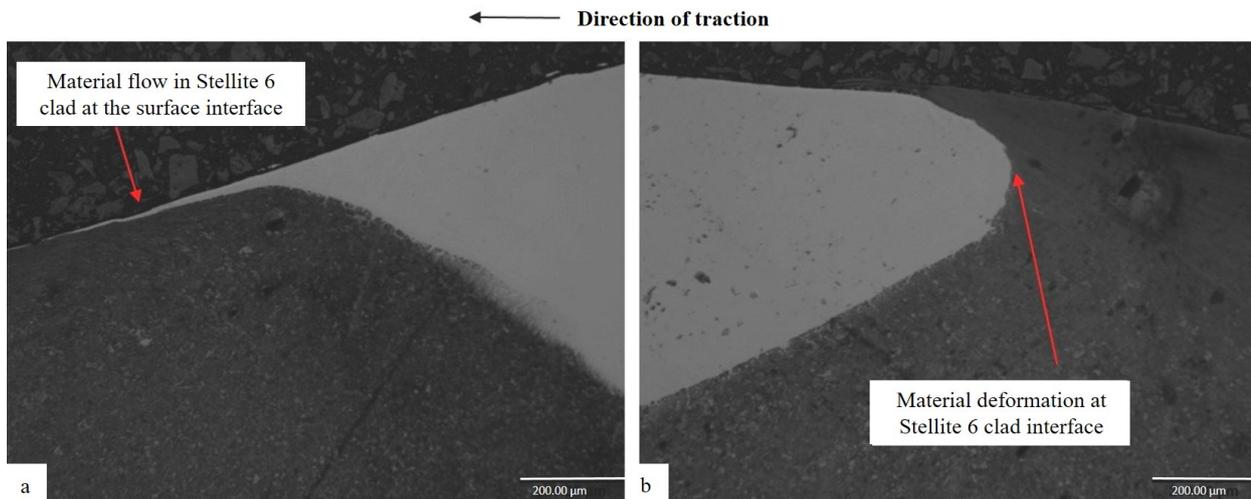
Figure 4.61: Repair 4: Stellite 6 repair after 30,000 dry cycles. Optical micrograph of a) material flow in the leading edge of Stellite repair and b) material deformation in the trailing edge.

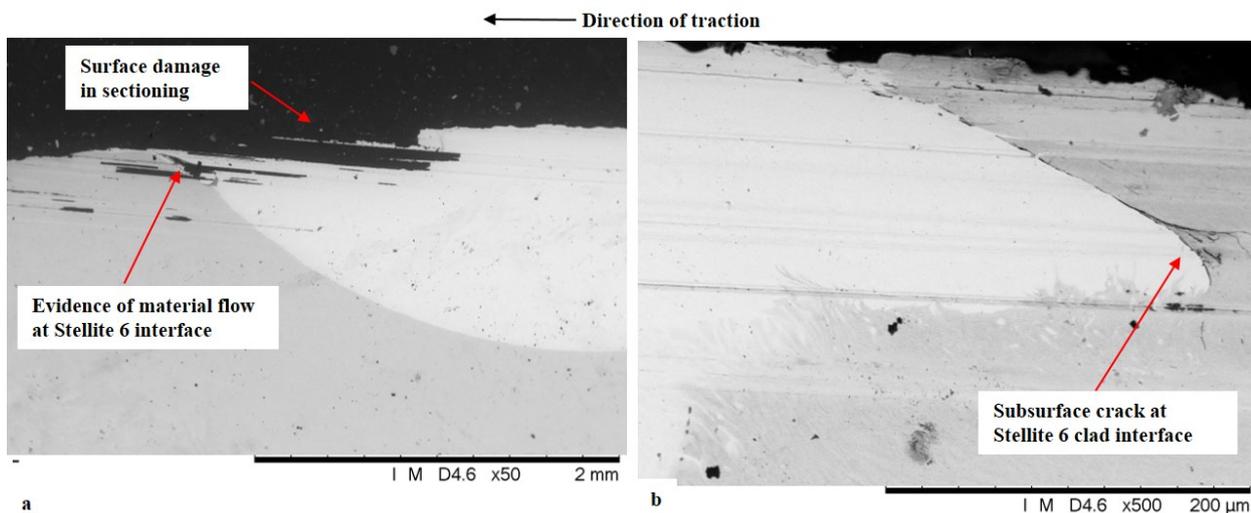
Figure 4.62: Repair 6: Stellite 6 repair after 30,000 dry cycles. Sample surface damage present from sectioning. SEM images showing a) evidence of material flow in the leading edge of Stellite 6 repair and b) material deformation and RCF crack in the trailing edge.

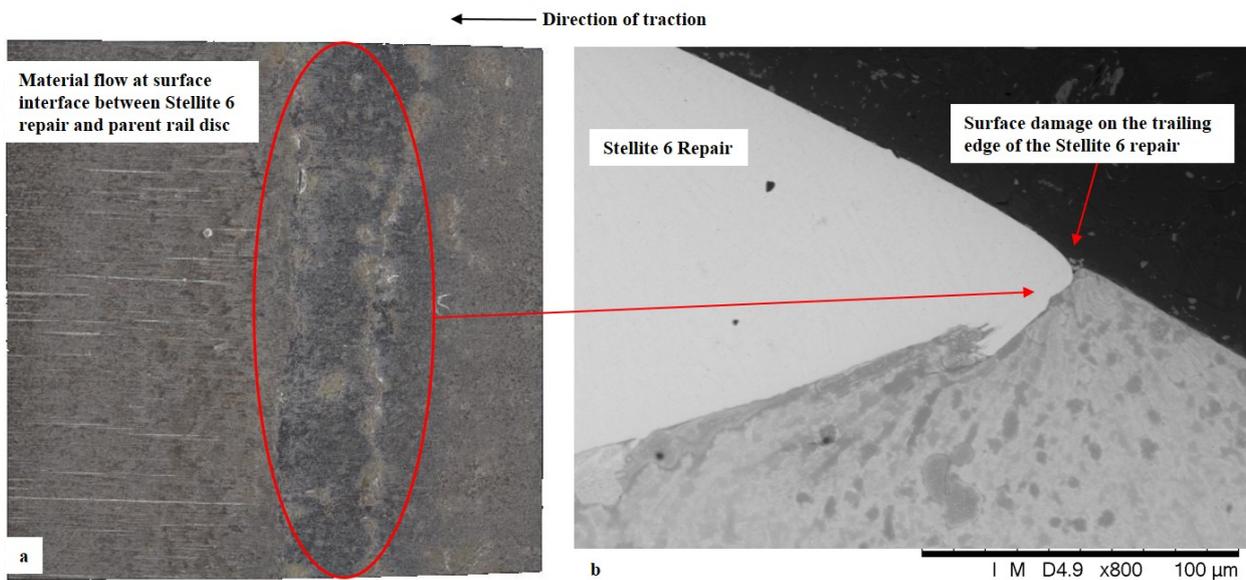
Figure 4.63: Repair 4: Stellite 6 repair trailing edge after RCF testing of 500 dry cycles followed by 5,000 water lubricated cycles. a) Alicona image showing material flow on the surface interface and b) SEM image showing crack initiation at the surface on the repair interface.

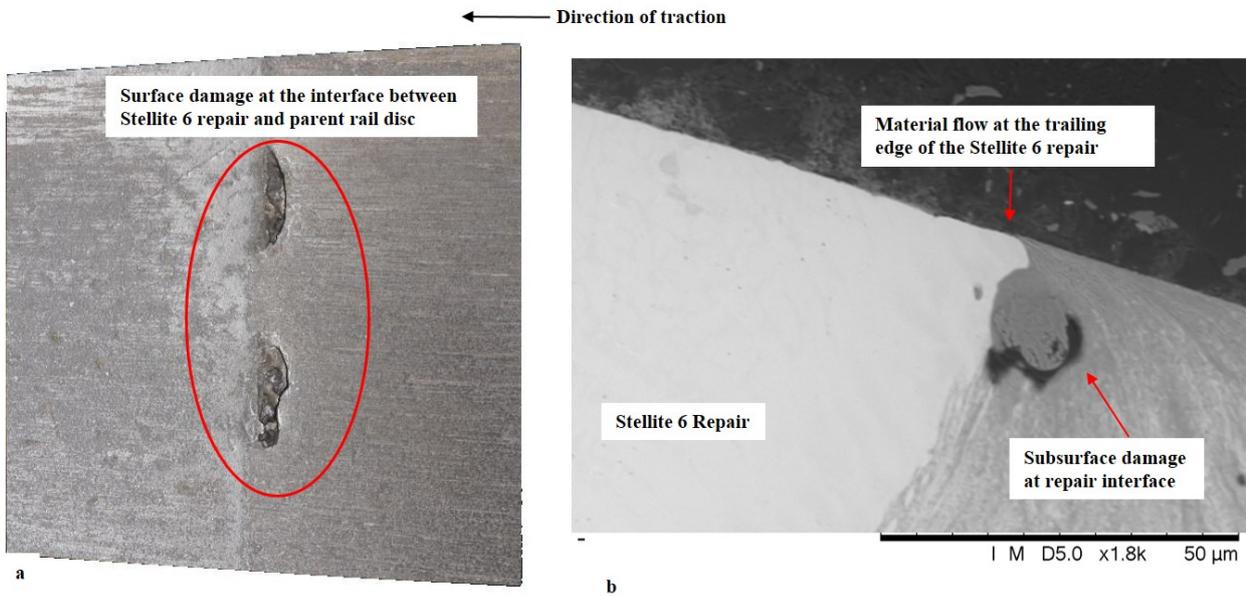
Figure 4.65: Repair 6: Stellite 6 repair trailing edge after RCF testing of 500 dry cycles followed by 5,000 water lubricated cycles. a) Alicona image showing material loss on the surface interface and b) SEM image showing subsurface material deformation within the parent rail on the repair interface.

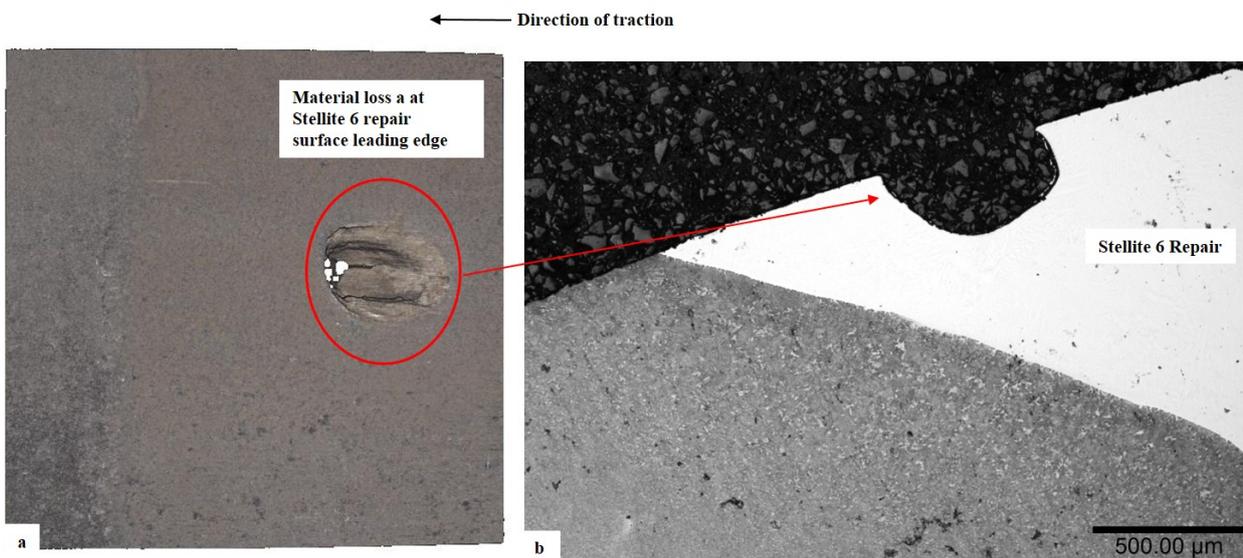
Figure 4.68: Repair 4: Stellite 6 repair leading edge after RCF testing of 500 dry cycles followed by 15,000 water lubricated cycles. a) Alicona image showing substantial material loss on the surface of the repair and b) optical micrograph of the cross section of cavity at the surface of the repair.

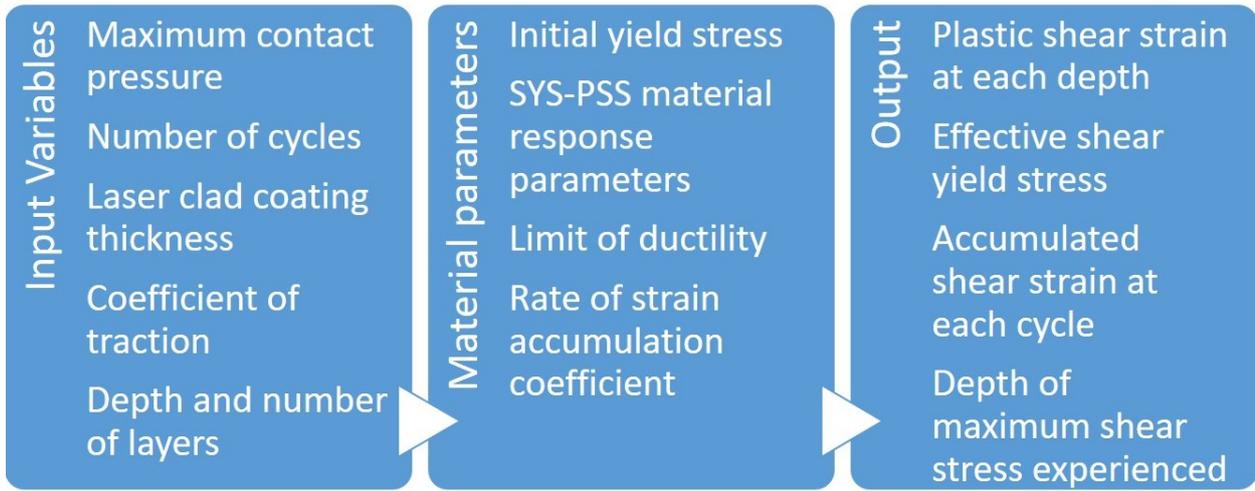
Figure 6.1: Simplified layer model process with input variables, material parameters and model output

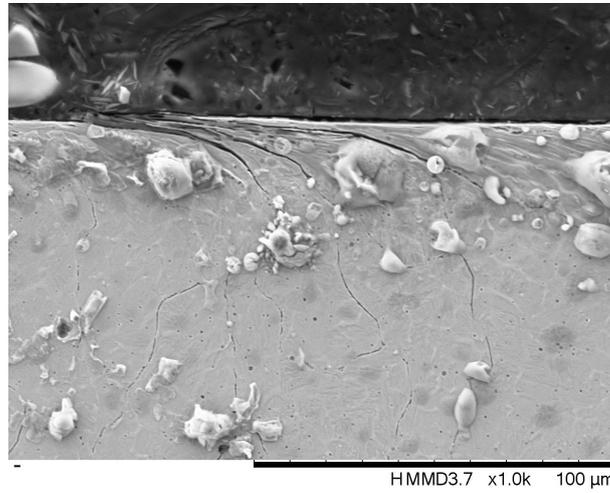
(c) Strain accumulation in MSS laser clad coating after 10,000 cycles. (Sample contaminated however the angle of deformation could still be gathered.)

Figure 6.11: Low cycle ratcheting in MSS laser clad coating to enable the calculation of rate of shear strain accumulation.

After testing all samples were sectioned, mounted, ground and polished using standard metallographic techniques. The subsurface hardness was once again measured using a Durascan microhardness. The samples were then etched to reveal the microstructure as described in Section 3.2.2. It has been seen throughout the previous chapters that the MSS laser clad coatings only accumulate shear strain in the shallow surface depths. The method of measuring strain 0.05 mm below the surface is not suitable for the laser clad coating and the angle of deformation is measured at 0.01 mm instead. The images of the subsurface cross section in Figure 6.11 are SEM rather than optical to enable the shallow deformation to be observed and measured. Although signs of sample contamination can be observed after 10,000 cycles, the angle of deformation can still be measured.
