**Monitoring, modelling and quantification of
accumulation of damage on masonry structures
due to recursive loads**

Dimitrios Dais

Submitted in accordance with the requirements for the degree of
Doctor of Philosophy

The University of Leeds
School of Civil Engineering

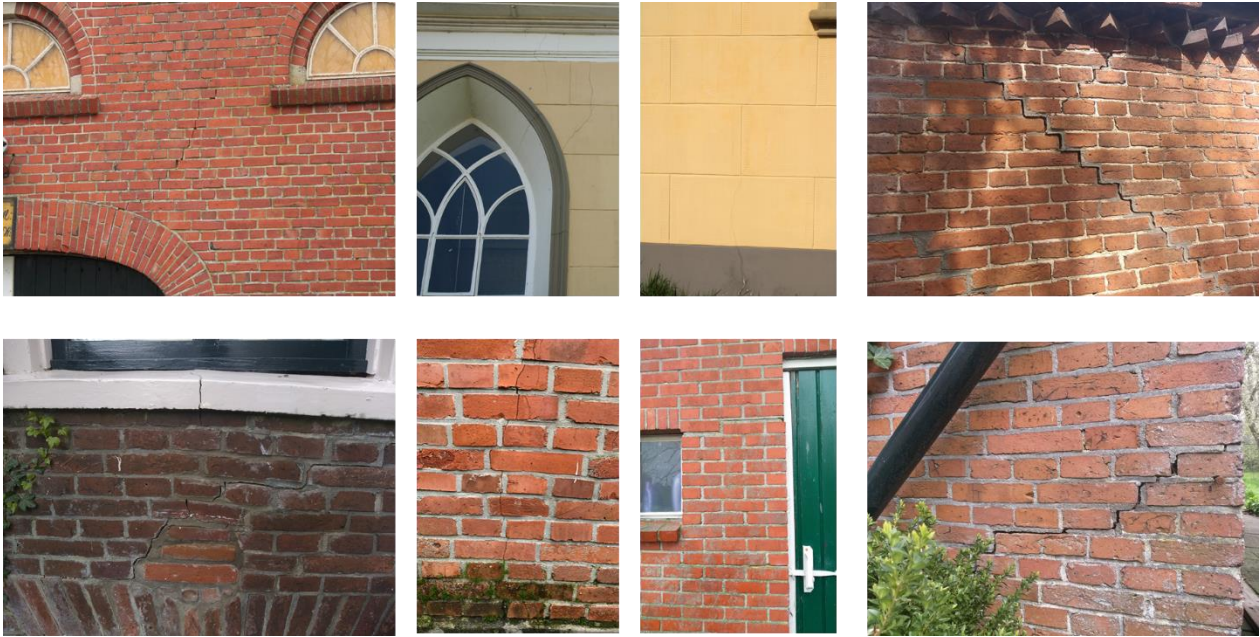
Figure 1-1: Typical examples of damage in buildings in the Groningen gas field. Photographs taken by Dimitrios Dais.

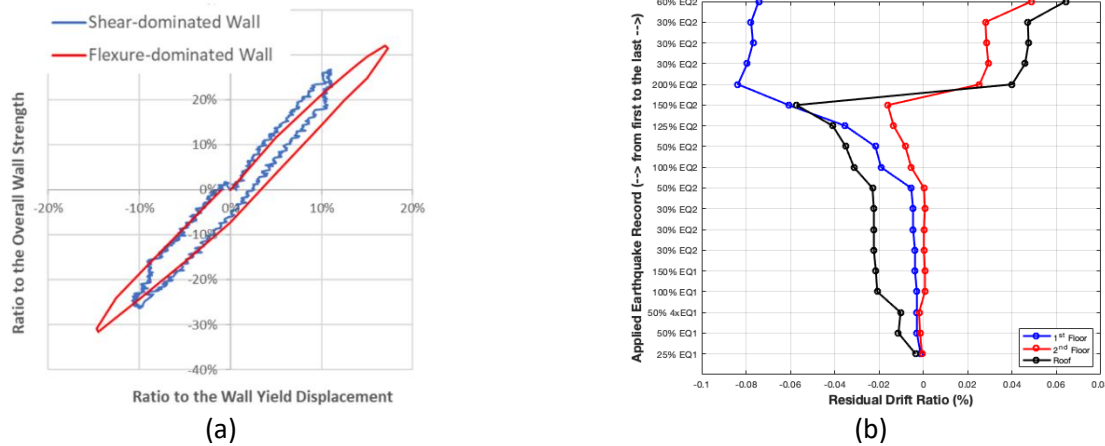
Figure 2-2: (a) First cycles from the quasi-static tests on calcium silicate specimens (Graziotti et al. 2015); (b) residual displacements from sequential shake table tests on the full-scale specimen (modified from Graziotti et al. (2015)), where 'y' axis shows the sequentially applied earthquake records).

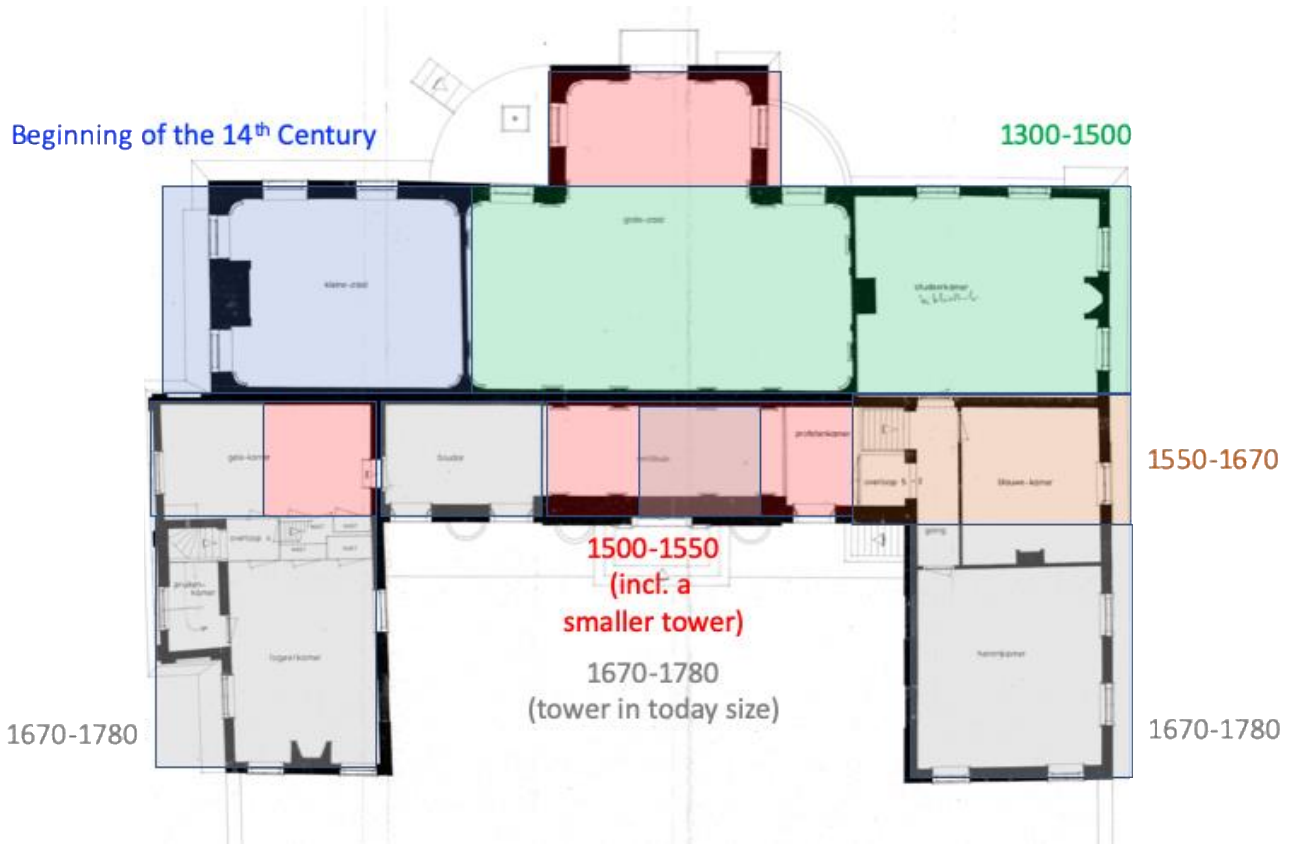
Figure 3-2: Construction phases of the building.

Fraeylemaborg is located in an estate of more than 0.23 km². The house dates back to the 14th century and reached its current form at the end of the 18th century. The structure was built in the 14th century as a stone house, a defensive dwelling, and grew into an impressive residence by an influential resident. After 1670 the two wings were added giving its current U-shaped form (Figure 3-2). Following a change of owners and a major restoration in 1972, Fraeylemaborg became a museum.

The estate includes a large park behind the main structure that is visited by more than 30,000 visitors per year. The complex is developed in the English style where the main house, the cowshed (now a restaurant) and the coach house (used as office, exhibition area and the museum shop) are in use by the museum administration to host events and exhibitions. The buildings are completed with 17th and 18th century sandstone garden ornaments in the park. The rooms reflect the character of mid-20th century, the era in which the home was last privately occupied. The Large Hall (Grote Zaal) is used for concerts and receptions, while the Small Hall (Kleine Zaal) is used as a wedding room (Figure 3-2).

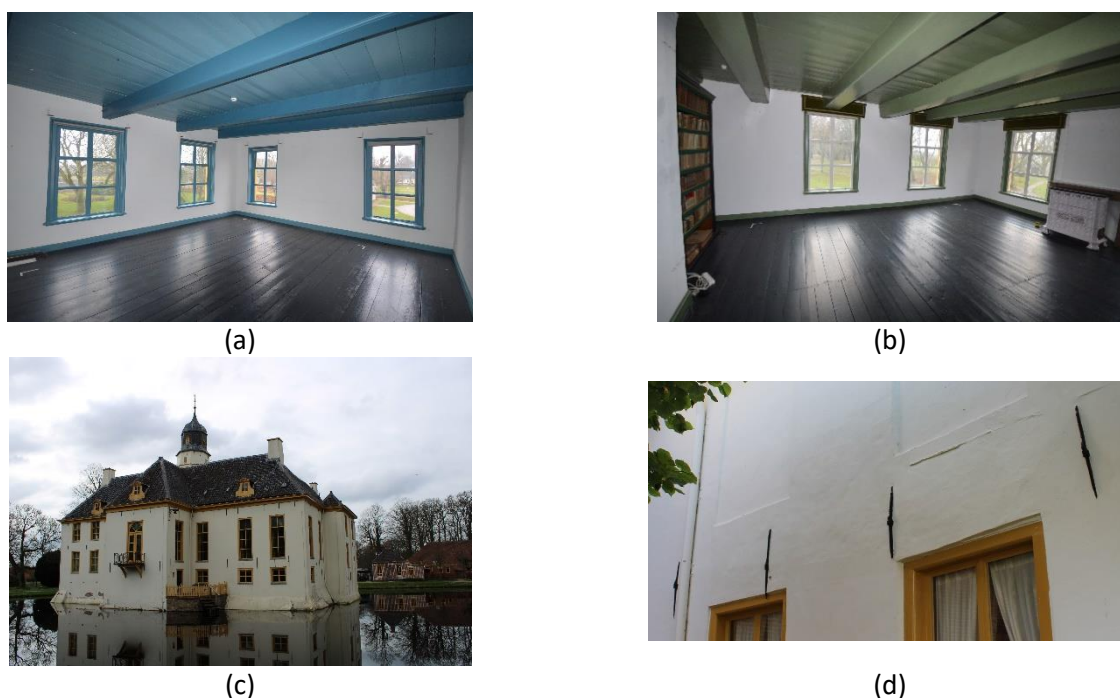
The timber elements of the floors (Figure 3-3a-b) are poorly connected to each other and thus a diaphragmatic action is not ensured. Numerous steel anchors exist at various locations of the structure (Figure 3-3c-d) in order to connect the floors to the peripheral walls. The structural elements of the roof are timber beams transferring the loads to the peripheral walls.

Figure 3-3: Details from the timber floors (a-b) and steel anchors (c-d) around the monument.

The structural members of the monument, i.e. masonry walls and timber slabs, were simulated with 3D solid continuum elements. The timber slab elements are characterized by the lack of proper connections to each other and to the walls (Figure 3-3a-b), and thus there is absence of diaphragmatic action. This behaviour was incorporated in the model by accounting for rather low stiffness for the slabs. Given the fact that no damage has been observed in the timber elements, the timber slabs were modelled as linear elastic.

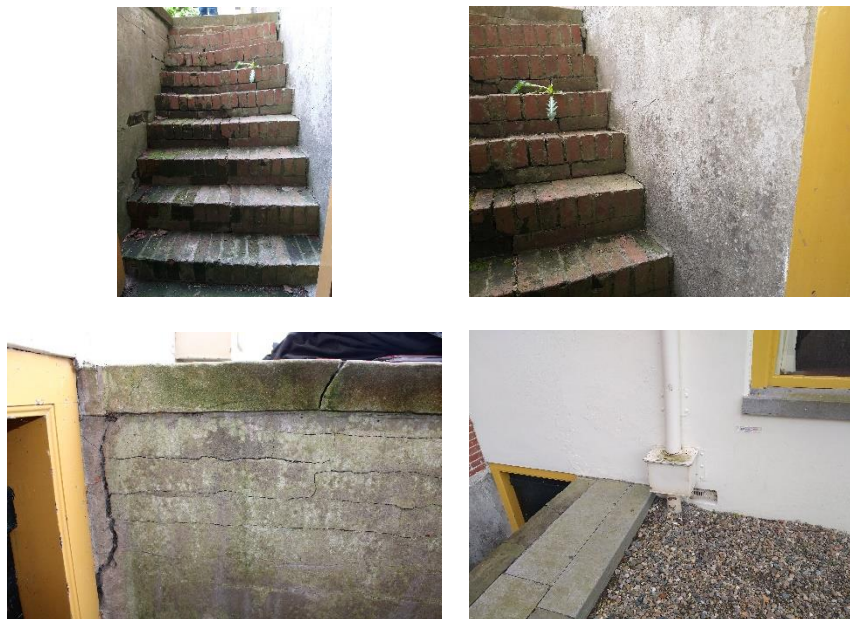
Figure 3-5: Signs of damage around the entrance of the basement located at the front NW wing.

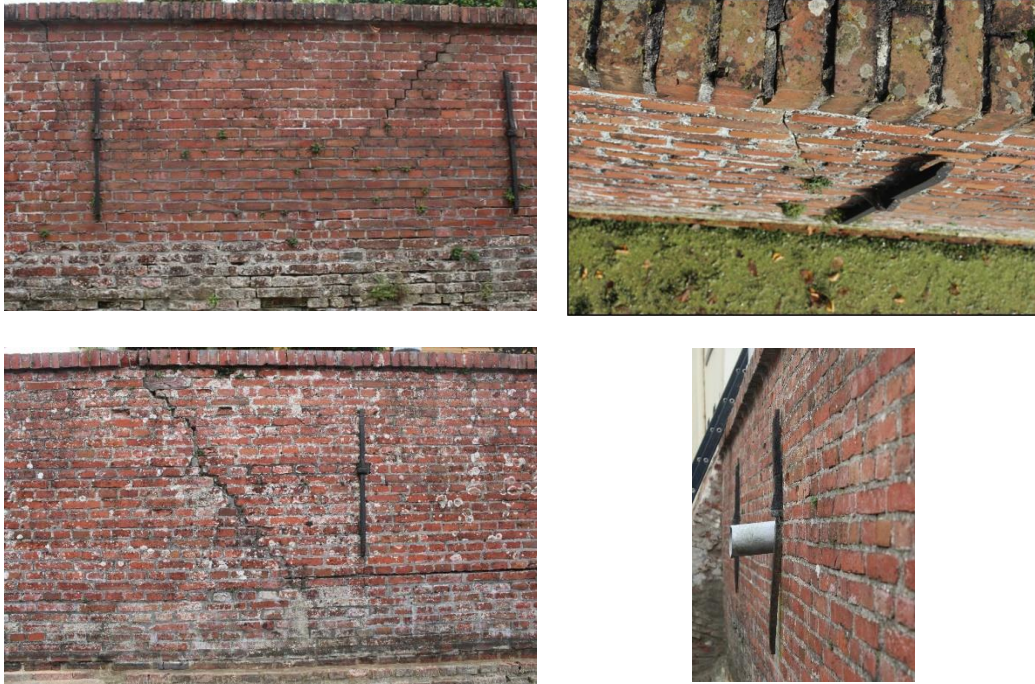
Figure 3-6: Cracks along the front retaining wall (left) and detachment of the steel anchors (right).

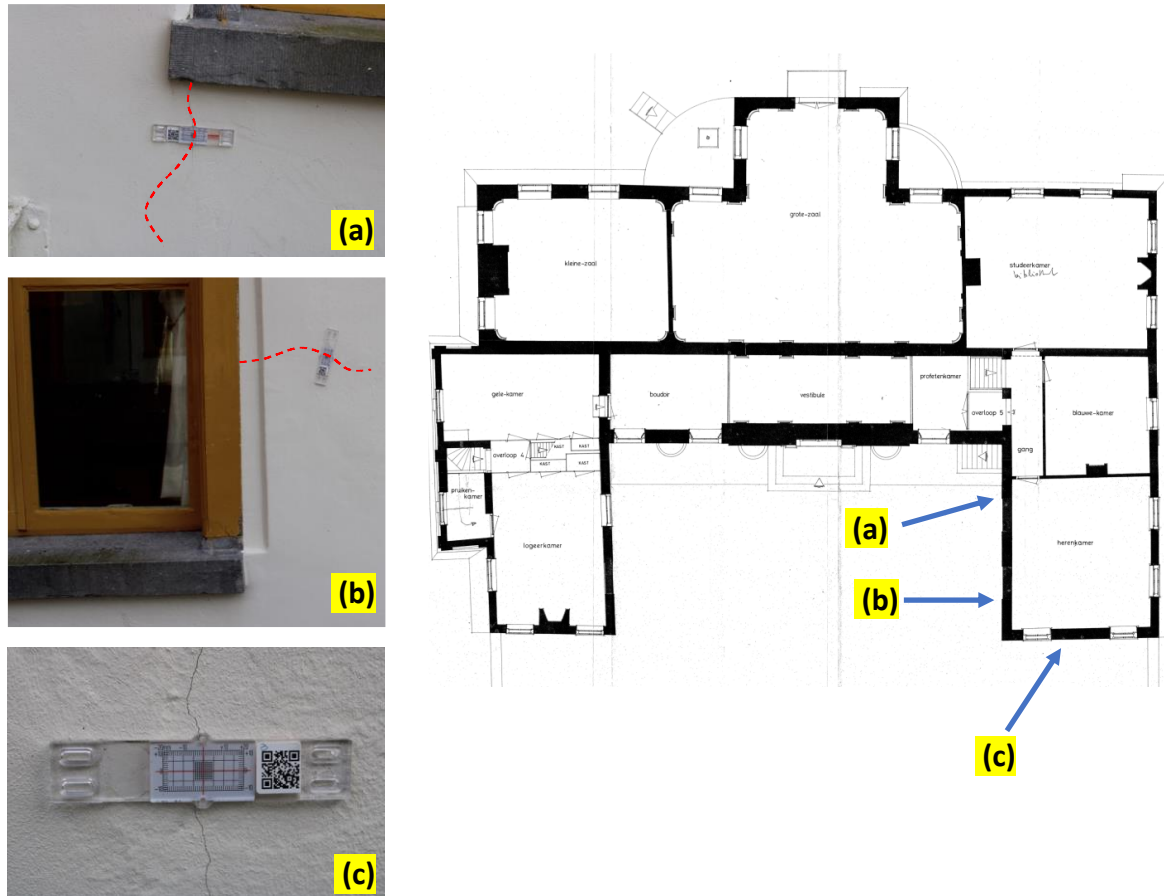
Figure 3-8. Minor cracks appeared in August 2018 at the façades of the NW wing of Fraeylemaborg.

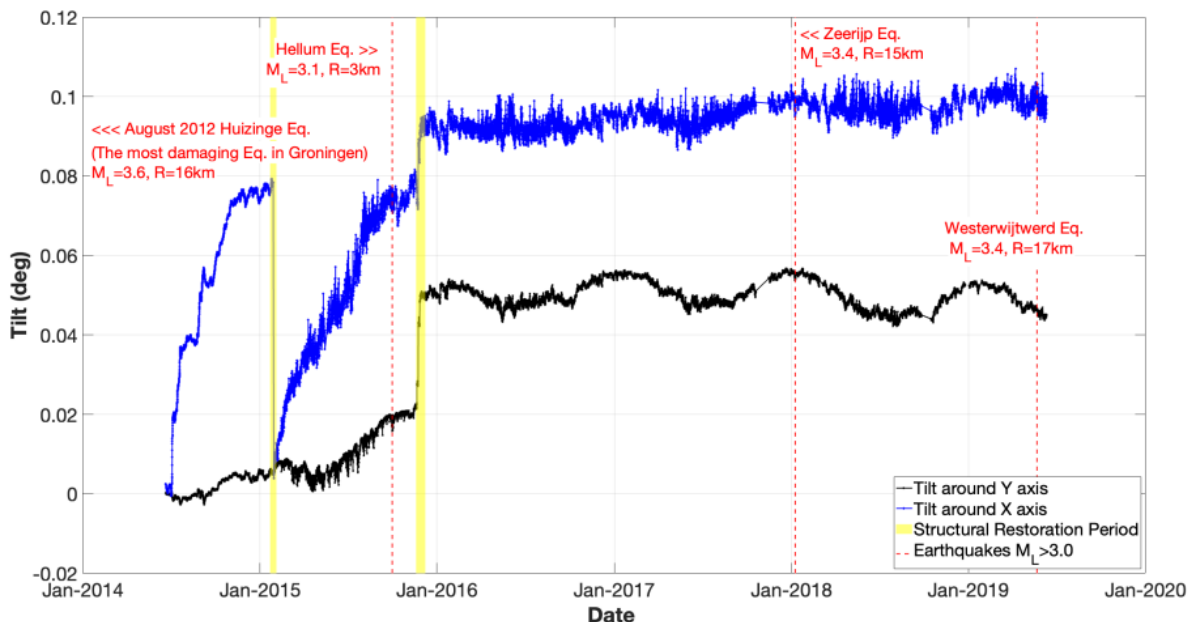
Figure 3-10. Tiltmeter measurements since 2014, together with significant earthquakes and restoration periods.

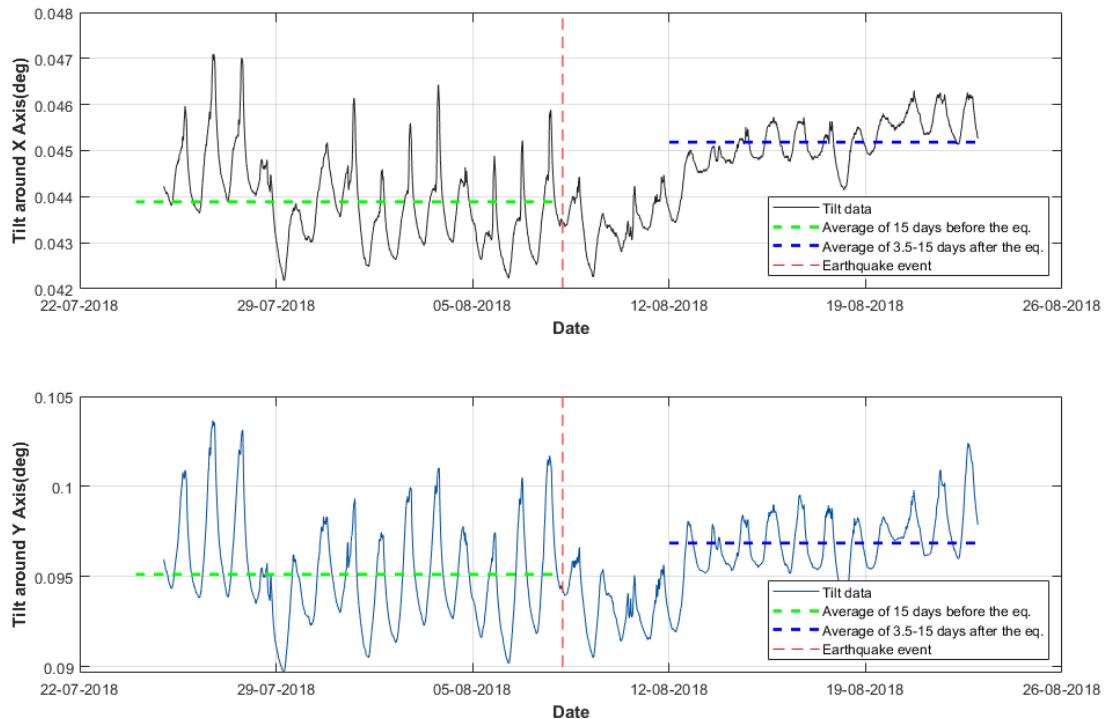
Figure 3-12. Low sampling rate tiltmeter data 15 days before and 15 days after the earthquake of 08.08.2018 Appingedam (ML 1.9).

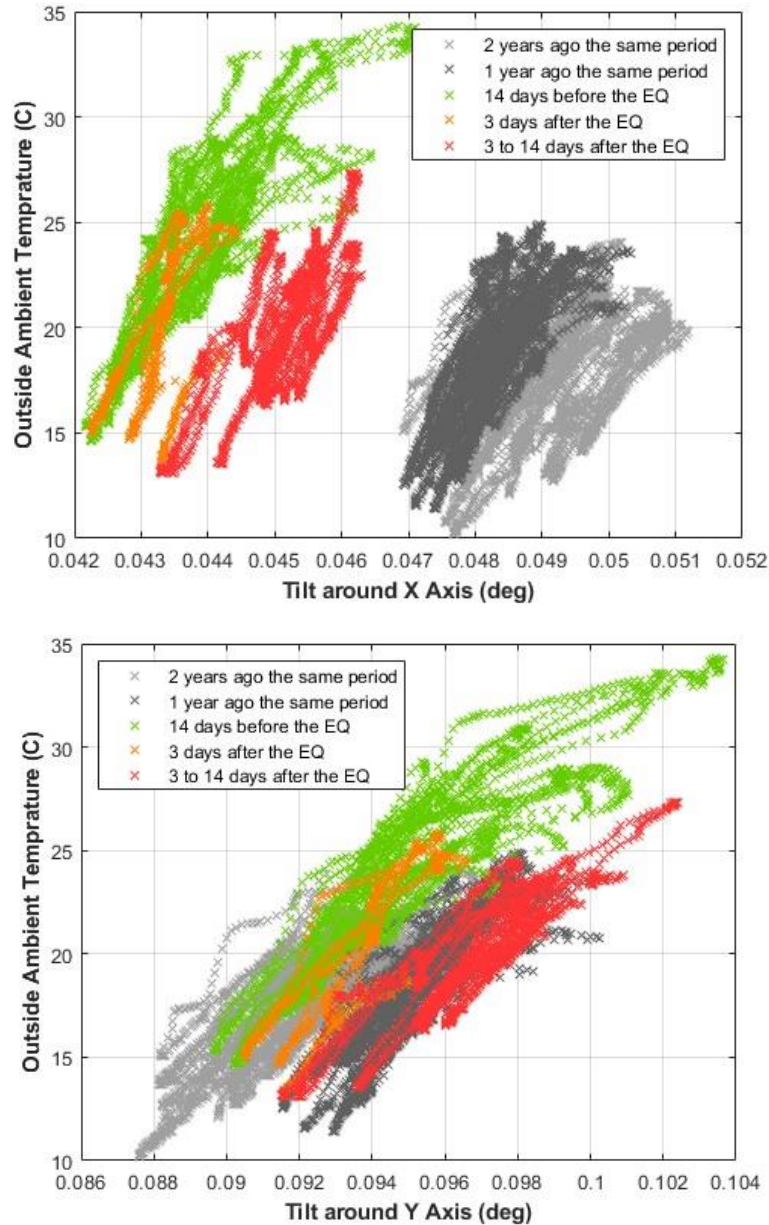
Figure 3-13: Tilt angles recorded +/-15 days from the earthquake and last two years before around X (top) and Y axis (bottom) (the axis are shown in Figure 3-9b).

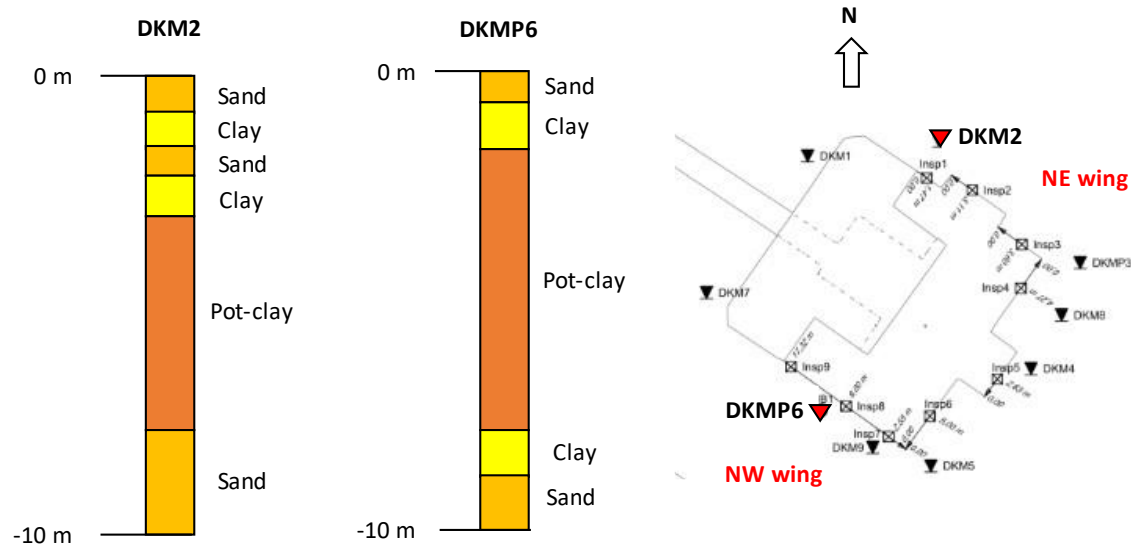
Figure 3-14: Soil stratigraphy for depth 0-10 m as obtained from boreholes for the NW (DKM2) and NE (DKMP6) wing.

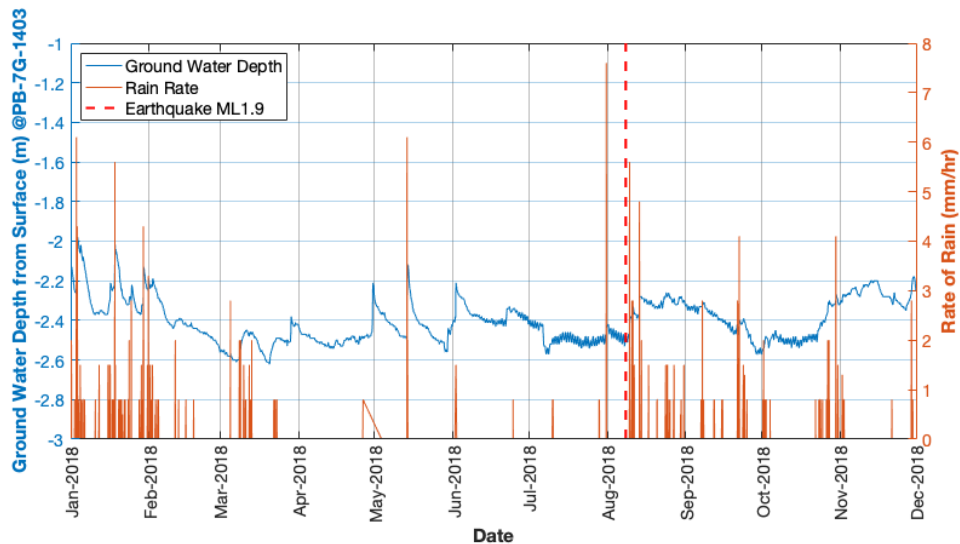
Figure 3-15. Ground water depth from the surface and the rate of rain in 2018 in the monitoring well 600 m south of the site.

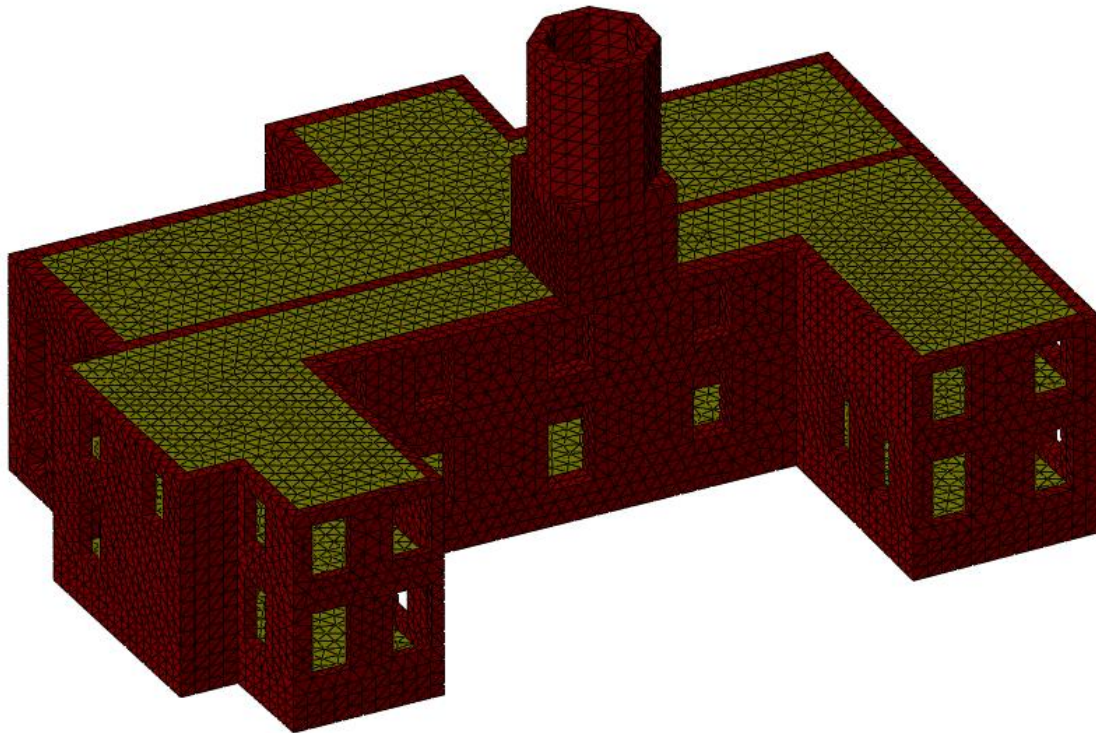
Figure 3-17: The three-dimensional numerical model of Fraeylemaborg (clay brick walls in maroon colour, wooden floor in yellow).

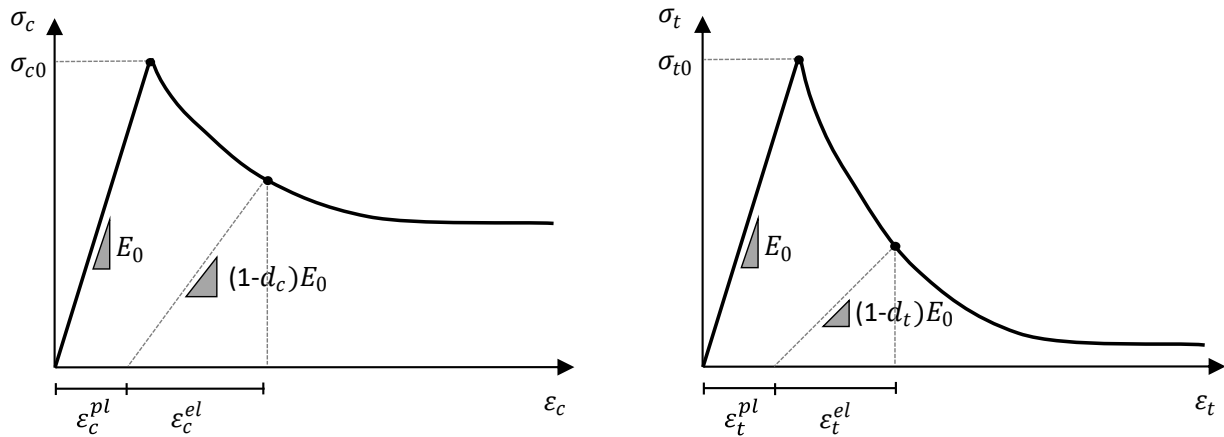
Figure 3-18: Schematic representation of the response of Concrete Damaged Plasticity to uniaxial loading in compression (left) and tension (right).

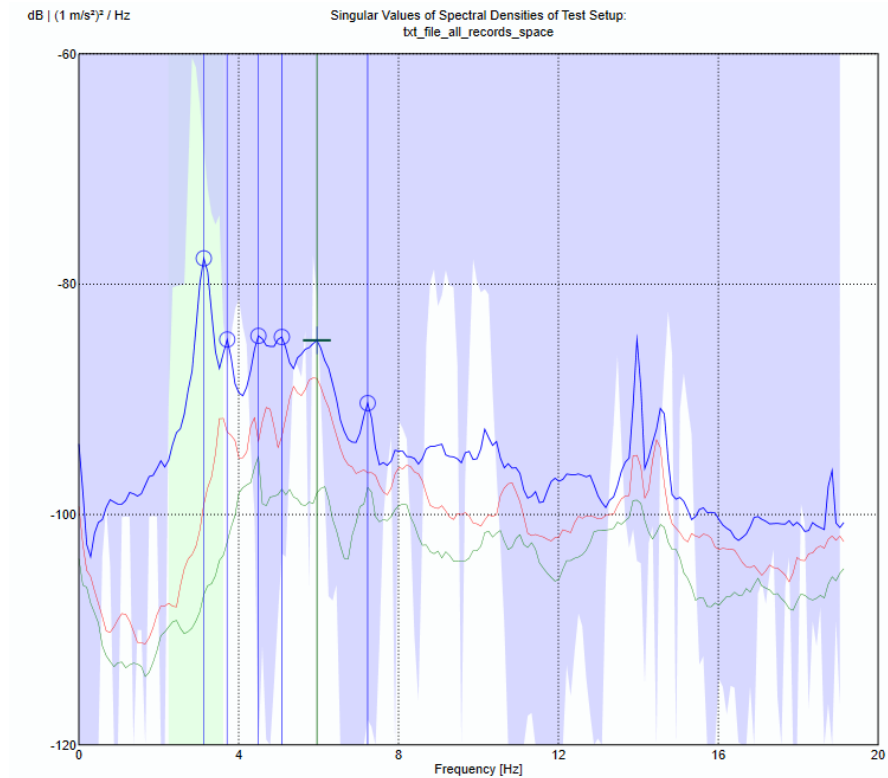
Figure 3-21: The first six natural frequencies of the model as obtained with ARTEMIS software by means of Frequency Domain Decomposition.

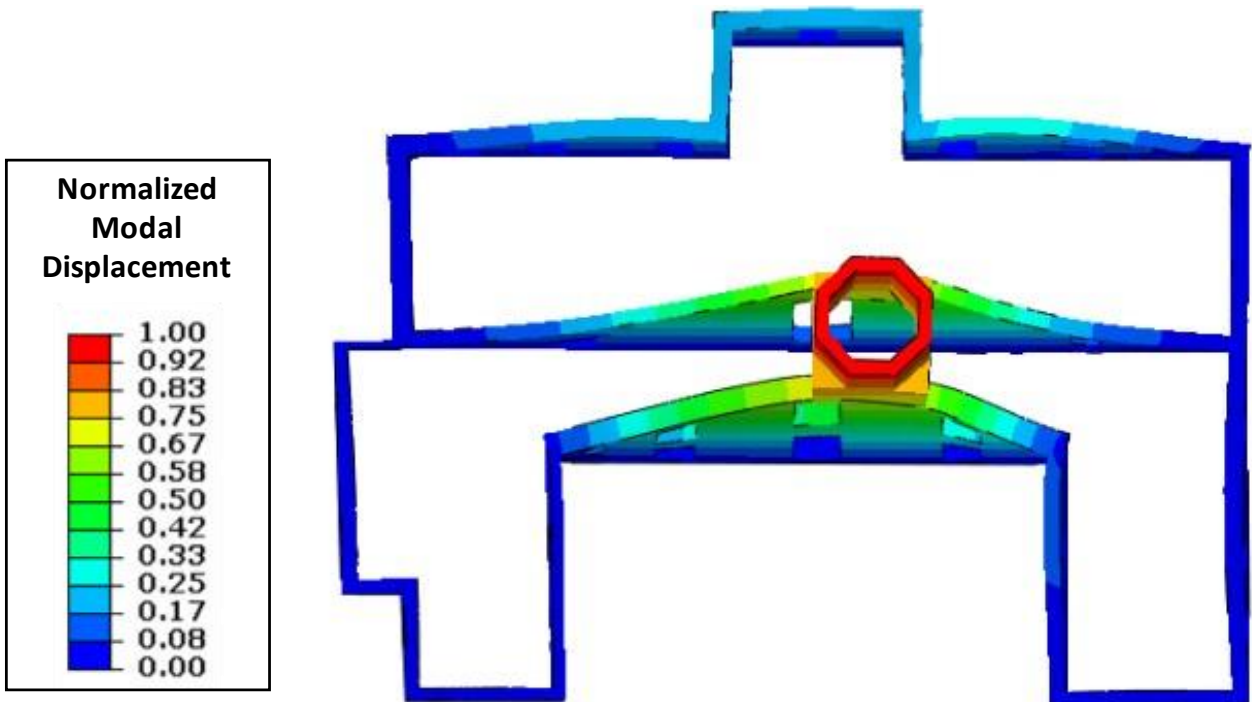
Figure 3-24: The first mode shape from the calibrated numerical model. The contours demonstrate the normalized modal displacement.

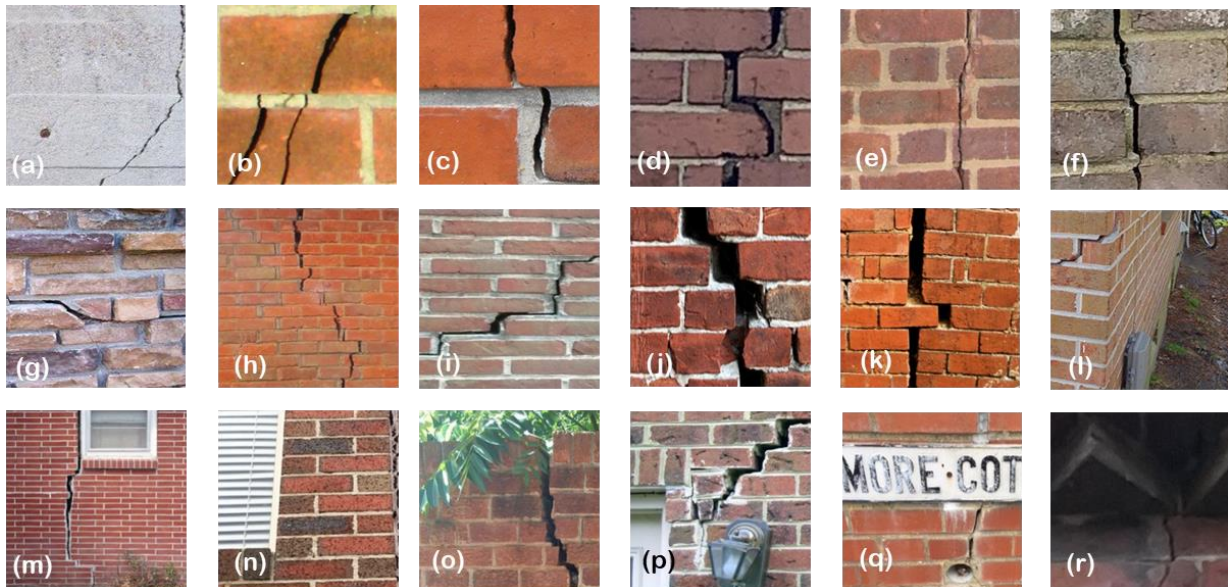
Figure 4-3: Images from the masonry dataset containing cracks.

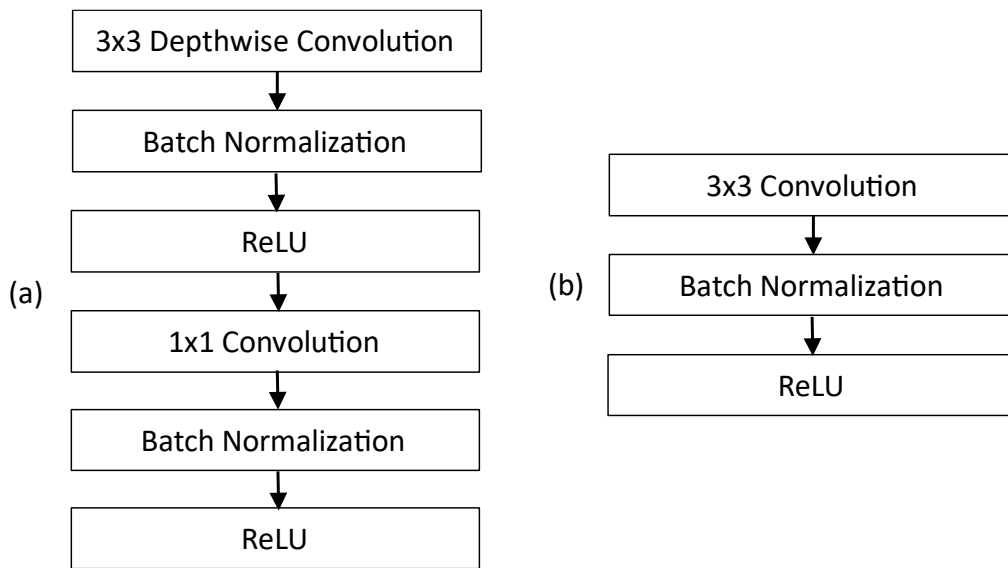
Figure 4-6: (a) Factorized layer with depthwise convolution, 1×1 pointwise convolution, batch normalization and ReLU activation. (b) Standard convolutional layer followed by batch normalization and ReLU activation.

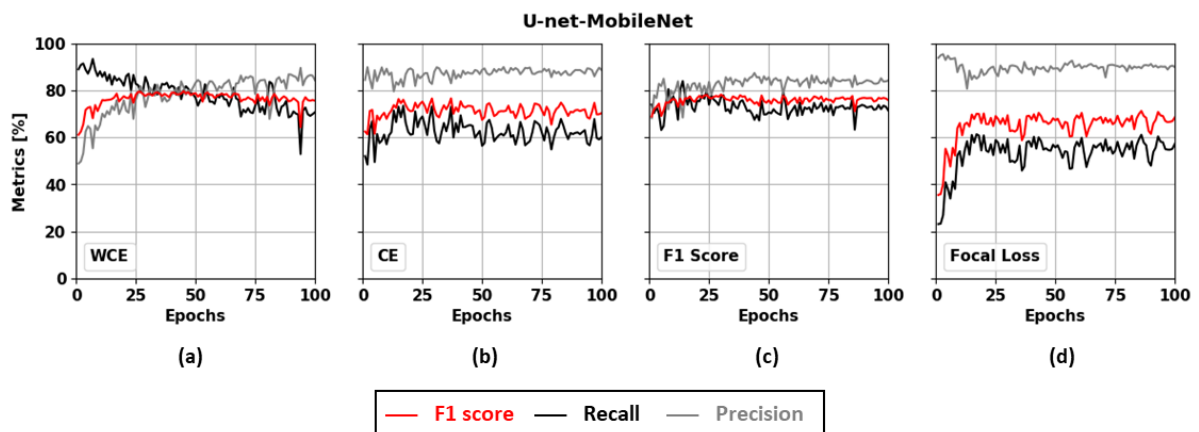
Figure 4-13: The metrics F1 score, Recall and Precision as obtained from the pretrained U-net-MobileNet for different loss functions: (a) weighted cross entropy (WCE), (b) cross entropy (CE), (c) F1 score, and (d) focal loss.

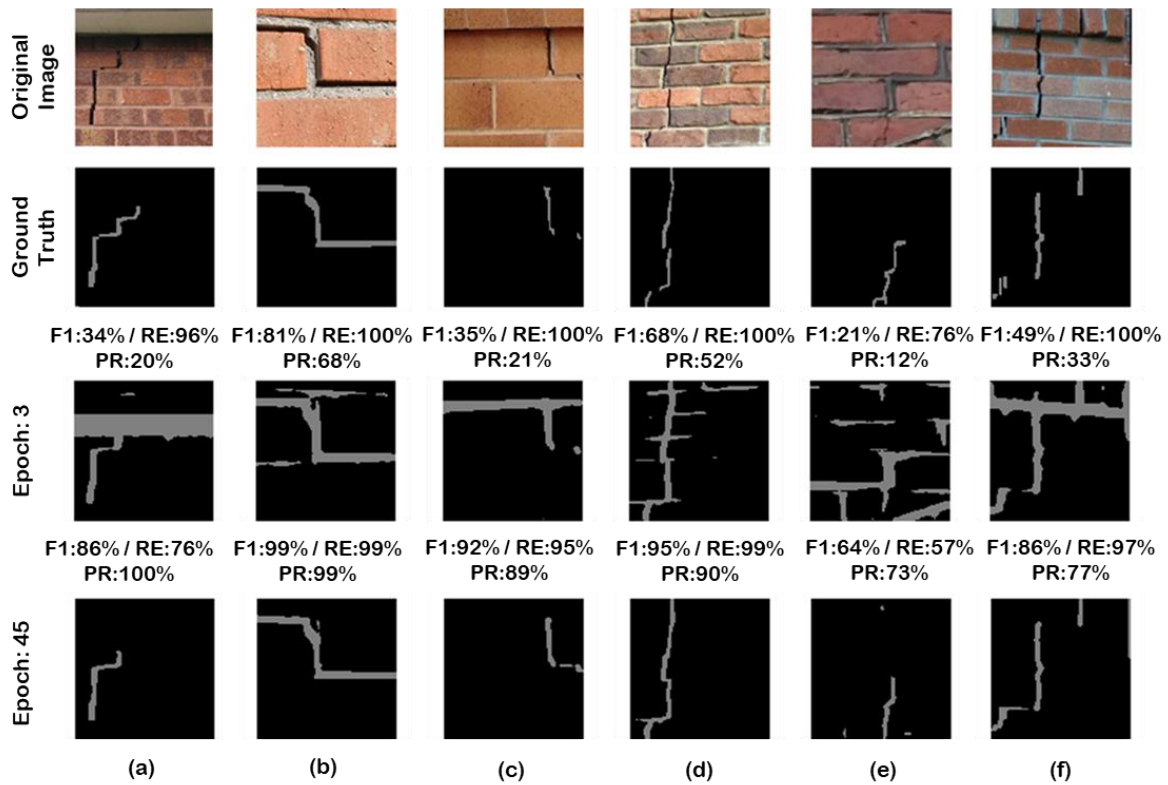
Figure 4-14: The original image, the ground truth and the predictions with U-net-MobileNet at epochs 3 and 45 are displayed for different images from the masonry dataset. At the top of each prediction the calculated metrics (F1: F1 score, RE: recall, and PR: precision) are highlighted.

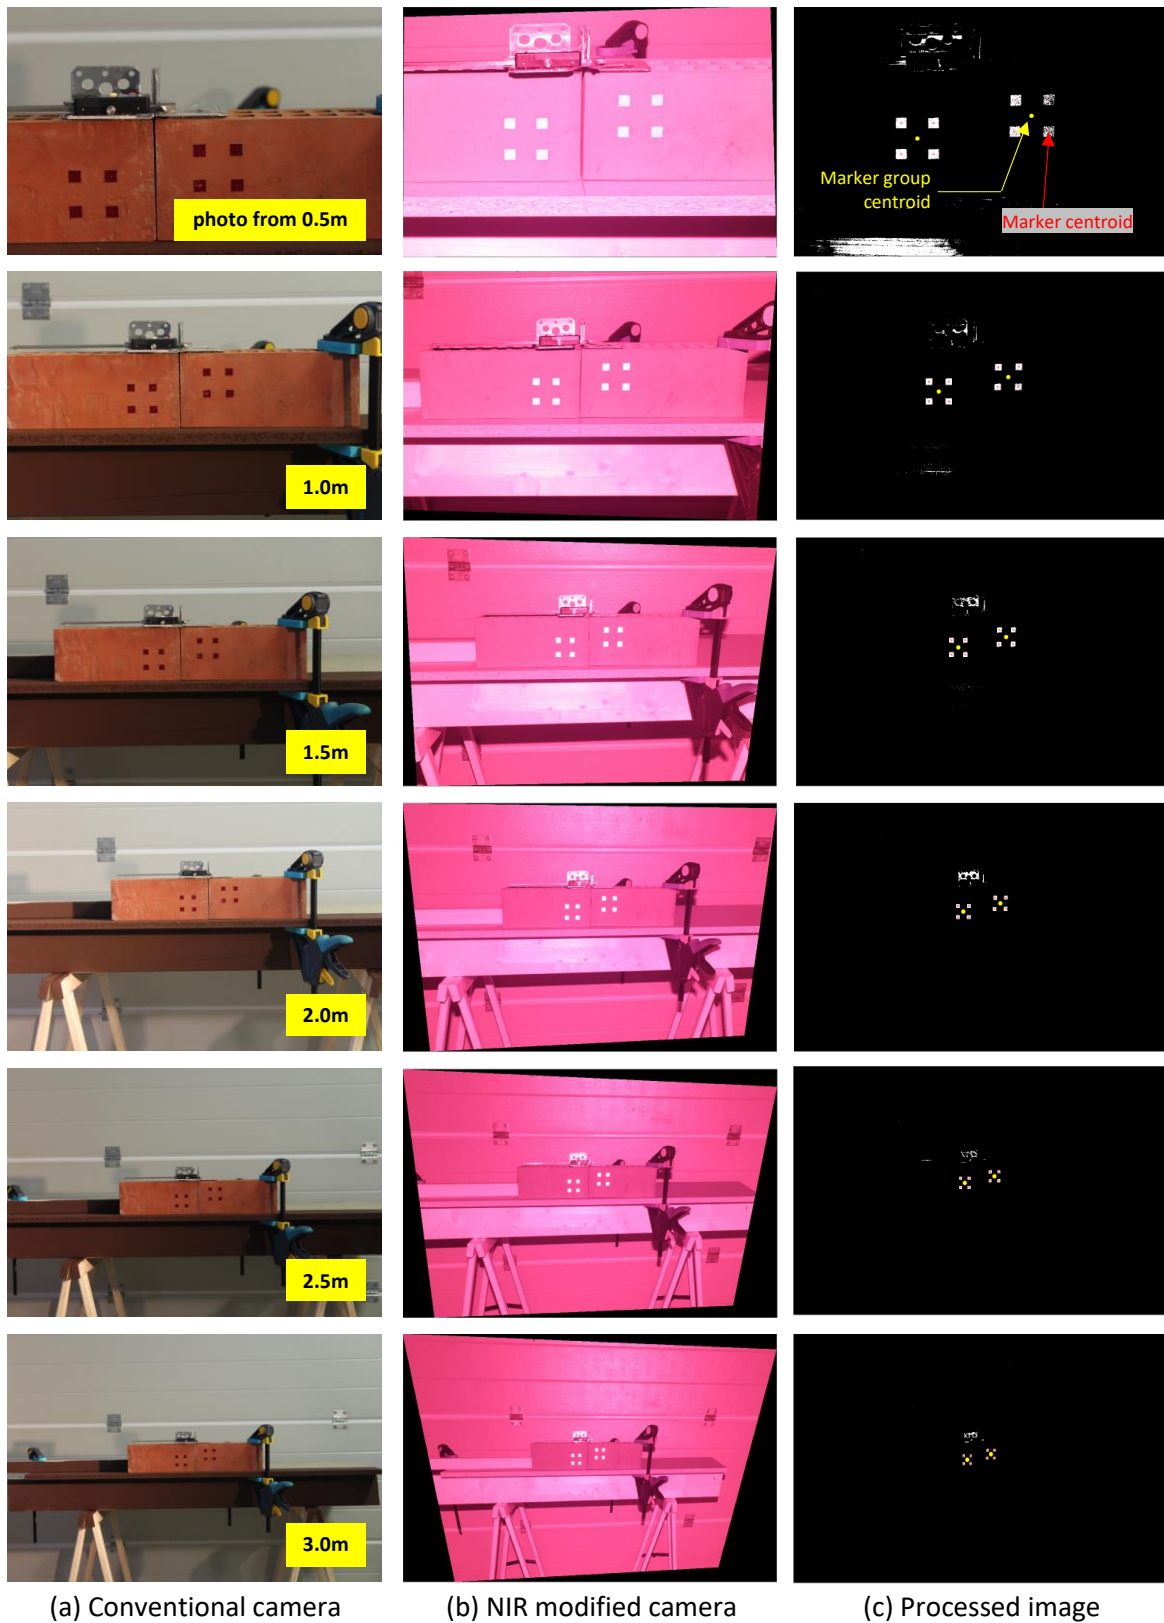
Figure 4-20. Photographs taken by a conventional camera (a), photographs taken by the NIR modified camera and perspective correction is applied (b), and binary (black & white) photographs created by the image processing procedure from the perspective corrected photographs (c) for the NIR tape markers.

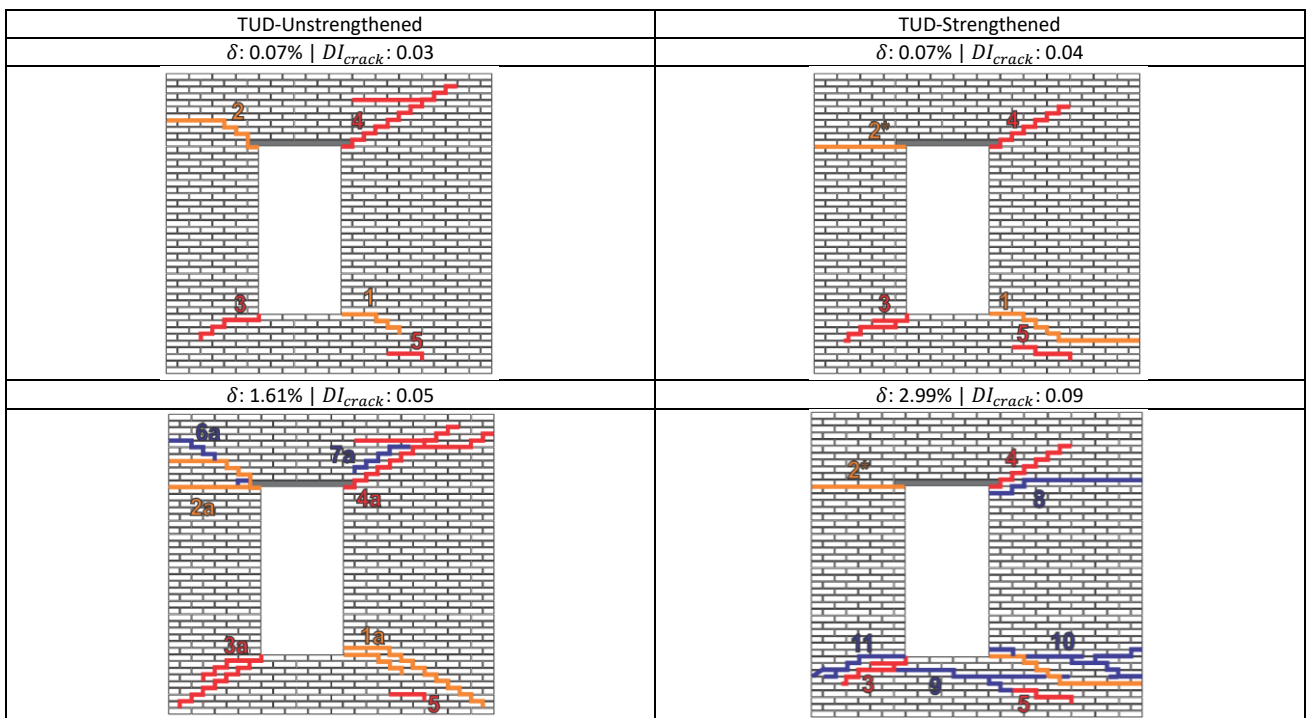
Figure 5-23: Crack patterns observed for the masonry walls with opening as reported in (Drougkas et al. 2020). The crack patterns, the drift ratio δ and the corresponding DI_{crack} are displayed for the Damage Limitation state (top) and the Near Collapse state (bottom).

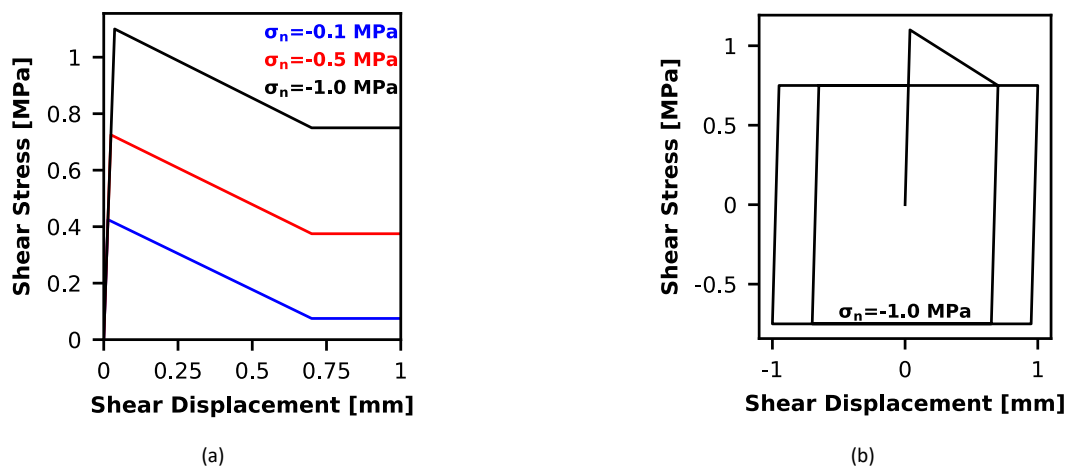
Figure 5-28: (a) Shear behaviour of discontinuous elements for different levels of axial stress. (b) Cyclic shear behaviour of discontinuous elements for axial stress 1.0 MPa. The curves correspond to material properties defined in 5.3.1.2.

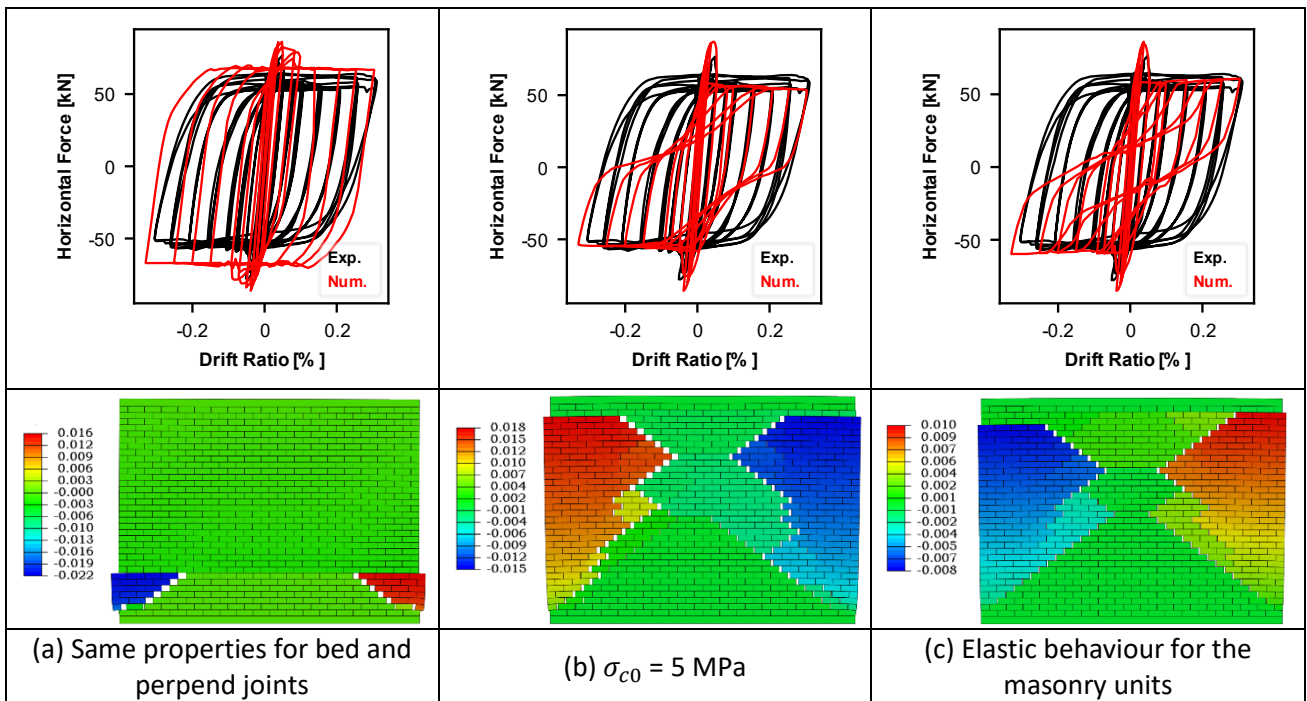
Figure 5-33: Hysteresis loops (top) and deformed shape (bottom) produced with different numerical configurations of the specimen EC-COMP-3: (a) same properties for bed and perpend joints; (b) compressive strength σ_{c0} equal to 5 MPa; and (c) elastic behaviour for the masonry units. Contours represent magnitude of deformations in m.

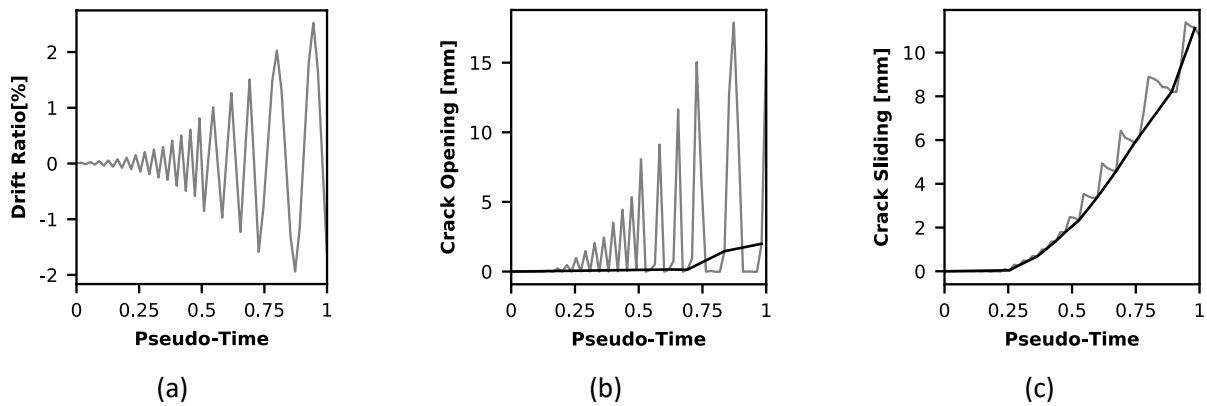
Figure 5-36: Time-history of (a) drift ratio; (b) crack opening and (c) crack sliding as measured at the top left corner of the EC-COMP2-1 specimen. For the sub-figures (b) and (c) the residual values at the end of each cycle are shown with black line.

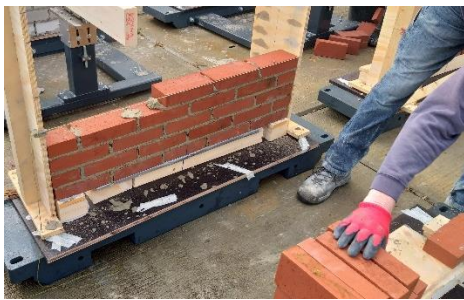
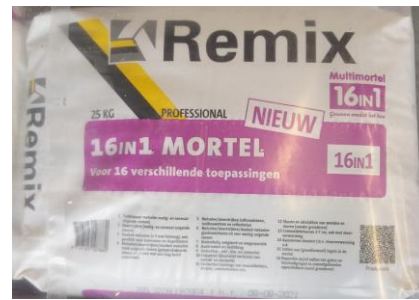
Figure 6-2: (a) Construction of the wall specimens; (b) multipurpose mortar.
