# Investigation of material removal mechanism and thermal response of compressor abradable materials

Andreas Hadjisoteriou

A thesis submitted in partial fulfilment of the requirements for the degree of

Department of Mechanical Engineering

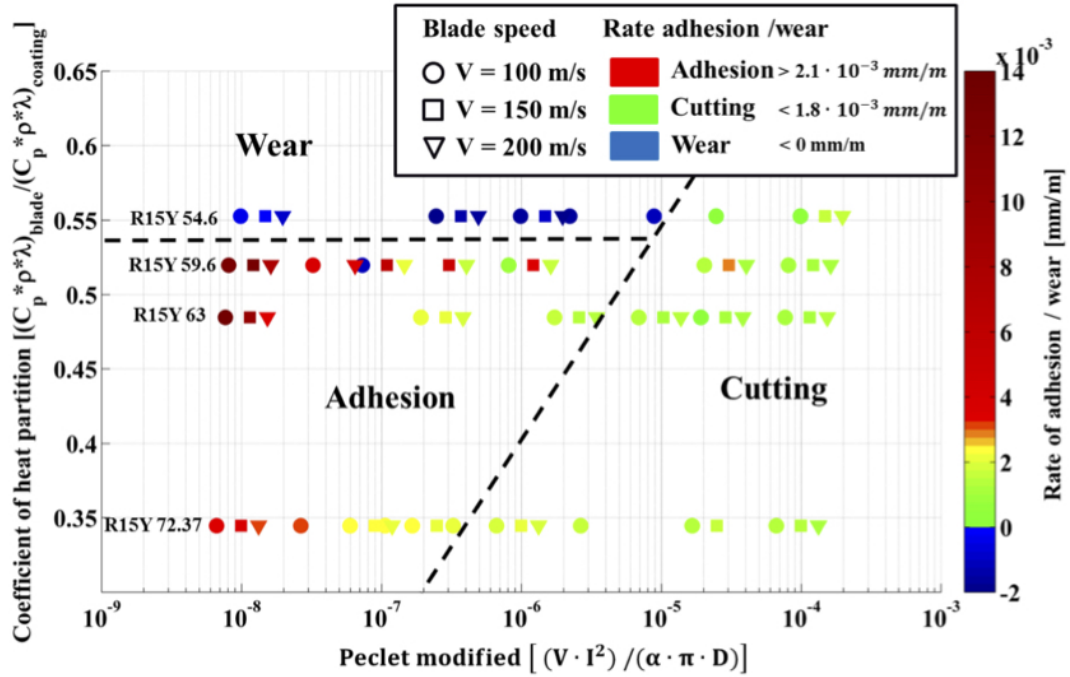
Figure 2.16: Wear map of Metco 320 NS constructed with the heat partition and modified Peclet number [15].

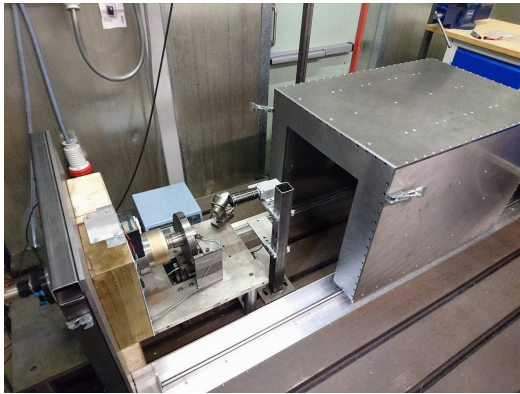
Another modification made on the test platform is the addition of a containment unit built around the rig for enhanced health and safety purposes and this is shown in figure 3.7. It is made of a sandwich structure consisting of an aluminium sheet in the inside and a steel sheet on the outside both bolted on a piece of wood holding the structure together. The test platform can be easily accessed for test preparation since the containment is mounted on a rail and can be moved to the back when not testing. It is not in direct contact with the test platform and therefore it does not affect its operation.

Figure 3.7: (a) Open containment, (b) Closed containment,

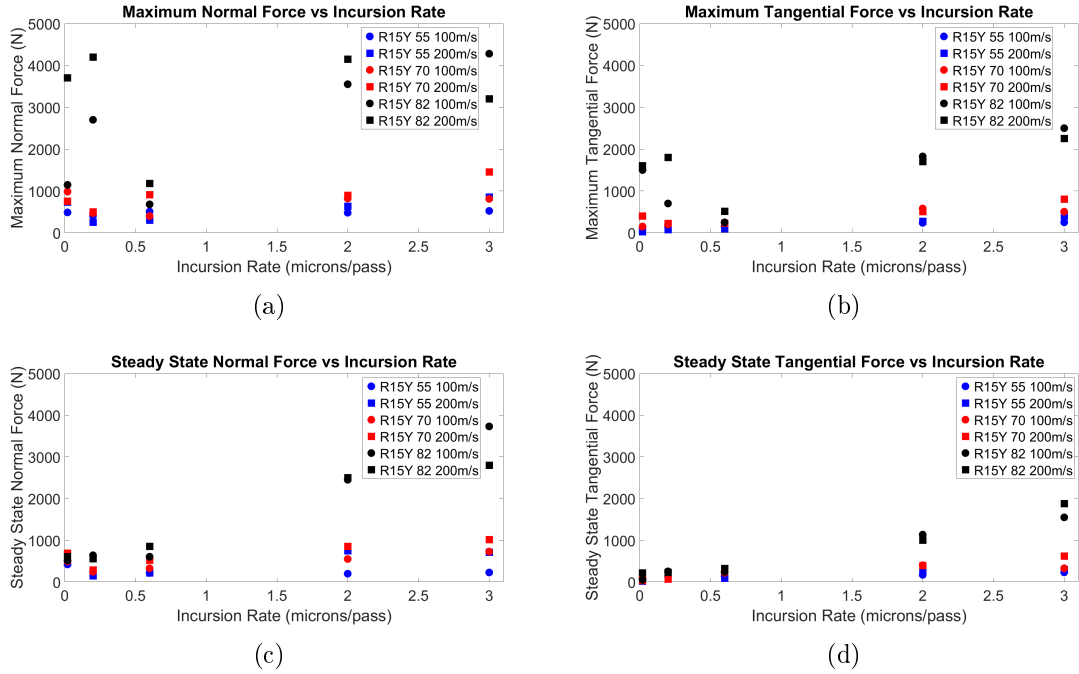
Figure 4.5: (a) Maximum normal force vs incursion rate, (b) Maximum tangential force vs incursion rate, (c) Steady state normal force vs incursion rate, (d) Steady state tangential force vs incursion rate

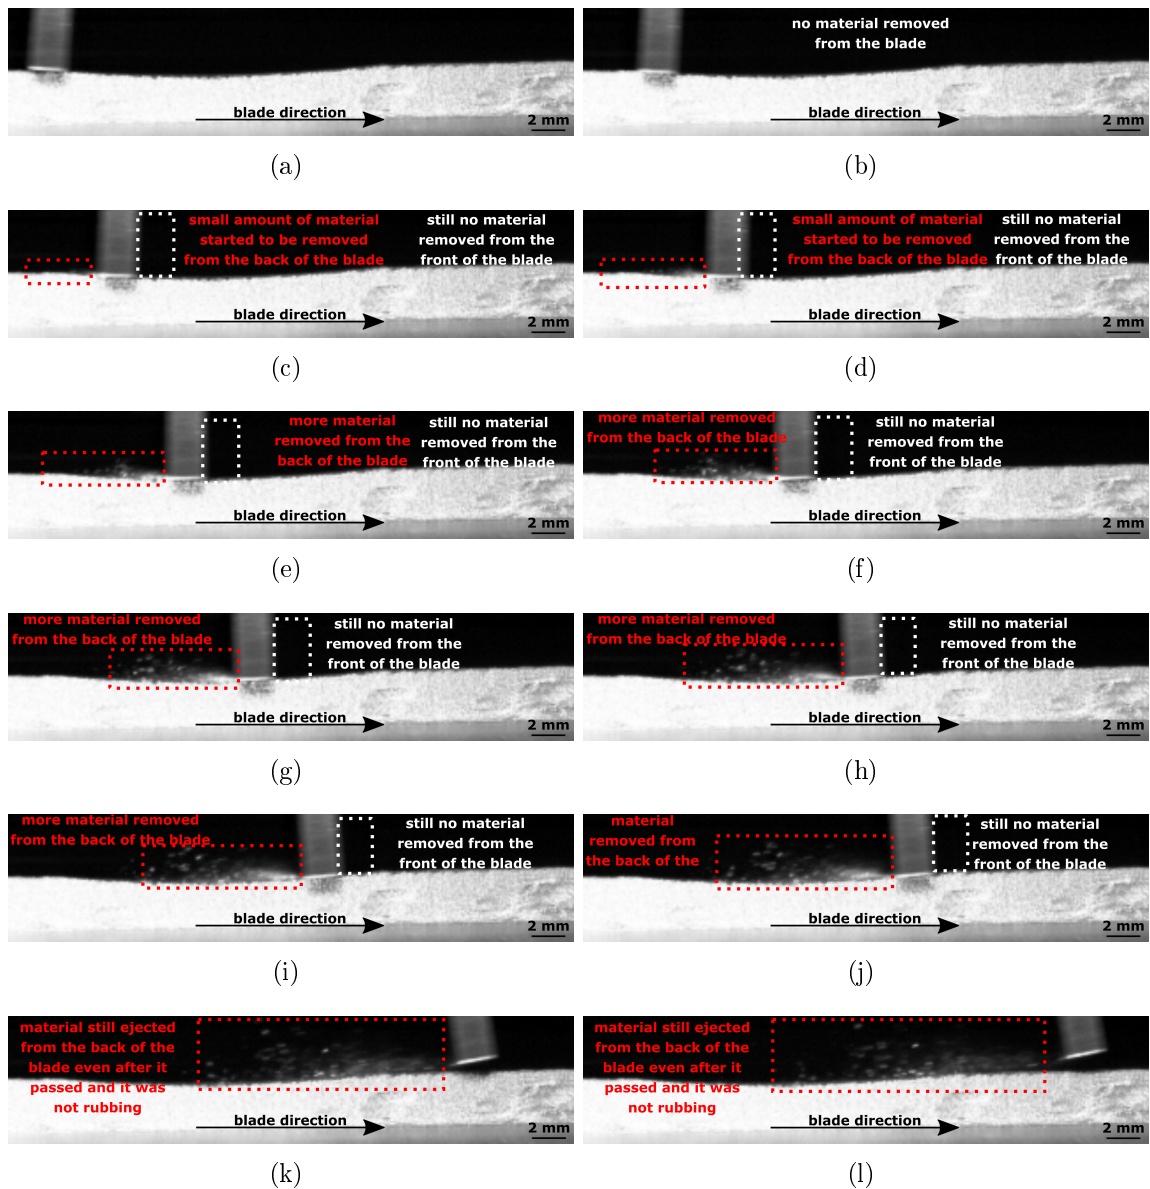
Figure 5.3: Series of 12 raw images from a Metco 601, RY15 55 sample, tested at 200 m/s and  $0.02 \mu\text{m}/\text{pass}$ . Images (a) to (j) have a time interval of  $8.33 \mu\text{s}$ . Image (k) was taken  $33.3 \mu\text{s}$  after image (j) and image (l) was taken  $8.33 \mu\text{s}$  after image (k).

The tests selected to be shown in figures 5.1 and 5.3 represented a high and a low incursion rate respectively. This was done because it was found that the debris generation mechanism was similar for the same incursion rates, while they changed as incursion rate was varied and these two extremes highlight these differences. The

first important insight gained by studying these figures was that at high incursion rates (figure 5.1) a lot of material was ejected from the front of the blade, while some of it sprang back from the back of the blade. However, in the case of the test at low incursion rates (figure 5.3) no material could be seen to be ejected from the front of the blade as the blade passed. All of the material sprang back after the blade passed. This suggested that there was a different chip generation and release mechanism that varied with the incursion rate. A second interesting finding could be observed by examining the case of the high incursion rate test (shown in figures (5.1) and 5.2). It could be seen that a large crack was present and as the blade passed over it, a large chip was removed from that region (see figures 5.2(a) and 5.2(b)). These images provided evidence that one of the material removal mechanisms taking place when testing at high incursion rates, was that chips were formed and removed from the abrasible after large cracks were formed. Another interesting finding was the fact that in both cases debris generated was significantly larger than the incursion rate. This was especially evident by looking at the last two pictures of the figures (5.1(k), 5.1(l), 5.3(k), 5.3(l)) that show the debris some time after the blade had passed. Large debris particles could be observed in these images, which were clearly larger than the incursion rate scale. It was expected that material removed was of a similar scale to the incursion rate, but it seems this was not the case and this finding was investigated further in a later section of this thesis.

However, under some conditions, the contact represented more of a sliding contact rather than an abrasive cut. This was more apparent in the low incursion rate testing conditions shown in figures 5.3 and 5.4. In this case, the vertical component of the force resulting from the contact compressed the material below it. This caused build-up of elastic energy in the bonds of the abradable, deforming the particles below and around the blade. When this energy was enough to break the bonds that hold the particles together, the material sprang upwards after the blade had passed. This mechanism was explained in more detail in section 2.2.2.

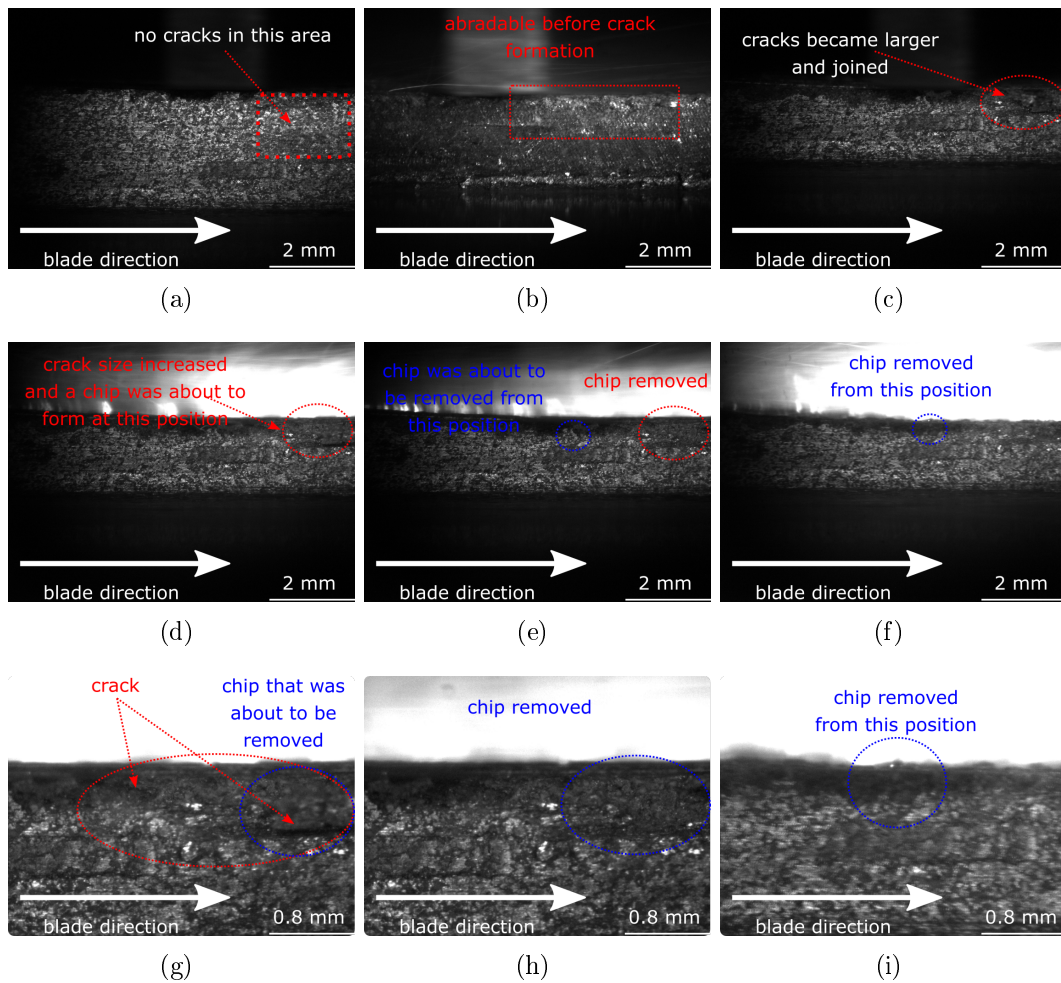
Figure 6.5: Series of images from a Metco 601, RY15 55, 200 m/s, 0.02 microns/pass test. (a) Image showing how the abrasible was before any cracks in that region, (b) Image showing the abrasible and blade taken 125.3 s after image (a), (c) Image showing the abrasible and blade taken 70.4 s after image (b), (d) Image showing the abrasible and blade taken 4.5 s after image (c), (e) Image showing the abrasible and blade taken 0.047 s after image (d), (f) Image showing the abrasible and blade taken 10.4 s after image (e), (g) Image showing an enlarged area from image (d) (2.5 magnification), (h) Image showing an enlarged area from image (e) (2.5 magnification), (i) Image showing an enlarged area from image (f) (2.5 magnification).

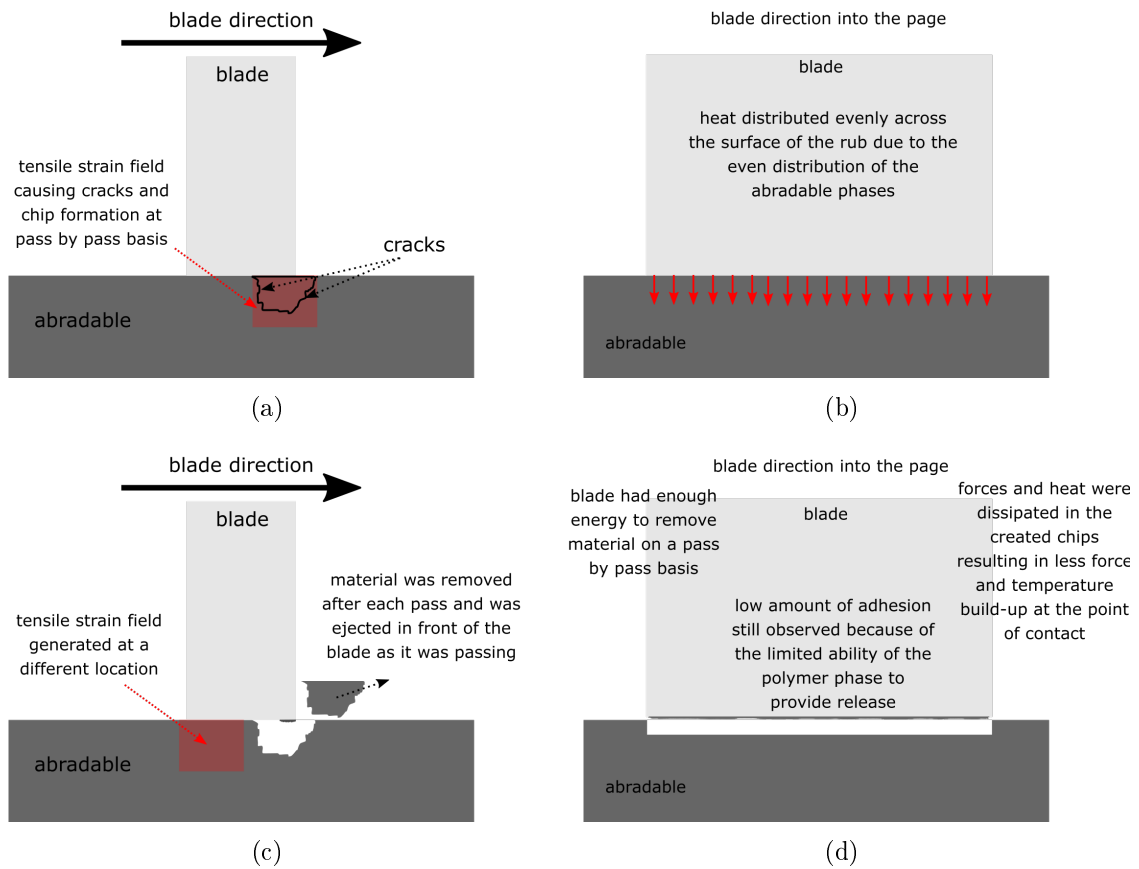
Figure 8.3: Schematic showing the wear mechanism of low and medium hardness Metco 601 tested at low incursion rate conditions ( $0.02 \mu\text{m}/\text{pass}$ ). Figures (a) and (c) show the material removal mechanism from the side of the contact, while figures (b) and (d) show the adhesion mechanism and heat distribution from the front of the contact.

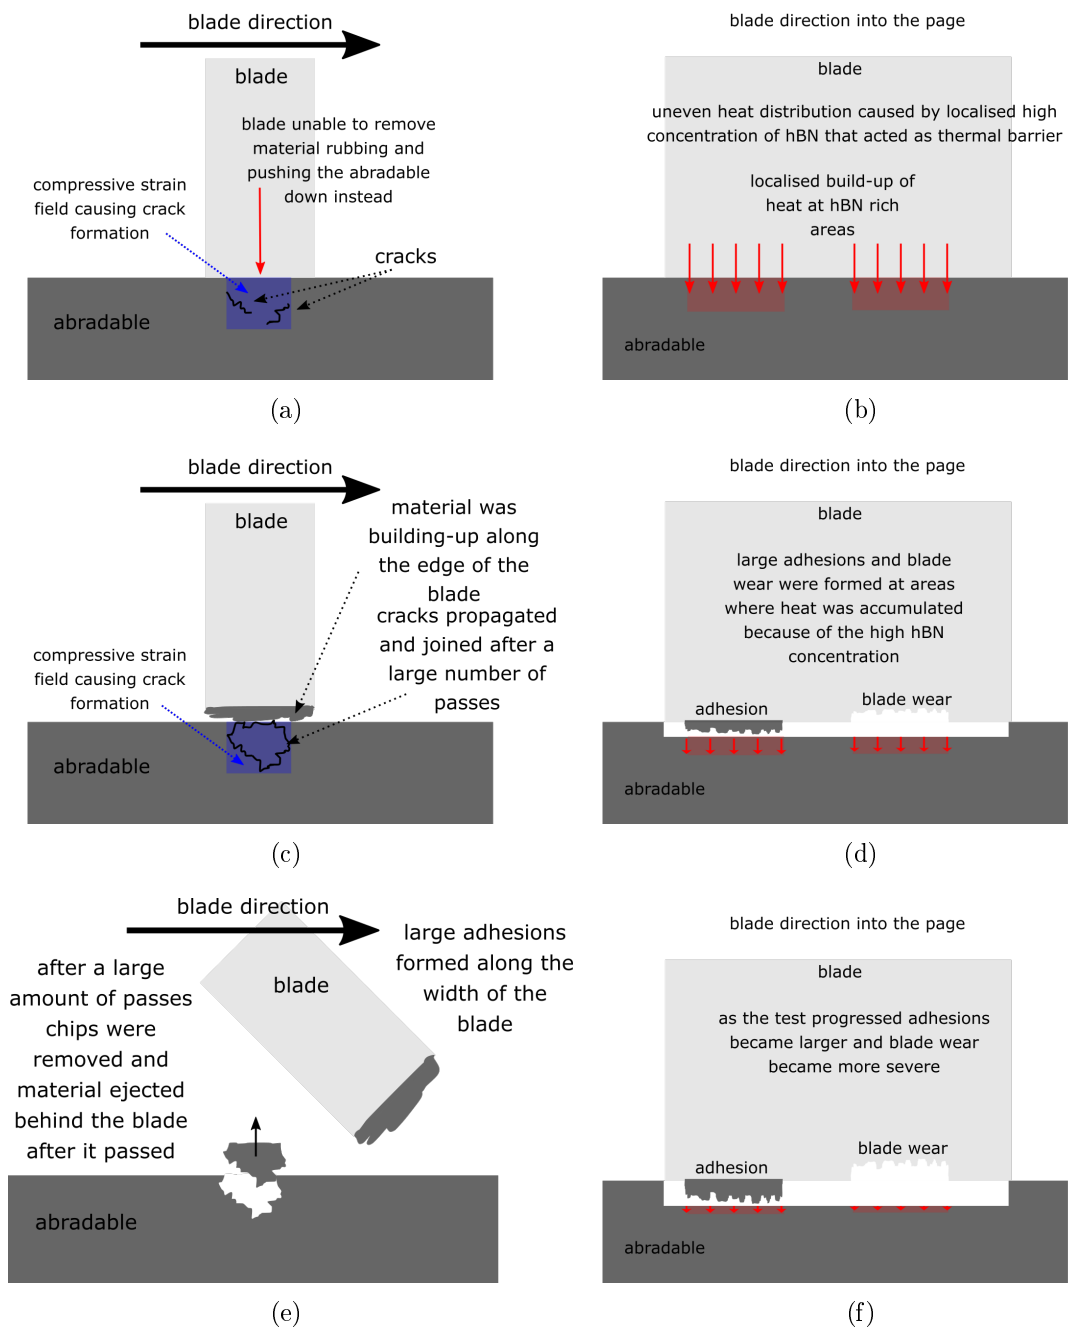
Figure 8.6: Schematic showing the wear mechanism of Metco 320 tested at low incursion rate conditions ( $0.02 \mu\text{m}/\text{pass}$ ). Figures (a), (c) and (e) show the material removal mechanism from the side of the contact, while figures (b), (d) and (f) show the uneven heat distribution and the resulting adhesion and blade wear mechanisms that were observed from the front of the contact.
