The role of flooding in the activation of landslides in rail infrastructure

Iain Gareth Johnston

The University of Leeds

Submitted in accordance with the requirements for the degree of Doctor of Philosophy

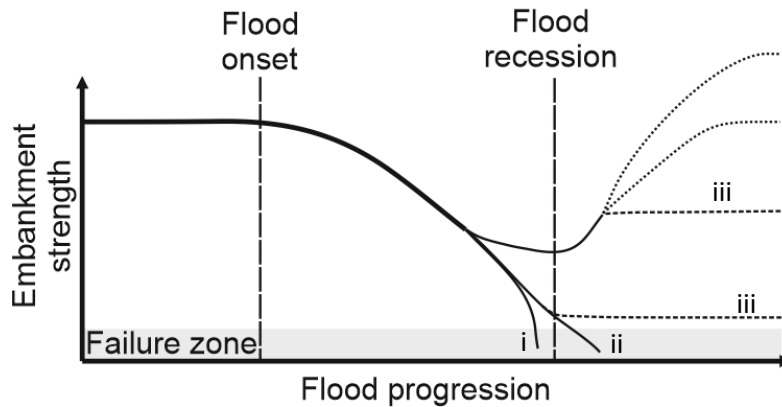
Figure 1: Potential progression of slope stability during a flood event. Some slopes will fail during (i), or shortly after (ii), flooding. Following flood recession the stability of slopes must be considered as stability may not rebound to its pre-flood condition (iii) - presenting questions about the effects of future live loading, flooding or other destabilisation events.

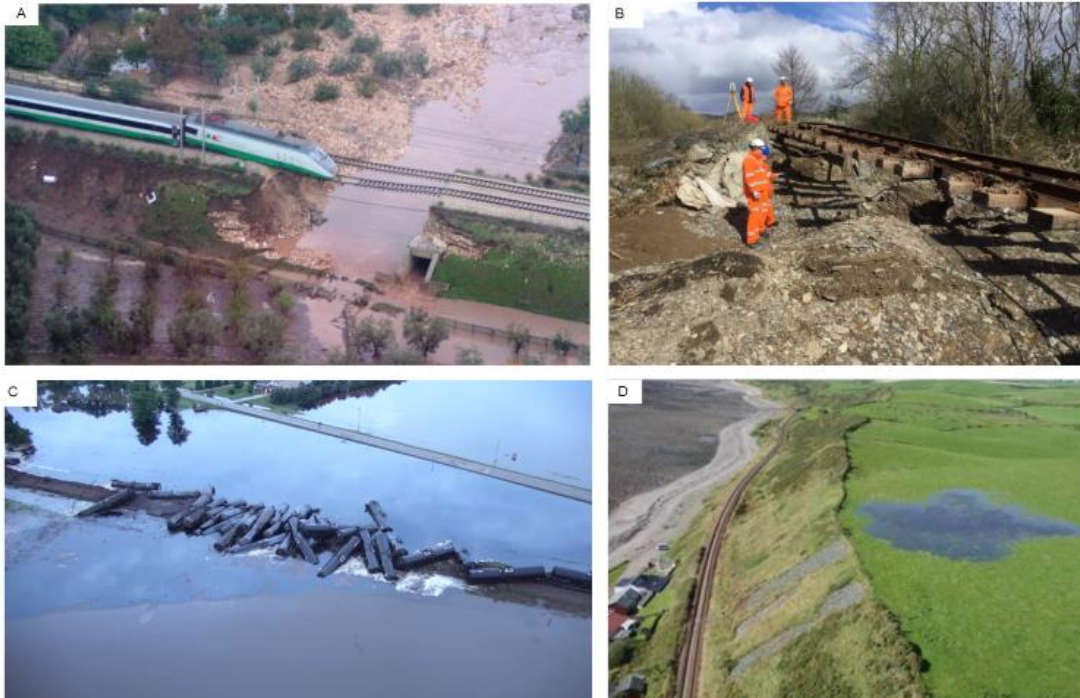
Figure 6: Illustrations of rail slopes subjected to flooding: a) embankment failure following offset head flooding in Acquivavia, Italy (October 2005); b) Embankment failure in Conwy, UK, following overtopping flood (March 2019); c) failure of embankment following train loading during basal flooding in Ohio, USA (June 2018); d) floodwater development above slope, causing infiltration in UK (a) reproduced from Polemio and Lollino (2011); b) and d) courtesy of Network Rail; c) courtesy of Sioux County Sherriff.

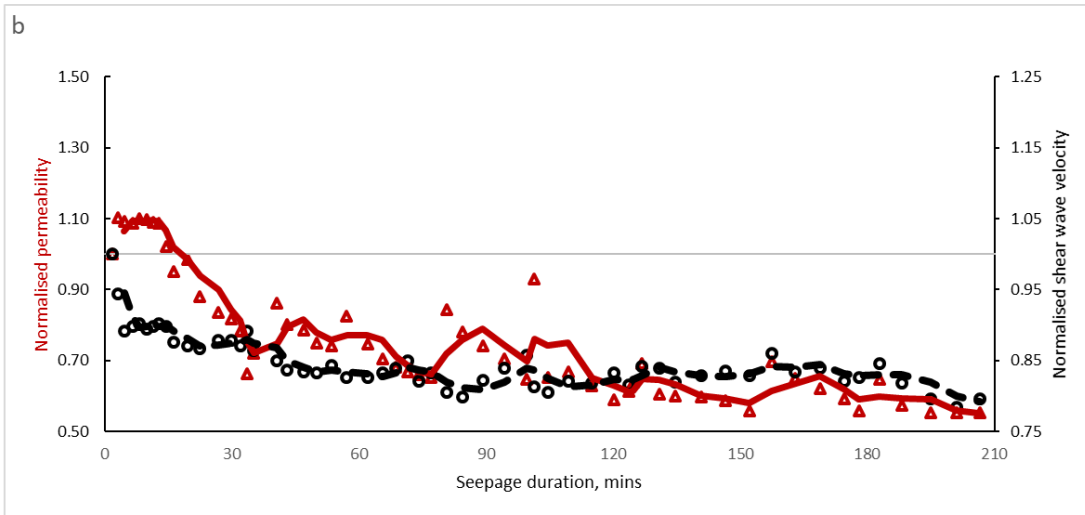
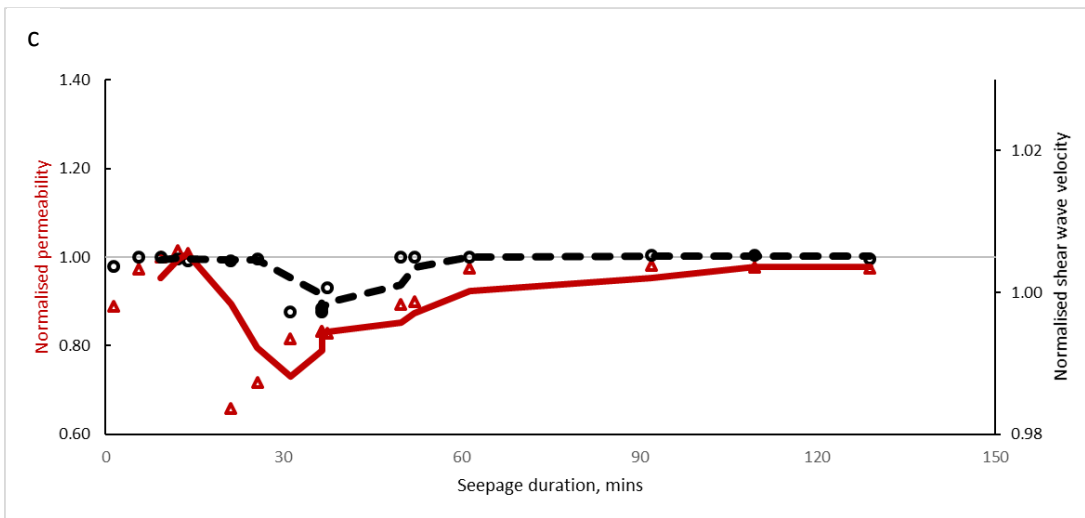
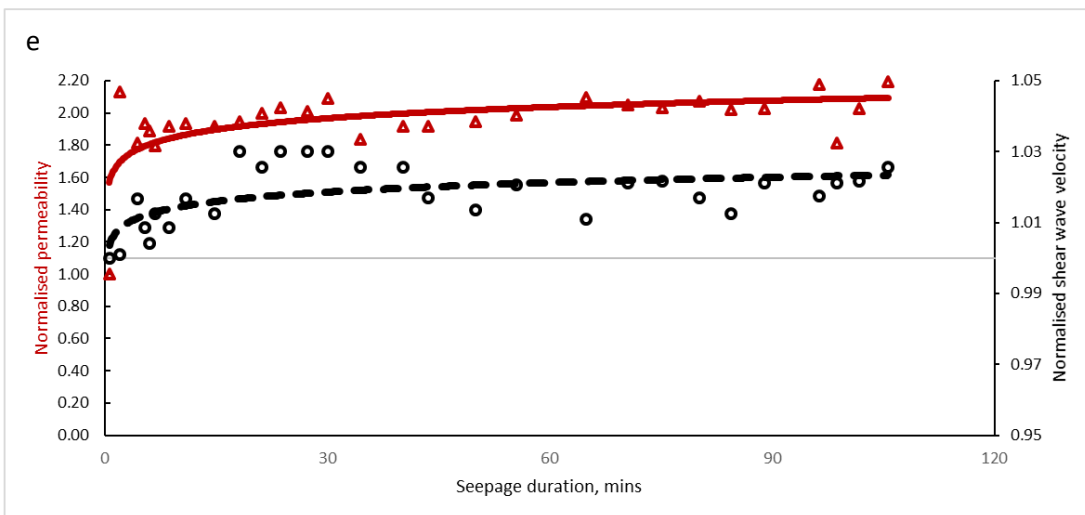
Figure 14: Observed V_s and K over time during seepage for tests a) 30D, b) 30C, c) 15D, d) 30H, e) 30B and f) 15A. d-f are continued over page. Values are normalised by the initial value for the respective property. Trend lines on A-D are three point moving averages and are logarithmic on graphs E and F.

--- ○ Shear wave velocity
 — △ Permeability

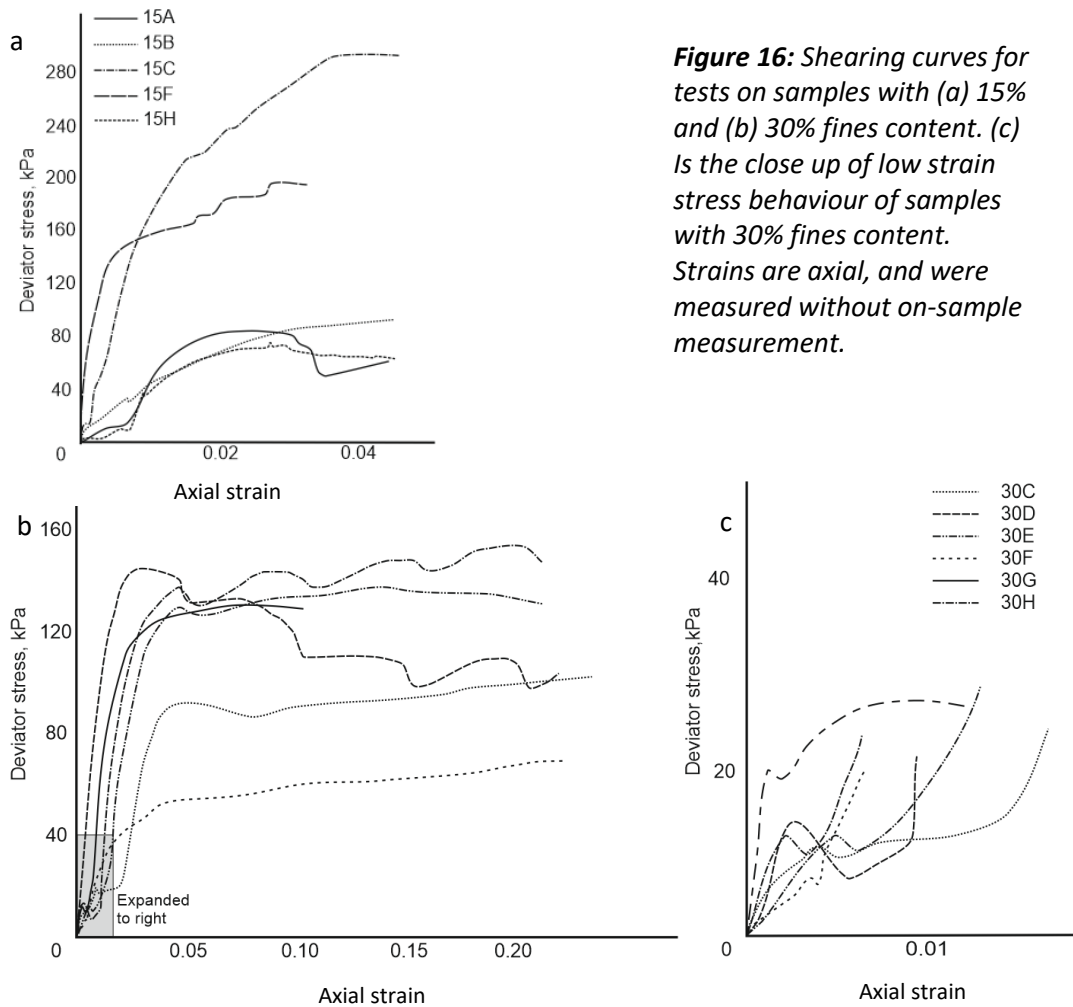
Figure 16: Shearing curves for tests on samples with (a) 15% and (b) 30% fines content. (c) Is the close up of low strain stress behaviour of samples with 30% fines content. Strains are axial, and were measured without on-sample measurement.

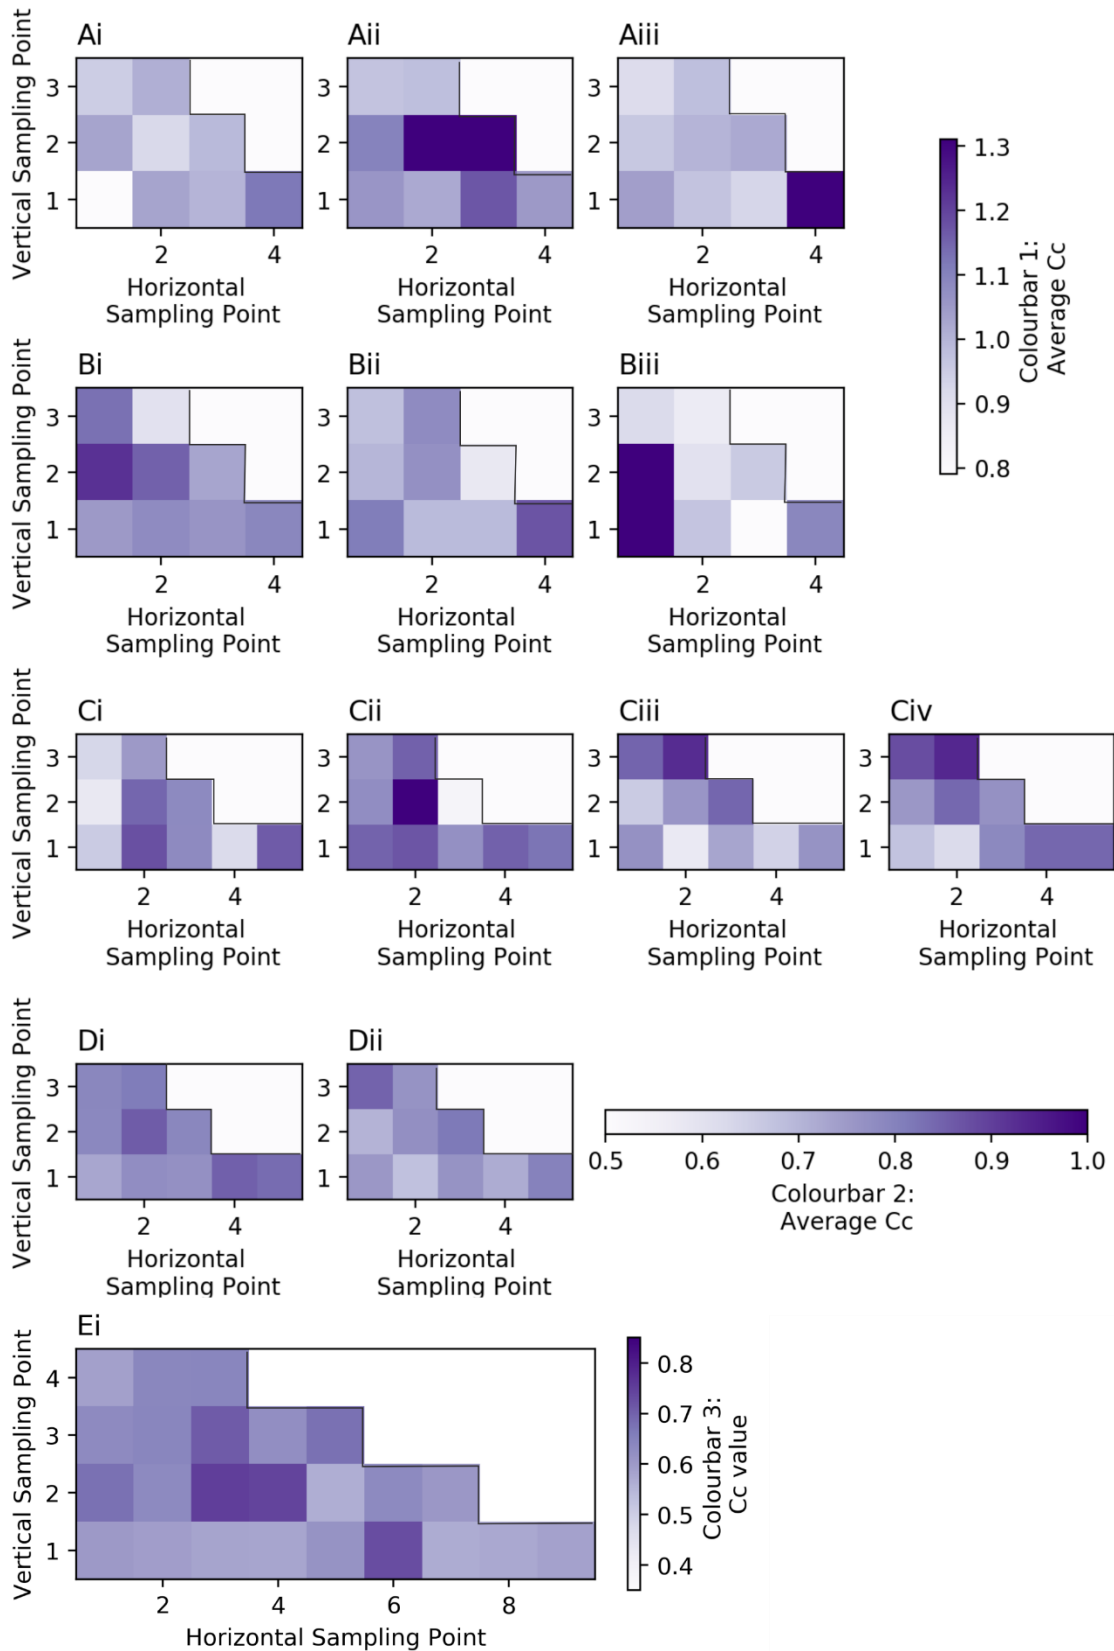
Figure 22: Mean C_c value for each sampling point in slopes A - E. In slopes C, transect (i) underwent the shortest duration of seepage. Transect D (i) was a control transect and underwent no seepage. Colour bar 1 refers to slope A, colour bar 2 to slopes B - D and colour bar 3 to slope E.

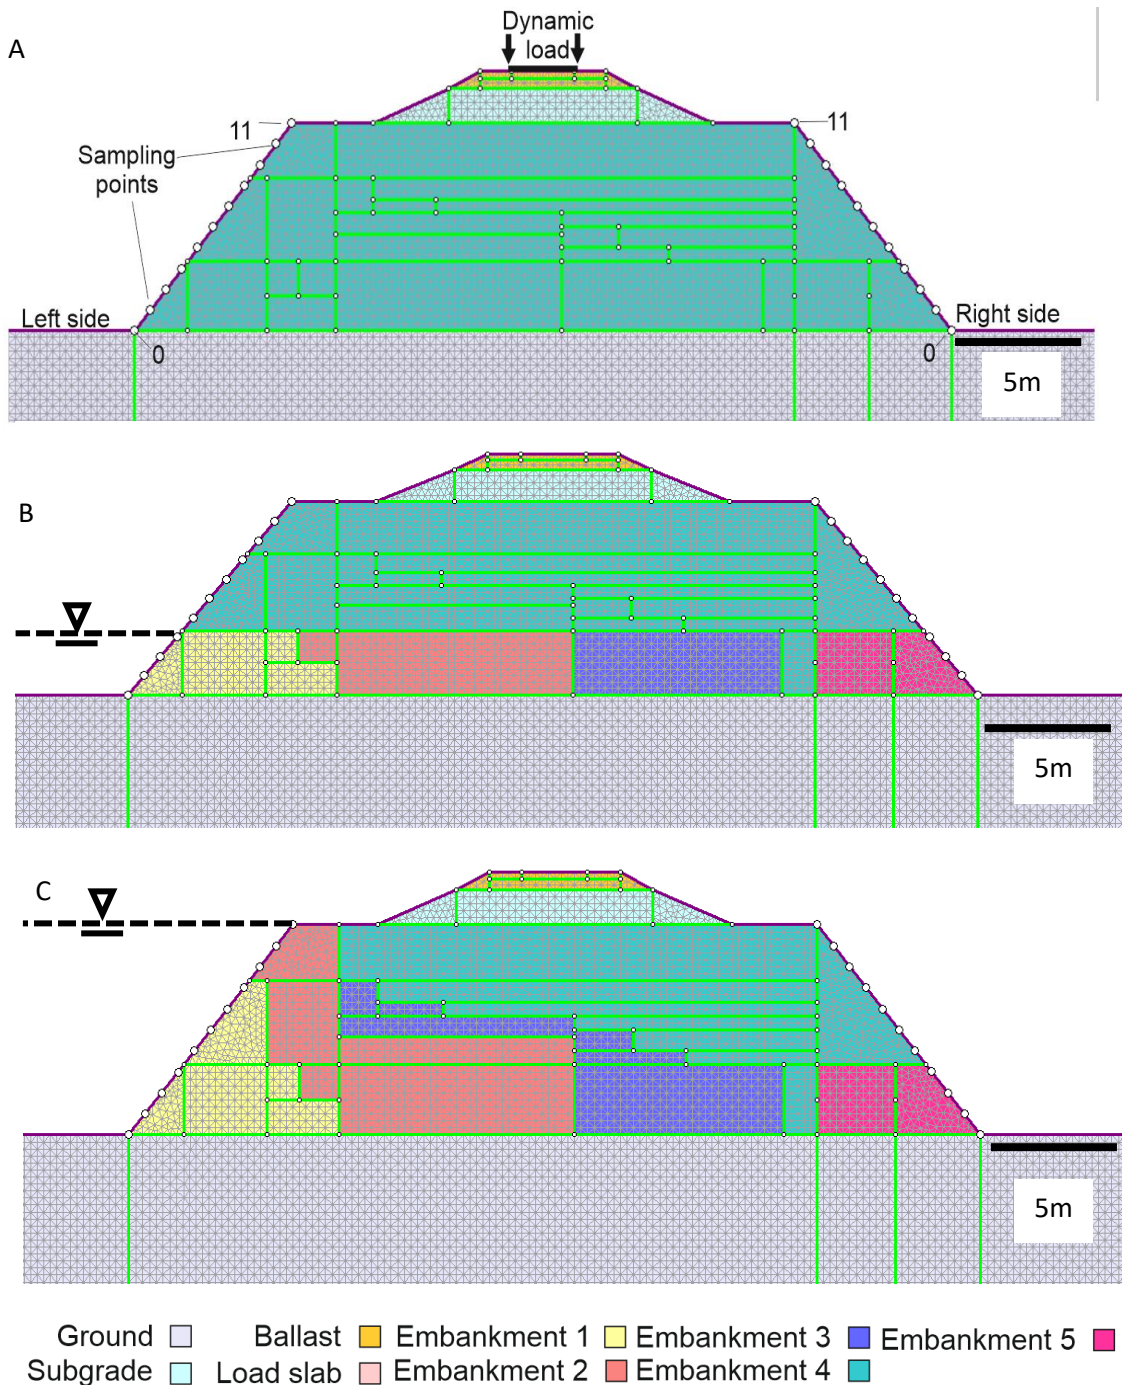
Figure 26: Locations of material zones used in the altered models. a) Uniform model b) Basal alteration (BO-AM) c) Large scale embankment alteration (FS-AM). The same material regions and mesh were applied to all three models. The ground below the model continued uniformly to a depth of 40 m. Material properties are defined in Table 1. In B and C theoretical water table level is indicated by black dashed lines. Sampling point location descriptions and dynamic load inputs are labelled in A, and the same sampling points and load locations were used in all models. Sampling points were numbered 0-11 left and right, with 0 at the base of the embankment body on each side. Sampling points had a 0.5 m horizontal spacing.

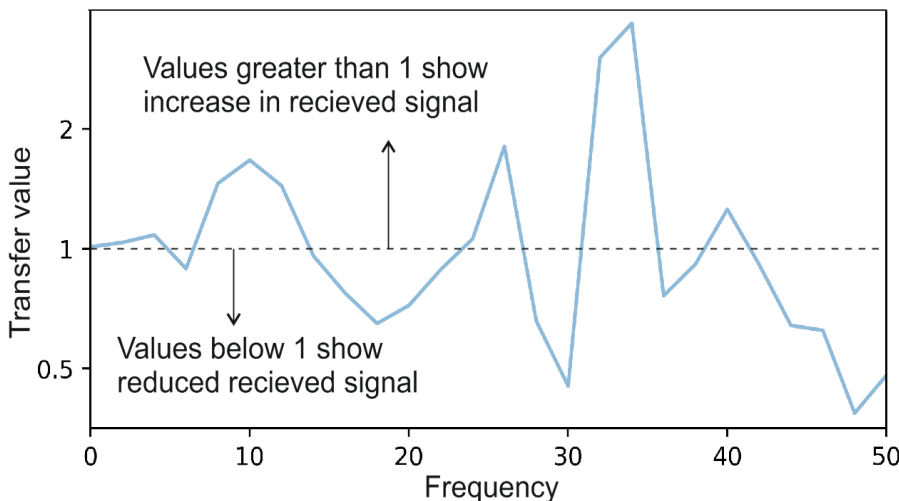
Figure 28: Example transfer graph for an individual sampling point. The transfer value represents a change in signal amplitude between two datasets and is calculated for each frequency.

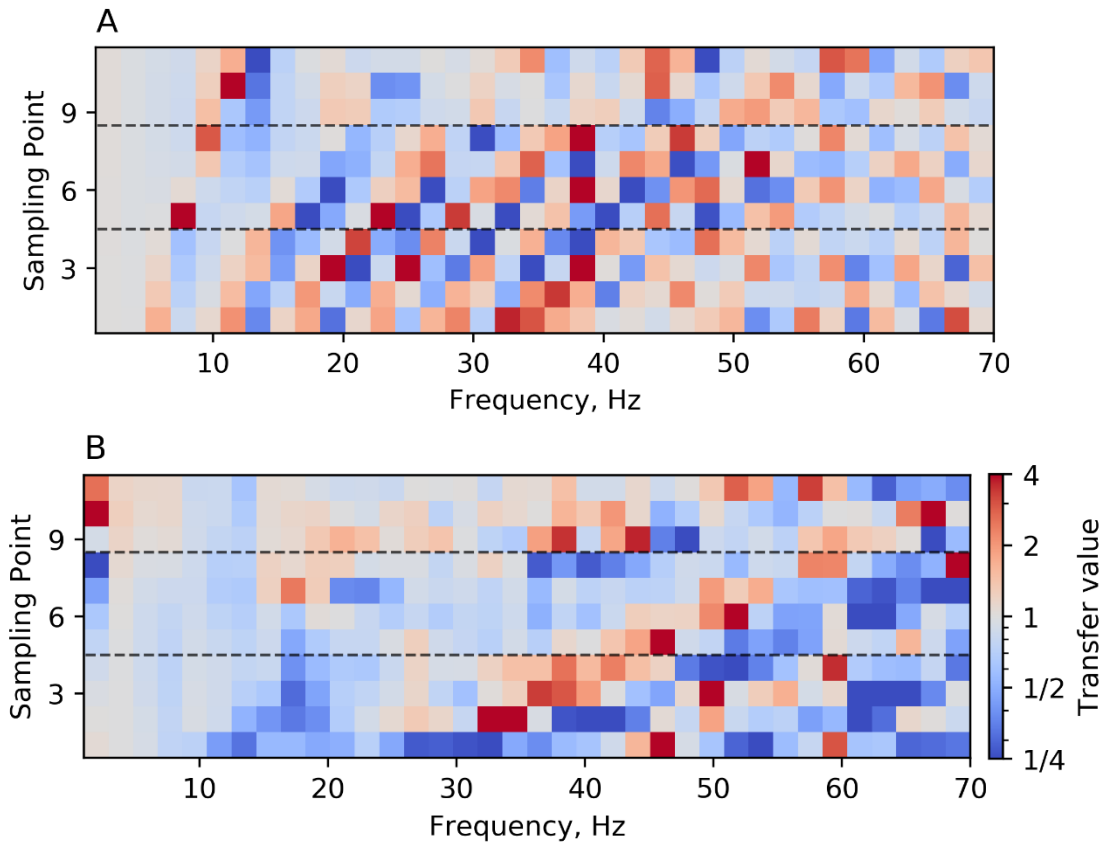
Figure 35: Transfer functions for the FS-AM showing differential change between the right and left sides of the embankment, for a) Vertical displacement and b) Horizontal displacement. The horizontal dashed black line across the plot denote points at which material boundaries were present on the slope face.

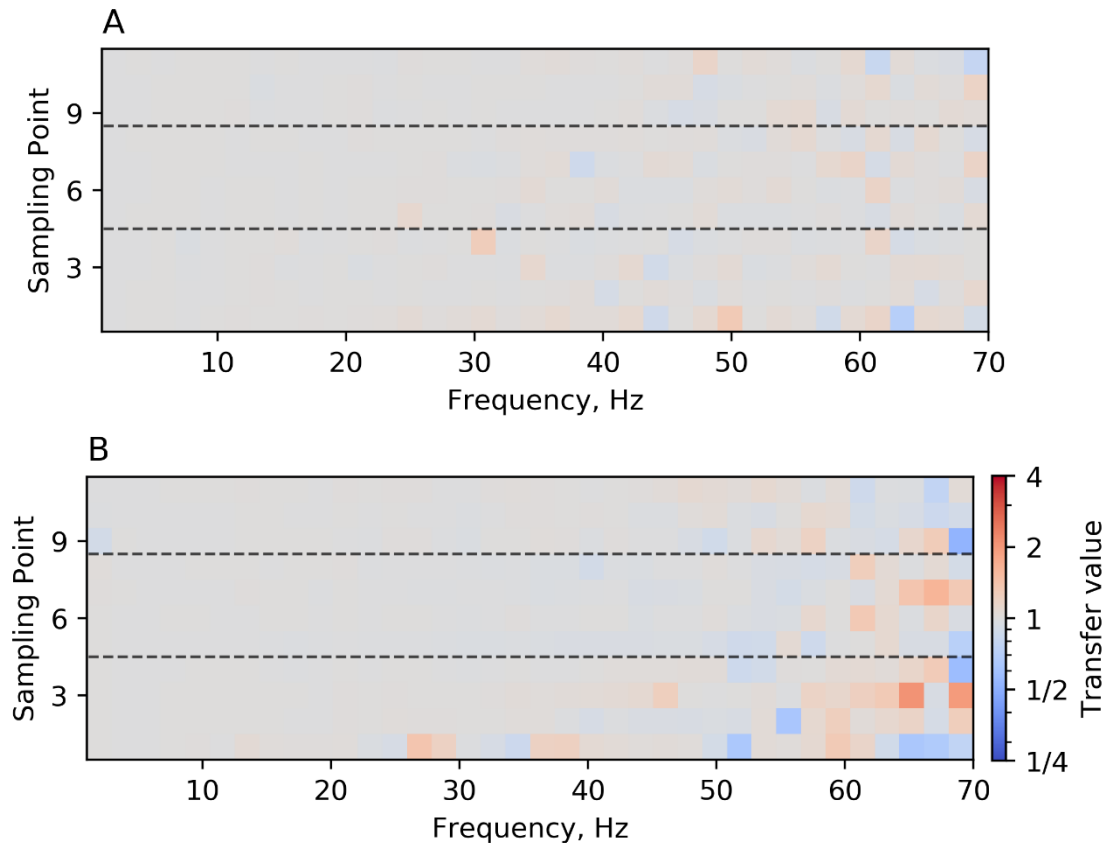
Figure 36: Transfer functions for the uniform model showing differential change between the right and left sides of the embankment, for a) vertical displacement and b) horizontal displacement. Black dashed lines represent the point mesh changes met the slope boundary.
