Department of Mechanical Engineering

DEVELOPMENT OF CVD COATED CERAMIC MILLING INSERTS FOR MILLING INCONEL 718

A Thesis submitted for the degree of
Doctor of Engineering
In Machining Science

2023

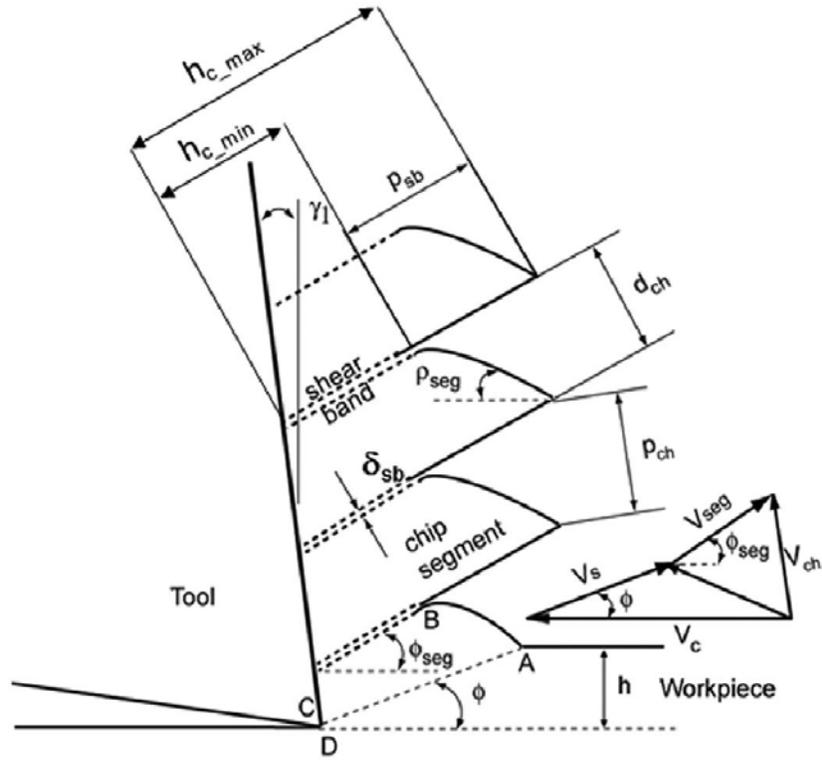
Figure 2.7. Serrated chip formation model and its hodograph. [27]

In Figure 2.7 a serrated chip formation model is depicted, Ulutan et al [27] states the model analytically describes serration process of a chip, which ultimately creates a saw- tooth shape.

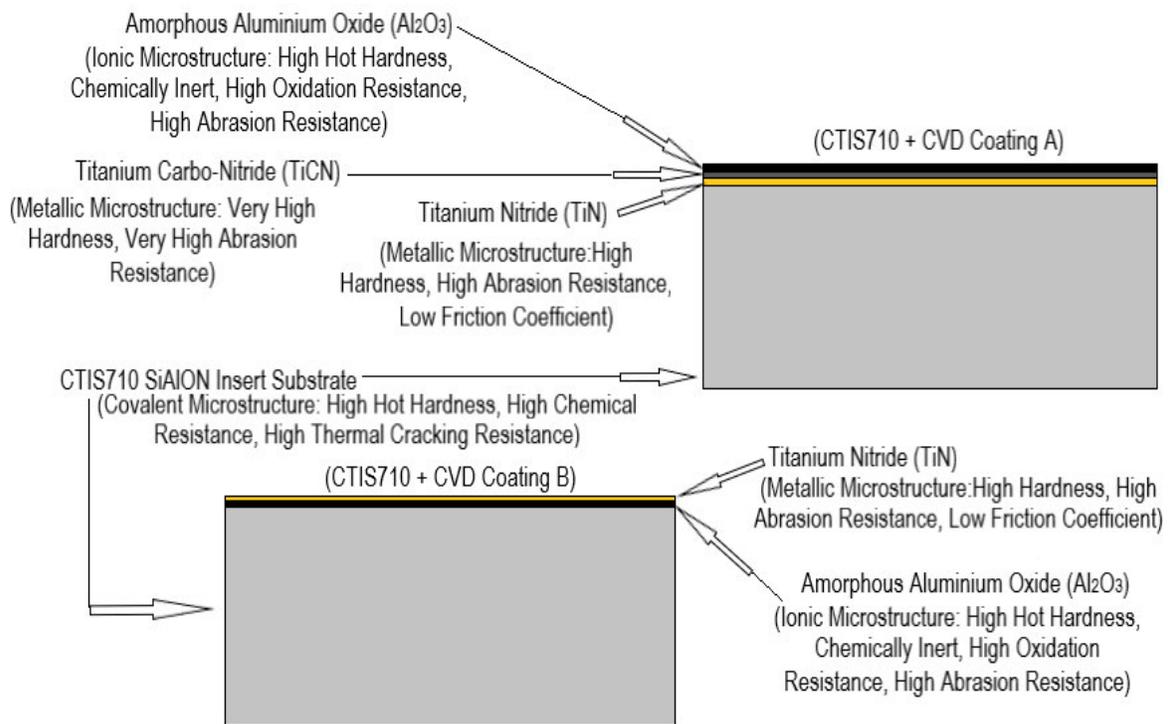
Figure 3.5. Experiment two coating microstructure and mechanical characteristics. [96]

Based on the results from the literature review aluminium oxide and titanium nitride was selected for Coating B. Aluminium oxide (Al_2O_3) was selected as it has high thermodynamic stability, high hot hardness, high resistance to chemical wear and exhibits high adhesion to SiAlON ceramic. Titanium nitride (TiN) was selected based on the high wear resistance and resistance to deformation. Al_2O_3 and TiN are also readily used by Ceratizit on an industrial production level, which meant the costs associated with introducing these CVD coated SiAlON inserts into production would be small. Figure 3.5 highlights the multilayer and bilayer coating systems for Coating A and Coating B and mechanical characteristics of each coating element.

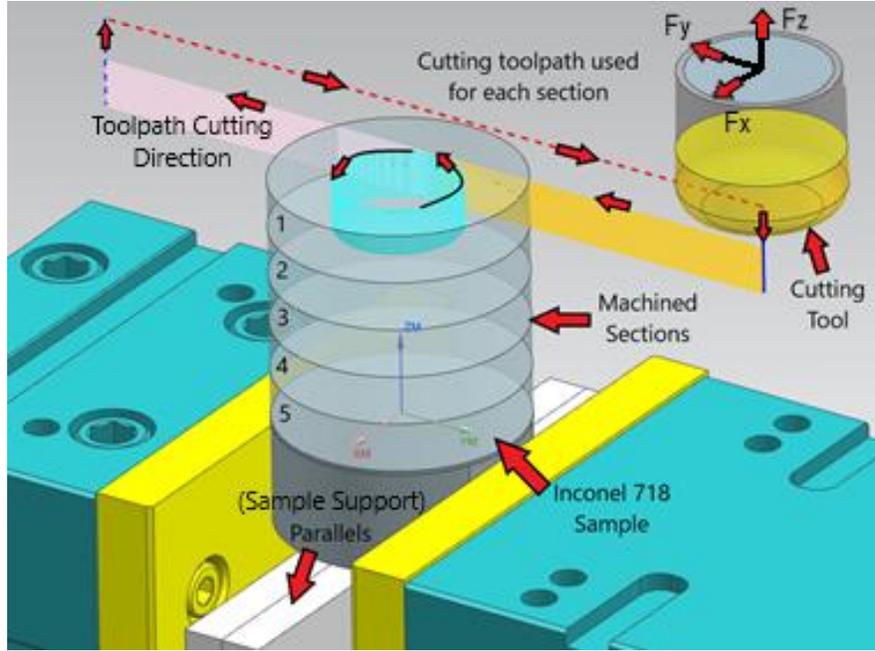
Figure 3.11. Siemens NX CAM model assembly 3D view of cutting tool path. [100]

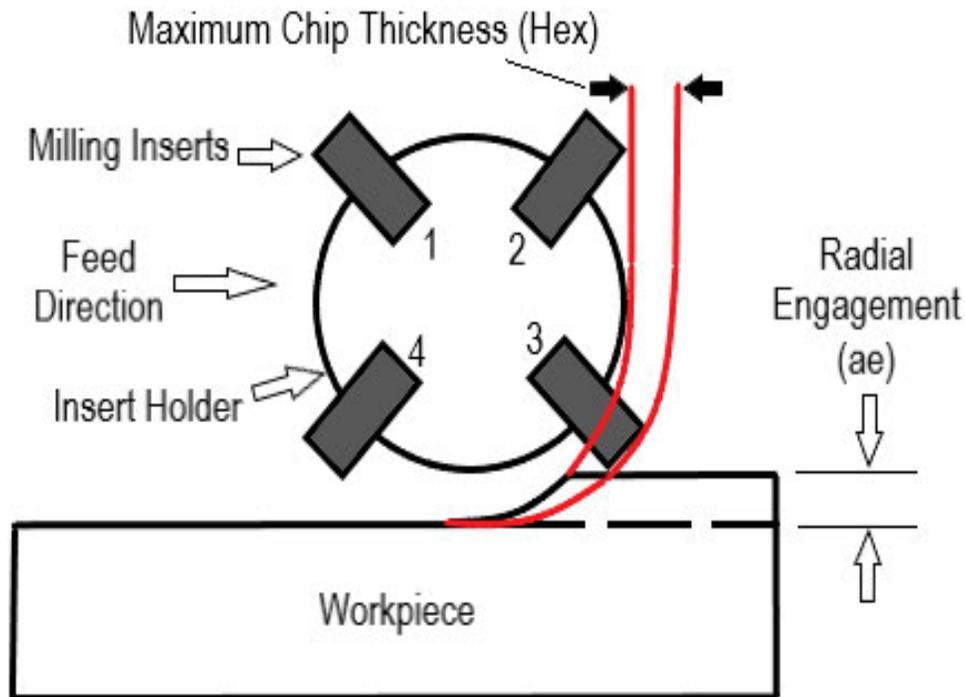
Figure 3.12. Schematic representation of the chip thinning effect. [24]

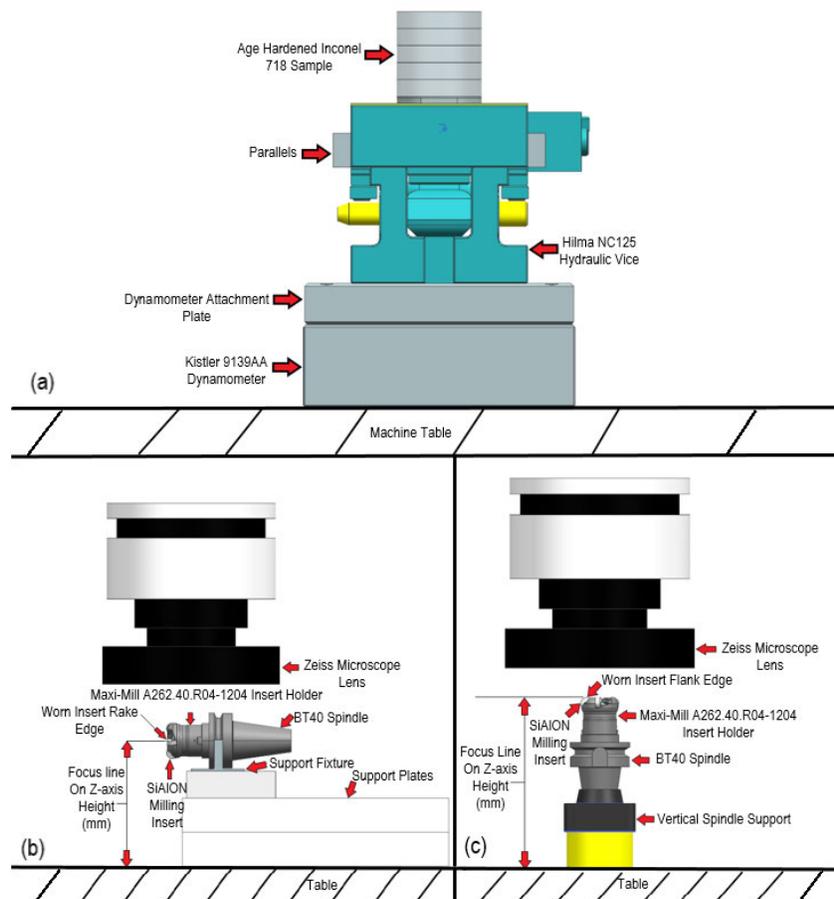
Figure 3.14. (Image a) Machine trial work-piece setup on the DMG Mori NVX5080 machining centre, (Image b-c) Zeiss set-up for rake and flank wear measurement. [100]

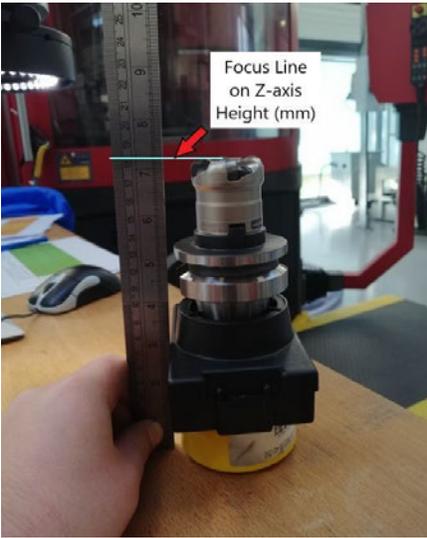
Figure 3.16 shows the setup that was utilised for capturing the magnitude of wear on the flank face for each of the four SiAION inserts. This set-up helped with the timely and efficient image capture of all the flank wear images that will be analysed in this Thesis.

Figure 3.16. Flank face wear examination setup for the Zeiss discovery V8 digital microscope.

A Zeiss Discovery V8 microscope was used for examining the worn inserts throughout the machining trials. The Zeiss microscope allowed for quick and efficient image capture during the machining trial. Figure 3.14 and Figure 3.15 shows the setup that was utilised for capturing the multitude of wear on the rake face for each of the four SiAION inserts.

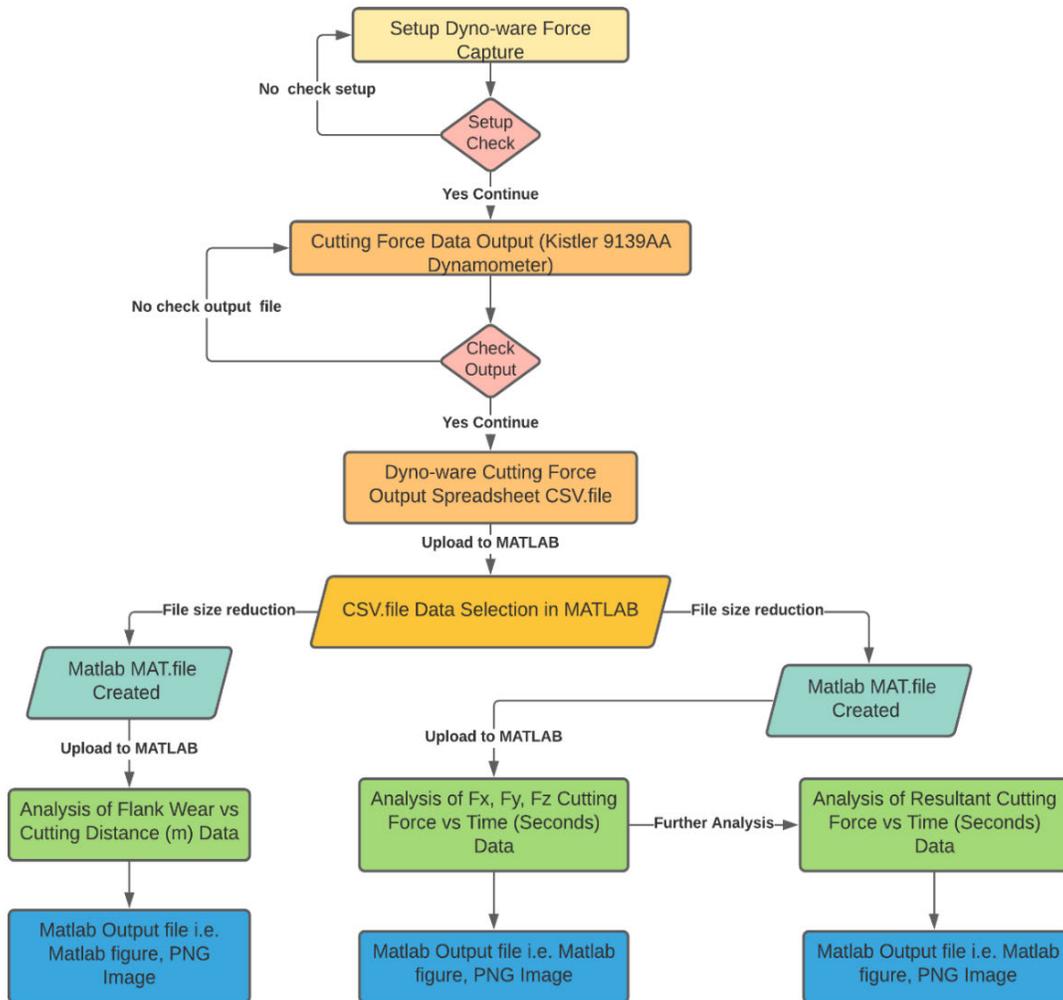
Figure 3.18. Cutting Force vs Time and Flank Wear vs Cutting Distance Data Collation Framework.

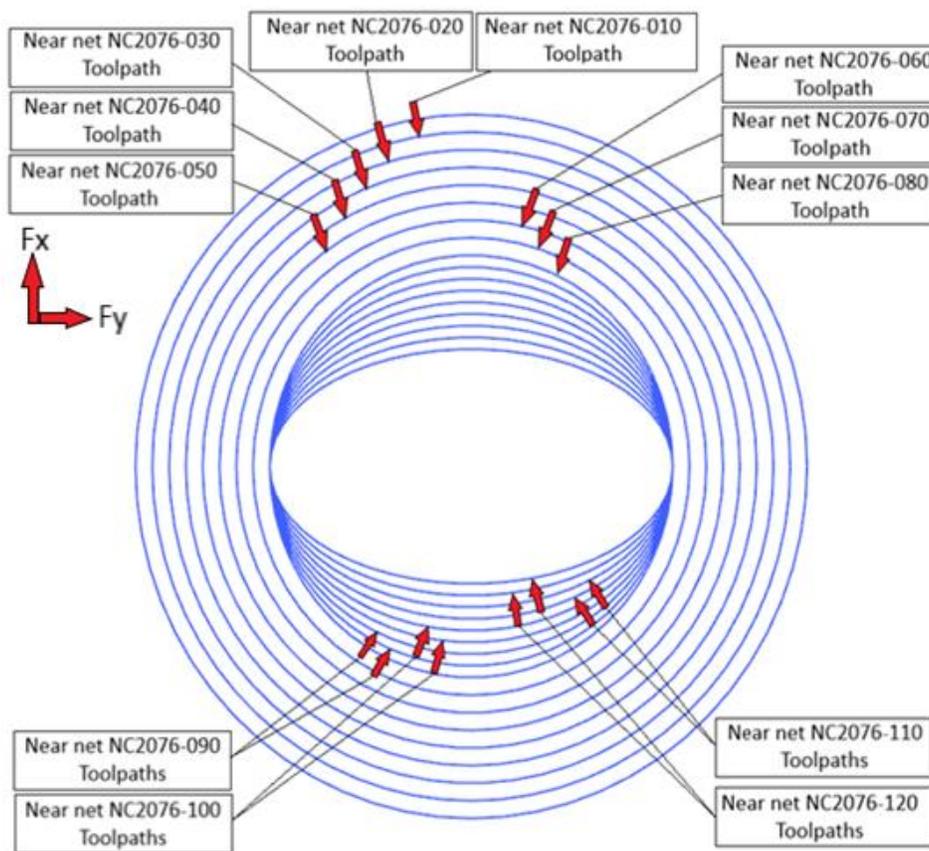
Figure 3.22. Cross section near net shape circular continuous and elliptical near-continuous toolpath.

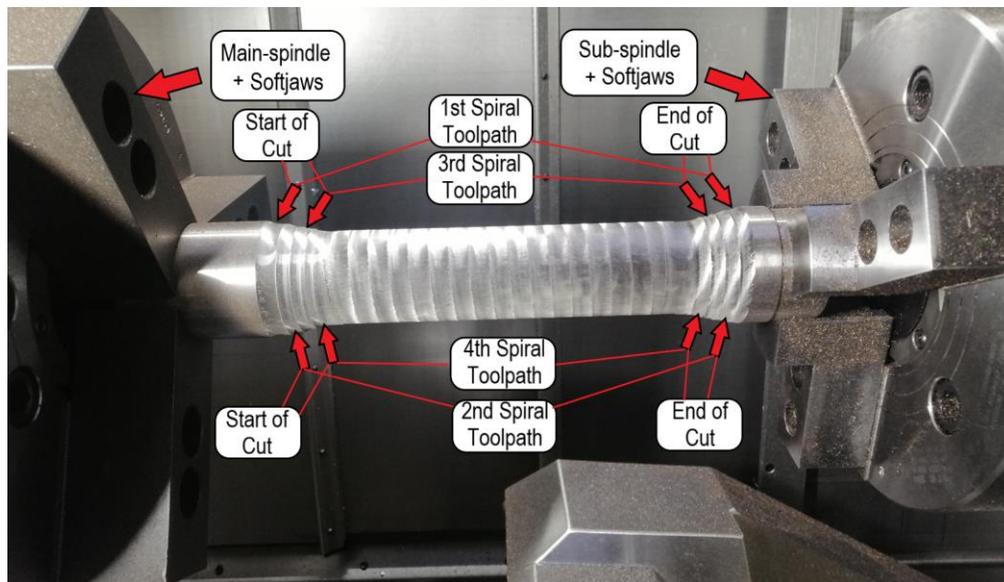
Figure 3.27. Partly machined Inconel 718 sample utilising spiral continuous toolpaths. (DMG Mori NTX2500 five-axis machining centre).

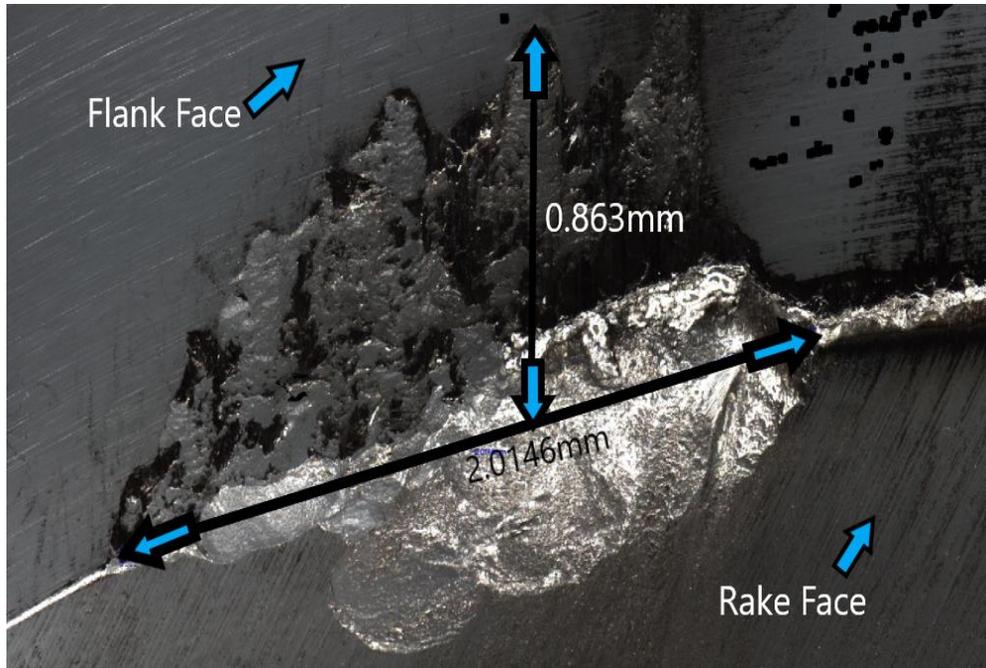
Figure 4.1. Image of the width and height of the wear scar on Insert A (SiAlON Grade 1). Image captured on Alicona infinite-focus SL microscope.

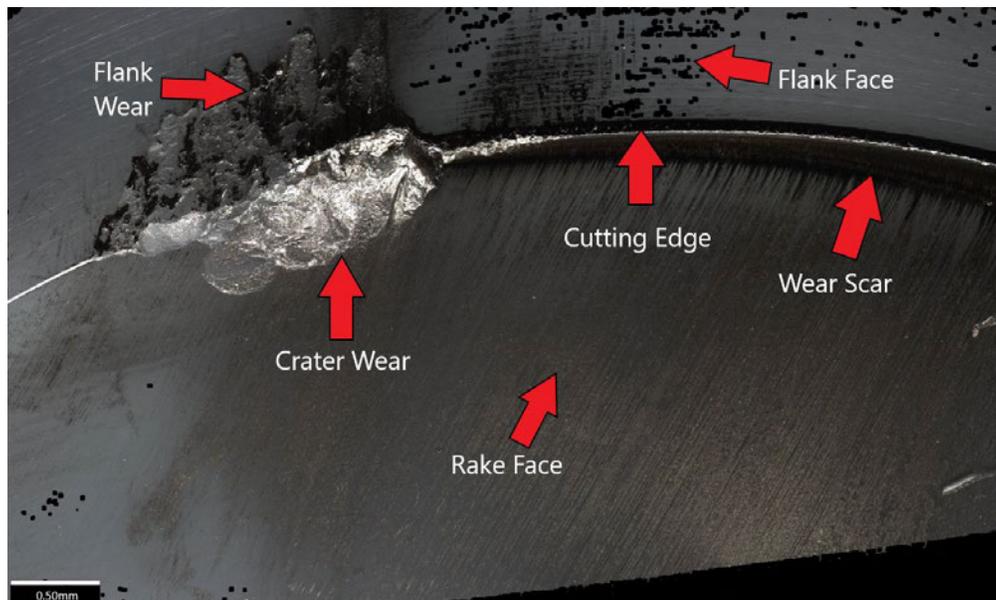
Figure 4.2. Wear scar on turning insert B (SiAlON Grade 1) after Test Cut T1.1. Test was classed as a failure.

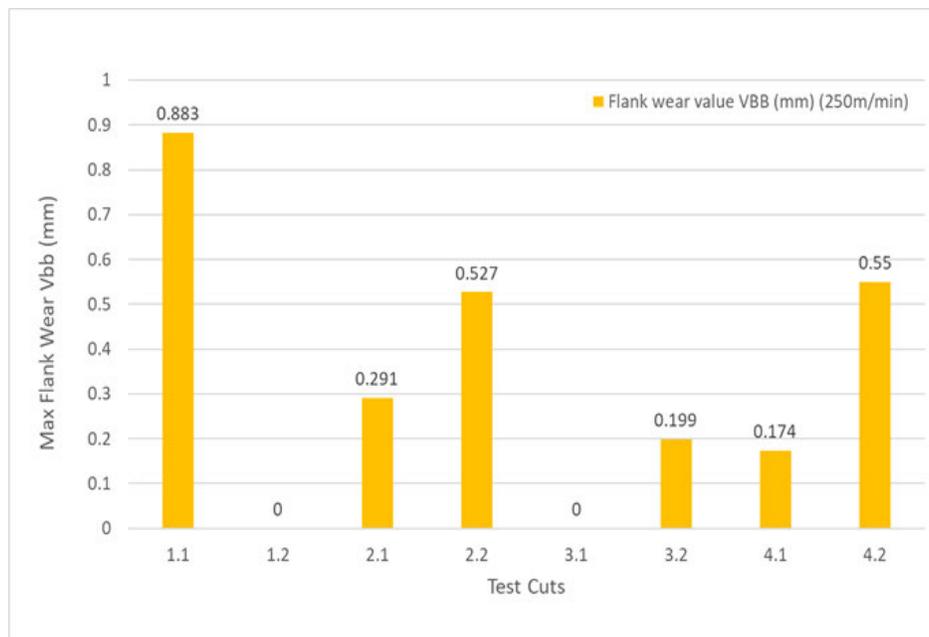
Figure 4.6. Measured flank wear (Vbb) experienced for each test cut at a cutting speed of 250 m/min.

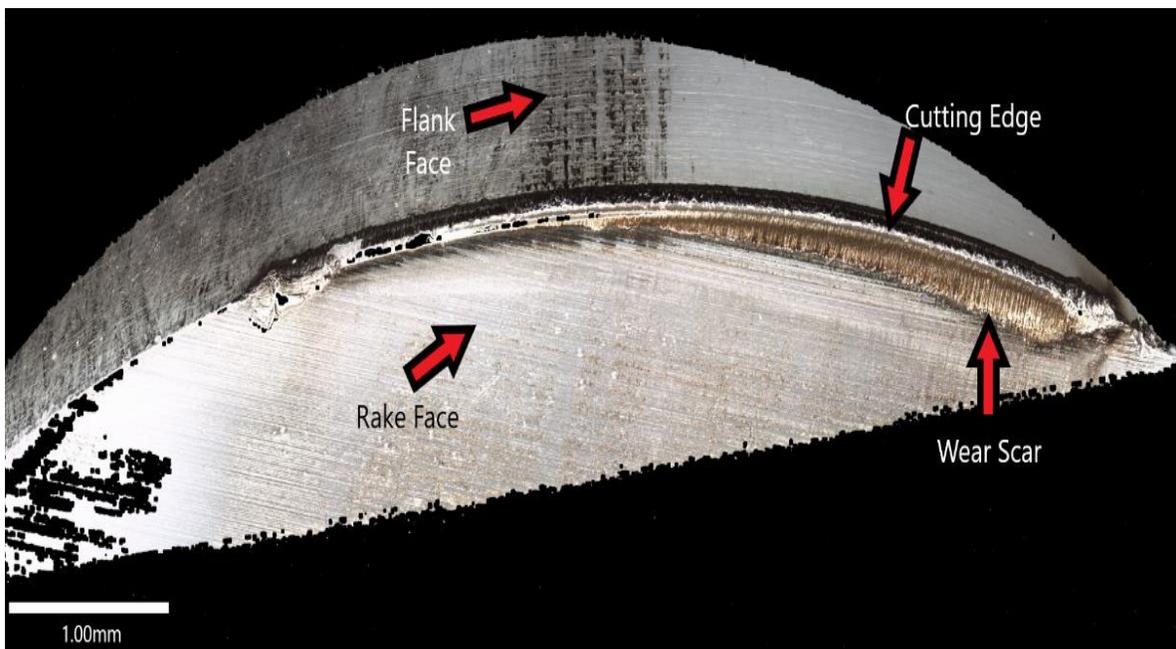
Figure 4.7. Wear scar on turning Insert A (SiAlON Grade 1) after Test Cut T5.2.

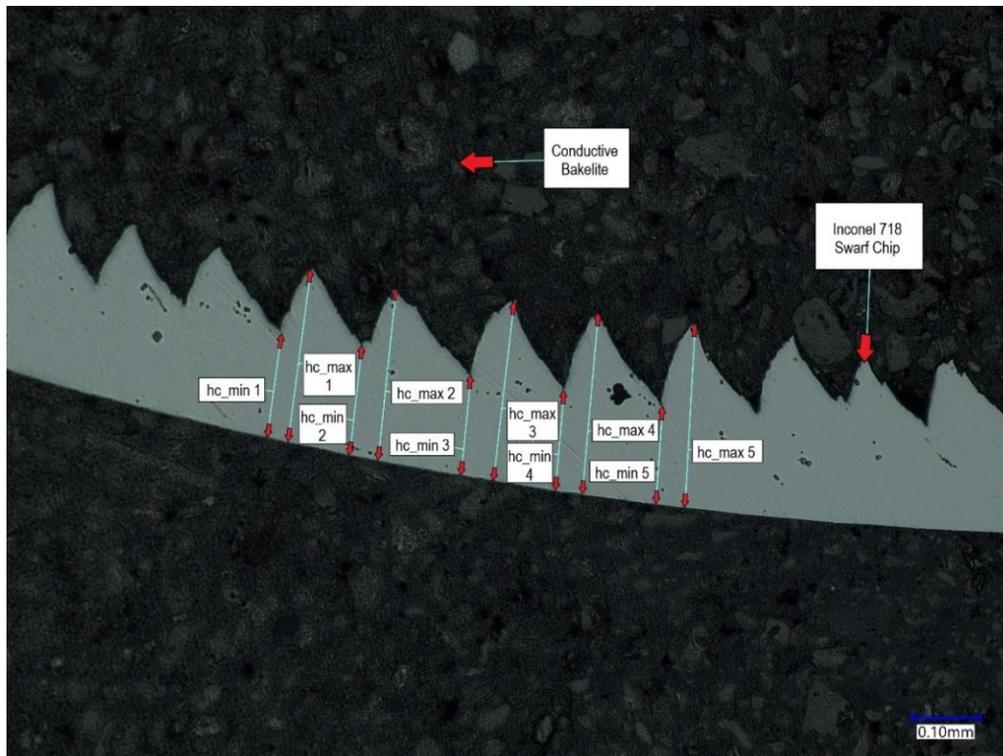
Figure 4.12. Test Cut T4.2 Image magnified 200x.

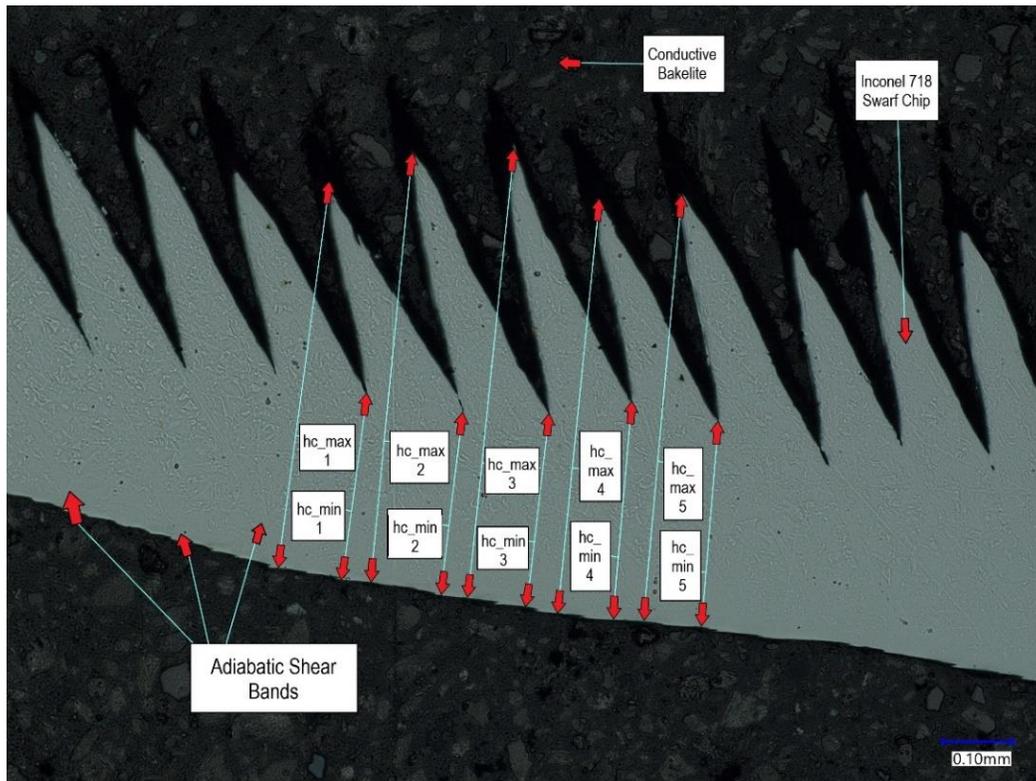
Figure 4.15. Test Cut T7.2 image magnified 200x.

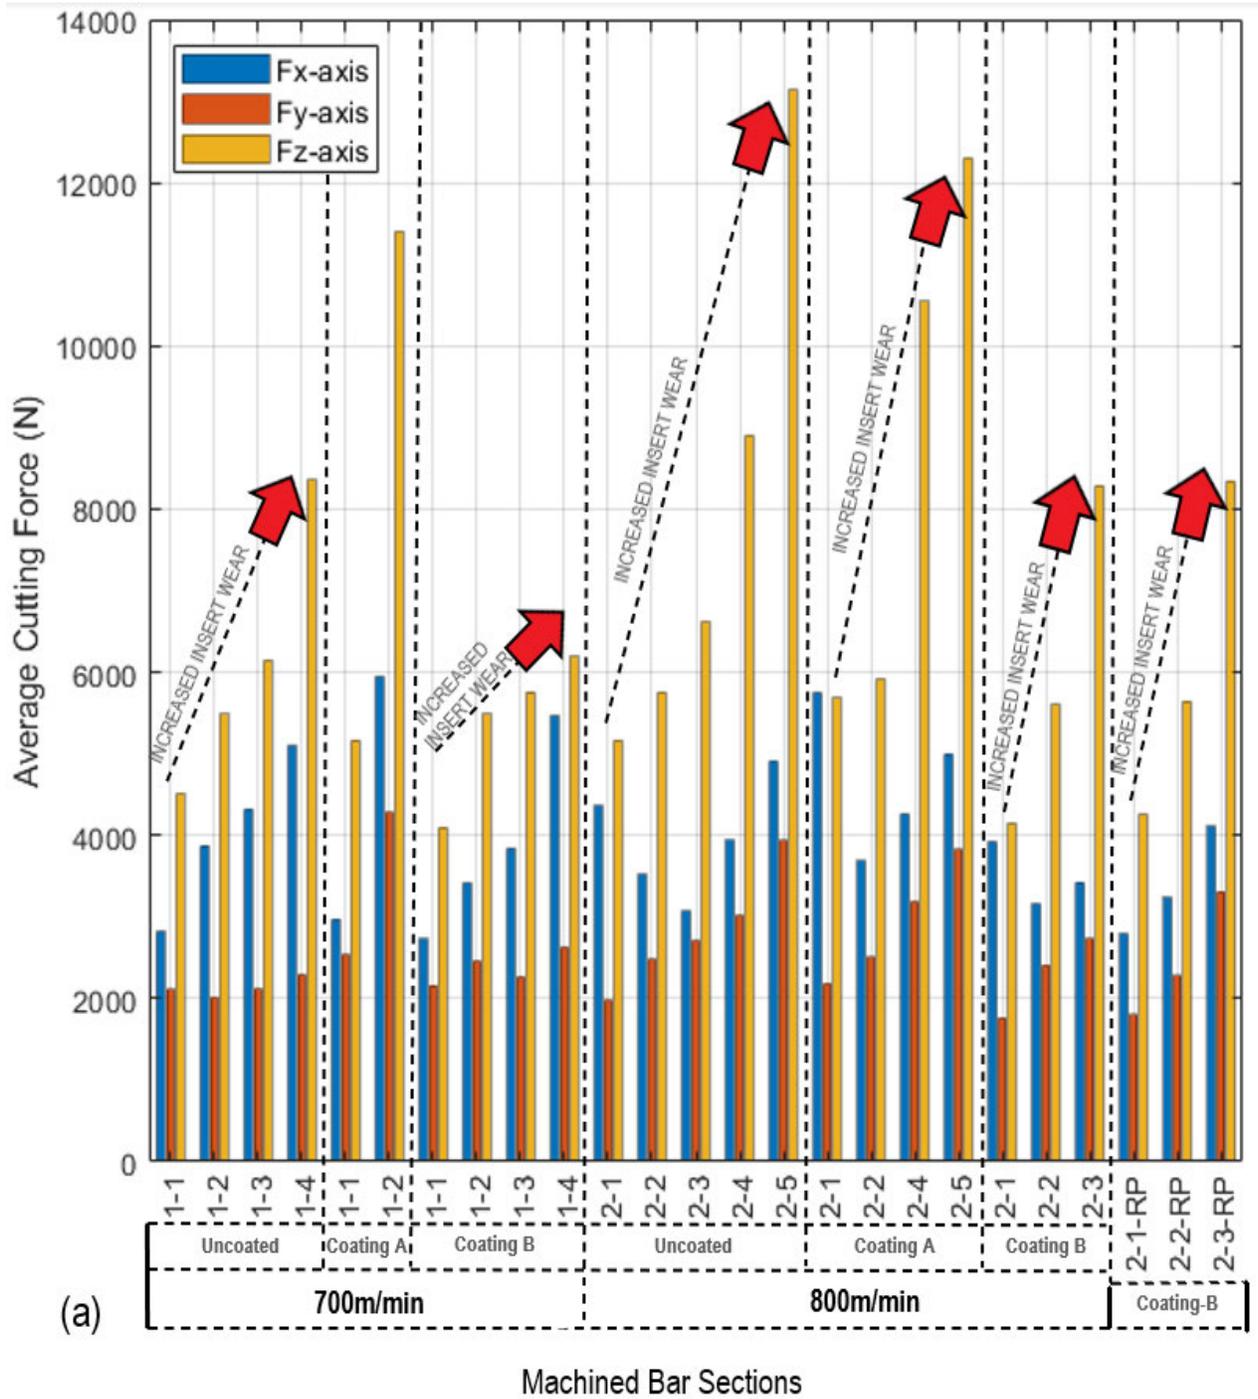
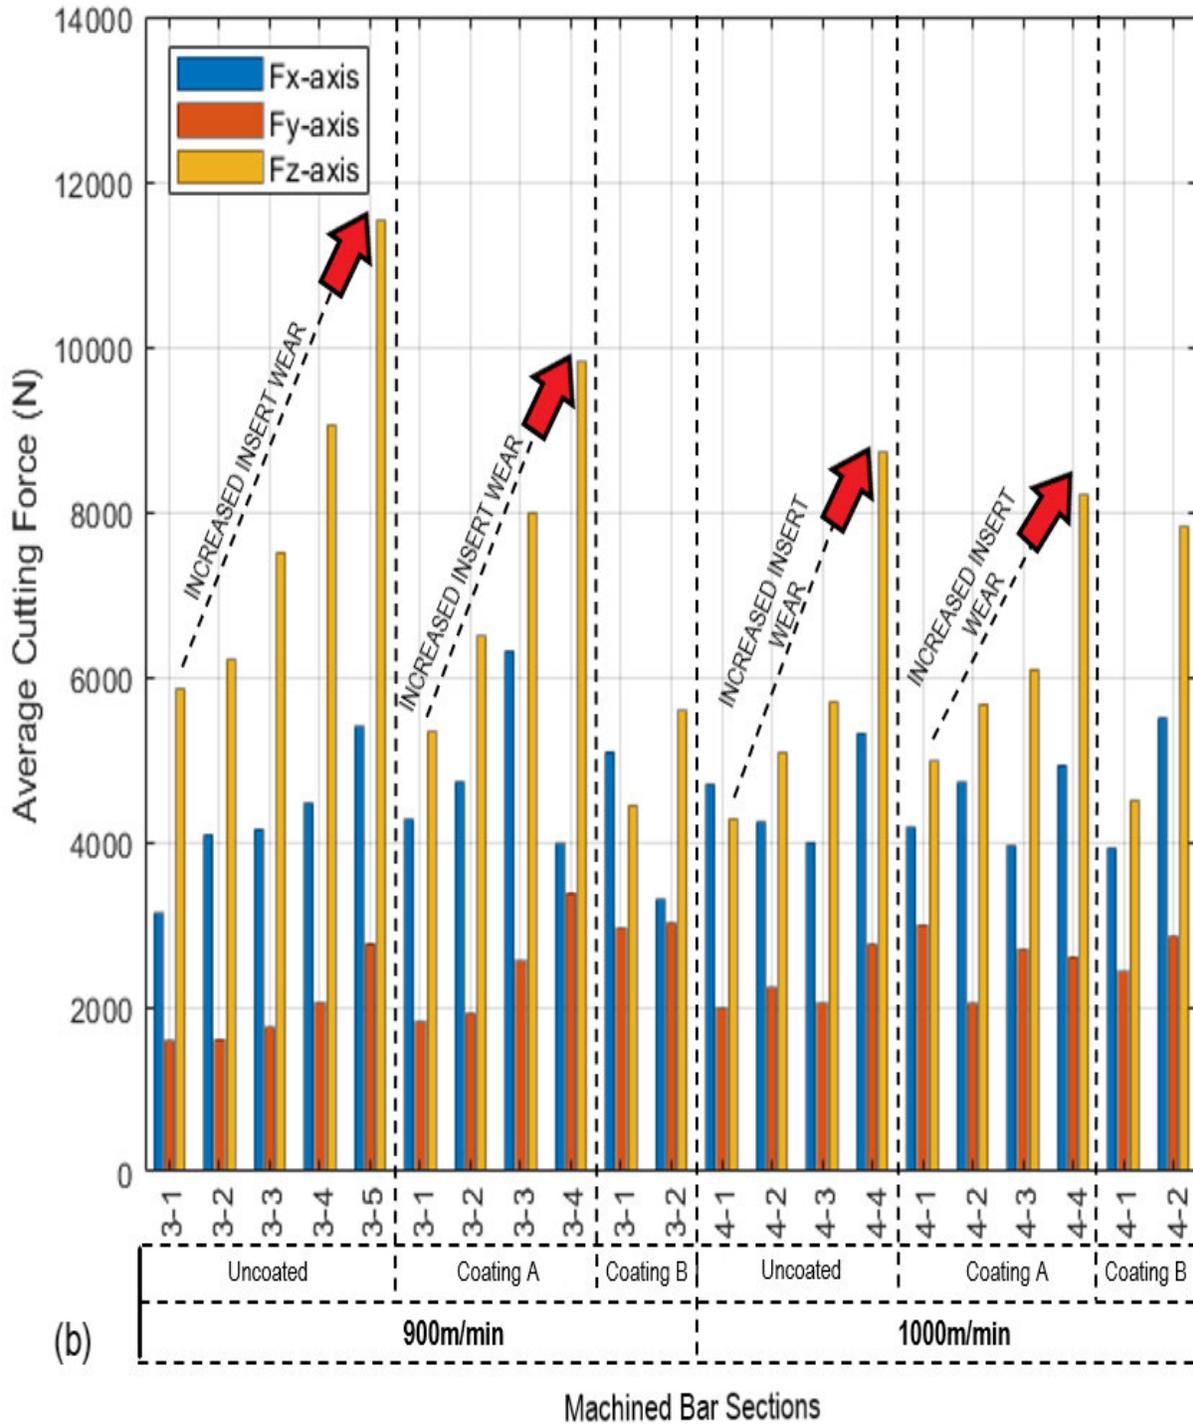
Figure 5.1. (a) Average Cutting Force versus Machined Bar Section at 700 m/min (Test No M1-M3) and 800 m/min (Test No M4-M6, M13), (b) Average Cutting Force versus Machined Bar Section at 900 m/min (Test No M7-M9) and 1000 m/min (Test No M10-M12).

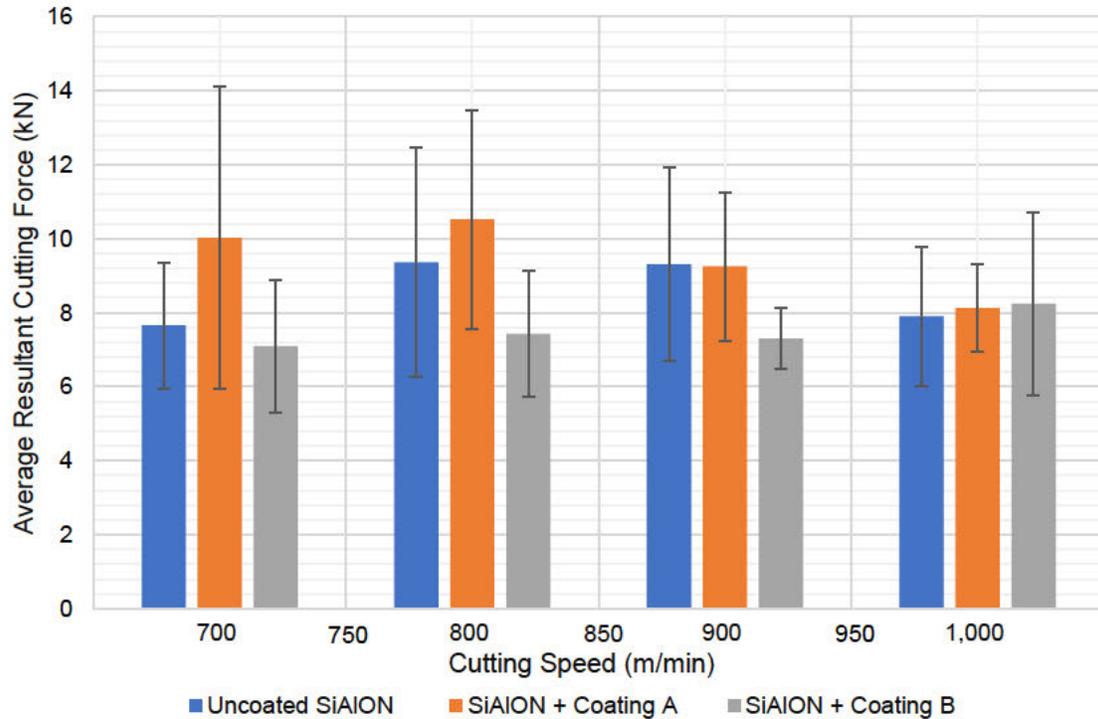
Figure 5.2. Resultant Cutting Force vs Cutting Speed (m/min) for Uncoated SiAlON milling inserts and for Coating A and Coating B.

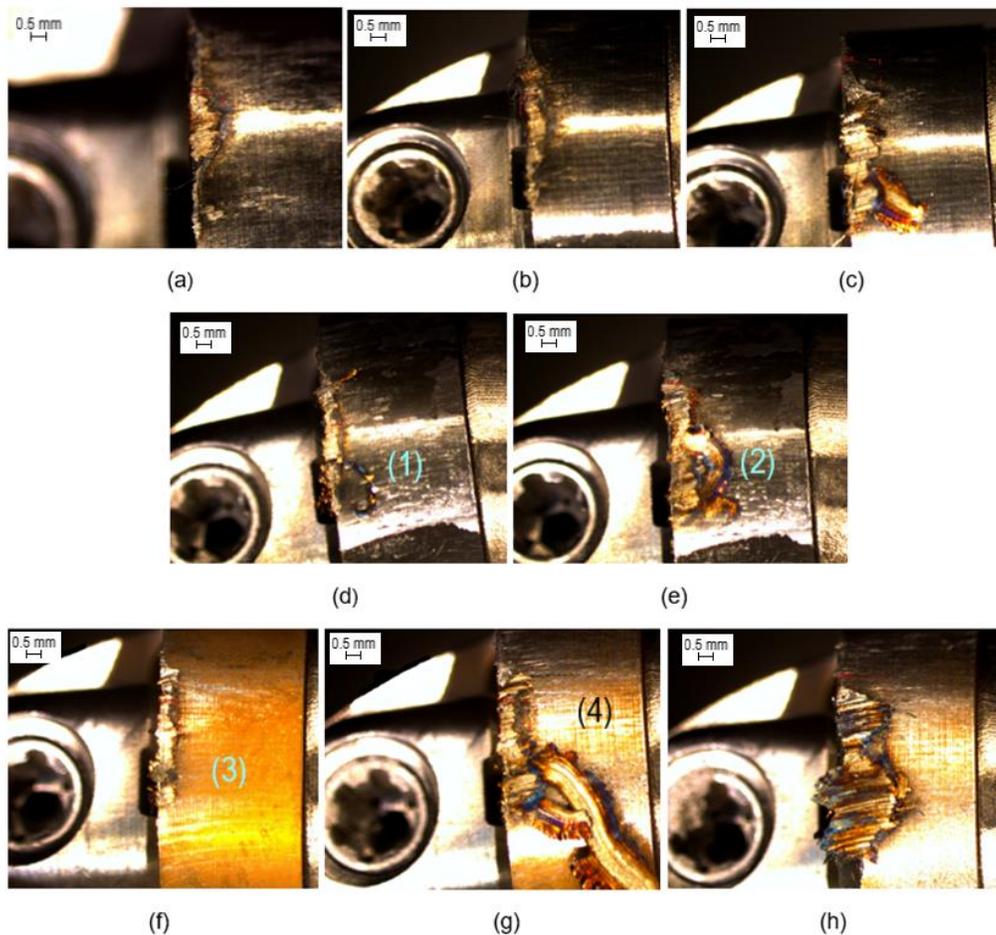
Figure 5.3. Flank wear visible (a-c) 700 m/min (Test No M1) and Flank wear visible (f-h) 700 m/min-(Test No M3), material removed is 101.80 cm³, flank wear visible (d-e) 700 m/min (Test No M2) material removed is 67.86 cm³.

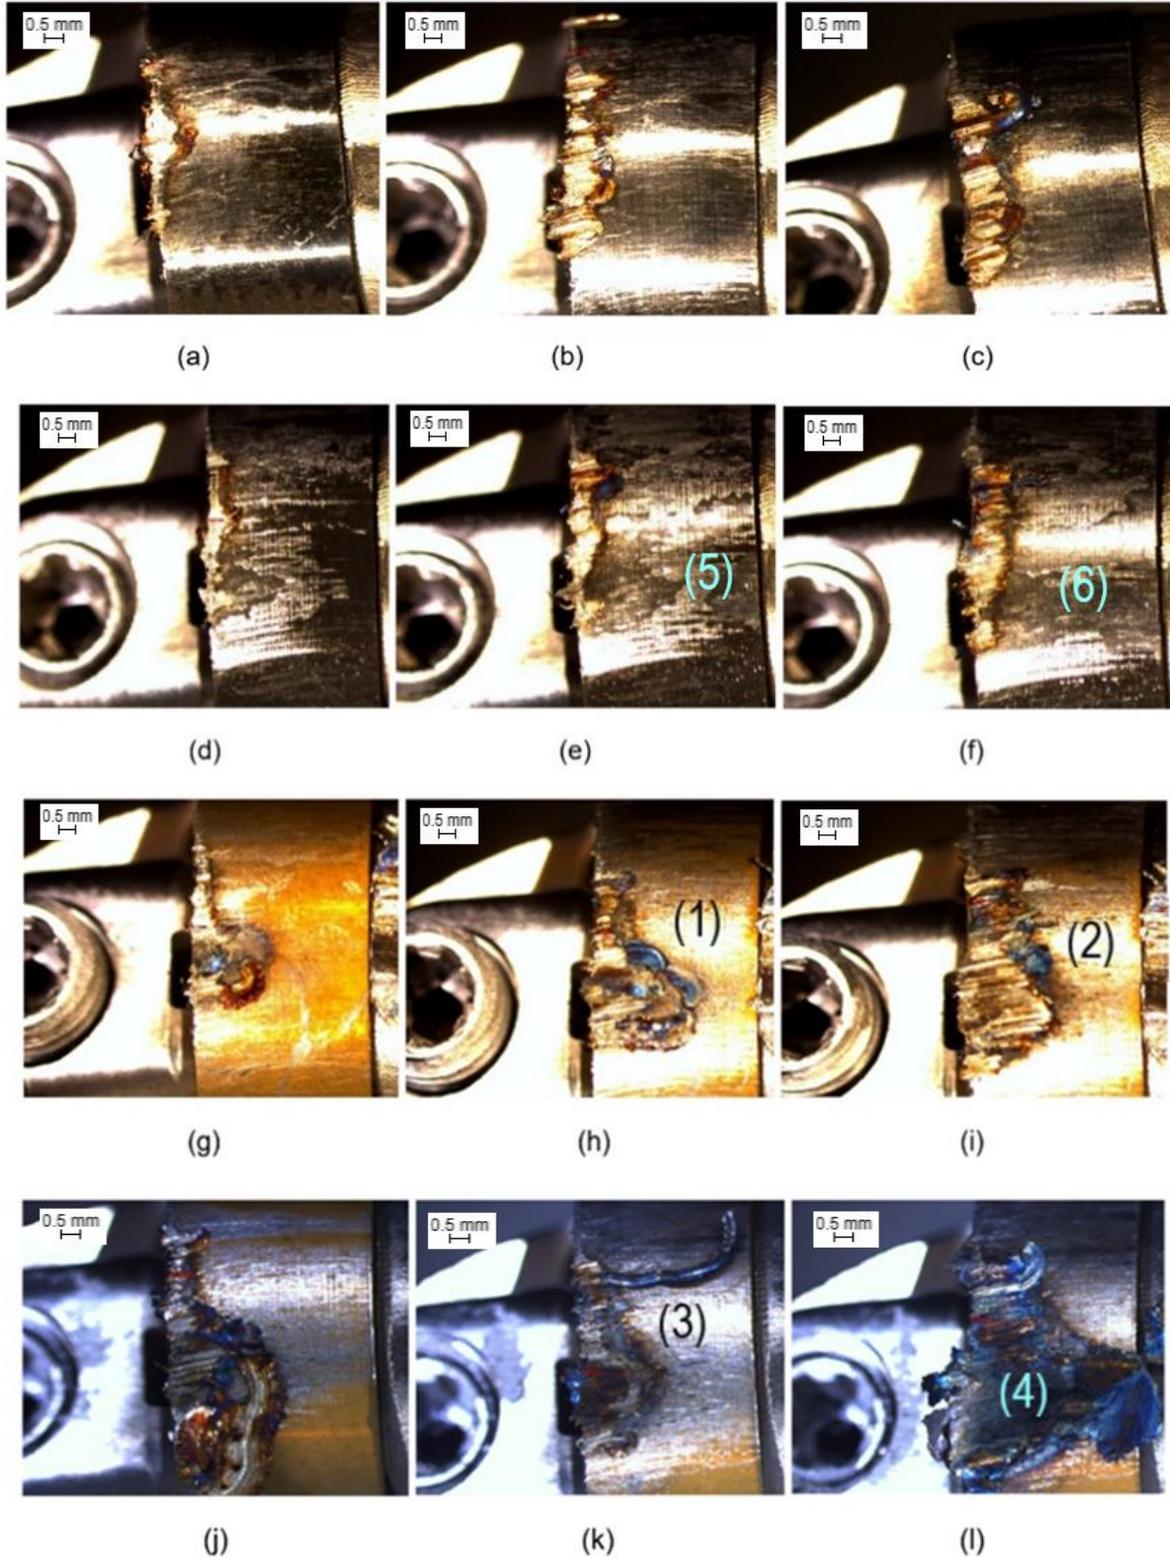
Figure 5.4. Flank wear visible (a-c) 800 m/min (Test No M4), Flank wear visible (d-f) 800 m/min (Test No M5), Flank wear visible (g-i) 800 m/min (Test No M6), Flank wear visible (j-l) 800 m/min (Test No M13). For all the material removed is 101.80 cm³.

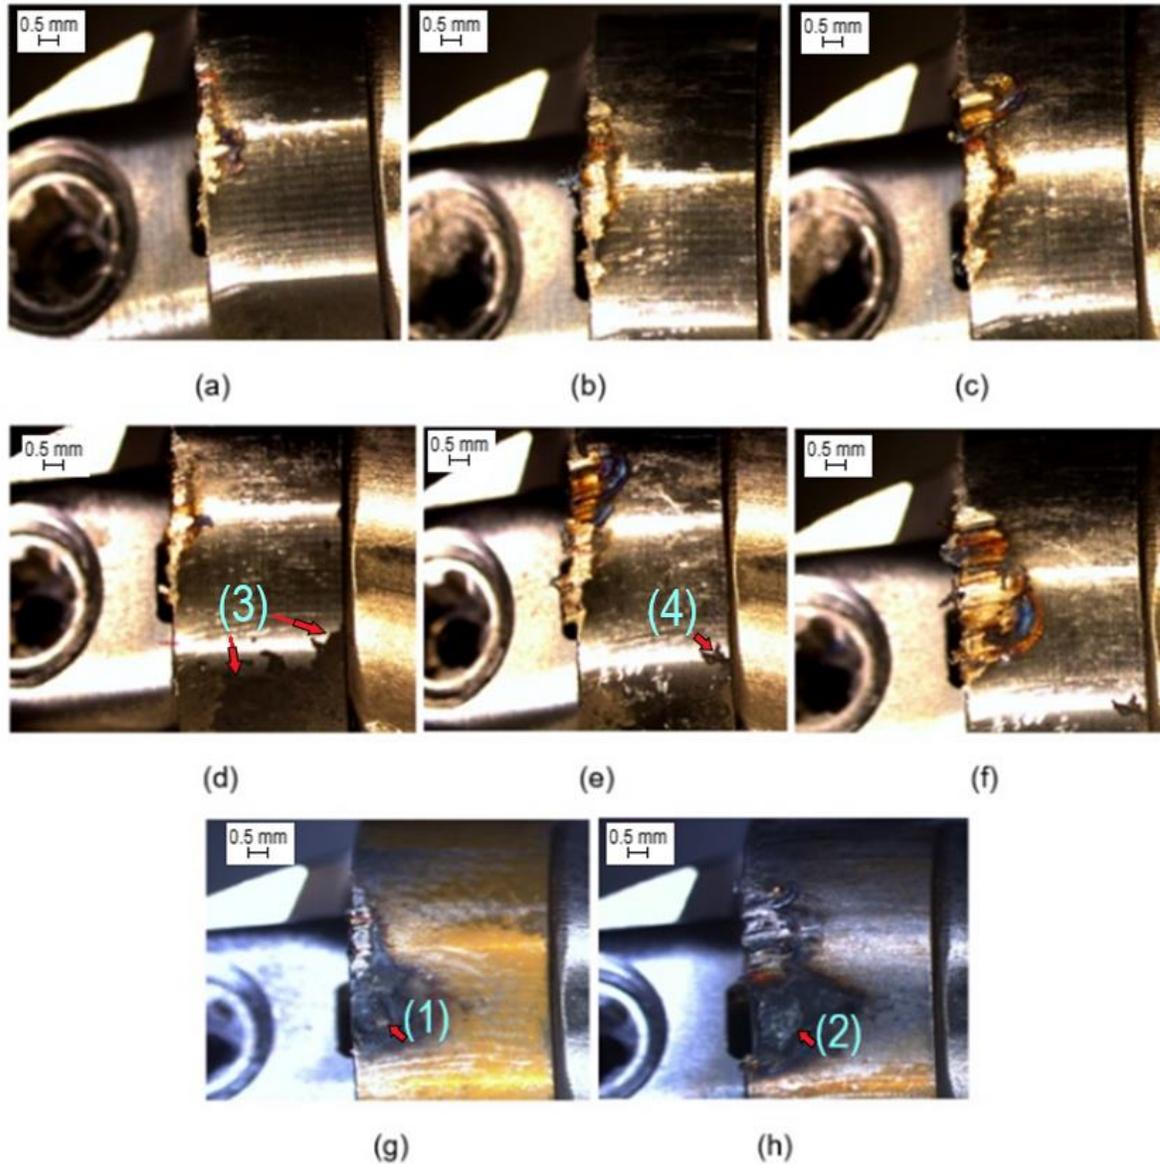
Figure 5.5. Flank wear visible (a-c) 900 m/min (Test No M7) and (d-f) 900 m/min (Test No M8) the material removed for both is 101.80 cm³, Flank wear visible (g-h) 900 m/min (Test No M9) the material removed is 67.86 cm³.

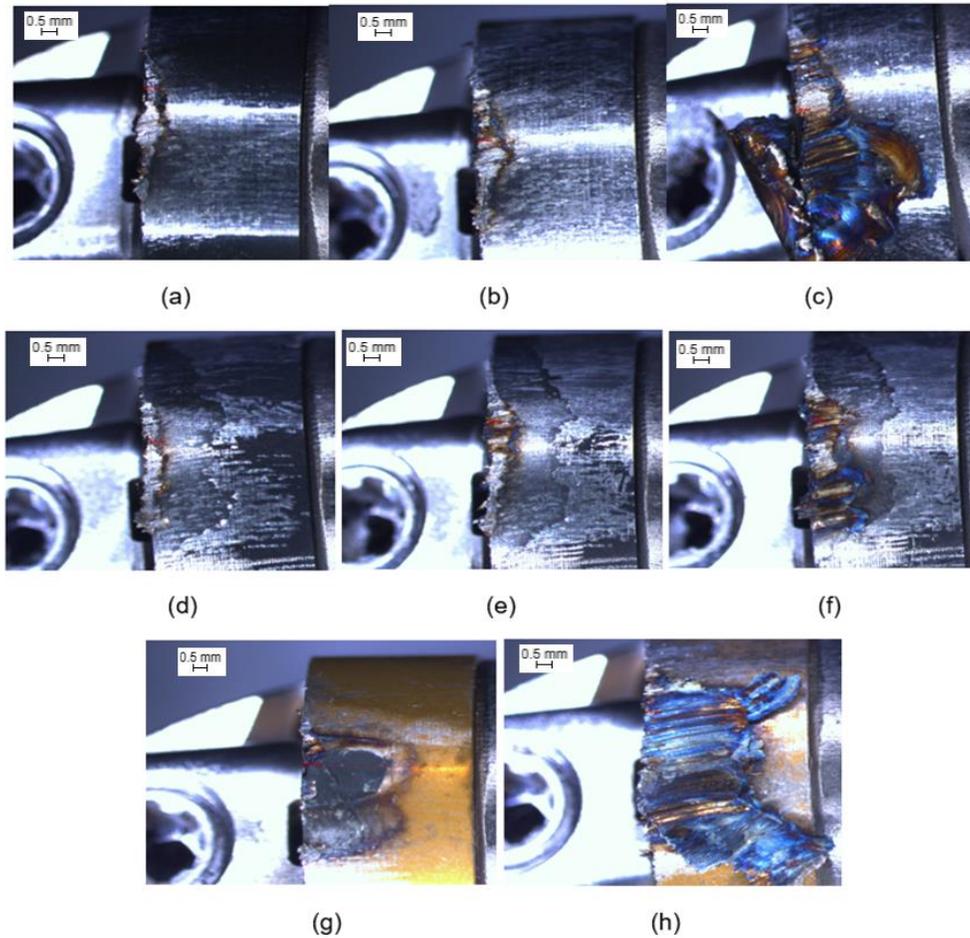
Figure 5.6. Flank wear visible (a-c) 1000 m/min (Test No M10) and (d-f) 1000 m/min (Test No M11) the material removed for both is 101.80 cm³, Flank wear visible (g-h) 1000 m/min (Test No M12) the material removed is 67.86 cm³.

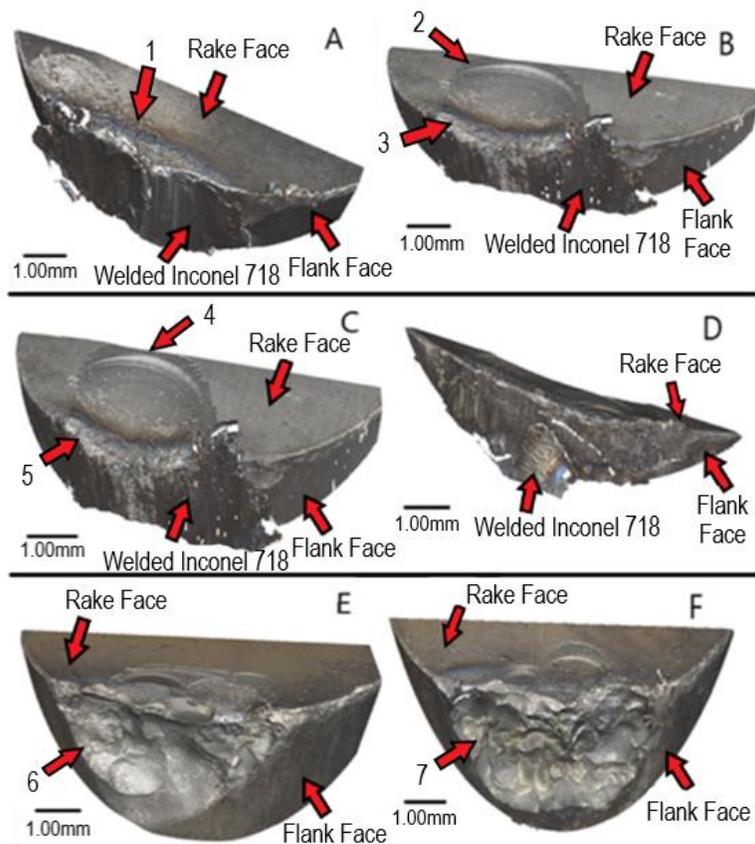
Figure 5.7. Non-contact 3D profilometer (focus variation type) scan: Test No M1(a-b) and Test No M1 (c-d) the material removed for both is 135.716 cm³, Test No M1 (c-d) the material removed is 67.858 cm³.

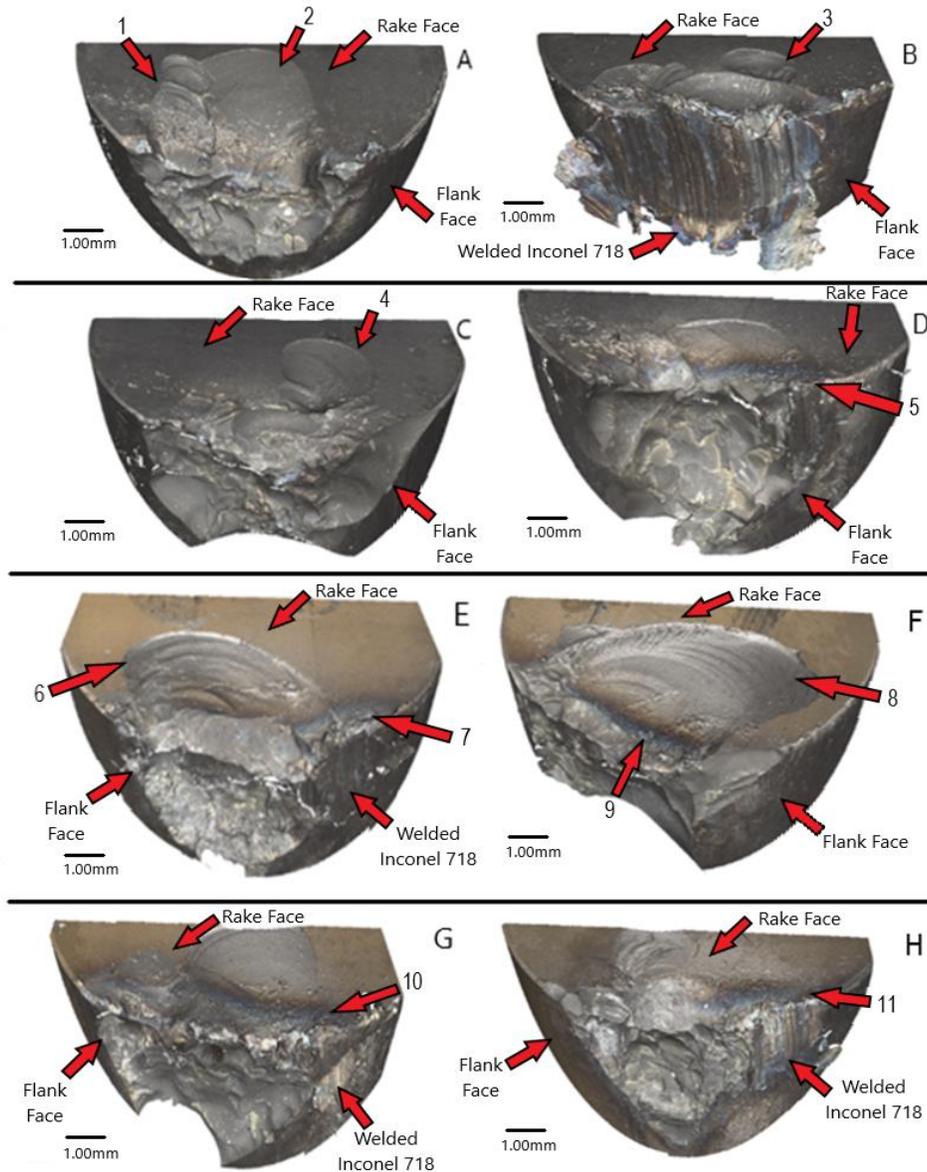
Figure 5.8. Non-contact 3D profilometer (focus - variation type) scan: Test No M4 (a-b) and Test No M5 (c-d) the material removed for both is 169.645 cm³, Test No M6 (e-f) the material removed is 135.716 cm³, Test No M13 (g-h) the material removed is 101.787 cm³.
