Department of Mechanical Engineering

DEVELOPMENT OF CVD COATED CERAMIC MILLING INSERTS FOR MILLING INCONEL 718

A Thesis submitted for the degree of
Doctor of Engineering
In Machining Science

2023

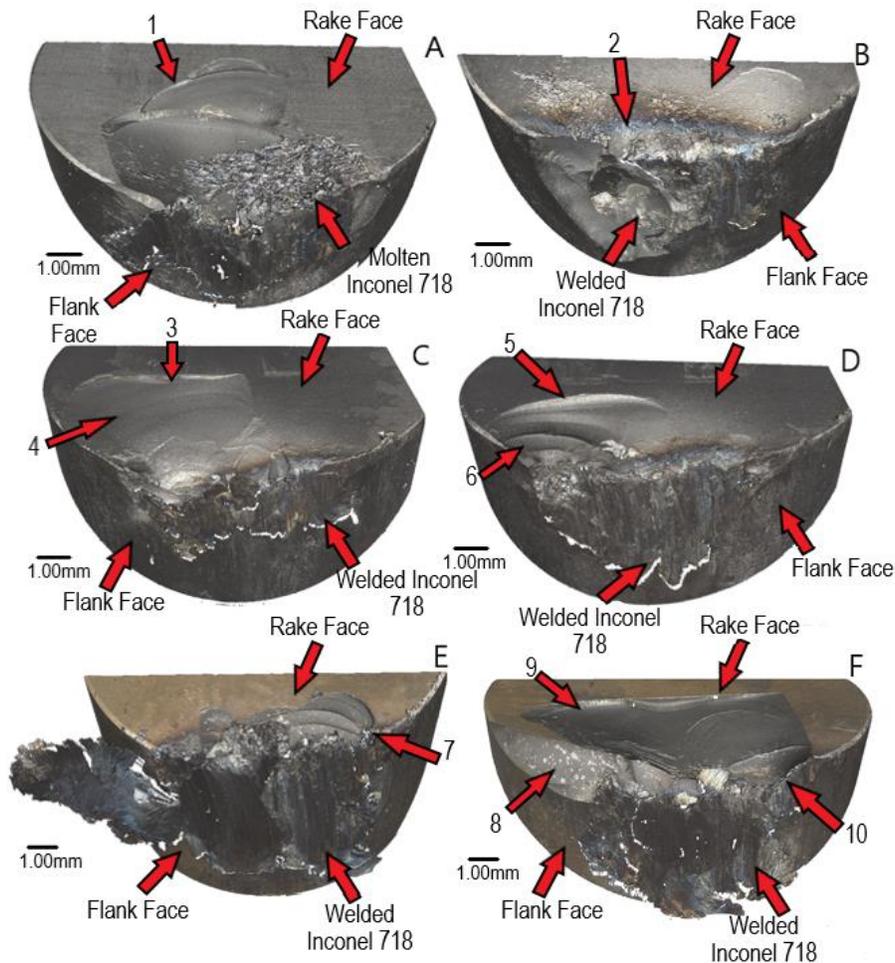
Figure 5.10. Non-contact 3D profilometer (focus - variation type) scan: Test No M10 (Images a-b) and Test No M11 (c-d) the material removed for both is 135.716 cm³, Test No M12 (e-f) the material removed is 67.858 cm³.

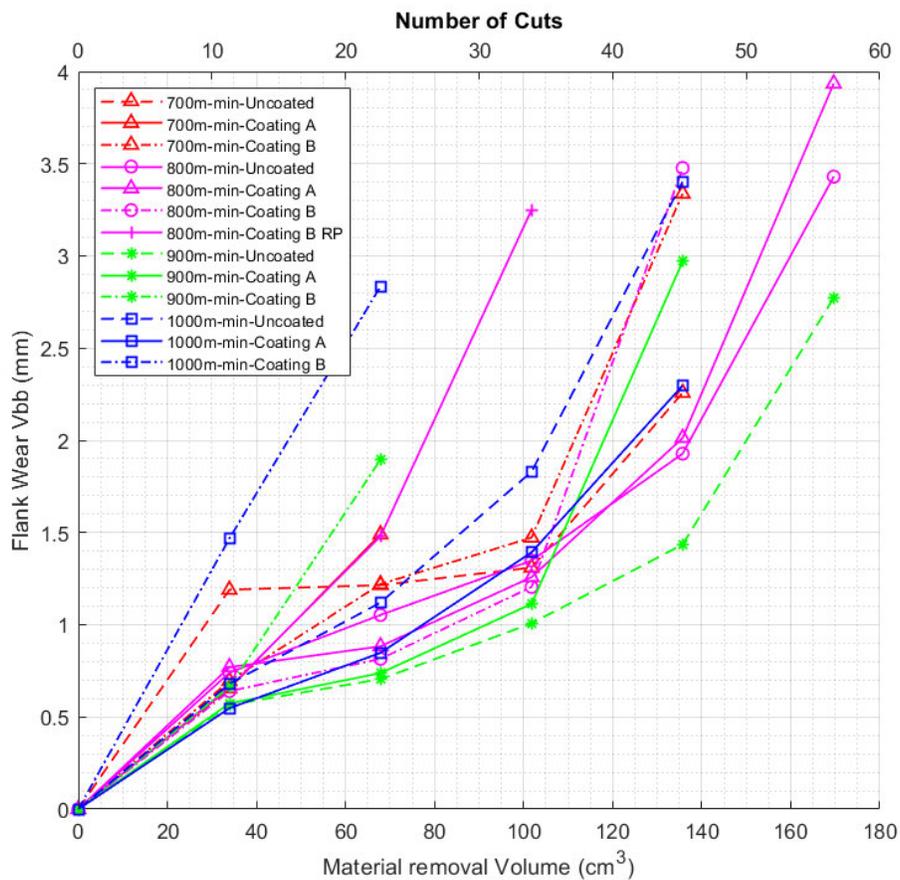
Figure 5.11. 700 m/min (Test No M1-M3), 800 m/min (Test No M4-M6 & M13), 900 m/min (Test No M7-M9), 1000 m/min (Test No M10-M12).

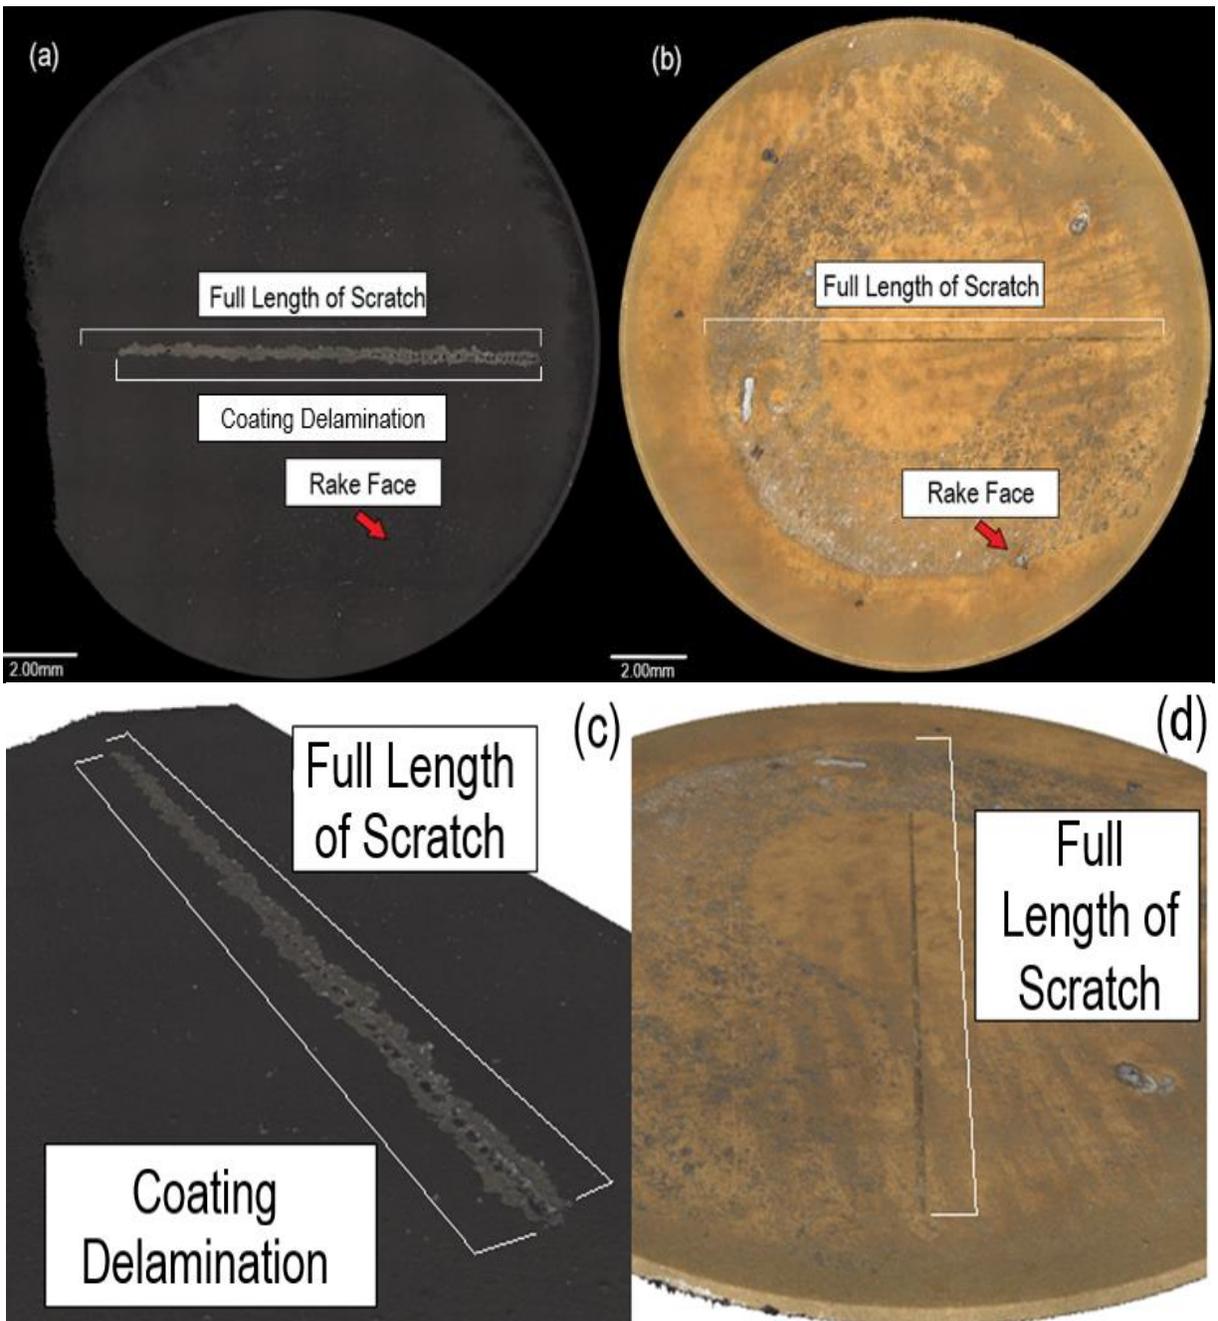
Figure 6.1. (Non-contact 3D profilometer (focus—variation type) scan of (a,c) the Coating A scratch and (b,d) the Coating B scratch.

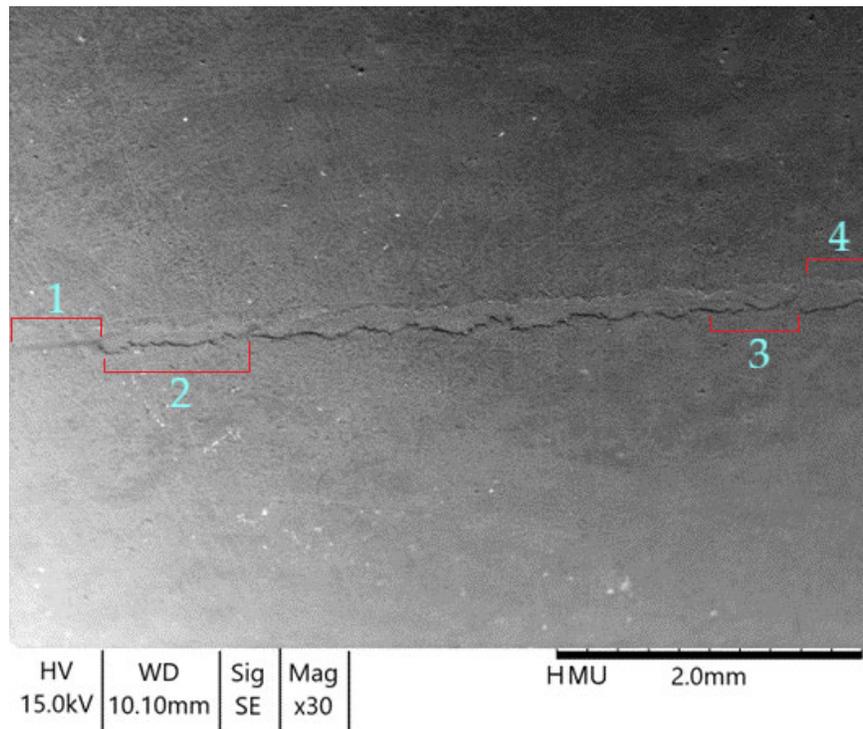
Figure 6.3. Coating A scratch Position 1, 2, 3, 4 at x30 Mag.

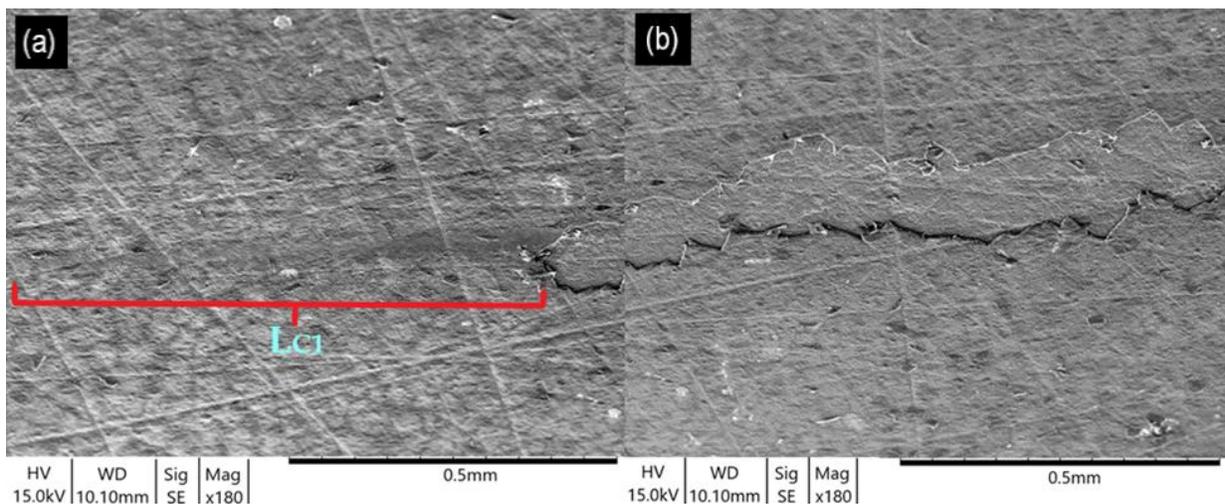
Figure 6.4. (a) Coating A Scratch Position 1, Initial scratch L_{C1} , (b) Coating A scratch Position 2 Coating fracture and delamination position, at x180 magnification.

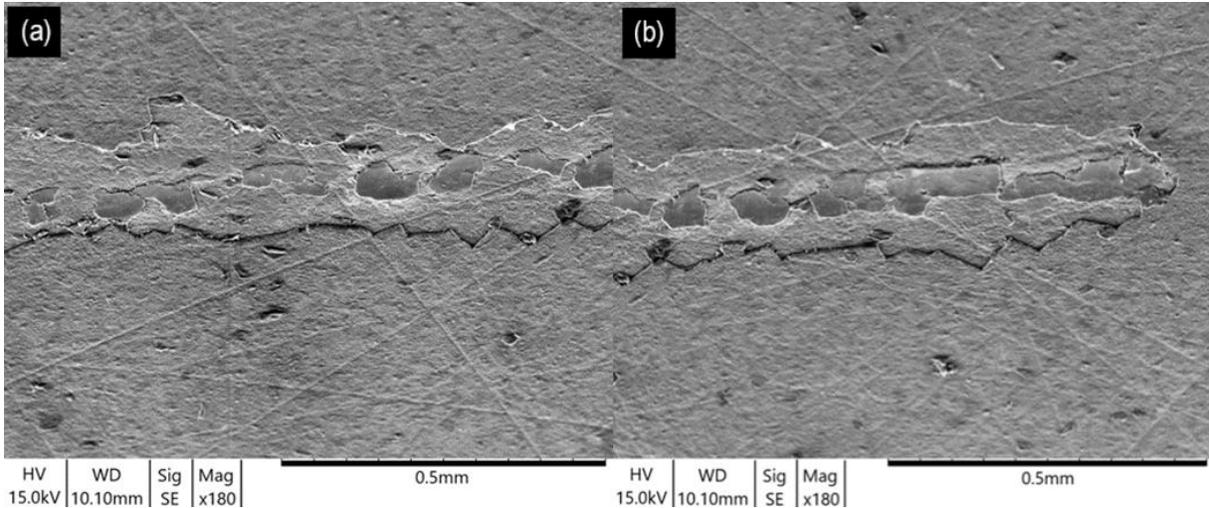
Figure 6.5.(a) Coating A scratch position 3 (continued delamination and spalling) and (b) Coating A scratch position 4 (end of the scratch SEM) at x180 magnification.

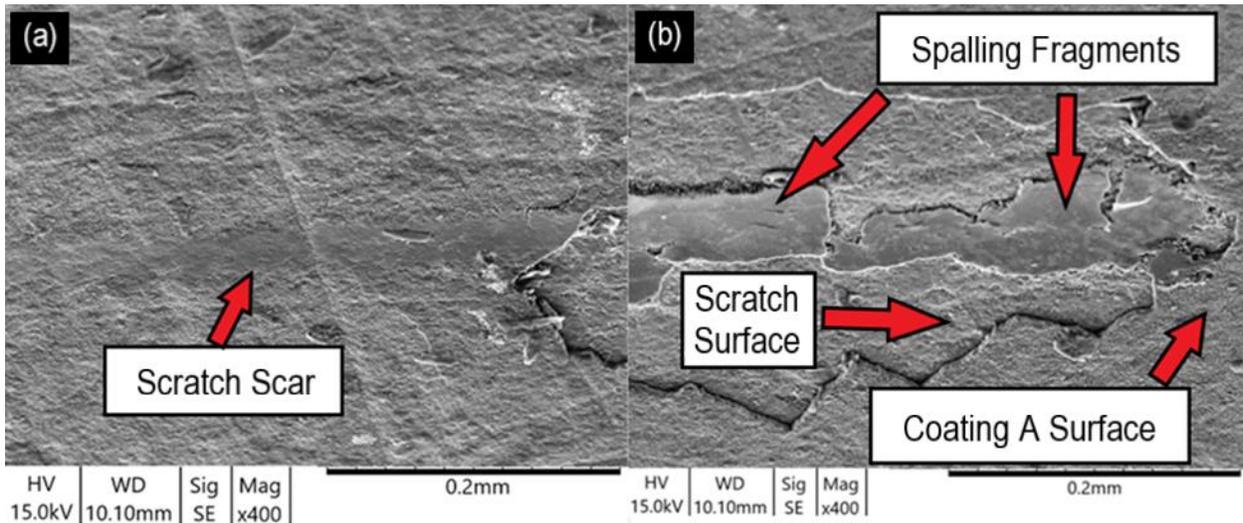
Figure 6.6. (a) Coating A Scratch Position 1, Initial scratch L_{C1} , (b) Coating A scratch Position 4, End of Scratch SEM, at x400 magnification.

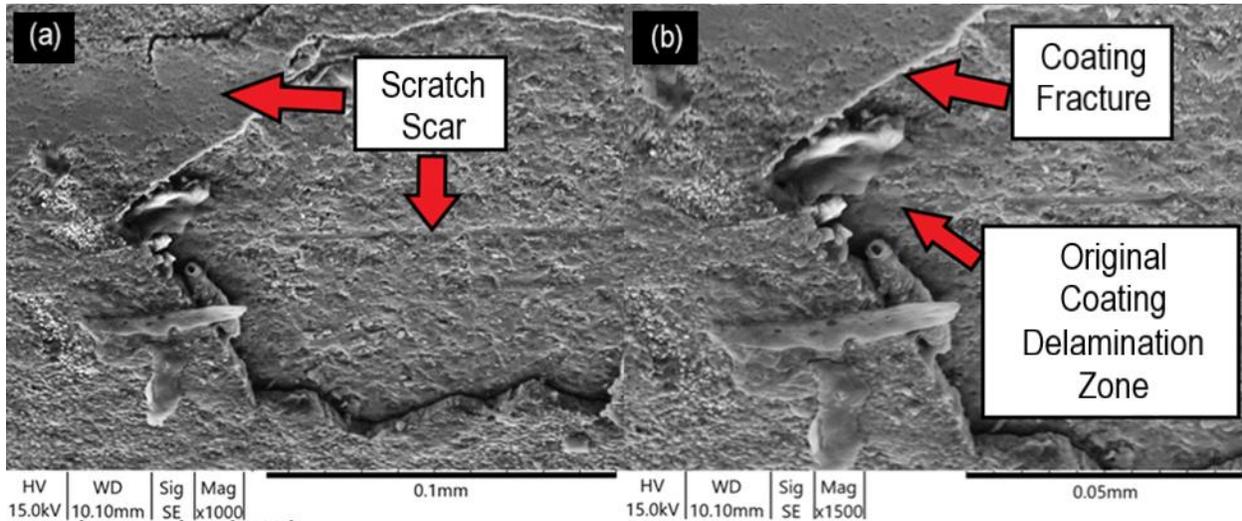
Figure 6.7. (a) Coating A Scratch Position 1, Initial scratch L_{C1} , at x1000 magnification (b) Coating A Scratch Position 1, Initial scratch L_{C1} , at x1500 magnification.

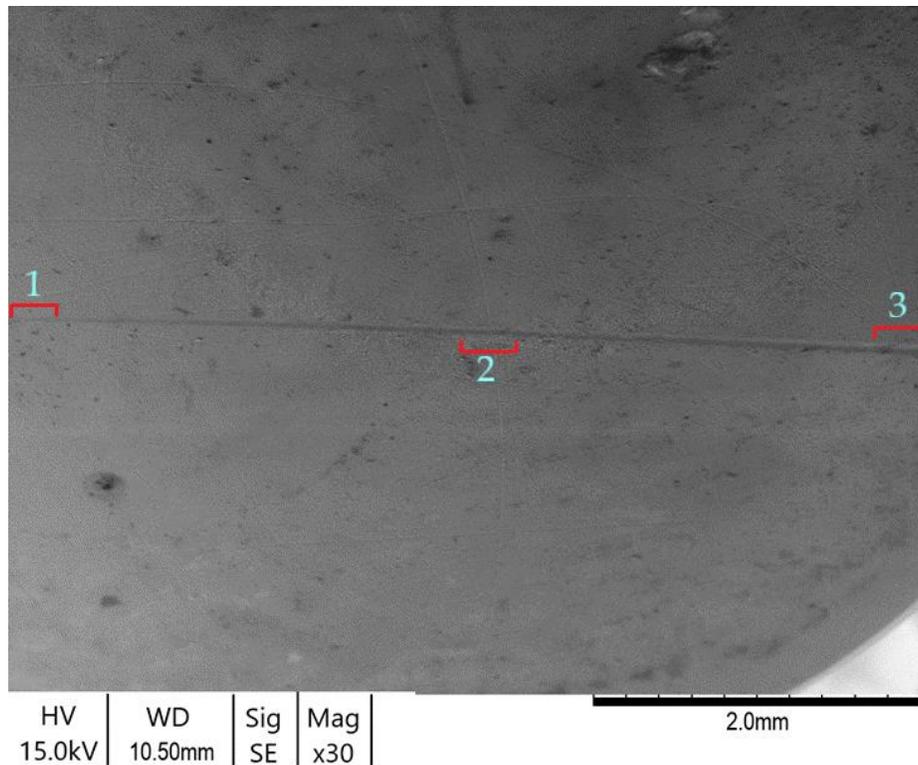
Figure 6.8. Coating B scratch Position 1, 2, 3, at x30 magnification.

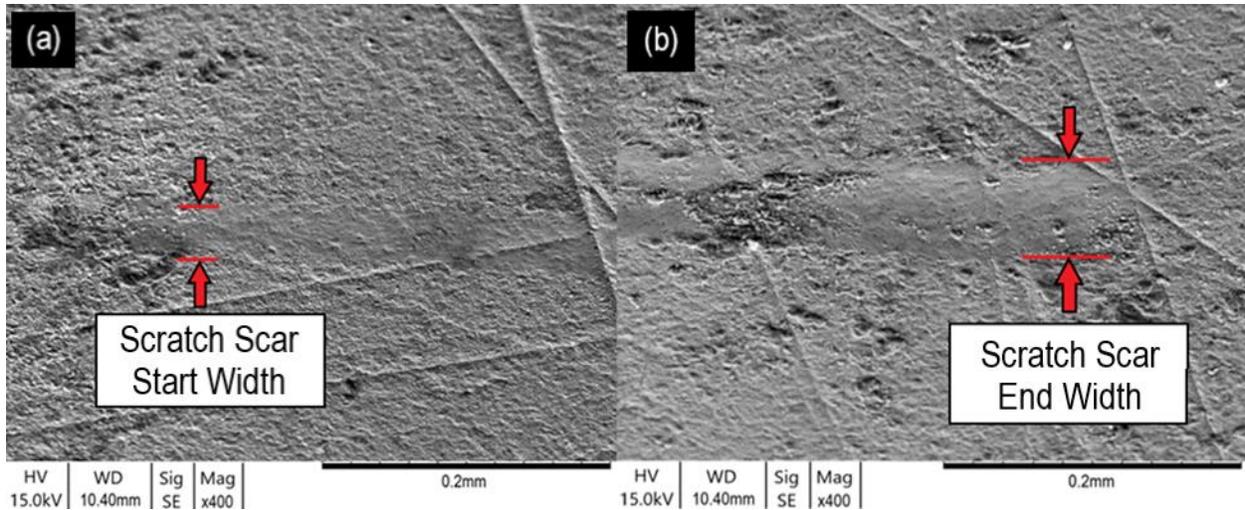
Figure 6.10. (a) Coating B scratch Position 1, (b) Coating B scratch Position 3, at x400 magnification.

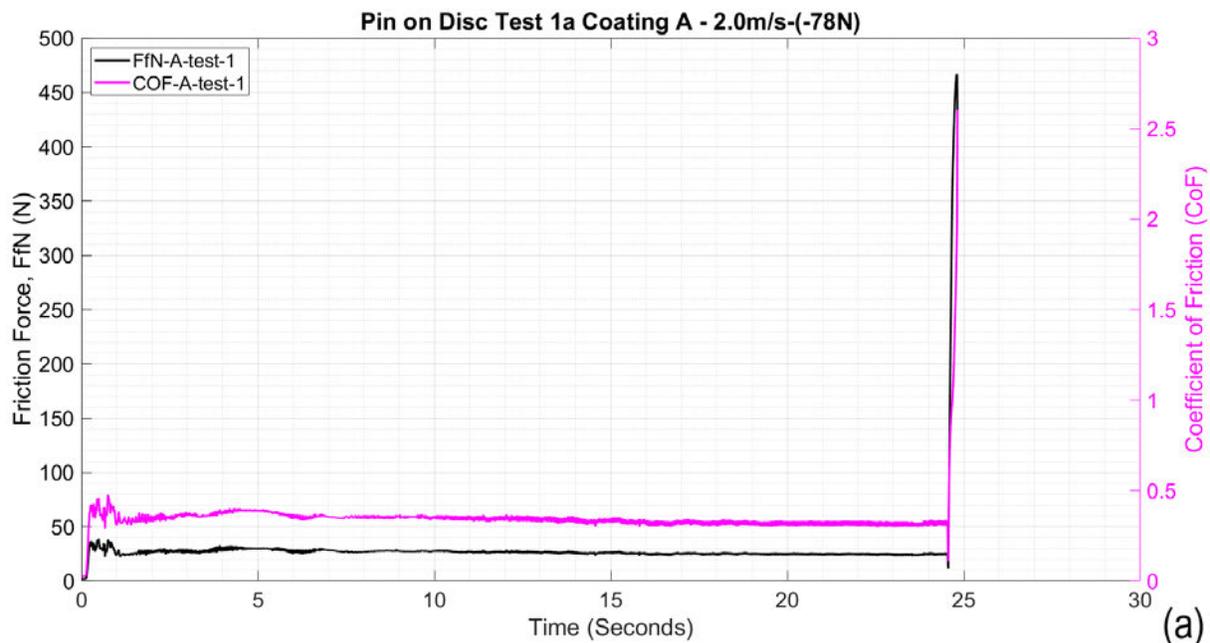
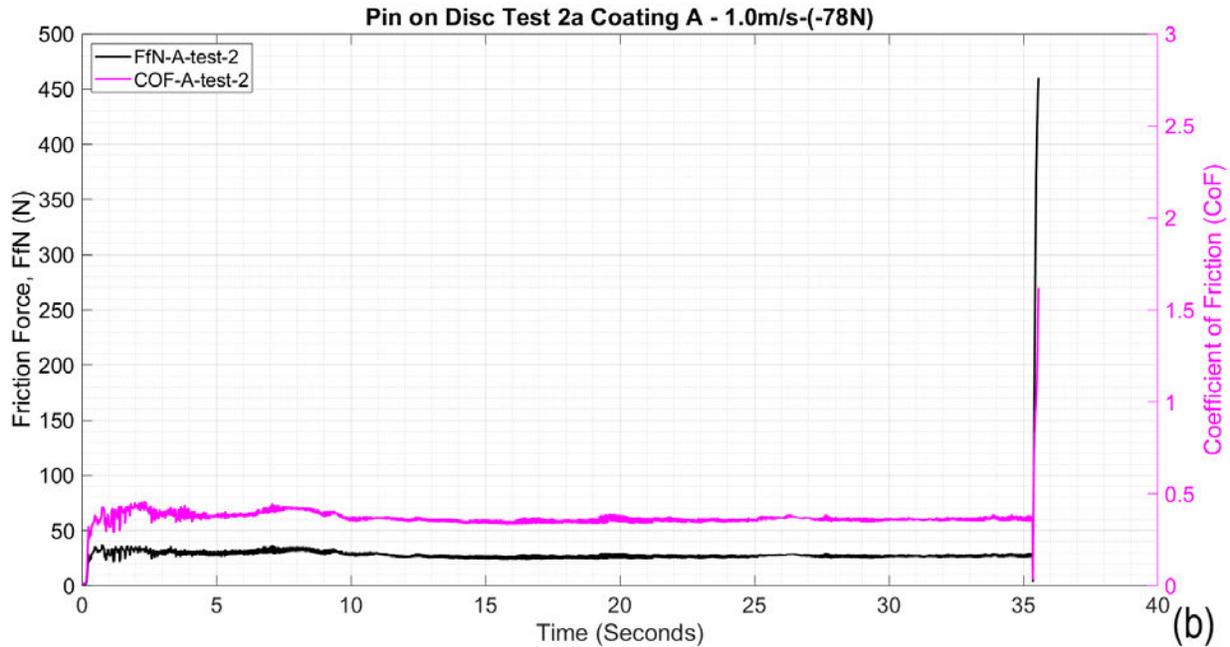
Figure 6.12. Friction coefficient plot vs. time (seconds) vs. friction force (N): (a) Test 1a and (b) Test 2a for Coating A.

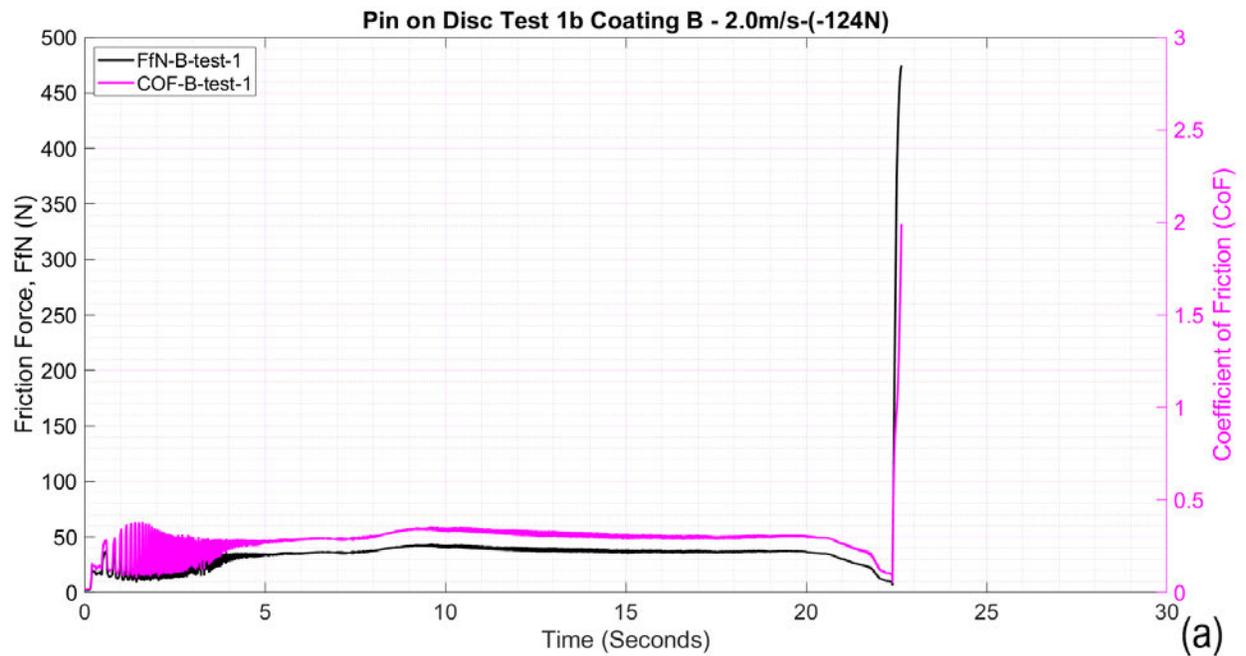
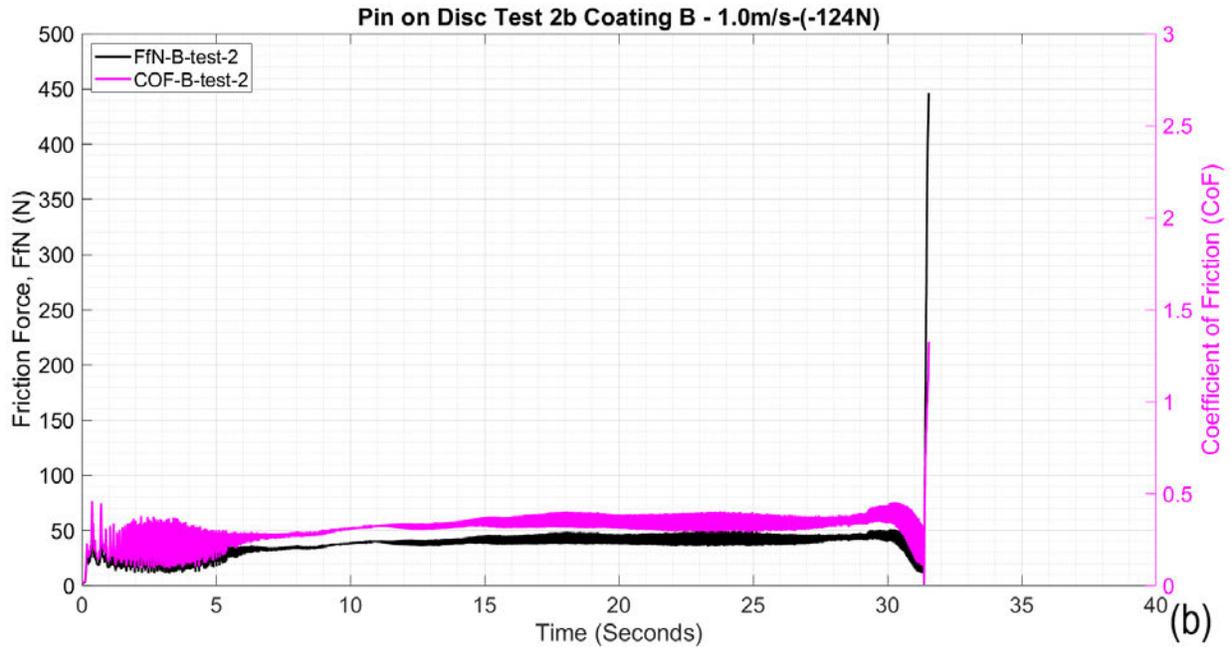
Figure 6.13. Friction coefficient plot vs. time (seconds) vs. friction force (N): (a) Test 1b and (b) Test 2b for Coating B.

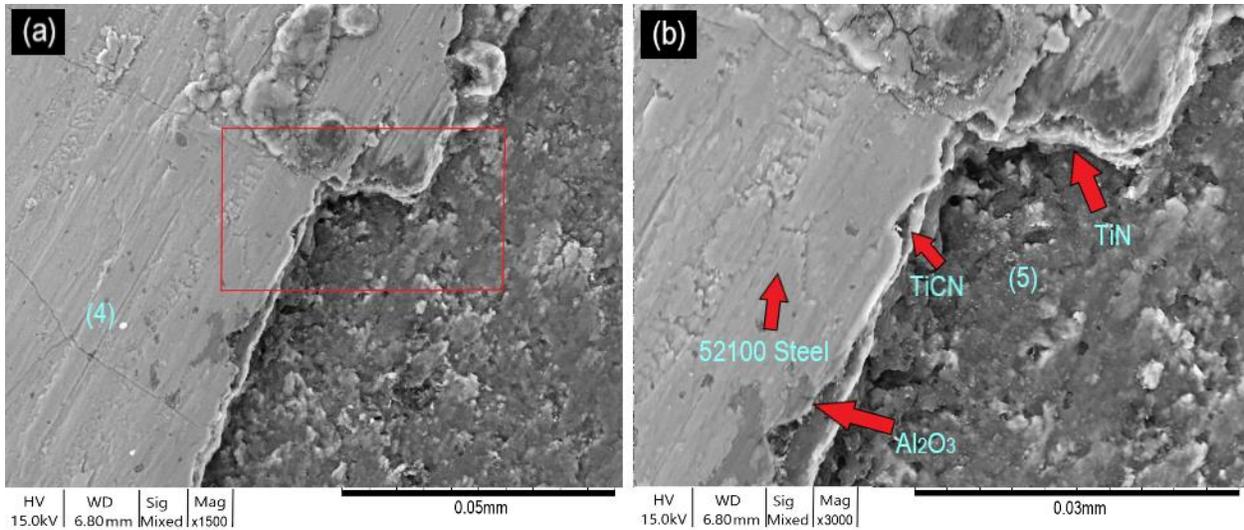
Figure 6.16. SEM images of Coating A after pin-on-disc Test 1a, (a) x1500 magnification, (b) x3000 magnification.

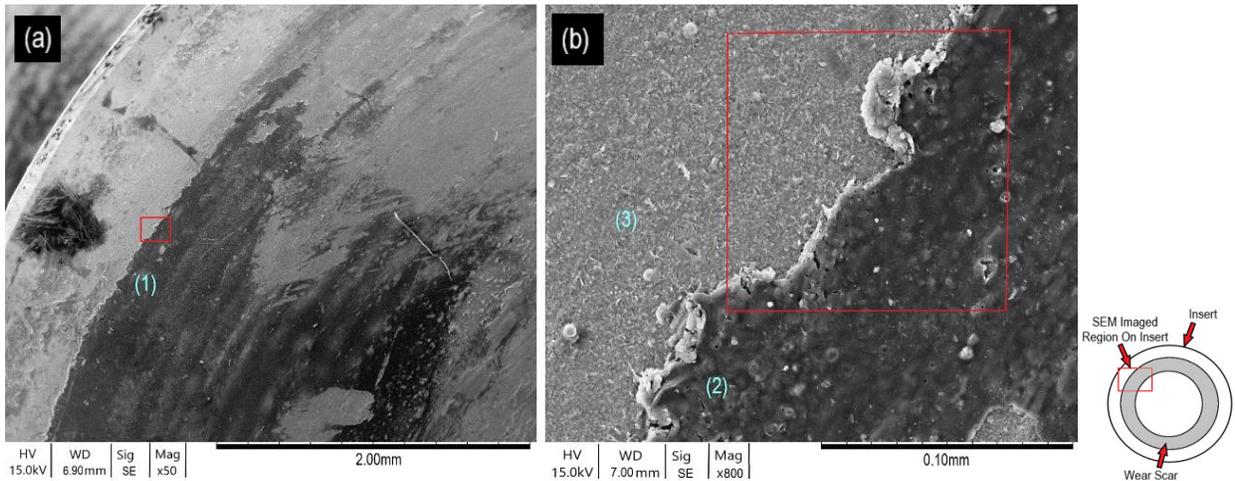
Figure 6.17. SEM images of Coating B after pin-on-disc Test 1b, (a) x50 magnification, (b) x800 magnification.

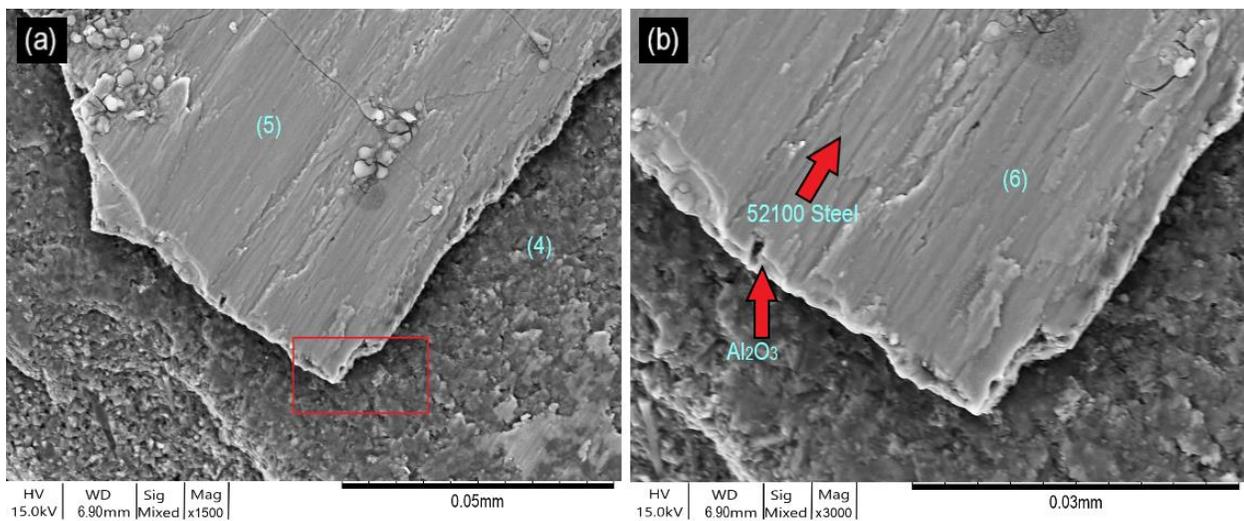
Figure 6.20. SEM images of Coating A after pin-on-disc Test 2a, (a) x1500 magnification, (b) x3000 magnification.

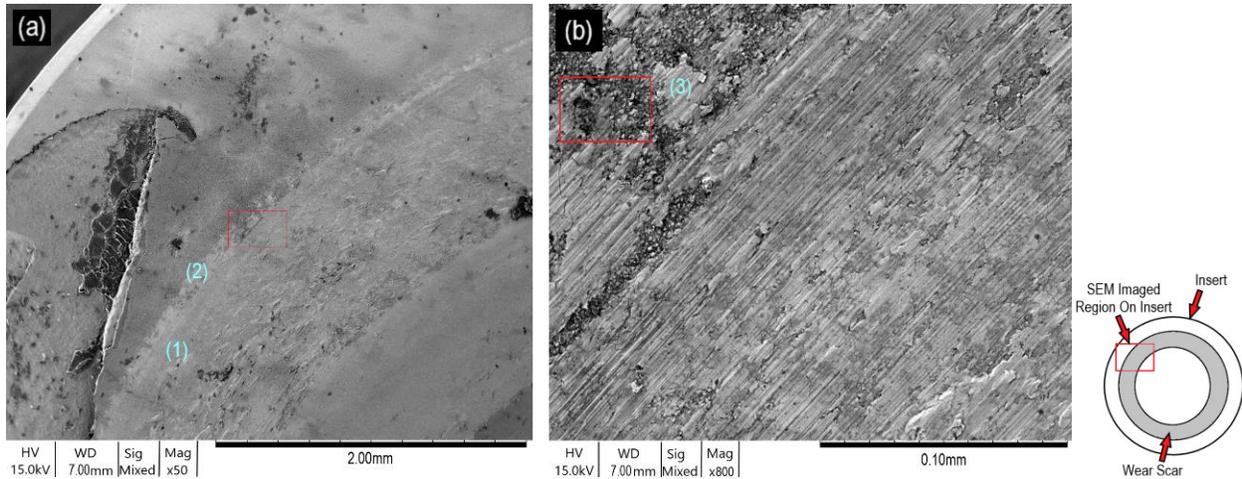
Figure 6.21. SEM images of Coating B after pin-on-disc Test 2b, (a) x50 magnification, (b) x800 magnification.

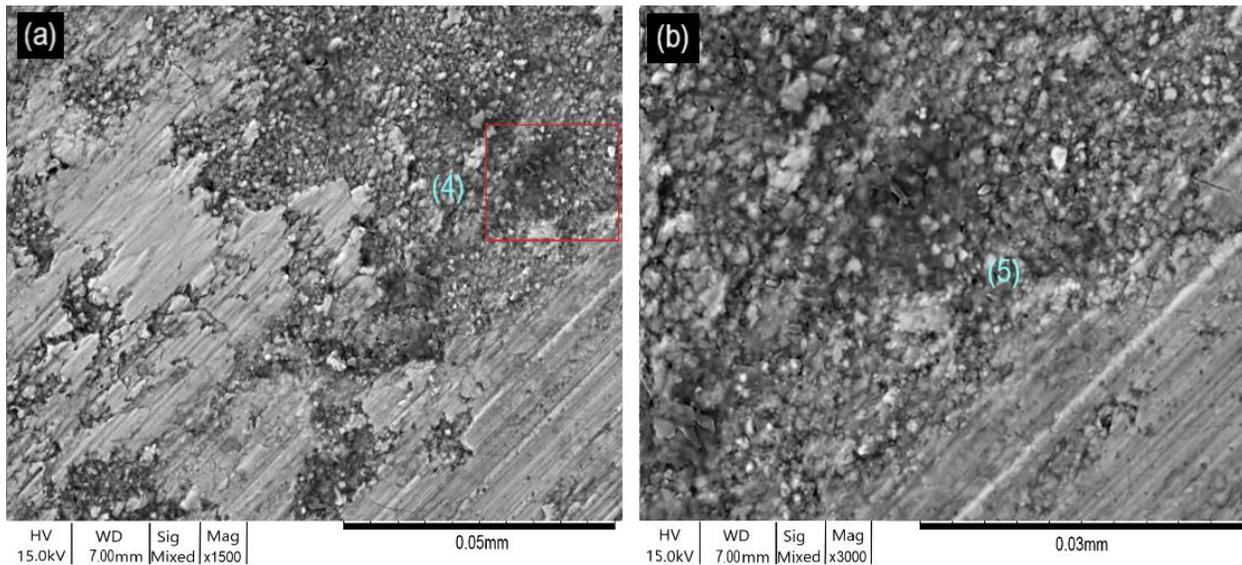
Figure 6.22. SEM images of Coating B after pin-on-disc Test 2b, (a) x1500 magnification, (b) x3000 magnification.

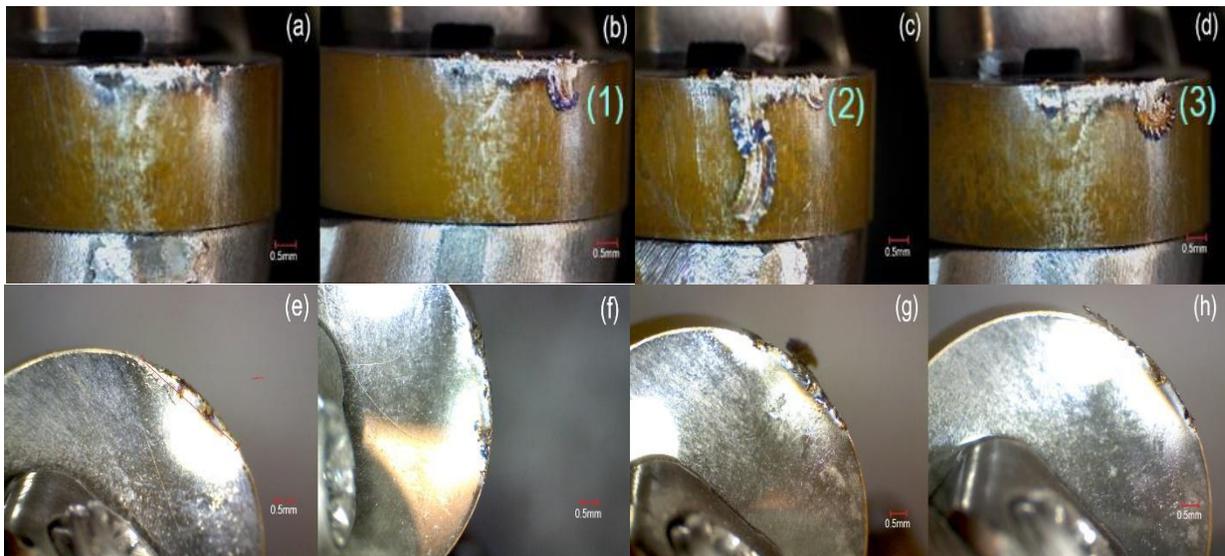
Figure 7.1. Test No M14-Bar Section-2.1-insert-Coating-C-insert-1-4 (a-d) flank face & Insert-1-4 (e-h) rake face.

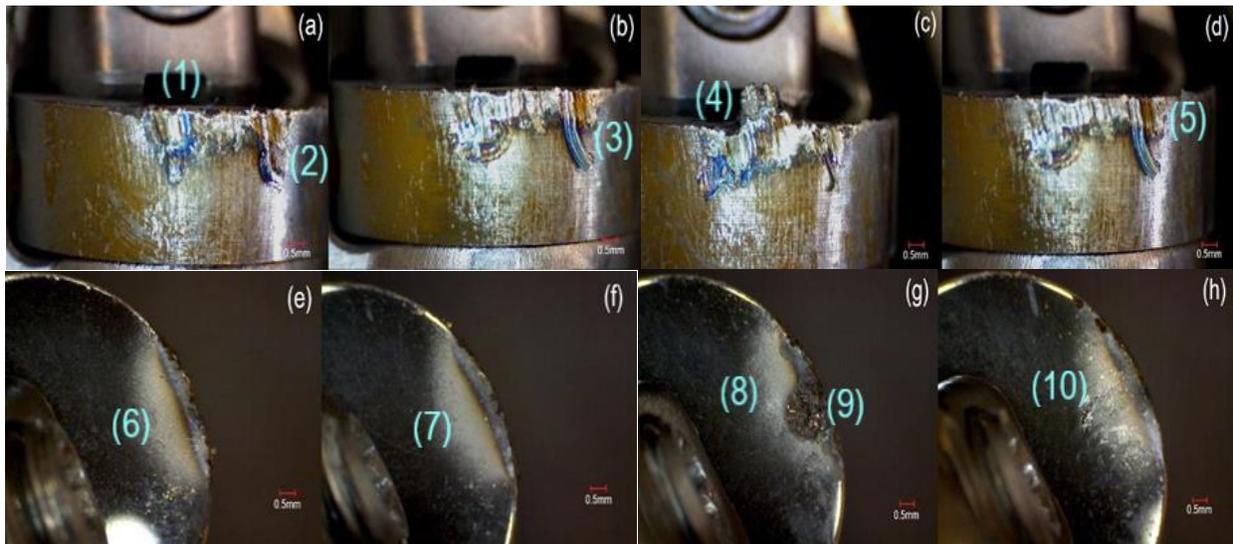
Figure 7.2. Test No M14-Bar Section-2.2-insert-Coating-C-insert-1-4 (a-d) flank face & Insert-1-4 (e-h) rake face.

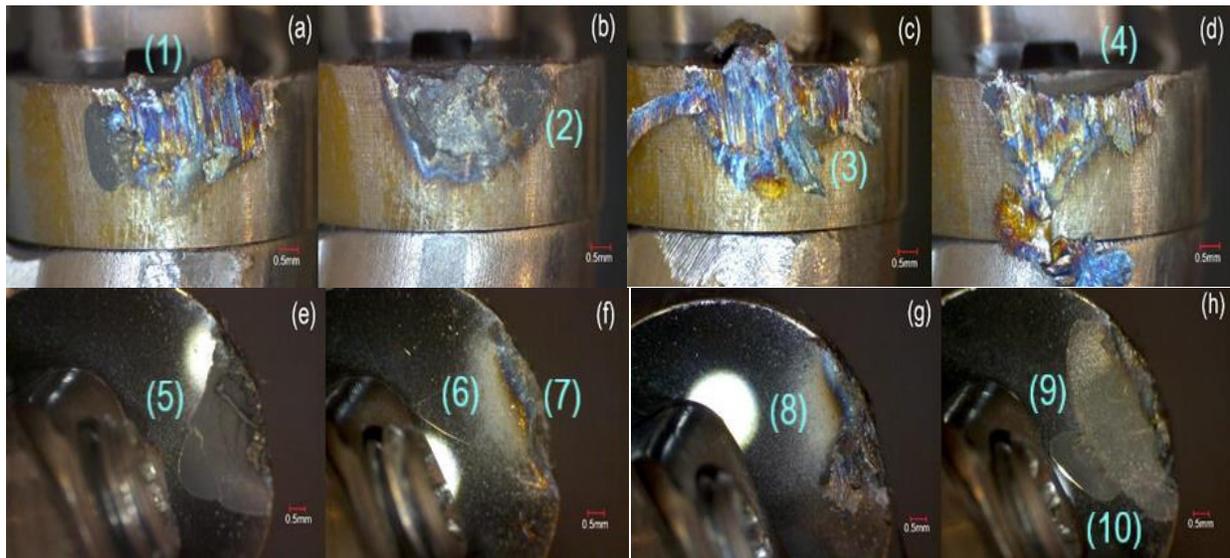
Figure 7.3. Test No M14-Bar Section-2.3-insert-Coating-C-insert-1-4 (a-d) flank face & Insert-1-4 (e-h) rake face.

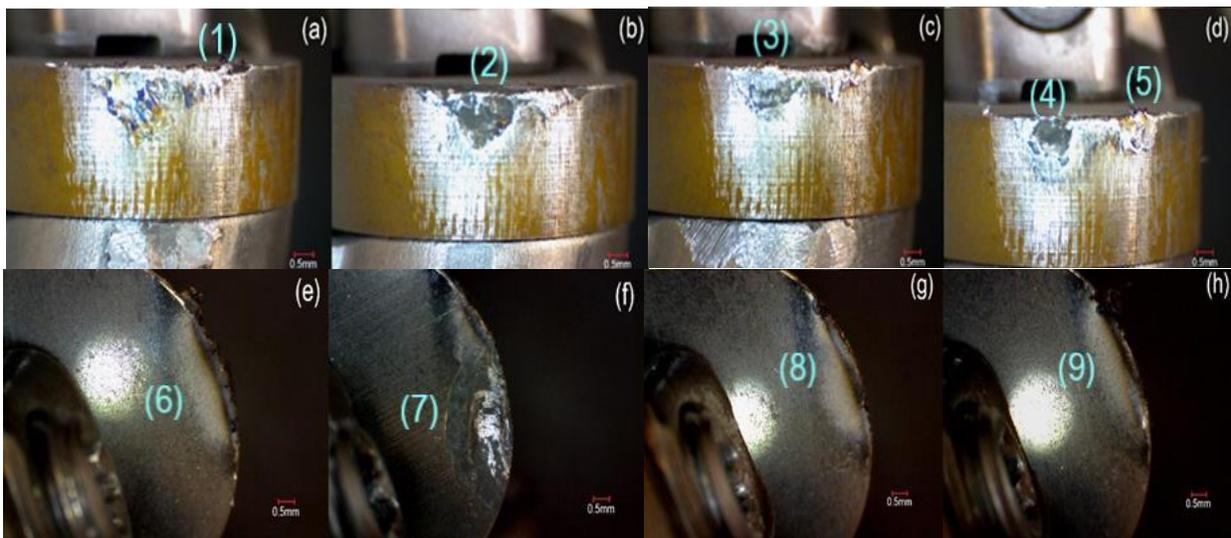
Figure 7.4. Test No M15-Bar Section-3.1-insert-Coating-C-insert-1-4 (a-d) flank face & Insert-1-4 (e-h) rake face.

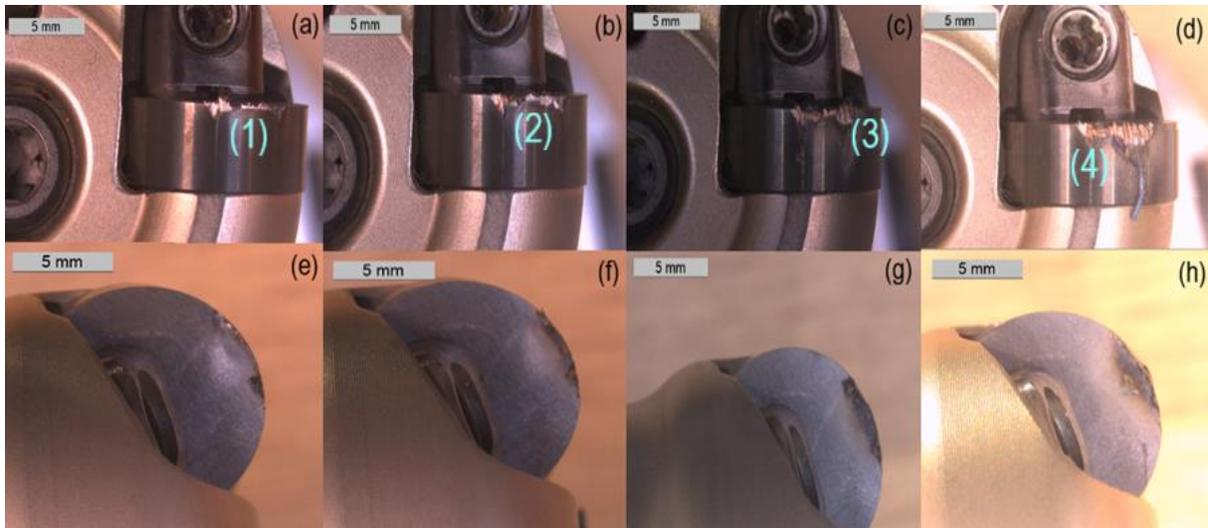
Figure 7.5. 840 m/min-test 16A-Stage-1-4-insert-uncoated-insert-1.3-edge-1.1 (a-d) flank face & Insert-1.3-edge-1.1 (e-h) rake face. Total material removed after four cuts 218857.3 mm³.

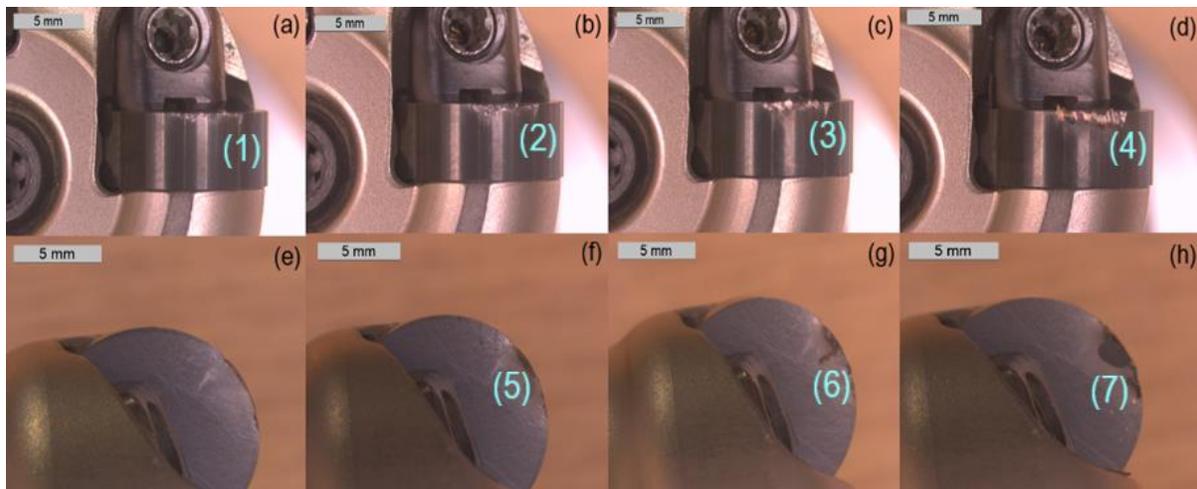
Figure 7.6. 840 m/min-test 16A-Stage-5-8-insert-uncoated-insert-2.4-edge-2.1 (a-d) flank face & Insert-1.4-edge-2.1 (e-h) rake face. Total material removed after eight cuts 347244.6 mm³.

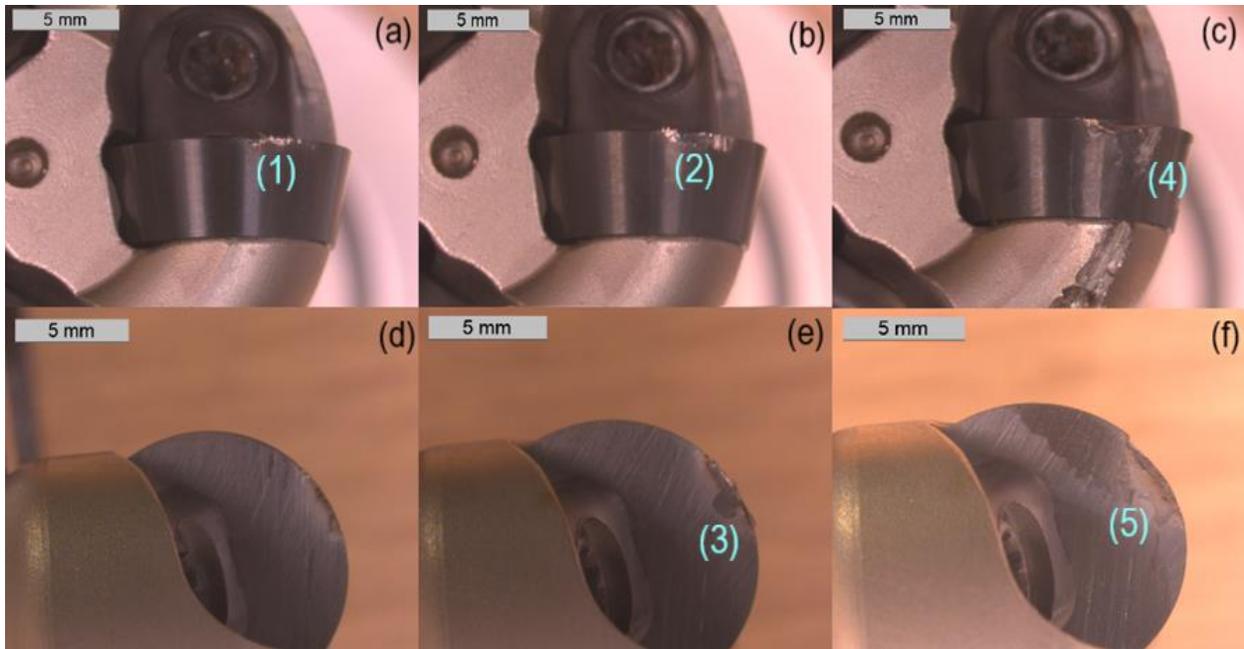
Figure 7.7. 880 m/min-test 16B-Stage-9-11-insert-uncoated-insert-1.1-edge-1.1 (a-d) flank face & Insert-1.1-edge-1.1 (e-h) rake face. Total material removed after Three cuts 31610.2 mm³.

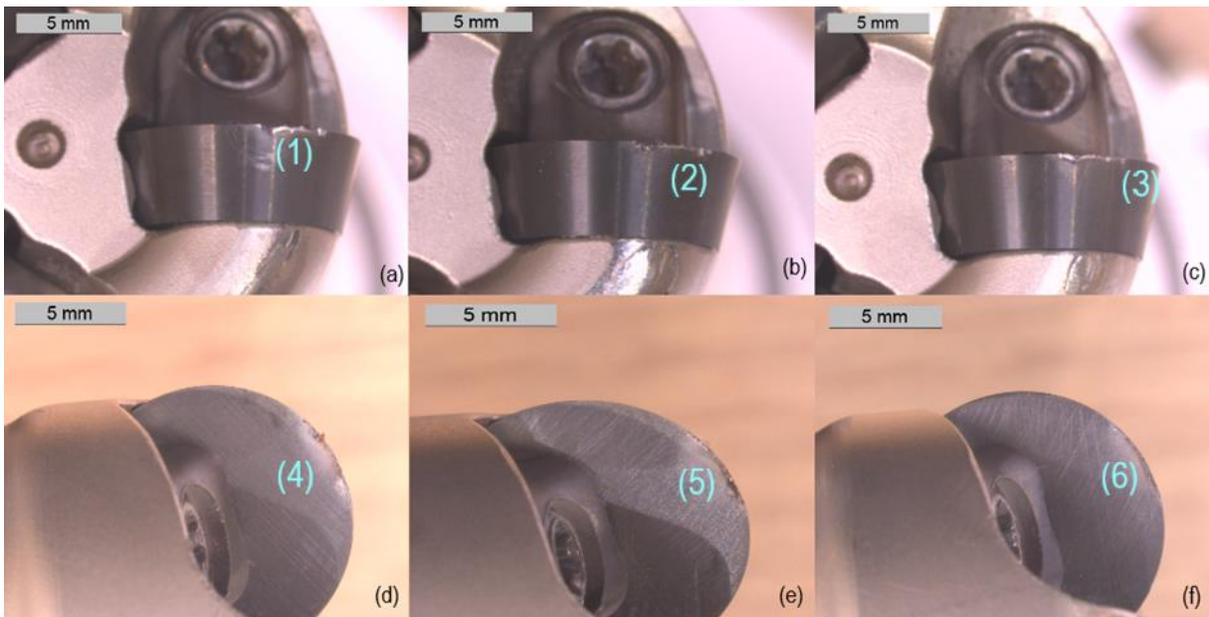
Figure 7.8. 880 m/min-test 16B-Stage-12-insert-uncoated-insert-2.1-2.3-edge-2.1 (a-c) flank face & Insert-2.1-2.3-edge-2.1 (d-f) rake face. Material removed for this cut 6936.2 mm³. Total material removed in after four cuts 38546.5 mm³.

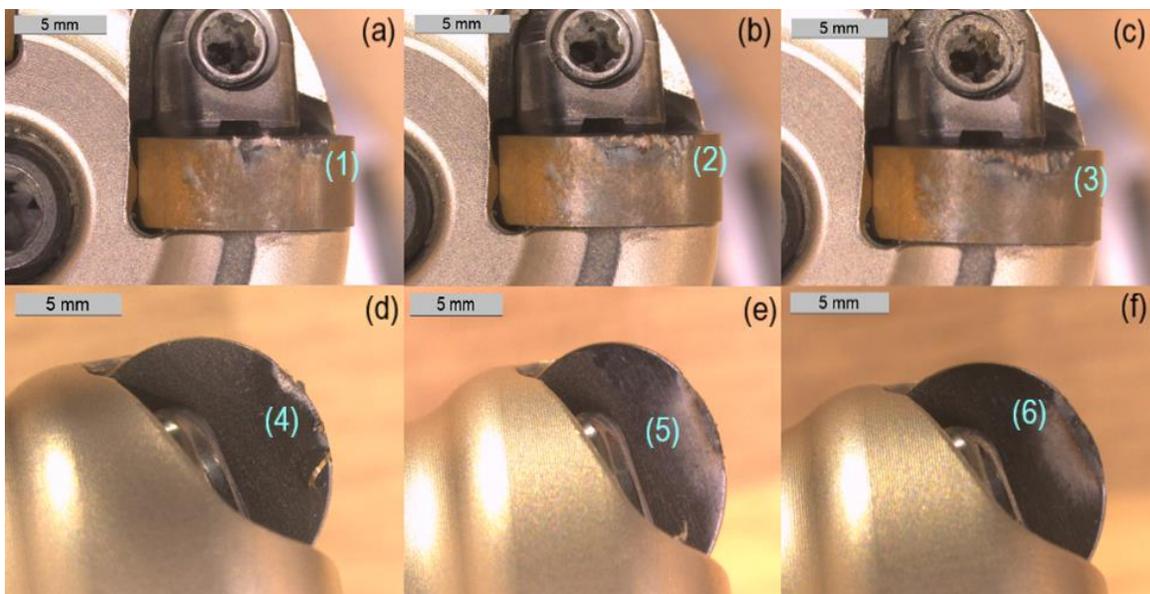
Figure 7.9. 840 m/min-test 17A-Stage-1-3-insert-uncoated-insert-1.1-edge-1.1 (a-c) flank face & Insert-1.1-edge-1.1 (d-f) rake face. Total material removed after three cuts 173631 mm³.

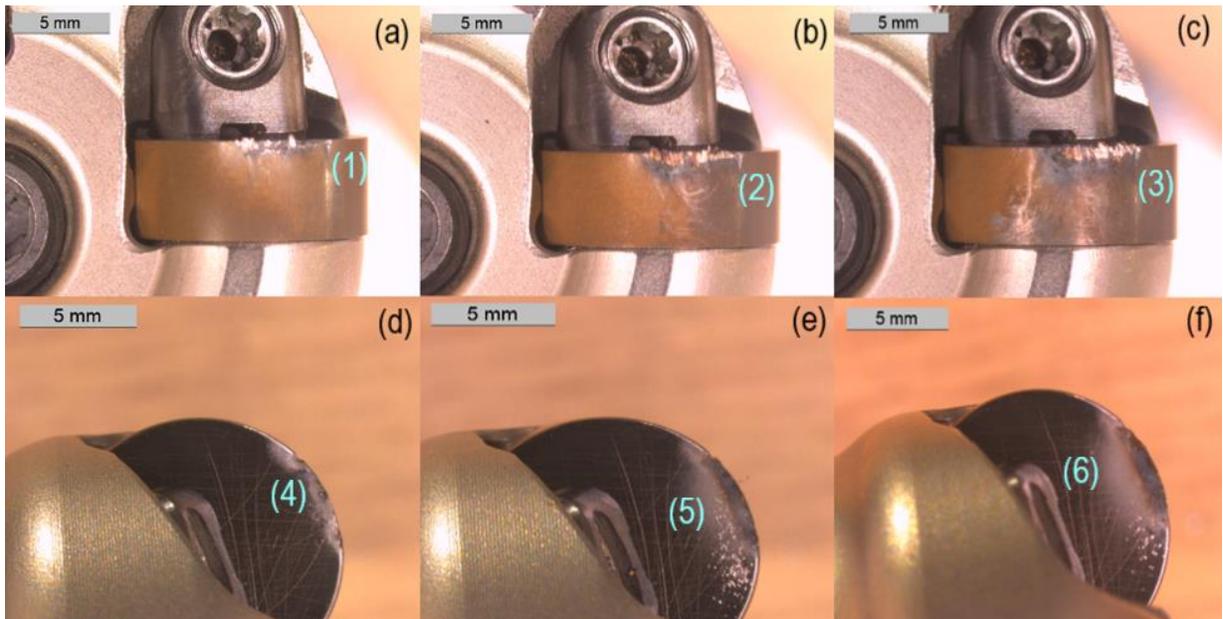
Figure 7.10. 840 m/min-test 17A-Stage-4-6-insert-uncoated-insert-2.1-edge-1.1 (a-c) flank face & Insert-2.1-edge-1.1 (d-f) rake face. Total material removed after six cuts 258456.8 mm³.

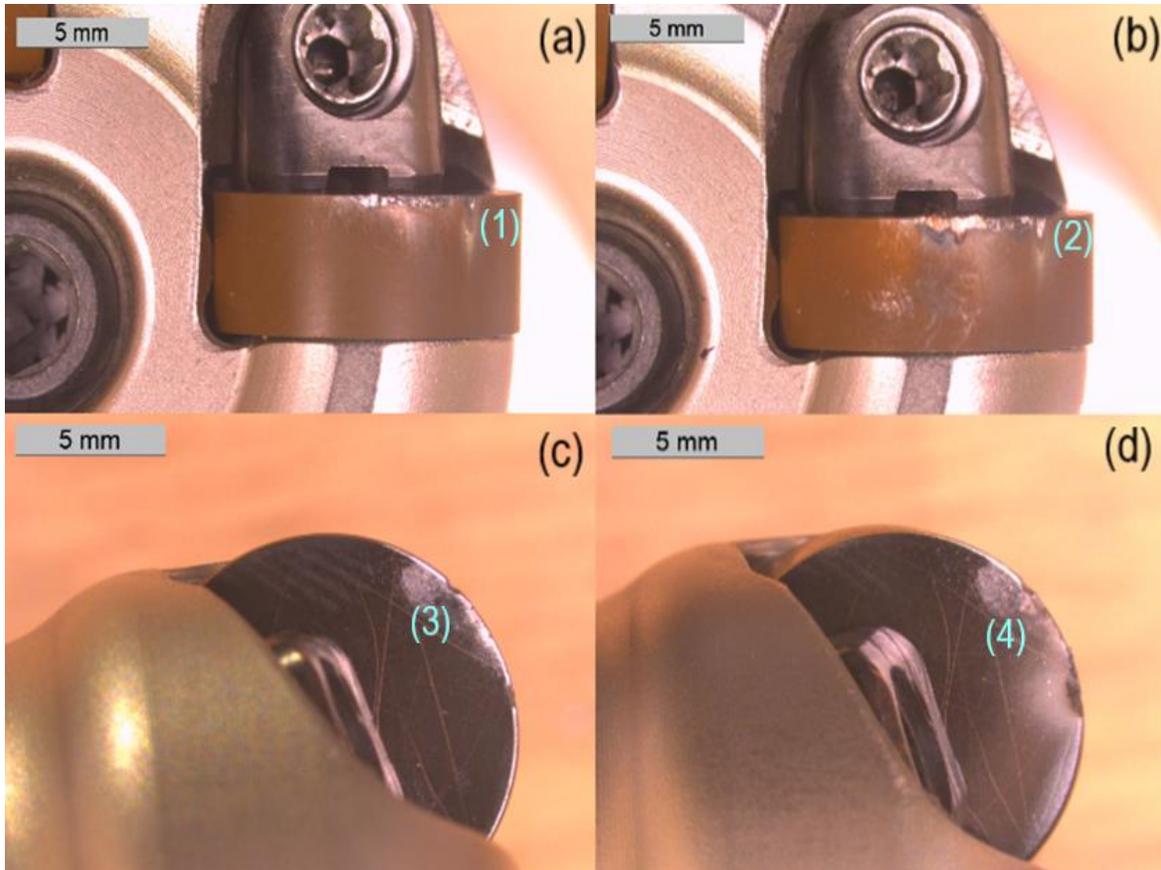
Figure 7.11. 840 m/min-test 17A-Stage-7-8-insert-uncoated-insert-1.4-edge-3.1 (a-d) flank face & Insert-1.4-edge-3.1 (e-h) rake face. Total material removed after eight cuts 347244.6 mm³.
